**Flood Control Project Maintenance
Levee Inspections**

Maintenance Issue Types Only, Levee Inspection Report By Mile - Fall 2020

Reclamation District No. 0784 Plumas Lake

Waterway	Bank	Unit Miles	Inspection Start/End	Inspector
Unit No. 01 Yuba River	Left	2.21	10/27/2020 10/27/2020	Brooks Weisser

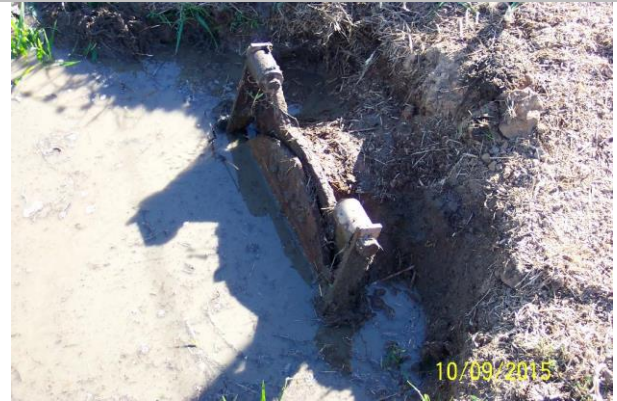
Photo 3 of 3 : UCIP_FA_2020_61757_74710.jpg

Comment Code						
Inspector Comment						
DS_ID:18593 FS_ID:61757 EP_NO: N/A Repair Type: Non-Urgent EVAL Issue: Crossing Status: Found UCIP Comments: 02/01/2019 - An attempt was made to video inspect this pipe crossing on 8-15-2018 but conditions were too muddy inside the pipe. (P. Meagher - RD784)11/14/2016 - Photos added of exposed flap gate on WS and possible inlet location on LS. Condition remains as Non-Urgent because of inlet not being fully operable. Unknown if pipe will operate as designed during high water or if it is full of sediment. (P. Meagher - RD784)11/01/2015 - Waterside Flap Gate Uncovered. Photo sent to DWR Matt Hoffman on 3-3-2014. Fresh photo sent to DWR Pavel Kazi on 9-9-2015. Landside toe has never been able to be located. Requesting DWR inspector to change the status of this issue to "No Action Needed". (P. Meagher - RD784).02/26/2013 - Pipe buried on LS toe and flap gate is blocked by soil on WS toe. (W. Wylie - DWR UCIP). FIELD_STRUCT_DESC: 18-inch corrugated metal drainage pipe through the levee, 10 feet below the crown. Flap gate on the waterside (WS) end. [Additional Reference(s): DWR Levee Log, 2005 (HLM 3.98), listed as an 18-inch pipe. USACE Sacramento O&M Manual, Unit No. 145, August 1955, Revised 6 Aug 2019, (Station 91+50)]. FS Date: 10/9/2015

LM Start	3.96	Rating **	M	Issue No.	20 (cont)
LM End	3.96	Issue Type +	Ma	Location *	
Category	Supplemental			GPS Latitude/Longitude	
				Start	End
Item	DWR UCIP LMA Responsibility			39.019787 °	39.019787 °
				-121.513386 °	-121.513386 °
DWR ID	18593
