**Flood Control Project Maintenance  
Levee Inspections**

## Maintenance Issue Types Only, Levee Inspection Report By Mile - Fall 2024

### Reclamation District No. 0784 Plumas Lake

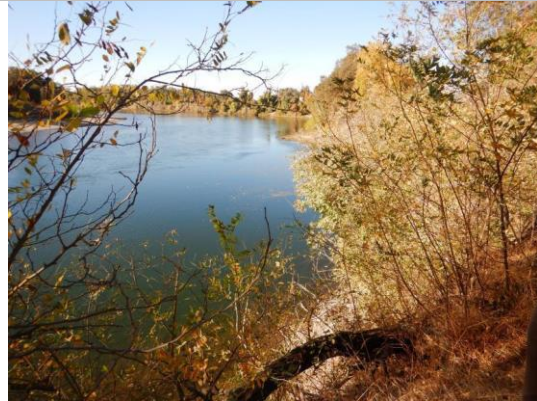
Photo 1 of 2 : FA\_2024\_RD0784\_532\_1\_20240829\_00001.jpg

USACE 2018 Erosion Photo #1

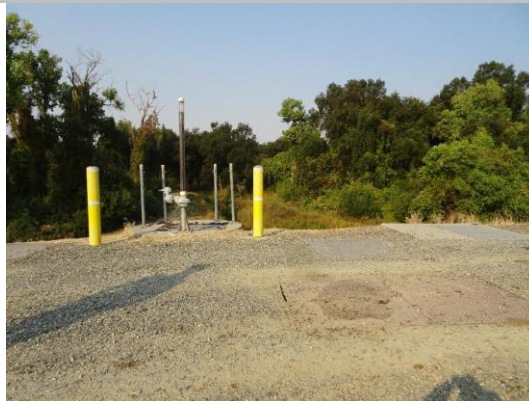
Photo 2 of 3 : UCIP\_FA\_2024\_69859\_101133.jpg

Water-Side: Vaults and screw gate at waterside shoulder.

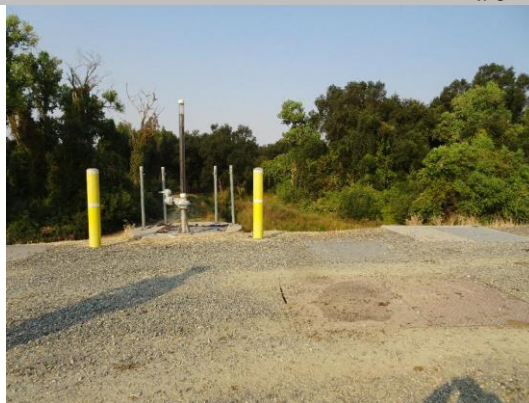
Photo 2 of 3 : UCIP\_FA\_2024\_69855\_101156.jpg

Water-Side: Vaults and screw gate at waterside shoulder.

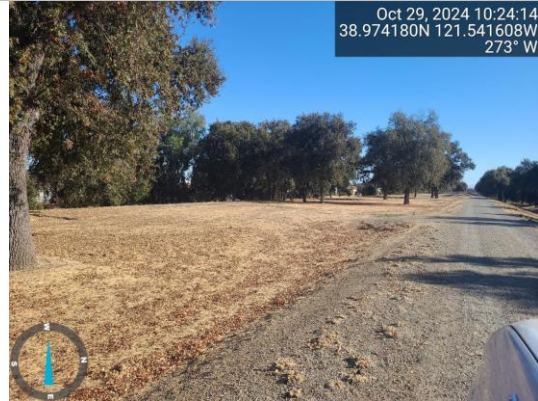
Photo 1 of 1 : FA\_2024\_RD0784\_533\_8\_20241031\_00022.jpg

LM Start	2.44	Rating **	A	Issue No.	8
LM End	3.20	Issue Type +	Ma	Location *	LS
Category	Earthen Levee			GPS Latitude/Longitude	
				Start	End
Item	Vegetation			38.970685°	38.974679°
				-121.547513°	-121.535269°
DWR ID	DWR_RD0784_03A_f_2024_8				
Comment Code					
V1 : Control annual grass and weeds on the levee slopes and easements.					
Inspector Comment					
Annual vegetation is well maintained, Fall 2024.

View of maintained vegetation on the landside slope, Fall 2024.

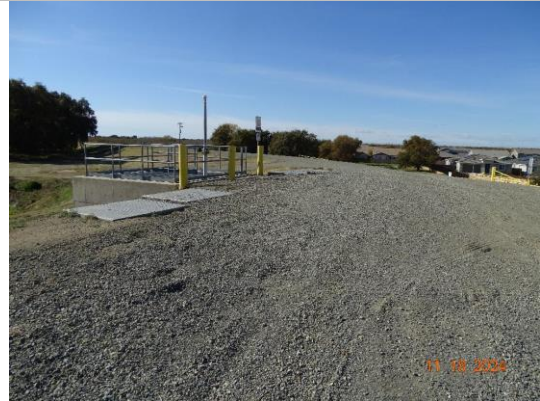
Photo 1 of 3 : UCIP\_FA\_2024\_85290\_126522.jpg

DS\_ID:18675  
FS\_ID:85290  
EP\_NO: 18090  
Repair Type: No Action Needed  
EVAL Issue:  
Crossing Status: Found  
UCIP Comments: 11/18/2024 Record remains No Action Needed. No issues observed during inspection. (M. Thao - DWR UCIP)  
09/29/2020 Record remains No Action Needed. No issues were observed during site inspection. (O. Magana - DWR UCIP)  
FIELD\_STRUCT\_DESC: 1 of 5: 42-inch concrete encased steel drainage pipe through the levee, 2.0 feet below the crown. Reinforced concrete (RC) cap through the levee crown. Siphon breaker and air release valve inside a vault on the waterside (WS) shoulder. (Four existing 42-inch high-density polyethylene [HDPE] discharge pipes, construct an 8-inch-thick concrete cap over the discharge pipes within the levee crown, and placing about 20 linear feet of riprap within the pumping plant discharge channel authorized under Permit No. 18090, 2006 - Three Rivers Levee Improvement Authority).

Levee crown looking downstream.

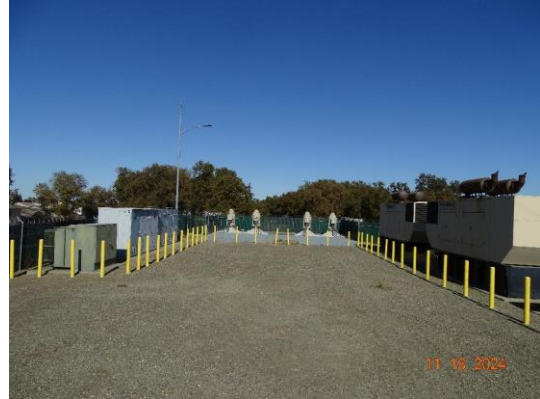
Photo 3 of 3 : UCIP\_FA\_2024\_85290\_126525.jpg

LS view: Pump station located approximately 100 feet from levee centerline; looking over fence.

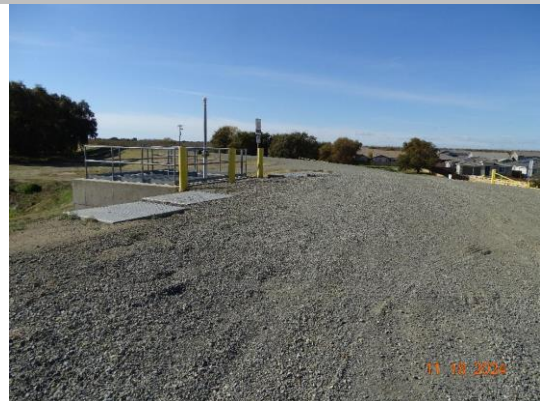
Photo 1 of 3 : UCIP\_FA\_2024\_85294\_126536.jpg

DS\_ID:18676  
FS\_ID:85294  
EP\_NO: 18090  
Repair Type: No Action Needed  
EVAL Issue:  
Crossing Status: Found  
UCIP Comments: 11/18/2024 Record remains No Action Needed. No issues observed during inspection. (M. Thao - DWR UCIP)  
09/29/2020 Record remains No Action Needed. No issues were observed during site inspection. (O. Magana - DWR UCIP)  
FIELD\_STRUCT\_DESC: 2 of 5: 42-inch concrete encased steel drainage pipe through the levee, 2.0 feet below the crown. Reinforced concrete (RC) cap through the levee crown. Siphon breaker and air release valve inside a vault on the waterside (WS) shoulder. (Four existing 42-inch high-density polyethylene [HDPE] discharge pipes, construct an 8-inch-thick concrete cap over the discharge pipes within the levee crown, and placing about 20 linear feet of riprap within the pumping plant discharge channel authorized under Permit No. 18090, 2006 - Three Rivers Levee Improvement Authority).

Levee crown looking downstream.

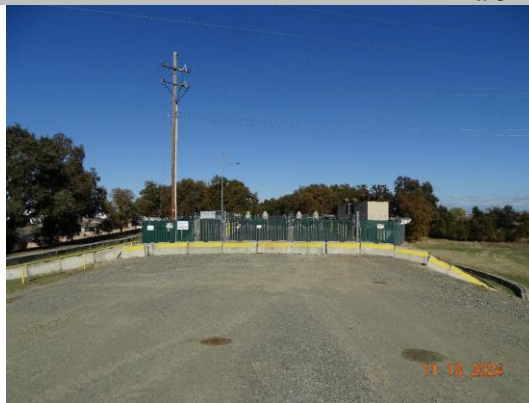
Photo 2 of 3 : UCIP\_FA\_2024\_85294\_126538.jpg

LS view: Pump station located approximately 100 feet from levee centerline.

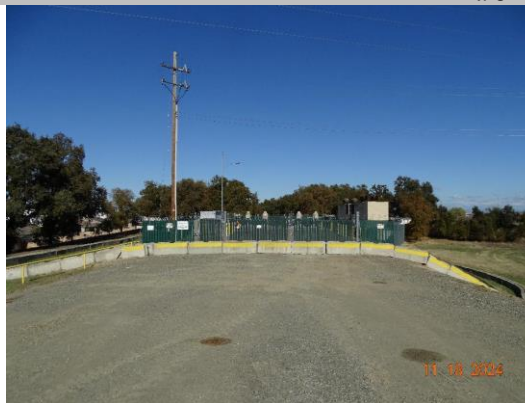
Photo 2 of 3 : UCIP\_FA\_2024\_85296\_126551.jpg

LS view: Pump station located approximately 100 feet from levee centerline.

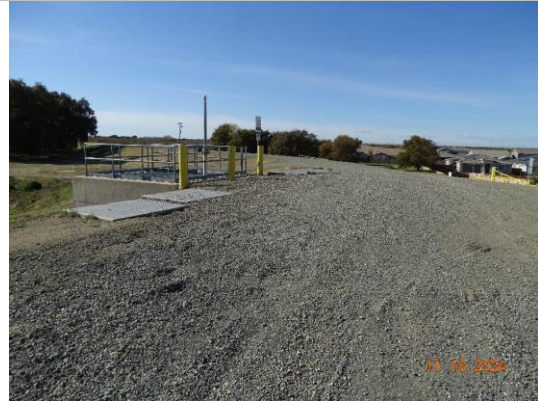
Photo 1 of 3 : UCIP\_FA\_2024\_85297\_126555.jpg

DS\_ID:18679  
FS\_ID:85297  
EP\_NO: 18090  
Repair Type: No Action Needed  
EVAL Issue:  
Crossing Status: Found  
UCIP Comments: 11/18/2024 Record remains No Action Needed. No issues observed during inspection. (M. Thao - DWR UCIP)  
09/29/2020 Record remains No Action Needed. No issues were observed during site inspection. (O. Magana - DWR UCIP)  
FIELD\_STRUCT\_DESC: 5 of 5: 42-inch concrete encased steel drainage pipe through the levee, 2.0 feet below the crown. Reinforced concrete (RC) cap through the levee crown. Siphon breaker and air release valve inside a vault on the waterside (WS) shoulder. (Four existing 42-inch high-density polyethylene [HDPE] discharge pipes, construct an 8-inch-thick concrete cap over the discharge pipes within the levee crown, and placing about 20 linear feet of riprap within the pumping plant discharge channel authorized under Permit No. 18090, 2006 - Three Rivers Levee Improvement Authority).

Levee crown looking downstream.

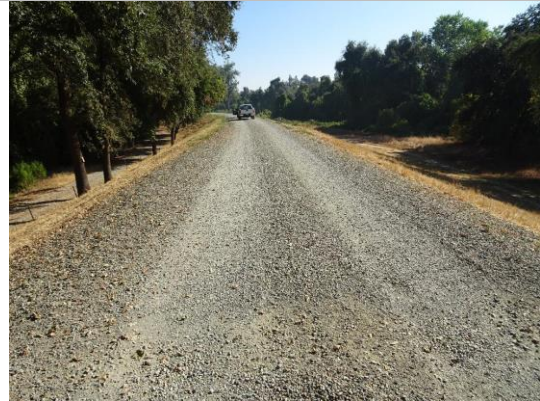
Photo 1 of 3 : UCIP\_FA\_2024\_85176\_101266.jpg

FIELD\_STRUCT\_DESC: 30-inch corrugated metal (CM) drainage pipe through the levee, 19.0 feet below the crown. Flap gate on the waterside (WS) end. Concrete headwall at the WS toe. (No permit found for this crossing. Owner unknown). [Additional Reference(s): DWR Levee Log, 2005, (HLM 3.56). USACE Sacramento O&M Manual, Unit No. 145, August 1955, Revised 6 August 2019, (Station 92+88)].  
FS Date: 10/5/2020

Overview of Levee: Looking upstream from crown.

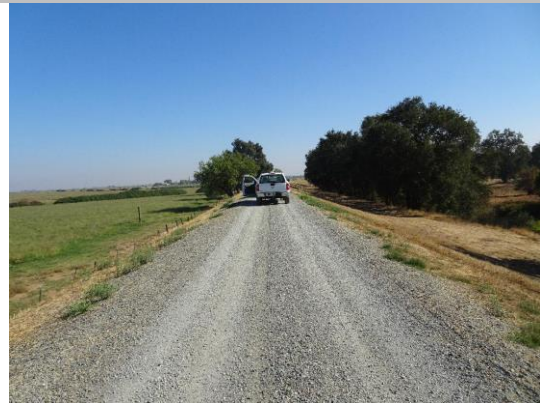
Photo 1 of 3 : UCIP\_FA\_2024\_69908\_101278.jpg

Overview of Levee: Looking upstream from crown.

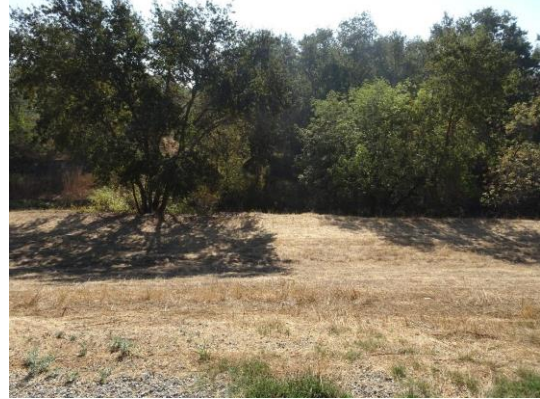
Photo 2 of 3 : UCIP\_FA\_2024\_69908\_101280.jpg

Water-Side: View of waterside looking from crown.

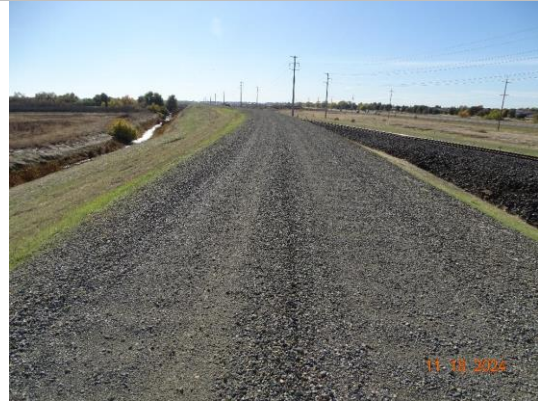
Photo 1 of 3 : UCIP\_FA\_2024\_85275\_126454.jpg

Levee crown looking downstream.

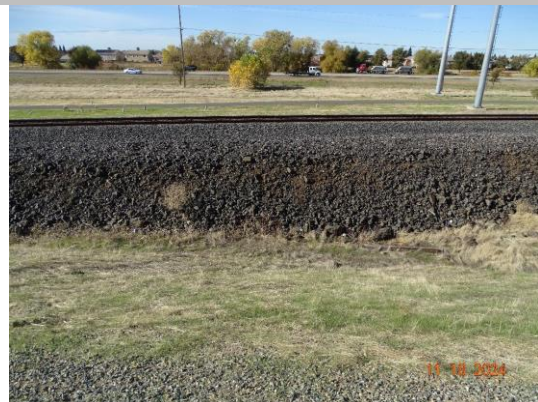
Photo 2 of 3 : UCIP\_FA\_2024\_85275\_126455.jpg

LS view: General overview looking from crown.

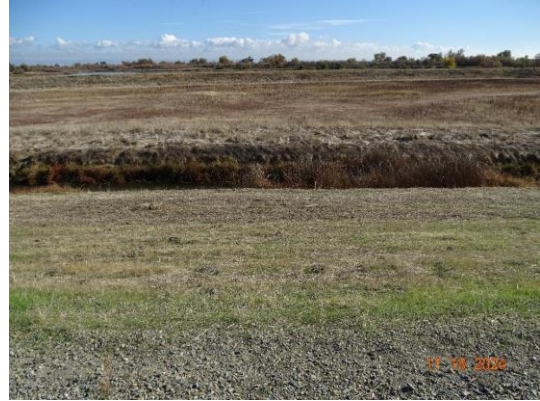
Photo 3 of 3 : UCIP\_FA\_2024\_85275\_126453.jpg

WS view: General overview looking from crown.

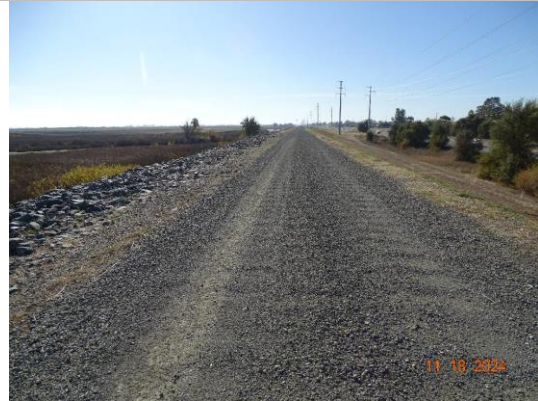
Photo 1 of 3 : UCIP\_FA\_2024\_85279\_126465.jpg

Comment Code						
Inspector Comment						
DS_ID:18628 FS_ID:85279 EP_NO: N/A Repair Type: Non-Urgent EVAL Issue: Crossing Status: Not Found UCIP Comments: 11/18/2024 Record remains Non-Urgent. Crossing not found. Geophysical results did not confirm presence of pipe through levee. Record will remain in UCIP's inspection records until future Levee Improvement Project can confirm no crossing was found through the levee. No issues observed during inspection. (M. Thao - DWR UCIP) 09/29/2020 Record has been updated from No Action Needed to Non-Urgent. DWR DMP geophysical study found no positive signal of pipe at latitude, longitude 38.046633, -121.542399. No signs or evidence of pipe were found during the site inspection. No permit was found authorizing this encroachment. CVFPB will need to review crossing to determine owner. Record will remain in UCIP's database and will remain active until a levee improvement project can confirm that this crossing has been removed from the levee. (O. Magana - DWR UCIP)  02/26/2013 Unable to locate. Likely abandoned with levee improvements. (W. Wylie - DWR UCIP) FIELD_STRUCT_DESC: 24-inch corrugated metal drainage pipe through the levee, 21.0 feet below the crown. [Additional Reference(s): USACE Sacramento O&M Manual, Unit No. 145, August 1955, Revised 6 August 2019, (Station 264+60). USACE As-Built Drawing No. 2-4-84-1, Sheet 84-1/3, (Station 264+60), September 1941]. FS Date: 11/18/2024 12:09:14 PM

Levee crown looking downstream.

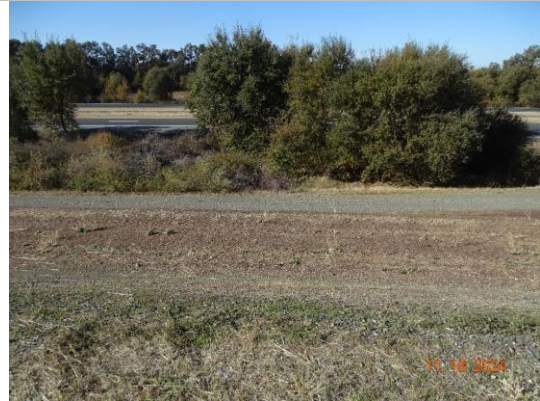
Photo 2 of 3 : UCIP\_FA\_2024\_85279\_126466.jpg

LS view: General overview looking from crown.

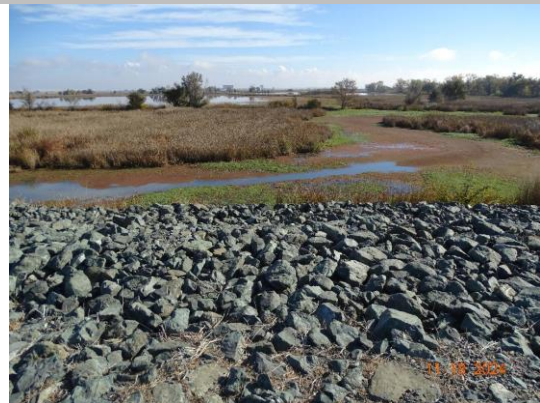
Photo 3 of 3 : UCIP\_FA\_2024\_85279\_126464.jpg

WS view: General overview looking from crown.

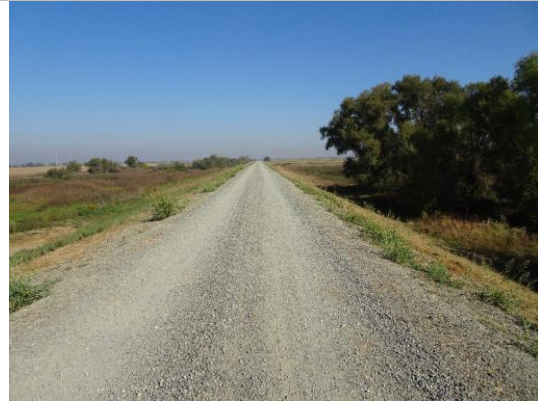
Photo 1 of 3 : UCIP\_FA\_2024\_85178\_100890.jpg

FIELD\_STRUCT\_DESC: 30-inch corrugated metal (CM) drainage pipe through the levee, 23.7 feet below the crown. Flap gate on the waterside (WS) end. Slide gate inside a concrete drop inlet on the landside (LS). (No permit found authorizing this pipe. Owner unknown).  
[Additional Reference(s): DWR Levee Log, 2005, (HLM 0.82). USACE Sacramento O&M Manual, Unit No. 145, August 1955, Revised 6 August 2019, (Station 63+00). USACE As-Built Drawing No. 2-4-106, Sheet No. 106/5, July 1944, (Station 63+00)].  
FS Date: 10/5/2020

Overview of Levee: Looking upstream from crown.

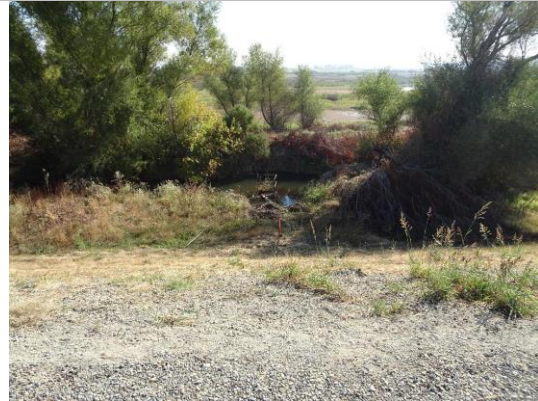
Photo 2 of 3 : UCIP\_FA\_2024\_85178\_100892.jpg

Land-Side: Drop inlet at landside toe.

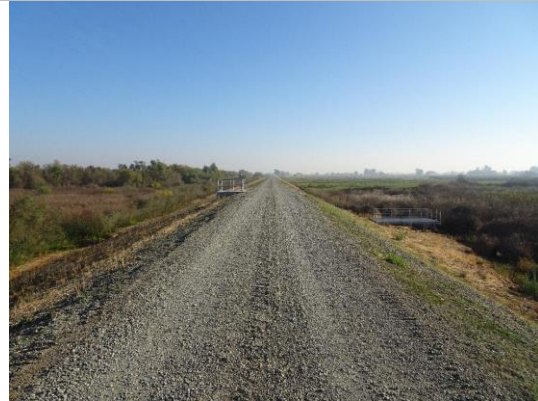
Photo 1 of 3 : UCIP\_FA\_2024\_82831\_100934.jpg

Comment Code						
Inspector Comment						
DS_ID:25591 FS_ID:82831 EP_NO: 12871-1 Repair Type: No Action Needed EVAL Issue: Crossing Status: Found UCIP Comments: 10/05/2020 - Record remains No Action Needed. No issues were found during site inspection. (O. Magana - DWR UCIP)1/10/2020 - Pipe replaces previous 18-inch pipe logged under UCIP dsid 18597. DSID 18597 has been retired. Construction photos of new pipe, courtesy of P. Meagher, have been uploaded to this record. This record will be used to log the maintenance and condition of new 18-inch pipe. Need photos of completed installation. (O. Magana - DWR UCIP) FIELD_STRUCT_DESC: 18-inch corrosion-proof steel storm drain gravity pipe through the levee, 15.5 feet below the crown. Improvements include a new inlet structure with trash rack, outfall structure with an 18-inch diameter automatic drainage gate, riprap apron, and facility markers. This crossing replaces 18-inch pipe (see DSID 18597). (18-inch pipe authorized under Permit No. 12817-1, 2019 - Reclamation District No. 784). [Additional Reference(s): DWR Levee Log, 2005, (HLM 2.47), listed as an 18-inch CMP. USACE Sacramento O&M Manual, Unit No. 145, August 1955, Revised 6 August 2019, (Station 13+72), listed as an 18-inch CMP. USACE As-Built Drawing No. 2-4-106, Sheet No. 106/6, July 1944, (Station 13+72), listed as an 18-inch CMP. Previous 18-inch pipe removed under Permit No. 12817-1 in 2019 (logged under UCIP DSID 18597)]. FS Date: 10/5/2020

Overview of Levee: Looking upstream from crown.

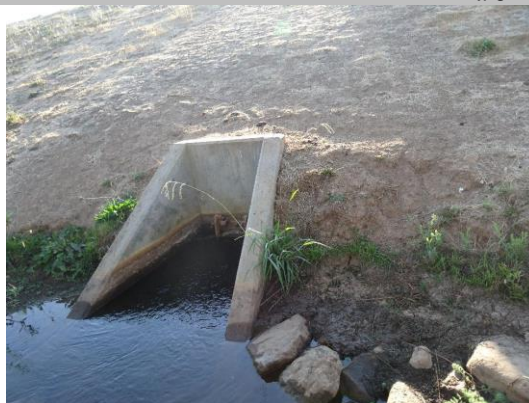
Photo 2 of 3 : UCIP\_FA\_2024\_82831\_100936.jpg

Water-Side: Outlet structure with flap gate at waterside toe.

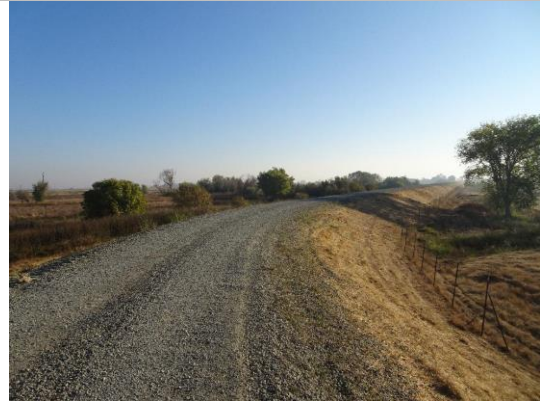
Photo 1 of 3 : UCIP\_FA\_2024\_85180\_100943.jpg

Comment Code						
Inspector Comment						
DS_ID:18595 FS_ID:85180 EP_NO: N/A Repair Type: Non-Urgent EVAL Issue: 11, Maintenance Compliance Issue Crossing Status: Found UCIP Comments: 11/05/2024 Record updated from Urgent to Non-Urgent. RD784 has received approval from CVFPB for pipe replacement authorized under WA2024155 and plans to go out to bid and award a contract in time for the 2025 construction season. This section of the levee is in the process of becoming a state maintenance area. UCIP will update the pipe rating back to ?URGENT? if pipe is not replaced by the end of 2025. (M. Thao - DWR UCIP)/05/2020 Record has been updated from No Action Needed to Urgent. DWR DMP has found integrity issues, LOF between 5 and 6. Recommend monitoring crossing until funding becomes available to address. No permit was found authorizing this encroachment. CVFPB will need to review crossing to determine owner. (O. Magana - DWR UCIP)/16/2019 - Pipe crossing was hydroflushed and video inspected in October 2019. Pending final review by RD784 District Engineer and DWR. (P. Meagher - RD784)/02/01/2019 - Pipe crossing was video inspected on 8-15-2018 (P. Meagher - RD784)/02/27/2013 - Good candidate for video inspection. (W. Wylie - DWR UCIP) FIELD_STRUCT_DESC: 18-inch corrugated metal (CM) drainage pipe through the levee, 15.8 feet below the crown. Flap gate on the waterside (WS) end. Polyvinyl chloride (PVC) weir on inlet at the landside (LS) toe. [Additional Reference(s): DWR Levee Log, 2005, (HLM 3.24). USACE Sacramento O&M Manual, Unit No. 145, August 1955, Revised 6 August 2019, (Station 53+86). USACE As-Built Drawing No. 2-4-106, Sheet No. 106/6, July 1944, (Station 53+86)]. FS Date: 10/5/2020

Overview of Levee: Looking upstream from crown.

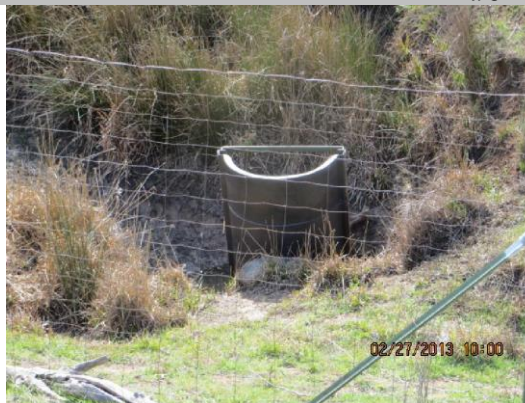
Photo 2 of 3 : UCIP\_FA\_2024\_85180\_16594.jpg

PVC weir inlet on LS toe.

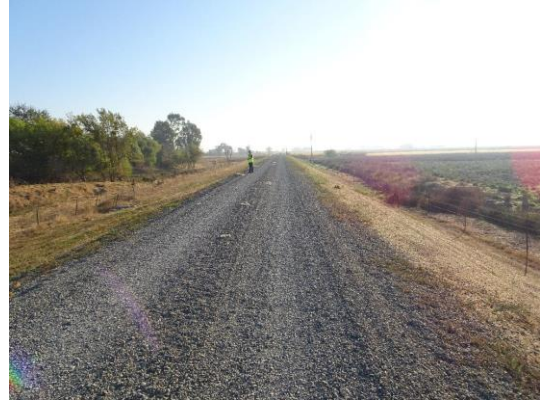
Photo 1 of 3 : UCIP\_FA\_2024\_70308\_100946.jpg

Comment Code					
Inspector Comment					
DS_ID:18594 FS_ID:70308 EP_NO: N/A Repair Type: Non-Urgent EVAL Issue: Crossing Status: Found UCIP Comments: 10/05/2020 - Record has been updated from No Action Needed to Non-Urgent. No permit was found authorizing this encroachment. CVFPB will need to review crossing to determine owner. DWR DMP has not found internal issues, LOF between 1 and 2. Recommend inspection in 5 years. (O. Magana - DWR UCIP) 2/16/2019 - Pipe crossing was video inspected in October 2019. Pending final review by RD784 Engineer and DWR. (P. Meagher - RD784) 2/01/2019 - Pipe crossing was video inspected on 8-15-2018. (P. Meagher - RD784) FIELD_STRUCT_DESC: 18-inch corrugated metal (CM) drainage pipe through the levee, 8.8 feet below the crown. Flap gate and headwall on the waterside (WS) end. [Additional Reference(s): DWR Levee Log, 2005, (HLM 3.81). USACE Sacramento O&M Manual, Unit No. 145, August 1955, Revised 6 August 2019, (Station 83+39). USACE As-Built Drawing No. 2-4-106, Sheet No. 106/6, July 1944, (Station 83+39)]. FS Date: 10/5/2020

Overview of Levee: Looking upstream from crown.

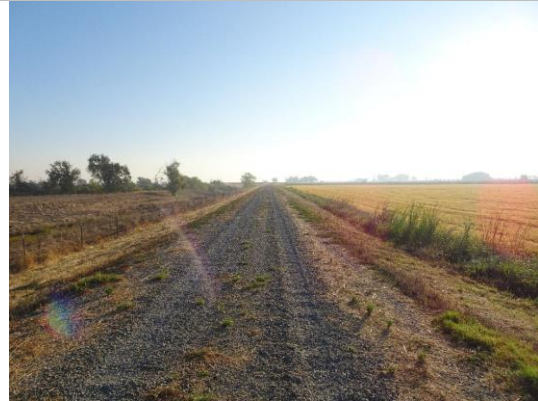
Photo 1 of 3 : UCIP\_FA\_2024\_70309\_100951.jpg

Comment Code						
Inspector Comment						
DS_ID:18593 FS_ID:70309 EP_NO: N/A Repair Type: Non-Urgent EVAL Issue: Crossing Status: Found UCIP Comments: 10/05/2020 - Record remains Non-Urgent. No permit was found authorizing this encroachment. CVFPB will need to review crossing to determine owner. No DWR DMP internal inspection has been completed yet. This crossing appears to be abandoned: buried inlet at landside toe. No access for internal video inspection. DWR DMP will complete assessment to determine final recommendation. (O. Magana - DWR UCIP 02/01/2019 - An attempt was made to video inspect this pipe crossing on 8-15-2018 but conditions were too muddy inside the pipe. (P. Meagher - RD784) 1/14/2016 - Photos added of exposed flap gate on WS and possible inlet location on LS. Condition remains as Non-Urgent because of inlet not being fully operable. Unknown if pipe will operate as designed during high water or if it is full of sediment. (P. Meagher - RD784) 1/01/2015 - Waterside Flap Gate Uncovered. Photo sent to DWR Matt Hoffman on 3-3-2014. Fresh photo sent to DWR Pavel Kazi on 9-9-2015. Landside toe has never been able to be located. Requesting DWR inspector to change the status of this issue to "No Action Needed". (P. Meagher - RD784) 02/26/2013 - Pipe buried on LS toe and flap gate is blocked by soil on WS toe. (W. Wylie - DWR UCIP). FIELD_STRUCT_DESC: 18-inch corrugated metal (CM) drainage pipe through the levee, 10.0 feet below the crown. Flap gate on the waterside (WS) end. [Additional Reference(s): DWR Levee Log, 2005, (HLM 3.98). USACE Sacramento O&M Manual, Unit No. 145, August 1955, Revised 6 August 2019, (Station 91+50). USACE As-Built Drawing No. 2-4-106, Sheet No. 106/6, July 1944, (Station 91+50)]. FS Date: 10/5/2020

Overview of Levee: Looking upstream from crown.

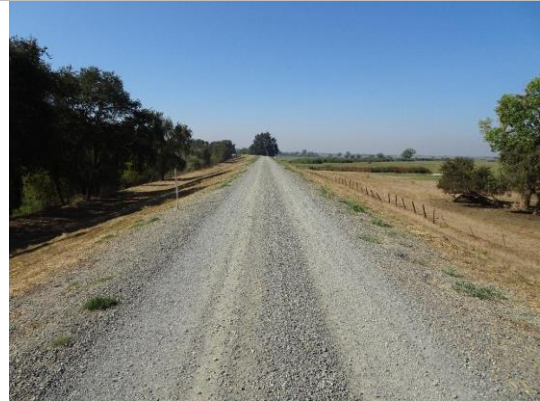
Photo 1 of 3 : UCIP\_FA\_2024\_85181\_100956.jpg

Comment Code						
Inspector Comment						
DS_ID:18626 FS_ID:85181 EP_NO: N/A Repair Type: Non-Urgent EVAL Issue: 11, Maintenance Compliance Issue Crossing Status: Found UCIP Comments: 11/05/2024 Record updated from Urgent to Non-Urgent. RD784 has received approval from CVFPB for pipe replacement authorized under WA2024155 and plans to go out to bid and award a contract in time for the 2025 construction season. This section of the levee is in the process of becoming a state maintenance area. UCIP will update the pipe rating back to ?URGENT? if pipe is not replaced by the end of 2025. (M. Thao - DWR UCIP 10/05/2020) Record has been updated from Non-Urgent to Urgent. DWR DMP has found integrity issues, LOF between 5 and 6. Recommend monitoring crossing until funding becomes available to address. No permit was found authorizing this encroachment. CVFPB will need to review crossing to determine owner. (O. Magana - DWR UCIP 12/16/2019) Pipe was hydroflushed and video inspected (again) in October 2019. Pending final review by RD784 District Engineer and DWR. (P. Meagher - RD784 01/01/2019 - Pipe was video inspected on 8-13-2018. (P. Meagher - RD784 10/30/2015 - Waterside flap gate was cleared in December 2014 and again in September 2015 No LMA access available on Landside. (P. Meagher - RD784 02/26/2013 - Pipe partially blocked on LS and flap gate blocked on WS (W. Wylie - DWR UCIP) FIELD_STRUCT_DESC: 18-inch corrugated metal (CM) storm drainage pipe through the levee, 19.0 feet below the crown. Gate valve on the waterside (WS). (No permit found authorizing this pipe. Owner unknown). [Additional Reference(s): USACE Sacramento O&M Manual, Unit No. 145, August 1955, Revised 6 August 2019, (Station 9+85). USACE As-Built Drawing No. 2-4-106, Sheet No. 106/2, July 1944, (Station 9+85)]. FS Date: 10/5/2020

Overview of Levee: Looking downstream from crown.

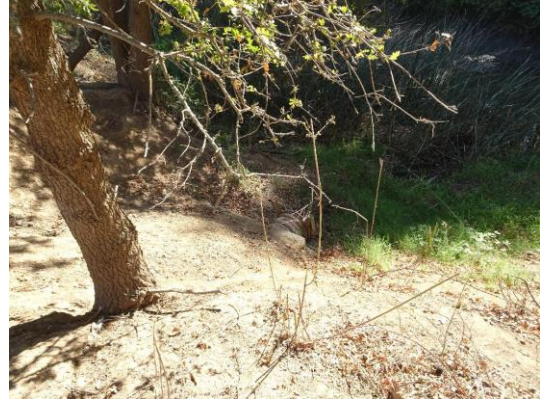
Photo 2 of 3 : UCIP\_FA\_2024\_85181\_100957.jpg

Water-Side: Headwall, outlet, and flap gate on waterside.

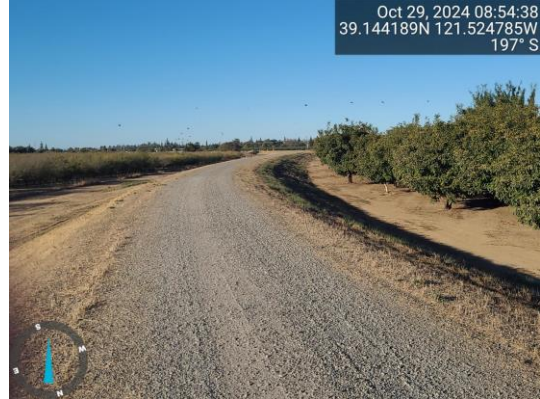
Photo 1 of 1 : FA\_2024\_RD0784\_184\_2\_20241031\_00002.jpg

LM Start	0.05	Rating **	A	Issue No.	2
LM End	3.79	Issue Type +	Ma	Location *	WS
Category	Earthen Levee			GPS Latitude/Longitude	
				Start	End
Item	Vegetation			39.134878°	39.165406°
				-121.551377°	-121.495955°
DWR ID	DWR_RD0784_07_f_2024_2				
Comment Code					
V1 : Control annual grass and weeds on the levee slopes and easements.					
Inspector Comment					
Annual vegetation is well maintained, Fall 2024.

View of maintained vegetation on the waterside slope, Fall 2024.

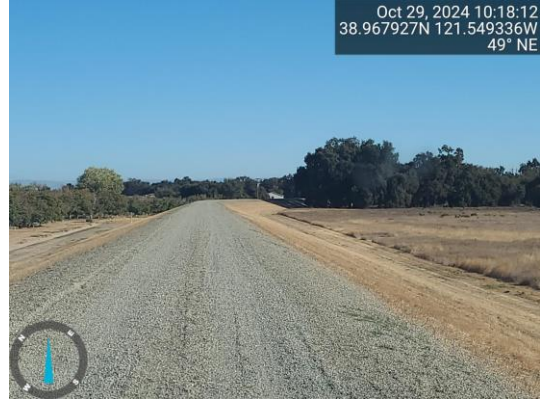
Photo 1 of 1 : FA\_2024\_RD0784\_437\_2\_20241031\_00002.jpg

LM Start	0.10	Rating **	A	Issue No.	2
LM End	1.92	Issue Type +	Ma	Location *	WS
Category	Earthen Levee			GPS Latitude/Longitude	
				Start	End
Item	Vegetation			38.955493°	38.970529°
				-121.573067°	-121.547613°
DWR ID	DWR_RD0784_08_f_2024_2				
Comment Code					
V1 : Control annual grass and weeds on the levee slopes and easements.					
Inspector Comment					
Annual vegetation is well maintained, Fall 2024.

View of maintained vegetation on the waterside slope, Fall 2024.

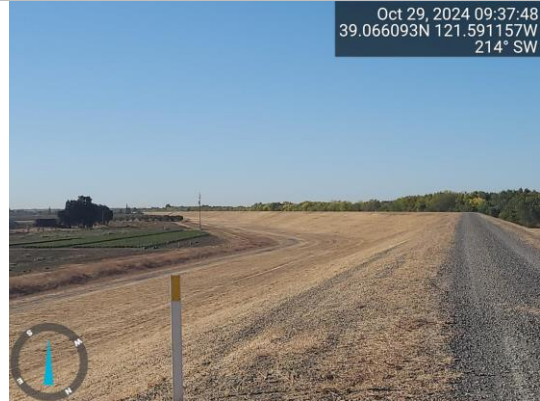
Photo 1 of 1 : FA\_2024\_RD0784\_530\_1\_20241031\_00001.jpg

LM Start	0.01	Rating **	A	Issue No.	1
LM End	5.70	Issue Type +	Ma	Location *	LS
Category	Earthen Levee			GPS Latitude/Longitude	
				Start	End
Item	Vegetation			39.090199°	39.010273°
				-121.584799°	-121.579542°
DWR ID	DWR_RD0784_09_f_2024_1				
Comment Code					
V1 : Control annual grass and weeds on the levee slopes and easements.					
Inspector Comment					
Annual vegetation is well maintained, Fall 2024.

View of maintained vegetation on the landside slope, Fall 2024.
