**Flood Control Project Maintenance
Levee Inspections**

Maintenance Issue Types Only, Levee Inspection Report By Mile - Spring 2017

Reclamation District No. 0784 Plumas Lake

Waterway	Bank	Unit Miles	Inspection Start/End	Inspector
Unit No. 01 Yuba River	Left	2.21	04/05/2017 04/05/2017	Sterling York

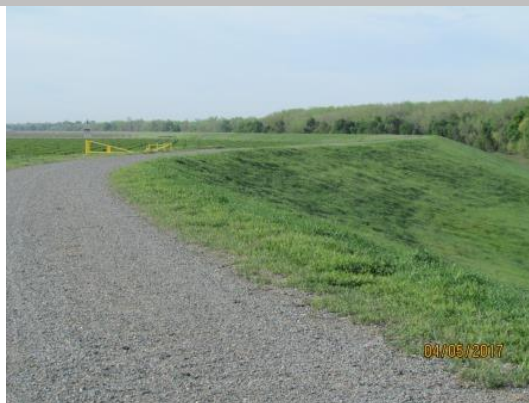
Photo 1 of 1 : SP_2017_RD0784_532_3_20170410_00005.jpg

LM Start	9.19	Rating **	A/W	Issue No.	3
LM End	12.86	Issue Type +	Ma	Location *	WS
Category	Earthen Levee			GPS Latitude/Longitude	
				Start	End
Item	Vegetation			39.006792 °	38.954616 °
				-121.577789 °	-121.574699 °
DWR ID	DWR_RD0784_02B_s_2017_3				
Comment Code					
V1 : Control annual grass and weeds on the levee slopes and easements.					
Inspector Comment					
Annual grasses are less than 6" tall at time of inspection, Spring 2017.

View looking downstream of annual grasses, Spring 2017.

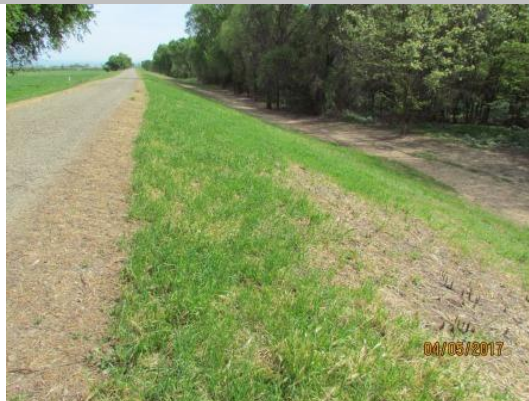
Photo 1 of 1 : SP_2017_RD0784_534_4_20170410_00004.jpg

LM Start	3.23	Rating **	A/W	Issue No.	4
LM End	4.69	Issue Type +	Ma	Location *	WS
Category	Earthen Levee			GPS Latitude/Longitude	
				Start	End
Item	Vegetation			38.974354 °	38.985522 °
				-121.532118 °	-121.510601 °
DWR ID	DWR_RD0784_03B_s_2017_4				
Comment Code					
V1 : Control annual grass and weeds on the levee slopes and easements.					
Inspector Comment					
Annual grasses are less than 6" tall at time of inspection, Spring 2017.

View looking upstream of well maintained annual grasses, Spring 2017.

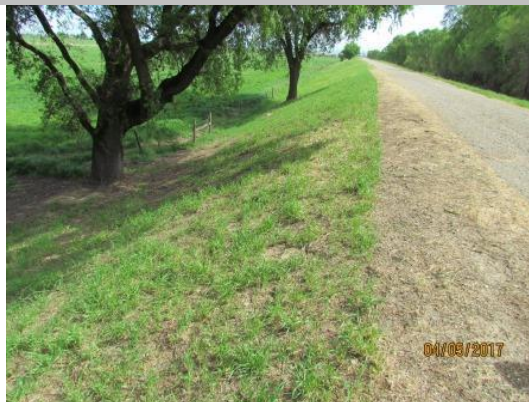
Photo 1 of 1 : SP_2017_RD0784_534_3_20170410_00005.jpg

LM Start	3.23	Rating **	A/W	Issue No.	3
LM End	4.69	Issue Type +	Ma	Location *	LS
Category	Earthen Levee			GPS Latitude/Longitude	
				Start	End
Item	Vegetation			38.974354 °	38.985522 °
				-121.532117 °	-121.510602 °
DWR ID	DWR_RD0784_03B_s_2017_3				
Comment Code					
V1 : Control annual grass and weeds on the levee slopes and easements.					
Inspector Comment					
Annual grasses are less than 6" tall at time of inspection, Spring 2017.

View looking upstream of well maintained annual grasses, Spring 2017.

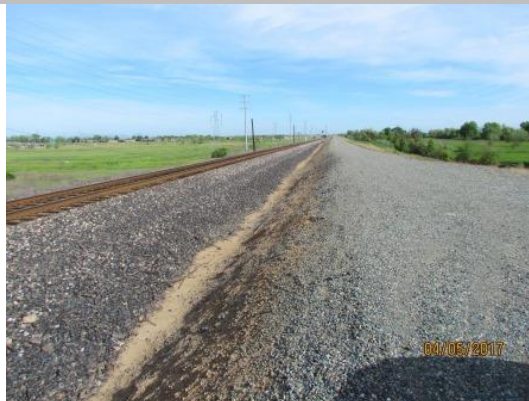
Photo 1 of 1 : SP_2017_RD0784_181_2_20170410_00004.jpg

LM Start	0.01	Rating **	A	Issue No.	2
LM End	2.52	Issue Type +	Ma	Location *	LS
Category	Earthen Levee			GPS Latitude/Longitude	
				Start	End
Item	Vegetation			38.974860 °	39.010938 °
				-121.535079 °	-121.541759 °
DWR ID	DWR_RD0784_04_s_2017_2				
Comment Code					
V1 : Control annual grass and weeds on the levee slopes and easements.					
Inspector Comment					
No unwanted vegetation, Spring 2017.

View looking upstream of no unwanted grasses or vegetation, Spring 2017.

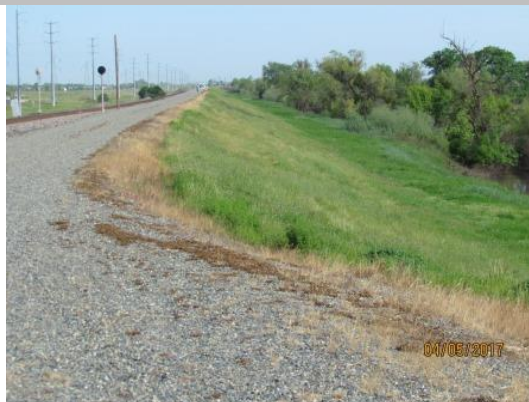
Photo 1 of 1 : SP_2017_RD0784_181_3_20170410_00005.jpg

LM Start	0.01	Rating **	M	Issue No.	3
LM End	6.32	Issue Type +	Ma	Location *	WS
Category	Earthen Levee			GPS Latitude/Longitude	
				Start	End
Item	Vegetation			38.974860 °	39.059299 °
				-121.535079 °	-121.551111 °
DWR ID	DWR_RD0784_04_s_2017_3				
Comment Code					
V1 : Control annual grass and weeds on the levee slopes and easements.					
Inspector Comment					
Maintain annual grasses, Spring 2017.

View looking upstream of annual grasses, Spring 2017.

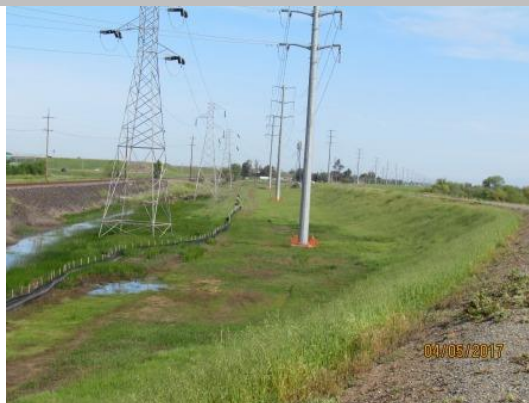
Photo 1 of 1 : SP_2017_RD0784_181_4_20170410_00006.jpg

LM Start	2.52	Rating **	M	Issue No.	4
LM End	6.32	Issue Type +	Ma	Location *	LS
Category	Earthen Levee			GPS Latitude/Longitude	
				Start	End
Item	Vegetation			39.010938 °	39.059298 °
				-121.541759 °	-121.551111 °
DWR ID	DWR_RD0784_04_s_2017_4				
Comment Code					
V1 : Control annual grass and weeds on the levee slopes and easements.					
Inspector Comment					
Maintain annual grasses, Spring 2017.

View looking upstream of annual grasses, Spring 2017.

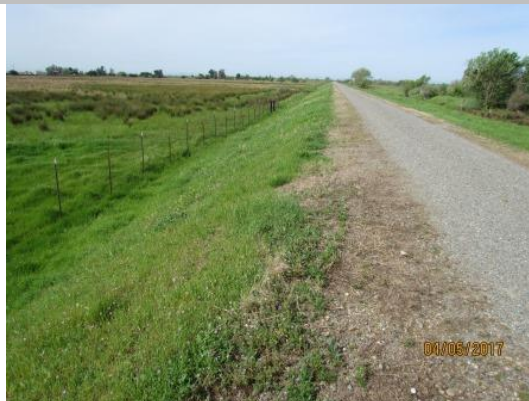
Photo 1 of 1 : SP_2017_RD0784_182_14_20170410_00032.jpg

LM Start	0.01	Rating **	A/W	Issue No.	14
LM End	4.19	Issue Type +	Ma	Location *	LS
Category	Earthen Levee			GPS Latitude/Longitude	
				Start	End
Item	Vegetation			38.974540 °	39.020560 °
				-121.532520 °	-121.509119 °
DWR ID	DWR_RD0784_05_s_2017_14				
Comment Code					
V1 : Control annual grass and weeds on the levee slopes and easements.					
Inspector Comment					
Annual grasses are less than 6" tall at time of inspection, Spring 2017.

View looking downstream at annual grasses, Spring 2017.

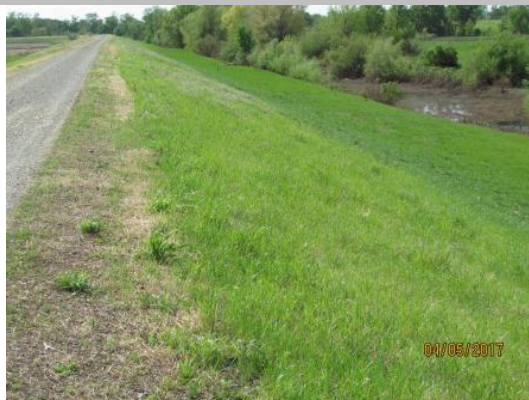
Photo 1 of 1 : SP_2017_RD0784_182_15_20170410_00033.jpg

LM Start	0.01	Rating **	A/W	Issue No.	15
LM End	4.19	Issue Type +	Ma	Location *	WS
Category	Earthen Levee			GPS Latitude/Longitude	
				Start	End
Item	Vegetation			38.974540 °	39.020560 °
				-121.532520 °	-121.509119 °
DWR ID	DWR_RD0784_05_s_2017_15				
Comment Code					
V1 : Control annual grass and weeds on the levee slopes and easements.					
Inspector Comment					
Annual grasses are less than 6" tall at time of inspection, Spring 2017.

View looking downstream at annual grasses, Spring 2017.

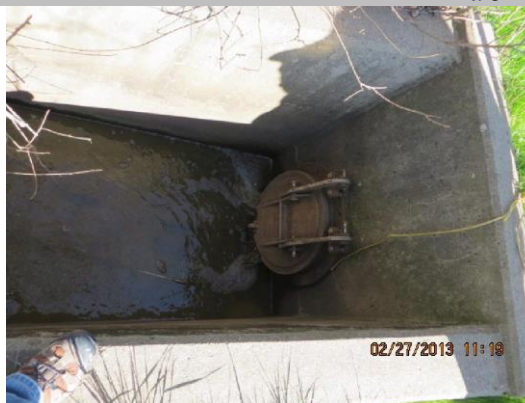
Photo 2 of 3 : UCIP_SP_2017_51711_16555.jpg

FS_ID:51711
DS_ID:18592
EP_NO: N/A
Repair Type: No Action Needed
Crossing Status: Found
UCIP Comments: Good candidate for video inspection.
FIELD_STRUCT_DESC: 18-inch CM drain pipe through the levee 18.0 feet below the crown. Flap gate on the waterward end. Concrete "U" headwall on the waterward end. PVC weir inlet on LS toe. Originally included in O+M manual (1955).
FS Date: 2/26/2013

Concrete U-shaped outlet with flap gate on WS toe.

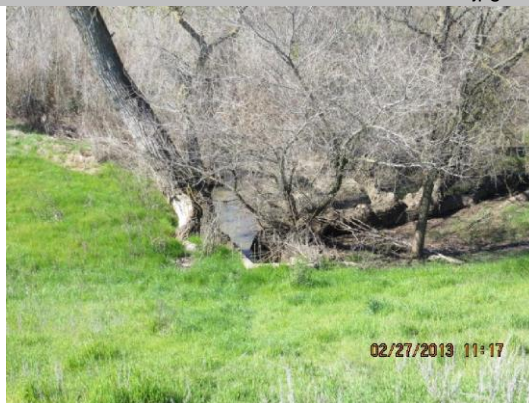
Photo 3 of 3 : UCIP_SP_2017_51711_16554.jpg

LM Start	0.12	Rating **	A/W	Issue No.	16 (cont)
LM End	0.12	Issue Type +	Ma	Location *	WS
Category	Supplemental			GPS Latitude/Longitude	
				Start	End
Item	DWR UCIP LMA Responsibility			38.976147 °	38.976147 °
				-121.533019 °	-121.533019 °
DWR ID					
Comment Code					
Inspector Comment					
FS_ID:51711 DS_ID:18592 EP_NO: N/A Repair Type: No Action Needed Crossing Status: Found UCIP Comments: Good candidate for video inspection. FIELD_STRUCT_DESC: 18-inch CM drain pipe through the levee 18.0 feet below the crown. Flap gate on the waterward end. Concrete "U" headwall on the waterward end. PVC weir inlet on LS toe. Originally included in O+M manual (1955). FS Date: 2/26/2013

Concrete U-shaped outlet on WS toe.

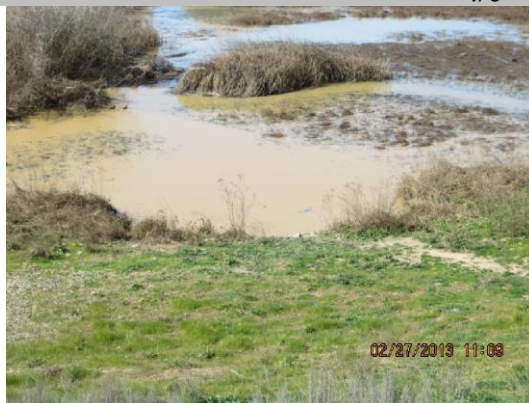
Photo 2 of 2 : UCIP_SP_2017_51710_54245.jpg

LM Start	0.84	Rating **	M	Issue No.	17 (cont)	
LM End	0.84	Issue Type +	Ma	Location *	WS	
Category	Supplemental			GPS Latitude/Longitude		
				Start	End	
Item	DWR UCIP LMA Responsibility			38.986432 °	38.986432 °	
				-121.534983 °	-121.534983 °	
DWR ID						
Comment Code						
Inspector Comment						
FS_ID:51710 DS_ID:18591 EP_NO: N/A Repair Type: Non-Urgent Crossing Status: Found UCIP Comments: No handle or access to slide gate on LS toe. FIELD_STRUCT_DESC: 30-inch CM pipe through the levee 23.7 feet below the crown. Flap gate on the waterward end. Slide gate in concrete drop inlet on the landward side. Originally included in O+M manual (1955). FS Date: 9/11/2015 9:05:00 AM

Outlet with riprap on WS toe.

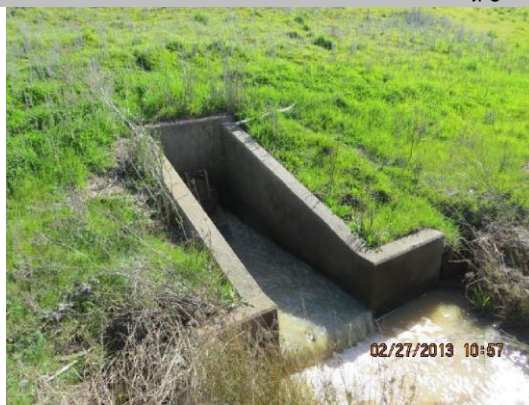
Photo 1 of 3 : UCIP_SP_2017_51709_16565.jpg

LM Start	1.60	Rating **	A/W	Issue No.	18
LM End	1.60	Issue Type +	Ma	Location *	WS
Category	Supplemental			GPS Latitude/Longitude	
				Start	End
Item	DWR UCIP LMA Responsibility			38.997305 °	38.997305 °
				-121.537081 °	-121.537081 °
DWR ID					
Comment Code					
Inspector Comment					
FS_ID:51709 DS_ID:18590 EP_NO: N/A Repair Type: No Action Needed Crossing Status: Found UCIP Comments: Good candidate for video inspection. FIELD_STRUCT_DESC: 18-inch CM drain pipe through the levee 14.5, feet below the crown. Flap gate on the waterward end. Concrete "U" headwall on the waterward side. PVC Weir on inlet. Originally included in O+M manual (1955) See drawing 2-4-106 sheet 5.. FS Date: 2/26/2013

Concrete U-shaped headwall and flap gate on WS toe.

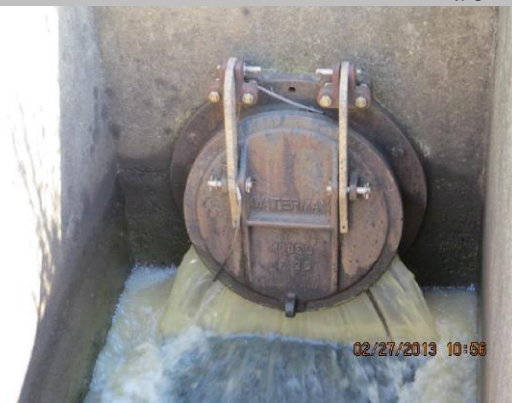
Photo 3 of 3 : UCIP_SP_2017_51709_16562.jpg

LM Start	1.60	Rating **	A/W	Issue No.	18 (cont)	
LM End	1.60	Issue Type +	Ma	Location *	WS	
Category	Supplemental			GPS Latitude/Longitude		
				Start	End	
Item	DWR UCIP LMA Responsibility			38.997305 °	38.997305 °	
				-121.537081 °	-121.537081 °	
DWR ID						
Comment Code						
Inspector Comment						
FS_ID:51709 DS_ID:18590 EP_NO: N/A Repair Type: No Action Needed Crossing Status: Found UCIP Comments: Good candidate for video inspection. FIELD_STRUCT_DESC: 18-inch CM drain pipe through the levee 14.5, feet below the crown. Flap gate on the waterward end. Concrete "U" headwall on the waterward side. PVC Weir on inlet. Originally included in O+M manual (1955) See drawing 2-4-106 sheet 5.. FS Date: 2/26/2013

Concrete U-shaped headwall and flap gate on WS toe.

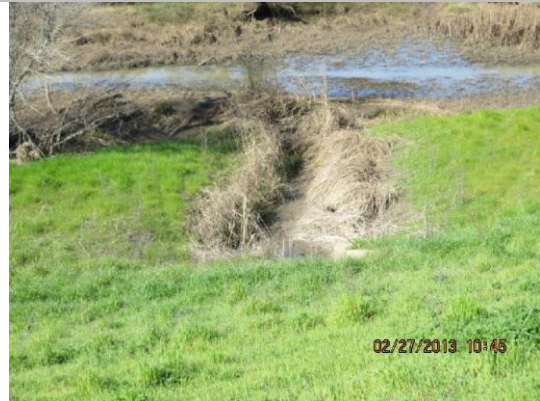
Photo 3 of 3 : UCIP_SP_2017_51719_54249.jpg

LM Start	1.86	Rating **	M	Issue No.	19 (cont)
LM End	1.86	Issue Type +	Ma	Location *	WS
Category	Supplemental			GPS Latitude/Longitude	
				Start	End
Item	DWR UCIP LMA Responsibility			39.000975 °	39.000975 °
				-121.537779 °	-121.537779 °
DWR ID					
Comment Code					
Inspector Comment					
FS_ID:51719					
DS_ID:18588					
EP_NO: N/A					
Repair Type: Non-Urgent					
Crossing Status: Found					
UCIP Comments: 09/11/2015 Inlet burried. Good candidate for video inspection as pipe is corroded. (G. Wylie - FPIIB)					
FIELD_STRUCT_DESC: 18-inch CM drain pipe through the levee, 14.5 feet below the crown. Flap gate on the waterward end. Concrete "U" headwall on the waterward side. Originally included in O+M manual (1955).					
FS Date: 9/11/2015 9:36:00 AM

Drainage outlet on WS toe.

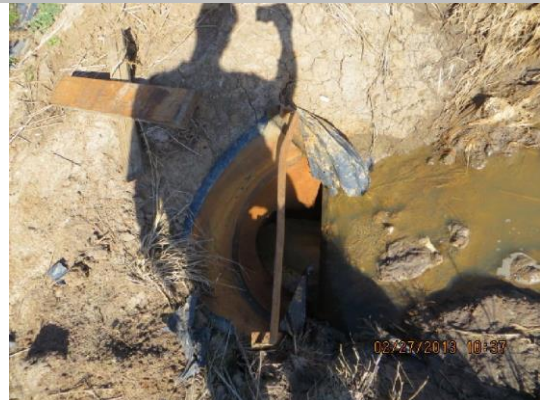
Photo 1 of 3 : UCIP_SP_2017_51707_54250.jpg

Comment Code					
Inspector Comment					
FS_ID:51707 DS_ID:18587 EP_NO: N/A Repair Type: Non-Urgent Crossing Status: Found UCIP Comments: On 1/31/2017 The waterside excess pipe end was discovered to be floating to the surface due to landside water runoff through the pipe. Because of the floating pipe, the water was not draining all the way through the pipe. Instead, the water was overtopping the levee shelf area. In order to resolve this issue, the excess portion of the pipe was cut off. After doing so, the water immediately started draining properly again. (P. Meagher, RD784 2/3/2017). Erosion at outlet may or may not be an issue. FIELD_STRUCT_DESC: 18-inch CM drain pipe through the levee, 14.5 feet below the crown. Flap gate on the waterward end. Concrete "U" headwall on the waterward side. PVC weir on inlet. Originally included in O+M manual (1955). FS Date: 2/3/2017

Inlet with PVC weir on LS toe.

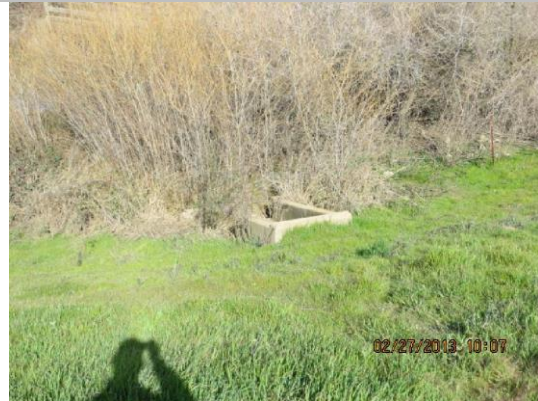
Photo 3 of 3 : UCIP_SP_2017_51714_54261.jpg

LM Start	3.06	Rating **	M	Issue No.	22 (cont)	
LM End	3.06	Issue Type +	Ma	Location *	WS	
Category	Supplemental			GPS Latitude/Longitude		
				Start	End	
Item	DWR UCIP LMA Responsibility			39.015549 °	39.015549 °	
				-121.528590 °	-121.528590 °	
DWR ID						
Comment Code						
Inspector Comment						
FS_ID:51714 DS_ID:18596 EP_NO: N/A Repair Type: Non-Urgent Crossing Status: Found UCIP Comments: Pipe has been sliplined with PVC, but the liner appears to be eroding at outlet and may be disjointed internal to the levee. See pic. Good candidate for video inspection. FIELD_STRUCT_DESC: 12-inch CM drain pipe through the levee, 12.0 feet below the crown. Flap gate and concrete "U" headwall on the waterward side. PVC weir on inlet at LS toe. Originally included in O+M manual (1955). FS Date: 9/11/2015 9:26:00 AM

Concrete U-shaped headwall on WS toe.

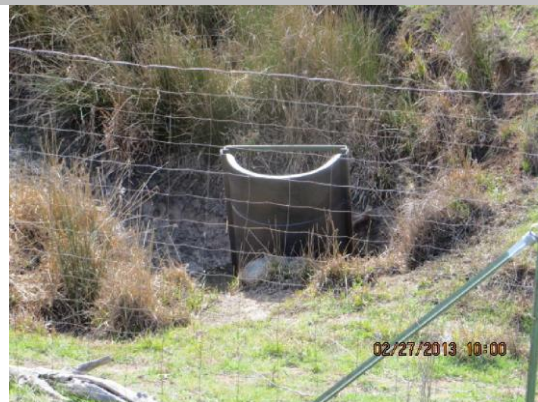
Photo 1 of 2 : UCIP_SP_2017_9566_16594.jpg

LM Start	3.23	Rating **	A/W	Issue No.	23
LM End	3.23	Issue Type +	Ma	Location *	WS
Category	Supplemental			GPS Latitude/Longitude	
				Start	End
Item	DWR UCIP LMA Responsibility			39.017336 °	39.017336 °
				-121.526530 °	-121.526530 °
DWR ID					
Comment Code					
Inspector Comment					
FS_ID:9566 DS_ID:18595 EP_NO: N/A Repair Type: No Action Needed Crossing Status: Found UCIP Comments: Good candidate for video inspection. FIELD_STRUCT_DESC: 18-inch CM drain pipe through the levee, 15.8 feet below the crown. Flap gate on the waterward end. PVC weir on inlet at LS toe. Originally included in O+M manual (1955). See Drawing 2-4-106 Sheet 6. FS Date: 2/27/2013

PVC weir inlet on LS toe.

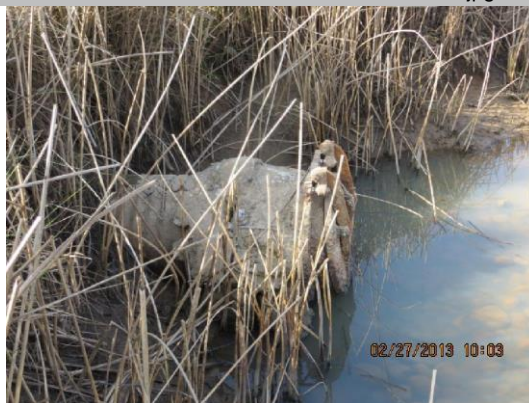
Photo 2 of 2 : UCIP_SP_2017_9566_16593.jpg

LM Start	3.23	Rating **	A/W	Issue No.	23 (cont)	
LM End	3.23	Issue Type +	Ma	Location *	WS	
Category	Supplemental			GPS Latitude/Longitude		
				Start	End	
Item	DWR UCIP LMA Responsibility			39.017336 °	39.017336 °	
				-121.526530 °	-121.526530 °	
DWR ID						
Comment Code						
Inspector Comment						
FS_ID:9566 DS_ID:18595 EP_NO: N/A Repair Type: No Action Needed Crossing Status: Found UCIP Comments: Good candidate for video inspection. FIELD_STRUCT_DESC: 18-inch CM drain pipe through the levee, 15.8 feet below the crown. Flap gate on the waterward end. PVC weir on inlet at LS toe. Originally included in O+M manual (1955). See Drawing 2-4-106 Sheet 6. FS Date: 2/27/2013

Flap gate at WS toe.

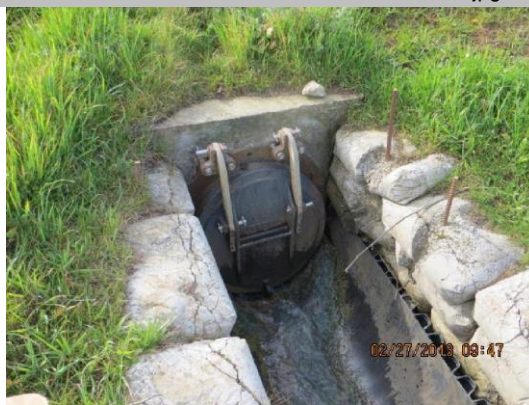
Photo 1 of 3 : UCIP_SP_2017_51713_16590.jpg

LM Start	3.79	Rating **	A/W	Issue No.	24
LM End	3.79	Issue Type +	Ma	Location *	WS
Category	Supplemental			GPS Latitude/Longitude	
				Start	End
Item	DWR UCIP LMA Responsibility			39.019222 °	39.019222 °
				-121.516414 °	-121.516414 °
DWR ID					
Comment Code					
Inspector Comment					
FS_ID:51713 DS_ID:18594 EP_NO: N/A Repair Type: No Action Needed Crossing Status: Found UCIP Comments: FIELD_STRUCT_DESC: 18-inch CM drain pipe through the levee, 8.8 feet below the crown. Flap gate and headwall on the waterward end. Originally included in O+M manual (1955). FS Date: 2/27/2013

Concrete outlet and flap gate on WS toe.

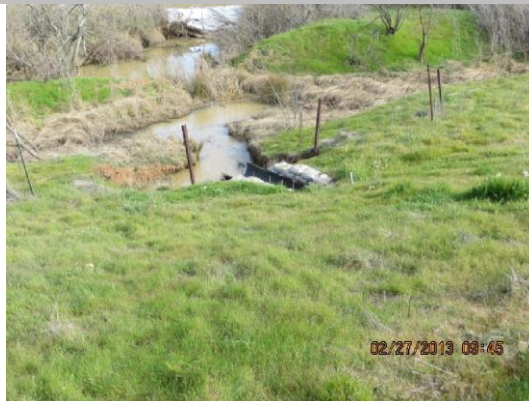
Photo 3 of 3 : UCIP_SP_2017_51713_16592.jpg

Concrete outlet on WS toe.

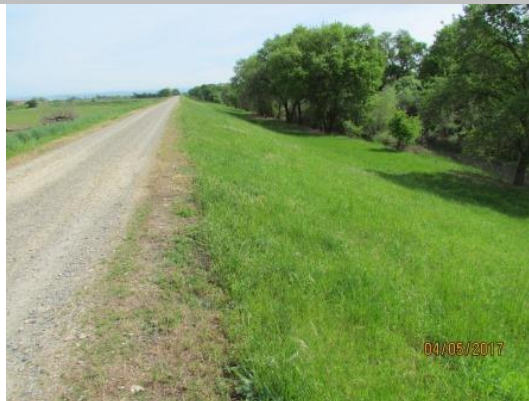
Photo 1 of 1 : SP_2017_RD0784_183_3_20170410_00004.jpg

LM Start	0.00	Rating **	M	Issue No.	3
LM End	0.25	Issue Type +	Ma	Location *	WS
Category	Earthen Levee			GPS Latitude/Longitude	
				Start	End
Item	Vegetation			38.985575 °	38.987580 °
				-121.510497 °	-121.506665 °
DWR ID	DWR_RD0784_06_s_2017_3				
Comment Code					
V1 : Control annual grass and weeds on the levee slopes and easements.					
Inspector Comment					
Maintain annual grasses, Spring 2017.

View looking upstream of annual grasses, Spring 2017.

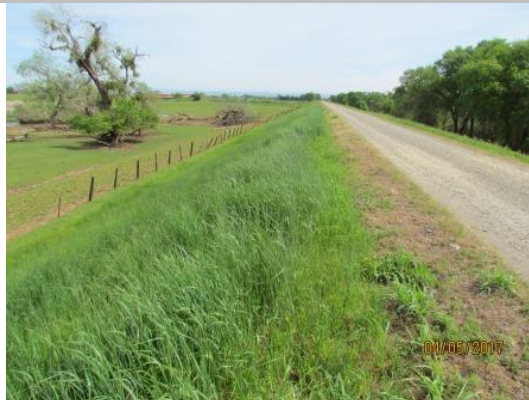
Photo 1 of 1 : SP_2017_RD0784_183_2_20170410_00005.jpg

LM Start	0.00	Rating **	M	Issue No.	2
LM End	0.25	Issue Type +	Ma	Location *	LS
Category	Earthen Levee			GPS Latitude/Longitude	
				Start	End
Item	Vegetation			38.985575 °	38.987580 °
				-121.510497 °	-121.506664 °
DWR ID	DWR_RD0784_06_s_2017_2				
Comment Code					
V1 : Control annual grass and weeds on the levee slopes and easements.					
Inspector Comment					
Maintain annual grasses, Spring 2017.

View looking upstream of annual grasses, Spring 2017.

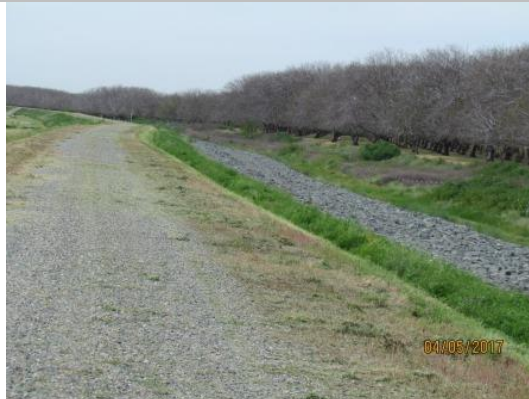
Photo 1 of 1 : SP_2017_RD0784_184_2_20170410_00001.jpg

LM Start	0.12	Rating **	M	Issue No.	2
LM End	3.81	Issue Type +	Ma	Location *	WS
Category	Earthen Levee			GPS Latitude/Longitude	
				Start	End
Item	Vegetation			39.135132 °	39.165534 °
				-121.550156 °	-121.495582 °
DWR ID	DWR_RD0784_07_s_2017_2				
Comment Code					
V1 : Control annual grass and weeds on the levee slopes and easements.					
Inspector Comment					
Shoulders of crown are mowed, maintained annual grasses on slopes, Spring 2017.

View looking downstream of annual grasses, Spring 2017.

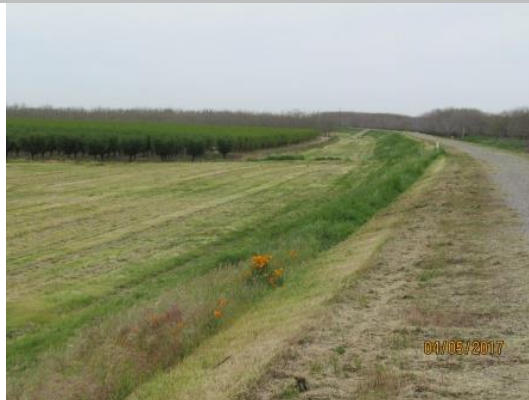
Photo 1 of 1 : SP_2017_RD0784_184_1_20170410_00002.jpg

LM Start	0.12	Rating **	M	Issue No.	1
LM End	3.81	Issue Type +	Ma	Location *	LS
Category	Earthen Levee			GPS Latitude/Longitude	
				Start	End
Item	Vegetation			39.135133 °	39.165534 °
				-121.550156 °	-121.495582 °
DWR ID	DWR_RD0784_07_s_2017_1				
Comment Code					
V1 : Control annual grass and weeds on the levee slopes and easements.					
Inspector Comment					
Shoulders of crown are mowed, maintained annual grasses on slopes, Spring 2017.

View looking downstream of annual grasses, Spring 2017.

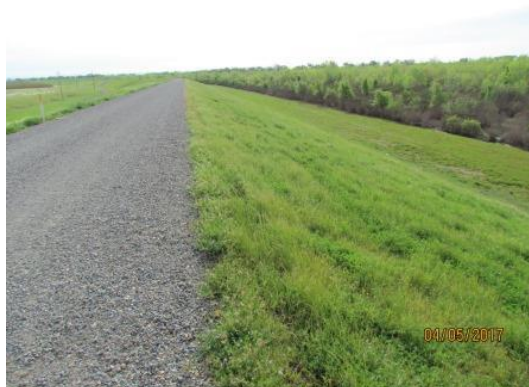
Photo 1 of 1 : SP_2017_RD0784_437_2_20170410_00001.jpg

LM Start	0.06	Rating **	M	Issue No.	2
LM End	1.92	Issue Type +	Ma	Location *	WS
Category	Earthen Levee			GPS Latitude/Longitude	
				Start	End
Item	Vegetation			38.955510 °	38.970527 °
				-121.573814 °	-121.547607 °
DWR ID	DWR_RD0784_08_s_2017_2				
Comment Code					
V1 : Control annual grass and weeds on the levee slopes and easements.					
Inspector Comment					
Maintain annual grasses, Spring 2017.

View looking upstream of annual grasses, Spring 2017.

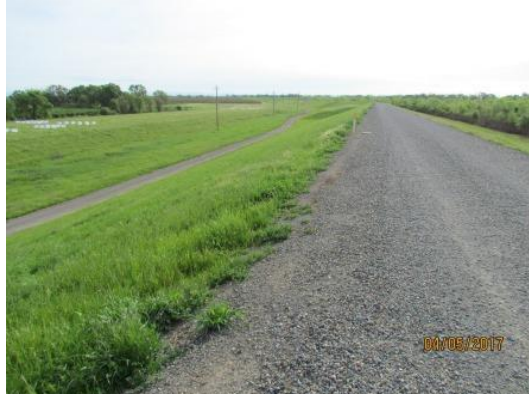
Photo 1 of 1 : SP_2017_RD0784_437_1_20170410_00002.jpg

LM Start	0.06	Rating **	M	Issue No.	1
LM End	1.92	Issue Type +	Ma	Location *	LS
Category	Earthen Levee			GPS Latitude/Longitude	
				Start	End
Item	Vegetation			38.955509 °	38.970526 °
				-121.573814 °	-121.547607 °
DWR ID	DWR_RD0784_08_s_2017_1				
Comment Code					
V1 : Control annual grass and weeds on the levee slopes and easements.					
Inspector Comment					
Maintain annual grasses, Spring 2017.

View looking upstream of annual grasses, Spring 2017.
