**Flood Control Project Maintenance
Levee Inspections**

Maintenance Issue Types Only, Levee Inspection Report By Mile - Spring 2019

Reclamation District No. 0784 Plumas Lake

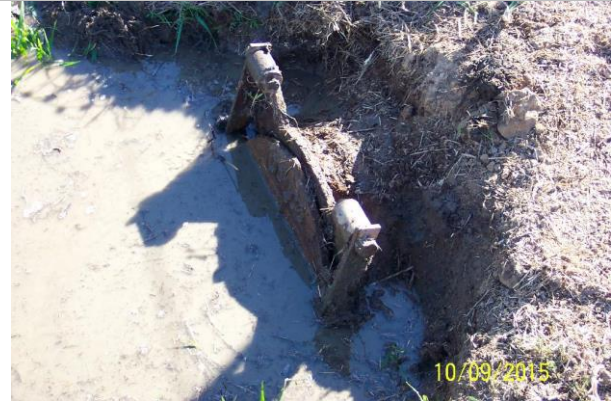
Photo 3 of 3 : UCIP_SP_2019_53550_74710.jpg

| FS_ID:53550 DS_ID:18593 EP_NO: N/A Repair Type: Non-Urgent Crossing Status: Found UCIP Comments: 2/1/2019 - An attempt was made to video inspect this pipe crossing on 8/15/2018 but conditions were too muddy inside the pipe. (P. Meagher)11/14/2016 - Photos added of exposed flap gate on WS and possible inlet location on LS. Condition remains as Non-Urgent because of inlet not being fully operable. Unknown if pipe will operate as designed during high water or if it is full of sediment.11/01/2015 - Waterside Flap Gate Uncovered. Photo sent to DWR Matt Hoffman on 3/3/2014. Fresh photo sent to DWR Pavel Kazi on 9/9/2015. Landside toe has never been able to be located. Requesting DWR inspector to change the status of this issue to "No Action Needed". (P.Meagher - RD784).Pipe buried on LS toe and flap gate is blocked by soil on WS toe. (W. Wylie - UCIP Inspector). FIELD_STRUCT_DESC: 18-inch corrugated metal drainage pipe through the levee, 10 feet below the crown. Flap gate on the waterside (WS) end. [Additional Reference(s): DWR Levee Log, 2005. USACE Sacramento O&M Manual 145, August 1955 (Station 91+50)]. FS Date: 10/9/2015 | | | | | | | | | | | | |
