**Flood Control Project Maintenance
Levee Inspections**

Maintenance Issue Types Only, Levee Inspection Report By Mile - Spring 2020

Reclamation District No. 0784 Plumas Lake

Waterway	Bank	Unit Miles	Inspection Start/End	Inspector
Unit No. 01 Yuba River	Left	2.21	03/09/2020 03/09/2020	Sterling York

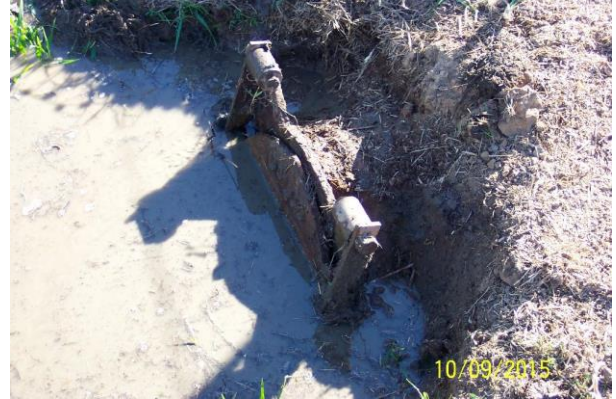
Photo 3 of 3 : UCIP_SP_2020_53550_74710.jpg

Comment Code						
Inspector Comment						
DS_ID:18593 FS_ID:53550 EP_NO: N/A Repair Type: Non-Urgent Crossing Status: Found UCIP Comments: 2/1/2019 - An attempt was made to video inspect this pipe crossing on 8/15/2018 but conditions were too muddy inside the pipe. (P. Meagher)11/14/2016 - Photos added of exposed flap gate on WS and possible inlet location on LS. Condition remains as Non-Urgent because of inlet not being fully operable. Unknown if pipe will operate as designed during high water or if it is full of sediment.11/01/2015 - Waterside Flap Gate Uncovered. Photo sent to DWR Matt Hoffman on 3/3/2014. Fresh photo sent to DWR Pavel Kazi on 9/9/2015. Landside toe has never been able to be located. Requesting DWR inspector to change the status of this issue to "No Action Needed". (P.Meagher - RD784).Pipe buried on LS toe and flap gate is blocked by soil on WS toe. (W. Wylie - UCIP Inspector). FIELD_STRUCT_DESC: 18-inch corrugated metal drainage pipe through the levee, 10 feet below the crown. Flap gate on the waterside (WS) end. [Additional Reference(s): DWR Levee Log, 2005. USACE Sacramento O&M Manual 145, August 1955 (Station 91+50)]. FS Date: 10/9/2015

LM Start	3.96	Rating **	M	Issue No.	23 (cont)
LM End	3.96	Issue Type +	Ma	Location *	
Category	Supplemental			GPS Latitude/Longitude	
				Start	End
Item	DWR UCIP LMA Responsibility			39.019787 °	39.019787 °
				-121.513386 °	-121.513386 °
DWR ID	18593
