**Flood Control Project Maintenance
Levee Inspections**

Maintenance Issue Types Only, Levee Inspection Report By Mile - Spring 2021

Reclamation District No. 0784 Plumas Lake

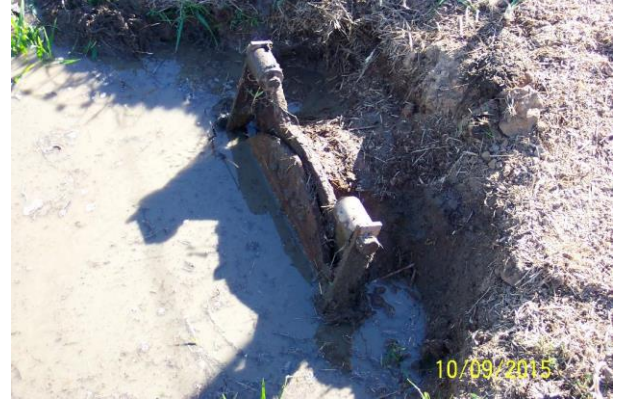
Photo 3 of 3 : UCIP_SP_2021_61757_74710.jpg

FS_ID:61757
DS_ID:18593
EP_NO: N/A
Repair Type: Non-Urgent
Crossing Status: Found
UCIP Comments: 02/01/2019 - An attempt was made to video inspect this pipe crossing on 8-15-2018 but conditions were too muddy inside the pipe. (P. Meagher - RD784)11/14/2016 - Photos added of exposed flap gate on WS and possible inlet location on LS. Condition remains as Non-Urgent because of inlet not being fully operable. Unknown if pipe will operate as designed during high water or if it is full of sediment. (P. Meagher - RD784)11/01/2015 - Waterside Flap Gate Uncovered. Photo sent to DWR Matt Hoffman on 3-3-2014. Fresh photo sent to DWR Pavel Kazi on 9-9-2015. Landside toe has never been able to be located. Requesting DWR inspector to change the status of this issue to "No Action Needed". (P. Meagher - RD784).02/26/2013 - Pipe buried on LS toe and flap gate is blocked by soil on WS toe. (W. Wylie - DWR UCIP).

LM Start	3.96	Rating **	M	Issue No.	12 (cont)
LM End	3.96	Issue Type +	Ma	Location *	
Category	Supplemental			GPS Latitude/Longitude	
				Start	End
Item	DWR UCIP LMA Responsibility			39.019787 °	39.019787 °
				-121.513386 °	-121.513386 °
DWR ID	18593
