**Flood Control Project Maintenance  
Levee Inspections**

## Maintenance Issue Types Only, Levee Inspection Report By Mile - Fall 2016

### Reclamation District No. 0785 Driver

Waterway	Bank	Unit Miles	Inspection Start/End	Inspector
Unit No. 01 Sacramento River	Right	2.26	10/24/2016 10/24/2016	Oleg Yakimov

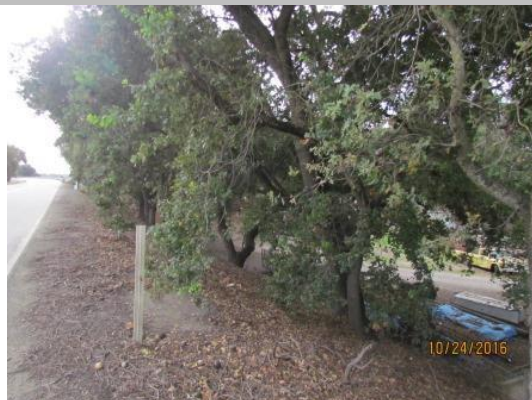
Photo 1 of 1 : FA\_2016\_RD0785\_185\_22\_20161024\_00044.jpg

LM Start	1.61	Rating **	M	Issue No.	22
LM End	1.62	Issue Type +	Ma	Location *	LS
Category	Earthen Levee			GPS Latitude/Longitude	
				Start	End
Item	Trim / Thin Trees			38.643359 °	38.643229 °
				-121.595237 °	-121.595011 °
DWR ID	DWR_RD0785_01_s_2016_22				
Comment Code					
T1 : Trim trees to at least five feet above ground level.					
Inspector Comment

Fall 2016.
