**Flood Control Project Maintenance  
Levee Inspections**

**Fall 2019 Levee Maintenance Deficiency Summary Report**

**Reclamation District No. 0827 Elkhorn**

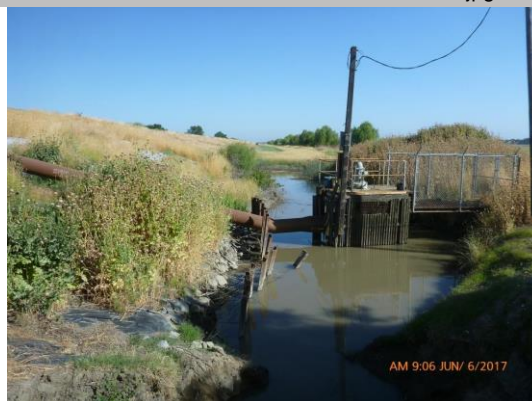
Photo 4 of 4 : LEVAL\_FA\_2019\_199\_1234.jpg

LM Start	2.72	Rating **	M	Issue No.	13 (cont)
LM End	2.73	Issue Type +	Ma	Location *	LS
Category	Supplemental			GPS Latitude/Longitude	
				Start	End
Item	2017 Storm Damage			38.642139 °	38.642028 °
				-121.620750 °	-121.620667 °
DWR ID	RD 827-01				
Comment Code					
Inspector Comment					
Levee Evaluation Comments					
Description:					
Site ID No:199					
Site Designation:RD 827-01					
Repair Type: Erosion					
Rating:Area of Concern					
Field Date:6/6/2017					
Notes: landside. Sloughing on the landside slope near pump.					
Movement has stabilized and the LMA will be constructing a setback levee within the next 3 years. Recommend monitoring.
