**Flood Control Project Maintenance
Levee Inspections**

Fall 2015 Levee Maintenance Deficiency Summary Report

Sacramento River Basin

Reclamation District No. 0900 West Sacramento

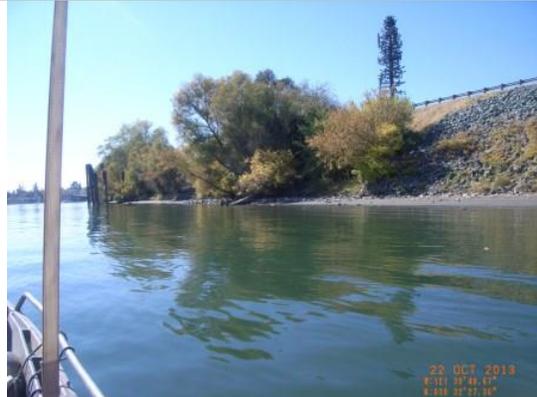
Photo 1 of 1 : USACE2013A_SAC_55-7_R_4.jpg

LM Start	3.27	Rating **	M	Issue No.	2
LM End	3.48	Issue Type +	Ma	Location *	WS
Category	Supplemental		GPS Latitude/Longitude		
			Start	End	
Item	2015 USACE Erosion Survey, DRAFT		38.541246 °	38.538689 °	
			-121.513561 °	-121.515916 °	
DWR ID					
Action/Comments					
Inspector Comments: 2008 - Erosion into levee toe. Over steepened levee slope, worst at the upstream end. 2009 - Near vertical banks from rotational slumping, hidden by vegetation. 2010 - Boat sinking more, may be causing eddy scour around it. Difficult to see the vertical slumps due to dense vegetation. 2011 - Minor new erosion at the toe. The paddleboat that was sitting at this site for years has been removed. 2012 - Site extended upstream due to additional erosion. 2015: No observed changes. [2015 Site ID: SAC_55-7_R]

USACE 2013 Photo #1

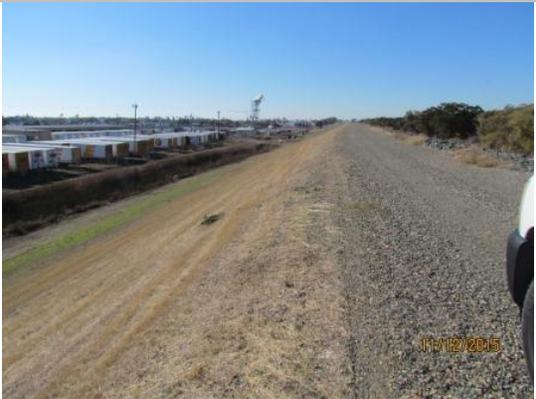
Photo 1 of 1 : FA_2015_RD0900_231_46_20151113_00008.jpg

LM Start	0.10	Rating **	A	Issue No.	46
LM End	0.10	Issue Type +	Ma	Location *	LS
Category	Earthen Levee			GPS Latitude/Longitude	
				Start	End
Item	Vegetation			38.580929 °	38.580929 °
				-121.568259 °	-121.568259 °
DWR ID	DWR_RD0900_02_f_2015_46				
Action/Comments					
Control annual grass and weeds on the levee slopes and easements. Inspector Comments: Acceptable vegetation.

View of the acceptable vegetation on the landside slope of the levee.

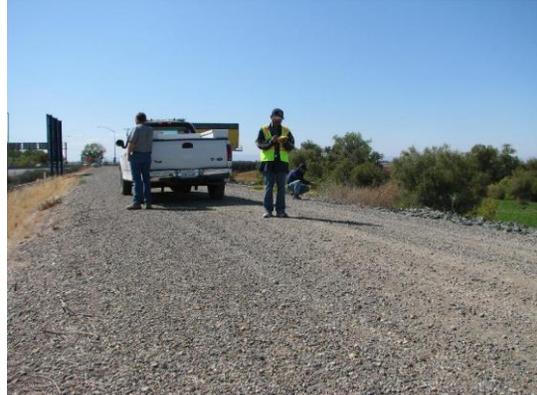
Photo 3 of 3 : UCIP_FA_2015_5922.jpg

LM Start	0.87	Rating **	M	Issue No.	47 (cont)
LM End	0.87	Issue Type +	En	Location *	LS
Category	Supplemental			GPS Latitude/Longitude	
				Start	End
Item	DWR UCIP Field Study			38.574732 °	38.574732 °
				-121.580124 °	-121.580124 °
DWR ID					
Action/Comments					
Inspector Comments: FS_ID:41825 DS_ID:17862 EP_NO: 2444 FS_HLM: 0.866 Repair Type: Non-Urgent Crossing Status: Indicator Found UCIP Comments: Records show 3 gas lines in general area--unable to confirm alignment and status of crossing. Markers visible in general area are for Kinder Morgan and not the owner listed on permit. Need to contact owner to clarify if crossing is still present and if so determine status of crossing. Need date of last inspection and confirmation that crossing is still in operable condition. FIELD_STRUCT_DESC: 16-inch high pressure steel gas line through the levee 3.0 feet below the crown. (Permit No. 2444 & 2893 - PG&E) FS Date: 10/05/2009

View of levee crown near marker.

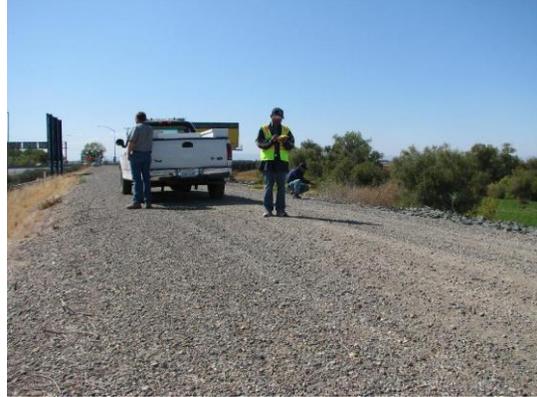
Photo 1 of 3 : UCIP_FA_2015_5919.jpg

LM Start	0.87	Rating **	M	Issue No.	48
LM End	0.87	Issue Type +	En	Location *	LS
Category	Supplemental			GPS Latitude/Longitude	
				Start	End
Item	DWR UCIP Field Study			38.574732 °	38.574732 °
				-121.580124 °	-121.580124 °
DWR ID					
Action/Comments					
Inspector Comments: FS_ID:41826 DS_ID:17874 EP_NO: 17739 FS_HLM: 0.866 Repair Type: Non-Urgent Crossing Status: Indicator Found

View of levee crown near marker.

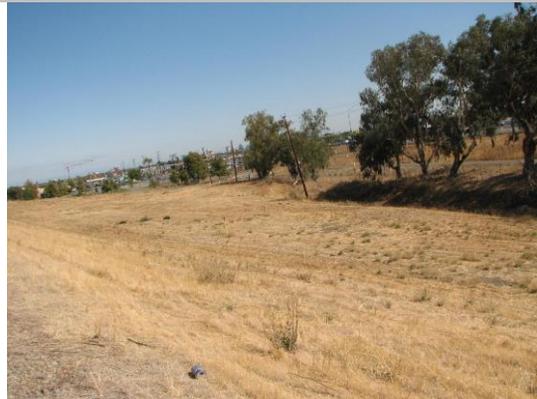
Photo 2 of 3 : UCIP_FA_2015_6401.jpg

View of additional marker visible on landward side.

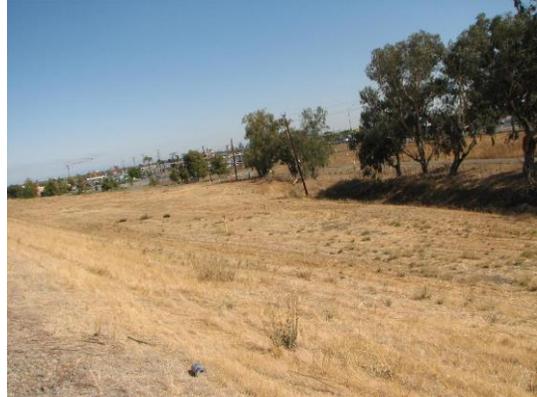
Photo 1 of 3 : UCIP_FA_2015_5923.jpg

LM Start	1.05	Rating **	M	Issue No.	49
LM End	1.05	Issue Type +	En	Location *	LS
Category	Supplemental			GPS Latitude/Longitude	
				Start	End
Item	DWR UCIP Field Study			38.572973 °	38.572973 °
				-121.582230 °	-121.582230 °
DWR ID					
Action/Comments					
Inspector Comments: FS_ID:41824 DS_ID:17861 EP_NO: 11539 FS_HLM: 1.05 Repair Type: Non-Urgent Crossing Status: Indicator Found UCIP Comments: Records show 3 gas lines in general area--unable to confirm alignment and status of crossing. Markers visible in general area are for Kinder Morgan and not the owner listed on permit. Need to contact owner to clarify if crossing is still present and if so determine status of crossing. Need date of last inspection and confirmation that crossing is still in operable condition. FIELD_STRUCT_DESC: 16-inch steel gas pipeline through the levee 3.5 feet below the crown. (Pending 1/77, App. No. 11539 - PG&E). FS Date: 10/05/2009

View of additional marker visible on landward side.

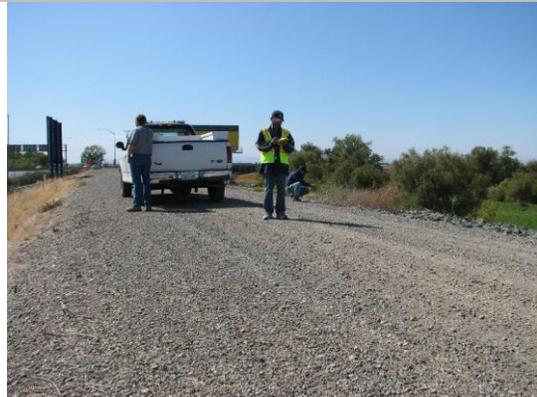
Photo 3 of 3 : UCIP_FA_2015_5925.jpg

LM Start	1.05	Rating **	M	Issue No.	49 (cont)
LM End	1.05	Issue Type +	En	Location *	LS
Category	Supplemental			GPS Latitude/Longitude	
				Start	End
Item	DWR UCIP Field Study			38.572973 °	38.572973 °
				-121.582230 °	-121.582230 °
DWR ID					
Action/Comments					
Inspector Comments: FS_ID:41824 DS_ID:17861 EP_NO: 11539 FS_HLM: 1.05 Repair Type: Non-Urgent Crossing Status: Indicator Found UCIP Comments: Records show 3 gas lines in general area--unable to confirm alignment and status of crossing. Markers visible in general area are for Kinder Morgan and not the owner listed on permit. Need to contact owner to clarify if crossing is still present and if so determine status of crossing. Need date of last inspection and confirmation that crossing is still in operable condition. FIELD_STRUCT_DESC: 16-inch steel gas pipeline through the levee 3.5 feet below the crown. (Pending 1/77, App. No. 11539 - PG&E). FS Date: 10/05/2009

View of levee crown near marker visible on landward shoulder.

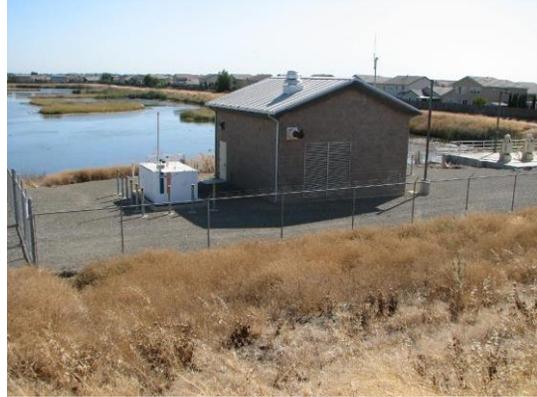
Photo 1 of 3 : UCIP_FA_2015_6703.jpg

House structure located on waterward side.

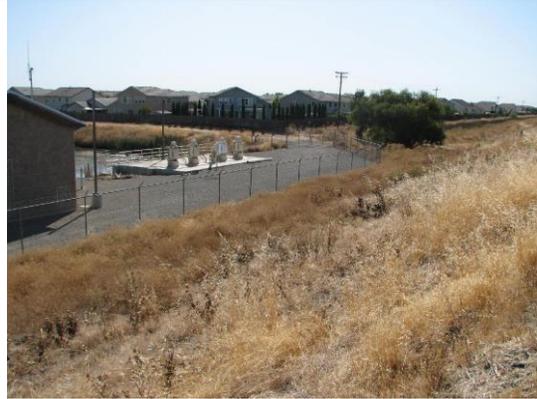
Photo 2 of 3 : UCIP_FA_2015_6704.jpg

Pump station located on waterward side.

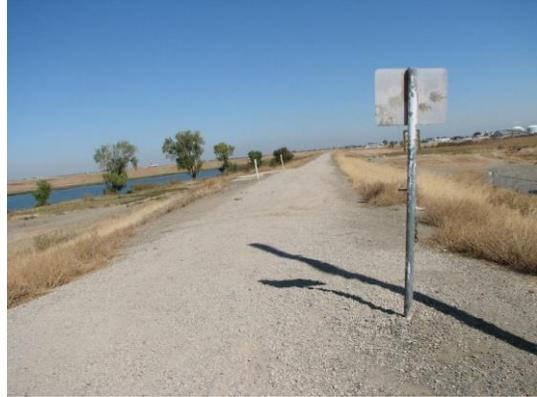
Photo 3 of 3 : UCIP_FA_2015_6705.jpg

LM Start	3.23	Rating **	M	Issue No.	61 (cont)
LM End	3.23	Issue Type +	En	Location *	LS
Category	Supplemental			GPS Latitude/Longitude	
				Start	End
Item	DWR UCIP Field Study			38.541353 °	38.541353 °
				-121.582202 °	-121.582202 °
DWR ID					
Action/Comments					
Inspector Comments: FS_ID:37770 DS_ID:17885 EP_NO: 17070 FS_HLM: 3.241 Repair Type: Non-Urgent Crossing Status: Found

View of levee crown at crossing.

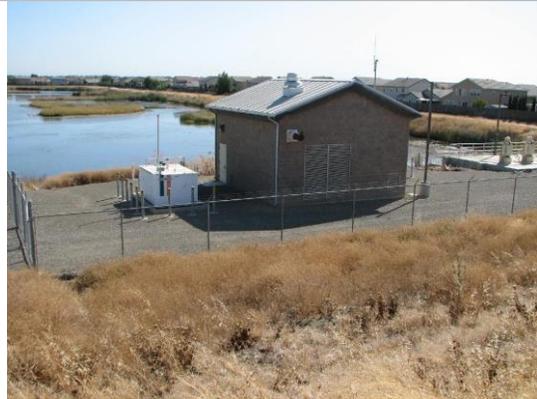
Photo 1 of 3 : UCIP_FA_2015_6700.jpg

LM Start	3.23	Rating **	M	Issue No.	62
LM End	3.23	Issue Type +	En	Location *	LS
Category	Supplemental			GPS Latitude/Longitude	
				Start	End
Item	DWR UCIP Field Study			38.541330 °	38.541330 °
				-121.582201 °	-121.582201 °
DWR ID					
Action/Comments					
Inspector Comments: FS_ID:37766 DS_ID:17876 EP_NO: 17070 FS_HLM: 3.242 Repair Type: Non-Urgent Crossing Status: Found UCIP Comments: Dense vegetation limits the inspector's visibility to identify signs of pipe failure (leaks) along the slope. Recommend removing vegetation along pipe alignment to conduct proper inspection of structure. FIELD_STRUCT_DESC: 2 of 5. 30-inch-diameter steel storm drain pipelines through the left (east) bank levee and a discharge structure in the floodway of the Sacramento River Deep Water Ship Channel. (Permit No. 17070-2000). The pipe depth is 2.0 ft. below the crown. FS Date: 10/05/2009

House structure located on landward side.

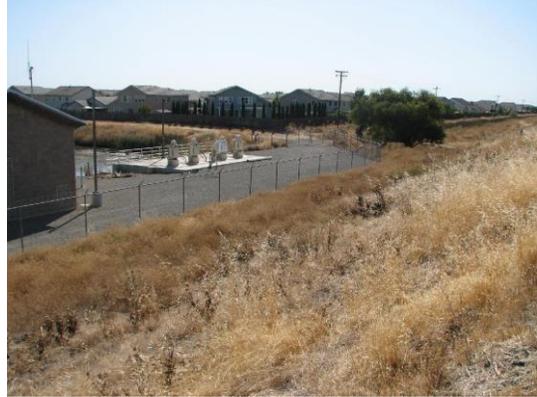
Photo 2 of 3 : UCIP_FA_2015_6701.jpg

Concrete pad with pumps located on landward side.

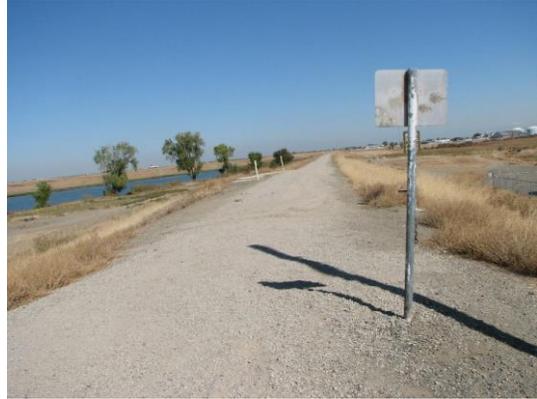
Photo 3 of 3 : UCIP_FA_2015_6702.jpg

View of levee crown at crossing.

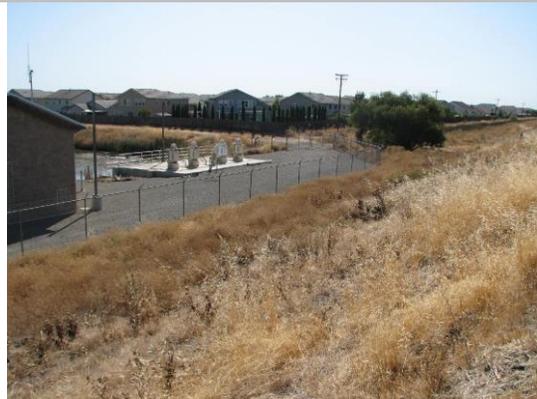
Photo 2 of 3 : UCIP_FA_2015_6753.jpg

Pump station located on landward side.

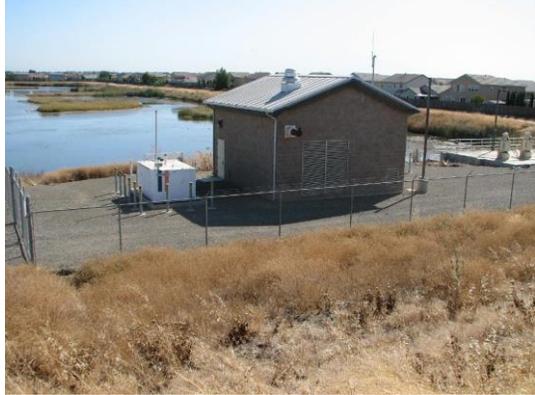
Photo 1 of 3 : UCIP_FA_2015_6205.jpg

LM Start	3.24	Rating **	M	Issue No.	65
LM End	3.24	Issue Type +	En	Location *	LS
Category	Supplemental			GPS Latitude/Longitude	
				Start	End
Item	DWR UCIP Field Study			38.541265 °	38.541265 °
				-121.582200 °	-121.582200 °
DWR ID					
Action/Comments					
Inspector Comments: FS_ID:37781 DS_ID:17886 EP_NO: 17070 FS_HLM: 3.245 Repair Type: Non-Urgent Crossing Status: Found

Pump station located on landward side, photo 2 of 2.

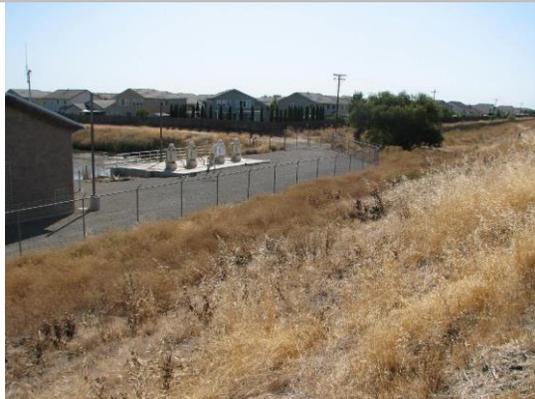
Photo 2 of 3 : UCIP_FA_2015_6206.jpg

Pump station located on landward side, photo 1 of 2.

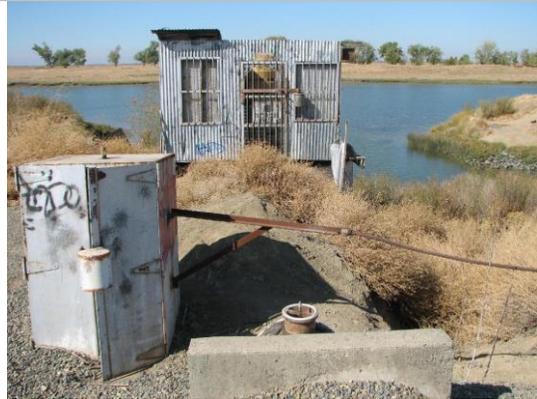
Photo 1 of 3 : UCIP_FA_2015_6208.jpg

LM Start	3.26	Rating **	M	Issue No.	66
LM End	3.26	Issue Type +	En	Location *	LS
Category	Supplemental			GPS Latitude/Longitude	
				Start	End
Item	DWR UCIP Field Study			38.540959 °	38.540959 °
				-121.582224 °	-121.582224 °
DWR ID					
Action/Comments					
Inspector Comments: FS_ID:37785 DS_ID:17856 EP_NO: 2721A FS_HLM: 3.28 Repair Type: Non-Urgent Crossing Status: Found UCIP Comments: Need to contact owner--crossing appears to no longer be in use. Abandoned pipe sections visible on landward side and damage to pump station on waterward side. FIELD_STRUCT_DESC: 30-inch corrugated metal pipe through the levee 3.0 feet below crown. Pump house and siphon breaker on the waterward slope. (App. No. 2721A - R.D. No. 900) (Station 2) FS Date: 10/05/2009

View of pump house visible on waterward side.

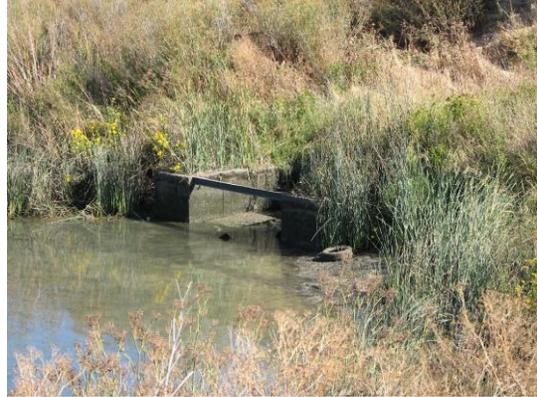
Photo 2 of 3 : UCIP_FA_2015_6209.jpg

LM Start	3.26	Rating **	M	Issue No.	66 (cont)
LM End	3.26	Issue Type +	En	Location *	LS
Category	Supplemental			GPS Latitude/Longitude	
				Start	End
Item	DWR UCIP Field Study			38.540959 °	38.540959 °
				-121.582224 °	-121.582224 °
DWR ID					
Action/Comments					
Inspector Comments: FS_ID:37785 DS_ID:17856 EP_NO: 2721A FS_HLM: 3.28 Repair Type: Non-Urgent Crossing Status: Found UCIP Comments: Need to contact owner--crossing appears to no longer be in use. Abandoned pipe sections visible on landward side and damage to pump station on waterward side. FIELD_STRUCT_DESC: 30-inch corrugated metal pipe through the levee 3.0 feet below crown. Pump house and siphon breaker on the waterward slope. (App. No. 2721A - R.D. No. 900) (Station 2) FS Date: 10/05/2009

Concrete outlet visible on waterward side.

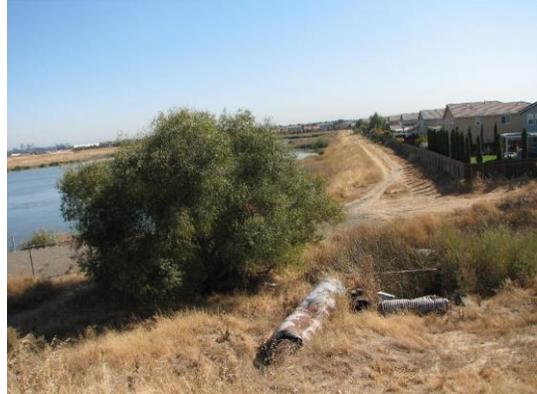
Photo 3 of 3 : UCIP_FA_2015_6242.jpg

View of pipe sections visible on landward side.

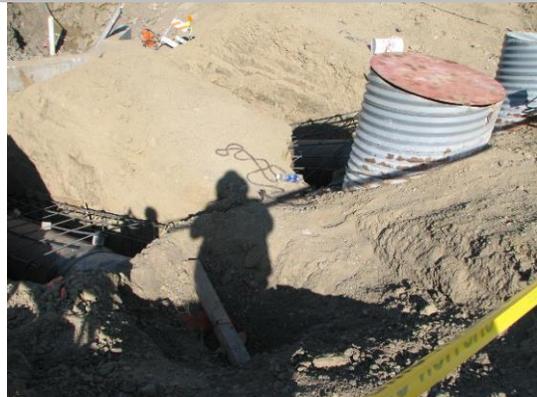
Photo 2 of 3 : UCIP_FA_2015_6196.jpg

Construction of structures in Oct-2009, photo 2 of 3.

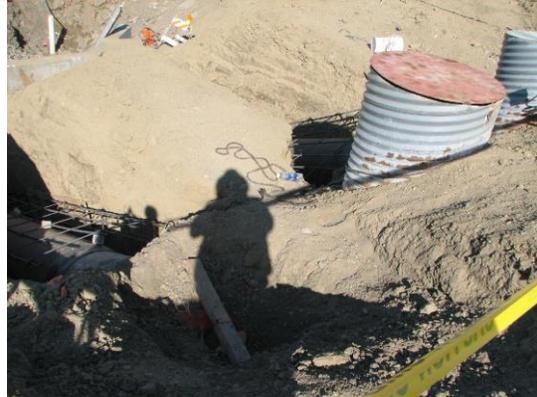
Photo 2 of 3 : UCIP_FA_2015_6199.jpg

LM Start	4.96	Rating **	M	Issue No.	68 (cont)
LM End	4.96	Issue Type +	En	Location *	LS
Category	Supplemental			GPS Latitude/Longitude	
				Start	End
Item	DWR UCIP Field Study			38.516225 °	38.516225 °
				-121.582194 °	-121.582194 °
DWR ID					
Action/Comments					
Inspector Comments: FS_ID:37891 DS_ID:17881 EP_NO: 18116 FS_HLM: 4.972 Repair Type: Non-Urgent Crossing Status: Found UCIP Comments: Under construction Oct-2009. Need updated photos of completed structure. FIELD_STRUCT_DESC: 2 of 4. 54-inch steel pipes through the levee, 12.9 feet below the crown. Pump house on the landward side, siphon breaker on the waterward slope. (Permit No. 18116 - 2007), (Permit No. 4257). FS Date: 10/05/2009

Construction of structures in Oct-2009, photo 2 of 3.

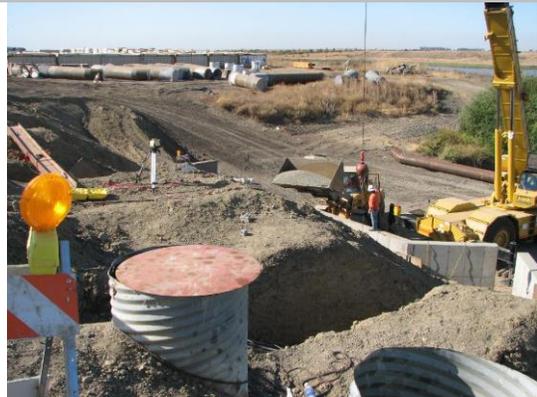
Photo 3 of 3 : UCIP_FA_2015_6200.jpg

Construction of structures in Oct-2009, photo 1 of 3.

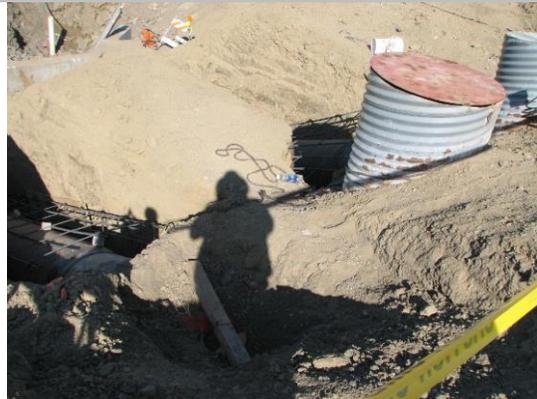
Photo 2 of 3 : UCIP_FA_2015_6371.jpg

LM Start	4.97	Rating **	M	Issue No.	69
LM End	4.97	Issue Type +	En	Location *	LS
Category	Supplemental			GPS Latitude/Longitude	
				Start	End
Item	DWR UCIP Field Study			38.516175 °	38.516175 °
				-121.582191 °	-121.582191 °
DWR ID					
Action/Comments					
Inspector Comments: FS_ID:37892 DS_ID:17882 EP_NO: 18116 FS_HLM: 4.973 Repair Type: Non-Urgent Crossing Status: Found

Construction of structures in Oct-2009, photo 2 of 3.

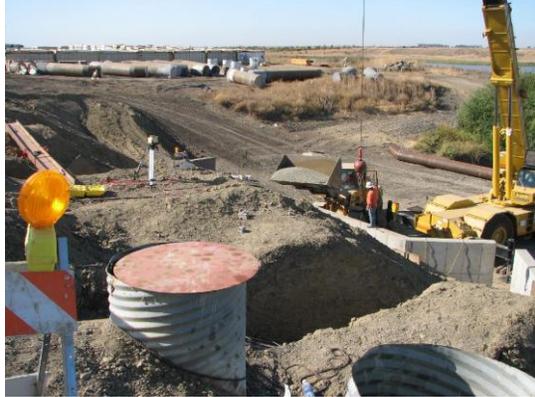
Photo 3 of 3 : UCIP_FA_2015_6372.jpg

LM Start	4.97	Rating **	M	Issue No.	69 (cont)
LM End	4.97	Issue Type +	En	Location *	LS
Category	Supplemental			GPS Latitude/Longitude	
				Start	End
Item	DWR UCIP Field Study			38.516175 °	38.516175 °
				-121.582191 °	-121.582191 °
DWR ID					
Action/Comments					
Inspector Comments: FS_ID:37892 DS_ID:17882 EP_NO: 18116 FS_HLM: 4.973 Repair Type: Non-Urgent Crossing Status: Found

Construction of structures in Oct-2009, photo 1 of 3.

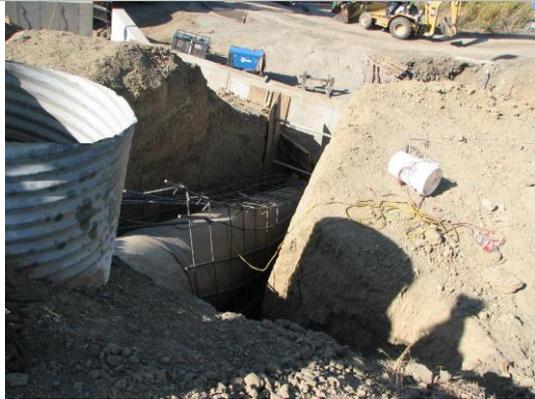
Photo 1 of 3 : UCIP_FA_2015_6373.jpg

LM Start	4.97	Rating **	M	Issue No.	70
LM End	4.97	Issue Type +	En	Location *	LS
Category	Supplemental			GPS Latitude/Longitude	
				Start	End
Item	DWR UCIP Field Study			38.516141 °	38.516141 °
				-121.582189 °	-121.582189 °
DWR ID					
Action/Comments					
Inspector Comments: FS_ID:37894 DS_ID:17883 EP_NO: 18116 FS_HLM: 4.974 Repair Type: Non-Urgent Crossing Status: Found UCIP Comments: Under construction Oct-2009. Need updated photos of completed structure. FIELD_STRUCT_DESC: 4 of 4. 54-inch steel pipes through the levee, 12.9 feet below the crown. Pump house on the landward side, siphon breaker on the waterward slope. (Permit No. 18116-2007), (Permit No. 4257). FS Date: 10/05/2009

Construction of structures in Oct-2009, photo 3 of 3.
