**Flood Control Project Maintenance
Levee Inspections**

Fall 2011 Levee Maintenance Deficiency Summary Report

Reclamation District No. 0999 Netherlands

Levee Inspection Report By Mile - Fall 2011

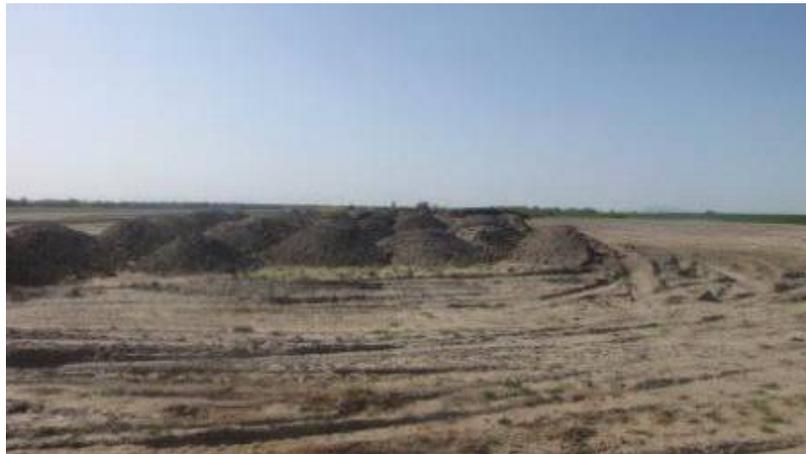
Levee Mile Report Line	1
Start Levee Mile	0.13
End Levee Mile	0.41
Location	Water Side
Category	Earthen Levee
Item	Encroachments
Looking south at fill on waterside shoulder and slope.	
richard_f_20110922_465.jpg

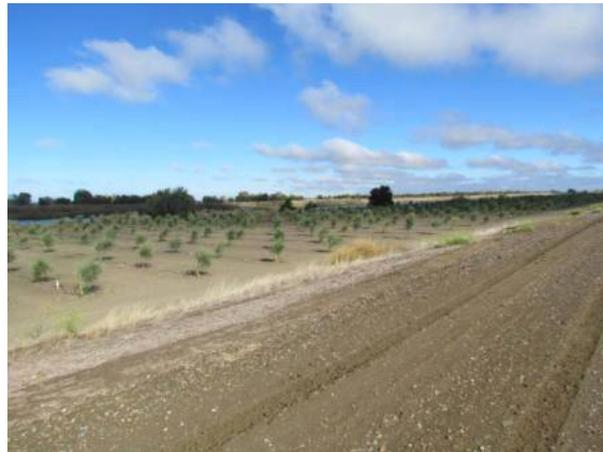
Levee Mile Report Line	8
Start Levee Mile	3.33
End Levee Mile	5.30
Location	Water Side
Category	Earthen Levee
Item	Encroachments
Looking northwest at olive grove on waterside berm at upstream end.	
richard_f_20111014_599.jpg

7	2.20	2.21	Earthen Levee	Trim / Thin Trees	WS	M	Thin trees to allow visibility of the ground and room to flood fight.	38.473542 ° -121.580793 °	38.473417 ° -121.580885 °	8
8	3.33	5.30	Earthen Levee	Encroachments	WS	PO	Crops Inspector Comments: Landowner has planted Olive grove on waterside berm several years ago without a board permit.	38.458197 ° -121.588062 °	38.431240 ° -121.600587 °	5 Y
9	3.63	3.66	Earthen Levee	Slope Stability	LS	U	Repair slope instability. Inspector Comments: District Manager (Bob Webber) indicated that the area has a history of cracking and sloughing. District plan to repair site this summer.	38.454032 ° -121.590025 °	38.453680 ° -121.590173 °	6 Y
10	4.09	4.09	Earthen Levee	Trim / Thin Trees	WS	M	Trim trees to at least five feet above ground level.	38.447772 ° -121.592912 °	38.447772 ° -121.592912 °	11
11	4.15	4.21	Earthen Levee	Encroachments	WS	W	Prunings	38.447017 ° -121.593338 °	38.446288 ° -121.593657 °	9 Y

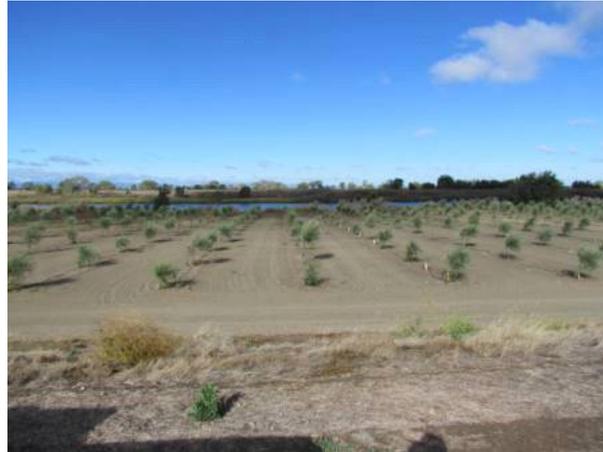
Levee Mile Report Line	8
Start Levee Mile	3.33
End Levee Mile	5.30
Location	Water Side
Category	Earthen Levee
Item	Encroachments
Looking west at olive grove on waterside berm.	
richard_f_20111014_600.jpg

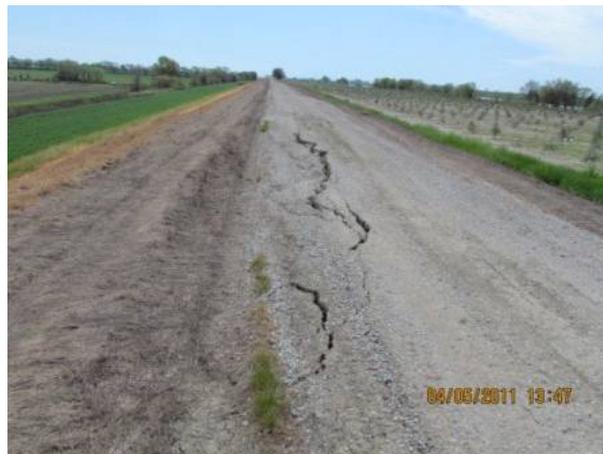
Levee Mile Report Line	9
Start Levee Mile	3.63
End Levee Mile	3.66
Location	Land Side
Category	Earthen Levee
Item	Slope Stability
Looking south at 130' long cracking on landside shoulder, slope, and crown	
richard_f_20110922_468.jpg

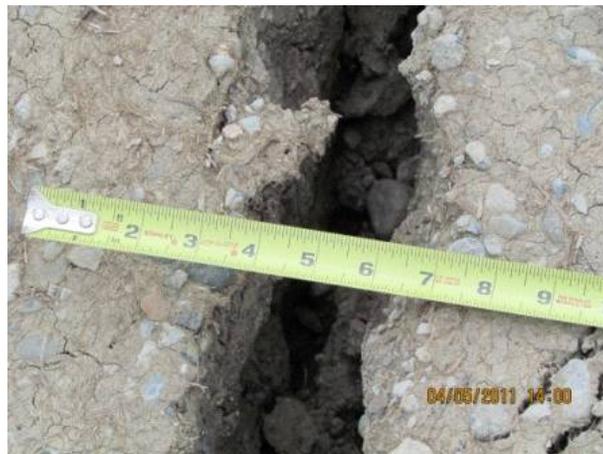
Levee Mile Report Line	9
Start Levee Mile	3.63
End Levee Mile	3.66
Location	Land Side
Category	Earthen Levee
Item	Slope Stability
Looking at cracks from 1 inch to 3 inches wide on levee crown.	
richard_f_20110922_471.jpg

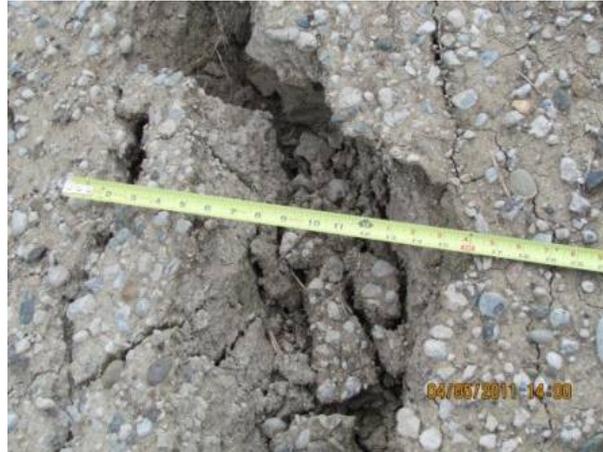
richard_f_20110922_472.jpg

Looking at crack 16 inch wide

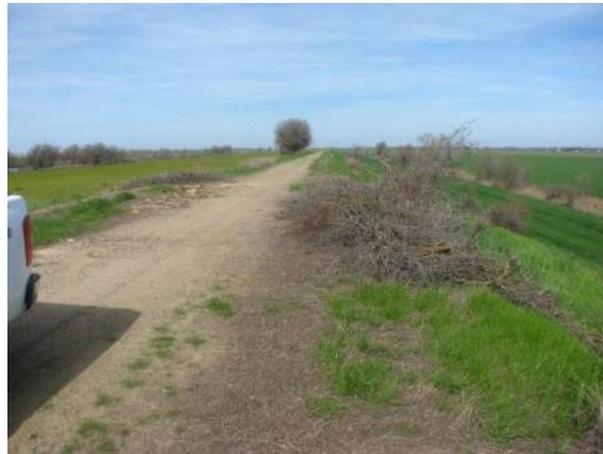
richard_f_20110922_473.jpg

Levee Mile Report Line	11
Start Levee Mile	4.15
End Levee Mile	4.21
Location	Water Side
Category	Earthen Levee
Item	Encroachments

Pruning pile on waterside shoulder.

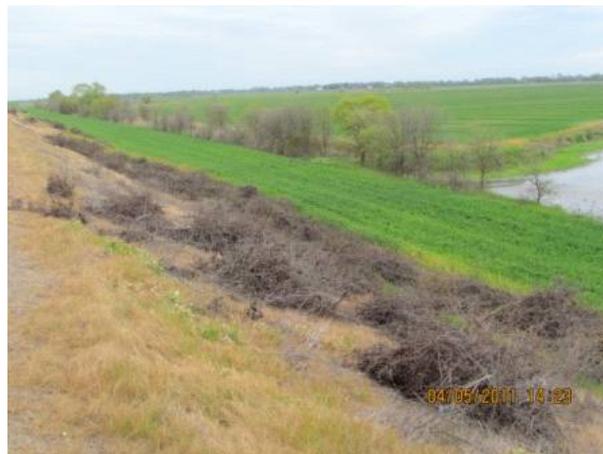
richard_f_20110922_474.jpg

Levee Mile Report Line	12
Start Levee Mile	4.17
End Levee Mile	4.18
Location	Land Side
Category	Earthen Levee
Item	Encroachments

Looking northeast at prunings along landside slope.

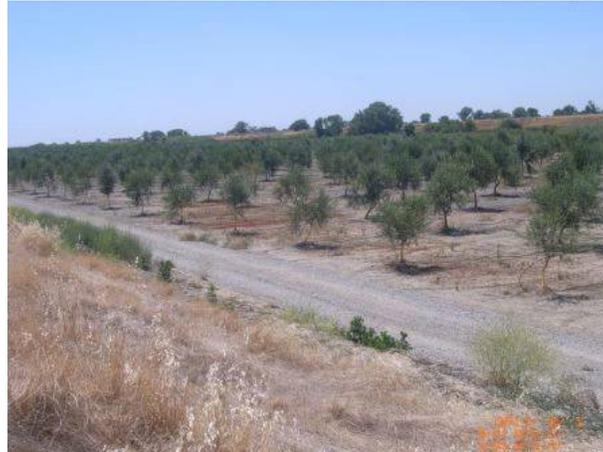
Levee Mile Report Line	17
Start Levee Mile	4.84
End Levee Mile	4.86
Location	Water Side
Category	Supplemental
Item	USACE Erosion Survey
USACE 2011 Photo #1	
USACE2011_DWS_5-0_L_1.jpg

LMIR No.	Levee Mile		Category	Item	* Location	** Rating	Action/Comment	GPS Latitude/Longitude		Issue No. Photo
	Start	End						Start	End	
17	4.84	4.86	Supplemental	USACE Erosion Survey	WS	M	Inspector Comments: 2006 - Slump failure of lower slope. Longitudinal cracks present along the levee slope. 2011: Difficult to see due to overgrown vegetation. A small section of the levee has slumped. Sties DWS 5.0 and DWS 5.01 were combined. [2011 Site ID: DWS_5-0_L]	38.437506 ° -121.597707 °	38.437296 ° -121.597803 °	34 Y
18	5.20	5.29	Earthen Levee	Crown Surface / Depressions / Rutting	CR	M	Add appropriate gravel or road base. Grade and compact.	38.432700 ° -121.599950 °	38.431425 ° -121.600528 °	12
19	6.55	6.60	Earthen Levee	Encroachments	LS	M	Prunings	38.414367 ° -121.608430 °	38.413698 ° -121.608762 °	18 Y
20	6.57	6.57	Earthen Levee	Trim / Thin Trees	LS	M	Thin trees to allow visibility of the ground and room to flood fight.	38.414002 ° -121.608573 °	38.414002 ° -121.608573 °	29

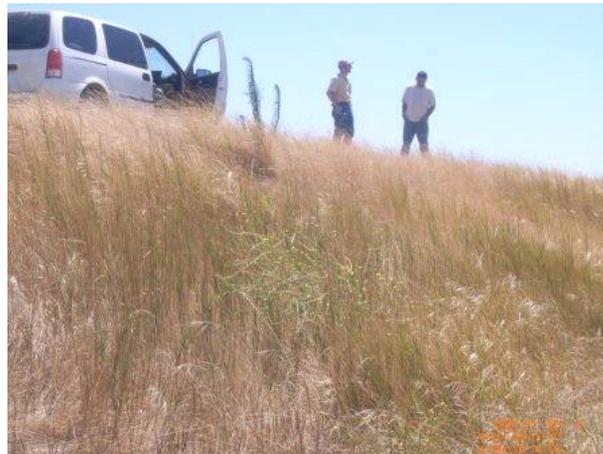
Levee Mile Report Line	17
Start Levee Mile	4.84
End Levee Mile	4.86
Location	Water Side
Category	Supplemental
Item	USACE Erosion Survey
USACE 2011 Photo #3	
USACE2011_DWS_5-0_L_3.jpg

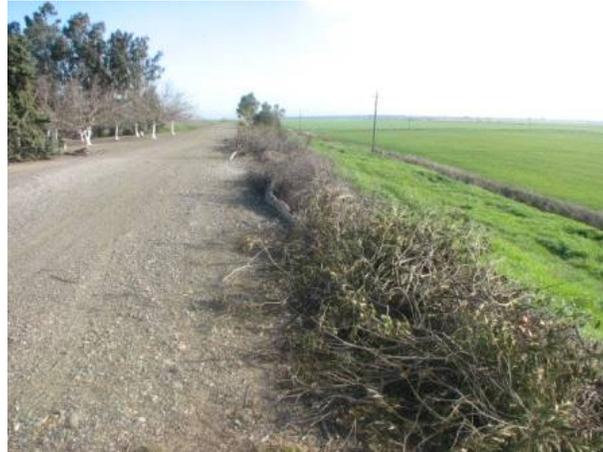
Levee Mile Report Line	19
Start Levee Mile	6.55
End Levee Mile	6.60
Location	Land Side
Category	Earthen Levee
Item	Encroachments
Prunings along landside shoulder.	
richard_f_20110922_476.jpg

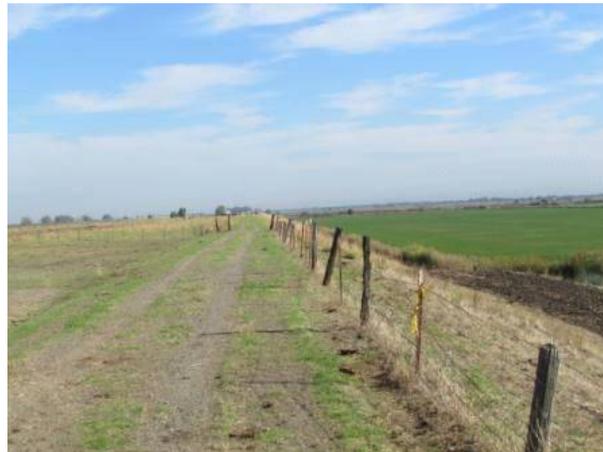
Levee Mile Report Line	23
Start Levee Mile	9.20
End Levee Mile	9.27
Location	Land Side
Category	Earthen Levee
Item	Encroachments
Looking north at fence along landside shoulder.	
richard_f_20111014_616.jpg

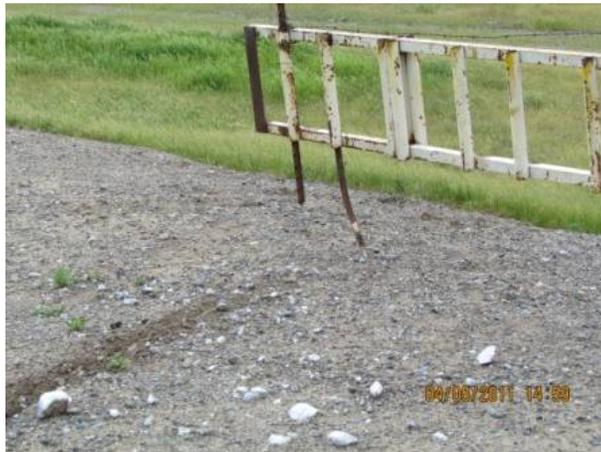
Levee Mile Report Line	29
Start Levee Mile	10.22
End Levee Mile	10.22
Location	Crown
Category	Earthen Levee
Item	Repair Gates
Looking west at gate with tee-post.	
richard_f_20110922_481.jpg

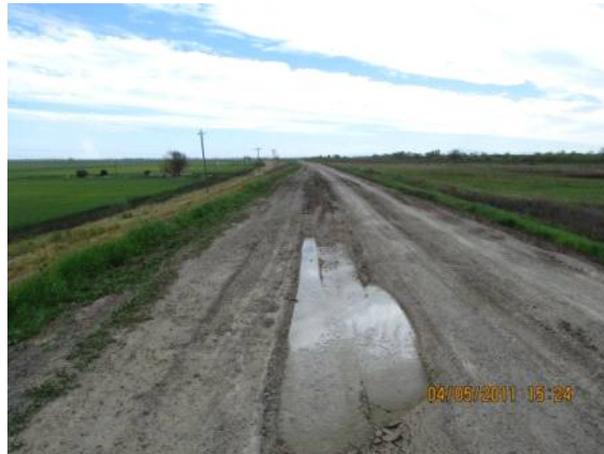
Levee Mile Report Line	35
Start Levee Mile	12.54
End Levee Mile	12.61
Location	Crown
Category	Earthen Levee
Item	Crown Surface / Depressions / Rutting
Looking south at rutting on levee crown.	
richard_f_20110922_477.jpg

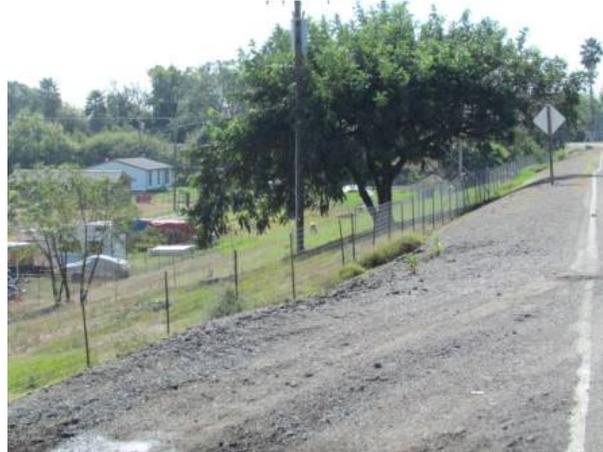
richard_f_20111014_618.jpg

Looking south at fence along landside slope.

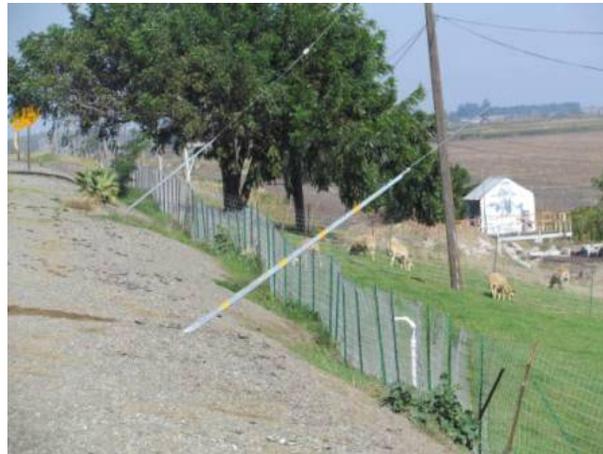
richard_f_20111014_619.jpg

Levee Mile Report Line	40
Start Levee Mile	15.28
End Levee Mile	15.42
Location	Land Side
Category	Earthen Levee
Item	Encroachments

Looking north at fence along landside slope.

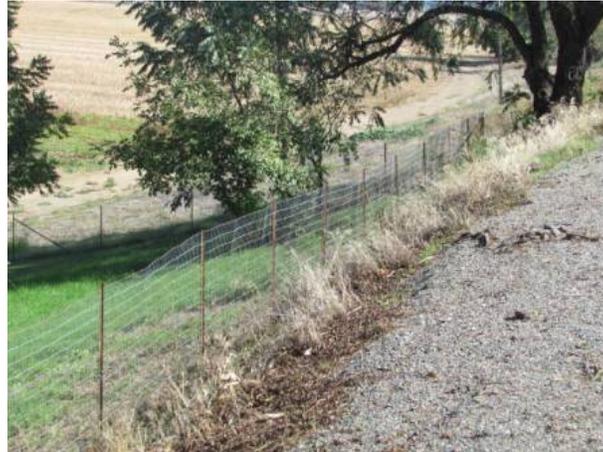
Levee Mile Report Line	1
Start Levee Mile	0.01
End Levee Mile	0.05
Location	Land Side
Category	Earthen Levee
Item	Encroachments
Looking northeast at fence along landside shoulder.	
richard_f_20111014_623.jpg

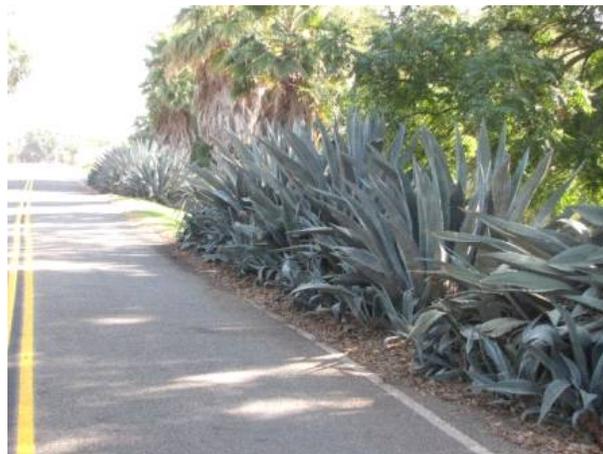
Levee Mile Report Line	2
Start Levee Mile	0.03
End Levee Mile	0.06
Location	Water Side
Category	Earthen Levee
Item	Encroachments
Looking north at century plant on landside shoulder.	
richard_f_20110922_483.jpg

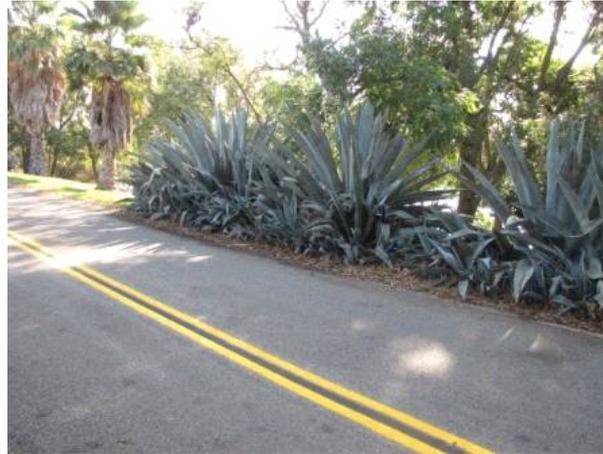
richard_f_20110922_484.jpg

Looking east at century plant on landside shoulder.

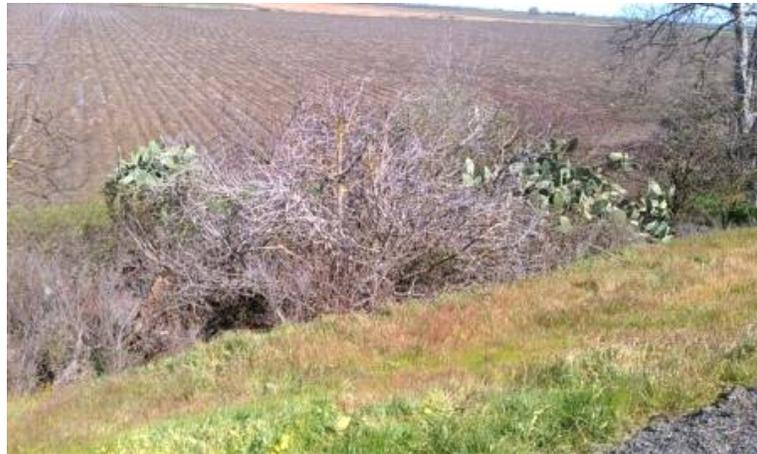
richard_f_20110922_489.jpg

Levee Mile Report Line	3
Start Levee Mile	0.15
End Levee Mile	0.15
Location	Land Side
Category	Earthen Levee
Item	Vegetation

Looking west at dense vegetation on landside toe.

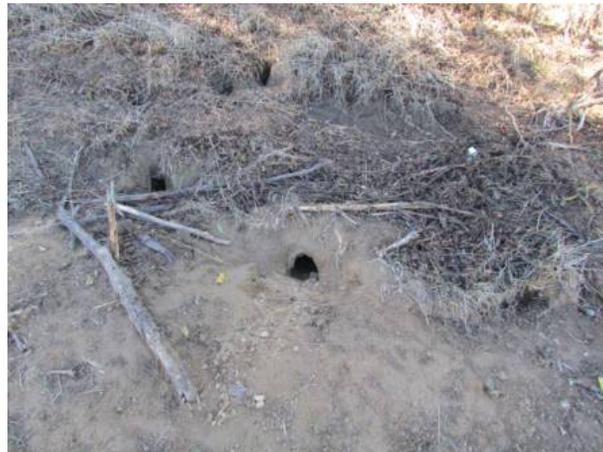
richard_f_20111014_620.jpg

Levee Mile Report Line	6
Start Levee Mile	0.92
End Levee Mile	1.02
Location	Land Side
Category	Earthen Levee
Item	Animal Control

Looking at several rodent holes on landside slope.

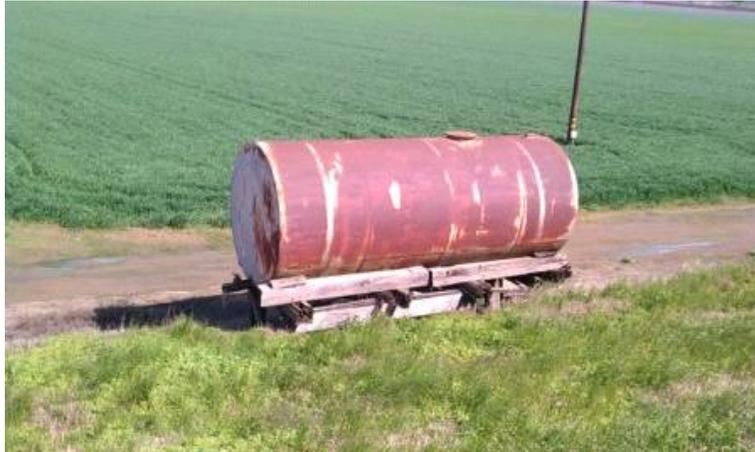
richard_f_20110922_487.jpg

Looking west at tank on landside toe.

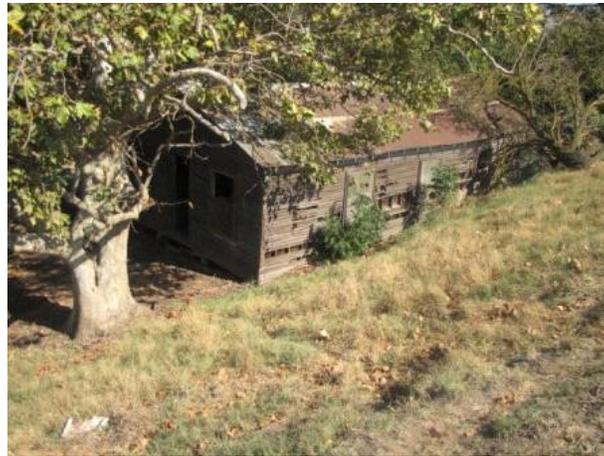
richard_f_20110922_485.jpg

Levee Mile Report Line	8
Start Levee Mile	1.66
End Levee Mile	1.68
Location	Land Side
Category	Earthen Levee
Item	Encroachments

Looking northwest at building at landside toe.

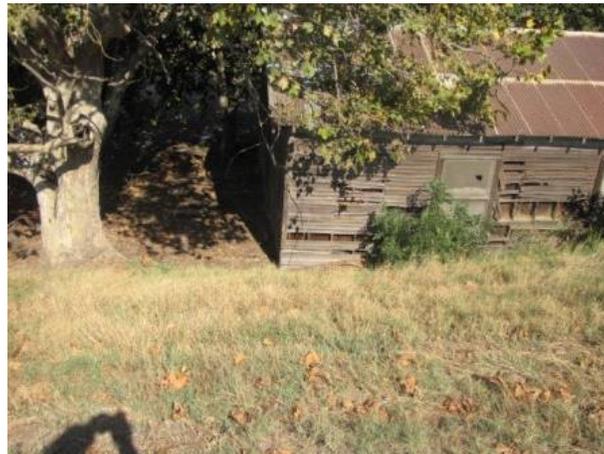
richard_f_20110922_486.jpg

Levee Mile Report Line	8
Start Levee Mile	1.66
End Levee Mile	1.68
Location	Land Side
Category	Earthen Levee
Item	Encroachments

Looking west at building at landside toe.

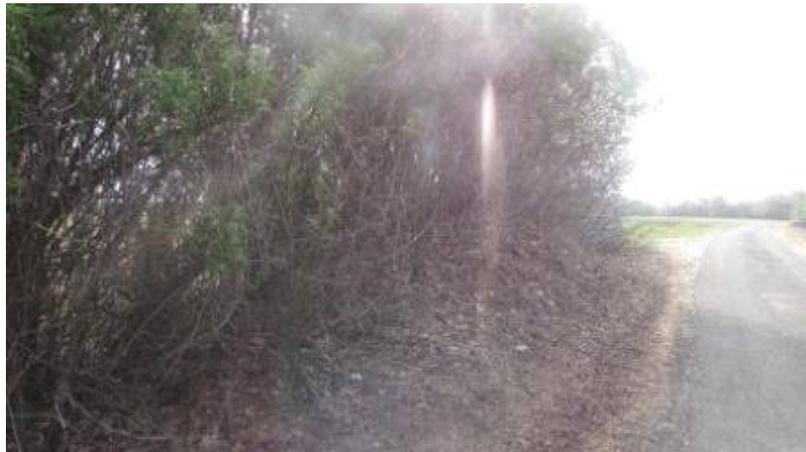
Levee Mile Report Line	14
Start Levee Mile	1.72
End Levee Mile	1.75
Location	Land Side
Category	Earthen Levee
Item	Vegetation
Looking southwest at elderberry bush on landside shoulder and slope.	
richard_f_20110922_488.jpg

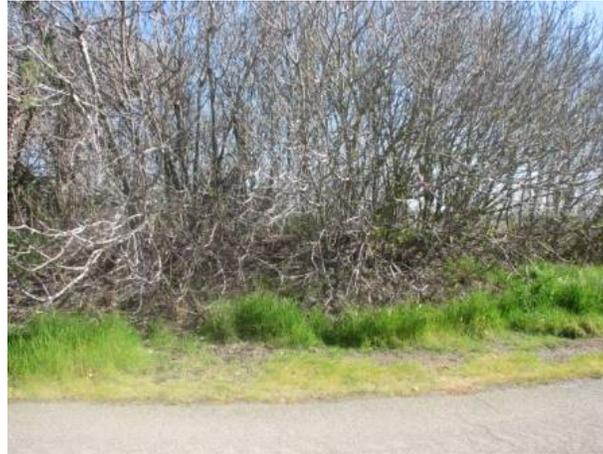
richard_f_20110922_492.jpg

Front view of overgrown fig tree on landside shoulder.

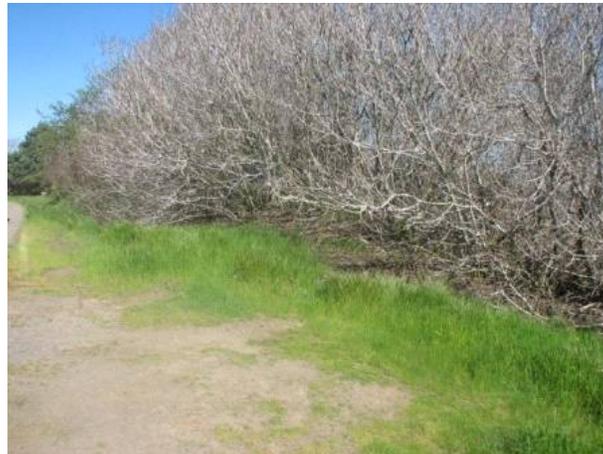
richard_f_20110922_493.jpg

Levee Mile Report Line	15
Start Levee Mile	1.73
End Levee Mile	1.73
Location	Land Side
Category	Earthen Levee
Item	Trim / Thin Trees

Side view of overgrown fig tree along landside shoulder.

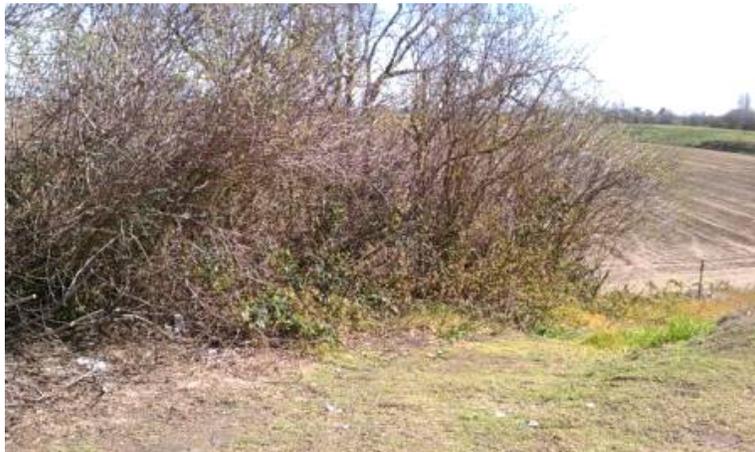
richard_f_20110922_494.jpg

Looking northwest at dense vegetation on landside toe next to ramp.

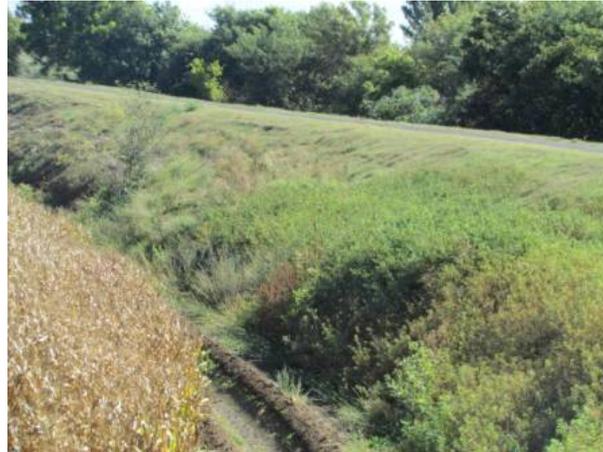
richard_f_20111014_621.jpg

Looking east at dense wild roses on landside toe.

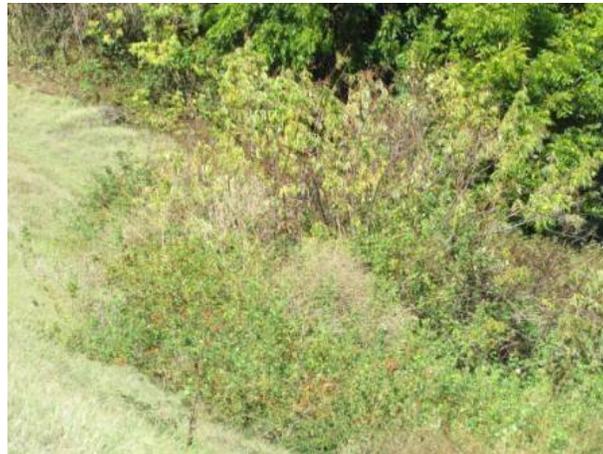
richard_f_20111014_622.jpg

Levee Mile Report Line	16
Start Levee Mile	1.79
End Levee Mile	1.92
Location	Land Side
Category	Earthen Levee
Item	Vegetation

Looking north at wild roses on landside toe.

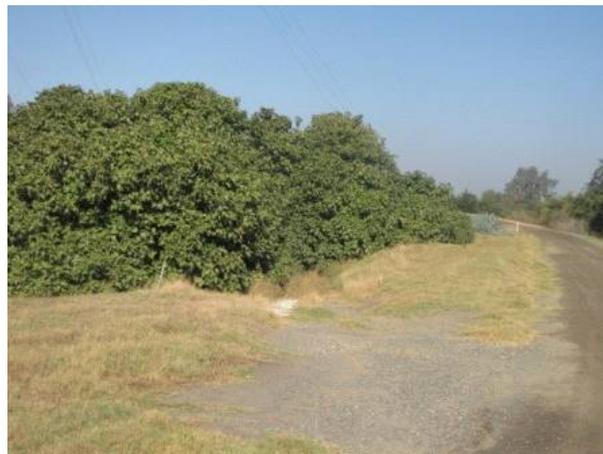
Levee Mile Report Line	2
Start Levee Mile	0.03
End Levee Mile	0.04
Location	Land Side
Category	Earthen Levee
Item	Trim / Thin Trees
Looking northwest at dense trees on landside slope and toe.	
richard_f_20110922_498.jpg

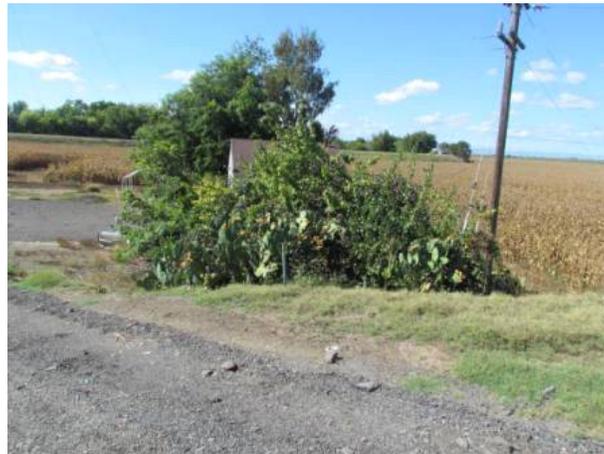
Levee Mile Report Line	4
Start Levee Mile	0.06
End Levee Mile	0.06
Location	Land Side
Category	Earthen Levee
Item	Vegetation
Looking west at dense vegetation on landside slope near ramp.	
richard_f_20111014_626.jpg

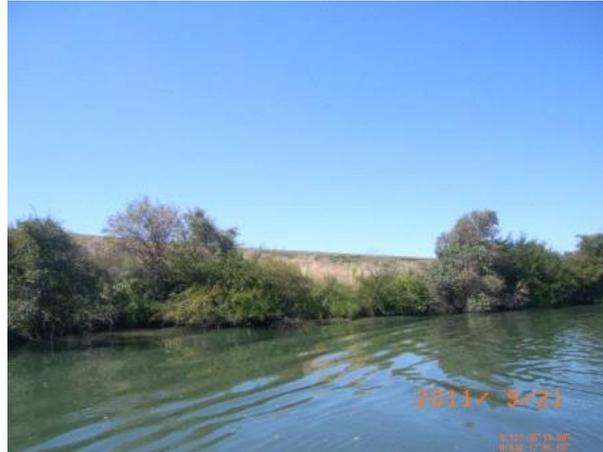
Levee Mile Report Line	5
Start Levee Mile	0.09
End Levee Mile	0.09
Location	Water Side
Category	Supplemental
Item	USACE Erosion Survey
USACE 2011 Photo #1	
USACE2011_STR_24-7_R_1.jpg

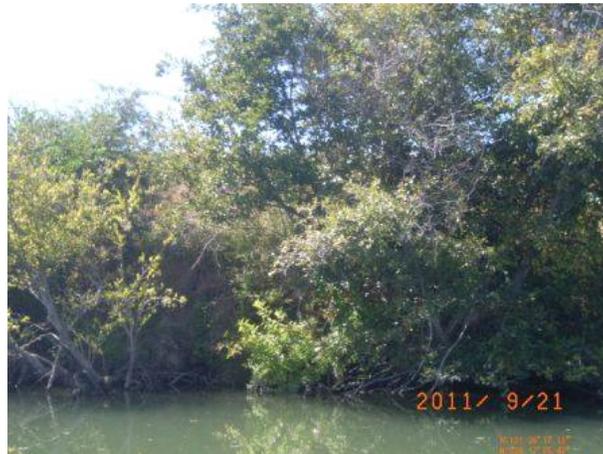
Levee Mile Report Line	5
Start Levee Mile	0.09
End Levee Mile	0.09
Location	Water Side
Category	Supplemental
Item	USACE Erosion Survey
USACE 2011 Photo #3	
USACE2011_STR_24-7_R_3.jpg

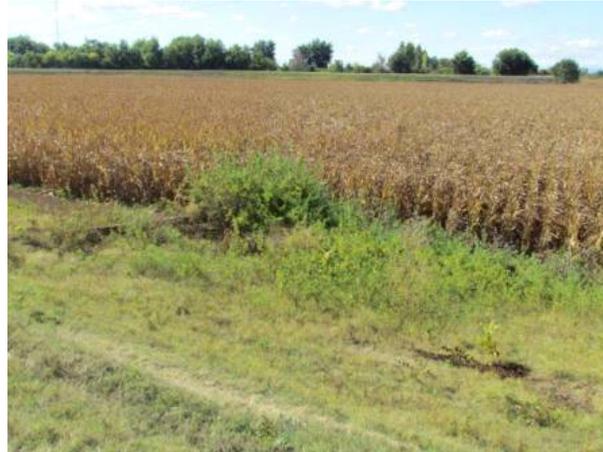
Levee Mile Report Line	6
Start Levee Mile	0.15
End Levee Mile	0.22
Location	Land Side
Category	Earthen Levee
Item	Vegetation
Looking west at berry vines on landside toe.	
richard_f_20111014_627.jpg

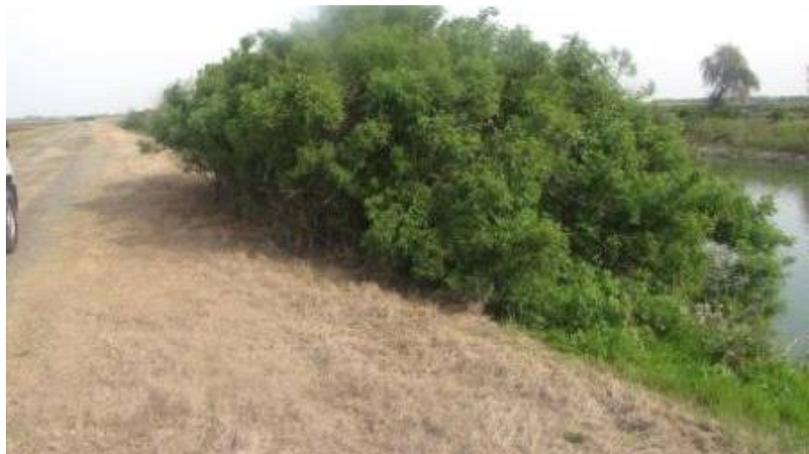
Levee Mile Report Line	7
Start Levee Mile	0.44
End Levee Mile	0.44
Location	Water Side
Category	Earthen Levee
Item	Vegetation
Looking north at elderberry bush on waterside slope.	
richard_f_20110922_501.jpg

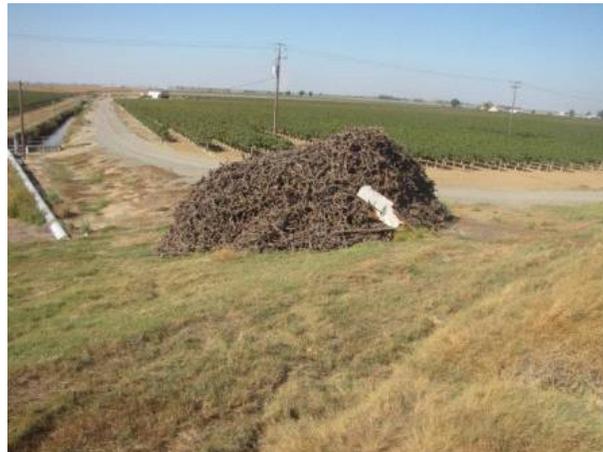
Levee Mile Report Line	13
Start Levee Mile	0.73
End Levee Mile	0.73
Location	Land Side
Category	Earthen Levee
Item	Encroachments
Looking northwest at pruning pile on landside toe.	
richard_f_20110922_495.jpg

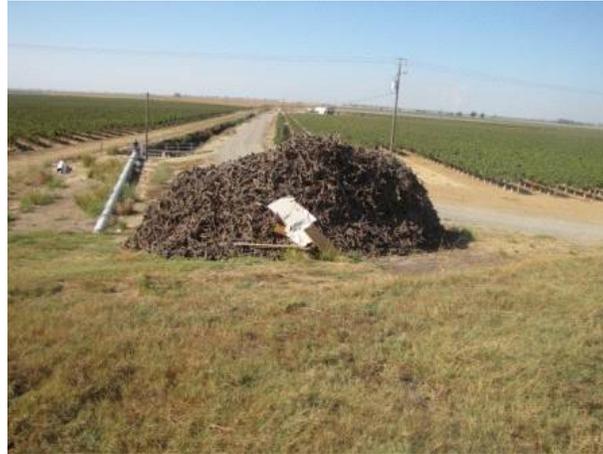
richard_f_20110922_496.jpg

Looking west at pruning pile on landside toe.

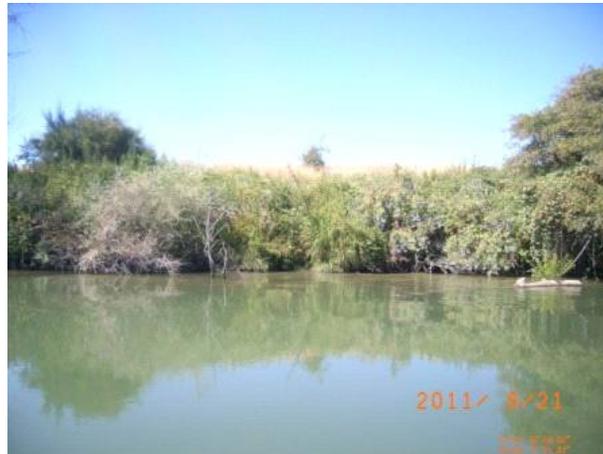
USACE2011_STR_25-2_R_1.jpg

Levee Mile Report Line	14
Start Levee Mile	0.89
End Levee Mile	0.89
Location	Water Side
Category	Supplemental
Item	USACE Erosion Survey

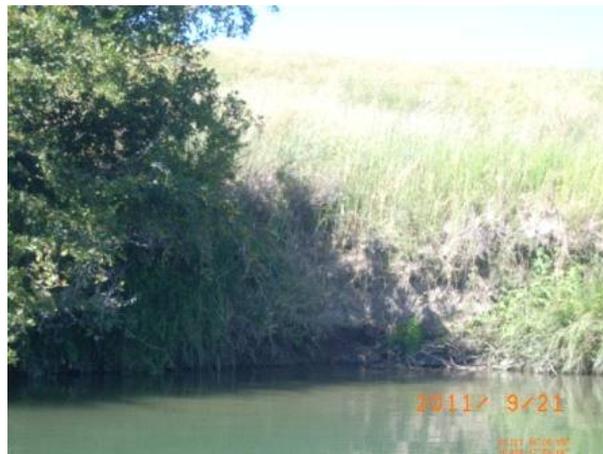
USACE2011_STR_25-2_R_2.jpg

Levee Mile Report Line	14
Start Levee Mile	0.89
End Levee Mile	0.89
Location	Water Side
Category	Supplemental
Item	USACE Erosion Survey

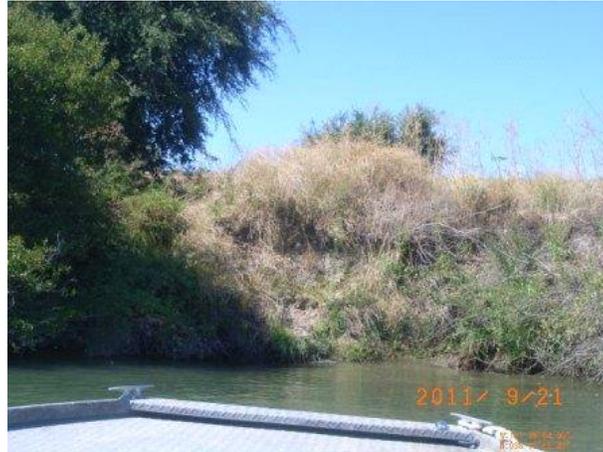
Levee Mile Report Line	16
Start Levee Mile	1.31
End Levee Mile	1.31
Location	Water Side
Category	Supplemental
Item	USACE Erosion Survey
USACE 2011 Photo #1	
USACE2011_STR_25-7_R_1.jpg

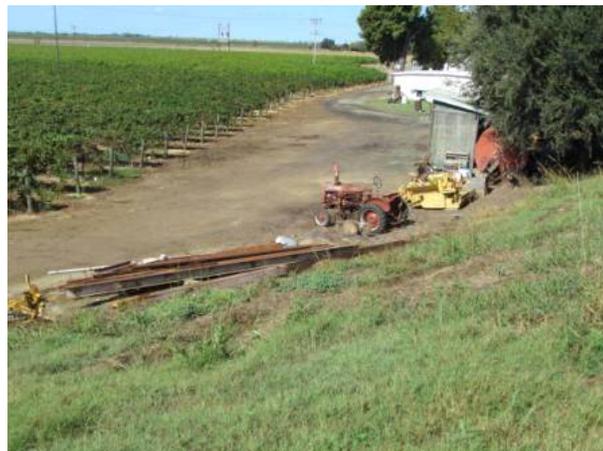
Levee Mile Report Line	26
Start Levee Mile	2.54
End Levee Mile	2.54
Location	Land Side
Category	Earthen Levee
Item	Encroachments
Looking northwest at equipment at landside toe.	
richard_f_20111014_628.jpg

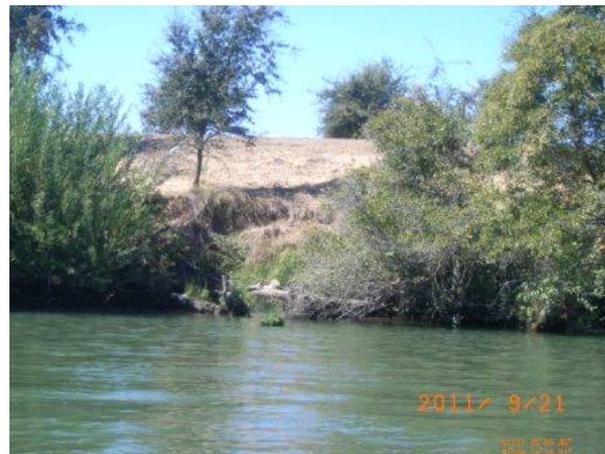
Levee Mile Report Line	30
Start Levee Mile	2.98
End Levee Mile	2.98
Location	Water Side
Category	Supplemental
Item	USACE Erosion Survey
USACE 2011 Photo #1	
USACE2011_STR_27-3_R_1.jpg

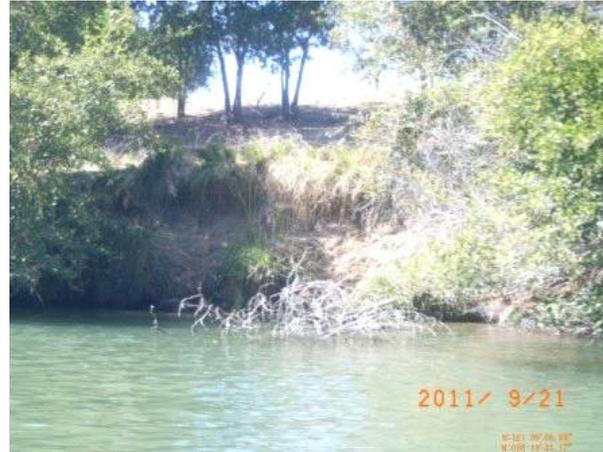
Levee Mile Report Line	30
Start Levee Mile	2.98
End Levee Mile	2.98
Location	Water Side
Category	Supplemental
Item	USACE Erosion Survey
USACE 2011 Photo #2	
USACE2011_STR_27-3_R_2.jpg

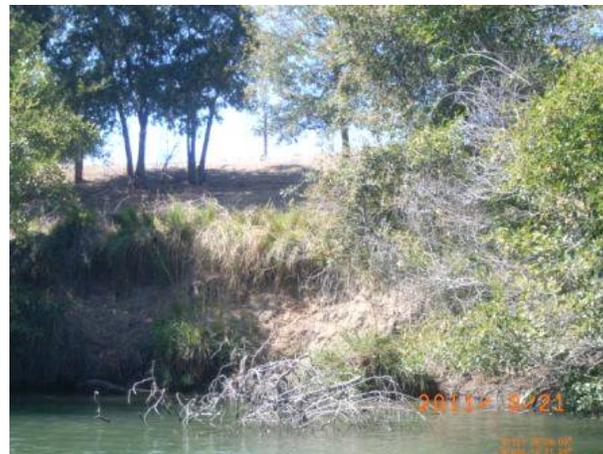
Levee Mile Report Line	30
Start Levee Mile	2.98
End Levee Mile	2.98
Location	Water Side
Category	Supplemental
Item	USACE Erosion Survey
USACE 2011 Photo #3	
USACE2011_STR_27-3_R_3.jpg

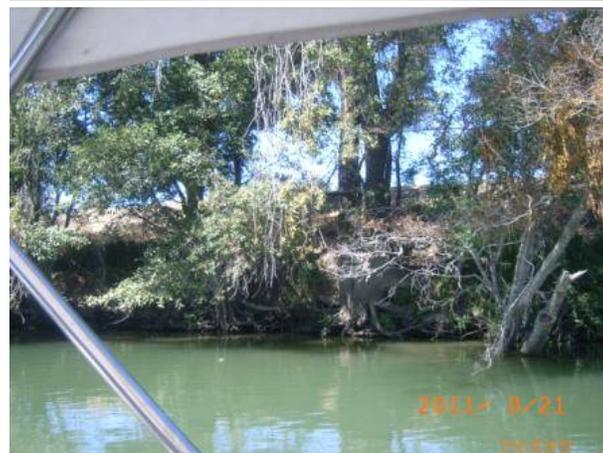
Levee Mile Report Line	30
Start Levee Mile	2.98
End Levee Mile	2.98
Location	Water Side
Category	Supplemental
Item	USACE Erosion Survey
USACE 2011 Photo #4	
USACE2011_STR_27-3_R_4.jpg

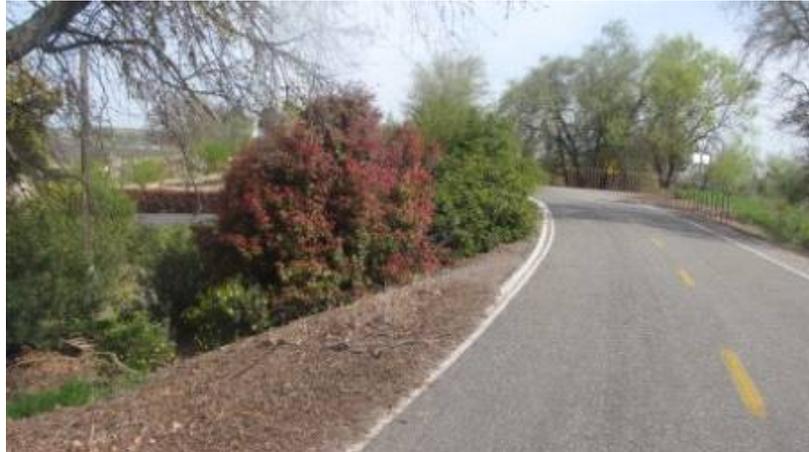
Levee Mile Report Line	34
Start Levee Mile	3.72
End Levee Mile	3.73
Location	Land Side
Category	Earthen Levee
Item	Encroachments
Looking northwest at landscaping on landside slope and toe.	
richard_f_20110922_509.jpg

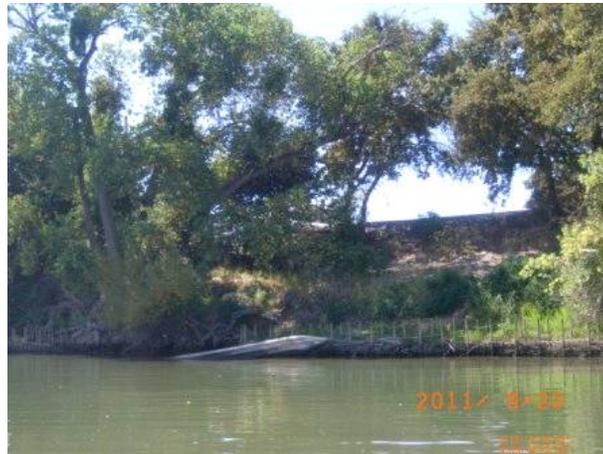
Levee Mile Report Line	1
Start Levee Mile	0.01
End Levee Mile	0.24
Location	Water Side
Category	Supplemental
Item	USACE Erosion Survey
USACE 2011 Photo #2	
USACE2011_SAC_41-9_R_2.jpg

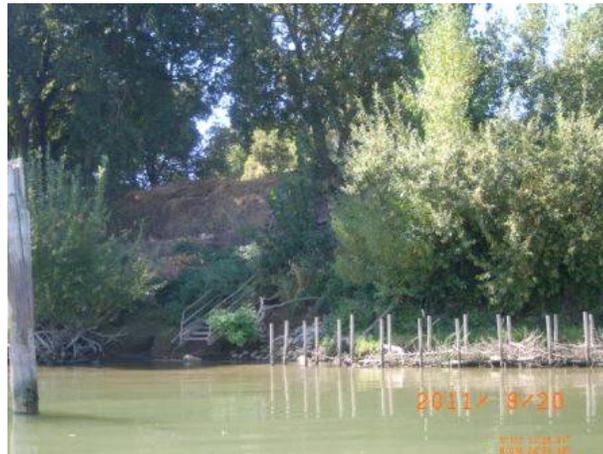
Levee Mile Report Line	1
Start Levee Mile	0.01
End Levee Mile	0.24
Location	Water Side
Category	Supplemental
Item	USACE Erosion Survey
USACE 2011 Photo #3	
USACE2011_SAC_41-9_R_3.jpg

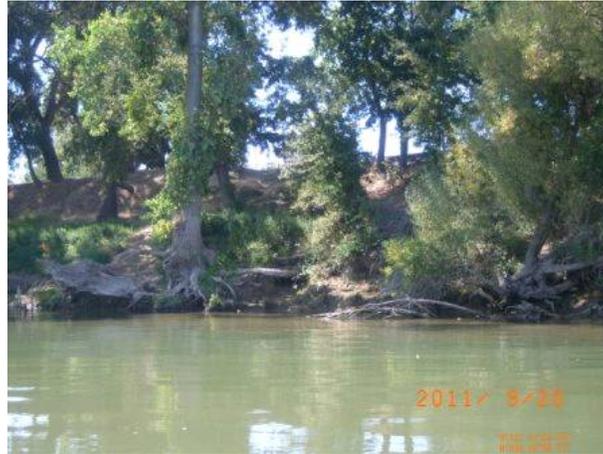
Levee Mile Report Line	1
Start Levee Mile	0.01
End Levee Mile	0.24
Location	Water Side
Category	Supplemental
Item	USACE Erosion Survey
USACE 2011 Photo #4	
USACE2011_SAC_41-9_R_4.jpg

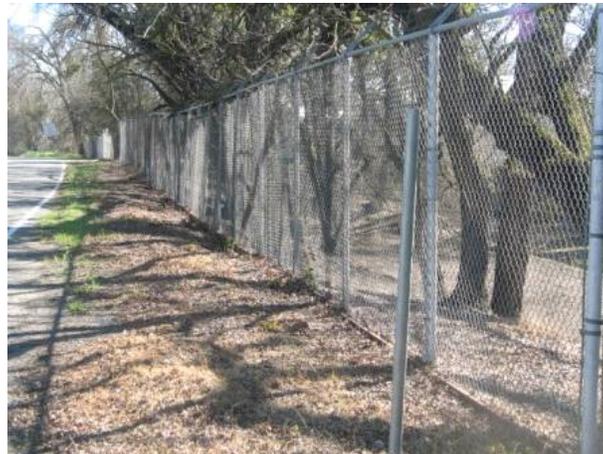
Levee Mile Report Line	3
Start Levee Mile	0.05
End Levee Mile	0.11
Location	Land Side
Category	Earthen Levee
Item	Encroachments
Cyclone fence along landside shoulder at LM 0.05 -0.11	
richard_f_20110922_518.jpg

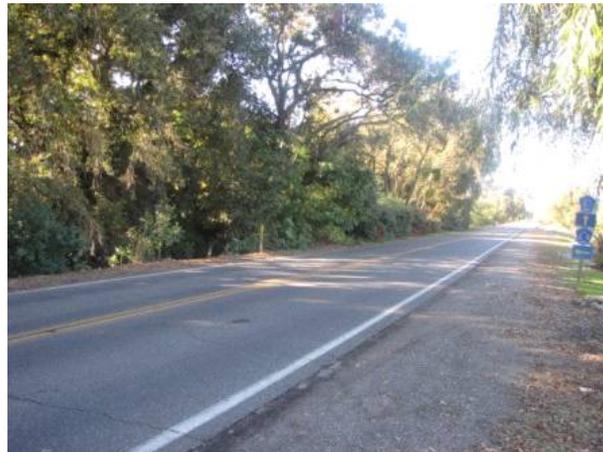
Levee Mile Report Line	6
Start Levee Mile	0.31
End Levee Mile	0.35
Location	Land Side
Category	Earthen Levee
Item	Encroachments
Looking northwest at dense veg on landside shoulder and slope.	
richard_f_20110922_516.jpg

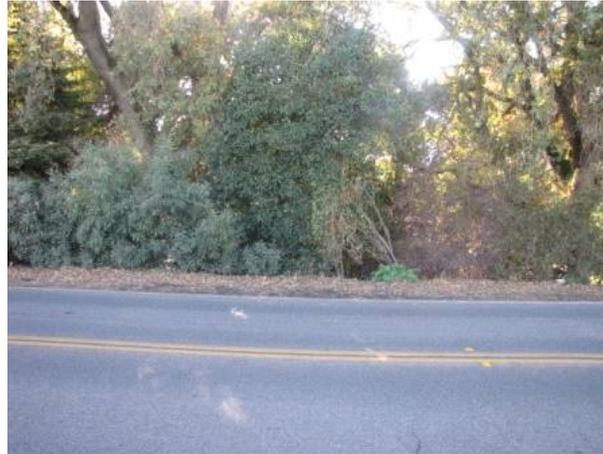
richard_f_20110922_517.jpg

Looking west at dense veg on landside slope and toe.

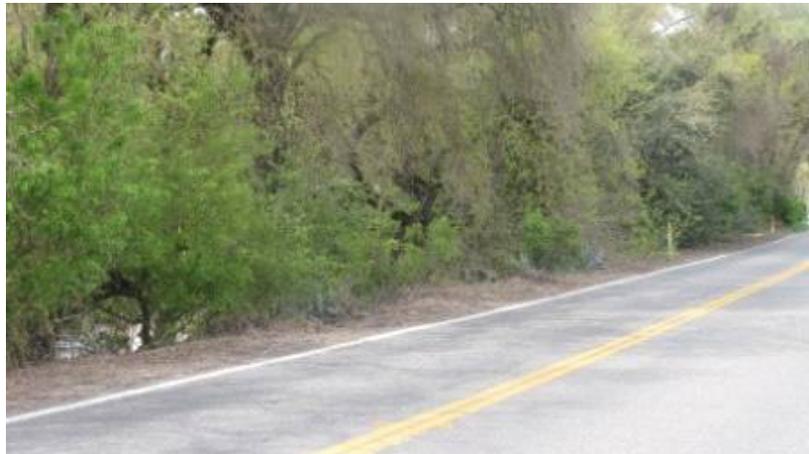
Looking west at dense trees on waterside slope.

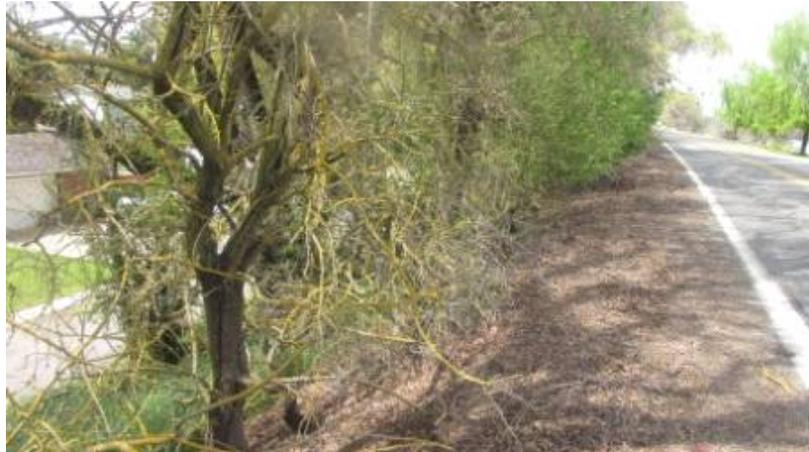
Levee Mile Report Line	8
Start Levee Mile	0.37
End Levee Mile	0.50
Location	Land Side
Category	Earthen Levee
Item	Trim / Thin Trees

Looking northwest at dense trees on landside slope and toe.

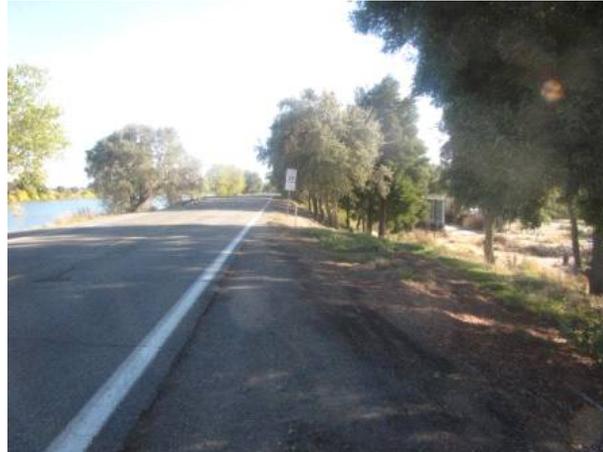
Levee Mile Report Line	13
Start Levee Mile	0.71
End Levee Mile	0.87
Location	Land Side
Category	Earthen Levee
Item	Trim / Thin Trees
Looking south at trimmed trees on landside slope and removed fence.	
richard_f_20110922_512.jpg

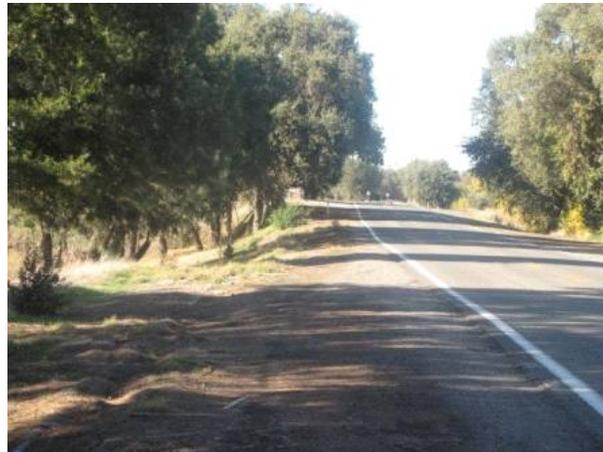
Levee Mile Report Line	13
Start Levee Mile	0.71
End Levee Mile	0.87
Location	Land Side
Category	Earthen Levee
Item	Trim / Thin Trees
Looking north at trimmed trees and removed fence on landside slope.	
richard_f_20110922_513.jpg

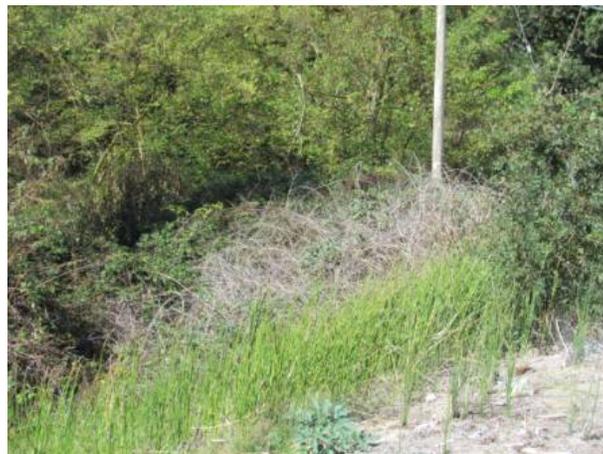
Levee Mile Report Line	19
Start Levee Mile	1.15
End Levee Mile	1.15
Location	Land Side
Category	Earthen Levee
Item	Vegetation
Looking northwest at dense wild roses and berry vines on landside toe near ramp.	
richard_f_20111014_629.jpg

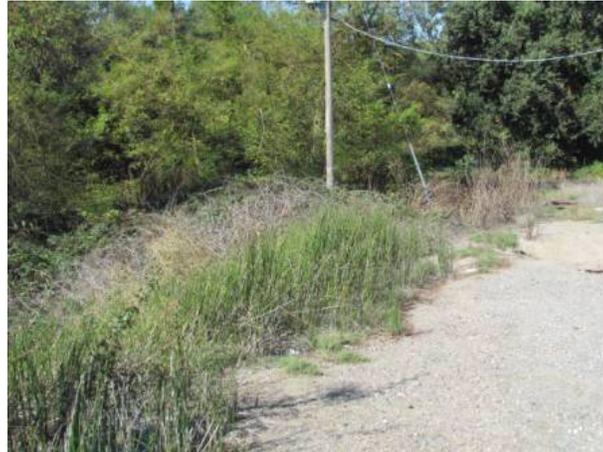
Levee Mile Report Line	19
Start Levee Mile	1.15
End Levee Mile	1.15
Location	Land Side
Category	Earthen Levee
Item	Vegetation
Looking north at dense vegetation on landside slope near ramp.	
richard_f_20111014_630.jpg

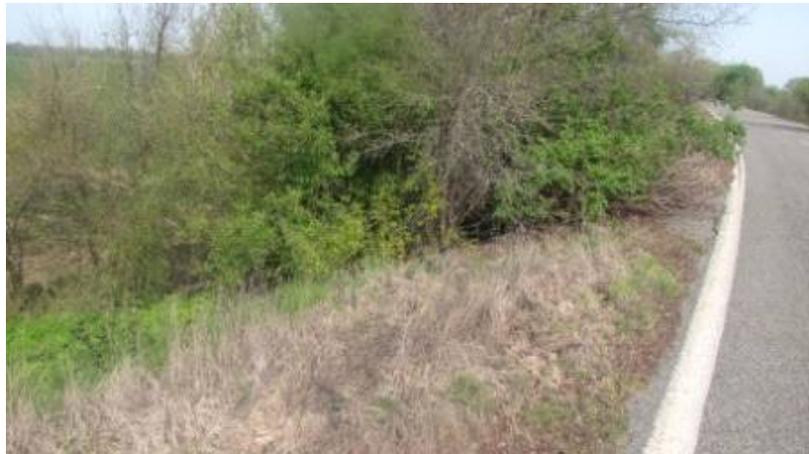
Levee Mile Report Line	6
Start Levee Mile	0.40
End Levee Mile	0.40
Location	Land Side
Category	Earthen Levee
Item	Trim / Thin Trees
Looking north at dense veg. on landside slope and toe.	
richard_f_20110922_522.jpg

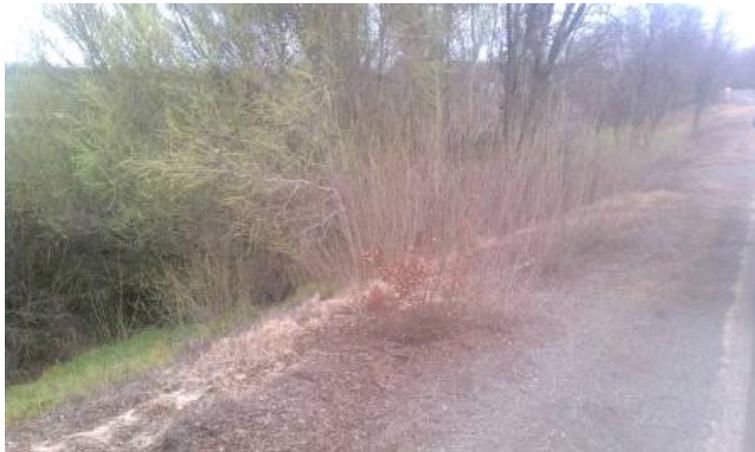
Levee Mile Report Line	9
Start Levee Mile	0.43
End Levee Mile	0.47
Location	Land Side
Category	Earthen Levee
Item	Vegetation
Looking northwest at dense vegetation on landside slope and toe.	
richard_f_20110922_530.jpg

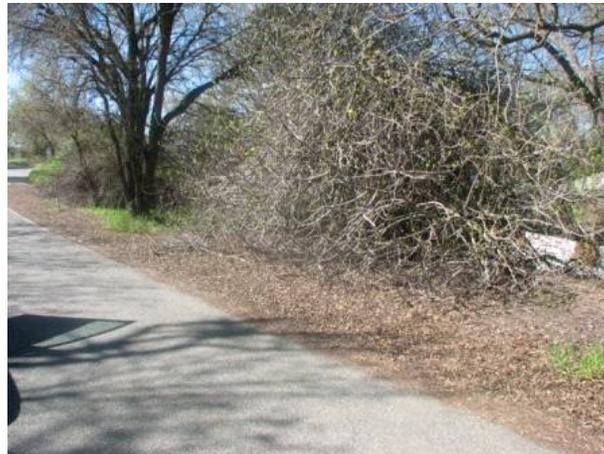
Front view of dense trees at landside shoulder.

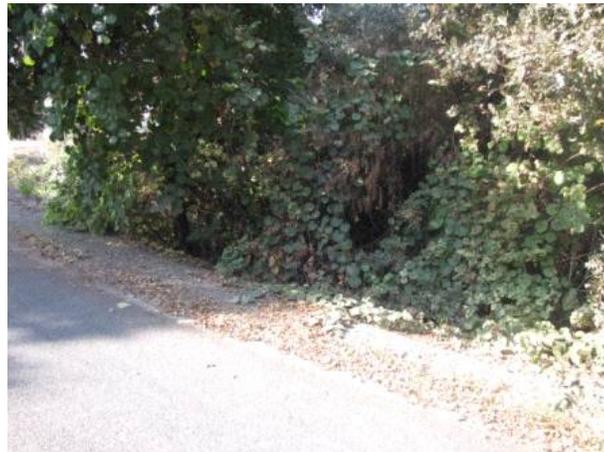
Levee Mile Report Line	13
Start Levee Mile	0.72
End Levee Mile	0.74
Location	Land Side
Category	Earthen Levee
Item	Trim / Thin Trees

Looking west at dense trees on landside slope and toe.

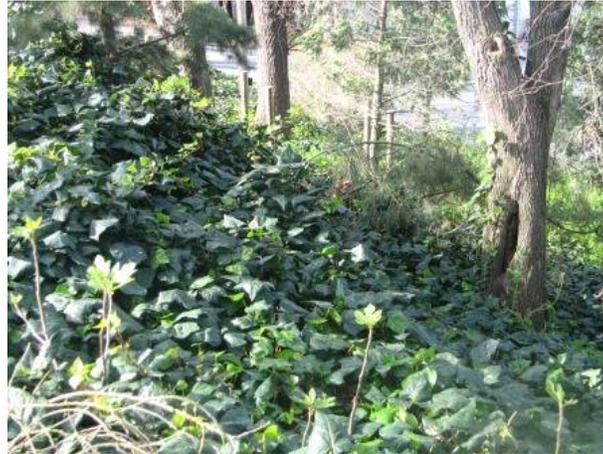
Levee Mile Report Line	15
Start Levee Mile	0.84
End Levee Mile	0.94
Location	Land Side
Category	Earthen Levee
Item	Encroachments
View of landscaping (Ivy) blocking view of landside slope from LM 0.84 to 0.94	
richard_f_20110922_525.jpg

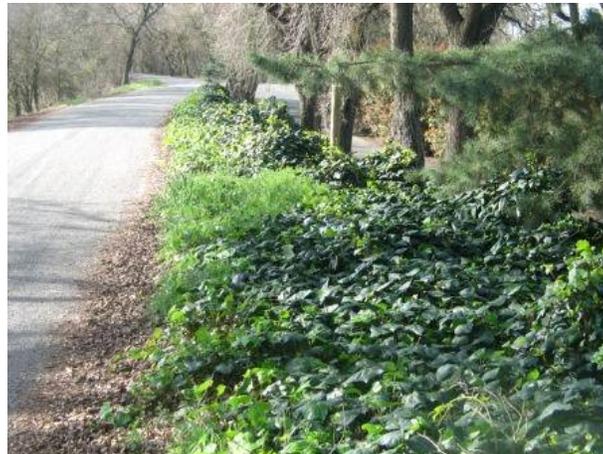
Levee Mile Report Line	15
Start Levee Mile	0.84
End Levee Mile	0.94
Location	Land Side
Category	Earthen Levee
Item	Encroachments
View of landscaping (Ivy) looking upstream from LM 0.84 to 0.94	
richard_f_20110922_526.jpg

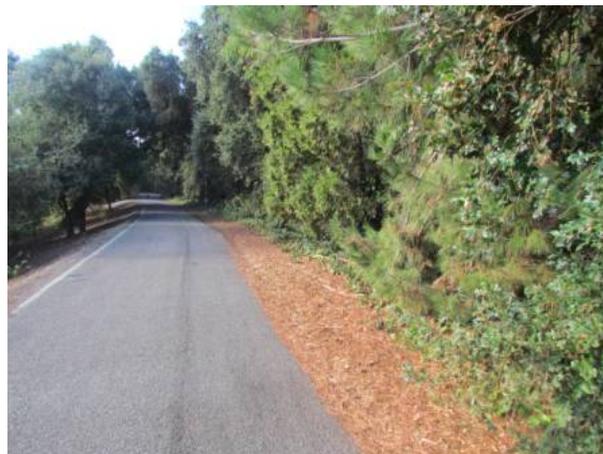
Levee Mile Report Line	16
Start Levee Mile	0.84
End Levee Mile	0.94
Location	Land Side
Category	Earthen Levee
Item	Encroachments
Looking north at dense landscaping on landside slope.	
richard_f_20111014_631.jpg
