**Flood Control Project Maintenance
Levee Inspections**

Fall 2011 Levee Maintenance Deficiency Summary Report

Reclamation District No. 0999 Netherlands

Levee Inspection Report By Mile - Fall 2011

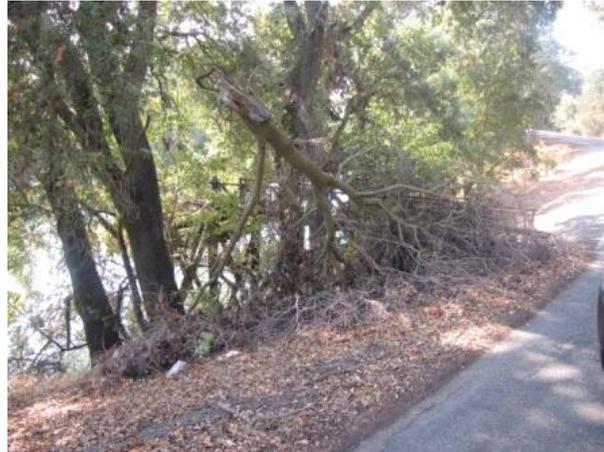
Levee Mile Report Line	19
Start Levee Mile	1.17
End Levee Mile	1.17
Location	Water Side
Category	Earthen Levee
Item	Encroachments
Looking southeast at a fallen limb on waterside slope and shoulder.	
richard_f_20110922_532.jpg

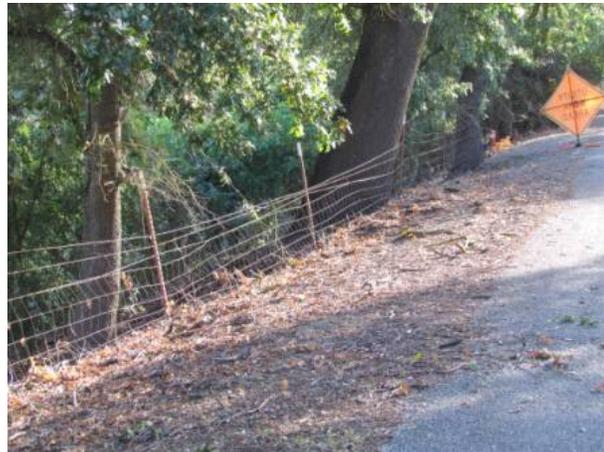
Levee Mile Report Line	21
Start Levee Mile	1.24
End Levee Mile	1.27
Location	Land Side
Category	Earthen Levee
Item	Encroachments
Looking north at fence along landside slope.	
richard_f_20111014_632.jpg

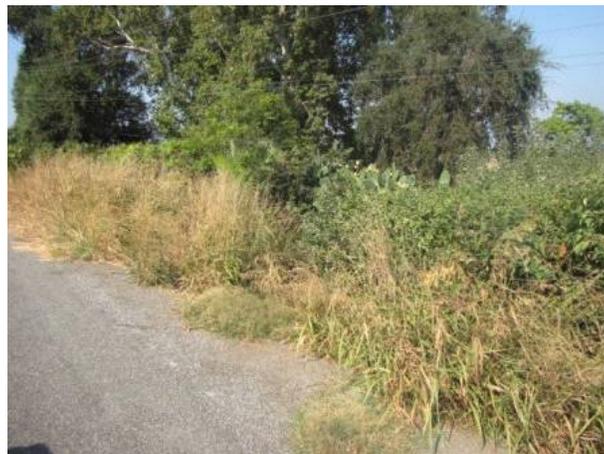
Levee Mile Report Line	22
Start Levee Mile	1.34
End Levee Mile	1.40
Location	Land Side
Category	Earthen Levee
Item	Encroachments
Looking southwest at overgrown landscaping on landside slope.	
richard_f_20110922_520.jpg

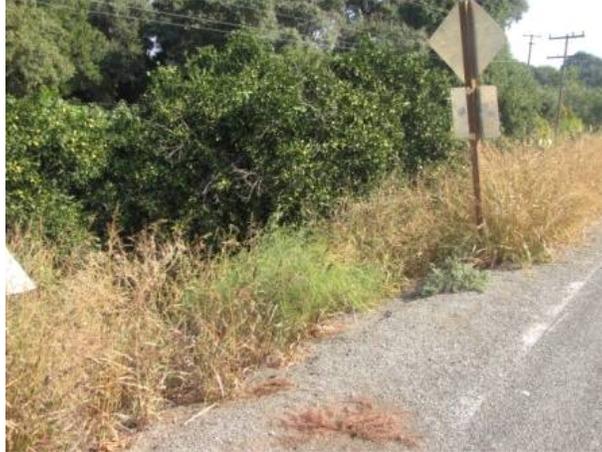
Levee Mile Report Line	22
Start Levee Mile	1.34
End Levee Mile	1.40
Location	Land Side
Category	Earthen Levee
Item	Encroachments
Looking northwest at overgrown landscaping on landside slope.	
richard_f_20110922_521.jpg

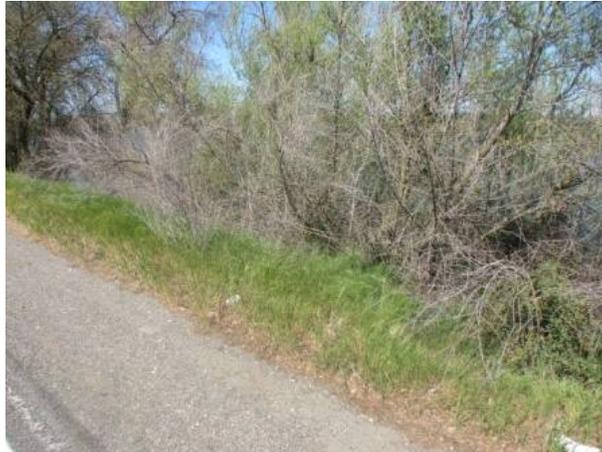
Levee Mile Report Line	24
Start Levee Mile	1.51
End Levee Mile	1.88
Location	Land Side
Category	Earthen Levee
Item	Trim / Thin Trees
Front view of dense trees along waterside slope.	
richard_f_20110922_527.jpg

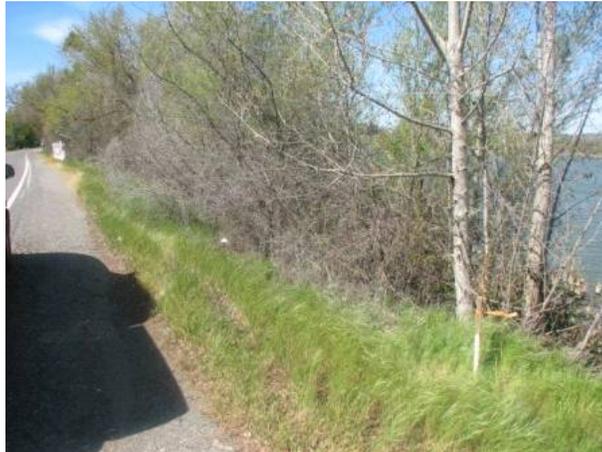
Levee Mile Report Line	24
Start Levee Mile	1.51
End Levee Mile	1.88
Location	Land Side
Category	Earthen Levee
Item	Trim / Thin Trees
Side view of dense trees along waterside slope.	
richard_f_20110922_528.jpg

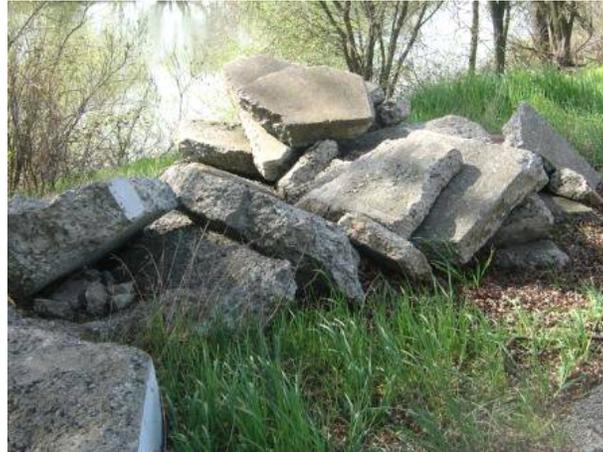
Levee Mile Report Line	29
Start Levee Mile	1.97
End Levee Mile	1.97
Location	Water Side
Category	Earthen Levee
Item	Encroachments
Concrete rubble on waterside sholder at LM 1.97	
richard_f_20110922_529.jpg

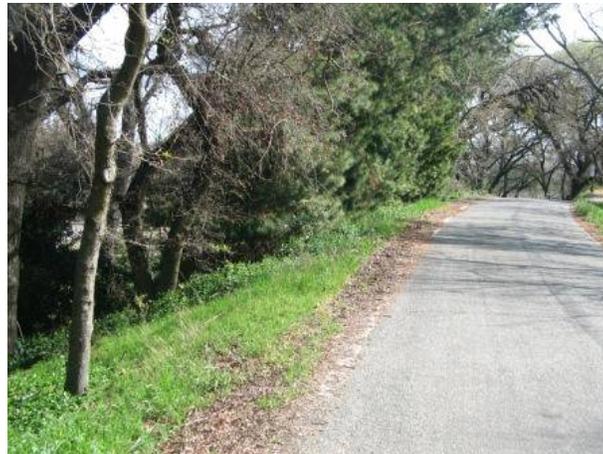
Levee Mile Report Line	38
Start Levee Mile	3.19
End Levee Mile	3.24
Location	Land Side
Category	Earthen Levee
Item	Encroachments
Looking downstream of landscaping blocking view of landside slope from LM 3.19 to 3.24	
richard_f_20110922_533.jpg

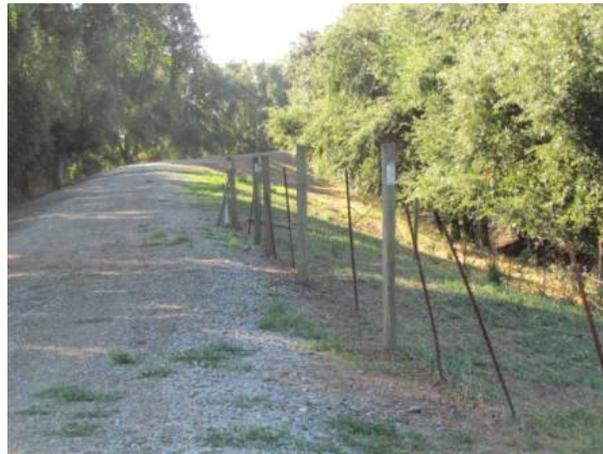
Levee Mile Report Line	44
Start Levee Mile	3.62
End Levee Mile	3.72
Location	Land Side
Category	Earthen Levee
Item	Encroachments
Looking north at fence along waterside shoulder.	
richard_f_20111014_633.jpg

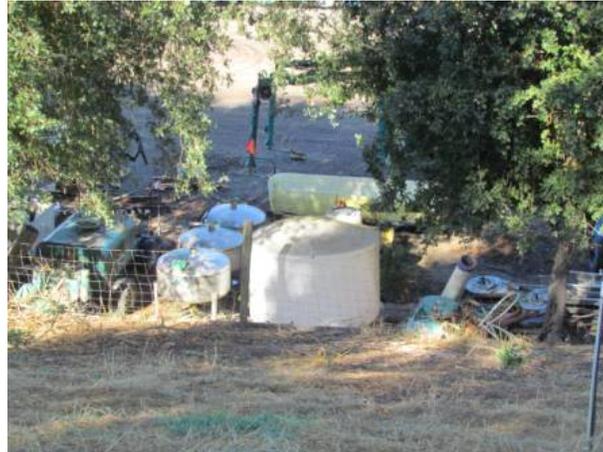
Looking west at equipment at landside toe.

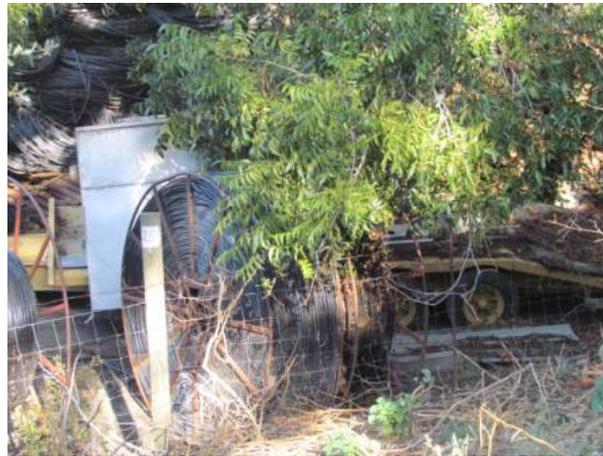
Levee Mile Report Line	45
Start Levee Mile	3.70
End Levee Mile	3.70
Location	Land Side
Category	Earthen Levee
Item	Encroachments

Looking northwest at equipment on landside toe.

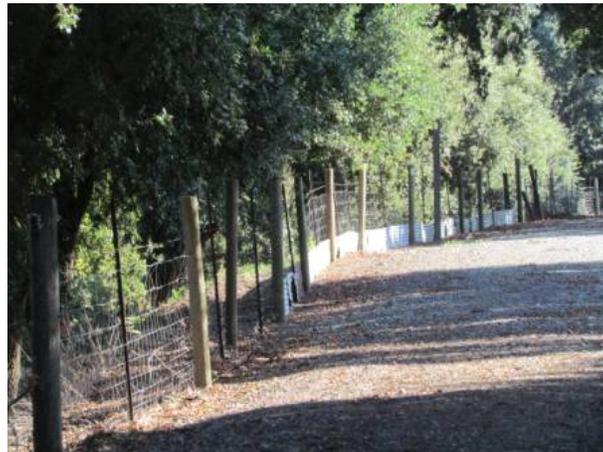
Levee Mile Report Line	46
Start Levee Mile	3.75
End Levee Mile	3.83
Location	Water Side
Category	Earthen Levee
Item	Encroachments

Looking north at fence along landside shoulder.

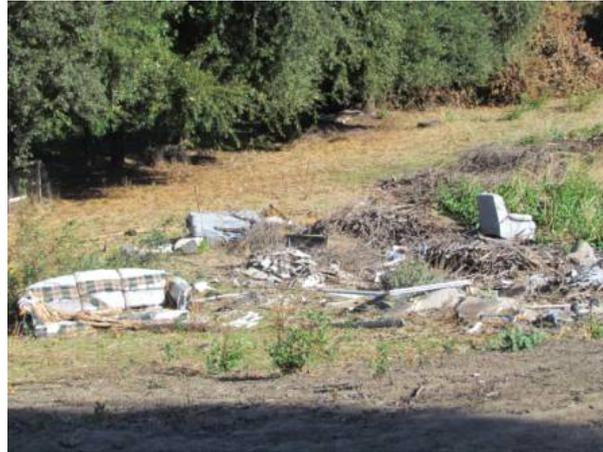
Looking northwest at garbage on landside toe and berm.

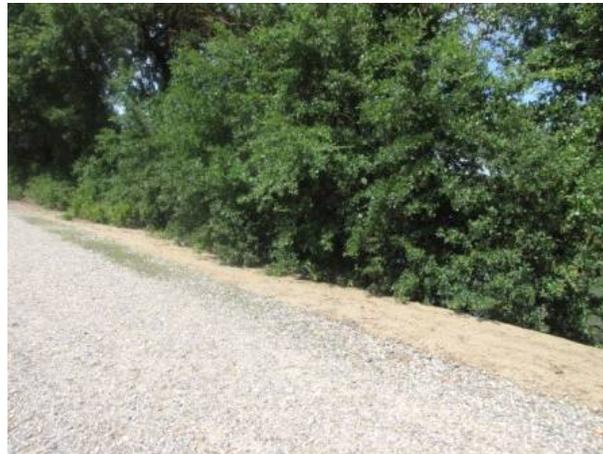
Levee Mile Report Line	50
Start Levee Mile	4.05
End Levee Mile	4.12
Location	Water Side
Category	Earthen Levee
Item	Trim / Thin Trees

Looking northeast at overgrown trees on waterside slope.

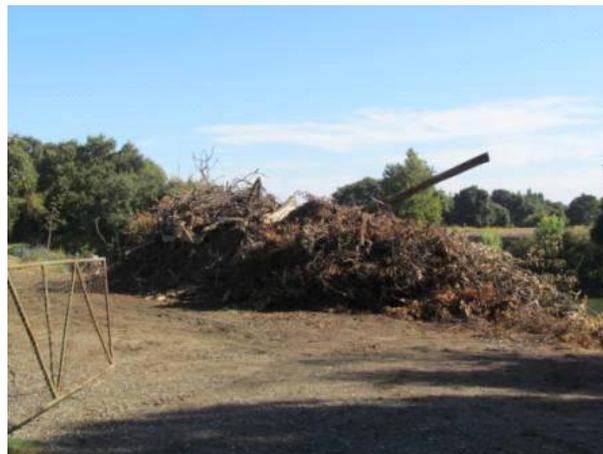
Levee Mile Report Line	51
Start Levee Mile	4.30
End Levee Mile	4.30
Location	Water Side
Category	Earthen Levee
Item	Encroachments

Looking northeast at larger pruning pile on waterside shoulder.

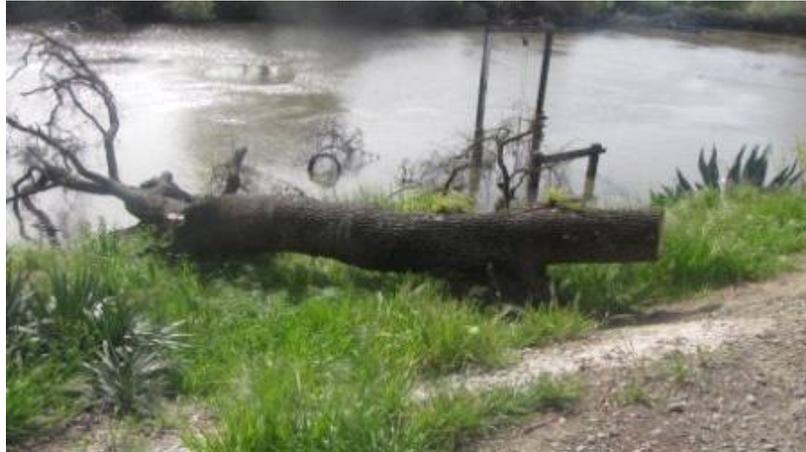
Levee Mile Report Line	52
Start Levee Mile	4.37
End Levee Mile	4.37
Location	Water Side
Category	Earthen Levee
Item	Encroachments
Looking south at down tree on waterside slope.	
richard_f_20110922_536.jpg

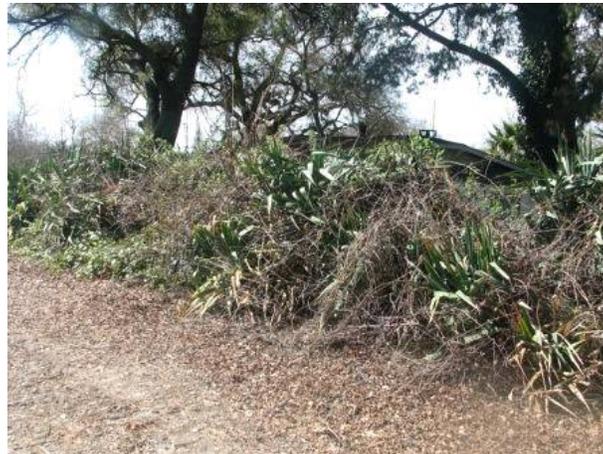
Levee Mile Report Line	53
Start Levee Mile	4.38
End Levee Mile	4.41
Location	Land Side
Category	Earthen Levee
Item	Encroachments
Overgrown landscaping on landside slope blocking view of slope from LM 4.38 to 4.41	
richard_f_20110922_535.jpg

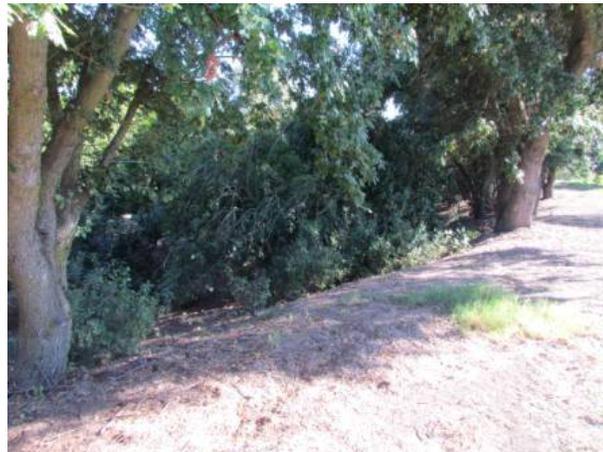
Levee Mile Report Line	60
Start Levee Mile	4.59
End Levee Mile	4.72
Location	Land Side
Category	Earthen Levee
Item	Trim / Thin Trees
Looking northwest at dense trees on landside slope.	
richard_f_20111014_638.jpg

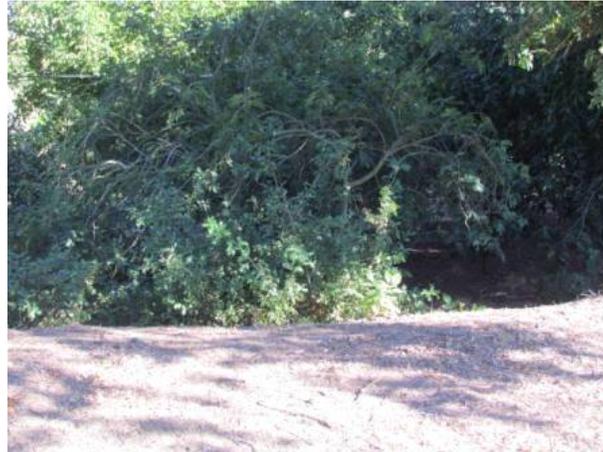
Levee Mile Report Line	60
Start Levee Mile	4.59
End Levee Mile	4.72
Location	Land Side
Category	Earthen Levee
Item	Trim / Thin Trees
Looking west at dense trees on landside slope.	
richard_f_20111014_639.jpg

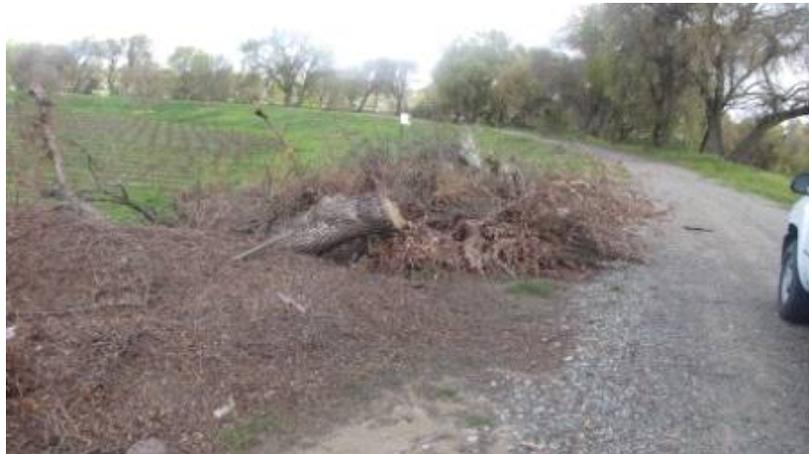
Levee Mile Report Line	69
Start Levee Mile	5.16
End Levee Mile	5.16
Location	Land Side
Category	Earthen Levee
Item	Encroachments
Looking northeast at prunings on landside shoulder and slope.	
richard_f_20110922_537.jpg

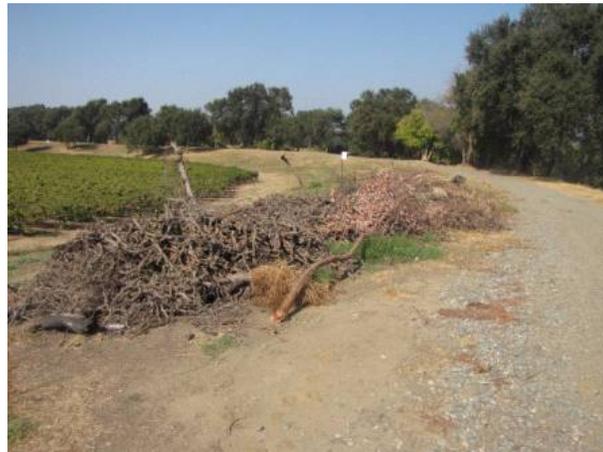
Levee Mile Report Line	69
Start Levee Mile	5.16
End Levee Mile	5.16
Location	Land Side
Category	Earthen Levee
Item	Encroachments
Looking northwest at pruning pile on landside slope.	
richard_f_20110922_538.jpg

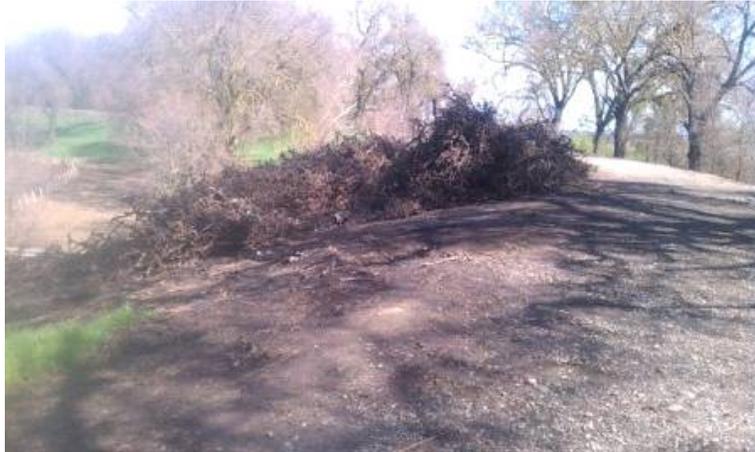
Levee Mile Report Line	85
Start Levee Mile	6.58
End Levee Mile	6.58
Location	Land Side
Category	Earthen Levee
Item	Encroachments
Looking northwest at pruning pile on landside slope.	
richard_f_20110922_542.jpg

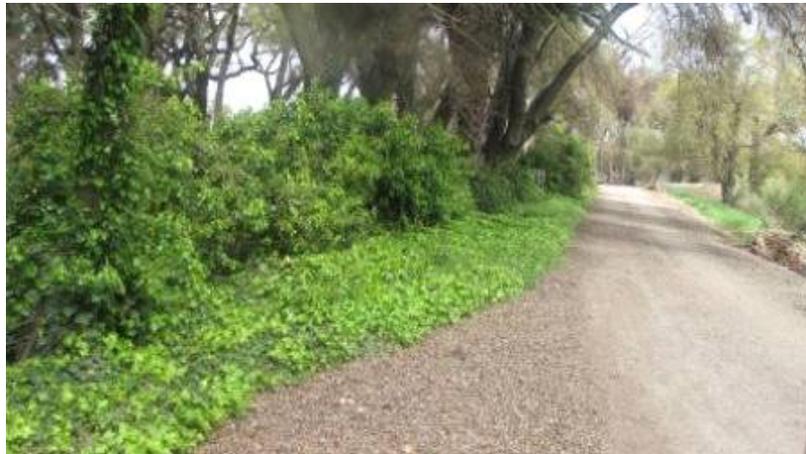
Levee Mile Report Line	86
Start Levee Mile	6.78
End Levee Mile	6.81
Location	Land Side
Category	Earthen Levee
Item	Encroachments
Looking north at overgrown landscape on landside slope and toe.	
richard_f_20110922_543.jpg

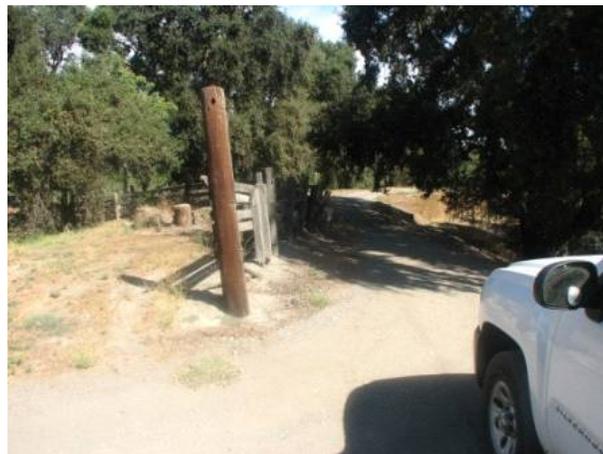
Levee Mile Report Line	87
Start Levee Mile	6.83
End Levee Mile	6.83
Location	Land Side
Category	Earthen Levee
Item	Encroachments
Fence, Firewood and material at landside shoulder.	
richard_f_20110922_544.jpg

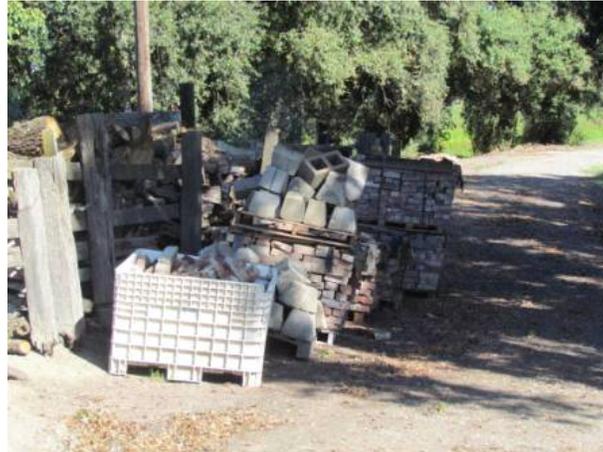
Levee Mile Report Line	87
Start Levee Mile	6.83
End Levee Mile	6.83
Location	Land Side
Category	Earthen Levee
Item	Encroachments
Looking north at firewood and other material on landside shoulder and crown.	
richard_f_20111014_640.jpg

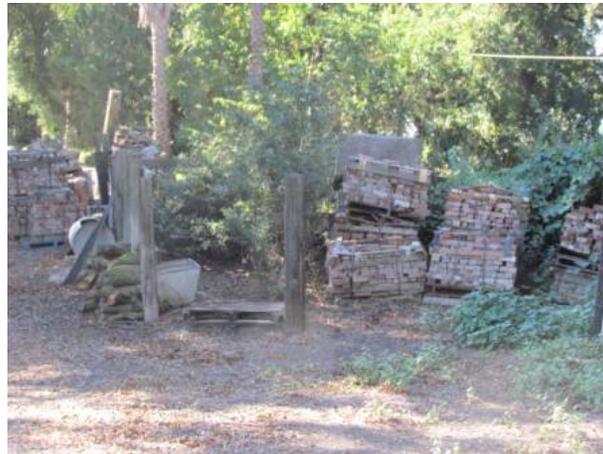
Levee Mile Report Line	87
Start Levee Mile	6.83
End Levee Mile	6.83
Location	Land Side
Category	Earthen Levee
Item	Encroachments
Looking south at firewood and other material on landside shoulder and crown.	
richard_f_20111014_641.jpg

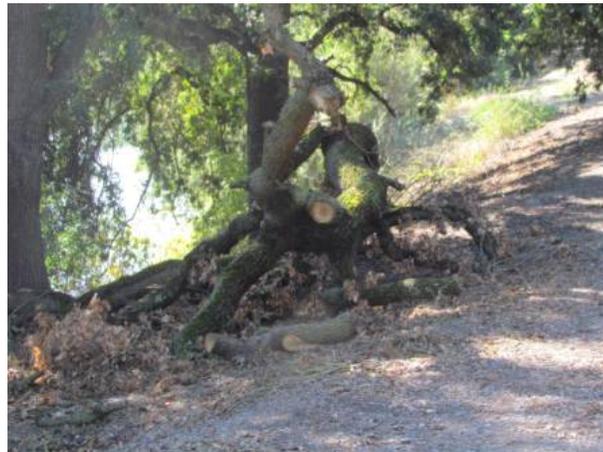
Levee Mile Report Line	88
Start Levee Mile	6.85
End Levee Mile	6.85
Location	Water Side
Category	Earthen Levee
Item	Encroachments
Looking southeast at tree limbs on waterside shoulder.	
richard_f_20111014_642.jpg

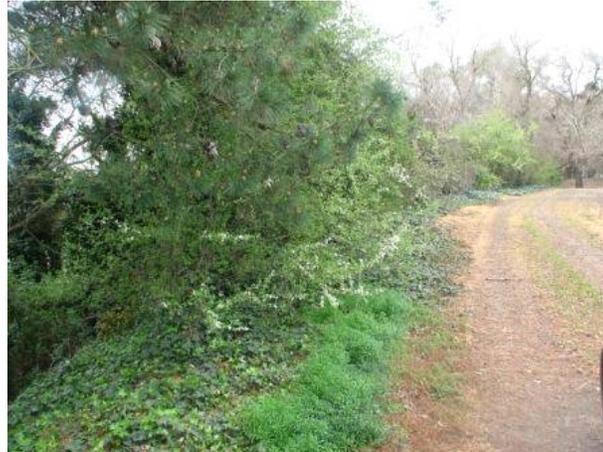
Levee Mile Report Line	90
Start Levee Mile	7.65
End Levee Mile	7.69
Location	Land Side
Category	Earthen Levee
Item	Encroachments
Landscaping on landside slope blocking view of slope from LM 7.65 to 7.72	
richard_f_20110922_539.jpg

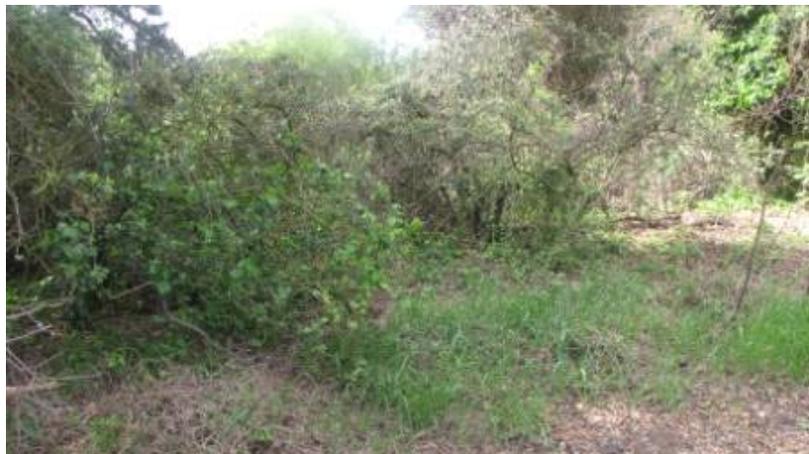
Levee Mile Report Line	90
Start Levee Mile	7.65
End Levee Mile	7.69
Location	Land Side
Category	Earthen Levee
Item	Encroachments
Looking east at overgrown landscape on landside slope.	
richard_f_20110922_540.jpg

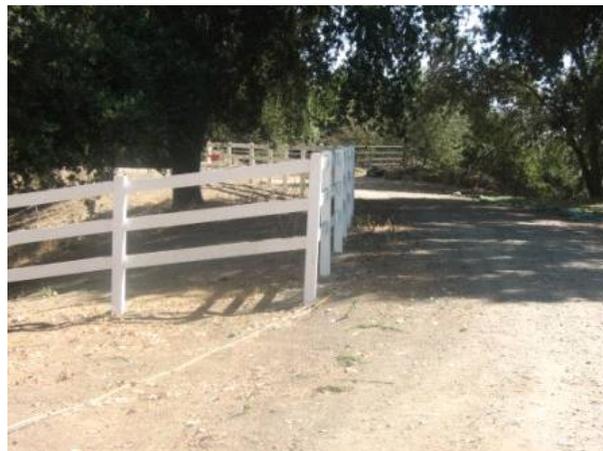
Levee Mile Report Line	102
Start Levee Mile	8.57
End Levee Mile	8.61
Location	Land Side
Category	Earthen Levee
Item	Encroachments
New installed unauthorized fence at landside slope and shoulder.	
richard_f_20110922_549.jpg

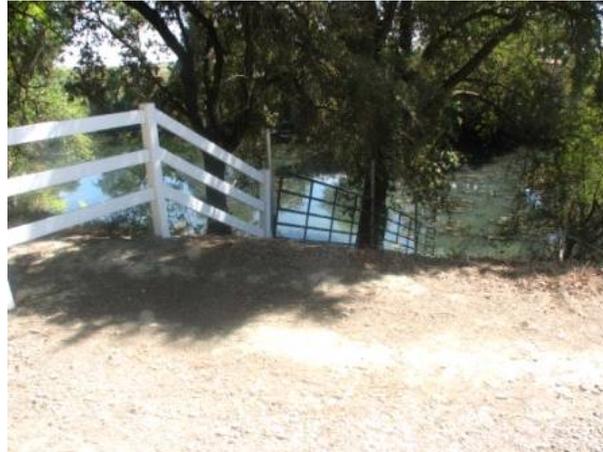
Levee Mile Report Line	111
Start Levee Mile	8.74
End Levee Mile	8.74
Location	Crown
Category	Earthen Levee
Item	Encroachments
New unauthorized fence that extend from landside toe to waterside toe.	
richard_f_20110922_550.jpg

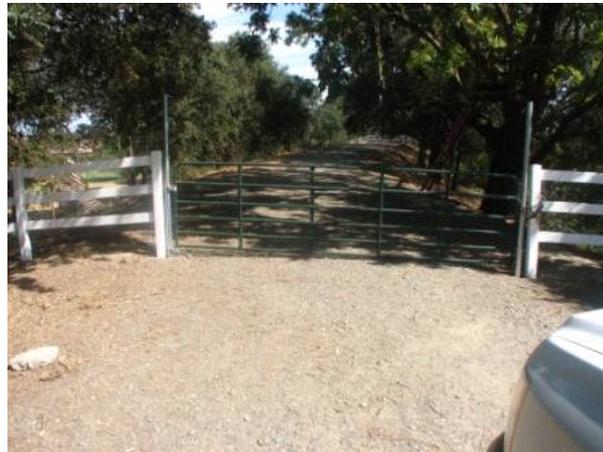
Levee Mile Report Line	111
Start Levee Mile	8.74
End Levee Mile	8.74
Location	Crown
Category	Earthen Levee
Item	Encroachments
View of fence & gate across levee crown, landside & waterside slope.	
richard_f_20110922_551.jpg

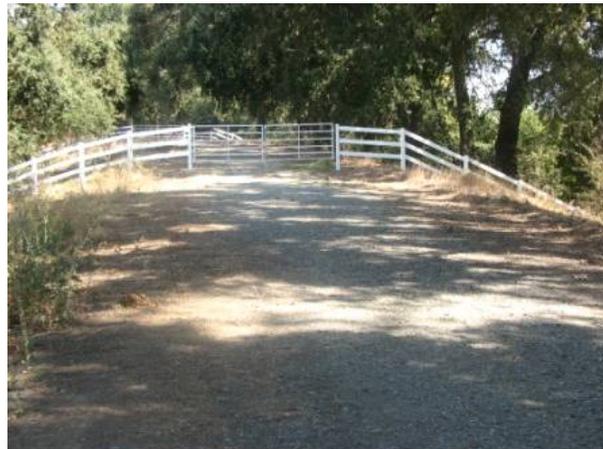
Levee Mile Report Line	113
Start Levee Mile	8.78
End Levee Mile	8.78
Location	Crown
Category	Earthen Levee
Item	Encroachments
New unauthorized fence and gate that extend from landside toe across levee crown to waterside toe.	
richard_f_20110922_552.jpg
