**Flood Control Project Maintenance
Levee Inspections
LMA District Cover Sheet
Spring 2010 Levee Inspection Results**

Reclamation District No. 0999 Netherlands

Spring 2010 Levee Inspection Results

Waterway		Bank	Unit Miles
Unit No. 01 Yolo Bypass		Left	15.43

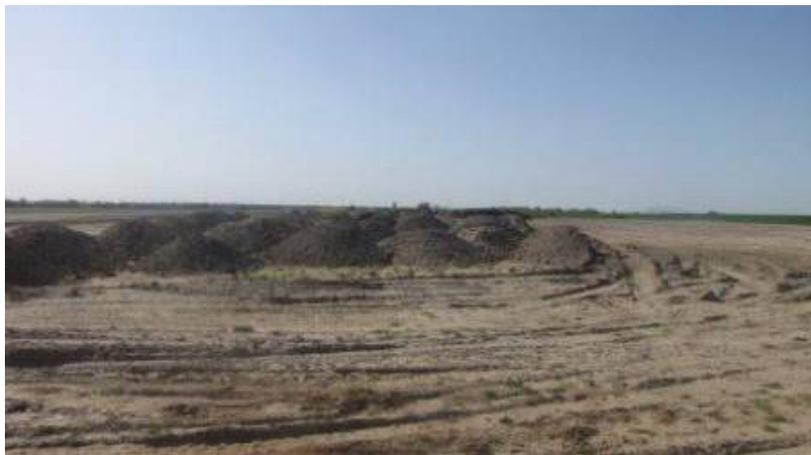
Levee Mile Report Line	1
Start Levee Mile	0.13
End Levee Mile	0.41
Location	Water Side
Category	Earthen Levee
Item	Encroachments
Looking south at fill on waterside shoulder and slope.	
richard_s_20100408_168.jpg

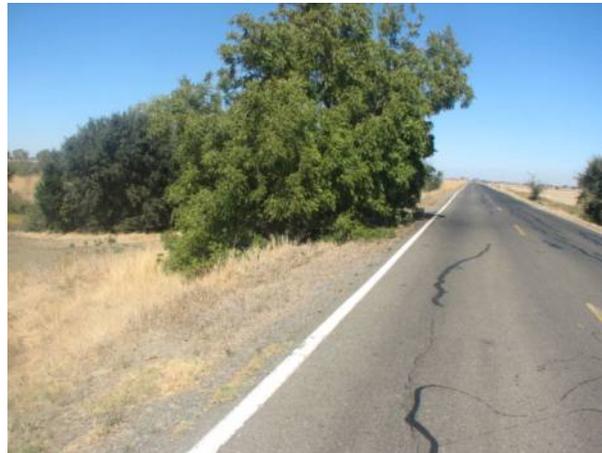
Levee Mile Report Line	5
Start Levee Mile	1.75
End Levee Mile	1.77
Location	Water Side
Category	Earthen Levee
Item	Trim / Thin Trees
Looking east at overgrown trees on waterside slope and shoulder	
richard_s_20100316_096.jpg

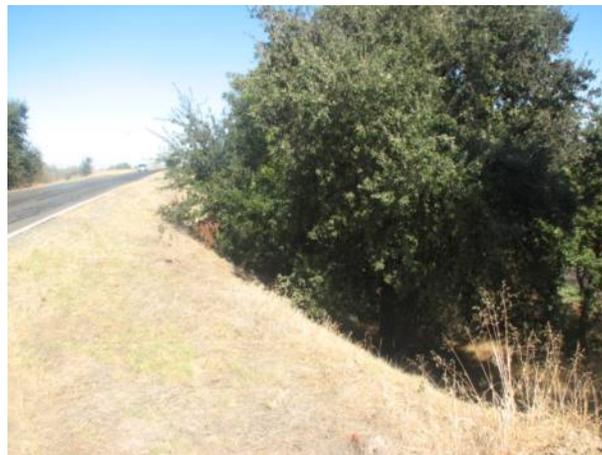
Levee Mile Report Line	5
Start Levee Mile	1.75
End Levee Mile	1.77
Location	Water Side
Category	Earthen Levee
Item	Trim / Thin Trees
Looking west at overgrown trees on waterside slope and toe.	
richard_s_20100316_097.jpg

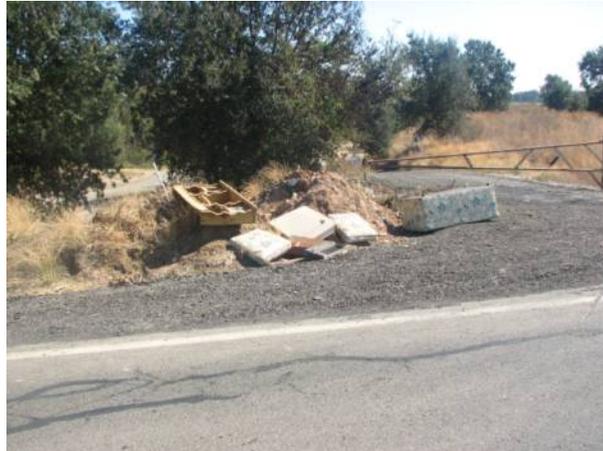
Levee Mile Report Line	6
Start Levee Mile	1.78
End Levee Mile	1.78
Location	Land Side
Category	Earthen Levee
Item	Encroachments
Looking north at garbage pile on landside shoulder.	
richard_s_20100316_099.jpg

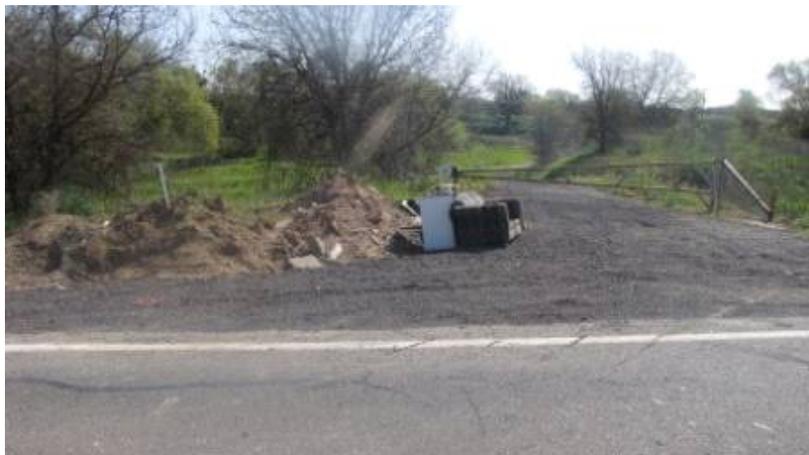
Levee Mile Report Line	6
Start Levee Mile	1.78
End Levee Mile	1.78
Location	Land Side
Category	Earthen Levee
Item	Encroachments
Looking east on garbage on landside shoulder and slope next to ramp.	
richard_s_20100408_170.jpg

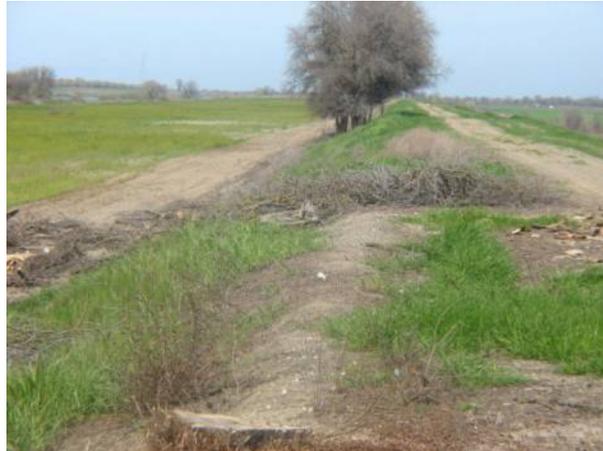
Levee Mile Report Line	13
Start Levee Mile	4.17
End Levee Mile	4.18
Location	Land Side
Category	Earthen Levee
Item	Encroachments
Prunings on waterside shoulder, slope & toe.	
richard_s_20100316_101.jpg

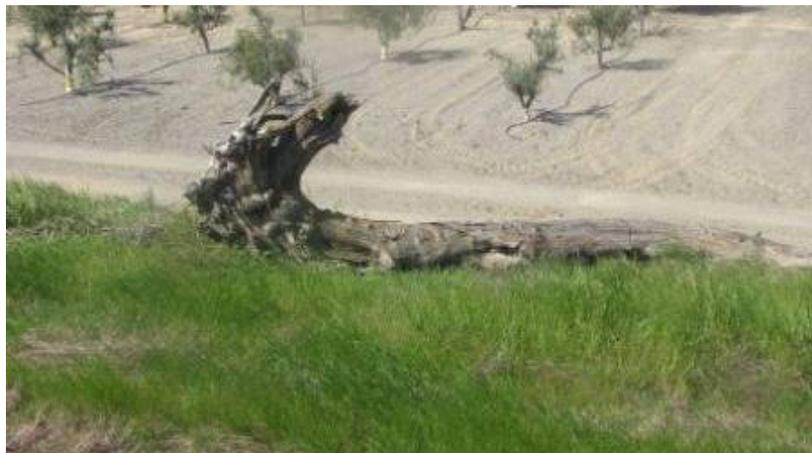
Levee Mile Report Line	22
Start Levee Mile	5.30
End Levee Mile	5.30
Location	Water Side
Category	Earthen Levee
Item	Encroachments
Looking west at large tree limb on waterside slope.	
richard_s_20100408_171.jpg

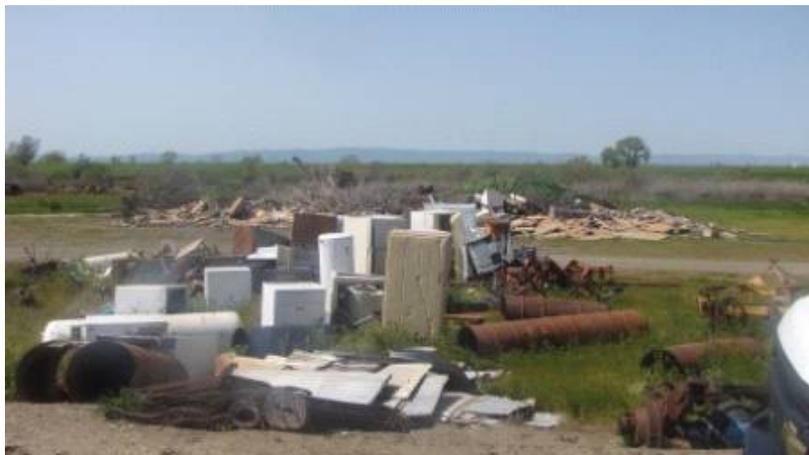
Levee Mile Report Line	33
Start Levee Mile	10.58
End Levee Mile	10.58
Location	Water Side
Category	Earthen Levee
Item	Encroachments
Looking southwest at garbage on waterside toe and berm.	
richard_s_20100408_173.jpg

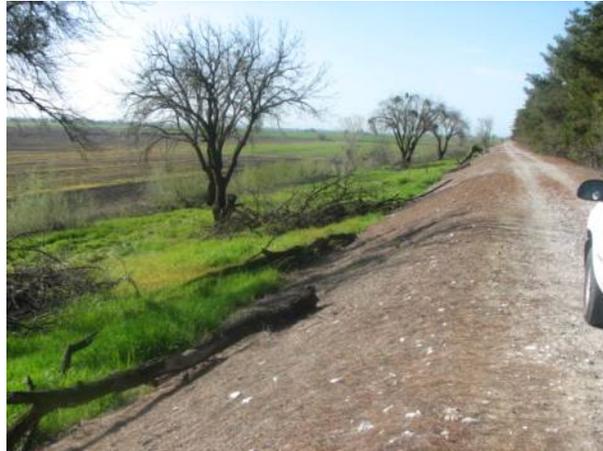
Levee Mile Report Line	35
Start Levee Mile	10.87
End Levee Mile	11.23
Location	Land Side
Category	Earthen Levee
Item	Encroachments
Tree limbs along landside slope & toe.	
richard_s_20100316_106.jpg

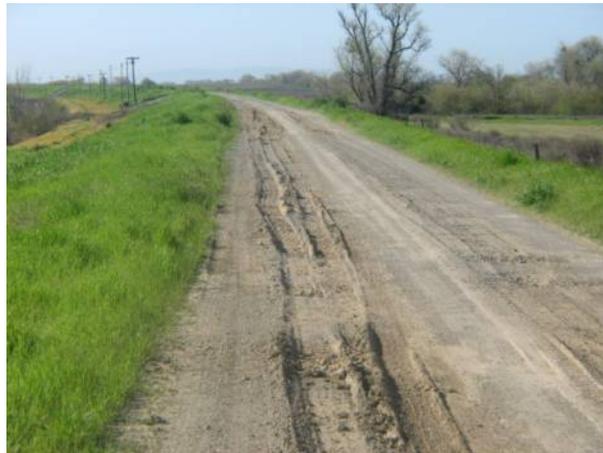
Levee Mile Report Line	36
Start Levee Mile	11.91
End Levee Mile	12.23
Location	Crown
Category	Earthen Levee
Item	Crown Surface / Depressions / Rutting
Vehicle ruts along crown road way.	
richard_s_20100316_107.jpg

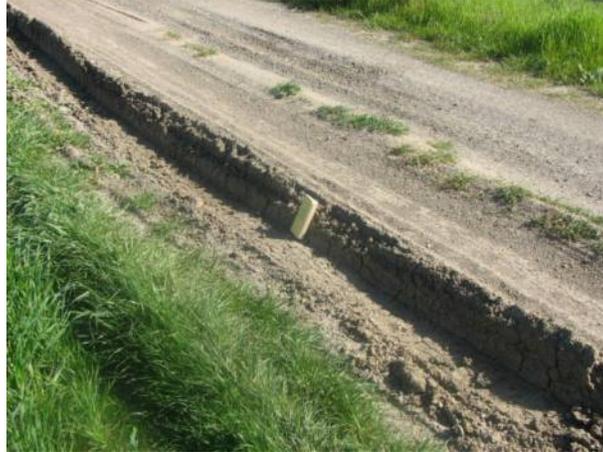
Levee Mile Report Line	38
Start Levee Mile	13.07
End Levee Mile	13.85
Location	Crown
Category	Earthen Levee
Item	Crown Surface / Depressions / Rutting
Deep (7" deep) rutting along crown roadway.	
richard_s_20100316_108.jpg

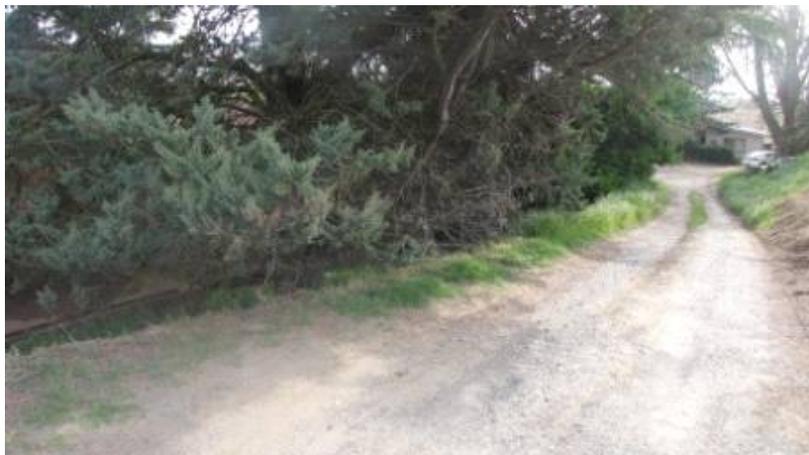
Levee Mile Report Line	10
Start Levee Mile	0.93
End Levee Mile	0.96
Location	Land Side
Category	Earthen Levee
Item	Trim / Thin Trees
Looking north at dense veg. on landside slope and toe.	
richard_s_20100408_178.jpg

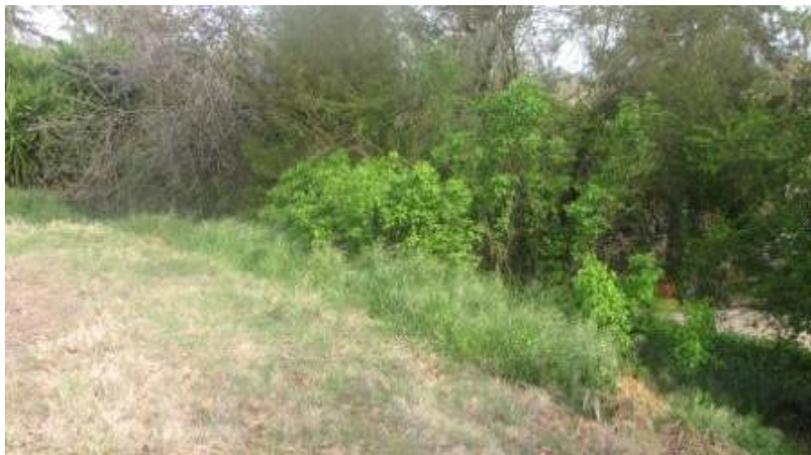
Levee Mile Report Line	15
Start Levee Mile	1.70
End Levee Mile	1.72
Location	Land Side
Category	Earthen Levee
Item	Encroachments
Looking southwes at dense veg. on landside toe.	
richard_s_20100408_181.jpg

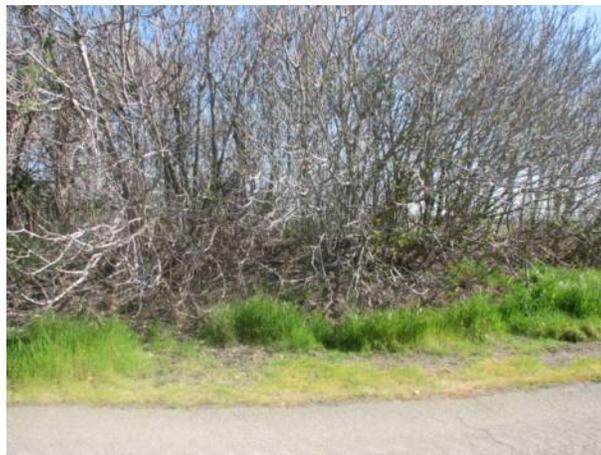
Levee Mile Report Line	18
Start Levee Mile	1.73
End Levee Mile	1.73
Location	Land Side
Category	Earthen Levee
Item	Trim / Thin Trees
Front view of overgrown fig tree on landside shoulder.	
richard_s_20100316_109.jpg

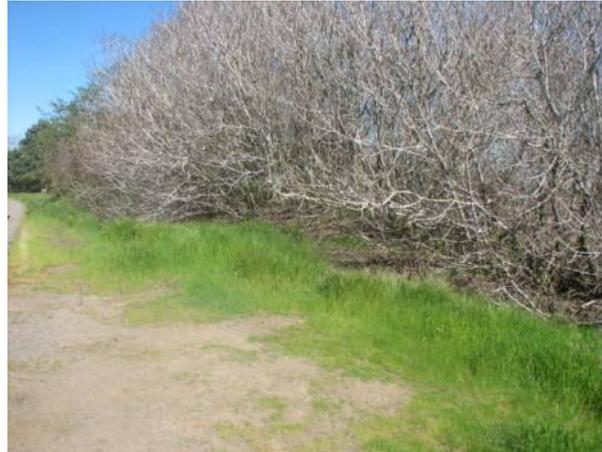
richard_s_20100316_110.jpg

Side view of overgrown fig tree along landside shoulder.

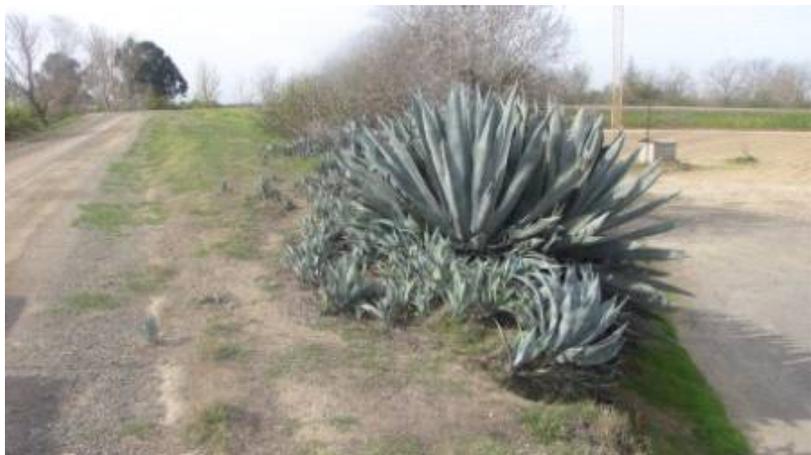
Levee Mile Report Line	4
Start Levee Mile	0.04
End Levee Mile	0.05
Location	Land Side
Category	Earthen Levee
Item	Encroachments
Looking east at cactus and landscaping on landside slope.	
richard_s_20100408_184.jpg

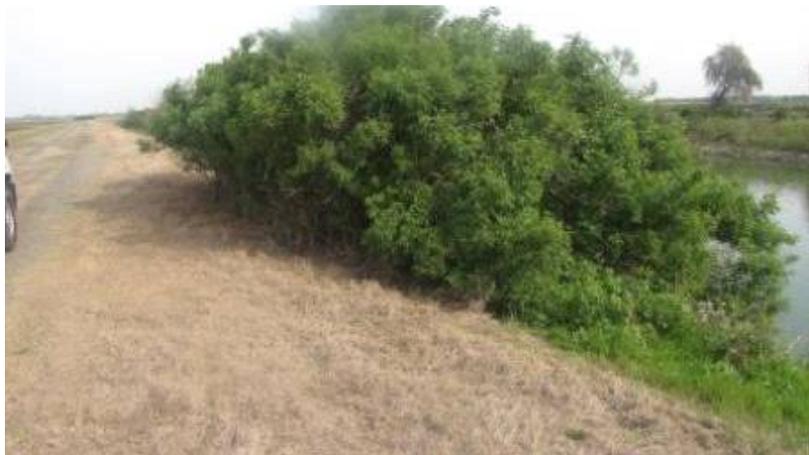
Levee Mile Report Line	6
Start Levee Mile	0.44
End Levee Mile	0.44
Location	Water Side
Category	Earthen Levee
Item	Vegetation
Looking north at elderberry bush on waterside slope.	
richard_s_20100408_186.jpg

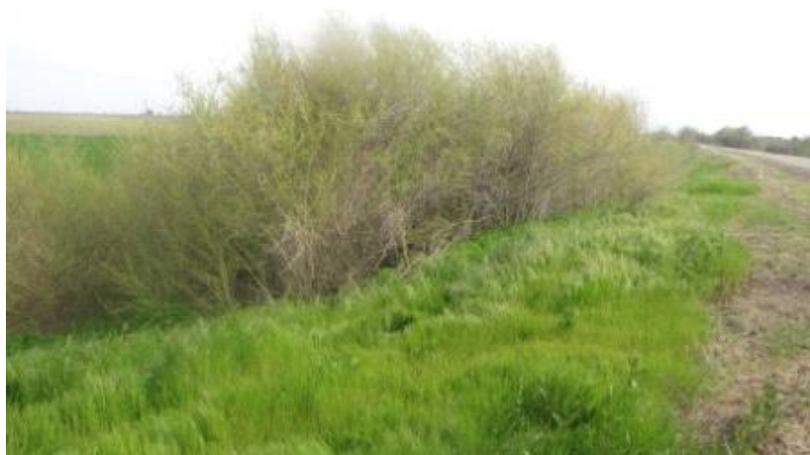
Levee Mile Report Line	21
Start Levee Mile	2.02
End Levee Mile	2.02
Location	Land Side
Category	Earthen Levee
Item	Trim / Thin Trees
Looking north at willow on landsie slope and toe.	
richard_s_20100408_187.jpg

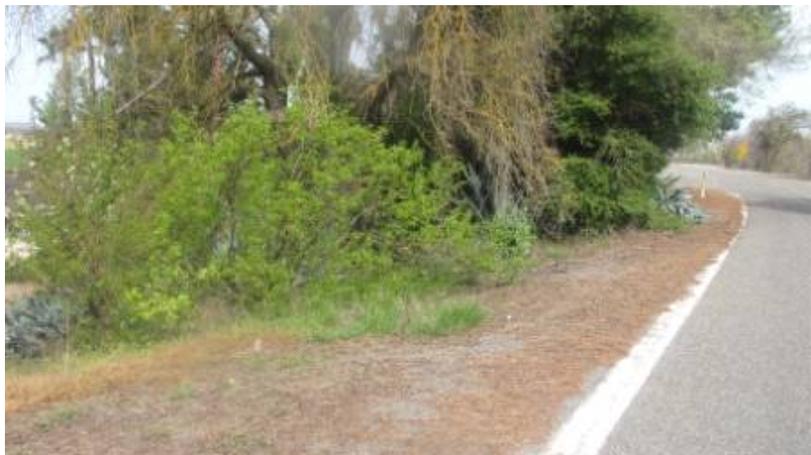
Levee Mile Report Line	26
Start Levee Mile	2.70
End Levee Mile	2.72
Location	Land Side
Category	Earthen Levee
Item	Encroachments
Looking northwest at landscaping and dense veg. on landside slope and toe.	
richard_s_20100408_190.jpg

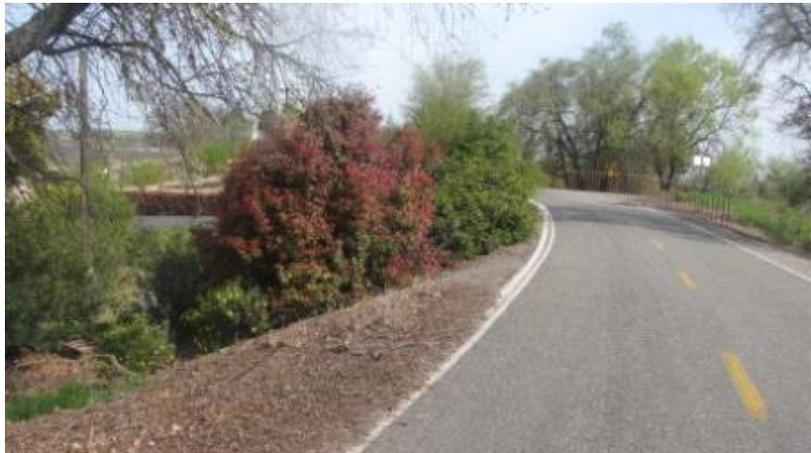
Levee Mile Report Line	31
Start Levee Mile	3.72
End Levee Mile	3.73
Location	Land Side
Category	Earthen Levee
Item	Encroachments
Looking northwest at landscaping on landside slope and toe.	
richard_s_20100408_192.jpg

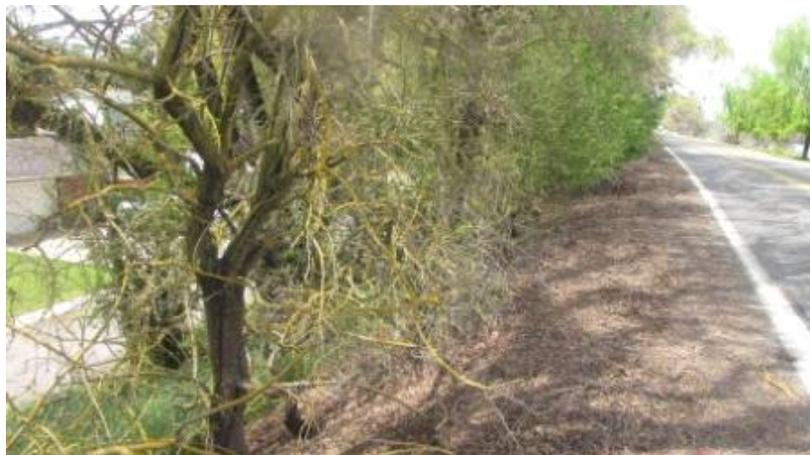
Levee Mile Report Line	8
Start Levee Mile	0.37
End Levee Mile	0.50
Location	Land Side
Category	Earthen Levee
Item	Trim / Thin Trees
Looking northwest at dense trees on landside slope and toe.	
richard_s_20100408_204.jpg

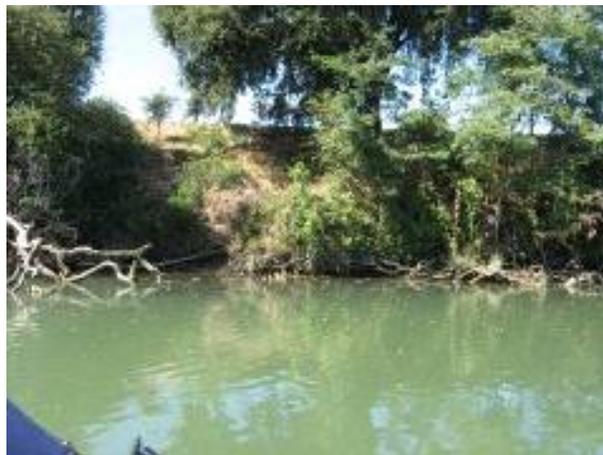
Levee Mile Report Line	6
Start Levee Mile	0.24
End Levee Mile	0.26
Location	Water Side
Category	Supplemental
Item	USACE Erosion Survey
2009: no berm, 1:1 slope, tree hazards, clays and cobbles, 3 ft/s [2009 SiteID:ELK_0-2_R]	
USACE2009_ELK_0-2_R_2009_09_17-D3bP40_small.JPG

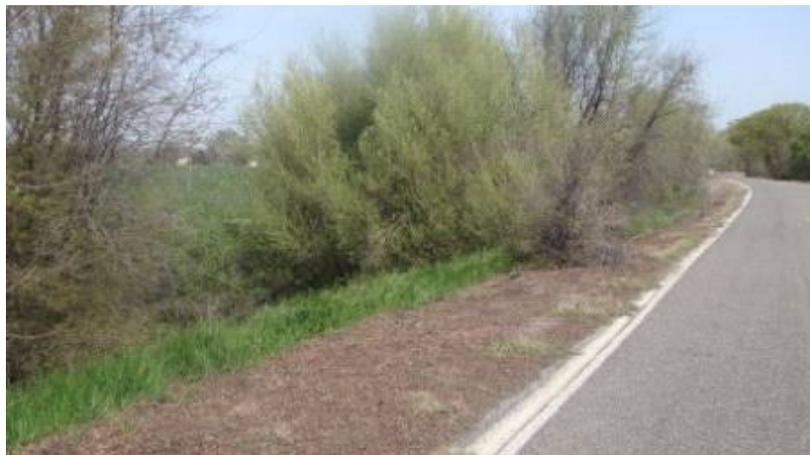
Levee Mile Report Line	12
Start Levee Mile	0.43
End Levee Mile	0.47
Location	Land Side
Category	Earthen Levee
Item	Trim / Thin Trees
Looking north at dense veg. on landside slope and toe. richard_s_20100408_194.jpg

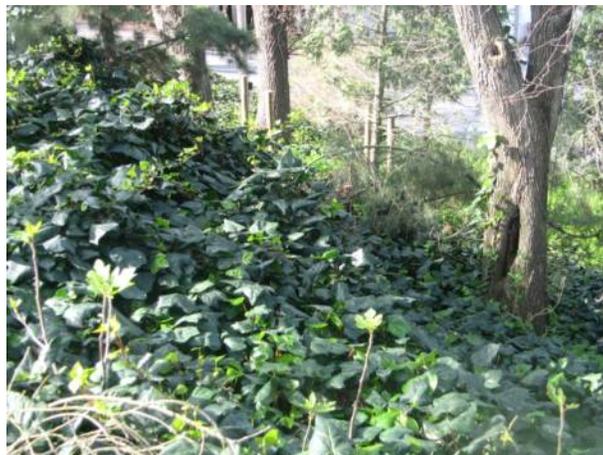
Levee Mile Report Line	19
Start Levee Mile	0.84
End Levee Mile	0.94
Location	Land Side
Category	Earthen Levee
Item	Encroachments
View of landscaping (Ivy) blocking view of landside slope from LM 0.84 to 0.94	
richard_s_20100316_119.jpg

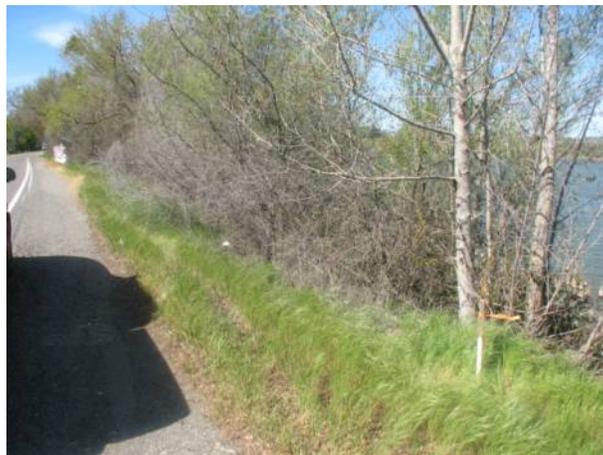
Levee Mile Report Line	28
Start Levee Mile	1.51
End Levee Mile	1.88
Location	Land Side
Category	Earthen Levee
Item	Trim / Thin Trees
Side view of dense trees along waterside slope.	
richard_s_20100316_122.jpg

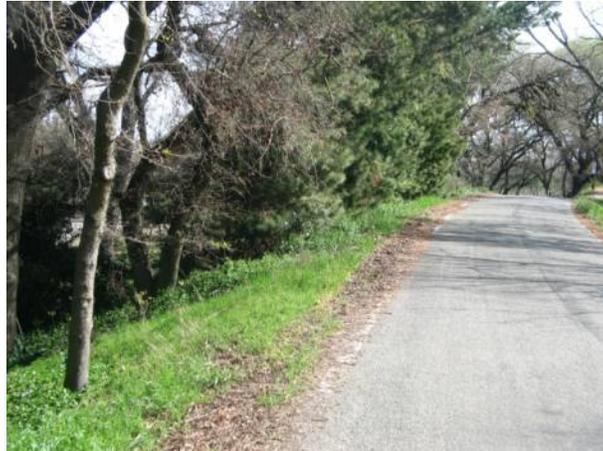
Levee Mile Report Line	43
Start Levee Mile	3.19
End Levee Mile	3.24
Location	Land Side
Category	Earthen Levee
Item	Encroachments
Looking downstream of landscaping blocking view of landside slope from LM 3.19 to 3.24	
richard_s_20100316_124.jpg

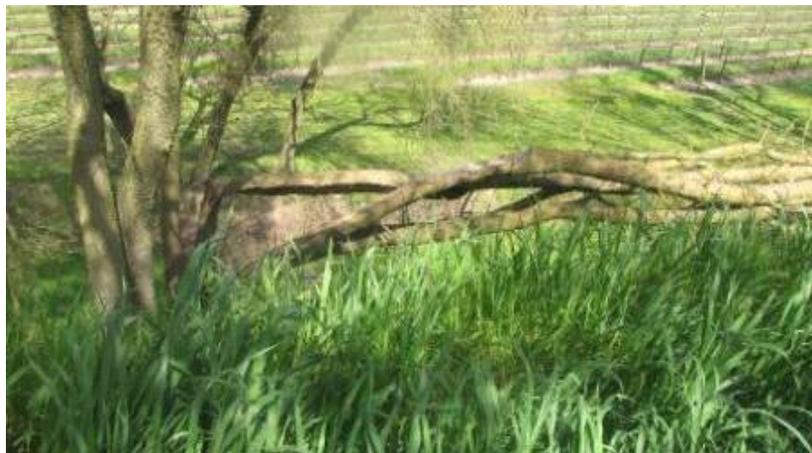
Levee Mile Report Line	46
Start Levee Mile	3.30
End Levee Mile	3.30
Location	Land Side
Category	Earthen Levee
Item	Encroachments
Looking east at down tree branch on landside slope.	
richard_s_20100408_196.jpg

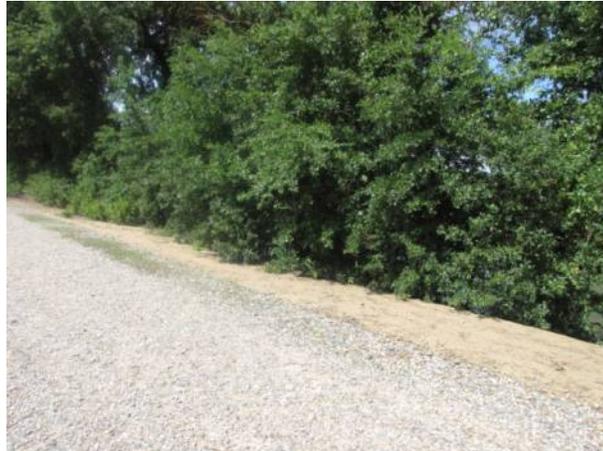
Levee Mile Report Line	55
Start Levee Mile	4.05
End Levee Mile	4.14
Location	Water Side
Category	Earthen Levee
Item	Trim / Thin Trees
Looking northeast at overgrown trees on waterside slope.	
jhirabay_s_20100610_203.jpg

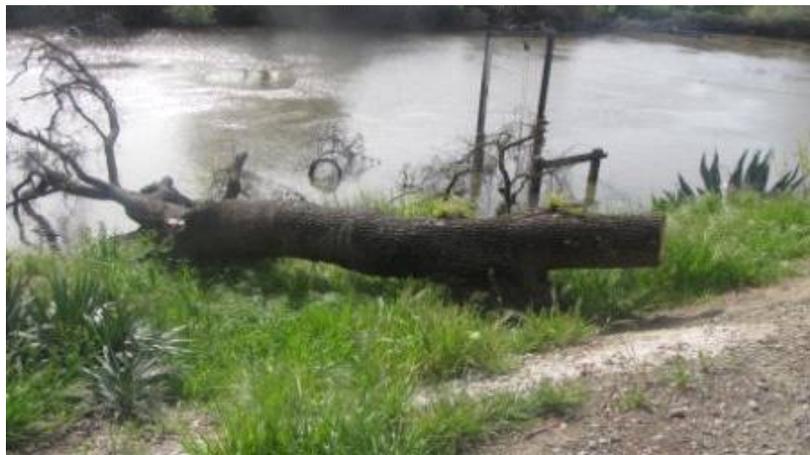
Levee Mile Report Line	57
Start Levee Mile	4.37
End Levee Mile	4.37
Location	Water Side
Category	Earthen Levee
Item	Encroachments
Looking south at down tree on waterside slope.	
richard_s_20100408_199.jpg

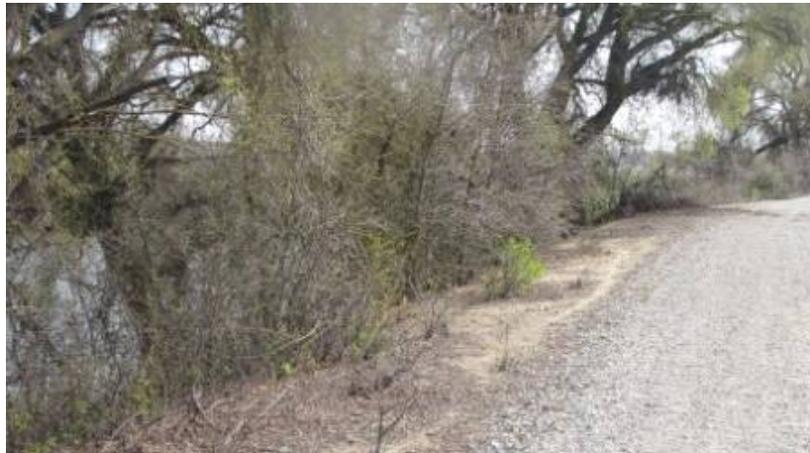
Levee Mile Report Line	62
Start Levee Mile	4.55
End Levee Mile	4.55
Location	Water Side
Category	Earthen Levee
Item	Encroachments
Looking southeast at dense trees on waterside slope	
richard_s_20100408_197.jpg

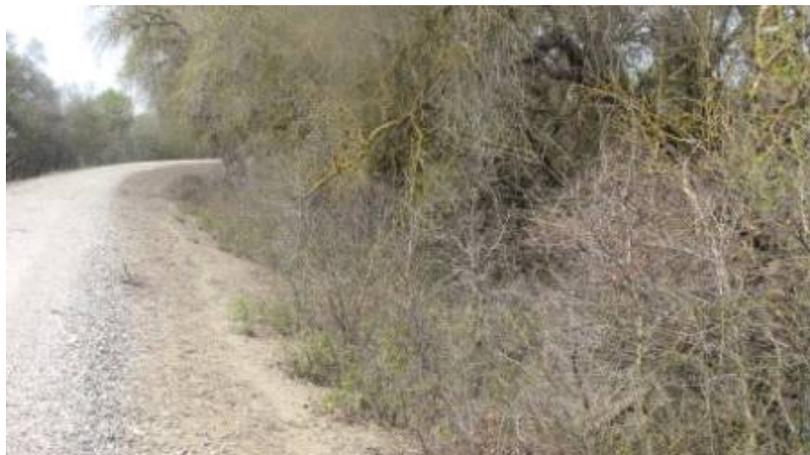
Levee Mile Report Line	62
Start Levee Mile	4.55
End Levee Mile	4.55
Location	Water Side
Category	Earthen Levee
Item	Encroachments
Looking north at dense trees on waterside slope.	
richard_s_20100408_198.jpg

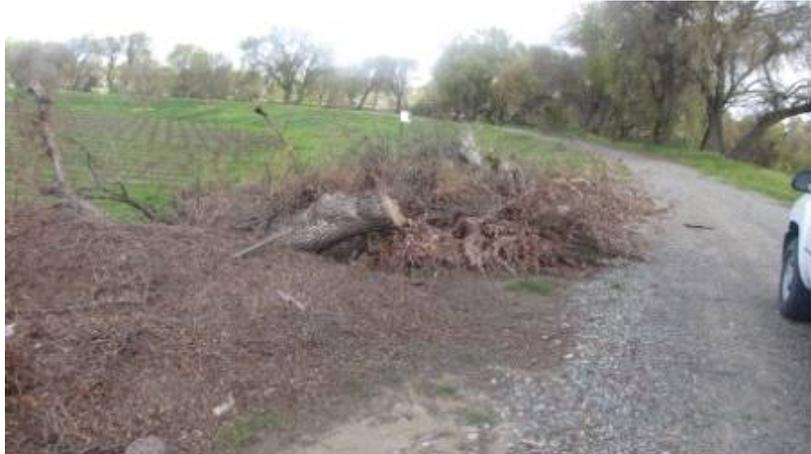
Levee Mile Report Line	75
Start Levee Mile	5.16
End Levee Mile	5.16
Location	Land Side
Category	Earthen Levee
Item	Encroachments
Looking northeast at prunings on landside shoulder and slope.	
richard_s_20100408_200.jpg

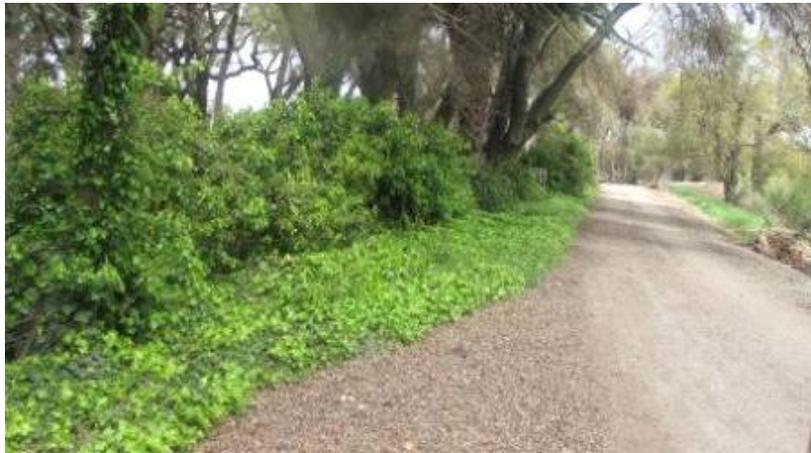
Levee Mile Report Line	88
Start Levee Mile	6.78
End Levee Mile	6.81
Location	Land Side
Category	Earthen Levee
Item	Encroachments
Looking north at overgrown landscape on landside slope and toe.	
richard_s_20100408_201.jpg

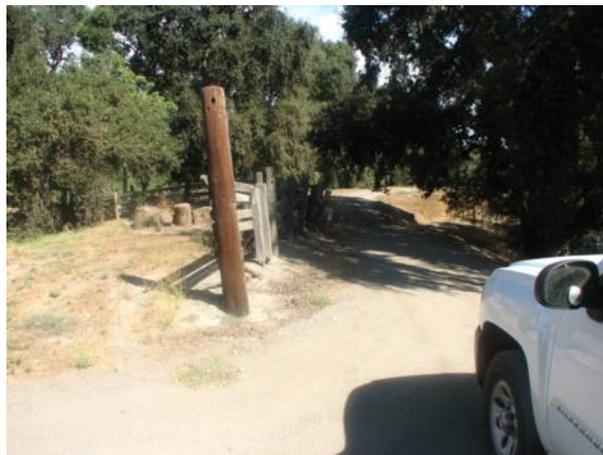
Levee Mile Report Line	89
Start Levee Mile	6.83
End Levee Mile	6.83
Location	Land Side
Category	Earthen Levee
Item	Encroachments
Fence and Firewood at landside shoulder.	
richard_s_20100316_130.jpg

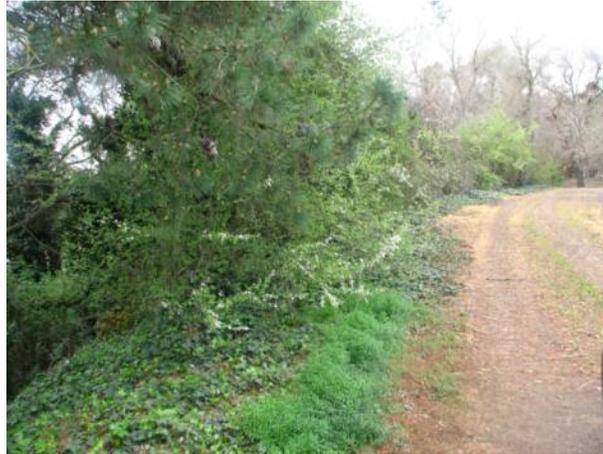
Levee Mile Report Line	90
Start Levee Mile	7.65
End Levee Mile	7.69
Location	Land Side
Category	Earthen Levee
Item	Encroachments
Landscaping on landside slope blocking view of slope from LM 7.65 to 7.72	
richard_s_20100316_129.jpg

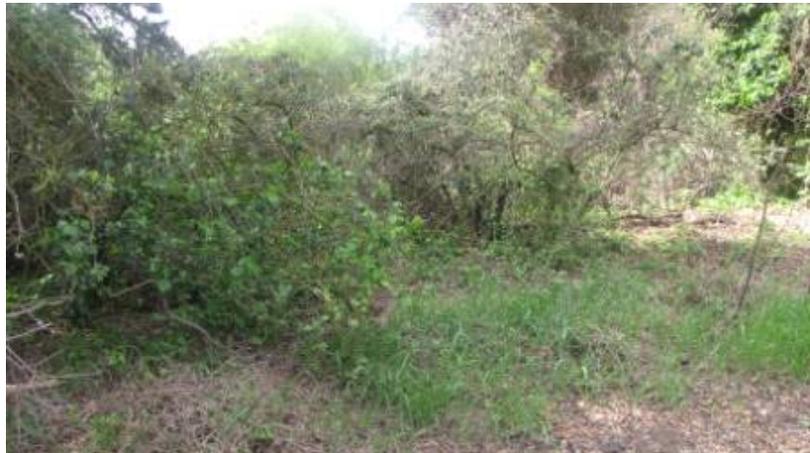
Levee Mile Report Line	90
Start Levee Mile	7.65
End Levee Mile	7.69
Location	Land Side
Category	Earthen Levee
Item	Encroachments
Looking east at overgrown landscape on landside slope.	
richard_s_20100408_202.jpg

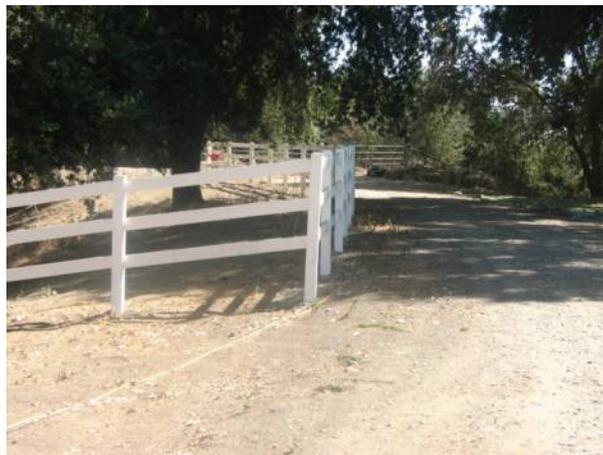
Levee Mile Report Line	98
Start Levee Mile	8.57
End Levee Mile	8.61
Location	Land Side
Category	Earthen Levee
Item	Encroachments
New installed unauthorized fence at landside slope and shoulder.	
richard_s_20100316_131.jpg

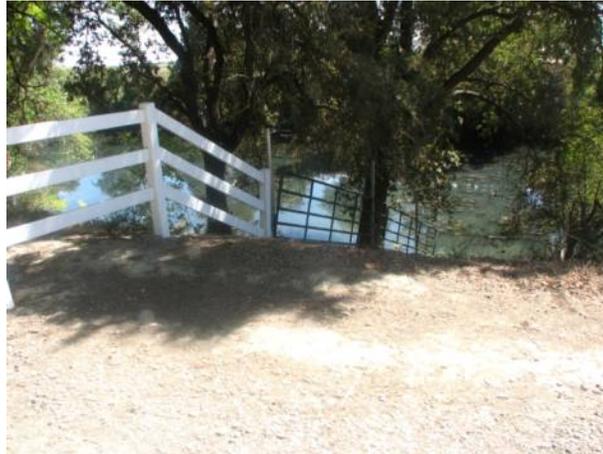
Levee Mile Report Line	101
Start Levee Mile	8.74
End Levee Mile	8.74
Location	Crown
Category	Earthen Levee
Item	Encroachments
New unauthorized fence that extend from landside toe to waterside toe.	
richard_s_20100316_132.jpg

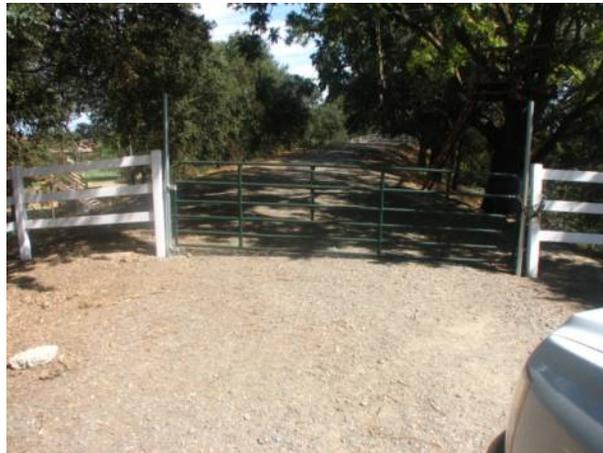
Levee Mile Report Line	101
Start Levee Mile	8.74
End Levee Mile	8.74
Location	Crown
Category	Earthen Levee
Item	Encroachments
View of fence & gate across levee crown, landside & waterside slope.	
richard_s_20100316_133.jpg

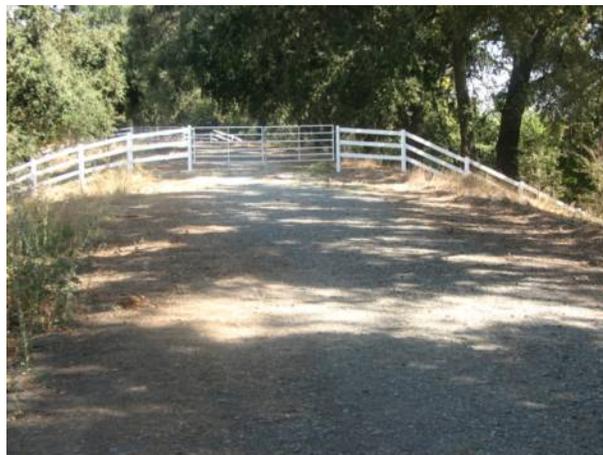
Levee Mile Report Line	102
Start Levee Mile	8.78
End Levee Mile	8.78
Location	Crown
Category	Earthen Levee
Item	Encroachments
New unauthorized fence and gate that extend from landside toe across levee crown to waterside toe.	
richard_s_20100316_134.jpg

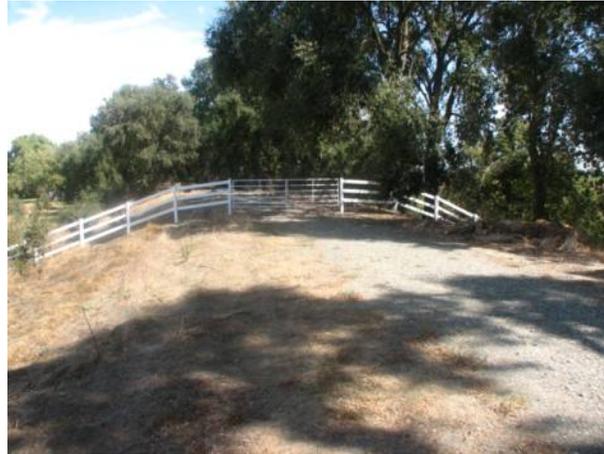
Levee Mile Report Line	103
Start Levee Mile	8.81
End Levee Mile	8.81
Location	Crown
Category	Earthen Levee
Item	Encroachments
New unauthorized fence and gate that extend from landside toe across levee crown to waterside toe.	
richard_s_20100316_135.jpg
