**Flood Control Project Maintenance  
Levee Inspections**  
**LMA District Cover Sheet**  
**Spring 2014 Levee Inspection Results**

**Reclamation District No. 0999 Netherlands**

**Spring 2014 Levee Inspection Results**

| Waterway | Bank | Unit Miles |
|---|---|---|
| Unit No. 01 Yolo Bypass | Left | 15.43 |

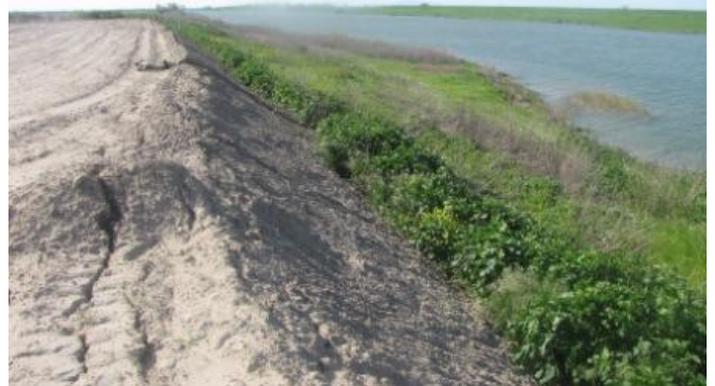
Photo 2 of 4 : richard\_s\_20140310\_149.jpg

Looking southwest at fill on waterside berm.

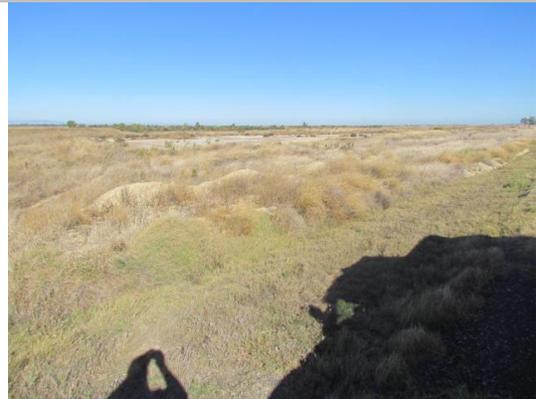
Photo 3 of 4 : richard\_s\_20140310\_151.jpg

Looking west at fill on waterward berm. 2013

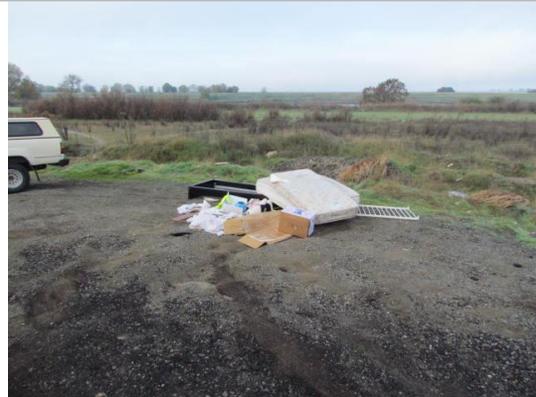
Photo 1 of 2 : richard\_s\_20140310\_162.jpg

| Garbage<br>Inspector Comments: Garbage on waterside shoulder. | | | | | |

Looking west at garbage on waterside shoulder and slope.

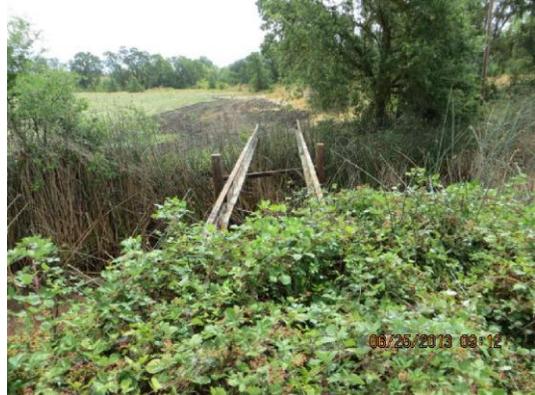
Photo 1 of 1 : UCIP\_1285.jpg

Pump platform visible off LS toe, but no appurtances remain.

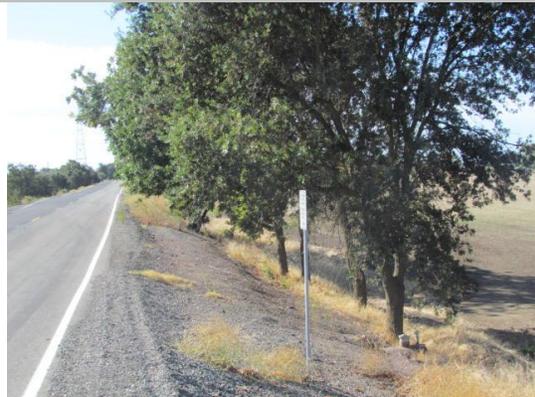
Photo 1 of 2 : richard\_s\_20140310\_153.jpg

Looking southwest at trimmed trees on waterward slope.

| Trim trees to at least five feet above ground level. | | | | | |

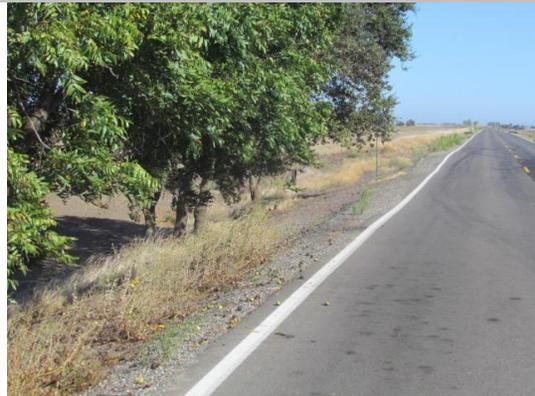
Photo 2 of 2 : richard\_s\_20140310\_154.jpg

Looking northwest at trimmed trees on waterward slope.

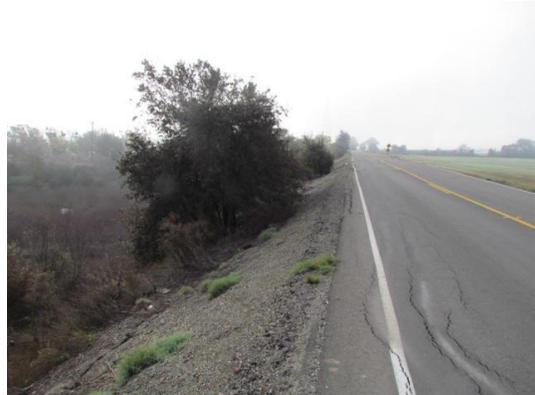
Photo 1 of 3 : richard\_s\_20140310\_175.jpg

Looking southeast at untrimmed tree on landside slope and toe.

| Trim trees to at least five feet above ground level. | | | | | |

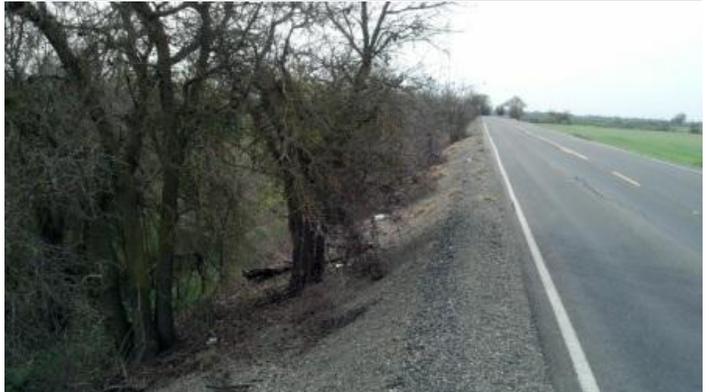
Photo 2 of 3 : richard\_s\_20140310\_176.jpg

Looking southeast at dense trees on landside slope and toe. (2013)

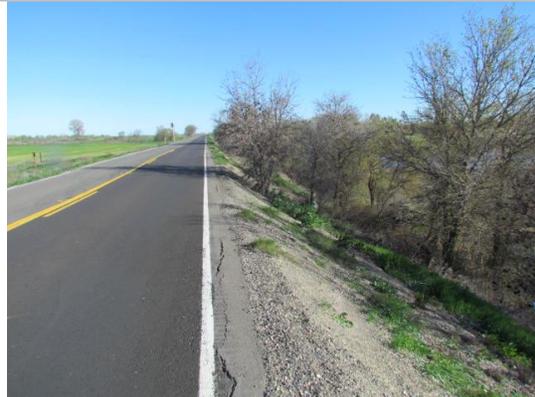
Photo 3 of 3 : richard\_s\_20140314\_433.jpg

Looking north at several untrimmed trees on landside slope.

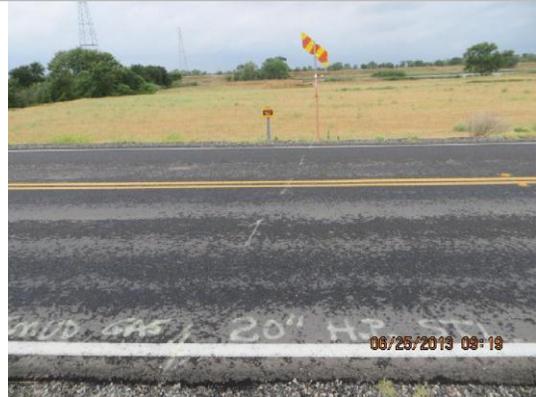
Photo 1 of 1 : UCIP\_1454.jpg

Gasline markers on WS shoulder with USAA paint on roadway.

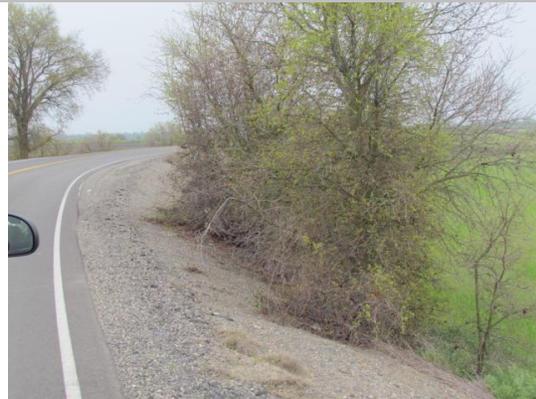
Photo 1 of 1 : richard\_s\_20140310\_160.jpg

Looking southwest at untrimmed trees on waterside slope.

| Trim trees to at least five feet above ground level. | | | | | |

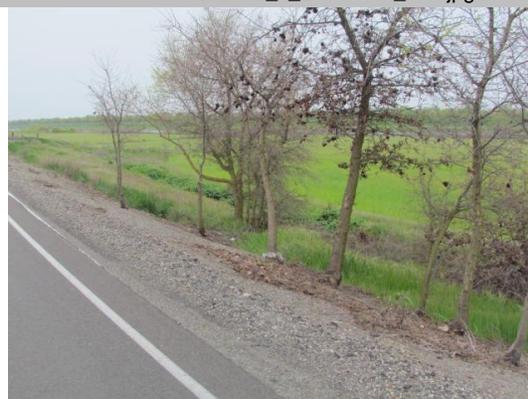
Photo 1 of 1 : richard\_s\_20140310\_161.jpg

Looking southwest at trimmed trees on waterside slope. (Spring 2012)

| Thin trees to allow visibility of the ground and room to flood fight. | | | | | |

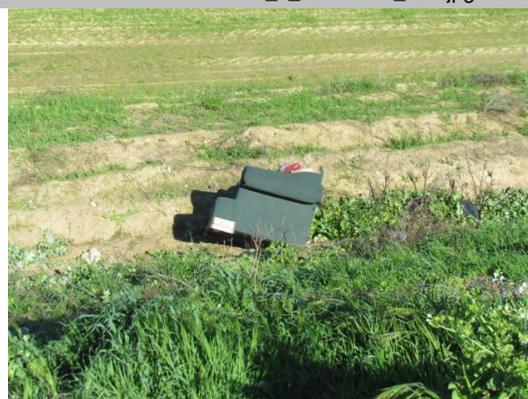
Photo 1 of 1 : richard\_s\_20140314\_434.jpg

| Garbage<br>Inspector Comments: Garbage (sofa) on waterside toe. | | | | | |

Looking west at garbage (sofa) on waterward toe.

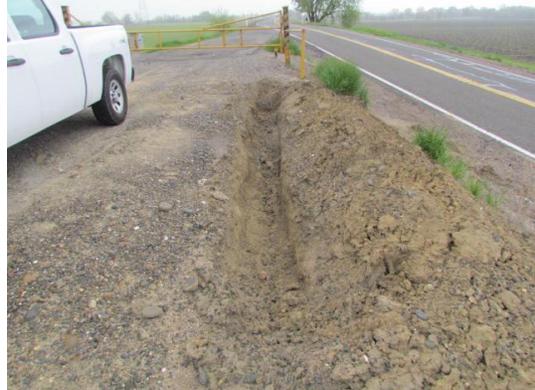
Photo 2 of 3 : richard\_s\_20140310\_183.jpg

| Inspector Comments: Excavation activity on landside shoulder. Hole is approximately 15ft x 12" x 15". Hole appears to be excavated by a backhoe. | | | | | |

Looking north at excavation on landside shoulder.

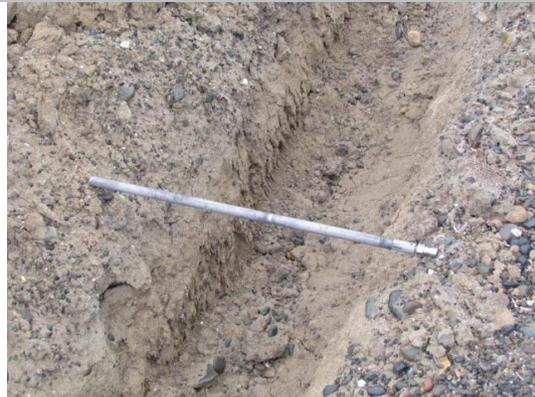
Photo 3 of 3 : richard\_s\_20140310\_184.jpg

Looking south at close-up view of excavation on landside shoulder.

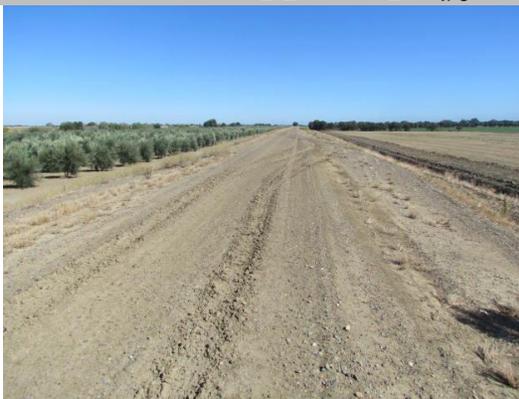
Photo 1 of 3 : richard\_s\_20140310\_188.jpg

Looking north at rutting on levee crown.

| Repair depressions or ruts in the crown or slope. | | | | | |

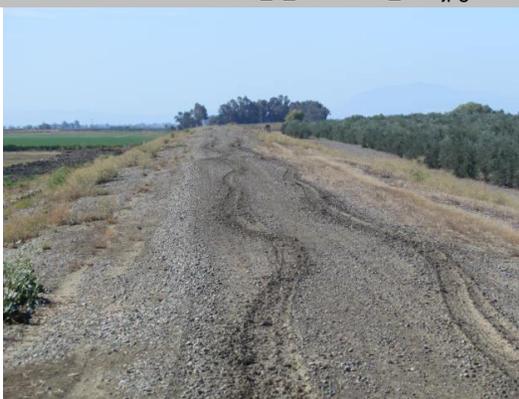
Photo 2 of 3 : richard\_s\_20140310\_189.jpg

Looking south at rutting on levee crown.

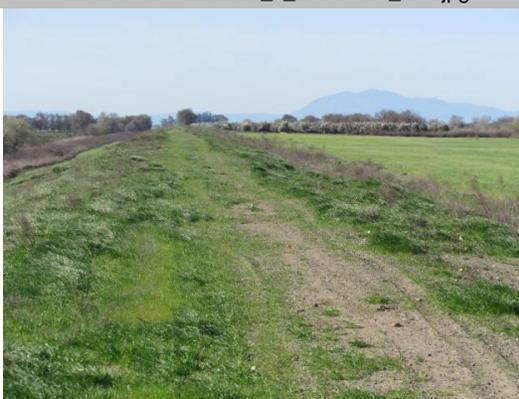
Photo 3 of 3 : richard\_s\_20140314\_435.jpg

Looking south at growth and ruts on levee crown.

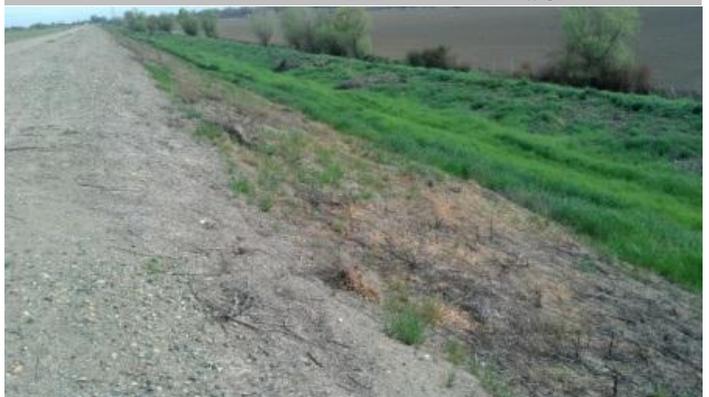
Photo 2 of 2 : richard\_s\_20140310\_197.jpg

Looking north at depression on landside should and slope.

| Repair slope instability. | | | | | |

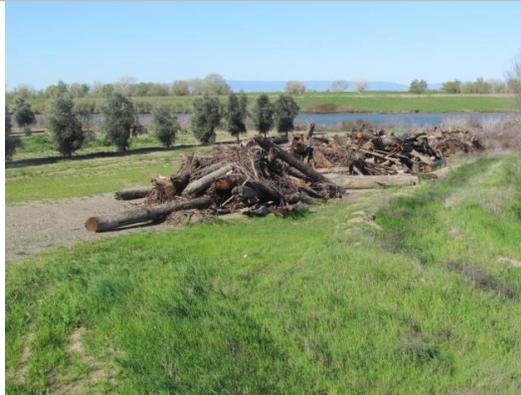
Photo 2 of 2 : richard\_s\_20140314\_437.jpg

| Tree or limb<br>Inspector Comments: Discarded tree branches, limbs and power poles stockpile on waterward berm. | | | | | |

Looking southwest at pruning on waterward berm.

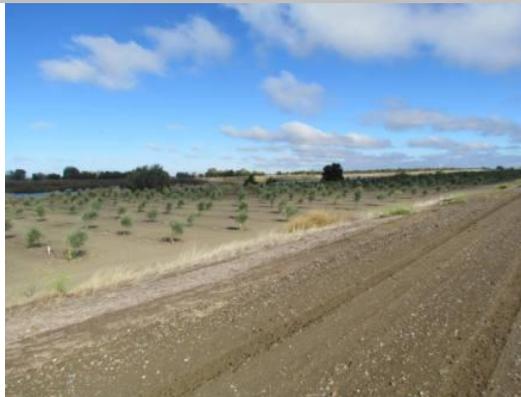
Photo 1 of 3 : richard\_s\_20140310\_155.jpg

| Crops<br>Inspector Comments: Landowner has planted an olive grove on waterside berm several years ago without a board permit. | | | | | |

Looking northwest at olive grove on waterside berm at upstream end.

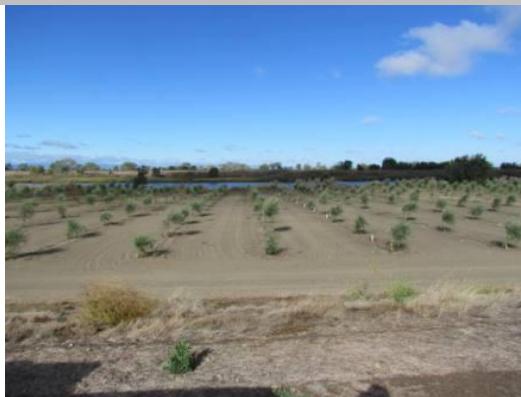
Photo 2 of 3 : richard\_s\_20140310\_156.jpg

Looking west at olive grove on waterside berm.

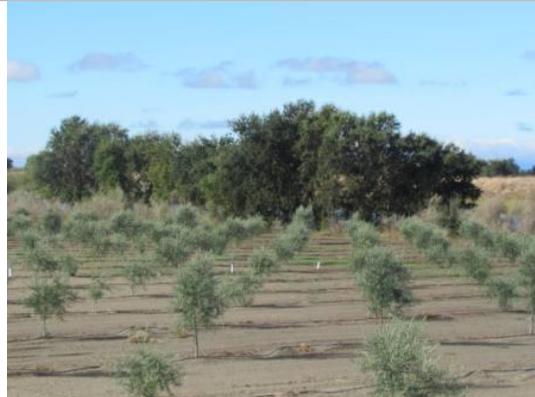
Photo 3 of 3 : richard\_s\_20140310\_157.jpg

Looking southwest at olive grove on waterside berm at downstream end.

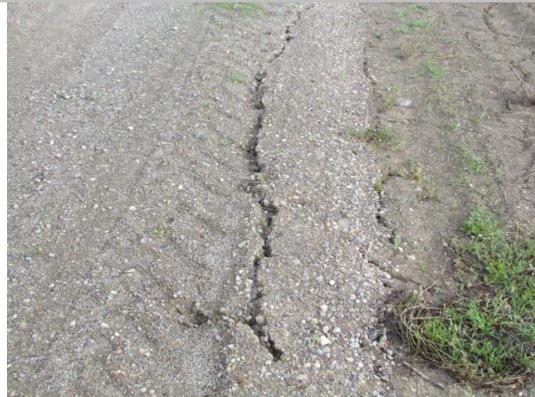
Photo 1 of 2 : richard\_s\_20140310\_158.jpg

| Repair slope instability.<br>Inspector Comments: District Manager (Bob Webber) indicated that the area has a history of cracking and sloughing. District plans to repair site this summer. District repaired site without notifying the Dept. No compaction results provided. Unclear how site was repaired. Need more information about repair from district. During the fall inspection small cracks and sloughing were seen re-appearing on landside shoulder and slope. | | | | | |

Looking north at cracking and sloughing on landside shoulder and slope.

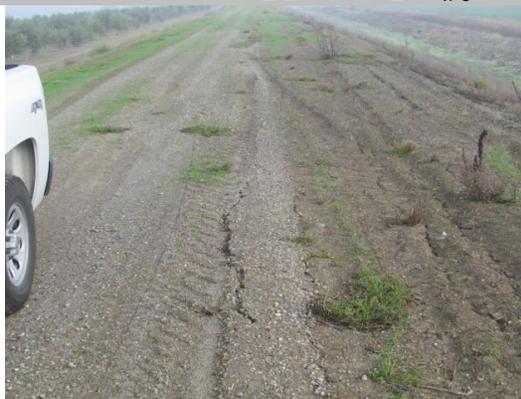
Photo 2 of 2 : richard\_s\_20140310\_159.jpg

| Repair slope instability.<br>Inspector Comments: District Manager (Bob Webber) indicated that the area has a history of cracking and sloughing. District plans to repair site this summer. District repaired site without notifying the Dept. No compaction results provided. Unclear how site was repaired. Need more information about repair from district. During the fall inspection small cracks and sloughing were seen re-appearing on landside shoulder and slope. | | | | | |

Looking north at sloughing on landside shoulder and slope.

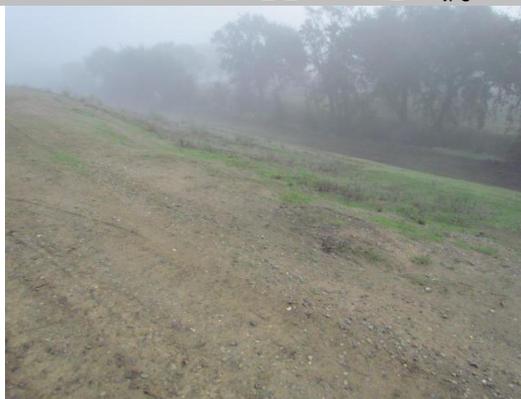
Photo 1 of 2 : richard\_s\_20140310\_178.jpg

Looking east at slope damage on landside slope.

| Repair the levee slope damaged by vehicle traffic and prevent access where possible. | | | | | |

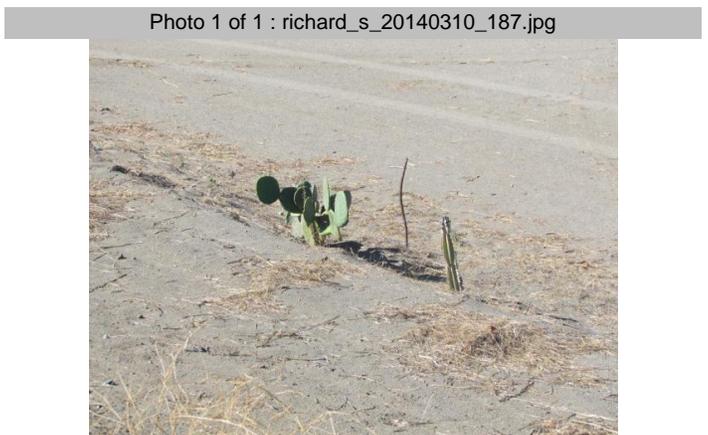
| Remove the wild growth other than native grasses from the levee slopes.<br>Inspector Comments: Landowner has planted cactus on waterward toe. | | | | | |

Looking west at cactus on waterward toe.

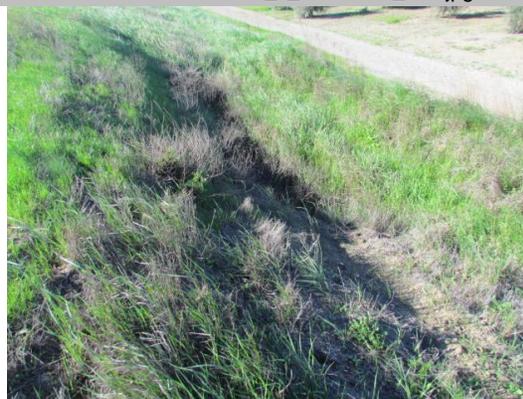
Photo 1 of 2 : richard\_s\_20140314\_438.jpg

| Repair slope instability.<br>Inspector Comments: Slope depression on waterward near toe of levee. Depression is approx. 18' x 14' x 4' in area. | | | | | |

Looking southwest at depression on waterward toe.

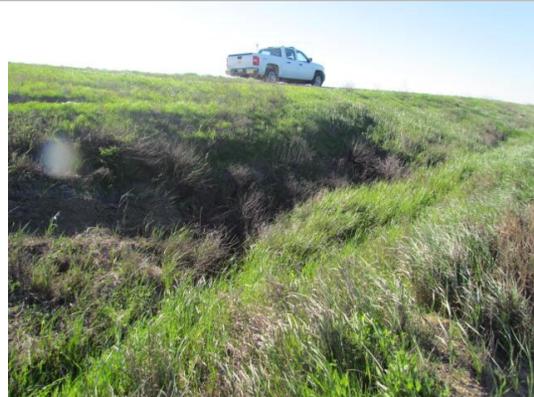
Photo 2 of 2 : richard\_s\_20140314\_439.jpg

| Repair slope instability.<br>Inspector Comments: Slope depression on waterward near toe of levee. Depression is approx. 18' x 14' x 4' in area. | | | | | |

Looking southeast at depression on waterward toe.

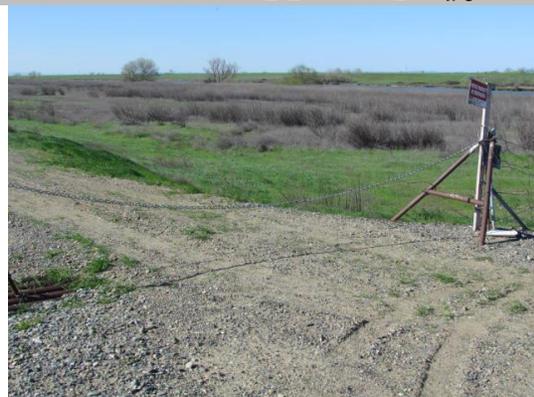
Photo 1 of 1 : richard\_s\_20140314\_440.jpg

| Inspector Comments: Steel chain across gate opening is not according to Title 23 standards. | | | | | |

Looking southwest at steel chain across levee crown.

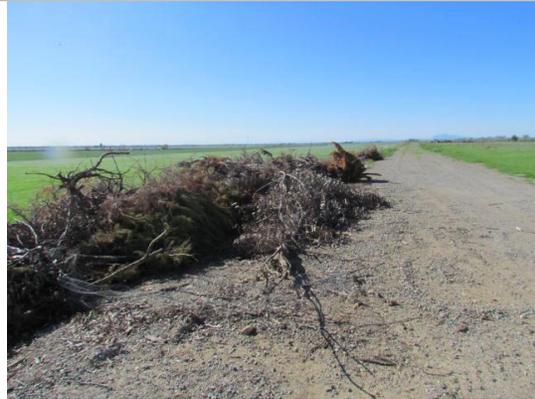
Photo 2 of 3 : richard\_s\_20140314\_442.jpg

| Prunings<br>Inspector Comments: Large pruning piles on landward shoulder. Part of pruning pile blocking levee crown. | | | | | |

Looking southeast at prunings on landward slope.

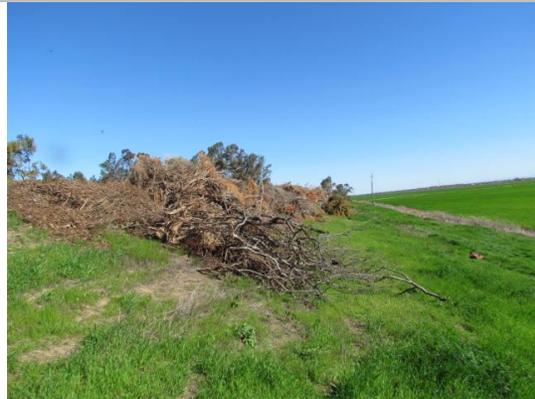
Photo 3 of 3 : richard\_s\_20140314\_443.jpg

Looking northwest at pruning pile on landward slope.

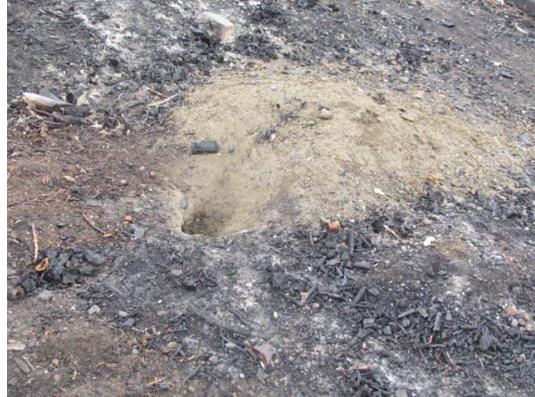
Photo 1 of 2 : richard\_s\_20140310\_185.jpg

| Exterminate rodents and backfill and compact or grout burrows.<br>Inspector Comments: More than five holes within 25' of levee. | | | | | |

Looking at typical rodent hole on landside slope.

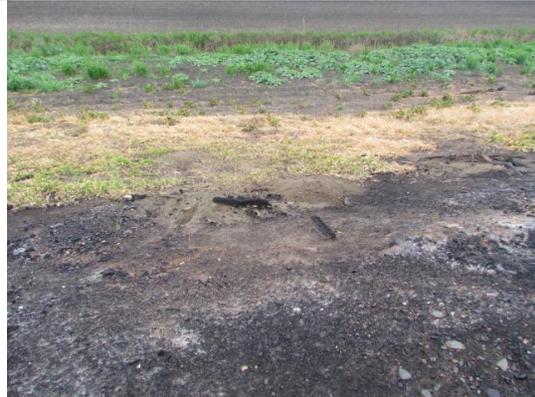
Photo 2 of 2 : richard\_s\_20140310\_186.jpg

Looking east at rodent holes on landside slope.

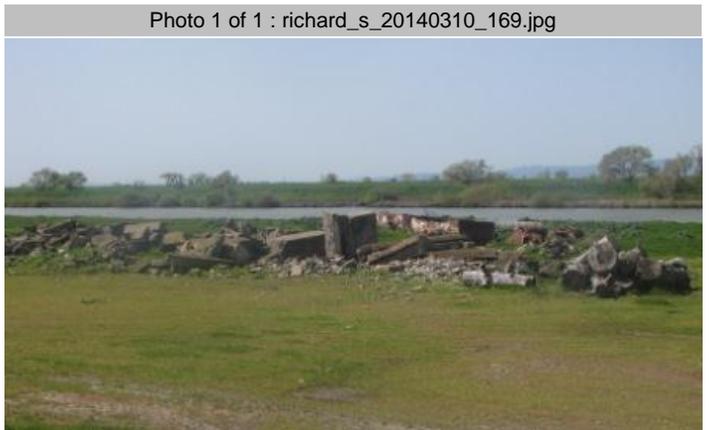
| Material<br>Inspector Comments: Concrete rubble on waterside berm. | | | | | |

Looking west at concrete rubble on waterside berm.

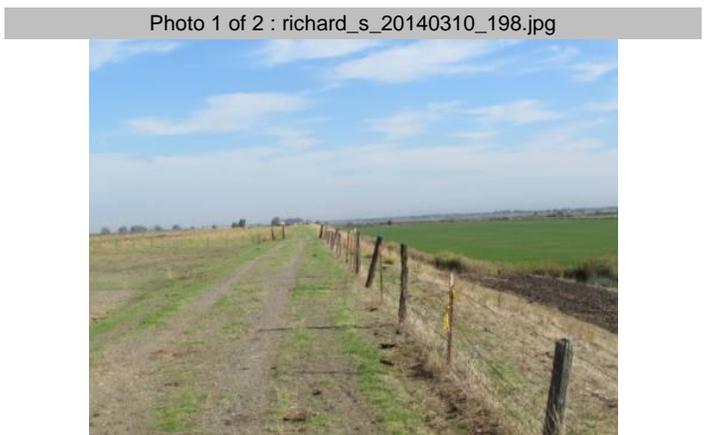
Looking north at fence along landside shoulder.

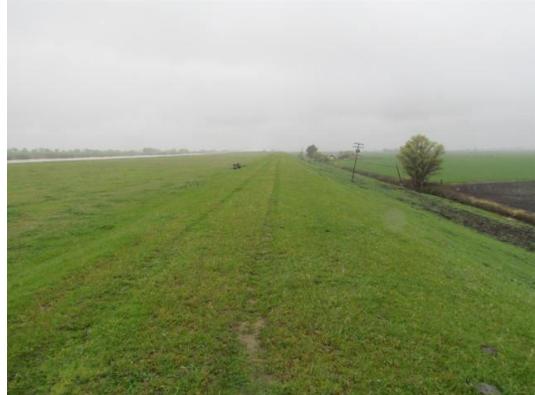
Photo 1 of 1 : richard\_s\_20140310\_200.jpg

Looking south at crown roadway.

| Add appropriate material and re-grade the levee to bring the crown | | | | | |

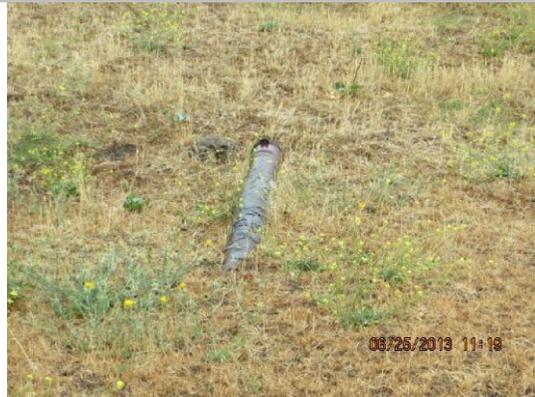
Photo 1 of 1 : UCIP\_4108.jpg

| Inspector Comments: FS_ID:24413<br>EP_NO: 13300<br>Repair Type:<br>Crossing Status:<br>UCIP Comments: Pipe abandoned and should be done so properly.<br>FIELD_STRUCT_DESC: 6-inch steel pipe through the levee 3.0 feet below the crown. JP and meter at abandoned pump location on LS toe (Permit No. 13300, 1983).<br>FS Date: 6/25/2013 | | | | | |

Pipe open on WS slope.

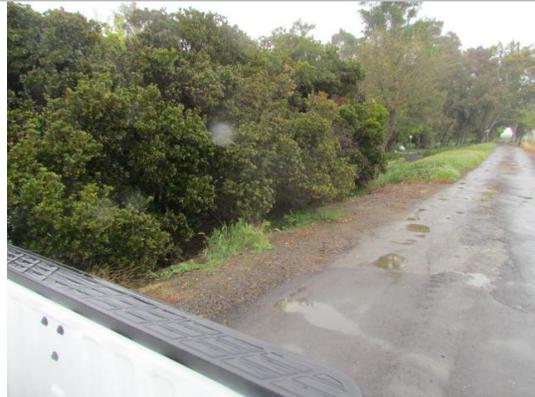
Photo 1 of 1 : richard\_s\_20140310\_170.jpg

| Landscaping<br>Inspector Comments: Trees should be trimmed for visibility. | | | | | |

Looking northwest at dense trees on waterside slope.

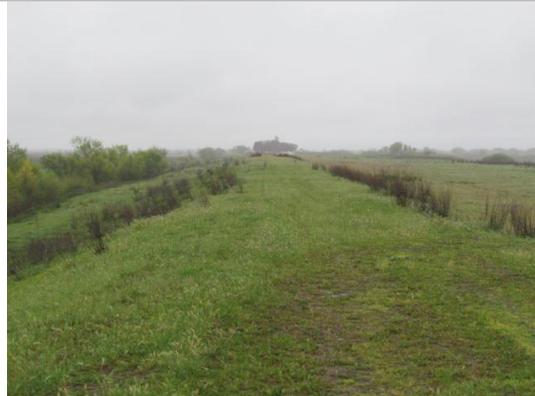
Photo 1 of 1 : richard\_s\_20140310\_201.jpg

Looking south at crown roadway.

| Add appropriate material and re-grade the levee to bring the crown above the design elevation. | | | | | |

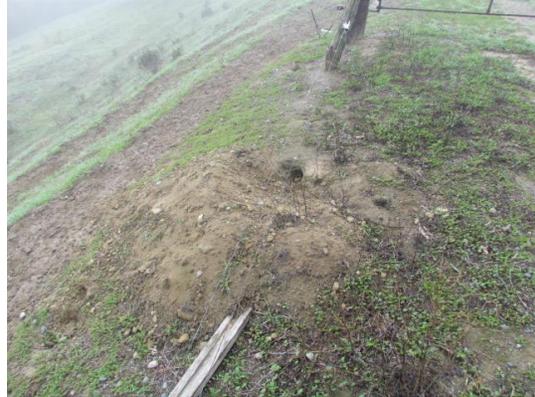
Photo 1 of 1 : richard\_s\_20140310\_152.jpg

Looking south at rodent hole on landside shoulder.

| Exterminate rodents and backfill and compact or grout burrows. | | | | | |

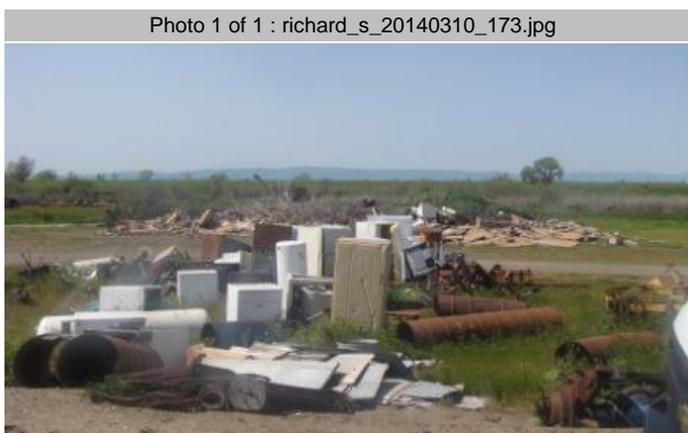
Looking southwest at garbage on waterside toe and berm.

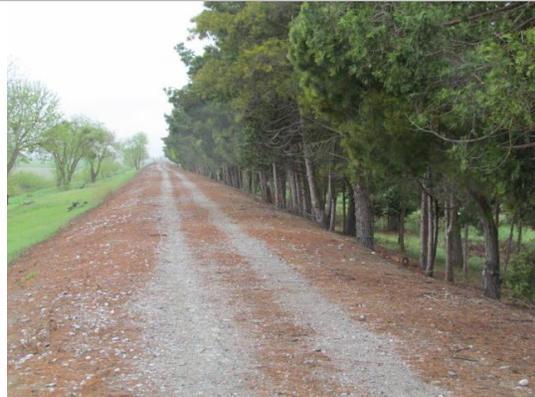
Photo 2 of 2 : richard\_s\_20140310\_168.jpg

Looking south at trimmed pine trees on waterside shoulder and slope. (Spring 2012)

| Trim trees to at least five feet above ground level. | | | | | |

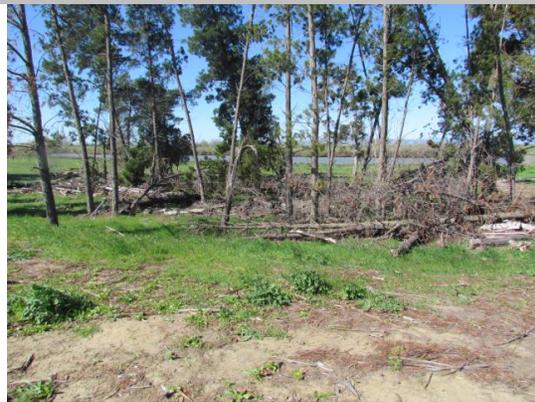
Photo 1 of 1 : richard\_s\_20140314\_444.jpg

Looking west at pruning piles on waterward berm.

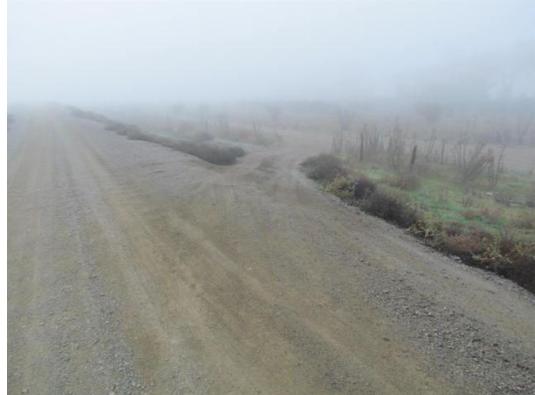
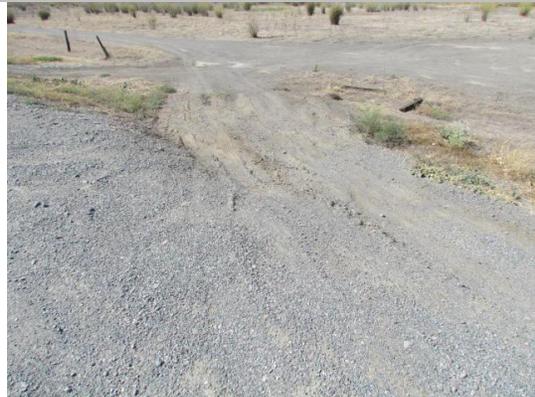
Looking southwest at slope damage caused by vehicle traffic on waterside slope.

Looking southwest at slope damage caused by vehicle traffic. 2013

| Repair the levee slope damaged by vehicle traffic and prevent access where possible.<br>Inspector Comments: Slope damage caused by vehicle traffic | | | | | |

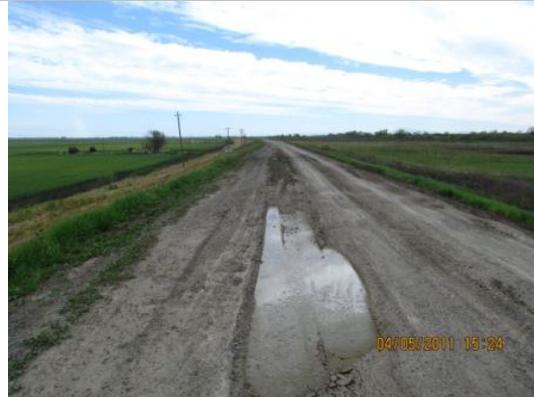
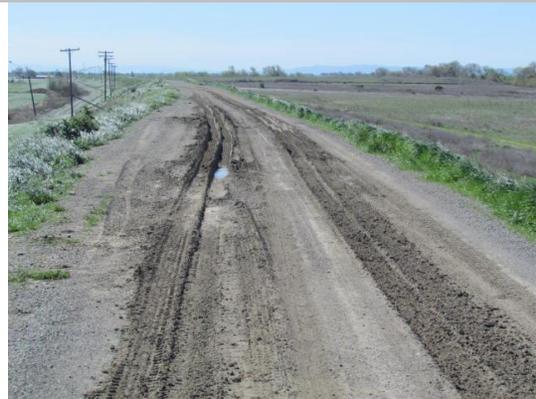
Looking south at rutting on levee crown.

| Repair depressions or ruts in the crown or slope. | | | | | |

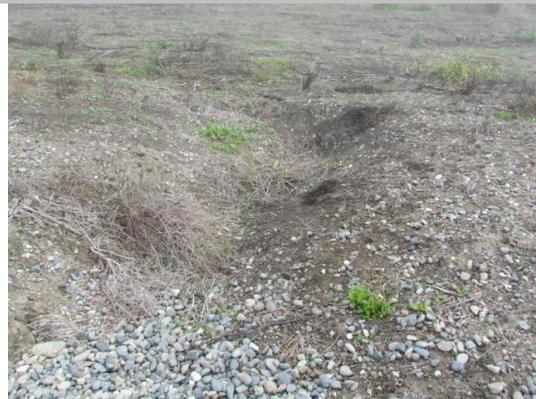
Photo 1 of 2 : richard\_s\_20140310\_193.jpg

| Note and monitor erosion site.<br>Inspector Comments: Caving, 4' x 10', on landside slope. | | | | | |

Looking east caving on landside slope.

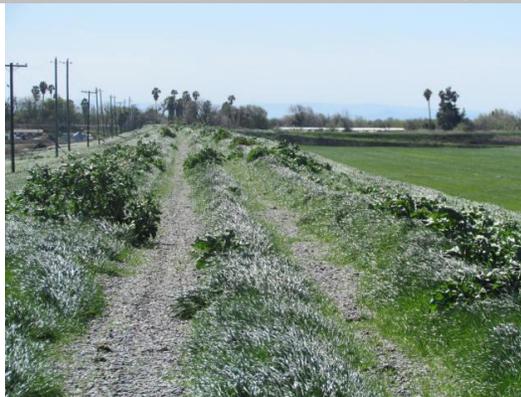
Photo 1 of 1 : richard\_s\_20140314\_446.jpg

Looking south at growth on levee crown.

| Add appropriate material and re-grade the levee to bring the crown | | | | | |

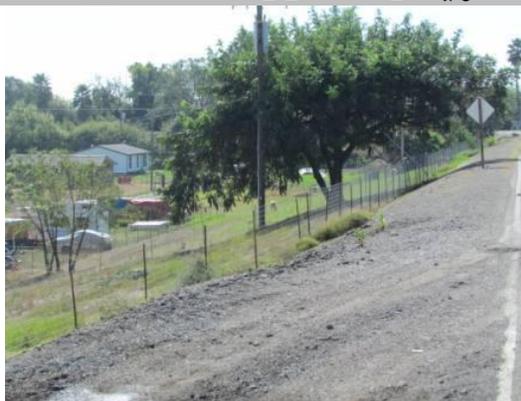
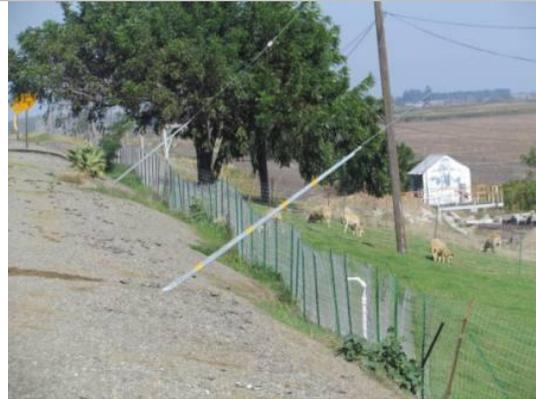
| Fence<br>Inspector Comments: Landowner has installed fence along landside slope for sheep to maintain levee slope. Landowner should apply for permit for fence. | | | | | |

Looking south at fence along landside slope.

Looking north at fence along landside slope.

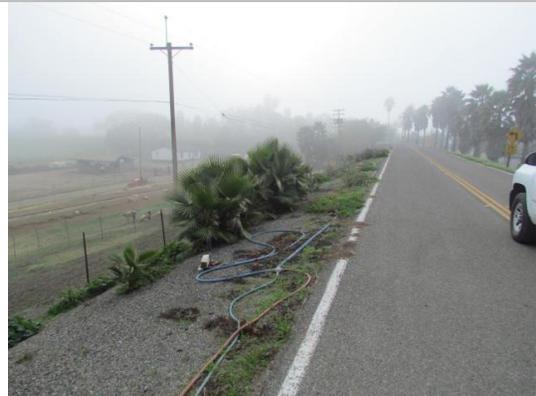
Photo 1 of 1 : richard\_s\_20140310\_195.jpg

| Tree or limb<br>Inspector Comments: Newly planted palm trees on landside shoulder. | | | | | |

Looking east at newly planted palm trees on landside shoulder and slope.

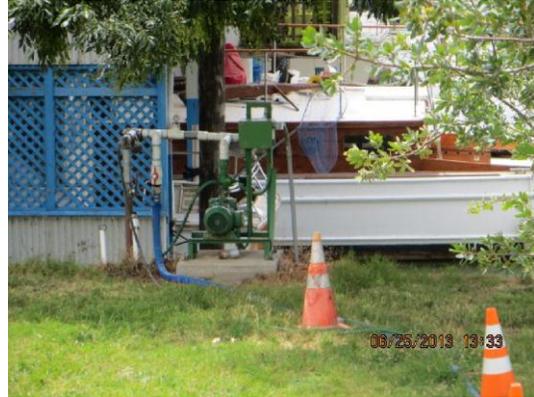
Photo 1 of 1 : UCIP\_1456.jpg

Possible pump visible off WS toe at waters edge.

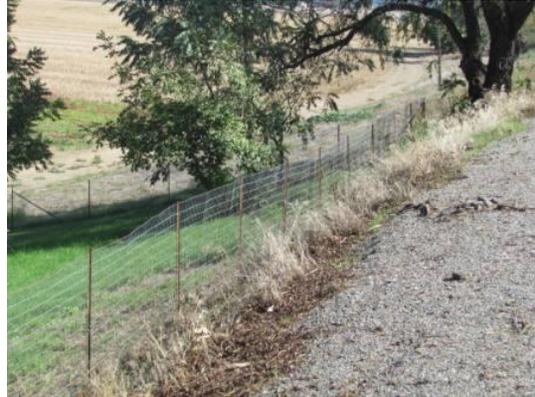
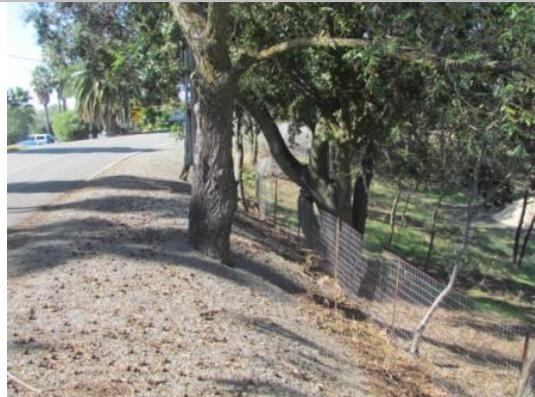
| Fence<br>Inspector Comments: Landowner has installed fence along landside slope for sheep to maintain levee slope. Landowner should apply for permit to keep fence. | | | | | |

Looking northeast at fence along landside shoulder.

Looking west at fence along landside slope.

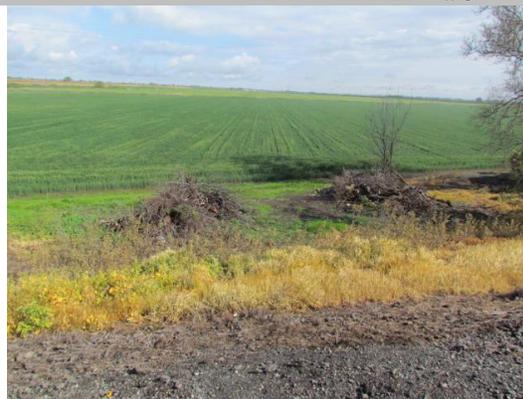
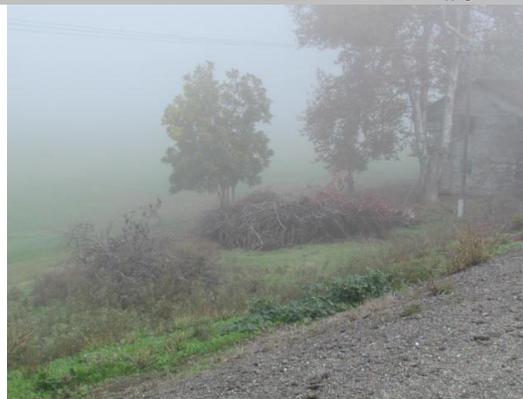
Looking west at prunings on landside berm.

Looking west at prunings on landside toe. (Fall Inspection 2012)

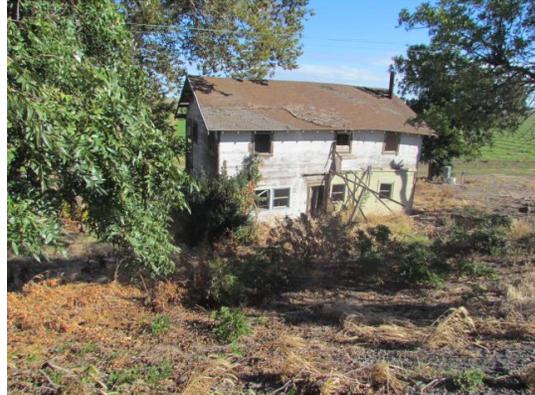
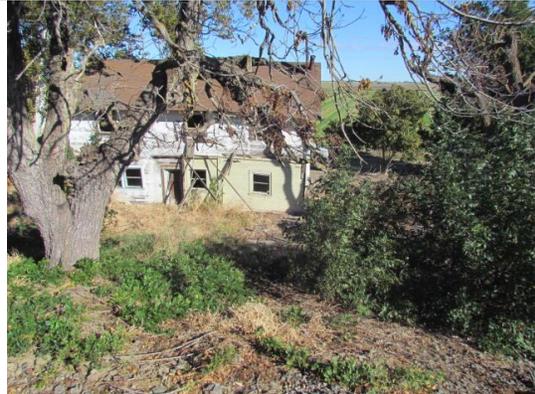
Looking west at abandoned building on landward berm.

Looking southwest at abandoned building on landward berm.

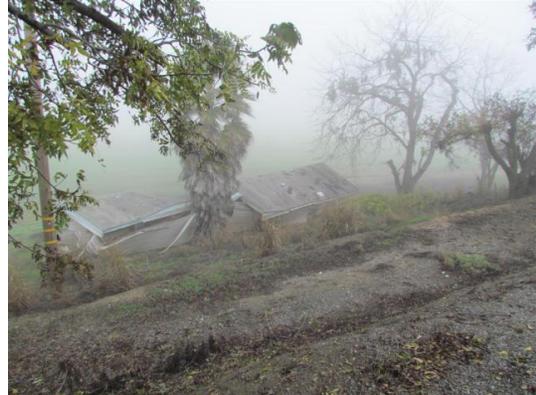
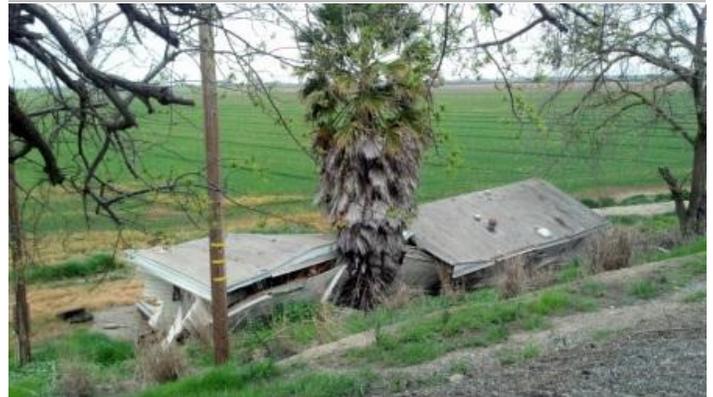
| Building<br>Inspector Comments: Dilapidated building at landside toe. | | | | | |

Looking northwest at dilapidated building at landside toe.

Looking northwest at dilapidated building on landside toe. Spring 2013

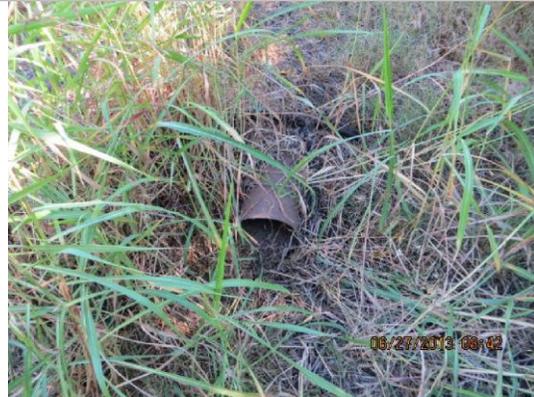
Photo 1 of 1 : UCIP\_1289.jpg

| Inspector Comments: FS_ID:15384<br>EP_NO: N/A<br>Repair Type:<br>Crossing Status:<br>UCIP Comments: Pipe open on both ends. Pumphouse has been removed. Needs to be abandoned properly.<br>FIELD_STRUCT_DESC: *Abandoned* 8-inch pipe through levee 4.5 feet below crown. Abandoned pump house on the waterward slope. Originally included in the 1966 O&M manual.<br>FS Date: 6/27/2013 | | | | | |

Pipe visible at concrete pad on WS slope.

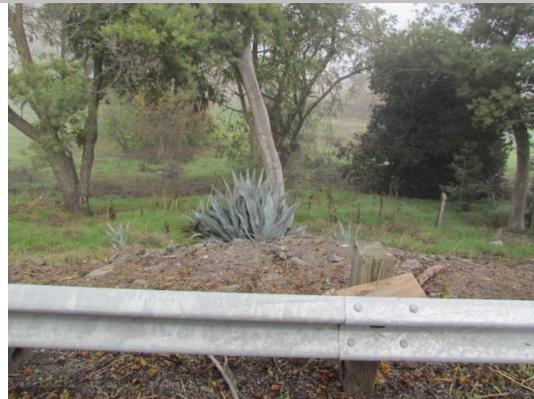
Photo 1 of 1 : richard\_s\_20140310\_219.jpg

| Remove the wild growth other than native grasses from the levee slopes.<br>Inspector Comments: Century plant on landside slope. | | | | | |

Looking east at century plant at landside toe.

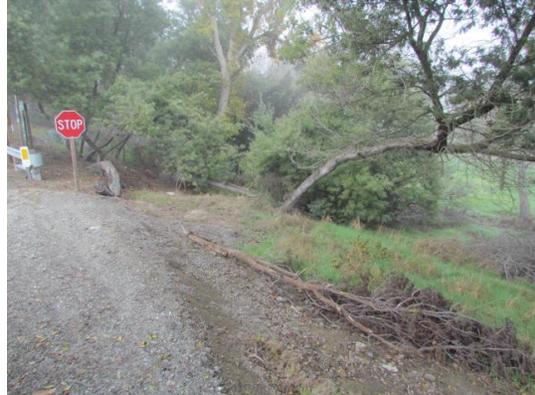
Photo 1 of 1 : richard\_s\_20140310\_225.jpg

Looking southeast at dense trees on landside slope and toe.

| Thin trees to allow visibility of the ground and room to flood fight. | | | | | |

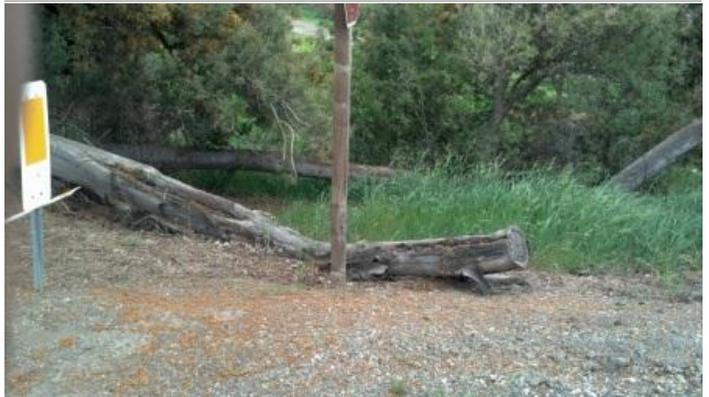
Photo 1 of 1 : richard\_s\_20140310\_218.jpg

Looking northwest at tree limb on landside slope.

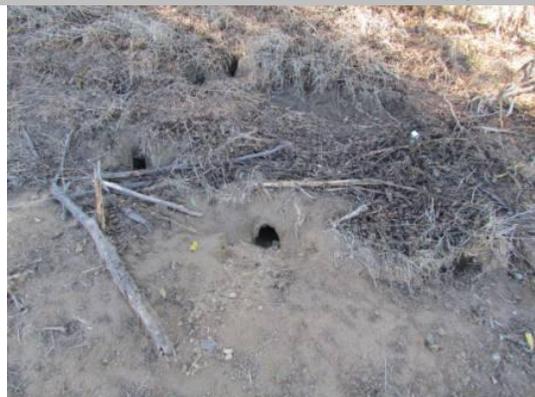
Photo 1 of 1 : richard\_s\_20140310\_209.jpg

Looking at several rodent holes on landside slope.

| Exterminate rodents and backfill and compact or grout burrows. | | | | | |

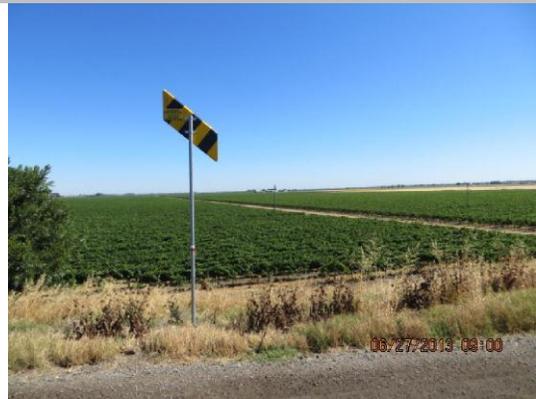
Photo 1 of 1 : UCIP\_1461.jpg

| Inspector Comments: FS_ID:16331<br>EP_NO: N/A<br>Repair Type:<br>Crossing Status:<br>UCIP Comments: Need to determine permit for this crossing.<br>FIELD_STRUCT_DESC: Gasline through the levee at an unknown depth. Markers on both shoulders.<br>FS Date: 6/27/2013 | | | | | |

Gasline marker on LS shoulder.

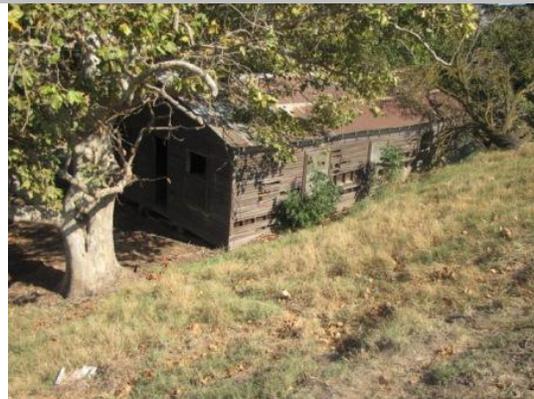
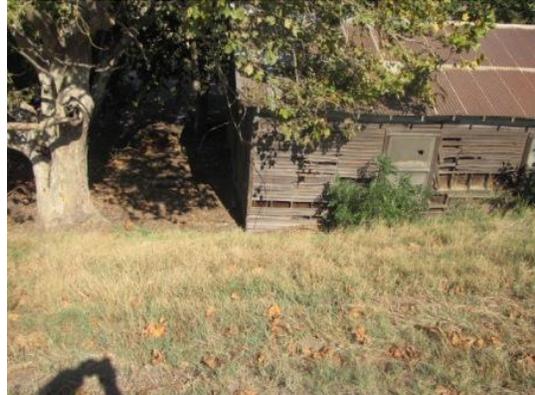
| Building<br>Inspector Comments: Old abandoned storage shed on landward toe and berm. | | | | | |

Looking northwest at building at landside toe.

Looking west at building at landside toe.

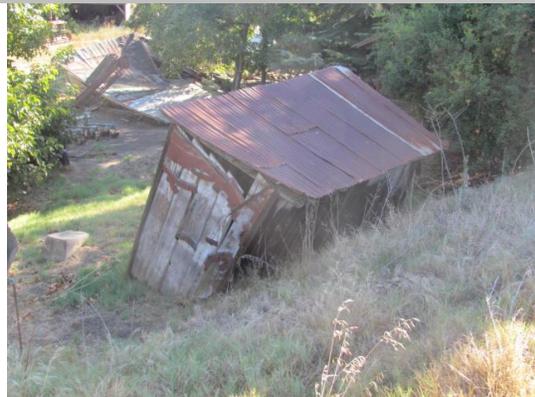
Photo 1 of 1 : richard\_s\_20140310\_234.jpg

| Building<br>Inspector Comments: Abandoned pump house on landward toe. | | | | | |

Looking northwest at abandoned pump house on landward toe.

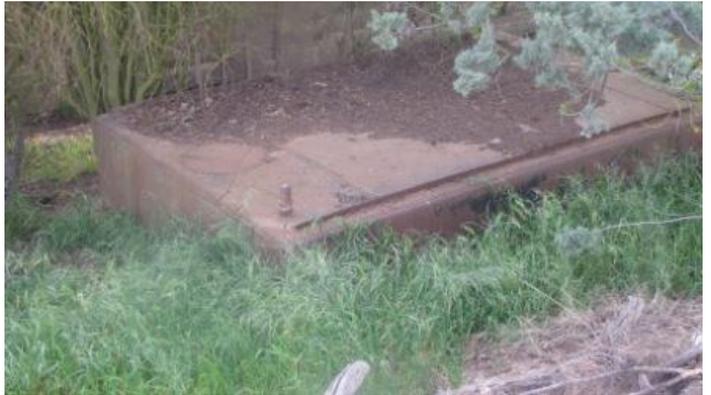
Photo 1 of 1 : richard\_s\_20140310\_216.jpg

| Tank | | | | | |

Looking north at a tank on the landside slope and toe.

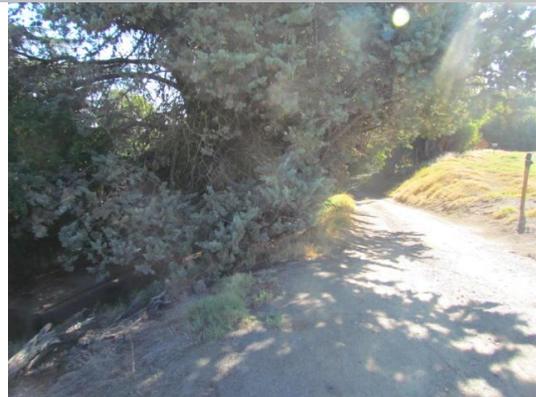
Photo 1 of 1 : richard\_s\_20140310\_217.jpg

Looking southwest at dense trees on landward slope.

| Trim trees to at least five feet above ground level. | | | | | |

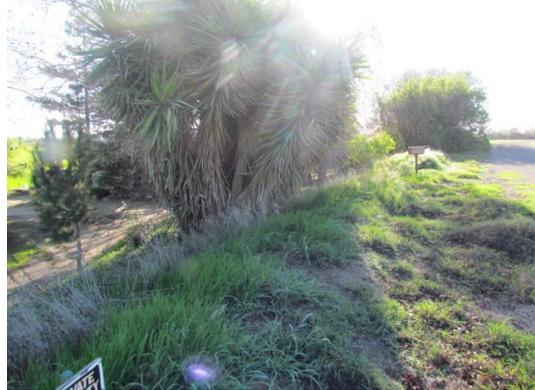
Photo 2 of 2 : richard\_s\_20140314\_447.jpg

| Landscaping | | | | | |

Looking north at landscaping on landside slope.

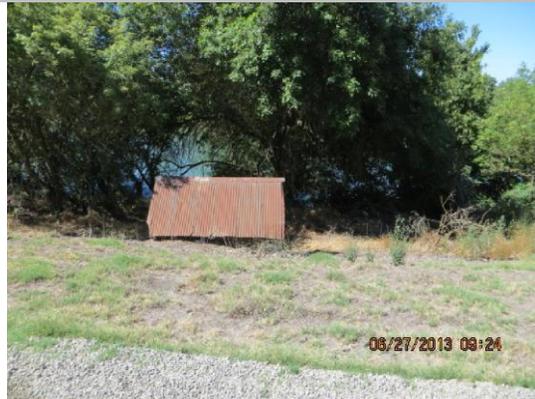
Photo 1 of 1 : UCIP\_1296.jpg

| Inspector Comments: FS_ID:15386<br>EP_NO: N/A<br>Repair Type:<br>Crossing Status:<br>UCIP Comments: Pipe abandoned and should be done so properly.<br>FIELD_STRUCT_DESC: *Abandoned* 10-inch pipe through levee 8.3 feet below crown. 6'X11' corrugated metal Pump house and gate valve on the waterward slope. 36-inch concrete standpipe on LS toe. Originally included in the 1966 O&M manual.<br>FS Date: 6/27/2013 | | | | | |

Pumphouse on WS slope.

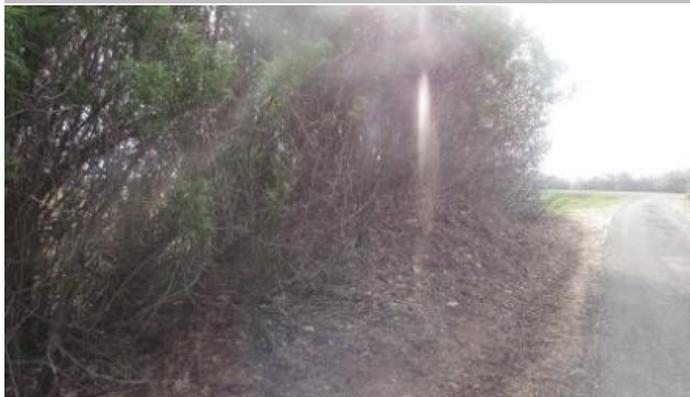
Photo 1 of 1 : richard\_s\_20140310\_215.jpg

Looking southwest at elderberry bush on landside shoulder and slope.

| Remove the wild growth other than native grasses from the levee slopes. | | | | | |

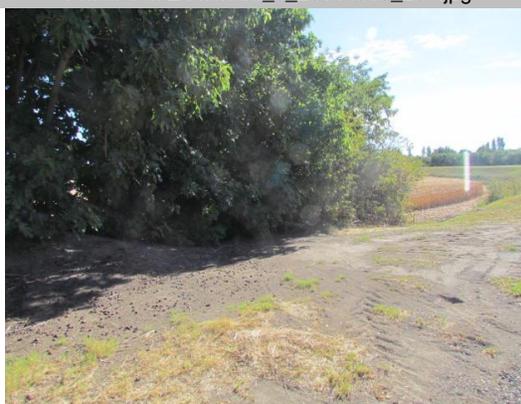
Photo 1 of 2 : richard\_s\_20140310\_230.jpg

Looking north at dense trees on landward slope and toe.

| Trim and thin trees to allow visibility of the ground and room to flood fight. | | | | | |

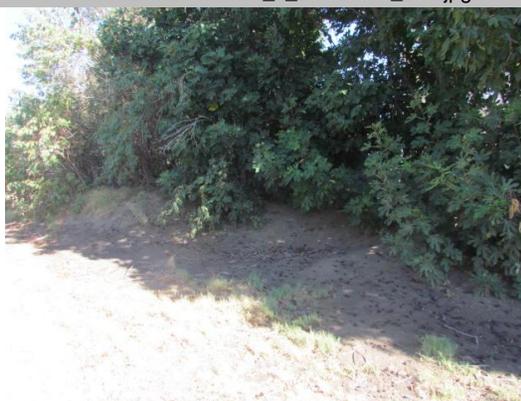
Photo 2 of 2 : richard\_s\_20140310\_231.jpg

Looking southwest at dense trees on landward slope and toe.

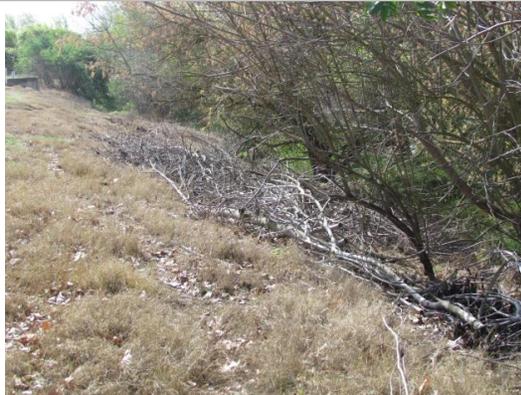
Photo 1 of 1 : richard\_s\_20140310\_226.jpg

| Prunings | | | | | |

Looking northeast at prunings on waterside slope.

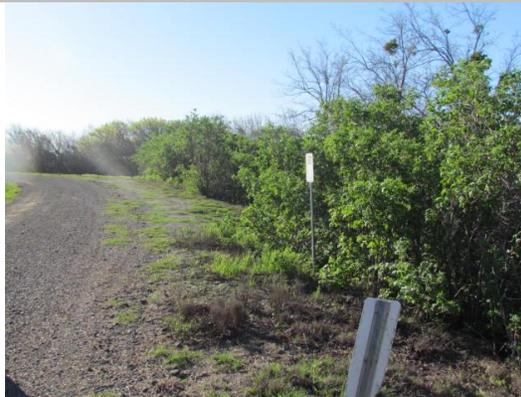
Photo 1 of 2 : richard\_s\_20140314\_448.jpg

| Elderberries are blocking visibility and flood fight capability. | | | | | |

Looking east at dense vegetation on waterside slope.

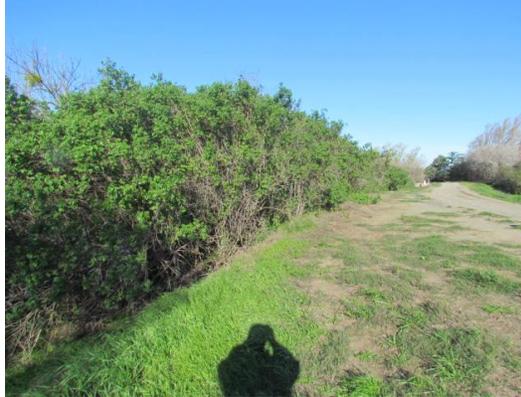
Photo 2 of 2 : richard\_s\_20140314\_449.jpg

Looking west at dense vegetation on waterside slope.

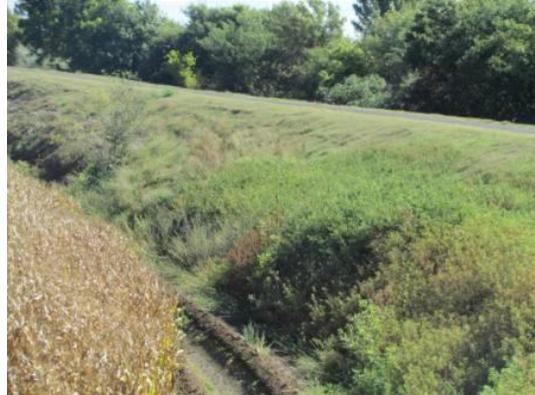
Photo 1 of 3 : richard\_s\_20140310\_212.jpg

Looking east at dense wild roses on landside toe. (Spring 2011)

| Remove the wild growth other than native grasses from the levee | | | | | |

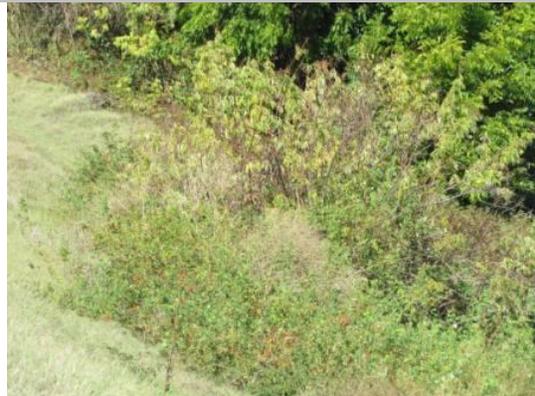
Photo 2 of 3 : richard\_s\_20140310\_213.jpg

Looking north at wild roses on landside toe. (Spring 2011)

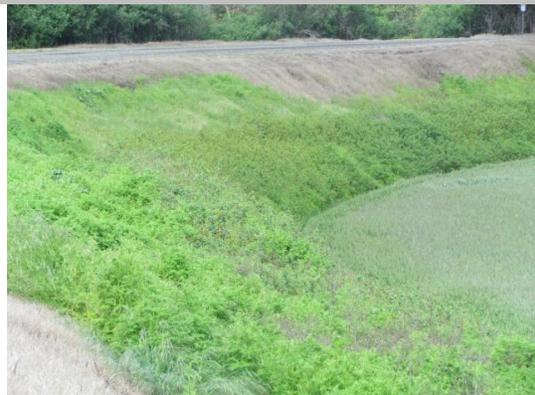
Photo 3 of 3 : richard\_s\_20140310\_214.jpg

Looking southeast to wild roses on landside slope and toe. (Spring 2012)

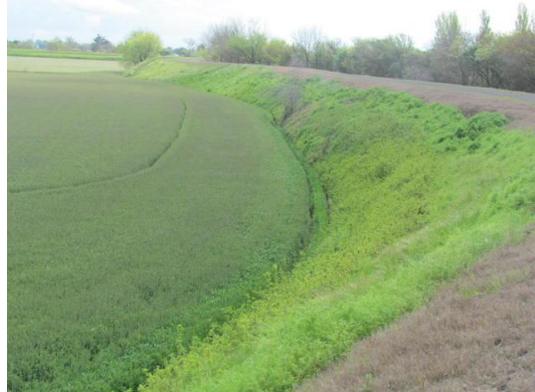
Photo 1 of 5 : richard\_s\_20140310\_227.jpg

| Crops | | | | | |

Looking north at crops encroaching onto landside toe.
