**Flood Control Project Maintenance  
Levee Inspections**  
**LMA District Cover Sheet**  
**Spring 2014 Levee Inspection Results**

**Reclamation District No. 0999 Netherlands**

**Spring 2014 Levee Inspection Results**

| Waterway | Bank | Unit Miles |
|---|---|---|
| Unit No. 01 Yolo Bypass | Left | 15.43 |

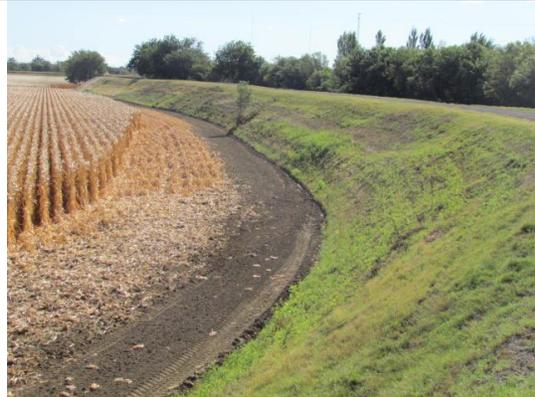
Photo 2 of 5 : richard\_s\_20140310\_228.jpg

Looking north at proper toe road on landward berm.

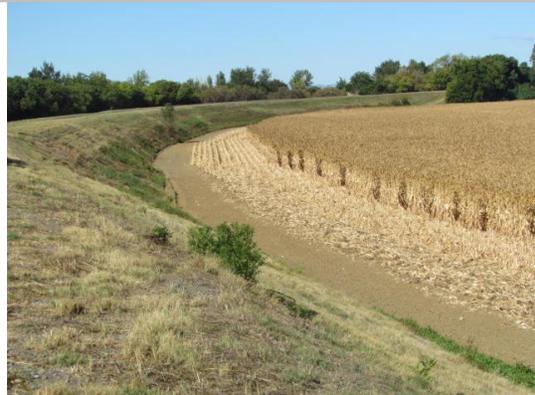
Photo 3 of 5 : richard\_s\_20140310\_229.jpg

Looking south at proper toe road on landward berm.

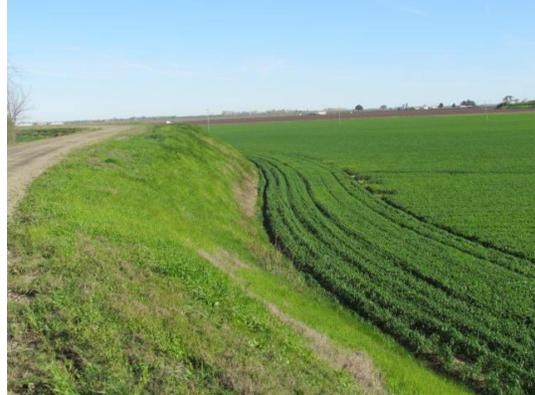
Photo 4 of 5 : richard\_s\_20140314\_450.jpg

| Crops | | | | | |

Looking west at crops encroaching on landside toe.

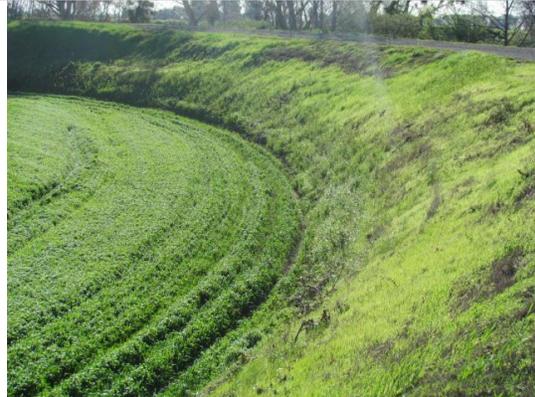
Photo 5 of 5 : richard\_s\_20140314\_451.jpg

Looking east at crops encroaching on landside toe.

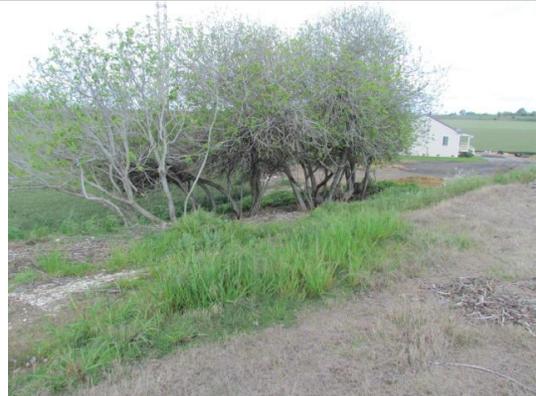
Photo 1 of 3 : richard\_s\_20140310\_245.jpg

Looking southwest at trimmed trees on landside toe. (Spring 2012)

| Trim trees to at least five feet above ground level.<br>Inspector Comments: Dense fig trees on landward slope and toe. | | | | | |

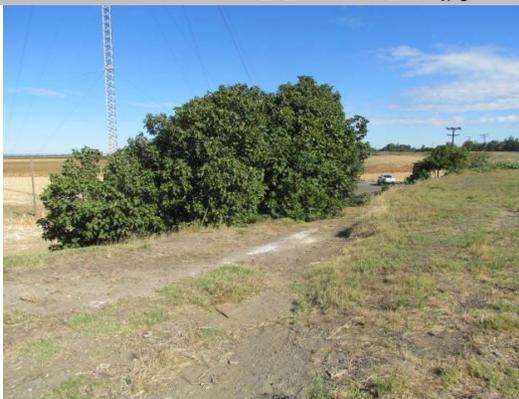
Photo 2 of 3 : richard\_s\_20140310\_246.jpg

Looking northwest at dense fig tree on landward slope and toe. 2013

| Trim trees to at least five feet above ground level.<br>Inspector Comments: Dense fig trees on landward slope and toe. | | | | | |

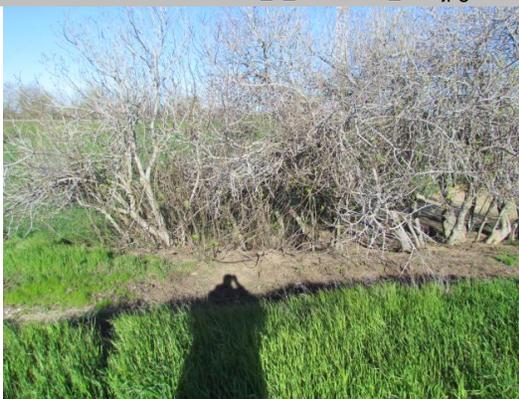
Photo 3 of 3 : richard\_s\_20140314\_452.jpg

Looking west at dense fig trees at landside toe.

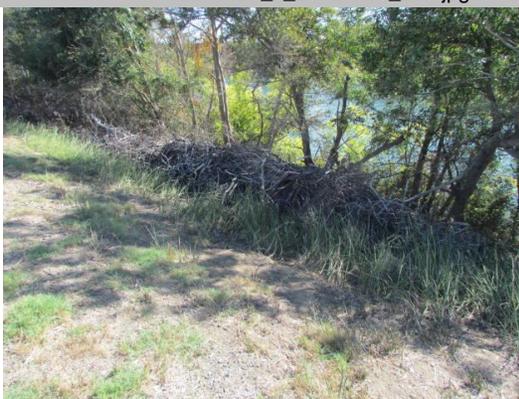
Photo 1 of 1 : richard\_s\_20140310\_275.jpg

| Prunings | | | | | |

Looking east at prunings on waterward slope.

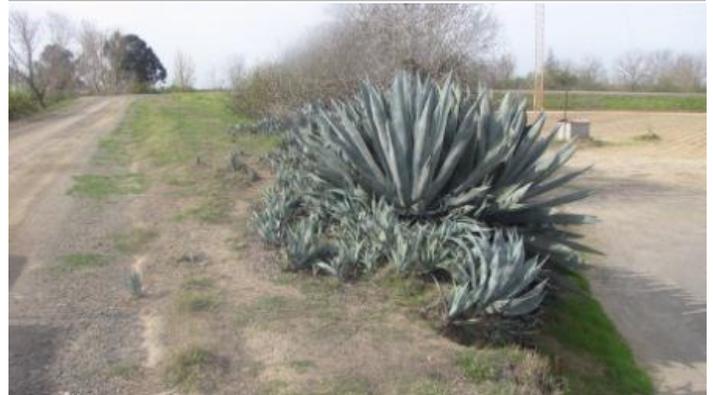
Photo 1 of 3 : richard\_s\_20140310\_247.jpg

| Landscaping | | | | | |

Looking east at cactus on landside slope during 2011 spring inspection.

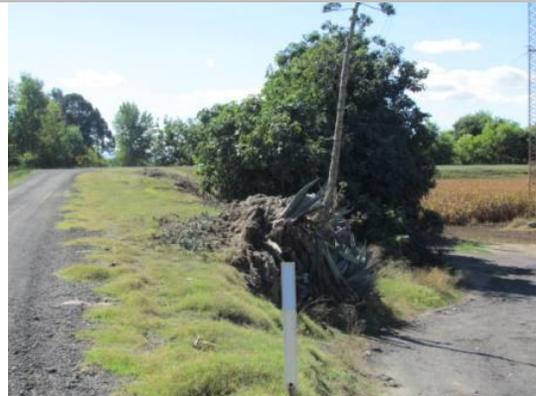
Photo 2 of 3 : richard\_s\_20140310\_248.jpg

Looking east at partially dead cactus plant on landside slope during 2011 fall inspection.

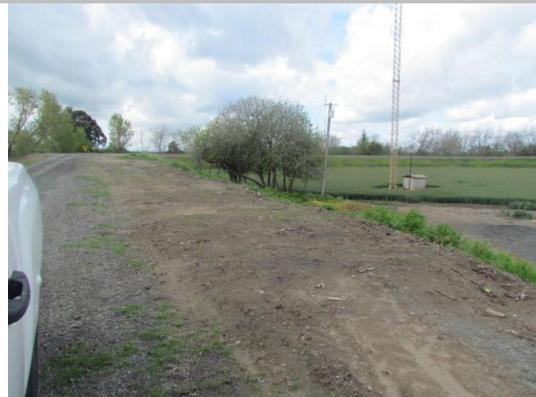
Photo 3 of 3 : richard\_s\_20140310\_249.jpg

Looking east at removed cactus on landside slope during 2012 spring inspection.

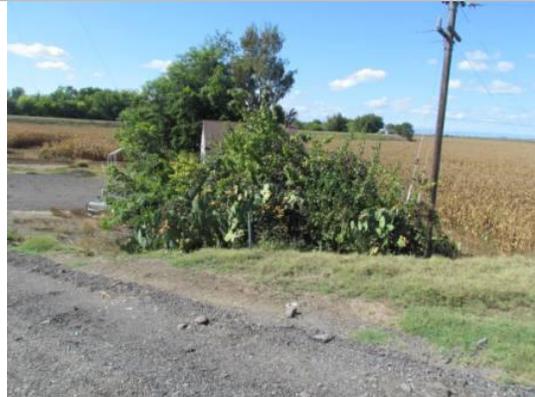
Photo 1 of 3 : richard\_s\_20140310\_241.jpg

Looking west at dense vegetation on landside slope near ramp. (Spring 2011)

| Remove the wild growth other than native grasses from the levee | | | | | |

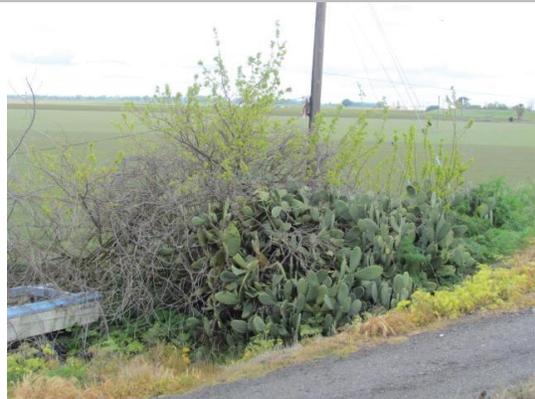
Photo 2 of 3 : richard\_s\_20140310\_242.jpg

Looking southwest at dense vegetation and cactus on landside slope. (Spring 2012)

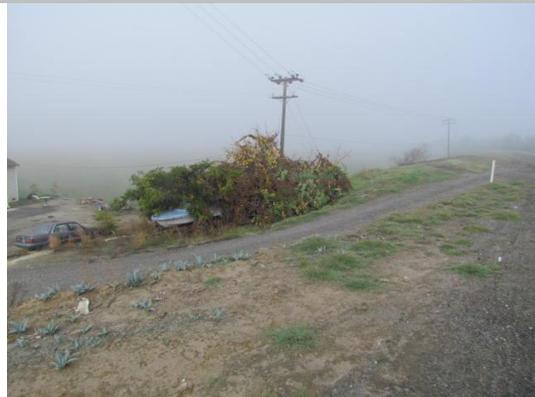
Photo 3 of 3 : richard\_s\_20140310\_243.jpg

Looking northeast at vegetation on landside slope and toe. (Fall Inspection 2012)

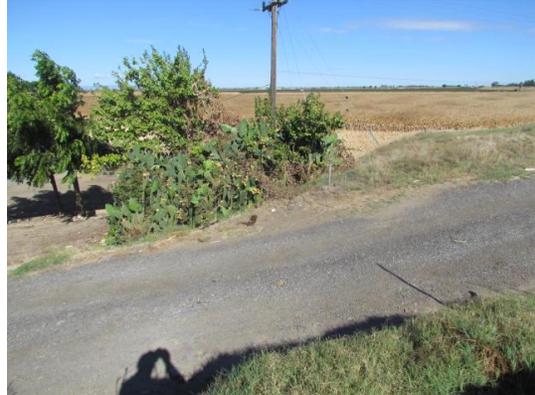
Photo 1 of 1 : richard\_s\_20140310\_276.jpg

| Landscaping | | | | | |

Looking southwest at dense cactus plants on landward slope.

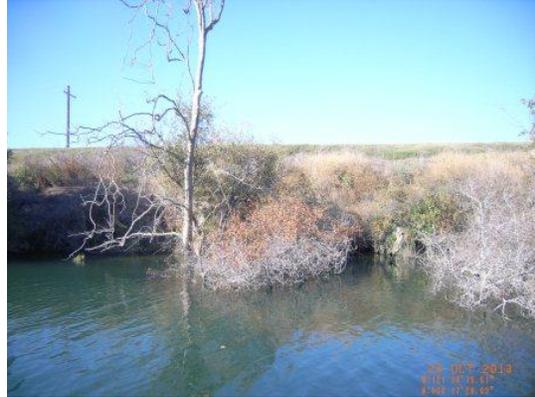
USACE 2013 Photo #1

| Inspector Comments: 1997 - Intermittent over-steepened sections. Large riparian vegetation along the length of the entire reach. Attempts to repair with rock on bank have failed. 1999 - New rock repair at the downstream end. 2002 - Some minor spot repairs. 2009 - Minimal new erosion. 2010 - Appears that fresh rock placed on downstream portion of site. Toe scour and overhanging trees with some overturned. 2012 - Minor new erosion at the toe. 2013: Site upgraded to CRITICAL. Severe slumping into levee at downstream end of site. Fresh erosion into bank toe. [2013 Site ID: STR_24-7_R] | | | | | |

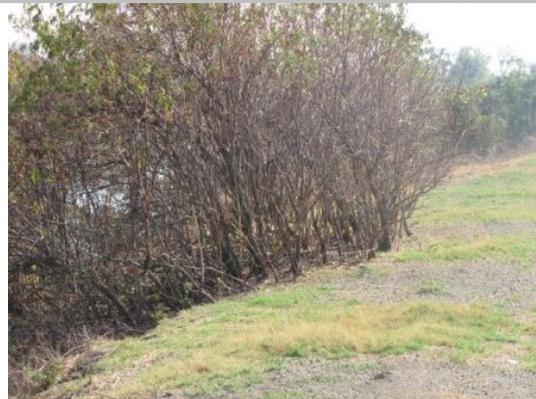
Photo 1 of 1 : richard\_s\_20140310\_250.jpg

| Elderberries are blocking visibility and flood fight capability. | | | | | |

Looking south at thinned Elderberry on waterside slope.

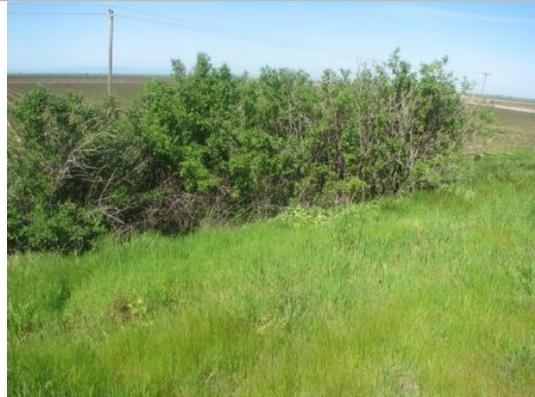
Photo 1 of 1 : richard\_s\_20140310\_251.jpg

| Elderberries are blocking visibility and flood fight capability. | | | | | |

Elderberries blocking view of landside toe.

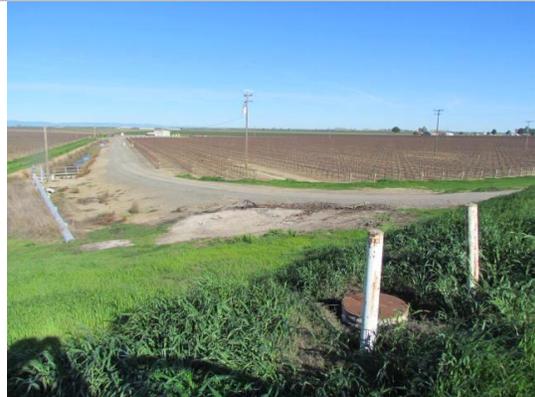
Photo 2 of 2 : richard\_s\_20140314\_454.jpg

| Prunings | | | | | |

Looking west at burned prunings on landward berm.

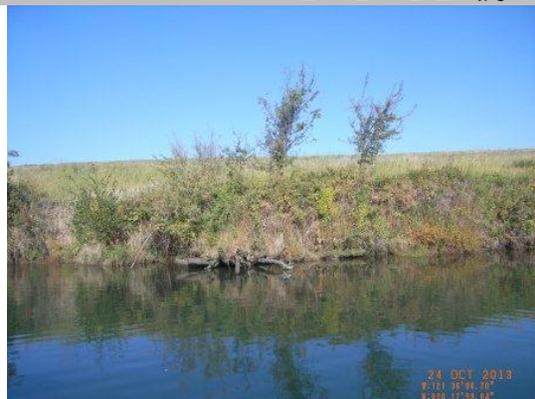
USACE 2013 Photo #1

| Inspector Comments: 2008 - Over steepened levee section. 2009 - Significant new erosion. 2010 - Minor new erosion. 2013: No observed changes. [2013 Site ID: STR_25-2_R] | | | | | |

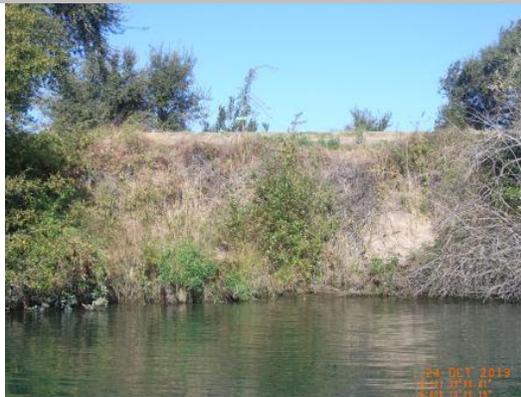
USACE 2013 Photo #1

| Inspector Comments: 2011 - Toe scour along length of site and erosion pockets. 2012 - Site extended slightly upstream due to new erosion pocket. 2013: Tall vertical sections at upstream end of site. [2013 Site ID: STR_25-7_R] | | | | | |

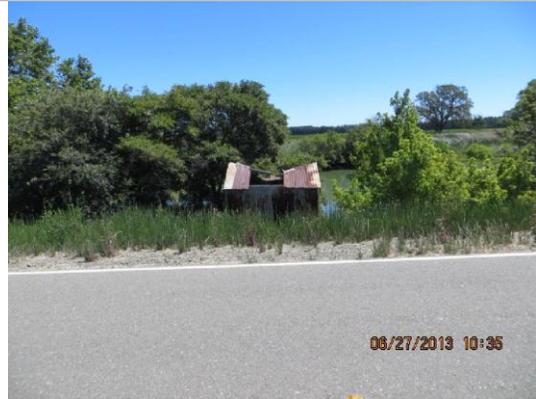
Photo 1 of 1 : UCIP\_1302.jpg

| Inspector Comments: FS_ID:15392<br>EP_NO: N/A<br>Repair Type:<br>Crossing Status:<br>UCIP Comments: Pipe abandoned and should be verified as being done so properly.<br>FIELD_STRUCT_DESC: *Abandoned* 5-inch pipe through levee 4.4 feet below crown. Pump and valve in pump house on the waterward slope (couldn't see landward end of pipe 2/91). 1-inch galvanized iron electric conduit at same location. Originally included in the 1966 O&M manual.<br>FS Date: 6/27/2013 | | | | | |

Pumphouse visible on WS slope.

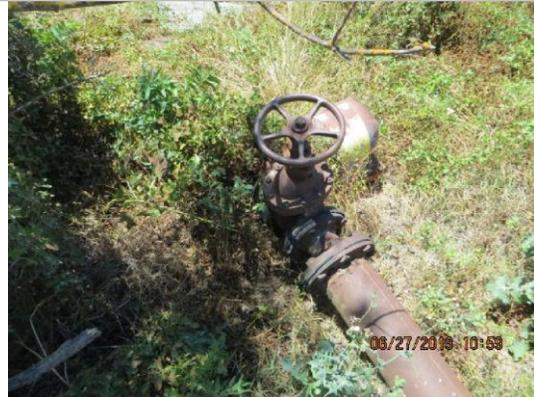
Photo 1 of 1 : UCIP\_1304.jpg

| Inspector Comments: FS_ID:15393<br>EP_NO: N/A<br>Repair Type:<br>Crossing Status:<br>UCIP Comments: Pipe abandoned and should be done so properly.<br>FIELD_STRUCT_DESC: 7-inch pipe through levee 4.6 feet below crown. Pump and gate valve on waterward slope. Service pole on the landward slope. 1-inch galvanized iron electrical conduit at same location. Originally included in the 1966 O&M manual.<br>FS Date: 6/27/2013 | | | | | |

Gate valve on WS slope at pump.

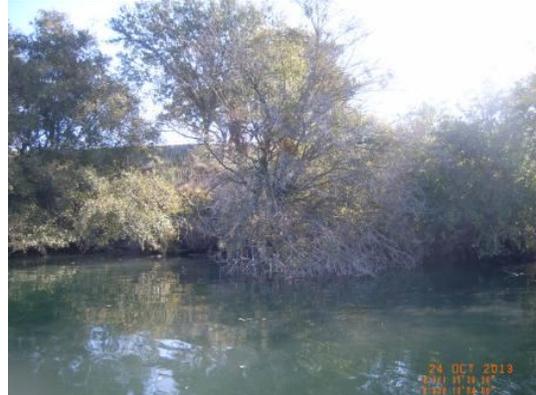
Photo 1 of 1 : USACE2013A\_STR\_26-5\_L\_8.jpg

| Inspector Comments: 2002 - Original rock over geotextile is sliding off and the end is coming unraveled. 2003 - Some minor new erosion on the downstream end. 2004 - Site has gotten worse. Underlined geofabric is exposed. 2005 - Still looks bad with exposed geotextile fabric. 2006 - Still have some new unraveling and exposed fabric. Site lengthened upstream. 2009 - Minimal new erosion. 2010 - geotextile fabric placed since last year, possible flood fight. 2012 - Exposed geotech style fabric, assume rock on top slid off. 2013: No observed changes. [2013 Site ID: STR_26-5_L] | | | | | |

USACE 2013 Photo #1

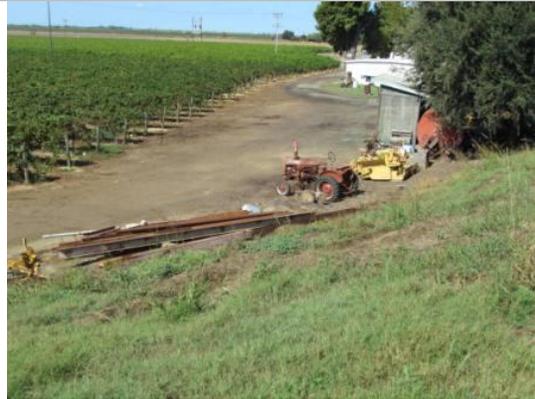
Photo 1 of 2 : richard\_s\_20140310\_260.jpg

| Equipment<br>Inspector Comments: Diesel tank stored at landside toe. | | | | | |

Looking northwest at equipment at landside toe.

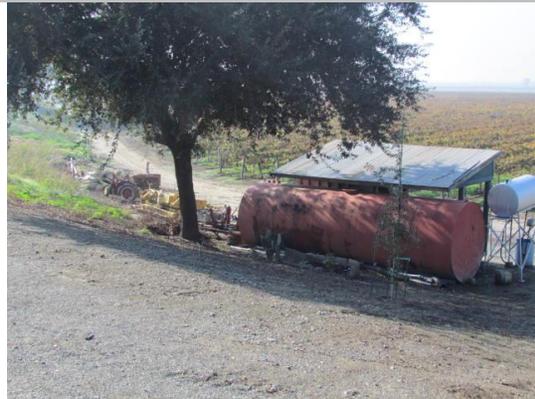
Photo 2 of 2 : richard\_s\_20140310\_261.jpg

Looking southwest at farm equipment stored at landside toe. (Fall Inspection 2012)

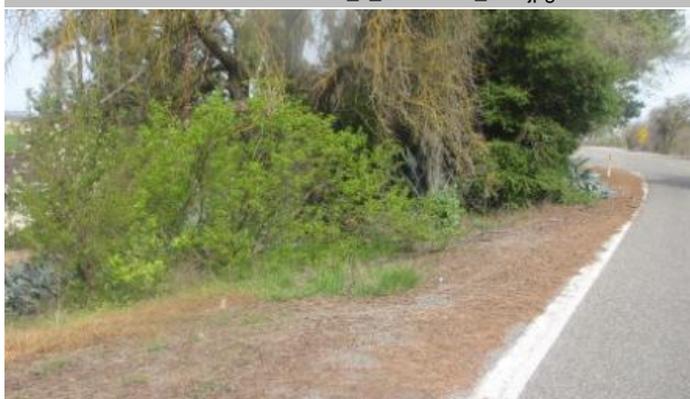
Photo 1 of 2 : richard\_s\_20140310\_255.jpg

Looking northwest at landscaping and dense veg. on landside slope and toe.

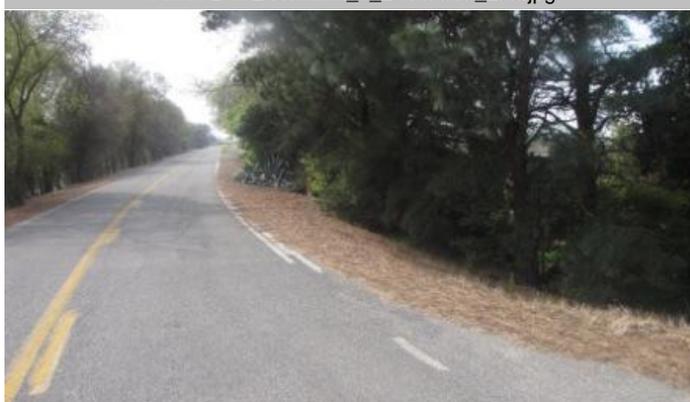
Photo 2 of 2 : richard\_s\_20140310\_256.jpg

Looking south at landscaping and dense veg. on landside slope and toe.

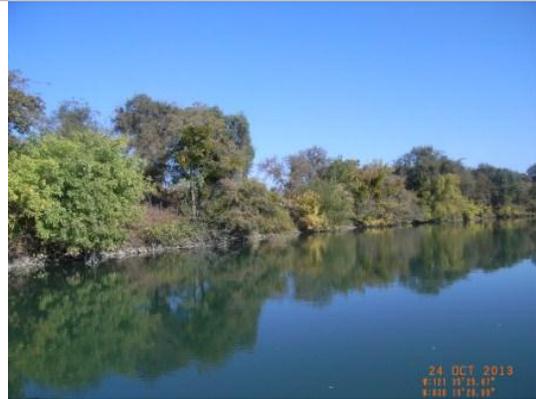
Photo 1 of 1 : USACE2013A\_STR\_27-1\_R\_2.jpg

| Inspector Comments: 2012 - Slumping of upper levee slope. 2013: No observed changes. [2013 Site ID: STR_27-1_R] | | | | | |

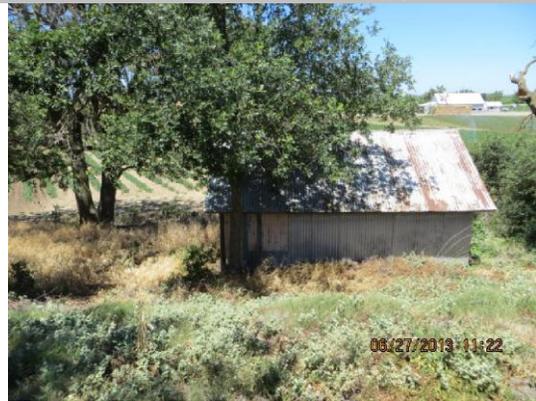
Photo 1 of 1 : UCIP\_1309.jpg

| Inspector Comments: FS_ID:15406<br>EP_NO: N/A<br>Repair Type:<br>Crossing Status:<br>UCIP Comments: This pipe is abandoned and should be done so properly.<br>FIELD_STRUCT_DESC: *Abandoned* 16-inch pipe through levee 9.3 feet below crown. Pump and gate valve in pump house on the landward slope. Originally included in the 1966 O&M manual.<br>FS Date: 6/27/2013 | | | | | |

Pumphouse on LS toe.

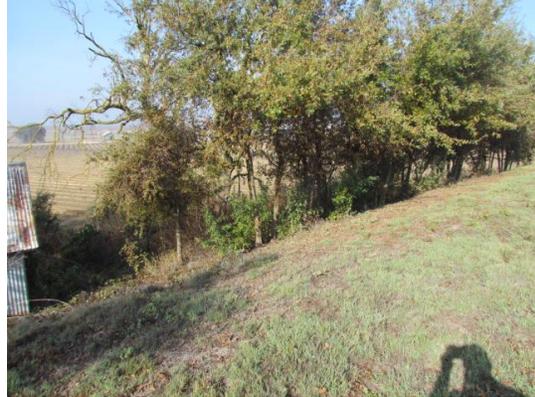
Photo 1 of 2 : richard\_s\_20140310\_252.jpg

| Remove the wild growth other than native grasses from the levee slopes.<br>Inspector Comments: Wild growth at landside slope and toe. | | | | | |

Looking northwest at dense vegetation at landside slope and toe.

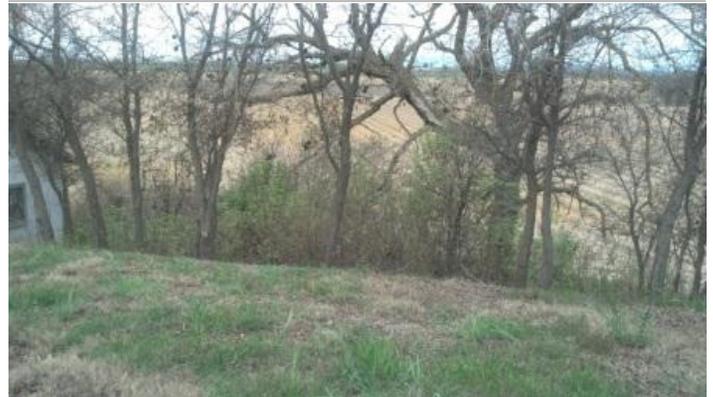
Photo 2 of 2 : richard\_s\_20140310\_253.jpg

Looking west at dense trees on landside toe.

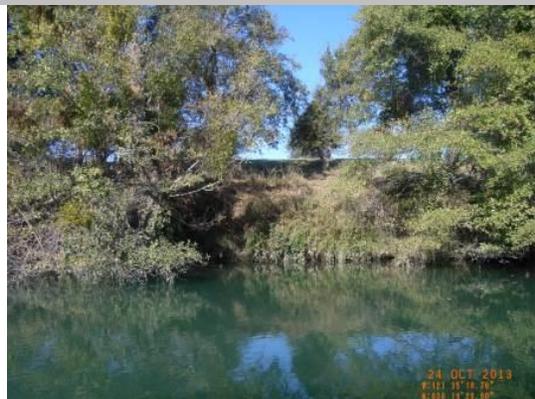
Photo 1 of 1 : USACE2013A\_STR\_27-3\_R\_10.jpg

| Inspector Comments: 2011 - Multiple erosion pockets. Some likely | | | | | |

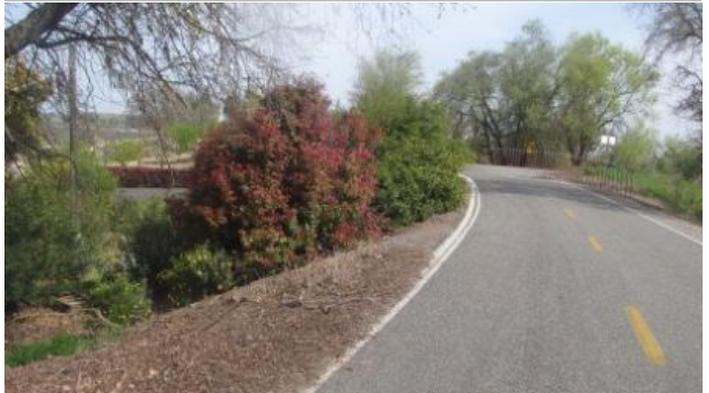
Photo 1 of 2 : richard\_s\_20140310\_258.jpg

Looking northwest at landscaping on landside slope and toe. (Spring 2011)

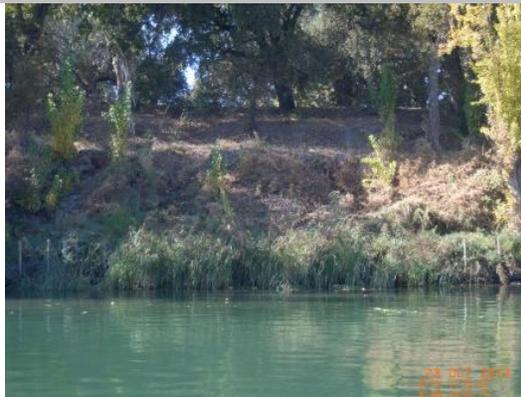
Photo 1 of 1 : USACE2013A\_SAC\_41-9\_R\_14.jpg

| Inspector Comments: 1997 - Structural problem rather than erosional, failed cobble at downstream end. 2005 - New brush boxes at waterline for several hundred feet downstream, No toe or bank protection present. 2006 - Some minor new erosion. Brush boxes not working well; most of the brush has floated out. 2007 - Brush boxes have recently been repaired. 2013: No observed changes. [2013 Site ID: SAC_41-9_R] | | | | | |

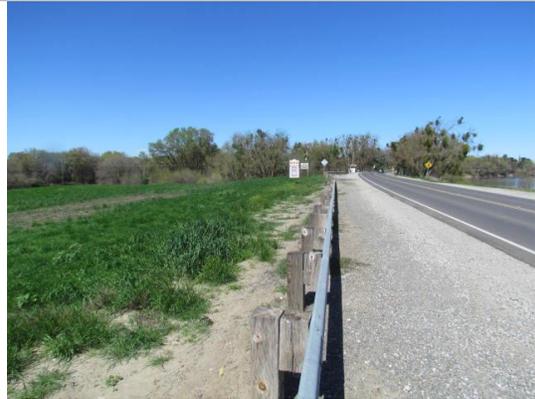
Photo 1 of 1 : richard\_s\_20140314\_467.jpg

Looking north at typical view of landside slope.

| Control annual grass and weeds on the levee slopes and easements. | | | | | |

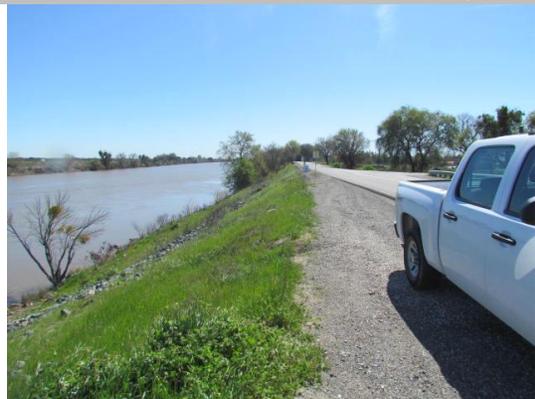
Photo 1 of 1 : richard\_s\_20140314\_468.jpg

Looking south at typical view of waterside slope.

| Control annual grass and weeds on the levee slopes and easements. | | | | | |

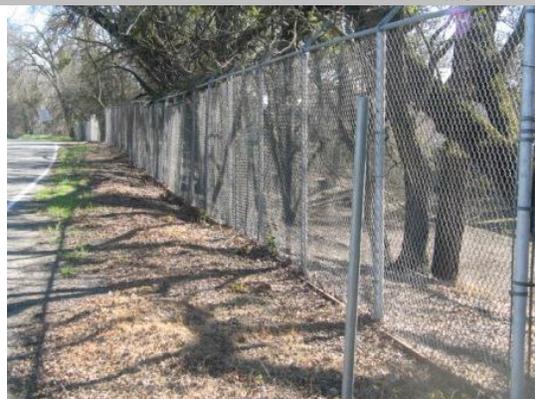
Photo 1 of 1 : richard\_s\_20140310\_295.jpg

Cyclone fence along landside shoulder at LM 0.05 -0.11

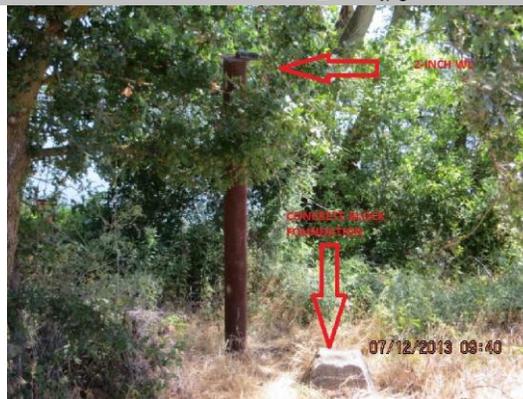
Photo 1 of 1 : UCIP\_1378.jpg

| Inspector Comments: FS_ID:15709<br>EP_NO: N/A<br>Repair Type:<br>Crossing Status:<br>UCIP Comments: Pipe abandoned and should be done so properly.<br>FIELD_STRUCT_DESC: 2-inch pipe through levee 4.5 feet below crown. Concrete blocks for missing Pump and pressure system visible on WS slope. 8-inch steel standpipe on WS toe with remnants of 2-inch pipe visible at top. Pipe visible at concrete foundation on LS shoulder. Originally included in the 1966 O&M manual.<br>FS Date: 7/12/2013 | | | | | |

Pipe visible at top of steel standpipe. Foundation for pump station visible on WS slope.

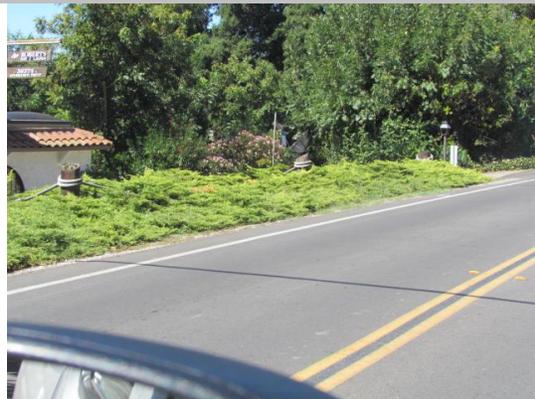
Photo 1 of 1 : richard\_s\_20140310\_298.jpg

Looking west at dense landscaping on landward slope.

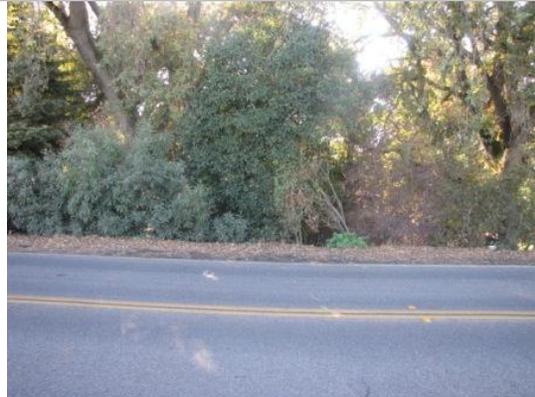
Photo 2 of 2 : richard\_s\_20140310\_294.jpg

Looking west at dense veg. on landside slope and toe.

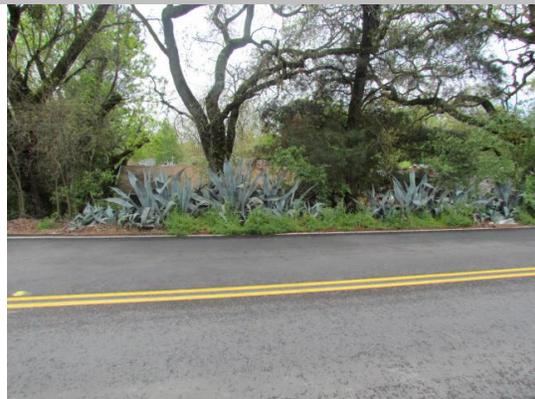
Photo 1 of 1 : richard\_s\_20140310\_292.jpg

Looking west at century plants on landside shoulder and slope.

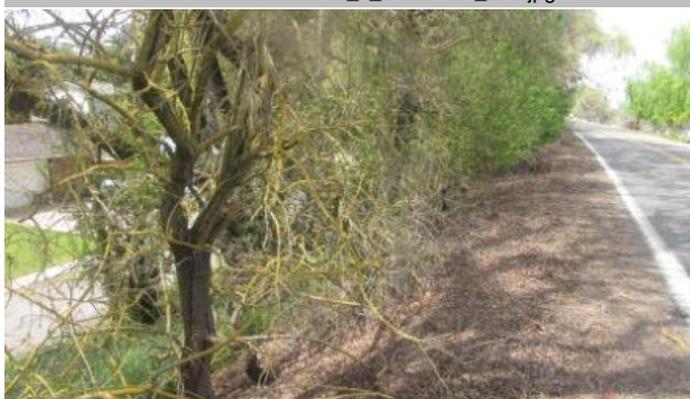
Photo 2 of 2 : richard\_s\_20140310\_291.jpg

Looking northwest at dense trees on landside slope and toe.

| Trim trees to at least five feet above ground level. | | | | | |

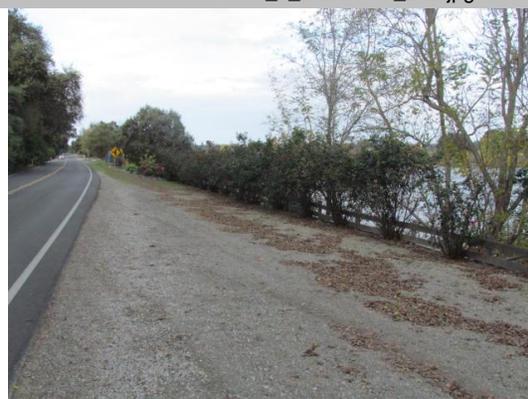
Photo 1 of 1 : richard\_s\_20140310\_282.jpg

Looking north at rose bushes on waterside slope.

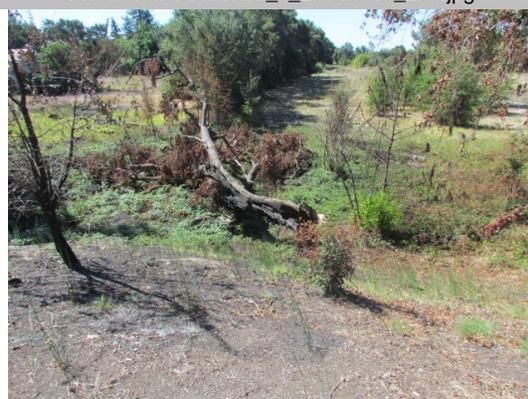
Photo 1 of 1 : richard\_s\_20140310\_299.jpg

| Tree or limb<br>Inspector Comments: Downed tree on landward toe and berm. | | | | | |

Looking west at dead tree on landward toe and berm.

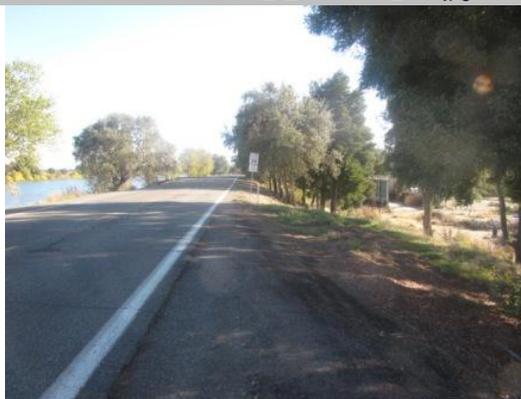
Photo 1 of 2 : richard\_s\_20140310\_285.jpg

Looking south at trimmed trees on landside slope and removed fence.

| Trim trees to at least five feet above ground level. | | | | | |

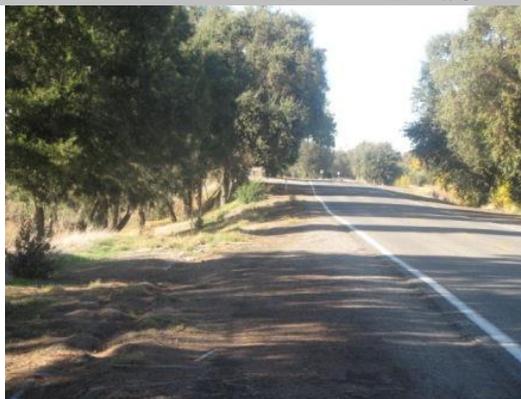
Photo 2 of 2 : richard\_s\_20140310\_286.jpg

Looking north at trimmed trees and removed fence on landside slope.

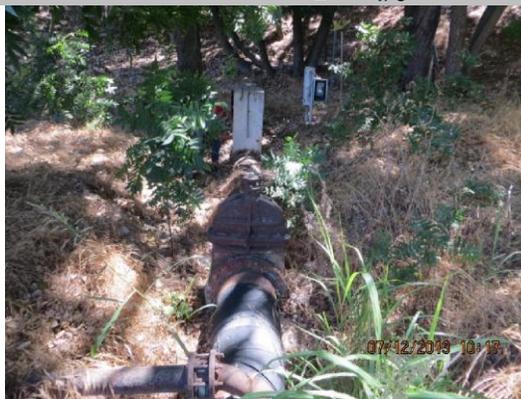
Photo 1 of 1 : UCIP\_1382.jpg

| Inspector Comments: FS_ID:15712 | | | | | |

Gate valve on LS toe.

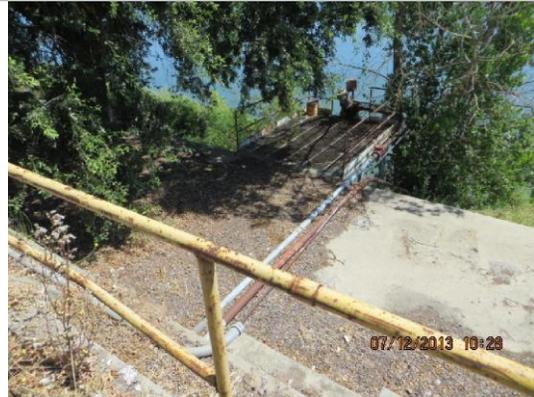
Photo 1 of 1 : UCIP\_1387.jpg

| Inspector Comments: FS_ID:15725<br>EP_NO: 10514<br>Repair Type:<br>Crossing Status:<br>UCIP Comments: Pipe appears abandoned and should be done so properly.<br>FIELD_STRUCT_DESC: 1 of 3: 3.5-inch discharge pipe through the levee 3.8 feet below the crown. Siphon breaker at headwall on the waterward slope. (Permit No. 10514, 1974)<br>FS Date: 7/12/2013 | | | | | |

Discharge pipe at concrete pad then down slope to water.

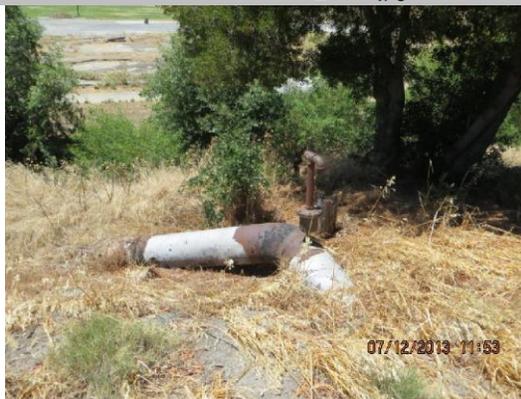
Photo 1 of 1 : UCIP\_1499.jpg

| Inspector Comments: FS_ID:16389<br>EP_NO: 1624<br>Repair Type:<br>Crossing Status:<br>UCIP Comments: Pipe abandoned and should be done so properly.<br>FIELD_STRUCT_DESC: 16-inch steel irrigation pipe through the levee 3.0 feet below the crown. Pump and pile structure removed from waterside toe. Steel plate welded over WS end (Permit No. 1624, 1959). Replaces an existing facility north of this location.<br>FS Date: 7/12/2013 | | | | | |

Pipe and vent/siphon breaker on LS slope.

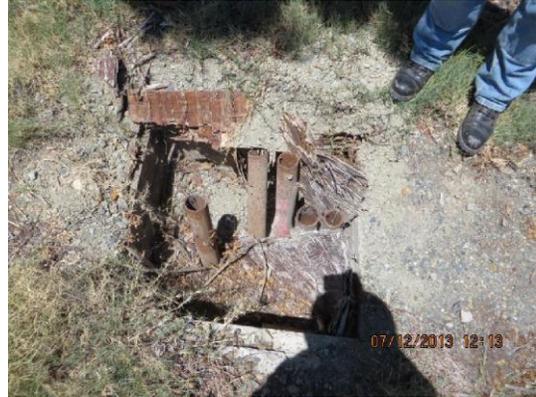
Photo 1 of 1 : UCIP\_1494.jpg

| Inspector Comments: FS_ID:16386<br>EP_NO: N/A<br>Repair Type:<br>Crossing Status:<br>UCIP Comments: Pipe abandoned and should be done so properly.<br>FIELD_STRUCT_DESC: 6 of 6: *Abandoned* 3.5-inch pipe through levee 2.5 feet below crown. Pipe visible in concrete well on LS shoulder.<br>FS Date: 7/12/2013 | | | | | |

Pipes visible in concrete well on LS shoulder.

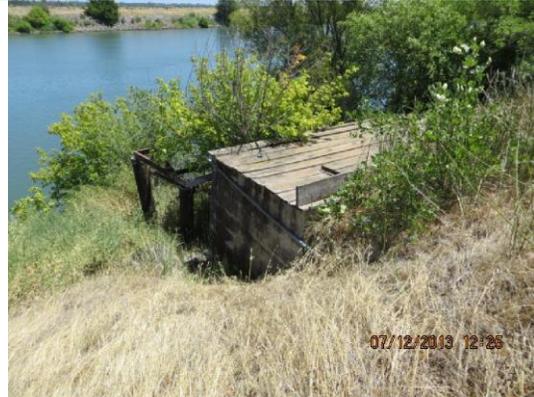
Photo 1 of 1 : UCIP\_1497.jpg

| Inspector Comments: FS_ID:16387<br>EP_NO: N/A<br>Repair Type:<br>Crossing Status:<br>UCIP Comments: Pipe appears abandoned and should be done so properly.<br>FIELD_STRUCT_DESC: 24-inch pipe through the levee 13.0 feet below the crown. Pipe measures 16-inches in diameter on WS and 24-inches on the LS toe. Gate valve in 9'X18' concrete well on the waterward slope. Slant pump missing from waterward slope. Concrete distribution house/box at LS toe. 1.5-inch galvanized iron electrical conduit at same location. Originally included in the 1966 O&M manual.<br>FS Date: 7/12/2013 | | | | | |

Slide gate in 9'X18' concrete box on WS slope.

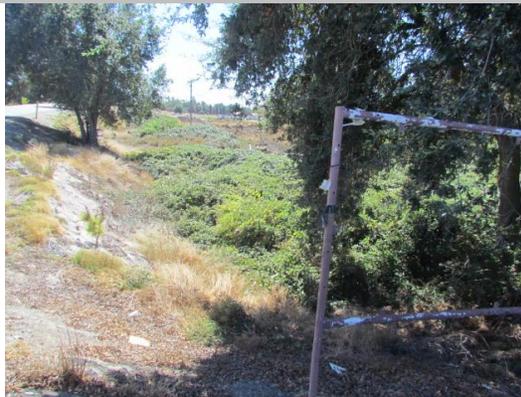
Photo 2 of 2 : richard\_s\_20140310\_297.jpg

Looking southwest at dense berry vines at landward toe. 2013

| Remove the wild growth other than native grasses from the levee slopes. | | | | | |

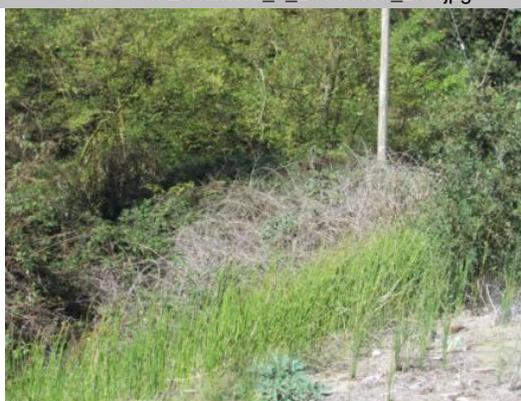
Photo 1 of 2 : richard\_s\_20140310\_283.jpg

| Remove the wild growth other than native grasses from the levee slopes.<br>Inspector Comments: Berry vines and wild roses on landside toe. | | | | | |

Looking northwest at dense wild roses and berry vines on landside toe near ramp.

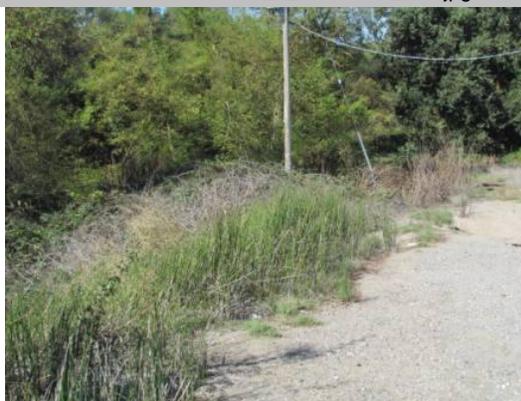
Photo 2 of 2 : richard\_s\_20140310\_284.jpg

Looking north at dense vegetation on landside slope near ramp.

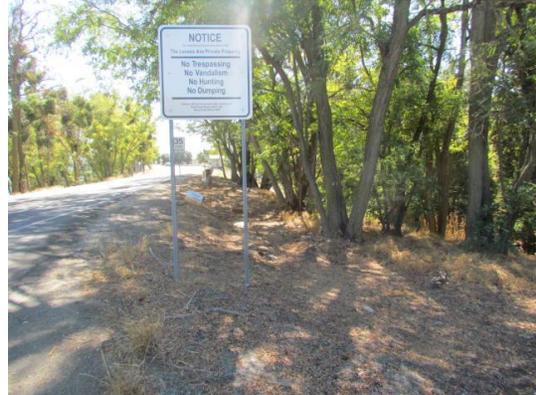
Photo 1 of 1 : richard\_s\_20140310\_300.jpg

Looking south at dense trees on landward slope.

| Trim and thin trees to allow visibility of the ground and room to flood | | | | | |

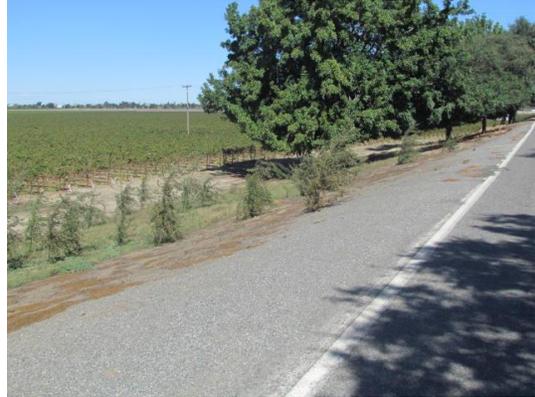
Photo 1 of 1 : richard\_s\_20140310\_353.jpg

| Trim and thin trees to allow visibility of the ground and room to flood fight.<br>Inspector Comments: Remove small oak trees from landward slope before trees are establish. | | | | | |

Looking west at small oak trees on landward slope.

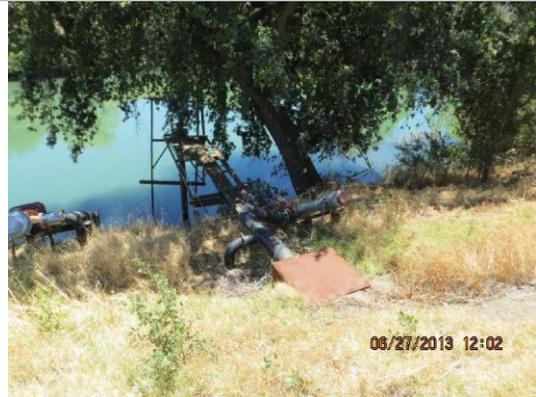
Photo 1 of 1 : UCIP\_1312.jpg

| Inspector Comments: FS_ID:15411<br>EP_NO: N/A<br>Repair Type:<br>Crossing Status:<br>UCIP Comments: Walkway to pump on pier is falling appart and should be removed.<br>FIELD_STRUCT_DESC: 12-inch pipe through levee 11.0 feet below crown. 10-inch pipe visible on slopes and at Slant pump on waterward slope (Pump on structure removed). Additional slant pump on WS slope ties into pipe at WS. 30-inch steel standpipe on LS toe. Butterfly valves located on both sides of levee. 3'X3' steel junction box on WS shoulder and a 31"X60" steel junction box on LS shoulder. Service pole on both slopes. Originally included in the 1966 O&M manual.<br>FS Date: 6/27/2013 | | | | | |

Pump and steel junction box visible on WS slope.

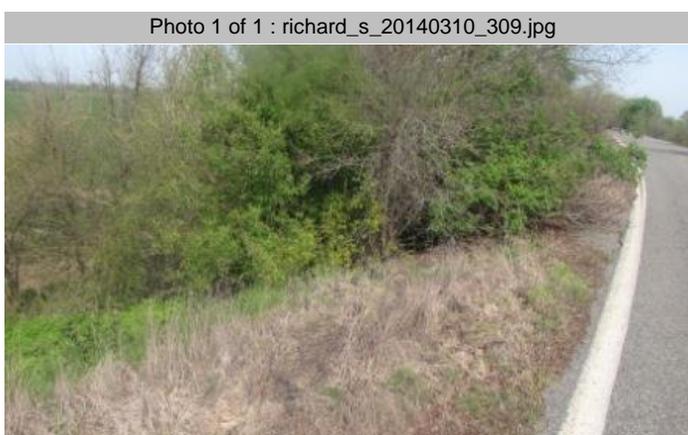
Looking north at dense vegetation on landside slope and toe.

| Trim and thin trees to allow visibility of the ground and room to flood fight. | | | | | |

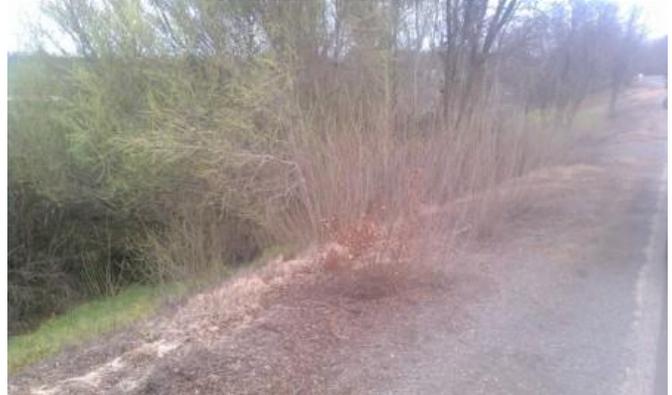
Photo 1 of 4 : richard\_s\_20140310\_325.jpg

| Remove the wild growth other than native grasses from the levee slopes.<br>Inspector Comments: Elderberries within vegetation area. | | | | | |

Looking northwest at dense vegetation on landside slope and toe.

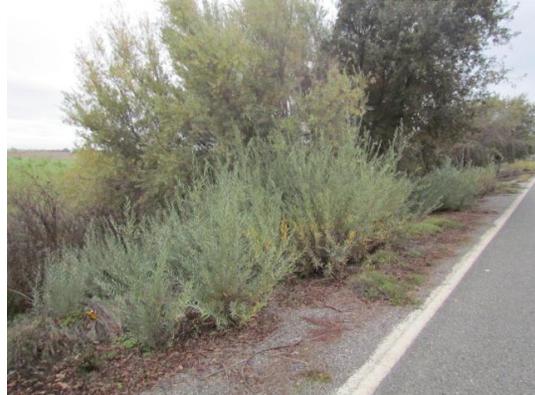
Photo 3 of 4 : richard\_s\_20140310\_327.jpg

Looking northwest at vegetation on landside shoulder. (Fall 2012)

| Remove the wild growth other than native grasses from the levee | | | | | |

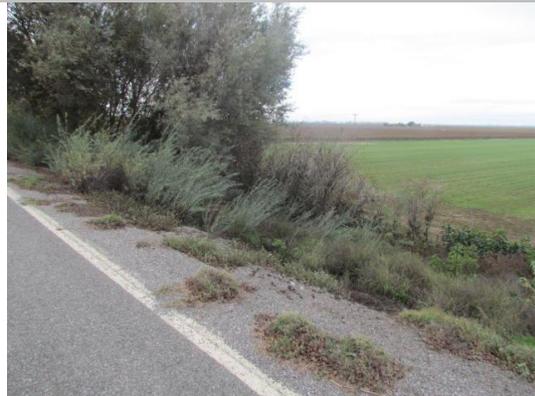
Photo 4 of 4 : richard\_s\_20140310\_328.jpg

Looking southwest at vegetation on landside slope and toe. (Fall 2012)

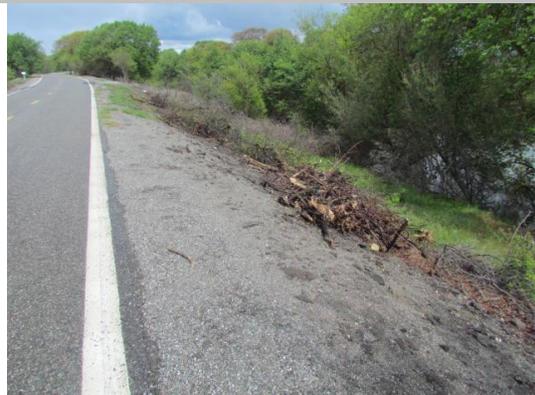
Photo 1 of 1 : richard\_s\_20140310\_329.jpg

| Prunings | | | | | |

Looking northeast at prunings on waterside slope.

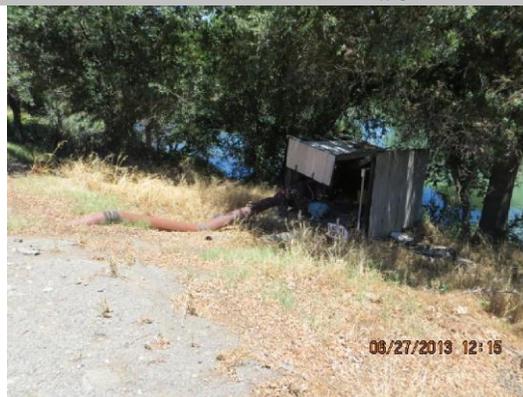
Photo 1 of 1 : UCIP\_1317.jpg

| Inspector Comments: FS_ID:15413<br>EP_NO: 6081<br>Repair Type:<br>Crossing Status:<br>UCIP Comments: Some settlement along LS and WS slopes. Good candidate for video inspection.<br>FIELD_STRUCT_DESC: 10-inch steel pipe through levee 3.3 feet below crown. Pump and butterfly valve in pump house on waterward slope. Vent in 10-inch steel standpipe on LS slope (Permit No. 6081,1968). Replaces an existing 10-inch pipe.<br>FS Date: 6/27/2013 | | | | | |

Pump in pumphouse on WSs lope.

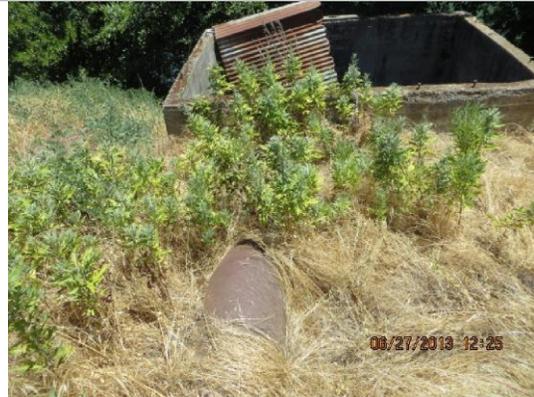
Photo 1 of 1 : UCIP\_1320.jpg

| Inspector Comments: FS_ID:15414<br>EP_NO: N/A<br>Repair Type:<br>Crossing Status:<br>UCIP Comments: Pipe abandoned and should be done so properly.<br>FIELD_STRUCT_DESC: *Abandoned* 16-inch pipe through levee 6.0 feet below crown. Concrete pumphouse on WS slope. Originally included in the 1966 O&M manual.<br>FS Date: 6/27/2013 | | | | | |

Pipe visible on WS slope.

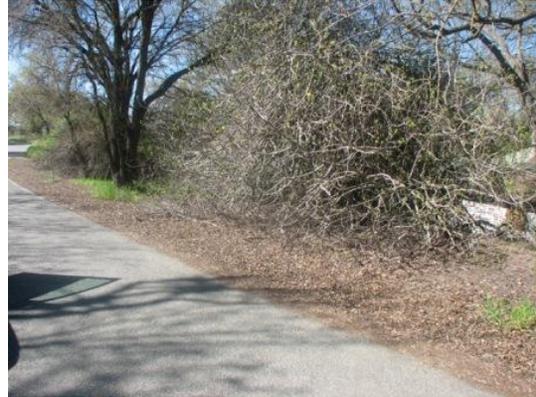
Photo 1 of 4 : richard\_s\_20140310\_310.jpg

| Trim and thin trees to allow visibility of the ground and room to flood fight.<br>Inspector Comments: District or Landowner trimmed trees to a moderate density. Still need to remove more limbs. | | | | | |

Front view of dense trees at landside shoulder.(Spring 2011)

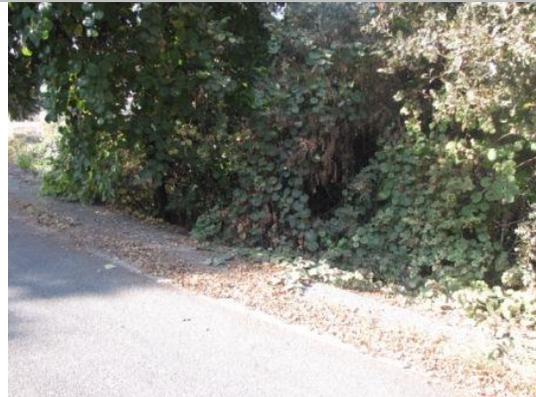
Photo 2 of 4 : richard\_s\_20140310\_311.jpg

Looking west at dense trees on landside slope and toe.(Spring 2011)

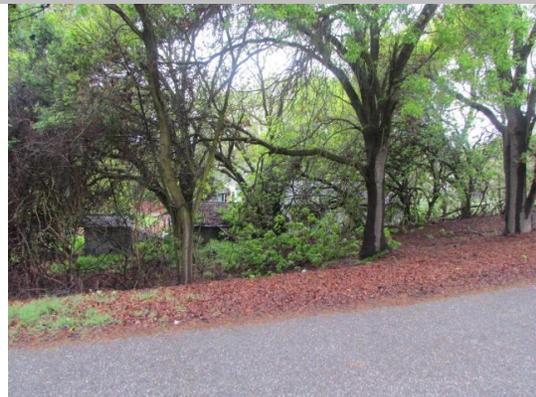
Photo 3 of 4 : richard\_s\_20140310\_312.jpg

Looking west at trimmed trees on landside slope.(Spring 2012)

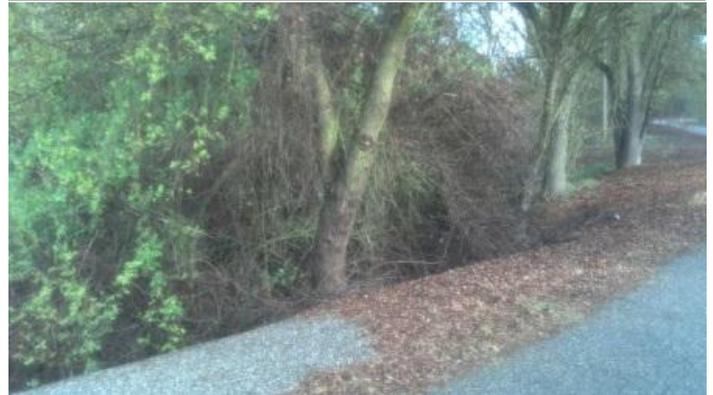
Photo 4 of 4 : richard\_s\_20140310\_313.jpg

Looking northwest at dense trees at landside slope and toe. Spring 2013

| Trim and thin trees to allow visibility of the ground and room to flood | | | | | |

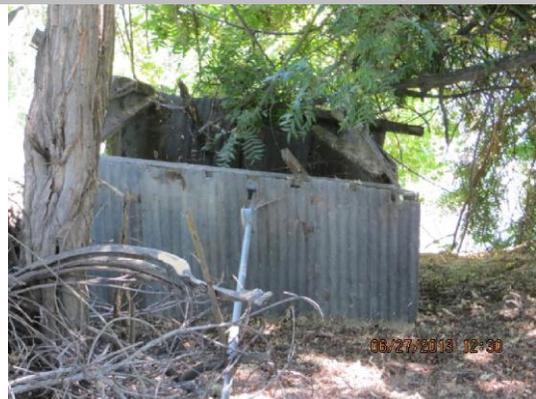
Photo 1 of 1 : UCIP\_1336.jpg

| Inspector Comments: FS_ID:15450<br>EP_NO: N/A<br>Repair Type:<br>Crossing Status:<br>UCIP Comments: Pipe abandoned and should be done so properly.<br>FIELD_STRUCT_DESC: *Abandoned* 6-inch pipe through levee 11.5 feet below crown. Pump and gate valve in pump house on the waterward slope. 1.5-inch galvanized iron electrical conduit at same location. Originally included in the 1966 O&M manual.<br>FS Date: 6/27/2013 | | | | | |

Pumphouse on WS slope with electrical conduit shown.

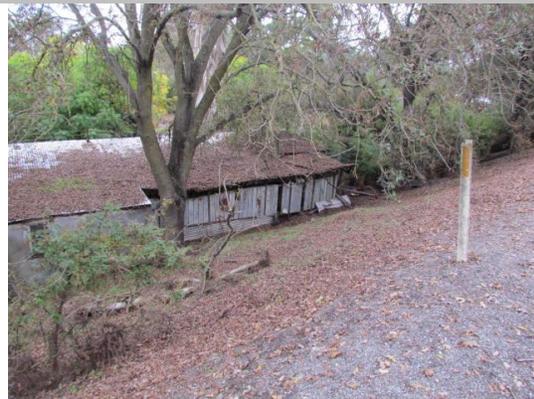
Photo 1 of 1 : richard\_s\_20140310\_324.jpg

| Building<br>Inspector Comments: Storage shed at landside toe and within the 10' easement. | | | | | |

Looking northwest at storage shed at landside toe and within the 10' easement.

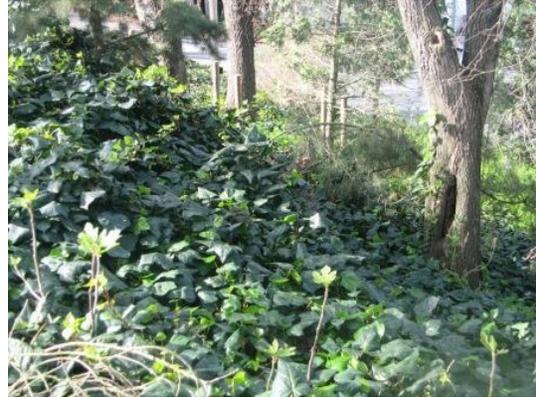
Photo 1 of 2 : richard\_s\_20140310\_314.jpg

| Landscaping | | | | | |

View of landscaping (Ivy) blocking view of landside slope from LM 0.84 to 0.94

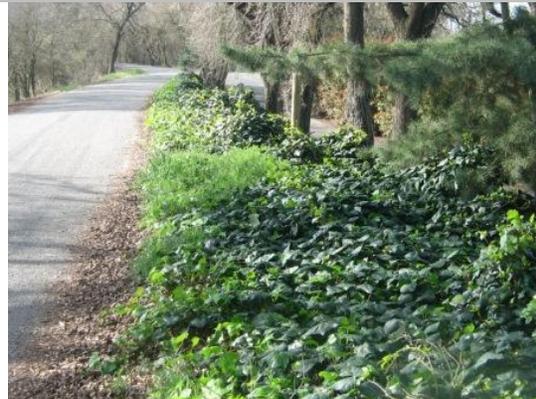
Photo 2 of 2 : richard\_s\_20140310\_315.jpg

View of landscaping (Ivy) looking upstream from LM 0.84 to 0.94

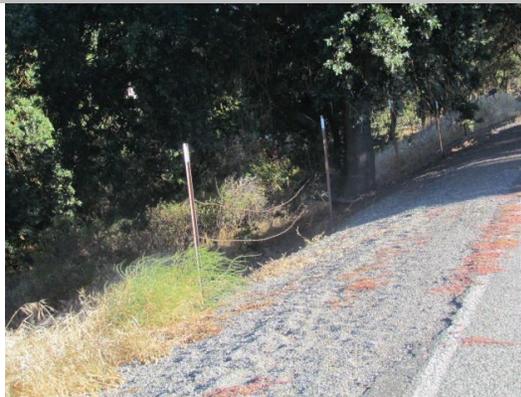
Photo 1 of 1 : richard\_s\_20140310\_386.jpg

| Fence<br>Inspector Comments: Fencing on landward slope | | | | | |

Looking northwest at fence on landward slope.

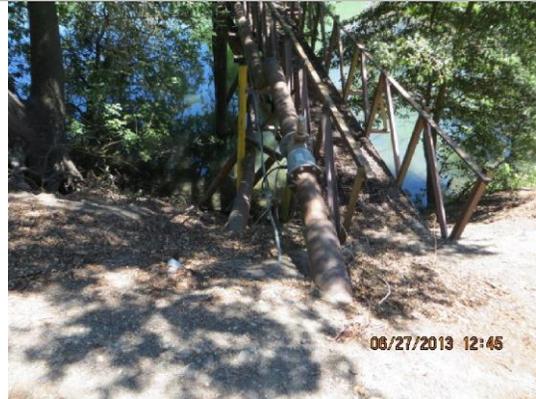
Photo 1 of 1 : UCIP\_1470.jpg

| Inspector Comments: FS_ID:16336<br>EP_NO: N/A<br>Repair Type:<br>Crossing Status:<br>UCIP Comments: Pipe appears abandoned and should be removed.<br>FIELD_STRUCT_DESC: *Abandoned*10-inch steel irrigation pipe through levee 6.5-feet below crown. Pipe extends under metal walkway on WS shoulder.<br>FS Date: 6/27/2013 | | | | | |

Pipe visible beneath 10-inch pipe that is currently in use. No connection.

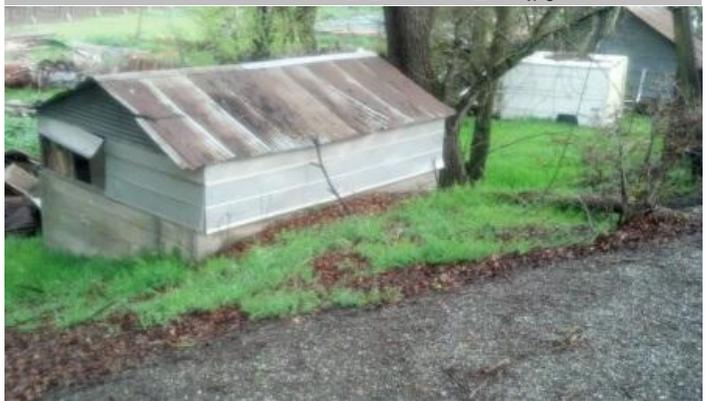
Photo 1 of 2 : richard\_s\_20140310\_387.jpg

| Building<br>Inspector Comments: Building is next to 10-inch pipe and pump station on waterside of levee. Building is not permitted. | | | | | |

Looking northwest at pump building on landside slope and toe.

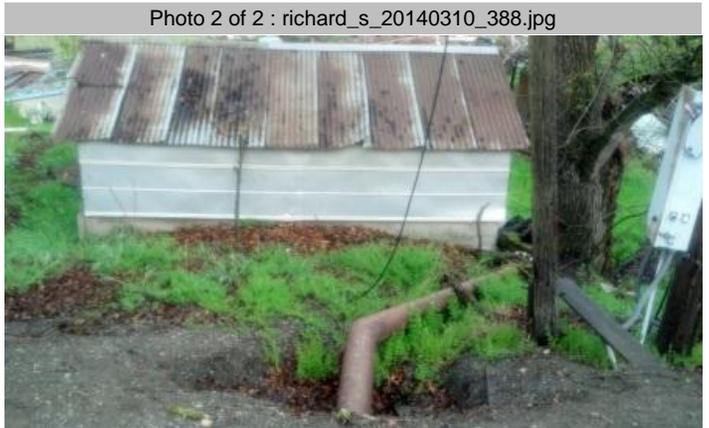
| Building<br>Inspector Comments: Building is next to 10-inch pipe and pump station on waterside of levee. Building is not permitted. | | | | | |

Looking west at pump building on landside slope and toe.

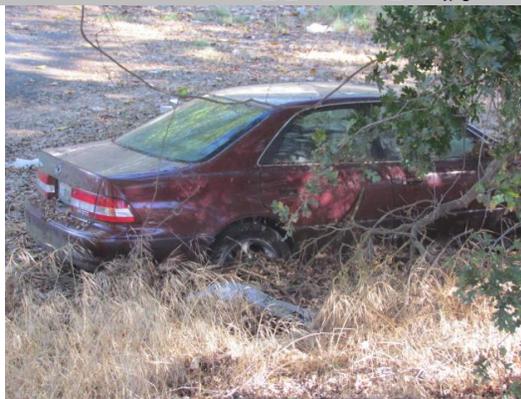
Photo 1 of 1 : richard\_s\_20140310\_392.jpg

| Abandoned vehicles<br>Inspector Comments: Abandoned vehicle at landward toe. | | | | | |

Looking west at abandoned vehicle on landward toe.

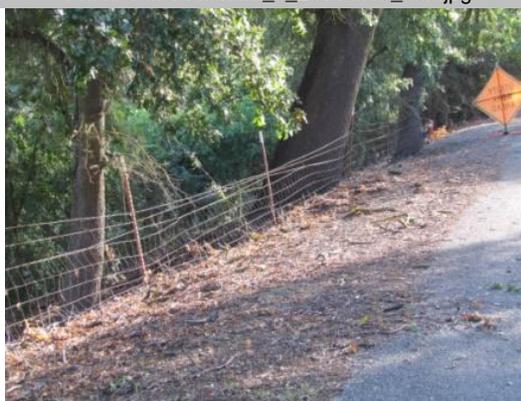
Photo 1 of 1 : richard\_s\_20140310\_355.jpg

| Fence<br>Inspector Comments: Fence is located on landside shoulder. | | | | | |

Looking north at fence along landside slope.
