**Flood Control Project Maintenance  
Levee Inspections**  
**LMA District Cover Sheet**  
**Spring 2014 Levee Inspection Results**

**Reclamation District No. 0999 Netherlands**

**Spring 2014 Levee Inspection Results**

| Waterway | Bank | Unit Miles |
|---|---|---|
| Unit No. 01 Yolo Bypass | Left | 15.43 |

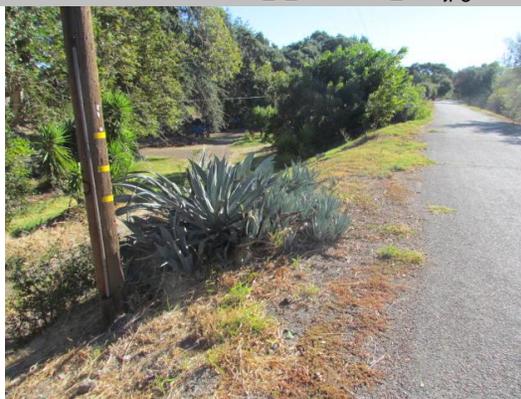
Photo 1 of 2 : richard\_s\_20140310\_307.jpg

| Landscaping<br>Inspector Comments: Control landscaping on landward slope. | | | | | |

Looking northwest at landscaping on landward slope.

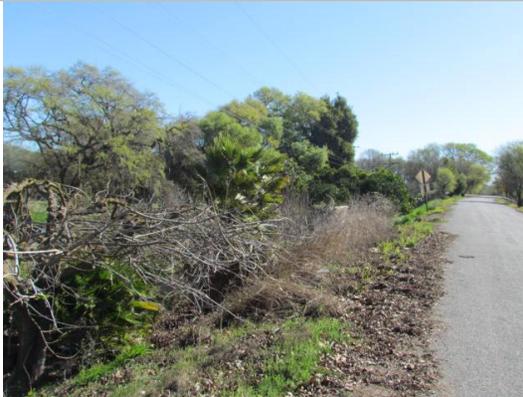
Photo 2 of 2 : richard\_s\_20140314\_455.jpg

| Landscaping<br>Inspector Comments: Control landscaping on landward slope. | | | | | |

Looking south at landscaping on landward slope.

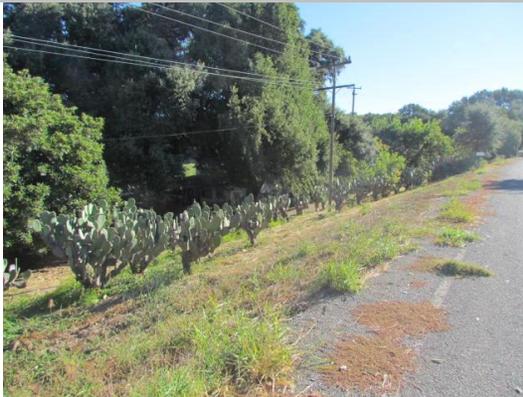
Photo 1 of 1 : richard\_s\_20140310\_393.jpg

| Landscaping<br>Inspector Comments: Large cactus plants on landward slope. | | | | | |

Looking northwest at several cactus plants on landward slope.

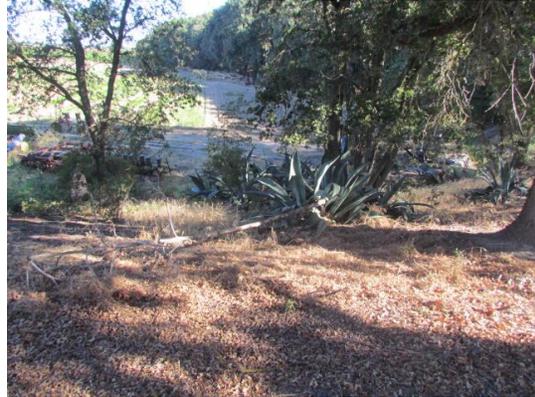
Photo 1 of 2 : richard\_s\_20140310\_383.jpg

| Remove the wild growth other than native grasses from the levee slopes.<br>Inspector Comments: Berry vines and century plants on landside toe and slope. | | | | | |

Looking west at century plants on landward slope.

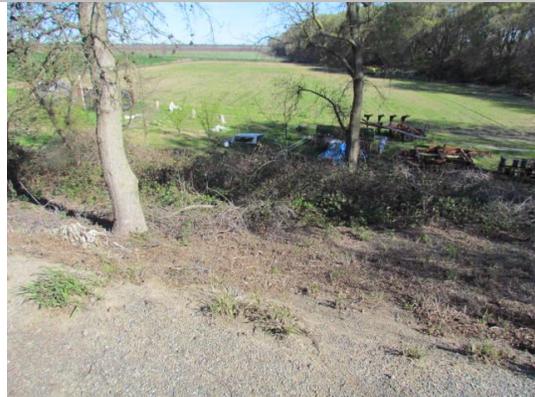
Photo 2 of 2 : richard\_s\_20140314\_456.jpg

Looking southwest at berryvines on landward slope.

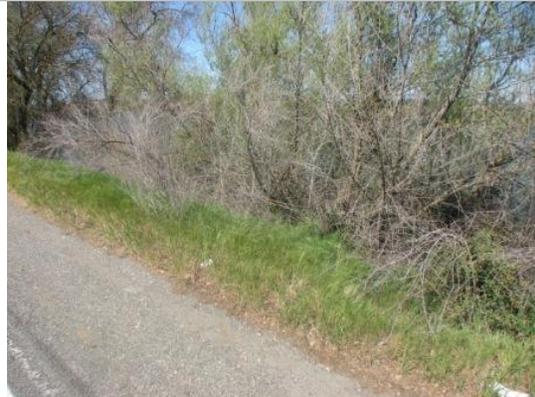
Photo 1 of 2 : richard\_s\_20140310\_321.jpg

Front view of dense trees along waterside slope.

| Trim and thin trees to allow visibility of the ground and room to flood | | | | | |

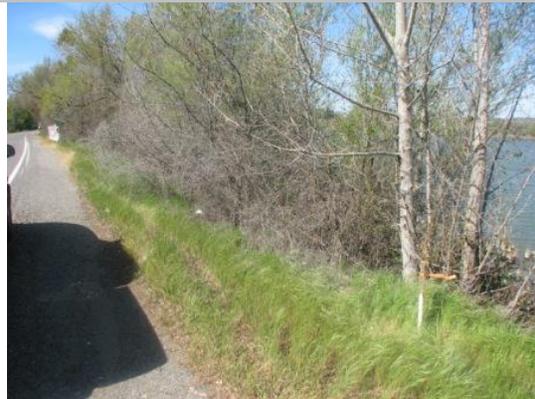
Photo 2 of 2 : richard\_s\_20140310\_322.jpg

Side view of dense trees along waterside slope.

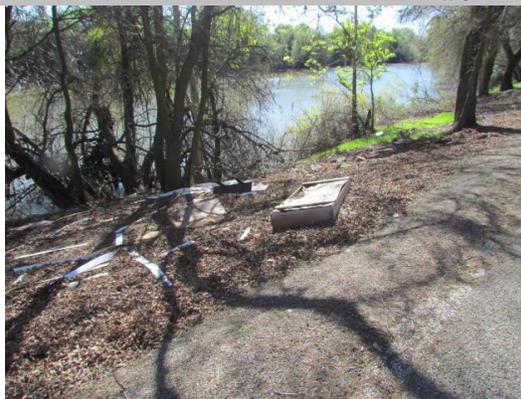
Photo 1 of 1 : richard\_s\_20140314\_457.jpg

| Garbage | | | | | |

Looking southeast at garbage on waterward slope.

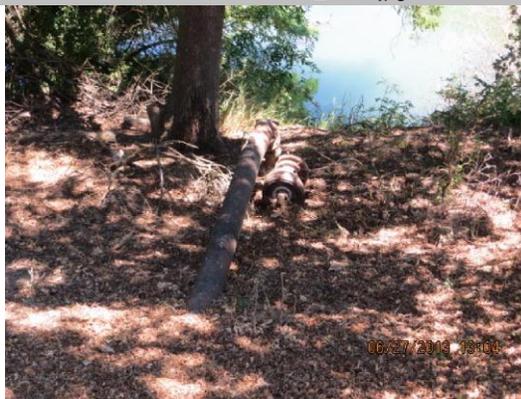
Photo 1 of 1 : UCIP\_1323.jpg

| Inspector Comments: FS_ID:15421<br>EP_NO: N/A<br>Repair Type:<br>Crossing Status:<br>UCIP Comments: Abandoned and should be done so properly.<br>FIELD_STRUCT_DESC: *Abandoned* 8-inch pipe through levee 4.7 feet below crown. Pump house on the waterward slope. Both ends open. Originally included in the 1966 O&M manual.<br>FS Date: 6/27/2013 | | | | | |

Pipe and pump remnants on WS slope.

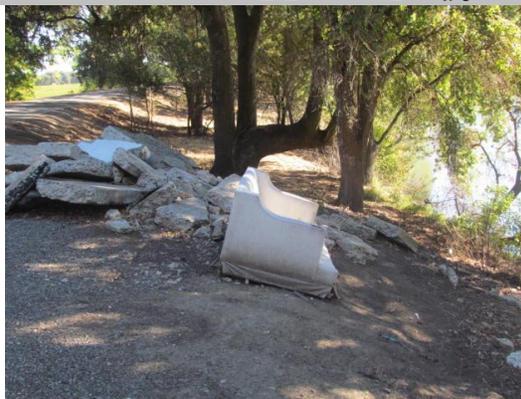
Photo 1 of 1 : richard\_s\_20140310\_394.jpg

| Garbage<br>Inspector Comments: Sofa on waterward shoulder. | | | | | |

Looking northeast at garbage (sofa) on waterward slope.

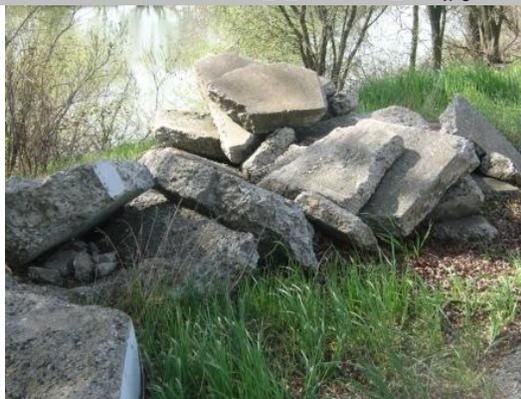
Photo 1 of 1 : richard\_s\_20140310\_323.jpg

| Material<br>Inspector Comments: Concrete rubble should be removed or broken up and spread out at waterward toe. | | | | | |

Concrete rubble on waterside sholder at LM 1.97

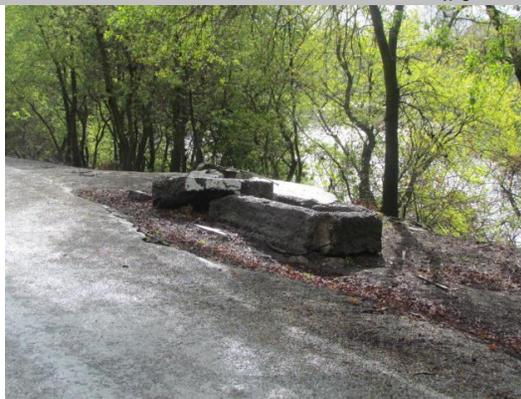
Photo 1 of 1 : richard\_s\_20140310\_356.jpg

| Material<br>Inspector Comments: District placed large concrete rubble on ramp to block access. District should remove concrete rubble and use a different method to block access. | | | | | |

Looking east at large concrete blocks at the top of ramp on waterside shoulder.

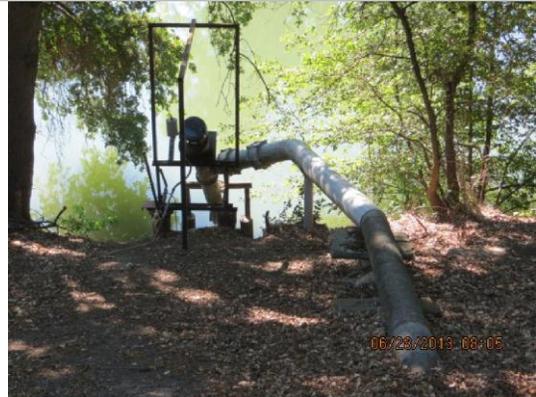
Photo 1 of 1 : UCIP\_1325.jpg

| Inspector Comments: FS_ID:15429<br>EP_NO: 7378<br>Repair Type:<br>Crossing Status:<br>UCIP Comments: Pipe outlet is eroding the LS slope of the levee, exposing the roots of an oak and threatening greater damage if allowed to continue.<br>FIELD_STRUCT_DESC: 10-inch steel pipe through levee 6-feet below crown. Slant pump and service pole on the waterward slope. 36-inch concrete standpipe on LS toe (Permit No. 7378, 1971). Replaced an existing 8-inch pipe at the same location.<br>FS Date: 6/28/2013 | | | | | |

Slant pump and pipe on WS slope.

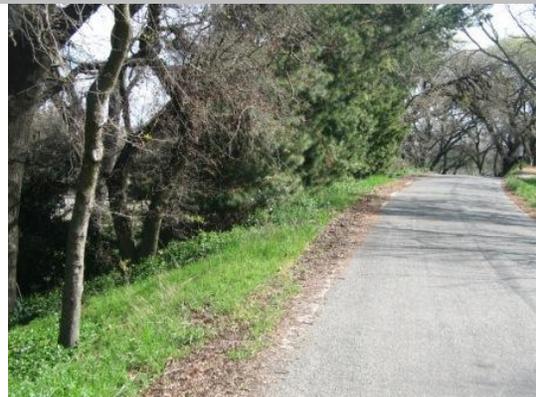
Photo 1 of 1 : richard\_s\_20140310\_331.jpg

Looking downstream of landscaping blocking view of landside slope from LM 3.19 to 3.24

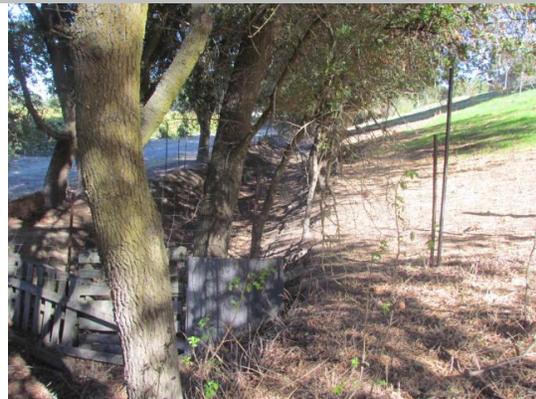
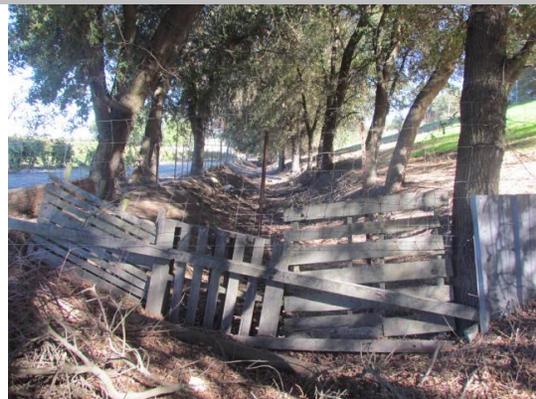
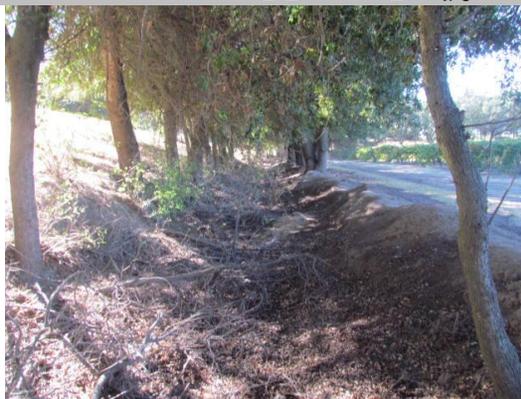
| Ditch<br>Inspector Comments: Adandoned irrigation ditch at landward toe. | | | | | |

Looking north at old irrigation ditch at landward toe.

Looking north at irrigation ditch at landward toe.

Looking south at irrigation ditch at landward toe.

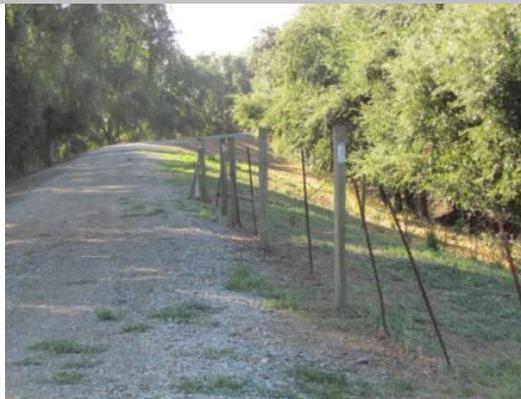
Photo 1 of 1 : richard\_s\_20140310\_357.jpg

Looking north at fence along waterside shoulder.

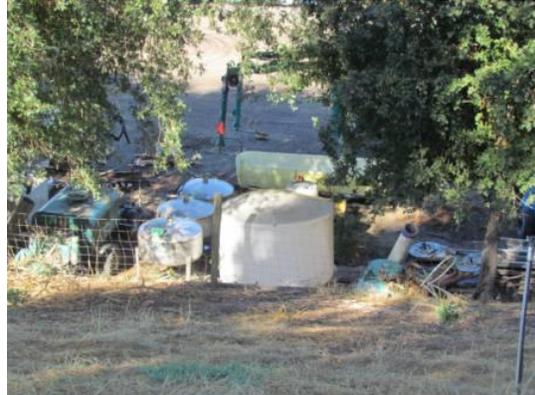
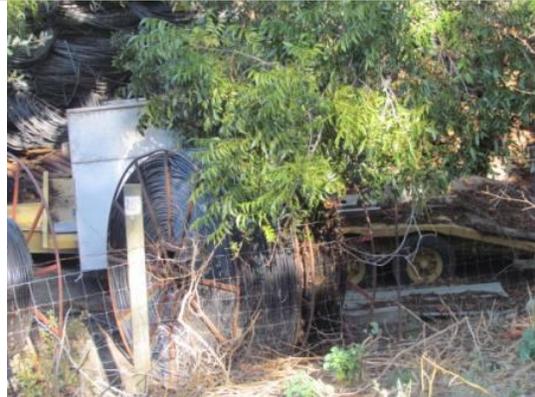
Looking west at equipment at landside toe.

Looking northwest at equipment on landside toe.

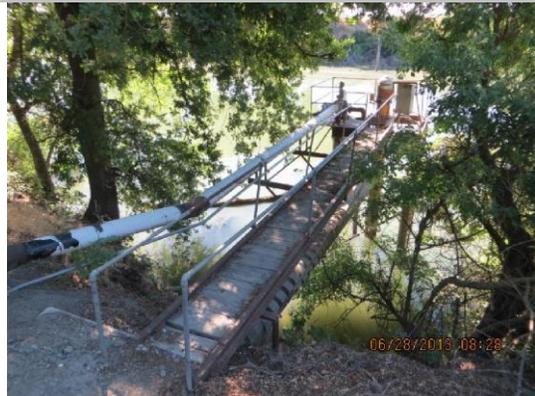
Photo 1 of 1 : UCIP\_1474.jpg

Pump on pier at WS.

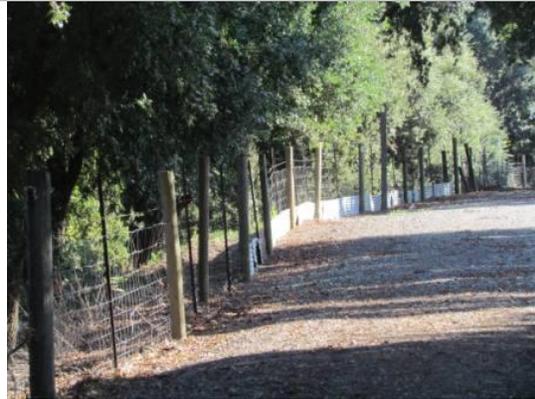
Photo 1 of 1 : richard\_s\_20140310\_358.jpg

Looking northg at fence along landside shoulder.

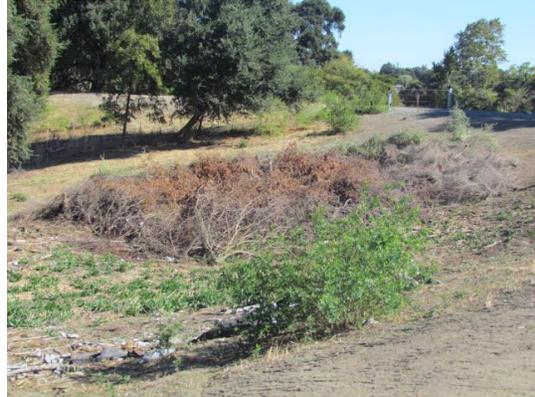
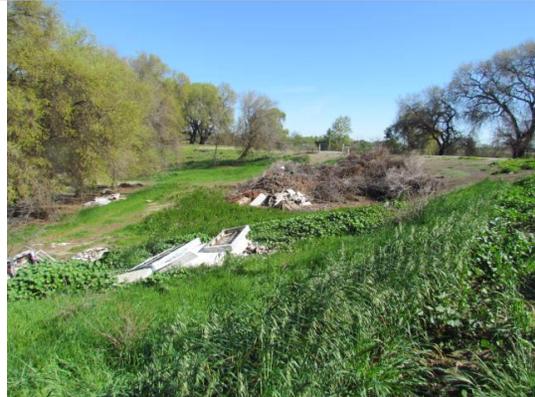
| Garbage<br>Inspector Comments: Garbage and prunings also located at site. | | | | | |

Looking south at large pruning pile on landward slope.

Looking south at prunings on landward slope and toe.

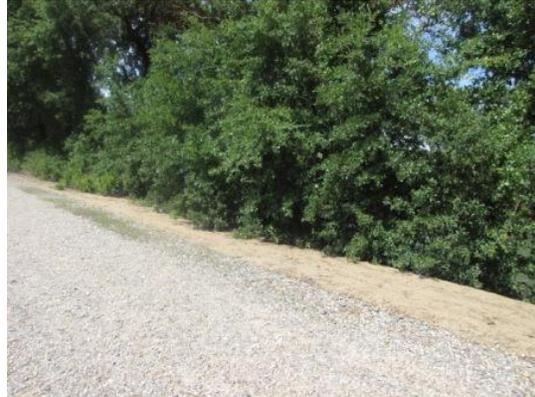
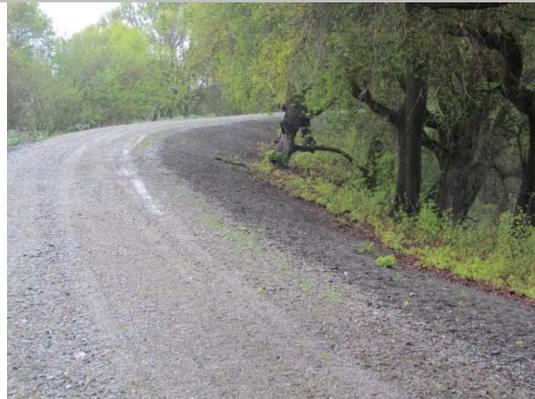
Looking northeast at overgrown trees on waterside slope.(Spring 2011)

Looking northeast at trimmed trees on waterside slope.

| Trim and thin trees to allow visibility of the ground and room to flood fight. | | | | | |

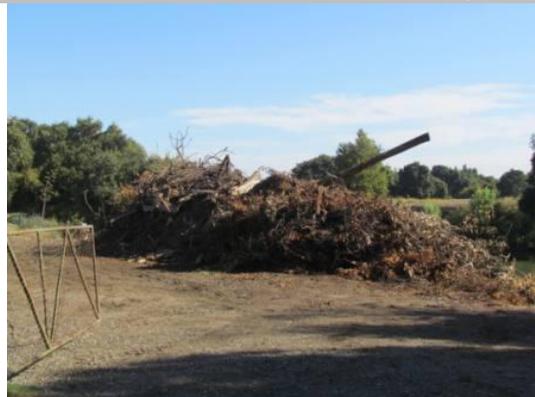
Photo 1 of 1 : richard\_s\_20140310\_333.jpg

Looking northeast at larger pruning pile on waterside shoulder.

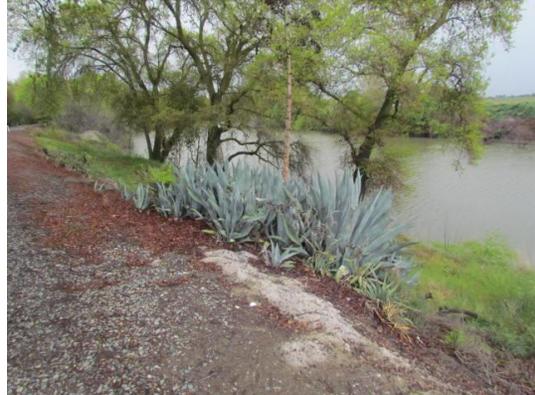
Photo 1 of 1 : richard\_s\_20140310\_346.jpg

| Landscaping<br>Inspector Comments: Century plant on waterside slope. | | | | | |

Looking at century plants on waterside shoulder.(Spring 2012)

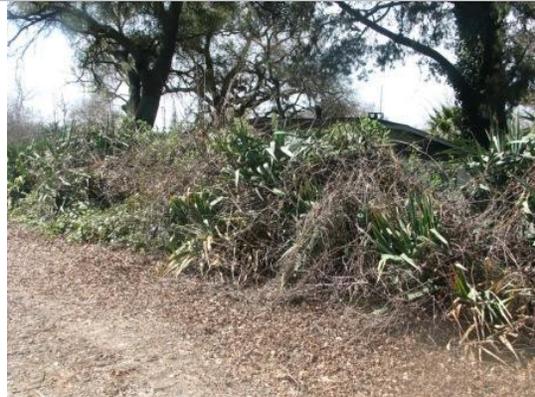
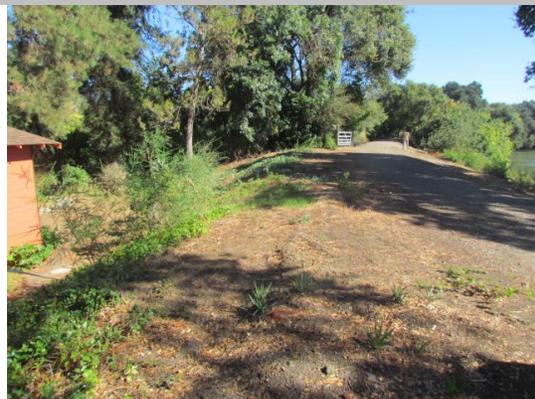
| Landscaping<br>Inspector Comments: Landowner has trimmed landscape, but still blocking view. | | | | | |

Overgrown landscaping on landside slope blocking view of slope from LM 4.38 to 4.41

Looking north at landscaping on landward slope.

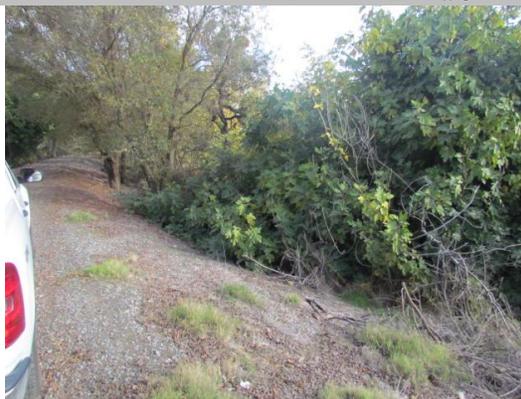
Photo 1 of 1 : richard\_s\_20140310\_330.jpg

Looking northeast at fig tree on waterside slope.

| Remove the wild growth other than native grasses from the levee slopes. | | | | | |

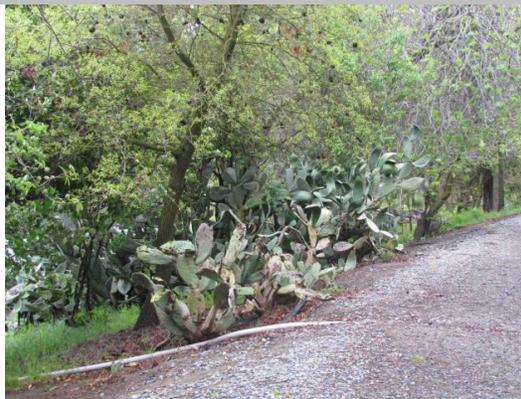
Photo 1 of 1 : richard\_s\_20140310\_347.jpg

| Landscaping<br>Inspector Comments: Cactus | | | | | |

Looking northwest at cactus on landside shoulder and slope. (Spring 2012)

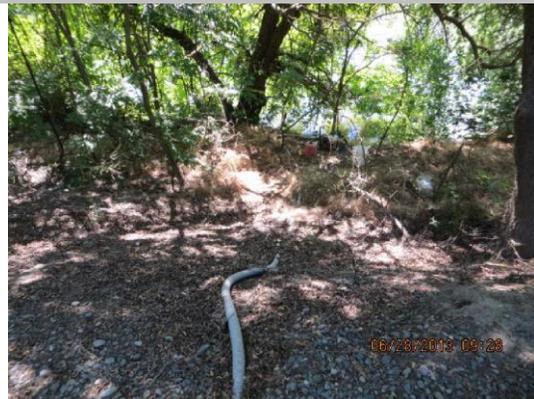
Photo 1 of 1 : UCIP\_1477.jpg

| Inspector Comments: FS_ID:16338<br>EP_NO: N/A<br>Repair Type:<br>Crossing Status:<br>UCIP Comments: This crossing should be permitted or removed.<br>FIELD_STRUCT_DESC: 2-inch plastic water line through the levee 6-inch below the crown. Portable pump on the WS toe.<br>FS Date: 6/28/2013 | | | | | |

Flex pipe through the levee 6-inches below the crown with portable pump on WS toe.

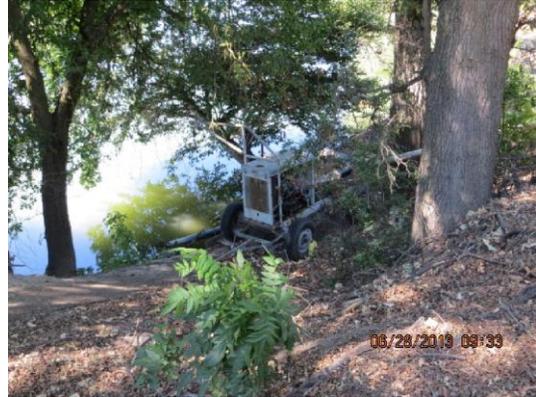
Photo 1 of 1 : UCIP\_1503.jpg

| Inspector Comments: FS_ID:16403<br>EP_NO: N/A<br>Repair Type:<br>Crossing Status:<br>UCIP Comments: Need to determine Permit No. for this crossing or remove it.<br>FIELD_STRUCT_DESC: 5-inch temporary alluminum pipe over the top of the levee. Portable pump on the WS toe.<br>FS Date: 6/28/2013 | | | | | |

Portable pump on WS toe.

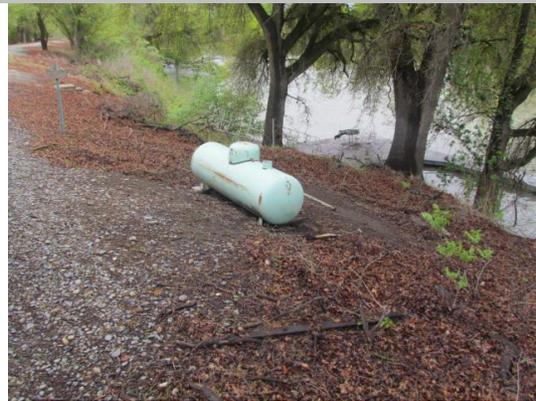
Photo 1 of 1 : richard\_s\_20140310\_384.jpg

| Equipment<br>Inspector Comments: Propane tank on waterside slope within the twenty foot zone. | | | | | |

Looking northeast at propane tank on waterside slope.

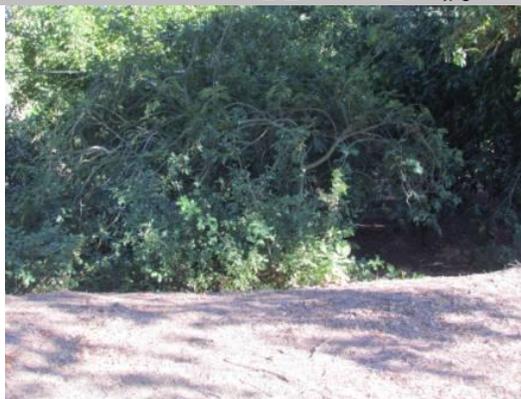
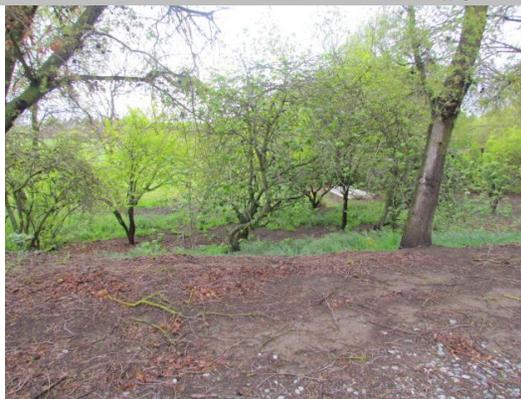
Looking west at dense trees on landside slope.(Spring 2011)

Looking west at trimmed trees on landside slope.(Spring 2012)

| Thin trees to allow visibility of the ground and room to flood fight. | | | | | |

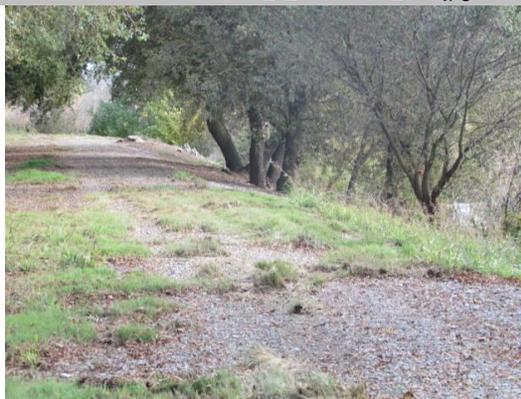
Photo 1 of 1 : richard\_s\_20140310\_332.jpg

Looking north at vegetation on levee crown.

| Add appropriate material and re-grade the levee to bring the crown | | | | | |

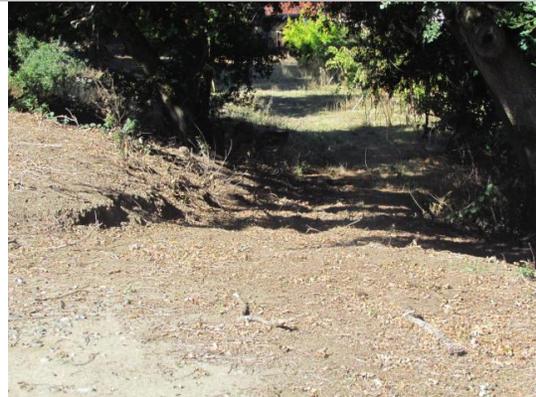
Photo 1 of 1 : richard\_s\_20140310\_400.jpg

| Inspector Comments: Levee damaged by vehicle traffic. | | | | | |

Looking west at levee damage due to vehicle traffic.

| Repair the levee slope damaged by vehicle traffic and prevent access where possible. | | | | | |

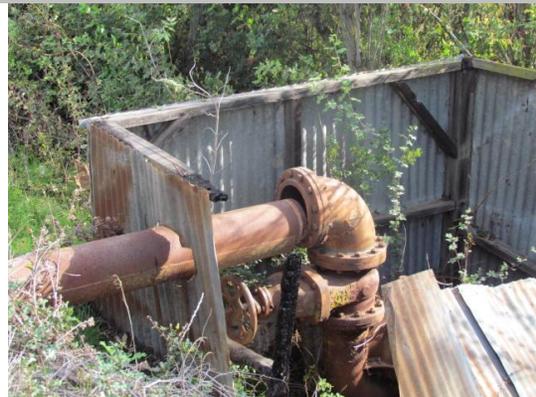
Photo 1 of 1 : richard\_s\_20140310\_344.jpg

| Inspector Comments: Pipe is disconnected from pump and should be reconnected or removed. | | | | | |

Looking east at pipe disconnected from pump.

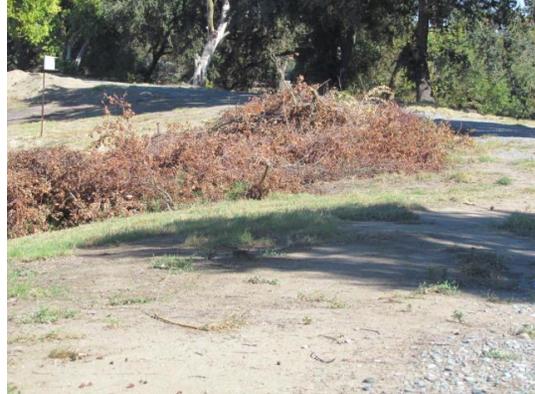
Photo 1 of 1 : richard\_s\_20140310\_348.jpg

| Prunings<br>Inspector Comments: Prunings on landside slope. | | | | | |

Looking northeast at prunings on landward slope.

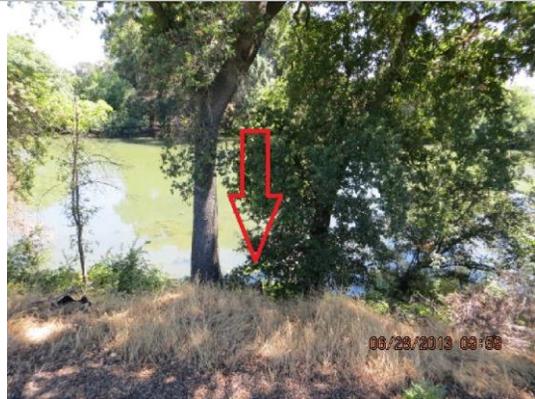
Photo 1 of 1 : UCIP\_1337.jpg

| Inspector Comments: FS_ID:15452<br>EP_NO: N/A<br>Repair Type:<br>Crossing Status:<br>UCIP Comments: Pipe abandoned and should be done so properly.<br>Pipe open on waterside.<br>FIELD_STRUCT_DESC: 7-inch steel irrigation pipe through the levee 6.5-feet below the crown. Originally included in the 1966 O&M manual.<br>FS Date: 6/28/2013 | | | | | |

Pipe visible on WS slope.

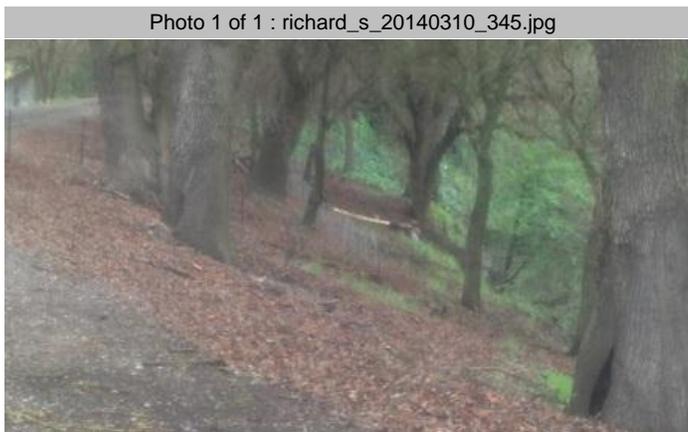
| Fence<br>Inspector Comments: Fence is installed down waterside slope. | | | | | |

Looking northeast at fence on waterside slope.

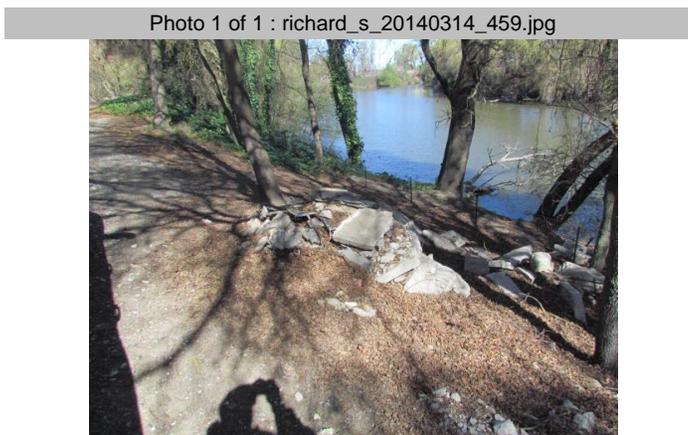
| Material<br>Inspector Comments: Concrete rubble dumped on waterward slope. | | | | | |

Looking northeast at concrete rubble on waterward slope.

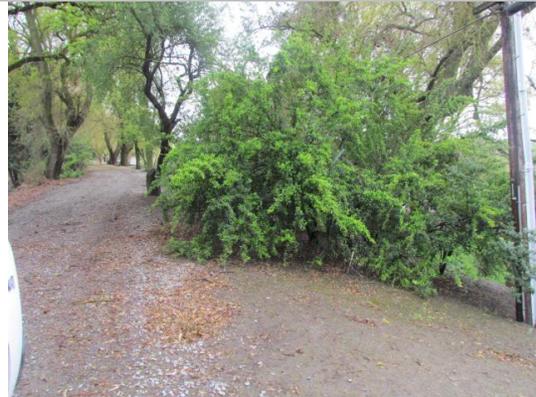
Photo 1 of 1 : richard\_s\_20140310\_351.jpg

Looking southwest at untrimmed tree on waterside shoulder and slope.

| Trim and thin trees to allow visibility of the ground and room to flood fight. | | | | | |

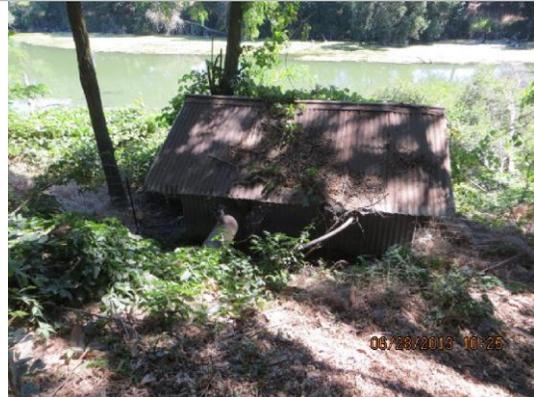
Photo 1 of 1 : UCIP\_1332.jpg

| Inspector Comments: FS_ID:15446<br>EP_NO: N/A<br>Repair Type:<br>Crossing Status:<br>UCIP Comments: Pipe appears abandoned and should be done so appropriately.<br>FIELD_STRUCT_DESC: 10-inch steel irrigation pipe through the levee 4-feet below the crown. Pumphouse and gate valve on the waterward slope. Vent on LS slope and a 42-inch concrete standpipe on LS toe. service pole on the landward slope with a 1.5-inch galvanized iron electrical conduit at same location. Originally included in the 1966 O&M manual.<br>FS Date: 6/28/2013 | | | | | |

Corrugated metal pumphouse on WS slope.

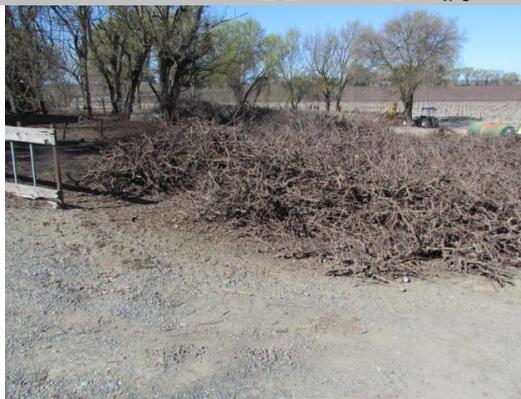
Photo 1 of 1 : richard\_s\_20140314\_460.jpg

| Prunings<br>Inspector Comments: Landowner pile prunings on landside slope. | | | | | |

Looking west at prunings on landward slope and toe.

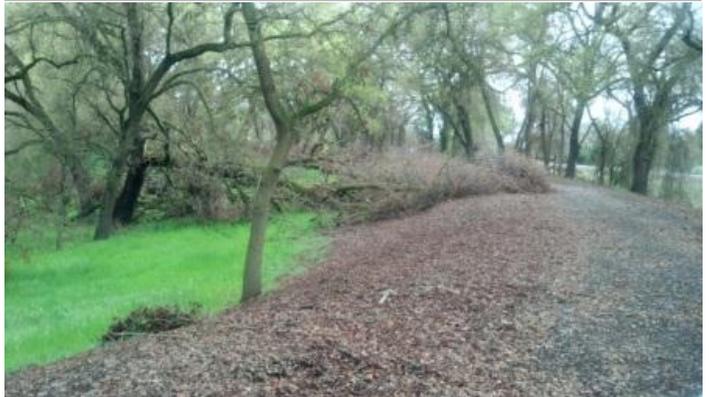
Photo 1 of 2 : richard\_s\_20140310\_337.jpg

| Tree or limb<br>Inspector Comments: Large downed trees and limbs on landside slope and toe. | | | | | |

Looking northwest at large tree limb on landside toe and slope.

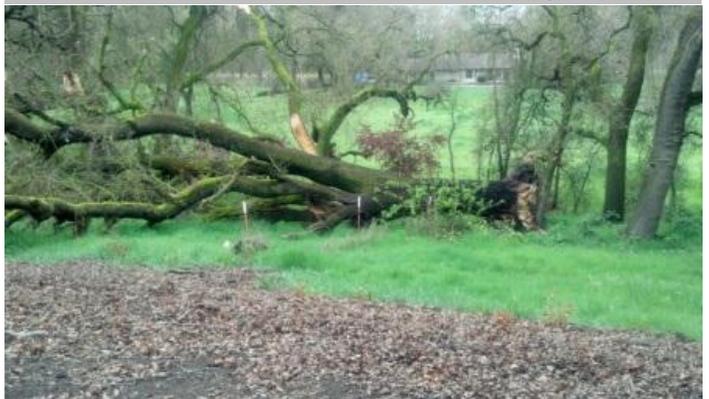
Photo 2 of 2 : richard\_s\_20140310\_338.jpg

Looking west at large tree on landside slope and toe.

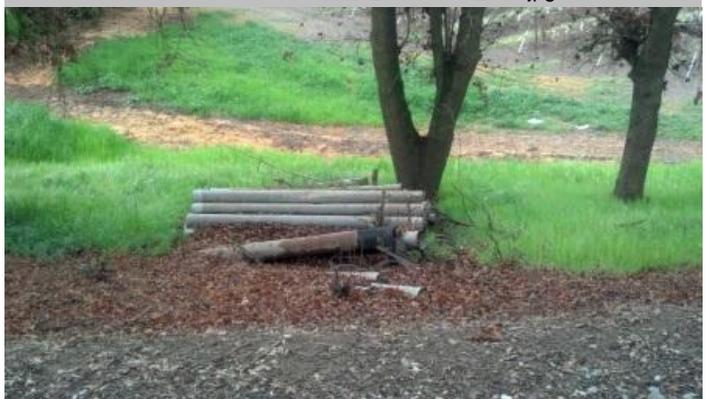
Photo 1 of 1 : richard\_s\_20140310\_389.jpg

Looking west at irrigation pipes on landside toe.

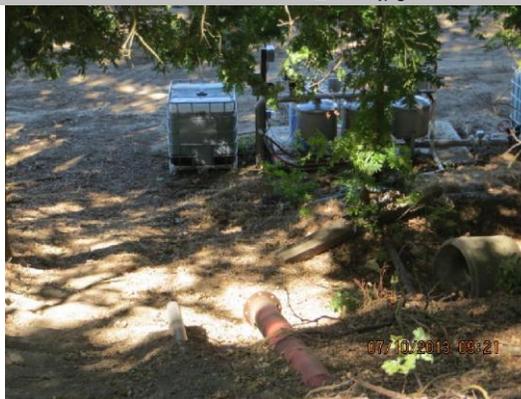
Photo 1 of 1 : UCIP\_1480.jpg

| Inspector Comments: FS_ID:16344<br>EP_NO: N/A<br>Repair Type:<br>Crossing Status:<br>UCIP Comments:<br>FIELD_STRUCT_DESC: 4-inch steel irrigation pipe through the levee 1.5-feet below the crown. Pump on WS. Filter, booster, and vent on LS toe. JP on WS shoulder.<br>FS Date: 7/10/2013 | | | | | |

Pipe visible on LS slope with filter plant in background.

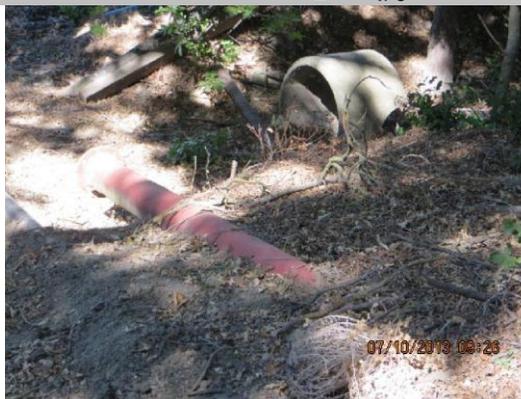
Photo 1 of 1 : UCIP\_1347.jpg

| Inspector Comments: FS_ID:15600<br>EP_NO: N/A<br>Repair Type:<br>Crossing Status:<br>UCIP Comments: Pipe appears abandoned and is open on both ends. Pipe should be abandoned properly.<br>FIELD_STRUCT_DESC: 6-inch steel irrigation pipe through the levee 6-feet below the crown. Evidence of Pump, gate valve on the WS toe along with a service pole. Evidence of a 36-inch standpipe at the landward toe. Originally included in the 1966 O&M manual.<br>FS Date: 7/10/2013 | | | | | |

6-inch steel pipe on LS slope with evidence of 36-inch standpipe in background.

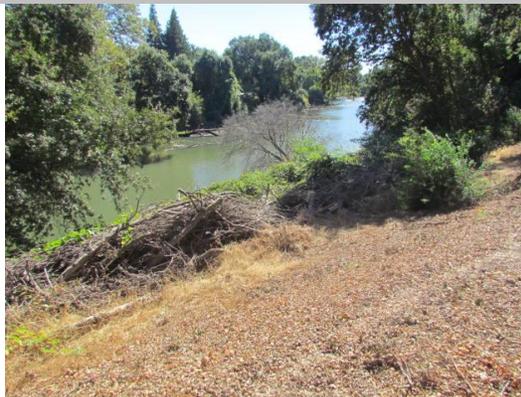
Photo 1 of 1 : richard\_s\_20140310\_354.jpg

| Trim and thin trees to allow visibility of the ground and room to flood fight.<br>Inspector Comments: Prunings are outside the twenty foot zone should be burned or removed from waterward slope. | | | | | |

Looking southeast at prunings on waterward slope.

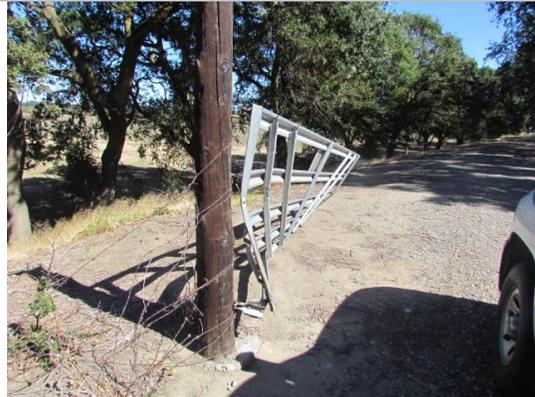
Photo 1 of 1 : richard\_s\_20140310\_360.jpg

| Inspector Comments: Gate should be repaired or removed. | | | | | |

Looking northwest at damaged gate on levee crown.

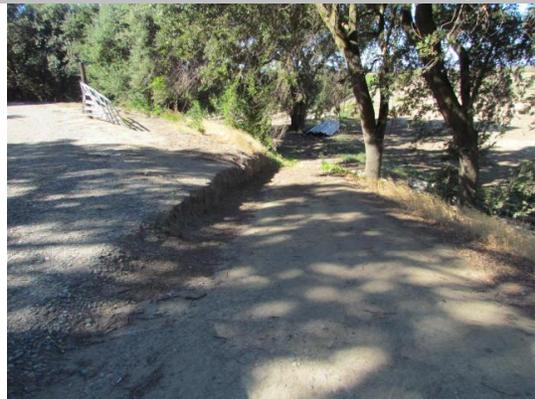
Photo 1 of 1 : richard\_s\_20140310\_401.jpg

| Ramp<br>Inspector Comments: Unauthorized ramp on landward slope. | | | | | |

Looking southwest at ramp on landward slope.

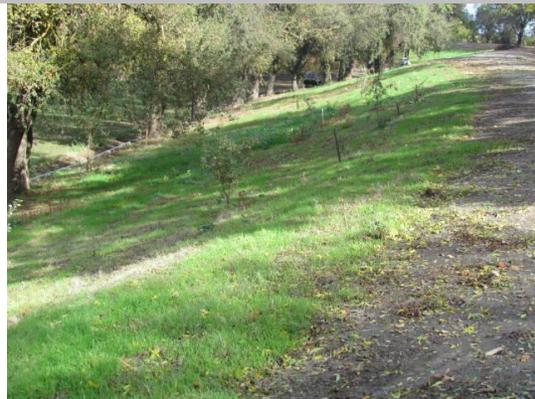
Photo 1 of 2 : richard\_s\_20140310\_376.jpg

| Tree or limb<br>Inspector Comments: Landowner planted trees on landside slope. | | | | | |

Looking northwest at newly planted trees on landside slope.

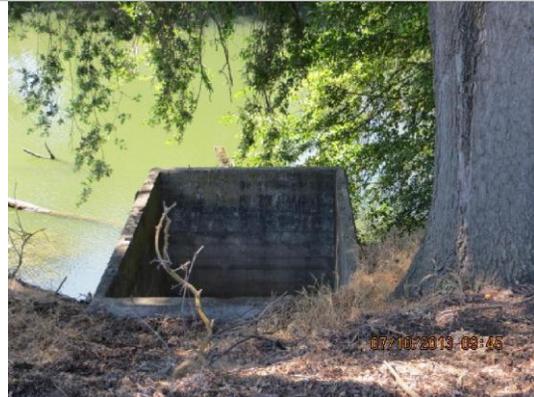
Photo 1 of 1 : UCIP\_1350.jpg

Concrete pump pit on WS slope.

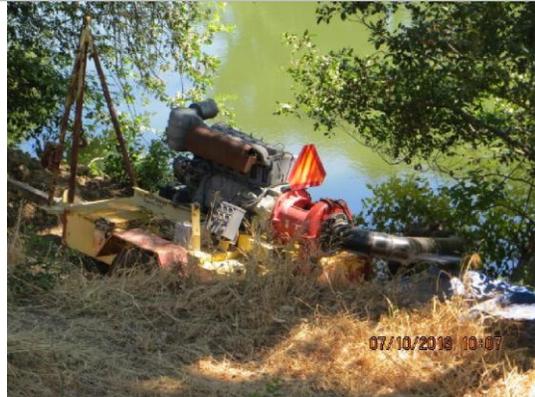
Photo 1 of 1 : UCIP\_1478.jpg

| Inspector Comments: FS_ID:16342<br>EP_NO: N/A<br>Repair Type:<br>Crossing Status:<br>UCIP Comments: Need to determine Permit No. for this crossing.<br>FIELD_STRUCT_DESC: 8-inch aluminum irrigation pipe over the crown-pipe blocks crown when in use. Portable pump on WS toe.<br>FS Date: 7/10/2013 | | | | | |

Portable pump on WS toe.

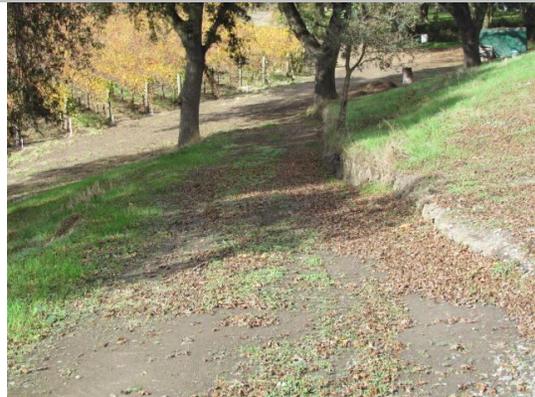
Photo 1 of 1 : richard\_s\_20140310\_385.jpg

| Ramp<br>Inspector Comments: Landowner installed ramp on landside slope without permit. | | | | | |

Looking east at unauthorized ramp on landside slope.

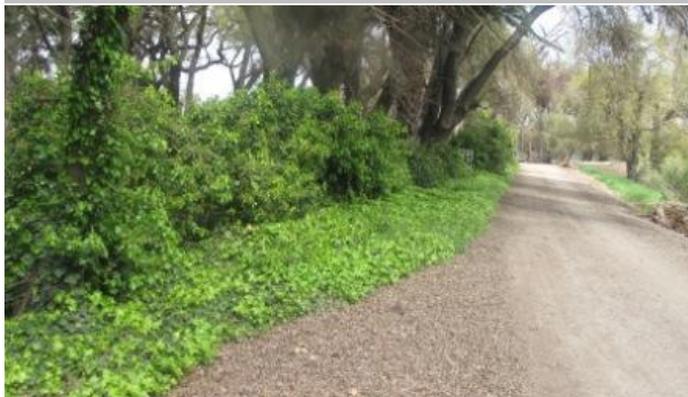
Photo 1 of 1 : richard\_s\_20140310\_365.jpg

Looking north at overgrown landscape on landside slope and toe.

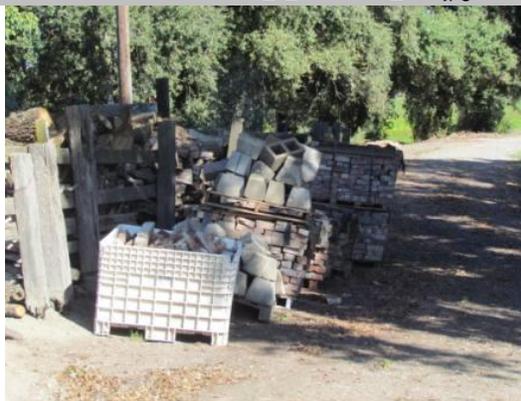
Photo 1 of 4 : richard\_s\_20140310\_373.jpg

| Material<br>Inspector Comments: Firewood and other material on landside shoulder. | | | | | |

Looking north at firewood and other material on landside shoulder and crown.

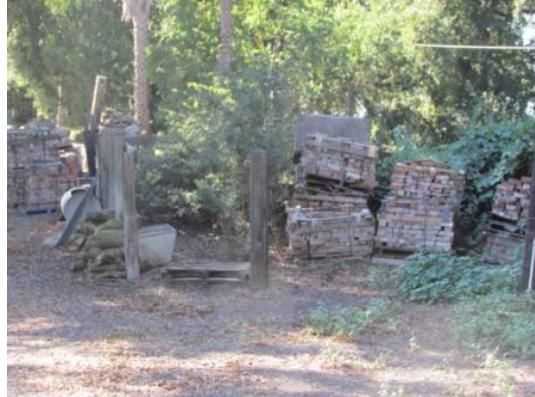
Photo 2 of 4 : richard\_s\_20140310\_374.jpg

| Inspector Comments: Firewood and other material on landside shoulder. | | | | | |

Looking south at firewood and other material on landside shoulder and crown.

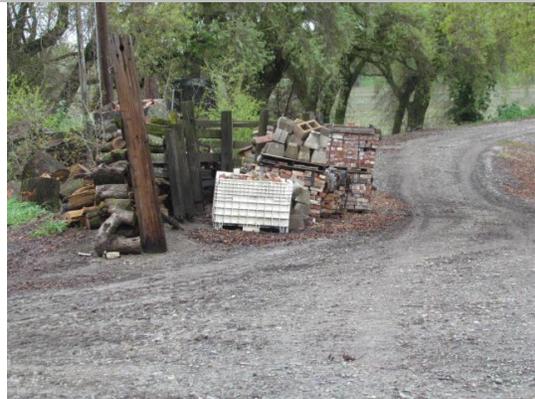
Photo 3 of 4 : richard\_s\_20140310\_375.jpg

Looking northeast at firewood and other material on landside shoulder. (Spring 2012)

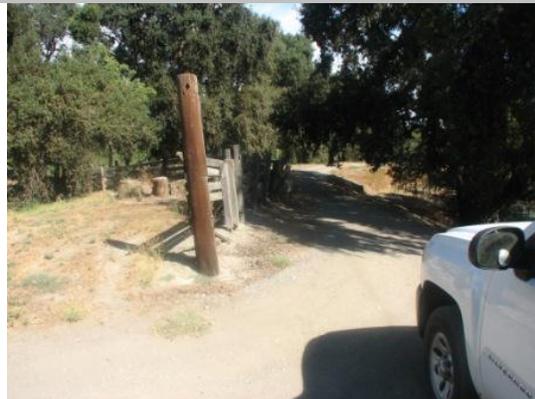
Photo 4 of 4 : richard\_s\_20140310\_372.jpg

Fence, firewood and material at landside shoulder.

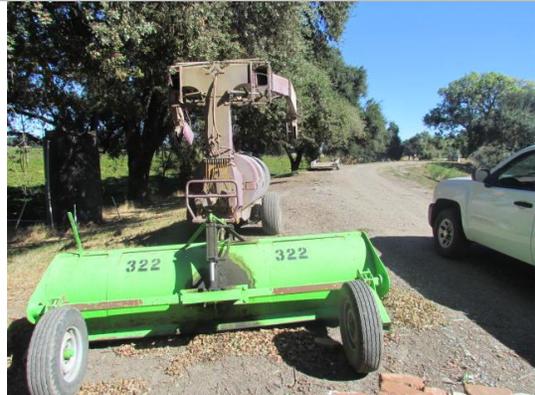
Photo 1 of 2 : richard\_s\_20140310\_402.jpg

Looking north at farm equipment on landward shoulder.

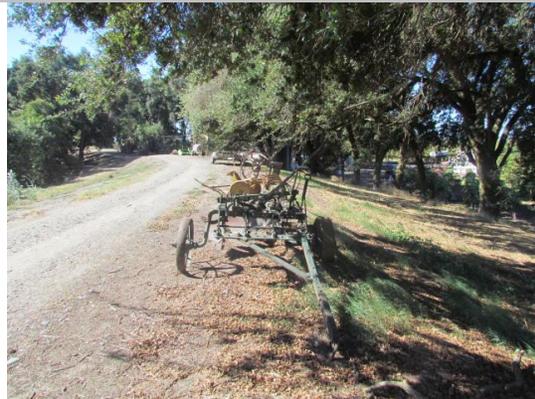
Photo 2 of 2 : richard\_s\_20140310\_403.jpg

Looking south at farm equipment on landward shoulder.

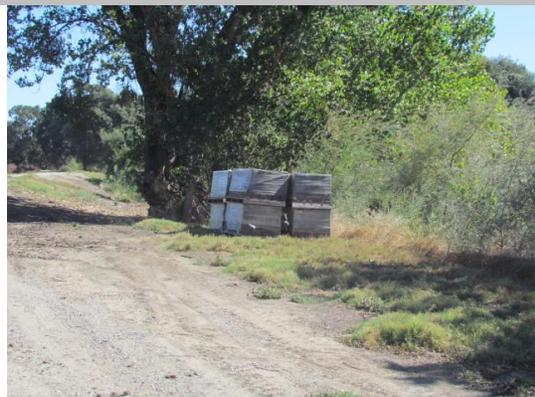
Photo 1 of 1 : richard\_s\_20140310\_404.jpg

Looking northeast at pallets of bricks store on waterward shoulder.

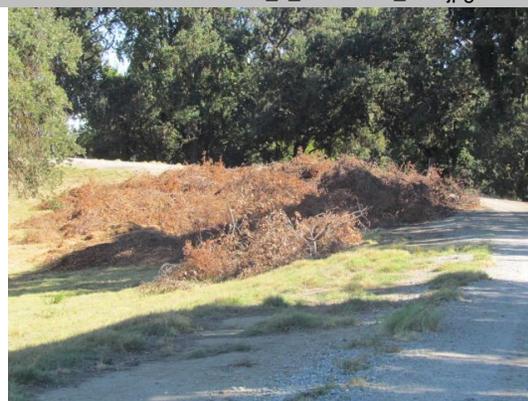
Photo 1 of 1 : richard\_s\_20140310\_390.jpg

| Prunings<br>Inspector Comments: Large pruning pile on landward shoulder and slope. | | | | | |

Looking northeast at large prunings on landward slope.

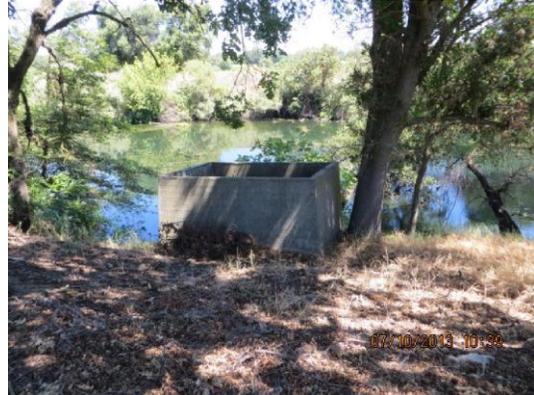
Photo 1 of 1 : UCIP\_1354.jpg

| Inspector Comments: FS_ID:15617<br>EP_NO: N/A<br>Repair Type:<br>Crossing Status:<br>UCIP Comments: Pipe abandoned and open on both ends. Concrete pump pit foundation undermined at WS toe. Pipe should be abandoned properly<br>FIELD_STRUCT_DESC: *Abandoned* 14-inch steel irrigation pipe through the levee 4.8 feet below the crown. Abandoned 9'X14' concrete pump pit on waterward slope. Pipe open at both ends. Originally included in the 1966 O&M manual.<br>FS Date: 7/10/2013 | | | | | |

Concrete pump pit on WS toe.

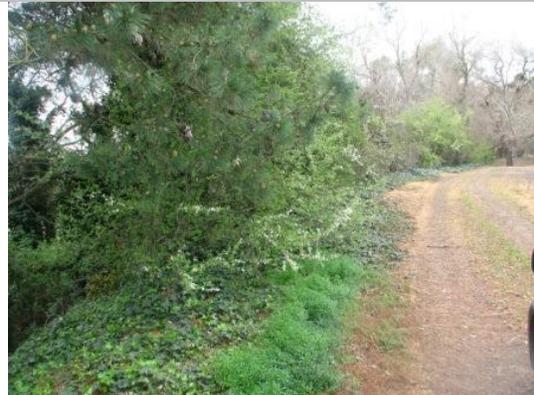
Photo 1 of 2 : richard\_s\_20140310\_349.jpg

Landscaping on landside slope blocking view of slope from LM 7.65 to 7.72

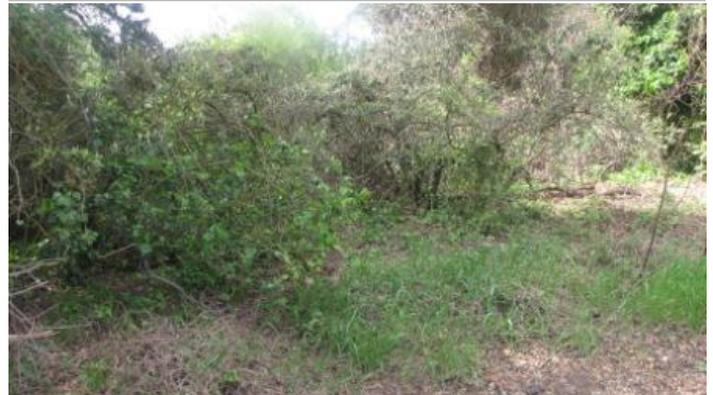
Photo 2 of 2 : richard\_s\_20140310\_350.jpg

Looking east at overgrown landscape on landside slope.

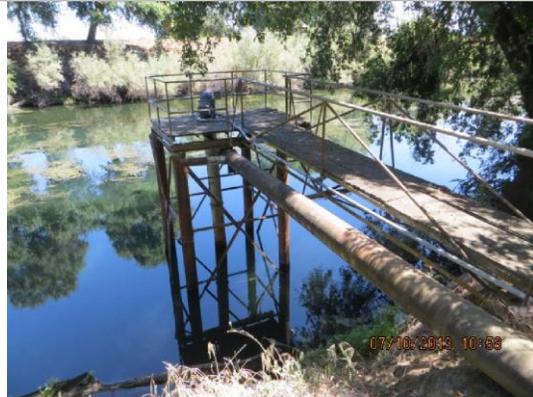
Photo 1 of 1 : UCIP\_1356.jpg

| Inspector Comments: FS_ID:15624<br>EP_NO: N/A<br>Repair Type:<br>Crossing Status:<br>UCIP Comments: Annular space needs to be grouted between the 12 and 14-inch pipes.<br>FIELD_STRUCT_DESC: 14-inch steel irrigation pipe through the levee 7.0 feet below the crown. 12-inch pipe sleeved through 14-inch pipe. Annular space not grouted. 36-inch concrete standpipe on LS toe. Originally included in the 1966 O&M manual.<br>FS Date: 7/10/2013 | | | | | |

Pump on metal pier with walkway at WS toe

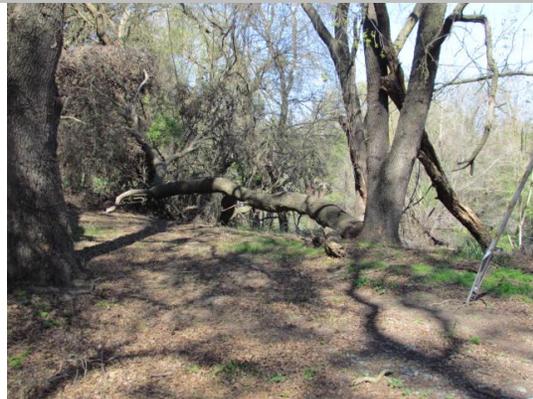
Photo 1 of 1 : richard\_s\_20140314\_462.jpg

| Tree or limb<br>Inspector Comments: Downed tree on waterward shoulder. | | | | | |

Looking east at downed tree on waterward shoulder.

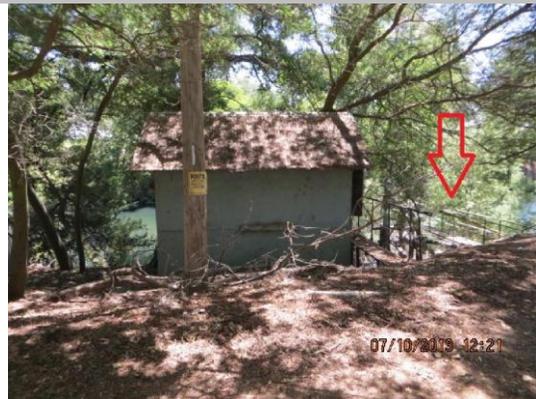
Photo 1 of 1 : UCIP\_1367.jpg

| Inspector Comments: FS_ID:15683<br>EP_NO: 13463<br>Repair Type:<br>Crossing Status:<br>UCIP Comments: Pipe exposed in excavation on LS shoulder at what may be a leak.<br>FIELD_STRUCT_DESC: 12-inch pipe through the levee 2.5-feet below the crown. Pump on pile structure with walkway on WS toe. 12-inch PVC standpipe on LS toe next to filter plant and shed. (Permit No. 13463, 1982). 1.5-inch PVC electrical conduit at same location. This pipe replaced an existing 8-inch pipe that was grouted in place.<br>FS Date: 7/10/2013 | | | | | |

Pump on metal pier with walkway on WS slope.

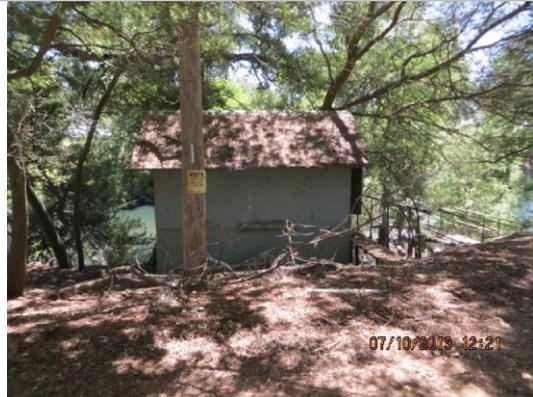
Photo 1 of 1 : UCIP\_1361.jpg

| Inspector Comments: FS_ID:15663<br>EP_NO: N/A<br>Repair Type:<br>Crossing Status:<br>UCIP Comments: Pipe abandoned and should be done so properly.<br>FIELD_STRUCT_DESC: *Abandoned* 14-inch pipe through levee 14.4 feet below crown. Gate valve at pump in Concrete pit under pumphouse on WS slope. Originally included in the 1966 O&M manual.<br>FS Date: 7/10/2013 | | | | | |

Concrete pumphouse on WS slope.

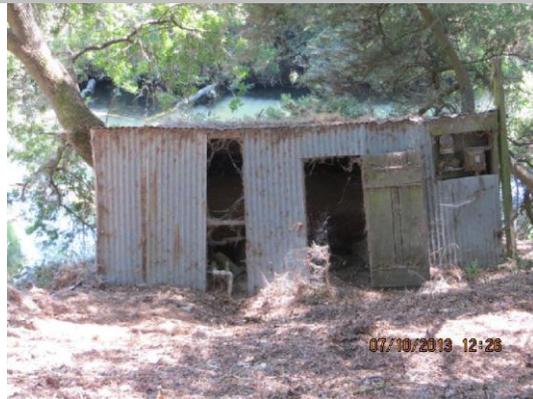
Photo 1 of 1 : UCIP\_1364.jpg

| Inspector Comments: FS_ID:15664<br>EP_NO: N/A<br>Repair Type:<br>Crossing Status:<br>UCIP Comments: Pipe appears abandoned and should be done so properly.<br>FIELD_STRUCT_DESC: 2-inch galvanized iron domestic water pipe through the levee 12.5 feet below the crown. Gate valve and domestic pressure system in pump house on the waterward slope. Originally included in the 1966 O&M manual.<br>FS Date: 7/10/2013 | | | | | |

Pipe visible inside pumphouse on WS slope.

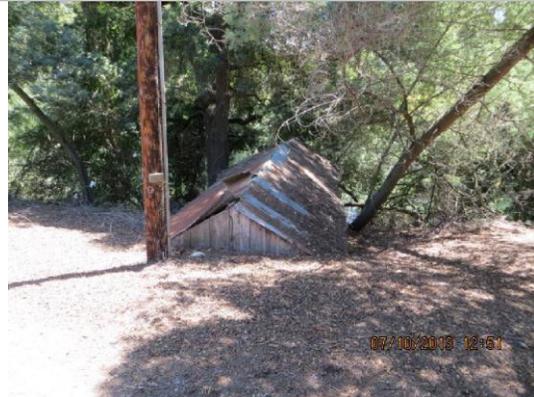
Photo 1 of 1 : UCIP\_1371.jpg

| Inspector Comments: FS_ID:15685<br>EP_NO: 4851<br>Repair Type:<br>Crossing Status:<br>UCIP Comments: Pipe appears to be abandoned and should be done so properly.<br>FIELD_STRUCT_DESC: 8-inch pipe through levee 6.2 feet below crown. Gate valve in pump house on the waterward slope, service pole on both slopes (Permit No 4851, 1965). Originally included in the 1966 O&M manual.<br>FS Date: 7/10/2013 | | | | | |

Pumphouse/concrete headwall on WS slopt.

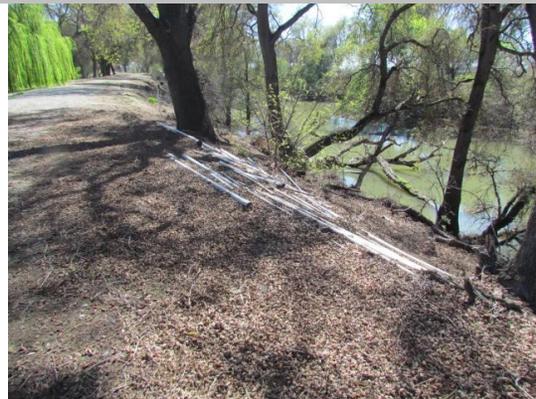
Photo 1 of 1 : richard\_s\_20140314\_463.jpg

| Pipe<br>Inspector Comments: PVC pipes stored on waterward shoulder. | | | | | |

Looking south at pvc pipes on waterward shoulder and slope.

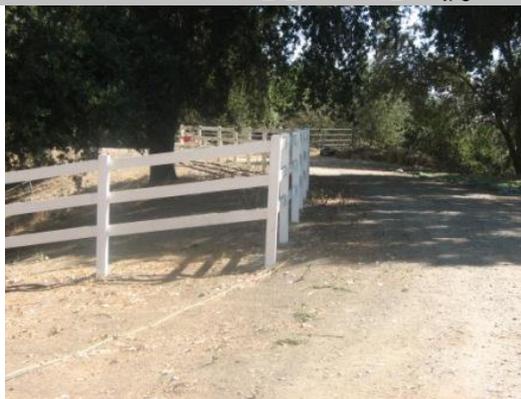
Photo 1 of 1 : richard\_s\_20140310\_378.jpg

| Fence<br>Inspector Comments: Fence installed without CVFPB permit in 2008.<br>Fence extends from landside toe to landside shoulder. | | | | | |

New installed unauthorized fence at landside slope and shoulder.

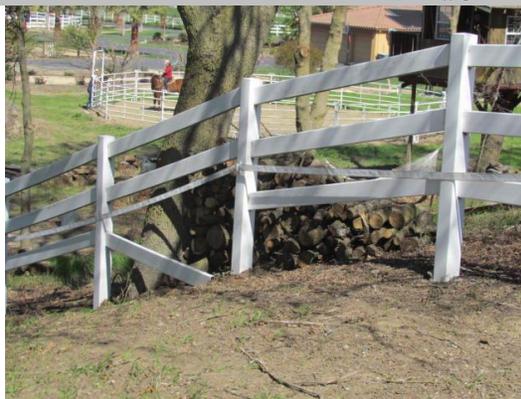
Photo 1 of 1 : richard\_s\_20140314\_464.jpg

| Firewood<br>Inspector Comments: Firewood stock piled on landside slope. | | | | | |

Looking northeast at firewood on landward slope.

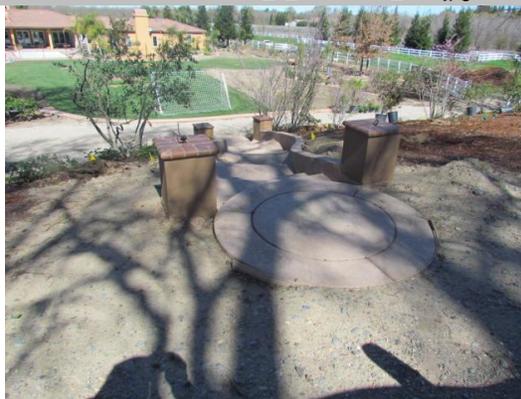
Photo 1 of 2 : richard\_s\_20140314\_465.jpg

| Stairway<br>Inspector Comments: Landowner installed concrete stairs and sprinkler and plantings on landside slope without CVFPB permit. | | | | | |

Looking north at concrete stairs on landward slope.

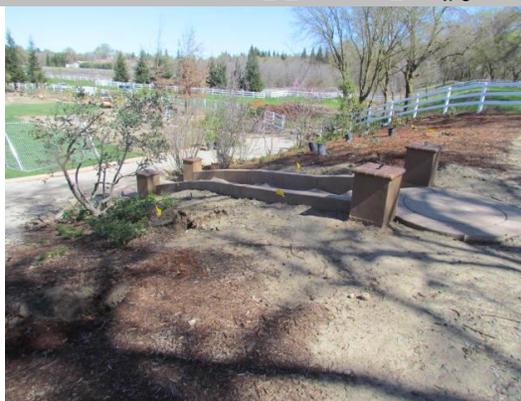
Photo 2 of 2 : richard\_s\_20140314\_466.jpg

Looking east at concrete stairs, sprinklers and plantings on landward slope.
