**Flood Control Project Maintenance  
Levee Inspections**  
**LMA District Cover Sheet**  
**Spring 2014 Levee Inspection Results**

**Reclamation District No. 0999 Netherlands**

**Spring 2014 Levee Inspection Results**

| Waterway | Bank | Unit Miles |
|---|---|---|
| Unit No. 01 Yolo Bypass | Left | 15.43 |

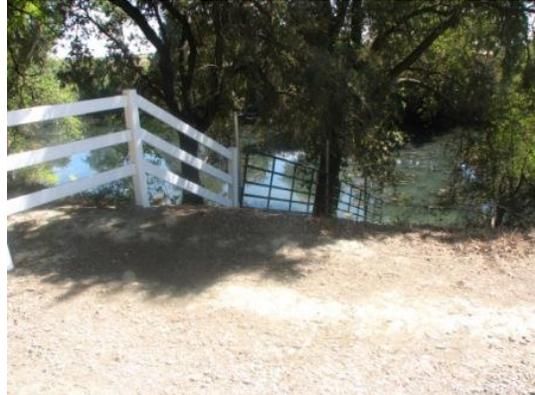
Photo 1 of 2 : richard\_s\_20140310\_379.jpg

New unauthorized fence that extend from landside toe to waterside toe.

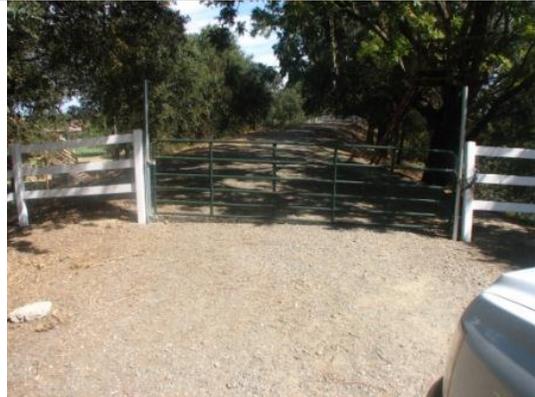
Photo 2 of 2 : richard\_s\_20140310\_380.jpg

View of fence & gate across levee crown, landside & waterside slope.

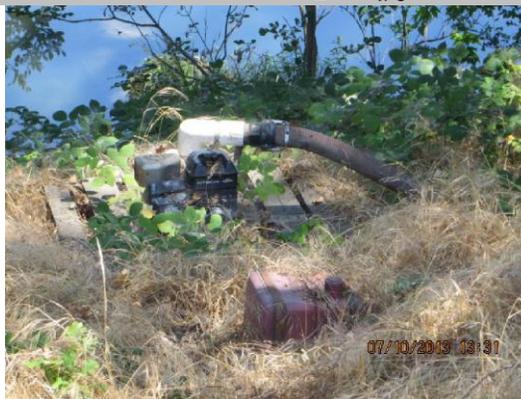
Photo 1 of 1 : UCIP\_1485.jpg

| Inspector Comments: FS_ID:16345<br>EP_NO: N/A<br>Repair Type:<br>Crossing Status:<br>UCIP Comments: Need to determine permit No for crossing or remove it.<br>FIELD_STRUCT_DESC: 3-inch plastic irrigation hose over the levee.<br>Small portable pump on WS toe.<br>FS Date: 7/10/2013 | | | | | |

Portable pump on WS toe.

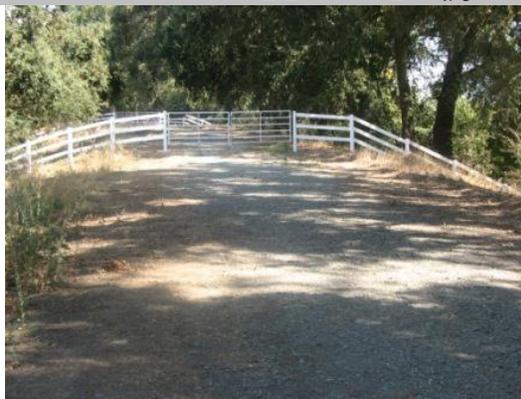
Photo 1 of 1 : richard\_s\_20140310\_381.jpg

New unauthorized fence and gate that extends from landside toe across levee crown to waterside toe.

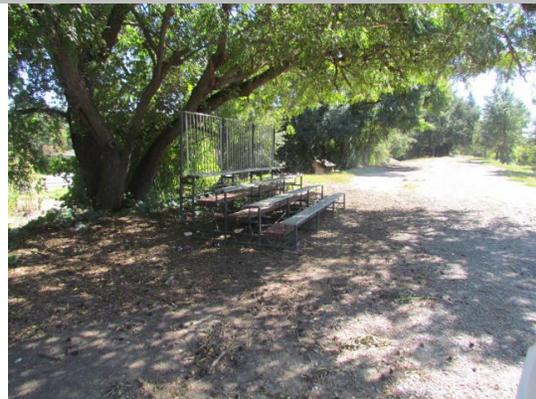
Photo 1 of 1 : richard\_s\_20140310\_405.jpg

| Equipment<br>Inspector Comments: Landowner has placed bleacher on landward shoulder. | | | | | |

Looking northeast at bleacher stored on landward shoulder.
