**Flood Control Project Maintenance
Levee Inspections**
LMA District Cover Sheet
Spring 2015 Levee Inspection Results

Reclamation District No. 0999 Netherlands

Spring 2015 Levee Inspection Results

Waterway	Bank	Unit Miles
Unit No. 01 Yolo Bypass	Left	15.41

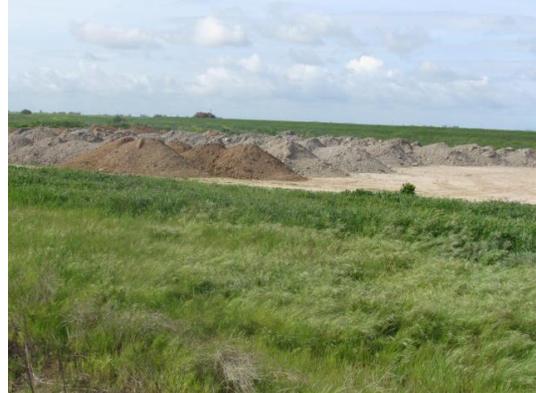
Photo 1 of 5 : SP_2015_RD0999_232_1_20150327_00071.jpg

LM Start	0.12	Rating **	M	Issue No.	1
LM End	0.39	Issue Type +	En	Location *	WS
Category	Earthen Levee		GPS Latitude/Longitude		
			Start	End	
Item	Encroachments		38.503346 °	38.499389 °	
			-121.582116 °	-121.581933 °	
DWR ID	DWR_RD0999_01_s_2012_1				
Action/Comments					
Material Inspector Comments: Landfill has been in place for several years. Landowner is hauling additional material on waterward berm.

Looking west at new material on waterward berm.

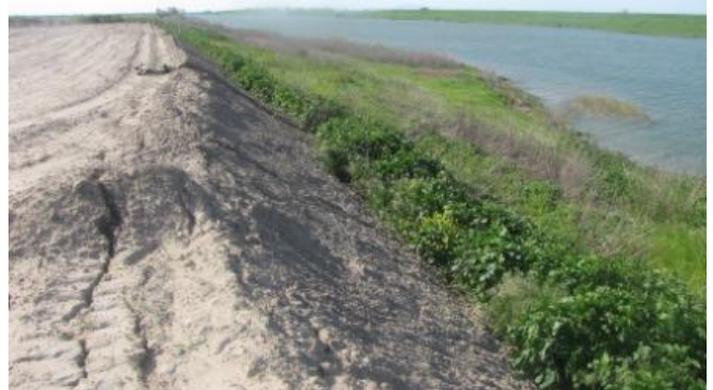
Photo 2 of 5 : SP_2015_RD0999_232_1_20150309_00001.jpg

Looking southwest at fill on waterside berm.

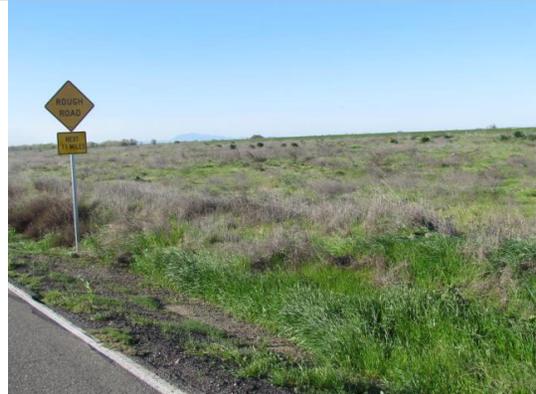
Photo 3 of 5 : SP_2015_RD0999_232_1_20150309_00002.jpg

Looking southwest at fill on waterside berm as of 3/2014

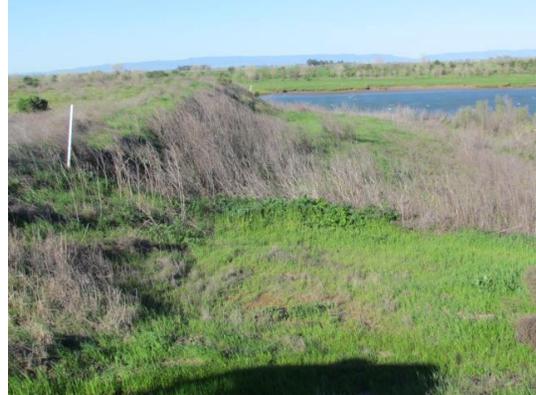
Photo 4 of 5 : SP_2015_RD0999_232_1_20150309_00003.jpg

LM Start	0.12	Rating **	M	Issue No.	1 (cont)
LM End	0.39	Issue Type +	En	Location *	WS
Category	Earthen Levee		GPS Latitude/Longitude		
			Start	End	
Item	Encroachments		38.503346 °	38.499389 °	
			-121.582116 °	-121.581933 °	
DWR ID	DWR_RD0999_01_s_2012_1				
Action/Comments					
Material Inspector Comments: Landfill has been in place for several years. Landowner is hauling additional material on waterward berm.

Looking west at fill on waterside berm as of 3/2014

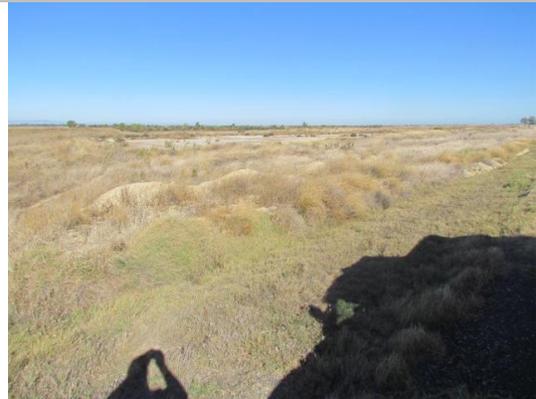
Photo 5 of 5 : SP_2015_RD0999_232_1_20150309_00004.jpg

Looking west at fill on waterward berm. 2013

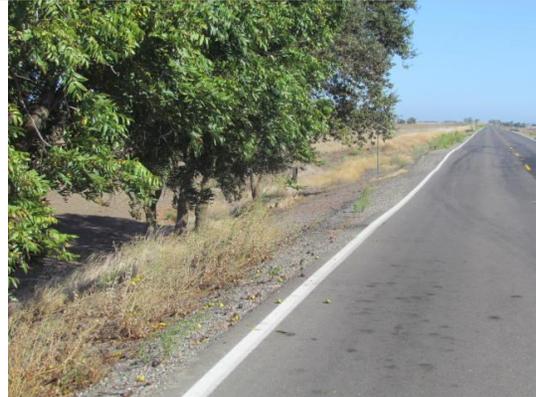
Photo 1 of 2 : SP_2015_RD0999_232_4_20150309_00006.jpg

Looking northwest at trimmed trees on waterward slope.

LM Start	1.73	Rating **	A/W	Issue No.	4
LM End	1.75	Issue Type +	Ma	Location *	WS
Category	Earthen Levee			GPS Latitude/Longitude	
				Start	End
Item	Trim / Thin Trees			38.480082 °	38.479788 °
				-121.580930 °	-121.580918 °
DWR ID	DWR_RD0999_01_s_2012_4				
Action/Comments					
Trim trees to at least five feet above ground level.

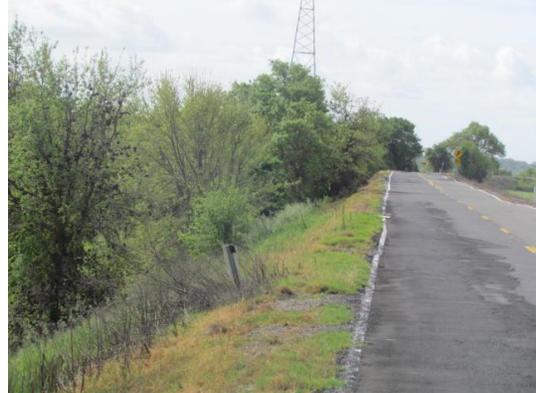
Photo 1 of 5 : SP_2015_RD0999_232_30_20150327_00072.jpg

Looking southeast at untrimmed trees on landward slope. (Spring 2015)

LM Start	1.79	Rating **	M	Issue No.	30
LM End	2.04	Issue Type +	Ma	Location *	LS
Category	Earthen Levee			GPS Latitude/Longitude	
				Start	End
Item	Trim / Thin Trees			38.479165 °	38.475463 °
				-121.580640 °	-121.580722 °
DWR ID	DWR_RD0999_01_s_2012_30				
Action/Comments					
Trim trees to at least five feet above ground level.

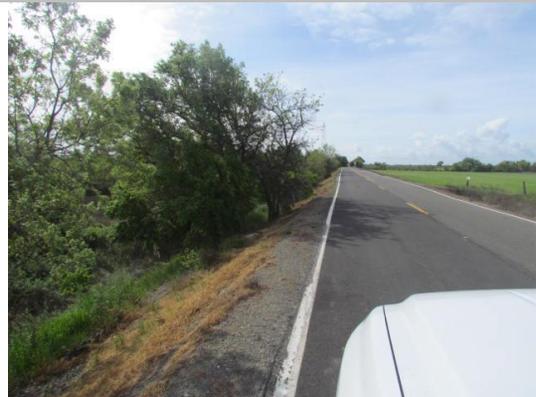
Photo 2 of 5 : SP_2015_RD0999_232_30_20150327_00073.jpg

Looking southeast at dense trees on landwater slope. (Spring 2015)

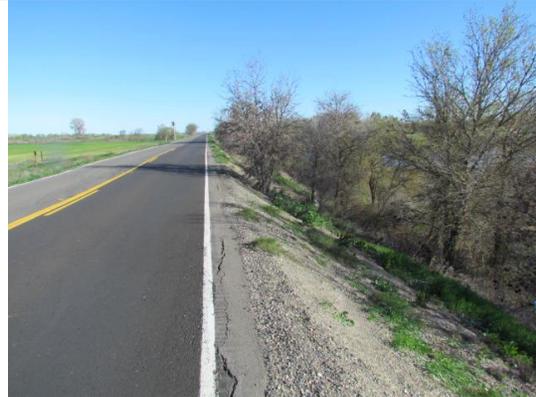
Photo 4 of 5 : SP_2015_RD0999_232_30_20150309_00031.jpg

Looking north at several untrimmed trees on landside slope.

LM Start	1.79	Rating **	M	Issue No.	30 (cont)
LM End	2.04	Issue Type +	Ma	Location *	LS
Category	Earthen Levee			GPS Latitude/Longitude	
				Start	End
Item	Trim / Thin Trees			38.479165 °	38.475463 °
				-121.580640 °	-121.580722 °
DWR ID	DWR_RD0999_01_s_2012_30				
Action/Comments					
Trim trees to at least five feet above ground level.

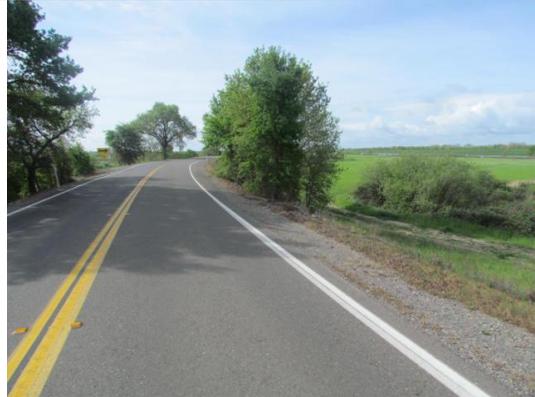
Photo 1 of 3 : SP_2015_RD0999_232_7_20150327_00074.jpg

Looking south at untrimmed trees on waterward slope. (Spring 2015)

LM Start	2.13	Rating **	M	Issue No.	7
LM End	2.13	Issue Type +	Ma	Location *	WS
Category	Earthen Levee		GPS Latitude/Longitude		
			Start	End	
Item	Trim / Thin Trees		38.474258 °	38.474258 °	
			-121.580528 °	-121.580528 °	
DWR ID	DWR_RD0999_01_s_2012_7				
Action/Comments					
Trim trees to at least five feet above ground level.

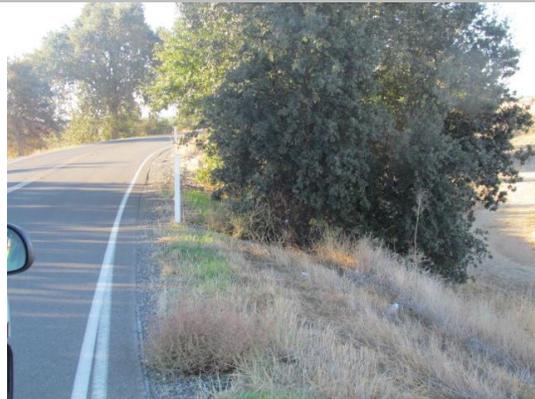
Photo 2 of 3 : SP_2015_RD0999_232_7_20150309_00013.jpg

Looking south at untrimmed trees on waterward slope. (Fall 2014)

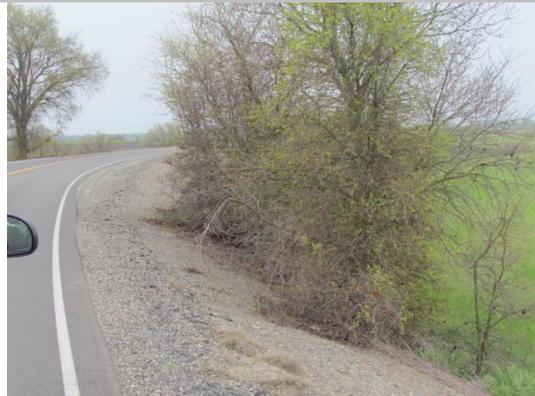
Photo 3 of 3 : SP_2015_RD0999_232_7_20150309_00014.jpg

Looking southwest at untrimmed trees on waterside slope.

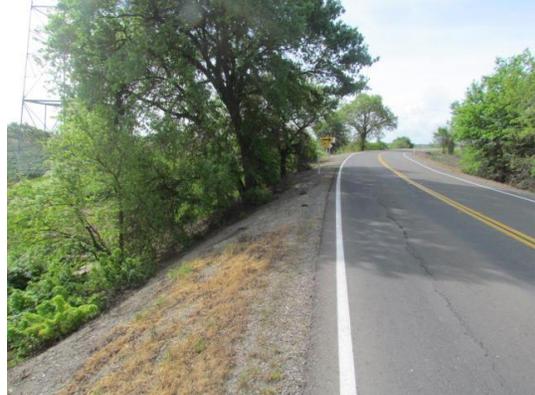
Photo 1 of 3 : SP_2015_RD0999_232_31_20150327_00075.jpg

Looking southeast at untrimmed trees on landward slope. (Spring 2015)

LM Start	2.13	Rating **	M	Issue No.	31
LM End	2.13	Issue Type +	Ma	Location *	LS
Category	Earthen Levee			GPS Latitude/Longitude	
				Start	End
Item	Trim / Thin Trees			38.474200 °	38.474200 °
				-121.580480 °	-121.580480 °
DWR ID	DWR_RD0999_01_s_2012_31				
Action/Comments					
Trim trees to at least five feet above ground level.

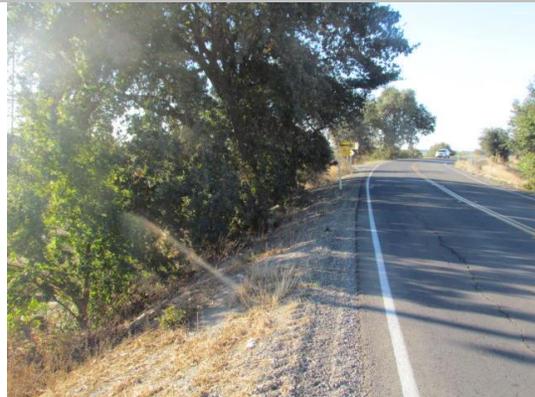
Photo 2 of 3 : SP_2015_RD0999_232_31_20150309_00033.jpg

Looking southeast at untrimmed trees on landward slope. (Fall 2014)

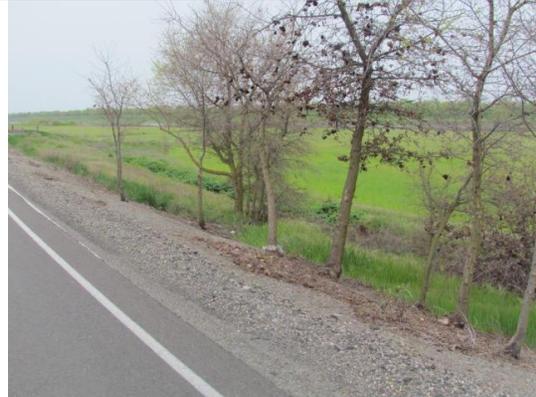
Photo 1 of 1 : SP_2015_RD0999_232_8_20150309_00015.jpg

Looking southwest at trimmed trees on waterside slope. (Spring 2012)

LM Start	2.18	Rating **	A/W	Issue No.	8
LM End	2.19	Issue Type +	Ma	Location *	WS
Category	Earthen Levee		GPS Latitude/Longitude		
			Start	End	
Item	Trim / Thin Trees		38.473542 °	38.473417 °	
			-121.580793 °	-121.580885 °	
DWR ID	DWR_RD0999_01_s_2012_8				
Action/Comments					
Thin trees to allow visibility of the ground and room to flood fight.

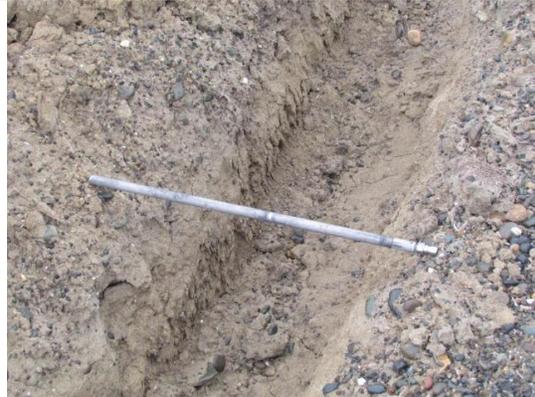
Photo 2 of 3 : SP_2015_RD0999_232_40_20150309_00040.jpg

LM Start	2.51	Rating **	M	Issue No.	40 (cont)
LM End	2.51	Issue Type +	En	Location *	LS
Category	Earthen Levee		GPS Latitude/Longitude		
			Start	End	
Item	Encroachments		38.469048 °	38.469048 °	
			-121.583075 °	-121.583075 °	
DWR ID	DWR_RD0999_01_s_2012_40				
Action/Comments					
Material					
Inspector Comments: Excavation activity on landside shoulder. Hole is approximately 15ft x 12" x 15". Hole appears to be excavated by a backhoe.

Looking south at close-up view of excavation on landside shoulder.

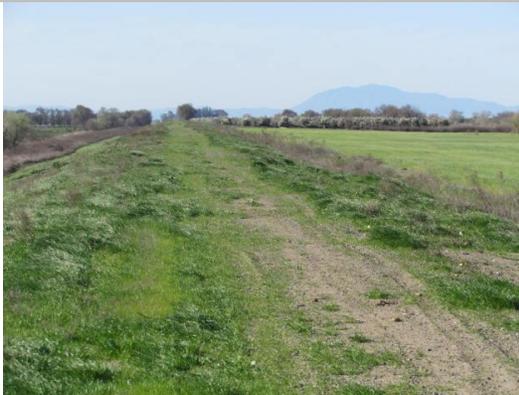
Photo 2 of 3 : SP_2015_RD0999_232_46_20150309_00047.jpg

Looking south at growth and ruts on levee crown.

LM Start	2.76	Rating **	A/W	Issue No.	46 (cont)
LM End	4.98	Issue Type +	Ma	Location *	CR
Category	Earthen Levee			GPS Latitude/Longitude	
				Start	End
Item	Crown Surface / Depressions / Rutting			38.465627 °	38.435378 °
				-121.584634 °	-121.598664 °
DWR ID	DWR_RD0999_01_f_2013_46				
Action/Comments					
Repair depressions or ruts in the crown or slope. Inspector Comments: Control growth on levee crown and repair ruts on levee crown.

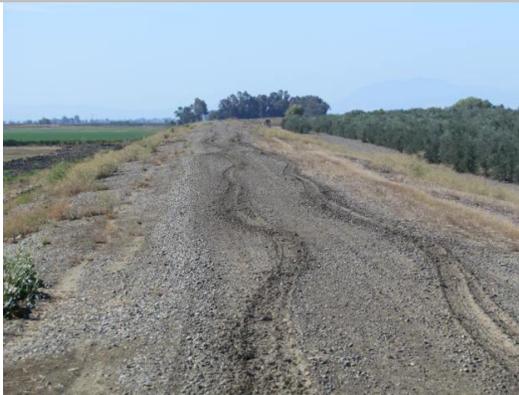
Photo 3 of 3 : SP_2015_RD0999_232_46_20150309_00048.jpg

Looking south at rutting on levee crown.

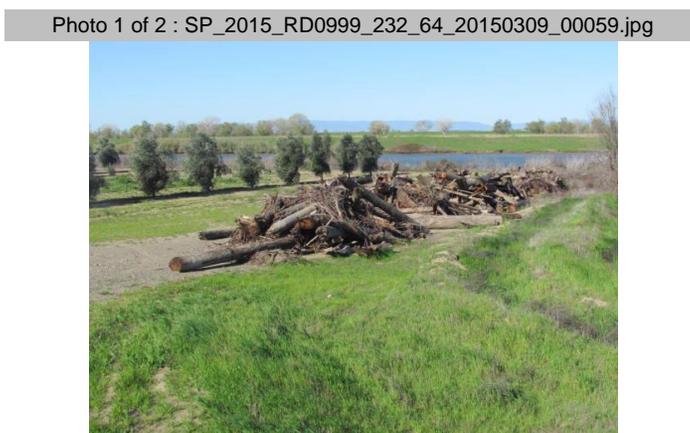
LM Start	3.30	Rating **	M	Issue No.	64
LM End	3.30	Issue Type +	En	Location *	WS
Category	Earthen Levee			GPS Latitude/Longitude	
				Start	End
Item	Encroachments			38.458346 °	38.458346 °
				-121.588008 °	-121.588008 °
DWR ID	DWR_RD0999_01_s_2014_64				
Action/Comments					
Tree or limb Inspector Comments: Discarded tree branches, limbs and power poles stockpile on waterward berm.

Looking southwest at pruning on waterward berm.

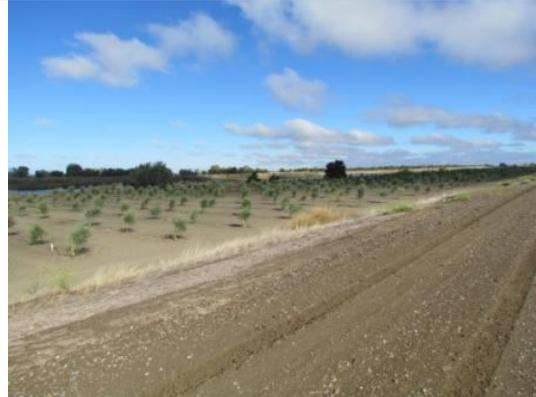
Photo 1 of 3 : SP_2015_RD0999_232_5_20150309_00008.jpg

LM Start	3.31	Rating **	M	Issue No.	5
LM End	5.29	Issue Type +	En	Location *	WS
Category	Earthen Levee		GPS Latitude/Longitude		
			Start	End	
Item	Encroachments		38.458197 °	38.431240 °	
			-121.588062 °	-121.600587 °	
DWR ID	DWR_RD0999_01_s_2012_5				
Action/Comments					
Crops Inspector Comments: Landowner has planted an olive grove on waterside berm several years ago without a board permit.

Looking northwest at olive grove on waterside berm at upstream end.

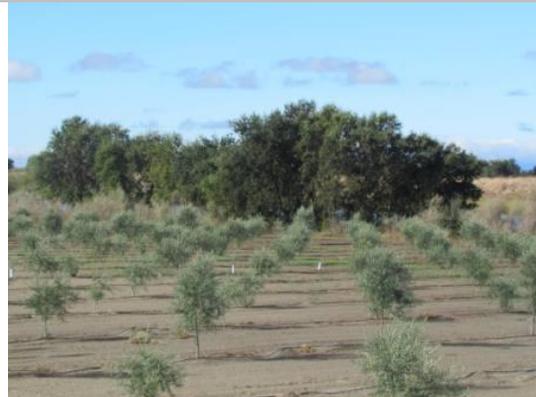
Photo 2 of 3 : SP_2015_RD0999_232_5_20150309_00009.jpg

Looking southwest at olive grove on waterside berm at downstream end.

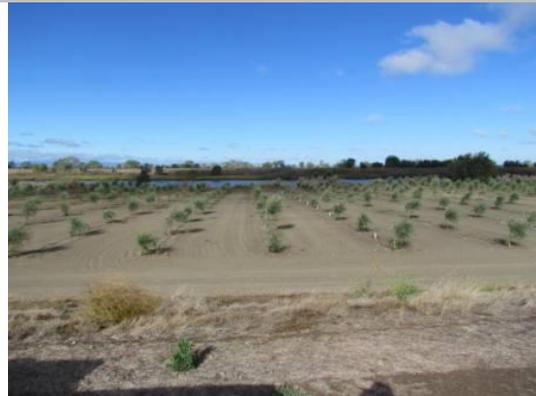
Photo 3 of 3 : SP_2015_RD0999_232_5_20150309_00010.jpg

Looking west at olive grove on waterside berm.

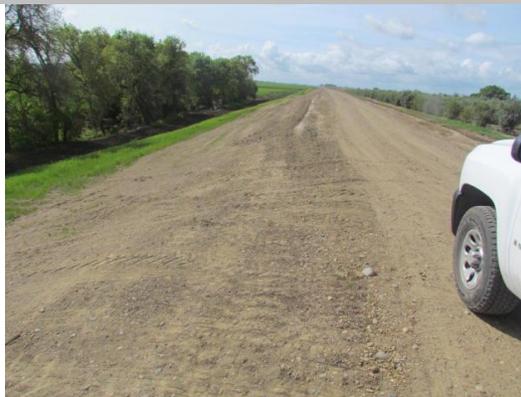
Photo 2 of 4 : SP_2015_RD0999_232_35_20150327_00077.jpg

LM Start	4.31	Rating **	M	Issue No.	35 (cont)
LM End	4.31	Issue Type +	Ma	Location *	LS
Category	Earthen Levee			GPS Latitude/Longitude	
				Start	End
Item	Slope Stability			38.444561 °	38.444561 °
				-121.594438 °	-121.594438 °
DWR ID	DWR_RD0999_01_f_2012_35				
Action/Comments					
Repair the levee slope damaged by vehicle traffic and prevent access where possible. Inspector Comments: Depression is caused by vehicle traffic.

Looking south at slope damage cause by vehicle traffic on landward slope. (Spring 2015)

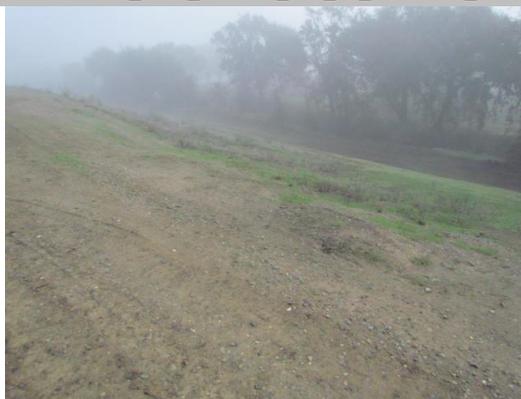
Photo 4 of 4 : SP_2015_RD0999_232_35_20150309_00036.jpg

Looking east at slope damage on landside slope.

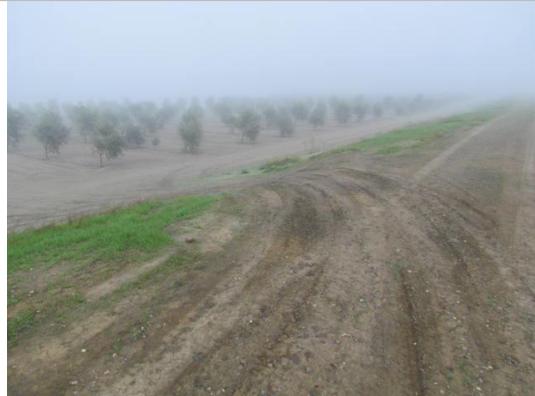
Photo 2 of 3 : SP_2015_RD0999_232_27_20150309_00027.jpg

LM Start	4.31	Rating **	M	Issue No.	27
LM End	4.31	Issue Type +	Ma	Location *	WS
Category	Earthen Levee			GPS Latitude/Longitude	
				Start	End
Item	Slope Stability			38.444560 °	38.444560 °
				-121.594440 °	-121.594440 °
DWR ID	DWR_RD0999_01_f_2012_27				
Action/Comments					
Repair the levee slope damaged by vehicle traffic and prevent access where possible. Inspector Comments: Local farmer causing slope damage by driving equipment and trucks on slope.

Looking northwest at slope damage caused by vehicle traffic. (Fall 2014)

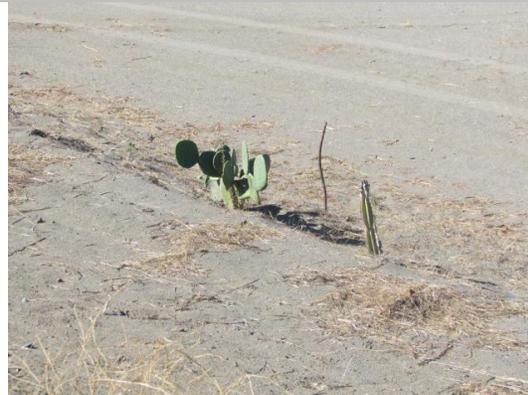
Photo 1 of 1 : SP_2015_RD0999_232_45_20150309_00045.jpg

Looking west at cactus on waterward toe.

LM Start	4.36	Rating **	A/W	Issue No.	45
LM End	4.36	Issue Type +	Ma	Location *	WS
Category	Earthen Levee		GPS Latitude/Longitude		
			Start	End	
Item	Vegetation		°	°	
			°	°	
DWR ID	DWR_RD0999_01_f_2013_45				
Action/Comments					
Remove the wild growth other than native grasses from the levee slopes. Inspector Comments: Landowner has planted cactus on waterward toe.

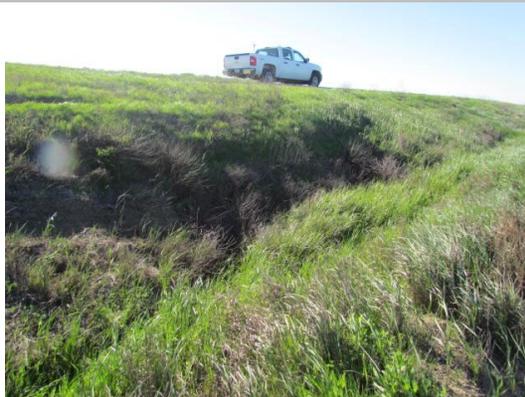
Photo 1 of 2 : SP_2015_RD0999_232_65_20150309_00061.jpg

LM Start	4.84	Rating **	M	Issue No.	65
LM End	4.84	Issue Type +	Ma	Location *	WS
Category	Earthen Levee			GPS Latitude/Longitude	
				Start	End
Item	Slope Stability			38.437388 °	38.437388 °
				-121.597741 °	-121.597741 °
DWR ID	DWR_RD0999_01_s_2014_65				
Action/Comments					
Repair slope instability. Inspector Comments: Slope depression on waterward near toe of levee. Depression is approx. 18' x 14' x 4' in area.

Looking southeast at depression on waterward toe.

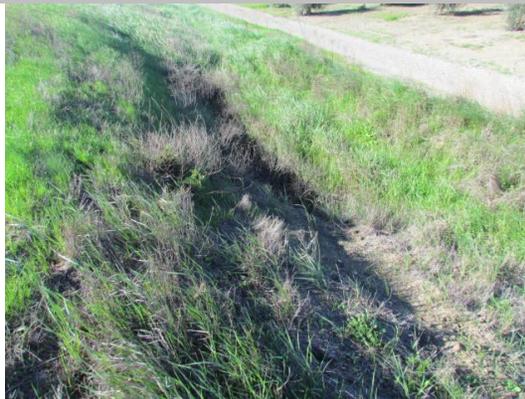
Photo 2 of 2 : SP_2015_RD0999_232_65_20150309_00062.jpg

Looking southwest at depression on waterward toe.

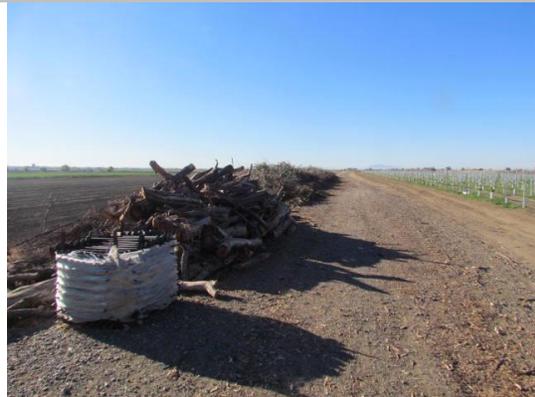
Photo 1 of 2 : SP_2015_RD0999_232_18_20150309_00016.jpg

LM Start	6.53	Rating **	A/W	Issue No.	18
LM End	6.58	Issue Type +	Ma	Location *	LS
Category	Earthen Levee			GPS Latitude/Longitude	
				Start	End
Item	Encroachments			38.414367 °	38.413698 °
				-121.608430 °	-121.608762 °
DWR ID	DWR_RD0999_01_s_2012_18				
Action/Comments					
Prunings Inspector Comments: Large pruning piles on landward shoulder. Part of pruning pile blocking levee crown.

Looking south at pruning piles on landward shoulder. (Fall 2014)

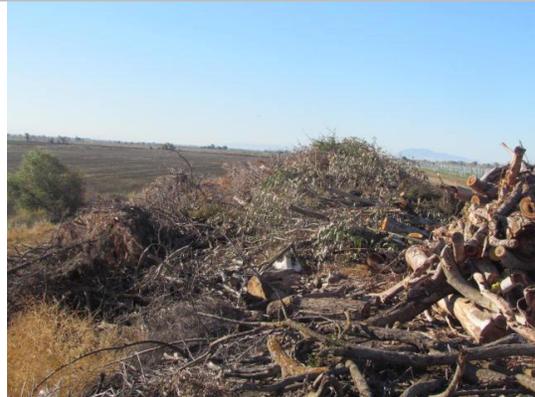
Photo 2 of 2 : SP_2015_RD0999_232_18_20150309_00017.jpg

Looking northwest at large pruning piles on landward shoulder and slope. (Fall 2014)

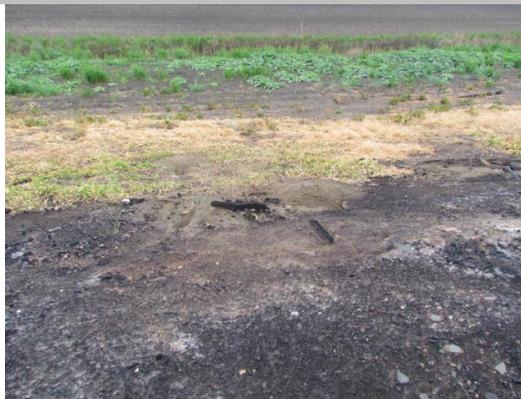
Photo 1 of 2 : SP_2015_RD0999_232_42_20150309_00042.jpg

LM Start	6.56	Rating **	A/W	Issue No.	42
LM End	6.56	Issue Type +	Ma	Location *	LS
Category	Earthen Levee			GPS Latitude/Longitude	
				Start	End
Item	Animal Control			38.413858 °	38.413858 °
				-121.608638 °	-121.608638 °
DWR ID	DWR_RD0999_01_s_2012_42				
Action/Comments					
Exterminate rodents and backfill and compact or grout burrows. Inspector Comments: More than five holes within 25' of levee.

Looking east at rodent holes on landside slope.

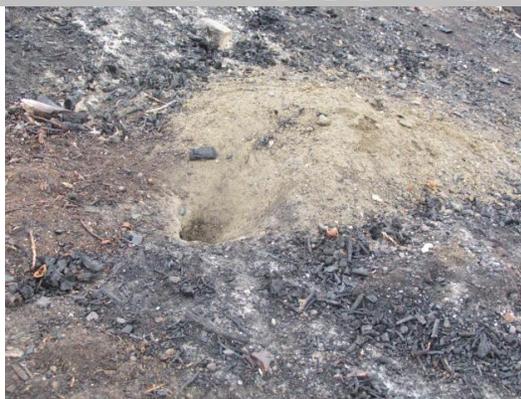
Photo 2 of 2 : SP_2015_RD0999_232_42_20150309_00043.jpg

Looking at typical rodent hole on landside slope.

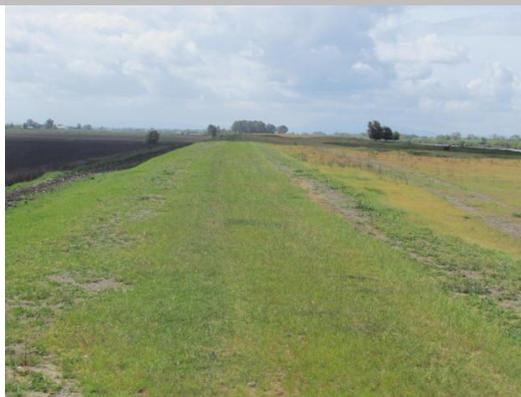
Photo 1 of 1 : SP_2015_RD0999_232_22_20150327_00079.jpg

Looking south at levee crown. (Spring 2015)

LM Start	8.11	Rating **	M	Issue No.	22
LM End	8.88	Issue Type +	Ma	Location *	CR
Category	Earthen Levee			GPS Latitude/Longitude	
				Start	End
Item	Crown Surface / Depressions / Rutting			38.392797 °	38.382338 °
				-121.618363 °	-121.623343 °
DWR ID	DWR_RD0999_01_s_2012_22				
Action/Comments					
Add appropriate gravel or road base. Grade and compact.

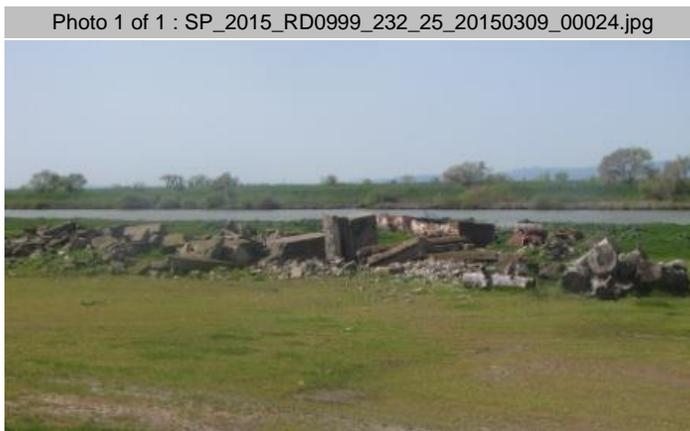
LM Start	8.15	Rating **	M	Issue No.	25
LM End	8.15	Issue Type +	Ma	Location *	WS
Category	Earthen Levee		GPS Latitude/Longitude		
			Start	End	
Item	Encroachments		38.392255 °	38.392255 °	
			-121.618709 °	-121.618709 °	
DWR ID	DWR_RD0999_01_s_2012_25				
Action/Comments					
Material Inspector Comments: Concrete rubble on waterside berm.

Looking west at concrete rubble on waterside berm.

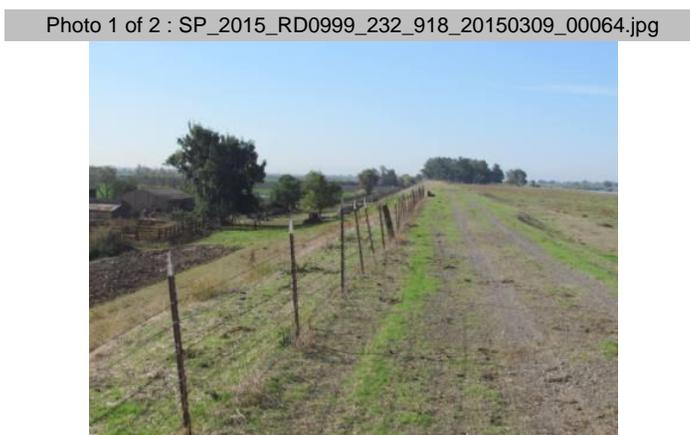
LM Start	9.19	Rating **	M	Issue No.	918
LM End	9.25	Issue Type +	En	Location *	LS
Category	Earthen Levee		GPS Latitude/Longitude		
			Start	End	
Item	Encroachments		38.378161 °	38.377261 °	
			-121.625181 °	-121.625619 °	
DWR ID	DWR_RD0999_01_s_2012_918				
Action/Comments					
Fence Inspector Comments: Fence along landward shoulder.

Looking south at fence along landside shoulder.

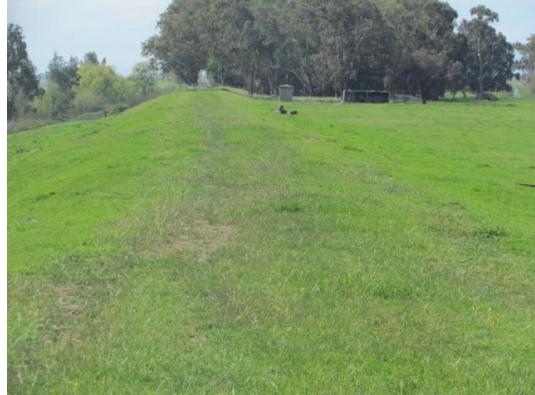
Photo 1 of 2 : SP_2015_RD0999_232_919_20150327_00080.jpg

Looking south at levee crown. Spring 2015

LM Start	9.30	Rating **	M	Issue No.	919
LM End	9.73	Issue Type +	Ma	Location *	CR
Category	Earthen Levee			GPS Latitude/Longitude	
				Start	End
Item	Crown Surface / Depressions / Rutting			38.376669 °	38.370762 °
				-121.625896 °	-121.628640 °
DWR ID	DWR_RD0999_01_s_2012_919				
Action/Comments					
Add appropriate material and re-grade the levee to bring the crown above the design elevation.

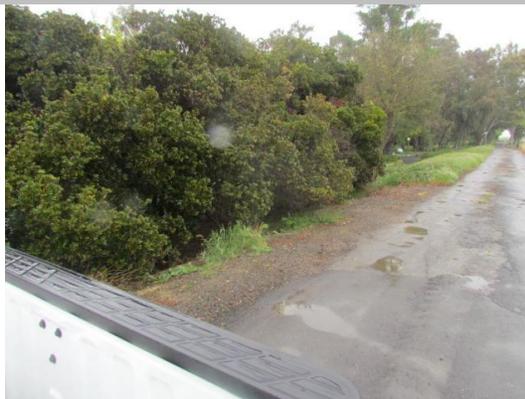
Photo 1 of 1 : SP_2015_RD0999_232_26_20150309_00025.jpg

LM Start	9.87	Rating **	M	Issue No.	26
LM End	9.87	Issue Type +	En	Location *	WS
Category	Earthen Levee			GPS Latitude/Longitude	
				Start	End
Item	Vegetation			38.368898 °	38.368898 °
				-121.629470 °	-121.629470 °
DWR ID	DWR_RD0999_01_s_2012_26				
Action/Comments					
Landscaping Inspector Comments: Trees should be trimmed for visibility.

Looking northwest at dense trees on waterside slope.

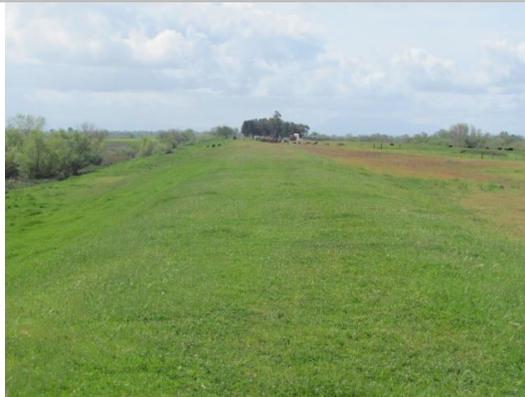
Photo 1 of 2 : SP_2015_RD0999_232_920_20150327_00081.jpg

Looking south at levee crown. (Spring 2015)

LM Start	9.94	Rating **	M	Issue No.	920
LM End	10.21	Issue Type +	Ma	Location *	CR
Category	Earthen Levee			GPS Latitude/Longitude	
				Start	End
Item	Crown Surface / Depressions / Rutting			38.367831 °	38.364238 °
				-121.629990 °	-121.631674 °
DWR ID	DWR_RD0999_01_s_2012_920				
Action/Comments					
Add appropriate material and re-grade the levee to bring the crown above the design elevation.

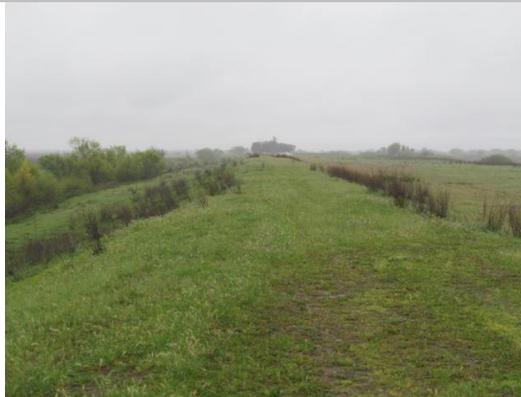
Photo 2 of 2 : SP_2015_RD0999_232_920_20150309_00067.jpg

Looking south at crown roadway. (Spring 2014)

LM Start	9.94	Rating **	M	Issue No.	920 (cont)
LM End	10.21	Issue Type +	Ma	Location *	CR
Category	Earthen Levee			GPS Latitude/Longitude	
				Start	End
Item	Crown Surface / Depressions / Rutting			38.367831 °	38.364238 °
				-121.629990 °	-121.631674 °
DWR ID	DWR_RD0999_01_s_2012_920				
Action/Comments					
Add appropriate material and re-grade the levee to bring the crown above the design elevation.

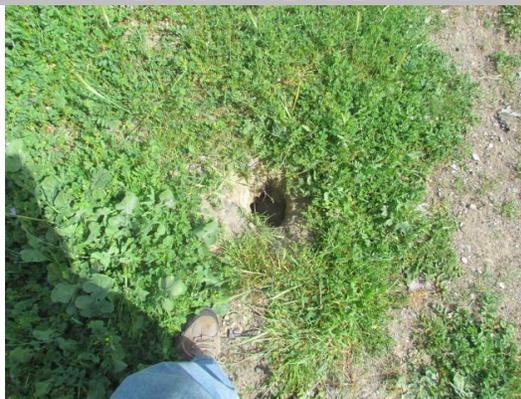
Photo 1 of 2 : SP_2015_RD0999_232_2_20150327_00082.jpg

LM Start	9.95	Rating **	M	Issue No.	2
LM End	9.95	Issue Type +	Ma	Location *	LS
Category	Earthen Levee			GPS Latitude/Longitude	
				Start	End
Item	Animal Control			38.367750 °	38.367750 °
				-121.630025 °	-121.630025 °
DWR ID	DWR_RD0999_01_s_2012_2				
Action/Comments					
Exterminate rodents and backfill and compact or grout burrows. Inspector Comments: Several large rodent holes on landward shoulder.

Looking at typical rodent holes on landward shoulder. (Spring 2015)

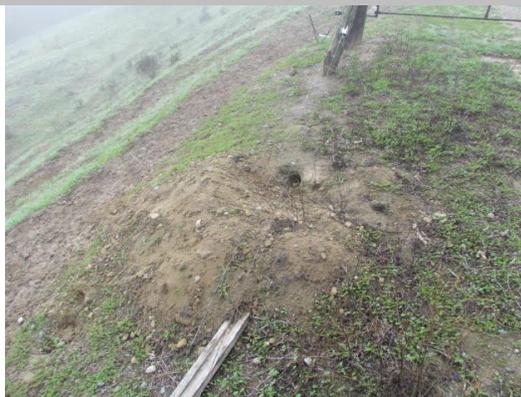
Photo 2 of 2 : SP_2015_RD0999_232_2_20150309_00005.jpg

Looking south at rodent hole on landside shoulder. (Fall 2014)

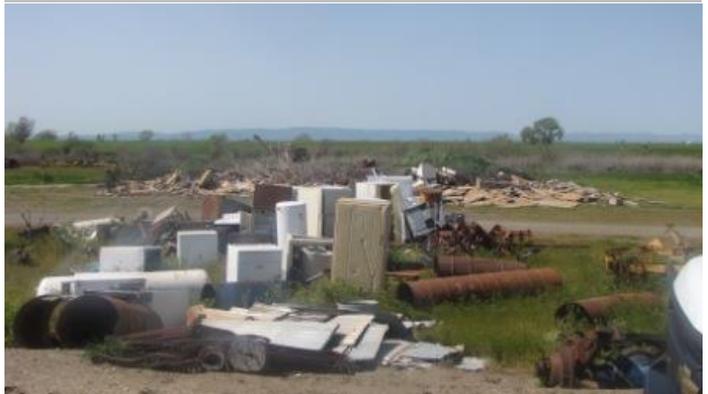
Photo 1 of 1 : SP_2015_RD0999_232_28_20150309_00028.jpg

LM Start	10.57	Rating **	A/W	Issue No.	28
LM End	10.57	Issue Type +	En	Location *	WS
Category	Earthen Levee			GPS Latitude/Longitude	
				Start	End
Item	Encroachments			38.359305 °	38.359305 °
				-121.633949 °	-121.633949 °
DWR ID	DWR_RD0999_01_s_2012_28				
Action/Comments					
Garbage Inspector Comments: Large garbage and pruning piles on waterward berm.

Looking southwest at garbage on waterside toe and berm.

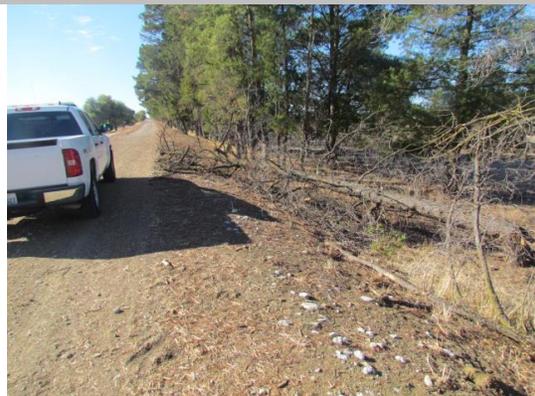
Photo 1 of 1 : SP_2015_RD0999_232_61_20150309_00058.jpg

LM Start	10.75	Rating **	M	Issue No.	61
LM End	10.75	Issue Type +	Ma	Location *	WS
Category	Earthen Levee			GPS Latitude/Longitude	
				Start	End
Item	Encroachments			38.356844 °	38.356844 °
				-121.635101 °	-121.635101 °
DWR ID	DWR_RD0999_01_f_2014_61				
Action/Comments					
Tree or limb Inspector Comments: Downed tree on waterward slope.

Looking southwest at downed tree on waterward slope.

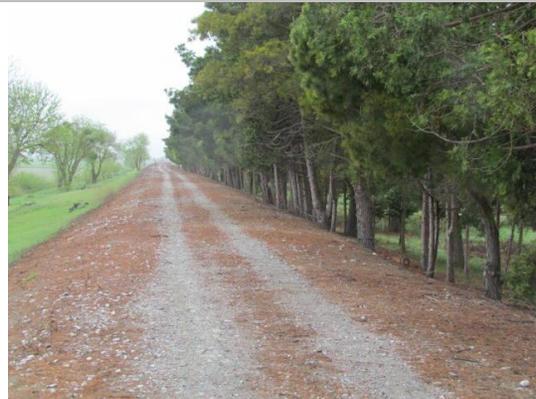
Photo 1 of 2 : SP_2015_RD0999_232_23_20150309_00022.jpg

Looking south at trimmed pine trees on waterside shoulder and slope. (Spring 2012)

LM Start	10.81	Rating **	A/W	Issue No.	23
LM End	11.06	Issue Type +	Ma	Location *	WS
Category	Earthen Levee			GPS Latitude/Longitude	
				Start	End
Item	Trim / Thin Trees			38.356077 °	38.352640 °
				-121.635598 °	-121.637078 °
DWR ID	DWR_RD0999_01_s_2012_23				
Action/Comments					
Trim trees to at least five feet above ground level.

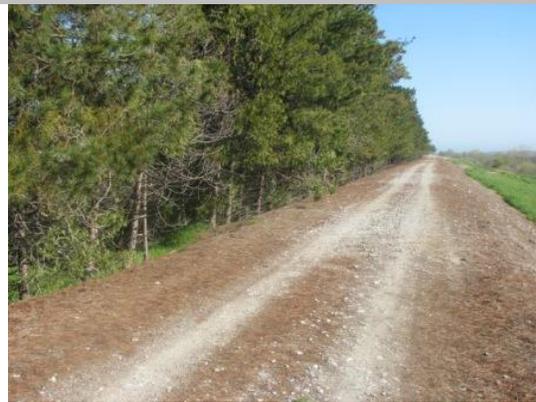
Photo 2 of 2 : SP_2015_RD0999_232_23_20150309_00023.jpg

Pine trees along waterside shoulder & slope. (Site of a old christmas tree farm). (Spring 2011)

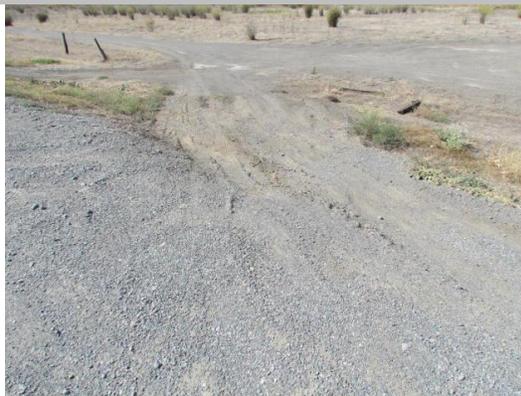
Photo 1 of 2 : SP_2015_RD0999_232_48_20150309_00050.jpg

LM Start	11.84	Rating **	M	Issue No.	48
LM End	11.84	Issue Type +	Ma	Location *	WS
Category	Earthen Levee			GPS Latitude/Longitude	
				Start	End
Item	Slope Stability			38.342068 °	38.342068 °
				-121.641944 °	-121.641944 °
DWR ID	DWR_RD0999_01_f_2012_48				
Action/Comments					
Repair the levee slope damaged by vehicle traffic and prevent access where possible. Inspector Comments: Slope damage caused by vehicle traffic.

Looking southwest at slope damage caused by vehicle traffic. 2013

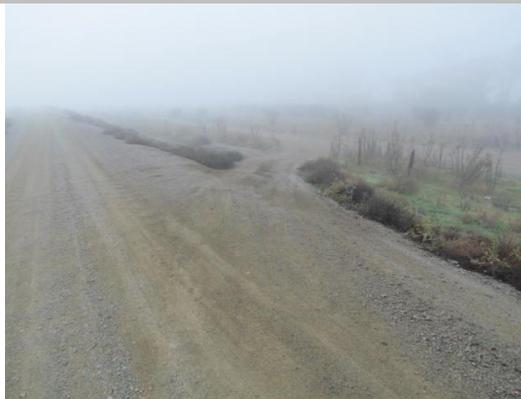
Photo 2 of 2 : SP_2015_RD0999_232_48_20150309_00051.jpg

Looking southwest at slope damage caused by vehicle traffic on waterside slope.

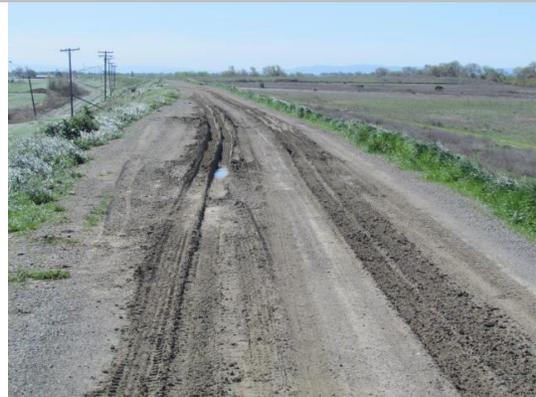
Photo 2 of 4 : SP_2015_RD0999_232_21_20150309_00019.jpg

Looking south at rutting on levee crown.

LM Start	12.53	Rating **	A/W	Issue No.	21
LM End	12.60	Issue Type +	Ma	Location *	CR
Category	Earthen Levee			GPS Latitude/Longitude	
				Start	End
Item	Crown Surface / Depressions / Rutting			38.332288 °	38.331247 °
				-121.644640 °	-121.644765 °
DWR ID	DWR_RD0999_01_s_2012_21				
Action/Comments					
Repair depressions or ruts in the crown or slope.

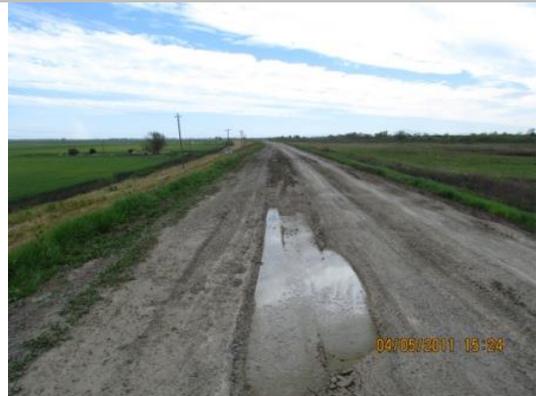
Photo 3 of 4 : SP_2015_RD0999_232_21_20150309_00020.jpg

Looking south at rutting on levee crown.

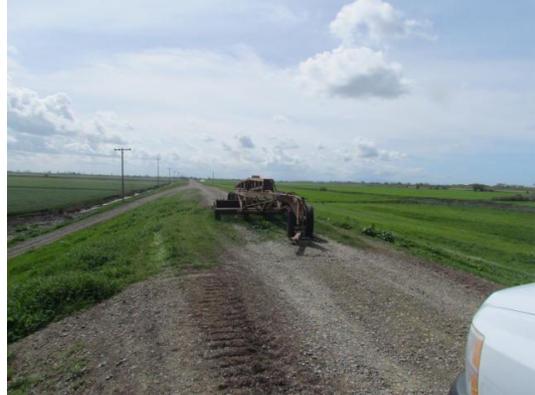
Photo 1 of 1 : SP_2015_RD0999_232_63_20150327_00084.jpg

LM Start	13.79	Rating **	M	Issue No.	63
LM End	13.79	Issue Type +	En	Location *	CR
Category	Earthen Levee		GPS Latitude/Longitude		
			Start	End	
Item	Encroachments		38.314006 °	38.314006 °	
			-121.644961 °	-121.644961 °	
DWR ID	DWR_RD0999_01_s_2015_63				
Action/Comments					
Equipment Inspector Comments: Landowner or farmer stored a land plane leveler in the middle of levee crown. The equipment is blocking access.

Looking south at farm equipment (land plane leveler) left on levee crown. (Spring 2015)

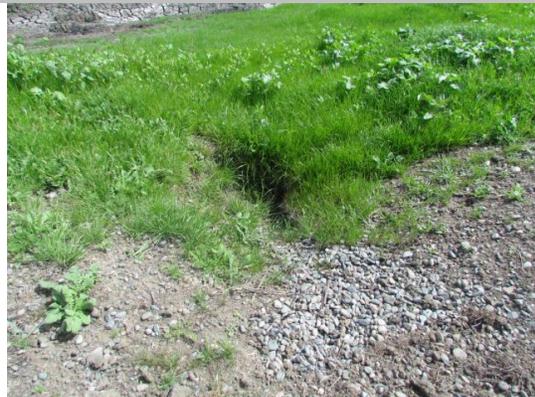
Photo 1 of 3 : SP_2015_RD0999_232_49_20150327_00085.jpg

LM Start	14.04	Rating **	M	Issue No.	49
LM End	14.04	Issue Type +	Ma	Location *	LS
Category	Earthen Levee		GPS Latitude/Longitude		
			Start	End	
Item	Erosion / Bank Caving		38.310347 °	38.310347 °	
			-121.644955 °	-121.644955 °	
DWR ID	DWR_RD0999_01_f_2012_49				
Action/Comments					
Note and monitor erosion site. Inspector Comments: Caving, 4' x 10', on landside slope.

Looking east at caving on landward shoulder and slope. (Spring 2015)

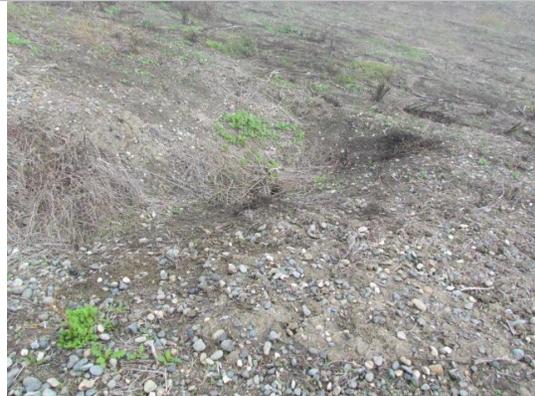
Photo 2 of 3 : SP_2015_RD0999_232_49_20150309_00052.jpg

Looking southeast at caving on landside slope.

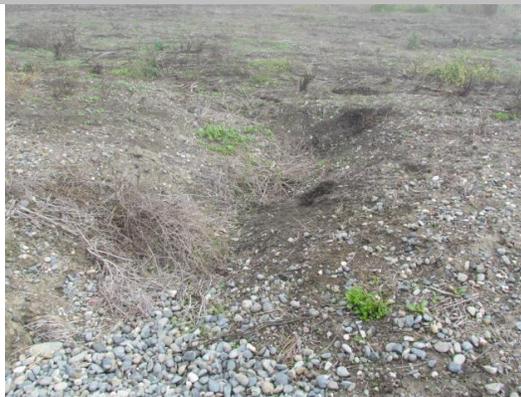
Photo 3 of 3 : SP_2015_RD0999_232_49_20150309_00053.jpg

LM Start	14.04	Rating **	M	Issue No.	49 (cont)
LM End	14.04	Issue Type +	Ma	Location *	LS
Category	Earthen Levee			GPS Latitude/Longitude	
				Start	End
Item	Erosion / Bank Caving			38.310347 °	38.310347 °
				-121.644955 °	-121.644955 °
DWR ID	DWR_RD0999_01_f_2012_49				
Action/Comments					
Note and monitor erosion site. Inspector Comments: Caving, 4' x 10', on landside slope.

Looking east caving on landside slope.

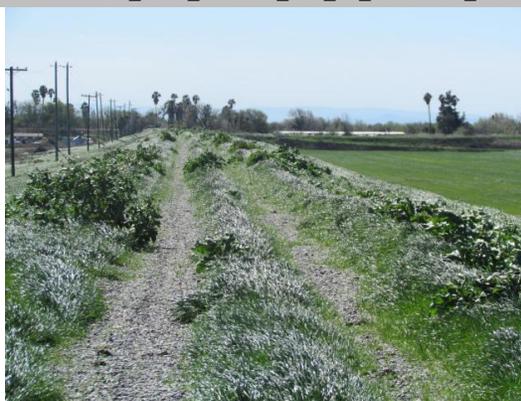
Photo 1 of 1 : SP_2015_RD0999_232_44_20150309_00044.jpg

LM Start	14.33	Rating **	A/W	Issue No.	44
LM End	15.17	Issue Type +	Ma	Location *	CR
Category	Earthen Levee			GPS Latitude/Longitude	
				Start	End
Item	Crown Surface / Depressions / Rutting			38.306113 °	38.293917 °
				-121.644942 °	-121.644958 °
DWR ID	DWR_RD0999_01_s_2012_44				
Action/Comments					
Add appropriate material and re-grade the levee to bring the crown above the design elevation. Inspector Comments: Control growth on levee crown.

Looking south at growth on levee crown.

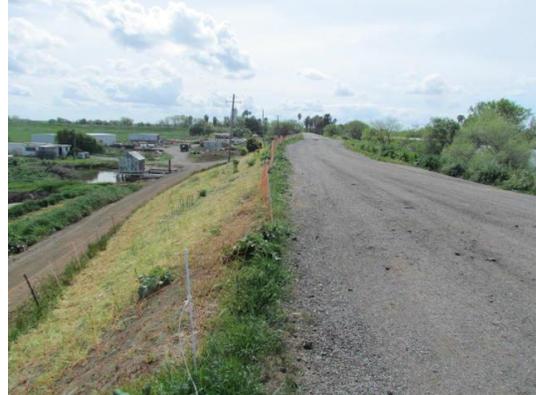
Photo 1 of 3 : SP_2015_RD0999_232_39_20150327_00086.jpg

LM Start	15.20	Rating **	M	Issue No.	39
LM End	15.41	Issue Type +	En	Location *	LS
Category	Earthen Levee		GPS Latitude/Longitude		
			Start	End	
Item	Encroachments		38.293584 °	38.290525 °	
			-121.644979 °	-121.644902 °	
DWR ID	DWR_RD0999_01_s_2012_39				
Action/Comments					
Fence Inspector Comments: Landowner has installed fence along landside slope for sheep to maintain levee slope. Landowner should apply for permit for fence. Landowner added additional fencing on landward shoulder and slope.

Looking east at new fencing on landward shoulder and slope. (Spring 2015)

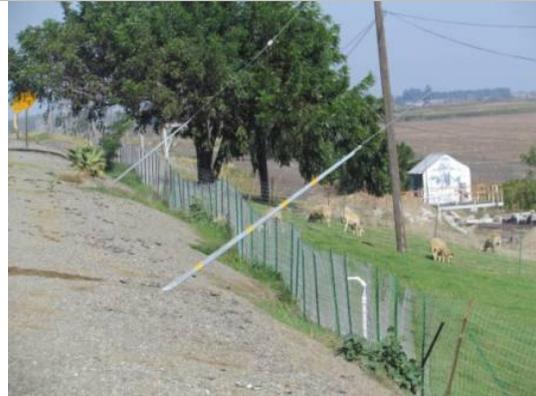
Photo 2 of 3 : SP_2015_RD0999_232_39_20150309_00037.jpg

Looking north at fence along landside slope.

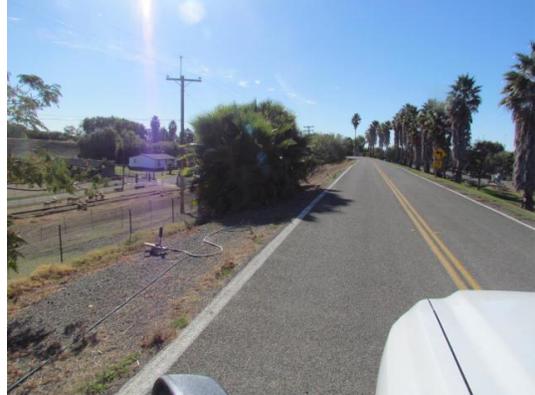
Photo 2 of 3 : SP_2015_RD0999_232_50_20150309_00054.jpg

LM Start	15.33	Rating **	M	Issue No.	50 (cont)
LM End	15.33	Issue Type +	Ma	Location *	LS
Category	Earthen Levee			GPS Latitude/Longitude	
				Start	End
Item	Encroachments			38.291663 °	38.291663 °
				-121.644962 °	-121.644962 °
DWR ID	DWR_RD0999_01_f_2012_50				
Action/Comments					
Tree or limb Inspector Comments: Newly planted palm trees on landside shoulder.

Looking east at a maturing plam trees on landward shoulder and slope. (Fall 2014)

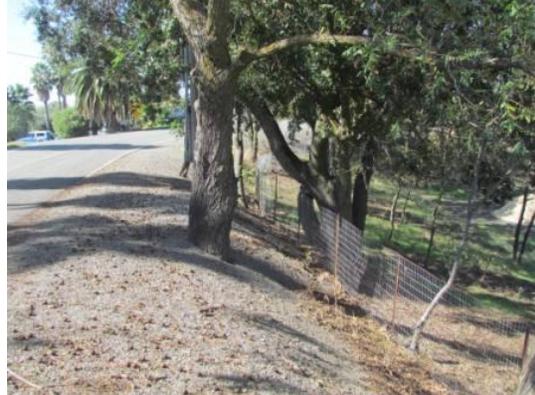
Photo 1 of 2 : SP_2015_RD0999_233_17_20150309_00016.jpg

LM Start	0.01	Rating **	M	Issue No.	17
LM End	0.06	Issue Type +	En	Location *	LS
Category	Earthen Levee		GPS Latitude/Longitude		
			Start	End	
Item	Encroachments		38.290355 °	38.290472 °	
			-121.644713 °	-121.643888 °	
DWR ID	DWR_RD0999_02_s_2012_17				
Action/Comments					
Fence Inspector Comments: Landowner has installed fence along landside slope for sheep to maintain levee slope. Landowner should apply for permit to keep fence.

Looking west at fence along landside slope.

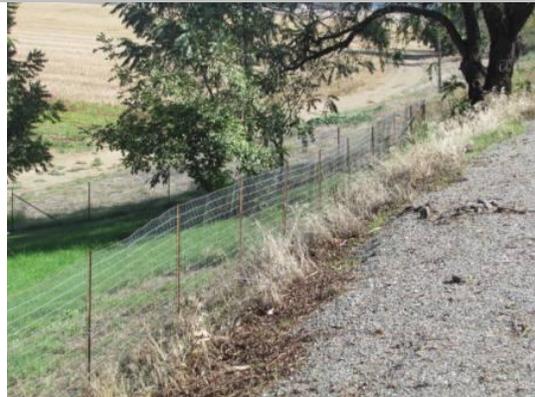
Photo 2 of 2 : SP_2015_RD0999_233_17_20150309_00017.jpg

Looking northeast at fence along landside shoulder.

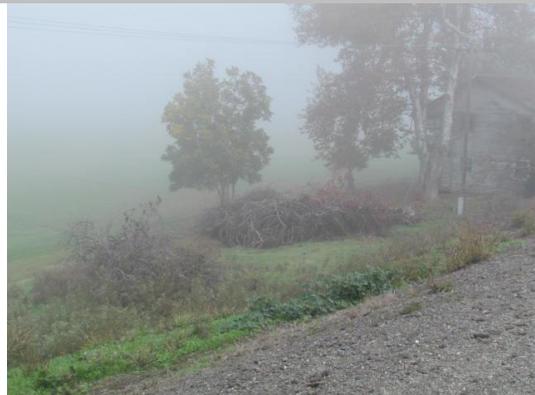
Photo 1 of 2 : SP_2015_RD0999_233_18_20150309_00018.jpg

LM Start	0.16	Rating **	A/W	Issue No.	18
LM End	0.16	Issue Type +	Ma	Location *	LS
Category	Earthen Levee		GPS Latitude/Longitude		
			Start	End	
Item	Encroachments		38.290793 °	38.290793 °	
			-121.642100 °	-121.642100 °	
DWR ID	DWR_RD0999_02_s_2012_18				
Action/Comments					
Prunings

Looking west at prunings on landside toe. (Fall Inspection 2012)

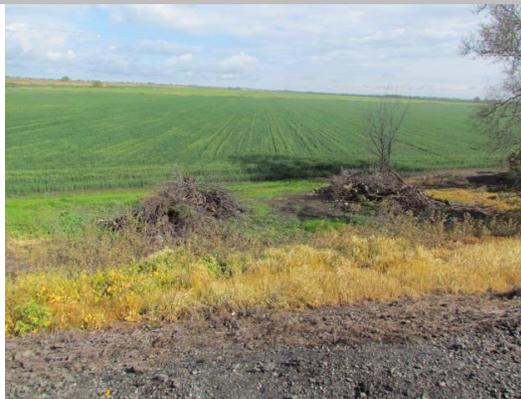
Photo 2 of 2 : SP_2015_RD0999_233_18_20150309_00019.jpg

LM Start	0.16	Rating **	A/W	Issue No.	18 (cont)
LM End	0.16	Issue Type +	Ma	Location *	LS
Category	Earthen Levee			GPS Latitude/Longitude	
				Start	End
Item	Encroachments			38.290793 °	38.290793 °
				-121.642100 °	-121.642100 °
DWR ID	DWR_RD0999_02_s_2012_18				
Action/Comments					
Prunings

Looking west at prunings on landside berm.

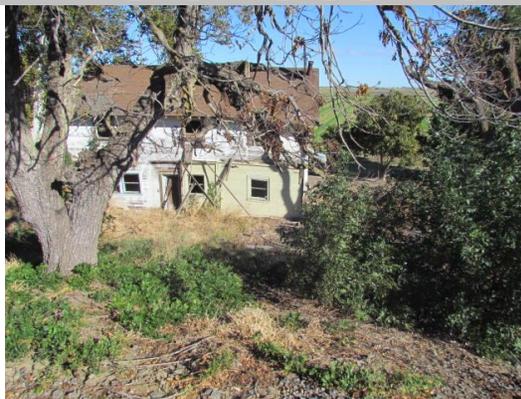
Photo 1 of 2 : SP_2015_RD0999_233_24_20150309_00026.jpg

LM Start	0.17	Rating **	U	Issue No.	24
LM End	0.17	Issue Type +	En	Location *	LS
Category	Earthen Levee			GPS Latitude/Longitude	
				Start	End
Item	Encroachments				
DWR ID	DWR_RD0999_02_f_2013_24				
Action/Comments					
Building Inspector Comments: Adandoned building on landward toe and berm.

Looking southwest at abandoned building on landward berm.

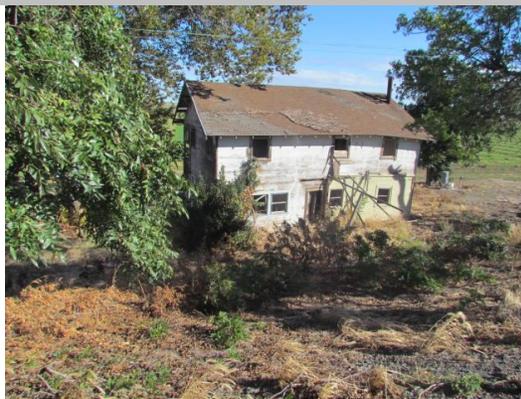
Photo 2 of 2 : SP_2015_RD0999_233_24_20150309_00027.jpg

Looking west at abandoned building on landward berm.

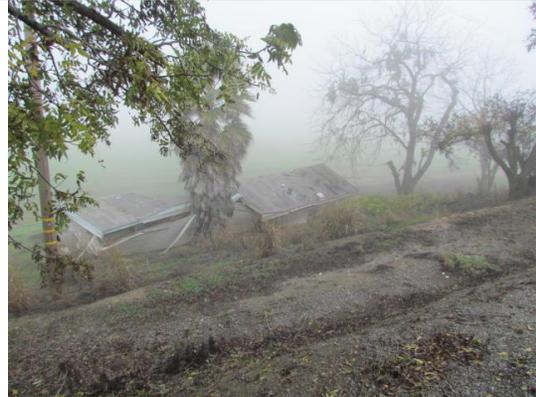
Photo 2 of 2 : SP_2015_RD0999_233_1_20150309_00002.jpg

LM Start	0.21	Rating **	U	Issue No.	1 (cont)
LM End	0.21	Issue Type +	En	Location *	LS
Category	Earthen Levee		GPS Latitude/Longitude		
			Start	End	
Item	Encroachments		38.290859 °	38.290859 °	
			-121.641220 °	-121.641220 °	
DWR ID	DWR_RD0999_02_f_2012_1				
Action/Comments					
Building Inspector Comments: Dilapidated building at landside toe.

Looking northwest at dilapidated building at landside toe.

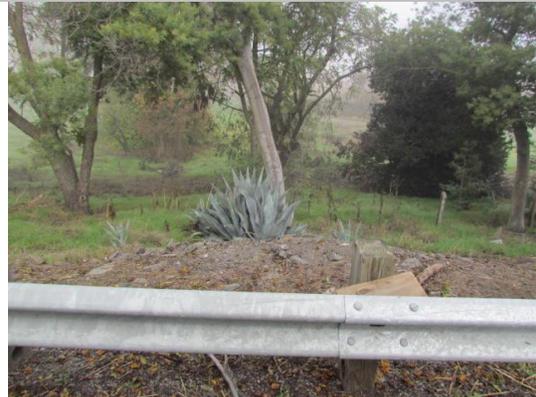
Photo 1 of 1 : SP_2015_RD0999_233_14_20150309_00013.jpg

LM Start	0.82	Rating **	M	Issue No.	14
LM End	0.82	Issue Type +	Ma	Location *	LS
Category	Earthen Levee			GPS Latitude/Longitude	
				Start	End
Item	Vegetation			38.292439 °	38.292439 °
				-121.630781 °	-121.630781 °
DWR ID	DWR_RD0999_02_f_2012_14				
Action/Comments					
Remove the wild growth other than native grasses from the levee slopes. Inspector Comments: Century plant on landside slope.

Looking east at century plant at landside toe.

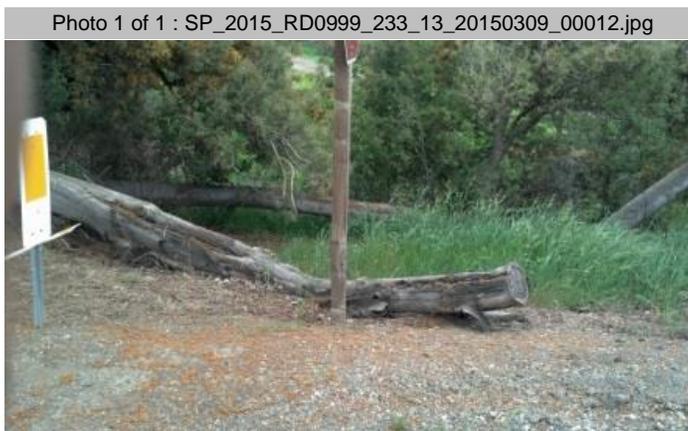
LM Start	0.84	Rating **	M	Issue No.	13
LM End	0.84	Issue Type +	En	Location *	LS
Category	Earthen Levee			GPS Latitude/Longitude	
				Start	End
Item	Encroachments			38.292352 °	38.292352 °
				-121.630452 °	-121.630452 °
DWR ID	DWR_RD0999_02_s_2012_13				
Action/Comments					
Tree or limb

Looking northwest at tree limb on landside slope.

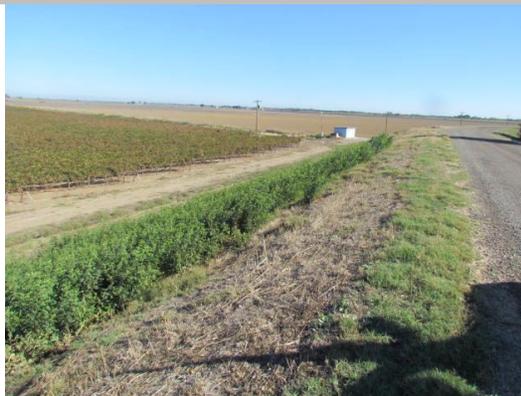
Photo 1 of 1 : SP_2015_RD0999_233_41_20150309_00031.jpg

LM Start	1.19	Rating **	A/W	Issue No.	41
LM End	1.19	Issue Type +	Ma	Location *	LS
Category	Earthen Levee			GPS Latitude/Longitude	
				Start	End
Item	Vegetation			38.291185 °	38.291185 °
				-121.624344 °	-121.624344 °
DWR ID	DWR_RD0999_02_f_2014_41				
Action/Comments					
Remove the wild growth other than native grasses from the levee slopes. Inspector Comments: Dense wild roses on landward slope.

Looking north at moderate vegetation on landward slope and toe.

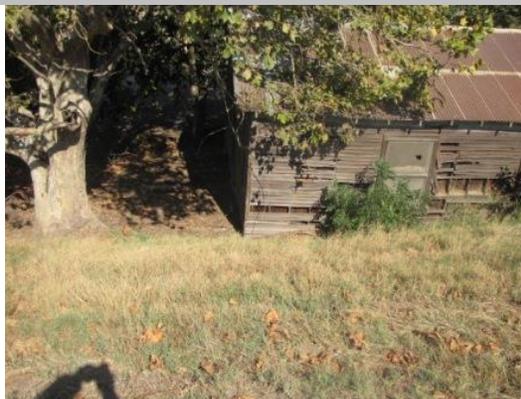
Photo 1 of 2 : SP_2015_RD0999_233_3_20150309_00004.jpg

LM Start	1.67	Rating **	U	Issue No.	3
LM End	1.68	Issue Type +	En	Location *	LS
Category	Earthen Levee			GPS Latitude/Longitude	
				Start	End
Item	Encroachments			38.290287 °	38.290217 °
				-121.615668 °	-121.615460 °
DWR ID	DWR_RD0999_02_s_2012_3				
Action/Comments					
Building Inspector Comments: Old abandoned storage shed on landward toe and berm.

Looking west at building at landside toe.

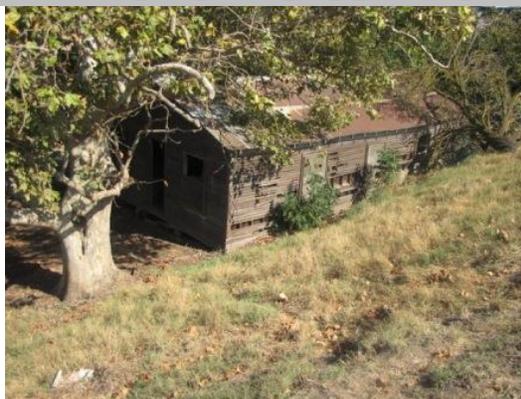
Photo 2 of 2 : SP_2015_RD0999_233_3_20150309_00005.jpg

Looking northwest at building at landside toe.

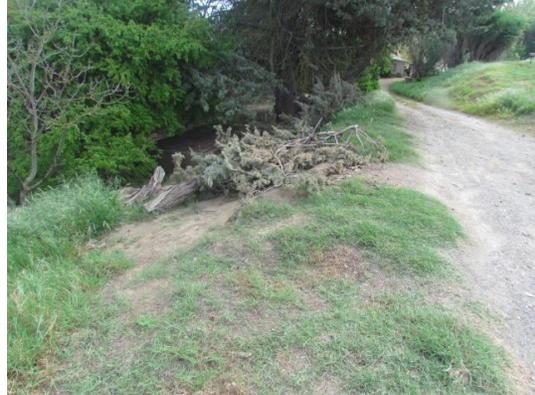
Photo 1 of 1 : SP_2015_RD0999_233_5_20150327_00039.jpg

LM Start	1.68	Rating **	M	Issue No.	5
LM End	1.68	Issue Type +	En	Location *	LS
Category	Earthen Levee		GPS Latitude/Longitude		
			Start	End	
Item	Encroachments		38.290248 °	38.290248 °	
			-121.615560 °	-121.615560 °	
DWR ID	DWR_RD0999_02_s_2012_5				
Action/Comments					
Tree or limb

Looking north at tree limbs on landward shoulder and slope. (Spring 2015)
