**Flood Control Project Maintenance
Levee Inspections**
LMA District Cover Sheet
Spring 2015 Levee Inspection Results

Reclamation District No. 0999 Netherlands

Spring 2015 Levee Inspection Results

Waterway	Bank	Unit Miles
Unit No. 01 Yolo Bypass	Left	15.41

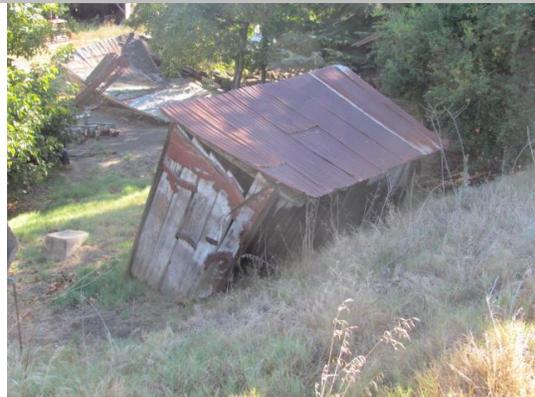
Photo 1 of 1 : SP_2015_RD0999_233_28_20150309_00028.jpg

LM Start	1.68	Rating **	U	Issue No.	28
LM End	1.68	Issue Type +	En	Location *	LS
Category	Earthen Levee		GPS Latitude/Longitude		
			Start	End	
Item	Encroachments				
DWR ID	DWR_RD0999_02_f_2013_28				
Action/Comments					
Building Inspector Comments: Abandoned pump house on landward toe.

Looking northwest at abandoned pump house on landward toe.

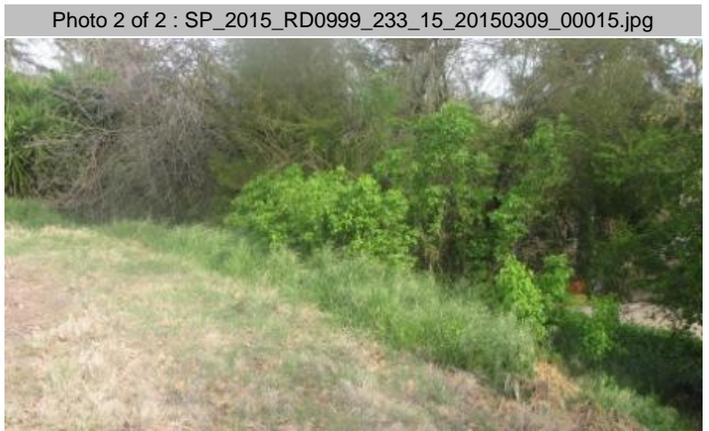
LM Start	1.72	Rating **	U	Issue No.	15 (cont)
LM End	1.73	Issue Type +	En	Location *	LS
Category	Earthen Levee			GPS Latitude/Longitude	
				Start	End
Item	Vegetation			38.290026 °	38.289865 °
				-121.614942 °	-121.614742 °
DWR ID	DWR_RD0999_02_s_2012_15				
Action/Comments					
Landscaping

Looking southwest at dense veg. on landside toe.

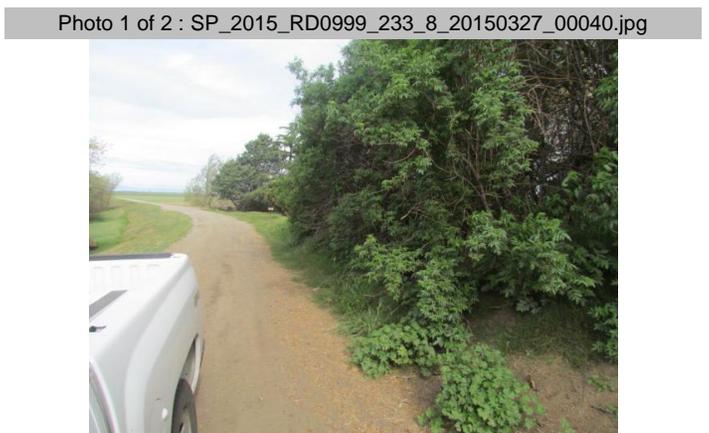
LM Start	1.73	Rating **	M	Issue No.	8
LM End	1.76	Issue Type +	Ma	Location *	LS
Category	Earthen Levee			GPS Latitude/Longitude	
				Start	End
Item	Vegetation			38.289895 °	38.289595 °
				-121.614688 °	-121.614337 °
DWR ID	DWR_RD0999_02_s_2012_8				
Action/Comments					
Remove the wild growth other than native grasses from the levee slopes.

Looking south at dense vegetation on landward shoulder and slope. (Spring 2015)

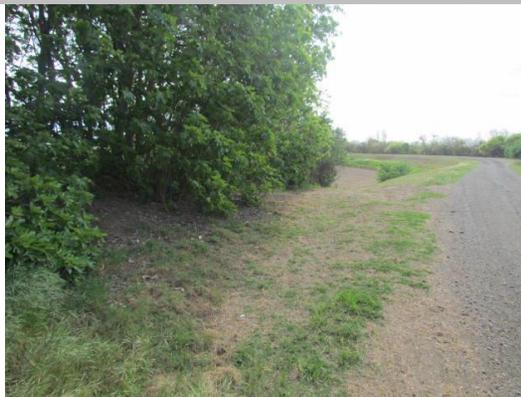
Photo 1 of 3 : SP_2015_RD0999_233_23_20150327_00041.jpg

LM Start	1.74	Rating **	U	Issue No.	23 (cont)
LM End	1.74	Issue Type +	Ma	Location *	LS

Looking north at dense vegetation on landward slope. (Spring 2015)

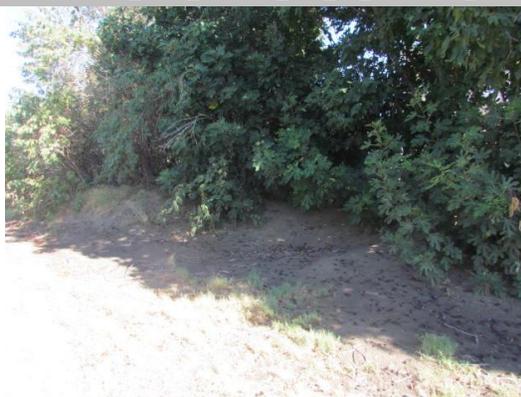
Photo 2 of 3 : SP_2015_RD0999_233_23_20150309_00024.jpg

Looking southwest at dense trees on landward slope and toe.

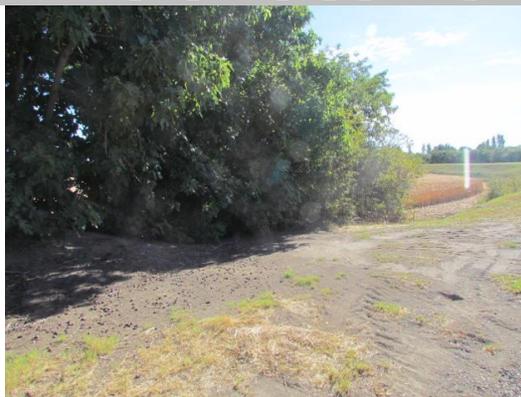
Photo 3 of 3 : SP_2015_RD0999_233_23_20150309_00025.jpg

Looking north at dense trees on landward slope and toe.

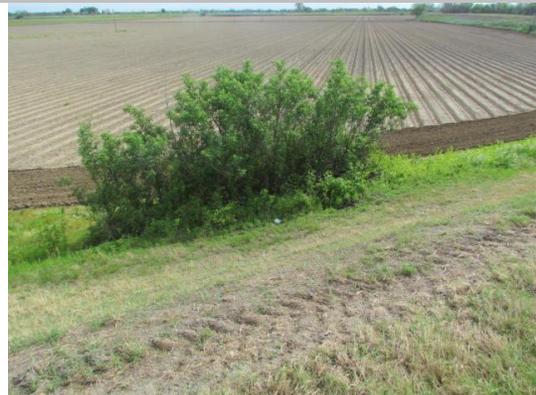
Photo 1 of 2 : SP_2015_RD0999_233_42_20150327_00042.jpg

LM Start	1.78	Rating **	M	Issue No.	42
LM End	1.78	Issue Type +	Ma	Location *	LS
Category	Earthen Levee		GPS Latitude/Longitude		
			Start	End	
Item	Vegetation		38.289399 °	38.289399 °	
			-121.614130 °	-121.614130 °	
DWR ID	DWR_RD0999_02_f_2014_42				
Action/Comments					
Elderberries are blocking visibility and flood fight capability. Inspector Comments: Elderberry and wildroses blocking landward toe.

Looking west at wild rose blocking landward toe. (Spring 2015)

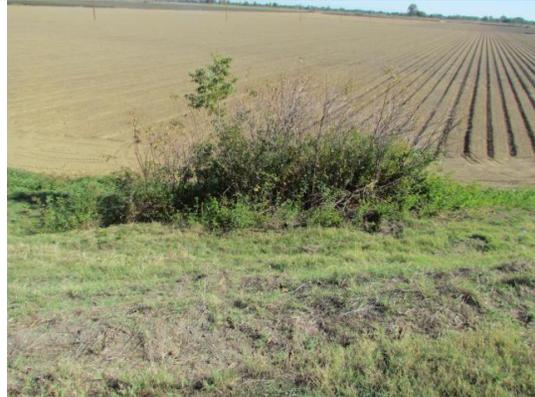
Photo 2 of 2 : SP_2015_RD0999_233_42_20150309_00032.jpg

LM Start	1.78	Rating **	M	Issue No.	42 (cont)
LM End	1.78	Issue Type +	Ma	Location *	LS
Category	Earthen Levee		GPS Latitude/Longitude		
			Start	End	
Item	Vegetation		38.289399 °	38.289399 °	
			-121.614130 °	-121.614130 °	
DWR ID	DWR_RD0999_02_f_2014_42				
Action/Comments					
Elderberries are blocking visibility and flood fight capability. Inspector Comments: Elderberry and wildroses blocking landward toe.

Looking west at elderberry and wild roses blocking view of landward toe.

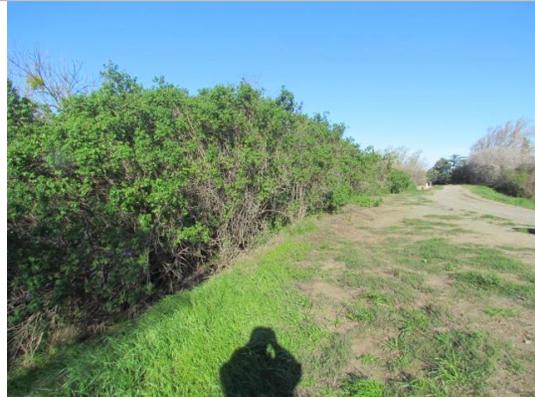
Photo 1 of 2 : SP_2015_RD0999_233_38_20150309_00029.jpg

LM Start	1.78	Rating **	M	Issue No.	38
LM End	1.82	Issue Type +	Ma	Location *	WS
Category	Earthen Levee		GPS Latitude/Longitude		
			Start	End	
Item	Vegetation		38.289360 °	38.289006 °	
			-121.614086 °	-121.613639 °	
DWR ID	DWR_RD0999_02_s_2014_38				
Action/Comments					
Elderberries are blocking visibility and flood fight capability.

Looking west at dense vegetation on waterside slope.

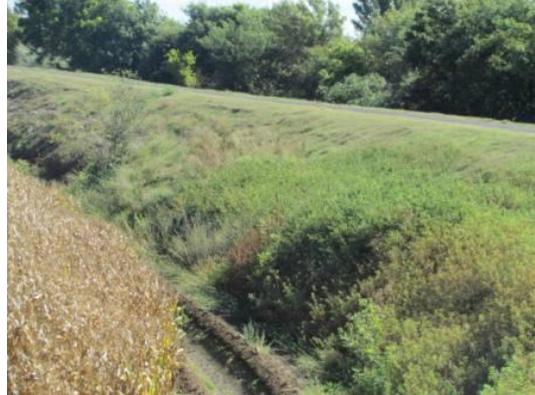
Photo 1 of 3 : SP_2015_RD0999_233_6_20150309_00006.jpg

LM Start	1.80	Rating **	A/W	Issue No.	6 (cont)
LM End	1.90	Issue Type +	Ma	Location *	LS

Looking east at dense wild roses on landside toe. (Spring 2011)

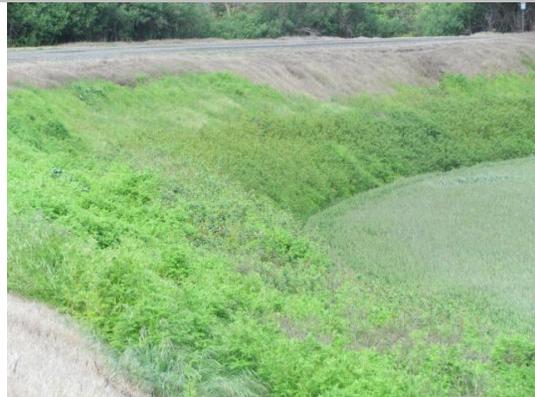
Photo 2 of 3 : SP_2015_RD0999_233_6_20150309_00007.jpg

Looking southeast to wild roses on landside slope and toe. (Spring 2012)

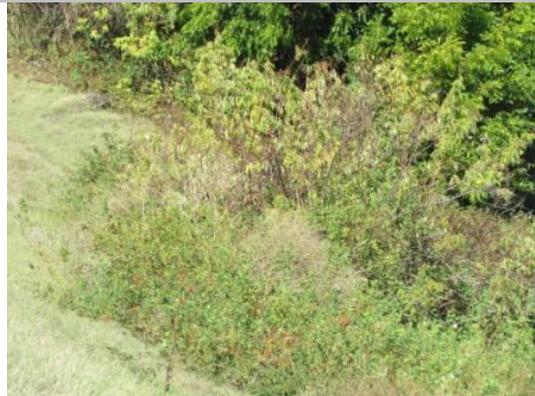
Photo 3 of 3 : SP_2015_RD0999_233_6_20150309_00008.jpg

Looking north at wild roses on landside toe. (Spring 2011)

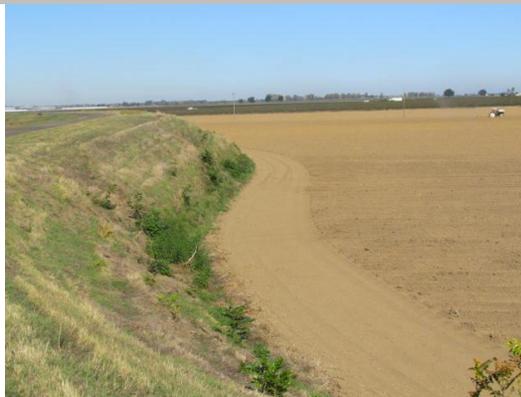
Photo 1 of 2 : SP_2015_RD0999_233_22_20150309_00022.jpg

LM Start	1.81	Rating **	A/W	Issue No.	22
LM End	2.32	Issue Type +	En	Location *	LS
Category	Earthen Levee		GPS Latitude/Longitude		
			Start	End	
Item	Encroachments		38.289002 °	38.286742 °	
			-121.613675 °	-121.605903 °	
DWR ID	DWR_RD0999_02_s_2012_22				
Action/Comments					
Crops Inspector Comments: Crops encroached within ten feet of the landside toe.

Looking west proper toe road at landward toe.(Fall 2014)

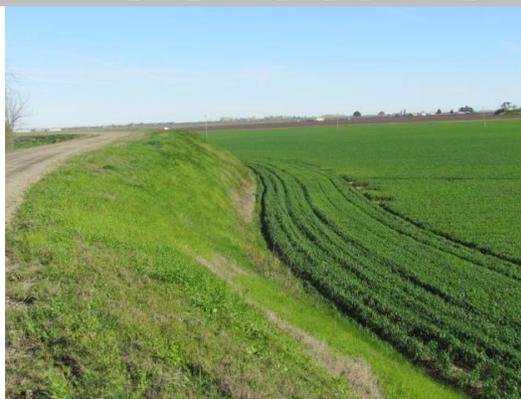
Photo 2 of 2 : SP_2015_RD0999_233_22_20150309_00023.jpg

Looking west at crops encroaching on landside toe.

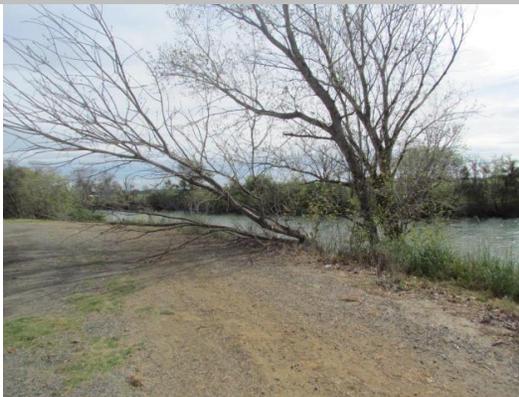
Photo 1 of 1 : SP_2015_RD0999_234_39_20150327_00038.jpg

LM Start	0.01	Rating **	M	Issue No.	39
LM End	0.01	Issue Type +	En	Location *	WS
Category	Earthen Levee		GPS Latitude/Longitude		
			Start	End	
Item	Encroachments		38.286727 °	38.286727 °	
			-121.606004 °	-121.606004 °	
DWR ID	DWR_RD0999_03_s_2015_39				
Action/Comments					
Tree or limb Inspector Comments: Downed tree on waterward shoulder.

Looking northeast at fallen tree on waterward shoulder. (Spring 2015)

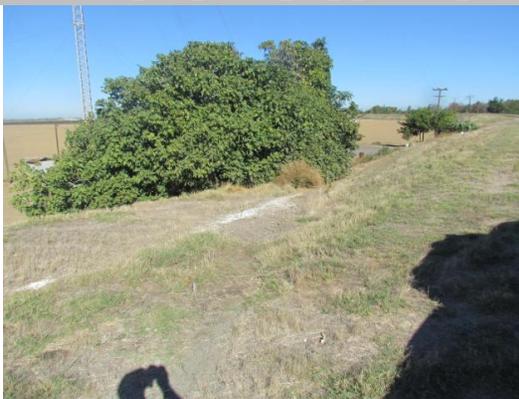
Photo 1 of 4 : SP_2015_RD0999_234_4_20150309_00006.jpg

LM Start	0.04	Rating **	U	Issue No.	4
LM End	0.04	Issue Type +	Ma	Location *	LS
Category	Earthen Levee		GPS Latitude/Longitude		
			Start	End	
Item	Trim / Thin Trees		38.287025 °	38.287025 °	
			-121.605690 °	-121.605690 °	
DWR ID	DWR_RD0999_03_s_2012_4				
Action/Comments					
Trim trees to at least five feet above ground level. Inspector Comments: Dense fig trees on landward slope and toe.

Looking northwest at dense fig tree on landward toe. 2014

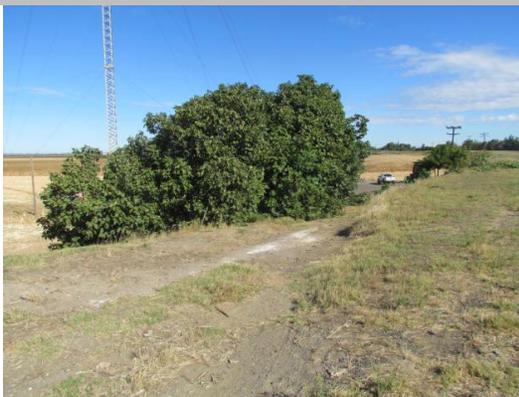
Photo 2 of 4 : SP_2015_RD0999_234_4_20150309_00007.jpg

Looking northwest at dense fig tree on landward slope and toe. 2013

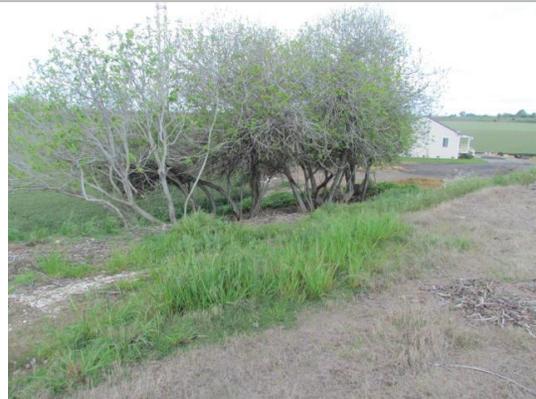
Photo 3 of 4 : SP_2015_RD0999_234_4_20150309_00008.jpg

LM Start	0.04	Rating **	U	Issue No.	4 (cont)
LM End	0.04	Issue Type +	Ma	Location *	LS
Category	Earthen Levee			GPS Latitude/Longitude	
				Start	End
Item	Trim / Thin Trees			38.287025 °	38.287025 °
				-121.605690 °	-121.605690 °
DWR ID	DWR_RD0999_03_s_2012_4				
Action/Comments					
Trim trees to at least five feet above ground level. Inspector Comments: Dense fig trees on landward slope and toe.

Looking southwest at trimmed trees on landside toe. (Spring 2012)

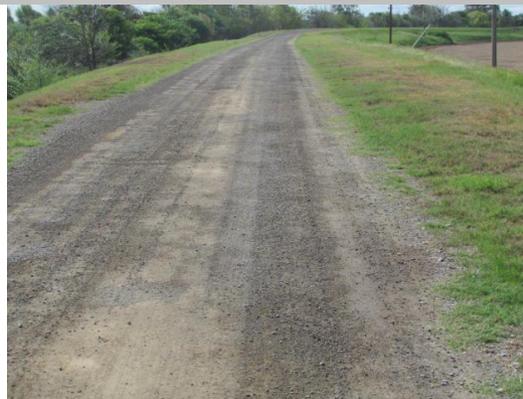
Photo 1 of 1 : SP_2015_RD0999_234_9_20150327_00039.jpg

LM Start	0.11	Rating **	M	Issue No.	9
LM End	1.51	Issue Type +	Ma	Location *	CR
Category	Earthen Levee			GPS Latitude/Longitude	
				Start	End
Item	Crown Surface / Depressions / Rutting			38.287873 °	38.306151 °
				-121.605108 °	-121.599374 °
DWR ID	DWR_RD0999_03_f_2012_9				
Action/Comments					
Repair depressions or ruts in the crown or slope.

Looking south at levee crown. (Spring 2015)

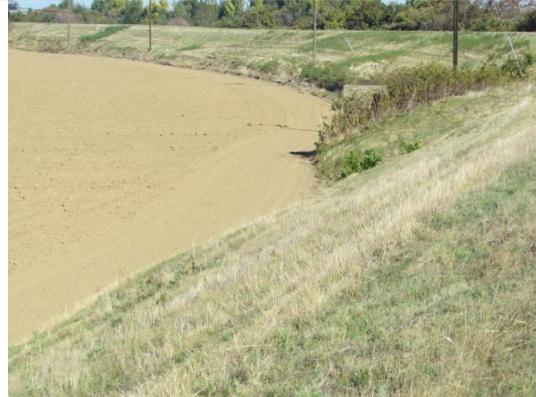
Photo 1 of 2 : SP_2015_RD0999_234_45_20150309_00031.jpg

LM Start	0.11	Rating **	A/W	Issue No.	45
LM End	0.41	Issue Type +	En	Location *	LS
Category	Earthen Levee			GPS Latitude/Longitude	
				Start	End
Item	Encroachments			38.287929 °	38.292129 °
				-121.605098 °	-121.604885 °
DWR ID	DWR_RD0999_03_s_2014_45				
Action/Comments					
Crops

Looking north at proper toe road at landward toe. Fall 2014

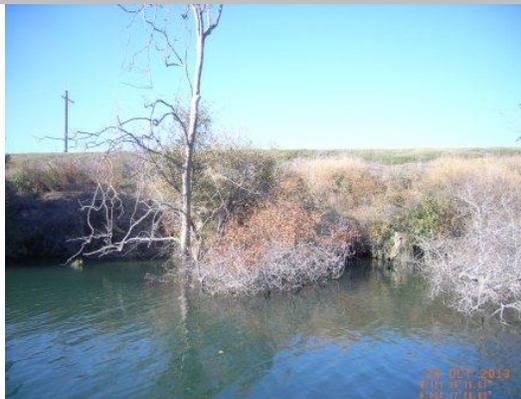
Photo 1 of 1 : SP_2015_RD0999_234_29_20150309_00022.jpg

LM Start	0.24	Rating **	U	Issue No.	29
LM End	0.65	Issue Type +	Ma	Location *	WS
Category	Supplemental			GPS Latitude/Longitude	
				Start	End
Item	USACE Erosion Survey			38.289634 °	38.295505 °
				-121.604343 °	-121.605648 °
DWR ID	DWR_RD0999_03_f_2014_29				
Action/Comments					
Inspector Comments: 1997 - Intermittent over-steepened sections. Large riparian vegetation along the length of the entire reach. Attempts to repair with rock on bank have failed. 1999 - New rock repair at the downstream end. 2002 - Some minor spot repairs. 2009 - Minimal new erosion. 2010 - Appears that fresh rock placed on downstream portion of site. Toe scour and overhanging trees with some overturned. 2012 - Minor new erosion at the toe. 2013: Site upgraded to CRITICAL. Severe slumping into levee at downstream end of site. Fresh erosion into bank toe. [2013 Site ID: STR_24-7_R]

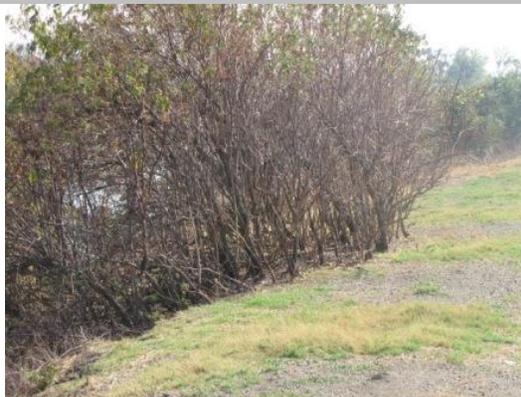
Photo 1 of 1 : SP_2015_RD0999_234_7_20150309_00010.jpg

LM Start	0.45	Rating **	M	Issue No.	7
LM End	0.45	Issue Type +	Ma	Location *	WS
Category	Earthen Levee			GPS Latitude/Longitude	
				Start	End
Item	Vegetation			38.292748 °	38.292748 °
				-121.604972 °	-121.604972 °
DWR ID	DWR_RD0999_03_s_2012_7				
Action/Comments					
Elderberries are blocking visibility and flood fight capability.

Looking south at thinned Elderberry on waterside slope.

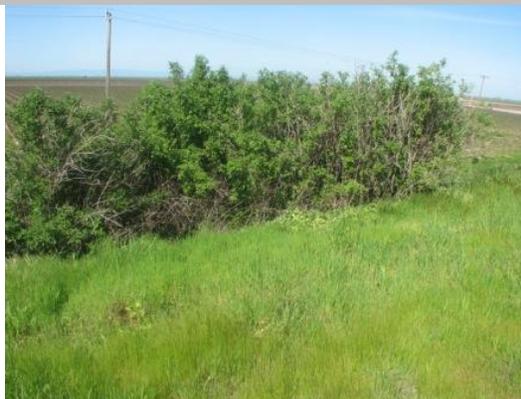
Photo 1 of 1 : SP_2015_RD0999_234_8_20150309_00011.jpg

LM Start	0.66	Rating **	M	Issue No.	8
LM End	0.66	Issue Type +	Ma	Location *	LS
Category	Earthen Levee			GPS Latitude/Longitude	
				Start	End
Item	Vegetation			38.295618 °	38.295618 °
				-121.605923 °	-121.605923 °
DWR ID	DWR_RD0999_03_s_2012_8				
Action/Comments					
Elderberries are blocking visibility and flood fight capability.

Elderberries blocking view of landside toe.

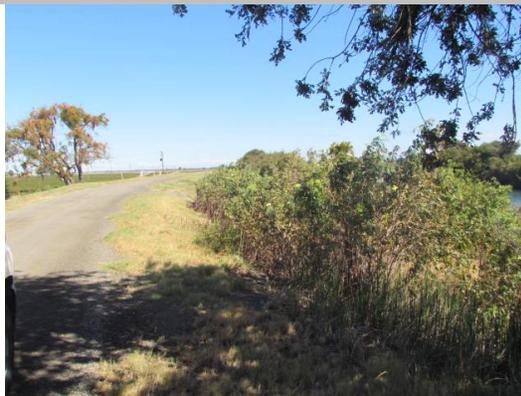
Photo 1 of 1 : SP_2015_RD0999_234_15_20150309_00015.jpg

LM Start	0.69	Rating **	A/W	Issue No.	15
LM End	0.70	Issue Type +	Ma	Location *	WS
Category	Earthen Levee		GPS Latitude/Longitude		
			Start	End	
Item	Vegetation		38.296073 °	38.296203 °	
			-121.605872 °	-121.605837 °	
DWR ID	DWR_RD0999_03_s_2012_15				
Action/Comments					
Elderberries are blocking visibility and flood fight capability.

Looking northeast at dense elderberry on waterward slope.

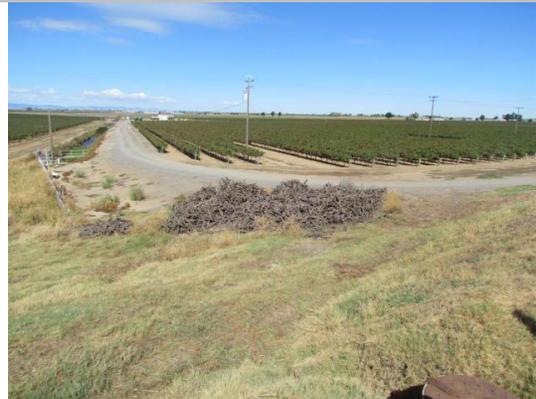
Photo 2 of 2 : SP_2015_RD0999_234_2_20150309_00005.jpg

Looking west at prunings on landward berm.

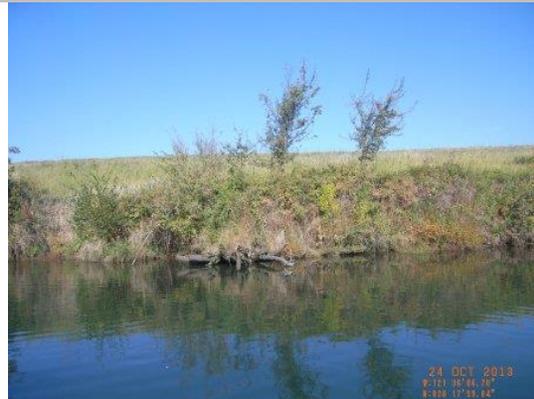
Photo 1 of 1 : SP_2015_RD0999_234_30_20150309_00023.jpg

LM Start	0.97	Rating **	M	Issue No.	30
LM End	1.10	Issue Type +	Ma	Location *	WS
Category	Supplemental			GPS Latitude/Longitude	
				Start	End
Item	USACE Erosion Survey			38.299402 °	38.300542 °
				-121.603056 °	-121.601118 °
DWR ID	DWR_RD0999_03_f_2014_30				
Action/Comments					
Inspector Comments: 2008 - Over steepened levee section. 2009 - Significant new erosion. 2010 - Minor new erosion. 2013: No observed changes. [2013 Site ID: STR_25-2_R]

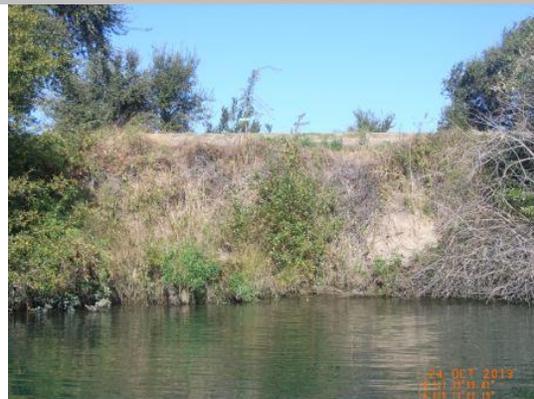
Photo 1 of 1 : SP_2015_RD0999_234_33_20150309_00025.jpg

LM Start	1.43	Rating **	M	Issue No.	33
LM End	1.57	Issue Type +	Ma	Location *	WS
Category	Supplemental			GPS Latitude/Longitude	
				Start	End
Item	USACE Erosion Survey			38.305229 °	38.306667 °
				-121.599933 °	-121.598266 °
DWR ID	DWR_RD0999_03_f_2014_33				
Action/Comments					
Inspector Comments: 2011 - Toe scour along length of site and erosion pockets. 2012 - Site extended slightly upstream due to new erosion pocket. 2013: Tall vertical sections at upstream end of site. [2013 Site ID: STR_25-7_R]

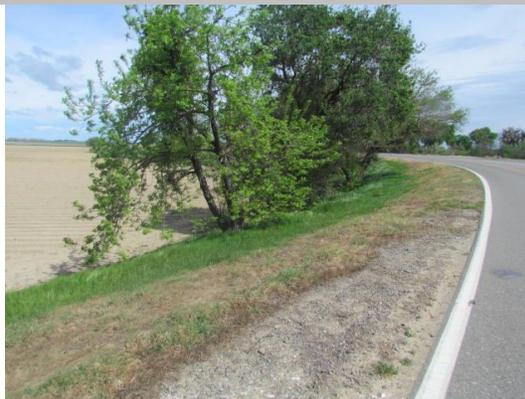
Photo 1 of 1 : SP_2015_RD0999_234_13_20150327_00040.jpg

LM Start	1.57	Rating **	M	Issue No.	13
LM End	1.59	Issue Type +	Ma	Location *	LS
Category	Earthen Levee			GPS Latitude/Longitude	
				Start	End
Item	Trim / Thin Trees			38.306762 °	38.306948 °
				-121.598541 °	-121.598320 °
DWR ID	DWR_RD0999_03_s_2012_13				
Action/Comments					
Trim and thin trees to allow visibility of the ground and room to flood fight.

Looking north at untrimmed trees on landward toe. (Spring 2015)

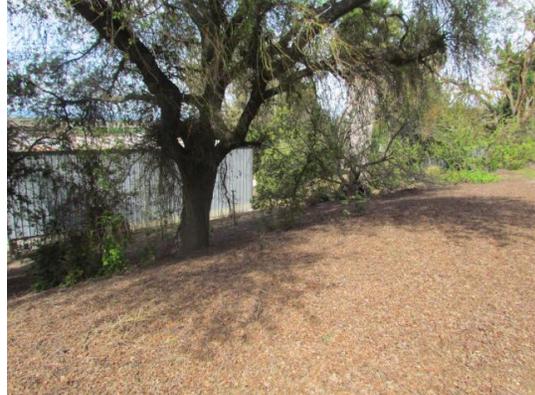
Photo 1 of 1 : SP_2015_RD0999_234_32_20150327_00041.jpg

LM Start	2.69	Rating **	M	Issue No.	32
LM End	2.74	Issue Type +	Ma	Location *	LS
Category	Earthen Levee			GPS Latitude/Longitude	
				Start	End
Item	Trim / Thin Trees			38.319943 °	38.320670 °
				-121.590737 °	-121.590802 °
DWR ID	DWR_RD0999_03_s_2012_32				
Action/Comments					
Trim trees to at least five feet above ground level.

Looking northwest at untrimmed trees on landward slope. (Spring 2015)

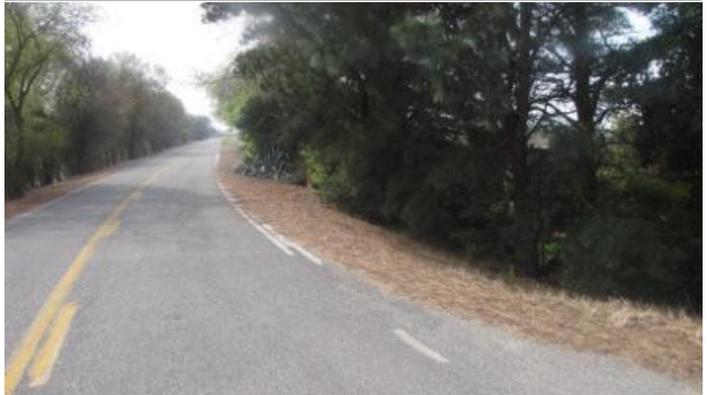
Photo 1 of 2 : SP_2015_RD0999_234_16_20150309_00016.jpg

LM Start	2.70	Rating **	U	Issue No.	16
LM End	2.71	Issue Type +	En	Location *	LS
Category	Earthen Levee			GPS Latitude/Longitude	
				Start	End
Item	Vegetation			38.320105 °	38.320340 °
				-121.590765 °	-121.590730 °
DWR ID	DWR_RD0999_03_s_2012_16				
Action/Comments					
Landscaping

Looking south at landscaping and dense veg. on landside slope and toe.

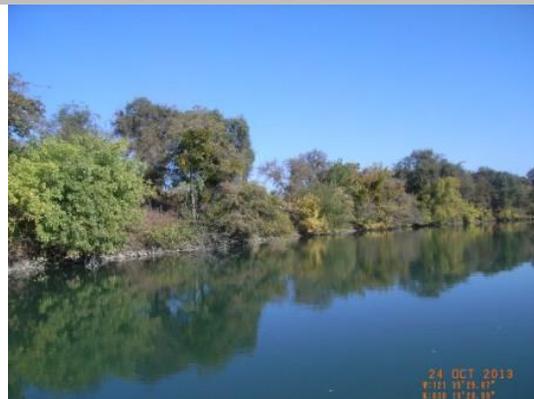
Photo 1 of 1 : SP_2015_RD0999_234_35_20150309_00027.jpg

LM Start	2.87	Rating **	M	Issue No.	35
LM End	2.92	Issue Type +	Ma	Location *	WS
Category	Supplemental		GPS Latitude/Longitude		
			Start	End	
Item	USACE Erosion Survey		38.322457 °	38.323042 °	
			-121.590693 °	-121.590209 °	
DWR ID	DWR_RD0999_03_f_2014_35				
Action/Comments					
Inspector Comments: 2012 - Slumping of upper levee slope. 2013: No observed changes. [2013 Site ID: STR_27-1_R]

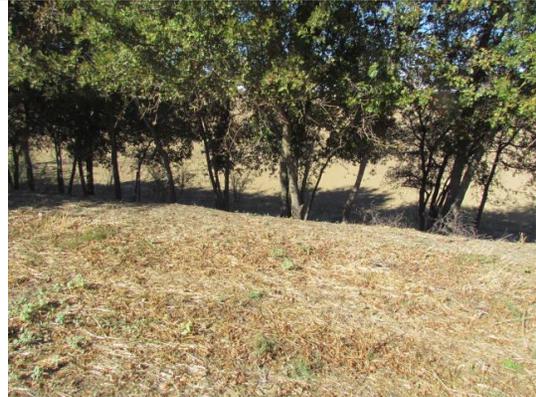
Photo 1 of 3 : SP_2015_RD0999_234_10_20150309_00012.jpg

LM Start	2.88	Rating **	M	Issue No.	10
LM End	2.88	Issue Type +	Ma	Location *	LS
Category	Earthen Levee		GPS Latitude/Longitude		
			Start	End	
Item	Vegetation		38.322757 °	38.322757 °	
			-121.590817 °	-121.590817 °	
DWR ID	DWR_RD0999_03_f_2012_10				
Action/Comments					
Remove the wild growth other than native grasses from the levee slopes. Inspector Comments: Wild growth at landside slope and toe.

Looking west at trimmed trees at landward toe. (Fall 2014)

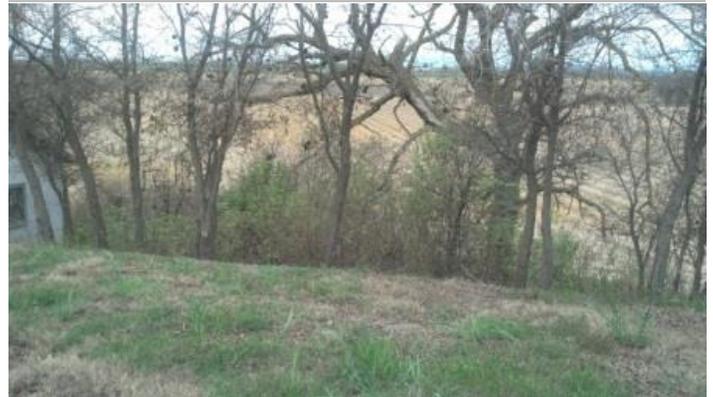
Photo 2 of 3 : SP_2015_RD0999_234_10_20150309_00013.jpg

LM Start	2.88	Rating **	M	Issue No.	10 (cont)
LM End	2.88	Issue Type +	Ma	Location *	LS

Looking west at dense trees on landside toe.

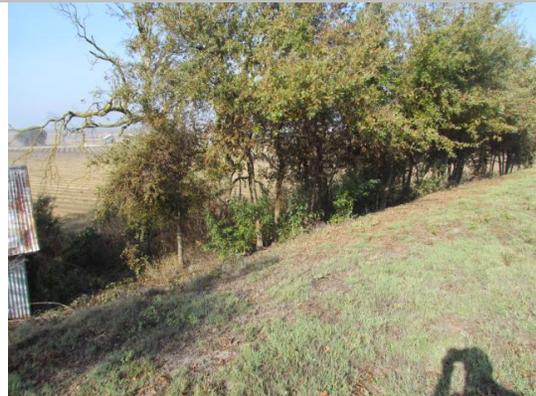
Photo 3 of 3 : SP_2015_RD0999_234_10_20150309_00014.jpg

LM Start	2.88	Rating **	M	Issue No.	10 (cont)
LM End	2.88	Issue Type +	Ma	Location *	LS

Looking northwest at dense vegetation at landside slope and toe.

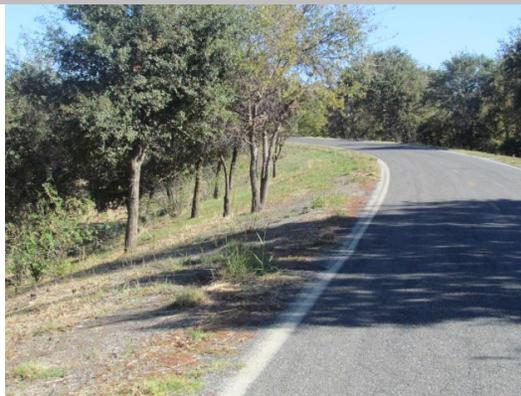
Photo 1 of 1 : SP_2015_RD0999_234_31_20150309_00024.jpg

Looking north at trimmed trees on landward slope.

LM Start	3.01	Rating **	M	Issue No.	31
LM End	3.25	Issue Type +	Ma	Location *	LS
Category	Earthen Levee			GPS Latitude/Longitude	
				Start	End
Item	Trim / Thin Trees			38.323770 °	38.326061 °
				-121.589035 °	-121.586028 °
DWR ID	DWR_RD0999_03_s_2012_31				
Action/Comments					
Trim and thin trees to allow visibility of the ground and room to flood fight.

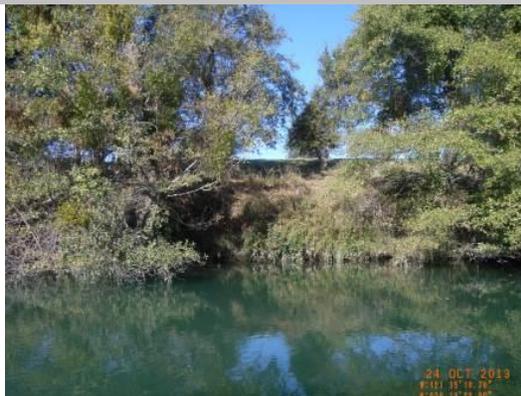
Photo 1 of 1 : SP_2015_RD0999_234_47_20150309_00033.jpg

LM Start	3.05	Rating **	M	Issue No.	47
LM End	3.22	Issue Type +	Ma	Location *	WS
Category	Supplemental			GPS Latitude/Longitude	
				Start	End
Item	USACE Erosion Survey			38.323667 °	38.325592 °
				-121.588226 °	-121.585925 °
DWR ID	DWR_RD0999_03_f_2014_47				
Action/Comments					
Inspector Comments: 2011 - Multiple erosion pockets. Some likely from tree popouts. 2013: Tall vertical sections. [2013 Site ID: STR_27-3_R]

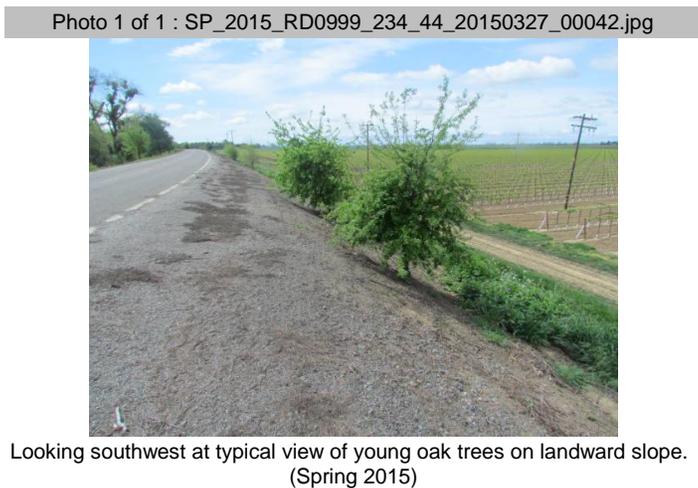
LM Start	3.60	Rating **	M	Issue No.	44
LM End	3.64	Issue Type +	Ma	Location *	LS
Category	Earthen Levee		GPS Latitude/Longitude		
			Start	End	
Item	Trim / Thin Trees		38.330946 °	38.331415 °	
			-121.585932 °	-121.585534 °	
DWR ID	DWR_RD0999_03_s_2015_44				
Action/Comments					
Thin trees to allow visibility of the ground and room to flood fight. Inspector Comments: Remove trees under an inch in diameter. Don't allow young trees to get establish on levee slope.

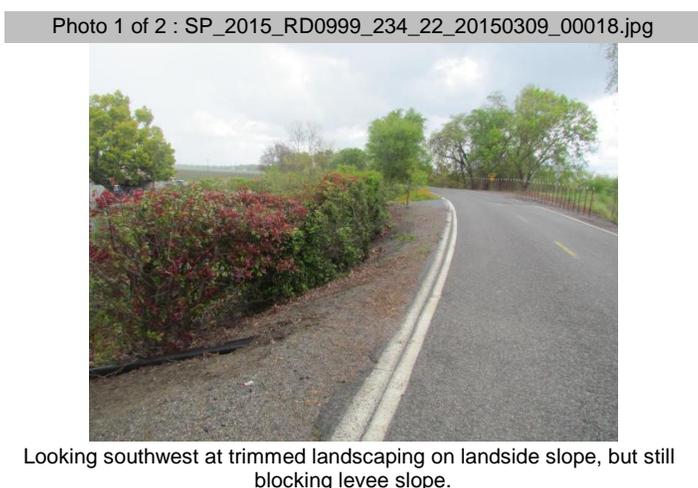
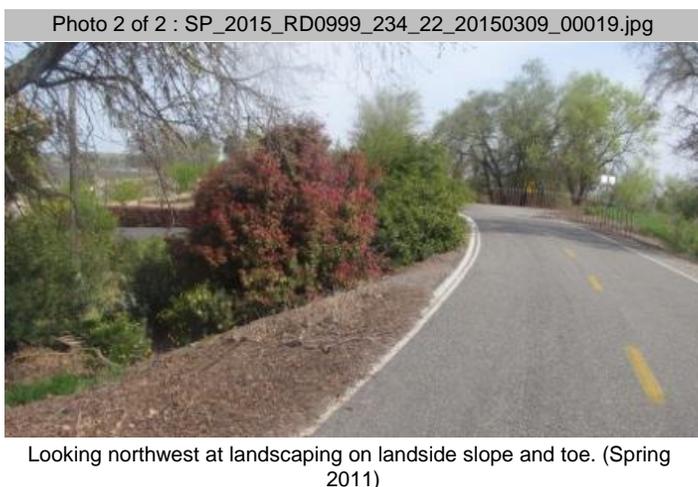
LM Start	3.70	Rating **	M	Issue No.	22
LM End	3.74	Issue Type +	En	Location *	LS
Category	Earthen Levee		GPS Latitude/Longitude		
			Start	End	
Item	Vegetation		38.332017 °	38.332543 °	
			-121.584807 °	-121.584602 °	
DWR ID	DWR_RD0999_03_s_2012_22				
Action/Comments					
Landscaping

LM Start	3.70	Rating **	M	Issue No.	22 (cont)
LM End	3.74	Issue Type +	En	Location *	LS

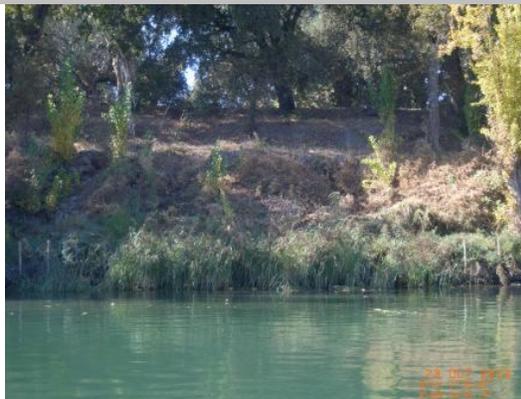
Photo 1 of 1 : SP_2015_RD0999_235_8_20150309_00006.jpg

LM Start	0.02	Rating **	M	Issue No.	8
LM End	0.28	Issue Type +	Ma	Location *	WS
Category	Supplemental			GPS Latitude/Longitude	
				Start	End
Item	USACE Erosion Survey			38.414387 °	38.417692 °
				-121.522871 °	-121.525083 °
DWR ID	DWR_RD0999_04_f_2014_8				
Action/Comments					
Inspector Comments: 1997 - Structural problem rather than erosional, failed cobble at downstream end. 2005 - New brush boxes at waterline for several hundred feet downstream, No toe or bank protection present. 2006 - Some minor new erosion. Brush boxes not working well; most of the brush has floated out. 2007 - Brush boxes have recently been repaired. 2013: No observed changes. [2013 Site ID: SAC_41-9_R]

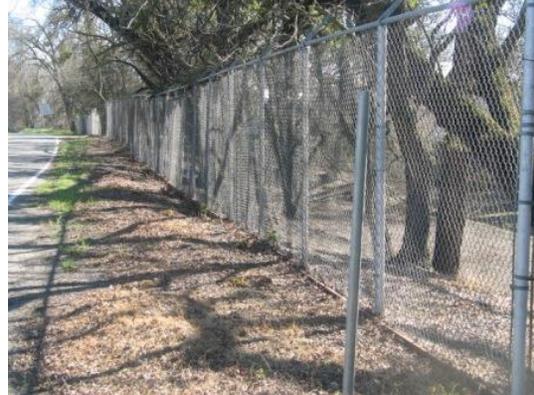
Photo 1 of 1 : SP_2015_RD0999_235_13_20150309_00012.jpg

LM Start	0.05	Rating **	M	Issue No.	13
LM End	0.11	Issue Type +	En	Location *	LS
Category	Earthen Levee			GPS Latitude/Longitude	
				Start	End
Item	Encroachments			38.414672 °	38.415468 °
				-121.523527 °	-121.524037 °
DWR ID	DWR_RD0999_04_s_2012_13				
Action/Comments					
Fence

Cyclone fence along landside shoulder at LM 0.05 -0.11

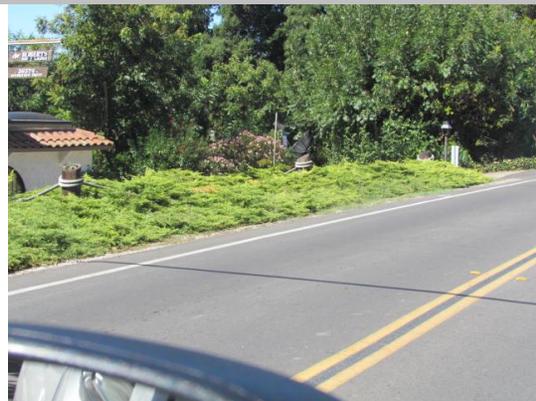
Photo 1 of 1 : SP_2015_RD0999_235_20_20150309_00015.jpg

LM Start	0.28	Rating **	M	Issue No.	20
LM End	0.30	Issue Type +	En	Location *	LS
Category	Earthen Levee		GPS Latitude/Longitude		
			Start	End	
Item	Vegetation				
DWR ID	DWR_RD0999_04_f_2013_20				
Action/Comments					
Landscaping

Looking west at dense landscaping on landward slope.

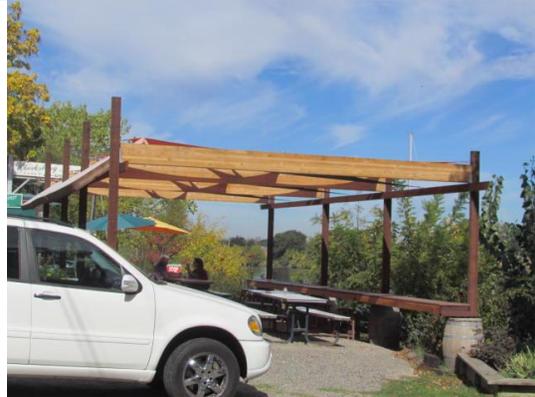
Photo 2 of 2 : SP_2015_RD0999_235_36_20150309_00019.jpg

LM Start	0.29	Rating **	M	Issue No.	36 (cont)
LM End	0.29	Issue Type +	En	Location *	WS
Category	Earthen Levee			GPS Latitude/Longitude	
				Start	End
Item	Encroachments			38.417809 °	38.417809 °
				-121.525488 °	-121.525488 °
DWR ID	DWR_RD0999_04_f_2014_36				
Action/Comments					
Building Inspector Comments: Landowner built patio stucture next to mobile diner on waterward shoulder area without Board permit.

Looking northeast at patio structure on waterward shoulder.

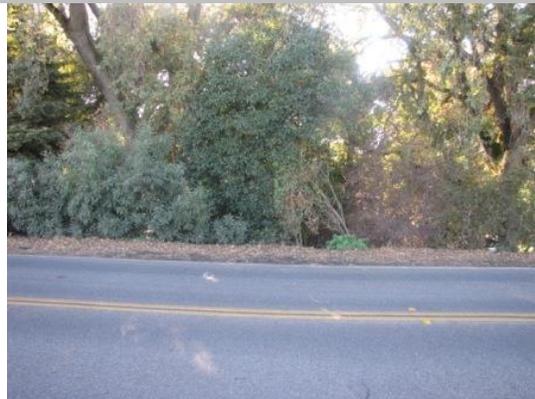
Photo 1 of 2 : SP_2015_RD0999_235_12_20150309_00010.jpg

LM Start	0.31	Rating **	U	Issue No.	12
LM End	0.35	Issue Type +	En	Location *	LS
Category	Earthen Levee			GPS Latitude/Longitude	
				Start	End
Item	Vegetation			38.418002 °	38.418470 °
				-121.525712 °	-121.526002 °
DWR ID	DWR_RD0999_04_s_2012_12				
Action/Comments					
Landscaping

Looking west at dense veg. on landside slope and toe.

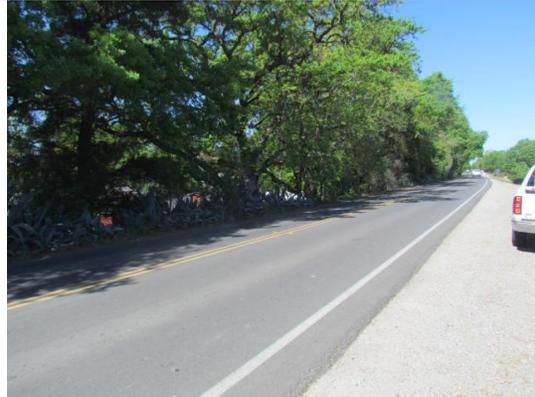
Photo 1 of 2 : SP_2015_RD0999_235_11_20150327_00026.jpg

LM Start	0.38	Rating **	U	Issue No.	11
LM End	0.49	Issue Type +	En	Location *	LS
Category	Earthen Levee		GPS Latitude/Longitude		
			Start	End	
Item	Vegetation		38.418838 °	38.420237 °	
			-121.526225 °	-121.527193 °	
DWR ID	DWR_RD0999_04_s_2012_11				
Action/Comments					
Landscaping

Looking northwest at dense landscaping on landward slope. (Spring 2015)

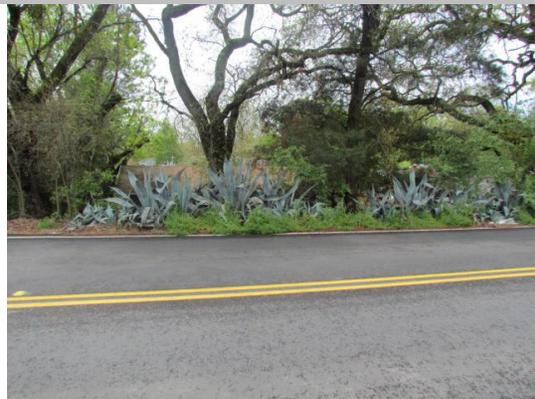
Photo 2 of 2 : SP_2015_RD0999_235_11_20150309_00009.jpg

LM Start	0.38	Rating **	U	Issue No.	11 (cont)
LM End	0.49	Issue Type +	En	Location *	LS

Looking west at century plants on landside shoulder and slope.

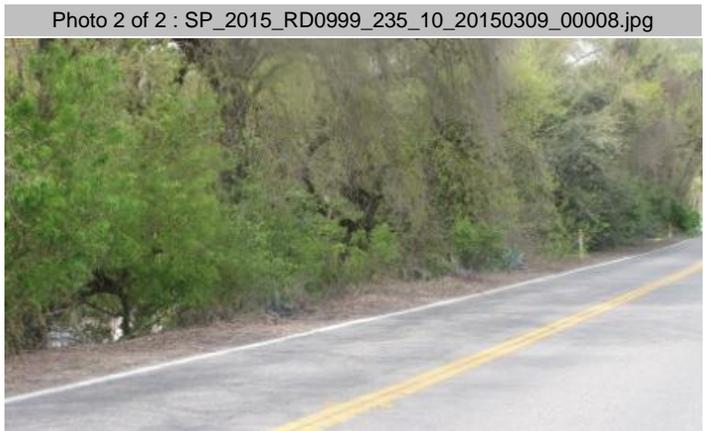
Looking west at dense trees on waterside slope.

LM Start	0.38	Rating **	M	Issue No.	10 (cont)
LM End	0.50	Issue Type +	Ma	Location *	LS
Category	Earthen Levee			GPS Latitude/Longitude	
				Start	End
Item	Trim / Thin Trees			38.418838 °	38.420447 °
				-121.526225 °	-121.527380 °
DWR ID	DWR_RD0999_04_s_2012_10				
Action/Comments					
Trim trees to at least five feet above ground level.

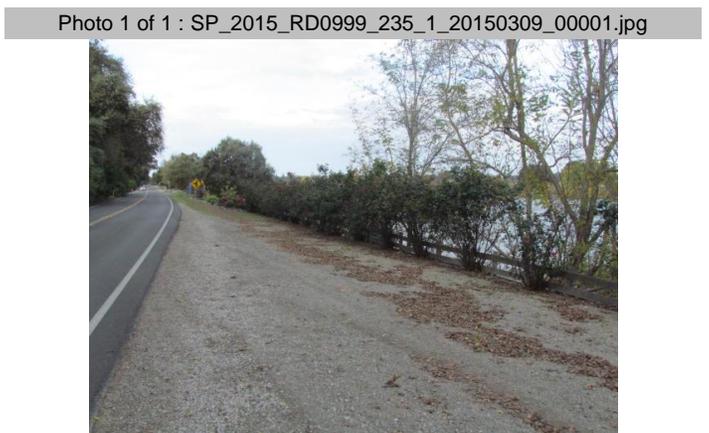
LM Start	0.40	Rating **	M	Issue No.	1
LM End	0.47	Issue Type +	En	Location *	WS
Category	Earthen Levee			GPS Latitude/Longitude	
				Start	End
Item	Vegetation			38.419137 °	38.420078 °
				-121.526280 °	-121.526913 °
DWR ID	DWR_RD0999_04_s_2012_1				
Action/Comments					
Landscaping

Looking north at rose bushes on waterside slope.

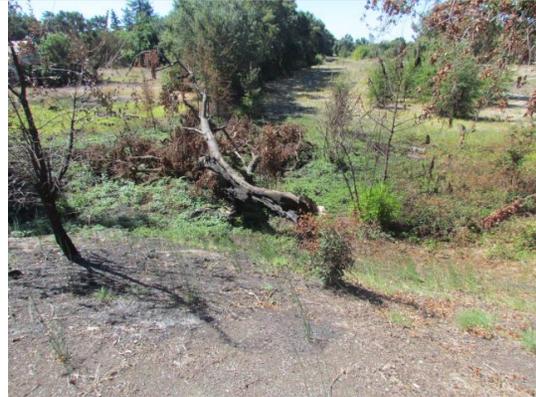
Photo 1 of 1 : SP_2015_RD0999_235_21_20150309_00016.jpg

LM Start	0.60	Rating **	A/W	Issue No.	21
LM End	0.60	Issue Type +	Ma	Location *	LS
Category	Earthen Levee		GPS Latitude/Longitude		
			Start	End	
Item	Encroachments		°	°	
			°	°	
DWR ID	DWR_RD0999_04_f_2013_21				
Action/Comments					
Tree or limb Inspector Comments: Downed tree on landward toe and berm.

Looking west at dead tree on landward toe and berm.

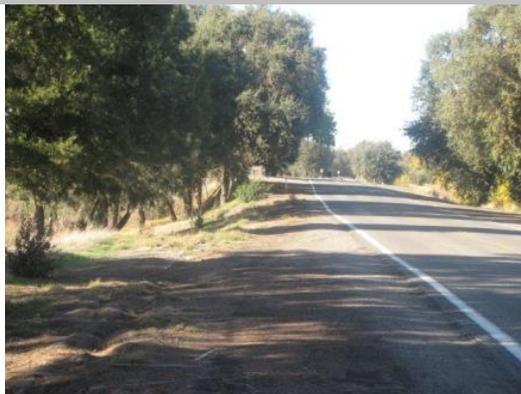
Photo 1 of 2 : SP_2015_RD0999_235_6_20150309_00004.jpg

Looking north at trimmed trees and removed fence on landside slope.

LM Start	0.71	Rating **	A/W	Issue No.	6
LM End	0.87	Issue Type +	Ma	Location *	LS
Category	Earthen Levee			GPS Latitude/Longitude	
				Start	End
Item	Trim / Thin Trees			38.423035 °	38.425140 °
				-121.529255 °	-121.530742 °
DWR ID	DWR_RD0999_04_s_2012_6				
Action/Comments					
Trim trees to at least five feet above ground level.

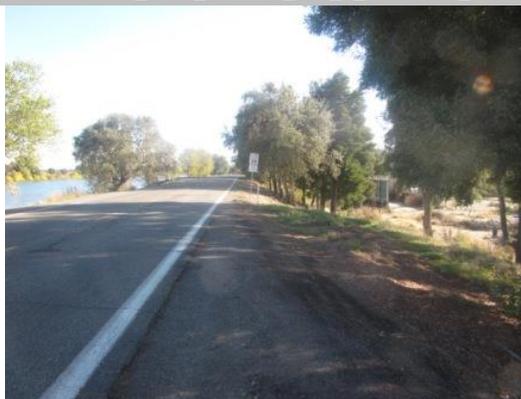
Photo 2 of 2 : SP_2015_RD0999_235_6_20150309_00005.jpg

Looking south at trimmed trees on landside slope and removed fence.

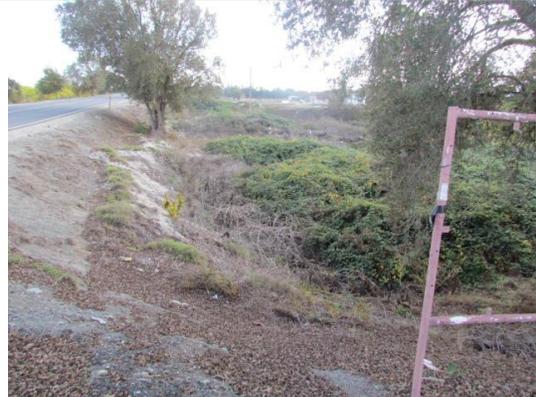
Photo 2 of 2 : SP_2015_RD0999_235_16_20150309_00014.jpg

LM Start	1.04	Rating **	A/W	Issue No.	16 (cont)
LM End	1.04	Issue Type +	Ma	Location *	LS
Category	Earthen Levee		GPS Latitude/Longitude		
			Start	End	
Item	Vegetation		38.427295 °	38.427295 °	
			-121.532164 °	-121.532164 °	
DWR ID	DWR_RD0999_04_f_2012_16				
Action/Comments					
Remove the wild growth other than native grasses from the levee slopes. Inspector Comments: Blackberries blocking view of landward toe.

Looking south at dense berryvines on landside toe. 2012

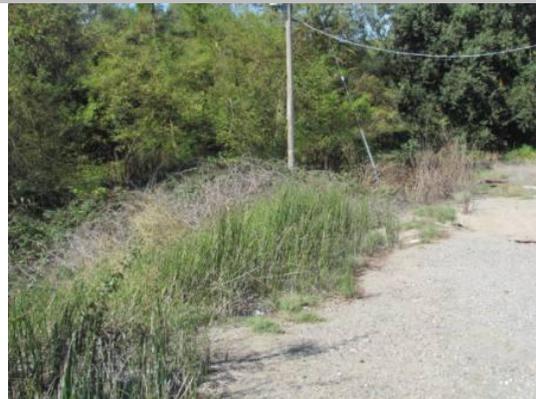
Photo 1 of 2 : SP_2015_RD0999_235_5_20150309_00002.jpg

LM Start	1.15	Rating **	M	Issue No.	5
LM End	1.15	Issue Type +	Ma	Location *	LS
Category	Earthen Levee		GPS Latitude/Longitude		
			Start	End	
Item	Vegetation		38.428823 °	38.428823 °	
			-121.532885 °	-121.532885 °	
DWR ID	DWR_RD0999_04_s_2012_5				
Action/Comments					
Remove the wild growth other than native grasses from the levee slopes. Inspector Comments: Berry vines and wild roses on landside toe.

Looking north at dense vegetation on landside slope near ramp.

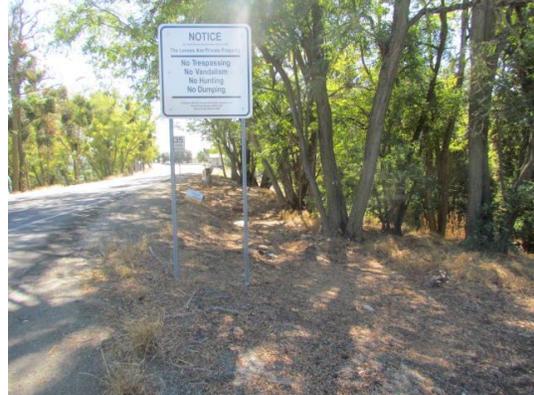
Photo 1 of 1 : SP_2015_RD0999_235_22_20150309_00017.jpg

Looking south at dense trees on landward slope.

LM Start	1.20	Rating **	M	Issue No.	22
LM End	1.22	Issue Type +	Ma	Location *	LS
Category	Earthen Levee		GPS Latitude/Longitude		
			Start		End
Item	Trim / Thin Trees		o		o
DWR ID	DWR_RD0999_04_f_2013_22				
Action/Comments					
Trim and thin trees to allow visibility of the ground and room to flood fight.

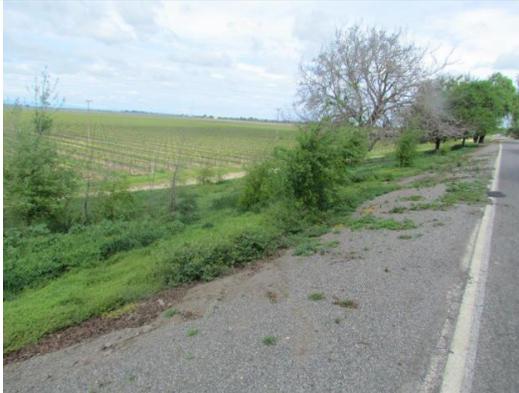
Photo 1 of 1 : SP_2015_RD0999_236_178_20150327_00141.jpg

Looking at typical view of young oak trees on landward slope. (Spring 2015)

LM Start	0.05	Rating **	M	Issue No.	178
LM End	0.05	Issue Type +	Ma	Location *	LS
Category	Earthen Levee			GPS Latitude/Longitude	
				Start	End
Item	Trim / Thin Trees			38.333308 °	38.333308 °
				-121.584494 °	-121.584494 °
DWR ID	DWR_RD0999_05_s_2015_178				
Action/Comments					
Thin trees to allow visibility of the ground and room to flood fight. Inspector Comments: Remove trees under an inch in diameter on landward slope. Don't allow young trees to get establish.

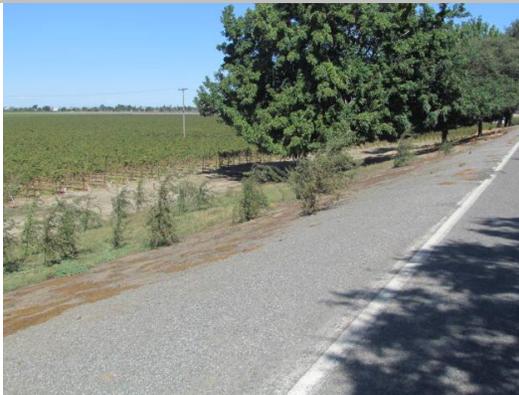
Photo 1 of 1 : SP_2015_RD0999_236_72_20150309_00054.jpg

LM Start	0.10	Rating **	A/W	Issue No.	72
LM End	0.10	Issue Type +	Ma	Location *	LS
Category	Earthen Levee			GPS Latitude/Longitude	
				Start	End
Item	Trim / Thin Trees				
DWR ID	DWR_RD0999_05_f_2013_72				
Action/Comments					
Trim and thin trees to allow visibility of the ground and room to flood fight. Inspector Comments: Remove small oak trees from landward slope before trees are establish.

Looking west at small oak trees on landward slope.

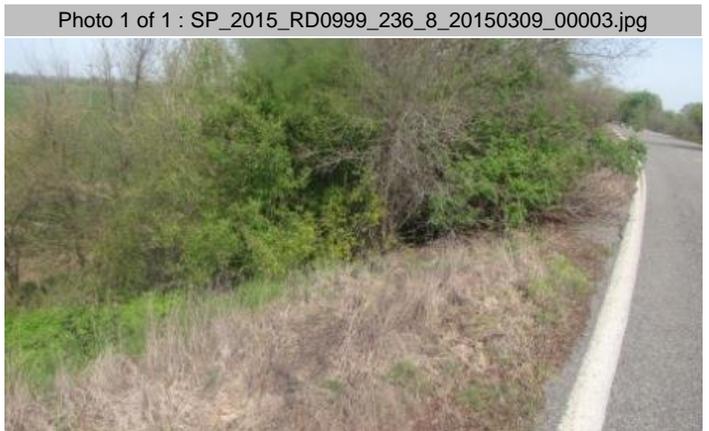
Looking north at dense vegetation on landside slope and toe.

LM Start	0.37	Rating **	M	Issue No.	8
LM End	0.45	Issue Type +	En	Location *	LS
Category	Earthen Levee		GPS Latitude/Longitude		
			Start	End	
Item	Trim / Thin Trees		38.337654 °	38.338790 °	
			-121.582427 °	-121.582184 °	
DWR ID	DWR_RD0999_05_s_2012_8				
Action/Comments					
Trim and thin trees to allow visibility of the ground and room to flood fight.

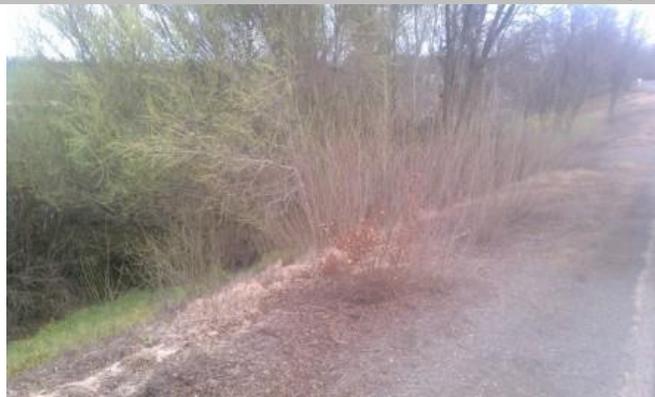
Photo 1 of 4 : SP_2015_RD0999_236_25_20150309_00019.jpg

LM Start	0.40	Rating **	M	Issue No.	25
LM End	0.44	Issue Type +	Ma	Location *	LS
Category	Earthen Levee			GPS Latitude/Longitude	
				Start	End
Item	Vegetation			38.338075 °	38.338688 °
				-121.582322 °	-121.582193 °
DWR ID	DWR_RD0999_05_s_2012_25				
Action/Comments					
Remove the wild growth other than native grasses from the levee slopes. Inspector Comments: Elderberries within vegetation area.

Looking northwest at dense vegetation on landside slope and toe.

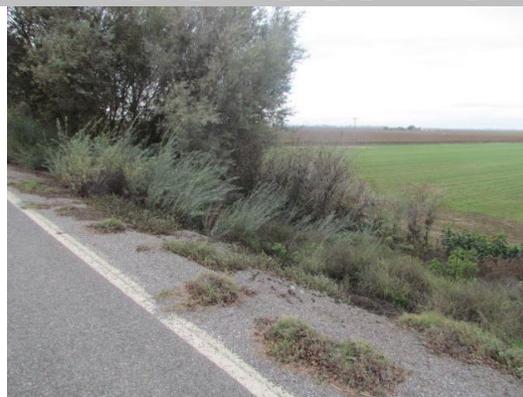
Photo 2 of 4 : SP_2015_RD0999_236_25_20150309_00020.jpg

Looking southwest at vegetation on landside slope and toe. (Fall 2012)

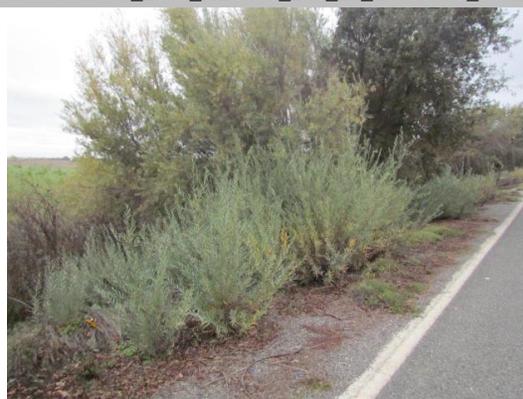
Photo 3 of 4 : SP_2015_RD0999_236_25_20150309_00021.jpg

Looking northwest at vegetation on landside shoulder. (Fall 2012)

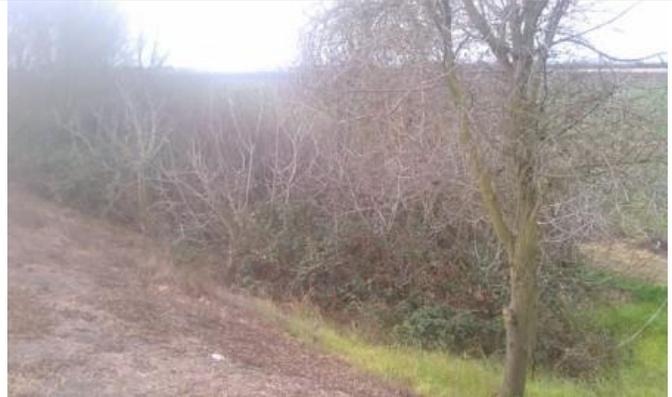
Photo 4 of 4 : SP_2015_RD0999_236_25_20150309_00022.jpg

LM Start	0.40	Rating **	M	Issue No.	25 (cont)
LM End	0.44	Issue Type +	Ma	Location *	LS
Category	Earthen Levee			GPS Latitude/Longitude	
				Start	End
Item	Vegetation			38.338075 °	38.338688 °
				-121.582322 °	-121.582193 °
DWR ID	DWR_RD0999_05_s_2012_25				
Action/Comments					
Remove the wild growth other than native grasses from the levee slopes. Inspector Comments: Elderberries within vegetation area.

Looking southwest at dense berry vines on landside toe.

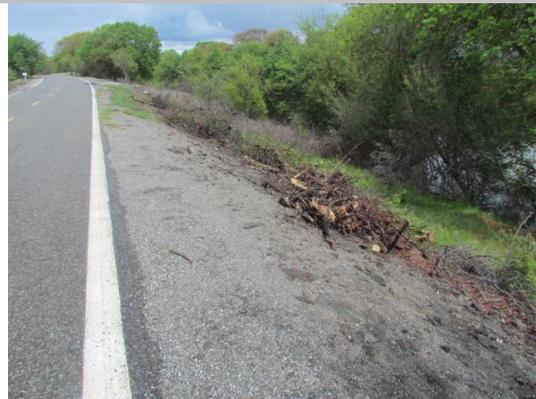
Photo 1 of 1 : SP_2015_RD0999_236_26_20150309_00023.jpg

LM Start	0.44	Rating **	A/W	Issue No.	26
LM End	0.45	Issue Type +	Ma	Location *	WS
Category	Earthen Levee			GPS Latitude/Longitude	
				Start	End
Item	Encroachments			38.338647 °	38.338868 °
				-121.582217 °	-121.582163 °
DWR ID	DWR_RD0999_05_s_2012_26				
Action/Comments					
Prunings

Looking northeast at prunings on waterside slope.

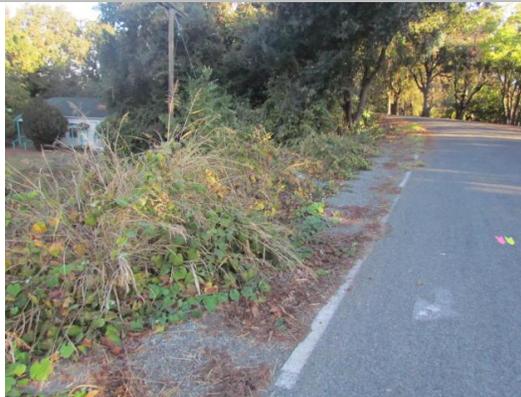
Photo 1 of 1 : SP_2015_RD0999_236_189_20150309_00103.jpg

LM Start	0.68	Rating **	A/W	Issue No.	189
LM End	0.68	Issue Type +	Ma	Location *	LS
Category	Earthen Levee			GPS Latitude/Longitude	
				Start	End
Item	Vegetation			38.342032 °	38.342032 °
				-121.581372 °	-121.581372 °
DWR ID	DWR_RD0999_05_f_2014_189				
Action/Comments					
Remove the wild growth other than native grasses from the levee slopes. Inspector Comments: Dense wild grapevines on landward slope.

Looking northwest at dense vegetation on landward slope.

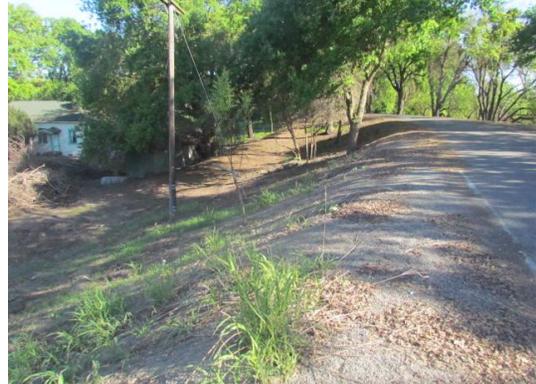
Photo 1 of 6 : SP_2015_RD0999_236_9_20150327_00142.jpg

Looking northwest at landward slope. (Spring 2015)

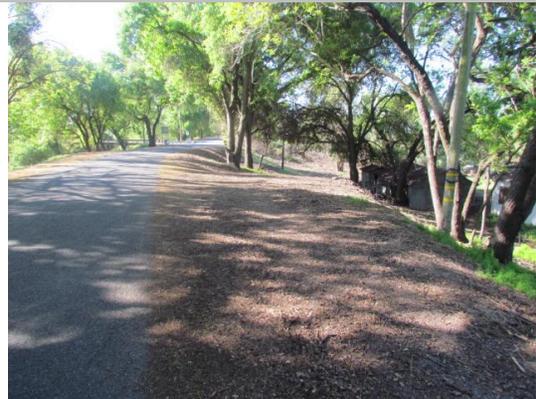
Photo 2 of 6 : SP_2015_RD0999_236_9_20150327_00143.jpg

Looking south at landward slope. (Spring 2015)

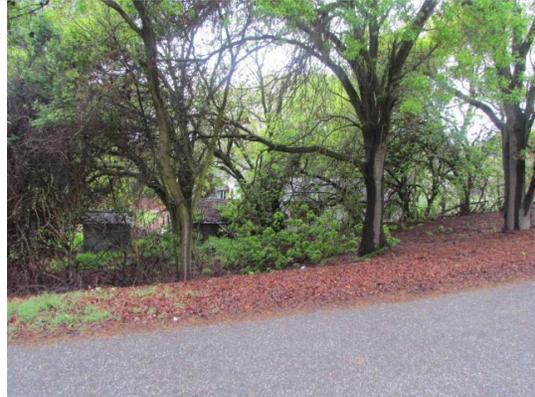
Photo 4 of 6 : SP_2015_RD0999_236_9_20150309_00006.jpg

Looking west at trimmed trees on landside slope. (Spring 2012)

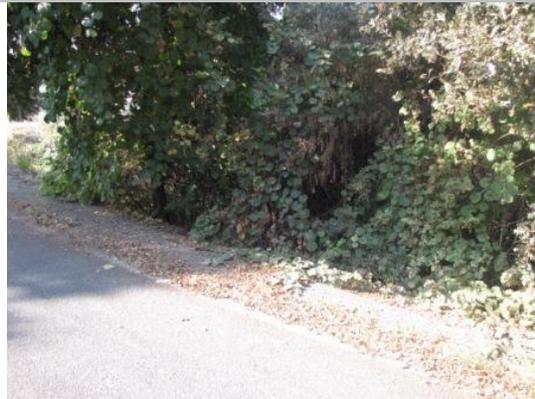
Photo 5 of 6 : SP_2015_RD0999_236_9_20150309_00007.jpg

Looking west at dense trees on landside slope and toe. (Spring 2011)

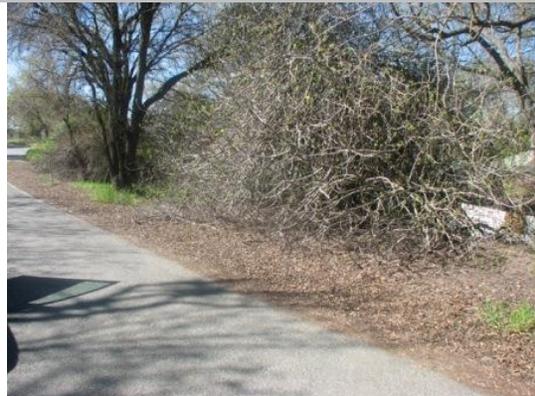
Photo 6 of 6 : SP_2015_RD0999_236_9_20150309_00004.jpg

Front view of dense trees at landside shoulder. (Spring 2011)
