**Flood Control Project Maintenance
Levee Inspections**
LMA District Cover Sheet
Spring 2015 Levee Inspection Results

Reclamation District No. 0999 Netherlands

Spring 2015 Levee Inspection Results

Waterway	Bank	Unit Miles
Unit No. 01 Yolo Bypass	Left	15.41

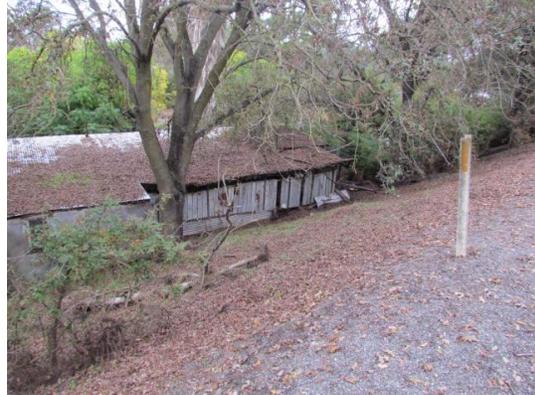
Photo 2 of 2 : SP_2015_RD0999_236_23_20150309_00018.jpg

LM Start	0.77	Rating **	U	Issue No.	23 (cont)
LM End	0.77	Issue Type +	En	Location *	LS
Category	Earthen Levee			GPS Latitude/Longitude	
				Start	End
Item	Encroachments			38.343358 °	38.343358 °
				-121.581295 °	-121.581295 °
DWR ID	DWR_RD0999_05_f_2012_23				
Action/Comments					
Building Inspector Comments: Storage shed at landside toe and within the 10' easement.

Looking northwest at storage shed at landside toe and within the 10' easement.

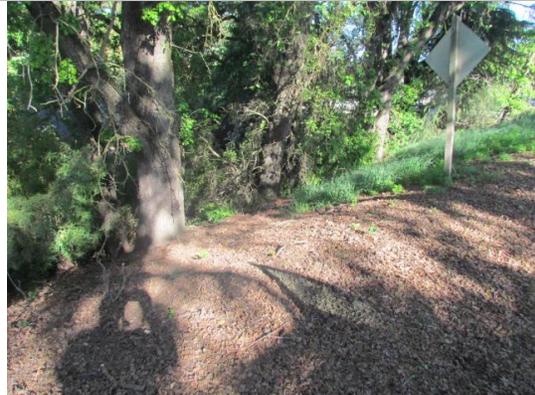
Photo 1 of 2 : SP_2015_RD0999_236_128_20150327_00145.jpg

Looking northwest at untrimmed trees on landward slope. (Spring 2015)

LM Start	0.78	Rating **	M	Issue No.	128
LM End	0.78	Issue Type +	Ma	Location *	LS
Category	Earthen Levee			GPS Latitude/Longitude	
				Start	End
Item	Trim / Thin Trees			38.343495 °	38.343495 °
				-121.581282 °	-121.581282 °
DWR ID	DWR_RD0999_05_s_2012_128				
Action/Comments					
Trim and thin trees to allow visibility of the ground and room to flood fight.

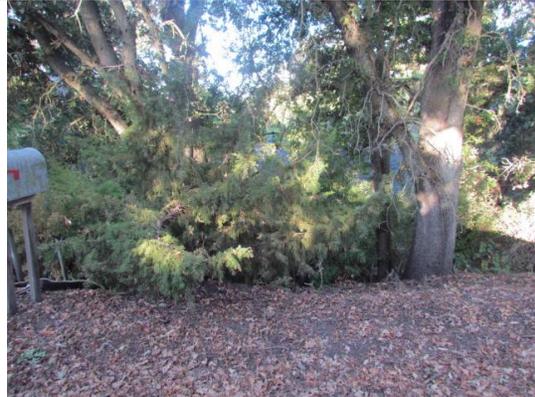
Photo 1 of 1 : SP_2015_RD0999_236_190_20150309_00104.jpg

Looking west at dense vegetation on landward slope and toe.

LM Start	0.79	Rating **	U	Issue No.	190
LM End	0.79	Issue Type +	Ma	Location *	LS
Category	Earthen Levee			GPS Latitude/Longitude	
				Start	End
Item	Trim / Thin Trees			38.343606 °	38.343606 °
				-121.581279 °	-121.581279 °
DWR ID	DWR_RD0999_05_f_2014_190				
Action/Comments					
Trim and thin trees to allow visibility of the ground and room to flood fight.

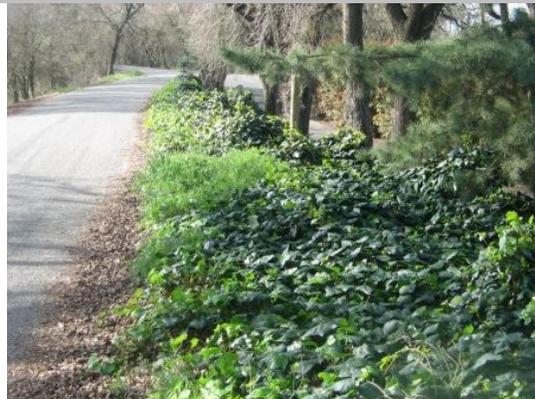
Photo 1 of 2 : SP_2015_RD0999_236_11_20150309_00008.jpg

LM Start	0.80	Rating **	U	Issue No.	11
LM End	0.90	Issue Type +	En	Location *	LS
Category	Earthen Levee			GPS Latitude/Longitude	
				Start	End
Item	Vegetation			38.343825 °	38.345215 °
				-121.581133 °	-121.580728 °
DWR ID	DWR_RD0999_05_s_2012_11				
Action/Comments					
Landscaping

View of landscaping (Ivy) looking upstream.

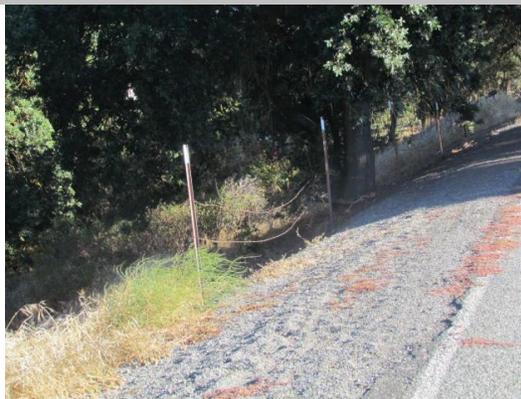
Photo 1 of 1 : SP_2015_RD0999_236_136_20150309_00082.jpg

LM Start	0.99	Rating **	M	Issue No.	136
LM End	1.02	Issue Type +	En	Location *	LS
Category	Earthen Levee			GPS Latitude/Longitude	
				Start	End
Item	Encroachments			°	°
				°	°
DWR ID	DWR_RD0999_05_f_2013_136				
Action/Comments					
Fence Inspector Comments: Fencing on landward slope.

Looking northwest at fence on landward slope.

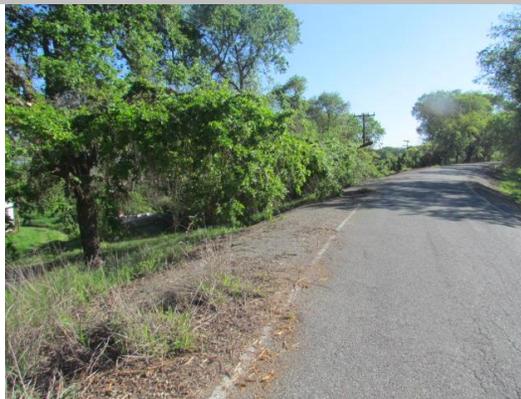
Photo 1 of 1 : SP_2015_RD0999_236_15_20150327_00146.jpg

Looking north at untrimmed trees on landward slope and toe. (Spring 2015)

LM Start	1.15	Rating **	M	Issue No.	15
LM End	1.19	Issue Type +	Ma	Location *	LS
Category	Earthen Levee		GPS Latitude/Longitude		
			Start	End	
Item	Trim / Thin Trees		38.348237 °	38.348328 °	
			-121.578440 °	-121.577735 °	
DWR ID	DWR_RD0999_05_s_2012_15				
Action/Comments					
Trim trees to at least five feet above ground level.

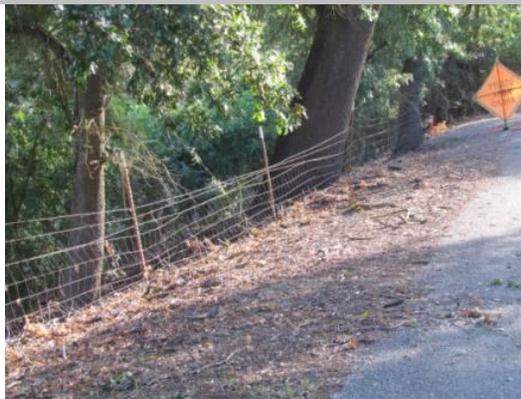
Photo 1 of 1 : SP_2015_RD0999_236_76_20150309_00056.jpg

LM Start	1.20	Rating **	M	Issue No.	76
LM End	1.22	Issue Type +	En	Location *	LS
Category	Earthen Levee			GPS Latitude/Longitude	
				Start	End
Item	Encroachments			38.348336 °	38.348332 °
				-121.577621 °	-121.577172 °
DWR ID	DWR_RD0999_05_s_2012_76				
Action/Comments					
Fence Inspector Comments: Fence is located on landside shoulder.

Looking north at fence along landside slope.

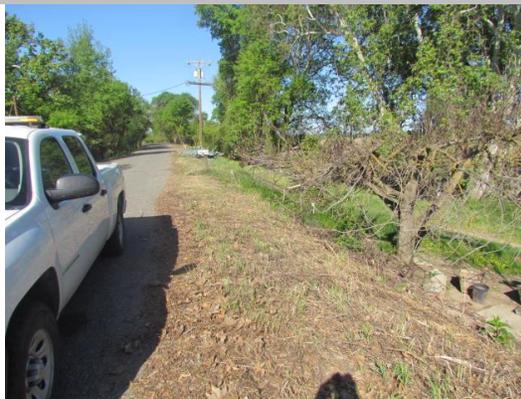
Photo 1 of 3 : SP_2015_RD0999_236_2_20150327_00147.jpg

LM Start	1.30	Rating **	M	Issue No.	2
LM End	1.36	Issue Type +	En	Location *	LS
Category	Earthen Levee			GPS Latitude/Longitude	
				Start	End
Item	Vegetation			38.348267 °	38.348188 °
				-121.575802 °	-121.574690 °
DWR ID	DWR_RD0999_05_s_2012_2				
Action/Comments					
Landscaping Inspector Comments: Control landscaping on landward slope. Landowner has trimmed landscaping. But has not removed century plant on landward shoulder.

Looking south at landward slope. (Spring 2015)

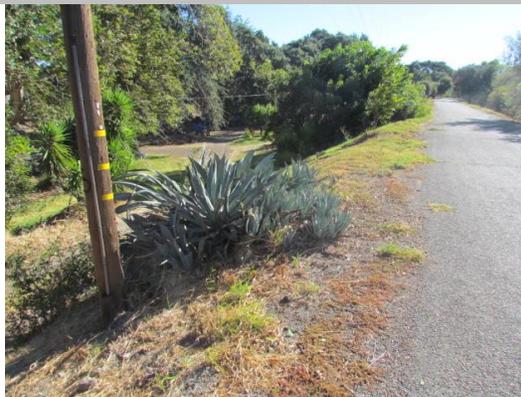
Photo 2 of 3 : SP_2015_RD0999_236_2_20150309_00002.jpg

LM Start	1.30	Rating **	M	Issue No.	2 (cont)
LM End	1.36	Issue Type +	En	Location *	LS
Category	Earthen Levee		GPS Latitude/Longitude		
			Start	End	
Item	Vegetation		38.348267 °	38.348188 °	
			-121.575802 °	-121.574690 °	
DWR ID	DWR_RD0999_05_s_2012_2				
Action/Comments					
Landscaping Inspector Comments: Control landscaping on landward slope. Landowner has trimmed landscaping. But has not removed century plant on landward shoulder.

Looking northwest at landscaping on landward slope.

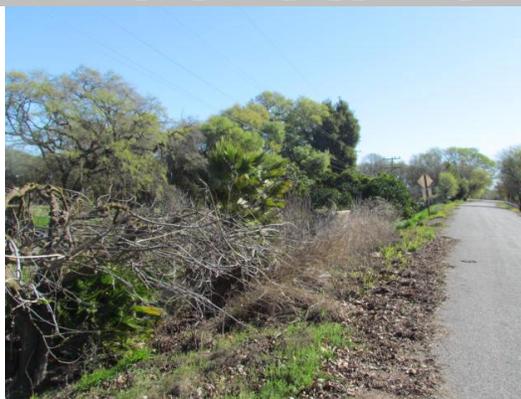
Photo 3 of 3 : SP_2015_RD0999_236_2_20150309_00001.jpg

Looking south at landscaping on landward slope.

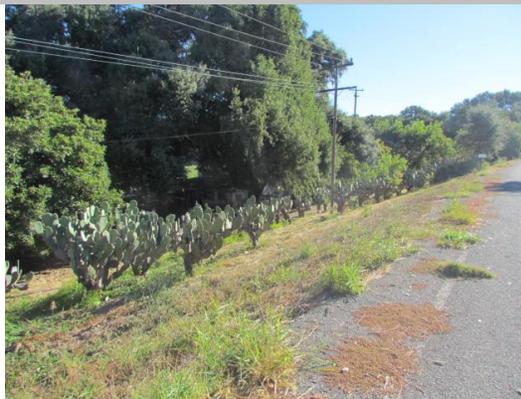
Photo 1 of 1 : SP_2015_RD0999_236_149_20150309_00090.jpg

LM Start	1.38	Rating **	M	Issue No.	149
LM End	1.41	Issue Type +	En	Location *	LS
Category	Earthen Levee			GPS Latitude/Longitude	
				Start	End
Item	Vegetation				
DWR ID	DWR_RD0999_05_f_2013_149				
Action/Comments					
Landscaping Inspector Comments: Large cactus plants on landward slope.

Looking northwest at several cactus plants on landward slope.

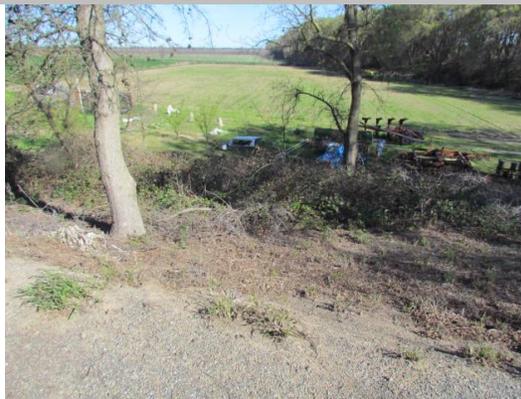
Photo 1 of 2 : SP_2015_RD0999_236_129_20150309_00077.jpg

LM Start	1.39	Rating **	M	Issue No.	129
LM End	1.39	Issue Type +	Ma	Location *	LS
Category	Earthen Levee			GPS Latitude/Longitude	
				Start	End
Item	Vegetation			38.348100 °	38.348100 °
				-121.574075 °	-121.574075 °
DWR ID	DWR_RD0999_05_s_2012_129				
Action/Comments					
Remove the wild growth other than native grasses from the levee slopes. Inspector Comments: Berry vines and century plants on landside toe and slope.

Looking southwest at berry vines on landward slope.

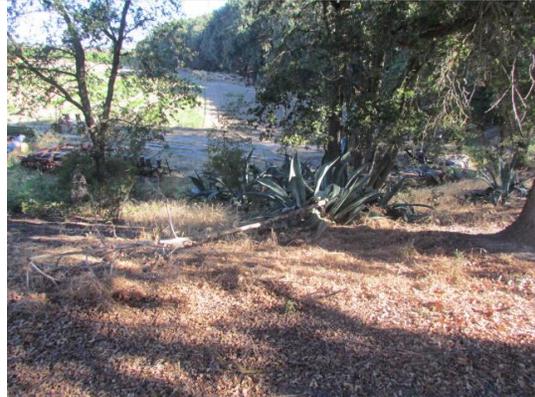
Photo 2 of 2 : SP_2015_RD0999_236_129_20150309_00078.jpg

LM Start	1.39	Rating **	M	Issue No.	129 (cont)
LM End	1.39	Issue Type +	Ma	Location *	LS
Category	Earthen Levee			GPS Latitude/Longitude	
				Start	End
Item	Vegetation			38.348100 °	38.348100 °
				-121.574075 °	-121.574075 °
DWR ID	DWR_RD0999_05_s_2012_129				
Action/Comments					
Remove the wild growth other than native grasses from the levee slopes. Inspector Comments: Berry vines and century plants on landside toe and slope.

Looking west at century plants on landward slope.

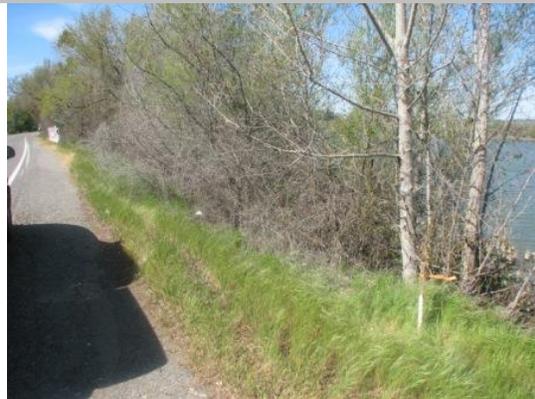
Photo 1 of 2 : SP_2015_RD0999_236_18_20150309_00015.jpg

LM Start	1.46	Rating **	M	Issue No.	18
LM End	1.83	Issue Type +	Ma	Location *	LS
Category	Earthen Levee			GPS Latitude/Longitude	
				Start	End
Item	Trim / Thin Trees			38.348670 °	38.353852 °
				-121.573320 °	-121.573570 °
DWR ID	DWR_RD0999_05_s_2012_18				
Action/Comments					
Trim and thin trees to allow visibility of the ground and room to flood fight.

Side view of dense trees along waterside slope.

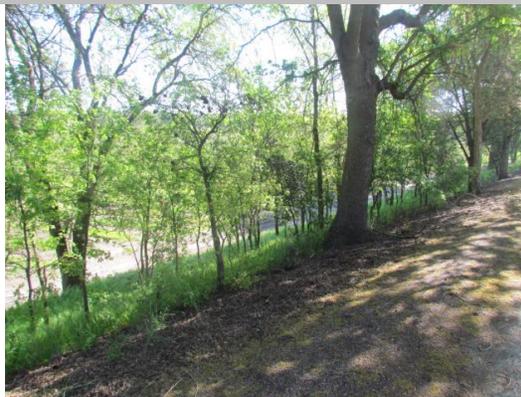
Photo 1 of 1 : SP_2015_RD0999_236_24_20150327_00148.jpg

LM Start	2.14	Rating **	M	Issue No.	24
LM End	2.16	Issue Type +	Ma	Location *	LS
Category	Earthen Levee			GPS Latitude/Longitude	
				Start	End
Item	Trim / Thin Trees			38.355402 °	38.355282 °
				-121.568893 °	-121.568547 °
DWR ID	DWR_RD0999_05_s_2012_24				
Action/Comments					
Trim and thin trees to allow visibility of the ground and room to flood fight.

Looking west at dense trees on landward slope. (Spring 2015)

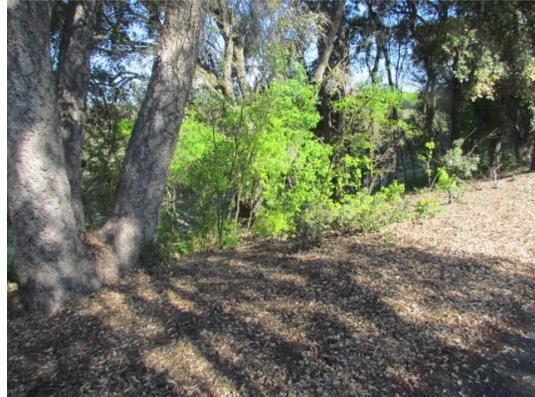
Photo 1 of 1 : SP_2015_RD0999_236_82_20150327_00149.jpg

LM Start	2.51	Rating **	M	Issue No.	82
LM End	2.65	Issue Type +	Ma	Location *	LS
Category	Earthen Levee		GPS Latitude/Longitude		
			Start	End	
Item	Trim / Thin Trees		38.356270 °	38.358132 °	
			-121.563218 °	-121.562347 °	
DWR ID	DWR_RD0999_05_s_2012_82				
Action/Comments					
Trim and thin trees to allow visibility of the ground and room to flood fight.

Looking northwest at dense trees on landward slope. (Spring 2015)

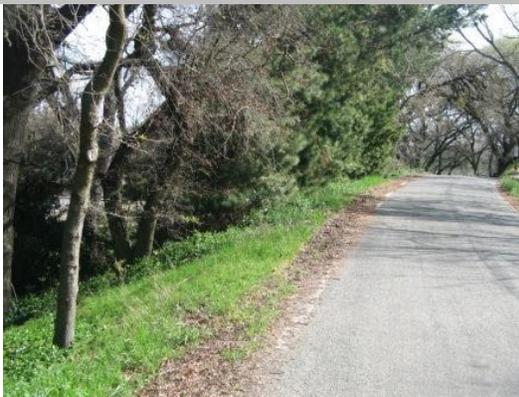
Photo 1 of 1 : SP_2015_RD0999_236_31_20150309_00025.jpg

LM Start	3.12	Rating **	M	Issue No.	31
LM End	3.17	Issue Type +	En	Location *	LS
Category	Earthen Levee		GPS Latitude/Longitude		
			Start	End	
Item	Vegetation		38.364392 °	38.364597 °	
			-121.561882 °	-121.561087 °	
DWR ID	DWR_RD0999_05_s_2012_31				
Action/Comments					
Landscaping

Looking downstream of landscaping blocking view of landside slope.

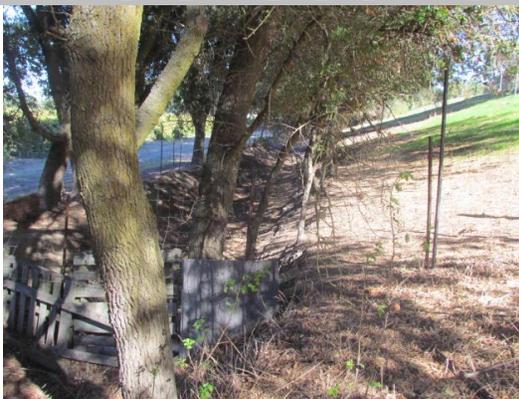
Photo 1 of 3 : SP_2015_RD0999_236_153_20150309_00093.jpg

LM Start	3.21	Rating **	M	Issue No.	153
LM End	4.22	Issue Type +	En	Location *	LS
Category	Earthen Levee		GPS Latitude/Longitude		
			Start	End	
Item	Encroachments		38.364694 °	38.372513 °	
			-121.560209 °	-121.552538 °	
DWR ID	DWR_RD0999_05_f_2013_153				
Action/Comments					
Ditch Inspector Comments: Adandoned irrigation ditch at landward toe.

Looking north at old irrigation ditch at landward toe.

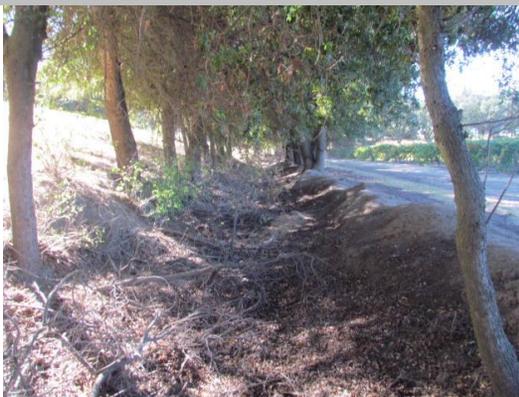
Photo 2 of 3 : SP_2015_RD0999_236_153_20150309_00094.jpg

Looking south at irrigation ditch at landward toe.

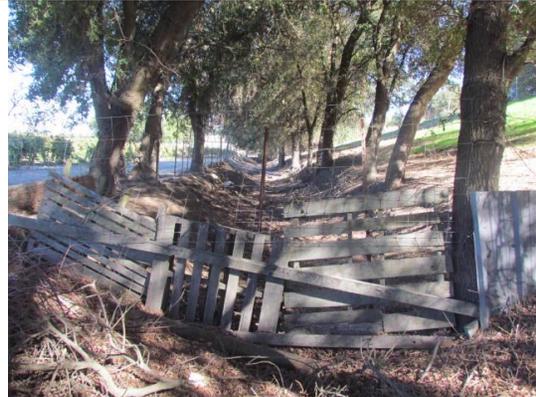
Photo 3 of 3 : SP_2015_RD0999_236_153_20150309_00095.jpg

LM Start	3.21	Rating **	M	Issue No.	153 (cont)
LM End	4.22	Issue Type +	En	Location *	LS
Category	Earthen Levee			GPS Latitude/Longitude	
				Start	End
Item	Encroachments			38.364694 °	38.372513 °
				-121.560209 °	-121.552538 °
DWR ID	DWR_RD0999_05_f_2013_153				
Action/Comments					
Ditch Inspector Comments: Adandoned irrigation ditch at landward toe.

Looking north at irrigation ditch at landward toe.

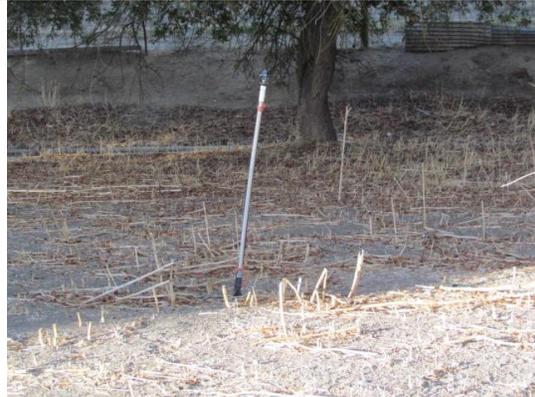
Photo 1 of 1 : SP_2015_RD0999_236_202_20150309_00113.jpg

LM Start	3.58	Rating **	M	Issue No.	202
LM End	3.64	Issue Type +	En	Location *	LS
Category	Earthen Levee		GPS Latitude/Longitude		
			Start	End	
Item	Encroachments		38.366100 °	38.367043 °	
			-121.556831 °	-121.556772 °	
DWR ID	DWR_RD0999_05_f_2014_202				
Action/Comments					
Landscape Irrigation Inspector Comments: Landowner installed sprinkler system on landward slope.

Looking west at one of several sprinklers installed on landward slope.

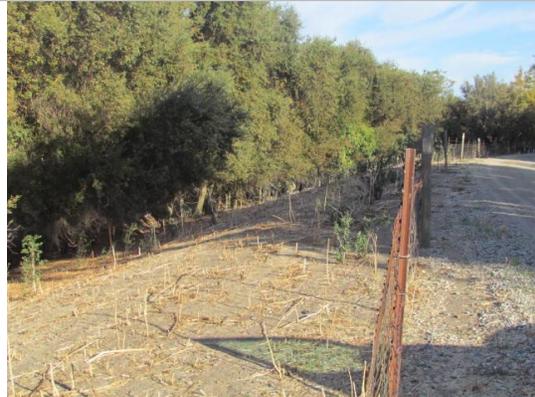
Photo 1 of 2 : SP_2015_RD0999_236_201_20150309_00111.jpg

LM Start	3.58	Rating **	M	Issue No.	201
LM End	3.64	Issue Type +	Ma	Location *	LS
Category	Earthen Levee		GPS Latitude/Longitude		
			Start	End	
Item	Trim / Thin Trees		38.366103 °	38.367035 °	
			-121.556820 °	-121.556781 °	
DWR ID	DWR_RD0999_05_f_2014_201				
Action/Comments					
Thin trees to allow visibility of the ground and room to flood fight. Inspector Comments: Landowner has planted oak trees and installed sprinklers on landward slope. Oak trees should be removed.

Looking northwest at several small oak trees planted along landward slope.

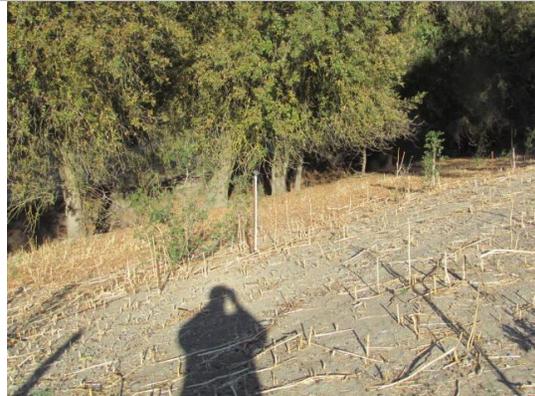
Photo 2 of 2 : SP_2015_RD0999_236_201_20150309_00112.jpg

Looking west a several small oak trees planted on landward slope.

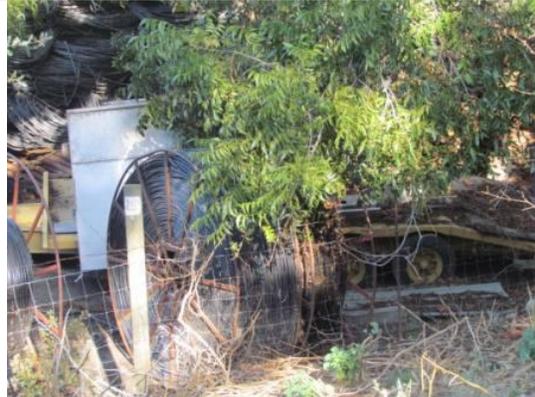
Photo 1 of 2 : SP_2015_RD0999_236_16_20150309_00011.jpg

LM Start	3.64	Rating **	M	Issue No.	16
LM End	3.64	Issue Type +	Ma	Location *	LS
Category	Earthen Levee		GPS Latitude/Longitude		
			Start	End	
Item	Encroachments		38.366958 °	38.366958 °	
			-121.556822 °	-121.556822 °	
DWR ID	DWR_RD0999_05_s_2012_16				
Action/Comments					
Equipment Inspector Comments: Equipment stored at landside toe.

Looking northwest at equipment on landside toe.

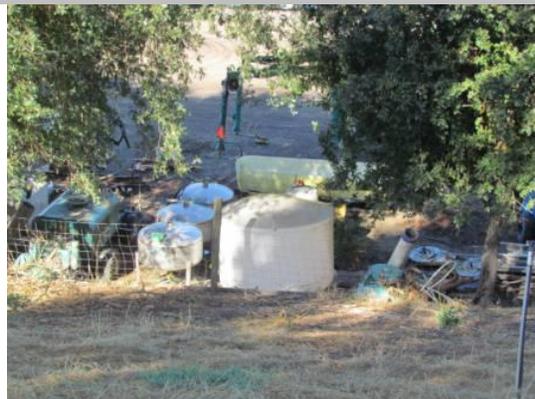
Photo 2 of 2 : SP_2015_RD0999_236_16_20150309_00012.jpg

Looking west at equipment at landside toe.

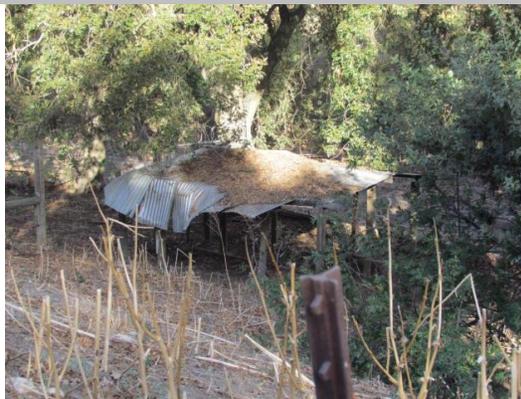
Photo 2 of 2 : SP_2015_RD0999_236_85_20150309_00060.jpg

LM Start	3.68	Rating **	M	Issue No.	85 (cont)
LM End	3.75	Issue Type +	En	Location *	LS
Category	Earthen Levee		GPS Latitude/Longitude		
			Start	End	
Item	Encroachments		38.367500 °	38.367997 °	
			-121.556478 °	-121.555348 °	
DWR ID	DWR_RD0999_05_s_2012_85				
Action/Comments					
Fence Inspector Comments: Fencing is for livestock.

Looking west at animal shelter within animal pen on landward slope.

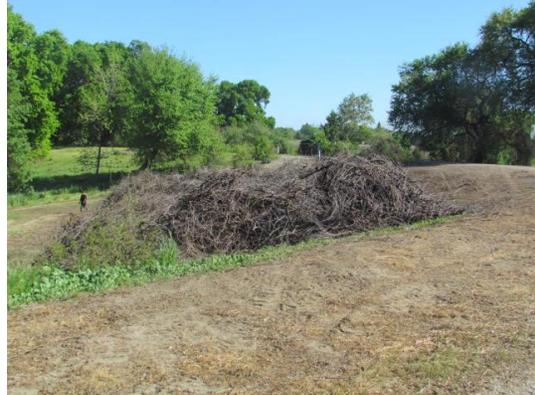
Photo 1 of 2 : SP_2015_RD0999_236_17_20150327_00150.jpg

LM Start	3.88	Rating **	U	Issue No.	17
LM End	3.88	Issue Type +	En	Location *	LS
Category	Earthen Levee		GPS Latitude/Longitude		
			Start	End	
Item	Encroachments		38.368307 °	38.368307 °	
			-121.552955 °	-121.552955 °	
DWR ID	DWR_RD0999_05_s_2012_17				
Action/Comments					
Prunings Inspector Comments: Large pruning pile on landward toe and slope.

Looking northwest at large pruning pile on landward slope and berm. (Spring 2015)

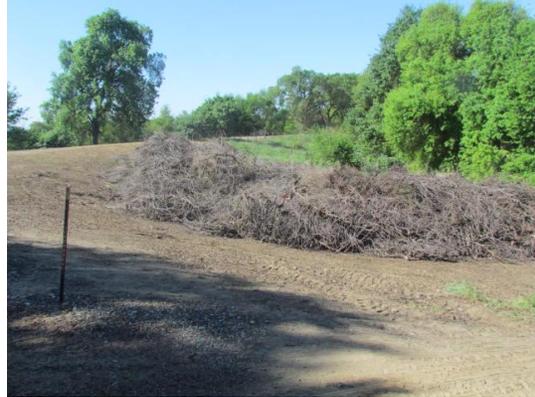
Photo 2 of 2 : SP_2015_RD0999_236_17_20150327_00151.jpg

Looking southwest at large pruning pile on landward slope and berm. (Spring 2015)

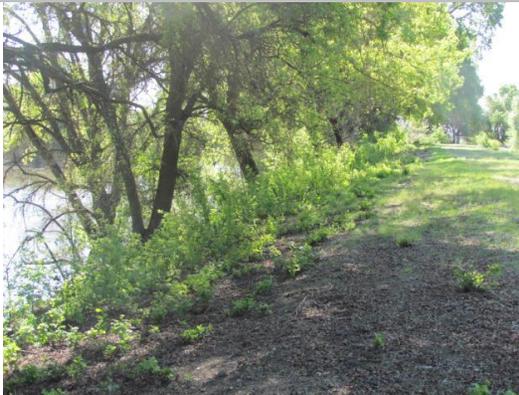
Photo 1 of 2 : SP_2015_RD0999_236_41_20150327_00153.jpg

Looking southeast at saplings on waterward slope. (Spring 2015)

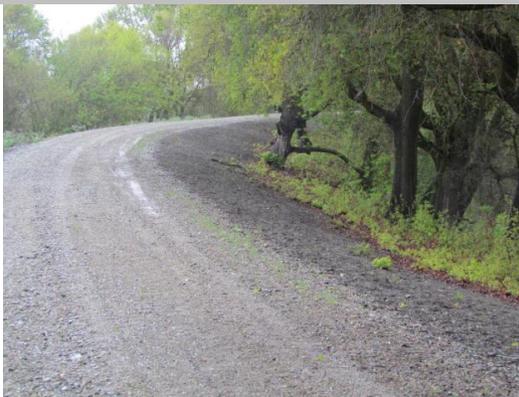
Photo 2 of 2 : SP_2015_RD0999_236_41_20150309_00035.jpg

Looking northeast at trimmed trees on waterside slope.

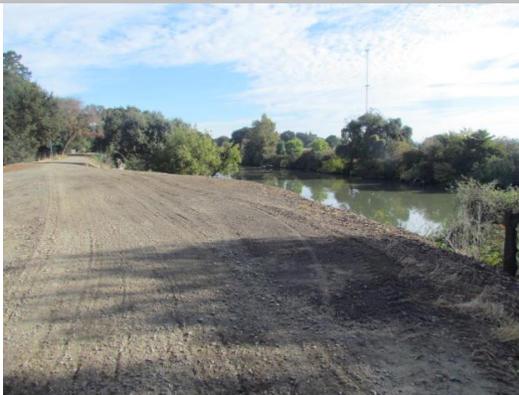
Photo 1 of 2 : SP_2015_RD0999_236_35_20150309_00027.jpg

LM Start	4.23	Rating **	A/W	Issue No.	35
LM End	4.23	Issue Type +	En	Location *	WS
Category	Earthen Levee		GPS Latitude/Longitude		
			Start	End	
Item	Encroachments		38.372672 °	38.372672 °	
			-121.552380 °	-121.552380 °	
DWR ID	DWR_RD0999_05_s_2012_35				
Action/Comments					
Prunings

Looking northeast at corrected pruning site on waterward shoulder and slope.

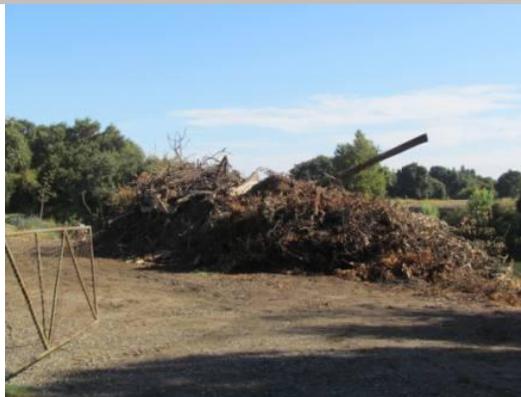
Photo 2 of 2 : SP_2015_RD0999_236_35_20150309_00028.jpg

Looking northeast at larger pruning pile on waterside shoulder.

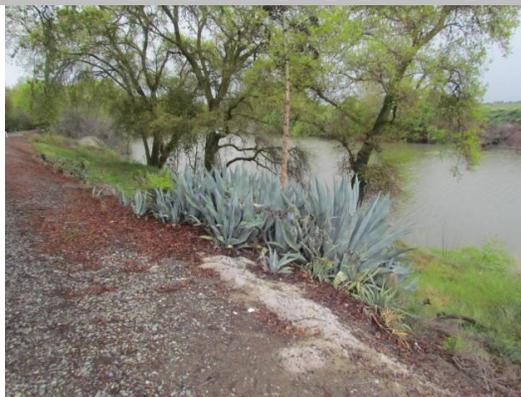
Photo 1 of 1 : SP_2015_RD0999_236_55_20150309_00045.jpg

LM Start	4.29	Rating **	M	Issue No.	55
LM End	4.29	Issue Type +	En	Location *	WS
Category	Earthen Levee			GPS Latitude/Longitude	
				Start	End
Item	Vegetation			38.373517 °	38.373517 °
				-121.551867 °	-121.551867 °
DWR ID	DWR_RD0999_05_s_2012_55				
Action/Comments					
Landscaping Inspector Comments: Century plant on waterside slope.

Looking at century plants on waterside shoulder.(Spring 2012)

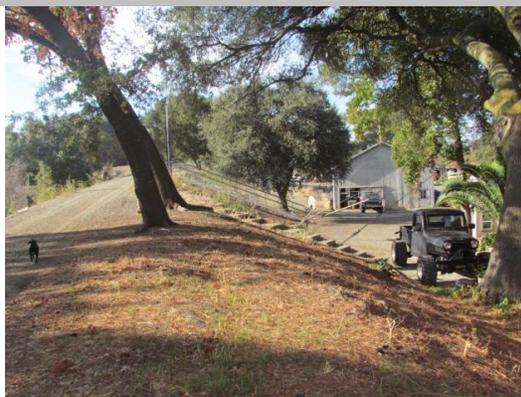
Photo 1 of 4 : SP_2015_RD0999_236_44_20150309_00038.jpg

LM Start	4.30	Rating **	A/W	Issue No.	44
LM End	4.33	Issue Type +	En	Location *	LS
Category	Earthen Levee			GPS Latitude/Longitude	
				Start	End
Item	Vegetation			38.373625 °	38.373907 °
				-121.551787 °	-121.551607 °
DWR ID	DWR_RD0999_05_s_2012_44				
Action/Comments					
Landscaping Inspector Comments: Landowner complies with Board standards.

Looking south at corrected landscaping on landward slope.

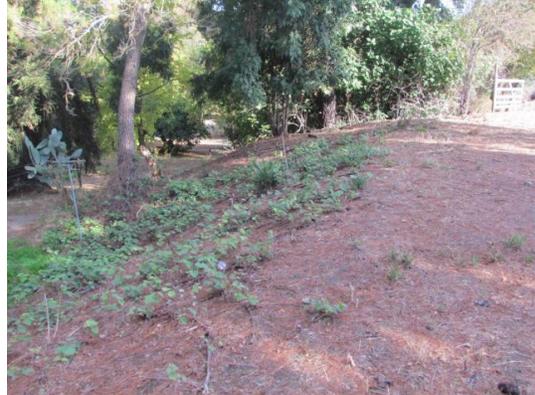
Photo 2 of 4 : SP_2015_RD0999_236_44_20150309_00039.jpg

Looking north at corrected landscaping on landward slope.

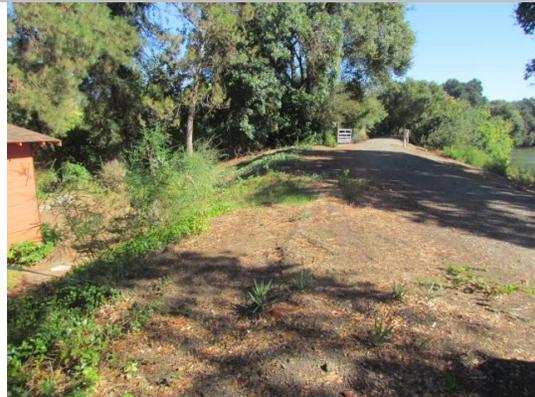
Photo 3 of 4 : SP_2015_RD0999_236_44_20150309_00040.jpg

Looking north at landscaping on landward slope.

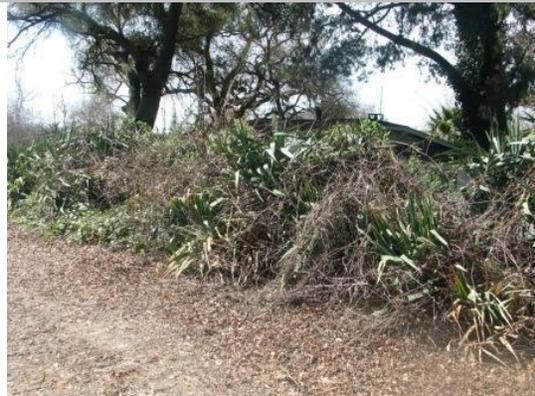
Photo 4 of 4 : SP_2015_RD0999_236_44_20150309_00041.jpg

Overgrown landscaping on landside slope blocking view of slope.

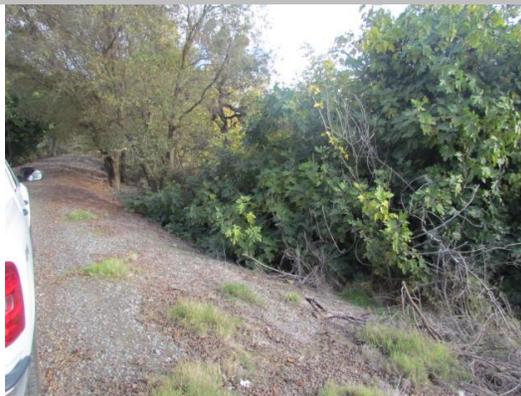
Photo 1 of 1 : SP_2015_RD0999_236_28_20150309_00024.jpg

Looking northeast at fig tree on waterside slope.

LM Start	4.35	Rating **	A/W	Issue No.	28
LM End	4.35	Issue Type +	Ma	Location *	WS
Category	Earthen Levee			GPS Latitude/Longitude	
				Start	End
Item	Vegetation			38.374215 °	38.374215 °
				-121.551352 °	-121.551352 °
DWR ID	DWR_RD0999_05_f_2012_28				
Action/Comments					
Remove the wild growth other than native grasses from the levee slopes.

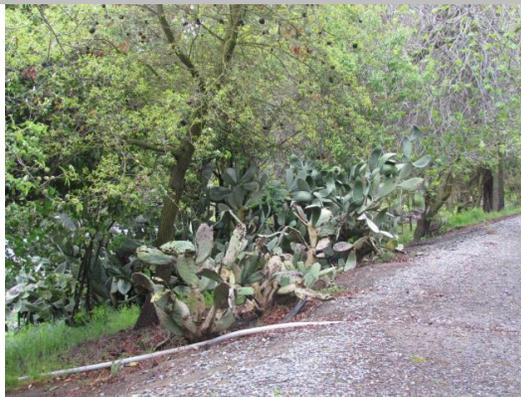
Photo 1 of 1 : SP_2015_RD0999_236_56_20150309_00046.jpg

LM Start	4.37	Rating **	M	Issue No.	56
LM End	4.37	Issue Type +	En	Location *	LS
Category	Earthen Levee		GPS Latitude/Longitude		
			Start	End	
Item	Vegetation		38.374410 °	38.374410 °	
			-121.551173 °	-121.551173 °	
DWR ID	DWR_RD0999_05_s_2012_56				
Action/Comments					
Landscaping Inspector Comments: Cactus

Looking northwest at cactus on landside shoulder and slope. (Spring 2012)

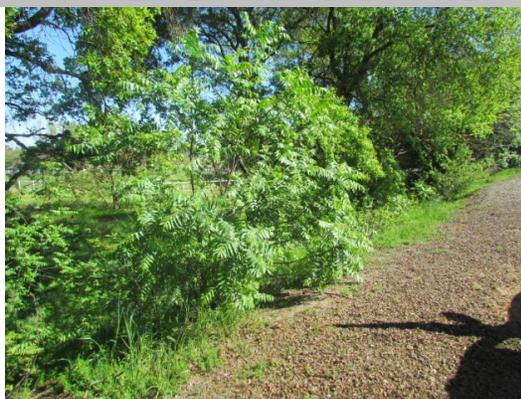
Photo 1 of 1 : SP_2015_RD0999_236_57_20150327_00154.jpg

Looking northwest at dense trees on landward slope. (Spring 2015)

LM Start	4.42	Rating **	M	Issue No.	57
LM End	4.46	Issue Type +	Ma	Location *	LS
Category	Earthen Levee		GPS Latitude/Longitude		
			Start	End	
Item	Trim / Thin Trees		38.374866 °	38.375061 °	
			-121.550491 °	-121.549800 °	
DWR ID	DWR_RD0999_05_s_2012_57				
Action/Comments					
Trim and thin trees to allow visibility of the ground and room to flood fight.

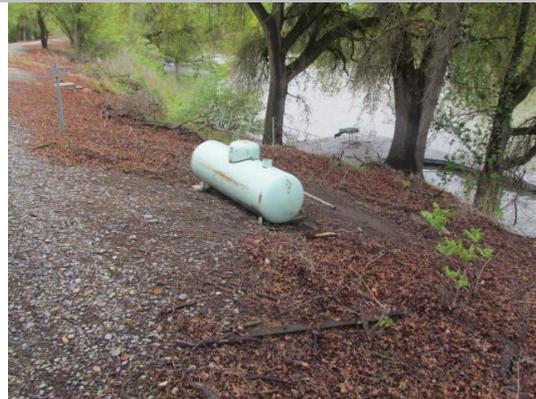
Photo 1 of 1 : SP_2015_RD0999_236_131_20150309_00079.jpg

LM Start	4.45	Rating **	M	Issue No.	131
LM End	4.45	Issue Type +	En	Location *	WS
Category	Earthen Levee			GPS Latitude/Longitude	
				Start	End
Item	Encroachments			38.375027 °	38.375027 °
				-121.549883 °	-121.549883 °
DWR ID	DWR_RD0999_05_s_2012_131				
Action/Comments					
Equipment Inspector Comments: Propane tank on waterside slope within the twenty foot zone.

Looking northeast at propane tank on waterside slope.

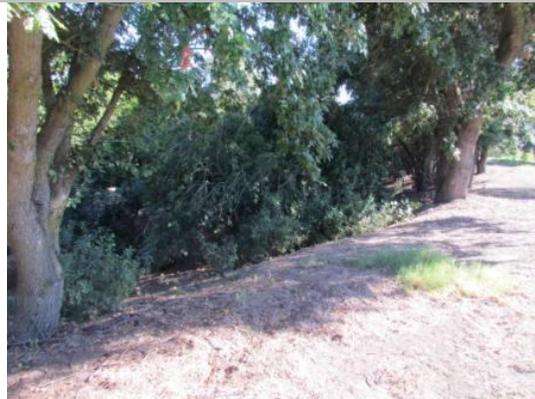
Photo 1 of 3 : SP_2015_RD0999_236_38_20150309_00029.jpg

Looking northwest at dense trees on landside slope. (Spring 2011)

LM Start	4.51	Rating **	A/W	Issue No.	38
LM End	4.64	Issue Type +	Ma	Location *	LS
Category	Earthen Levee			GPS Latitude/Longitude	
				Start	End
Item	Trim / Thin Trees			38.375055 °	38.375313 °
				-121.548792 °	-121.546438 °
DWR ID	DWR_RD0999_05_s_2012_38				
Action/Comments					
Thin trees to allow visibility of the ground and room to flood fight.

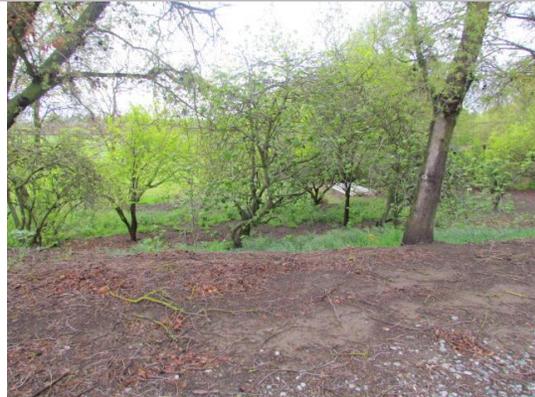
Photo 2 of 3 : SP_2015_RD0999_236_38_20150309_00030.jpg

Looking west at trimmed trees on landside slope. (Spring 2012)

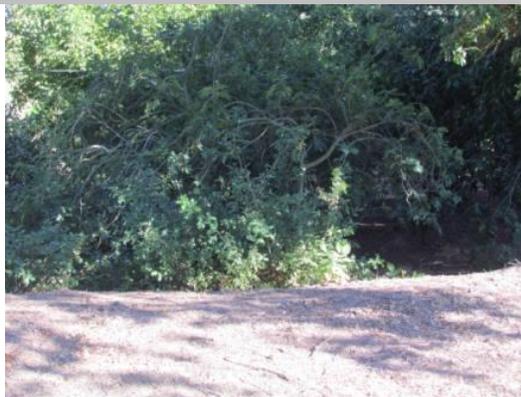
Photo 3 of 3 : SP_2015_RD0999_236_38_20150309_00031.jpg

Looking west at dense trees on landside slope. (Spring 2011)

LM Start	4.51	Rating **	A/W	Issue No.	38 (cont)
LM End	4.64	Issue Type +	Ma	Location *	LS
Category	Earthen Levee			GPS Latitude/Longitude	
				Start	End
Item	Trim / Thin Trees			38.375055 °	38.375313 °
				-121.548792 °	-121.546438 °
DWR ID	DWR_RD0999_05_s_2012_38				
Action/Comments					
Thin trees to allow visibility of the ground and room to flood fight.

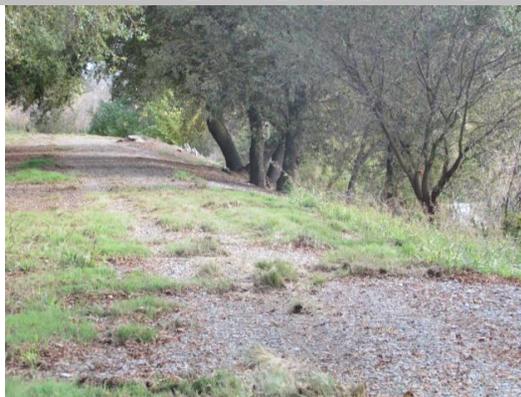
Photo 1 of 1 : SP_2015_RD0999_236_32_20150309_00026.jpg

Looking north at vegetation on levee crown.

LM Start	4.51	Rating **	A/W	Issue No.	32
LM End	4.85	Issue Type +	Ma	Location *	CR
Category	Earthen Levee			GPS Latitude/Longitude	
				Start	End
Item	Crown Surface / Depressions / Rutting			38.375084 °	38.377176 °
				-121.548750 °	-121.543571 °
DWR ID	DWR_RD0999_05_f_2012_32				
Action/Comments					
Add appropriate material and re-grade the levee to bring the crown above the design elevation.

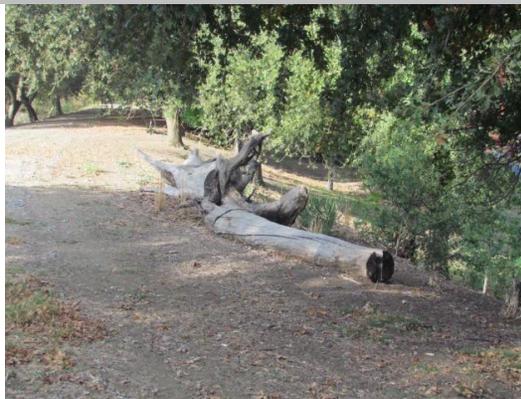
Photo 1 of 1 : SP_2015_RD0999_236_50_20150309_00043.jpg

LM Start	4.65	Rating **	A/W	Issue No.	50
LM End	4.65	Issue Type +	Ma	Location *	LS
Category	Earthen Levee		GPS Latitude/Longitude		
			Start	End	
Item	Encroachments		38.375373 °	38.375373 °	
			-121.546200 °	-121.546200 °	
DWR ID	DWR_RD0999_05_s_2012_50				
Action/Comments					
Tree or limb Inspector Comments: Old tree limbs on landward shoulder blocking access.

Looking southwest at tree limbs on landward shoulder.

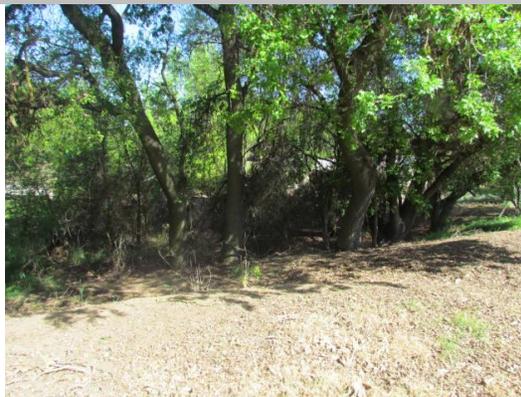
Photo 1 of 1 : SP_2015_RD0999_236_52_20150327_00155.jpg

Looking west at untrimmed trees on landward toe. (Spring 2015)

LM Start	4.67	Rating **	M	Issue No.	52
LM End	4.67	Issue Type +	Ma	Location *	LS
Category	Earthen Levee			GPS Latitude/Longitude	
				Start	End
Item	Trim / Thin Trees			38.375478 °	38.375478 °
				-121.545852 °	-121.545852 °
DWR ID	DWR_RD0999_05_s_2012_52				
Action/Comments					
Trim trees to at least five feet above ground level.

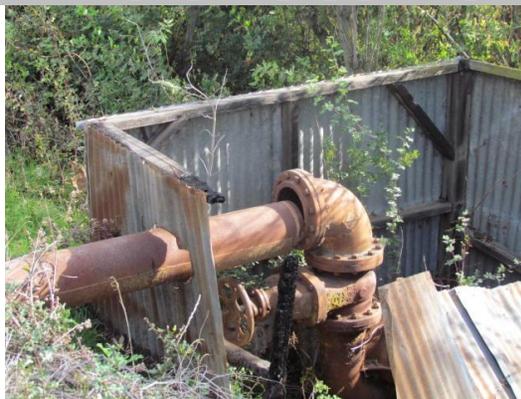
Photo 1 of 1 : SP_2015_RD0999_236_46_20150309_00042.jpg

LM Start	4.68	Rating **	M	Issue No.	46
LM End	4.68	Issue Type +	Ma	Location *	WS
Category	Earthen Levee			GPS Latitude/Longitude	
				Start	End
Item	Encroachments			38.375548 °	38.375548 °
				-121.545693 °	-121.545693 °
DWR ID	DWR_RD0999_05_f_2012_46				
Action/Comments					
Pipe Inspector Comments: Pipe is disconnected from pump and should be reconnected or removed.

Looking east at pipe disconnected from pump.

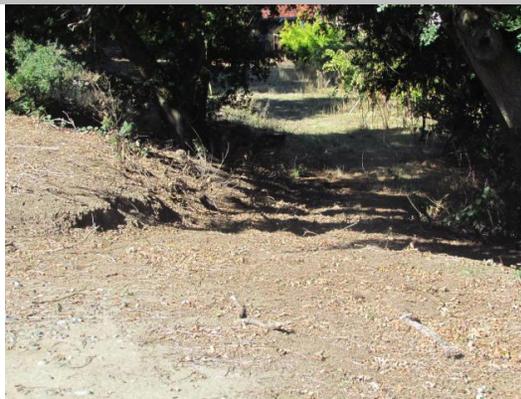
Photo 1 of 1 : SP_2015_RD0999_236_154_20150309_00096.jpg

Looking west at levee damage due to vehicle traffic.

LM Start	4.76	Rating **	A/W	Issue No.	154
LM End	4.76	Issue Type +	Ma	Location *	LS
Category	Earthen Levee			GPS Latitude/Longitude	
				Start	End
Item	Slope Stability				
DWR ID	DWR_RD0999_05_f_2013_154				
Action/Comments					
Repair the levee slope damaged by vehicle traffic and prevent access where possible. Inspector Comments: Levee damaged by vehicle traffic.

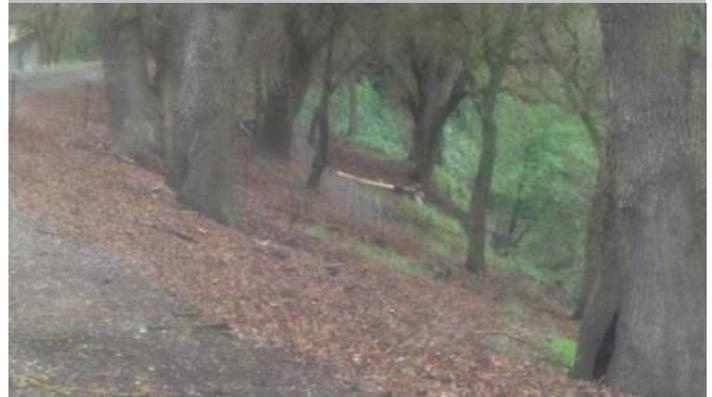
Photo 1 of 1 : SP_2015_RD0999_236_51_20150309_00044.jpg

LM Start	5.38	Rating **	M	Issue No.	51
LM End	5.42	Issue Type +	En	Location *	WS
Category	Earthen Levee			GPS Latitude/Longitude	
				Start	End
Item	Encroachments			38.381490 °	38.381795 °
				-121.545477 °	-121.545996 °
DWR ID	DWR_RD0999_05_s_2012_51				
Action/Comments					
Fence Inspector Comments: Fence is installed down waterside slope.

Looking northeast at fence on waterside slope.

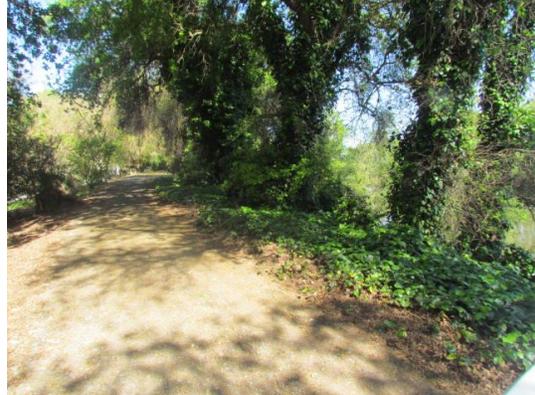
Photo 1 of 2 : SP_2015_RD0999_236_43_20150327_00157.jpg

LM Start	5.42	Rating **	U	Issue No.	43
LM End	5.44	Issue Type +	En	Location *	WS
Category	Earthen Levee		GPS Latitude/Longitude		
			Start	End	
Item	Vegetation		38.381815 °	38.382137 °	
			-121.546058 °	-121.546338 °	
DWR ID	DWR_RD0999_05_s_2012_43				
Action/Comments					
Landscaping Inspector Comments: Ground cover blocking view of waterward slope.

Looking north at dense groundcover and vegetation on waterward slope. (Spring 2015)

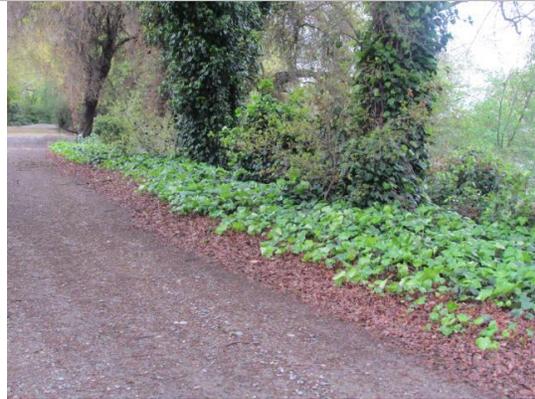
Photo 2 of 2 : SP_2015_RD0999_236_43_20150309_00037.jpg

Looking northeast at dense groundcover and vegetation on waterside slope.

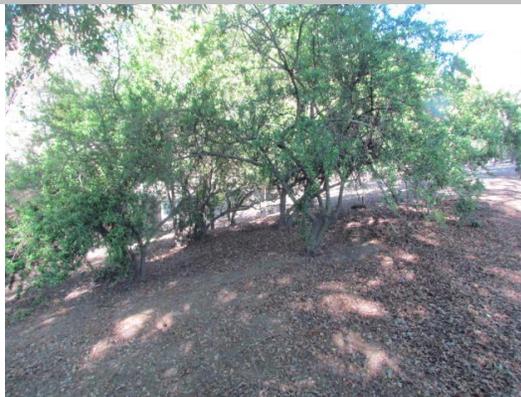
Photo 1 of 1 : SP_2015_RD0999_236_68_20150327_00158.jpg

Looking northeast at untrimmed trees on landward slope. (Spring 2015)

LM Start	5.48	Rating **	M	Issue No.	68
LM End	5.48	Issue Type +	Ma	Location *	LS
Category	Earthen Levee		GPS Latitude/Longitude		
			Start	End	
Item	Trim / Thin Trees		38.382553 °	38.382553 °	
			-121.546651 °	-121.546651 °	
DWR ID	DWR_RD0999_05_s_2012_68				
Action/Comments					
Trim trees to at least five feet above ground level.

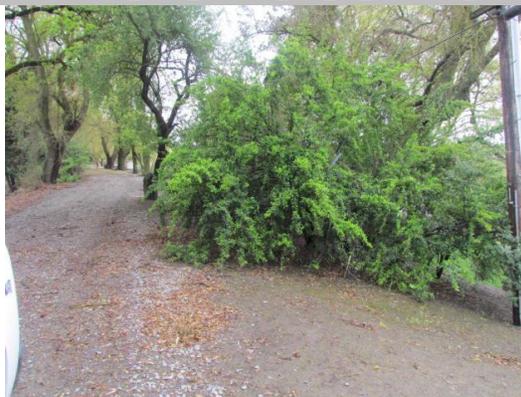
Photo 1 of 1 : SP_2015_RD0999_236_70_20150309_00052.jpg

Looking southwest at untrimmed tree on waterside shoulder and slope.

LM Start	5.49	Rating **	M	Issue No.	70
LM End	5.49	Issue Type +	Ma	Location *	LS
Category	Earthen Levee		GPS Latitude/Longitude		
			Start	End	
Item	Trim / Thin Trees		38.382698 °	38.382698 °	
			-121.546711 °	-121.546711 °	
DWR ID	DWR_RD0999_05_s_2012_70				
Action/Comments					
Trim and thin trees to allow visibility of the ground and room to flood fight.

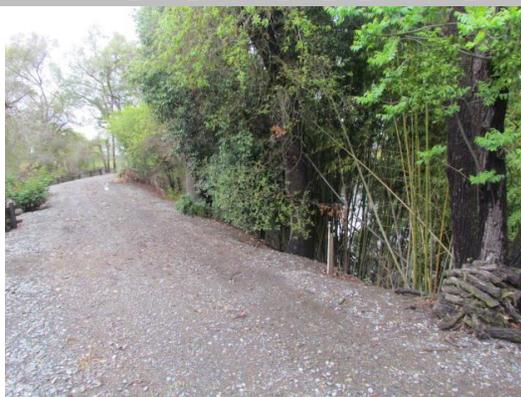
Photo 1 of 1 : SP_2015_RD0999_236_71_20150309_00053.jpg

Looking northeast at dense vegetation on waterside slope.

LM Start	5.50	Rating **	U	Issue No.	71
LM End	5.55	Issue Type +	Ma	Location *	WS
Category	Earthen Levee		GPS Latitude/Longitude		
			Start	End	
Item	Vegetation		38.382790 °	38.383548 °	
			-121.546754 °	-121.546728 °	
DWR ID	DWR_RD0999_05_s_2012_71				
Action/Comments					
Remove the wild growth other than native grasses from the levee slopes.

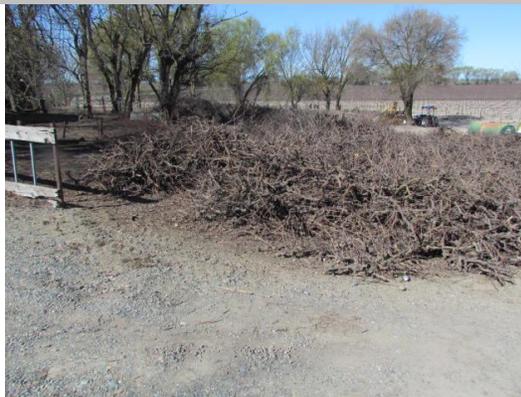
Photo 1 of 1 : SP_2015_RD0999_236_192_20150309_00105.jpg

LM Start	5.58	Rating **	A/W	Issue No.	192
LM End	5.58	Issue Type +	Ma	Location *	LS
Category	Earthen Levee			GPS Latitude/Longitude	
				Start	End
Item	Encroachments			38.383978 °	38.383978 °
				-121.546435 °	-121.546435 °
DWR ID	DWR_RD0999_05_s_2014_192				
Action/Comments					
Prunings Inspector Comments: Landowner pile prunings on landside slope.

Looking west at prunings on landward slope and toe.

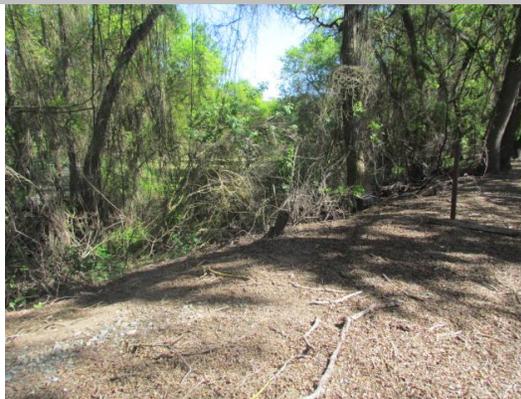
Photo 1 of 1 : SP_2015_RD0999_236_48_20150327_00159.jpg

Looking east at dense vegetation on landward slope. (Spring 2015)

LM Start	5.80	Rating **	M	Issue No.	48
LM End	5.84	Issue Type +	Ma	Location *	LS
Category	Earthen Levee		GPS Latitude/Longitude		
			Start	End	
Item	Vegetation		38.384718 °	38.384930 °	
			-121.542590 °	-121.541883 °	
DWR ID	DWR_RD0999_05_s_2012_48				
Action/Comments					
Remove the wild growth other than native grasses from the levee slopes.

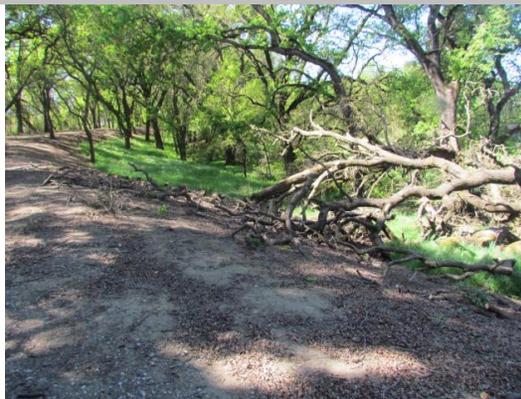
Photo 1 of 5 : SP_2015_RD0999_236_39_20150327_00160.jpg

LM Start	5.93	Rating **	M	Issue No.	39
LM End	5.93	Issue Type +	Ma	Location *	LS
Category	Earthen Levee		GPS Latitude/Longitude		
			Start	End	
Item	Encroachments		38.385729 °	38.385729 °	
			-121.540863 °	-121.540863 °	
DWR ID	DWR_RD0999_05_s_2013_39				
Action/Comments					
Tree or limb Inspector Comments: Large downed trees and limbs on landside slope and toe. District is in the process of removing tree branches and limbs from landward slope.

Looking south at fallen tree on landward slope. (Spring 2015)

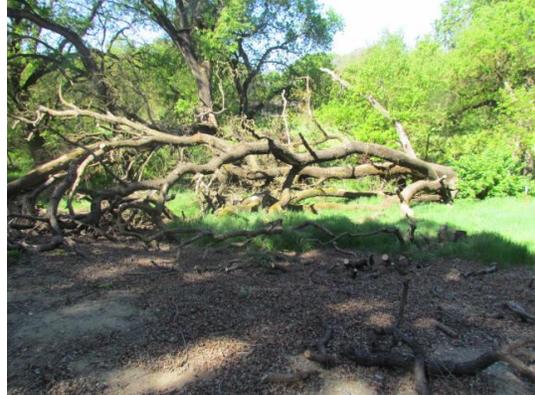
Photo 2 of 5 : SP_2015_RD0999_236_39_20150327_00161.jpg

Looking west at fallen tree on landward slope and toe. (Spring 2015)

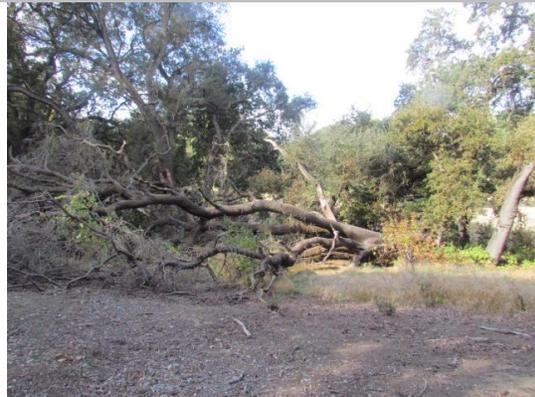
Photo 4 of 5 : SP_2015_RD0999_236_39_20150309_00033.jpg

Looking southwest at downed tree on landward toe. (Fall 2014)

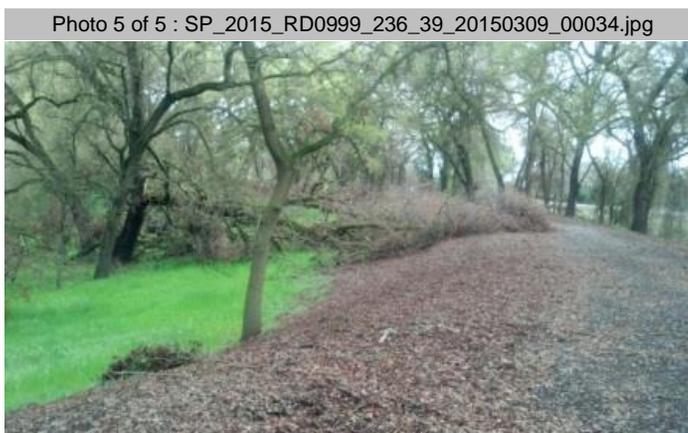
LM Start	5.93	Rating **	M	Issue No.	39 (cont)
LM End	5.93	Issue Type +	Ma	Location *	LS
Category	Earthen Levee		GPS Latitude/Longitude		
			Start	End	
Item	Encroachments		38.385729 °	38.385729 °	
			-121.540863 °	-121.540863 °	
DWR ID	DWR_RD0999_05_s_2013_39				
Action/Comments					
Tree or limb Inspector Comments: Large downed trees and limbs on landside slope and toe. District is in the process of removing tree branches and limbs from landward slope.

Looking northwest at large tree limb on landside toe and slope.

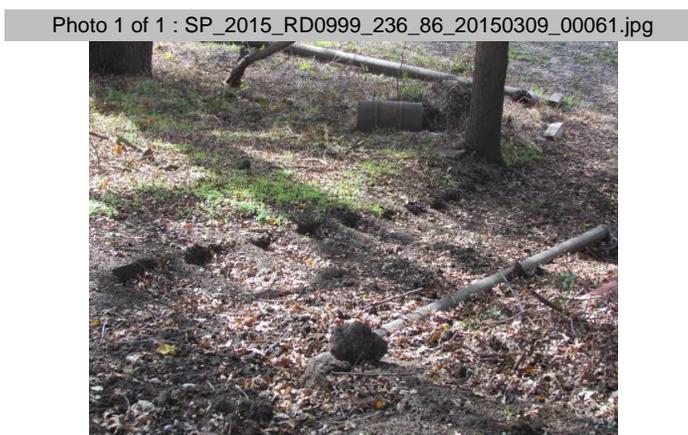
LM Start	6.13	Rating **	M	Issue No.	86
LM End	6.13	Issue Type +	En	Location *	LS
Category	Earthen Levee		GPS Latitude/Longitude		
			Start	End	
Item	Encroachments		38.388159 °	38.388159 °	
			-121.542646 °	-121.542646 °	
DWR ID	DWR_RD0999_05_f_2012_86				
Action/Comments					
Stairway Inspector Comments: Landowner dug stairs into landside slope.

Looking east at excavated stairs on landside slope

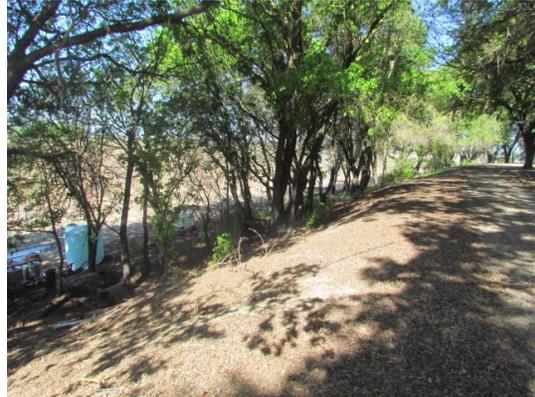
Photo 1 of 1 : SP_2015_RD0999_236_60_20150327_00162.jpg

Looking north at dense trees on landward slope. (Spring 2015)

LM Start	6.13	Rating **	M	Issue No.	60
LM End	6.13	Issue Type +	Ma	Location *	LS
Category	Earthen Levee		GPS Latitude/Longitude		
			Start	End	
Item	Trim / Thin Trees		38.388225 °	38.388225 °	
			-121.542697 °	-121.542697 °	
DWR ID	DWR_RD0999_05_s_2012_60				
Action/Comments					
Trim and thin trees to allow visibility of the ground and room to flood fight.

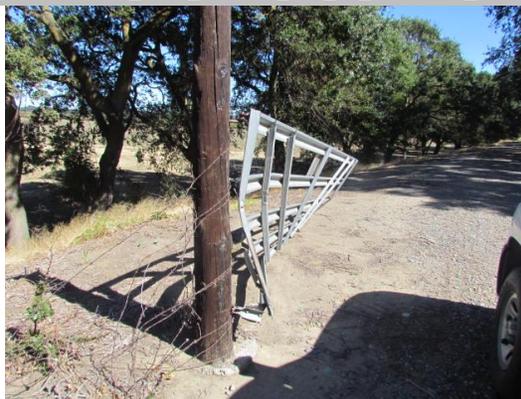
Photo 1 of 1 : SP_2015_RD0999_236_90_20150309_00062.jpg

LM Start	6.26	Rating **	M	Issue No.	90
LM End	6.26	Issue Type +	Ma	Location *	CR
Category	Earthen Levee			GPS Latitude/Longitude	
				Start	End
Item	Repair Gates			38.389851 °	38.389851 °
				-121.542583 °	-121.542583 °
DWR ID	DWR_RD0999_05_f_2012_90				
Action/Comments					
Inspector Comments: Gate should be repaired or removed.

Looking northwest at damaged gate on levee crown.

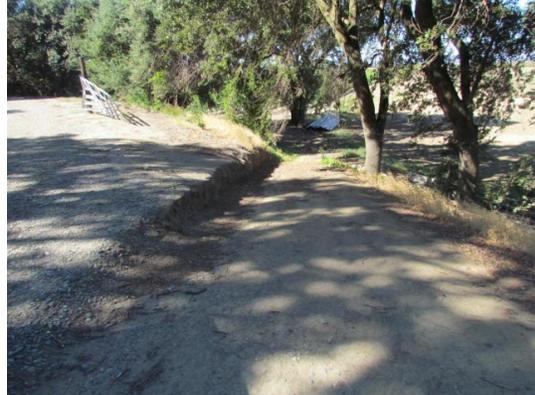
Photo 1 of 1 : SP_2015_RD0999_236_155_20150309_00097.jpg

LM Start	6.26	Rating **	M	Issue No.	155
LM End	6.26	Issue Type +	En	Location *	LS
Category	Earthen Levee			GPS Latitude/Longitude	
				Start	End
Item	Encroachments			38.389946 °	38.389946 °
				-121.542461 °	-121.542461 °
DWR ID	DWR_RD0999_05_f_2013_155				
Action/Comments					
Ramp Inspector Comments: Unauthorized ramp on landward slope.

Looking southwest at ramp on landward slope.

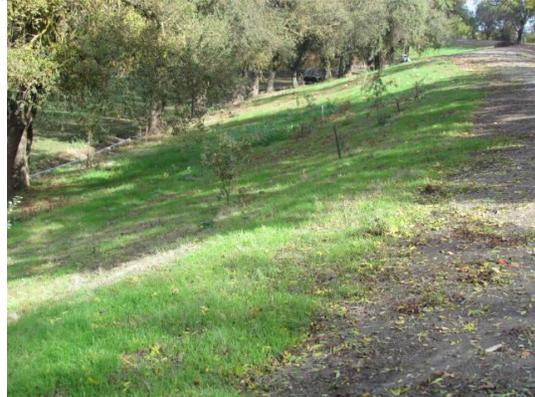
Photo 2 of 2 : SP_2015_RD0999_236_97_20150309_00070.jpg

LM Start	6.37	Rating **	M	Issue No.	97 (cont)
LM End	6.49	Issue Type +	En	Location *	LS
Category	Earthen Levee			GPS Latitude/Longitude	
				Start	End
Item	Encroachments			38.390848 °	38.391880 °
				-121.540826 °	-121.539215 °
DWR ID	DWR_RD0999_05_f_2012_97				
Action/Comments					
Tree or limb Inspector Comments: Landowner planted trees on landside slope.

Looking northwest at newly planted trees on landside slope.

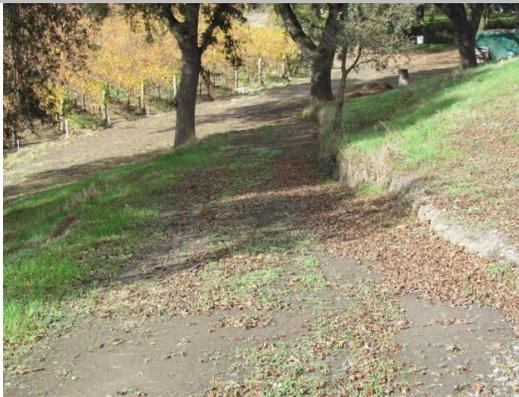
Photo 1 of 1 : SP_2015_RD0999_236_132_20150309_00080.jpg

LM Start	6.61	Rating **	M	Issue No.	132
LM End	6.61	Issue Type +	En	Location *	LS
Category	Earthen Levee			GPS Latitude/Longitude	
				Start	End
Item	Encroachments			38.393578 °	38.393578 °
				-121.539295 °	-121.539295 °
DWR ID	DWR_RD0999_05_f_2012_132				
Action/Comments					
Ramp Inspector Comments: Landowner installed ramp on landside slope without permit.

Looking east at unauthorized ramp on landside slope.

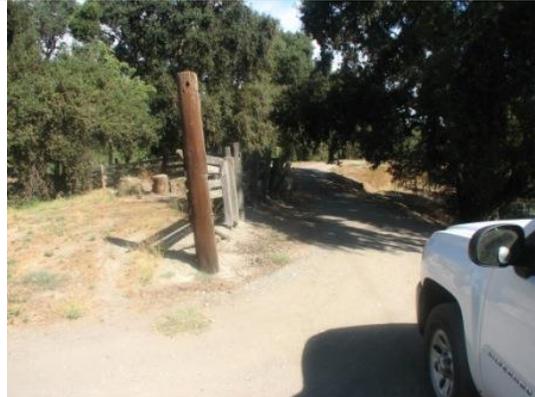
Photo 1 of 4 : SP_2015_RD0999_236_96_20150309_00065.jpg

LM Start	6.73	Rating **	M	Issue No.	96
LM End	6.73	Issue Type +	Ma	Location *	LS
Category	Earthen Levee		GPS Latitude/Longitude		
			Start	End	
Item	Encroachments		38.395234 °	38.395234 °	
			-121.539323 °	-121.539323 °	
DWR ID	DWR_RD0999_05_s_2012_96				
Action/Comments					
Material Inspector Comments: Firewood and other material on landside shoulder.

Fence, firewood and material at landside shoulder.

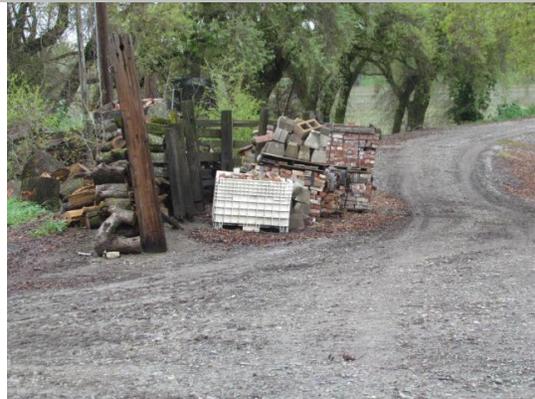
Photo 2 of 4 : SP_2015_RD0999_236_96_20150309_00066.jpg

Looking northeast at firewood and other material on landside shoulder. (Spring 2012)
