**Flood Control Project Maintenance
Levee Inspections**
LMA District Cover Sheet
Spring 2015 Levee Inspection Results

Reclamation District No. 0999 Netherlands

Spring 2015 Levee Inspection Results

Waterway	Bank	Unit Miles
Unit No. 01 Yolo Bypass	Left	15.41

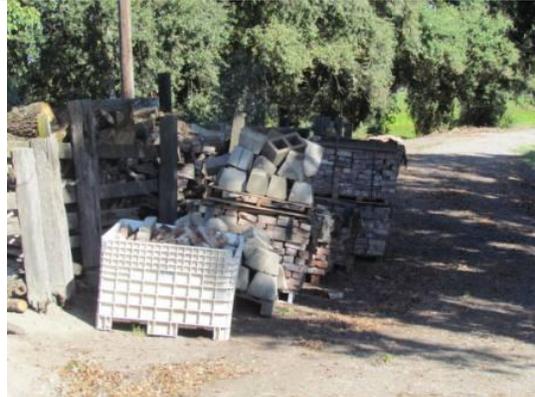
Photo 4 of 4 : SP_2015_RD0999_236_96_20150309_00068.jpg

LM Start	6.73	Rating **	M	Issue No.	96 (cont)
LM End	6.73	Issue Type +	Ma	Location *	LS
Category	Earthen Levee			GPS Latitude/Longitude	
				Start	End
Item	Encroachments			38.395234 °	38.395234 °
				-121.539323 °	-121.539323 °
DWR ID	DWR_RD0999_05_s_2012_96				
Action/Comments					
Material Inspector Comments: Firewood and other material on landside shoulder.

Looking north at firewood and other material on landside shoulder and crown.

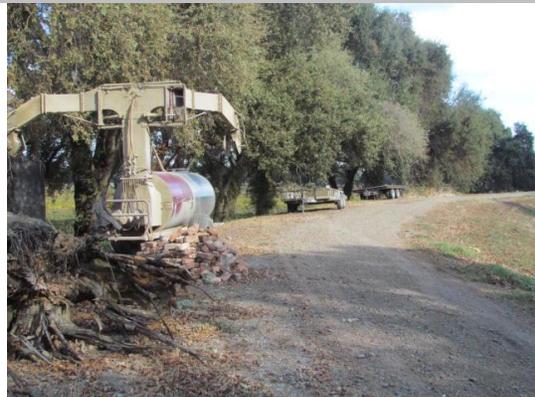
Photo 1 of 3 : SP_2015_RD0999_236_156_20150309_00098.jpg

LM Start	6.79	Rating **	M	Issue No.	156
LM End	6.79	Issue Type +	En	Location *	LS
Category	Earthen Levee			GPS Latitude/Longitude	
				Start	End
Item	Encroachments			38.395945 °	38.395945 °
				-121.538859 °	-121.538859 °
DWR ID	DWR_RD0999_05_f_2013_156				
Action/Comments					
Equipment Inspector Comments: Landowner is storing farm equipment on landward shoulder.

Looking north at farm equipment on landward shoulder (Fall 2014)

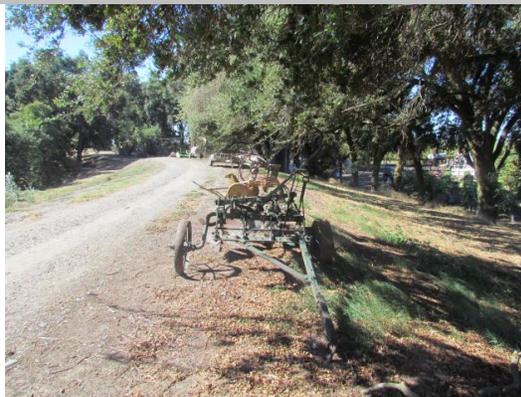
Photo 3 of 3 : SP_2015_RD0999_236_156_20150309_00100.jpg

LM Start	6.79	Rating **	M	Issue No.	156 (cont)
LM End	6.79	Issue Type +	En	Location *	LS
Category	Earthen Levee			GPS Latitude/Longitude	
				Start	End
Item	Encroachments			38.395945 °	38.395945 °
				-121.538859 °	-121.538859 °
DWR ID	DWR_RD0999_05_f_2013_156				
Action/Comments					
Equipment Inspector Comments: Landowner is storing farm equipment on landward shoulder.

Looking south at farm equipment on landward shoulder.

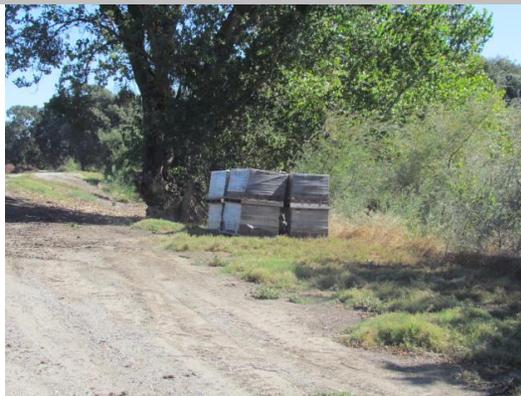
Photo 1 of 1 : SP_2015_RD0999_236_157_20150309_00101.jpg

LM Start	6.80	Rating **	M	Issue No.	157
LM End	6.80	Issue Type +	En	Location *	WS
Category	Earthen Levee			GPS Latitude/Longitude	
				Start	End
Item	Encroachments			38.396099 °	38.396099 °
				-121.538585 °	-121.538585 °
DWR ID	DWR_RD0999_05_f_2013_157				
Action/Comments					
Material Inspector Comments: Landowner is storing pallets of bricks on waterward shoulder.

Looking northeast at pallets of bricks store on waterward shoulder.

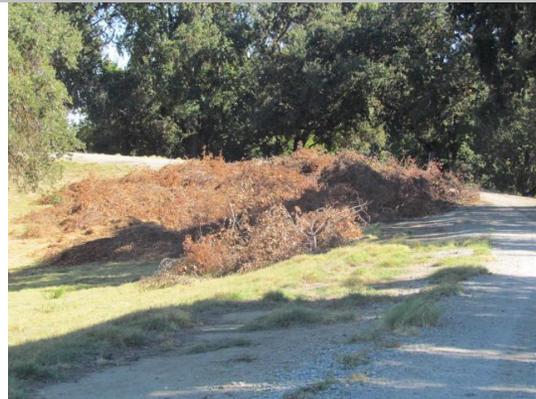
Photo 1 of 1 : SP_2015_RD0999_236_142_20150309_00087.jpg

LM Start	6.95	Rating **	A/W	Issue No.	142
LM End	6.95	Issue Type +	Ma	Location *	LS
Category	Earthen Levee			GPS Latitude/Longitude	
				Start	End
Item	Encroachments			38.396958 °	38.396958 °
				-121.536148 °	-121.536148 °
DWR ID	DWR_RD0999_05_s_2013_142				
Action/Comments					
Prunings Inspector Comments: Large pruning pile on landward shoulder and slope.

Looking northeast at large prunings on landward slope.

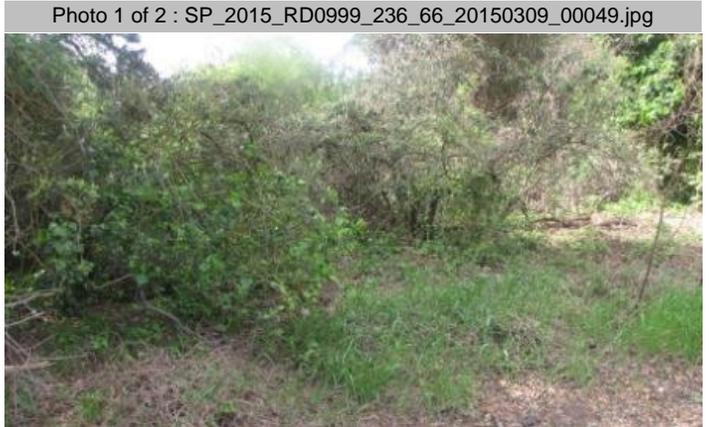
LM Start	7.54	Rating **	U	Issue No.	66
LM End	7.58	Issue Type +	En	Location *	LS
Category	Earthen Levee			GPS Latitude/Longitude	
				Start	End
Item	Vegetation			38.403895 °	38.404145 °
				-121.541113 °	-121.541835 °
DWR ID	DWR_RD0999_05_s_2012_66				
Action/Comments					
Landscaping

Looking east at overgrown landscape on landside slope.

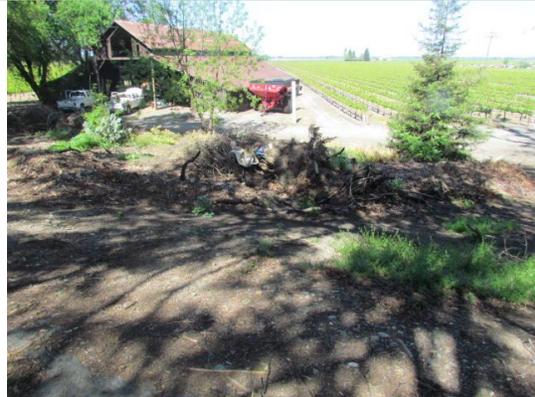
Photo 1 of 1 : SP_2015_RD0999_236_185_20150327_00163.jpg

LM Start	8.03	Rating **	M	Issue No.	185
LM End	8.03	Issue Type +	Ma	Location *	LS
Category	Earthen Levee			GPS Latitude/Longitude	
				Start	End
Item	Encroachments			38.409324 °	38.409324 °
				-121.541223 °	-121.541223 °
DWR ID	DWR_RD0999_05_s_2015_185				
Action/Comments					
Prunings Inspector Comments: Garbage within prunings piles.

Looking west at pruning piles on landward slope. (Spring 2015)

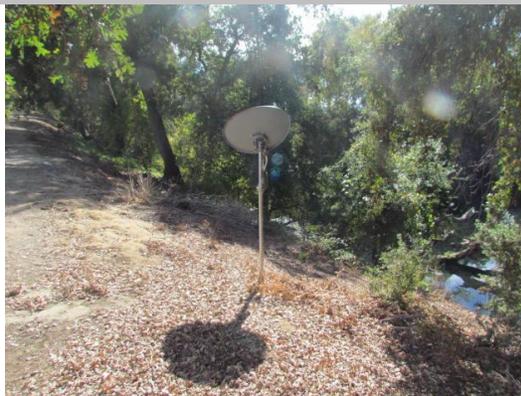
Photo 1 of 3 : SP_2015_RD0999_236_207_20150309_00114.jpg

LM Start	8.28	Rating **	M	Issue No.	207
LM End	8.28	Issue Type +	En	Location *	LS
Category	Earthen Levee			GPS Latitude/Longitude	
				Start	End
Item	Encroachments			38.409389 °	38.409389 °
				-121.536881 °	-121.536881 °
DWR ID	DWR_RD0999_05_f_2014_207				
Action/Comments					
Pipe Inspector Comments: Electrical conduct buried across levee crown. Conduct connects to satellite dish on waterward shoulder.

Looking south at satellite dish on waterward shoulder.

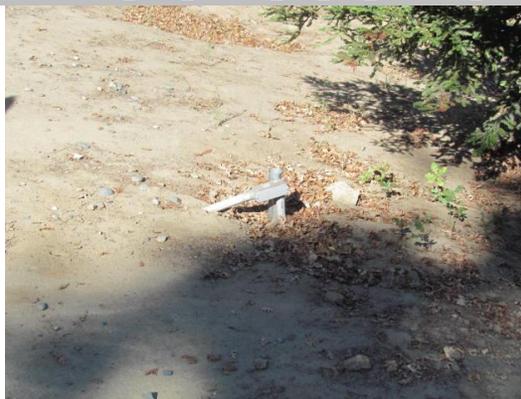
Photo 2 of 3 : SP_2015_RD0999_236_207_20150309_00115.jpg

Looking west at electrical box on landward shoulder.

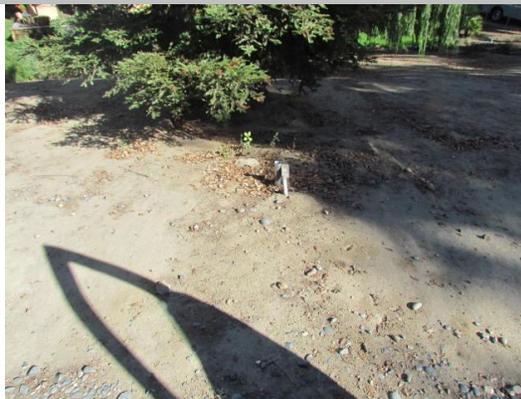
Photo 3 of 3 : SP_2015_RD0999_236_207_20150309_00116.jpg

LM Start	8.28	Rating **	M	Issue No.	207 (cont)
LM End	8.28	Issue Type +	En	Location *	LS
Category	Earthen Levee			GPS Latitude/Longitude	
				Start	End
Item	Encroachments			38.409389 °	38.409389 °
				-121.536881 °	-121.536881 °
DWR ID	DWR_RD0999_05_f_2014_207				
Action/Comments					
Pipe Inspector Comments: Electrical conduct buried across levee crown. Conduct connects to satellite dish on waterward shoulder.

Looking northeast at electrical box on landward shoulder.

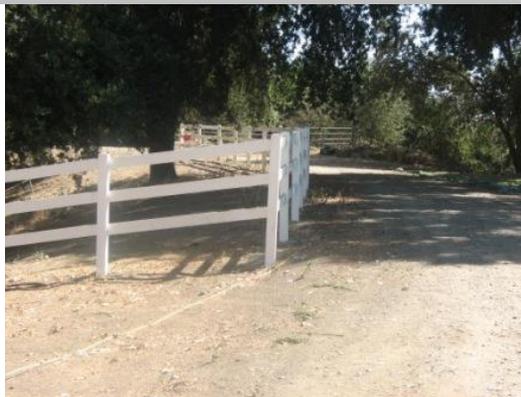
Photo 1 of 1 : SP_2015_RD0999_236_101_20150309_00071.jpg

LM Start	8.39	Rating **	M	Issue No.	101
LM End	8.43	Issue Type +	En	Location *	LS
Category	Earthen Levee		GPS Latitude/Longitude		
			Start	End	
Item	Encroachments		38.408586 °	38.408748 °	
			-121.534992 °	-121.534437 °	
DWR ID	DWR_RD0999_05_s_2012_101				
Action/Comments					
Fence Inspector Comments: Fence installed without CVFPB permit in 2008. Fence extends from landside toe to landside shoulder.

New installed unauthorized fence at landside slope and shoulder.

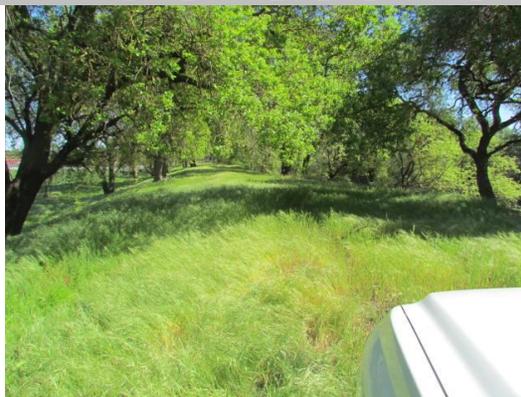
Photo 1 of 1 : SP_2015_RD0999_236_186_20150327_00164.jpg

LM Start	8.42	Rating **	M	Issue No.	186
LM End	8.75	Issue Type +	Ma	Location *	CR
Category	Earthen Levee		GPS Latitude/Longitude		
			Start	End	
Item	Vegetation		38.408623 °	38.411767 °	
			-121.534525 °	-121.530079 °	
DWR ID	DWR_RD0999_05_s_2015_186				
Action/Comments					
Control annual grass and weeds on the levee slopes and easements. Inspector Comments: Tall grasses on levee crown should be controlled.

Looking east at levee crown. (Spring 2015)

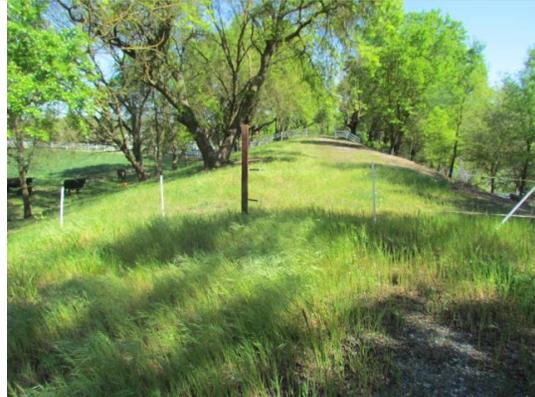
Photo 1 of 1 : SP_2015_RD0999_236_187_20150327_00165.jpg

LM Start	8.50	Rating **	M	Issue No.	187
LM End	8.50	Issue Type +	En	Location *	CR
Category	Earthen Levee		GPS Latitude/Longitude		
			Start	End	
Item	Encroachments		38.409395 °	38.409395 °	
			-121.533593 °	-121.533593 °	
DWR ID	DWR_RD0999_05_s_2015_187				
Action/Comments					
Fence Inspector Comments: Landowner installed a electrical fence across levee crown.

Looking east at new electrical fence across levee crown and landward slope. (Spring 2015)

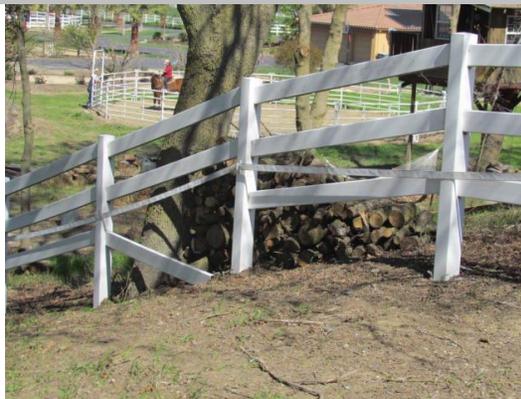
Photo 1 of 1 : SP_2015_RD0999_236_195_20150309_00107.jpg

LM Start	8.54	Rating **	M	Issue No.	195
LM End	8.54	Issue Type +	En	Location *	LS
Category	Earthen Levee			GPS Latitude/Longitude	
				Start	End
Item	Encroachments			38.409880 °	38.409880 °
				-121.533078 °	-121.533078 °
DWR ID	DWR_RD0999_05_s_2014_195				
Action/Comments					
Firewood Inspector Comments: Firewood stock piled on landside slope.

Looking northeast at firewood on landward slope.

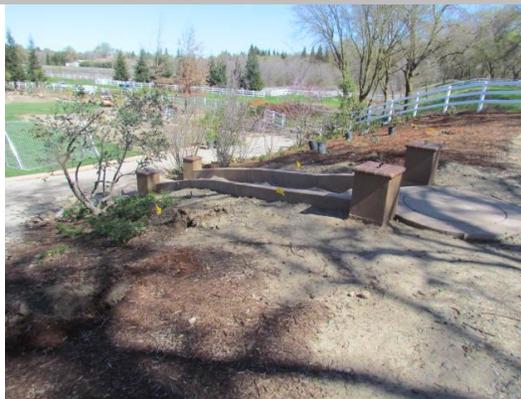
Photo 1 of 2 : SP_2015_RD0999_236_196_20150309_00108.jpg

LM Start	8.58	Rating **	M	Issue No.	196
LM End	8.58	Issue Type +	En	Location *	LS
Category	Earthen Levee			GPS Latitude/Longitude	
				Start	End
Item	Encroachments			38.410279 °	38.410279 °
				-121.532414 °	-121.532414 °
DWR ID	DWR_RD0999_05_s_2014_196				
Action/Comments					
Stairway Inspector Comments: Landowner installed concrete stairs and sprinkler and plantings on landside slope without CVFPB permit.

Looking east at concrete stairs, sprinklers and plantings on landward slope.

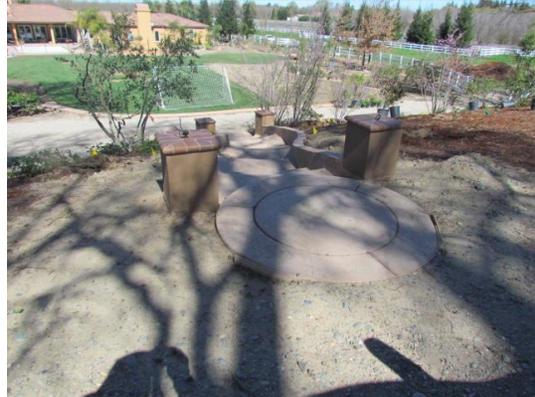
Photo 2 of 2 : SP_2015_RD0999_236_196_20150309_00109.jpg

LM Start	8.58	Rating **	M	Issue No.	196 (cont)
LM End	8.58	Issue Type +	En	Location *	LS
Category	Earthen Levee			GPS Latitude/Longitude	
				Start	End
Item	Encroachments			38.410279 °	38.410279 °
				-121.532414 °	-121.532414 °
DWR ID	DWR_RD0999_05_s_2014_196				
Action/Comments					
Stairway Inspector Comments: Landowner installed concrete stairs and sprinkler and plantings on landside slope without CVFPB permit.

Looking north at concrete stairs on landward slope.

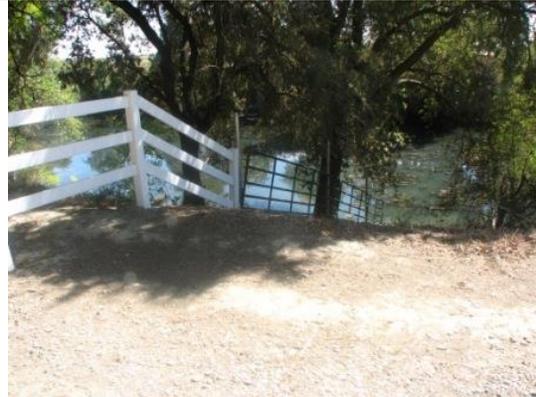
Photo 2 of 2 : SP_2015_RD0999_236_103_20150309_00073.jpg

LM Start	8.59	Rating **	M	Issue No.	103 (cont)
LM End	8.59	Issue Type +	En	Location *	CR
Category	Earthen Levee			GPS Latitude/Longitude	
				Start	End
Item	Encroachments			38.410332 °	38.410332 °
				-121.532277 °	-121.532277 °
DWR ID	DWR_RD0999_05_s_2012_103				
Action/Comments					
Fence

New unauthorized fence that extend from landside toe to waterside toe.

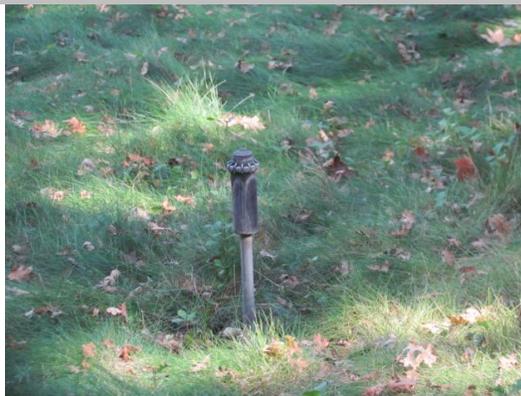
Photo 1 of 1 : SP_2015_RD0999_236_134_20150309_00081.jpg

LM Start	8.73	Rating **	M	Issue No.	134
LM End	8.82	Issue Type +	En	Location *	LS
Category	Earthen Levee			GPS Latitude/Longitude	
				Start	End
Item	Encroachments			38.411577 °	38.412619 °
				-121.530375 °	-121.529691 °
DWR ID	DWR_RD0999_05_f_2012_134				
Action/Comments					
Landscape Irrigation Inspector Comments: Sprinklers on landward and waterward shoulder.

Looking at one of several sprinklers on waterward and landward slope.

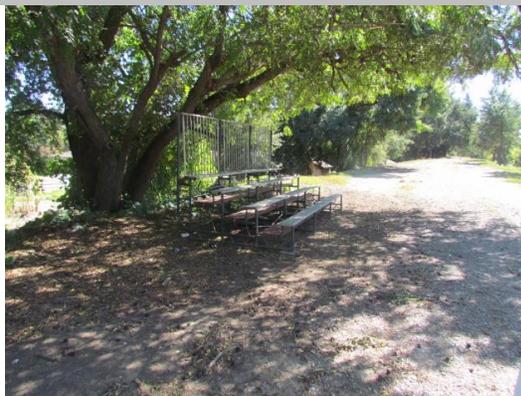
Photo 1 of 1 : SP_2015_RD0999_236_158_20150309_00102.jpg

LM Start	9.15	Rating **	M	Issue No.	158
LM End	9.15	Issue Type +	En	Location *	LS
Category	Earthen Levee			GPS Latitude/Longitude	
				Start	End
Item	Encroachments			38.415709 °	38.415709 °
				-121.527393 °	-121.527393 °
DWR ID	DWR_RD0999_05_f_2013_158				
Action/Comments					
Equipment Inspector Comments: Landowner has placed bleacher on landward shoulder.

Looking northeast at bleacher stored on landward shoulder.
