**Flood Control Project Maintenance  
Levee Inspections**

**Maintenance Issue Types Only, Levee Inspection Report By Mile - Fall 2014**

**Reclamation District No. 0999 Netherlands**

Waterway	Bank	Unit Miles	Inspection Start/End	Inspector
Unit No. 01 Yolo Bypass	Left	15.41	10/28/2014 10/28/2014	Richard Willoughby

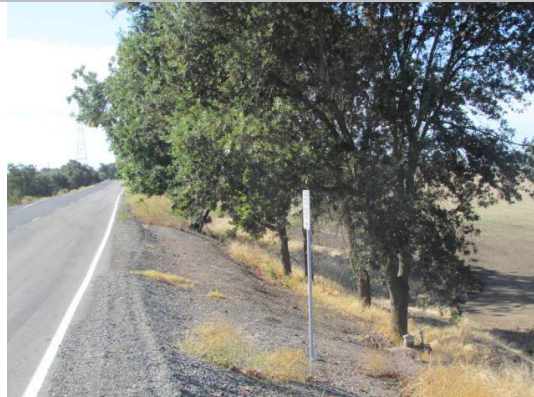
Photo 2 of 2 : FA\_2014\_RD0999\_232\_4\_20141020\_00007.jpg

Looking southwest at trimmed trees on waterward slope.

LM Start	1.75	Rating **	A/W	Issue No.	4 (cont)
LM End	1.77	Issue Type +	Ma	Location *	WS
Category	Earthen Levee			GPS Latitude/Longitude	
				Start	End
Item	Trim / Thin Trees			38.480082 °	38.479788 °
				-121.580930 °	-121.580918 °
DWR ID	DWR_RD0999_01_s_2012_4				
Action/Comments					
Trim trees to at least five feet above ground level.

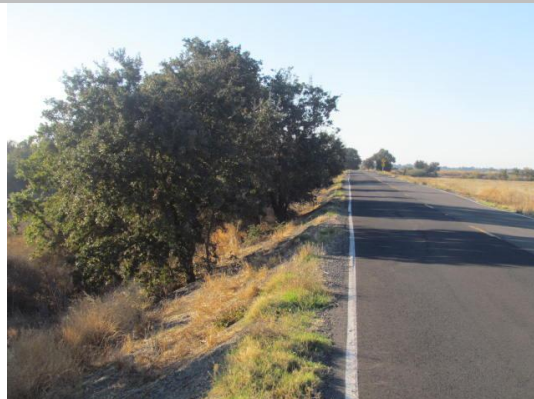
Photo 1 of 3 : FA\_2014\_RD0999\_232\_30\_20141030\_00070.jpg

Looking south at typical view of untrimmed trees on landward slope.

LM Start	1.81	Rating **	M	Issue No.	30
LM End	2.07	Issue Type +	Ma	Location *	LS
Category	Earthen Levee			GPS Latitude/Longitude	
				Start	End
Item	Trim / Thin Trees			38.479165 °	38.475463 °
				-121.580640 °	-121.580722 °
DWR ID	DWR_RD0999_01_s_2012_30				
Action/Comments					
Trim trees to at least five feet above ground level.

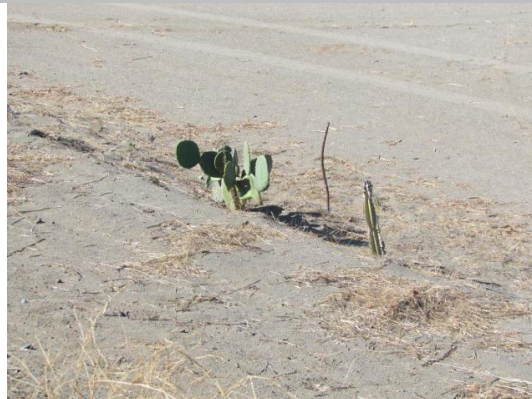
Photo 1 of 1 : FA\_2014\_RD0999\_232\_45\_20141020\_00045.jpg

LM Start	4.36	Rating **	A/W	Issue No.	45
LM End	4.36	Issue Type +	Ma	Location *	WS
Category	Earthen Levee			GPS Latitude/Longitude	
				Start	End
Item	Vegetation				°
					°
DWR ID	DWR_RD0999_01_f_2013_45				
Action/Comments					
Remove the wild growth other than native grasses from the levee slopes. Inspector Comments: Landowner has planted cactus on waterward toe.

Looking west at cactus on waterward toe.

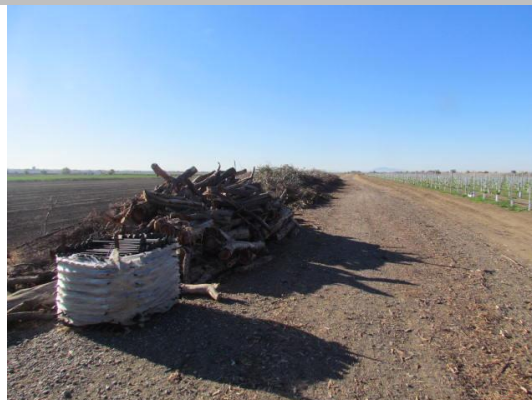
Photo 1 of 2 : FA\_2014\_RD0999\_232\_18\_20141030\_00073.jpg

LM Start	6.55	Rating **	U	Issue No.	18
LM End	6.60	Issue Type +	Ma	Location *	LS
Category	Earthen Levee			GPS Latitude/Longitude	
				Start	End
Item	Encroachments			38.414367 °	38.413698 °
				-121.608430 °	-121.608762 °
DWR ID	DWR_RD0999_01_s_2012_18				
Action/Comments					
Prunings					
Inspector Comments: Large pruning piles on landward shoulder. Part of pruning pile blocking levee crown.

Looking south at pruning piles on landward shoulder. (Fall 2014)

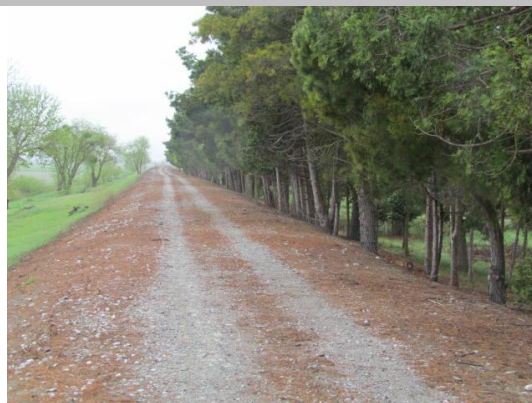
Photo 1 of 2 : FA\_2014\_RD0999\_232\_23\_20141020\_00023.jpg

Looking south at trimmed pine trees on waterside shoulder and slope.  
(Spring 2012)**\* Location**

LM Start	10.83	Rating **	A/W	Issue No.	23
LM End	11.07	Issue Type +	Ma	Location *	WS
Category	Earthen Levee			GPS Latitude/Longitude	
				Start	End
Item	Trim / Thin Trees			38.356077 °	38.352640 °
				-121.635598 °	-121.637078 °
DWR ID	DWR_RD0999_01_s_2012_23				
Action/Comments					
Trim trees to at least five feet above ground level.

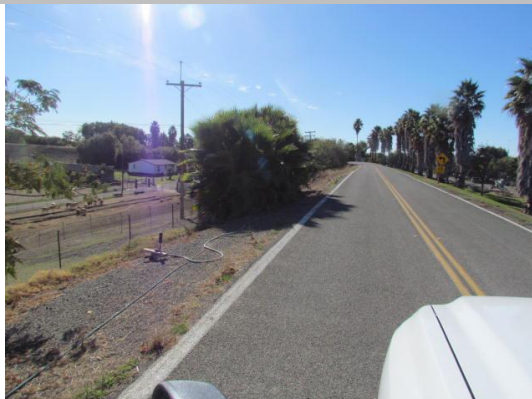
Photo 1 of 2 : FA\_2014\_RD0999\_232\_50\_20141030\_00077.jpg

LM Start	15.34	Rating **	M	Issue No.	50
LM End	15.34	Issue Type +	Ma	Location *	LS
Category	Earthen Levee			GPS Latitude/Longitude	
				Start	End
Item	Encroachments			38.291663 °	38.291663 °
				-121.644962 °	-121.644962 °
DWR ID	DWR_RD0999_01_f_2012_50				
Action/Comments					
Tree or limb					
Inspector Comments: Newly planted palm trees on landside shoulder.

Looking east at maturing plam trees on landward shoulder and slope.  
(Fall 2014)

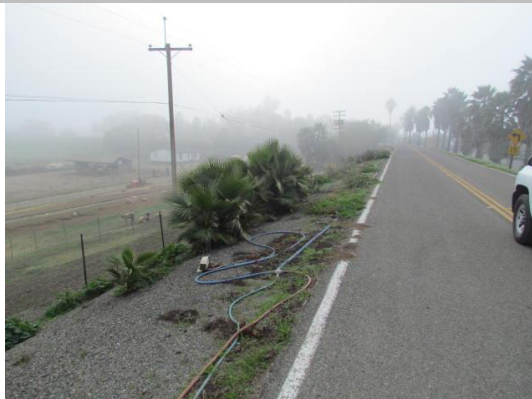
Photo 2 of 2 : FA\_2014\_RD0999\_232\_50\_20141020\_00054.jpg

Looking east at newly planted palm trees on landside shoulder and slope.

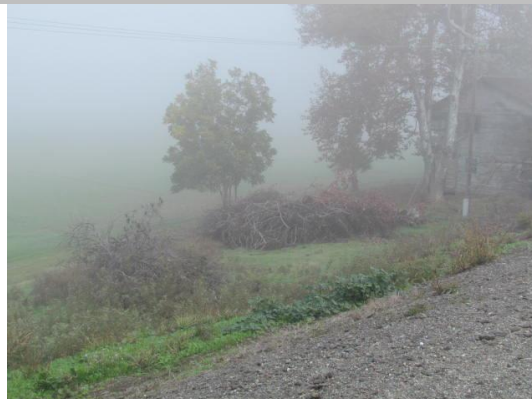
Photo 1 of 2 : FA\_2014\_RD0999\_233\_18\_20141020\_00018.jpg

LM Start	0.15	Rating **	M	Issue No.	18
LM End	0.15	Issue Type +	Ma	Location *	LS
Category	Earthen Levee			GPS Latitude/Longitude	
				Start	End
Item	Encroachments			38.290793 °	38.290793 °
				-121.642100 °	-121.642100 °
DWR ID	DWR_RD0999_02_s_2012_18				
Action/Comments					
Prunings

Looking west at prunings on landside toe. (Fall Inspection 2012)

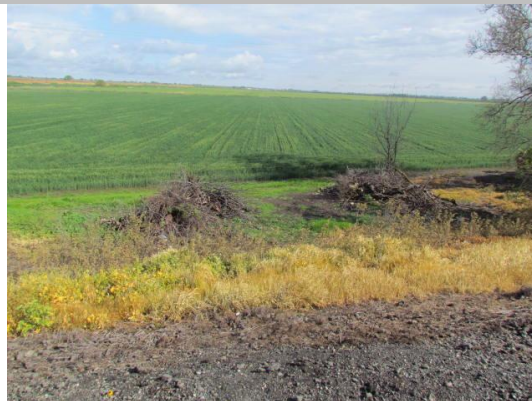
Photo 2 of 2 : FA\_2014\_RD0999\_233\_18\_20141020\_00019.jpg

Looking west at prunings on landside berm.

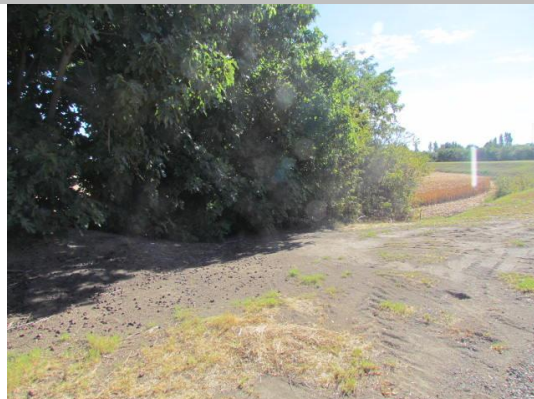
Photo 2 of 2 : FA\_2014\_RD0999\_233\_23\_20141020\_00028.jpg

Looking north at dense trees on landward slope and toe.

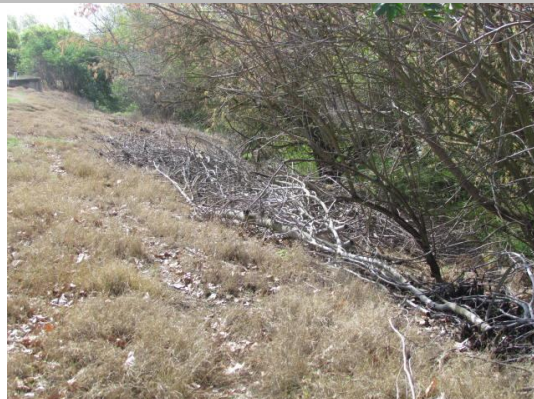
Photo 1 of 1 : FA\_2014\_RD0999\_233\_21\_20141020\_00021.jpg

LM Start	1.73	Rating **	A/W	Issue No.	21
LM End	1.73	Issue Type +	Ma	Location *	WS
Category	Earthen Levee			GPS Latitude/Longitude	
				Start	End
Item	Encroachments			38.289747 °	38.289747 °
				-121.614587 °	-121.614587 °
DWR ID	DWR_RD0999_02_s_2012_21				
Action/Comments					
Prunings

Looking northeast at prunings on waterside slope.

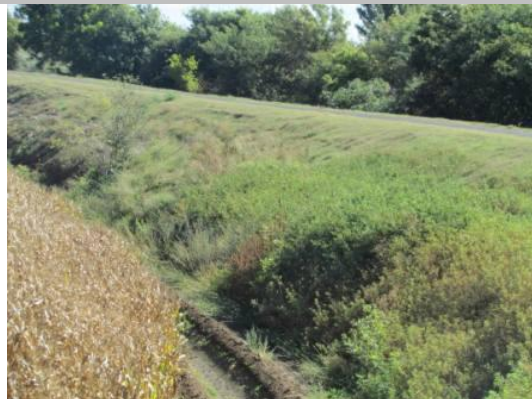
Photo 1 of 3 : FA\_2014\_RD0999\_233\_6\_20141020\_00006.jpg

LM Start	1.79	Rating **	A/W	Issue No.	6
LM End	1.89	Issue Type +	Ma	Location *	LS
Category	Earthen Levee			GPS Latitude/Longitude	
				Start	End
Item	Vegetation			38.289117 °	38.288718 °
				-121.613777 °	-121.612227 °
DWR ID	DWR_RD0999_02_s_2012_6				
Action/Comments					
Remove the wild growth other than native grasses from the levee slopes.					
Inspector Comments: Wild roses and berry vines at landside toe.

Looking east at dense wild roses on landside toe. (Spring 2011)

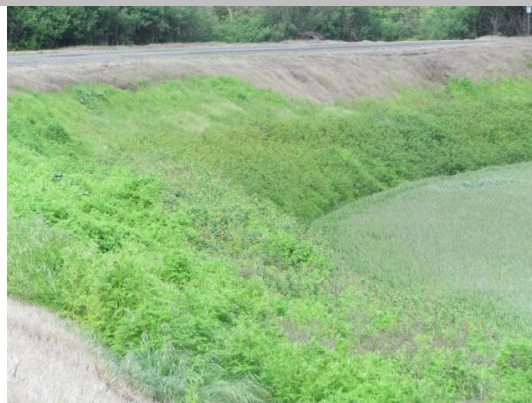
Photo 2 of 3 : FA\_2014\_RD0999\_233\_6\_20141020\_00007.jpg

Looking southeast to wild roses on landside slope and toe. (Spring 2012)

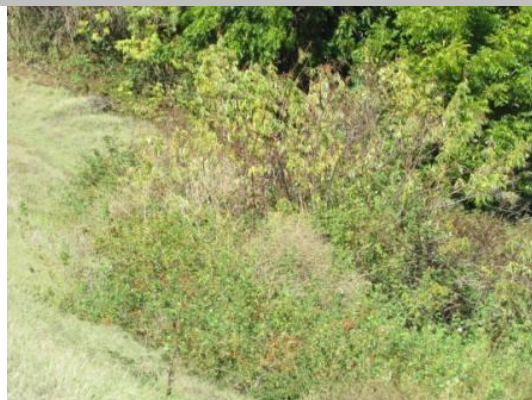
Photo 3 of 3 : FA\_2014\_RD0999\_233\_6\_20141020\_00008.jpg

Looking north at wild roses on landside toe. (Spring 2011)

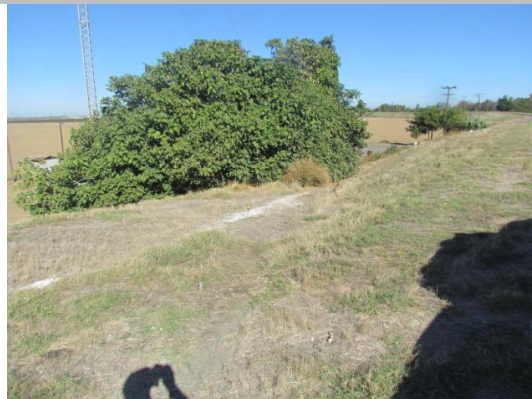
Photo 1 of 4 : FA\_2014\_RD0999\_234\_4\_20141030\_00038.jpg

LM Start	0.03	Rating **	U	Issue No.	4
LM End	0.04	Issue Type +	Ma	Location *	LS
Category	Earthen Levee			GPS Latitude/Longitude	
				Start	End
Item	Trim / Thin Trees			38.287145 °	38.287267 °
				-121.605572 °	-121.605478 °
DWR ID	DWR_RD0999_03_s_2012_4				
Action/Comments					
Trim trees to at least five feet above ground level. Inspector Comments: Dense fig trees on landward slope and toe.

Looking northwest at dense fig tree on landward toe. 2014

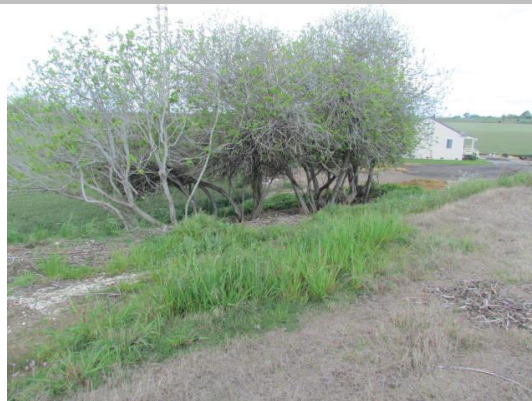
Photo 3 of 4 : FA\_2014\_RD0999\_234\_4\_20141020\_00006.jpg

Looking southwest at trimmed trees on landside toe. (Spring 2012)

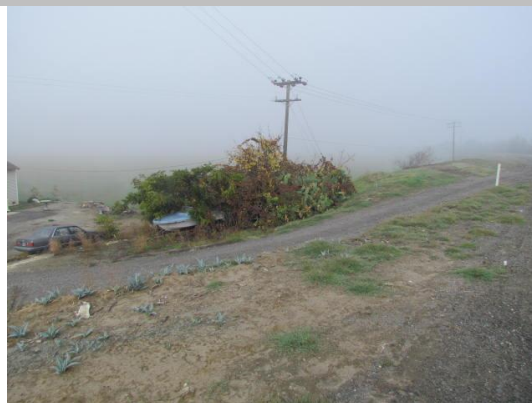
Photo 2 of 3 : FA\_2014\_RD0999\_234\_1\_20141020\_00002.jpg

Looking northeast at vegetation on landside slope and toe. (Fall Inspection 2012)

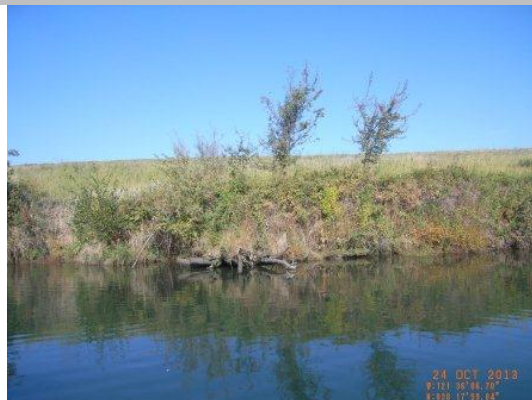
Photo 1 of 1 : FA\_2014\_RD0999\_234\_30\_20141020\_00025.jpg

LM Start	0.96	Rating **	M	Issue No.	30
LM End	0.96	Issue Type +	Ma	Location *	WS
Category	Supplemental			GPS Latitude/Longitude	
				Start	End
Item	USACE Erosion Survey			38.299402 °	38.300542 °
				-121.603056 °	-121.601118 °
DWR ID	DWR_RD0999_03_f_2014_30				
Action/Comments					
Inspector Comments: 2008 - Over steepened levee section. 2009 - Significant new erosion. 2010 - Minor new erosion. 2013: No observed changes. [2013 Site ID: STR_25-2_R]

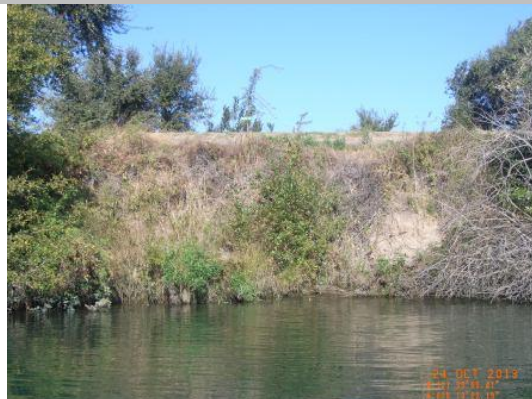
Photo 1 of 1 : FA\_2014\_RD0999\_234\_33\_20141020\_00026.jpg

LM Start	1.31	Rating **	M	Issue No.	33
LM End	1.31	Issue Type +	Ma	Location *	WS
Category	Supplemental			GPS Latitude/Longitude	
				Start	End
Item	USACE Erosion Survey			38.305229 °	38.306667 °
				-121.599933 °	-121.598266 °
DWR ID	DWR_RD0999_03_f_2014_33				
Action/Comments					
Inspector Comments: 2011 - Toe scour along length of site and erosion pockets. 2012 - Site extended slightly upstream due to new erosion pocket. 2013: Tall vertical sections at upstream end of site. [2013 Site ID: STR_25-7_R]

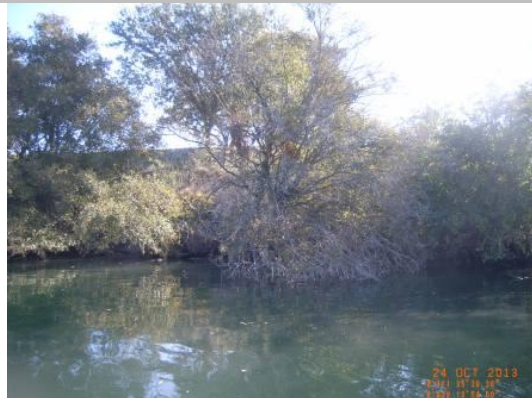
Photo 1 of 1 : FA\_2014\_RD0999\_234\_34\_20141020\_00027.jpg

LM Start	2.25	Rating **	M	Issue No.	34
LM End	2.36	Issue Type +	Ma	Location *	WS
Category	Supplemental			GPS Latitude/Longitude	
				Start	End
Item	USACE Erosion Survey			38.315407 °	38.313836 °
				-121.591433 °	-121.592259 °
DWR ID	DWR_RD0999_03_f _ 2014_34				
Action/Comments					
Inspector Comments: 2002 - Original rock over geotextile is sliding off and the end is coming unraveled. 2003 - Some minor new erosion on the downstream end. 2004 - Site has gotten worse. Underlined geofabric is exposed. 2005 - Still looks bad with exposed geotextile fabric. 2006 - Still have some new unraveling and exposed fabric. Site lengthened upstream. 2009 - Minimal new erosion. 2010 - geotextile fabric placed since last year, possible flood fight. 2012 - Exposed geotech style fabric, assume rock on top slid off. 2013: No observed changes. [2013 Site ID: STR_26-5_L]

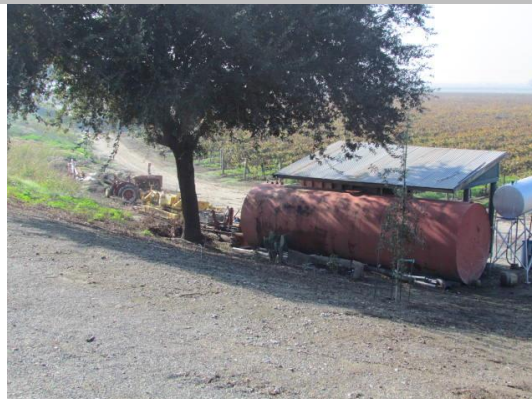
Photo 1 of 2 : FA\_2014\_RD0999\_234\_27\_20141020\_00022.jpg

LM Start	2.54	Rating **	M	Issue No.	27
LM End	2.54	Issue Type +	Ma	Location *	LS
Category	Earthen Levee			GPS Latitude/Longitude	
				Start	End
Item	Encroachments			38.317840 °	38.317840 °
				-121.590895 °	-121.590895 °
DWR ID	DWR_RD0999_03_s_2012_27				
Action/Comments					
Equipment					
Inspector Comments: Diesel tank stored at landside toe.

Looking southwest at farm equipment stored at landside toe. (Fall Inspection 2012)

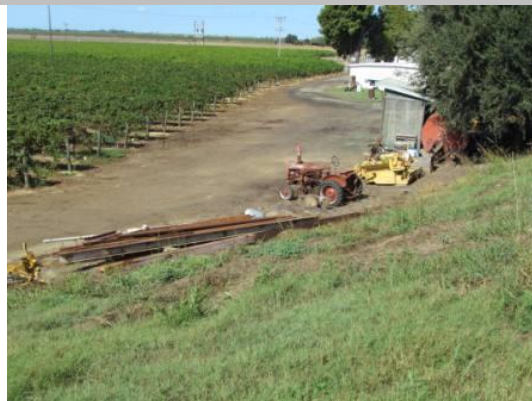
Photo 2 of 2 : FA\_2014\_RD0999\_234\_27\_20141020\_00023.jpg

Looking northwest at equipment at landside toe.

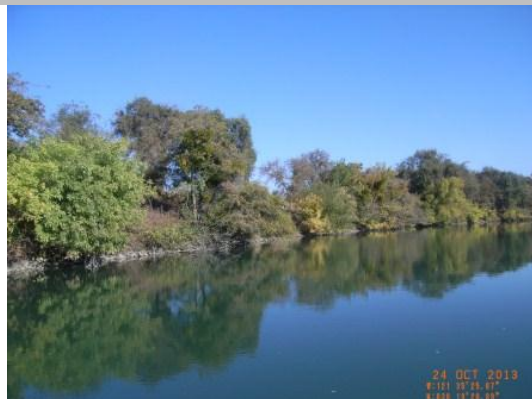
Photo 1 of 1 : FA\_2014\_RD0999\_234\_35\_20141020\_00028.jpg

LM Start	2.79	Rating **	M	Issue No.	35
LM End	2.79	Issue Type +	Ma	Location *	WS
Category	Supplemental			GPS Latitude/Longitude	
				Start	End
Item	USACE Erosion Survey			38.322457 °	38.323042 °
				-121.590693 °	-121.590209 °
DWR ID	DWR_RD0999_03_f_2014_35				
Action/Comments					
Inspector Comments: 2012 - Slumping of upper levee slope. 2013: No observed changes. [2013 Site ID: STR_27-1_R]

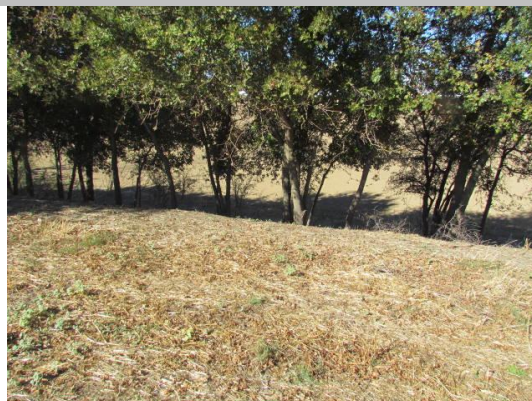
Photo 1 of 3 : FA\_2014\_RD0999\_234\_10\_20141030\_00040.jpg

LM Start	2.89	Rating **	A/W	Issue No.	10
LM End	2.89	Issue Type +	Ma	Location *	LS
Category	Earthen Levee			GPS Latitude/Longitude	
				Start	End
Item	Vegetation			38.322757 °	38.322757 °
				-121.590817 °	-121.590817 °
DWR ID	DWR_RD0999_03_f_2012_10				
Action/Comments					
Remove the wild growth other than native grasses from the levee slopes.					
Inspector Comments: Wild growth at landside slope and toe.

Looking west at trimmed trees at landward toe. (Fall 2014)

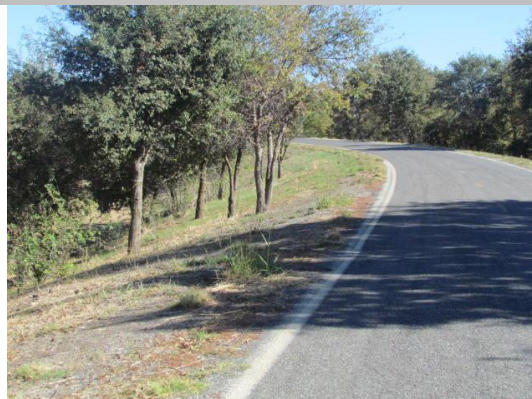
Photo 1 of 1 : FA\_2014\_RD0999\_234\_31\_20141030\_00041.jpg

LM Start	3.02	Rating **	A/W	Issue No.	31
LM End	3.27	Issue Type +	Ma	Location *	LS
Category	Earthen Levee			GPS Latitude/Longitude	
				Start	End
Item	Trim / Thin Trees			38.323770 °	38.326061 °
				-121.589035 °	-121.586028 °
DWR ID	DWR_RD0999_03_s_2012_31				
Action/Comments					
Trim and thin trees to allow visibility of the ground and room to flood fight.

Looking north at trimmed trees on landward slope.

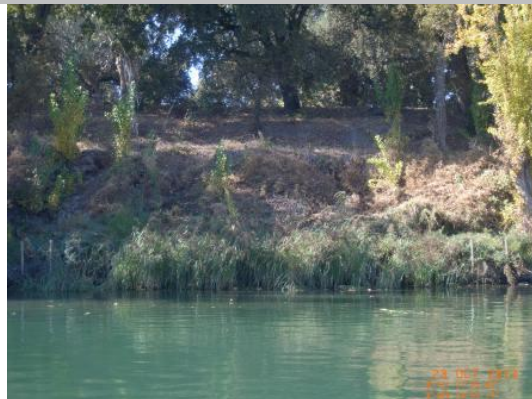
Photo 1 of 1 : FA\_2014\_RD0999\_235\_8\_20141020\_00006.jpg

LM Start	0.01	Rating **	M	Issue No.	8
LM End	0.01	Issue Type +	Ma	Location *	WS
Category	Supplemental			GPS Latitude/Longitude	
				Start	End
Item	USACE Erosion Survey			38.414387 °	38.417692 °
				-121.522871 °	-121.525083 °
DWR ID	DWR_RD0999_04_f_2014_8				
Action/Comments					
Inspector Comments: 1997 - Structural problem rather than erosional, failed cobble at downstream end. 2005 - New brush boxes at waterline for several hundred feet downstream, No toe or bank protection present. 2006 - Some minor new erosion. Brush boxes not working well; most of the brush has floated out. 2007 - Brush boxes have recently been repaired. 2013: No observed changes. [2013 Site ID: SAC_41-9_R]

USACE 2013 Photo #1

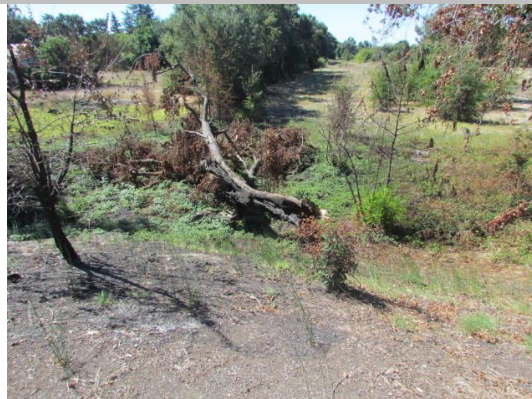
Photo 1 of 1 : FA\_2014\_RD0999\_235\_21\_20141020\_00016.jpg

LM Start	0.60	Rating **	M	Issue No.	21
LM End	0.60	Issue Type +	Ma	Location *	LS
Category	Earthen Levee			GPS Latitude/Longitude	
				Start	End
Item	Encroachments				°
					°
DWR ID	DWR_RD0999_04_f_2013_21				
Action/Comments					
Tree or limb					
Inspector Comments: Downed tree on landward toe and berm.

Looking west at dead tree on landward toe and berm.

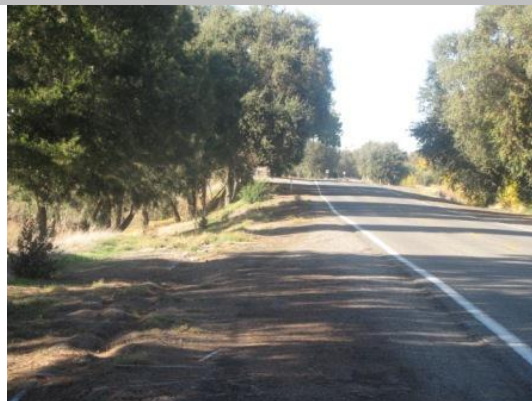
Photo 1 of 2 : FA\_2014\_RD0999\_235\_6\_20141020\_00004.jpg

LM Start	0.71	Rating **	A/W	Issue No.	6
LM End	0.87	Issue Type +	Ma	Location *	LS
Category	Earthen Levee			GPS Latitude/Longitude	
				Start	End
Item	Trim / Thin Trees			38.423035 °	38.425140 °
				-121.529255 °	-121.530742 °
DWR ID	DWR_RD0999_04_s_2012_6				
Action/Comments					
Trim trees to at least five feet above ground level.

Looking north at trimmed trees and removed fence on landside slope.

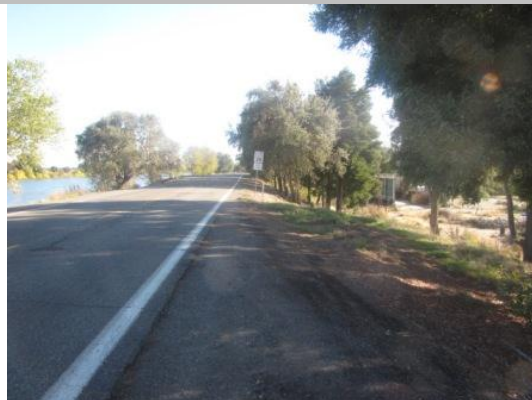
Photo 2 of 2 : FA\_2014\_RD0999\_235\_6\_20141020\_00005.jpg

Looking south at trimmed trees on landside slope and removed fence.

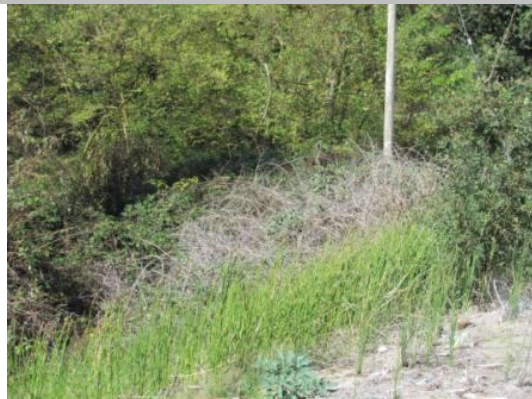
Photo 2 of 2 : FA\_2014\_RD0999\_235\_5\_20141020\_00003.jpg

LM Start	1.15	Rating **	M	Issue No.	5 (cont)	
LM End	1.15	Issue Type +	Ma	Location *	LS	
Category	Earthen Levee			GPS Latitude/Longitude		
				Start		End
Item	Vegetation			38.428823 °		38.428823 °
				-121.532885 °		-121.532885 °
DWR ID	DWR_RD0999_04_s_2012_5					
Action/Comments						
Remove the wild growth other than native grasses from the levee slopes.						
Inspector Comments: Berry vines and wild roses on landside toe.

Looking northwest at dense wild roses and berry vines on landside toe near ramp.

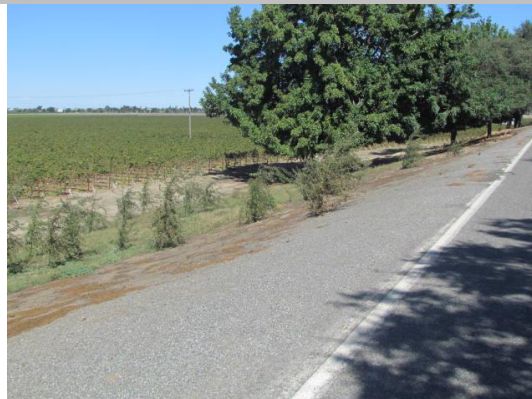
Photo 1 of 1 : FA\_2014\_RD0999\_236\_72\_20141020\_00049.jpg

LM Start	0.10	Rating **	M	Issue No.	72
LM End	0.10	Issue Type +	Ma	Location *	LS
Category	Earthen Levee			GPS Latitude/Longitude	
				Start	End
Item	Trim / Thin Trees				°
					°
DWR ID	DWR_RD0999_05_f_2013_72				
Action/Comments					
Trim and thin trees to allow visibility of the ground and room to flood fight.					
Inspector Comments: Remove small oak trees from landward slope before trees are establish.

Looking west at small oak trees on landward slope.

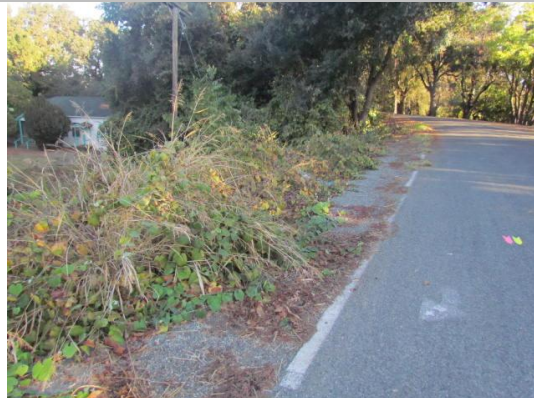
Photo 1 of 1 : FA\_2014\_RD0999\_236\_189\_20141030\_00125.jpg

LM Start	0.71	Rating **	U	Issue No.	189
LM End	0.71	Issue Type +	Ma	Location *	LS
Category	Earthen Levee			GPS Latitude/Longitude	
				Start	End
Item	Vegetation			38.342032 °	38.342032 °
				-121.581372 °	-121.581372 °
DWR ID	DWR_RD0999_05_f_2014_189				
Action/Comments					
Remove the wild growth other than native grasses from the levee slopes.					
Inspector Comments: Dense wild grapevines on landward slope.

Looking northwest at dense vegetation on landward slope.

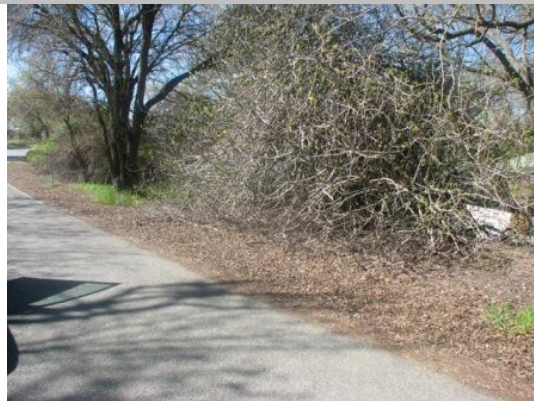
Photo 1 of 4 : FA\_2014\_RD0999\_236\_9\_20141020\_00005.jpg

LM Start	0.72	Rating **	M	Issue No.	9
LM End	0.74	Issue Type +	Ma	Location *	LS
Category	Earthen Levee			GPS Latitude/Longitude	
				Start	End
Item	Trim / Thin Trees			38.342180 °	38.342537 °
				-121.581230 °	-121.581263 °
DWR ID	DWR_RD0999_05_s_2012_9				
Action/Comments					
Trim and thin trees to allow visibility of the ground and room to flood fight.					
Inspector Comments: District or Landowner trimmed trees to a moderate density. Still need to remove more limbs.

Front view of dense trees at landside shoulder.(Spring 2011)

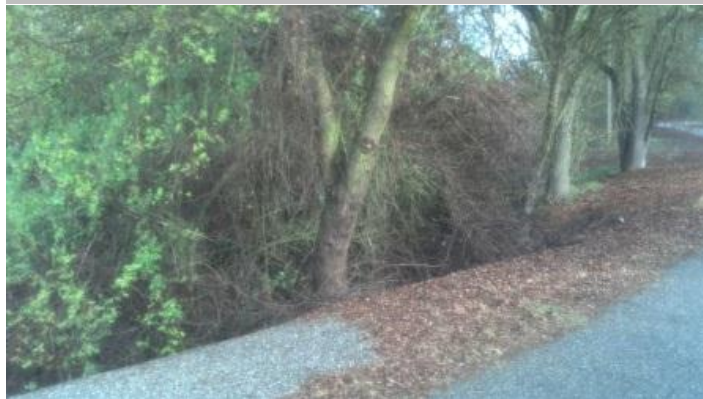
Photo 2 of 4 : FA\_2014\_RD0999\_236\_9\_20141020\_00006.jpg

Looking northwest at dense trees at landside slope and toe. Spring 2013

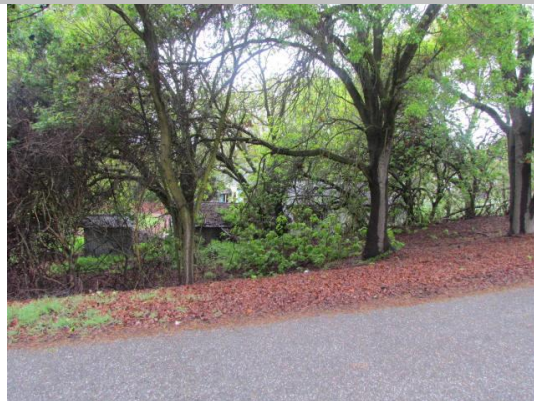
Photo 3 of 4 : FA\_2014\_RD0999\_236\_9\_20141020\_00007.jpg

Looking west at trimmed trees on landside slope.(Spring 2012)

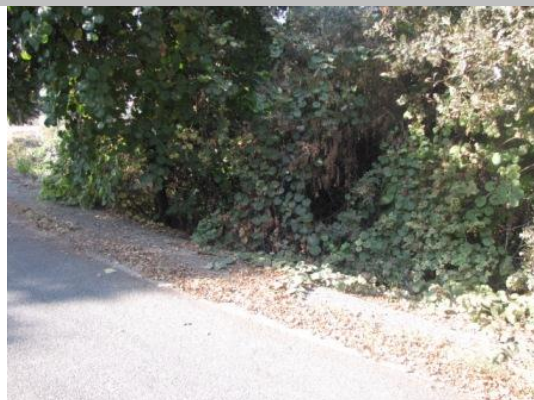
Photo 4 of 4 : FA\_2014\_RD0999\_236\_9\_20141020\_00008.jpg

Looking west at dense trees on landside slope and toe.(Spring 2011)

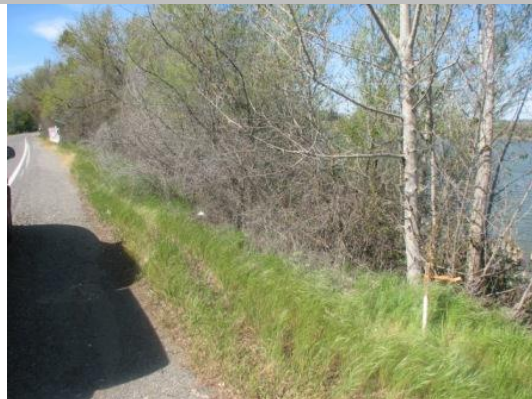
Photo 1 of 2 : FA\_2014\_RD0999\_236\_18\_20141020\_00017.jpg

LM Start	1.51	Rating **	M	Issue No.	18
LM End	1.88	Issue Type +	Ma	Location *	LS
Category	Earthen Levee			GPS Latitude/Longitude	
				Start	End
Item	Trim / Thin Trees			38.348670 °	38.353852 °
				-121.573320 °	-121.573570 °
DWR ID	DWR_RD0999_05_s_2012_18				
Action/Comments					
Trim and thin trees to allow visibility of the ground and room to flood fight.

Side view of dense trees along waterside slope.

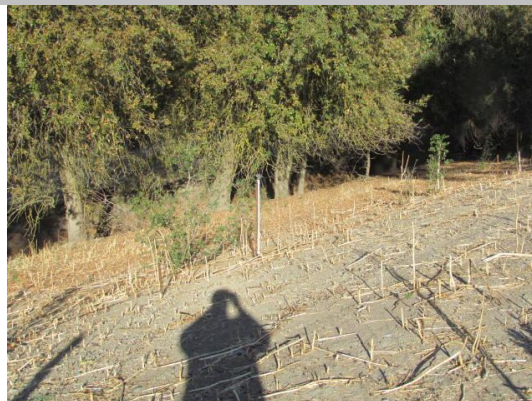
Photo 1 of 2 : FA\_2014\_RD0999\_236\_201\_20141030\_00129.jpg

LM Start	3.63	Rating **	M	Issue No.	201
LM End	3.70	Issue Type +	Ma	Location *	LS
Category	Earthen Levee			GPS Latitude/Longitude	
				Start	End
Item	Trim / Thin Trees			38.366103 °	38.367035 °
				-121.556820 °	-121.556781 °
DWR ID	DWR_RD0999_05_f_2014_201				
Action/Comments					
Thin trees to allow visibility of the ground and room to flood fight. Inspector Comments: Landowner has planted oak trees and installed sprinklers on landward slope. Oak trees should be removed.

Looking west a several small oak trees planted on landward slope.

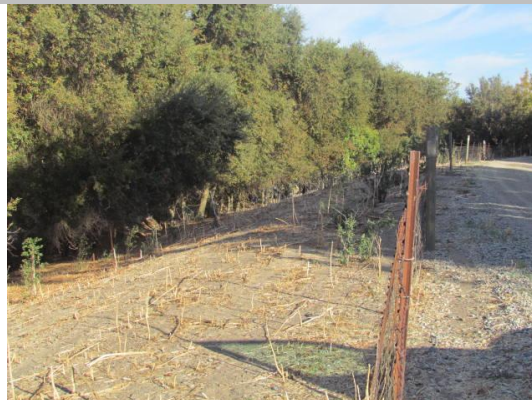
Photo 2 of 2 : FA\_2014\_RD0999\_236\_201\_20141030\_00130.jpg

Looking northwest at several small oak trees planted along landward slope.

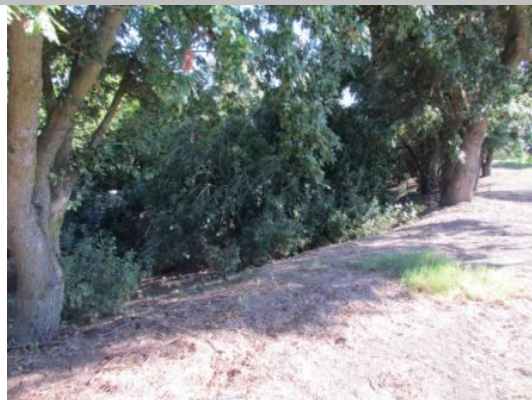
Photo 1 of 3 : FA\_2014\_RD0999\_236\_38\_20141020\_00030.jpg

LM Start	4.59	Rating **	A/W	Issue No.	38
LM End	4.72	Issue Type +	Ma	Location *	LS
Category	Earthen Levee			GPS Latitude/Longitude	
				Start	End
Item	Trim / Thin Trees			38.375055 °	38.375313 °
				-121.548792 °	-121.546438 °
DWR ID	DWR_RD0999_05_s_2012_38				
Action/Comments					
Thin trees to allow visibility of the ground and room to flood fight.

Looking northwest at dense trees on landside slope.(Spring 2011)

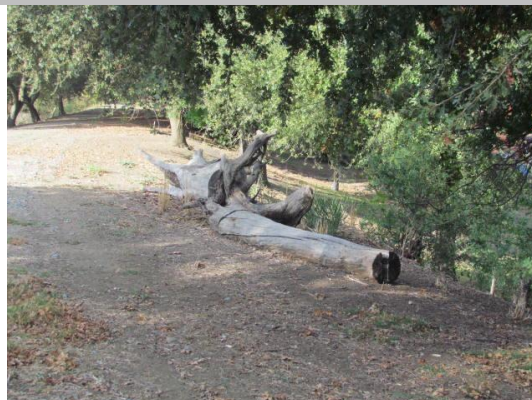
Photo 1 of 1 : FA\_2014\_RD0999\_236\_50\_20141030\_00137.jpg

LM Start	4.73	Rating **	M	Issue No.	50
LM End	4.73	Issue Type +	Ma	Location *	LS
Category	Earthen Levee			GPS Latitude/Longitude	
				Start	End
Item	Encroachments			38.375373 °	38.375373 °
				-121.546200 °	-121.546200 °
DWR ID	DWR_RD0999_05_s_2012_50				
Action/Comments					
Tree or limb					
Inspector Comments: Old tree limbs on landward shoulder blocking access.

Looking southwest at tree limbs on landward shoulder.

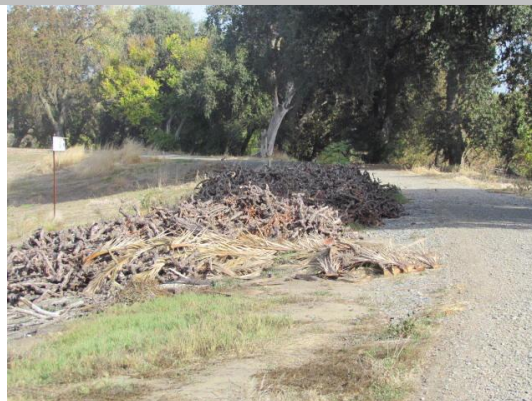
Photo 1 of 2 : FA\_2014\_RD0999\_236\_65\_20141030\_00138.jpg

LM Start	5.16	Rating **	M	Issue No.	65
LM End	5.23	Issue Type +	Ma	Location *	LS
Category	Earthen Levee			GPS Latitude/Longitude	
				Start	End
Item	Encroachments			38.379752 °	38.380640 °
				-121.541048 °	-121.541325 °
DWR ID	DWR_RD0999_05_s_2012_65				
Action/Comments					
Prunings					
Inspector Comments: Prunings on landside slope.

Looking northeast at prunings on landward slope. (Fall 2014)

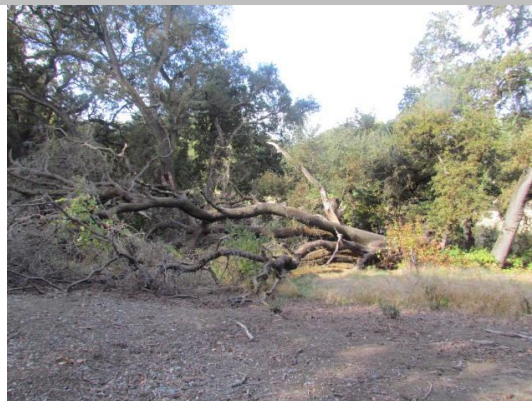
Photo 1 of 3 : FA\_2014\_RD0999\_236\_39\_20141030\_00140.jpg

LM Start	6.03	Rating **	U	Issue No.	39
LM End	6.03	Issue Type +	Ma	Location *	LS
Category	Earthen Levee			GPS Latitude/Longitude	
				Start	End
Item	Encroachments				°
					°
DWR ID	DWR_RD0999_05_s_2013_39				
Action/Comments					
Tree or limb Inspector Comments: Large downed trees and limbs on landside slope and toe.

Looking southwest at downed tree on landward toe. (Fall 2014)

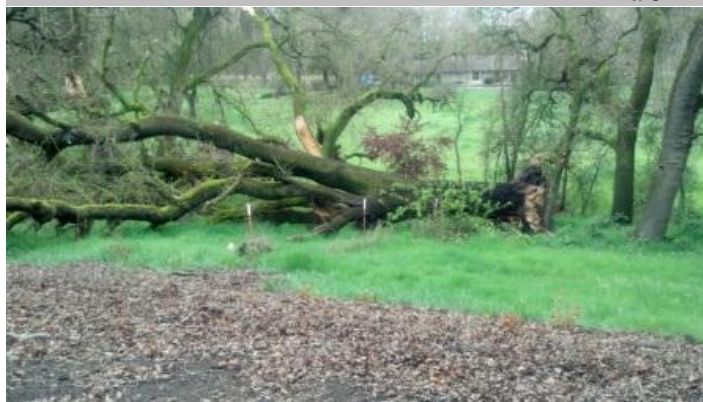
Photo 2 of 3 : FA\_2014\_RD0999\_236\_39\_20141020\_00033.jpg

Looking west at large tree on landside slope and toe.

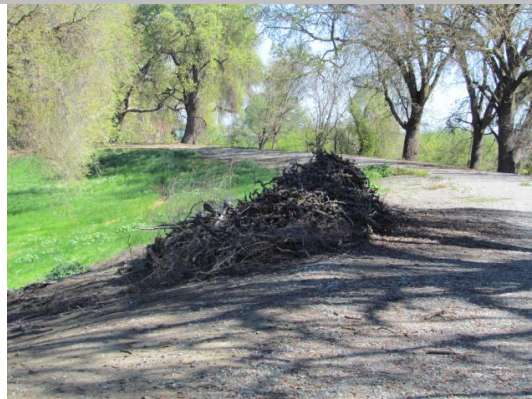
Photo 1 of 1 : FA\_2014\_RD0999\_236\_92\_20141020\_00057.jpg

LM Start	6.58	Rating **	M	Issue No.	92
LM End	6.58	Issue Type +	Ma	Location *	LS
Category	Earthen Levee			GPS Latitude/Longitude	
				Start	End
Item	Encroachments			38.391776 °	38.391776 °
				-121.539295 °	-121.539295 °
DWR ID	DWR_RD0999_05_s _ 2012_92				
Action/Comments					
Prunings

Looking east prunings on landward slope.

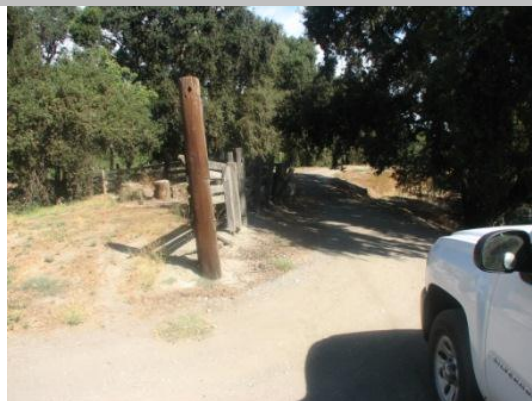
Photo 1 of 4 : FA\_2014\_RD0999\_236\_96\_20141020\_00059.jpg

LM Start	6.83	Rating **	M	Issue No.	96
LM End	6.83	Issue Type +	Ma	Location *	LS
Category	Earthen Levee			GPS Latitude/Longitude	
				Start	End
Item	Encroachments			38.395234 °	38.395234 °
				-121.539323 °	-121.539323 °
DWR ID	DWR_RD0999_05_s _ 2012_96				
Action/Comments					
Material					
Inspector Comments: Firewood and other material on landside shoulder.

Fence, firewood and material at landside shoulder.

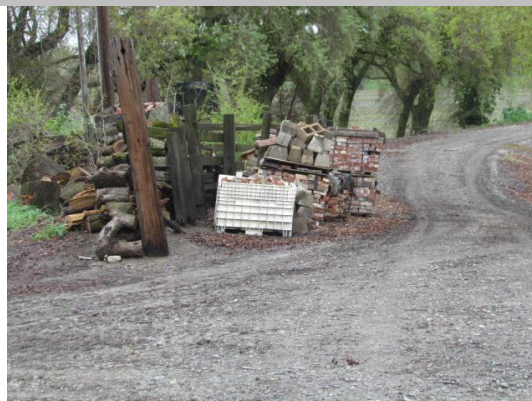
Photo 2 of 4 : FA\_2014\_RD0999\_236\_96\_20141020\_00060.jpg

LM Start	6.83	Rating **	M	Issue No.	96 (cont)
LM End	6.83	Issue Type +	Ma	Location *	LS
Category	Earthen Levee			GPS Latitude/Longitude	
				Start	End
Item	Encroachments			38.395234 °	38.395234 °
				-121.539323 °	-121.539323 °
DWR ID	DWR_RD0999_05_s_2012_96				
Action/Comments					
Material					
Inspector Comments: Firewood and other material on landside shoulder.

Looking northeast at firewood and other material on landside shoulder.  
(Spring 2012)

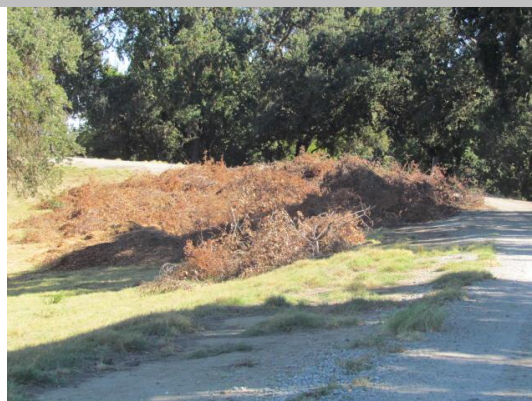
Photo 1 of 1 : FA\_2014\_RD0999\_236\_142\_20141020\_00079.jpg

LM Start	7.06	Rating **	A/W	Issue No.	142
LM End	7.06	Issue Type +	Ma	Location *	LS
Category	Earthen Levee			GPS Latitude/Longitude	
				Start	End
Item	Encroachments				°
					°
DWR ID	DWR_RD0999_05_s_2013_142				
Action/Comments					
Prunings Inspector Comments: Large pruning pile on landward shoulder and slope.

Looking northeast at large prunings on landward slope.
