**Flood Control Project Maintenance
Levee Inspections**

Maintenance Issue Types Only, Levee Inspection Report By Mile - Fall 2015

Reclamation District No. 0999 Netherlands

Waterway	Bank	Unit Miles	Inspection Start/End	Inspector
Unit No. 01 Yolo Bypass	Left	15.41	11/02/2015 11/04/2015	Richard Willoughby

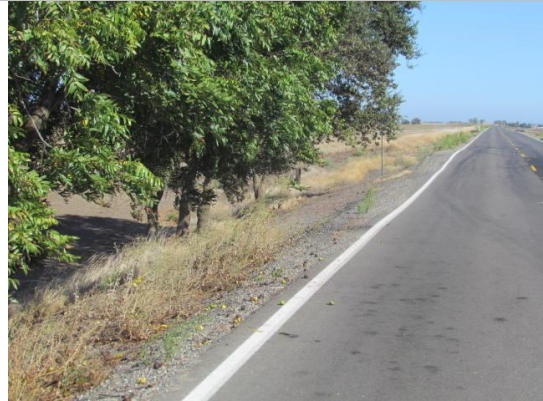
Photo 1 of 2 : FA_2015_RD0999_232_4_20150914_00008.jpg

Looking northwest at trimmed trees on waterward slope.

LM Start	1.73	Rating **	M	Issue No.	4
LM End	1.75	Issue Type +	Ma	Location *	WS
Category	Earthen Levee			GPS Latitude/Longitude	
				Start	End
Item	Trim / Thin Trees			38.480082 °	38.479788 °
				-121.580930 °	-121.580918 °
DWR ID	DWR_RD0999_01_s_2012_4				
Action/Comments					
Trim trees to at least five feet above ground level.

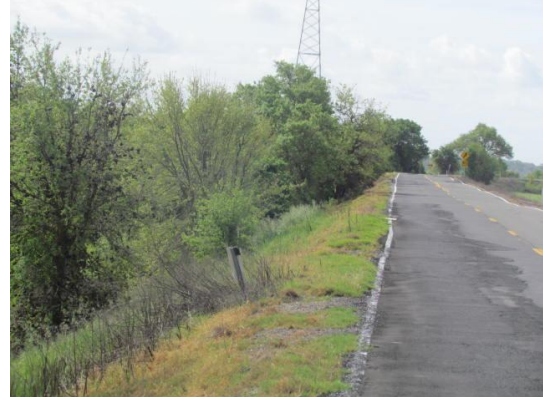
Photo 1 of 5 : FA_2015_RD0999_232_30_20150914_00034.jpg

Looking southeast at untrimmed trees on landward slope. (Spring 2015)

LM Start	1.79	Rating **	M	Issue No.	30 (cont)
LM End	2.04	Issue Type +	Ma	Location *	LS
Category	Earthen Levee			GPS Latitude/Longitude	
				Start	End
Item	Trim / Thin Trees			38.479165 °	38.475463 °
				-121.580640 °	-121.580722 °
DWR ID	DWR_RD0999_01_s _ 2012_30				
Action/Comments					
Trim trees to at least five feet above ground level.

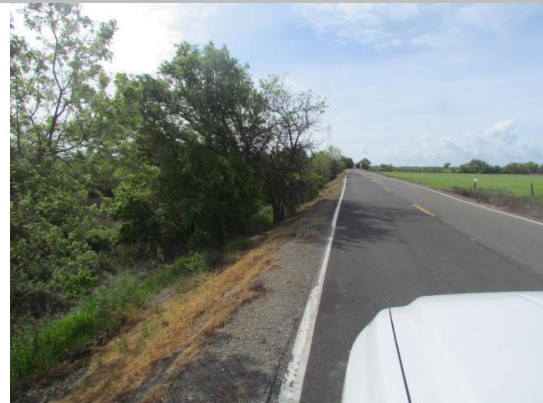
Photo 2 of 5 : FA_2015_RD0999_232_30_20150914_00035.jpg

Looking southeast at dense trees on landward slope. (Spring 2015)

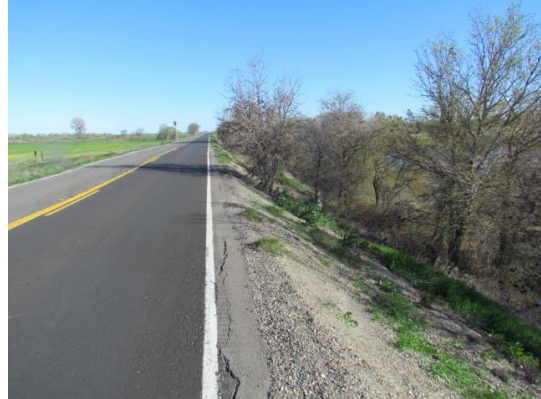
Photo 4 of 5 : FA_2015_RD0999_232_30_20150914_00037.jpg

Looking north at several untrimmed trees on landside slope.

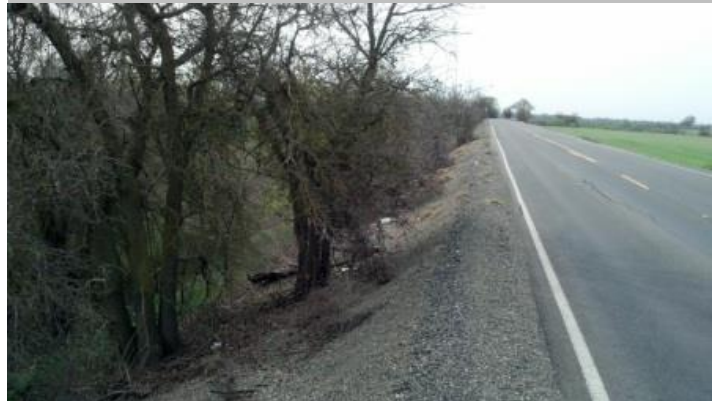
Photo 5 of 5 : FA_2015_RD0999_232_30_20150914_00038.jpg

Looking southeast at dense trees on landside slope and toe. (2013)

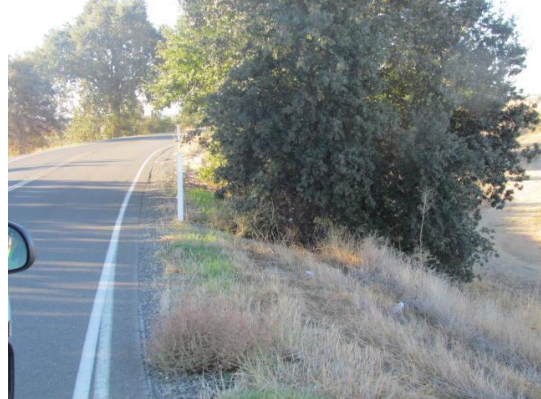
Photo 2 of 3 : FA_2015_RD0999_232_7_20150914_00016.jpg

Looking south at untrimmed trees on waterward slope. (Fall 2014)

LM Start	2.13	Rating **	U	Issue No.	7 (cont)
LM End	2.13	Issue Type +	Ma	Location *	WS
Category	Earthen Levee			GPS Latitude/Longitude	
				Start	End
Item	Trim / Thin Trees			38.474258 °	38.474258
				-121.580528 °	-121.580528
DWR ID	DWR_RD0999_01_s_2012_7				
Action/Comments					
Trim trees to at least five feet above ground level.

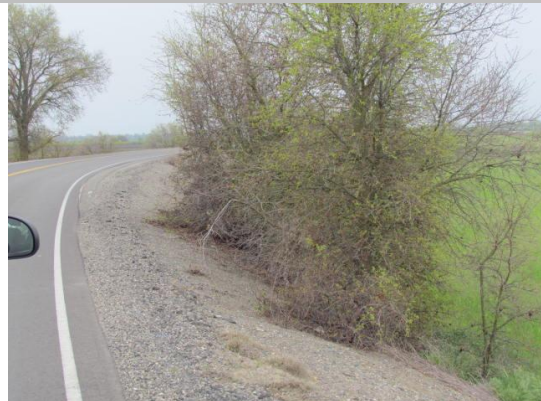
Photo 3 of 3 : FA_2015_RD0999_232_7_20150914_00017.jpg

Looking southwest at untrimmed trees on waterside slope.

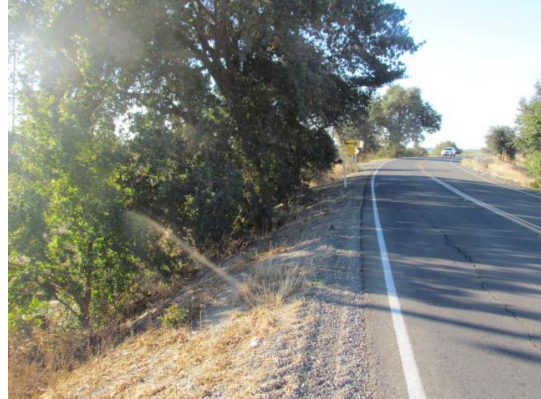
Photo 2 of 3 : FA_2015_RD0999_232_31_20150914_00040.jpg

Looking southeast at untrimmed trees on landward slope. (Fall 2014)

LM Start	2.13	Rating **	U	Issue No.	31
LM End	2.13	Issue Type +	Ma	Location *	LS
Category	Earthen Levee			GPS Latitude/Longitude	
				Start	End
Item	Trim / Thin Trees			38.474200 °	38.474200 °
				-121.580480 °	-121.580480 °
DWR ID	DWR_RD0999_01_s_2012_31				
Action/Comments					
Trim trees to at least five feet above ground level.

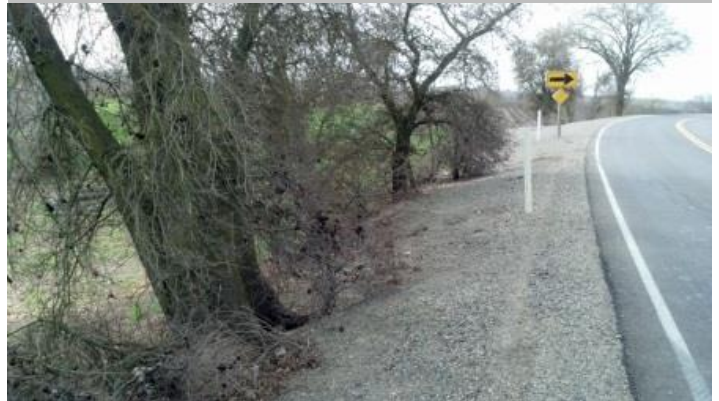
Photo 3 of 3 : FA_2015_RD0999_232_31_20150914_00041.jpg

Looking southeast at untrimmed trees on landside slope.

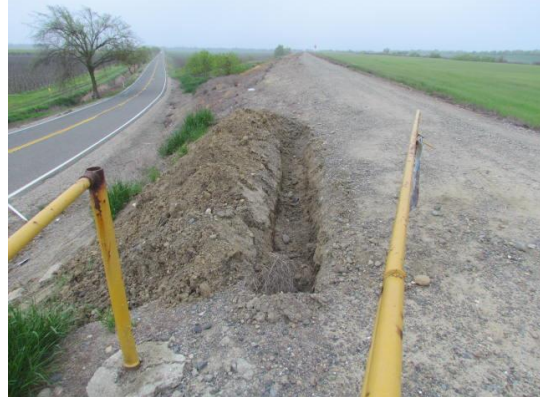
Photo 1 of 3 : FA_2015_RD0999_232_40_20150914_00049.jpg

Looking south at excavation with backhoe on landside shoulder.

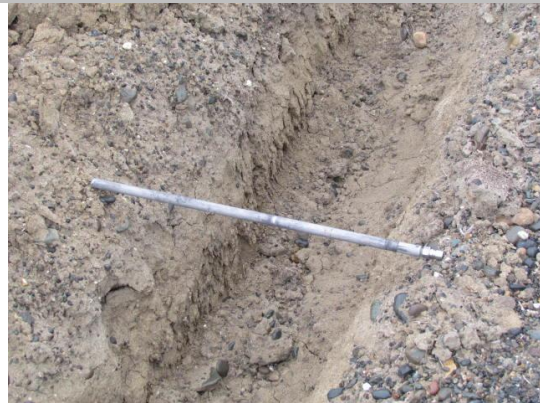
Photo 2 of 3 : FA_2015_RD0999_232_40_20150914_00050.jpg

Looking south at close-up view of excavation on landside shoulder.

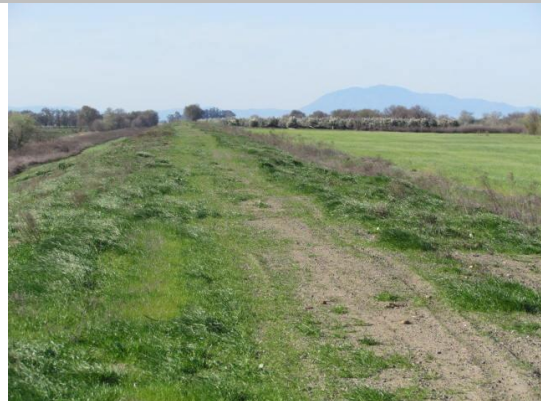
Photo 2 of 3 : FA_2015_RD0999_232_46_20150914_00057.jpg

Looking south at growth and ruts on levee crown.

LM Start	2.76	Rating **	A/W	Issue No.	46
LM End	4.98	Issue Type +	Ma	Location *	CR
Category	Earthen Levee			GPS Latitude/Longitude	
				Start	End
Item	Crown Surface / Depressions / Rutting			38.465627 °	38.435378 °
				-121.584634 °	-121.598664 °
DWR ID	DWR_RD0999_01_f_2013_46				
Action/Comments					
Repair depressions or ruts in the crown or slope. Inspector Comments: Control growth on levee crown and repair ruts on levee crown.

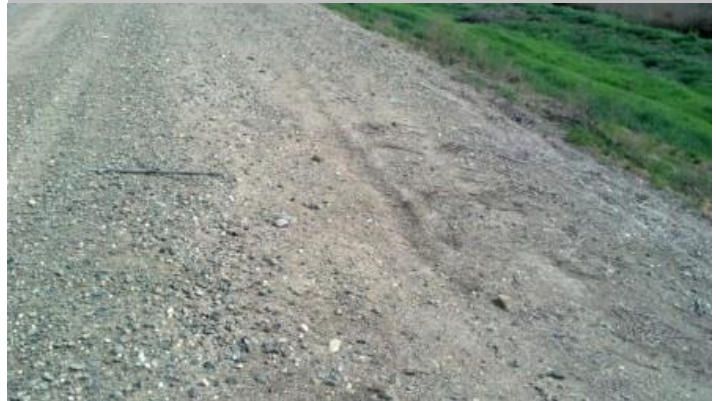
Photo 2 of 2 : FA_2015_RD0999_232_51_20150914_00068.jpg

Looking northeast at depression on landside shoulder.

LM Start	3.24	Rating **	M	Issue No.	51
LM End	3.26	Issue Type +	Ma	Location *	LS
Category	Earthen Levee			GPS Latitude/Longitude	
				Start	End
Item	Slope Stability				°
					°
DWR ID	DWR_RD0999_01_s_2013_51				
Action/Comments					
Repair slope instability. Inspector Comments: Depression on waterside shoulder and slope 60' x 20'. Earthen material appears to be sliding toward levee toe.

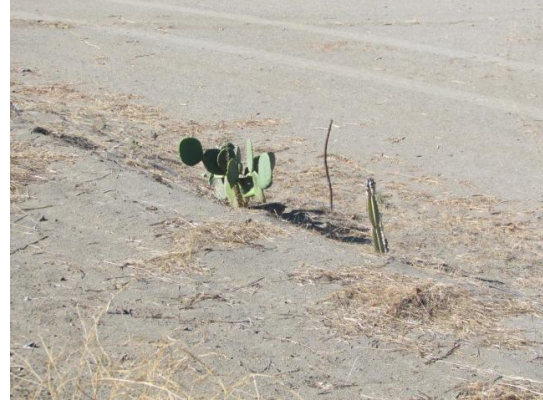
Photo 1 of 1 : FA_2015_RD0999_232_45_20150914_00055.jpg

Looking west at cactus on waterward toe.

LM Start	4.36	Rating **	A/W	Issue No.	45
LM End	4.36	Issue Type +	Ma	Location *	WS
Category	Earthen Levee			GPS Latitude/Longitude	
				Start	End
Item	Vegetation				°
					°
DWR ID	DWR_RD0999_01_f_2013_45				
Action/Comments					
Remove the wild growth other than native grasses from the levee slopes.					
Inspector Comments: Landowner has planted cactus on waterward toe.

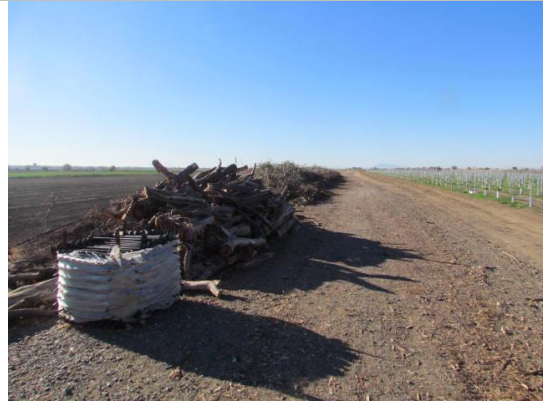
Photo 1 of 2 : FA_2015_RD0999_232_18_20150914_00019.jpg

Looking south at pruning piles on landward shoulder. (Fall 2014)

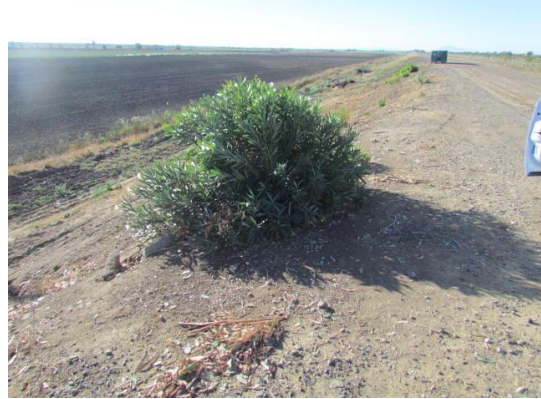
Photo 1 of 1 : FA_2015_RD0999_232_38_20151106_00088.jpg

Looking at oleander on landward shoulder.

LM Start	6.53	Rating **	M	Issue No.	38
LM End	6.53	Issue Type +	Ma	Location *	LS
Category	Earthen Levee			GPS Latitude/Longitude	
				Start	End
Item	Vegetation			38.414332 °	38.414332 °
				-121.608413 °	-121.608413 °
DWR ID	DWR_RD0999_01_f_2015_38				
Action/Comments					
Remove the wild growth other than native grasses from the levee slopes. Inspector Comments: Remove young oleander from landward shoulder and slope.

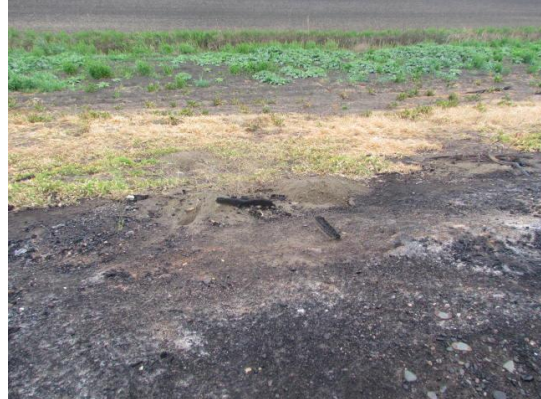
Photo 1 of 2 : FA_2015_RD0999_232_42_20150914_00052.jpg

Looking east at rodent holes on landside slope.

LM Start	6.56	Rating **	M	Issue No.	42
LM End	6.56	Issue Type +	Ma	Location *	LS
Category	Earthen Levee			GPS Latitude/Longitude	
				Start	End
Item	Animal Control			38.413858 °	38.413858 °
				-121.608638 °	-121.608638 °
DWR ID	DWR_RD0999_01_s_2012_42				
Action/Comments					
Exterminate rodents and backfill and compact or grout burrows. Inspector Comments: More than five holes within 25' of levee.

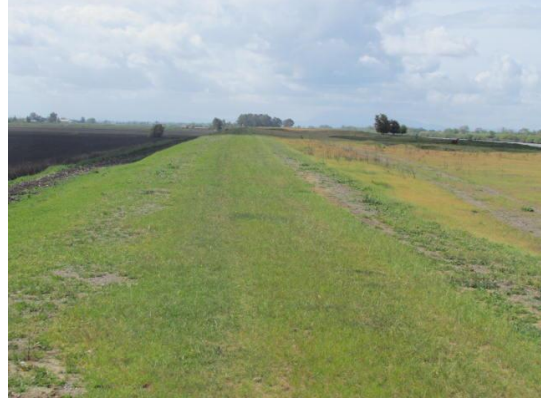
Photo 1 of 1 : FA_2015_RD0999_232_22_20150914_00025.jpg

Looking south at levee crown. (Spring 2015)

LM Start	7.08	Rating **	M	Issue No.	22
LM End	8.88	Issue Type +	Ma	Location *	CR
Category	Earthen Levee			GPS Latitude/Longitude	
				Start	End
Item	Crown Surface / Depressions / Rutting			38.406842 °	38.382338 °
				-121.611897 °	-121.623343 °
DWR ID	DWR_RD0999_01_s _ 2012_22				
Action/Comments					
Add appropriate gravel or road base. Grade and compact.

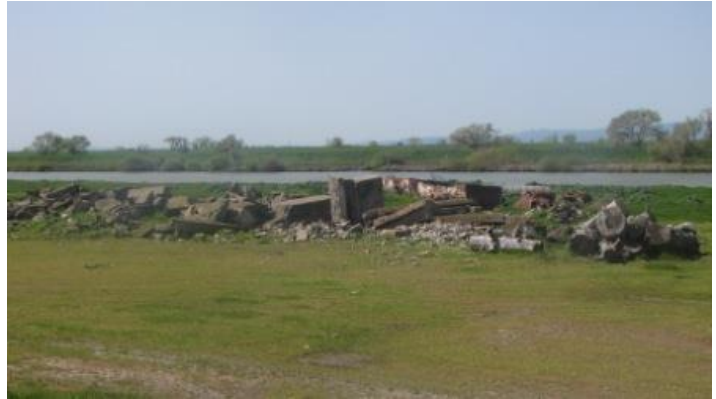
Photo 1 of 1 : FA_2015_RD0999_232_25_20150914_00028.jpg

Looking west at concrete rubble on waterside berm.

LM Start	8.15	Rating **	M	Issue No.	25
LM End	8.15	Issue Type +	Ma	Location *	WS
Category	Earthen Levee			GPS Latitude/Longitude	
				Start	End
Item	Encroachments			38.392255 °	38.392255 °
				-121.618709 °	-121.618709 °
DWR ID	DWR_RD0999_01_s _ 2012_25				
Action/Comments					
Material					
Inspector Comments: Concrete rubble on waterside berm.

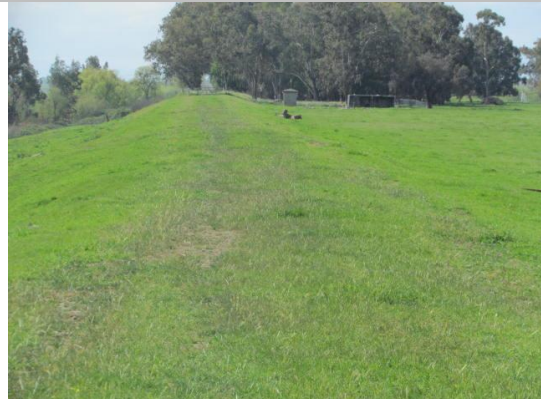
Photo 1 of 2 : FA_2015_RD0999_232_919_20150914_00079.jpg

Looking south at levee crown. Spring 2015

LM Start	9.30	Rating **	M	Issue No.	919
LM End	9.73	Issue Type +	Ma	Location *	CR
Category	Earthen Levee			GPS Latitude/Longitude	
				Start	End
Item	Crown Surface / Depressions / Rutting			38.376669 °	38.370762 °
				-121.625896 °	-121.628640 °
DWR ID	DWR_RD0999_01_s _ 2012_919				
Action/Comments					
Add appropriate material and re-grade the levee to bring the crown above the design elevation.

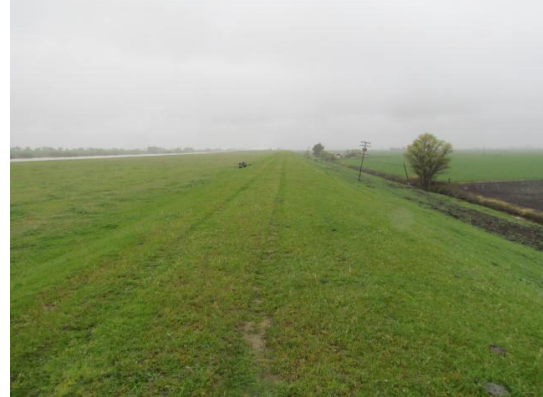
Photo 2 of 2 : FA_2015_RD0999_232_919_20150914_00080.jpg

Looking south at crown roadway. Spring 2014

LM Start	9.30	Rating **	M	Issue No.	919 (cont)
LM End	9.73	Issue Type +	Ma	Location *	CR
Category	Earthen Levee			GPS Latitude/Longitude	
				Start	End
Item	Crown Surface / Depressions / Rutting			38.376669 °	38.370762 °
				-121.625896 °	-121.628640 °
DWR ID	DWR_RD0999_01_s_2012_919				
Action/Comments					
Add appropriate material and re-grade the levee to bring the crown above the design elevation.

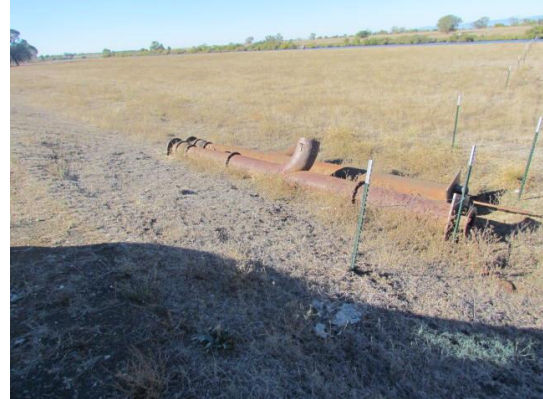
Photo 1 of 1 : FA_2015_RD0999_232_47_20151106_00089.jpg

Looking southwest at abandoned irrigation pipes at waterward toe.

LM Start	9.51	Rating **	M	Issue No.	47
LM End	9.51	Issue Type +	Ma	Location *	WS
Category	Earthen Levee			GPS Latitude/Longitude	
				Start	End
Item	Encroachments			38.373740 °	38.373740 °
				-121.627257 °	-121.627257 °
DWR ID	DWR_RD0999_01_f_2015_47				
Action/Comments					
Pipe					
Inspector Comments: Abandoned pipes at waterward toe.

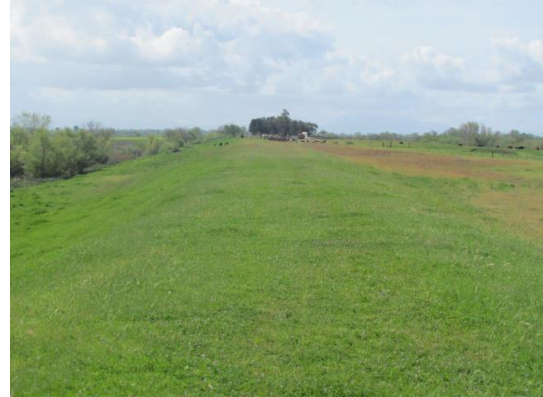
Photo 1 of 2 : FA_2015_RD0999_232_920_20150914_00081.jpg

Looking south at levee crown. (Spring 2015)

LM Start	9.94	Rating **	M	Issue No.	920
LM End	10.21	Issue Type +	Ma	Location *	CR
Category	Earthen Levee			GPS Latitude/Longitude	
				Start	End
Item	Crown Surface / Depressions / Rutting			38.367831 °	38.364238 °
				-121.629990 °	-121.631674 °
DWR ID	DWR_RD0999_01_s_2012_920				
Action/Comments					
Add appropriate material and re-grade the levee to bring the crown above the design elevation.

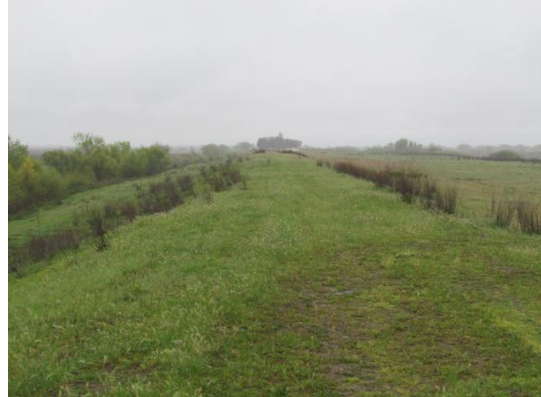
Photo 2 of 2 : FA_2015_RD0999_232_920_20150914_00082.jpg

Looking south at crown roadway. (Spring 2014)

LM Start	9.94	Rating **	M	Issue No.	920 (cont)	
LM End	10.21	Issue Type +	Ma	Location *	CR	
Category	Earthen Levee			GPS Latitude/Longitude		
				Start		End
Item	Crown Surface / Depressions / Rutting			38.367831 °		38.364238 °
				-121.629990 °		-121.631674 °
DWR ID	DWR_RD0999_01_s_2012_920					
Action/Comments						
Add appropriate material and re-grade the levee to bring the crown above the design elevation.

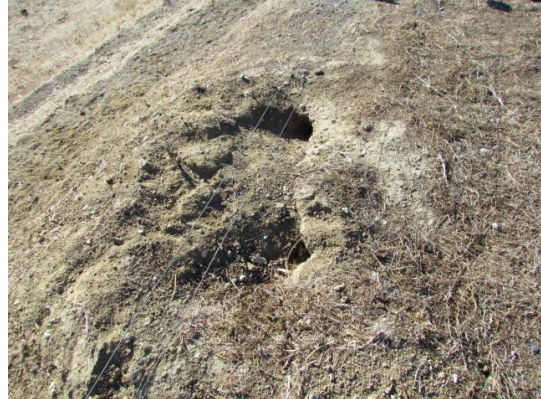
Photo 1 of 4 : FA_2015_RD0999_232_2_20151106_00091.jpg

Looking southeast at rodent holes on landward shoulder fall 2015.

LM Start	9.95	Rating **	U	Issue No.	2
LM End	9.95	Issue Type +	Ma	Location *	LS
Category	Earthen Levee			GPS Latitude/Longitude	
				Start	End
Item	Animal Control			38.367750 °	38.367750 °
				-121.630025 °	-121.630025 °
DWR ID	DWR_RD0999_01_s_2012_2				
Action/Comments					
Exterminate rodents and backfill and compact or grout burrows. Inspector Comments: Several large rodent holes on landward shoulder.

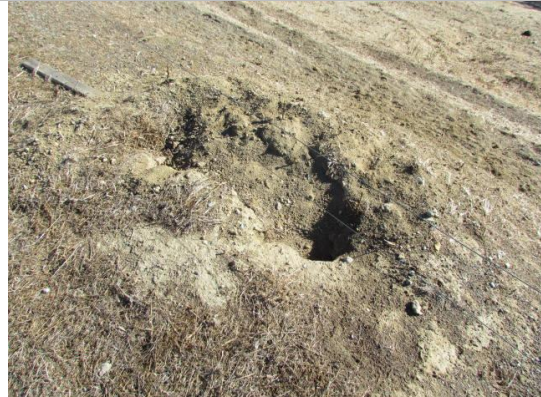
Photo 2 of 4 : FA_2015_RD0999_232_2_20151106_00092.jpg

Looking northeast at rodent holes on landward shoulder fall 2015.

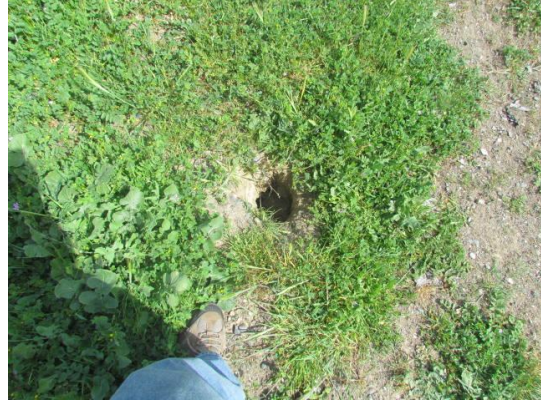
Photo 3 of 4 : FA_2015_RD0999_232_2_20150914_00006.jpg

Looking at typical rodent holes on landward shoulder. (Spring 2015)

LM Start	9.95	Rating **	U	Issue No.	2 (cont)
LM End	9.95	Issue Type +	Ma	Location *	LS
Category	Earthen Levee			GPS Latitude/Longitude	
				Start	End
Item	Animal Control			38.367750 °	38.367750 °
				-121.630025 °	-121.630025 °
DWR ID	DWR_RD0999_01_s_2012_2				
Action/Comments					
Exterminate rodents and backfill and compact or grout burrows. Inspector Comments: Several large rodent holes on landward shoulder.

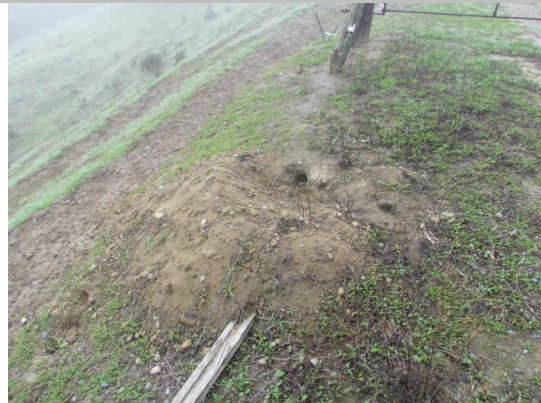
Photo 4 of 4 : FA_2015_RD0999_232_2_20150914_00007.jpg

Looking south at rodent hole on landside shoulder. (Fall 2014)

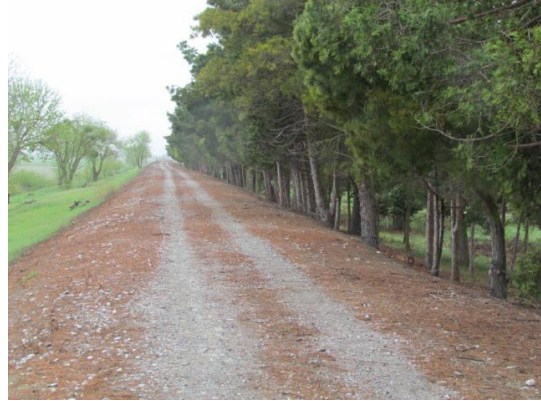
Photo 1 of 2 : FA_2015_RD0999_232_23_20150914_00026.jpg

LM Start	10.81	Rating **	A/W	Issue No.	23
LM End	11.06	Issue Type +	Ma	Location *	WS
Category	Earthen Levee			GPS Latitude/Longitude	
				Start	End
Item	Trim / Thin Trees			38.356077 °	38.352640 °
				-121.635598 °	-121.637078 °
DWR ID	DWR_RD0999_01_s _ 2012_23				
Action/Comments					
Trim trees to at least five feet above ground level.

Looking south at trimmed pine trees on waterside shoulder and slope.
(Spring 2012)

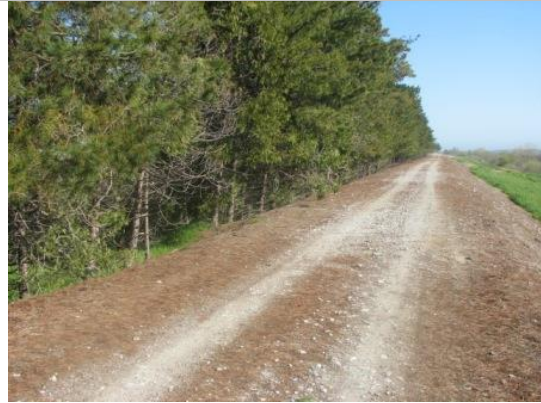
Photo 2 of 2 : FA_2015_RD0999_232_23_20150914_00027.jpg

Pine trees along waterside shoulder & slope. (Site of a old christmas tree farm). (Spring 2011)

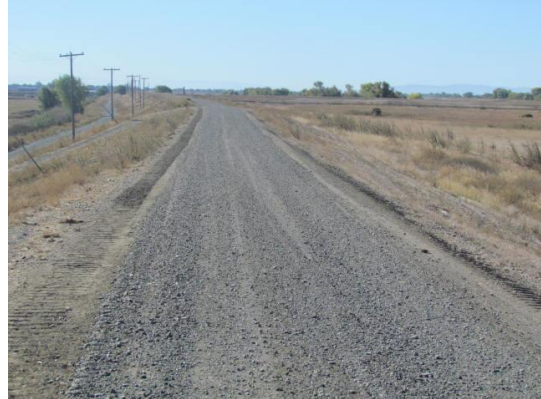
Photo 1 of 1 : FA_2015_RD0999_232_21_20150914_00021.jpg

LM Start	12.53	Rating **	M	Issue No.	21
LM End	12.60	Issue Type +	Ma	Location *	CR
Category	Earthen Levee			GPS Latitude/Longitude	
				Start	End
Item	Crown Surface / Depressions / Rutting			38.332288 °	38.331247 °
				-121.644640 °	-121.644765 °
DWR ID	DWR_RD0999_01_s _ 2012_21				
Action/Comments					
Add appropriate gravel or road base. Grade and compact. Inspector Comments: Ruts have been fixed, but need to add appropriate gravel or road base.

Looking south at graded levee crown.(Fall 2014)

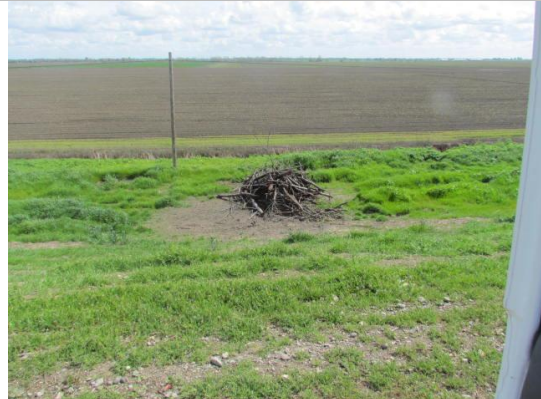
Photo 1 of 1 : FA_2015_RD0999_232_59_20150914_00069.jpg

LM Start	13.46	Rating **	M	Issue No.	59
LM End	13.46	Issue Type +	Ma	Location *	LS
Category	Earthen Levee			GPS Latitude/Longitude	
				Start	End
Item	Encroachments			38.318717 °	38.318717 °
				-121.644955 °	-121.644955 °
DWR ID	DWR_RD0999_01_s _ 2015_59				
Action/Comments					
Prunings					
Inspector Comments: Pruning pile on landward berm.

Looking east at pruning pile on landward berm.

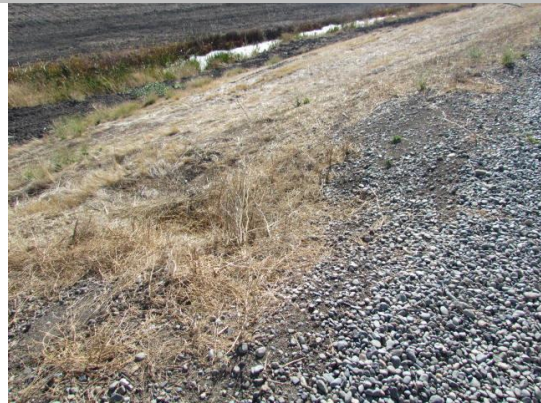
Photo 1 of 4 : FA_2015_RD0999_232_49_20151106_00095.jpg

LM Start	14.04	Rating **	U	Issue No.	49
LM End	14.04	Issue Type +	Ma	Location *	LS
Category	Earthen Levee			GPS Latitude/Longitude	
				Start	End
Item	Erosion / Bank Caving			38.310347 °	38.310347 °
				-121.644955 °	-121.644955 °
DWR ID	DWR_RD0999_01_f_2012_49				
Action/Comments					
Note and monitor erosion site.					
Inspector Comments: Caving, 4' x 10', on landside slope.

Looking southeast at caving on landward slope fall 2015.

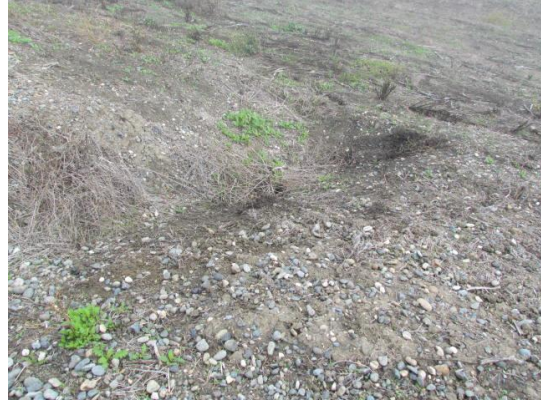
Photo 3 of 4 : FA_2015_RD0999_232_49_20150914_00062.jpg

LM Start	14.04	Rating **	U	Issue No.	49 (cont)
LM End	14.04	Issue Type +	Ma	Location *	LS
Category	Earthen Levee			GPS Latitude/Longitude	
				Start	End
Item	Erosion / Bank Caving			38.310347 °	38.310347 °
				-121.644955 °	-121.644955 °
DWR ID	DWR_RD0999_01_f_2012_49				
Action/Comments					
Note and monitor erosion site.					
Inspector Comments: Caving, 4' x 10', on landside slope.

Looking southeast at caving on landside slope.

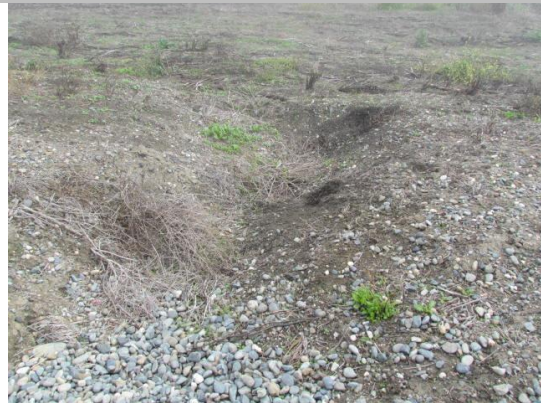
Photo 4 of 4 : FA_2015_RD0999_232_49_20150914_00063.jpg

Looking east caving on landside slope.

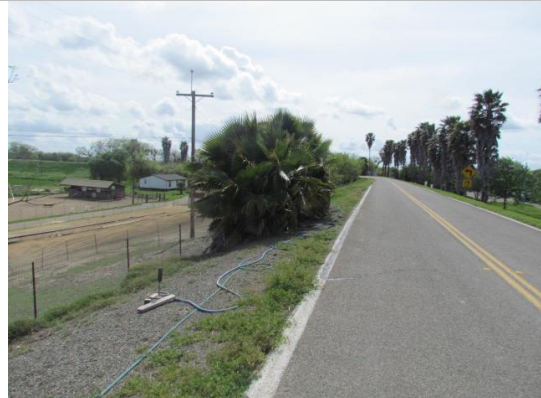
Photo 1 of 3 : FA_2015_RD0999_232_50_20150914_00064.jpg

LM Start	15.33	Rating **	M	Issue No.	50
LM End	15.33	Issue Type +	Ma	Location *	LS
Category	Earthen Levee			GPS Latitude/Longitude	
				Start	End
Item	Encroachments			38.291663 °	38.291663 °
				-121.644962 °	-121.644962 °
DWR ID	DWR_RD0999_01_f_2012_50				
Action/Comments					
Tree or limb					
Inspector Comments: Newly planted palm trees on landside shoulder.

Looking northeast at a mature palm trees on landward shoulder and slope. (Spring 2015)

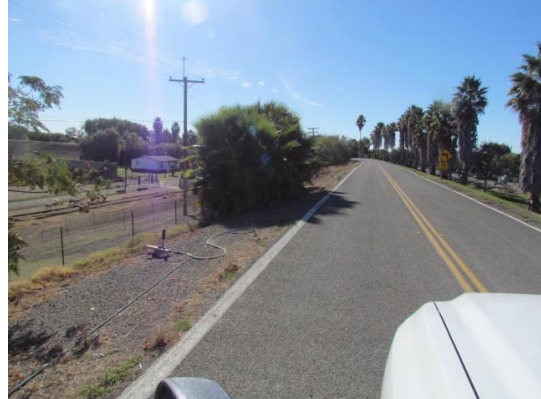
Photo 2 of 3 : FA_2015_RD0999_232_50_20150914_00065.jpg

LM Start	15.33	Rating **	M	Issue No.	50 (cont)
LM End	15.33	Issue Type +	Ma	Location *	LS
Category	Earthen Levee			GPS Latitude/Longitude	
				Start	End
Item	Encroachments			38.291663 °	38.291663 °
				-121.644962 °	-121.644962 °
DWR ID	DWR_RD0999_01_f_2012_50				
Action/Comments					
Tree or limb					
Inspector Comments: Newly planted palm trees on landside shoulder.

Looking east at a maturing plam trees on landward shoulder and slope.
(Fall 2014)

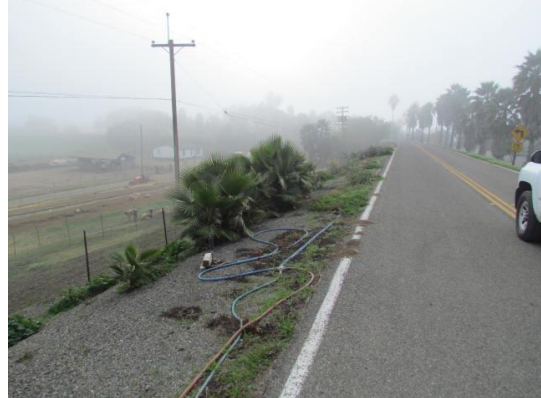
Photo 3 of 3 : FA_2015_RD0999_232_50_20150914_00066.jpg

Looking east at newly planted palm trees on landside shoulder and slope.

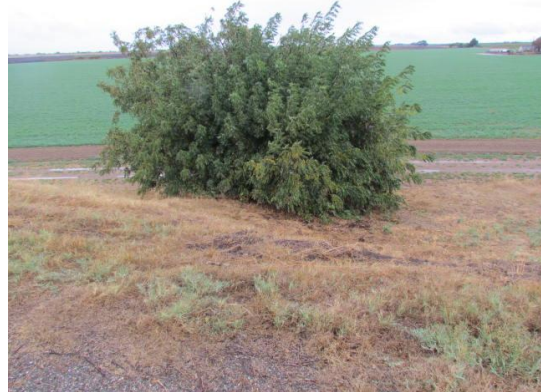
Photo 1 of 1 : FA_2015_RD0999_233_37_20151106_00045.jpg

LM Start	0.73	Rating **	U	Issue No.	37
LM End	0.73	Issue Type +	Ma	Location *	LS
Category	Earthen Levee			GPS Latitude/Longitude	
				Start	End
Item	Trim / Thin Trees			38.292783 °	38.292783 °
				-121.632317 °	-121.632317 °
DWR ID	DWR_RD0999_02_s_2014_37				
Action/Comments					
Trim trees to at least five feet above ground level.

Looking east at untrimmed tree on landward slope.

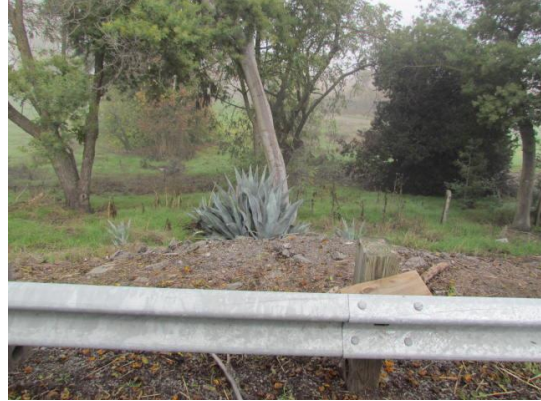
Photo 2 of 2 : FA_2015_RD0999_233_14_20150914_00015.jpg

LM Start	0.82	Rating **	U	Issue No.	14 (cont)
LM End	0.82	Issue Type +	Ma	Location *	LS
Category	Earthen Levee			GPS Latitude/Longitude	
				Start	End
Item	Vegetation			38.292439 °	38.292439 °
				-121.630781 °	-121.630781 °
DWR ID	DWR_RD0999_02_f_2012_14				
Action/Comments					
Remove the wild growth other than native grasses from the levee slopes.					
Inspector Comments: Century plant on landside slope.

Looking north at century plant at landside toe.

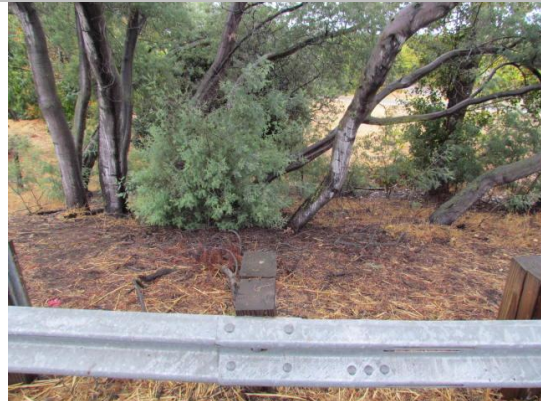
Photo 1 of 2 : FA_2015_RD0999_233_19_20151106_00046.jpg

LM Start	0.83	Rating **	U	Issue No.	19
LM End	0.83	Issue Type +	Ma	Location *	LS
Category	Earthen Levee			GPS Latitude/Longitude	
				Start	End
Item	Trim / Thin Trees			38.292386 °	38.292386 °
				-121.630543 °	-121.630543 °
DWR ID	DWR_RD0999_02_f_2012_19				
Action/Comments					
Thin trees to allow visibility of the ground and room to flood fight.

Looking north at untrimmed trees to be thinned at landward toe fall 2015.

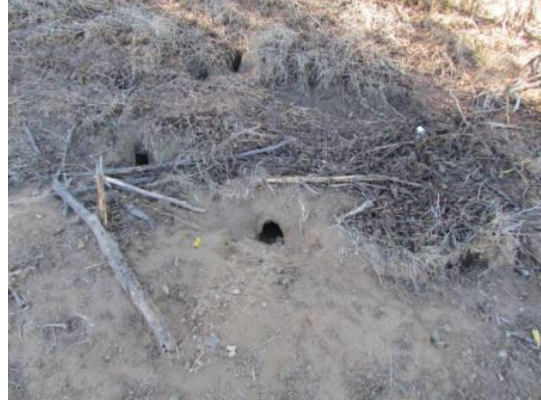
Photo 1 of 1 : FA_2015_RD0999_233_2_20150914_00003.jpg

LM Start	0.93	Rating **	M	Issue No.	2
LM End	1.03	Issue Type +	Ma	Location *	LS
Category	Earthen Levee			GPS Latitude/Longitude	
				Start	End
Item	Animal Control			38.291823 °	38.291250 °
				-121.628973 °	-121.627285 °
DWR ID	DWR_RD0999_02_s_2012_2				
Action/Comments					
Exterminate rodents and backfill and compact or grout burrows.

Looking at several rodent holes on landside slope.

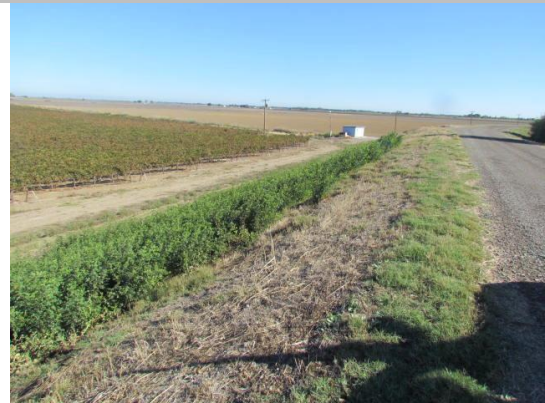
Photo 1 of 1 : FA_2015_RD0999_233_41_20150914_00034.jpg

LM Start	1.19	Rating **	M	Issue No.	41
LM End	1.19	Issue Type +	Ma	Location *	LS
Category	Earthen Levee			GPS Latitude/Longitude	
				Start	End
Item	Vegetation			38.291185 °	38.291185 °
				-121.624344 °	-121.624344 °
DWR ID	DWR_RD0999_02_f_2014_41				
Action/Comments					
Remove the wild growth other than native grasses from the levee slopes.					
Inspector Comments: Dense wild roses on landward slope.

Looking north at moderate vegetation on landward slope and toe.

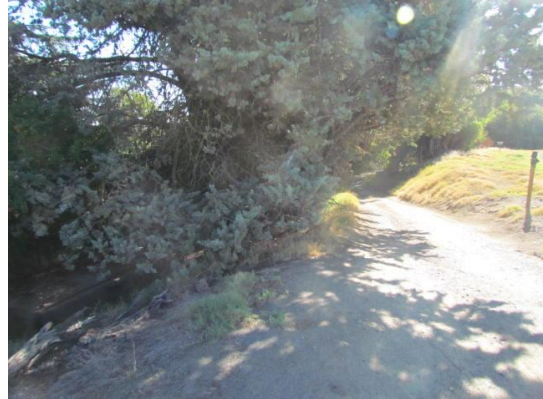
Photo 2 of 2 : FA_2015_RD0999_233_11_20150914_00013.jpg

LM Start	1.70	Rating **	U	Issue No.	11 (cont)
LM End	1.70	Issue Type +	Ma	Location *	LS
Category	Earthen Levee			GPS Latitude/Longitude	
				Start	End
Item	Trim / Thin Trees			38.290171 °	38.290171 °
				-121.615260 °	-121.615260 °
DWR ID	DWR_RD0999_02_s_2012_11				
Action/Comments					
Trim trees to at least five feet above ground level.

Looking southwest at dense trees on landward slope.

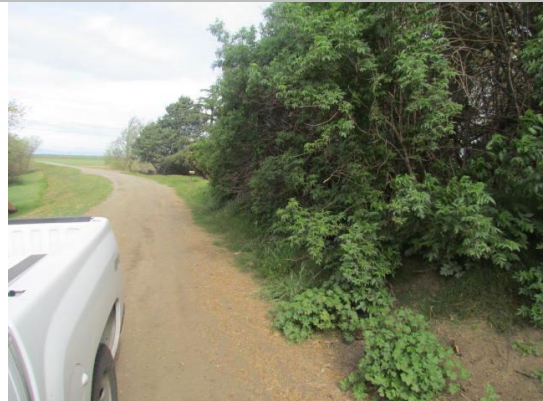
Photo 1 of 2 : FA_2015_RD0999_233_8_20150914_00010.jpg

LM Start	1.73	Rating **	M	Issue No.	8
LM End	1.76	Issue Type +	Ma	Location *	LS
Category	Earthen Levee			GPS Latitude/Longitude	
				Start	End
Item	Vegetation			38.289895 °	38.289595 °
				-121.614688 °	-121.614337 °
DWR ID	DWR_RD0999_02_s_2012_8				
Action/Comments					
Remove the wild growth other than native grasses from the levee slopes.

Looking west at dense vegetation on landward shoulder and slope.
(Spring 2015)

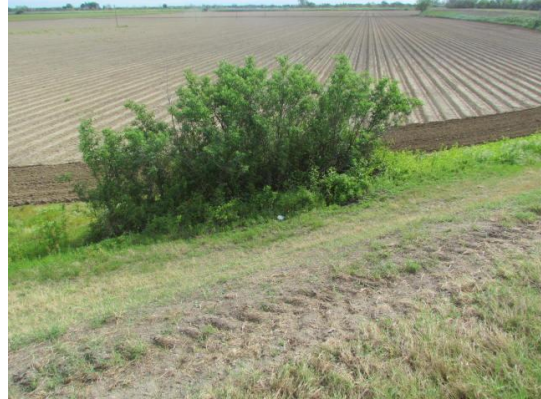
Photo 1 of 2 : FA_2015_RD0999_233_42_20150914_00035.jpg

Looking east at wild rose blocking landward toe. (Spring 2015)

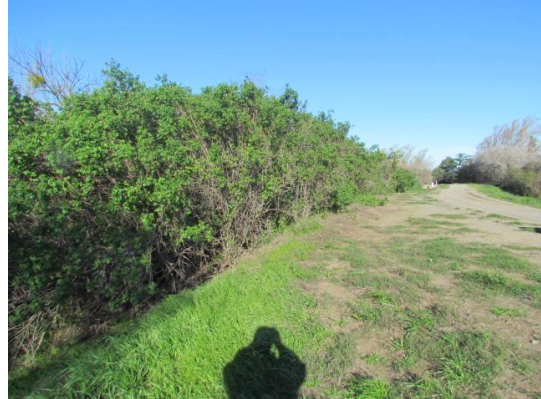
Photo 1 of 2 : FA_2015_RD0999_233_38_20150914_00032.jpg

LM Start	1.78	Rating **	M	Issue No.	38
LM End	1.82	Issue Type +	Ma	Location *	WS
Category	Earthen Levee			GPS Latitude/Longitude	
				Start	End
Item	Vegetation			38.289360 °	38.289006 °
				-121.614086 °	-121.613639 °
DWR ID	DWR_RD0999_02_s_2014_38				
Action/Comments					
Elderberries are blocking visibility and flood fight capability.

Looking west at dense vegetation on waterside slope.

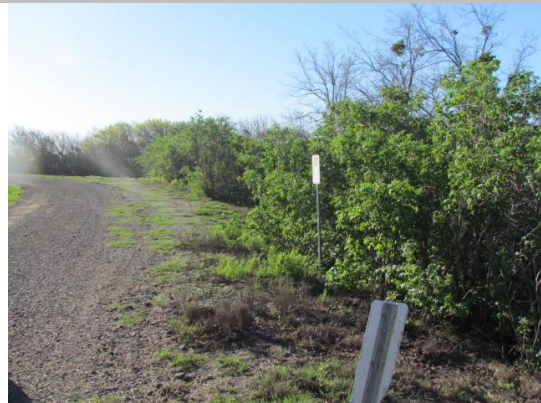
Photo 2 of 2 : FA_2015_RD0999_233_38_20150914_00033.jpg

Looking east at dense vegetation on waterside slope.

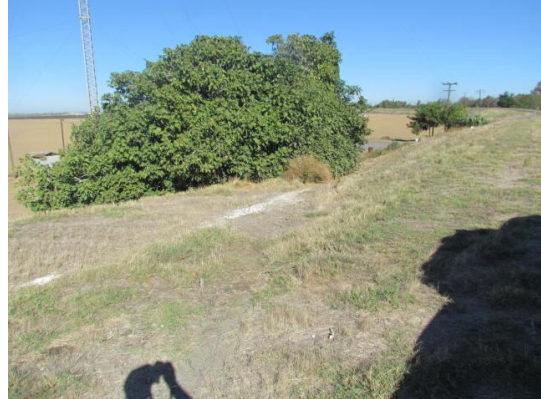
Photo 1 of 4 : FA_2015_RD0999_234_4_20150914_00003.jpg

Looking northwest at dense fig tree on landward toe. 2014

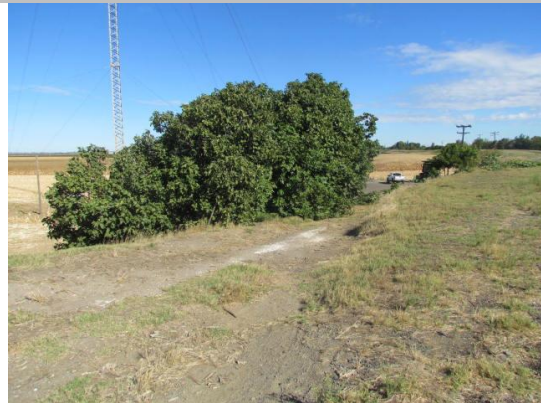
Photo 2 of 4 : FA_2015_RD0999_234_4_20150914_00004.jpg

Looking northwest at dense fig tree on landward slope and toe. 2013

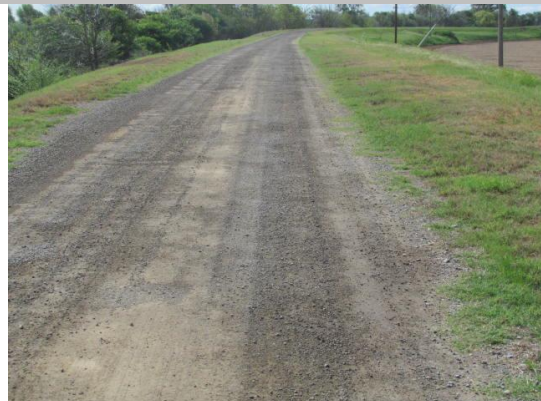
Photo 1 of 1 : FA_2015_RD0999_234_9_20150914_00009.jpg

LM Start	0.11	Rating **	M	Issue No.	9
LM End	1.37	Issue Type +	Ma	Location *	CR
Category	Earthen Levee			GPS Latitude/Longitude	
				Start	End
Item	Crown Surface / Depressions / Rutting			38.287873 °	38.304451 °
				-121.605108 °	-121.600419 °
DWR ID	DWR_RD0999_03_f_2012_9				
Action/Comments					
Repair depressions or ruts in the crown or slope.

Looking south at levee crown. (Spring 2015)

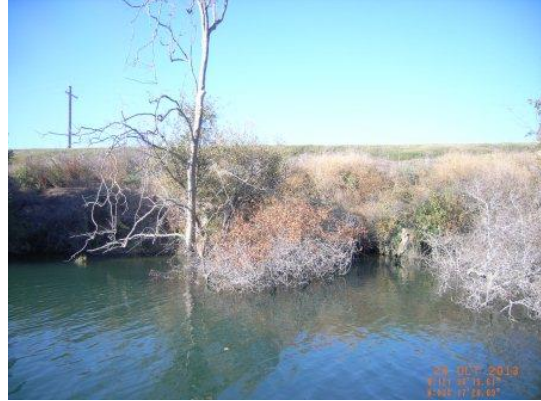
Photo 1 of 1 : USACE2013A_STR_24-7_R_12.jpg

LM Start	0.24	Rating **	U	Issue No.	29
LM End	0.65	Issue Type +	Ma	Location *	WS
Category	Supplemental			GPS Latitude/Longitude	
				Start	End
Item	2015 USACE Erosion Survey, DRAFT			38.289634 °	38.295505 °
				-121.604343 °	-121.605648 °
DWR ID					
Action/Comments					
Inspector Comments: 1997 - Intermittent over-steepened sections. Large riparian vegetation along the length of the entire reach. Attempts to repair with rock on bank have failed. 1999 - New rock repair at the downstream end. 2002 - Some minor spot repairs. 2009 - Minimal new erosion. 2010 - Appears that fresh rock placed on downstream portion of site. Toe scour and overhanging trees with some overturned. 2012 - Minor new erosion at the toe. 2013 - Site upgraded to CRITICAL. Severe slumping into levee at downstream end of site. Fresh erosion into bank toe. 2015: New slumping, tall vertical sections. [2015 Site ID: STR_24-7_R]

USACE 2013 Photo #1

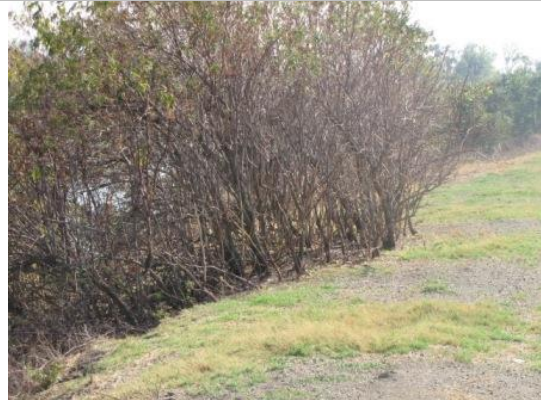
Photo 1 of 1 : FA_2015_RD0999_234_7_20150914_00007.jpg

LM Start	0.45	Rating **	M	Issue No.	7
LM End	0.45	Issue Type +	Ma	Location *	WS
Category	Earthen Levee			GPS Latitude/Longitude	
				Start	End
Item	Vegetation			38.292748 °	38.292748 °
				-121.604972 °	-121.604972 °
DWR ID	DWR_RD0999_03_s_2012_7				
Action/Comments					
Elderberries are blocking visibility and flood fight capability.

Looking south at thinned Elderberry on waterside slope.

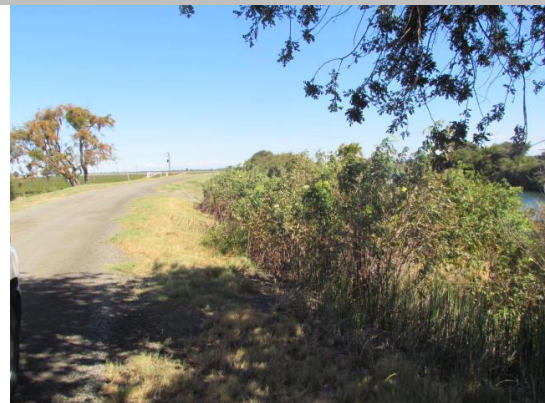
Photo 1 of 1 : FA_2015_RD0999_234_15_20150914_00014.jpg

LM Start	0.69	Rating **	M	Issue No.	15
LM End	0.70	Issue Type +	Ma	Location *	WS
Category	Earthen Levee			GPS Latitude/Longitude	
				Start	End
Item	Vegetation			38.296073 °	38.296203 °
				-121.605872 °	-121.605837 °
DWR ID	DWR_RD0999_03_s_2012_15				
Action/Comments					
Elderberries are blocking visibility and flood fight capability.

Looking northeast at dense elderberry on waterward slope.

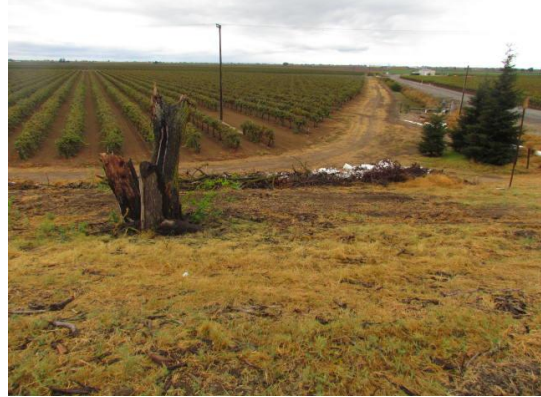
Photo 1 of 1 : FA_2015_RD0999_234_2_20151106_00038.jpg

LM Start	0.75	Rating **	M	Issue No.	2
LM End	0.75	Issue Type +	Ma	Location *	LS
Category	Earthen Levee			GPS Latitude/Longitude	
				Start	End
Item	Encroachments			38.296942 °	38.296942
				-121.605528 °	-121.605528
DWR ID	DWR_RD0999_03_s_2012_2				
Action/Comments					
Prunings

Looking at prunings at landward toe.

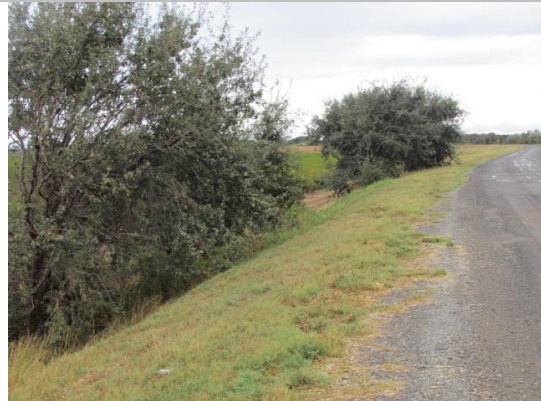
Photo 1 of 1 : FA_2015_RD0999_234_43_20151106_00039.jpg

Looking at untrimmed trees on landward slope and toe.

LM Start	0.93	Rating **	U	Issue No.	43
LM End	0.95	Issue Type +	Ma	Location *	LS
Category	Earthen Levee			GPS Latitude/Longitude	
				Start	End
Item	Trim / Thin Trees			38.299130 °	38.299362 °
				-121.603768 °	-121.603462 °
DWR ID	DWR_RD0999_03_f_2014_43				
Action/Comments					
Trim trees to at least five feet above ground level.

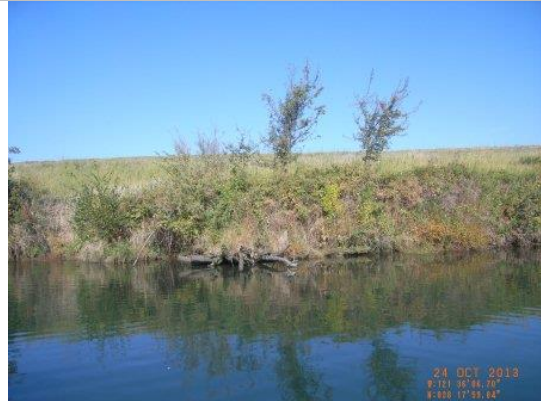
Photo 1 of 1 : USACE2013A_STR_25-2_R_11.jpg

LM Start	0.97	Rating **	M	Issue No.	30
LM End	1.10	Issue Type +	Ma	Location *	WS
Category	Supplemental			GPS Latitude/Longitude	
				Start	End
Item	2015 USACE Erosion Survey, DRAFT			38.299402 °	38.300542 °
				-121.603056 °	-121.601118 °
DWR ID					
Action/Comments					
Inspector Comments: 2008 - Over steepened levee section. 2009 - Significant new erosion. 2010 - Minor new erosion. 2015: No observed changes. [2015 Site ID: STR_25-2_R]

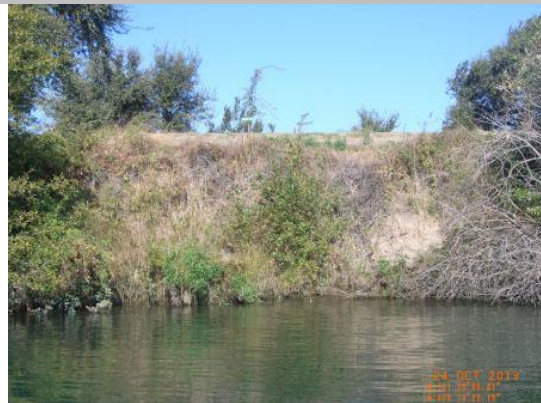
Photo 1 of 1 : USACE2013A_STR_25-7_R_11.jpg

LM Start	1.43	Rating **	M	Issue No.	1
LM End	1.58	Issue Type +	Ma	Location *	WS
Category	Supplemental			GPS Latitude/Longitude	
				Start	End
Item	2015 USACE Erosion Survey, DRAFT			38.305229 °	38.306667 °
				-121.599933 °	-121.598266 °
DWR ID					
Action/Comments					
Inspector Comments: 2011 - Toe scour along length of site and erosion pockets. 2012 - Site extended slightly upstream due to new erosion pocket. 2013 - Tall vertical sections at upstream end of site. 2015: No observed changes. [2015 Site ID: STR_25-7_R]

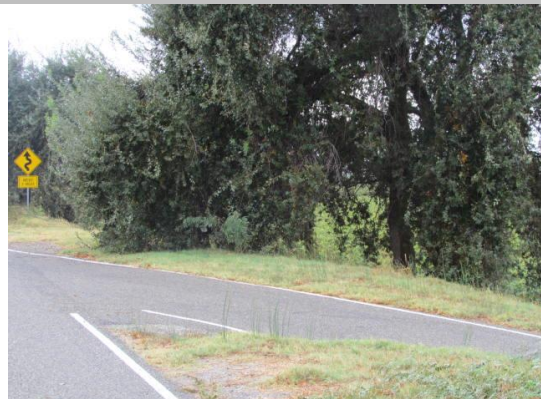
Photo 1 of 1 : FA_2015_RD0999_234_11_20151106_00040.jpg

Looking at untrimmed trees on landward slope and toe.

LM Start	1.50	Rating **	U	Issue No.	11
LM End	1.50	Issue Type +	Ma	Location *	LS
Category	Earthen Levee			GPS Latitude/Longitude	
				Start	End
Item	Trim / Thin Trees			38.306062 °	38.306062 °
				-121.599495 °	-121.599495 °
DWR ID	DWR_RD0999_03_s_2012_11				
Action/Comments					
Trim trees to at least five feet above ground level.

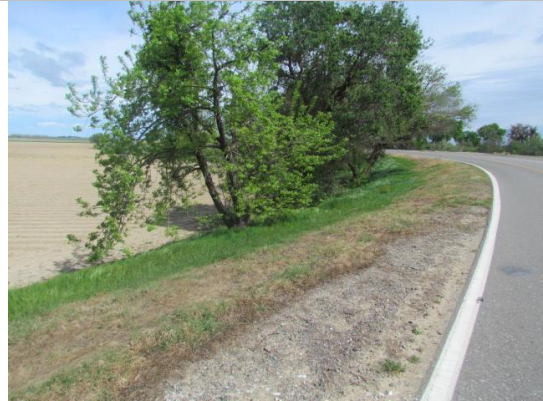
Photo 1 of 1 : FA_2015_RD0999_234_13_20150914_00013.jpg

Looking north at untrimmed trees on landward toe. (Spring 2015)

LM Start	1.57	Rating **	M	Issue No.	13
LM End	1.59	Issue Type +	Ma	Location *	LS
Category	Earthen Levee			GPS Latitude/Longitude	
				Start	End
Item	Trim / Thin Trees			38.306762 °	38.306948 °
				-121.598541 °	-121.598320 °
DWR ID	DWR_RD0999_03_s_2012_13				
Action/Comments					
Trim and thin trees to allow visibility of the ground and room to flood fight.

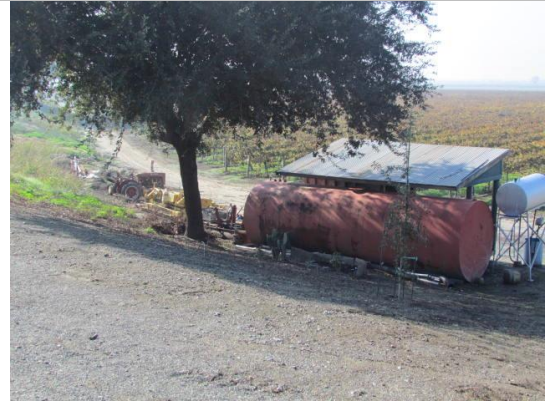
Photo 1 of 2 : FA_2015_RD0999_234_27_20150914_00019.jpg

LM Start	2.54	Rating **	M	Issue No.	27
LM End	2.54	Issue Type +	Ma	Location *	LS
Category	Earthen Levee			GPS Latitude/Longitude	
				Start	End
Item	Encroachments			38.317840 °	38.317840 °
				-121.590895 °	-121.590895 °
DWR ID	DWR_RD0999_03_s_2012_27				
Action/Comments					
Equipment					
Inspector Comments: Diesel tank stored at landside toe.

Looking southwest at farm equipment stored at landside toe. (Fall Inspection 2012)

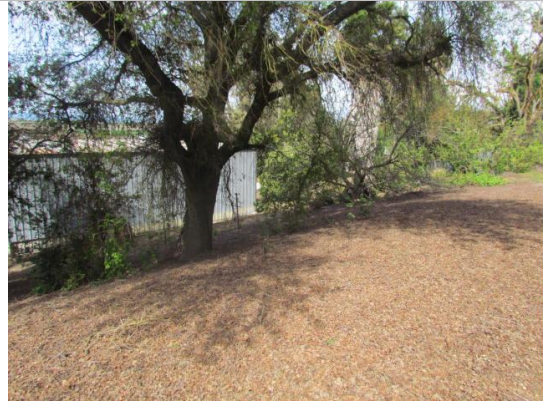
Photo 1 of 1 : FA_2015_RD0999_234_32_20150914_00024.jpg

Looking northwest at untrimmed trees on landward slope. (Spring 2015)

LM Start	2.69	Rating **	A/W	Issue No.	32
LM End	2.74	Issue Type +	Ma	Location *	LS
Category	Earthen Levee			GPS Latitude/Longitude	
				Start	End
Item	Trim / Thin Trees			38.319943 °	38.320670 °
				-121.590737 °	-121.590802 °
DWR ID	DWR_RD0999_03_s_2012_32				
Action/Comments					
Trim trees to at least five feet above ground level.

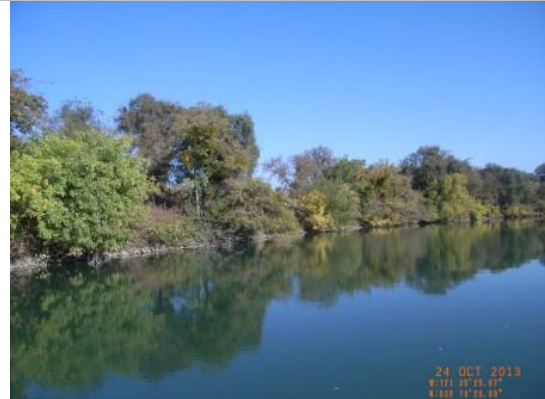
Photo 1 of 1 : USACE2013A_STR_27-1_R_2.jpg

LM Start	2.87	Rating **	M	Issue No.	21
LM End	2.92	Issue Type +	Ma	Location *	WS
Category	Supplemental			GPS Latitude/Longitude	
				Start	End
Item	2015 USACE Erosion Survey, DRAFT			38.322457 °	38.323042 °
				-121.590693 °	-121.590209 °
DWR ID					
Action/Comments					
Inspector Comments: 2012 - Slumping of upper levee slope. 2015: No observed changes. [2015 Site ID: STR_27-1_R]

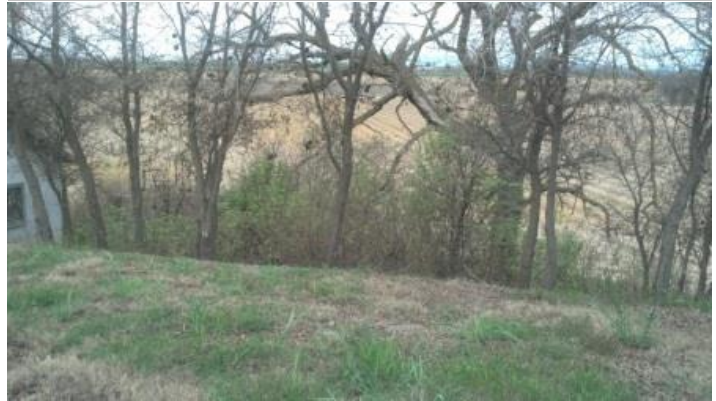
Photo 2 of 3 : FA_2015_RD0999_234_10_20150914_00011.jpg

LM Start	2.88	Rating **	M	Issue No.	10 (cont)
LM End	2.88	Issue Type +	Ma	Location *	LS
Category	Earthen Levee			GPS Latitude/Longitude	
				Start	End
Item	Vegetation			38.322757 °	38.322757 °
				-121.590817 °	-121.590817 °
DWR ID	DWR_RD0999_03_f_2012_10				
Action/Comments					
Remove the wild growth other than native grasses from the levee slopes.					
Inspector Comments: Wild growth at landside slope and toe.

Looking west at dense trees on landside toe.

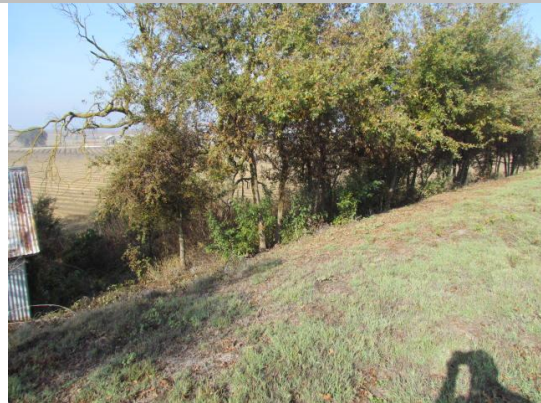
Photo 3 of 3 : FA_2015_RD0999_234_10_20150914_00012.jpg

Looking northwest at dense vegetation at landside slope and toe.

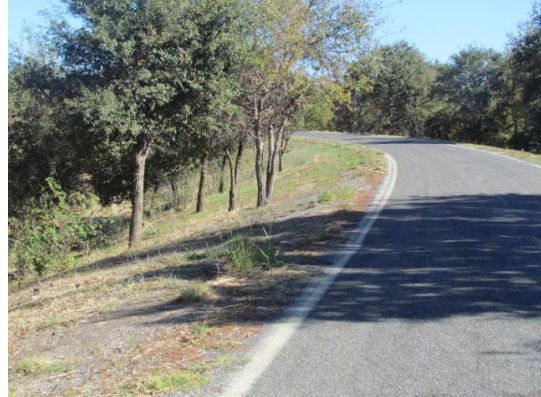
Photo 1 of 1 : FA_2015_RD0999_234_31_20150914_00023.jpg

Looking north at trimmed trees on landward slope.

LM Start	3.01	Rating **	M	Issue No.	31
LM End	3.25	Issue Type +	Ma	Location *	LS
Category	Earthen Levee			GPS Latitude/Longitude	
				Start	End
Item	Trim / Thin Trees			38.323770 °	38.326061 °
				-121.589035 °	-121.586028 °
DWR ID	DWR_RD0999_03_s_2012_31				
Action/Comments					
Trim and thin trees to allow visibility of the ground and room to flood fight.

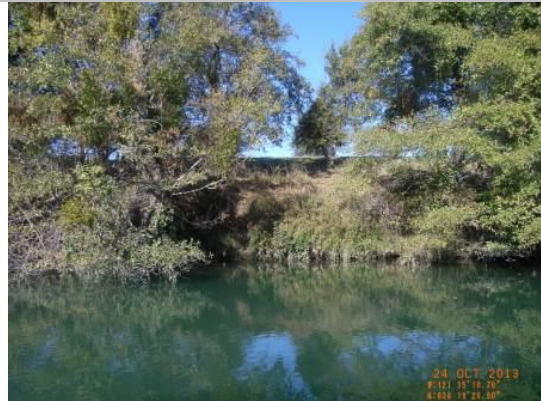
Photo 1 of 1 : USACE2013A_STR_27-3_R_10.jpg

LM Start	3.05	Rating **	M	Issue No.	5
LM End	3.23	Issue Type +	Ma	Location *	WS
Category	Supplemental			GPS Latitude/Longitude	
				Start	End
Item	2015 USACE Erosion Survey, DRAFT			38.323667 °	38.325592 °
				-121.588226 °	-121.585925 °
DWR ID					
Action/Comments					
Inspector Comments: 2011 - Multiple erosion pockets. Some likely from tree popouts. 2013 - Tall vertical sections. 2015: New tree popout and significant new erosion. [2015 Site ID: STR_27-3_R]
