**Flood Control Project Maintenance
Levee Inspections**

Maintenance Issue Types Only, Levee Inspection Report By Mile - Fall 2015

Reclamation District No. 0999 Netherlands

Waterway	Bank	Unit Miles	Inspection Start/End	Inspector
Unit No. 01 Yolo Bypass	Left	15.41	11/02/2015 11/04/2015	Richard Willoughby

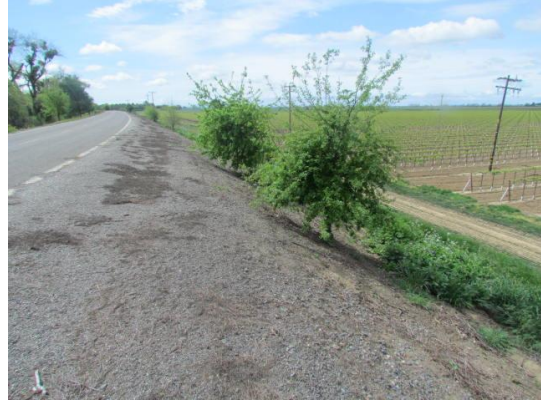
Photo 1 of 1 : FA_2015_RD0999_234_44_20150914_00030.jpg

Looking southwest at typical view of young oak trees on landward slope.
(Spring 2015)

LM Start	3.60	Rating **	M	Issue No.	44
LM End	3.64	Issue Type +	Ma	Location *	LS
Category	Earthen Levee			GPS Latitude/Longitude	
				Start	End
Item	Trim / Thin Trees			38.330946 °	38.331415 °
				-121.585932 °	-121.585534 °
DWR ID	DWR_RD0999_03_s_2015_44				
Action/Comments					
Thin trees to allow visibility of the ground and room to flood fight. Inspector Comments: Remove trees under an inch in diameter. Don't allow young trees to get establish on levee slope.

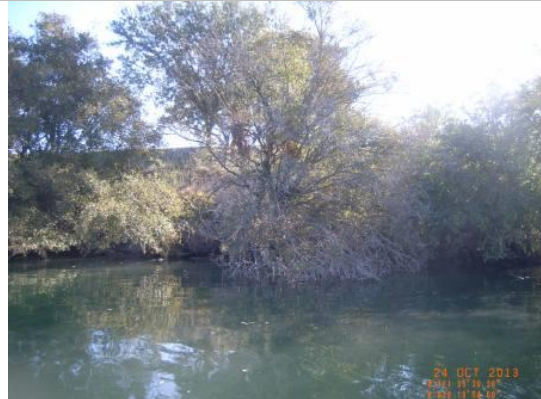
Photo 1 of 1 : USACE2013A_STR_26-5_L_8.jpg

LM Start	4.56	Rating **	M	Issue No.	18
LM End	4.68	Issue Type +	Ma	Location *	WS
Category	Supplemental			GPS Latitude/Longitude	
				Start	End
Item	2015 USACE Erosion Survey, DRAFT			38.313836 °	38.315407 °
				-121.592259 °	-121.591433 °
DWR ID					
Action/Comments					
Inspector Comments: 2002 - Original rock over geotextile is sliding off and the end is coming unraveled. 2003 - Some minor new erosion on the downstream end. 2004 - Site has gotten worse. Underlined geofabric is exposed. 2005 - Still looks bad with exposed geotextile fabric. 2006 - Still have some new unraveling and exposed fabric. Site lengthened upstream. 2009 - Minimal new erosion. 2010 - geotextile fabric placed since last year, possible flood fight. 2012 - Exposed geotech style fabric, assume rock on top slid off. 2015: Erosion pockets covered with plastic. [2015 Site ID: STR_26-5_L]

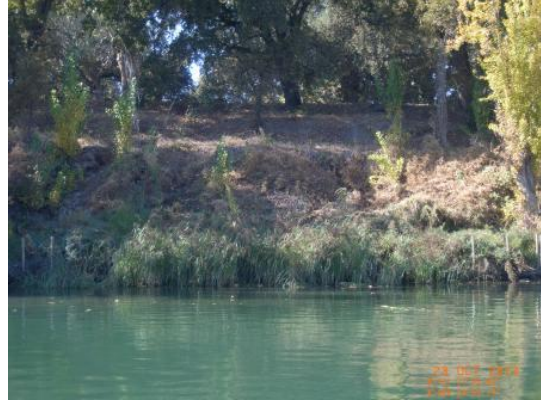
Photo 1 of 1 : USACE2013A_SAC_41-9_R_14.jpg

LM Start	0.02	Rating **	M	Issue No.	8
LM End	0.28	Issue Type +	Ma	Location *	WS
Category	Supplemental			GPS Latitude/Longitude	
				Start	End
Item	2015 USACE Erosion Survey, DRAFT			38.414387 °	38.417692 °
				-121.522871 °	-121.525083 °
DWR ID					
Action/Comments					
Inspector Comments: 1997 - Structural problem rather than erosional, failed cobble at downstream end. 2005 - New brush boxes at waterline for several hundred feet downstream, No toe or bank protection present. 2006 - Some minor new erosion. Brush boxes not working well; most of the brush has floated out. 2007 - Brush boxes have recently been repaired. 2015: No observed changes. [2015 Site ID: SAC_41-9_R]

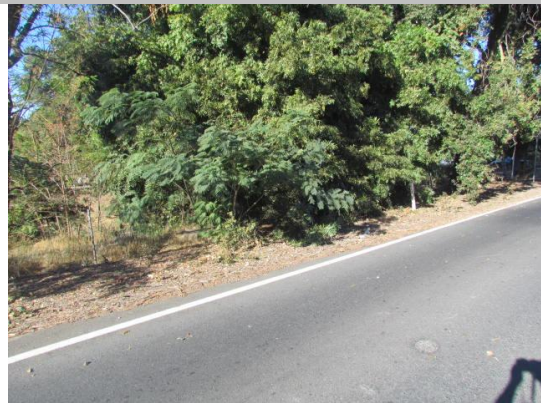
Photo 1 of 1 : FA_2015_RD0999_235_35_20151106_00027.jpg

LM Start	0.03	Rating **	U	Issue No.	35
LM End	0.03	Issue Type +	Ma	Location *	LS
Category	Earthen Levee			GPS Latitude/Longitude	
				Start	End
Item	Trim / Thin Trees			38.414450 °	38.414450 °
				-121.523308 °	-121.523308 °
DWR ID	DWR_RD0999_04_f_2014_35				
Action/Comments					
Trim trees to at least five feet above ground level.					
Inspector Comments: Untrimmed trees on landward slope and toe.

Looking at untrimmed trees on landward slope.

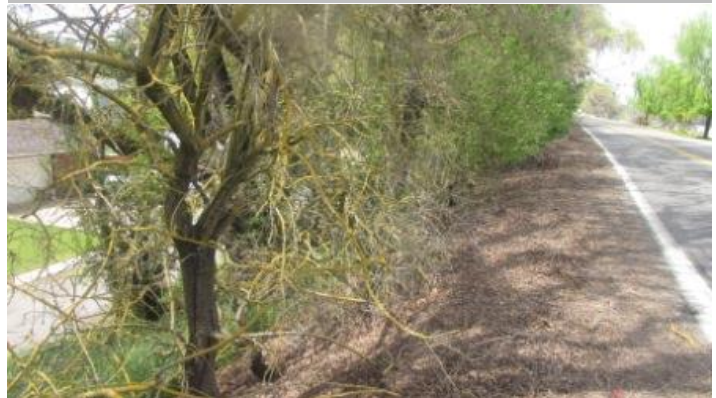
Photo 1 of 2 : FA_2015_RD0999_235_10_20150914_00007.jpg

Looking northwest at dense trees on landside slope and toe.

LM Start	0.38	Rating **	M	Issue No.	10
LM End	0.50	Issue Type +	Ma	Location *	LS
Category	Earthen Levee			GPS Latitude/Longitude	
				Start	End
Item	Trim / Thin Trees			38.418838 °	38.420447 °
				-121.526225 °	-121.527380 °
DWR ID	DWR_RD0999_04_s _ 2012_10				
Action/Comments					
Trim trees to at least five feet above ground level.

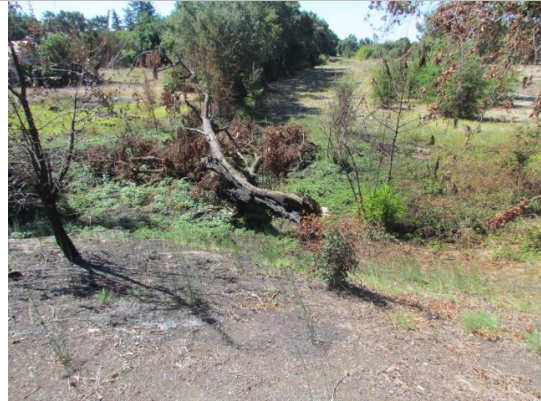
Photo 1 of 1 : FA_2015_RD0999_235_21_20150914_00017.jpg

LM Start	0.60	Rating **	A/W	Issue No.	21
LM End	0.60	Issue Type +	Ma	Location *	LS
Category	Earthen Levee			GPS Latitude/Longitude	
				Start	End
Item	Encroachments				o
					o
DWR ID	DWR_RD0999_04_f_2013_21				
Action/Comments					
Tree or limb					
Inspector Comments: Downed tree on landward toe and berm.

Looking west at dead tree on landward toe and berm.

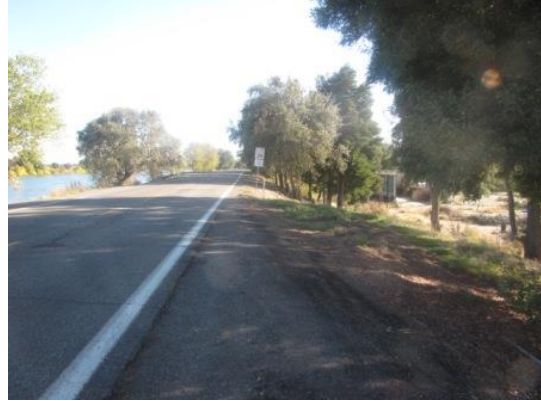
Photo 2 of 2 : FA_2015_RD0999_235_6_20150914_00005.jpg

Looking south at trimmed trees on landside slope and removed fence.

LM Start	0.71	Rating **	A/W	Issue No.	6 (cont)	
LM End	0.87	Issue Type +	Ma	Location *	LS	
Category	Earthen Levee			GPS Latitude/Longitude		
				Start		End
Item	Trim / Thin Trees			38.423035 °		38.425140 °
				-121.529255 °		-121.530742 °
DWR ID	DWR_RD0999_04_s _ 2012_6					
Action/Comments						
Trim trees to at least five feet above ground level.

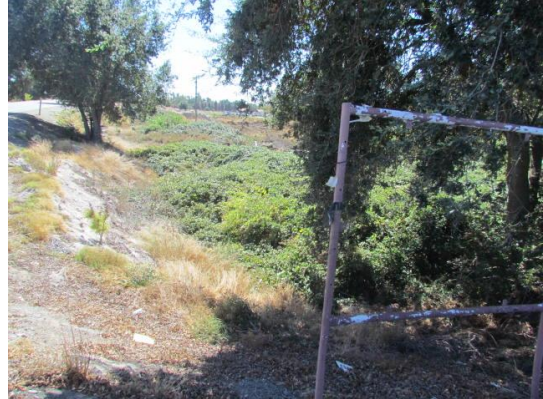
Photo 2 of 3 : FA_2015_RD0999_235_16_20150914_00014.jpg

LM Start	1.04	Rating **	U	Issue No.	16 (cont)
LM End	1.04	Issue Type +	Ma	Location *	LS

Looking southwest at dense berry vines at landward toe. 2013

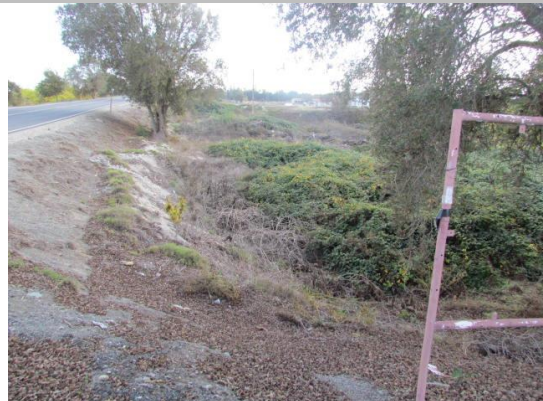
Photo 3 of 3 : FA_2015_RD0999_235_16_20150914_00015.jpg

Looking south at dense berryvines on landside toe. 2012

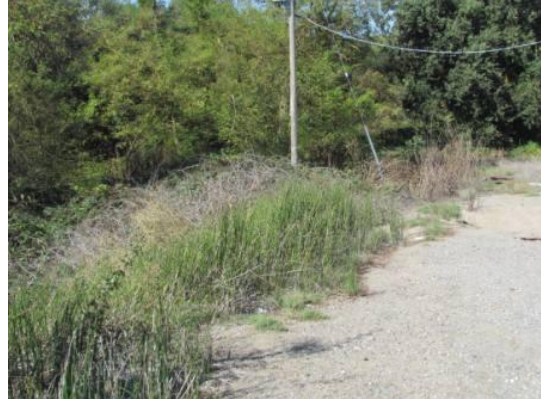
Photo 2 of 3 : FA_2015_RD0999_235_5_20150914_00002.jpg

LM Start	1.15	Rating **	U	Issue No.	5 (cont)	
LM End	1.15	Issue Type +	Ma	Location *	LS	
Category	Earthen Levee			GPS Latitude/Longitude		
				Start		End
Item	Vegetation			38.428823 °		38.428823
				-121.532885 °		-121.532885
DWR ID	DWR_RD0999_04_s_2012_5					
Action/Comments						
Remove the wild growth other than native grasses from the levee slopes.						
Inspector Comments: Berry vines and wild roses on landside toe.

Looking north at dense vegetation on landside slope near ramp.

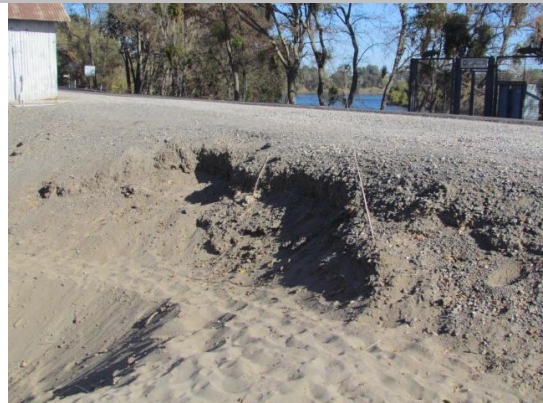
Photo 3 of 3 : FA_2015_RD0999_235_40_20151106_00035.jpg

LM Start	1.16	Rating **	U	Issue No.	40 (cont)
LM End	1.16	Issue Type +	Ma	Location *	LS
Category	Earthen Levee			GPS Latitude/Longitude	
				Start	End
Item	Erosion / Bank Caving			38.428877 °	38.428877 °
				-121.532922 °	-121.532922 °
DWR ID	DWR_RD0999_04_f_2015_40				
Action/Comments					
Schedule repair of erosion site prior to the next inspection. Inspector Comments: Large hole and erosion on landward shoulder, slope and toe.

Looking east at erosion on landward shoulder.

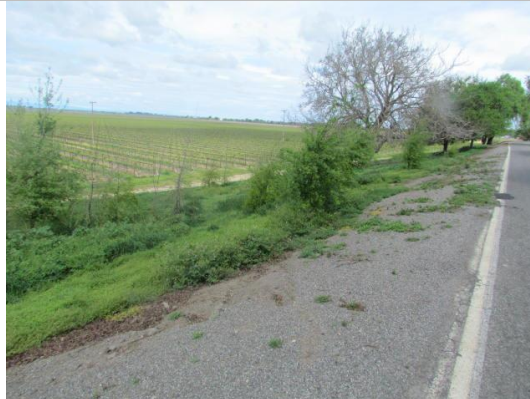
Photo 1 of 1 : FA_2015_RD0999_236_178_20150914_00112.jpg

LM Start	0.05	Rating **	M	Issue No.	178
LM End	0.05	Issue Type +	Ma	Location *	LS
Category	Earthen Levee			GPS Latitude/Longitude	
				Start	End
Item	Trim / Thin Trees			38.333308 °	38.333308 °
				-121.584494 °	-121.584494 °
DWR ID	DWR_RD0999_05_s_2015_178				
Action/Comments					
Thin trees to allow visibility of the ground and room to flood fight. Inspector Comments: Remove trees under an inch in diameter on landward slope. Don't allow young trees to get established.

Looking at typical view of young oak trees on landward slope. (Spring 2015)

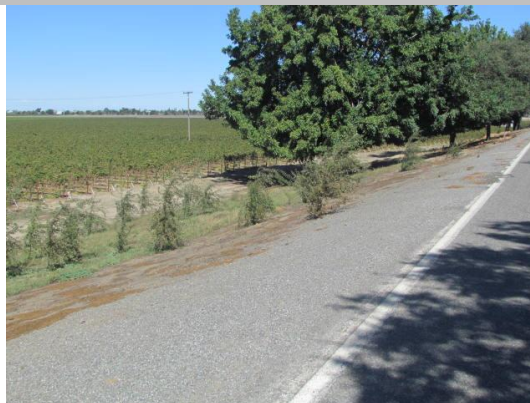
Photo 1 of 1 : FA_2015_RD0999_236_72_20150914_00066.jpg

LM Start	0.10	Rating **	A/W	Issue No.	72	
LM End	0.10	Issue Type +	Ma	Location *	LS	
Category	Earthen Levee			GPS Latitude/Longitude		
				Start		End
Item	Trim / Thin Trees				°	°
					°	°
DWR ID	DWR_RD0999_05_f_2013_72					
Action/Comments						
Trim and thin trees to allow visibility of the ground and room to flood fight.						
Inspector Comments: Remove small oak trees from landward slope before trees are established.

Looking west at small oak trees on landward slope.

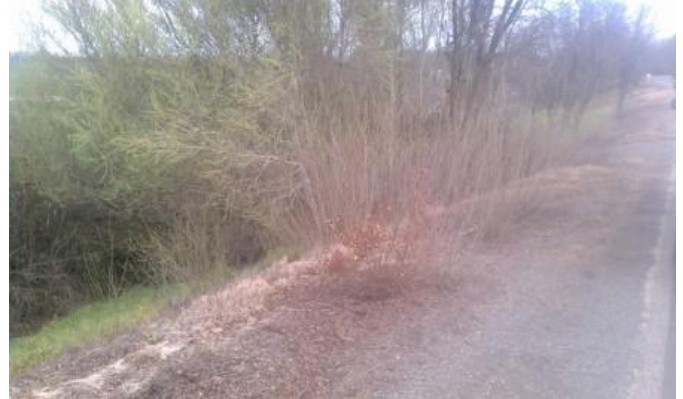
Photo 1 of 4 : FA_2015_RD0999_236_25_20150914_00024.jpg

Looking northwest at dense vegetation on landside slope and toe.

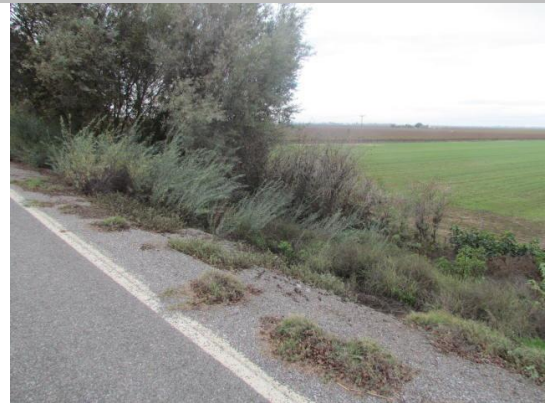
Photo 2 of 4 : FA_2015_RD0999_236_25_20150914_00025.jpg

Looking southwest at vegetation on landside slope and toe. (Fall 2012)

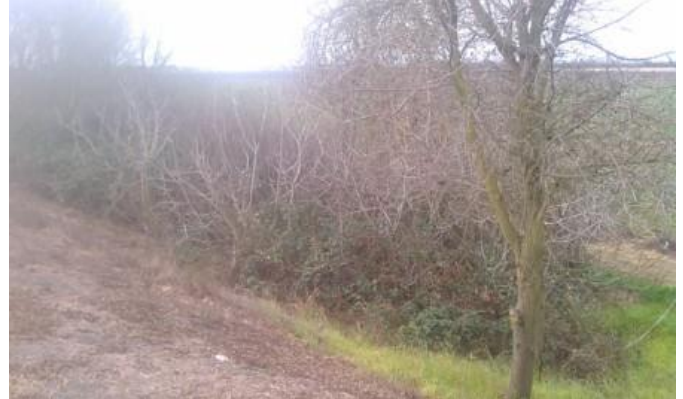
Photo 4 of 4 : FA_2015_RD0999_236_25_20150914_00027.jpg

LM Start	0.40	Rating **	U	Issue No.	25 (cont)	
LM End	0.44	Issue Type +	Ma	Location *	LS	
Category	Earthen Levee			GPS Latitude/Longitude		
				Start		End
Item	Vegetation			38.338075 °		38.338688
				-121.582322 °		-121.582193
DWR ID	DWR_RD0999_05_s_2012_25					
Action/Comments						
Remove the wild growth other than native grasses from the levee slopes.						
Inspector Comments: Elderberries within vegetation area.

Looking southwest at dense berry vines on landside toe.

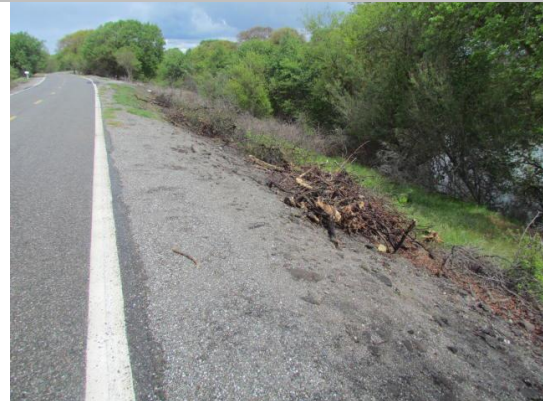
Photo 1 of 1 : FA_2015_RD0999_236_26_20150914_00028.jpg

LM Start	0.44	Rating **	A/W	Issue No.	26
LM End	0.45	Issue Type +	Ma	Location *	WS
Category	Earthen Levee			GPS Latitude/Longitude	
				Start	End
Item	Encroachments			38.338647 °	38.338868 °
				-121.582217 °	-121.582163 °
DWR ID	DWR_RD0999_05_s_2012_26				
Action/Comments					
Prunings

Looking northeast at prunings on waterside slope.

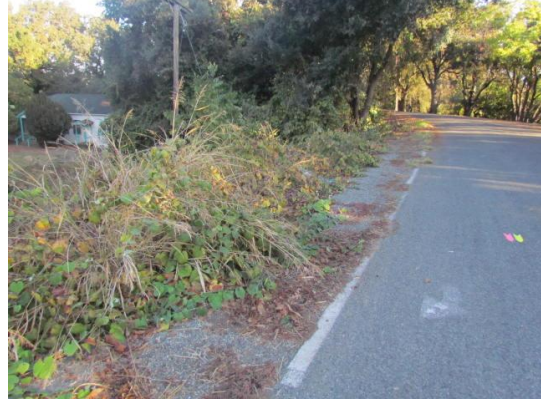
Photo 1 of 1 : FA_2015_RD0999_236_189_20150914_00115.jpg

LM Start	0.68	Rating **	A/W	Issue No.	189
LM End	0.68	Issue Type +	Ma	Location *	LS
Category	Earthen Levee			GPS Latitude/Longitude	
				Start	End
Item	Vegetation			38.342032 °	38.342032 °
				-121.581372 °	-121.581372 °
DWR ID	DWR_RD0999_05_f_2014_189				
Action/Comments					
Remove the wild growth other than native grasses from the levee slopes.					
Inspector Comments: Dense wild grapevines on landward slope.

Looking northwest at dense vegetation on landward slope.

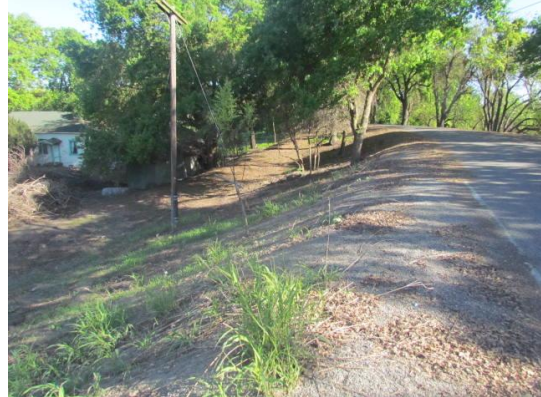
Photo 1 of 6 : FA_2015_RD0999_236_9_20150914_00005.jpg

LM Start	0.69	Rating **	A/W	Issue No.	9
LM End	0.71	Issue Type +	Ma	Location *	LS
Category	Earthen Levee			GPS Latitude/Longitude	
				Start	End
Item	Trim / Thin Trees			38.342180 °	38.342537 °
				-121.581230 °	-121.581263 °
DWR ID	DWR_RD0999_05_s_2012_9				
Action/Comments					
Trim and thin trees to allow visibility of the ground and room to flood fight.					
Inspector Comments: District or landowner trimmed trees to comply with standards.

Looking northwest at landward slope. (Spring 2015)

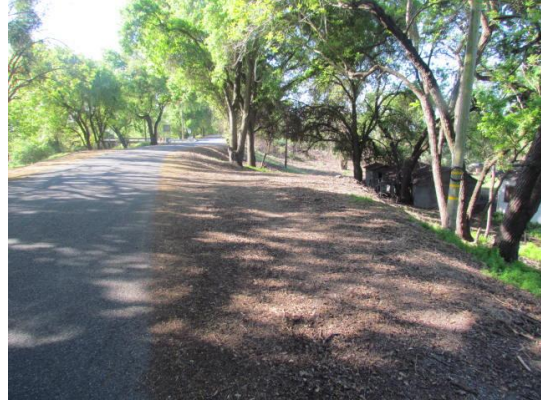
Photo 2 of 6 : FA_2015_RD0999_236_9_20150914_00006.jpg

LM Start	0.69	Rating **	A/W	Issue No.	9 (cont)	
LM End	0.71	Issue Type +	Ma	Location *	LS	
Category	Earthen Levee			GPS Latitude/Longitude		
				Start		End
Item	Trim / Thin Trees			38.342180 °		38.342537 °
				-121.581230 °		-121.581263 °
DWR ID	DWR_RD0999_05_s_2012_9					
Action/Comments						
Trim and thin trees to allow visibility of the ground and room to flood fight.						
Inspector Comments: District or landowner trimmed trees to comply with standards.

Looking south at landward slope. (Spring 2015)

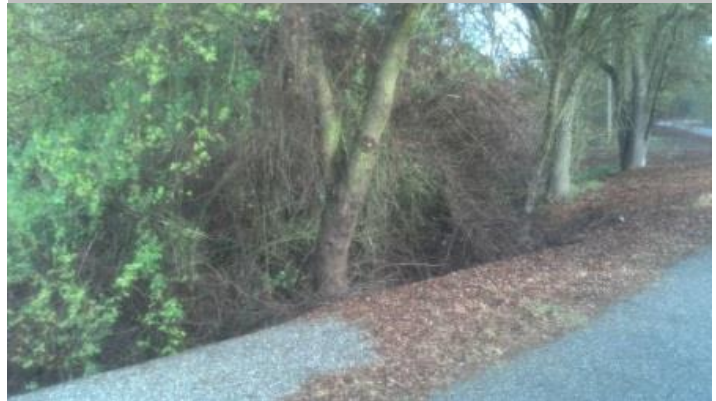
Photo 3 of 6 : FA_2015_RD0999_236_9_20150914_00007.jpg

Looking northwest at dense trees at landside slope and toe. (Spring 2013)

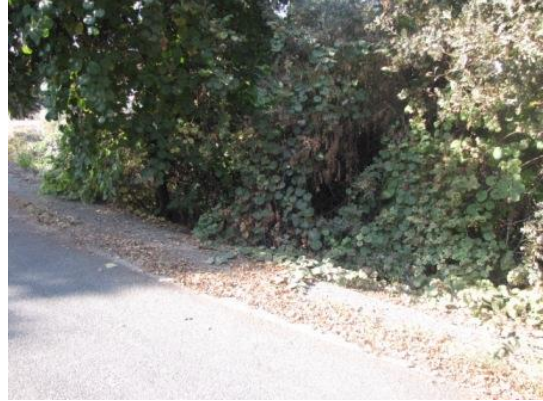
Photo 5 of 6 : FA_2015_RD0999_236_9_20150914_00009.jpg

LM Start	0.69	Rating **	A/W	Issue No.	9 (cont)	
LM End	0.71	Issue Type +	Ma	Location *	LS	
Category	Earthen Levee			GPS Latitude/Longitude		
				Start		End
Item	Trim / Thin Trees			38.342180 °		38.342537 °
				-121.581230 °		-121.581263 °
DWR ID	DWR_RD0999_05_s _ 2012_9					
Action/Comments						
Trim and thin trees to allow visibility of the ground and room to flood fight.						
Inspector Comments: District or landowner trimmed trees to comply with standards.

Looking west at dense trees on landside slope and toe. (Spring 2011)

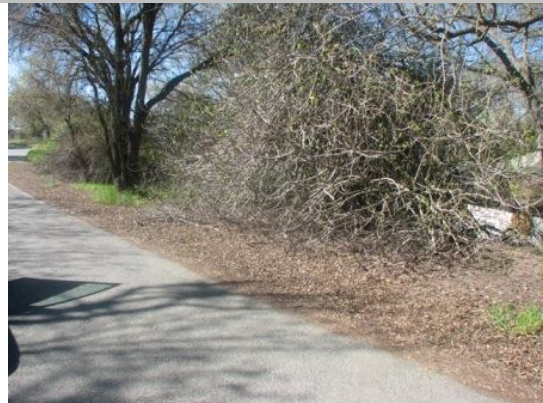
Photo 6 of 6 : FA_2015_RD0999_236_9_20150914_00010.jpg

Front view of dense trees at landside shoulder. (Spring 2011)

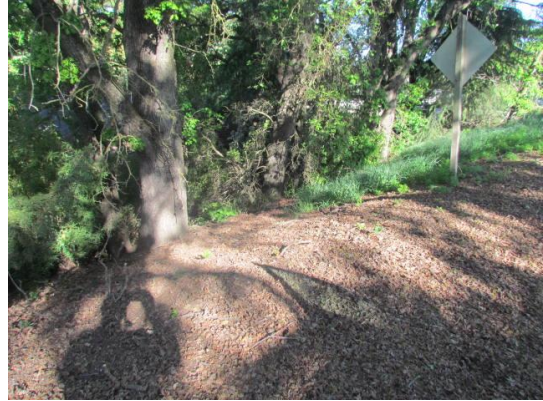
Photo 1 of 2 : FA_2015_RD0999_236_128_20150914_00088.jpg

Looking northwest at untrimmed trees on landward slope. (Spring 2015)

LM Start	0.78	Rating **	M	Issue No.	128
LM End	0.78	Issue Type +	Ma	Location *	LS
Category	Earthen Levee			GPS Latitude/Longitude	
				Start	End
Item	Trim / Thin Trees			38.343495 °	38.343495 °
				-121.581282 °	-121.581282 °
DWR ID	DWR_RD0999_05_s_2012_128				
Action/Comments					
Trim and thin trees to allow visibility of the ground and room to flood fight.

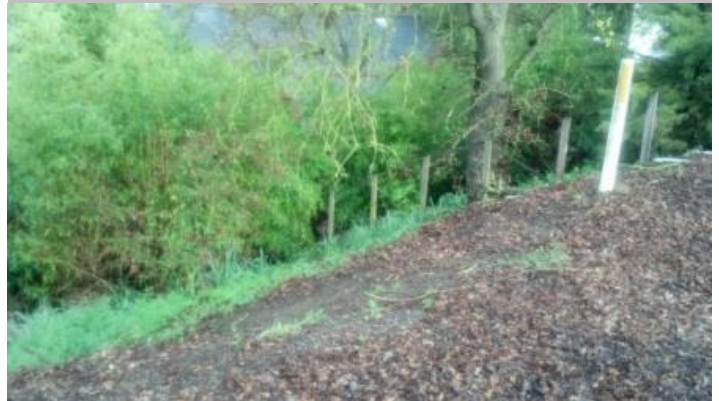
Photo 2 of 2 : FA_2015_RD0999_236_128_20150914_00089.jpg

Looking at dense trees on landside slope and toe.

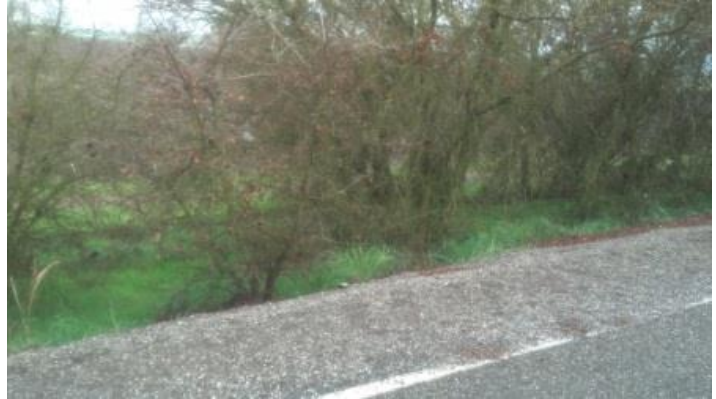
Photo 1 of 1 : FA_2015_RD0999_236_14_20150914_00013.jpg

Looking west at dense trees on landside slope and toe.

LM Start	1.07	Rating **	M	Issue No.	14
LM End	1.11	Issue Type +	Ma	Location *	LS
Category	Earthen Levee			GPS Latitude/Longitude	
				Start	End
Item	Trim / Thin Trees			38.347427 °	38.347863 °
				-121.579395 °	-121.579113 °
DWR ID	DWR_RD0999_05_s_2012_14				
Action/Comments					
Trim trees to at least five feet above ground level.

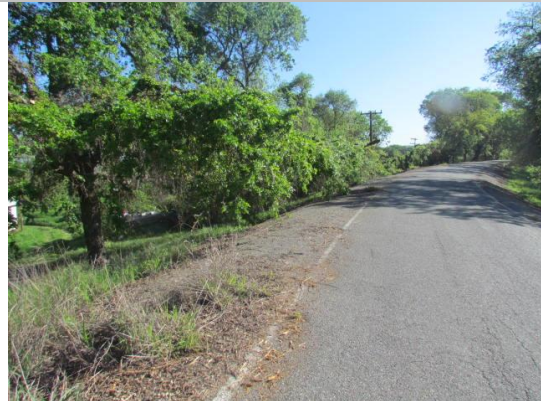
Photo 1 of 1 : FA_2015_RD0999_236_15_20150914_00014.jpg

Looking north at untrimmed trees on landward slope and toe. (Spring 2015)

LM Start	1.15	Rating **	M	Issue No.	15
LM End	1.19	Issue Type +	Ma	Location *	LS
Category	Earthen Levee			GPS Latitude/Longitude	
				Start	End
Item	Trim / Thin Trees			38.348237 °	38.348328 °
				-121.578440 °	-121.577735 °
DWR ID	DWR_RD0999_05_s_2012_15				
Action/Comments					
Trim trees to at least five feet above ground level.

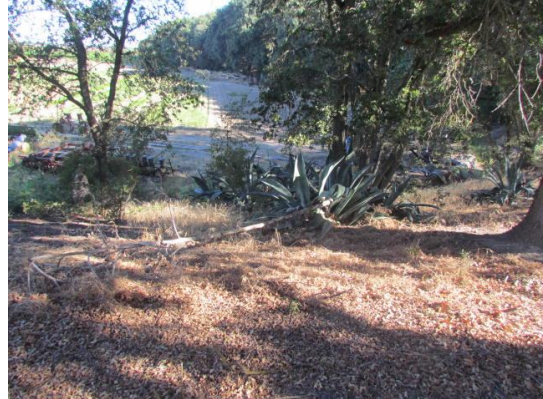
Photo 2 of 2 : FA_2015_RD0999_236_129_20150914_00091.jpg

LM Start	1.39	Rating **	M	Issue No.	129 (cont)
LM End	1.39	Issue Type +	Ma	Location *	LS
Category	Earthen Levee			GPS Latitude/Longitude	
				Start	End
Item	Vegetation			38.348100 °	38.348100 °
				-121.574075 °	-121.574075 °
DWR ID	DWR_RD0999_05_s_2012_129				
Action/Comments					
Remove the wild growth other than native grasses from the levee slopes. Inspector Comments: Berry vines and century plants on landside toe and slope.

Looking west at century plants on landward slope.

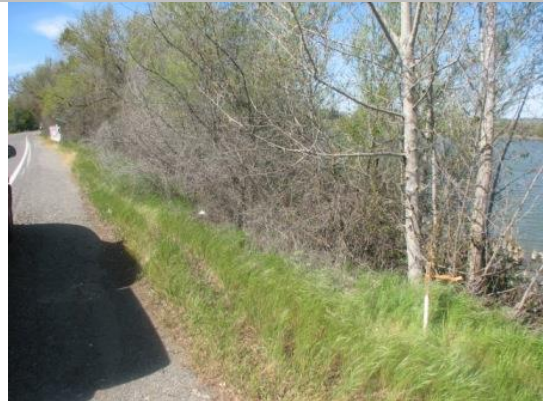
Photo 1 of 2 : FA_2015_RD0999_236_18_20150914_00019.jpg

Side view of dense trees along waterside slope.

LM Start	1.46	Rating **	M	Issue No.	18
LM End	1.83	Issue Type +	Ma	Location *	LS
Category	Earthen Levee			GPS Latitude/Longitude	
				Start	End
Item	Trim / Thin Trees			38.348670 °	38.353852 °
				-121.573320 °	-121.573570 °
DWR ID	DWR_RD0999_05_s_2012_18				
Action/Comments					
Trim and thin trees to allow visibility of the ground and room to flood fight.

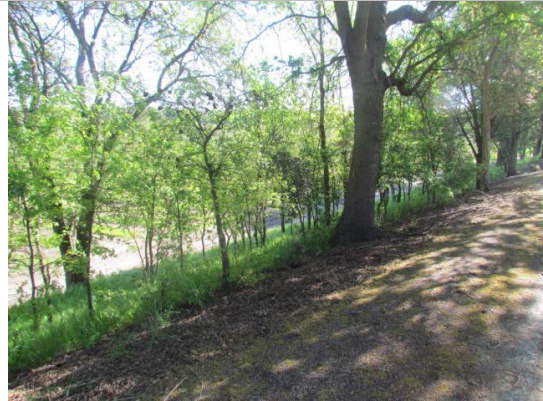
Photo 1 of 1 : FA_2015_RD0999_236_24_20150914_00023.jpg

Looking west at dense trees on landward slope. (Spring 2015)

LM Start	2.14	Rating **	M	Issue No.	24
LM End	2.16	Issue Type +	Ma	Location *	LS
Category	Earthen Levee			GPS Latitude/Longitude	
				Start	End
Item	Trim / Thin Trees			38.355402 °	38.355282 °
				-121.568893 °	-121.568547 °
DWR ID	DWR_RD0999_05_s _ 2012_24				
Action/Comments					
Trim and thin trees to allow visibility of the ground and room to flood fight.

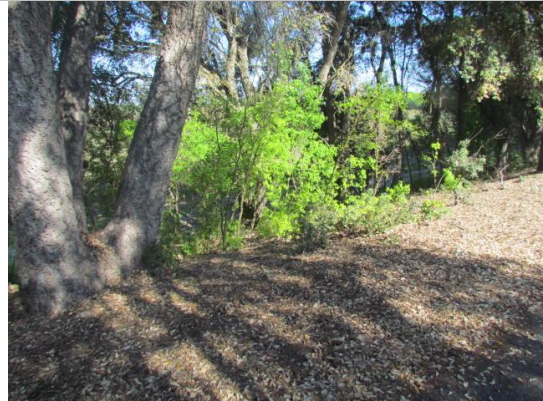
Photo 1 of 1 : FA_2015_RD0999_236_82_20150914_00069.jpg

LM Start	2.51	Rating **	M	Issue No.	82
LM End	2.65	Issue Type +	Ma	Location *	LS
Category	Earthen Levee			GPS Latitude/Longitude	
				Start	End
Item	Trim / Thin Trees			38.356270 °	38.358132 °
				-121.563218 °	-121.562347 °
DWR ID	DWR_RD0999_05_s _ 2012_82				
Action/Comments					
Trim and thin trees to allow visibility of the ground and room to flood fight.

Looking northwest at dense trees on landward slope. (Spring 2015)

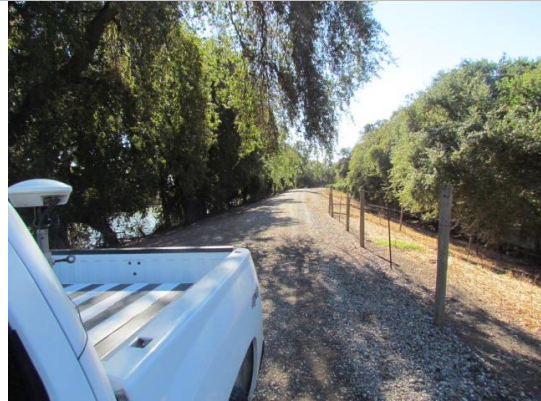
Photo 1 of 1 : FA_2015_RD0999_236_173_20151106_00158.jpg

LM Start	3.56	Rating **	M	Issue No.	173
LM End	3.56	Issue Type +	Ma	Location *	WS
Category	Earthen Levee			GPS Latitude/Longitude	
				Start	End
Item	Trim / Thin Trees			38.365882 °	38.365882
				-121.556762 °	-121.556762
DWR ID	DWR_RD0999_05_f_2015_173				
Action/Comments					
Trim trees over roadway to at least 12 feet above ground level.

Looking at the tree overhanging the levee crown.

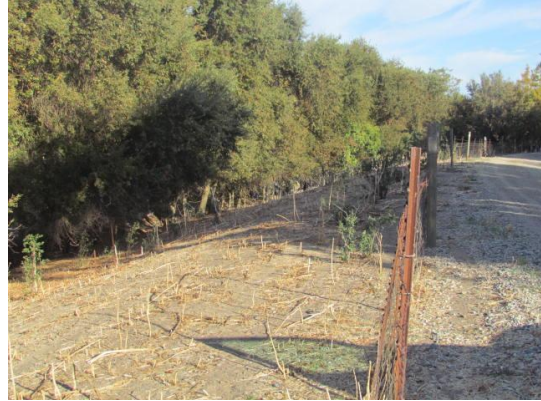
Photo 2 of 2 : FA_2015_RD0999_236_201_20150914_00123.jpg

LM Start	3.58	Rating **	M	Issue No.	201 (cont)	
LM End	3.64	Issue Type +	Ma	Location *	LS	
Category	Earthen Levee			GPS Latitude/Longitude		
				Start	End	
Item	Trim / Thin Trees			38.366103 °	38.367035 °	
				-121.556820 °	-121.556781 °	
DWR ID	DWR_RD0999_05_f_2014_201					
Action/Comments						
Thin trees to allow visibility of the ground and room to flood fight. Inspector Comments: Landowner has planted oak trees and installed sprinklers on landward slope. Oak trees should be removed.

Looking northwest at several small oak trees planted along landward slope.

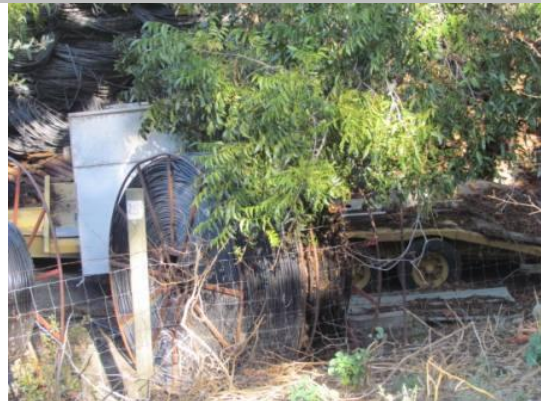
Photo 1 of 2 : FA_2015_RD0999_236_16_20150914_00015.jpg

LM Start	3.64	Rating **	M	Issue No.	16
LM End	3.64	Issue Type +	Ma	Location *	LS
Category	Earthen Levee			GPS Latitude/Longitude	
				Start	End
Item	Encroachments			38.366958 °	38.366958 °
				-121.556822 °	-121.556822 °
DWR ID	DWR_RD0999_05_s_2012_16				
Action/Comments					
Equipment					
Inspector Comments: Equipment stored at landward toe.

Looking northwest at equipment on landside toe.

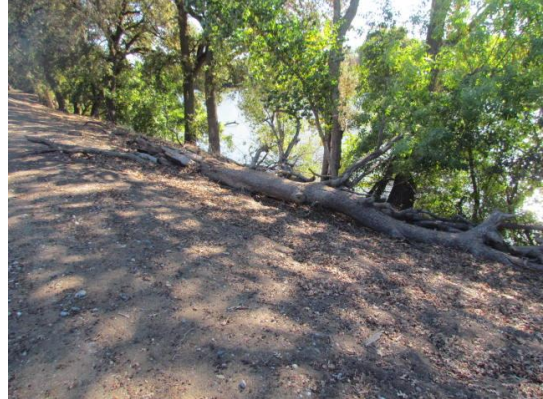
Photo 1 of 1 : FA_2015_RD0999_236_174_20151106_00159.jpg

LM Start	3.80	Rating **	M	Issue No.	174
LM End	3.80	Issue Type +	Ma	Location *	WS
Category	Earthen Levee			GPS Latitude/Longitude	
				Start	End
Item	Encroachments			38.368207 °	38.368207 °
				-121.554360 °	-121.554360 °
DWR ID	DWR_RD0999_05_f_2015_174				
Action/Comments					
Tree or limb					
Inspector Comments: Downed tree branch and limbs on waterward slope.

Looking at downed tree branch on waterward slope.

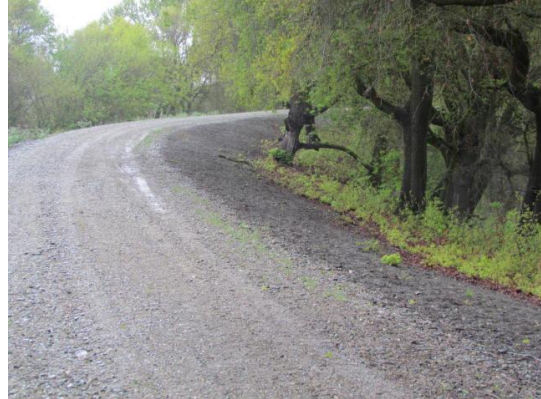
Photo 2 of 2 : FA_2015_RD0999_236_41_20150914_00043.jpg

LM Start	3.98	Rating **	M	Issue No.	41 (cont)
LM End	4.05	Issue Type +	Ma	Location *	WS
Category	Earthen Levee			GPS Latitude/Longitude	
				Start	End
Item	Trim / Thin Trees			38.369440 °	38.370398 °
				-121.552747 °	-121.553373 °
DWR ID	DWR_RD0999_05_s_2012_41				
Action/Comments					
Trim and thin trees to allow visibility of the ground and room to flood fight.					
Inspector Comments: Control oak saplings on waterward slope.

Looking northeast at trimmed trees on waterside slope.

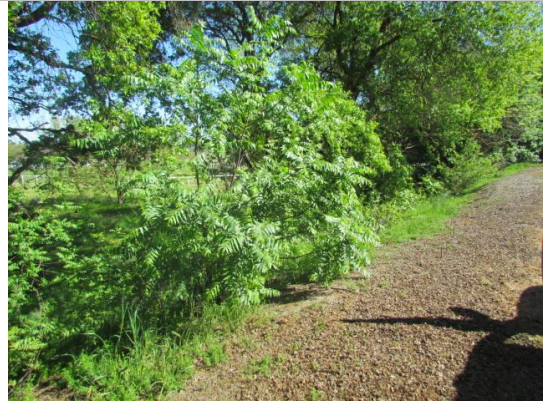
Photo 1 of 1 : FA_2015_RD0999_236_57_20150914_00057.jpg

LM Start	4.42	Rating **	M	Issue No.	57
LM End	4.46	Issue Type +	Ma	Location *	LS
Category	Earthen Levee			GPS Latitude/Longitude	
				Start	End
Item	Trim / Thin Trees			38.374866 °	38.375061 °
				-121.550491 °	-121.549800 °
DWR ID	DWR_RD0999_05_s _ 2012_57				
Action/Comments					
Trim and thin trees to allow visibility of the ground and room to flood fight.

Looking northwest at dense trees on landward slope. (Spring 2015)

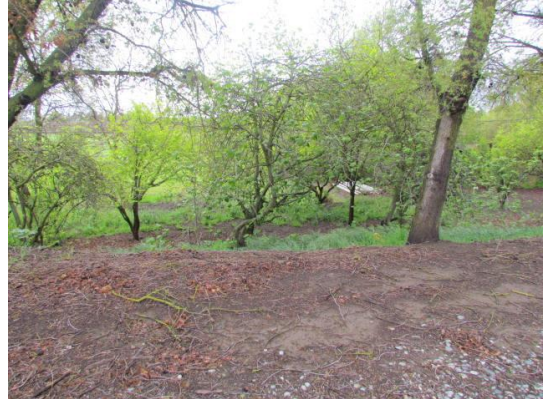
Photo 2 of 3 : FA_2015_RD0999_236_38_20150914_00035.jpg

LM Start	4.51	Rating **	A/W	Issue No.	38 (cont)
LM End	4.64	Issue Type +	Ma	Location *	LS
Category	Earthen Levee			GPS Latitude/Longitude	
				Start	End
Item	Trim / Thin Trees			38.375055 °	38.375313 °
				-121.548792 °	-121.546438 °
DWR ID	DWR_RD0999_05_s_2012_38				
Action/Comments					
Thin trees to allow visibility of the ground and room to flood fight.

Looking west at trimmed trees on landside slope. (Spring 2012)

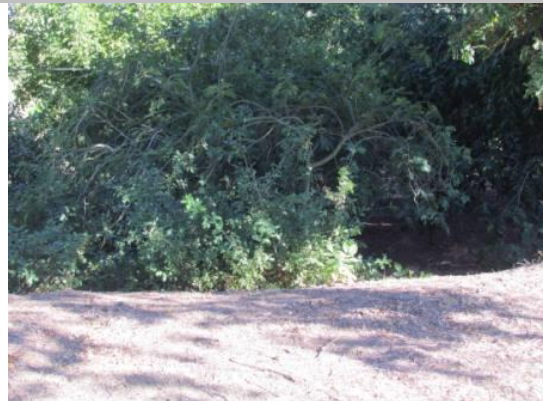
Photo 3 of 3 : FA_2015_RD0999_236_38_20150914_00036.jpg

Looking west at dense trees on landside slope. (Spring 2011)

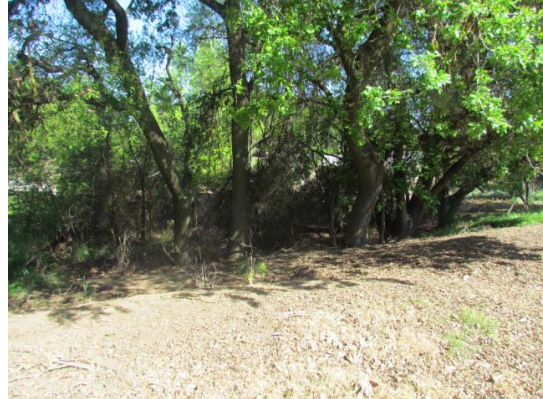
Photo 1 of 1 : FA_2015_RD0999_236_52_20150914_00054.jpg

LM Start	4.67	Rating **	M	Issue No.	52
LM End	4.67	Issue Type +	Ma	Location *	LS
Category	Earthen Levee			GPS Latitude/Longitude	
				Start	End
Item	Trim / Thin Trees			38.375478 °	38.375478 °
				-121.545852 °	-121.545852 °
DWR ID	DWR_RD0999_05_s_2012_52				
Action/Comments					
Trim trees to at least five feet above ground level.

Looking west at untrimmed trees on landward toe. (Spring 2015)

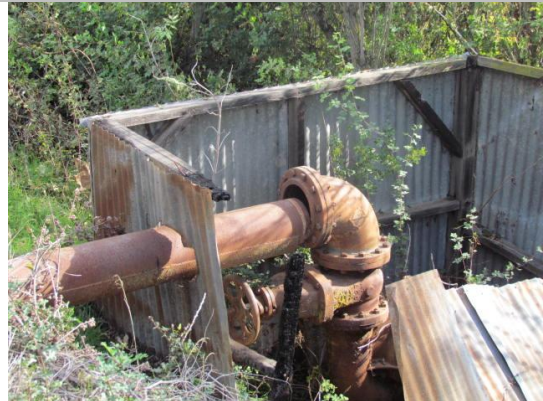
Photo 1 of 1 : FA_2015_RD0999_236_46_20150914_00050.jpg

LM Start	4.68	Rating **	M	Issue No.	46
LM End	4.68	Issue Type +	Ma	Location *	WS
Category	Earthen Levee			GPS Latitude/Longitude	
				Start	End
Item	Encroachments			38.375548 °	38.375548 °
				-121.545693 °	-121.545693 °
DWR ID	DWR_RD0999_05_f_2012_46				
Action/Comments					
Pipe					
Inspector Comments: Pipe is disconnected from pump and should be reconnected or removed.

Looking east at pipe disconnected from pump.

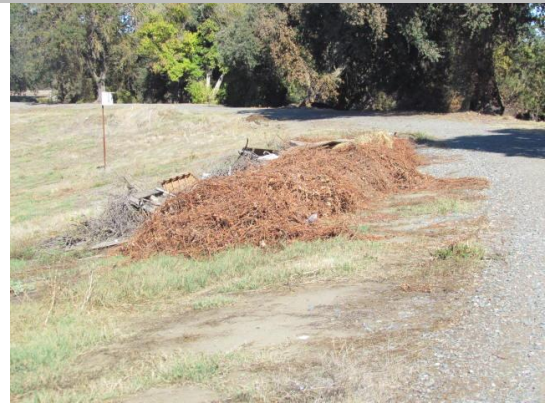
Photo 1 of 2 : FA_2015_RD0999_236_65_20151106_00162.jpg

Looking northwest at prunings on landward slope fall 2015

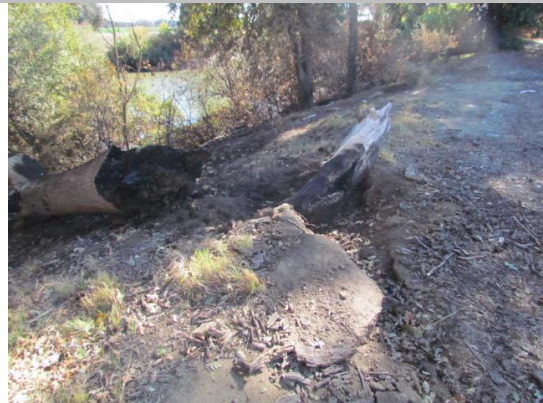
Photo 2 of 2 : FA_2015_RD0999_236_176_20151106_00164.jpg

LM Start	5.12	Rating **	U	Issue No.	176 (cont)
LM End	5.12	Issue Type +	Ma	Location *	WS

Looking at fallen tree and hole on waterward slope and shoulder.

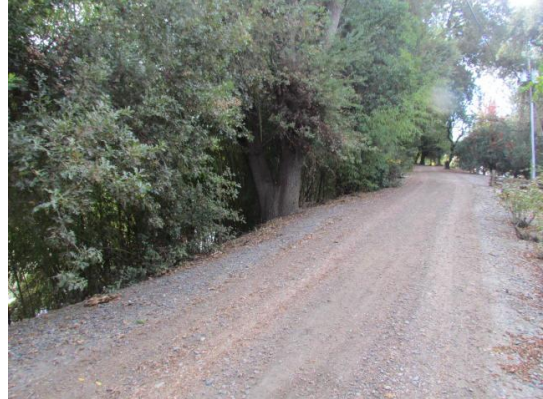
Photo 1 of 1 : FA_2015_RD0999_236_67_20150914_00062.jpg

LM Start	5.47	Rating **	U	Issue No.	67
LM End	5.52	Issue Type +	Ma	Location *	WS
Category	Earthen Levee			GPS Latitude/Longitude	
				Start	End
Item	Trim / Thin Trees			38.382454 °	38.383141 °
				-121.546579 °	-121.546870 °
DWR ID	DWR_RD0999_05_s_2012_67				
Action/Comments					
Trim trees to at least five feet above ground level.

Looking north at dense vegetation on landward shoulder and slope.

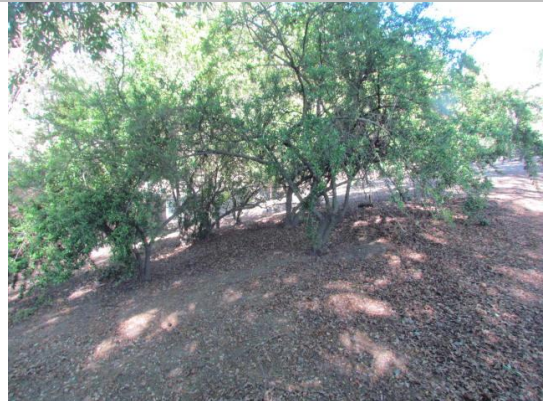
Photo 1 of 1 : FA_2015_RD0999_236_68_20150914_00063.jpg

LM Start	5.48	Rating **	M	Issue No.	68
LM End	5.48	Issue Type +	Ma	Location *	LS
Category	Earthen Levee			GPS Latitude/Longitude	
				Start	End
Item	Trim / Thin Trees			38.382553 °	38.382553 °
				-121.546651 °	-121.546651 °
DWR ID	DWR_RD0999_05_s_2012_68				
Action/Comments					
Trim trees to at least five feet above ground level.

Looking northeast at untrimmed trees on landward slope. (Spring 2015)

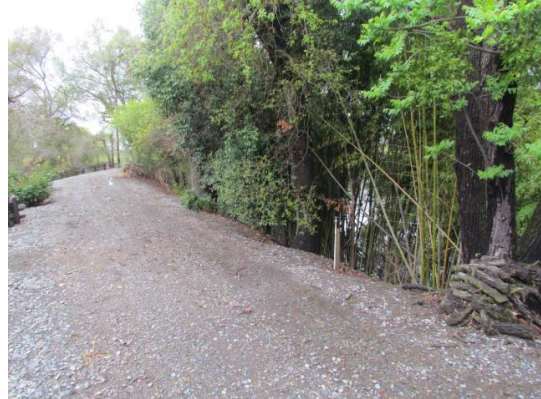
Photo 1 of 1 : FA_2015_RD0999_236_71_20150914_00065.jpg

LM Start	5.50	Rating **	U	Issue No.	71
LM End	5.55	Issue Type +	Ma	Location *	WS
Category	Earthen Levee			GPS Latitude/Longitude	
				Start	End
Item	Vegetation			38.382790 °	38.383548 °
				-121.546754 °	-121.546728 °
DWR ID	DWR_RD0999_05_s_2012_71				
Action/Comments					
Remove the wild growth other than native grasses from the levee slopes.

Looking northeast at dense vegetation on waterside slope.

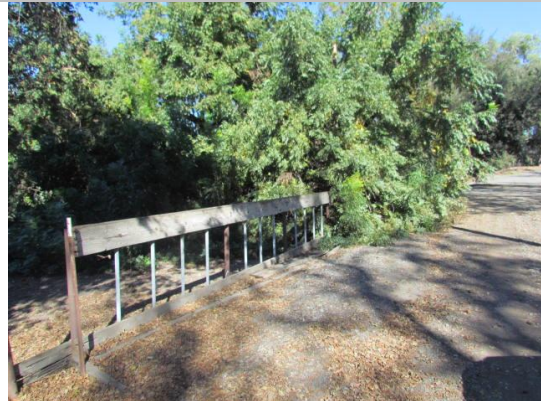
Photo 1 of 1 : FA_2015_RD0999_236_203_20151106_00165.jpg

LM Start	5.56	Rating **	U	Issue No.	203
LM End	5.61	Issue Type +	Ma	Location *	LS
Category	Earthen Levee			GPS Latitude/Longitude	
				Start	End
Item	Trim / Thin Trees			38.383740 °	38.384218 °
				-121.546628 °	-121.546095 °
DWR ID	DWR_RD0999_05_f_2014_203				
Action/Comments					
Trim trees to at least five feet above ground level.

Looking at untrimmed trees on landward slope and toe.

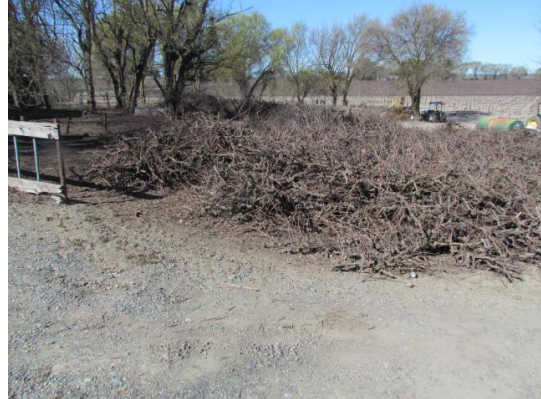
Photo 1 of 1 : FA_2015_RD0999_236_192_20150914_00117.jpg

LM Start	5.58	Rating **	A/W	Issue No.	192
LM End	5.58	Issue Type +	Ma	Location *	LS
Category	Earthen Levee			GPS Latitude/Longitude	
				Start	End
Item	Encroachments			38.383978 °	38.383978 °
				-121.546435 °	-121.546435 °
DWR ID	DWR_RD0999_05_s _ 2014_192				
Action/Comments					
Prunings					
Inspector Comments: Landowner pile prunings on landside slope.

Looking west at prunings on landward slope and toe.

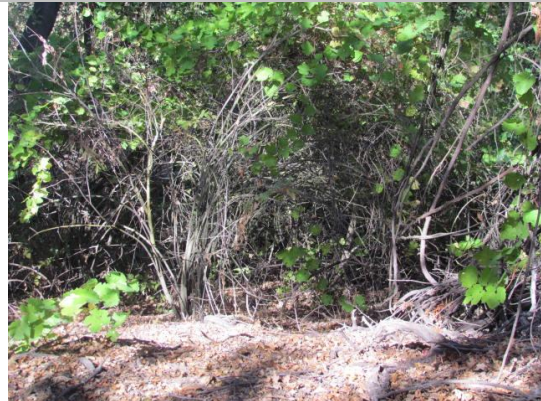
Photo 1 of 2 : FA_2015_RD0999_236_48_20151106_00166.jpg

LM Start	5.80	Rating **	U	Issue No.	48
LM End	5.84	Issue Type +	Ma	Location *	LS
Category	Earthen Levee			GPS Latitude/Longitude	
				Start	End
Item	Vegetation			38.384718 °	38.384930 °
				-121.542590 °	-121.541883 °
DWR ID	DWR_RD0999_05_s _ 2012_48				
Action/Comments					
Remove the wild growth other than native grasses from the levee slopes.

Looking west at dense vegetation on landward slope and toe. Fall 2015

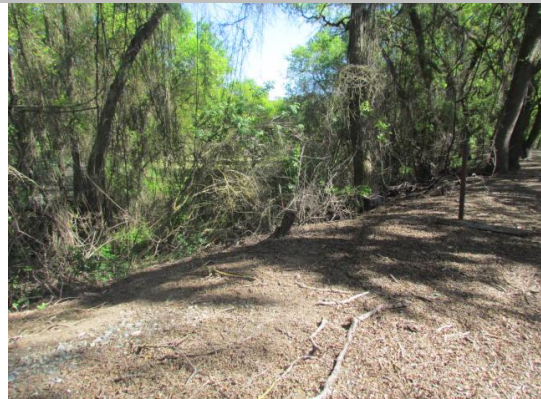
Photo 2 of 2 : FA_2015_RD0999_236_48_20150914_00051.jpg

LM Start	5.80	Rating **	U	Issue No.	48 (cont)
LM End	5.84	Issue Type +	Ma	Location *	LS

Looking east at dense vegetation on landward slope. (Spring 2015)

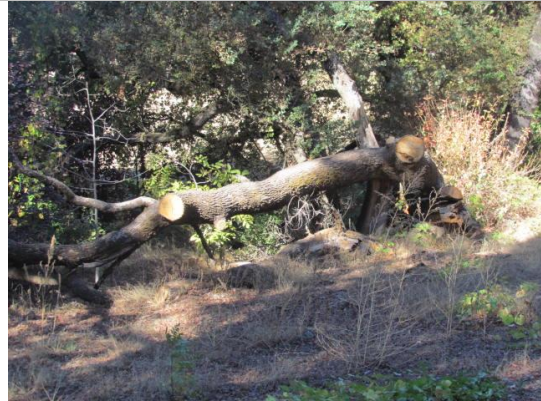
Photo 1 of 2 : FA_2015_RD0999_236_39_20151106_00167.jpg

LM Start	5.93	Rating **	U	Issue No.	39
LM End	5.93	Issue Type +	Ma	Location *	LS
Category	Earthen Levee			GPS Latitude/Longitude	
				Start	End
Item	Encroachments			38.385729 °	38.385729 °
				-121.540863 °	-121.540863 °
DWR ID	DWR_RD0999_05_s _ 2013_39				
Action/Comments					
Tree or limb Inspector Comments: Large downed trees and vegetation blocking landward toe.

Looking west at fallen tree and dense vegetation blocking landward toe. Fall 2015.

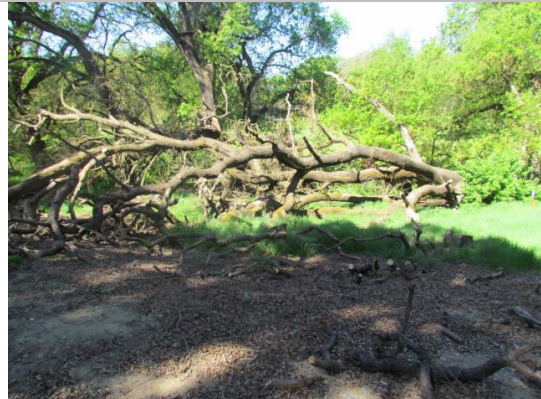
Photo 2 of 2 : FA_2015_RD0999_236_39_20150914_00037.jpg

LM Start	5.93	Rating **	U	Issue No.	39 (cont)
LM End	5.93	Issue Type +	Ma	Location *	LS

Looking west at fallen tree on landward slope and toe. (Spring 2015)

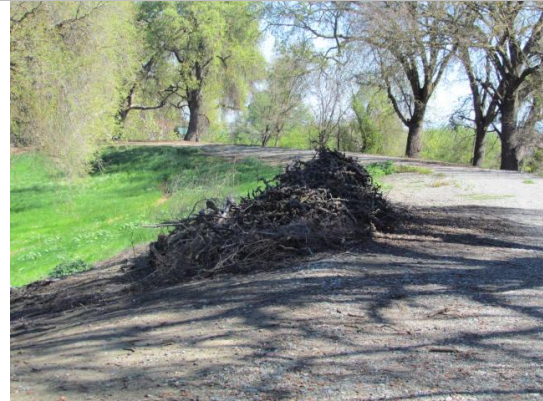
Photo 1 of 1 : FA_2015_RD0999_236_92_20150914_00075.jpg

LM Start	6.48	Rating **	M	Issue No.	92
LM End	6.48	Issue Type +	Ma	Location *	LS
Category	Earthen Levee			GPS Latitude/Longitude	
				Start	End
Item	Encroachments			38.391776 °	38.391776 °
				-121.539295 °	-121.539295 °
DWR ID	DWR_RD0999_05_s_2012_92				
Action/Comments					
Prunings

Looking east prunings on landward slope.

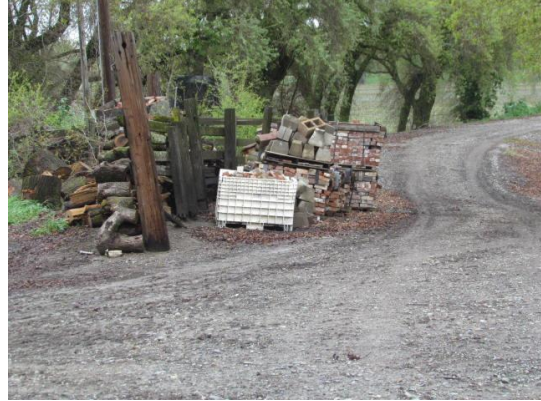
Photo 2 of 4 : FA_2015_RD0999_236_96_20150914_00078.jpg

LM Start	6.73	Rating **	M	Issue No.	96 (cont)
LM End	6.73	Issue Type +	Ma	Location *	LS
Category	Earthen Levee			GPS Latitude/Longitude	
				Start	End
Item	Encroachments			38.395234 °	38.395234 °
				-121.539323 °	-121.539323 °
DWR ID	DWR_RD0999_05_s _ 2012_96				
Action/Comments					
Material					
Inspector Comments: Firewood and other material on landside shoulder.

Looking northeast at firewood and other material on landside shoulder.
(Spring 2012)

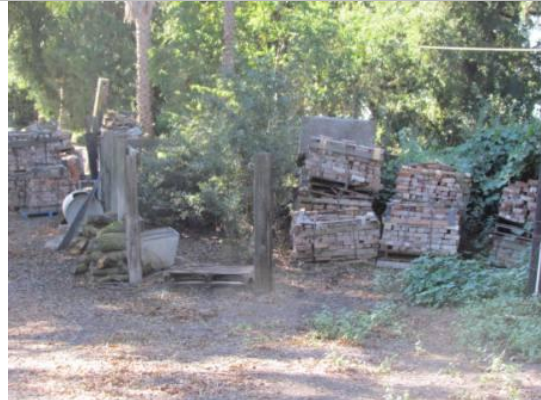
Photo 3 of 4 : FA_2015_RD0999_236_96_20150914_00079.jpg

Looking south at firewood and other material on landside shoulder and crown.

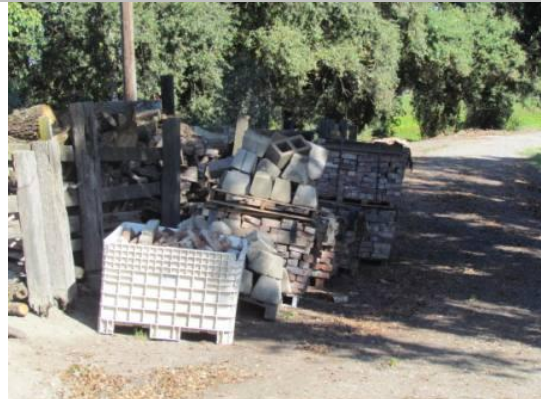
Photo 4 of 4 : FA_2015_RD0999_236_96_20150914_00080.jpg

Looking north at firewood and other material on landside shoulder and crown.

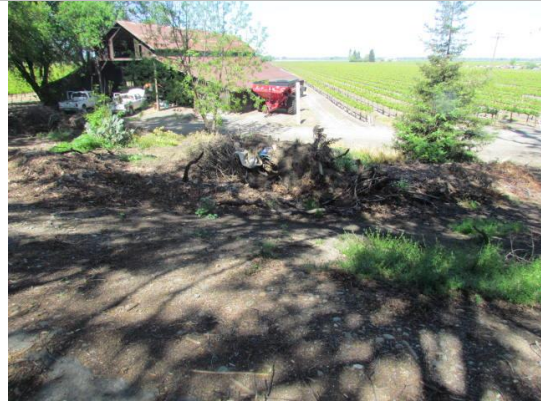
Photo 1 of 1 : FA_2015_RD0999_236_185_20150914_00113.jpg

LM Start	8.03	Rating **	M	Issue No.	185
LM End	8.03	Issue Type +	Ma	Location *	LS
Category	Earthen Levee			GPS Latitude/Longitude	
				Start	End
Item	Encroachments			38.409324 °	38.409324 °
				-121.541223 °	-121.541223 °
DWR ID	DWR_RD0999_05_s _ 2015_185				
Action/Comments					
Prunings					
Inspector Comments: Garbage within prunings piles.

Looking west at pruning piles on landward slope. (Spring 2015)
