**Flood Control Project Maintenance
Levee Inspections**

Maintenance Issue Types Only, Levee Inspection Report By Mile - Fall 2016

Reclamation District No. 0999 Netherlands

Waterway	Bank	Unit Miles	Inspection Start/End	Inspector
Unit No. 01 Yolo Bypass	Left	15.41	09/19/2016 09/20/2016	Richard Willoughby

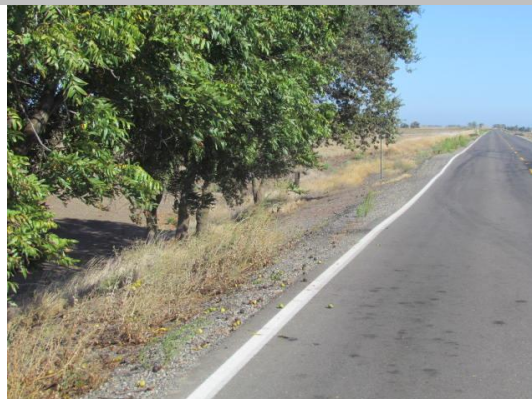
Photo 1 of 2 : FA_2016_RD0999_232_4_20160915_00011.jpg

LM Start	1.73	Rating **	M	Issue No.	4
LM End	1.75	Issue Type +	Ma	Location *	WS
Category	Earthen Levee			GPS Latitude/Longitude	
				Start	End
Item	Trim / Thin Trees			38.480082 °	38.479788 °
				-121.580930 °	-121.580918 °
DWR ID	DWR_RD0999_01_s_2012_4				
Comment Code					
T1 : Trim trees to at least five feet above ground level.					
Inspector Comment

Looking northwest at trimmed trees on waterward slope.

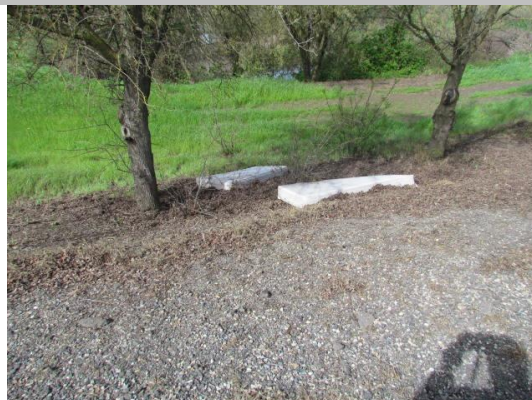
Photo 1 of 1 : FA_2016_RD0999_232_66_20160915_00083.jpg

LM Start	1.73	Rating **	A/W	Issue No.	66
LM End	1.73	Issue Type +	Ma	Location *	WS
Category	Earthen Levee			GPS Latitude/Longitude	
				Start	End
Item	Encroachments			38.480009 °	38.480009 °
				-121.580865 °	-121.580865 °
DWR ID	DWR_RD0999_01_s_2016_66				
Comment Code					
GA : Garbage					
Inspector Comment					
Garbage on waterward slope.

Looking northwest at garbage on waterward slope and toe.

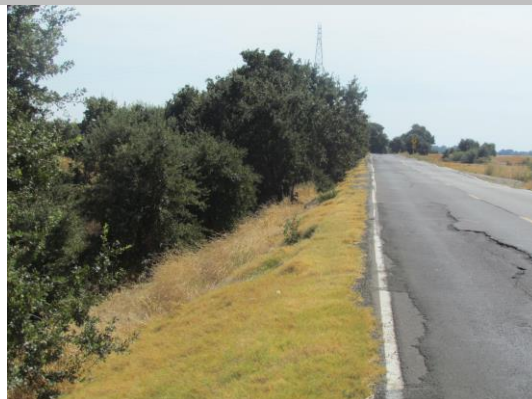
Photo 1 of 2 : FA_2016_RD0999_232_30_20160923_00110.jpg

LM Start	1.79	Rating **	U	Issue No.	30
LM End	2.04	Issue Type +	Ma	Location *	LS
Category	Earthen Levee			GPS Latitude/Longitude	
				Start	End
Item	Trim / Thin Trees			38.479165 °	38.475463 °
				-121.580640 °	-121.580722 °
DWR ID	DWR_RD0999_01_s_2012_30				
Comment Code					
T1 : Trim trees to at least five feet above ground level.					
Inspector Comment

Looking southeast at dense trees on landward slope. (Fall 2016)

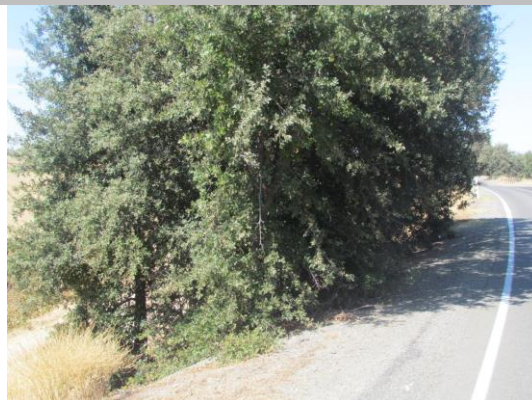
Photo 1 of 2 : FA_2016_RD0999_232_7_20160923_00111.jpg

LM Start	2.13	Rating **	U	Issue No.	7
LM End	2.13	Issue Type +	Ma	Location *	WS
Category	Earthen Levee			GPS Latitude/Longitude	
				Start	End
Item	Trim / Thin Trees			38.474258 °	38.474258 °
				-121.580528 °	-121.580528 °
DWR ID	DWR_RD0999_01_s_2012_7				
Comment Code					
T1 : Trim trees to at least five feet above ground level.					
Inspector Comment

Looking north at untrimmed trees on waterward slope. (Fall 2016)

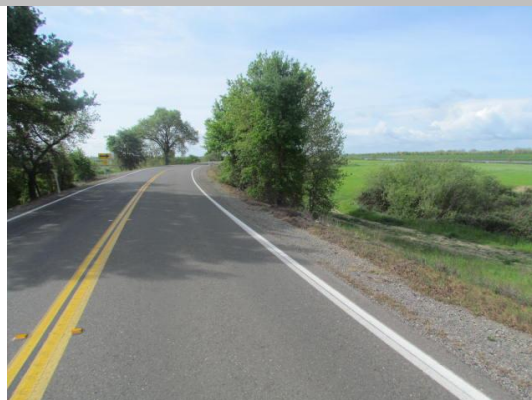
Photo 2 of 2 : FA_2016_RD0999_232_7_20160915_00015.jpg

Looking south at untrimmed trees on waterward slope. (Spring 2016)

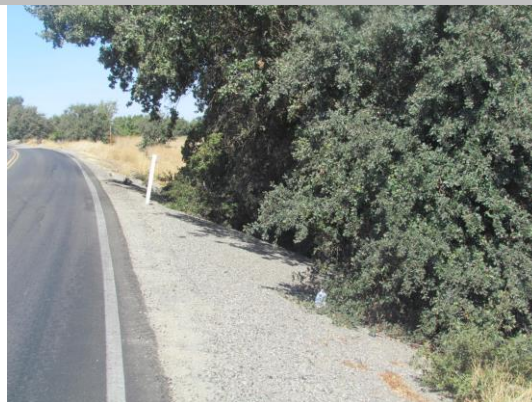
Photo 1 of 2 : FA_2016_RD0999_232_31_20160923_00112.jpg

LM Start	2.13	Rating **	U	Issue No.	31
LM End	2.13	Issue Type +	Ma	Location *	LS
Category	Earthen Levee			GPS Latitude/Longitude	
				Start	End
Item	Trim / Thin Trees			38.474200 °	38.474200 °
				-121.580480 °	-121.580480 °
DWR ID	DWR_RD0999_01_s_2012_31				
Comment Code					
T1 : Trim trees to at least five feet above ground level.					
Inspector Comment

Looking north at untrimmed trees on landward slope. (Fall 2016)

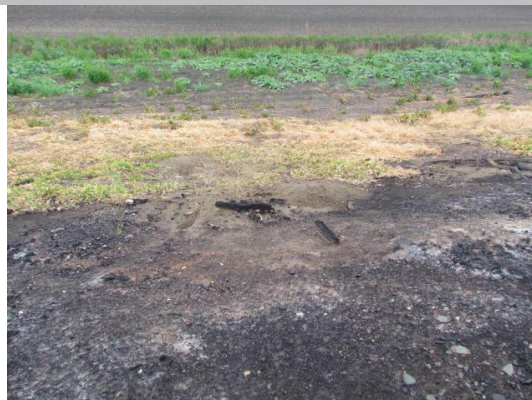
Photo 1 of 2 : FA_2016_RD0999_232_42_20160915_00054.jpg

LM Start	6.56	Rating **	M	Issue No.	42
LM End	6.56	Issue Type +	Ma	Location *	LS
Category	Earthen Levee			GPS Latitude/Longitude	
				Start	End
Item	Animal Control			38.413858 °	38.413858 °
				-121.608638 °	-121.608638 °
DWR ID	DWR_RD0999_01_s_2012_42				
Comment Code					
A1 : Exterminate rodents and backfill and compact or grout burrows.					
Inspector Comment					
More than five holes within 25' of levee.

Looking east at rodent holes on landside slope.

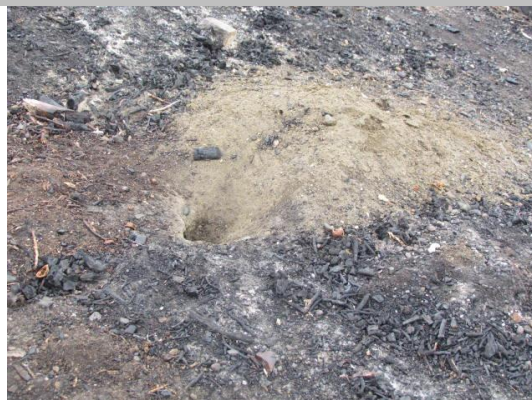
Photo 2 of 2 : FA_2016_RD0999_232_42_20160915_00055.jpg

Looking at typical rodent hole on landside slope.

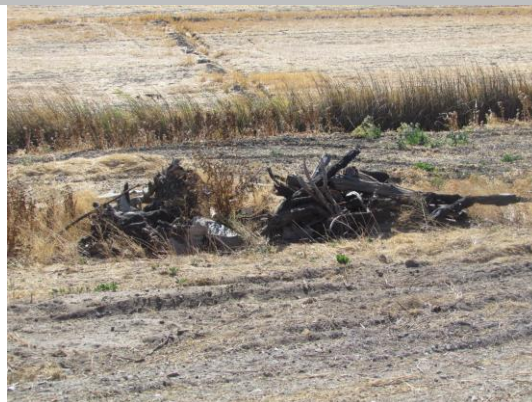
Photo 1 of 2 : FA_2016_RD0999_232_41_20160923_00116.jpg

LM Start	6.56	Rating **	M	Issue No.	41
LM End	6.59	Issue Type +	Ma	Location *	LS
Category	Earthen Levee			GPS Latitude/Longitude	
				Start	End
Item	Encroachments			38.413856 °	38.413475 °
				-121.608635 °	-121.608817 °
DWR ID	DWR_RD0999_01_s_2016_41				
Comment Code					
PR : Prunings					
Inspector Comment					
Pruning piles on landward toe.

Looking east at prunings at landward toe and berm. (Fall 2016)

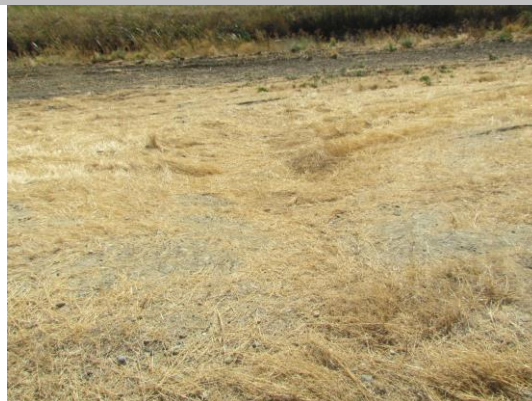
Photo 1 of 2 : FA_2016_RD0999_232_58_20160923_00117.jpg

LM Start	7.61	Rating **	U	Issue No.	58
LM End	7.61	Issue Type +	Ma	Location *	LS
Category	Earthen Levee			GPS Latitude/Longitude	
				Start	End
Item	Erosion / Bank Caving			38.399600°	38.399600°
				-121.615224°	-121.615224°
DWR ID	DWR_RD0999_01_f_2016_58				
Comment Code					
Inspector Comment					
Depression 10' by 20' on landward slope.

Looking northeast at depression on landward slope.

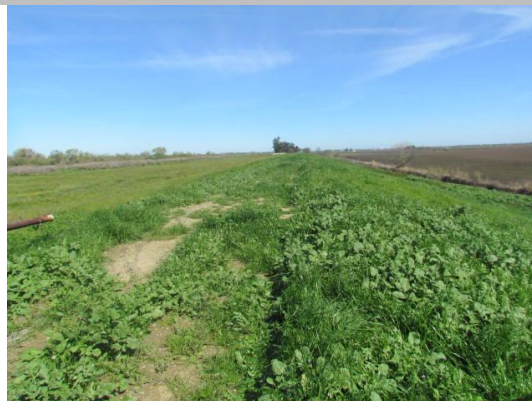
Photo 1 of 3 : FA_2016_RD0999_232_920_20160915_00093.jpg

LM Start	9.94	Rating **	A/W	Issue No.	920
LM End	11.60	Issue Type +	Ma	Location *	CR
Category	Earthen Levee			GPS Latitude/Longitude	
				Start	End
Item	Crown Surface / Depressions / Rutting			38.367831°	38.345274°
				-121.629990°	-121.640482°
DWR ID	DWR_RD0999_01_s_2012_920				
Comment Code					
C1 : Add appropriate material and re-grade the levee to bring the crown above the design elevation.					
Inspector Comment

Looking south at growth on levee crown (Spring 2016)

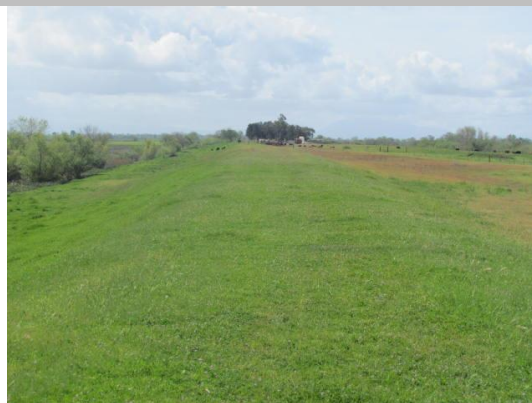
Photo 2 of 3 : FA_2016_RD0999_232_920_20160915_00094.jpg

Looking south at levee crown. (Spring 2015)

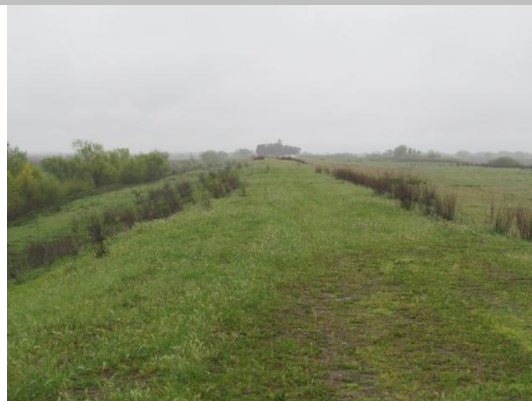
Photo 3 of 3 : FA_2016_RD0999_232_920_20160915_00095.jpg

Looking south at crown roadway. (Spring 2014)

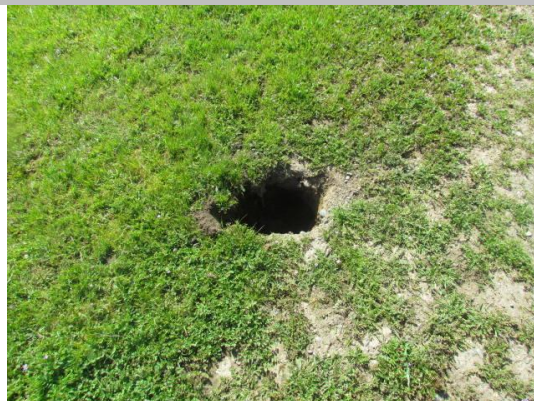
Photo 1 of 5 : FA_2016_RD0999_232_2_20160915_00006.jpg

LM Start	9.95	Rating **	U	Issue No.	2
LM End	9.95	Issue Type +	Ma	Location *	LS
Category	Earthen Levee			GPS Latitude/Longitude	
				Start	End
Item	Animal Control			38.367750 °	38.367750 °
				-121.630025 °	-121.630025 °
DWR ID	DWR_RD0999_01_s_2012_2				
Comment Code					
A1 : Exterminate rodents and backfill and compact or grout burrows.					
Inspector Comment					
Several large rodent holes on landward shoulder.

Looking southeast at large rodent hole on landward shoulder. (Spring 2016)

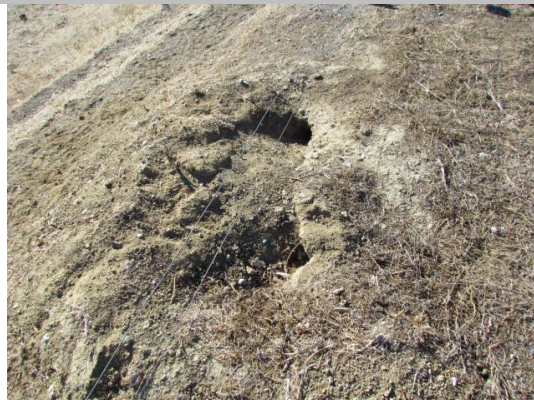
Photo 2 of 5 : FA_2016_RD0999_232_2_20160915_00007.jpg

Looking southeast at rodent holes on landward shoulder fall 2015.

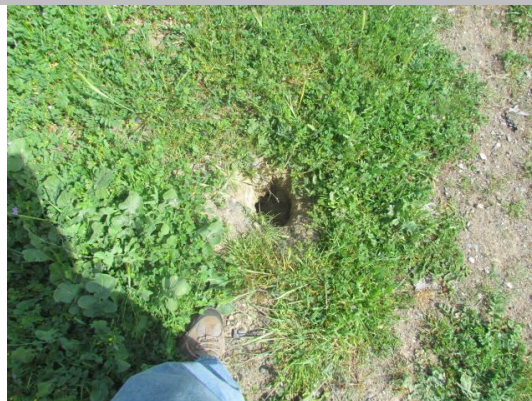
Photo 4 of 5 : FA_2016_RD0999_232_2_20160915_00009.jpg

LM Start	9.95	Rating **	U	Issue No.	2 (cont)	
LM End	9.95	Issue Type +	Ma	Location *	LS	
Category	Earthen Levee			GPS Latitude/Longitude		
				Start		End
Item	Animal Control			38.367750 °		38.367750 °
				-121.630025 °		-121.630025 °
DWR ID	DWR_RD0999_01_s_2012_2					
Comment Code						
A1 : Exterminate rodents and backfill and compact or grout burrows.						
Inspector Comment						
Several large rodent holes on landward shoulder.

Looking at typical rodent holes on landward shoulder. (Spring 2015)

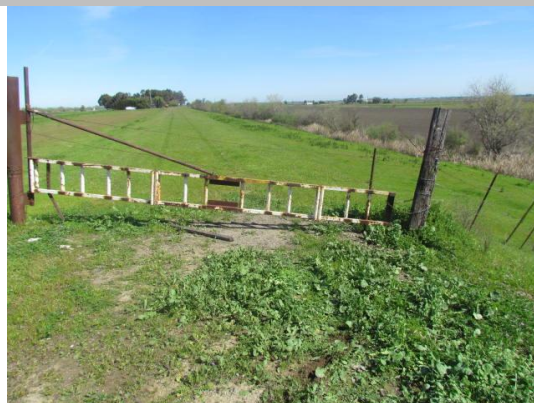
Photo 3 of 3 : FA_2016_RD0999_232_70_20160915_00090.jpg

LM Start	10.21	Rating **	A/W	Issue No.	70 (cont)	
LM End	10.21	Issue Type +	Ma	Location *	CR	
Category	Earthen Levee			GPS Latitude/Longitude		
				Start		End
Item	Repair Gates			38.364229°		38.364229°
				-121.631673°		-121.631673°
DWR ID	DWR_RD0999_01_s_2016_70					
Comment Code						
Inspector Comment						
Gate drags difficult to open and close. Gate pole leaning.

Looking south at fence pole.

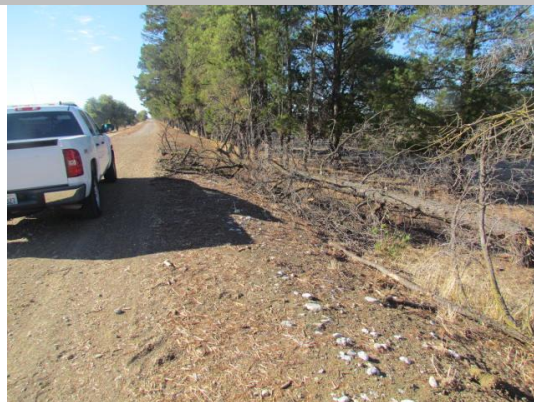
Photo 1 of 1 : FA_2016_RD0999_232_61_20160915_00077.jpg

LM Start	10.75	Rating **	A/W	Issue No.	61
LM End	10.75	Issue Type +	Ma	Location *	WS
Category	Earthen Levee			GPS Latitude/Longitude	
				Start	End
Item	Encroachments			38.356844 °	38.356844 °
				-121.635101 °	-121.635101 °
DWR ID	DWR_RD0999_01_f_2014_61				
Comment Code					
TR : Tree or limb					
Inspector Comment					
Downed tree on waterward slope has been removed, but should be monitored.

Looking southwest at downed tree on waterward slope.

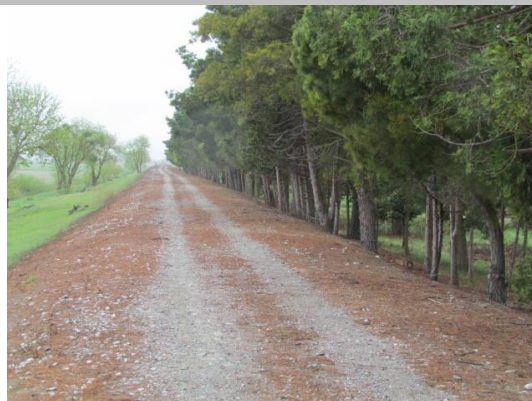
Photo 1 of 2 : FA_2016_RD0999_232_23_20160915_00024.jpg

LM Start	10.81	Rating **	A/W	Issue No.	23
LM End	11.06	Issue Type +	Ma	Location *	WS
Category	Earthen Levee			GPS Latitude/Longitude	
				Start	End
Item	Trim / Thin Trees			38.356077°	38.352640°
				-121.635598°	-121.637078°
DWR ID	DWR_RD0999_01_s_2012_23				
Comment Code					
T1 : Trim trees to at least five feet above ground level.					
Inspector Comment

Looking south at trimmed pine trees on waterside shoulder and slope. (Spring 2012)

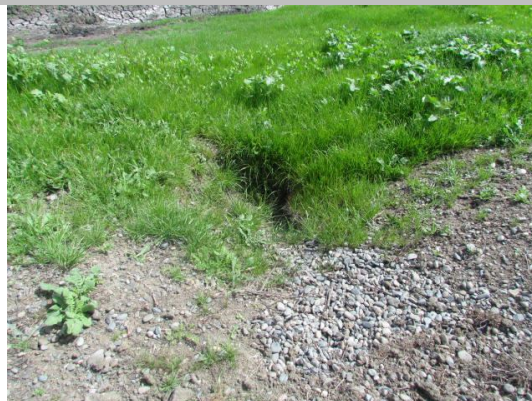
Photo 2 of 4 : FA_2016_RD0999_232_49_20160915_00064.jpg

Looking east at caving on landward shoulder and slope. (Spring 2015)

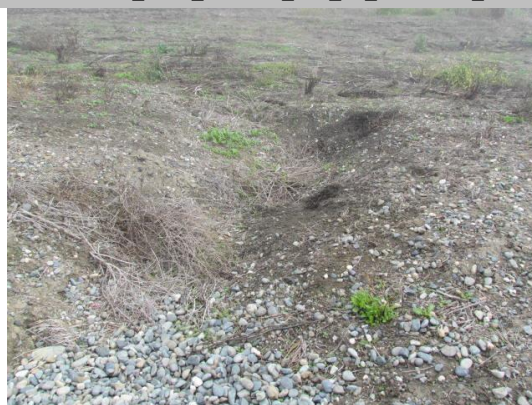
Photo 3 of 4 : FA_2016_RD0999_232_49_20160915_00065.jpg

Looking east caving on landside slope.

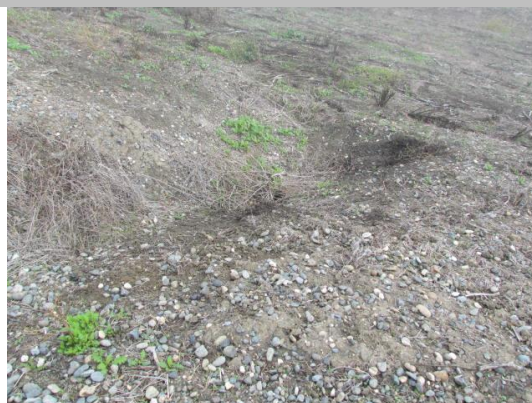
Photo 4 of 4 : FA_2016_RD0999_232_49_20160915_00066.jpg

Looking southeast at caving on landside slope.

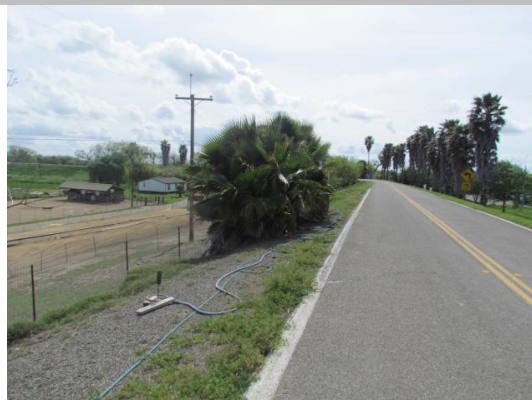
Photo 1 of 3 : FA_2016_RD0999_232_50_20160915_00067.jpg

LM Start	15.33	Rating **	M	Issue No.	50
LM End	15.33	Issue Type +	Ma	Location *	LS
Category	Earthen Levee			GPS Latitude/Longitude	
				Start	End
Item	Encroachments			38.291663°	38.291663°
				-121.644962°	-121.644962°
DWR ID	DWR_RD0999_01_f_2012_50				
Comment Code					
TR : Tree or limb					
Inspector Comment					
Planted palm trees on landside shoulder.

Looking northeast at a mature palm trees on landward shoulder and slope. (Spring 2015)

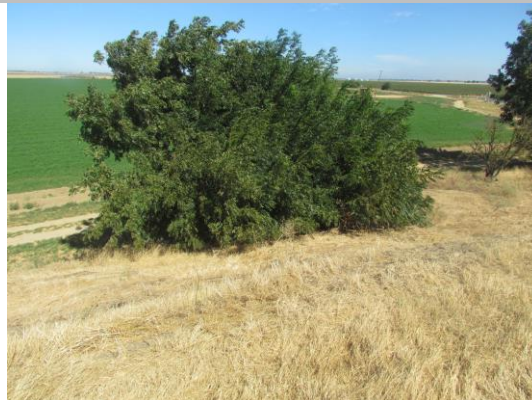
Photo 1 of 2 : FA_2016_RD0999_233_37_20160923_00060.jpg

LM Start	0.73	Rating **	U	Issue No.	37
LM End	0.73	Issue Type +	Ma	Location *	LS
Category	Earthen Levee			GPS Latitude/Longitude	
				Start	End
Item	Trim / Thin Trees			38.292783 °	38.292783 °
				-121.632317 °	-121.632317 °
DWR ID	DWR_RD0999_02_s_2014_37				
Comment Code					
T1 : Trim trees to at least five feet above ground level.					
Inspector Comment

Looking at untrimmed tree on landward slope and toe. (Fall 2016)

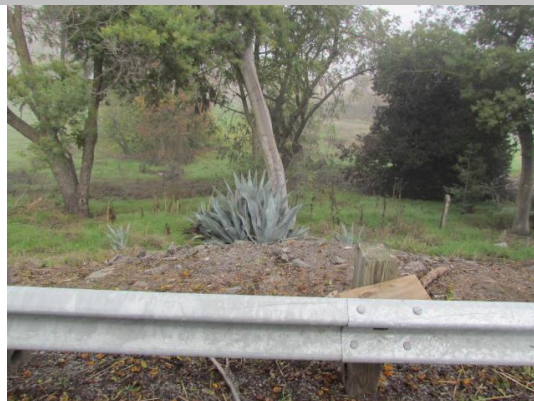
Photo 2 of 2 : FA_2016_RD0999_233_14_20160915_00016.jpg

LM Start	0.82	Rating **	U	Issue No.	14 (cont)	
LM End	0.82	Issue Type +	Ma	Location *	LS	
Category	Earthen Levee			GPS Latitude/Longitude		
				Start		End
Item	Vegetation			38.292439 °		38.292439 °
				-121.630781 °		-121.630781 °
DWR ID	DWR_RD0999_02_f_2012_14					
Comment Code						
V2 : Remove the wild growth other than native grasses from the levee slopes.						
Inspector Comment						
Century plant on landside slope.

Looking north at century plant at landside toe.

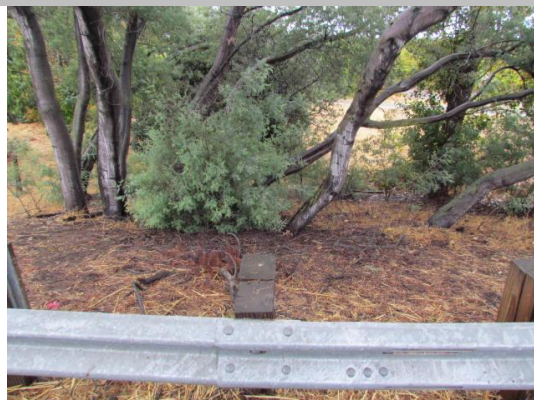
Photo 1 of 2 : FA_2016_RD0999_233_19_20160915_00021.jpg

LM Start	0.83	Rating **	U	Issue No.	19
LM End	0.83	Issue Type +	Ma	Location *	LS
Category	Earthen Levee			GPS Latitude/Longitude	
				Start	End
Item	Trim / Thin Trees			38.292386 °	38.292386 °
				-121.630543 °	-121.630543 °
DWR ID	DWR_RD0999_02_f_2012_19				
Comment Code					
T2 : Thin trees to allow visibility of the ground and room to flood fight.					
Inspector Comment

Looking north at untrimmed and trees to be thinned at landward toe fall 2015.

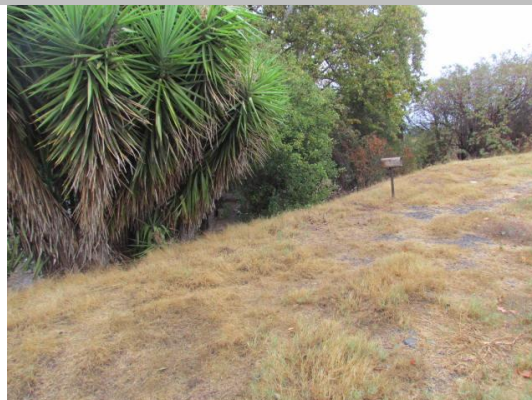
Photo 1 of 2 : FA_2016_RD0999_233_11_20160915_00012.jpg

LM Start	1.70	Rating **	U	Issue No.	11
LM End	1.70	Issue Type +	Ma	Location *	LS
Category	Earthen Levee			GPS Latitude/Longitude	
				Start	End
Item	Trim / Thin Trees			38.290171 °	38.290171 °
				-121.615260 °	-121.615260 °
DWR ID	DWR_RD0999_02_s_2012_11				
Comment Code					
T1 : Trim trees to at least five feet above ground level.					
Inspector Comment

Looking at dense trees on landward slope.

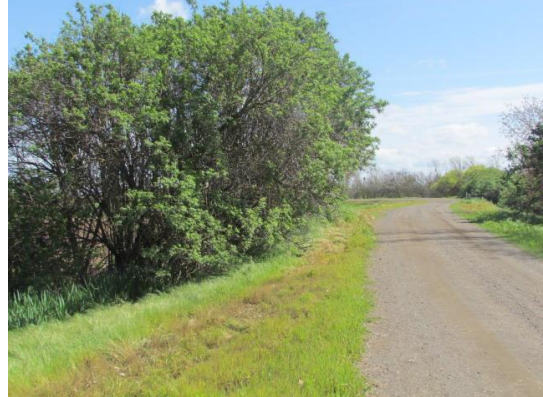
Photo 1 of 3 : FA_2016_RD0999_233_8_20160915_00008.jpg

LM Start	1.73	Rating **	A/W	Issue No.	8
LM End	1.76	Issue Type +	Ma	Location *	LS
Category	Earthen Levee			GPS Latitude/Longitude	
				Start	End
Item	Vegetation			38.289895°	38.289595°
				-121.614688°	-121.614337°
DWR ID	DWR_RD0999_02_s_2012_8				
Comment Code					
V2 : Remove the wild growth other than native grasses from the levee slopes.					
Inspector Comment

Looking east at dense vegetation on landward shoulder and slope.
(Spring 2016)

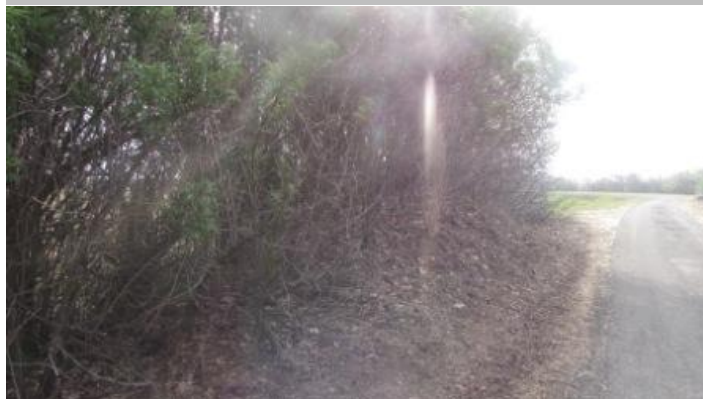
Photo 3 of 3 : FA_2016_RD0999_233_8_20160915_00010.jpg

LM Start	1.73	Rating **	A/W	Issue No.	8 (cont)	
LM End	1.76	Issue Type +	Ma	Location *	LS	
Category	Earthen Levee			GPS Latitude/Longitude		
				Start		End
Item	Vegetation			38.289895 °		38.289595 °
				-121.614688 °		-121.614337 °
DWR ID	DWR_RD0999_02_s_2012_8					
Comment Code						
V2 : Remove the wild growth other than native grasses from the levee slopes.						
Inspector Comment

Looking east at elderberry bush on landside shoulder and slope. (Fall 2014)

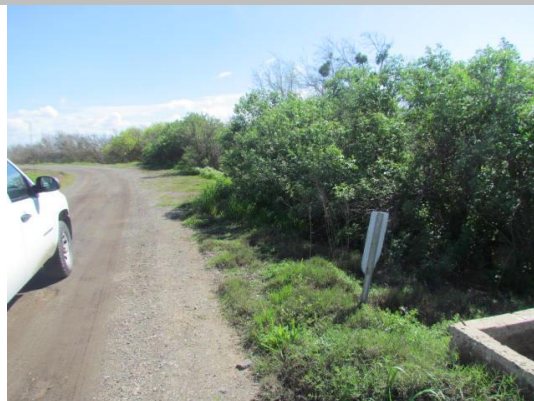
Photo 1 of 3 : FA_2016_RD0999_233_38_20160915_00030.jpg

LM Start	1.78	Rating **	A/W	Issue No.	38
LM End	1.82	Issue Type +	Ma	Location *	WS
Category	Earthen Levee			GPS Latitude/Longitude	
				Start	End
Item	Vegetation			38.289360 °	38.289006 °
				-121.614086 °	-121.613639 °
DWR ID	DWR_RD0999_02_s_2014_38				
Comment Code					
V4 : Elderberries are blocking visibility and flood fight capability.					
Inspector Comment

Looking east at dense vegetation on waterward shoulder and slope. (Spring 2016)

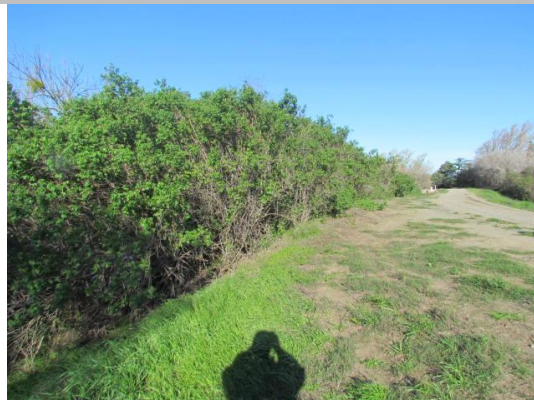
Photo 2 of 3 : FA_2016_RD0999_233_38_20160915_00031.jpg

Looking west at dense vegetation on waterside slope. (Spring 2015)

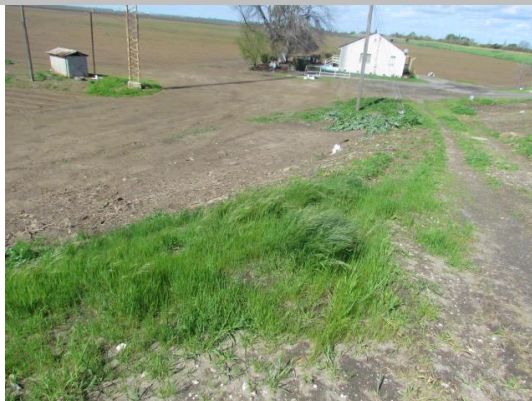
Photo 1 of 5 : FA_2016_RD0999_234_4_20160915_00004.jpg

LM Start	0.04	Rating **	A	Issue No.	4
LM End	0.04	Issue Type +	Ma	Location *	LS
Category	Earthen Levee			GPS Latitude/Longitude	
				Start	End
Item	Trim / Thin Trees			38.287025 °	38.287025 °
				-121.605690 °	-121.605690 °
DWR ID	DWR_RD0999_03_s_2012_4				
Comment Code					
T1 : Trim trees to at least five feet above ground level.					
Inspector Comment					
Dense fig trees on landward slope and toe. Fig tree has been removed. GREAT JOB!

Looking southwest at cleared fig tree from landward slope and toe.
(Spring 2016) GREAT JOB!

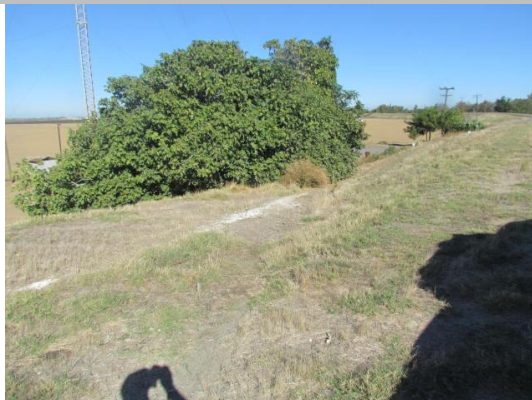
Photo 2 of 5 : FA_2016_RD0999_234_4_20160915_00005.jpg

Looking northwest at dense fig tree on landward toe. 2014

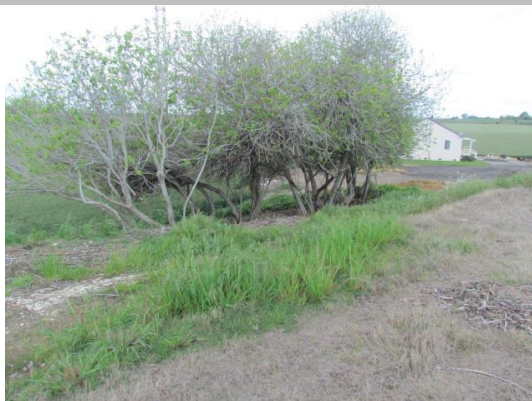
Photo 4 of 5 : FA_2016_RD0999_234_4_20160915_00007.jpg

LM Start	0.04	Rating **	A	Issue No.	4 (cont)	
LM End	0.04	Issue Type +	Ma	Location *	LS	
Category	Earthen Levee			GPS Latitude/Longitude		
				Start		End
Item	Trim / Thin Trees			38.287025 °		38.287025 °
				-121.605690 °		-121.605690 °
DWR ID	DWR_RD0999_03_s_2012_4					
Comment Code						
T1 : Trim trees to at least five feet above ground level.						
Inspector Comment						
Dense fig trees on landward slope and toe. Fig tree has been removed. GREAT JOB!

Looking southwest at trimmed trees on landside toe. (Spring 2012)

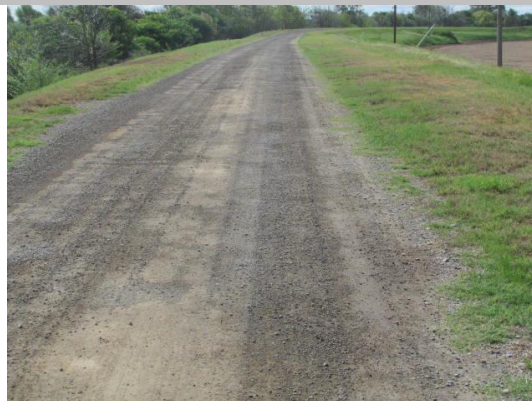
Photo 1 of 1 : FA_2016_RD0999_234_9_20160915_00014.jpg

LM Start	0.11	Rating **	A	Issue No.	9
LM End	1.37	Issue Type +	Ma	Location *	CR
Category	Earthen Levee			GPS Latitude/Longitude	
				Start	End
Item	Crown Surface / Depressions / Rutting			38.287873°	38.304451°
				-121.605108°	-121.600419°
DWR ID	DWR_RD0999_03_f_2012_9				
Comment Code					
C2 : Repair depressions or ruts in the crown or slope.					
Inspector Comment

Looking south at levee crown. (Spring 2015)

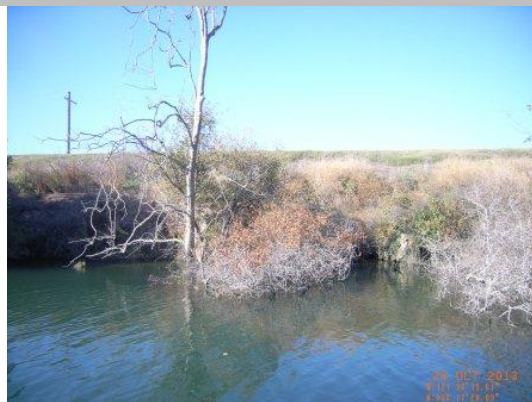
Photo 1 of 1 : FA_2016_RD0999_234_29_20160915_00031.jpg

LM Start	0.24	Rating **	U	Issue No.	29
LM End	0.65	Issue Type +	Ma	Location *	WS
Category	Supplemental			GPS Latitude/Longitude	
				Start	End
Item	2015 USACE Erosion Survey, DRAFT			38.289634°	38.295505°
				-121.604343°	-121.605648°
DWR ID	DWR_RD0999_03_s_2016_29

Comment Code					
Inspector Comment					
1997 - Intermittent over-steepened sections. Large riparian vegetation along the length of the entire reach. Attempts to repair with rock on bank have failed. 1999 - New rock repair at the downstream end. 2002 - Some minor spot repairs. 2009 - Minimal new erosion. 2010 - Appears that fresh rock placed on downstream portion of site. Toe scour and overhanging trees with some overturned. 2012 - Minor new erosion at the toe. 2013 - Site upgraded to CRITICAL. Severe slumping into levee at downstream end of site. Fresh erosion into bank toe. 2015: New slumping, tall vertical sections. [2015 Site ID: STR_24-7 R]

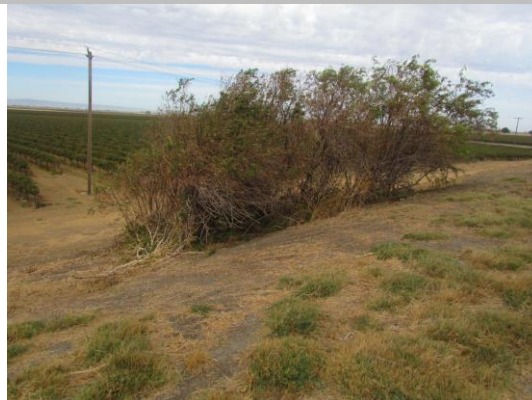
Photo 1 of 2 : FA_2016_RD0999_234_8_20160923_00054.jpg

LM Start	0.66	Rating **	M	Issue No.	8
LM End	0.66	Issue Type +	Ma	Location *	LS
Category	Earthen Levee			GPS Latitude/Longitude	
				Start	End
Item	Vegetation			38.295618 °	38.295618 °
				-121.605923 °	-121.605923 °
DWR ID	DWR_RD0999_03_s_2012_8				
Comment Code					
V4 : Elderberries are blocking visibility and flood fight capability.					
Inspector Comment					
LMA trimmed back brush.

Looking east at brush on landward slope and toe. (Fall 2016)

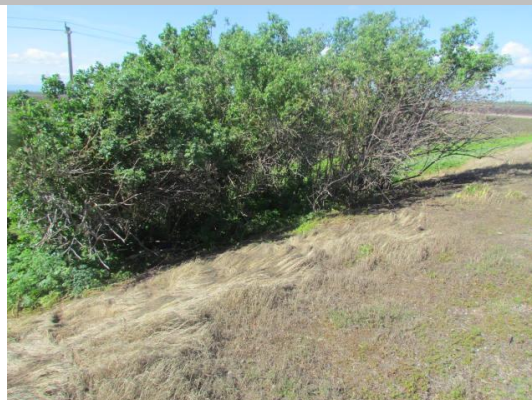
Photo 2 of 2 : FA_2016_RD0999_234_8_20160915_00012.jpg

Looking east at elderberry at landward slope and toe. (Spring 2016)

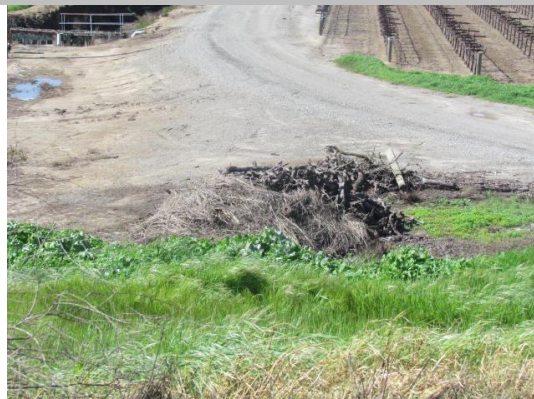
Photo 1 of 2 : FA_2016_RD0999_234_2_20160915_00002.jpg

LM Start	0.75	Rating **	A/W	Issue No.	2
LM End	0.75	Issue Type +	Ma	Location *	LS
Category	Earthen Levee			GPS Latitude/Longitude	
				Start	End
Item	Encroachments			38.296942 °	38.296942 °
				-121.605528 °	-121.605528 °
DWR ID	DWR_RD0999_03_s_2012_2				
Comment Code					
PR : Prunings					
Inspector Comment					
Pruning pile is outside the fifteen foot zone on landside berm.

Looing west at prunings at landward toe and berm. (Spring 2016)

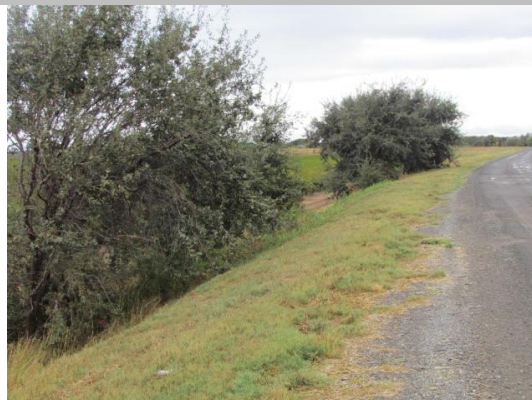
Photo 1 of 1 : FA_2016_RD0999_234_43_20160915_00038.jpg

LM Start	0.93	Rating **	U	Issue No.	43
LM End	0.95	Issue Type +	Ma	Location *	LS
Category	Earthen Levee			GPS Latitude/Longitude	
				Start	End
Item	Trim / Thin Trees			38.299130°	38.299362°
				-121.603768°	-121.603462°
DWR ID	DWR_RD0999_03_f_2014_43				
Comment Code					
T1 : Trim trees to at least five feet above ground level.					
Inspector Comment

Looking at untrimmed trees on landward slope and toe.

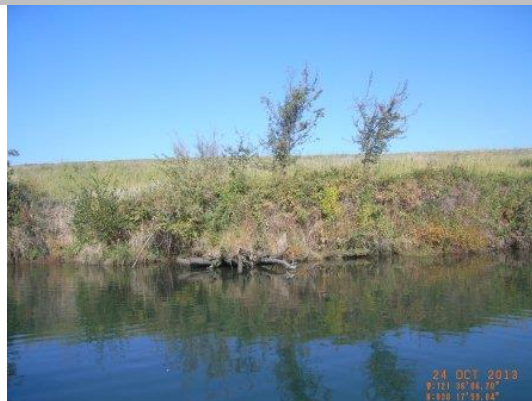
Photo 1 of 1 : FA_2016_RD0999_234_30_20160915_00032.jpg

LM Start	0.97	Rating **	M	Issue No.	30
LM End	1.10	Issue Type +	Ma	Location *	WS
Category	Supplemental			GPS Latitude/Longitude	
				Start	End
Item	2015 USACE Erosion Survey, DRAFT			38.299402 °	38.300542 °
				-121.603056 °	-121.601118 °
DWR ID	DWR_RD0999_03_s_2016_30				
Comment Code					
Inspector Comment					
2008 - Over steepened levee section. 2009 - Significant new erosion. 2010 - Minor new erosion. 2015: No observed changes. [2015 Site ID: STR_25-2_R]

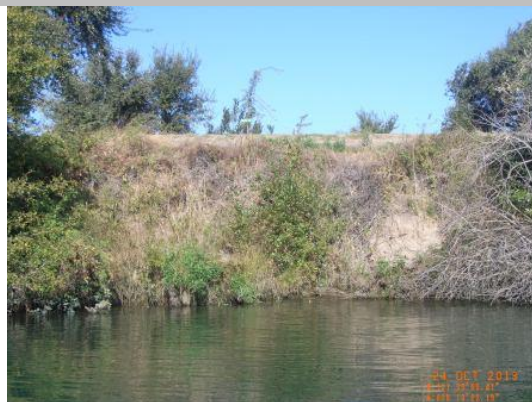
Photo 1 of 1 : FA_2016_RD0999_234_1_20160915_00001.jpg

LM Start	1.43	Rating **	M	Issue No.	1
LM End	1.58	Issue Type +	Ma	Location *	WS
Category	Supplemental			GPS Latitude/Longitude	
				Start	End
Item	2015 USACE Erosion Survey, DRAFT			38.305229 °	38.306667 °
				-121.599933 °	-121.598266 °
DWR ID	DWR_RD0999_03_s_2016_1				
Comment Code					
Inspector Comment					
2011 - Toe scour along length of site and erosion pockets. 2012 - Site extended slightly upstream due to new erosion pocket. 2013 - Tall vertical sections at upstream end of site. 2015: No observed changes. [2015 Site ID: STR_25-7_R]

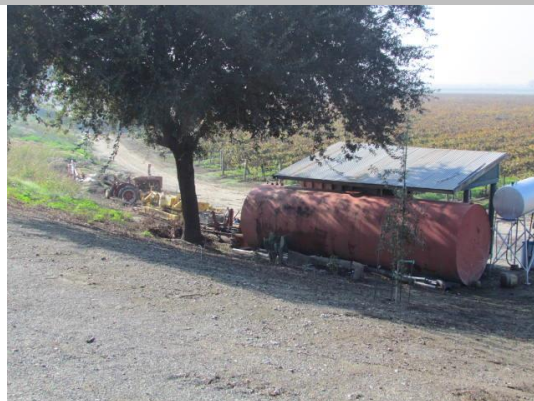
Photo 2 of 3 : FA_2016_RD0999_234_27_20160915_00029.jpg

LM Start	2.54	Rating **	U	Issue No.	27 (cont)	
LM End	2.54	Issue Type +	Ma	Location *	LS	
Category	Earthen Levee			GPS Latitude/Longitude		
				Start		End
Item	Encroachments			38.317840 °		38.317840 °
				-121.590895 °		-121.590895 °
DWR ID	DWR_RD0999_03_s_2012_27					
Comment Code						
EQ : Equipment						
Inspector Comment						
Diesel tank stored at landside toe.

Looking southwest at farm equipment stored at landside toe. (Fall Inspection 2012)

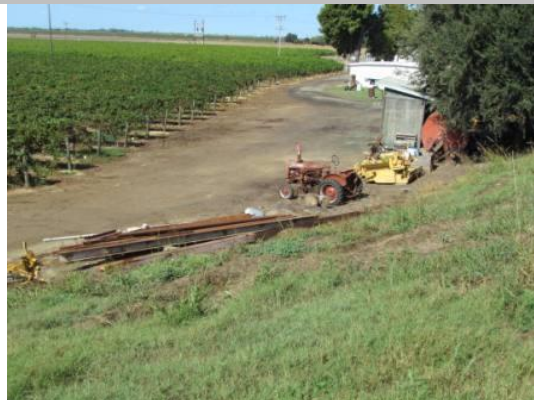
Photo 3 of 3 : FA_2016_RD0999_234_27_20160915_00030.jpg

Looking northwest at equipment at landside toe.

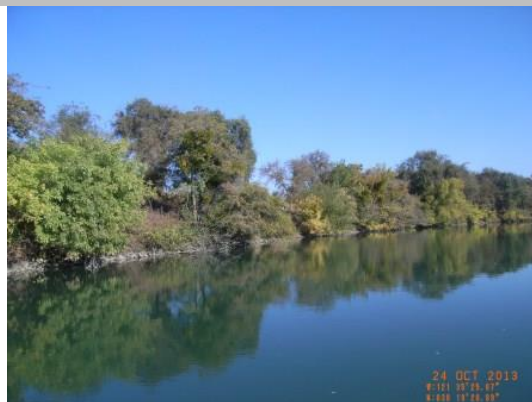
Photo 1 of 1 : FA_2016_RD0999_234_21_20160915_00025.jpg

LM Start	2.87	Rating **	M	Issue No.	21
LM End	2.92	Issue Type +	Ma	Location *	WS
Category	Supplemental			GPS Latitude/Longitude	
				Start	End
Item	2015 USACE Erosion Survey, DRAFT			38.322457 °	38.323042 °
				-121.590693 °	-121.590209 °
DWR ID	DWR_RD0999_03_s_2016_21				
Comment Code					
Inspector Comment					
2012 - Slumping of upper levee slope. 2015: No observed changes. [2015 Site ID: STR_27-1_R]

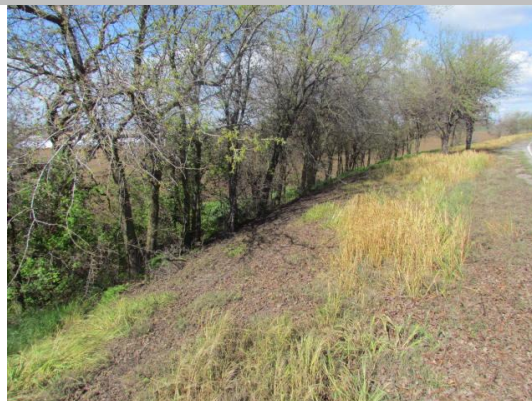
Photo 1 of 4 : FA_2016_RD0999_234_10_20160915_00015.jpg

LM Start	2.88	Rating **	U	Issue No.	10
LM End	2.88	Issue Type +	Ma	Location *	LS
Category	Earthen Levee			GPS Latitude/Longitude	
				Start	End
Item	Trim / Thin Trees			38.322757 °	38.322757 °
				-121.590817 °	-121.590817 °
DWR ID	DWR_RD0999_03_f _ 2012_10				
Comment Code					
T3 : Trim and thin trees to allow visibility of the ground and room to flood fight.					
Inspector Comment					
Wild growth at landside slope and toe.

Looking northwest at dense vegetation on landward slope and toe.
(Spring 2016)

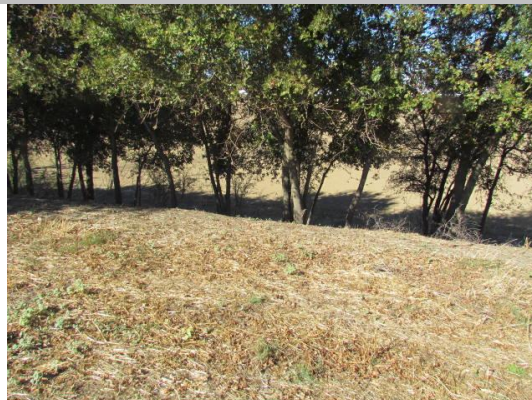
Photo 2 of 4 : FA_2016_RD0999_234_10_20160915_00016.jpg

Looking west at trimmed trees at landward toe. (Fall 2014)

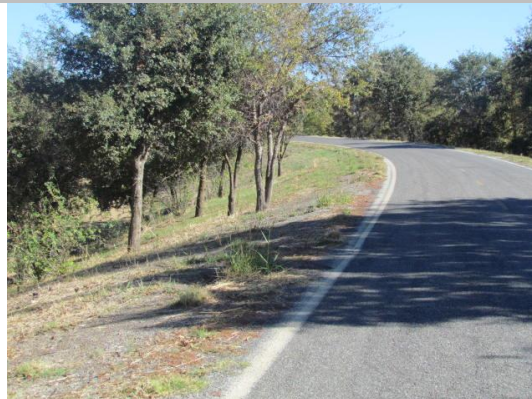
Photo 2 of 2 : FA_2016_RD0999_234_31_20160915_00034.jpg

LM Start	3.01	Rating **	U	Issue No.	31 (cont)
LM End	3.25	Issue Type +	Ma	Location *	LS
Category	Earthen Levee			GPS Latitude/Longitude	
				Start	End
Item	Trim / Thin Trees			38.323770 °	38.326061 °
				-121.589035 °	-121.586028 °
DWR ID	DWR_RD0999_03_s_2012_31				
Comment Code					
T3 : Trim and thin trees to allow visibility of the ground and room to flood fight.					
Inspector Comment

Looking north at trimmed trees on landward slope.

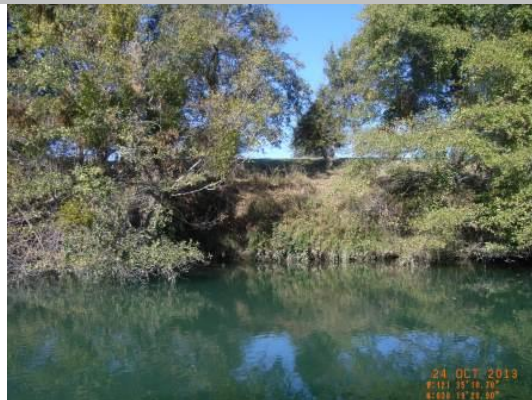
Photo 1 of 1 : FA_2016_RD0999_234_5_20160915_00009.jpg

LM Start	3.05	Rating **	M	Issue No.	5
LM End	3.23	Issue Type +	Ma	Location *	WS
Category	Supplemental			GPS Latitude/Longitude	
				Start	End
Item	2015 USACE Erosion Survey, DRAFT			38.323667 °	38.325592 °
				-121.588226 °	-121.585925 °
DWR ID	DWR_RD0999_03_s_2016_5				
Comment Code					
Inspector Comment					
2011 - Multiple erosion pockets. Some likely from tree popouts. 2013 - Tall vertical sections. 2015: New tree popout and significant new erosion. [2015 Site ID: STR_27-3_R]

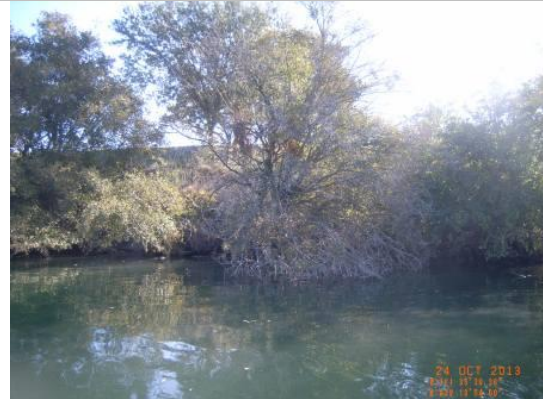
Photo 1 of 1 : FA_2016_RD0999_234_18_20160915_00024.jpg

2002 - Original rock over geotextile is sliding off and the end is coming unraveled. 2003 - Some minor new erosion on the downstream end. 2004 - Site has gotten worse. Underlined geofabric is exposed. 2005 - Still looks bad with exposed geotextile fabric. 2006 - Still have some new unraveling and exposed fabric. Site lengthened upstream. 2009 - Minimal new erosion. 2010 - geotextile fabric placed since last year, possible flood fight. 2012 - Exposed geotech style fabric, assume rock on top slid off. 2015: Erosion pockets covered with plastic. [2015 Site ID: STR_26-5_L]

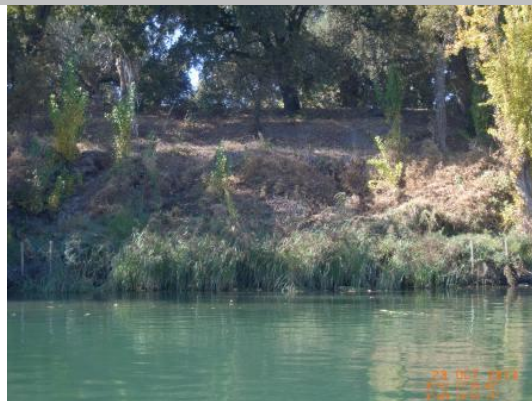
Photo 1 of 1 : FA_2016_RD0999_235_8_20160915_00007.jpg

LM Start	0.02	Rating **	M	Issue No.	8
LM End	0.28	Issue Type +	Ma	Location *	WS
Category	Supplemental			GPS Latitude/Longitude	
				Start	End
Item	2015 USACE Erosion Survey, DRAFT			38.414387 °	38.417692 °
				-121.522871 °	-121.525083 °
DWR ID	DWR_RD0999_04_s_2016_8				
Comment Code					
Inspector Comment					
1997 - Structural problem rather than erosional, failed cobble at downstream end. 2005 - New brush boxes at waterline for several hundred feet downstream, No toe or bank protection present. 2006 - Some minor new erosion. Brush boxes not working well; most of the brush has floated out. 2007 - Brush boxes have recently been repaired. 2015: No observed changes. [2015 Site ID: SAC 41-9 R]

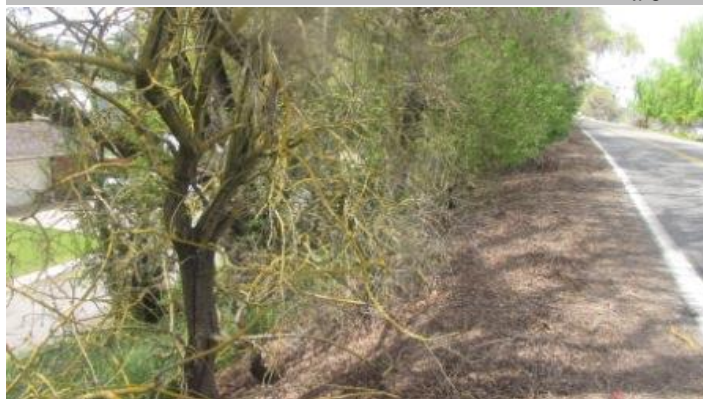
Photo 1 of 2 : FA_2016_RD0999_235_10_20160915_00008.jpg

LM Start	0.38	Rating **	M	Issue No.	10
LM End	0.50	Issue Type +	Ma	Location *	LS
Category	Earthen Levee		GPS Latitude/Longitude		
			Start	End	
Item	Trim / Thin Trees		38.418838 °	38.420447 °	
			-121.526225 °	-121.527380 °	
DWR ID	DWR_RD0999_04_s_2012_10				
Comment Code					
T1 : Trim trees to at least five feet above ground level.					
Inspector Comment

Looking northwest at dense trees on landside slope and toe.

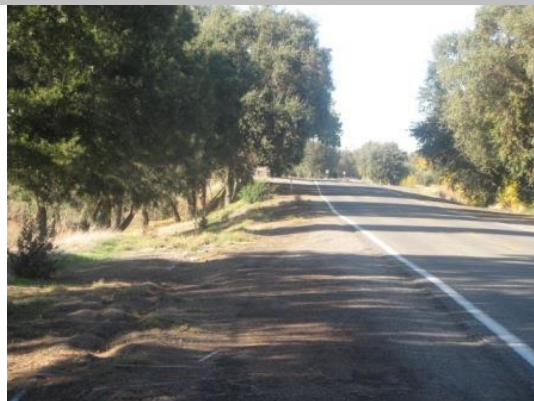
Photo 1 of 2 : FA_2016_RD0999_235_6_20160915_00005.jpg

LM Start	0.71	Rating **	A	Issue No.	6
LM End	0.87	Issue Type +	Ma	Location *	LS
Category	Earthen Levee			GPS Latitude/Longitude	
				Start	End
Item	Trim / Thin Trees			38.423035 °	38.425140 °
				-121.529255 °	-121.530742 °
DWR ID	DWR_RD0999_04_s_2012_6				
Comment Code					
T1 : Trim trees to at least five feet above ground level.					
Inspector Comment					
Acceptable vegetation

Looking north at trimmed trees and removed fence on landside slope.

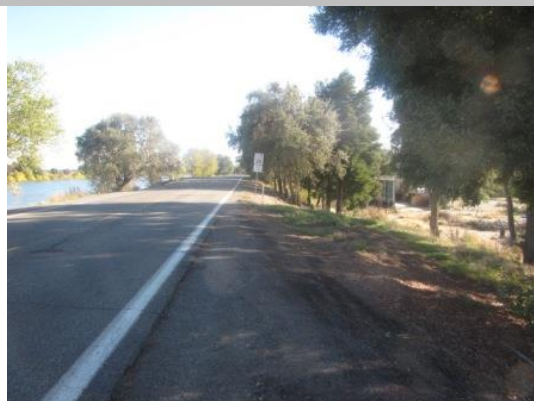
Photo 2 of 2 : FA_2016_RD0999_235_6_20160915_00006.jpg

Looking south at trimmed trees on landside slope and removed fence.

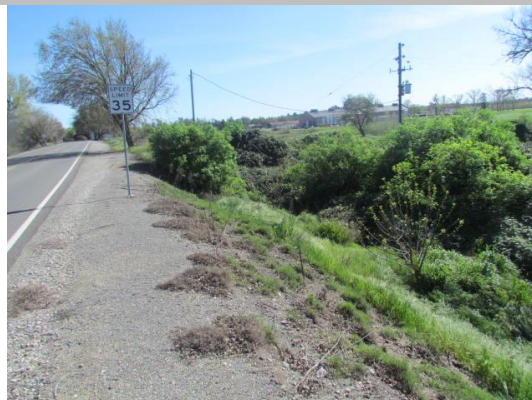
Photo 1 of 4 : FA_2016_RD0999_235_16_20160915_00015.jpg

LM Start	1.01	Rating **	U	Issue No.	16
LM End	1.04	Issue Type +	Ma	Location *	LS
Category	Earthen Levee			GPS Latitude/Longitude	
				Start	End
Item	Vegetation			38.426873 °	38.427295 °
				-121.531778 °	-121.532164 °
DWR ID	DWR_RD0999_04_f_2012_16				
Comment Code					
V2 : Remove the wild growth other than native grasses from the levee slopes.					
Inspector Comment					
Blackberries blocking view of landward toe.

Looking southwest at dense vegetation on landward slope and toe.
(Spring 2016)

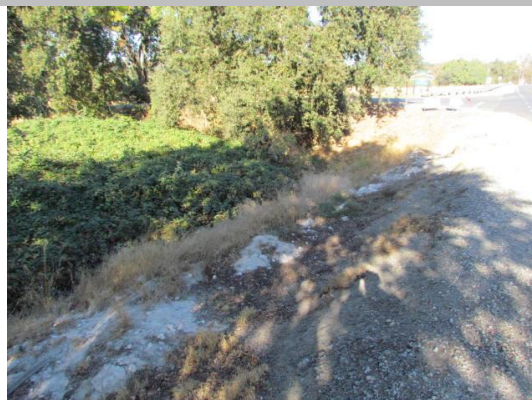
Photo 2 of 4 : FA_2016_RD0999_235_16_20160915_00016.jpg

Looking northwest at dense vines at landward toe. Fall 2015

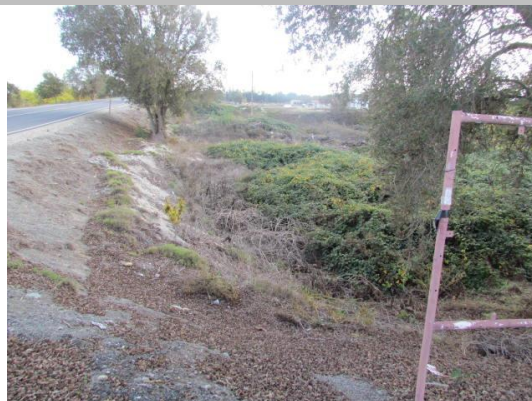
Photo 4 of 4 : FA_2016_RD0999_235_16_20160915_00018.jpg

LM Start	1.01	Rating **	U	Issue No.	16 (cont)	
LM End	1.04	Issue Type +	Ma	Location *	LS	
Category	Earthen Levee			GPS Latitude/Longitude		
				Start		End
Item	Vegetation			38.426873 °		38.427295 °
				-121.531778 °		-121.532164 °
DWR ID	DWR_RD0999_04_f_2012_16					
Comment Code						
V2 : Remove the wild growth other than native grasses from the levee slopes.						
Inspector Comment						
Blackberries blocking view of landward toe.

Looking south at dense berryvines on landside toe. 2012

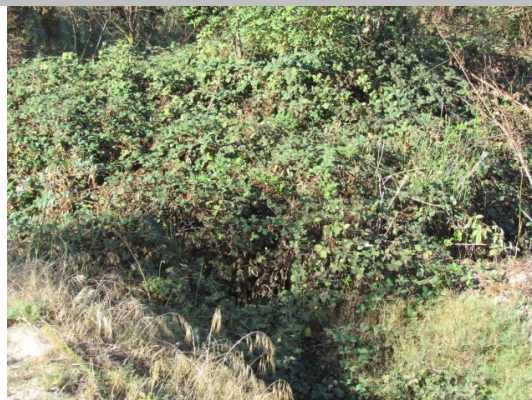
Photo 1 of 3 : FA_2016_RD0999_235_5_20160915_00002.jpg

LM Start	1.15	Rating **	U	Issue No.	5
LM End	1.15	Issue Type +	Ma	Location *	LS
Category	Earthen Levee			GPS Latitude/Longitude	
				Start	End
Item	Vegetation			38.428823 °	38.428823 °
				-121.532885 °	-121.532885 °
DWR ID	DWR_RD0999_04_s_2012_5				
Comment Code					
V2 : Remove the wild growth other than native grasses from the levee slopes.					
Inspector Comment					
Berry vines and wild roses on landside toe.

Looking at dense vines at landward toe. Fall 2015.

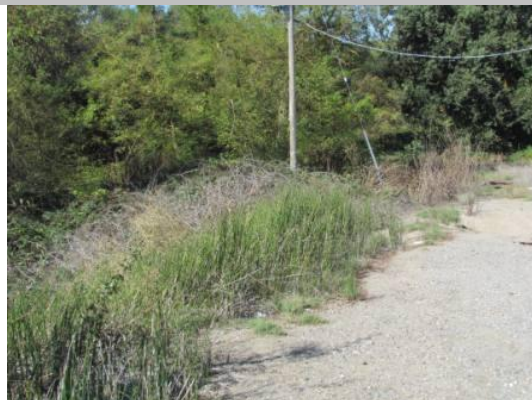
Photo 2 of 3 : FA_2016_RD0999_235_5_20160915_00003.jpg

Looking north at dense vegetation on landside slope near ramp.

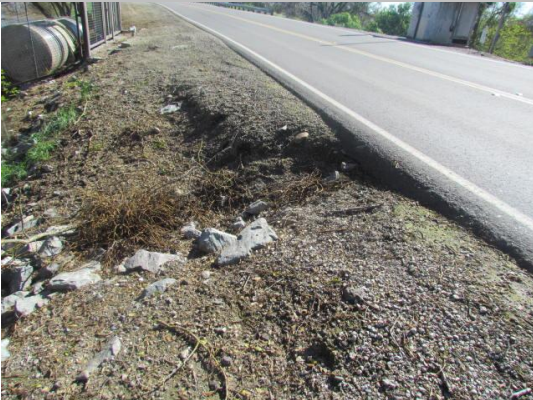
Photo 2 of 2 : FA_2016_RD0999_235_46_20160915_00035.jpg

LM Start	1.18	Rating **	U	Issue No.	46
LM End	1.18	Issue Type +	Ma	Location *	WS
Category	Earthen Levee			GPS Latitude/Longitude	
				Start	End
Item	Erosion / Bank Caving			38.429201 °	38.429201 °
				-121.533012 °	-121.533012 °
DWR ID	DWR_RD0999_04_s_2016_46				
Comment Code					
E2 : Schedule repair of erosion site prior to the next inspection.					
Inspector Comment					
Erosion located just below asphalt on waterward shoulder.

Looking south at foot erosion on waterward shoulder and slope.

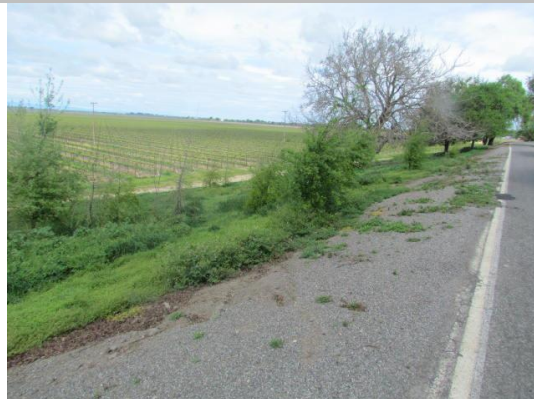
Photo 1 of 1 : FA_2016_RD0999_236_178_20160915_00129.jpg

LM Start	0.02	Rating **	M	Issue No.	178
LM End	0.05	Issue Type +	Ma	Location *	LS
Category	Earthen Levee			GPS Latitude/Longitude	
				Start	End
Item	Trim / Thin Trees			38.332946°	38.333308°
				-121.584502°	-121.584494°
DWR ID	DWR_RD0999_05_s_2015_178				
Comment Code					
T2 : Thin trees to allow visibility of the ground and room to flood fight.					
Inspector Comment					
Remove trees under an inch in diameter on landward slope. Don't allow young trees to get established.

Looking at typical view of young oak trees on landward slope. (Spring 2015)

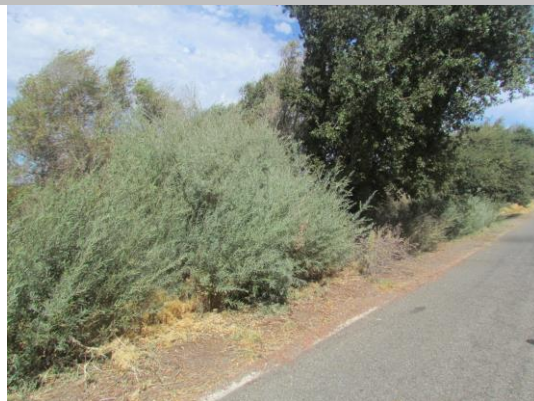
Photo 1 of 1 : FA_2016_RD0999_236_25_20160923_00223.jpg

LM Start	0.40	Rating **	U	Issue No.	25
LM End	0.44	Issue Type +	Ma	Location *	LS
Category	Earthen Levee			GPS Latitude/Longitude	
				Start	End
Item	Vegetation			38.338075 °	38.338688 °
				-121.582322 °	-121.582193 °
DWR ID	DWR_RD0999_05_s_2012_25				
Comment Code					
V2 : Remove the wild growth other than native grasses from the levee slopes.					
Inspector Comment					
Willows within vegetation area.

Looking southwest at dense vegetation (willows) on landward slope.

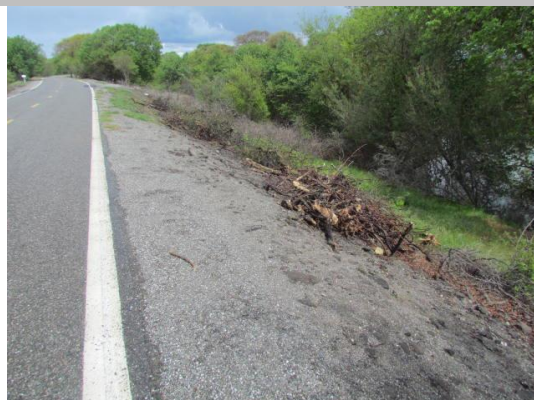
Photo 1 of 1 : FA_2016_RD0999_236_26_20160915_00030.jpg

LM Start	0.44	Rating **	A/W	Issue No.	26
LM End	0.45	Issue Type +	Ma	Location *	WS
Category	Earthen Levee			GPS Latitude/Longitude	
				Start	End
Item	Encroachments			38.338647 °	38.338868 °
				-121.582217 °	-121.582163 °
DWR ID	DWR_RD0999_05_s_2012_26				
Comment Code					
PR : Prunings					
Inspector Comment

Looking northeast at prunings on waterside slope.

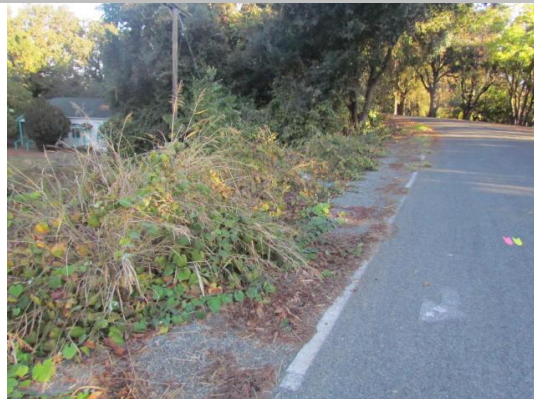
Photo 2 of 2 : FA_2016_RD0999_236_189_20160915_00132.jpg

LM Start	0.68	Rating **	U	Issue No.	189 (cont)	
LM End	0.68	Issue Type +	Ma	Location *	LS	
Category	Earthen Levee			GPS Latitude/Longitude		
				Start		End
Item	Vegetation			38.342032°		38.342032°
				-121.581372°		-121.581372°
DWR ID	DWR_RD0999_05_f_2014_189					
Comment Code						
V2 : Remove the wild growth other than native grasses from the levee slopes.						
Inspector Comment						
Dense wild grapevines on landward slope.

Looking northwest at dense vegetation on landward slope. (Spring 2016)

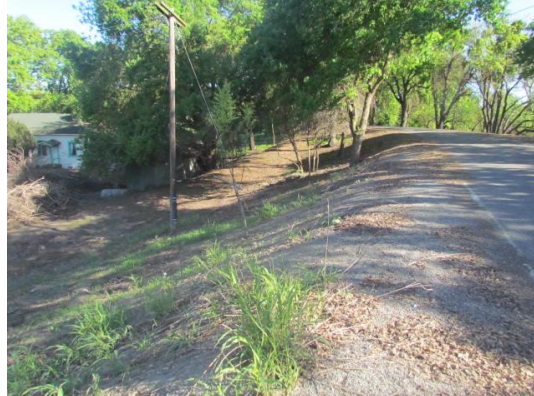
Photo 1 of 6 : FA_2016_RD0999_236_9_20160915_00007.jpg

LM Start	0.69	Rating **	A/W	Issue No.	9
LM End	0.71	Issue Type +	Ma	Location *	LS
Category	Earthen Levee			GPS Latitude/Longitude	
				Start	End
Item	Trim / Thin Trees			38.342180 °	38.342537 °
				-121.581230 °	-121.581263 °
DWR ID	DWR_RD0999_05_s_2012_9				
Comment Code					
T3 : Trim and thin trees to allow visibility of the ground and room to flood fight.					
Inspector Comment					
District or landowner trimmed trees to comply with standards.

Looking northwest at landward slope. (Spring 2015)

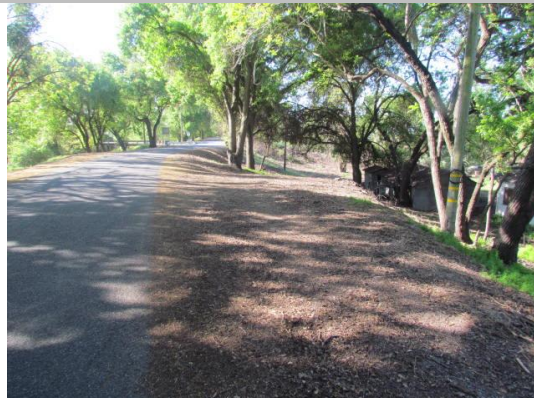
Photo 2 of 6 : FA_2016_RD0999_236_9_20160915_00008.jpg

Looking south at landward slope. (Spring 2015)
