**Flood Control Project Maintenance
Levee Inspections**

Maintenance Issue Types Only, Levee Inspection Report By Mile - Fall 2016

Reclamation District No. 0999 Netherlands

Waterway	Bank	Unit Miles	Inspection Start/End	Inspector
Unit No. 01 Yolo Bypass	Left	15.41	09/19/2016 09/20/2016	Richard Willoughby

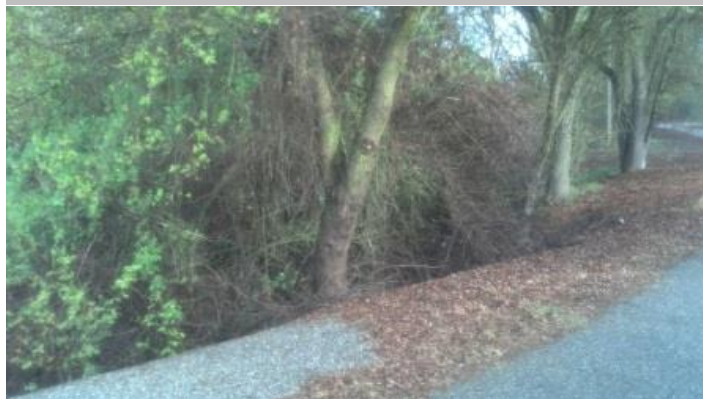
Photo 3 of 6 : FA_2016_RD0999_236_9_20160915_00009.jpg

LM Start	0.69	Rating **	A/W	Issue No.	9 (cont)	
LM End	0.71	Issue Type +	Ma	Location *	LS	
Category	Earthen Levee			GPS Latitude/Longitude		
				Start		End
Item	Trim / Thin Trees			38.342180°		38.342537°
				-121.581230°		-121.581263°
DWR ID	DWR_RD0999_05_s_2012_9					
Comment Code						
T3 : Trim and thin trees to allow visibility of the ground and room to flood fight.						
Inspector Comment						
District or landowner trimmed trees to comply with standards.

Looking northwest at dense trees at landside slope and toe. (Spring 2013)

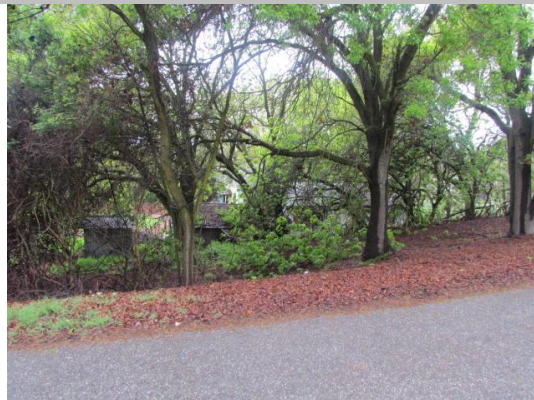
Photo 4 of 6 : FA_2016_RD0999_236_9_20160915_00010.jpg

Looking west at trimmed trees on landside slope. (Spring 2012)

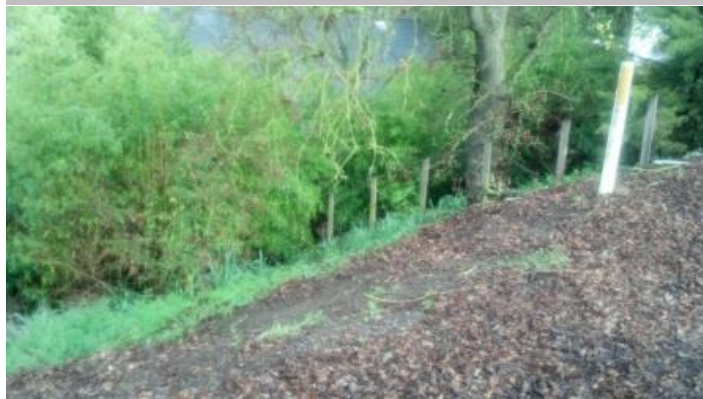
Photo 2 of 2 : FA_2016_RD0999_236_128_20160915_00095.jpg

LM Start	0.78	Rating **	M	Issue No.	128 (cont)	
LM End	0.78	Issue Type +	Ma	Location *	LS	
Category	Earthen Levee			GPS Latitude/Longitude		
				Start		End
Item	Trim / Thin Trees			38.343495 °		38.343495 °
				-121.581282 °		-121.581282 °
DWR ID	DWR_RD0999_05_s_2012_128					
Comment Code						
T3 : Trim and thin trees to allow visibility of the ground and room to flood fight.						
Inspector Comment

Looking at dense trees on landside slope and toe.

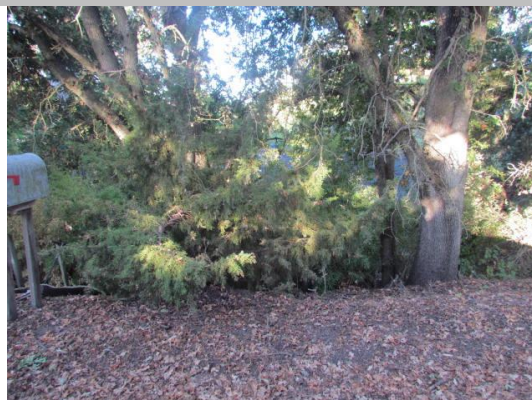
Photo 1 of 1 : FA_2016_RD0999_236_190_20160915_00133.jpg

LM Start	0.79	Rating **	U	Issue No.	190
LM End	0.79	Issue Type +	Ma	Location *	LS
Category	Earthen Levee			GPS Latitude/Longitude	
				Start	End
Item	Trim / Thin Trees			38.343606 °	38.343606 °
				-121.581279 °	-121.581279 °
DWR ID	DWR_RD0999_05_f_2014_190				
Comment Code					
T3 : Trim and thin trees to allow visibility of the ground and room to flood fight.					
Inspector Comment

Looking west at dense vegetation on landward slope and toe.

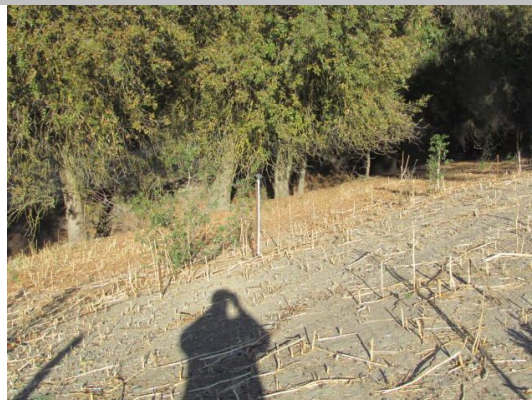
Photo 1 of 2 : FA_2016_RD0999_236_201_20160915_00141.jpg

LM Start	3.58	Rating **	M	Issue No.	201
LM End	3.64	Issue Type +	Ma	Location *	LS
Category	Earthen Levee			GPS Latitude/Longitude	
				Start	End
Item	Trim / Thin Trees			38.366103°	38.367035°
				-121.556820°	-121.556781°
DWR ID	DWR_RD0999_05_f_2014_201				
Comment Code					
T2 : Thin trees to allow visibility of the ground and room to flood fight.					
Inspector Comment					
Landowner has planted oak trees and installed sprinklers on landward slope. Oak trees should be removed.

Looking west a several small oak trees planted on landward slope.

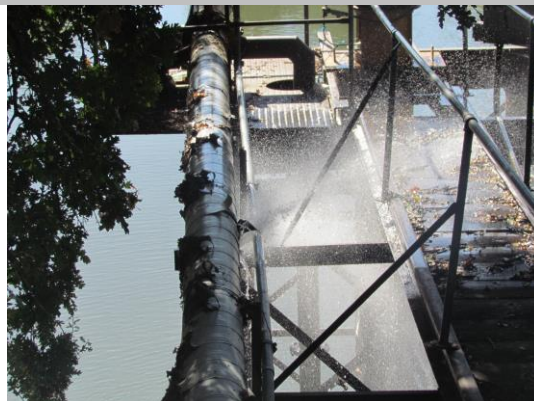
Photo 2 of 2 : FA_2016_RD0999_236_188_20160926_00231.jpg

LM Start	3.67	Rating **	U	Issue No.	188 (cont)	
LM End	3.67	Issue Type +	Ma	Location *	WS	
Category	Interior Drainage & Piping Systems			GPS Latitude/Longitude		
				Start		End
Item	Metal Pipes			38.367444 °		38.367444 °
				-121.556513 °		-121.556513 °
DWR ID	DWR_RD0999_05_f_2016_188					
Comment Code						
Inspector Comment						
Pipe leaking on waterside of levee.

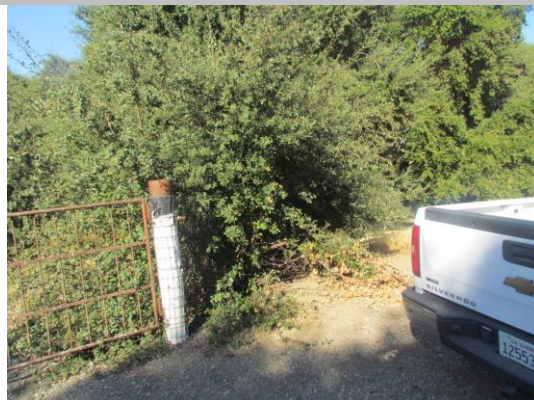
Photo 1 of 2 : FA_2016_RD0999_236_175_20160926_00233.jpg

LM Start	3.94	Rating **	U	Issue No.	175
LM End	3.94	Issue Type +	Ma	Location *	LS
Category	Earthen Levee			GPS Latitude/Longitude	
				Start	End
Item	Trim / Thin Trees			38.368928 °	38.368928 °
				-121.552473 °	-121.552473 °
DWR ID	DWR_RD0999_05_f_2015_175				
Comment Code					
T2 : Thin trees to allow visibility of the ground and room to flood fight.					
Inspector Comment					
Thin or remove young tree from landward shoulder and slope.

Looking west at untrimmed trees along fenceline on landward slope.
(Fall 2016)

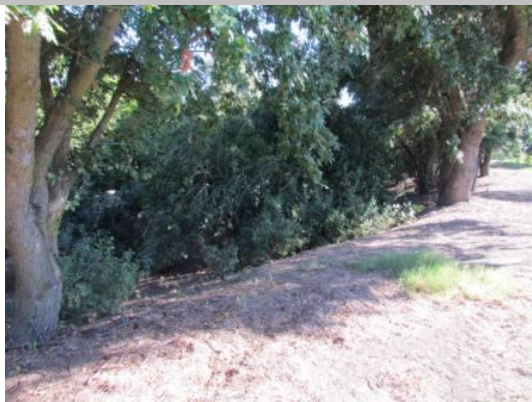
Photo 1 of 3 : FA_2016_RD0999_236_38_20160915_00036.jpg

Looking northwest at dense trees on landside slope. (Spring 2011)

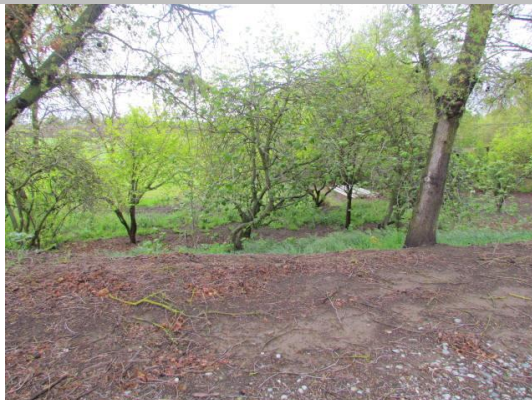
Photo 2 of 3 : FA_2016_RD0999_236_38_20160915_00037.jpg

Looking west at trimmed trees on landside slope. (Spring 2012)

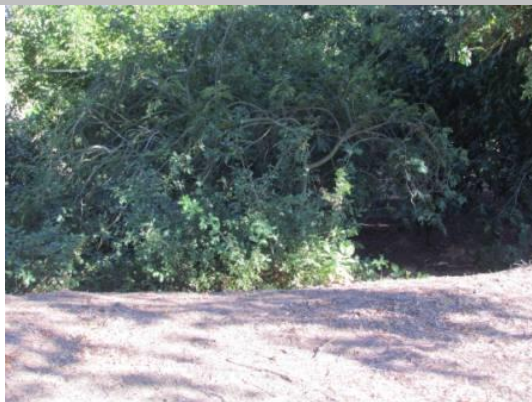
Photo 3 of 3 : FA_2016_RD0999_236_38_20160915_00038.jpg

Looking west at dense trees on landside slope. (Spring 2011)

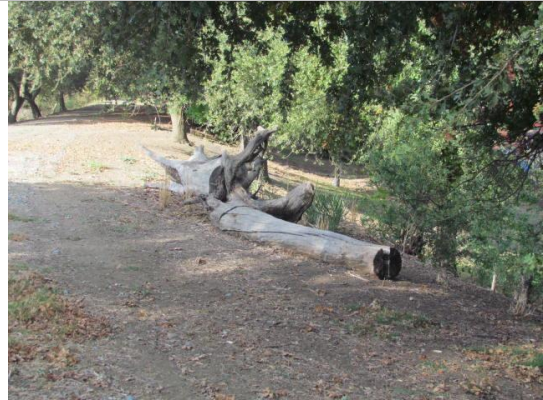
Photo 1 of 1 : FA_2016_RD0999_236_50_20160915_00052.jpg

LM Start	4.65	Rating **	A/W	Issue No.	50
LM End	4.65	Issue Type +	Ma	Location *	LS
Category	Earthen Levee			GPS Latitude/Longitude	
				Start	End
Item	Encroachments			38.375373 °	38.375373 °
				-121.546200 °	-121.546200 °
DWR ID	DWR_RD0999_05_s_2012_50				
Comment Code					
TR : Tree or limb					
Inspector Comment					
Old tree limbs on landward shoulder blocking access.

Looking southwest at tree limbs on landward shoulder.

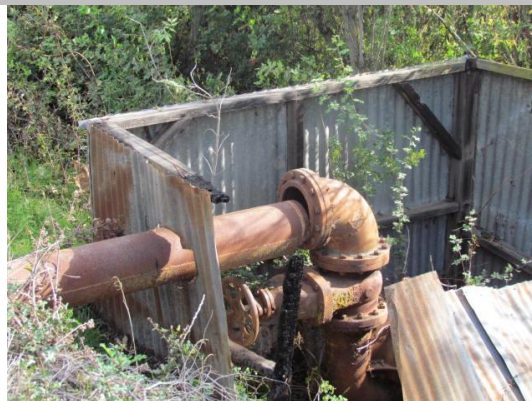
Photo 1 of 1 : FA_2016_RD0999_236_46_20160915_00049.jpg

LM Start	4.68	Rating **	M	Issue No.	46
LM End	4.68	Issue Type +	Ma	Location *	WS
Category	Earthen Levee			GPS Latitude/Longitude	
				Start	End
Item	Encroachments			38.375548 °	38.375548 °
				-121.545693 °	-121.545693 °
DWR ID	DWR_RD0999_05_f_2012_46				
Comment Code					
PI : Pipe					
Inspector Comment					
Pipe is disconnected from pump and should be reconnected or removed.

Looking east at pipe disconnected from pump.

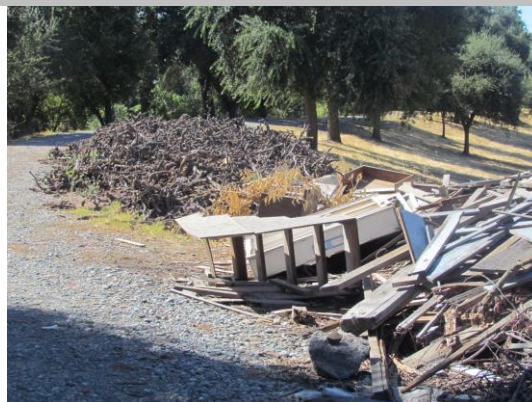
Photo 1 of 2 : FA_2016_RD0999_236_65_20160926_00235.jpg

LM Start	5.07	Rating **	U	Issue No.	65
LM End	5.07	Issue Type +	Ma	Location *	LS
Category	Earthen Levee			GPS Latitude/Longitude	
				Start	End
Item	Encroachments			38.379711 °	38.379711 °
				-121.541070 °	-121.541070 °
DWR ID	DWR_RD0999_05_s _ 2012_65				
Comment Code					
PR : Prunings					
Inspector Comment					
Prunings and garbage pile on landside shoulder and slope.

Looking south at prunings and garbage on landward shoulder and slope.
(Fall 2016)

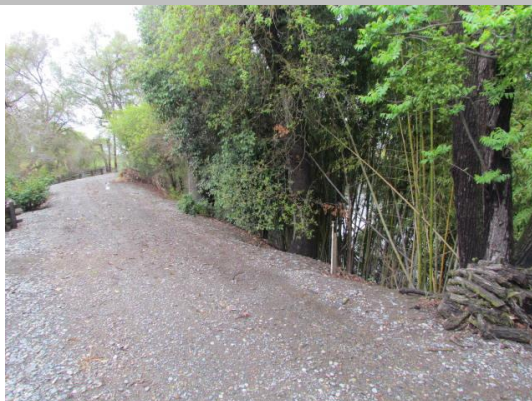
Photo 1 of 1 : FA_2016_RD0999_236_71_20160915_00068.jpg

LM Start	5.50	Rating **	U	Issue No.	71
LM End	5.55	Issue Type +	Ma	Location *	WS
Category	Earthen Levee			GPS Latitude/Longitude	
				Start	End
Item	Vegetation			38.382790 °	38.383548 °
				-121.546754 °	-121.546728 °
DWR ID	DWR_RD0999_05_s_2012_71				
Comment Code					
V2 : Remove the wild growth other than native grasses from the levee slopes.					
Inspector Comment

Looking northeast at dense vegetation on waterside slope.

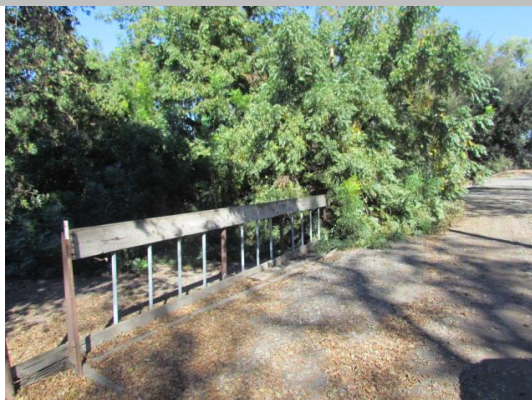
Photo 1 of 1 : FA_2016_RD0999_236_203_20160915_00144.jpg

LM Start	5.56	Rating **	A/W	Issue No.	203
LM End	5.61	Issue Type +	Ma	Location *	LS
Category	Earthen Levee			GPS Latitude/Longitude	
				Start	End
Item	Trim / Thin Trees			38.383740 °	38.384218 °
				-121.546628 °	-121.546095 °
DWR ID	DWR_RD0999_05_f_2014_203				
Comment Code					
T1 : Trim trees to at least five feet above ground level.					
Inspector Comment

Looking at untrimmed trees on landward slope and toe.

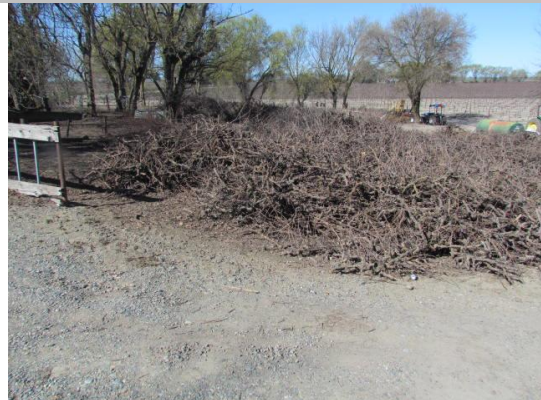
Photo 1 of 1 : FA_2016_RD0999_236_192_20160915_00134.jpg

LM Start	5.58	Rating **	A/W	Issue No.	192
LM End	5.58	Issue Type +	Ma	Location *	LS
Category	Earthen Levee			GPS Latitude/Longitude	
				Start	End
Item	Encroachments			38.383978 °	38.383978 °
				-121.546435 °	-121.546435 °
DWR ID	DWR_RD0999_05_s_2014_192				
Comment Code					
PR : Prunings					
Inspector Comment					
Landowner pile prunings on landside slope.

Looking west at prunings on landward slope and toe.

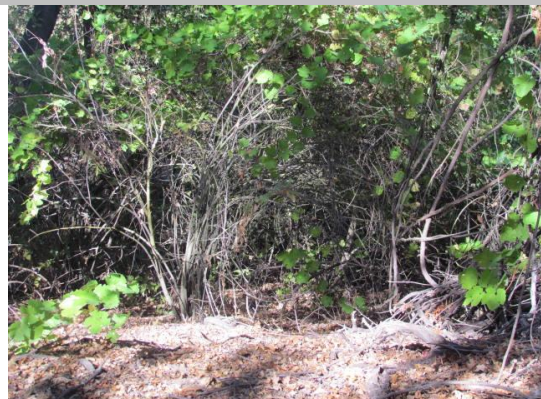
Photo 1 of 2 : FA_2016_RD0999_236_48_20160915_00050.jpg

LM Start	5.80	Rating **	A/W	Issue No.	48
LM End	5.84	Issue Type +	Ma	Location *	LS
Category	Earthen Levee			GPS Latitude/Longitude	
				Start	End
Item	Vegetation			38.384718 °	38.384930 °
				-121.542590 °	-121.541883 °
DWR ID	DWR_RD0999_05_s_2012_48				
Comment Code					
V2 : Remove the wild growth other than native grasses from the levee slopes.					
Inspector Comment					
Dense vegetation at landward slope and toe.

Looking west at dense vegetation on landward slope and toe. Fall 2015

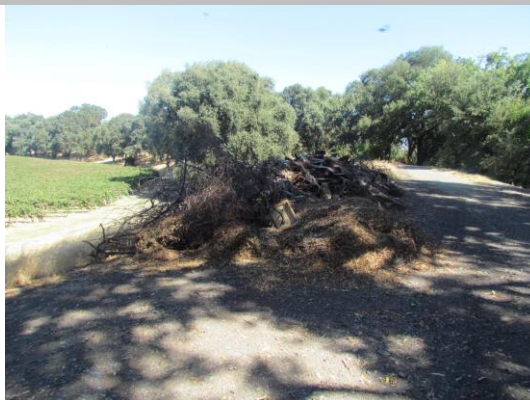
Photo 1 of 1 : FA_2016_RD0999_236_92_20160926_00238.jpg

LM Start	6.48	Rating **	U	Issue No.	92
LM End	6.48	Issue Type +	Ma	Location *	LS
Category	Earthen Levee			GPS Latitude/Longitude	
				Start	End
Item	Encroachments			38.391776 °	38.391776 °
				-121.539295 °	-121.539295 °
DWR ID	DWR_RD0999_05_s_2012_92				
Comment Code					
PR : Prunings					
Inspector Comment

Looking east at pruning pile on landward shoulder and slope.

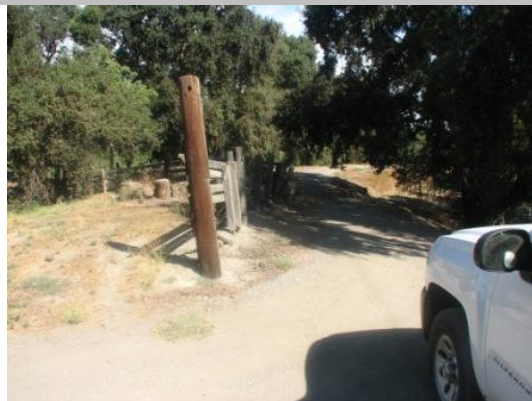
Photo 1 of 4 : FA_2016_RD0999_236_96_20160915_00083.jpg

LM Start	6.73	Rating **	M	Issue No.	96
LM End	6.73	Issue Type +	Ma	Location *	LS
Category	Earthen Levee			GPS Latitude/Longitude	
				Start	End
Item	Encroachments			38.395234 °	38.395234 °
				-121.539323 °	-121.539323 °
DWR ID	DWR_RD0999_05_s_2012_96				
Comment Code					
MA : Material					
Inspector Comment					
Firewood and other material on landside shoulder.

Fence, firewood and material at landside shoulder.

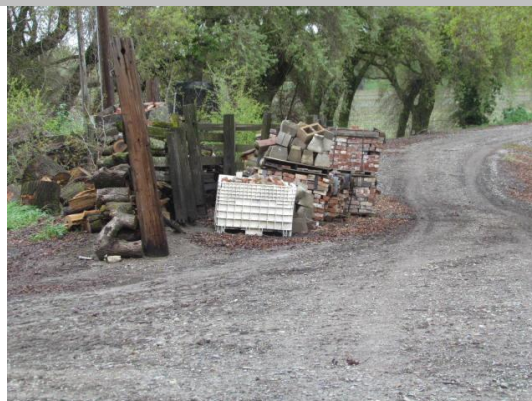
Photo 2 of 4 : FA_2016_RD0999_236_96_20160915_00084.jpg

Looking northeast at firewood and other material on landside shoulder.
(Spring 2012)

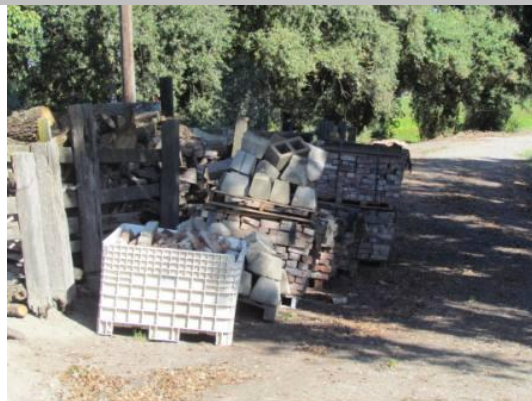
Photo 4 of 4 : FA_2016_RD0999_236_96_20160915_00086.jpg

LM Start	6.73	Rating **	M	Issue No.	96 (cont)	
LM End	6.73	Issue Type +	Ma	Location *	LS	
Category	Earthen Levee			GPS Latitude/Longitude		
				Start		End
Item	Encroachments			38.395234 °		38.395234 °
				-121.539323 °		-121.539323 °
DWR ID	DWR_RD0999_05_s_2012_96					
Comment Code						
MA : Material						
Inspector Comment						
Firewood and other material on landside shoulder.

Looking north at firewood and other material on landside shoulder and crown.

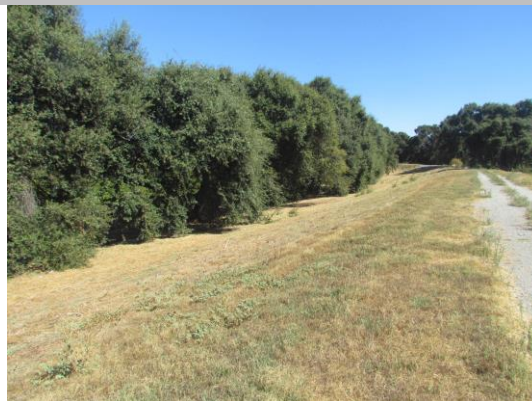
Photo 1 of 1 : FA_2016_RD0999_236_204_20160926_00239.jpg

LM Start	6.85	Rating **	U	Issue No.	204
LM End	7.49	Issue Type +	Ma	Location *	LS
Category	Earthen Levee			GPS Latitude/Longitude	
				Start	End
Item	Trim / Thin Trees			38.396379 °	38.403600 °
				-121.537814 °	-121.540311 °
DWR ID	DWR_RD0999_05_f_2014_204				
Comment Code					
T1 : Trim trees to at least five feet above ground level.					
Inspector Comment					
Trees at landward toe blocking visibility.

Looking northwest at dense trees at landward toe.

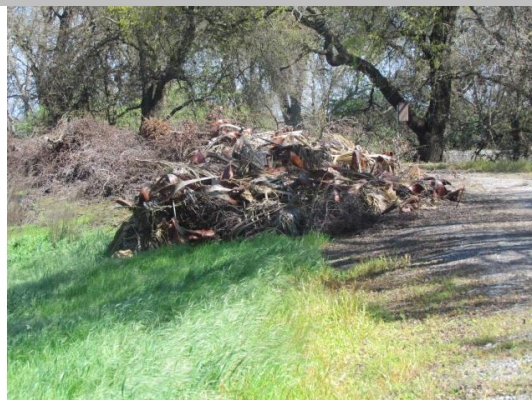
Photo 1 of 1 : FA_2016_RD0999_236_142_20160915_00104.jpg

LM Start	6.95	Rating **	A/W	Issue No.	142
LM End	6.95	Issue Type +	Ma	Location *	LS
Category	Earthen Levee			GPS Latitude/Longitude	
				Start	End
Item	Encroachments			38.396958 °	38.396958 °
				-121.536148 °	-121.536148 °
DWR ID	DWR_RD0999_05_s_2013_142				
Comment Code					
PR : Prunings					
Inspector Comment					
Large pruning pile on landward shoulder and slope.

Looking northeast at prunings on landward shoulder.

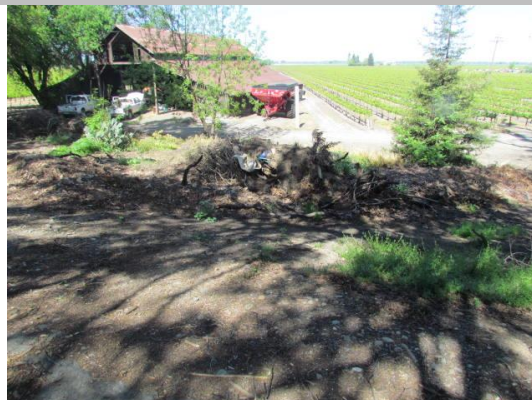
Photo 1 of 1 : FA_2016_RD0999_236_185_20160915_00130.jpg

LM Start	8.03	Rating **	A/W	Issue No.	185
LM End	8.03	Issue Type +	Ma	Location *	LS
Category	Earthen Levee			GPS Latitude/Longitude	
				Start	End
Item	Encroachments			38.409324 °	38.409324 °
				-121.541223 °	-121.541223 °
DWR ID	DWR_RD0999_05_s_2015_185				
Comment Code					
PR : Prunings					
Inspector Comment					
Garbage within prunings piles.

Looking west at pruning piles on landward slope. (Spring 2015)

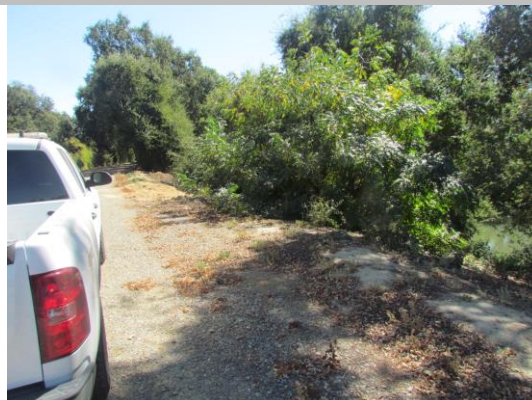
Photo 1 of 1 : FA_2016_RD0999_236_118_20160926_00241.jpg

LM Start	8.22	Rating **	U	Issue No.	118
LM End	8.22	Issue Type +	Ma	Location *	WS
Category	Earthen Levee			GPS Latitude/Longitude	
				Start	End
Item	Trim / Thin Trees			38.409665 °	38.409665 °
				-121.537898 °	-121.537898 °
DWR ID	DWR_RD0999_05_s_2012_118				
Comment Code					
T1 : Trim trees to at least five feet above ground level.					
Inspector Comment

Looking northeast at untrimmed trees on watward slope.

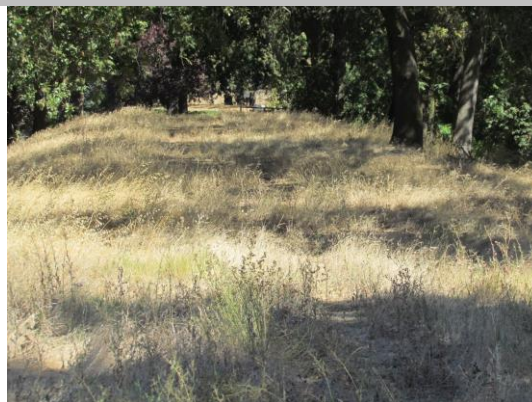
Photo 1 of 1 : FA_2016_RD0999_236_223_20160926_00248.jpg

LM Start	8.64	Rating **	M	Issue No.	223
LM End	8.72	Issue Type +	Ma	Location *	CR
Category	Earthen Levee			GPS Latitude/Longitude	
				Start	End
Item	Vegetation			38.410696 °	38.411560 °
				-121.531584 °	-121.530479 °
DWR ID	DWR_RD0999_05_f_2016_223				
Comment Code					
V9 : Keep the crown roadway free of vegetation.					
Inspector Comment					
Control growth on levee crown

Looking east at overgrowth on levee crown.
