**Flood Control Project Maintenance
Levee Inspections**

Maintenance Issue Types Only, Levee Inspection Report By Mile - Fall 2017

Reclamation District No. 0999 Netherlands

Waterway	Bank	Unit Miles	Inspection Start/End	Inspector
Unit No. 01 Yolo Bypass	Left	15.41	10/10/2017 10/10/2017	Dave Torres

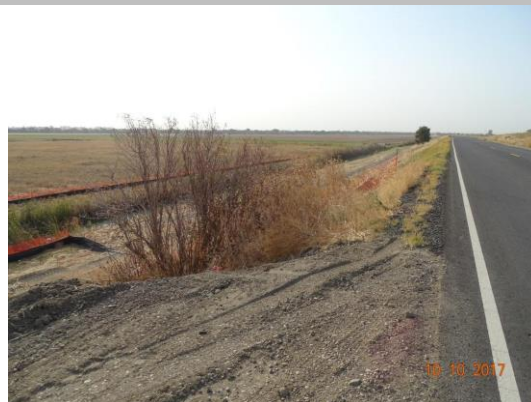
Photo 1 of 1 : FA_2017_RD0999_232_3_20171016_00125.jpg

LM Start	0.27	Rating **	M	Issue No.	3
LM End	0.27	Issue Type +	Ma	Location *	LS
Category	Earthen Levee			GPS Latitude/Longitude	
				Start	End
Item	Vegetation			38.501113 °	38.501113 °
				-121.581975 °	-121.581975 °
DWR ID	DWR_RD0999_01_s_2012_3				
Comment Code					
V4 : Elderberries are blocking visibility and flood fight capability.					
Inspector Comment

View of landside slope looking south.

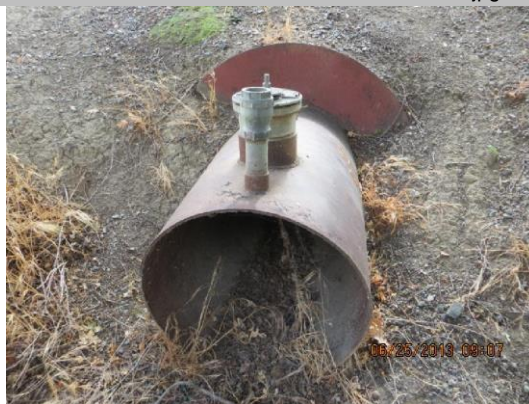
Photo 1 of 3 : UCIP_FA_2017_50092_25191.jpg

FS_ID:50092
DS_ID:22743
EP_NO: N/A
Repair Type: Urgent
Crossing Status: Found
UCIP Comments: 07/07/2016 Condition largely unchanged from previous inspection. Pipe open on the WS, waterward of the siphon breaker. Dense vegetation and steep slope limited inspection of WS outlet into Ship Channel. (T. Hatch/UCIP)
06/25/2013 Pipe abandoned and open on WS slope. Pipe should be abandoned properly. (W. Wylie/UCIP)
FIELD_STRUCT_DESC: *ABANDONED* 30-inch steel drainage pipe through the levee, 6.5 feet below the crown. Pump on a platform in the canal off the landside (LS) toe, not found. Flap gate on the waterside (WS), not found. Siphon breaker and an air vent on the WS shoulder. 1-inch galvanized iron filler pipe visible on the WS shoulder along same alignment. [Additional Reference(s): DWR Levee Log, 1992. USACE Sacramento O&M Manual 113 (Revised), October 1966, (HLM 1.73)].
FS Date: 7/7/2016

Pipe open on WS slope

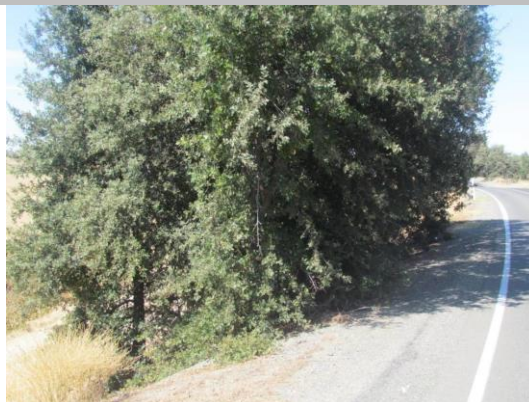
Photo 1 of 2 : FA_2017_RD0999_232_7_20171010_00016.jpg

Looking north at untrimmed trees on waterward slope. (Fall 2016)

LM Start	2.13	Rating **	U	Issue No.	7
LM End	2.13	Issue Type +	Ma	Location *	WS
Category	Earthen Levee			GPS Latitude/Longitude	
				Start	End
Item	Trim / Thin Trees			38.474258 °	38.474258 °
				-121.580528 °	-121.580528 °
DWR ID	DWR_RD0999_01_s_2012_7				
Comment Code					
T1 : Trim trees to at least five feet above ground level.					
Inspector Comment

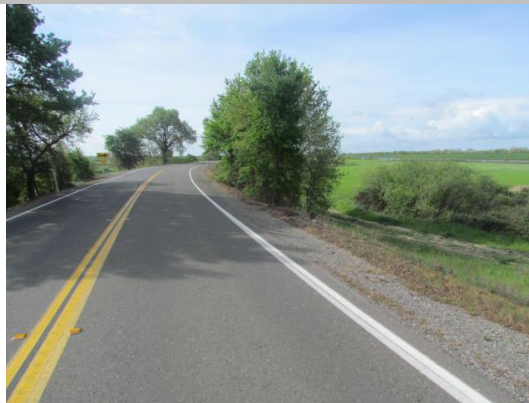
Photo 2 of 2 : FA_2017_RD0999_232_7_20171010_00017.jpg

Looking south at untrimmed trees on waterward slope. (Spring 2016)

LM Start	2.13	Rating **	U	Issue No.	7 (cont)	
LM End	2.13	Issue Type +	Ma	Location *	WS	
Category	Earthen Levee			GPS Latitude/Longitude		
				Start		End
Item	Trim / Thin Trees			38.474258 °		38.474258 °
				-121.580528 °		-121.580528 °
DWR ID	DWR_RD0999_01_s_2012_7					
Comment Code						
T1 : Trim trees to at least five feet above ground level.						
Inspector Comment

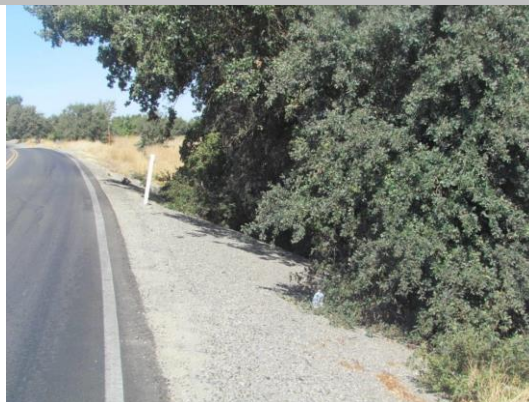
Photo 1 of 2 : FA_2017_RD0999_232_31_20171010_00030.jpg

Looking north at untrimmed trees on landward slope. (Fall 2016)

LM Start	2.13	Rating **	U	Issue No.	31
LM End	2.13	Issue Type +	Ma	Location *	LS
Category	Earthen Levee			GPS Latitude/Longitude	
				Start	End
Item	Trim / Thin Trees			38.474200 °	38.474200 °
				-121.580480 °	-121.580480 °
DWR ID	DWR_RD0999_01_s_2012_31				
Comment Code					
T1 : Trim trees to at least five feet above ground level.					
Inspector Comment

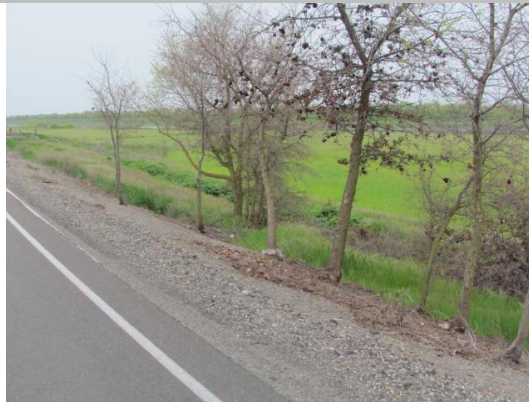
Photo 1 of 1 : FA_2017_RD0999_232_8_20171010_00018.jpg

Looking southwest at trimmed trees on waterside slope. (Spring 2012)

LM Start	2.18	Rating **	M	Issue No.	8
LM End	2.19	Issue Type +	Ma	Location *	WS
Category	Earthen Levee			GPS Latitude/Longitude	
				Start	End
Item	Trim / Thin Trees			38.473542 °	38.473417 °
				-121.580793 °	-121.580885 °
DWR ID	DWR_RD0999_01_s_2012_8				
Comment Code					
T2 : Thin trees to allow visibility of the ground and room to flood fight.					
Inspector Comment

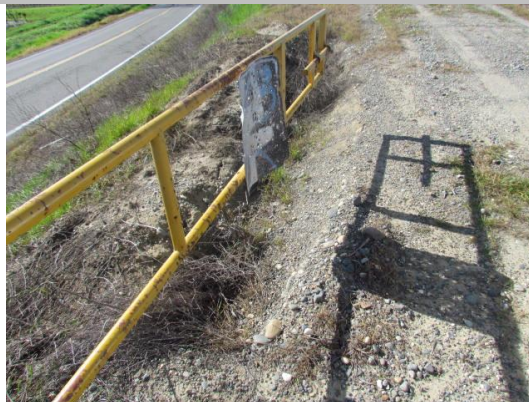
Photo 1 of 4 : FA_2017_RD0999_232_40_20171010_00038.jpg

LM Start	2.51	Rating **	M	Issue No.	40
LM End	2.51	Issue Type +	Ma	Location *	LS
Category	Earthen Levee			GPS Latitude/Longitude	
				Start	End
Item	Encroachments			38.469048 °	38.469048 °
				-121.583075 °	-121.583075 °
DWR ID	DWR_RD0999_01_s_2012_40				
Comment Code					
MA : Material					
Inspector Comment					
Excavation activity on landside shoulder. Hole is approximately 15ft x 12" x 15". Hole appears to be excavated by a backhoe.

Looking south at trench along landward shoulder. (spring 2016)

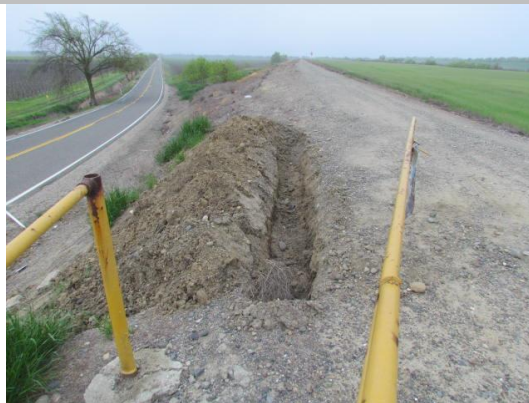
Photo 2 of 4 : FA_2017_RD0999_232_40_20171010_00039.jpg

LM Start	2.51	Rating **	M	Issue No.	40 (cont)	
LM End	2.51	Issue Type +	Ma	Location *	LS	
Category	Earthen Levee			GPS Latitude/Longitude		
				Start	End	
Item	Encroachments			38.469048 °	38.469048 °	
				-121.583075 °	-121.583075 °	
DWR ID	DWR_RD0999_01_s_2012_40					
Comment Code						
MA : Material						
Inspector Comment						
Excavation activity on landside shoulder. Hole is approximately 15ft x 12" x 15". Hole appears to be excavated by a backhoe.

Looking south at excavation on landside shoulder.

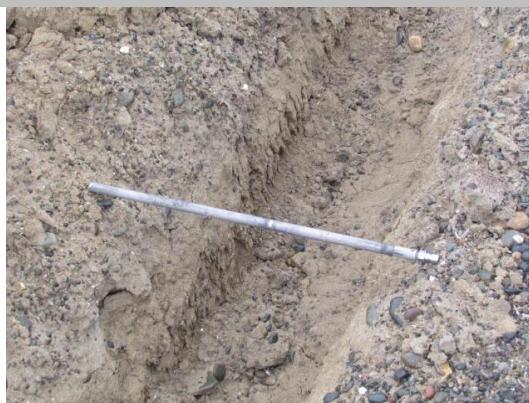
Photo 3 of 4 : FA_2017_RD0999_232_40_20171010_00040.jpg

Looking south at close-up view of excavation on landside shoulder.

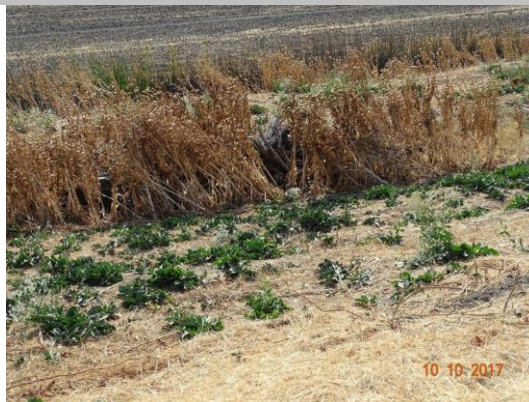
Photo 1 of 3 : FA_2017_RD0999_232_41_20171016_00132.jpg

LM Start	6.56	Rating **	M	Issue No.	41	
LM End	6.59	Issue Type +	Ma	Location *	LS	
Category	Earthen Levee			GPS Latitude/Longitude		
				Start		End
Item	Encroachments			38.413856 °		38.413475 °
				-121.608635 °		-121.608817 °
DWR ID	DWR_RD0999_01_s_2016_41					
Comment Code						
PR : Prunings						
Inspector Comment						
Pruning piles on landward toe.

View of landside slope looking southwest.

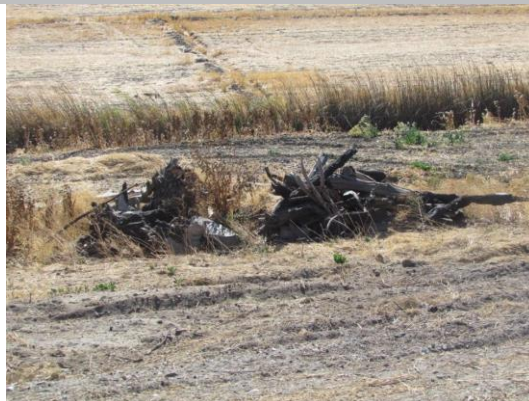
Photo 3 of 3 : FA_2017_RD0999_232_41_20171010_00042.jpg

LM Start	6.56	Rating **	M	Issue No.	41 (cont)	
LM End	6.59	Issue Type +	Ma	Location *	LS	
Category	Earthen Levee			GPS Latitude/Longitude		
				Start		End
Item	Encroachments			38.413856 °		38.413475 °
				-121.608635 °		-121.608817 °
DWR ID	DWR_RD0999_01_s_2016_41					
Comment Code						
PR : Prunings						
Inspector Comment						
Pruning piles on landward toe.

Looking east at prunings at landward toe and berm. (Fall 2016)

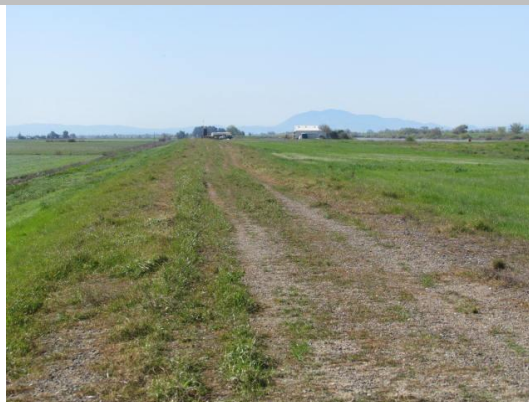
Photo 1 of 2 : FA_2017_RD0999_232_22_20171010_00019.jpg

LM Start	7.13	Rating **	M	Issue No.	22
LM End	9.67	Issue Type +	Ma	Location *	CR
Category	Earthen Levee			GPS Latitude/Longitude	
				Start	End
Item	Crown Surface / Depressions / Rutting			38.406130 °	38.371621 °
				-121.612211 °	-121.628232 °
DWR ID	DWR_RD0999_01_s_2012_22				
Comment Code					
C3 : Add appropriate gravel or road base. Grade and compact.					
Inspector Comment					
Also control growth on levee crown. LMA has controlled growth on portions of the crown but still need to add appropriate road base.

Looking south at levee crown. (Spring 2016)

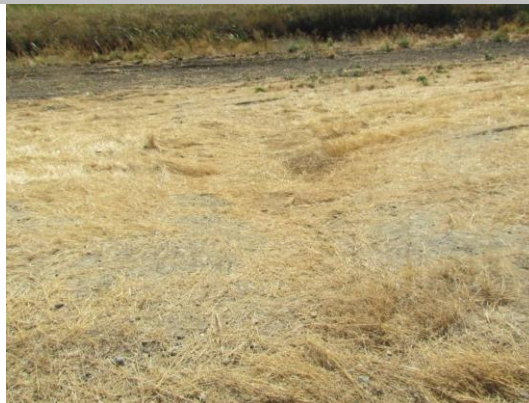
Photo 1 of 2 : FA_2017_RD0999_232_58_20171010_00065.jpg

LM Start	7.61	Rating **	M	Issue No.	58
LM End	7.61	Issue Type +	Ma	Location *	LS
Category	Earthen Levee			GPS Latitude/Longitude	
				Start	End
Item	Erosion / Bank Caving			38.399600 °	38.399600 °
				-121.615224 °	-121.615224 °
DWR ID	DWR_RD0999_01_f_2016_58				
Comment Code					
Inspector Comment					
Depression 10' by 20' on landward slope.

Looking northeast at depression on landward slope.

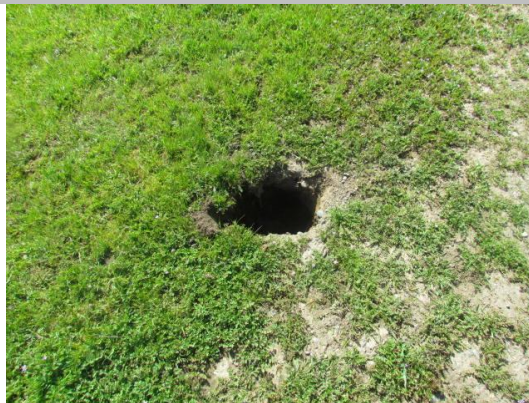
Photo 1 of 5 : FA_2017_RD0999_232_2_20171010_00006.jpg

LM Start	9.95	Rating **	M	Issue No.	2
LM End	9.95	Issue Type +	Ma	Location *	LS
Category	Earthen Levee			GPS Latitude/Longitude	
				Start	End
Item	Animal Control			38.367750 °	38.367750 °
				-121.630025 °	-121.630025 °
DWR ID	DWR_RD0999_01_s_2012_2				
Comment Code					
A3 : No rodents visible, but rodent burrows visible; need to backfill and compact or grout burrows.					
Inspector Comment					
Several large rodent holes on landward shoulder. Rodent holes exists no active rodents identified.

Looking southeast at large rodent hole on landward shoulder. (Spring 2016)

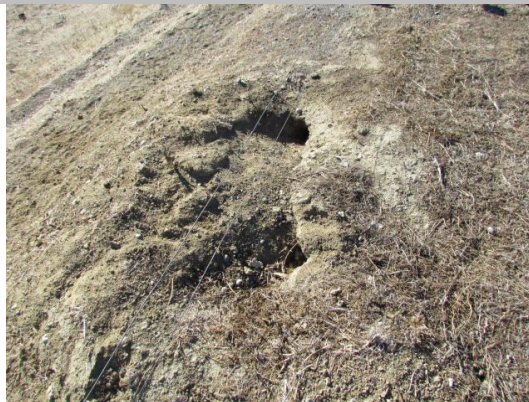
Photo 2 of 5 : FA_2017_RD0999_232_2_20171010_00007.jpg

Looking southeast at rodent holes on landward shoulder fall 2015.

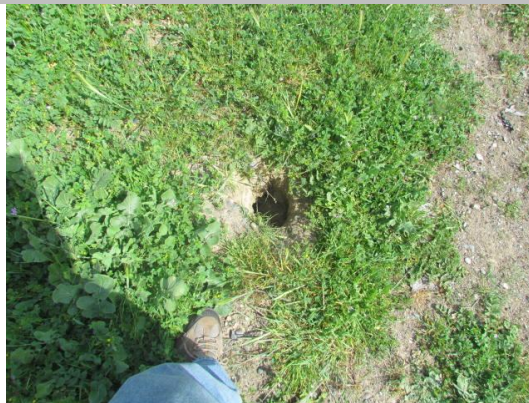
Photo 4 of 5 : FA_2017_RD0999_232_2_20171010_00009.jpg

LM Start	9.95	Rating **	M	Issue No.	2 (cont)	
LM End	9.95	Issue Type +	Ma	Location *	LS	
Category	Earthen Levee			GPS Latitude/Longitude		
				Start		End
Item	Animal Control			38.367750 °		38.367750 °
				-121.630025 °		-121.630025 °
DWR ID	DWR_RD0999_01_s_2012_2					
Comment Code						
A3 : No rodents visible, but rodent burrows visible; need to backfill and compact or grout burrows.						
Inspector Comment						
Several large rodent holes on landward shoulder. Rodent holes exists no active rodents identified.

Looking at typical rodent holes on landward shoulder. (Spring 2015)

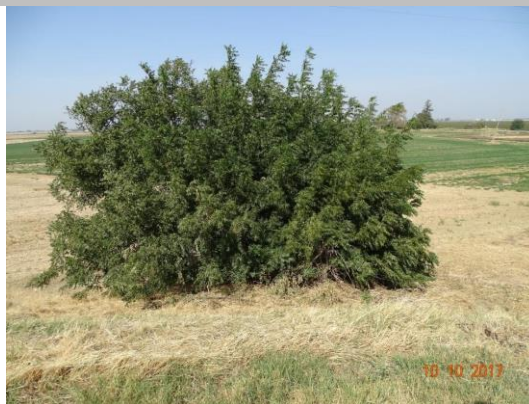
Photo 1 of 3 : FA_2017_RD0999_233_37_20171016_00049.jpg

View of landside slope looking north.

LM Start	0.73	Rating **	U	Issue No.	37
LM End	0.73	Issue Type +	Ma	Location *	LS
Category	Earthen Levee			GPS Latitude/Longitude	
				Start	End
Item	Trim / Thin Trees			38.292783 °	38.292783 °
				-121.632317 °	-121.632317 °
DWR ID	DWR_RD0999_02_s_2014_37				
Comment Code					
T1 : Trim trees to at least five feet above ground level.					
Inspector Comment

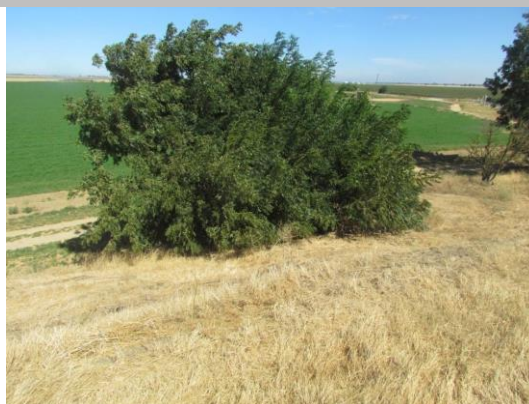
Photo 2 of 3 : FA_2017_RD0999_233_37_20170919_00021.jpg

Looking at untrimmed tree on landward slope and toe. (Fall 2016)

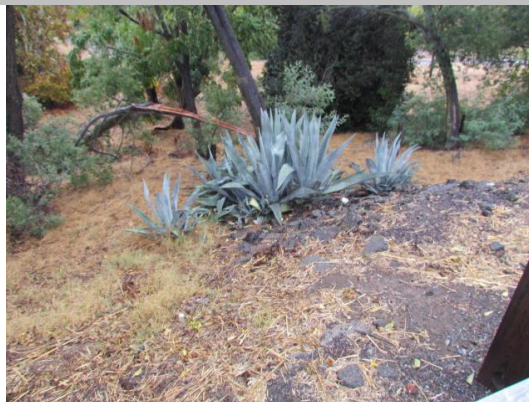
Photo 1 of 2 : FA_2017_RD0999_233_14_20170919_00011.jpg

LM Start	0.82	Rating **	M	Issue No.	14
LM End	0.82	Issue Type +	Ma	Location *	LS
Category	Earthen Levee			GPS Latitude/Longitude	
				Start	End
Item	Vegetation			38.292439 °	38.292439 °
				-121.630781 °	-121.630781 °
DWR ID	DWR_RD0999_02_f_2012_14				
Comment Code					
V2 : Remove the wild growth other than native grasses from the levee slopes.					
Inspector Comment					
Century plant on landside slope.

Looking north at century plant at landward toe fall 2015.

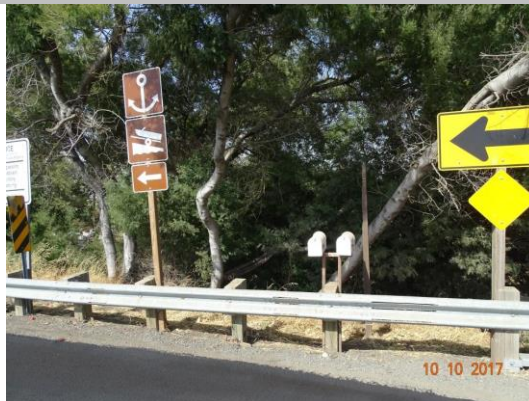
Photo 1 of 2 : FA_2017_RD0999_233_19_20171016_00050.jpg

View of landside slope looking north.

LM Start	0.83	Rating **	M	Issue No.	19
LM End	0.83	Issue Type +	Ma	Location *	LS
Category	Earthen Levee			GPS Latitude/Longitude	
				Start	End
Item	Trim / Thin Trees			38.292386 °	38.292386 °
				-121.630543 °	-121.630543 °
DWR ID	DWR_RD0999_02_f_2012_19				
Comment Code					
T2 : Thin trees to allow visibility of the ground and room to flood fight.					
Inspector Comment

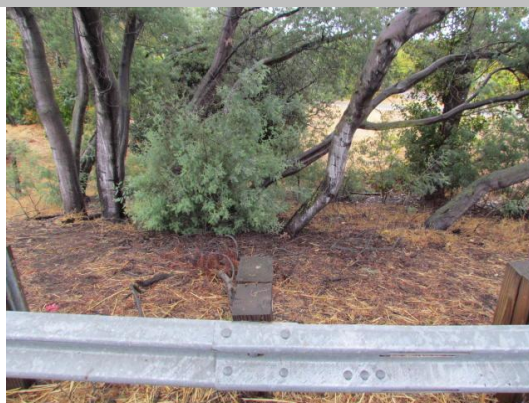
Photo 2 of 2 : FA_2017_RD0999_233_19_20170919_00015.jpg

Looking north at untrimmed trees to be thinned at landward toe fall 2015.

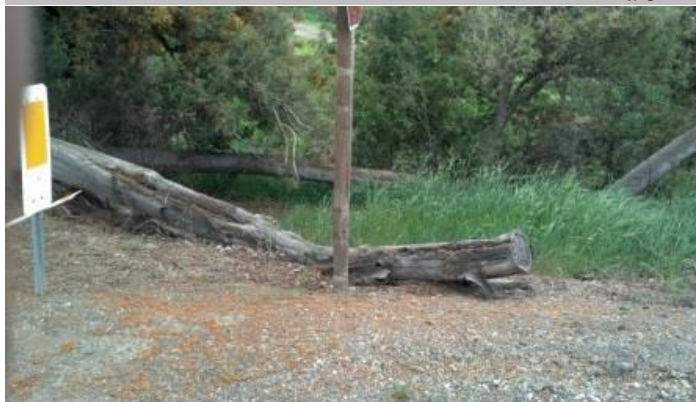
Photo 1 of 1 : FA_2017_RD0999_233_13_20170919_00010.jpg

LM Start	0.84	Rating **	M	Issue No.	13
LM End	0.84	Issue Type +	Ma	Location *	LS
Category	Earthen Levee			GPS Latitude/Longitude	
				Start	End
Item	Encroachments			38.292352 °	38.292352 °
				-121.630452 °	-121.630452 °
DWR ID	DWR_RD0999_02_s_2012_13				
Comment Code					
TR : Tree or limb					
Inspector Comment

Looking northwest at tree limb on landside slope.

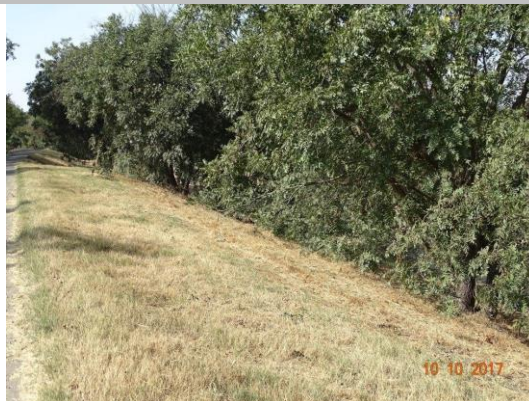
Photo 1 of 2 : FA_2017_RD0999_233_39_20171016_00051.jpg

LM Start	0.96	Rating **	U	Issue No.	39
LM End	1.01	Issue Type +	Ma	Location *	LS
Category	Earthen Levee			GPS Latitude/Longitude	
				Start	End
Item	Trim / Thin Trees			38.291603 °	38.291292 °
				-121.628485 °	-121.627577 °
DWR ID	DWR_RD0999_02_f_2014_39				
Comment Code					
T1 : Trim trees to at least five feet above ground level.					
Inspector Comment					
Untrimmed trees along landward toe.

View of landside slope looking northwest.

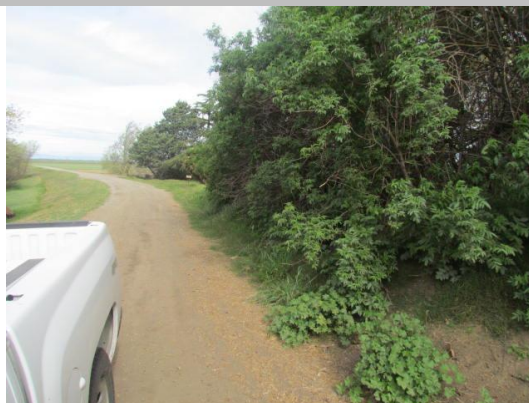
Photo 2 of 3 : FA_2017_RD0999_233_8_20170919_00005.jpg

LM Start	1.73	Rating **	M	Issue No.	8 (cont)	
LM End	1.76	Issue Type +	Ma	Location *	LS	
Category	Earthen Levee			GPS Latitude/Longitude		
				Start		End
Item	Vegetation			38.289895 °		38.289595 °
				-121.614688 °		-121.614337 °
DWR ID	DWR_RD0999_02_s_2012_8					
Comment Code						
V2 : Remove the wild growth other than native grasses from the levee slopes.						
Inspector Comment

Looking west at dense vegetation on landward shoulder and slope.
(Spring 2015)

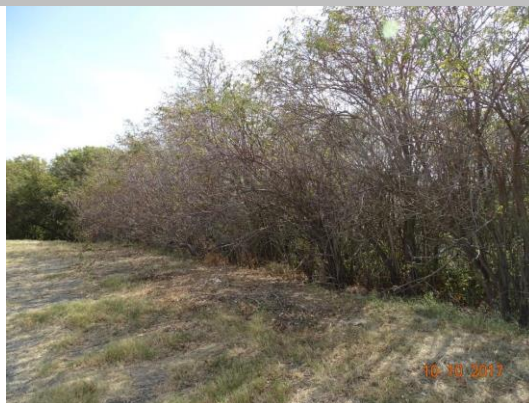
Photo 1 of 1 : FA_2017_RD0999_233_30_20171016_00053.jpg

LM Start	1.81	Rating **	M	Issue No.	30
LM End	1.81	Issue Type +	Ma	Location *	WS
Category	Earthen Levee			GPS Latitude/Longitude	
				Start	End
Item	Vegetation			38.289079 °	38.289079 °
				-121.613765 °	-121.613765 °
DWR ID	DWR_RD0999_02_f_2017_30				
Comment Code					
V4 : Elderberries are blocking visibility and flood fight capability.					
Inspector Comment

View of waterside slope looking southeast.

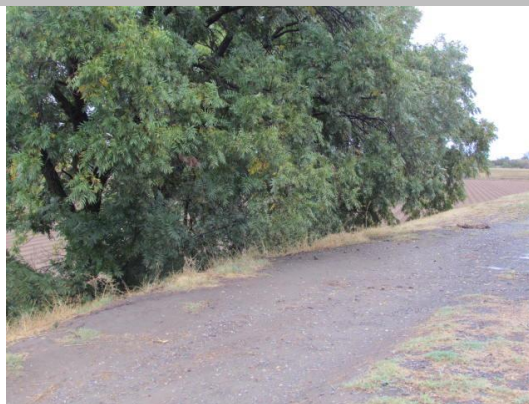
Photo 1 of 1 : FA_2017_RD0999_233_29_20170919_00020.jpg

LM Start	2.06	Rating **	A/W	Issue No.	29
LM End	2.07	Issue Type +	Ma	Location *	LS
Category	Earthen Levee			GPS Latitude/Longitude	
				Start	End
Item	Trim / Thin Trees			38.288870 °	38.288844 °
				-121.609259 °	-121.609008 °
DWR ID	DWR_RD0999_02_f_2013_29				
Comment Code					
T1 : Trim trees to at least five feet above ground level.					
Inspector Comment

Looking at untrimmed trees on landward slope fall 2015.

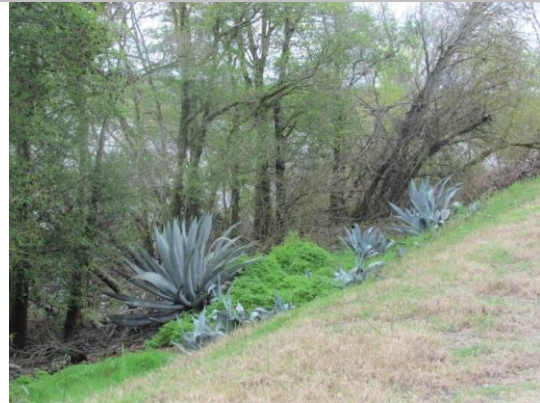
Photo 1 of 1 : FA_2017_RD0999_234_17_20170919_00014.jpg

LM Start	0.06	Rating **	M	Issue No.	17
LM End	0.06	Issue Type +	Ma	Location *	WS
Category	Earthen Levee			GPS Latitude/Longitude	
				Start	End
Item	Vegetation			38.287290 °	38.287290 °
				-121.605472 °	-121.605472 °
DWR ID	DWR_RD0999_03_s_2017_17				
Comment Code					
V2 : Remove the wild growth other than native grasses from the levee slopes.					
Inspector Comment					
Century plants on waterward slope.

Looking east at century plants on waterward slope.

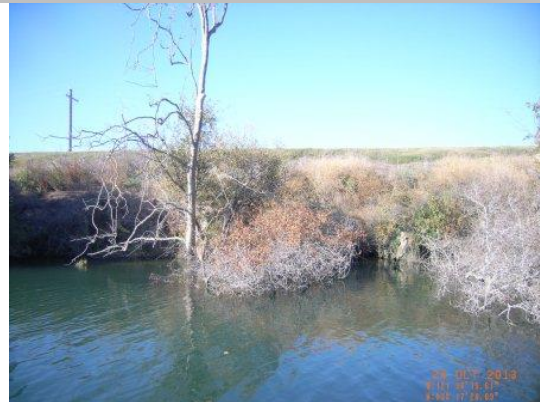
Photo 1 of 1 : FA_2017_RD0999_234_29_20170919_00024.jpg

LM Start	0.24	Rating **	U	Issue No.	29
LM End	0.65	Issue Type +	Ma	Location *	WS
Category	Supplemental			GPS Latitude/Longitude	
				Start	End
Item	2015 USACE Erosion Survey, DRAFT			38.289634 °	38.295505 °
				-121.604343 °	-121.605648 °
DWR ID	DWR_RD0999_03_s_2016_29

Comment Code					
Inspector Comment					
1997 - Intermittent over-steepened sections. Large riparian vegetation along the length of the entire reach. Attempts to repair with rock on bank have failed. 1999 - New rock repair at the downstream end. 2002 - Some minor spot repairs. 2009 - Minimal new erosion. 2010 - Appears that fresh rock placed on downstream portion of site. Toe scour and overhanging trees with some overturned. 2012 - Minor new erosion at the toe. 2013 - Site upgraded to CRITICAL. Severe slumping into levee at downstream end of site. Fresh erosion into bank toe. 2015: New slumping, tall vertical sections. [2015 Site ID: STR_24-7_R]

USACE 2013 Photo #1

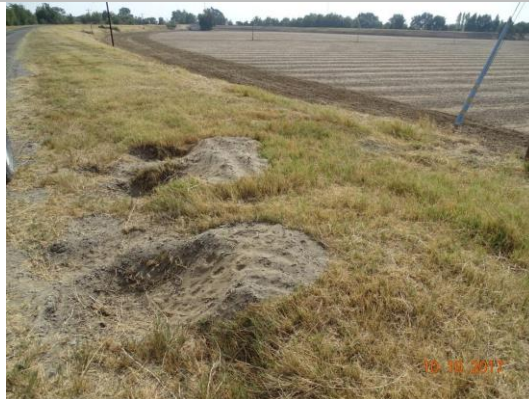
Photo 1 of 1 : FA_2017_RD0999_234_33_20171016_00050.jpg

LM Start	0.38	Rating **	M	Issue No.	33
LM End	0.38	Issue Type +	Ma	Location *	LS
Category	Earthen Levee			GPS Latitude/Longitude	
				Start	End
Item	Slope Stability			38.291640 °	38.291640 °
				-121.604799 °	-121.604799 °
DWR ID	DWR_RD0999_03_f_2017_33				
Comment Code					
S3 : Repair the levee slope damaged by vehicle traffic and prevent access where possible.					
Inspector Comment

View of landside slope looking southwest.

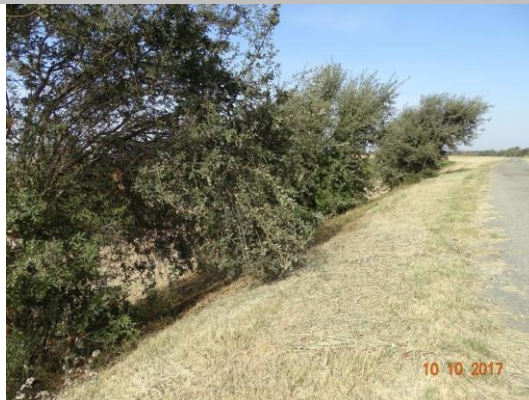
Photo 1 of 2 : FA_2017_RD0999_234_43_20171016_00051.jpg

LM Start	0.93	Rating **	U	Issue No.	43
LM End	0.95	Issue Type +	Ma	Location *	LS
Category	Earthen Levee			GPS Latitude/Longitude	
				Start	End
Item	Trim / Thin Trees			38.299130 °	38.299362 °
				-121.603768 °	-121.603462 °
DWR ID	DWR_RD0999_03_f_2014_43				
Comment Code					
T1 : Trim trees to at least five feet above ground level.					
Inspector Comment

View of landside slope looking northeast.

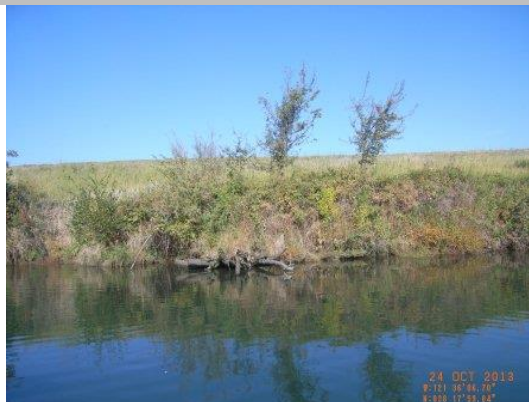
Photo 1 of 1 : FA_2017_RD0999_234_30_20170919_00025.jpg

LM Start	0.97	Rating **	M	Issue No.	30
LM End	1.10	Issue Type +	Ma	Location *	WS
Category	Supplemental			GPS Latitude/Longitude	
				Start	End
Item	2015 USACE Erosion Survey, DRAFT			38.299402 °	38.300542 °
				-121.603056 °	-121.601118 °
DWR ID	DWR_RD0999_03_s_2016_30				
Comment Code					
Inspector Comment					
2008 - Over steepened levee section. 2009 - Significant new erosion. 2010 - Minor new erosion. 2015: No observed changes. [2015 Site ID: STR_25-2_R]

USACE 2013 Photo #1

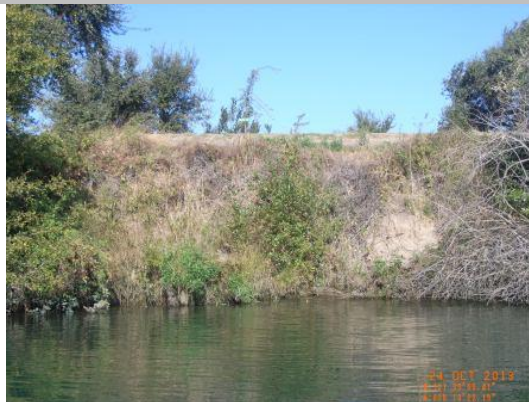
Photo 1 of 1 : FA_2017_RD0999_234_1_20170919_00001.jpg

LM Start	1.43	Rating **	M	Issue No.	1
LM End	1.58	Issue Type +	Ma	Location *	WS
Category	Supplemental			GPS Latitude/Longitude	
				Start	End
Item	2015 USACE Erosion Survey, DRAFT			38.305229 °	38.306667 °
				-121.599933 °	-121.598266 °
DWR ID	DWR_RD0999_03_s_2016_1				
Comment Code					
Inspector Comment					
2011 - Toe scour along length of site and erosion pockets. 2012 - Site extended slightly upstream due to new erosion pocket. 2013 - Tall vertical sections at upstream end of site. 2015: No observed changes. [2015 Site ID: STR_25-7_R]

USACE 2013 Photo #1

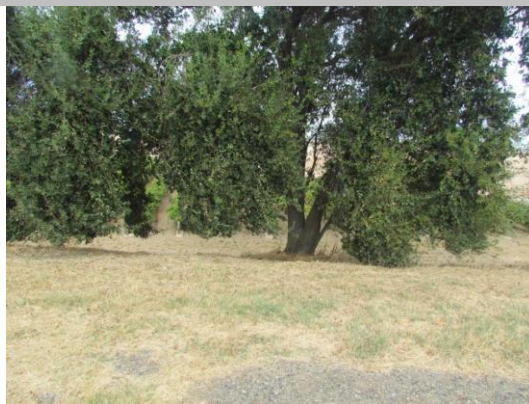
Photo 1 of 2 : FA_2017_RD0999_234_11_20170919_00010.jpg

LM Start	1.50	Rating **	M	Issue No.	11
LM End	1.50	Issue Type +	Ma	Location *	LS
Category	Earthen Levee			GPS Latitude/Longitude	
				Start	End
Item	Trim / Thin Trees			38.306062 °	38.306062 °
				-121.599495 °	-121.599495 °
DWR ID	DWR_RD0999_03_s_2012_11				
Comment Code					
T1 : Trim trees to at least five feet above ground level.					
Inspector Comment

Looking at untrimmed trees on landward slope and toe. (Fall 2016)

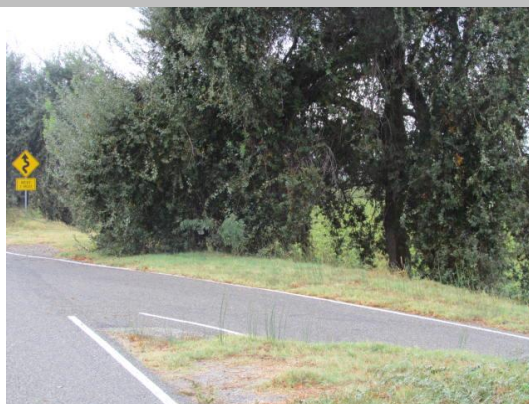
Photo 2 of 2 : FA_2017_RD0999_234_11_20170919_00011.jpg

LM Start	1.50	Rating **	M	Issue No.	11 (cont)
LM End	1.50	Issue Type +	Ma	Location *	LS

Looking at untrimmed trees on landward slope and toe. (Spring 2016)

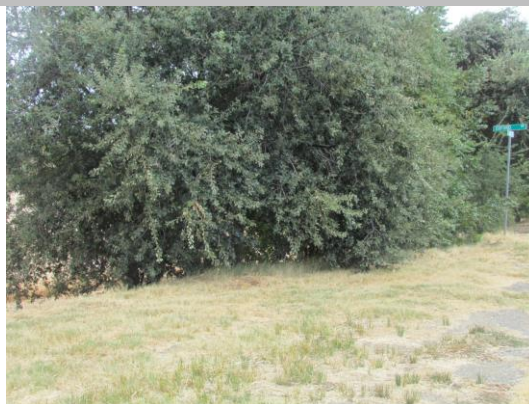
Photo 1 of 1 : FA_2017_RD0999_234_12_20170919_00012.jpg

LM Start	1.53	Rating **	U	Issue No.	12
LM End	1.53	Issue Type +	Ma	Location *	LS
Category	Earthen Levee			GPS Latitude/Longitude	
				Start	End
Item	Trim / Thin Trees			38.306332 °	38.306332 °
				-121.599109 °	-121.599109 °
DWR ID	DWR_RD0999_03_s_2012_12				
Comment Code					
T1 : Trim trees to at least five feet above ground level.					
Inspector Comment

Looking east at untrimmed trees on landward slope.

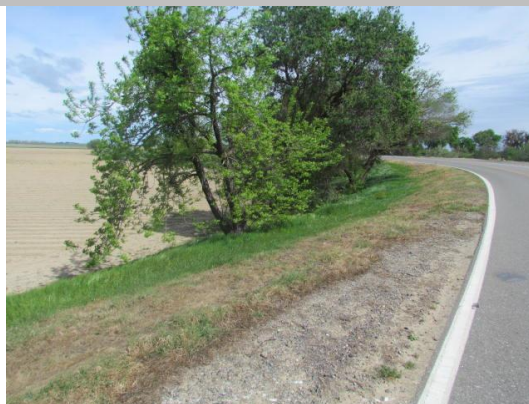
Photo 1 of 1 : FA_2017_RD0999_234_13_20170919_00013.jpg

LM Start	1.57	Rating **	M	Issue No.	13
LM End	1.59	Issue Type +	Ma	Location *	LS
Category	Earthen Levee			GPS Latitude/Longitude	
				Start	End
Item	Trim / Thin Trees			38.306762 °	38.306948 °
				-121.598541 °	-121.598320 °
DWR ID	DWR_RD0999_03_s_2012_13				
Comment Code					
T3 : Trim and thin trees to allow visibility of the ground and room to flood fight.					
Inspector Comment

Looking north at untrimmed trees on landward toe. (Spring 2015)

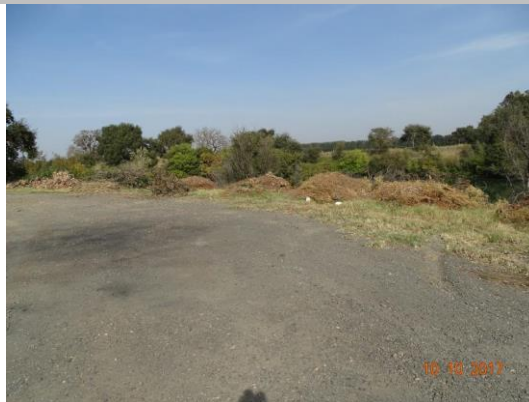
Photo 1 of 2 : FA_2017_RD0999_234_25_20171016_00052.jpg

LM Start	1.61	Rating **	U	Issue No.	25
LM End	1.61	Issue Type +	Ma	Location *	WS
Category	Earthen Levee			GPS Latitude/Longitude	
				Start	End
Item	Encroachments			38.307295 °	38.307295 °
				-121.598202 °	-121.598202 °
DWR ID	DWR_RD0999_03_s_2017_25				
Comment Code					
PR : Prunings					
Inspector Comment

View of waterside slope looking east.

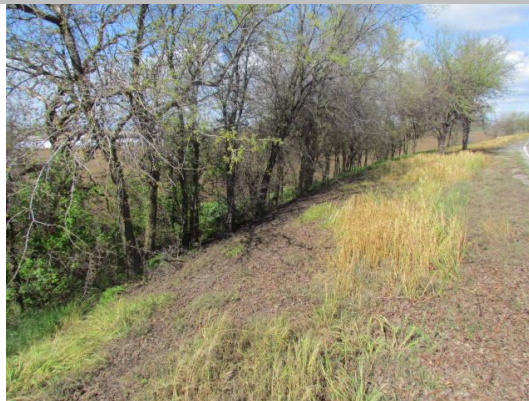
Photo 1 of 4 : FA_2017_RD0999_234_10_20170919_00006.jpg

LM Start	2.88	Rating **	U	Issue No.	10 (cont)
LM End	2.88	Issue Type +	Ma	Location *	LS

Looking northwest at dense vegetation on landward slope and toe. (Spring 2016)

LM Start	2.88	Rating **	U	Issue No.	10 (cont)	
LM End	2.88	Issue Type +	Ma	Location *	LS	
Category	Earthen Levee			GPS Latitude/Longitude		
				Start		End
Item	Trim / Thin Trees			38.322757 °		38.322757 °
				-121.590817 °		-121.590817 °
DWR ID	DWR_RD0999_03_f_2012_10					
Comment Code						
T3 : Trim and thin trees to allow visibility of the ground and room to flood fight.						
Inspector Comment						
Wild growth at landside slope and toe.

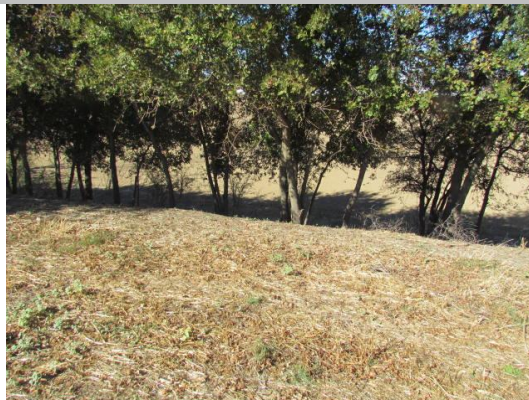
Photo 2 of 4 : FA_2017_RD0999_234_10_20170919_00007.jpg

Looking west at trimmed trees at landward toe. (Fall 2014)

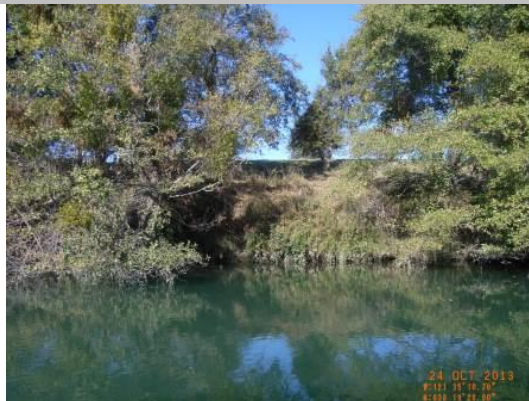
Photo 1 of 1 : FA_2017_RD0999_234_5_20170919_00002.jpg

LM Start	3.05	Rating **	A/W	Issue No.	5
LM End	3.23	Issue Type +	Ma	Location *	WS
Category	Supplemental			GPS Latitude/Longitude	
				Start	End
Item	2015 USACE Erosion Survey, DRAFT			38.323667 °	38.325592 °
				-121.588226 °	-121.585925 °
DWR ID	DWR_RD0999_03_s_2016_5				
Comment Code					
Inspector Comment					
2011 - Multiple erosion pockets. Some likely from tree popouts. 2013 - Tall vertical sections. 2015: New tree popout and significant new erosion. [2015 Site ID: STR_27-3_R]

USACE 2013 Photo #1

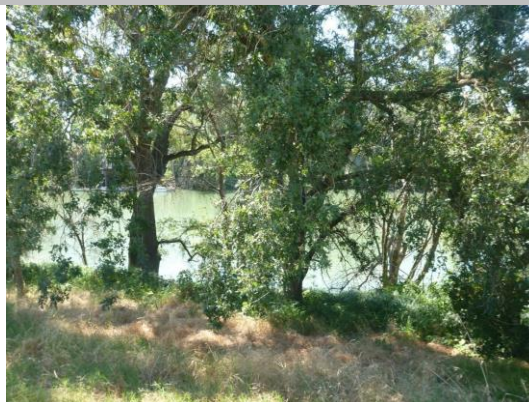
Photo 1 of 3 : LEVAL_FA_2017_355_2523.jpg

LM Start	3.09	Rating **	A/W	Issue No.	9
LM End	3.12	Issue Type +	Ma	Location *	
Category	Supplemental			GPS Latitude/Longitude	
				Start	End
Item	2017 Storm Damage			38.323986 °	38.324275 °
				-121.587403 °	-121.586967 °
DWR ID	DWR_RD0999_03_f_2017_9				
Comment Code					
Inspector Comment					
Levee Evaluation Comments					
Description:The damage consists of erosion of the lower waterside levee slope and bank approximately 147 feet in length along the west (right) bank of Sutter Slough. See attached pages for photos. Site location T06N R03E Section 36 and 25.					
Site ID No:355					
Site Designation:LMA-182					
Repair Type: Erosion					
Rating:Area of Concern					
Field Date:7/27/2017					
Notes:

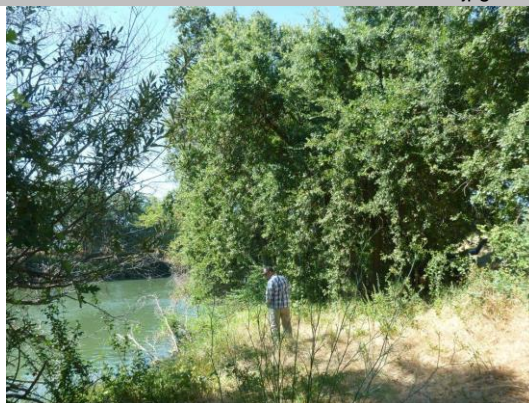
Photo 1 of 3 : LEVAL_FA_2017_356_2492.jpg

LM Start	3.18	Rating **	A/W	Issue No.	15	
LM End	3.21	Issue Type +	Ma	Location *		
Category	Supplemental			GPS Latitude/Longitude		
				Start	End	
Item	2017 Storm Damage			38.325053 °	38.325489 °	
				-121.586347 °	-121.586100 °	
DWR ID	DWR_RD0999_03_f_2017_15					
Comment Code						
Inspector Comment						
Levee Evaluation Comments						
Description:The damage consists of erosion of the lower waterside levee slope and bank approximately 172 feet in length along the west (right) bank of Sutter Slough. See attached pages for photos. Site location T06N R04E Section 3 and 4.						
Site ID No:356						
Site Designation:LMA-183						
Repair Type: Erosion						
Rating:Area of Concern						
Field Date:7/27/2017						
Notes:

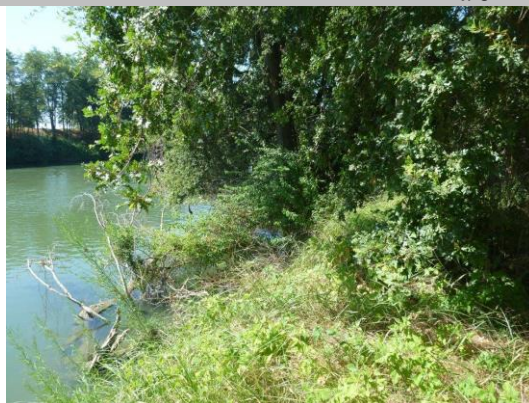
Photo 2 of 3 : LEVAL_FA_2017_356_2493.jpg

LM Start	3.18	Rating **	A/W	Issue No.	15 (cont)
LM End	3.21	Issue Type +	Ma	Location *

LM Start	3.18	Rating **	A/W	Issue No.	15 (cont)	
LM End	3.21	Issue Type +	Ma	Location *		
Category	Supplemental			GPS Latitude/Longitude		
				Start	End	
Item	2017 Storm Damage			38.325053 °	38.325489 °	
				-121.586347 °	-121.586100 °	
DWR ID	DWR_RD0999_03_f_2017_15					
Comment Code						
Inspector Comment						
Levee Evaluation Comments						
Description:The damage consists of erosion of the lower waterside levee slope and bank approximately 172 feet in length along the west (right) bank of Sutter Slough. See attached pages for photos. Site location T06N R04E Section 3 and 4.						
Site ID No:356						
Site Designation:LMA-183						
Repair Type: Erosion						
Rating:Area of Concern						
Field Date:7/27/2017						
Notes:

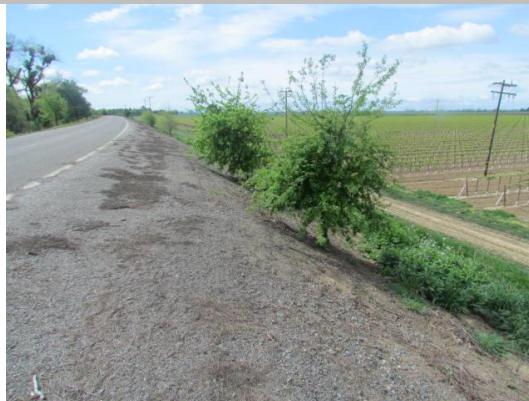
Photo 1 of 1 : FA_2017_RD0999_234_44_20170919_00029.jpg

LM Start	3.60	Rating **	A/W	Issue No.	44
LM End	3.64	Issue Type +	Ma	Location *	LS
Category	Earthen Levee			GPS Latitude/Longitude	
				Start	End
Item	Trim / Thin Trees			38.330946 °	38.331415 °
				-121.585932 °	-121.585534 °
DWR ID	DWR_RD0999_03_s_2015_44				
Comment Code					
T2 : Thin trees to allow visibility of the ground and room to flood fight.					
Inspector Comment					
Remove trees less than four inches in diameter at chest height. Don't allow young trees to get establish on levee slope.

Looking southwest at typical view of young oak trees on landward slope. (Spring 2015)

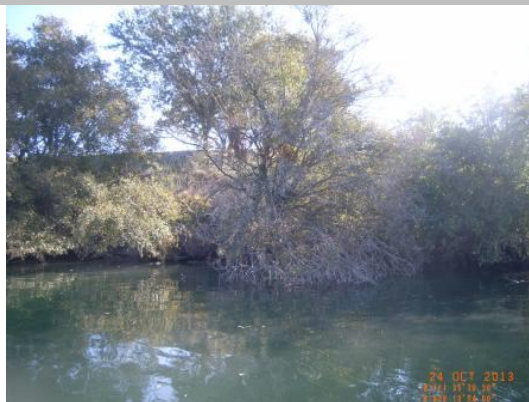
Photo 1 of 1 : FA_2017_RD0999_234_18_20170919_00015.jpg

LM Start	4.56	Rating **	M	Issue No.	18
LM End	4.68	Issue Type +	Ma	Location *	WS
Category	Supplemental			GPS Latitude/Longitude	
				Start	End
Item	2015 USACE Erosion Survey, DRAFT			38.313836 °	38.315407 °
				-121.592259 °	-121.591433 °
DWR ID	DWR_RD0999_03_s_2016_18				
Comment Code					
Inspector Comment					
2002 - Original rock over geotextile is sliding off and the end is coming unraveled. 2003 - Some minor new erosion on the downstream end. 2004 - Site has gotten worse. Underlined geofabric is exposed. 2005 - Still looks bad with exposed geotextile fabric. 2006 - Still have some new unraveling and exposed fabric. Site lengthened upstream. 2009 - Minimal new erosion. 2010 - geotextile fabric placed since last year, possible flood fight. 2012 - Exposed geotech style fabric, assume rock on top slid off. 2015: Erosion pockets covered with plastic. [2015 Site ID: STR_26-5_L]

USACE 2013 Photo #1

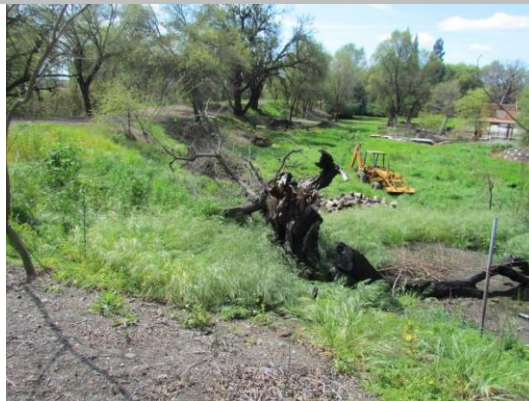
Photo 2 of 2 : FA_2017_RD0999_235_45_20170919_00033.jpg

LM Start	0.03	Rating **	M	Issue No.	45 (cont)	
LM End	0.03	Issue Type +	Ma	Location *	LS	
Category	Earthen Levee			GPS Latitude/Longitude		
				Start		End
Item	Encroachments			38.414335 °		38.414335 °
				-121.523348 °		-121.523348 °
DWR ID	DWR_RD0999_04_s_2017_45					
Comment Code						
TR : Tree or limb						
Inspector Comment						
Large downed tree on landside slope.

Looking west at fallen tree on landward slope.

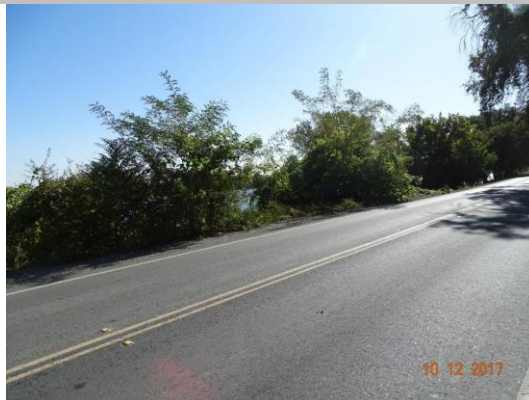
Photo 1 of 1 : FA_2017_RD0999_235_53_20171030_00096.jpg

LM Start	0.04	Rating **	U	Issue No.	53
LM End	0.06	Issue Type +	Ma	Location *	WS
Category	Earthen Levee			GPS Latitude/Longitude	
				Start	End
Item	Vegetation			38.414533 °	38.414750 °
				-121.523394 °	-121.523543 °
DWR ID	DWR_RD0999_04_f_2017_53				
Comment Code					
V2 : Remove the wild growth other than native grasses from the levee slopes.					
Inspector Comment					
Dense vegetation on waterside slope.

Looking southeast at the waterside slope.

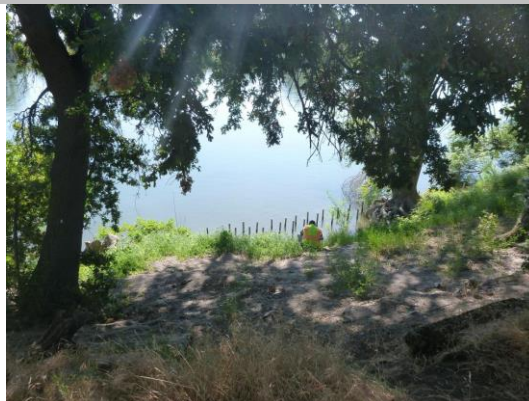
Photo 3 of 3 : LEVAL_FA_2017_357_2475.jpg

LM Start	0.10	Rating **	A/W	Issue No.	42 (cont)
LM End	0.29	Issue Type +	Ma	Location *	
Category	Supplemental			GPS Latitude/Longitude	
				Start	End
Item	2017 Storm Damage			38.415319 °	38.417744 °
				-121.523717 °	-121.525344 °
DWR ID	DWR_RD0999_04_f_2017_42				
Comment Code					
Inspector Comment					
Levee Evaluation Comments					
Description:The damage consists of erosion of the lower and mid waterside levee slope approximately 997 feet in length along the west (right) bank of the Sacramento River. See attached pages for photos.					
Site location T06N R04E Section 3 and 4.					
Site ID No:357					
Site Designation:LMA-184					
Repair Type: Erosion					
Rating:Serious					
Field Date:7/27/2017					
Notes: on bank slope, big trees with exposed tree roots observed

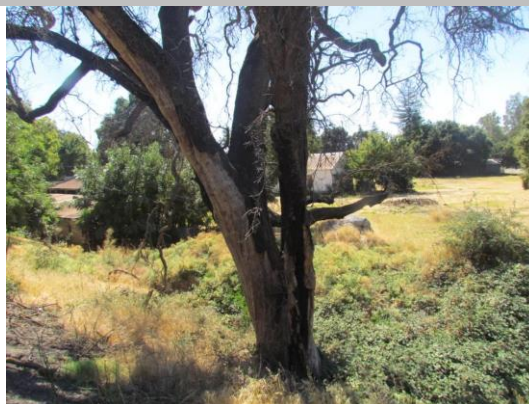
Photo 1 of 2 : FA_2017_RD0999_235_21_20170919_00020.jpg

LM Start	0.58	Rating **	A/W	Issue No.	21
LM End	0.58	Issue Type +	Ma	Location *	LS
Category	Earthen Levee			GPS Latitude/Longitude	
				Start	End
Item	Vegetation			38.421394 °	38.421394 °
				-121.527963 °	-121.527963 °
DWR ID	DWR_RD0999_04_f_2013_21				
Comment Code					
V7 : Trees / Woody Vegetation					
Inspector Comment					
Dead tree on landside slope and toe.

Looking southwest at dead tree at landward toe.

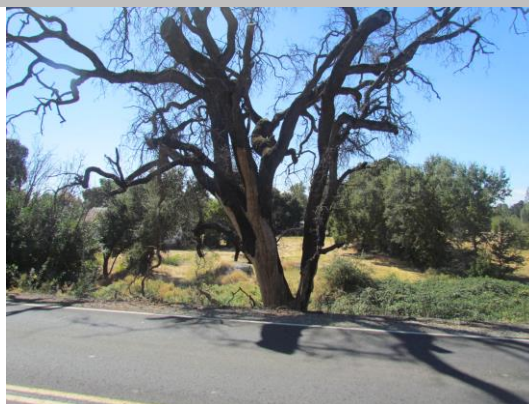
Photo 2 of 2 : FA_2017_RD0999_235_21_20170919_00021.jpg

Looking west at dead tree at landward toe.

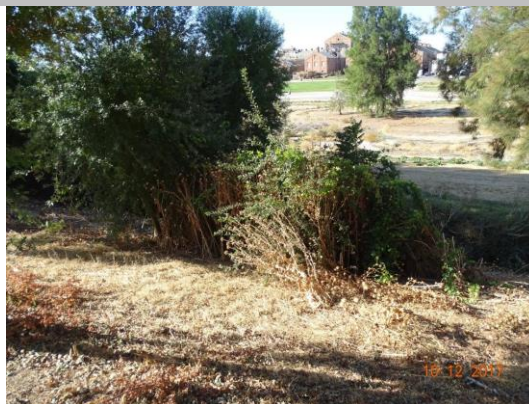
Photo 1 of 1 : FA_2017_RD0999_235_50_20171030_00094.jpg

LM Start	0.85	Rating **	U	Issue No.	50
LM End	0.85	Issue Type +	Ma	Location *	LS
Category	Earthen Levee			GPS Latitude/Longitude	
				Start	End
Item	Vegetation			38.424805 °	38.424805 °
				-121.530541 °	-121.530541 °
DWR ID	DWR_RD0999_04_f_2017_50				
Comment Code					
V2 : Remove the wild growth other than native grasses from the levee slopes.					
Inspector Comment

Looking west at the landside slope.

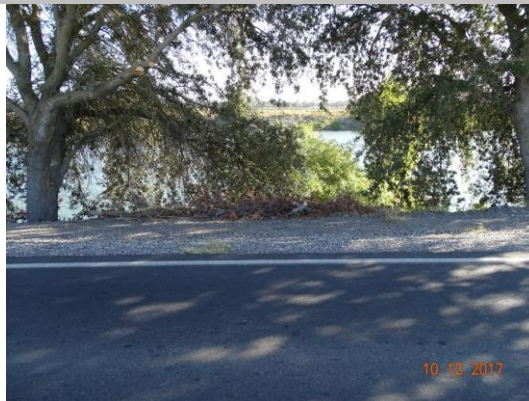
Photo 1 of 1 : FA_2017_RD0999_235_43_20171030_00093.jpg

LM Start	0.94	Rating **	M	Issue No.	43
LM End	0.94	Issue Type +	Ma	Location *	WS
Category	Earthen Levee			GPS Latitude/Longitude	
				Start	End
Item	Encroachments			38.426005 °	38.426005 °
				-121.531382 °	-121.531382 °
DWR ID	DWR_RD0999_04_f_2017_43				
Comment Code					
PR : Prunings					
Inspector Comment					
Pruning piles on waterside slope,

Looking east at the waterside slope.

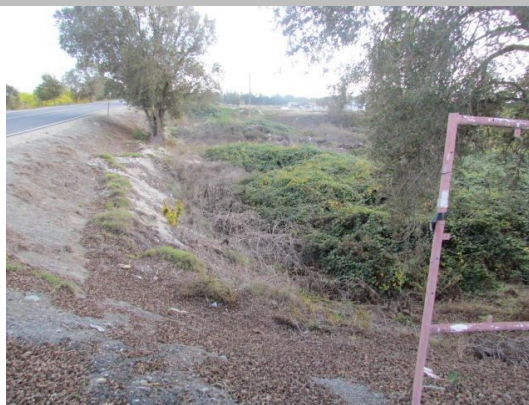
Photo 4 of 4 : FA_2017_RD0999_235_16_20170919_00018.jpg

LM Start	1.01	Rating **	U	Issue No.	16 (cont)	
LM End	1.04	Issue Type +	Ma	Location *	LS	
Category	Earthen Levee			GPS Latitude/Longitude		
				Start	End	
Item	Vegetation			38.426873 °	38.427295 °	
				-121.531778 °	-121.532164 °	
DWR ID	DWR_RD0999_04_f_2012_16					
Comment Code						
V2 : Remove the wild growth other than native grasses from the levee slopes.						
Inspector Comment						
Blackberries blocking view of landside toe.

Looking south at dense berryvines on landside toe. 2012

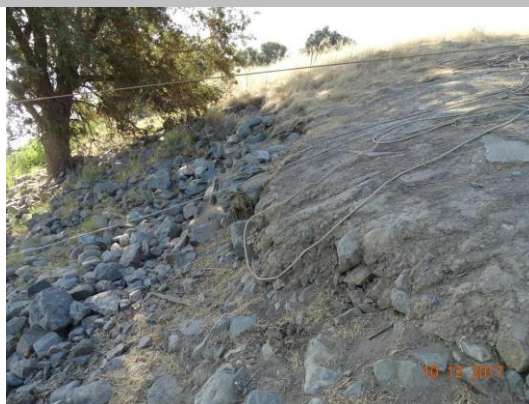
Photo 1 of 3 : FA_2017_RD0999_235_47_20171030_00090.jpg

LM Start	1.10	Rating **	U	Issue No.	47
LM End	1.10	Issue Type +	Ma	Location *	WS
Category	Earthen Levee			GPS Latitude/Longitude	
				Start	End
Item	Erosion / Bank Caving			38.428152 °	38.428152 °
				-121.532502 °	-121.532502 °
DWR ID	DWR_RD0999_04_s_2017_47				
Comment Code					
E1 : Note and monitor erosion site.					
Inspector Comment					
Small erosion just above rip rap on waterside toe and runoff erosion on waterside slope.

Looking southeast at the waterside slope.

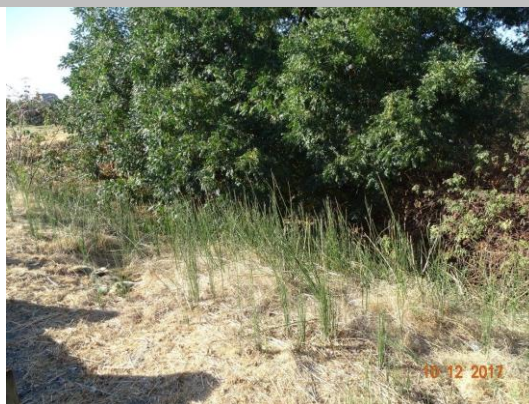
Photo 1 of 3 : FA_2017_RD0999_235_5_20171030_00089.jpg

LM Start	1.15	Rating **	U	Issue No.	5
LM End	1.15	Issue Type +	Ma	Location *	LS
Category	Earthen Levee			GPS Latitude/Longitude	
				Start	End
Item	Vegetation			38.428823 °	38.428823 °
				-121.532885 °	-121.532885 °
DWR ID	DWR_RD0999_04_s_2012_5				
Comment Code					
V2 : Remove the wild growth other than native grasses from the levee slopes.					
Inspector Comment					
Berry vines and wild roses on landside toe.

Looking south at the dense vegetation on the landside slope.

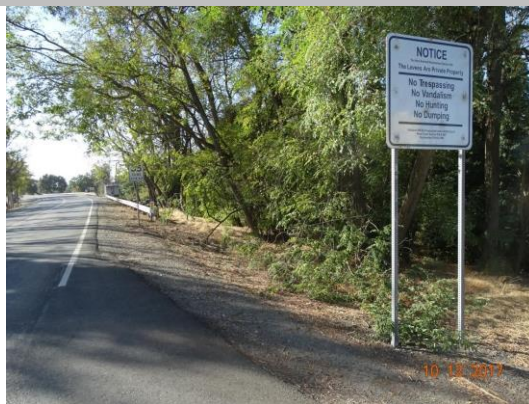
Photo 1 of 2 : FA_2017_RD0999_235_22_20171030_00086.jpg

LM Start	1.20	Rating **	M	Issue No.	22
LM End	1.22	Issue Type +	Ma	Location *	LS
Category	Earthen Levee			GPS Latitude/Longitude	
				Start	End
Item	Trim / Thin Trees			38.429467 °	38.429750 °
				-121.533110 °	-121.533188 °
DWR ID	DWR_RD0999_04_f_2013_22				
Comment Code					
T3 : Trim and thin trees to allow visibility of the ground and room to flood fight.					
Inspector Comment

Looking south at dense trees on landside slope.

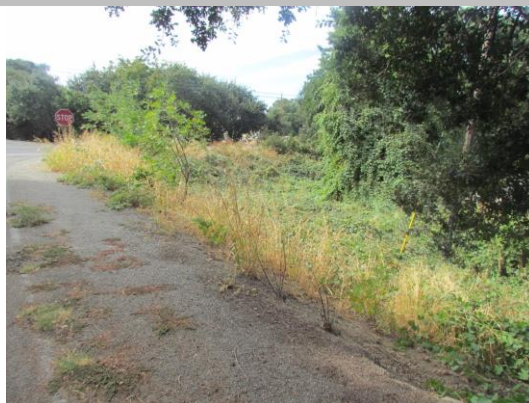
Photo 1 of 2 : FA_2017_RD0999_236_189_20170919_00129.jpg

LM Start	0.68	Rating **	M	Issue No.	189	
LM End	0.68	Issue Type +	Ma	Location *	LS	
Category	Earthen Levee			GPS Latitude/Longitude		
				Start		End
Item	Vegetation			38.342032 °		38.342032 °
				-121.581372 °		-121.581372 °
DWR ID	DWR_RD0999_05_f_2014_189					
Comment Code						
V2 : Remove the wild growth other than native grasses from the levee slopes.						
Inspector Comment						
Dense wild grapevines on landside slope.

Looking southwest at dense vegetation on landward slope and toe. (Fall 2016)

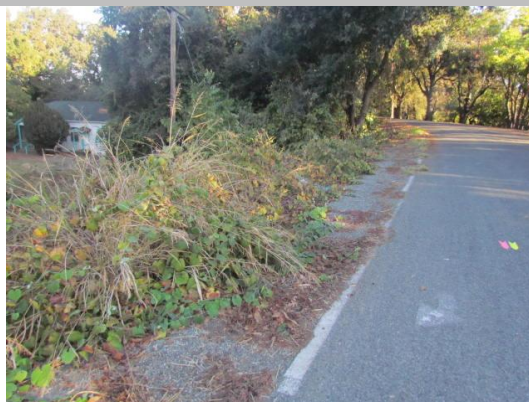
Photo 2 of 2 : FA_2017_RD0999_236_189_20170919_00130.jpg

Looking northwest at dense vegetation on landward slope. (Spring 2016)

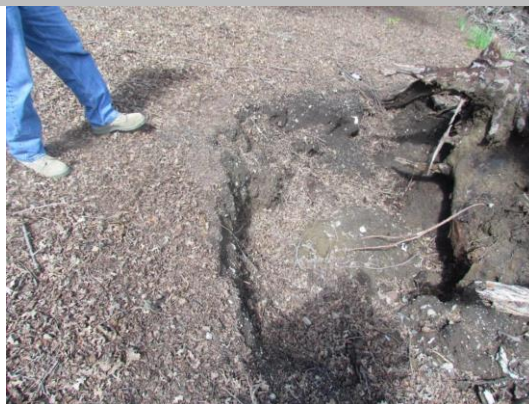
Photo 1 of 3 : FA_2017_RD0999_236_166_20170919_00106.jpg

LM Start	0.71	Rating **	U	Issue No.	166
LM End	0.71	Issue Type +	Ma	Location *	WS
Category	Earthen Levee			GPS Latitude/Longitude	
				Start	End
Item	Encroachments			38.342483 °	38.342483 °
				-121.581235 °	-121.581235 °
DWR ID	DWR_RD0999_05_s_2017_166				
Comment Code					
TR : Tree or limb					
Inspector Comment					
Dead tree fallen on waterward slope. Left hole on waterward slope 10 to 12 inches.

Looking at hole left by fallen tree on waterward slope.

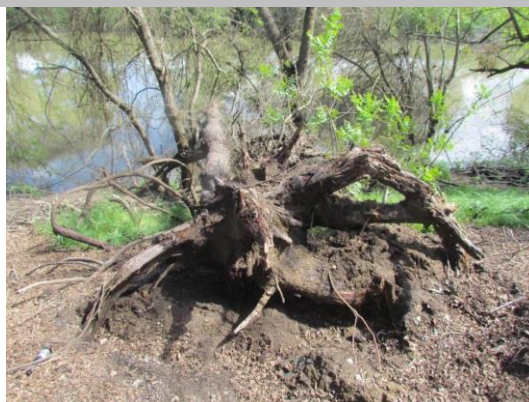
Photo 2 of 3 : FA_2017_RD0999_236_166_20170919_00107.jpg

Looking downstream at fallen tree on waterward slope.

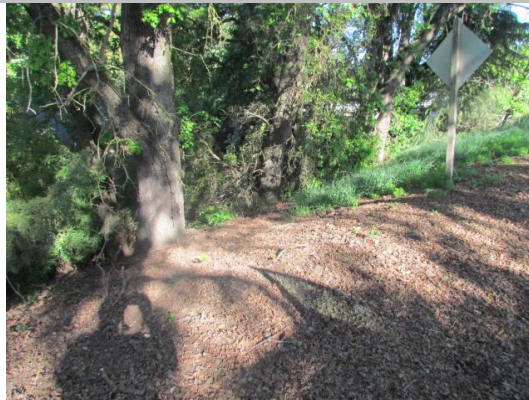
Photo 1 of 2 : FA_2017_RD0999_236_128_20170919_00079.jpg

LM Start	0.78	Rating **	M	Issue No.	128
LM End	0.78	Issue Type +	Ma	Location *	LS
Category	Earthen Levee			GPS Latitude/Longitude	
				Start	End
Item	Trim / Thin Trees			38.343495 °	38.343495 °
				-121.581282 °	-121.581282 °
DWR ID	DWR_RD0999_05_s _ 2012_128				
Comment Code					
T3 : Trim and thin trees to allow visibility of the ground and room to flood fight.					
Inspector Comment

Looking northwest at untrimmed trees on landward slope. (Spring 2015)

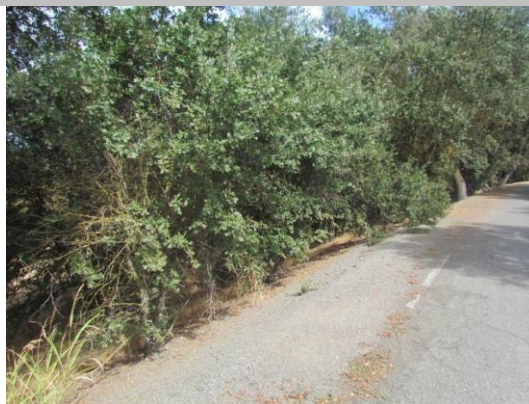
Photo 1 of 1 : FA_2017_RD0999_236_14_20170919_00011.jpg

LM Start	1.07	Rating **	M	Issue No.	14
LM End	1.11	Issue Type +	Ma	Location *	LS
Category	Earthen Levee			GPS Latitude/Longitude	
				Start	End
Item	Trim / Thin Trees			38.347427 °	38.347863 °
				-121.579395 °	-121.579113 °
DWR ID	DWR_RD0999_05_s_2012_14				
Comment Code					
T1 : Trim trees to at least five feet above ground level.					
Inspector Comment

Looking west at untrimmed trees on landward slope and toe.

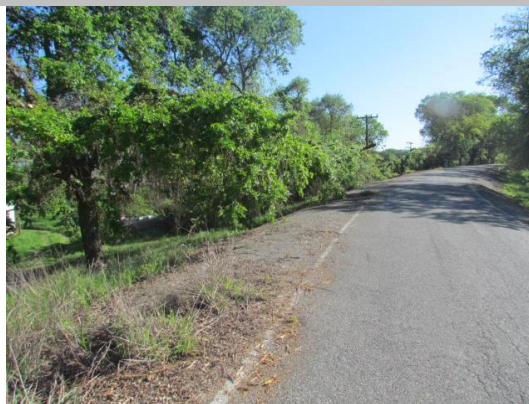
Photo 1 of 1 : FA_2017_RD0999_236_15_20170919_00012.jpg

LM Start	1.15	Rating **	U	Issue No.	15
LM End	1.19	Issue Type +	Ma	Location *	LS
Category	Earthen Levee			GPS Latitude/Longitude	
				Start	End
Item	Trim / Thin Trees			38.348237 °	38.348328 °
				-121.578440 °	-121.577735 °
DWR ID	DWR_RD0999_05_s_2012_15				
Comment Code					
T1 : Trim trees to at least five feet above ground level.					
Inspector Comment

Looking north at untrimmed trees on landward slope and toe.
