**Flood Control Project Maintenance
Levee Inspections**

Maintenance Issue Types Only, Levee Inspection Report By Mile - Fall 2017

Reclamation District No. 0999 Netherlands

Waterway	Bank	Unit Miles	Inspection Start/End	Inspector
Unit No. 01 Yolo Bypass	Left	15.41	10/10/2017 10/10/2017	Dave Torres

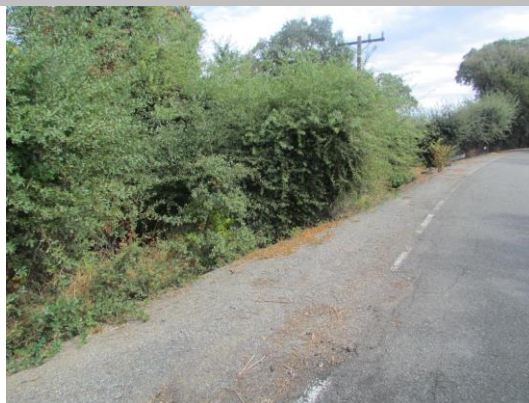
Photo 1 of 1 : FA_2017_RD0999_236_147_20170919_00091.jpg

LM Start	1.19	Rating **	U	Issue No.	147
LM End	1.19	Issue Type +	Ma	Location *	LS
Category	Earthen Levee			GPS Latitude/Longitude	
				Start	End
Item	Vegetation			38.348329 °	38.348329 °
				-121.577740 °	-121.577740 °
DWR ID	DWR_RD0999_05_f_2013_147				
Comment Code					
V2 : Remove the wild growth other than native grasses from the levee slopes.					
Inspector Comment					
Dense vegetation at landside toe.

Looking northwest at untrimmed trees on landward slope.

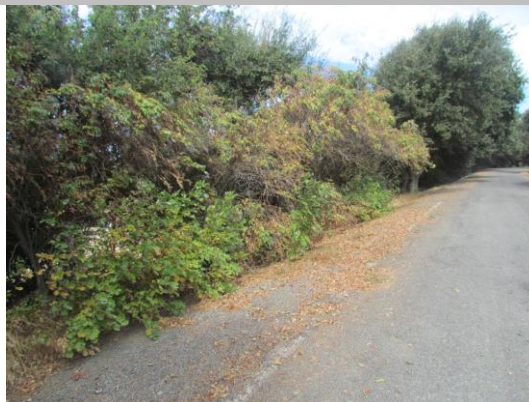
Photo 1 of 1 : FA_2017_RD0999_236_199_20170919_00137.jpg

LM Start	1.69	Rating **	U	Issue No.	199
LM End	1.69	Issue Type +	Ma	Location *	LS
Category	Earthen Levee			GPS Latitude/Longitude	
				Start	End
Item	Vegetation			38.351957 °	38.351957 °
				-121.574096 °	-121.574096 °
DWR ID	DWR_RD0999_05_f_2014_199				
Comment Code					
V2 : Remove the wild growth other than native grasses from the levee slopes.					
Inspector Comment					
Dense vegetation on landward slope.

Looking northwest at dense vegetation on landward slope.

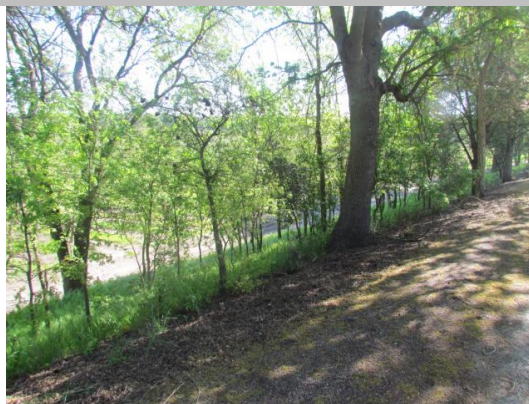
Photo 1 of 1 : FA_2017_RD0999_236_24_20170919_00020.jpg

LM Start	2.14	Rating **	M	Issue No.	24
LM End	2.16	Issue Type +	Ma	Location *	LS
Category	Earthen Levee			GPS Latitude/Longitude	
				Start	End
Item	Trim / Thin Trees			38.355402 °	38.355282 °
				-121.568893 °	-121.568547 °
DWR ID	DWR_RD0999_05_s_2012_24				
Comment Code					
T3 : Trim and thin trees to allow visibility of the ground and room to flood fight.					
Inspector Comment

Looking west at dense trees on landward slope. (Spring 2015)

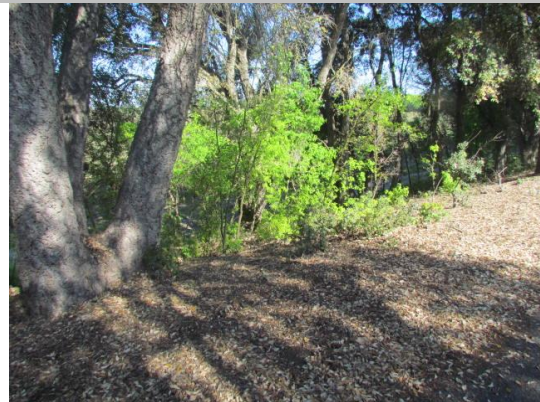
Photo 1 of 1 : FA_2017_RD0999_236_82_20170919_00060.jpg

LM Start	2.51	Rating **	M	Issue No.	82
LM End	2.65	Issue Type +	Ma	Location *	LS
Category	Earthen Levee			GPS Latitude/Longitude	
				Start	End
Item	Trim / Thin Trees			38.356270 °	38.358132 °
				-121.563218 °	-121.562347 °
DWR ID	DWR_RD0999_05_s _ 2012_82				
Comment Code					
T3 : Trim and thin trees to allow visibility of the ground and room to flood fight.					
Inspector Comment

Looking northwest at dense trees on landward slope. (Spring 2015)

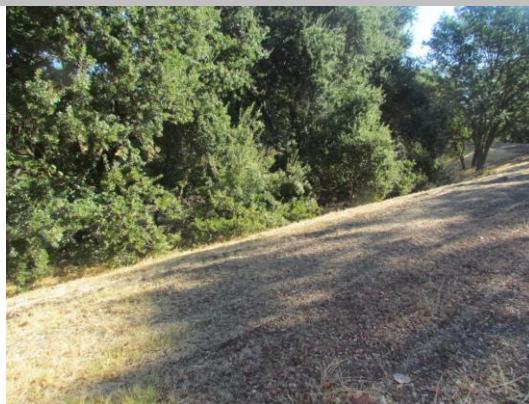
Photo 1 of 2 : FA_2017_RD0999_236_213_20170919_00146.jpg

LM Start	3.39	Rating **	U	Issue No.	213
LM End	3.39	Issue Type +	Ma	Location *	LS
Category	Earthen Levee			GPS Latitude/Longitude	
				Start	End
Item	Trim / Thin Trees			38.363906 °	38.363906 °
				-121.557220 °	-121.557220 °
DWR ID	DWR_RD0999_05_s _ 2016_213				
Comment Code					
T1 : Trim trees to at least five feet above ground level.					
Inspector Comment

Looking northwest at untrimmed trees on landward toe. (Fall 2016)

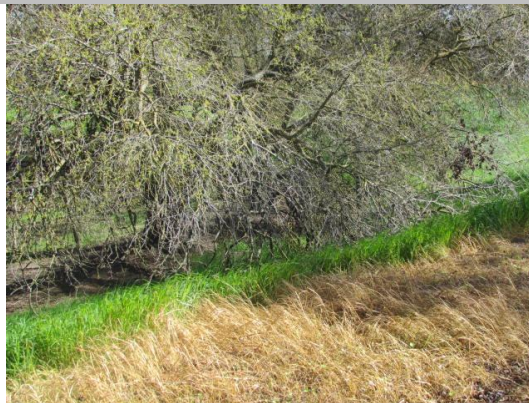
Photo 2 of 2 : FA_2017_RD0999_236_213_20170919_00147.jpg

LM Start	3.39	Rating **	U	Issue No.	213 (cont)	
LM End	3.39	Issue Type +	Ma	Location *	LS	
Category	Earthen Levee			GPS Latitude/Longitude		
				Start		End
Item	Trim / Thin Trees			38.363906 °		38.363906 °
				-121.557220 °		-121.557220 °
DWR ID	DWR_RD0999_05_s_2016_213					
Comment Code						
T1 : Trim trees to at least five feet above ground level.						
Inspector Comment

Looking northwest at untrimmed trees at landward toe. (Spring 2016)

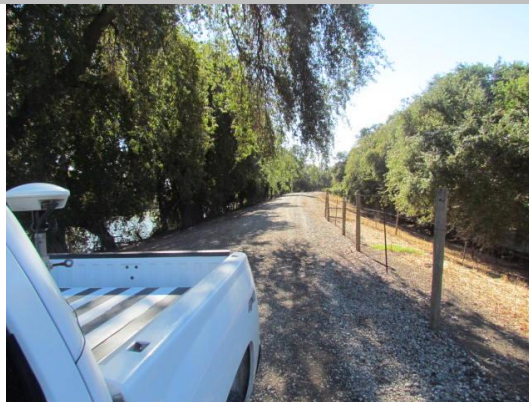
Photo 1 of 1 : FA_2017_RD0999_236_173_20170919_00118.jpg

LM Start	3.56	Rating **	M	Issue No.	173
LM End	3.56	Issue Type +	Ma	Location *	WS
Category	Earthen Levee			GPS Latitude/Longitude	
				Start	End
Item	Trim / Thin Trees			38.365882 °	38.365882 °
				-121.556762 °	-121.556762 °
DWR ID	DWR_RD0999_05_f_2015_173				
Comment Code					
T4 : Trim trees over roadway to at least 12 feet above ground level.					
Inspector Comment

Looking at the tree overhanging the levee crown.

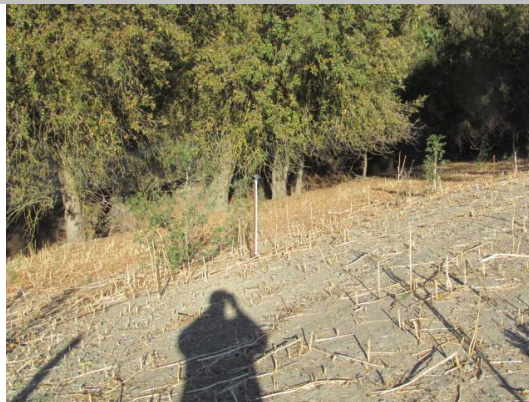
Photo 1 of 2 : FA_2017_RD0999_236_201_20170919_00139.jpg

LM Start	3.58	Rating **	M	Issue No.	201
LM End	3.64	Issue Type +	Ma	Location *	LS
Category	Earthen Levee			GPS Latitude/Longitude	
				Start	End
Item	Trim / Thin Trees			38.366103 °	38.367035 °
				-121.556820 °	-121.556781 °
DWR ID	DWR_RD0999_05_f_2014_201				
Comment Code					
T2 : Thin trees to allow visibility of the ground and room to flood fight.					
Inspector Comment					
Landowner has planted oak trees and installed sprinklers on landside slope. Oak trees should be removed.

Looking west a several small oak trees planted on landward slope.

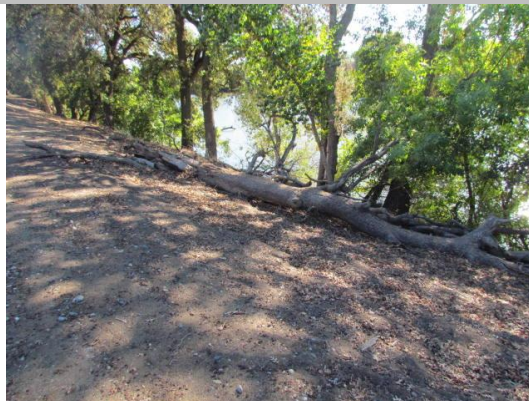
Photo 1 of 1 : FA_2017_RD0999_236_174_20170919_00119.jpg

LM Start	3.80	Rating **	M	Issue No.	174
LM End	3.80	Issue Type +	Ma	Location *	WS
Category	Earthen Levee			GPS Latitude/Longitude	
				Start	End
Item	Encroachments			38.368207 °	38.368207 °
				-121.554360 °	-121.554360 °
DWR ID	DWR_RD0999_05_f_2015_174				
Comment Code					
TR : Tree or limb					
Inspector Comment					
Downed tree branch and limbs on waterward slope.

Looking at downed tree branch on waterward slope.

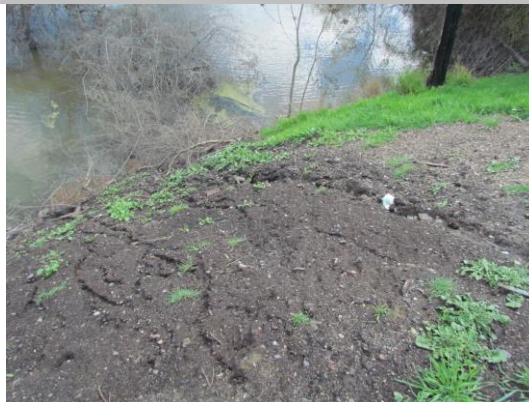
Photo 1 of 2 : FA_2017_RD0999_236_12_20170919_00009.jpg

LM Start	4.25	Rating **	U	Issue No.	12
LM End	4.25	Issue Type +	Ma	Location *	WS
Category	Earthen Levee			GPS Latitude/Longitude	
				Start	End
Item	Slope Stability			38.372872 °	38.372872 °
				-121.552185 °	-121.552185 °
DWR ID	DWR_RD0999_05_s_2017_12				
Comment Code					
S1 : Repair slope instability.					
Inspector Comment					
Large slough on waterside slope.

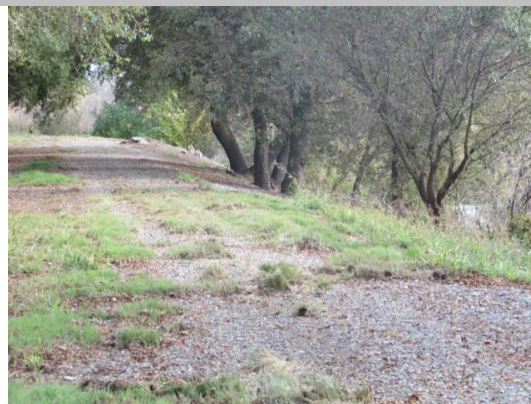
Photo 1 of 1 : FA_2017_RD0999_236_32_20170919_00023.jpg

LM Start	4.51	Rating **	M	Issue No.	32
LM End	4.85	Issue Type +	Ma	Location *	CR
Category	Earthen Levee			GPS Latitude/Longitude	
				Start	End
Item	Crown Surface / Depressions / Rutting			38.375084 °	38.377176 °
				-121.548750 °	-121.543571 °
DWR ID	DWR_RD0999_05_f_2012_32				
Comment Code					
C1 : Add appropriate material and re-grade the levee to bring the crown above the design elevation.					
Inspector Comment

Looking north at vegetation on levee crown.

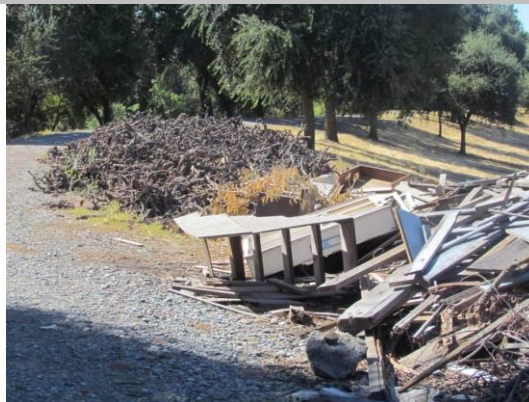
Photo 1 of 2 : FA_2017_RD0999_236_65_20170919_00044.jpg

LM Start	5.07	Rating **	M	Issue No.	65
LM End	5.07	Issue Type +	Ma	Location *	LS
Category	Earthen Levee			GPS Latitude/Longitude	
				Start	End
Item	Encroachments			38.379711 °	38.379711 °
				-121.541070 °	-121.541070 °
DWR ID	DWR_RD0999_05_s_2012_65				
Comment Code					
PR : Prunings					
Inspector Comment					
Prunings and garbage pile on landside shoulder and slope.

Looking south at prunings and garbage on landward shoulder and slope. (Fall 2016)

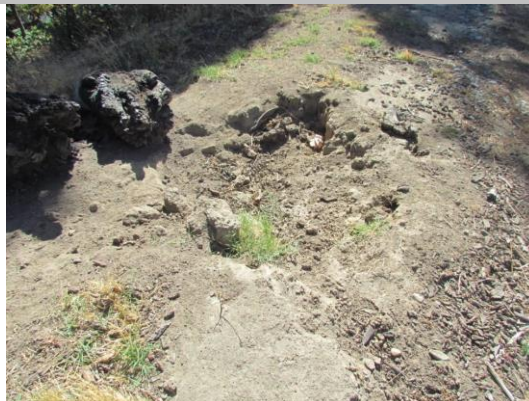
Photo 1 of 3 : FA_2017_RD0999_236_176_20170919_00122.jpg

LM Start	5.12	Rating **	U	Issue No.	176
LM End	5.12	Issue Type +	Ma	Location *	WS
Category	Earthen Levee			GPS Latitude/Longitude	
				Start	End
Item	Slope Stability			38.380420 °	38.380420 °
				-121.541102 °	-121.541102 °
DWR ID	DWR_RD0999_05_f_2015_176				
Comment Code					
S1 : Repair slope instability.					
Inspector Comment					
Large hole on waterside shoulder caused by fallen tree.

Looking at hole from falling tree on waterward shoulder. (Fall 2016)

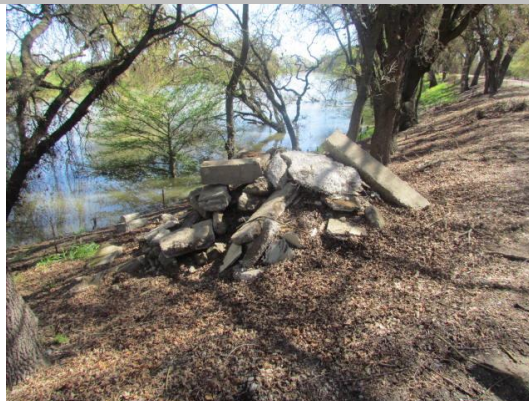
Photo 1 of 1 : FA_2017_RD0999_236_215_20170919_00149.jpg

LM Start	5.41	Rating **	M	Issue No.	215
LM End	5.41	Issue Type +	Ma	Location *	WS
Category	Earthen Levee			GPS Latitude/Longitude	
				Start	End
Item	Encroachments			38.381763 °	38.381763 °
				-121.545904 °	-121.545904 °
DWR ID	DWR_RD0999_05_s _ 2016_215				
Comment Code					
MA : Material					
Inspector Comment					
Concrete piled on waterside shoulder and slope

Looking southeast at concrete rubble piled on waterward shoulder.

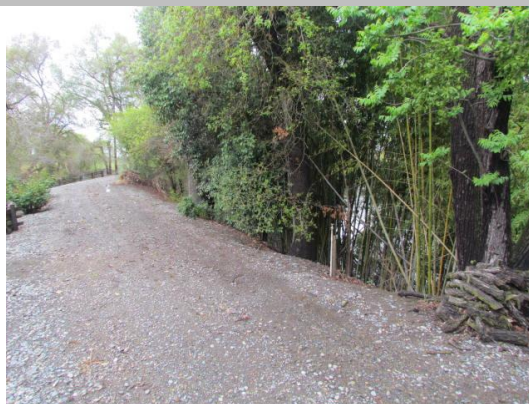
Photo 1 of 1 : FA_2017_RD0999_236_71_20170919_00051.jpg

LM Start	5.50	Rating **	U	Issue No.	71
LM End	5.55	Issue Type +	Ma	Location *	WS
Category	Earthen Levee			GPS Latitude/Longitude	
				Start	End
Item	Vegetation			38.382790 °	38.383548 °
				-121.546754 °	-121.546728 °
DWR ID	DWR_RD0999_05_s_2012_71				
Comment Code					
V2 : Remove the wild growth other than native grasses from the levee slopes.					
Inspector Comment

Looking northeast at dense vegetation on waterside slope.

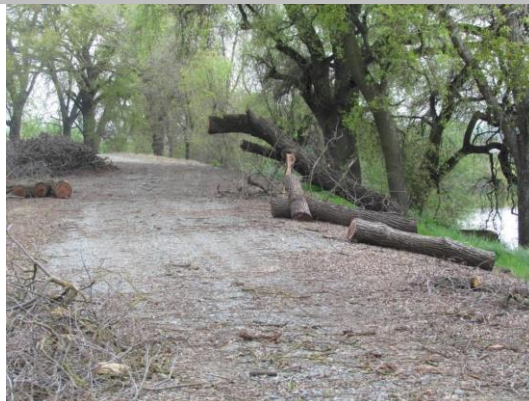
Photo 1 of 2 : FA_2017_RD0999_236_92_20170919_00064.jpg

LM Start	6.43	Rating **	U	Issue No.	92
LM End	6.48	Issue Type +	Ma	Location *	LS
Category	Earthen Levee			GPS Latitude/Longitude	
				Start	End
Item	Encroachments			38.391355 °	38.391776 °
				-121.540113 °	-121.539295 °
DWR ID	DWR_RD0999_05_s_2012_92				
Comment Code					
PR : Prunings					
Inspector Comment					
Large pruning piles and fallen tree on waterside and landside shoulder and slope.

Looking east at tree branches and limbs on waterward and landward shoulder and slope.

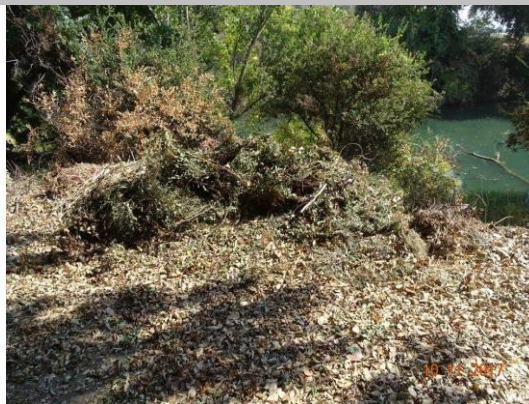
Photo 1 of 1 : FA_2017_RD0999_236_108_20171030_00229.jpg

LM Start	9.01	Rating **	M	Issue No.	108
LM End	9.01	Issue Type +	Ma	Location *	WS
Category	Earthen Levee			GPS Latitude/Longitude	
				Start	End
Item	Encroachments			38.415412 °	38.415412 °
				-121.529500 °	-121.529500 °
DWR ID	DWR_RD0999_05_f_2017_108				
Comment Code					
PR : Prunings					
Inspector Comment

Looking southeast at the waterside slope.
