**Flood Control Project Maintenance
Levee Inspections**

Maintenance Issue Types Only, Levee Inspection Report By Mile - Fall 2018

Reclamation District No. 0999 Netherlands

Waterway	Bank	Unit Miles	Inspection Start/End	Inspector
Unit No. 01 Yolo Bypass	Left	15.41	11/02/2018 11/07/2018	Luz Dial

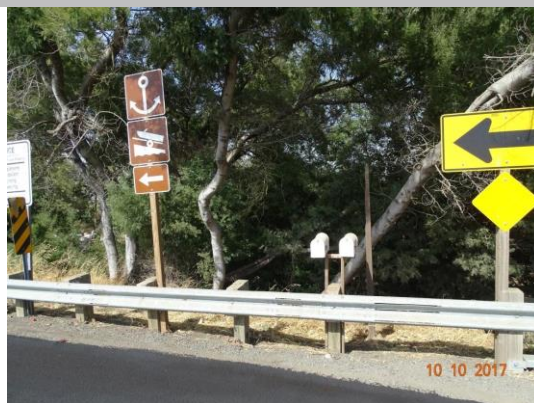
Photo 1 of 2 : FA_2018_RD0999_233_19_20180910_00016.jpg

LM Start	0.83	Rating **	M	Issue No.	19
LM End	0.83	Issue Type +	Ma	Location *	LS
Category	Earthen Levee			GPS Latitude/Longitude	
				Start	End
Item	Trim / Thin Trees			38.292386 °	38.292386 °
				-121.630543 °	-121.630543 °
DWR ID	DWR_RD0999_02_f _ 2012_19				
Comment Code					
T2 : Thin trees to allow visibility of the ground and room to flood fight.					
Inspector Comment

View of landside slope looking north. Fall 2017

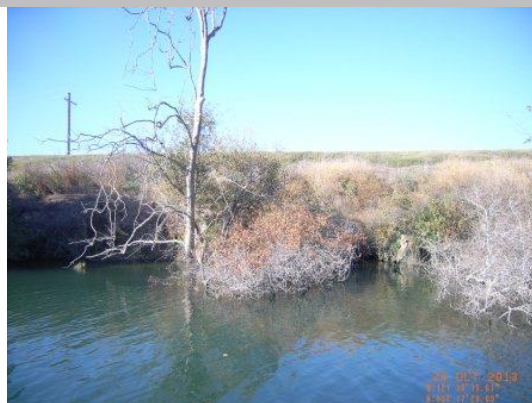
Photo 1 of 1 : FA_2018_RD0999_234_5_20181119_00004.jpg

Comment Code					
Inspector Comment					
2017 Site ID: STR 24.7 R					
Status: Critical					
2017 Field Notes: Locals have placed rock in worst sections. Fresh erosion at toe. New tall vertical sections observed.					
Site History: 1997 - Intermittent over-steepened sections. Large riparian vegetation along the length of the entire reach. Attempts to repair with rock on bank have failed. 1999 - New rock repair at the downstream end. 2002 - Some minor spot repairs. 2009 - Minimal new erosion. 2010 - Appears that fresh rock placed on downstream portion of site. Toe scour and overhanging trees with some overturned. 2012 - Minor new erosion at the toe. 2013 - Site upgraded to CRITICAL. Severe slumping into levee at downstream end of site. Fresh erosion into bank toe. 2015 - New slumping, tall vertical sections. 2016 - Upper slumped section continues to worsen. 2017 DWR Inspector: Erosion not easily visible from levee crown or slope.

USACE 2013 Photo #1

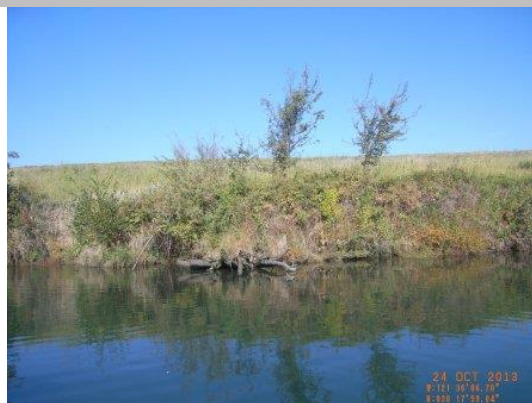
Photo 1 of 1 : FA_2018_RD0999_234_6_20181119_00005.jpg

LM Start	0.97	Rating **	M	Issue No.	6
LM End	1.10	Issue Type +	Ma	Location *	WS
Category	Supplemental			GPS Latitude/Longitude	
				Start	End
Item	2017 USACE Erosion Survey, DRAFT			38.299402 °	38.300542 °
				-121.603056 °	-121.601118 °
DWR ID	DWR_RD0999_03_f_2018_6				
Comment Code					
Inspector Comment					
2017 Site ID: STR 25.2 R					
Status: Eroding					
2017 Field Notes: Minor new erosion at toe.					
Site History: 2008 - Over steepened levee section. 2009 - Significant new erosion. 2010 - Minor new erosion. 2018 DWR Inspector: Erosion not visible from levee slope.

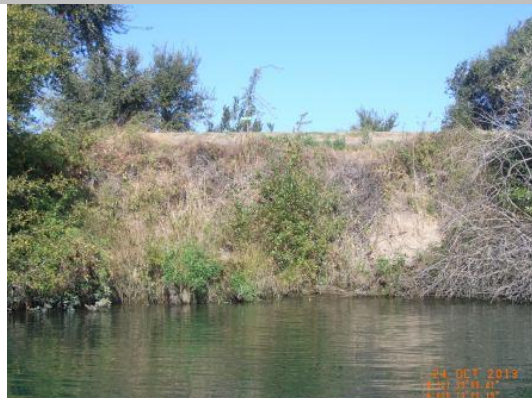
Photo 1 of 1 : FA_2018_RD0999_234_18_20181119_00046.jpg

LM Start	1.43	Rating **	M	Issue No.	18
LM End	1.58	Issue Type +	Ma	Location *	WS
Category	Supplemental			GPS Latitude/Longitude	
				Start	End
Item	2017 USACE Erosion Survey, DRAFT			38.305229 °	38.306667 °
				-121.599933 °	-121.598266 °
DWR ID	DWR_RD0999_03_f_2018_18				
Comment Code					
Inspector Comment					
2017 Site ID: STR 25.7 R					
Status: Eroding					
2017 Field Notes: Large erosion scarp near downstream end.					
Site History: 2011 - Toe scour along length of site and erosion pockets.					
2012 - Site extended slightly upstream due to new erosion pocket.					
2013 - Tall vertical sections at upstream end of site.

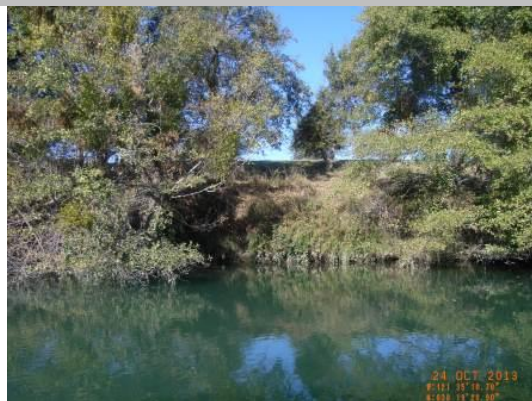
Photo 1 of 1 : FA_2018_RD0999_234_29_20181119_00048.jpg

LM Start	2.97	Rating **	A/W	Issue No.	29
LM End	3.23	Issue Type +	Ma	Location *	WS
Category	Supplemental			GPS Latitude/Longitude	
				Start	End
Item	2017 USACE Erosion Survey, DRAFT			38.323419 °	38.325592 °
				-121.589645 °	-121.585925 °
DWR ID	DWR_RD0999_03_f_2018_29				
Comment Code					
Inspector Comment					
2017 Site ID: STR 27.3 R Status: Eroding 2017 Field Notes: site extended downstream. section of lower bank has slumped off. fresh toe erosion. pipe encroachment. fresh tree popout Site History: 2011 - Multiple erosion pockets. Some likely from tree popouts. 2013 - Tall vertical sections. 2015 - New tree pop-out and significant new erosion. 2016 - New erosion at toe. 2018 DWR Inspector: Erosion not visible from levee slope.

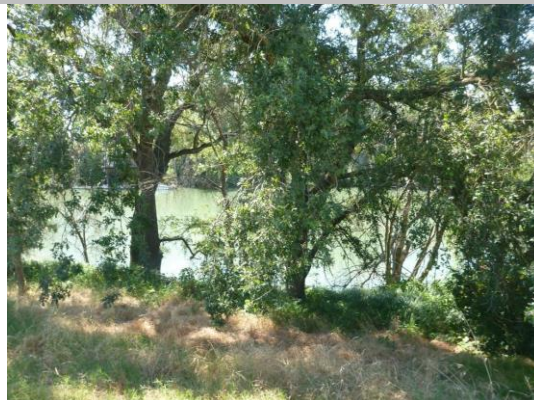
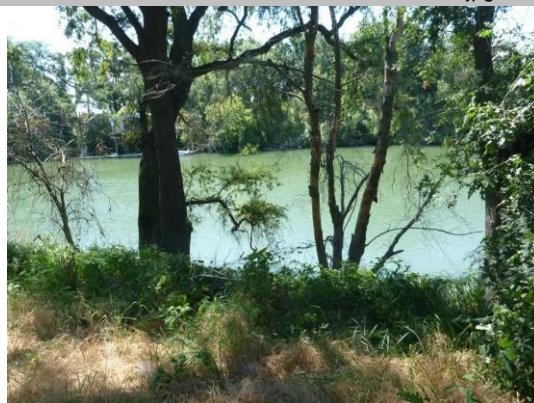
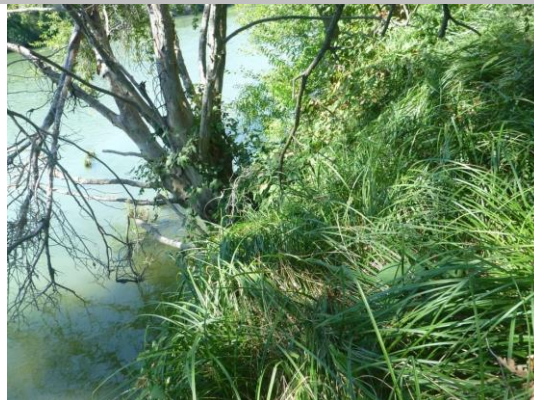
LM Start	3.09	Rating **	M	Issue No.	9 (cont)
LM End	3.12	Issue Type +	Ma	Location *	WS
Category	Supplemental			GPS Latitude/Longitude	
				Start	End
Item	2017 Storm Damage			38.323986 °	38.324275 °
				-121.587403 °	-121.586967 °
DWR ID	DWR_RD0999_03_f_2017_9

Description: The damage consists of erosion of the lower waterside levee slope and bank approximately 147 feet in length along the west (right) bank of Sutter Slough. See attached pages for photos. Site location T06N R03E Section 36 and 25.

Notes: Fall 2018 DWR Inspector: Observed erosion into the bank and fallen tree. End LM not given on report.

LM Start	3.09	Rating **	M	Issue No.	9 (cont)							
LM End	3.12	Issue Type +	Ma	Location *	WS							
Category	Supplemental		GPS Latitude/Longitude									
			Start	End								
Item	2017 Storm Damage		38.323986°	38.324275°								
			-121.587403°	-121.586967°								
DWR ID	DWR_RD0999_03_f_2017_9											
Comment Code												
Inspector Comment												
Levee Evaluation Comments Description: The damage consists of erosion of the lower waterside levee slope and bank approximately 147 feet in length along the west (right) bank of Sutter Slough. See attached pages for photos. Site location T06N R03E Section 36 and 25. Site ID No: 355 Site Designation: LMA-182 Repair Type: Erosion Rating: Area of Concern Field Date: 7/27/2017 Notes: Fall 2018 DWR Inspector: Observed erosion into the bank and fallen tree. End LM not given on report.

Repair Type: Erosion

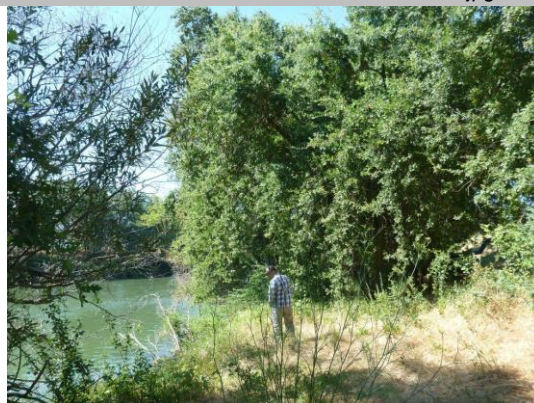
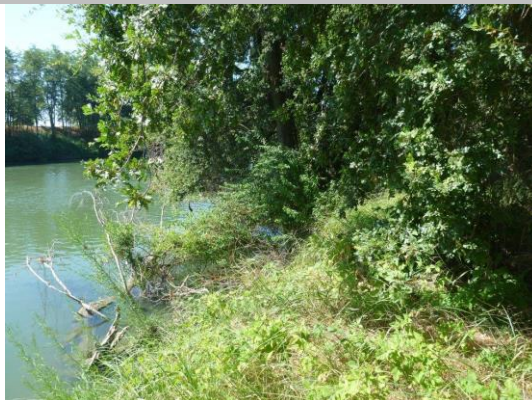
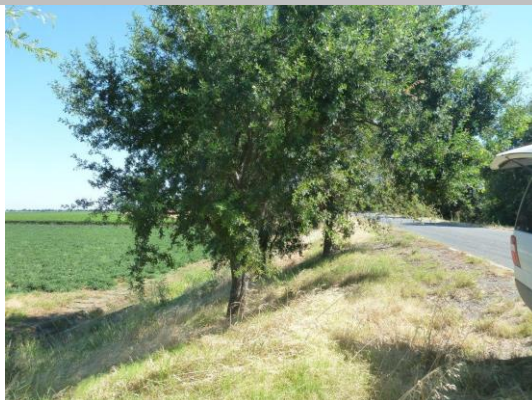
LM Start	3.18	Rating **	A/W	Issue No.	15							
LM End	3.21	Issue Type +	Ma	Location *	WS							
Category	Supplemental		GPS Latitude/Longitude									
			Start	End								
Item	2017 Storm Damage		38.325053°	38.325489°								
			-121.586347°	-121.586100°								
DWR ID	DWR_RD0999_03_f_2017_15											
Comment Code												
Inspector Comment												
Levee Evaluation Comments Description: The damage consists of erosion of the lower waterside levee slope and bank approximately 172 feet in length along the west (right) bank of Sutter Slough. See attached pages for photos. Site location T06N R04E Section 3 and 4. Site ID No: 356 Site Designation: LMA-183 Repair Type: Erosion Rating: Area of Concern Field Date: 7/27/2017 Notes: 2018 DWR Inspector: Erosion not visible from levee slope.

Description: The damage consists of erosion of the lower waterside levee slope and bank approximately 172 feet in length along the west (right) bank of Sutter Slough. See attached pages for photos. Site location T06N R04E Section 3 and 4.

Repair Type: Erosion

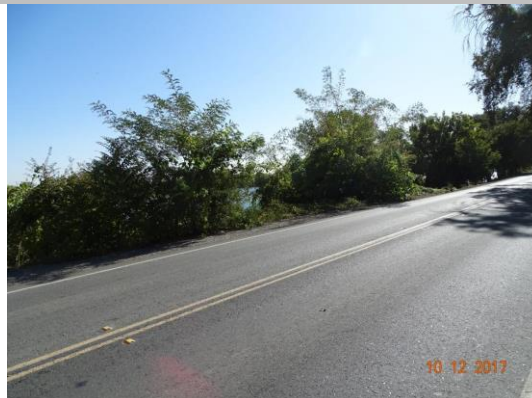
Photo 1 of 1 : FA_2018_RD0999_235_53_20180910_00039.jpg

LM Start	0.04	Rating **	U	Issue No.	53
LM End	0.06	Issue Type +	Ma	Location *	WS
Category	Earthen Levee			GPS Latitude/Longitude	
				Start	End
Item	Vegetation			38.414533 °	38.414750 °
				-121.523394 °	-121.523543 °
DWR ID	DWR_RD0999_04_f_2017_53				
Comment Code					
V2 : Remove the wild growth other than native grasses from the levee slopes.					
Inspector Comment					
Dense vegetation on waterside slope.

Looking southeast at the waterside slope.

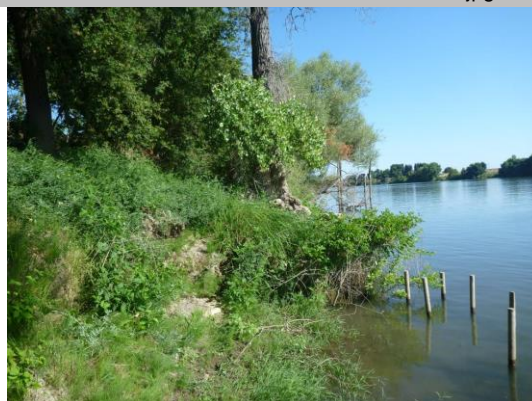
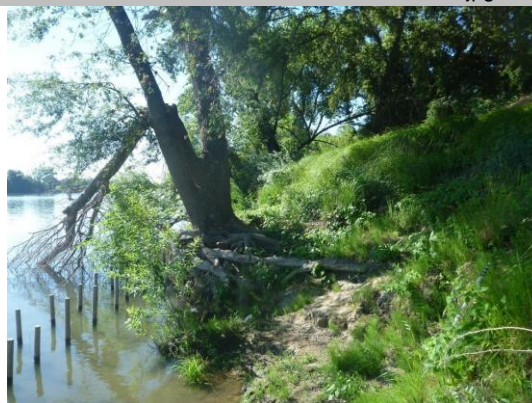
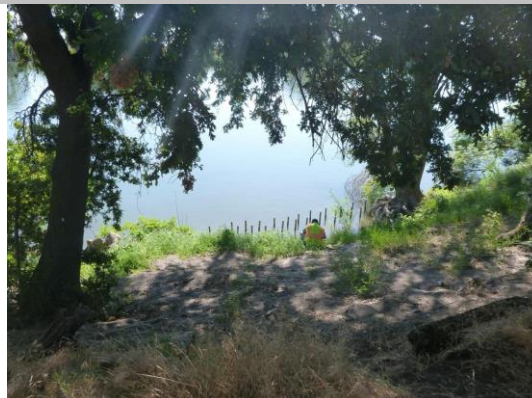
LM Start	0.10	Rating **	A/W	Issue No.	42 (cont)
LM End	0.29	Issue Type +	Ma	Location *	WS
Category	Supplemental			GPS Latitude/Longitude	
				Start	End
Item	2017 Storm Damage			38.415319 °	38.417744 °
				-121.523717 °	-121.525344 °
DWR ID	DWR_RD0999_04_f_2017_42				
Comment Code					
Inspector Comment					
Levee Evaluation Comments					
Description:The damage consists of erosion of the lower and mid waterside levee slope approximately 997 feet in length along the west (right) bank of the Sacramento River. See attached pages for photos. Site location T06N R04E Section 3 and 4.					
Site ID No:357					
Site Designation:LMA-184					
Repair Type: Erosion					
Rating:Serious					
Field Date:7/27/2017					
Notes: on bank slope, big trees with exposed tree roots observed 2018 DWR Inspector: Fallen tree on water's edge.					
Erosion not visible from slope.

LM Start	0.10	Rating **	A/W	Issue No.	42 (cont)	
LM End	0.29	Issue Type +	Ma	Location *	WS	
Category	Supplemental			GPS Latitude/Longitude		
				Start	End	
Item	2017 Storm Damage			38.415319 °	38.417744 °	
				-121.523717 °	-121.525344 °	
DWR ID	DWR_RD0999_04_f_2017_42					
Comment Code						
Inspector Comment						
Levee Evaluation Comments						
Description:The damage consists of erosion of the lower and mid waterside levee slope approximately 997 feet in length along the west (right) bank of the Sacramento River. See attached pages for photos. Site location T06N R04E Section 3 and 4.						
Site ID No:357						
Site Designation:LMA-184						
Repair Type: Erosion						
Rating:Serious						
Field Date:7/27/2017						
Notes: on bank slope, big trees with exposed tree roots observed 2018 DWR Inspector: Fallen tree on water's edge.						
Erosion not visible from slope.

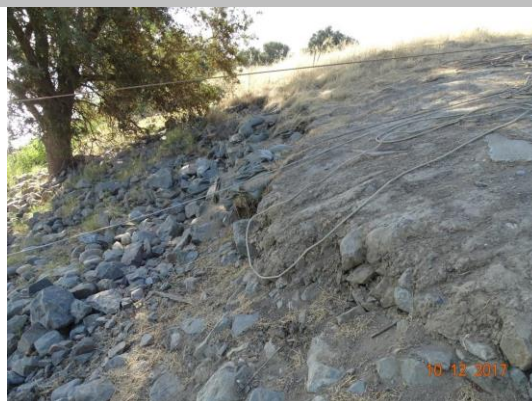
Photo 1 of 3 : FA_2018_RD0999_235_47_20180910_00035.jpg

LM Start	1.10	Rating **	M	Issue No.	47
LM End	1.10	Issue Type +	Ma	Location *	WS
Category	Earthen Levee			GPS Latitude/Longitude	
				Start	End
Item	Erosion / Bank Caving			38.428152 °	38.428152 °
				-121.532502 °	-121.532502 °
DWR ID	DWR_RD0999_04_s_2017_47				
Comment Code					
E1 : Note and monitor erosion site.					
Inspector Comment					
Small erosion just above riprap on waterside toe and runoff erosion on waterside slope.

Looking southeast at the waterside slope.

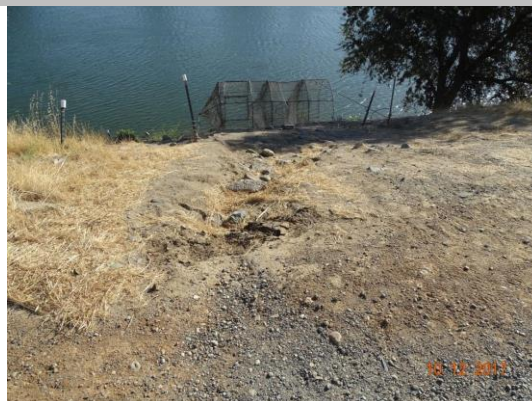
Photo 2 of 3 : FA_2018_RD0999_235_47_20180910_00036.jpg

Looking east at the waterside slope.

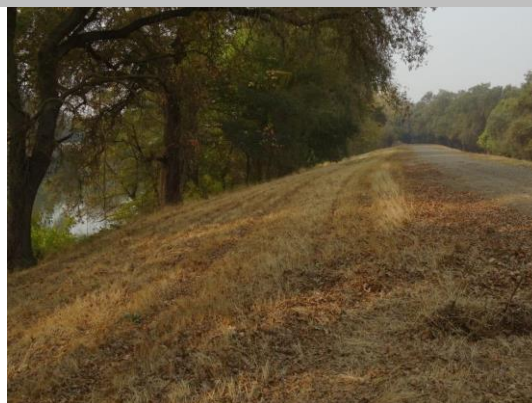
Photo 1 of 1 : FA_2018_RD0999_236_80_20181116_00195.jpg

LM Start	3.38	Rating **	A	Issue No.	80
LM End	3.60	Issue Type +	Ma	Location *	WS
Category	Earthen Levee			GPS Latitude/Longitude	
				Start	End
Item	Vegetation			38.363812 °	38.366448 °
				-121.557258 °	-121.556888 °
DWR ID	DWR_RD0999_05_f_2018_80				
Comment Code					
V1 : Control annual grass and weeds on the levee slopes and easements.					
Inspector Comment					
Waterside vegetation is maintained.

View of maintained waterside vegetation. Fall 2018

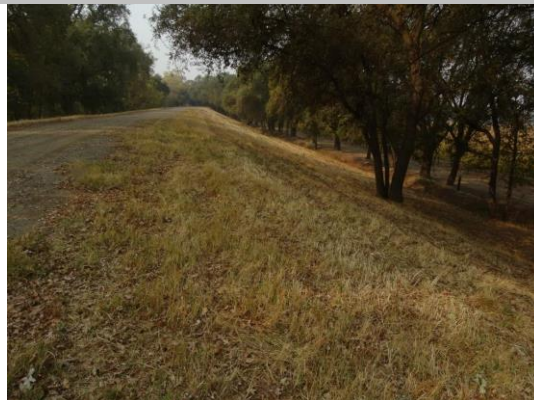
Photo 1 of 1 : FA_2018_RD0999_236_79_20181116_00194.jpg

LM Start	3.39	Rating **	A	Issue No.	79
LM End	3.57	Issue Type +	Ma	Location *	LS
Category	Earthen Levee			GPS Latitude/Longitude	
				Start	End
Item	Vegetation			38.363853 °	38.366057 °
				-121.557218 °	-121.556822 °
DWR ID	DWR_RD0999_05_f_2018_79				
Comment Code					
V1 : Control annual grass and weeds on the levee slopes and easements.					
Inspector Comment					
Landside vegetation is maintained.

View of maintained landside vegetation. Fall 2018
