**Flood Control Project Maintenance  
Levee Inspections**

**Maintenance Issue Types Only, Levee Inspection Report By Mile - Fall 2019**

**Reclamation District No. 0999 Netherlands**

Waterway	Bank	Unit Miles	Inspection Start/End	Inspector
Unit No. 01 Yolo Bypass	Left	15.41	09/25/2019 09/25/2019	Luz Dial

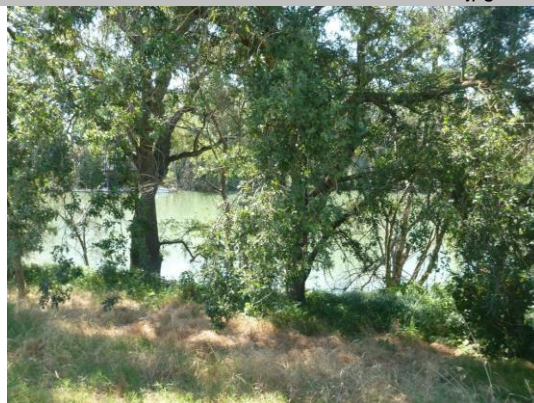
Photo 3 of 5 : LEVAL\_FA\_2019\_355\_2523.jpg

Description: The damage consists of erosion of the lower waterside levee slope and bank approximately 147 feet in length along the west (right) bank of Sutter Slough. See attached pages for photos. Site location T06N R03E Section 36 and 25.

Notes: Fall 2018 DWR Inspector: Observed erosion into the bank and fallen tree. End LM not given on report.

View of fallen tree at water's edge. Fall 2018

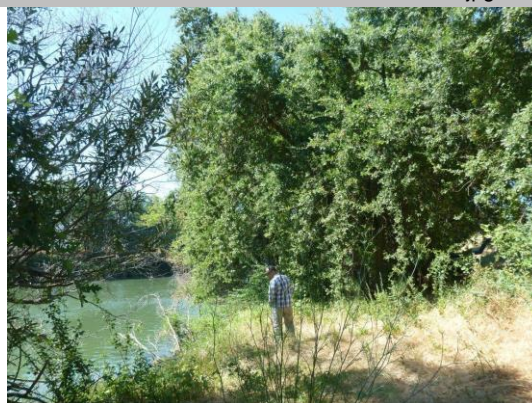
Photo 1 of 3 : LEVAL\_FA\_2019\_356\_2492.jpg

LM Start	3.18	Rating **	A/W	Issue No.	15
LM End	3.21	Issue Type +	Ma	Location *	WS
Category	Supplemental			GPS Latitude/Longitude	
				Start	End
Item	2017 Storm Damage			38.325053 °	38.325489 °
				-121.586347 °	-121.586100 °
DWR ID	LMA-183				
Comment Code					
Inspector Comment					
Levee Evaluation Comments					
Description:The damage consists of erosion of the lower waterside levee slope and bank approximately 172 feet in length along the west (right) bank of Sutter Slough. See attached pages for photos. Site location T06N R04E Section 3 and 4.					
Site ID No:356					
Site Designation:LMA-183					
Repair Type: Erosion					
Rating:Area of Concern					
Field Date:7/27/2017					
Notes: 2018 DWR Inspector: Erosion not visible from levee slope.

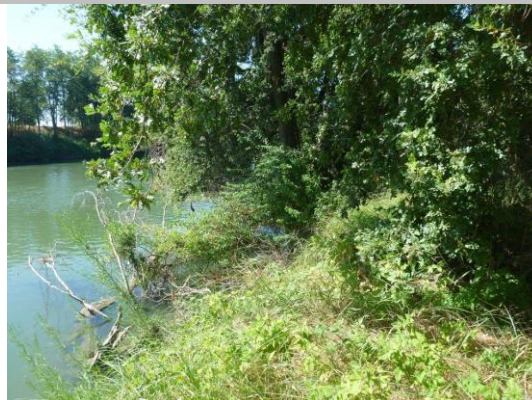
Photo 2 of 3 : LEVAL\_FA\_2019\_356\_2493.jpg

LM Start	3.18	Rating **	A/W	Issue No.	15 (cont)	
LM End	3.21	Issue Type +	Ma	Location *	WS	
Category	Supplemental			GPS Latitude/Longitude		
				Start	End	
Item	2017 Storm Damage			38.325053 °	38.325489 °	
				-121.586347 °	-121.586100 °	
DWR ID	LMA-183					
Comment Code						
Inspector Comment						
Levee Evaluation Comments						
Description:The damage consists of erosion of the lower waterside levee slope and bank approximately 172 feet in length along the west (right) bank of Sutter Slough. See attached pages for photos. Site location T06N R04E Section 3 and 4.						
Site ID No:356						
Site Designation:LMA-183						
Repair Type: Erosion						
Rating:Area of Concern						
Field Date:7/27/2017						
Notes: 2018 DWR Inspector: Erosion not visible from levee slope.

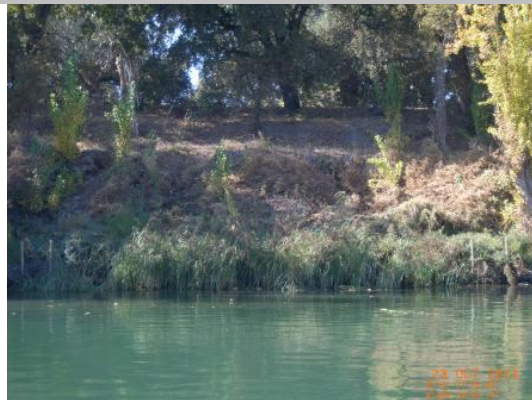
Photo 1 of 1 : FA\_2019\_RD0999\_235\_23\_20190904\_00011.jpg

LM Start	0.02	Rating **	U	Issue No.	23
LM End	0.28	Issue Type +	Ma	Location *	WS
Category	Supplemental			GPS Latitude/Longitude	
				Start	End
Item	2017 USACE Erosion Survey			38.414387 °	38.417692 °
				-121.522871 °	-121.525083 °
DWR ID	DWR_RD0999_04_f_2019_23				
Comment Code					
Inspector Comment					
2017 Site ID: SAC 41.9 R					
Status: Critical					
2017 Field Notes: Fresh erosion on entire bank. Upgraded to critical.					
Site History: 1997 - Structural problem rather than erosional, failed cobble at downstream end. 2005 - New brush boxes at waterline for several hundred feet downstream, No toe or bank protection present.					
2006 - Some minor new erosion. Brush boxes not working well; most of the brush has floated out. 2007 - Brush boxes have recently been repaired. 2016 - Minor new slumping.

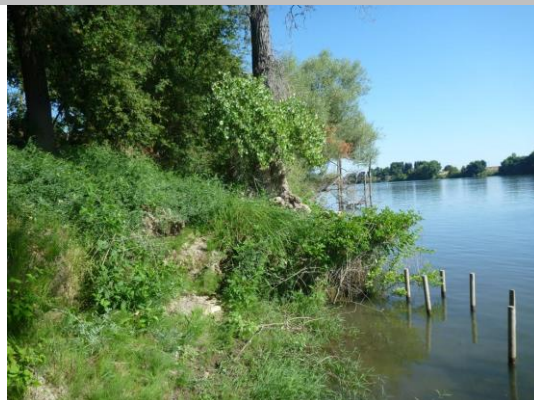
Photo 2 of 4 : LEVAL\_FA\_2019\_357\_2461.jpg

Comment Code					
Inspector Comment					
Levee Evaluation Comments					
Description:The damage consists of erosion of the lower and mid waterside levee slope approximately 997 feet in length along the west (right) bank of the Sacramento River. See attached pages for photos. Site location T06N R04E Section 3 and 4.					
Site ID No:357					
Site Designation:LMA-184					
Repair Type: Erosion					
Rating:Serious					
Field Date:7/27/2017					
Notes: on bank slope, big trees with exposed tree roots observed 2018 DWR Inspector: Fallen tree on water's edge. Erosion not visible from slope. Fall 2019 DWR Inspector: A tree with exposed rootball and a fallen tree exist on the erosion site between LM 0.19-0.20.

View of fallen tree. Fall 2018

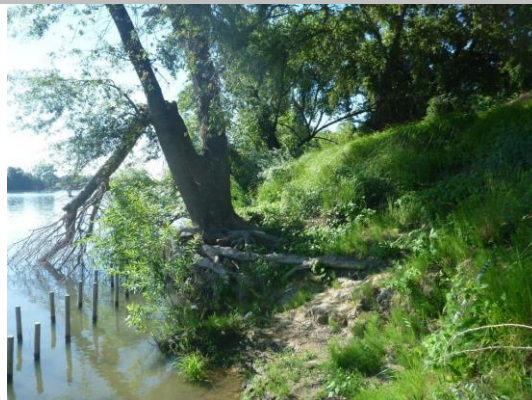
Photo 3 of 4 : LEVAL\_FA\_2019\_357\_2465.jpg

Item	2017 Storm Damage			38.415319 °		38.417744 °
				-121.523717 °		-121.525344 °
DWR ID	LMA-184					
Comment Code						
Inspector Comment						
Levee Evaluation Comments						
Description:The damage consists of erosion of the lower and mid waterside levee slope approximately 997 feet in length along the west (right) bank of the Sacramento River. See attached pages for photos. Site location T06N R04E Section 3 and 4.						
Site ID No:357						
Site Designation:LMA-184						
Repair Type: Erosion						
Rating:Serious						
Field Date:7/27/2017						
Notes: on bank slope, big trees with exposed tree roots observed 2018 DWR Inspector: Fallen tree on water's edge. Erosion not visible from slope. Fall 2019 DWR Inspector: A tree with exposed rootball and a fallen tree exist on the erosion site between LM 0.19-0.20.
