**Flood Control Project Maintenance  
Levee Inspections**

## Maintenance Issue Types Only, Levee Inspection Report By Mile - Fall 2021

### Reclamation District No. 0999 Netherlands

Waterway	Bank	Unit Miles	Inspection Start/End	Inspector
Unit No. 01 Yolo Bypass	Left	15.41	09/30/2021 09/30/2021	Marvin Marshall

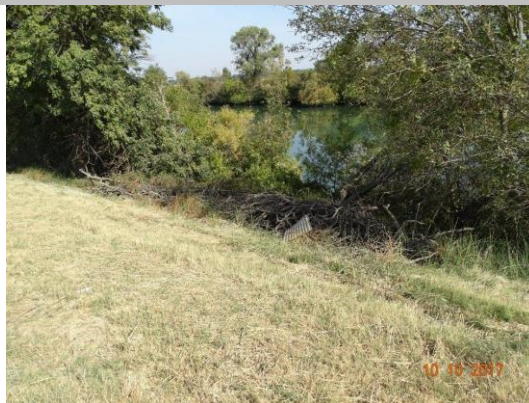
Photo 1 of 1 : FA\_2021\_RD0999\_234\_32\_20210823\_00016.jpg

LM Start	0.04	Rating **	A/W	Issue No.	32
LM End	0.04	Issue Type +	Ma	Location *	WS
Category	Earthen Levee			GPS Latitude/Longitude	
				Start	End
Item	Encroachments			38.287040 °	38.287040 °
				-121.605667 °	-121.605667 °
DWR ID	DWR_RD0999_03_f_2017_32				
Comment Code					
PR : Prunings					
Inspector Comment					
Remove the large pruning pile on the waterside slope.

View of waterside slope looking east. Fall 2017

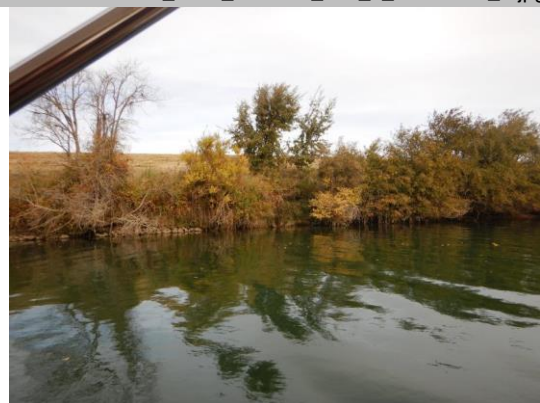
Photo 1 of 2 : FA\_2021\_RD0999\_234\_6\_20211218\_4.jpg

LM Start	0.97	Rating **	M	Issue No.	6
LM End	1.10	Issue Type +	Ma	Location *	WS
Category	Supplemental			GPS Latitude/Longitude	
				Start	End
Item	2018 USACE Erosion Survey			38.299402 °	38.300542 °
				-121.603056 °	-121.601118 °
DWR ID					
Comment Code					
Inspector Comment					
2018 Site ID: STR 25.2 R					
Status: Eroding					
2018 Field Notes: New large slump on upper levee slope.					
Site History: 2008 - Over steepened levee section. 2009 - Significant new erosion. 2010 - Minor new erosion. 2017 - Minor new erosion at toe.

USACE 2018 Erosion Photo #1

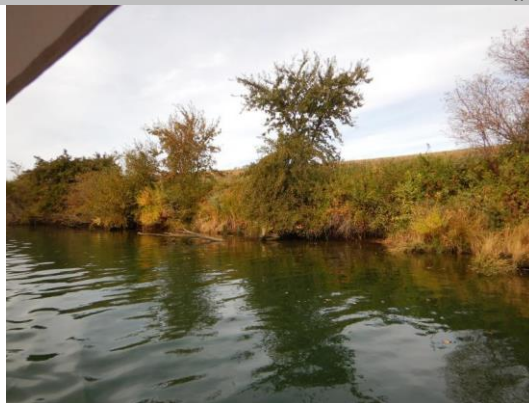
Photo 2 of 2 : FA\_2021\_RD0999\_234\_6\_20211218\_5.jpg

LM Start	0.97	Rating **	M	Issue No.	6 (cont)
LM End	1.10	Issue Type +	Ma	Location *	WS
Category	Supplemental			GPS Latitude/Longitude	
				Start	End
Item	2018 USACE Erosion Survey			38.299402 °	38.300542 °
				-121.603056 °	-121.601118 °
DWR ID

USACE 2018 Erosion Photo #2

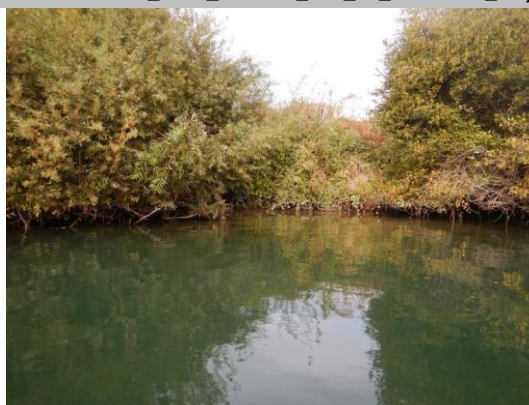
Photo 1 of 2 : FA\_2021\_RD0999\_234\_10\_20211218\_18.jpg

2018 Site ID: STR 25.7 R  
 Status: Eroding  
 2018 Field Notes: Site extended upstream.  
 Site History: 2011 - Toe scour along length of site and erosion pockets.  
 2012 - Site extended slightly upstream due to new erosion pocket.  
 2013 - Tall vertical sections at upstream end of site. 2017 - Large erosion scarp near downstream end.

USACE 2018 Erosion Photo #1

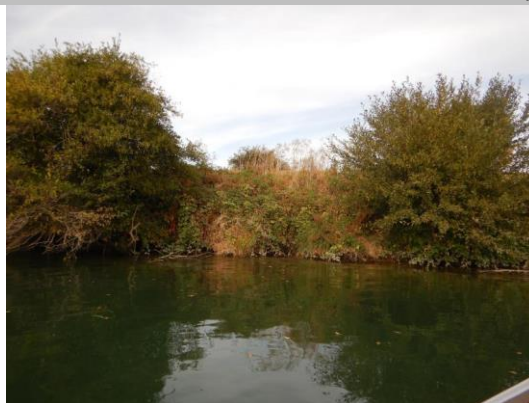
Photo 2 of 2 : FA\_2021\_RD0999\_234\_10\_20211218\_19.jpg

LM Start	<b>1.43</b>	Rating **	A/W	Issue No.	<b>10 (cont)</b>
LM End	<b>1.57</b>	Issue Type +	Ma	Location *	WS
Category	Supplemental		GPS Latitude/Longitude		
			Start	End	
Item	2018 USACE Erosion Survey		38.305229 °	38.306667 °	
			-121.599933 °	-121.598266 °	
DWR ID

USACE 2018 Erosion Photo #2

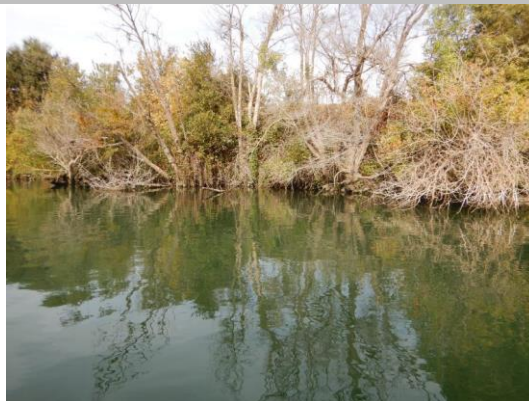
Photo 2 of 2 : FA\_2021\_RD0999\_234\_12\_20211218\_21.jpg

2018 Site ID: STR 26.1 R  
Status: Eroding  
2018 Field Notes: No observed change.  
Site History: 2015 - Tall vertical sections into the levee slope and erosion along the toe. 2016 - New tree pop-out observed.

USACE 2018 Erosion Photo #2

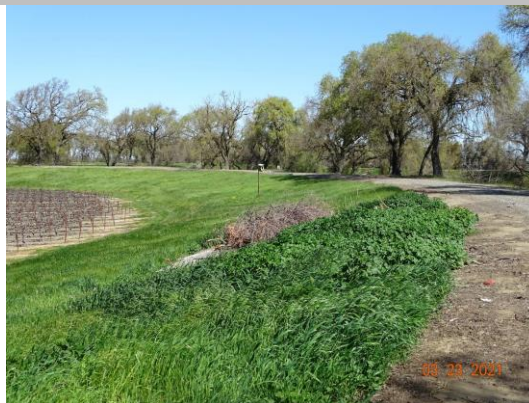
Photo 1 of 1 : FA\_2021\_RD0999\_236\_106\_20210823\_00035.jpg

LM Start	5.06	Rating **	M	Issue No.	106
LM End	5.06	Issue Type +	Ma	Location *	LS
Category	Earthen Levee			GPS Latitude/Longitude	
				Start	End
Item	Encroachments			38.379604 °	38.379604 °
				-121.541102 °	-121.541102 °
DWR ID	DWR_RD0999_05_s_2019_106				
Comment Code					
DE : Debris					
Inspector Comment					
Remove the debris and prunings on the LS levee slope. Spring 2021.

View of the debris and pruning pile on the LS levee slope. Spring 2021.
