**Flood Control Project Maintenance  
Levee Inspections**

**Maintenance Issue Types Only, Levee Inspection Report By Mile - Fall 2022**

**Reclamation District No. 0999 Netherlands**

Waterway	Bank	Unit Miles	Inspection Start/End	Inspector
Unit No. 01 Yolo Bypass	Left	15.41	10/10/2022 10/10/2022	Marvin Marshall

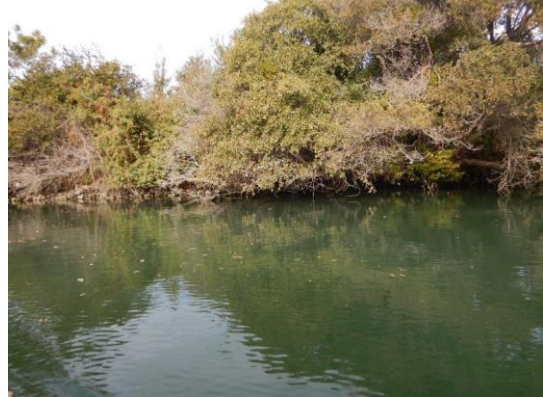
Photo 1 of 2 : FA\_2022\_RD0999\_234\_12\_20220822\_00009.jpg

LM Start	1.93	Rating **	M	Issue No.	12
LM End	1.97	Issue Type +	Ma	Location *	WS
Category	Supplemental			GPS Latitude/Longitude	
				Start	End
Item	2018 USACE Erosion Survey			38.311013 °	38.311342 °
				-121.597751 °	-121.596976 °
DWR ID	DWR_RD0999_03_s_2022_12				
Comment Code					
Inspector Comment					
2018 Site ID: STR 26.1 R					
Status: Eroding					
2022 Field Notes: No observed change.					
Site History: 2015 - Tall vertical sections into the levee slope and erosion along the toe. 2016 - New tree pop-out observed. 2018 - No observed change.

USACE 2018 Erosion Photo #1

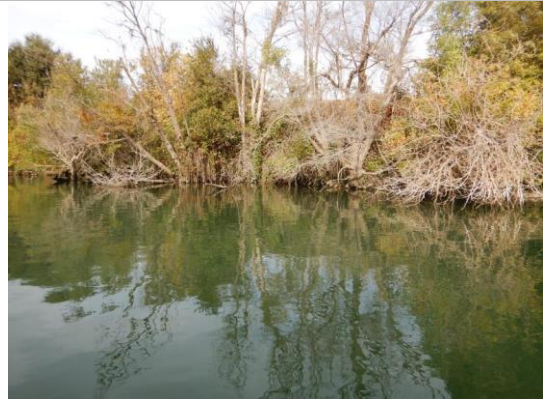
Photo 2 of 2 : FA\_2022\_RD0999\_234\_12\_20220822\_00010.jpg

USACE 2018 Erosion Photo #2

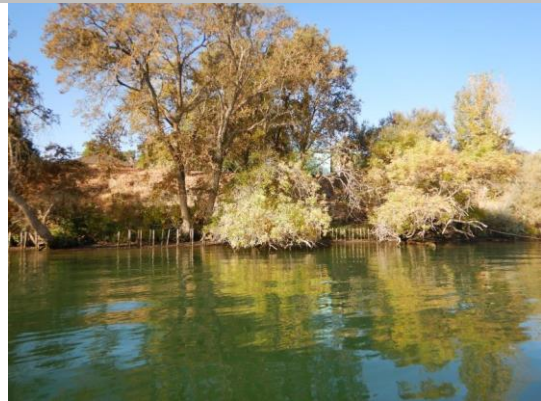
Photo 1 of 2 : FA\_2022\_RD0999\_235\_23\_20220822\_00004.jpg

2018 Site ID: SAC 41.9 R  
Status: Critical  
2022 Field Notes: No observed changes.  
Site History: 1997 - Structural problem rather than erosional, failed cobble at downstream end. 2005 - New brush boxes at waterline for several hundred feet downstream, No toe or bank protection present. 2006 - Some minor new erosion. Brush boxes not working well; most of the brush has floated out. 2007 - Brush boxes have recently been repaired. 2016 - Minor new slumping. 2017 - Fresh erosion on entire bank. Upgraded to CRITICAL. 2018 - Site continues to look worse.

USACE 2018 Erosion Photo #1

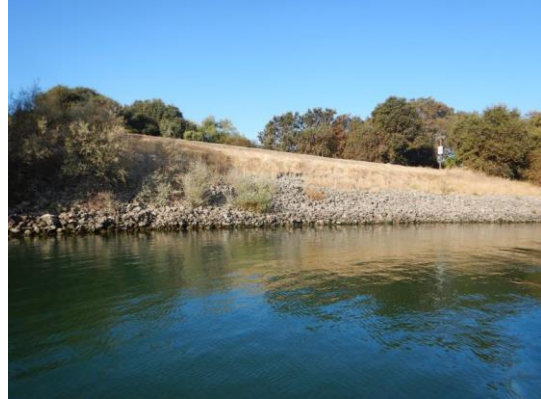
Photo 2 of 2 : FA\_2022\_RD0999\_235\_23\_20220822\_00005.jpg

USACE 2018 Erosion Photo #2
