**Flood Control Project Maintenance  
Levee Inspections**

**Maintenance Issue Types Only, Levee Inspection Report By Mile - Fall 2023**

**Reclamation District No. 0999 Netherlands**

Waterway	Bank	Unit Miles	Inspection Start/End	Inspector
Unit No. 01 Yolo Bypass	Left	15.41	10/27/2023 10/27/2023	Marvin Marshall

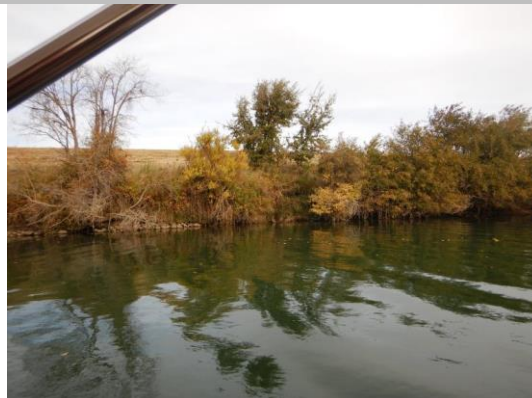
Photo 1 of 2 : FA\_2023\_RD0999\_234\_6\_20230905\_00003.jpg

LM Start	0.97	Rating **	M	Issue No.	6
LM End	1.10	Issue Type +	Ma	Location *	WS
Category	Supplemental			GPS Latitude/Longitude	
				Start	End
Item	2018 USACE Erosion Survey			38.299402°	38.300542°
				-121.603056°	-121.601118°
DWR ID	DWR_RD0999_03_s_2022_6				
Comment Code					
Inspector Comment					
2018 Site ID: STR 25.2 R					
Status: Eroding					
2022 Field Notes: No observed changes.					
Site History: 2008 - Over steepened levee section. 2009 - Significant new erosion. 2010 - Minor new erosion. 2017 - Minor new erosion at toe. 2018 - New large slump on upper levee slope.

USACE 2018 Erosion Photo #1
