**Flood Control Project Maintenance  
Levee Inspections**

## Maintenance Issue Types Only, Levee Inspection Report By Mile - Spring 2015

### Reclamation District No. 0999 Netherlands

Waterway	Bank	Unit Miles	Inspection Start/End	Inspector
Unit No. 01 Yolo Bypass	Left	15.41	03/23/2015 03/23/2015	Richard Willoughby

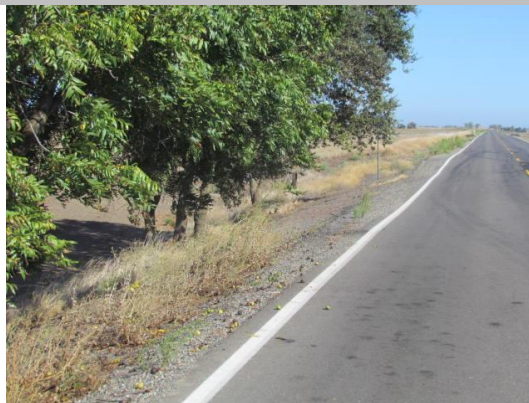
Photo 1 of 2 : SP\_2015\_RD0999\_232\_4\_20150309\_00006.jpg

LM Start	1.73	Rating **	A/W	Issue No.	4
LM End	1.75	Issue Type +	Ma	Location *	WS
Category	Earthen Levee			GPS Latitude/Longitude	
				Start	End
Item	Trim / Thin Trees			38.480082 °	38.479788 °
				-121.580930 °	-121.580918 °
DWR ID	DWR_RD0999_01_s _ 2012_4				
Action/Comments					
Trim trees to at least five feet above ground level.

Looking northwest at trimmed trees on waterward slope.

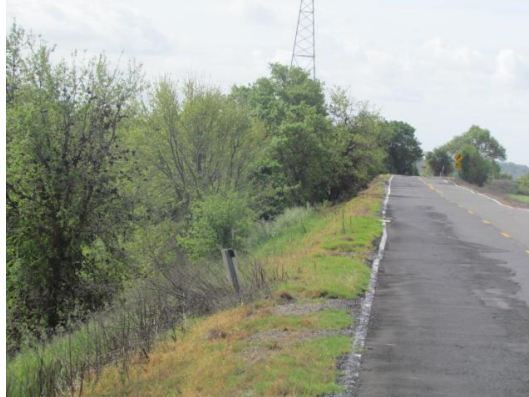
Photo 1 of 5 : SP\_2015\_RD0999\_232\_30\_20150327\_00072.jpg

LM Start	1.79	Rating **	M	Issue No.	30
LM End	2.04	Issue Type +	Ma	Location *	LS
Category	Earthen Levee			GPS Latitude/Longitude	
				Start	End
Item	Trim / Thin Trees			38.479165 °	38.475463 °
				-121.580640 °	-121.580722 °
DWR ID	DWR_RD0999_01_s_2012_30				
Action/Comments					
Trim trees to at least five feet above ground level.

Looking southeast at untrimmed trees on landward slope. (Spring 2015)

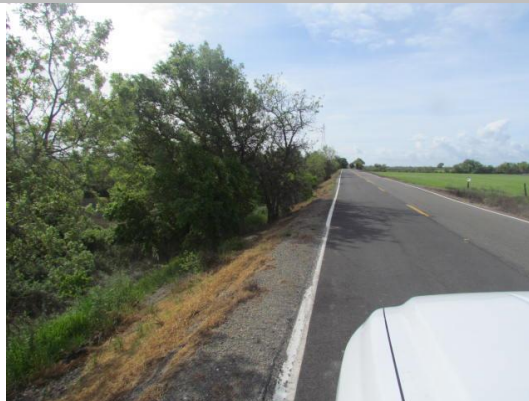
Photo 2 of 5 : SP\_2015\_RD0999\_232\_30\_20150327\_00073.jpg

Looking southeast at dense trees on landward slope. (Spring 2015)

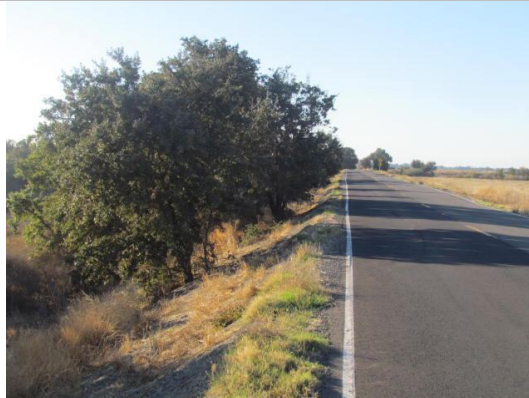
Photo 3 of 5 : SP\_2015\_RD0999\_232\_30\_20150309\_00030.jpg

Looking south at typical view of untrimmed trees on landward slope.

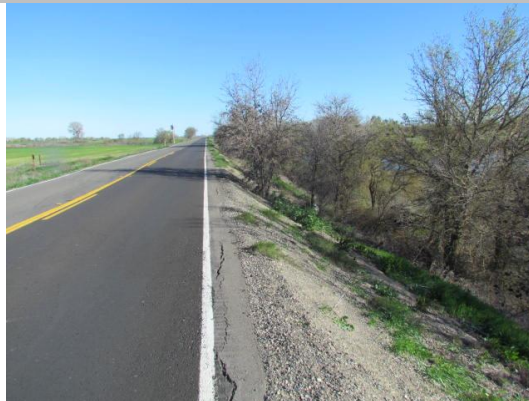
Photo 4 of 5 : SP\_2015\_RD0999\_232\_30\_20150309\_00031.jpg

LM Start	1.79	Rating **	M	Issue No.	30 (cont)	
LM End	2.04	Issue Type +	Ma	Location *	LS	
Category	Earthen Levee			GPS Latitude/Longitude		
				Start		End
Item	Trim / Thin Trees			38.479165 °		38.475463 °
				-121.580640 °		-121.580722 °
DWR ID	DWR_RD0999_01_s _ 2012_30					
Action/Comments						
Trim trees to at least five feet above ground level.

Looking north at several untrimmed trees on landside slope.

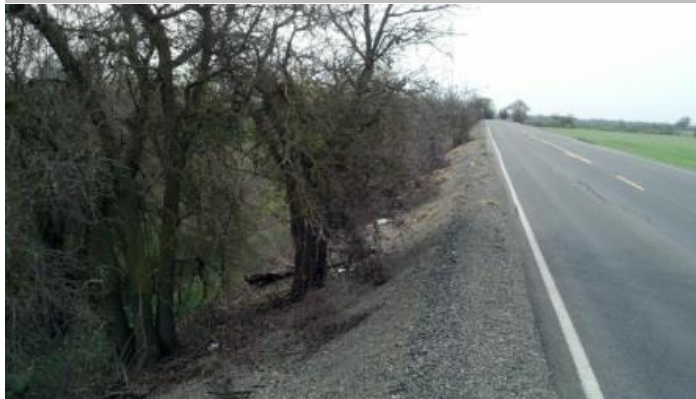
Photo 5 of 5 : SP\_2015\_RD0999\_232\_30\_20150309\_00032.jpg

Looking southeast at dense trees on landside slope and toe. (2013)

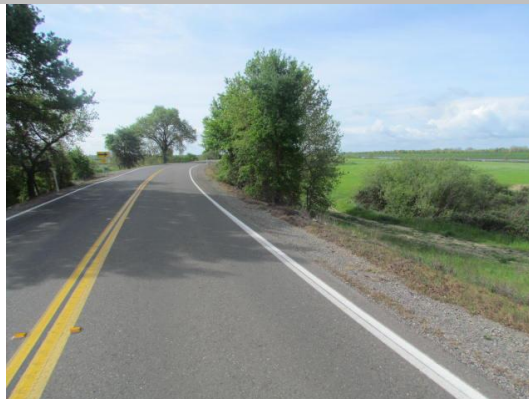
Photo 1 of 3 : SP\_2015\_RD0999\_232\_7\_20150327\_00074.jpg

LM Start	2.13	Rating **	M	Issue No.	7
LM End	2.13	Issue Type +	Ma	Location *	WS
Category	Earthen Levee			GPS Latitude/Longitude	
				Start	End
Item	Trim / Thin Trees			38.474258 °	38.474258 °
				-121.580528 °	-121.580528 °
DWR ID	DWR_RD0999_01_s _ 2012_7				
Action/Comments					
Trim trees to at least five feet above ground level.

Looking south at untrimmed trees on waterward slope. (Spring 2015)

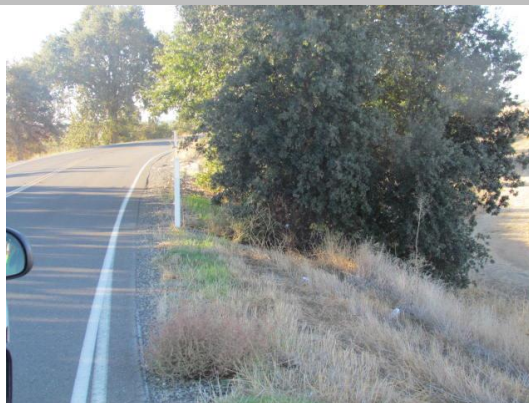
Photo 2 of 3 : SP\_2015\_RD0999\_232\_7\_20150309\_00013.jpg

LM Start	2.13	Rating **	M	Issue No.	7 (cont)	
LM End	2.13	Issue Type +	Ma	Location *	WS	
Category	Earthen Levee			GPS Latitude/Longitude		
				Start		End
Item	Trim / Thin Trees			38.474258 °	38.474258 °	
				-121.580528 °	-121.580528 °	
DWR ID	DWR_RD0999_01_s_2012_7					
Action/Comments						
Trim trees to at least five feet above ground level.

Looking south at untrimmed trees on waterward slope. (Fall 2014)

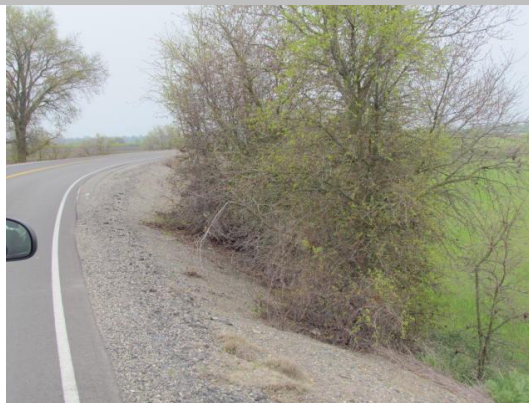
Photo 3 of 3 : SP\_2015\_RD0999\_232\_7\_20150309\_00014.jpg

Looking southwest at untrimmed trees on waterside slope.

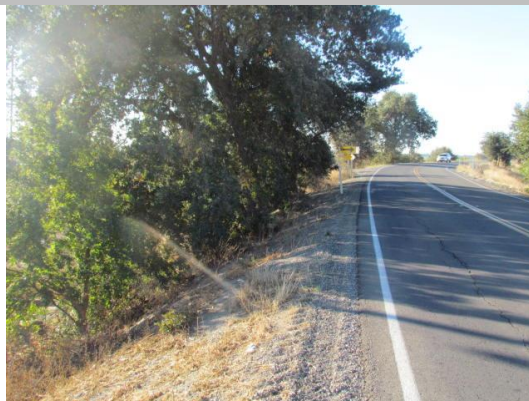
Photo 2 of 3 : SP\_2015\_RD0999\_232\_31\_20150309\_00033.jpg

LM Start	2.13	Rating **	M	Issue No.	31 (cont)	
LM End	2.13	Issue Type +	Ma	Location *	LS	
Category	Earthen Levee			GPS Latitude/Longitude		
				Start		End
Item	Trim / Thin Trees			38.474200 °		38.474200 °
				-121.580480 °		-121.580480 °
DWR ID	DWR_RD0999_01_s _ 2012_31					
Action/Comments						
Trim trees to at least five feet above ground level.

Looking southeast at untrimmed trees on landward slope. (Fall 2014)

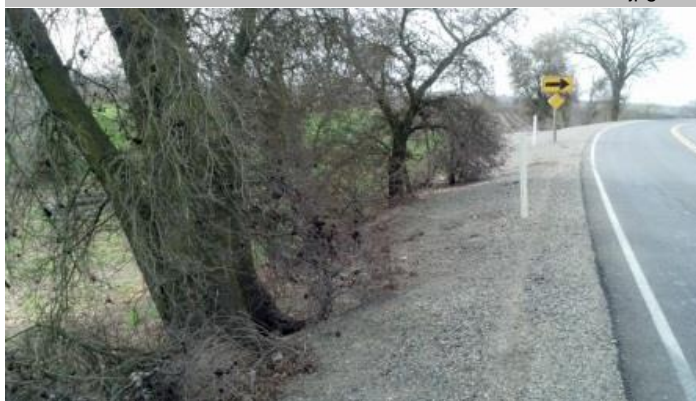
Photo 3 of 3 : SP\_2015\_RD0999\_232\_31\_20150309\_00034.jpg

Looking southeast at untrimmed trees on landside slope.

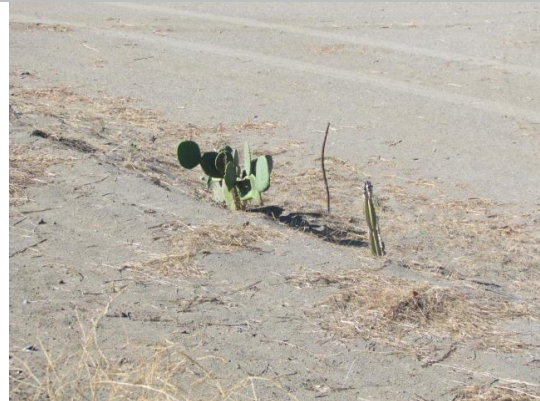
Photo 1 of 1 : SP\_2015\_RD0999\_232\_45\_20150309\_00045.jpg

LM Start	4.36	Rating **	A/W	Issue No.	45
LM End	4.36	Issue Type +	Ma	Location *	WS
Category	Earthen Levee			GPS Latitude/Longitude	
				Start	End
Item	Vegetation				o
					o
DWR ID	DWR_RD0999_01_f_2013_45				
Action/Comments					
Remove the wild growth other than native grasses from the levee slopes.					
Inspector Comments: Landowner has planted cactus on waterward toe.

Looking west at cactus on waterward toe.

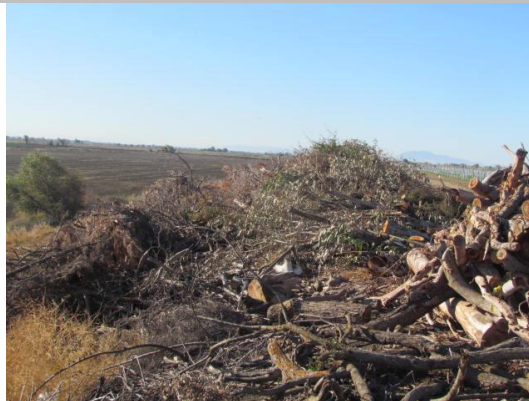
Photo 2 of 2 : SP\_2015\_RD0999\_232\_18\_20150309\_00017.jpg

LM Start	6.53	Rating **	A/W	Issue No.	18 (cont)	
LM End	6.58	Issue Type +	Ma	Location *	LS	
Category	Earthen Levee			GPS Latitude/Longitude		
				Start		End
Item	Encroachments			38.414367 °	38.413698 °	
				-121.608430 °	-121.608762 °	
DWR ID	DWR_RD0999_01_s _ 2012_18					
Action/Comments						
Prunings						
Inspector Comments: Large pruning piles on landward shoulder. Part of pruning pile blocking levee crown.

Looking northwest at large pruning piles on landward shoulder and slope. (Fall 2014)

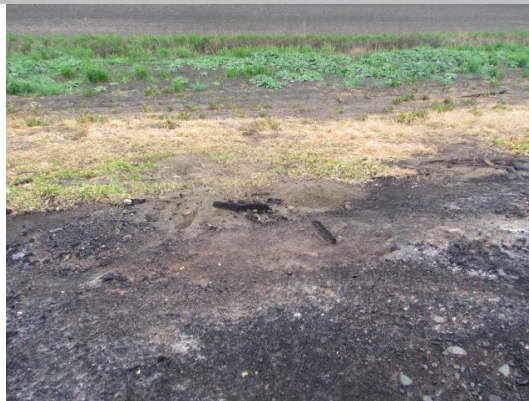
Photo 1 of 2 : SP\_2015\_RD0999\_232\_42\_20150309\_00042.jpg

LM Start	6.56	Rating **	A/W	Issue No.	42
LM End	6.56	Issue Type +	Ma	Location *	LS
Category	Earthen Levee			GPS Latitude/Longitude	
				Start	End
Item	Animal Control			38.413858 °	38.413858 °
				-121.608638 °	-121.608638 °
DWR ID	DWR_RD0999_01_s _ 2012_42				
Action/Comments					
Exterminate rodents and backfill and compact or grout burrows. Inspector Comments: More than five holes within 25' of levee.

Looking east at rodent holes on landside slope.

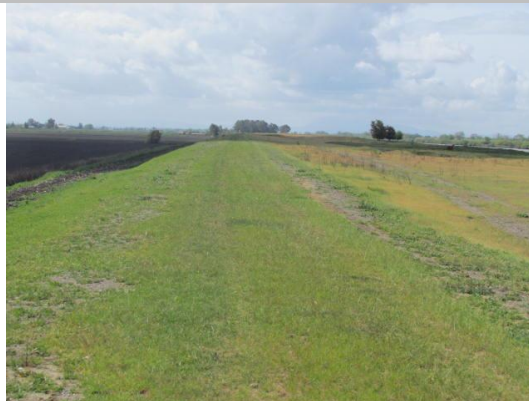
Photo 1 of 1 : SP\_2015\_RD0999\_232\_22\_20150327\_00079.jpg

LM Start	8.11	Rating **	M	Issue No.	22
LM End	8.88	Issue Type +	Ma	Location *	CR
Category	Earthen Levee			GPS Latitude/Longitude	
				Start	End
Item	Crown Surface / Depressions / Rutting			38.392797 °	38.382338 °
				-121.618363 °	-121.623343 °
DWR ID	DWR_RD0999_01_s _ 2012_22				
Action/Comments					
Add appropriate gravel or road base. Grade and compact.

Looking south at levee crown. (Spring 2015)

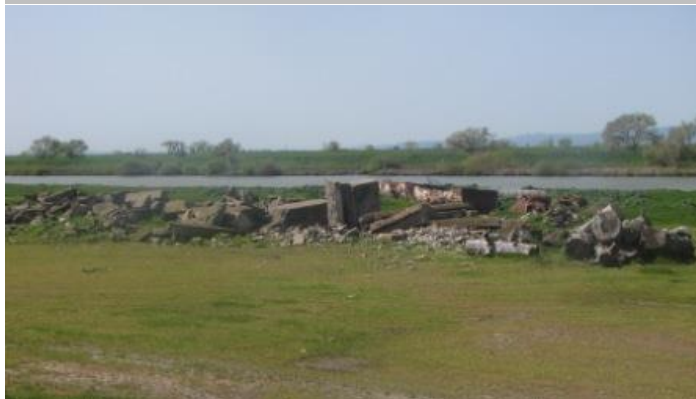
Photo 1 of 1 : SP\_2015\_RD0999\_232\_25\_20150309\_00024.jpg

LM Start	8.15	Rating **	M	Issue No.	25
LM End	8.15	Issue Type +	Ma	Location *	WS
Category	Earthen Levee			GPS Latitude/Longitude	
				Start	End
Item	Encroachments			38.392255 °	38.392255 °
				-121.618709 °	-121.618709 °
DWR ID	DWR_RD0999_01_s _ 2012_25				
Action/Comments					
Material Inspector Comments: Concrete rubble on waterside berm.

Looking west at concrete rubble on waterside berm.

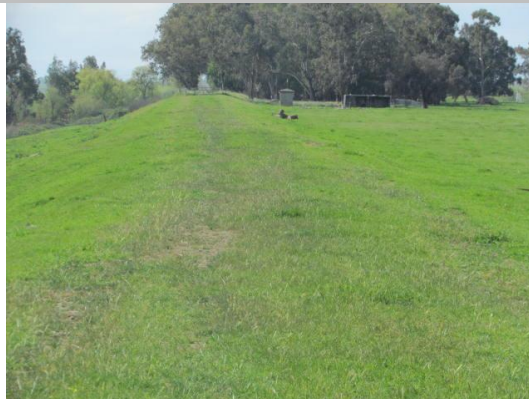
Photo 1 of 2 : SP\_2015\_RD0999\_232\_919\_20150327\_00080.jpg

LM Start	9.30	Rating **	M	Issue No.	919
LM End	9.73	Issue Type +	Ma	Location *	CR
Category	Earthen Levee			GPS Latitude/Longitude	
				Start	End
Item	Crown Surface / Depressions / Rutting			38.376669 °	38.370762 °
				-121.625896 °	-121.628640 °
DWR ID	DWR_RD0999_01_s _ 2012_919				
Action/Comments					
Add appropriate material and re-grade the levee to bring the crown above the design elevation.

Looking south at levee crown. Spring 2015

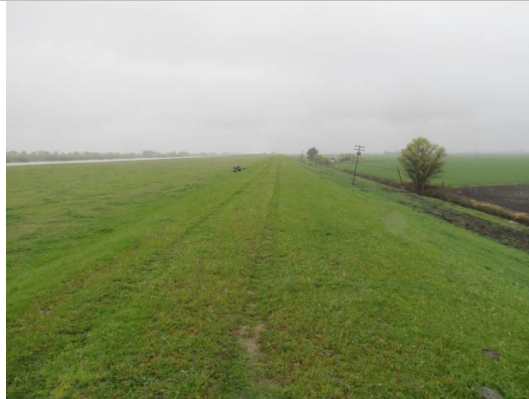
Photo 2 of 2 : SP\_2015\_RD0999\_232\_919\_20150309\_00066.jpg

LM Start	9.30	Rating **	M	Issue No.	919 (cont)
LM End	9.73	Issue Type +	Ma	Location *	CR
Category	Earthen Levee			GPS Latitude/Longitude	
				Start	End
Item	Crown Surface / Depressions / Rutting			38.376669 °	38.370762 °
				-121.625896 °	-121.628640 °
DWR ID	DWR_RD0999_01_s_2012_919				
Action/Comments					
Add appropriate material and re-grade the levee to bring the crown above the design elevation.

Looking south at crown roadway. Spring 2014

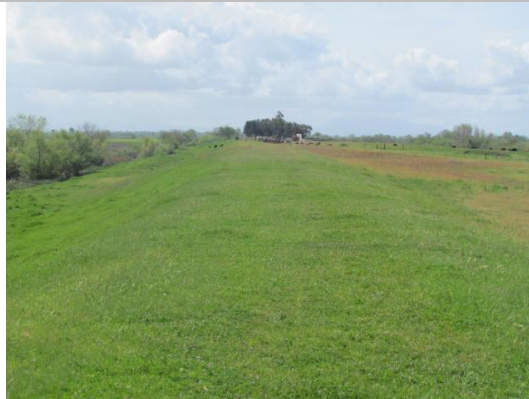
Photo 1 of 2 : SP\_2015\_RD0999\_232\_920\_20150327\_00081.jpg

LM Start	9.94	Rating **	M	Issue No.	920
LM End	10.21	Issue Type +	Ma	Location *	CR
Category	Earthen Levee			GPS Latitude/Longitude	
				Start	End
Item	Crown Surface / Depressions / Rutting			38.367831 °	38.364238 °
				-121.629990 °	-121.631674 °
DWR ID	DWR_RD0999_01_s_2012_920				
Action/Comments					
Add appropriate material and re-grade the levee to bring the crown above the design elevation.

Looking south at levee crown. (Spring 2015)

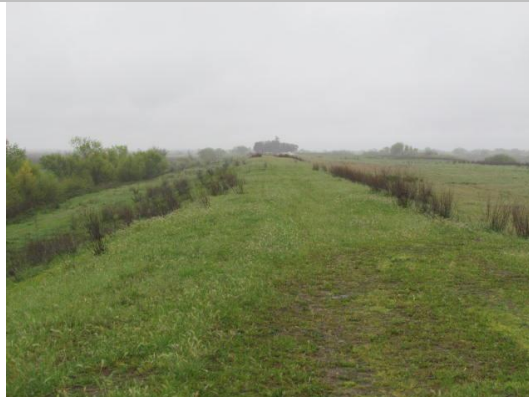
Photo 2 of 2 : SP\_2015\_RD0999\_232\_920\_20150309\_00067.jpg

Looking south at crown roadway. (Spring 2014)

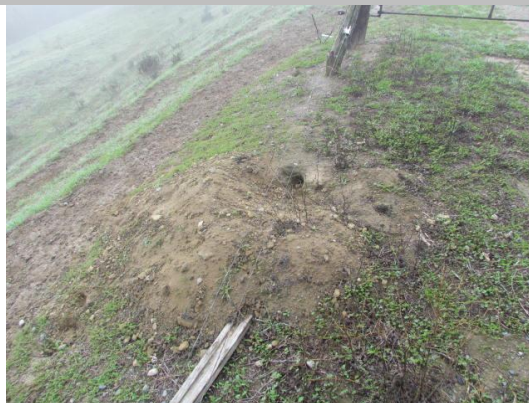
Photo 2 of 2 : SP\_2015\_RD0999\_232\_2\_20150309\_00005.jpg

Looking south at rodent hole on landside shoulder. (Fall 2014)

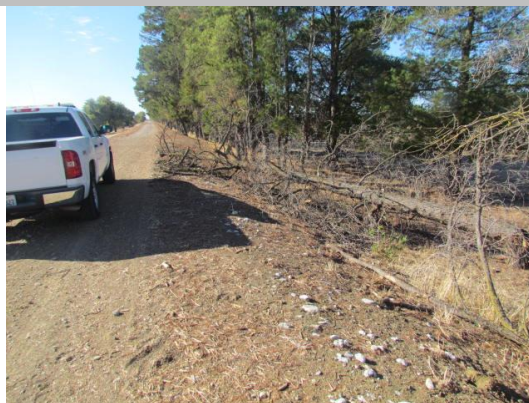
Photo 1 of 1 : SP\_2015\_RD0999\_232\_61\_20150309\_00058.jpg

LM Start	10.75	Rating **	M	Issue No.	61
LM End	10.75	Issue Type +	Ma	Location *	WS
Category	Earthen Levee			GPS Latitude/Longitude	
				Start	End
Item	Encroachments			38.356844 °	38.356844 °
				-121.635101 °	-121.635101 °
DWR ID	DWR_RD0999_01_f_2014_61				
Action/Comments					
Tree or limb					
Inspector Comments: Downed tree on waterward slope.

Looking southwest at downed tree on waterward slope.

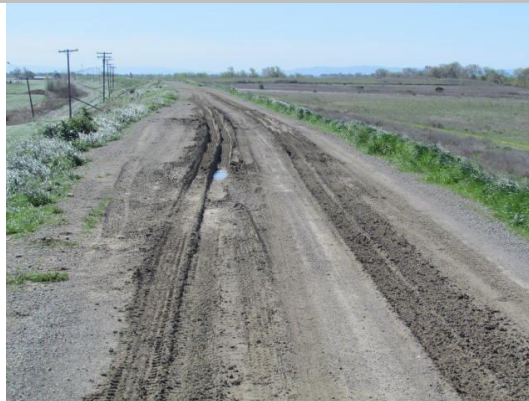
Photo 2 of 4 : SP\_2015\_RD0999\_232\_21\_20150309\_00019.jpg

Looking south at rutting on levee crown.

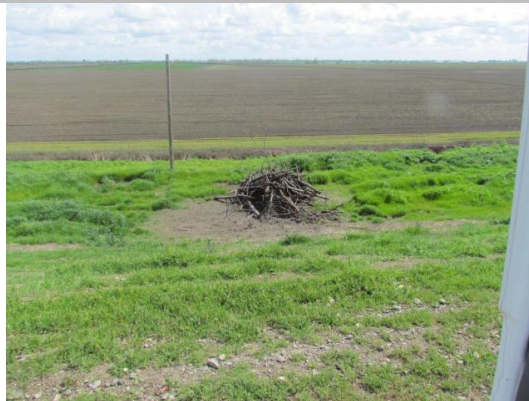
Photo 1 of 1 : SP\_2015\_RD0999\_232\_59\_20150327\_00083.jpg

LM Start	13.46	Rating **	M	Issue No.	59
LM End	13.46	Issue Type +	Ma	Location *	LS
Category	Earthen Levee			GPS Latitude/Longitude	
				Start	End
Item	Encroachments			38.318717 °	38.318717 °
				-121.644955 °	-121.644955 °
DWR ID	DWR_RD0999_01_s _ 2015_59				
Action/Comments					
Prunings					
Inspector Comments: Pruning pile on landward berm.

Looking east at pruning pile on landward berm.

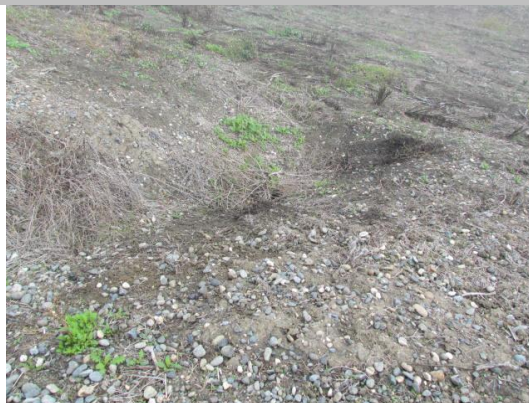
Photo 2 of 3 : SP\_2015\_RD0999\_232\_49\_20150309\_00052.jpg

Looking southeast at caving on landside slope.

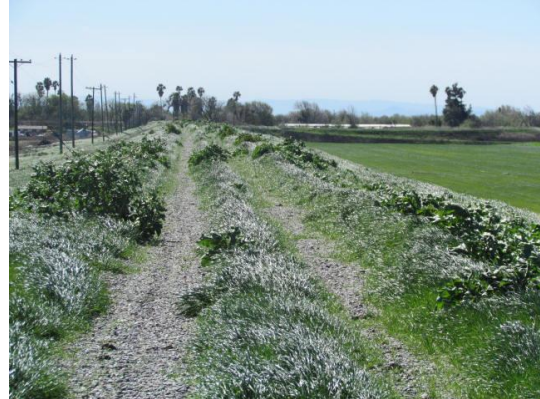
Photo 1 of 1 : SP\_2015\_RD0999\_232\_44\_20150309\_00044.jpg

LM Start	14.33	Rating **	A/W	Issue No.	44
LM End	15.17	Issue Type +	Ma	Location *	CR
Category	Earthen Levee			GPS Latitude/Longitude	
				Start	End
Item	Crown Surface / Depressions / Rutting			38.306113 °	38.293917 °
				-121.644942 °	-121.644958 °
DWR ID	DWR_RD0999_01_s_2012_44				
Action/Comments					
Add appropriate material and re-grade the levee to bring the crown above the design elevation.					
Inspector Comments: Control growth on levee crown.

Looking south at growth on levee crown.

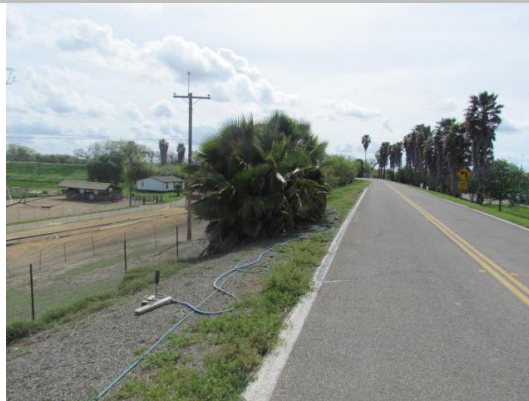
Photo 1 of 3 : SP\_2015\_RD0999\_232\_50\_20150327\_00087.jpg

LM Start	15.33	Rating **	M	Issue No.	50
LM End	15.33	Issue Type +	Ma	Location *	LS
Category	Earthen Levee			GPS Latitude/Longitude	
				Start	End
Item	Encroachments			38.291663 °	38.291663 °
				-121.644962 °	-121.644962 °
DWR ID	DWR_RD0999_01_f_2012_50				
Action/Comments					
Tree or limb					
Inspector Comments: Newly planted palm trees on landside shoulder.

Looking northeast at a mature palm trees on landward shoulder and slope. (Spring 2015)

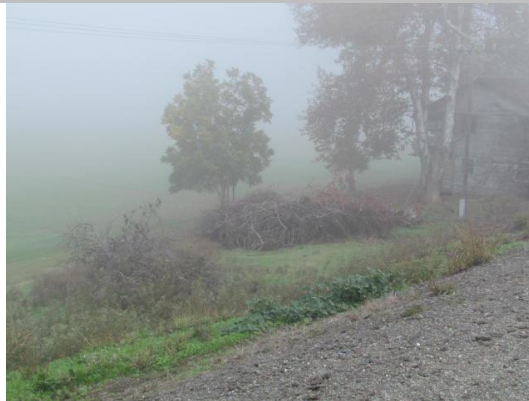
Photo 1 of 2 : SP\_2015\_RD0999\_233\_18\_20150309\_00018.jpg

LM Start	0.16	Rating **	A/W	Issue No.	18
LM End	0.16	Issue Type +	Ma	Location *	LS
Category	Earthen Levee			GPS Latitude/Longitude	
				Start	End
Item	Encroachments			38.290793 °	38.290793 °
				-121.642100 °	-121.642100 °
DWR ID	DWR_RD0999_02_s_2012_18				
Action/Comments					
Prunings

Looking west at prunings on landside toe. (Fall Inspection 2012)

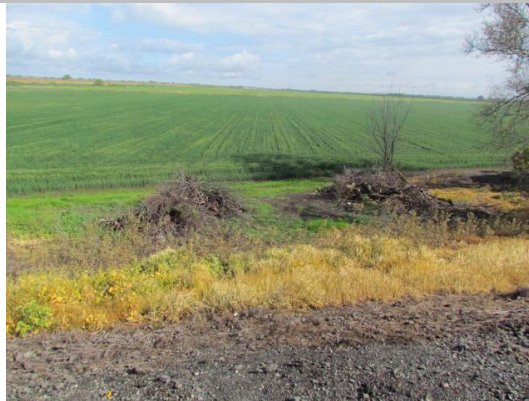
Photo 2 of 2 : SP\_2015\_RD0999\_233\_18\_20150309\_00019.jpg

Looking west at prunings on landside berm.

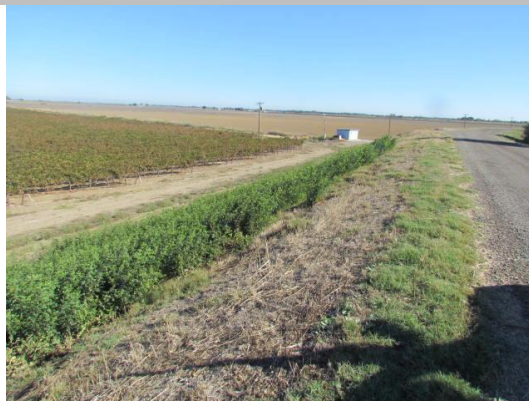
Photo 1 of 1 : SP\_2015\_RD0999\_233\_41\_20150309\_00031.jpg

LM Start	1.19	Rating **	A/W	Issue No.	41
LM End	1.19	Issue Type +	Ma	Location *	LS
Category	Earthen Levee			GPS Latitude/Longitude	
				Start	End
Item	Vegetation			38.291185 °	38.291185 °
				-121.624344 °	-121.624344 °
DWR ID	DWR_RD0999_02_f_2014_41				
Action/Comments					
Remove the wild growth other than native grasses from the levee slopes.					
Inspector Comments: Dense wild roses on landward slope.

Looking north at moderate vegetation on landward slope and toe.

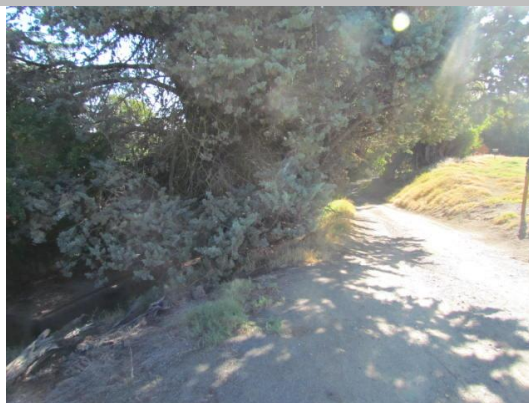
Photo 1 of 1 : SP\_2015\_RD0999\_233\_11\_20150309\_00011.jpg

LM Start	1.70	Rating **	U	Issue No.	11
LM End	1.70	Issue Type +	Ma	Location *	LS
Category	Earthen Levee			GPS Latitude/Longitude	
				Start	End
Item	Trim / Thin Trees			38.290171 °	38.290171 °
				-121.615260 °	-121.615260 °
DWR ID	DWR_RD0999_02_s_2012_11				
Action/Comments					
Trim trees to at least five feet above ground level.

Looking southwest at dense trees on landward slope.

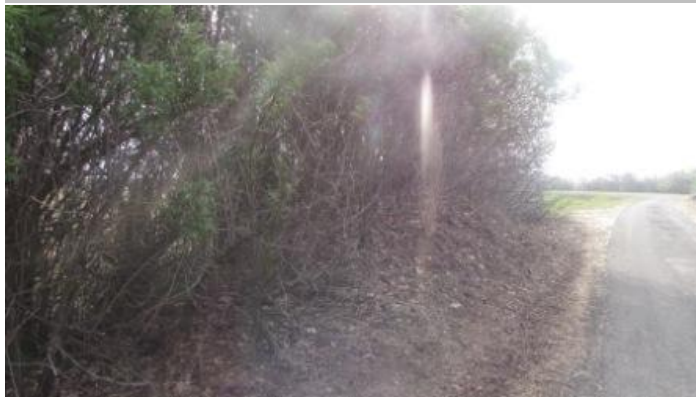
Photo 2 of 2 : SP\_2015\_RD0999\_233\_8\_20150309\_00009.jpg

LM Start	1.73	Rating **	M	Issue No.	8 (cont)	
LM End	1.76	Issue Type +	Ma	Location *	LS	
Category	Earthen Levee			GPS Latitude/Longitude		
				Start		End
Item	Vegetation			38.289895 °		38.289595 °
				-121.614688 °		-121.614337 °
DWR ID	DWR_RD0999_02_s_2012_8					
Action/Comments						
Remove the wild growth other than native grasses from the levee slopes.

Looking southwest at elderberry bush on landside shoulder and slope.  
(Fall 2014)

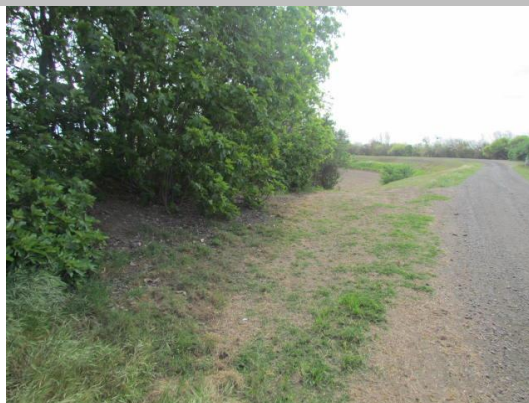
Photo 1 of 3 : SP\_2015\_RD0999\_233\_23\_20150327\_00041.jpg

LM Start	1.74	Rating **	U	Issue No.	23
LM End	1.74	Issue Type +	Ma	Location *	LS
Category	Earthen Levee			GPS Latitude/Longitude	
				Start	End
Item	Trim / Thin Trees			38.289755 °	38.289755 °
				-121.614653 °	-121.614653 °
DWR ID	DWR_RD0999_02_s_2012_23				
Action/Comments					
Trim and thin trees to allow visibility of the ground and room to flood fight.

Looking north at dense vegetation on landward slope. (Spring 2015)

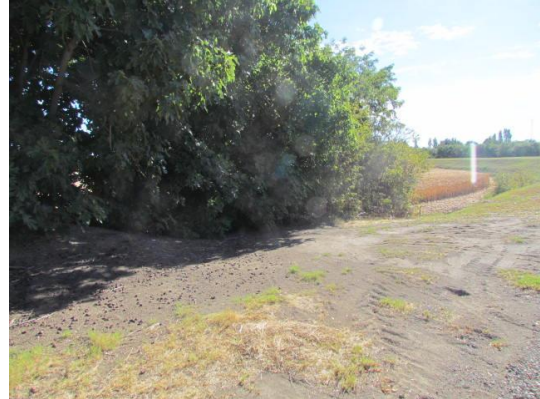
Photo 3 of 3 : SP\_2015\_RD0999\_233\_23\_20150309\_00025.jpg

LM Start	1.74	Rating **	U	Issue No.	23 (cont)
LM End	1.74	Issue Type +	Ma	Location *	LS
Category	Earthen Levee			GPS Latitude/Longitude	
				Start	End
Item	Trim / Thin Trees			38.289755 °	38.289755 °
				-121.614653 °	-121.614653 °
DWR ID	DWR_RD0999_02_s_2012_23				
Action/Comments					
Trim and thin trees to allow visibility of the ground and room to flood fight.

Looking north at dense trees on landward slope and toe.

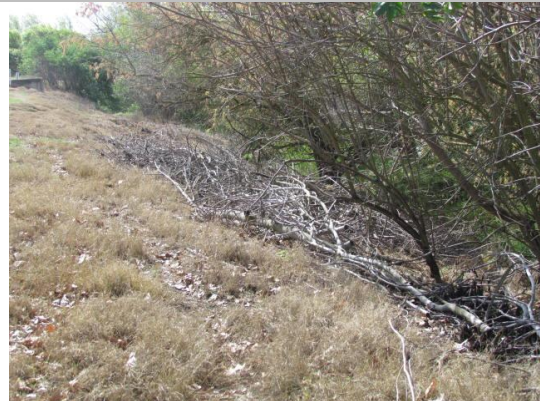
Photo 1 of 1 : SP\_2015\_RD0999\_233\_21\_20150309\_00021.jpg

LM Start	1.74	Rating **	A/W	Issue No.	21
LM End	1.74	Issue Type +	Ma	Location *	WS
Category	Earthen Levee			GPS Latitude/Longitude	
				Start	End
Item	Encroachments			38.289747 °	38.289747 °
				-121.614587 °	-121.614587 °
DWR ID	DWR_RD0999_02_s_2012_21				
Action/Comments					
Prunings

Looking northeast at prunings on waterside slope.

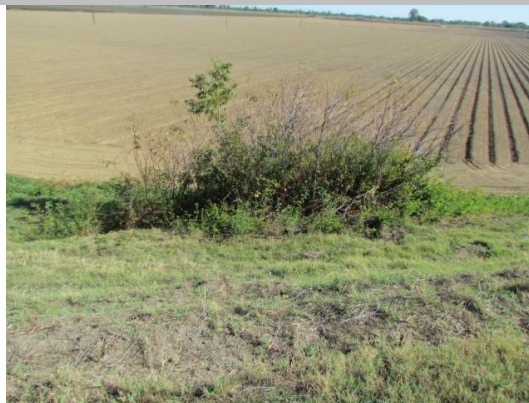
Photo 2 of 2 : SP\_2015\_RD0999\_233\_42\_20150309\_00032.jpg

LM Start	1.78	Rating **	M	Issue No.	42 (cont)
LM End	1.78	Issue Type +	Ma	Location *	LS
Category	Earthen Levee			GPS Latitude/Longitude	
				Start	End
Item	Vegetation			38.289399 °	38.289399 °
				-121.614130 °	-121.614130 °
DWR ID	DWR_RD0999_02_f_2014_42				
Action/Comments					
Elderberries are blocking visibility and flood fight capability. Inspector Comments: Elderberry and wildroses blocking landward toe.

Looking west at elderberry and wild roses blocking view of landward toe.

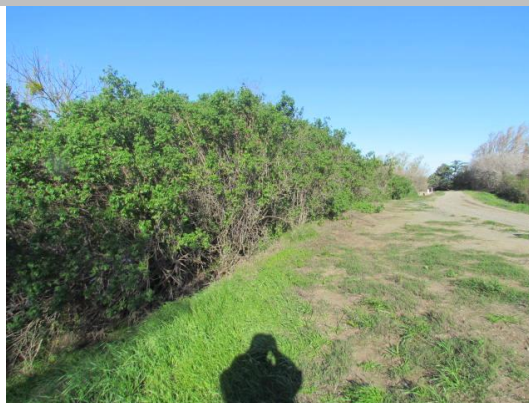
Photo 1 of 2 : SP\_2015\_RD0999\_233\_38\_20150309\_00029.jpg

LM Start	1.78	Rating **	M	Issue No.	38
LM End	1.82	Issue Type +	Ma	Location *	WS
Category	Earthen Levee			GPS Latitude/Longitude	
				Start	End
Item	Vegetation			38.289360 °	38.289006 °
				-121.614086 °	-121.613639 °
DWR ID	DWR_RD0999_02_s_2014_38				
Action/Comments					
Elderberries are blocking visibility and flood fight capability.

Looking west at dense vegetation on waterside slope.

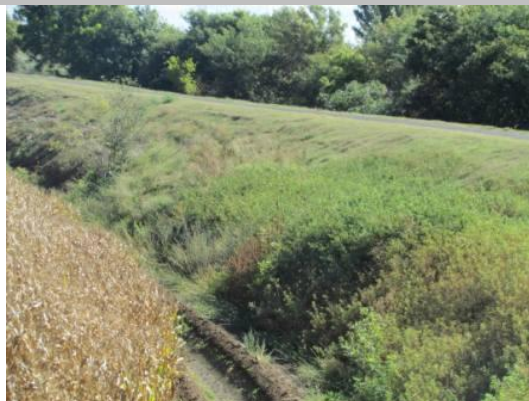
Photo 1 of 3 : SP\_2015\_RD0999\_233\_6\_20150309\_00006.jpg

Looking east at dense wild roses on landside toe. (Spring 2011)

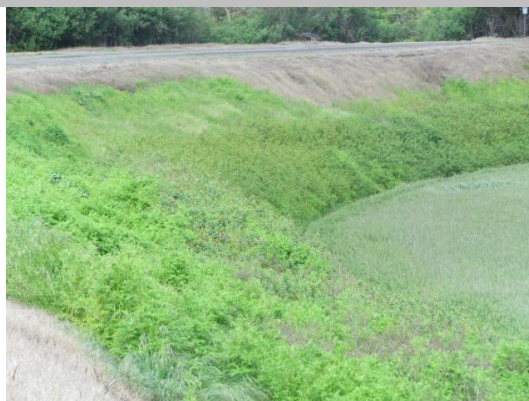
Photo 2 of 3 : SP\_2015\_RD0999\_233\_6\_20150309\_00007.jpg

Looking southeast to wild roses on landside slope and toe. (Spring 2012)

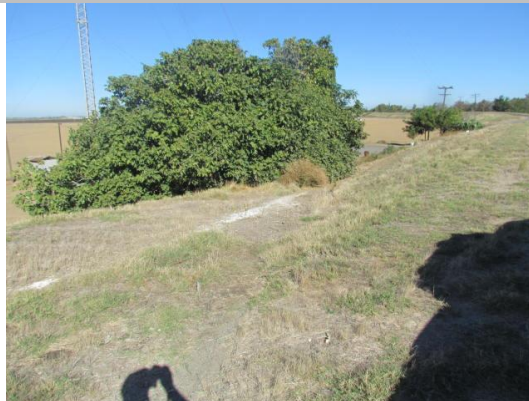
Photo 1 of 4 : SP\_2015\_RD0999\_234\_4\_20150309\_00006.jpg

LM Start	0.04	Rating **	U	Issue No.	4
LM End	0.04	Issue Type +	Ma	Location *	LS
Category	Earthen Levee			GPS Latitude/Longitude	
				Start	End
Item	Trim / Thin Trees			38.287025 °	38.287025 °
				-121.605690 °	-121.605690 °
DWR ID	DWR_RD0999_03_s_2012_4				
Action/Comments					
Trim trees to at least five feet above ground level.					
Inspector Comments: Dense fig trees on landward slope and toe.

Looking northwest at dense fig tree on landward toe. 2014

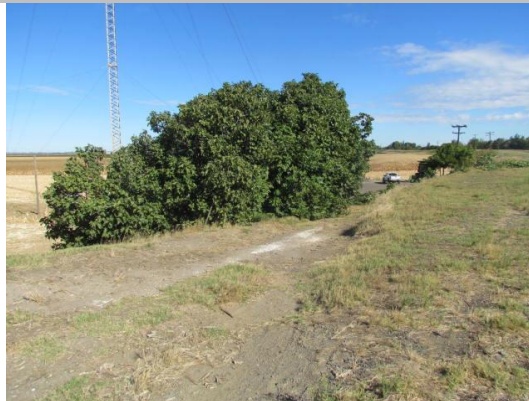
Photo 2 of 4 : SP\_2015\_RD0999\_234\_4\_20150309\_00007.jpg

Looking northwest at dense fig tree on landward slope and toe. 2013

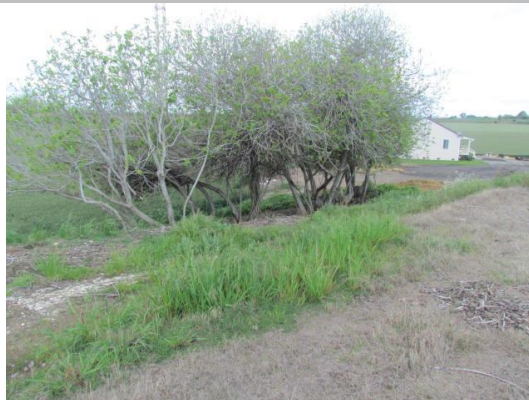
Photo 3 of 4 : SP\_2015\_RD0999\_234\_4\_20150309\_00008.jpg

Looking southwest at trimmed trees on landside toe. (Spring 2012)

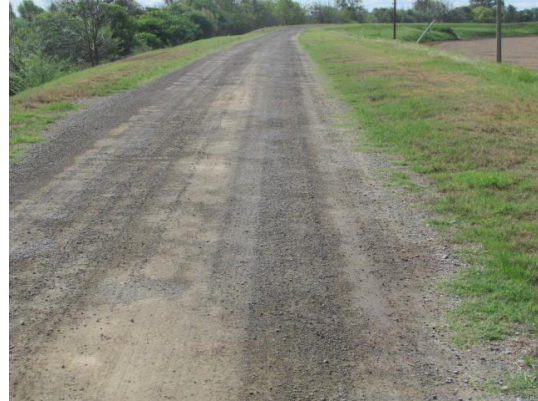
Photo 1 of 1 : SP\_2015\_RD0999\_234\_9\_20150327\_00039.jpg

LM Start	0.11	Rating **	M	Issue No.	9
LM End	1.51	Issue Type +	Ma	Location *	CR
Category	Earthen Levee			GPS Latitude/Longitude	
				Start	End
Item	Crown Surface / Depressions / Rutting			38.287873 °	38.306151 °
				-121.605108 °	-121.599374 °
DWR ID	DWR_RD0999_03_f_2012_9				
Action/Comments					
Repair depressions or ruts in the crown or slope.

Looking south at levee crown. (Spring 2015)

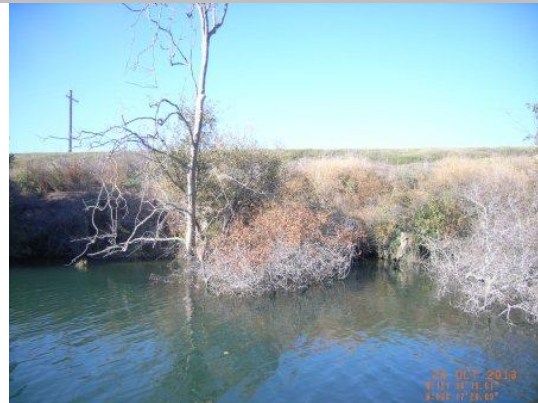
Photo 1 of 1 : SP\_2015\_RD0999\_234\_29\_20150309\_00022.jpg

LM Start	0.24	Rating **	U	Issue No.	29
LM End	0.65	Issue Type +	Ma	Location *	WS
Category	Supplemental			GPS Latitude/Longitude	
				Start	End
Item	USACE Erosion Survey			38.289634 °	38.295505 °
				-121.604343 °	-121.605648 °
DWR ID	DWR_RD0999_03_f_2014_29				
Action/Comments					
Inspector Comments: 1997 - Intermittent over-steepened sections. Large riparian vegetation along the length of the entire reach. Attempts to repair with rock on bank have failed. 1999 - New rock repair at the downstream end. 2002 - Some minor spot repairs. 2009 - Minimal new erosion. 2010 - Appears that fresh rock placed on downstream portion of site. Toe scour and overhanging trees with some overturned. 2012 - Minor new erosion at the toe. 2013: Site upgraded to CRITICAL. Severe slumping into levee at downstream end of site. Fresh erosion into bank toe. [2013 Site ID: STR_24-7_R]

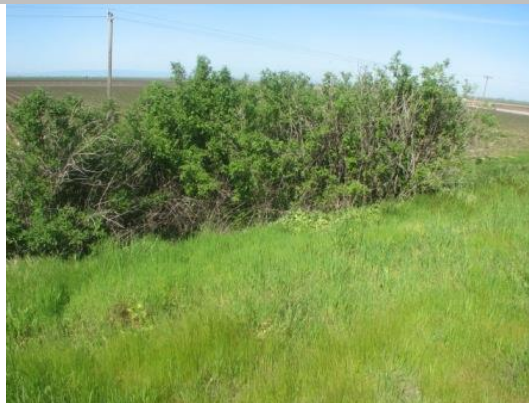
Photo 1 of 1 : SP\_2015\_RD0999\_234\_8\_20150309\_00011.jpg

LM Start	0.66	Rating **	M	Issue No.	8
LM End	0.66	Issue Type +	Ma	Location *	LS
Category	Earthen Levee			GPS Latitude/Longitude	
				Start	End
Item	Vegetation			38.295618 °	38.295618 °
				-121.605923 °	-121.605923 °
DWR ID	DWR_RD0999_03_s _ 2012_8				
Action/Comments					
Elderberries are blocking visibility and flood fight capability.

Elderberries blocking view of landside toe.

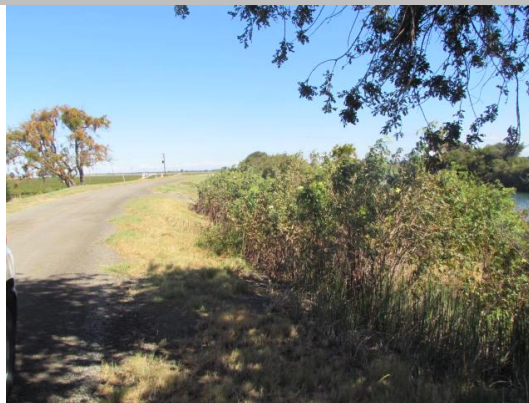
Photo 1 of 1 : SP\_2015\_RD0999\_234\_15\_20150309\_00015.jpg

LM Start	0.69	Rating **	A/W	Issue No.	15
LM End	0.70	Issue Type +	Ma	Location *	WS
Category	Earthen Levee			GPS Latitude/Longitude	
				Start	End
Item	Vegetation			38.296073 °	38.296203 °
				-121.605872 °	-121.605837 °
DWR ID	DWR_RD0999_03_s _ 2012_15				
Action/Comments					
Elderberries are blocking visibility and flood fight capability.

Looking northeast at dense elderberry on waterward slope.

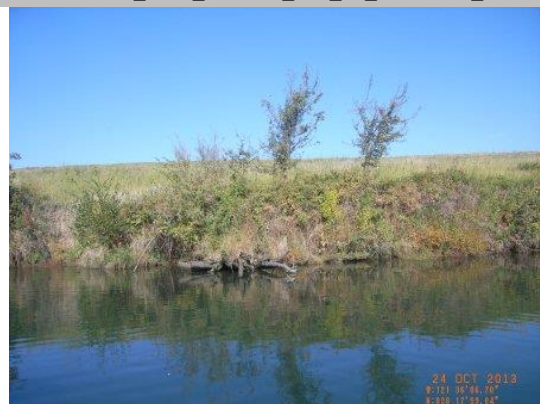
Photo 1 of 1 : SP\_2015\_RD0999\_234\_30\_20150309\_00023.jpg

LM Start	0.97	Rating **	M	Issue No.	30
LM End	1.10	Issue Type +	Ma	Location *	WS
Category	Supplemental			GPS Latitude/Longitude	
				Start	End
Item	USACE Erosion Survey			38.299402 °	38.300542 °
				-121.603056 °	-121.601118 °
DWR ID	DWR_RD0999_03_f_2014_30				
Action/Comments					
Inspector Comments: 2008 - Over steepened levee section. 2009 - Significant new erosion. 2010 - Minor new erosion. 2013: No observed changes. [2013 Site ID: STR_25-2_R]

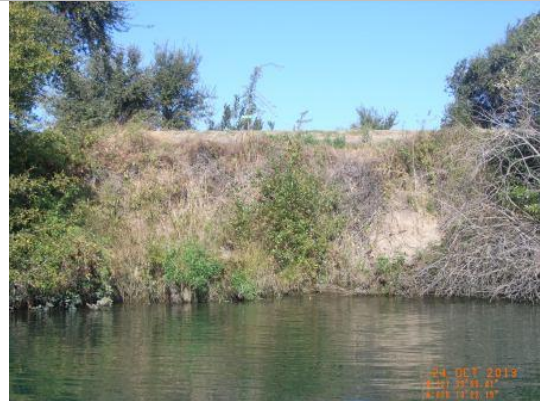
Photo 1 of 1 : SP\_2015\_RD0999\_234\_33\_20150309\_00025.jpg

LM Start	1.43	Rating **	M	Issue No.	33
LM End	1.57	Issue Type +	Ma	Location *	WS
Category	Supplemental			GPS Latitude/Longitude	
				Start	End
Item	USACE Erosion Survey			38.305229 °	38.306667 °
				-121.599933 °	-121.598266 °
DWR ID	DWR_RD0999_03_f_2014_33				
Action/Comments					
Inspector Comments: 2011 - Toe scour along length of site and erosion pockets. 2012 - Site extended slightly upstream due to new erosion pocket. 2013: Tall vertical sections at upstream end of site. [2013 Site ID: STR_25-7_R]

USACE 2013 Photo #1

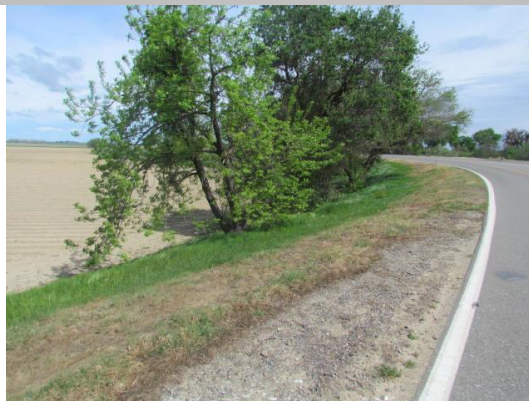
Photo 1 of 1 : SP\_2015\_RD0999\_234\_13\_20150327\_00040.jpg

LM Start	1.57	Rating **	M	Issue No.	13
LM End	1.59	Issue Type +	Ma	Location *	LS
Category	Earthen Levee			GPS Latitude/Longitude	
				Start	End
Item	Trim / Thin Trees			38.306762 °	38.306948 °
				-121.598541 °	-121.598320 °
DWR ID	DWR_RD0999_03_s_2012_13				
Action/Comments					
Trim and thin trees to allow visibility of the ground and room to flood fight.

Looking north at untrimmed trees on landward toe. (Spring 2015)

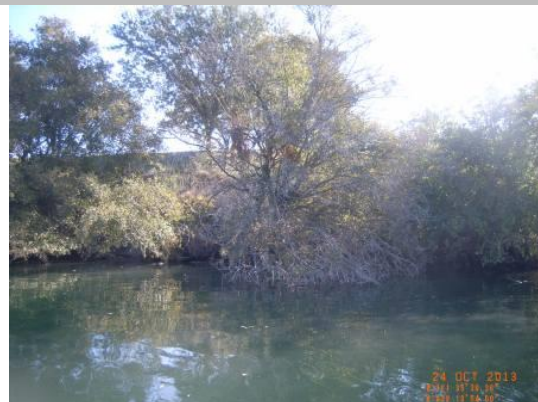
Photo 1 of 1 : SP\_2015\_RD0999\_234\_34\_20150309\_00026.jpg

LM Start	2.25	Rating **	M	Issue No.	34
LM End	2.36	Issue Type +	Ma	Location *	WS
Category	Supplemental			GPS Latitude/Longitude	
				Start	End
Item	USACE Erosion Survey			38.315407 °	38.313836 °
				-121.591433 °	-121.592259 °
DWR ID	DWR_RD0999_03_f _ 2014_34				
Action/Comments					
Inspector Comments: 2002 - Original rock over geotextile is sliding off and the end is coming unraveled. 2003 - Some minor new erosion on the downstream end. 2004 - Site has gotten worse. Underlined geofabric is exposed. 2005 - Still looks bad with exposed geotextile fabric. 2006 - Still have some new unraveling and exposed fabric. Site lengthened upstream. 2009 - Minimal new erosion. 2010 - geotextile fabric placed since last year, possible flood fight. 2012 - Exposed geotech style fabric, assume rock on top slid off. 2013: No observed changes. [2013 Site ID: STR 26-5 L]

USACE 2013 Photo #1

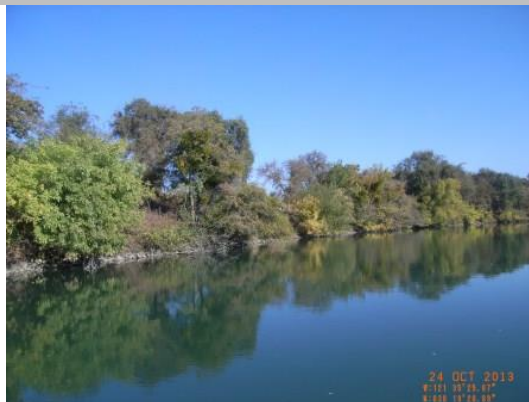
Photo 1 of 1 : SP\_2015\_RD0999\_234\_35\_20150309\_00027.jpg

LM Start	2.87	Rating **	M	Issue No.	35
LM End	2.92	Issue Type +	Ma	Location *	WS
Category	Supplemental			GPS Latitude/Longitude	
				Start	End
Item	USACE Erosion Survey			38.322457 °	38.323042 °
				-121.590693 °	-121.590209 °
DWR ID	DWR_RD0999_03_f_2014_35				
Action/Comments					
Inspector Comments: 2012 - Slumping of upper levee slope. 2013: No observed changes. [2013 Site ID: STR_27-1_R]

USACE 2013 Photo #1

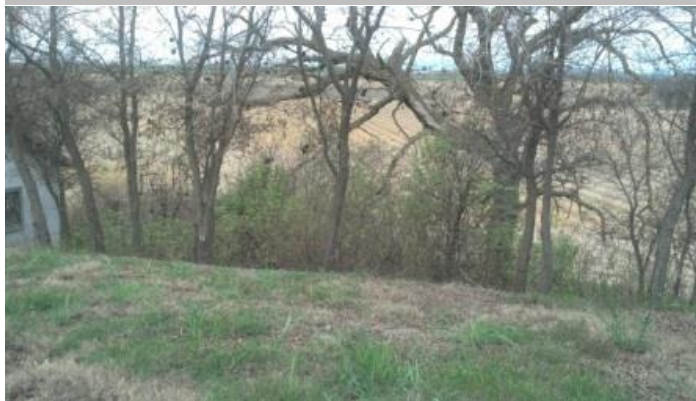
Photo 2 of 3 : SP\_2015\_RD0999\_234\_10\_20150309\_00013.jpg

Looking west at dense trees on landside toe.

LM Start	2.88	Rating **	M	Issue No.	10
LM End	2.88	Issue Type +	Ma	Location *	LS
Category	Earthen Levee			GPS Latitude/Longitude	
				Start	End
Item	Vegetation			38.322757 °	38.322757 °
				-121.590817 °	-121.590817 °
DWR ID	DWR_RD0999_03_f_2012_10				
Action/Comments					
Remove the wild growth other than native grasses from the levee slopes.					
Inspector Comments: Wild growth at landside slope and toe.

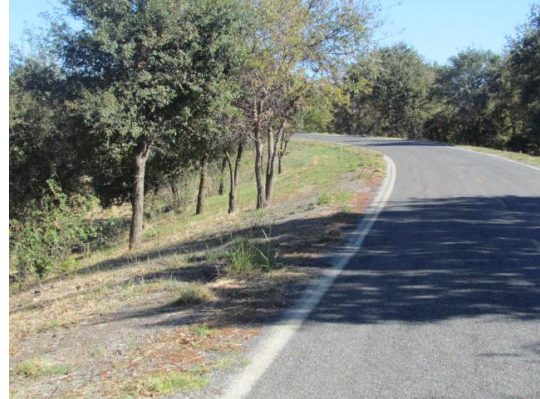
Photo 1 of 1 : SP\_2015\_RD0999\_234\_31\_20150309\_00024.jpg

Looking north at trimmed trees on landward slope.

LM Start	3.01	Rating **	M	Issue No.	31
LM End	3.25	Issue Type +	Ma	Location *	LS
Category	Earthen Levee			GPS Latitude/Longitude	
				Start	End
Item	Trim / Thin Trees			38.323770 °	38.326061 °
				-121.589035 °	-121.586028 °
DWR ID	DWR_RD0999_03_s_2012_31				
Action/Comments					
Trim and thin trees to allow visibility of the ground and room to flood fight.

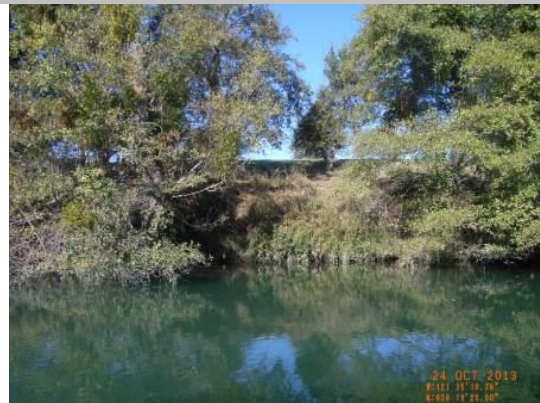
Photo 1 of 1 : SP\_2015\_RD0999\_234\_47\_20150309\_00033.jpg

LM Start	3.05	Rating **	M	Issue No.	47
LM End	3.22	Issue Type +	Ma	Location *	WS
Category	Supplemental			GPS Latitude/Longitude	
				Start	End
Item	USACE Erosion Survey			38.323667 °	38.325592 °
				-121.588226 °	-121.585925 °
DWR ID	DWR_RD0999_03_f_2014_47				
Action/Comments					
Inspector Comments: 2011 - Multiple erosion pockets. Some likely from tree popouts. 2013: Tall vertical sections. [2013 Site ID: STR_27-3_R]

USACE 2013 Photo #1

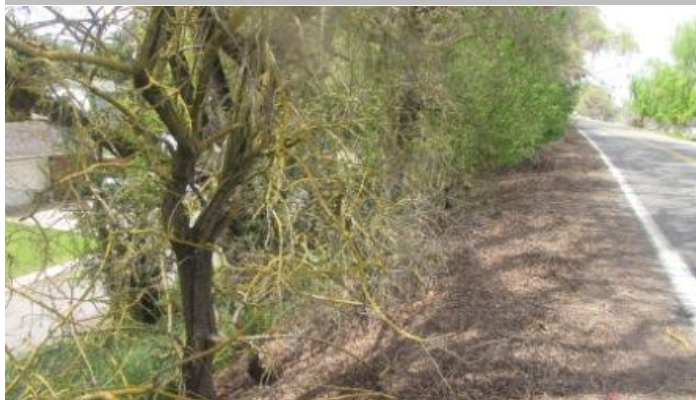
Photo 1 of 2 : SP\_2015\_RD0999\_235\_10\_20150309\_00007.jpg

Looking northwest at dense trees on landside slope and toe.

LM Start	0.38	Rating **	M	Issue No.	10
LM End	0.50	Issue Type +	Ma	Location *	LS
Category	Earthen Levee			GPS Latitude/Longitude	
				Start	End
Item	Trim / Thin Trees			38.418838 °	38.420447 °
				-121.526225 °	-121.527380 °
DWR ID	DWR_RD0999_04_s _ 2012_10				
Action/Comments					
Trim trees to at least five feet above ground level.

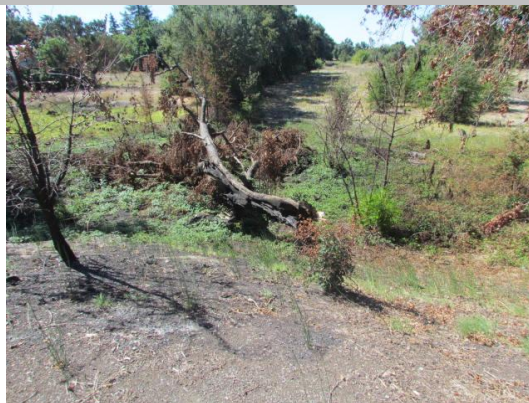
Photo 1 of 1 : SP\_2015\_RD0999\_235\_21\_20150309\_00016.jpg

LM Start	0.60	Rating **	A/W	Issue No.	21	
LM End	0.60	Issue Type +	Ma	Location *	LS	
Category	Earthen Levee			GPS Latitude/Longitude		
				Start	End	
Item	Encroachments				°	
					°	
DWR ID	DWR_RD0999_04_f_2013_21					
Action/Comments						
Tree or limb						
Inspector Comments: Downed tree on landward toe and berm.

Looking west at dead tree on landward toe and berm.

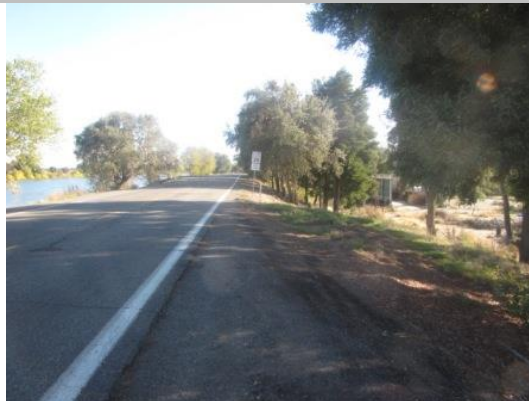
Photo 2 of 2 : SP\_2015\_RD0999\_235\_6\_20150309\_00005.jpg

Looking south at trimmed trees on landside slope and removed fence.

LM Start	0.71	Rating **	A/W	Issue No.	6 (cont)	
LM End	0.87	Issue Type +	Ma	Location *	LS	
Category	Earthen Levee			GPS Latitude/Longitude		
				Start		End
Item	Trim / Thin Trees			38.423035 °		38.425140 °
				-121.529255 °		-121.530742 °
DWR ID	DWR_RD0999_04_s_2012_6					
Action/Comments						
Trim trees to at least five feet above ground level.

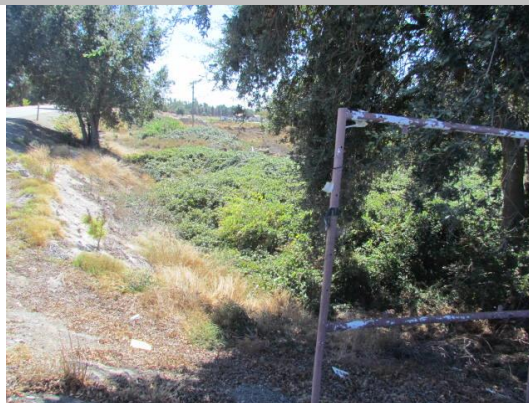
Photo 1 of 2 : SP\_2015\_RD0999\_235\_16\_20150309\_00013.jpg

LM Start	1.04	Rating **	A/W	Issue No.	16
LM End	1.04	Issue Type +	Ma	Location *	LS
Category	Earthen Levee			GPS Latitude/Longitude	
				Start	End
Item	Vegetation			38.427295 °	38.427295 °
				-121.532164 °	-121.532164 °
DWR ID	DWR_RD0999_04_f_2012_16				
Action/Comments					
Remove the wild growth other than native grasses from the levee slopes.					
Inspector Comments: Blackberries blocking view of landward toe.

Looking southwest at dense berry vines at landward toe. 2013

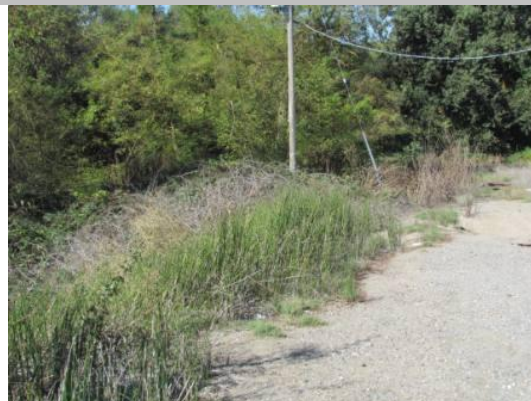
Photo 1 of 2 : SP\_2015\_RD0999\_235\_5\_20150309\_00002.jpg

LM Start	1.15	Rating **	M	Issue No.	5
LM End	1.15	Issue Type +	Ma	Location *	LS
Category	Earthen Levee			GPS Latitude/Longitude	
				Start	End
Item	Vegetation			38.428823 °	38.428823 °
				-121.532885 °	-121.532885 °
DWR ID	DWR_RD0999_04_s_2012_5				
Action/Comments					
Remove the wild growth other than native grasses from the levee slopes.					
Inspector Comments: Berry vines and wild roses on landside toe.

Looking north at dense vegetation on landside slope near ramp.

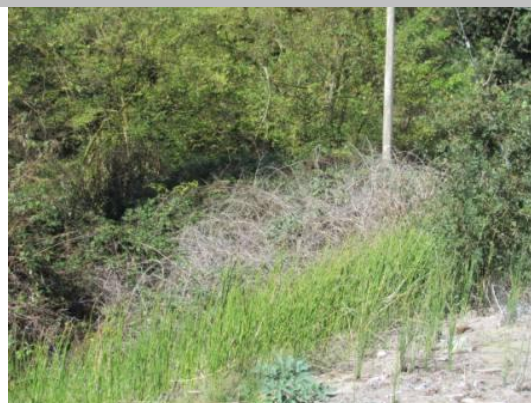
Photo 2 of 2 : SP\_2015\_RD0999\_235\_5\_20150309\_00003.jpg

Looking northwest at dense wild roses and berry vines on landside toe near ramp.

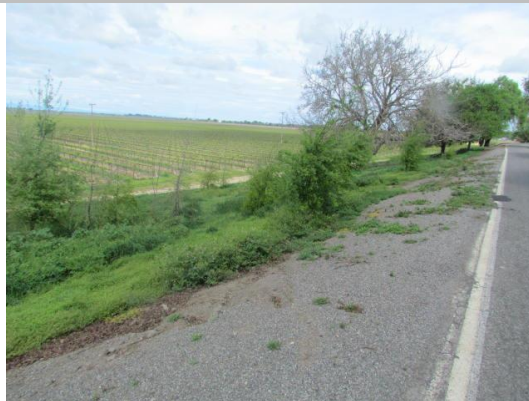
Photo 1 of 1 : SP\_2015\_RD0999\_236\_178\_20150327\_00141.jpg

Looking at typical view of young oak trees on landward slope. (Spring 2015)

LM Start	0.05	Rating **	M	Issue No.	178
LM End	0.05	Issue Type +	Ma	Location *	LS
Category	Earthen Levee			GPS Latitude/Longitude	
				Start	End
Item	Trim / Thin Trees			38.333308 °	38.333308 °
				-121.584494 °	-121.584494 °
DWR ID	DWR_RD0999_05_s_2015_178				
Action/Comments					
Thin trees to allow visibility of the ground and room to flood fight. Inspector Comments: Remove trees under an inch in diameter on landward slope. Don't allow young trees to get establish.

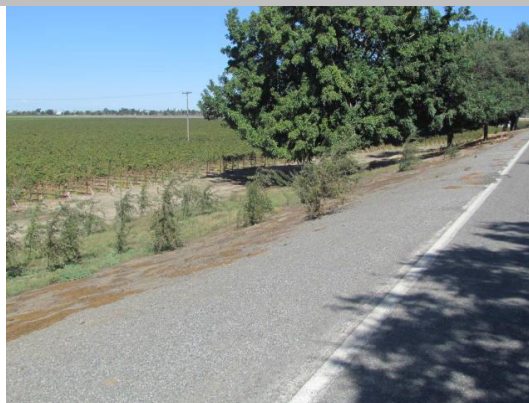
Photo 1 of 1 : SP\_2015\_RD0999\_236\_72\_20150309\_00054.jpg

Looking west at small oak trees on landward slope.

LM Start	0.10	Rating **	A/W	Issue No.	72
LM End	0.10	Issue Type +	Ma	Location *	LS
Category	Earthen Levee			GPS Latitude/Longitude	
				Start	End
Item	Trim / Thin Trees				°
					°
DWR ID	DWR_RD0999_05_f_2013_72				
Action/Comments					
Trim and thin trees to allow visibility of the ground and room to flood fight.					
Inspector Comments: Remove small oak trees from landward slope before trees are establish.

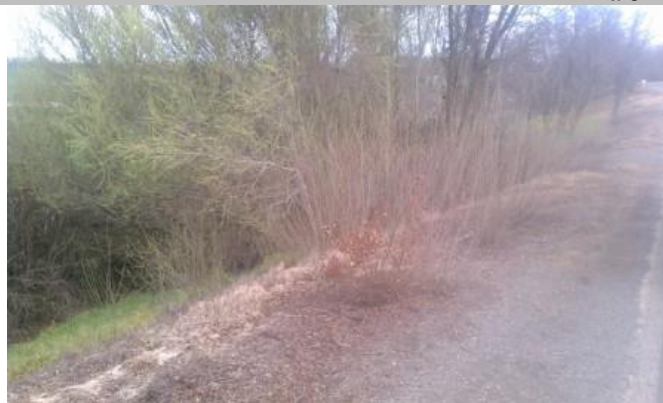
Photo 1 of 4 : SP\_2015\_RD0999\_236\_25\_20150309\_00019.jpg

LM Start	0.40	Rating **	M	Issue No.	25
LM End	0.44	Issue Type +	Ma	Location *	LS
Category	Earthen Levee			GPS Latitude/Longitude	
				Start	End
Item	Vegetation			38.338075 °	38.338688 °
				-121.582322 °	-121.582193 °
DWR ID	DWR_RD0999_05_s_2012_25				
Action/Comments					
Remove the wild growth other than native grasses from the levee slopes.					
Inspector Comments: Elderberries within vegetation area.

Looking northwest at dense vegetation on landside slope and toe.

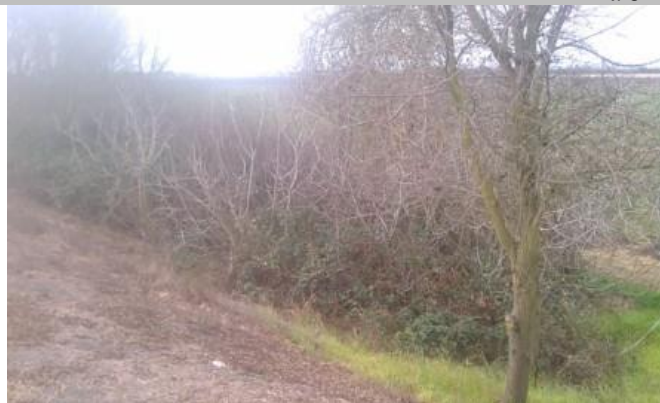
Photo 4 of 4 : SP\_2015\_RD0999\_236\_25\_20150309\_00022.jpg

LM Start	0.40	Rating **	M	Issue No.	25 (cont)	
LM End	0.44	Issue Type +	Ma	Location *	LS	
Category	Earthen Levee			GPS Latitude/Longitude		
				Start		End
Item	Vegetation			38.338075 °		38.338688 °
				-121.582322 °		-121.582193 °
DWR ID	DWR_RD0999_05_s _ 2012_25					
Action/Comments						
Remove the wild growth other than native grasses from the levee slopes.						
Inspector Comments: Elderberries within vegetation area.

Looking southwest at dense berry vines on landside toe.

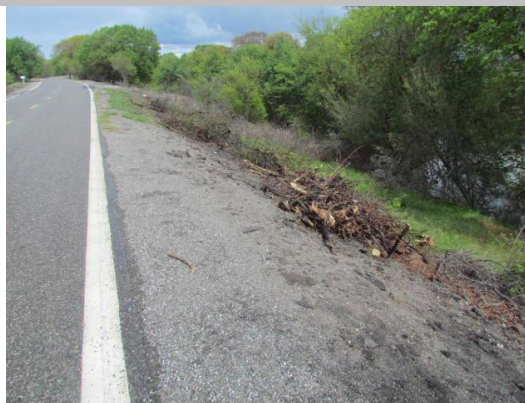
Photo 1 of 1 : SP\_2015\_RD0999\_236\_26\_20150309\_00023.jpg

LM Start	0.44	Rating **	A/W	Issue No.	26
LM End	0.45	Issue Type +	Ma	Location *	WS
Category	Earthen Levee			GPS Latitude/Longitude	
				Start	End
Item	Encroachments			38.338647 °	38.338868 °
				-121.582217 °	-121.582163 °
DWR ID	DWR_RD0999_05_s _ 2012_26				
Action/Comments					
Prunings

Looking northeast at prunings on waterside slope.

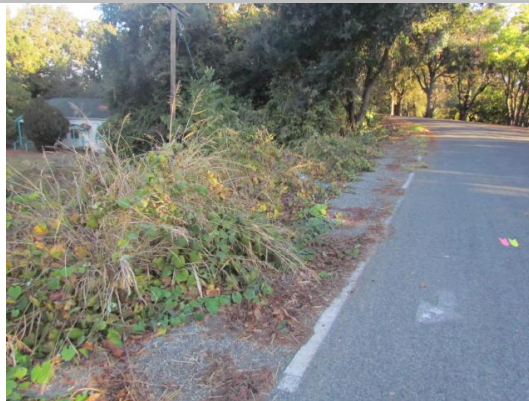
Photo 1 of 1 : SP\_2015\_RD0999\_236\_189\_20150309\_00103.jpg

LM Start	0.68	Rating **	A/W	Issue No.	189
LM End	0.68	Issue Type +	Ma	Location *	LS
Category	Earthen Levee			GPS Latitude/Longitude	
				Start	End
Item	Vegetation			38.342032 °	38.342032 °
				-121.581372 °	-121.581372 °
DWR ID	DWR_RD0999_05_f_2014_189				
Action/Comments					
Remove the wild growth other than native grasses from the levee slopes.					
Inspector Comments: Dense wild grapevines on landward slope.

Looking northwest at dense vegetation on landward slope.
