**Flood Control Project Maintenance  
Levee Inspections**

## Maintenance Issue Types Only, Levee Inspection Report By Mile - Spring 2015

### Reclamation District No. 0999 Netherlands

Waterway	Bank	Unit Miles	Inspection Start/End	Inspector
Unit No. 01 Yolo Bypass	Left	15.41	03/23/2015 03/23/2015	Richard Willoughby

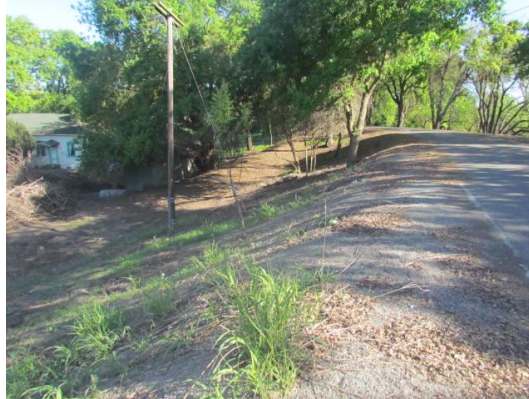
Photo 1 of 6 : SP\_2015\_RD0999\_236\_9\_20150327\_00142.jpg

LM Start	0.69	Rating **	A/W	Issue No.	9
LM End	0.71	Issue Type +	Ma	Location *	LS
Category	Earthen Levee			GPS Latitude/Longitude	
				Start	End
Item	Trim / Thin Trees			38.342180 °	38.342537 °
				-121.581230 °	-121.581263 °
DWR ID	DWR_RD0999_05_s_2012_9				
Action/Comments					
Trim and thin trees to allow visibility of the ground and room to flood fight.					
Inspector Comments: District or landowner trimmed trees to comply with standards.

Looking northwest at landward slope. (Spring 2015)

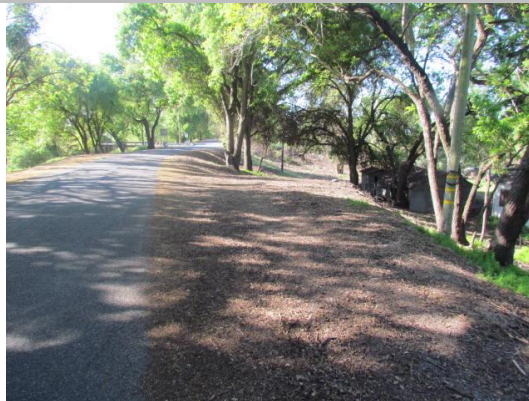
Photo 2 of 6 : SP\_2015\_RD0999\_236\_9\_20150327\_00143.jpg

Looking south at landward slope. (Spring 2015)

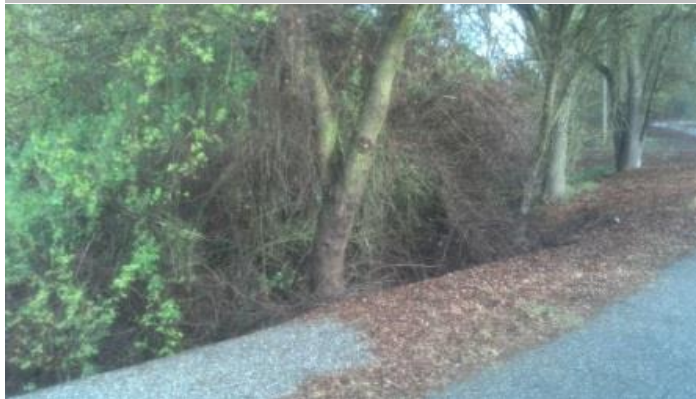
Photo 3 of 6 : SP\_2015\_RD0999\_236\_9\_20150309\_00005.jpg

Looking northwest at dense trees at landside slope and toe. (Spring 2013)

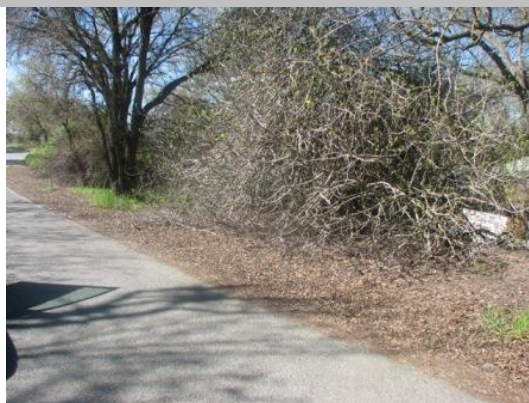
Photo 6 of 6 : SP\_2015\_RD0999\_236\_9\_20150309\_00004.jpg

Front view of dense trees at landside shoulder. (Spring 2011)

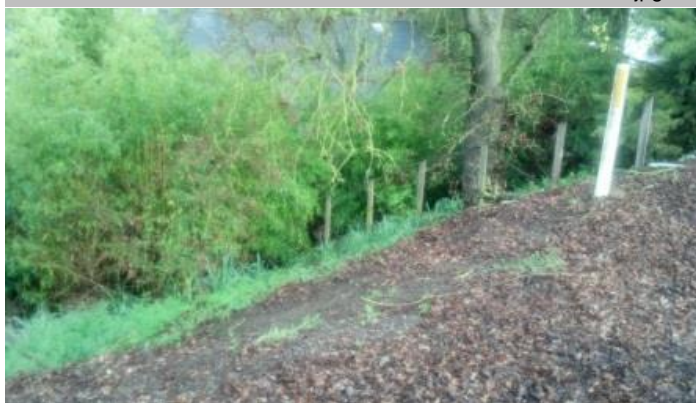
Photo 2 of 2 : SP\_2015\_RD0999\_236\_128\_20150309\_00076.jpg

Looking at dense trees on landside slope and toe.

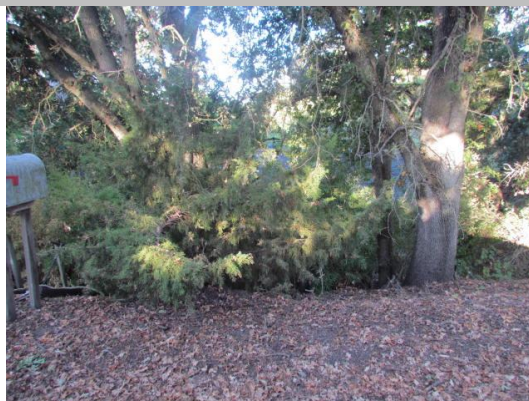
Photo 1 of 1 : SP\_2015\_RD0999\_236\_190\_20150309\_00104.jpg

LM Start	0.79	Rating **	U	Issue No.	190
LM End	0.79	Issue Type +	Ma	Location *	LS
Category	Earthen Levee			GPS Latitude/Longitude	
				Start	End
Item	Trim / Thin Trees			38.343606 °	38.343606 °
				-121.581279 °	-121.581279 °
DWR ID	DWR_RD0999_05_f _ 2014_190				
Action/Comments					
Trim and thin trees to allow visibility of the ground and room to flood fight.

Looking west at dense vegetation on landward slope and toe.

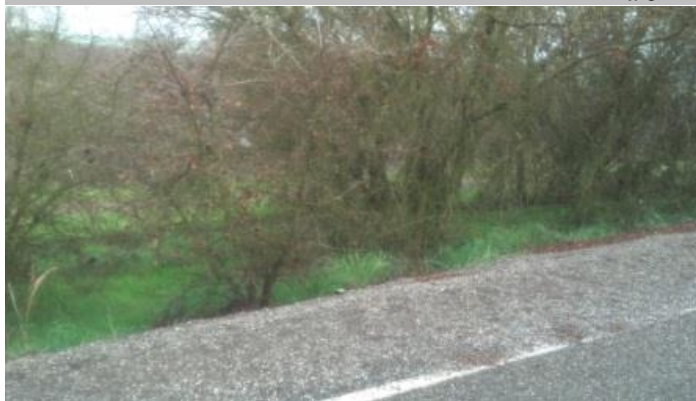
Photo 1 of 1 : SP\_2015\_RD0999\_236\_14\_20150309\_00010.jpg

LM Start	1.07	Rating **	M	Issue No.	14
LM End	1.11	Issue Type +	Ma	Location *	LS
Category	Earthen Levee			GPS Latitude/Longitude	
				Start	End
Item	Trim / Thin Trees			38.347427 °	38.347863 °
				-121.579395 °	-121.579113 °
DWR ID	DWR_RD0999_05_s_2012_14				
Action/Comments					
Trim trees to at least five feet above ground level.

Looking west at dense trees on landside slope and toe.

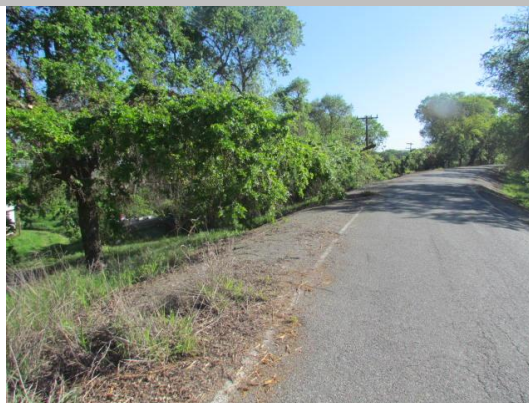
Photo 1 of 1 : SP\_2015\_RD0999\_236\_15\_20150327\_00146.jpg

LM Start	1.15	Rating **	M	Issue No.	15
LM End	1.19	Issue Type +	Ma	Location *	LS
Category	Earthen Levee			GPS Latitude/Longitude	
				Start	End
Item	Trim / Thin Trees			38.348237 °	38.348328 °
				-121.578440 °	-121.577735 °
DWR ID	DWR_RD0999_05_s_2012_15				
Action/Comments					
Trim trees to at least five feet above ground level.

Looking north at untrimmed trees on landward slope and toe. (Spring 2015)

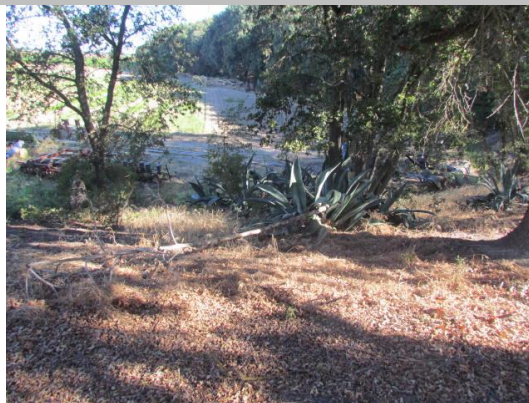
Photo 2 of 2 : SP\_2015\_RD0999\_236\_129\_20150309\_00078.jpg

LM Start	1.39	Rating **	M	Issue No.	129 (cont)
LM End	1.39	Issue Type +	Ma	Location *	LS
Category	Earthen Levee			GPS Latitude/Longitude	
				Start	End
Item	Vegetation			38.348100 °	38.348100 °
				-121.574075 °	-121.574075 °
DWR ID	DWR_RD0999_05_s _ 2012_129				
Action/Comments					
Remove the wild growth other than native grasses from the levee slopes.					
Inspector Comments: Berry vines and century plants on landside toe and slope.

Looking west at century plants on landward slope.

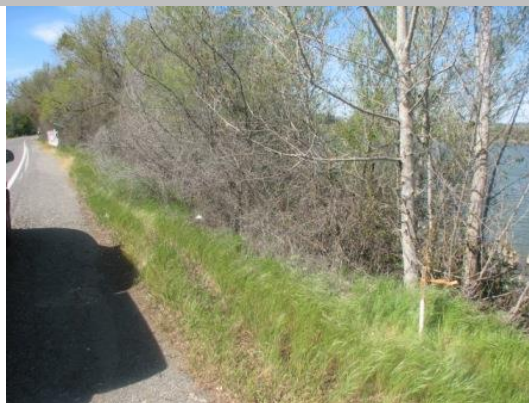
Photo 1 of 2 : SP\_2015\_RD0999\_236\_18\_20150309\_00015.jpg

LM Start	1.46	Rating **	M	Issue No.	18
LM End	1.83	Issue Type +	Ma	Location *	LS
Category	Earthen Levee			GPS Latitude/Longitude	
				Start	End
Item	Trim / Thin Trees			38.348670 °	38.353852 °
				-121.573320 °	-121.573570 °
DWR ID	DWR_RD0999_05_s _ 2012_18				
Action/Comments					
Trim and thin trees to allow visibility of the ground and room to flood fight.

Side view of dense trees along waterside slope.

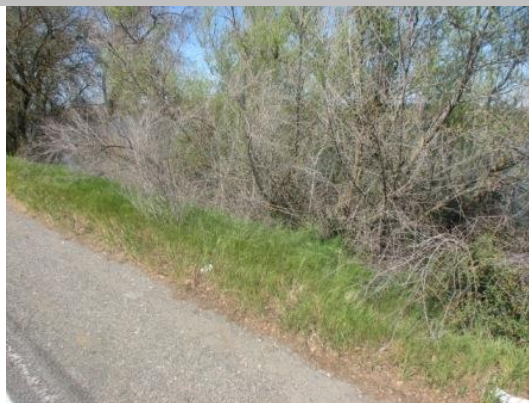
Photo 2 of 2 : SP\_2015\_RD0999\_236\_18\_20150309\_00016.jpg

Front view of dense trees along waterside slope.

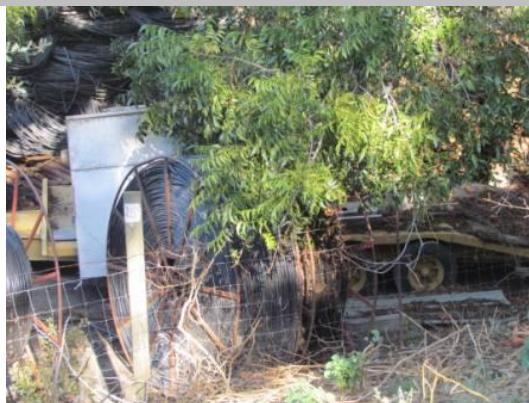
Photo 1 of 2 : SP\_2015\_RD0999\_236\_16\_20150309\_00011.jpg

LM Start	3.64	Rating **	M	Issue No.	16
LM End	3.64	Issue Type +	Ma	Location *	LS
Category	Earthen Levee			GPS Latitude/Longitude	
				Start	End
Item	Encroachments			38.366958 °	38.366958 °
				-121.556822 °	-121.556822 °
DWR ID	DWR_RD0999_05_s_2012_16				
Action/Comments					
Equipment Inspector Comments: Equipment stored at landward toe.

Looking northwest at equipment on landside toe.

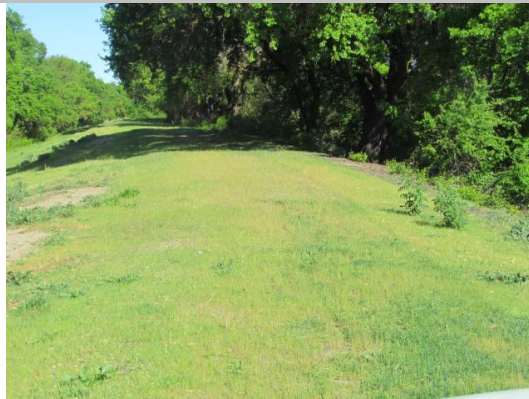
Photo 1 of 1 : SP\_2015\_RD0999\_236\_181\_20150327\_00152.jpg

LM Start	3.94	Rating **	M	Issue No.	181
LM End	4.22	Issue Type +	Ma	Location *	CR
Category	Earthen Levee			GPS Latitude/Longitude	
				Start	End
Item	Vegetation			38.368919 °	38.372558 °
				-121.552485 °	-121.552484 °
DWR ID	DWR_RD0999_05_s_2015_181				
Action/Comments					
Control annual grass and weeds on the levee slopes and easements.					
Inspector Comments: Control grasses on levee crown.

Looking north at vegetation on levee crown. (Spring 2015)

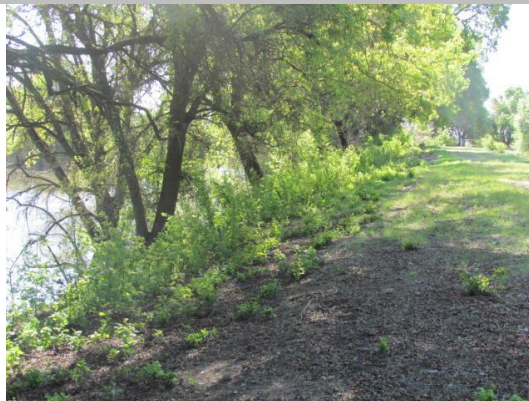
Photo 1 of 2 : SP\_2015\_RD0999\_236\_41\_20150327\_00153.jpg

LM Start	3.98	Rating **	M	Issue No.	41
LM End	4.05	Issue Type +	Ma	Location *	WS
Category	Earthen Levee			GPS Latitude/Longitude	
				Start	End
Item	Trim / Thin Trees			38.369440 °	38.370398 °
				-121.552747 °	-121.553373 °
DWR ID	DWR_RD0999_05_s_2012_41				
Action/Comments					
Trim and thin trees to allow visibility of the ground and room to flood fight.					
Inspector Comments: Control oak saplings on waterward slope.

Looking southeast at saplings on waterward slope. (Spring 2015)

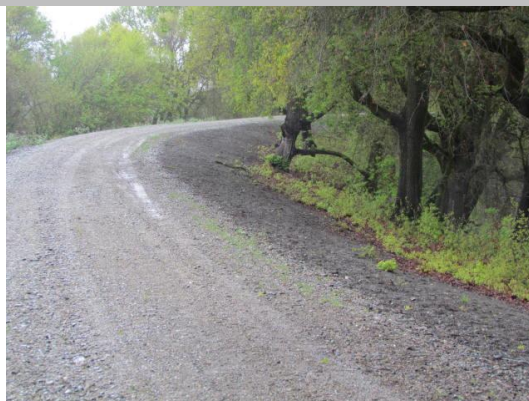
Photo 2 of 2 : SP\_2015\_RD0999\_236\_41\_20150309\_00035.jpg

Looking northeast at trimmed trees on waterside slope.

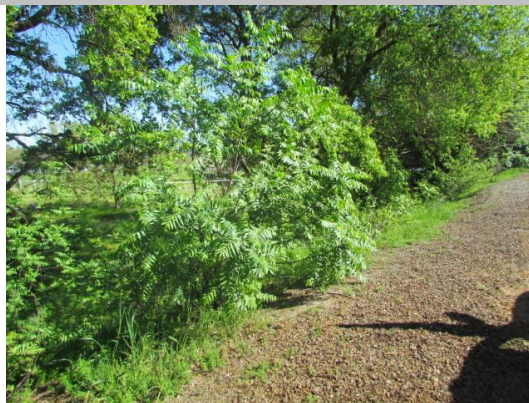
Photo 1 of 1 : SP\_2015\_RD0999\_236\_57\_20150327\_00154.jpg

LM Start	4.42	Rating **	M	Issue No.	57
LM End	4.46	Issue Type +	Ma	Location *	LS
Category	Earthen Levee			GPS Latitude/Longitude	
				Start	End
Item	Trim / Thin Trees			38.374866 °	38.375061 °
				-121.550491 °	-121.549800 °
DWR ID	DWR_RD0999_05_s_2012_57				
Action/Comments					
Trim and thin trees to allow visibility of the ground and room to flood fight.

Looking northwest at dense trees on landward slope. (Spring 2015)

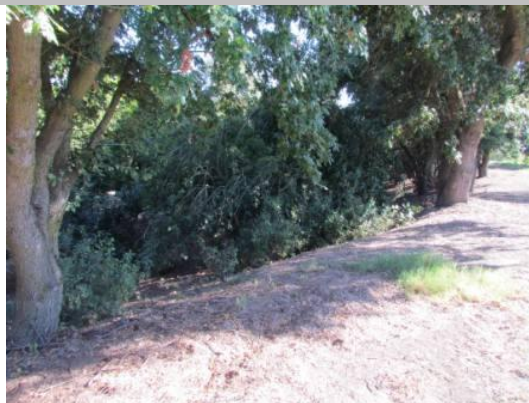
Photo 1 of 3 : SP\_2015\_RD0999\_236\_38\_20150309\_00029.jpg

LM Start	4.51	Rating **	A/W	Issue No.	38
LM End	4.64	Issue Type +	Ma	Location *	LS
Category	Earthen Levee			GPS Latitude/Longitude	
				Start	End
Item	Trim / Thin Trees			38.375055 °	38.375313 °
				-121.548792 °	-121.546438 °
DWR ID	DWR_RD0999_05_s _ 2012_38				
Action/Comments					
Thin trees to allow visibility of the ground and room to flood fight.

Looking northwest at dense trees on landside slope. (Spring 2011)

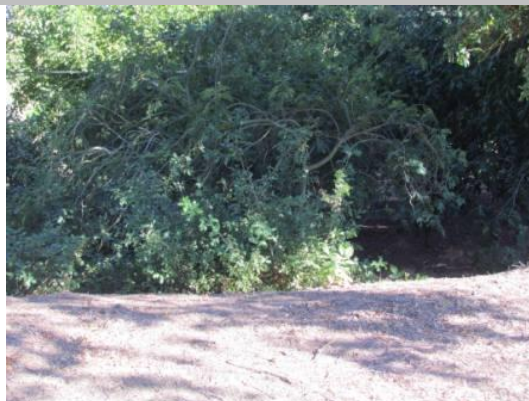
Photo 3 of 3 : SP\_2015\_RD0999\_236\_38\_20150309\_00031.jpg

LM Start	4.51	Rating **	A/W	Issue No.	38 (cont)	
LM End	4.64	Issue Type +	Ma	Location *	LS	
Category	Earthen Levee			GPS Latitude/Longitude		
				Start		End
Item	Trim / Thin Trees			38.375055 °	38.375313 °	
				-121.548792 °	-121.546438 °	
DWR ID	DWR_RD0999_05_s _ 2012_38					
Action/Comments						
Thin trees to allow visibility of the ground and room to flood fight.

Looking west at dense trees on landside slope. (Spring 2011)

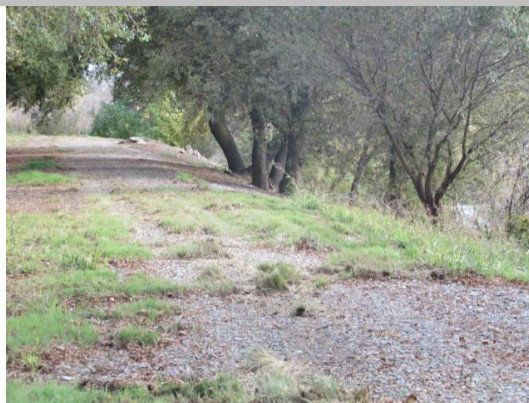
Photo 1 of 1 : SP\_2015\_RD0999\_236\_32\_20150309\_00026.jpg

LM Start	4.51	Rating **	A/W	Issue No.	32
LM End	4.85	Issue Type +	Ma	Location *	CR
Category	Earthen Levee			GPS Latitude/Longitude	
				Start	End
Item	Crown Surface / Depressions / Rutting			38.375084 °	38.377176 °
				-121.548750 °	-121.543571 °
DWR ID	DWR_RD0999_05_f _ 2012_32				
Action/Comments					
Add appropriate material and re-grade the levee to bring the crown above the design elevation.

Looking north at vegetation on levee crown.

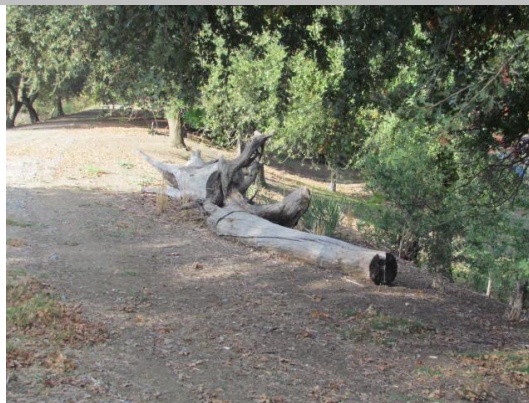
Photo 1 of 1 : SP\_2015\_RD0999\_236\_50\_20150309\_00043.jpg

LM Start	4.65	Rating **	A/W	Issue No.	50
LM End	4.65	Issue Type +	Ma	Location *	LS
Category	Earthen Levee			GPS Latitude/Longitude	
				Start	End
Item	Encroachments			38.375373 °	38.375373 °
				-121.546200 °	-121.546200 °
DWR ID	DWR_RD0999_05_s _ 2012_50				
Action/Comments					
Tree or limb Inspector Comments: Old tree limbs on landward shoulder blocking access.

Looking southwest at tree limbs on landward shoulder.

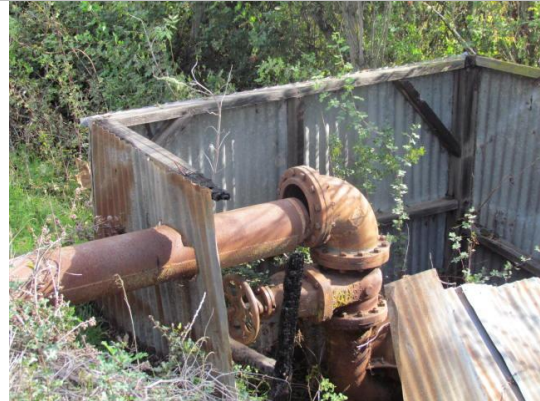
Photo 1 of 1 : SP\_2015\_RD0999\_236\_46\_20150309\_00042.jpg

LM Start	4.68	Rating **	M	Issue No.	46
LM End	4.68	Issue Type +	Ma	Location *	WS
Category	Earthen Levee			GPS Latitude/Longitude	
				Start	End
Item	Encroachments			38.375548 °	38.375548 °
				-121.545693 °	-121.545693 °
DWR ID	DWR_RD0999_05_f_2012_46				
Action/Comments					
Pipe					
Inspector Comments: Pipe is disconnected from pump and should be reconnected or removed.

Looking east at pipe disconnected from pump.

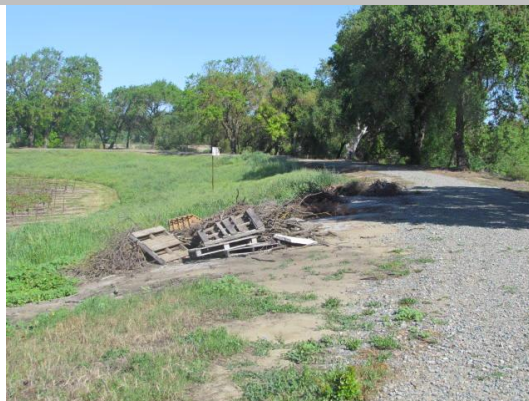
Photo 1 of 1 : SP\_2015\_RD0999\_236\_65\_20150327\_00156.jpg

LM Start	5.07	Rating **	M	Issue No.	65
LM End	5.07	Issue Type +	Ma	Location *	LS
Category	Earthen Levee			GPS Latitude/Longitude	
				Start	End
Item	Encroachments			38.379711 °	38.379711 °
				-121.541070 °	-121.541070 °
DWR ID	DWR_RD0999_05_s _ 2012_65				
Action/Comments					
Prunings					
Inspector Comments: Prunings on landside slope.

Looking north at prunings on landward slope. (Spring 2015)

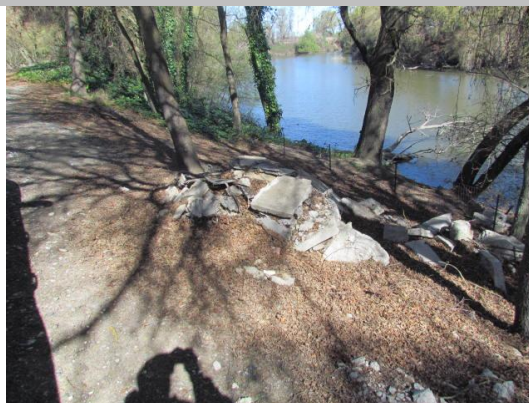
Photo 1 of 1 : SP\_2015\_RD0999\_236\_138\_20150309\_00085.jpg

LM Start	5.41	Rating **	M	Issue No.	138
LM End	5.41	Issue Type +	Ma	Location *	WS
Category	Earthen Levee			GPS Latitude/Longitude	
				Start	End
Item	Encroachments			38.381740 °	38.381740 °
				-121.545864 °	-121.545864 °
DWR ID	DWR_RD0999_05_s _ 2014_138				
Action/Comments					
Material					
Inspector Comments: Concrete rubble dumped on waterward slope.

Looking northeast at concrete rubble on waterward slope.

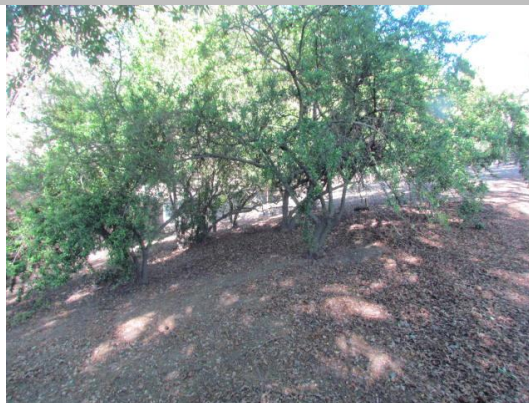
Photo 1 of 1 : SP\_2015\_RD0999\_236\_68\_20150327\_00158.jpg

LM Start	5.48	Rating **	M	Issue No.	68
LM End	5.48	Issue Type +	Ma	Location *	LS
Category	Earthen Levee			GPS Latitude/Longitude	
				Start	End
Item	Trim / Thin Trees			38.382553 °	38.382553 °
				-121.546651 °	-121.546651 °
DWR ID	DWR_RD0999_05_s _ 2012_68				
Action/Comments					
Trim trees to at least five feet above ground level.

Looking northeast at untrimmed trees on landward slope. (Spring 2015)

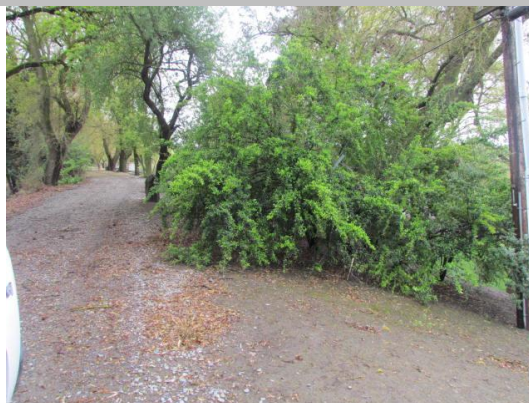
Photo 1 of 1 : SP\_2015\_RD0999\_236\_70\_20150309\_00052.jpg

LM Start	5.49	Rating **	M	Issue No.	70
LM End	5.49	Issue Type +	Ma	Location *	LS
Category	Earthen Levee			GPS Latitude/Longitude	
				Start	End
Item	Trim / Thin Trees			38.382698 °	38.382698 °
				-121.546711 °	-121.546711 °
DWR ID	DWR_RD0999_05_s _ 2012_70				
Action/Comments					
Trim and thin trees to allow visibility of the ground and room to flood fight.

Looking southwest at untrimmed tree on waterside shoulder and slope.

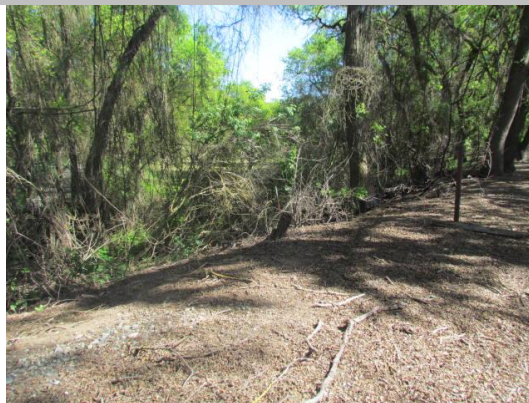
Photo 1 of 1 : SP\_2015\_RD0999\_236\_48\_20150327\_00159.jpg

LM Start	5.80	Rating **	M	Issue No.	48
LM End	5.84	Issue Type +	Ma	Location *	LS
Category	Earthen Levee			GPS Latitude/Longitude	
				Start	End
Item	Vegetation			38.384718 °	38.384930 °
				-121.542590 °	-121.541883 °
DWR ID	DWR_RD0999_05_s_2012_48				
Action/Comments					
Remove the wild growth other than native grasses from the levee slopes.

Looking east at dense vegetation on landward slope. (Spring 2015)

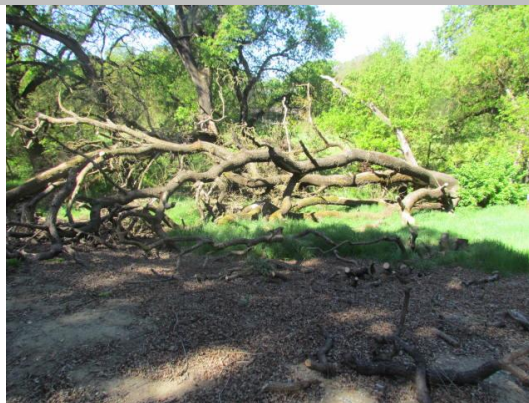
Photo 2 of 5 : SP\_2015\_RD0999\_236\_39\_20150327\_00161.jpg

LM Start	5.93	Rating **	M	Issue No.	39 (cont)
LM End	5.93	Issue Type +	Ma	Location *	LS
Category	Earthen Levee			GPS Latitude/Longitude	
				Start	End
Item	Encroachments			38.385729 °	38.385729 °
				-121.540863 °	-121.540863 °
DWR ID	DWR_RD0999_05_s_2013_39				
Action/Comments					
Tree or limb Inspector Comments: Large downed trees and limbs on landside slope and toe. District is in the process of removing tree branches and limbs from landward slope.

Looking west at fallen tree on landward slope and toe. (Spring 2015)

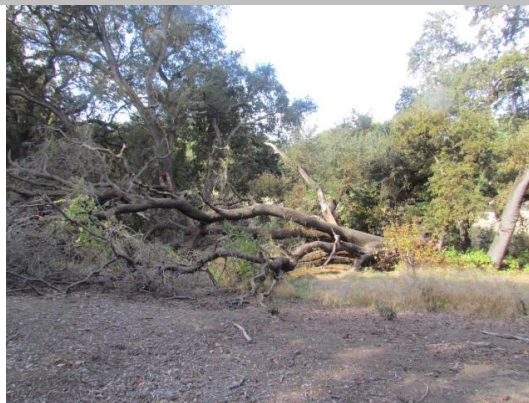
Photo 3 of 5 : SP\_2015\_RD0999\_236\_39\_20150309\_00032.jpg

Looking southwest at downed tree on landward toe. (Fall 2014)

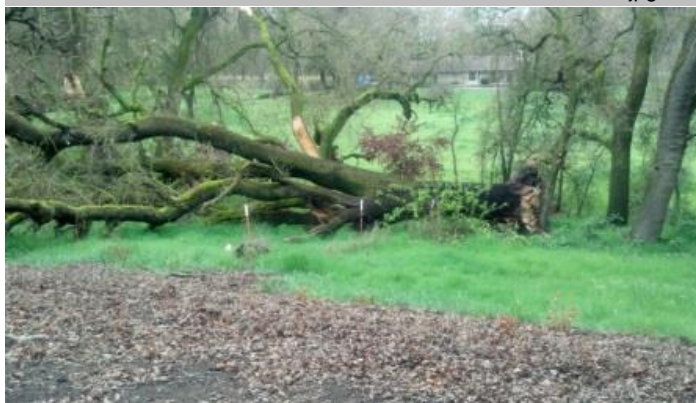
Photo 4 of 5 : SP\_2015\_RD0999\_236\_39\_20150309\_00033.jpg

Looking west at large tree on landside slope and toe.

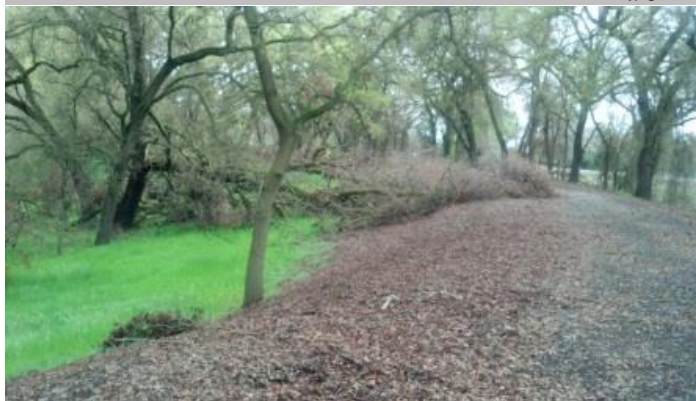
Photo 5 of 5 : SP\_2015\_RD0999\_236\_39\_20150309\_00034.jpg

LM Start	5.93	Rating **	M	Issue No.	39 (cont)
LM End	5.93	Issue Type +	Ma	Location *	LS
Category	Earthen Levee			GPS Latitude/Longitude	
				Start	End
Item	Encroachments			38.385729 °	38.385729 °
				-121.540863 °	-121.540863 °
DWR ID	DWR_RD0999_05_s _ 2013_39				
Action/Comments					
Tree or limb Inspector Comments: Large downed trees and limbs on landside slope and toe. District is in the process of removing tree branches and limbs from landward slope.

Looking northwest at large tree limb on landside toe and slope.

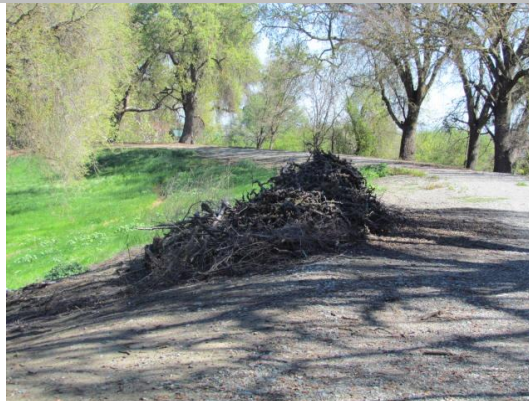
Photo 1 of 1 : SP\_2015\_RD0999\_236\_92\_20150309\_00063.jpg

LM Start	6.48	Rating **	M	Issue No.	92
LM End	6.48	Issue Type +	Ma	Location *	LS
Category	Earthen Levee			GPS Latitude/Longitude	
				Start	End
Item	Encroachments			38.391776 °	38.391776 °
				-121.539295 °	-121.539295 °
DWR ID	DWR_RD0999_05_s _ 2012_92				
Action/Comments					
Prunings

Looking east prunings on landward slope.

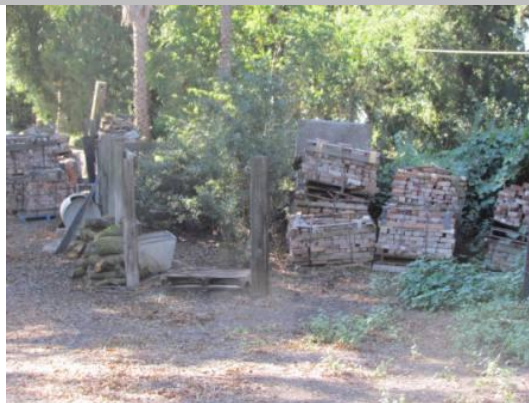
Photo 3 of 4 : SP\_2015\_RD0999\_236\_96\_20150309\_00067.jpg

Looking south at firewood and other material on landside shoulder and crown.

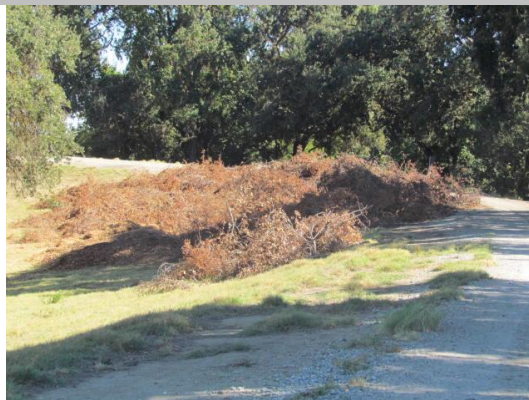
Photo 1 of 1 : SP\_2015\_RD0999\_236\_142\_20150309\_00087.jpg

LM Start	6.95	Rating **	A/W	Issue No.	142
LM End	6.95	Issue Type +	Ma	Location *	LS
Category	Earthen Levee			GPS Latitude/Longitude	
				Start	End
Item	Encroachments			38.396958 °	38.396958 °
				-121.536148 °	-121.536148 °
DWR ID	DWR_RD0999_05_s_2013_142				
Action/Comments					
Prunings					
Inspector Comments: Large pruning pile on landward shoulder and slope.

Looking northeast at large prunings on landward slope.

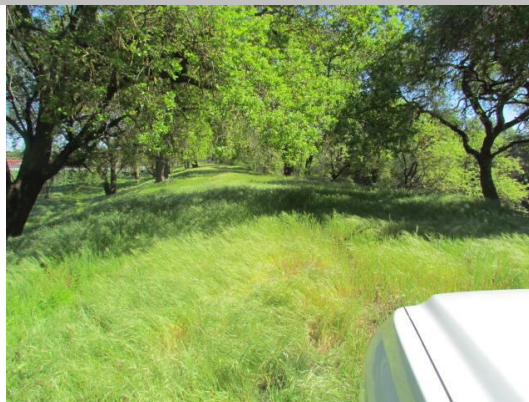
Photo 1 of 1 : SP\_2015\_RD0999\_236\_186\_20150327\_00164.jpg

LM Start	8.42	Rating **	M	Issue No.	186
LM End	8.75	Issue Type +	Ma	Location *	CR
Category	Earthen Levee			GPS Latitude/Longitude	
				Start	End
Item	Vegetation			38.408623 °	38.411767 °
				-121.534525 °	-121.530079 °
DWR ID	DWR_RD0999_05_s _ 2015_186				
Action/Comments					
Control annual grass and weeds on the levee slopes and easements. Inspector Comments: Tall grasses on levee crown should be controlled.

Looking east at levee crown. (Spring 2015)
