**Flood Control Project Maintenance
Levee Inspections**

Maintenance Issue Types Only, Levee Inspection Report By Mile - Spring 2016

Reclamation District No. 0999 Netherlands

Waterway	Bank	Unit Miles	Inspection Start/End	Inspector
Unit No. 01 Yolo Bypass	Left	15.41	03/14/2016 03/16/2016	Richard Willoughby

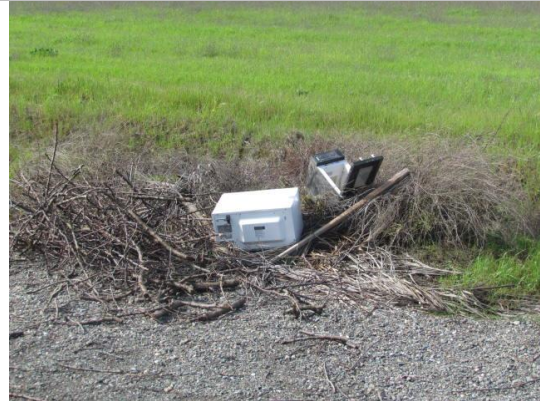
Photo 1 of 1 : SP_2016_RD0999_232_65_20160317_00097.jpg

LM Start	1.33	Rating **	M	Issue No.	65
LM End	1.33	Issue Type +	Ma	Location *	WS
Category	Earthen Levee			GPS Latitude/Longitude	
				Start	End
Item	Encroachments			38.485772 °	38.485772 °
				-121.581182 °	-121.581182 °
DWR ID	DWR_RD0999_01_s_2016_65				
Comment Code					
GA : Garbage					
Inspector Comment					
Garbage and prunings on waterward shoulder.

Looking west at garbage on waterward shoulder.

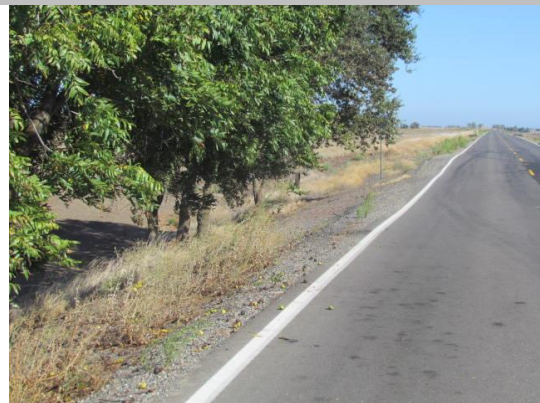
Photo 1 of 2 : SP_2016_RD0999_232_4_20160308_00008.jpg

LM Start	1.73	Rating **	M	Issue No.	4
LM End	1.75	Issue Type +	Ma	Location *	WS
Category	Earthen Levee			GPS Latitude/Longitude	
				Start	End
Item	Trim / Thin Trees			38.480082 °	38.479788 °
				-121.580930 °	-121.580918 °
DWR ID	DWR_RD0999_01_s_2012_4				
Comment Code					
T1 : Trim trees to at least five feet above ground level.					
Inspector Comment

Looking northwest at trimmed trees on waterward slope.

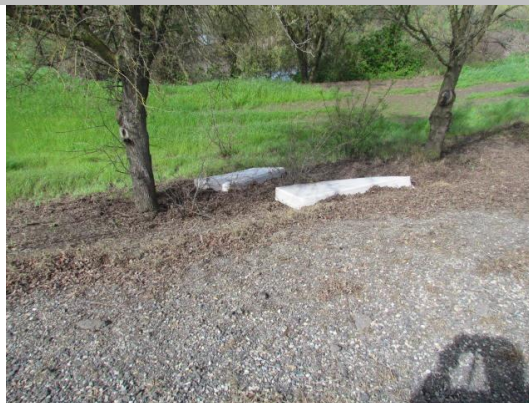
Photo 1 of 1 : SP_2016_RD0999_232_66_20160317_00098.jpg

LM Start	1.73	Rating **	M	Issue No.	66
LM End	1.73	Issue Type +	Ma	Location *	WS
Category	Earthen Levee			GPS Latitude/Longitude	
				Start	End
Item	Encroachments			38.480009 °	38.480009 °
				-121.580865 °	-121.580865 °
DWR ID	DWR_RD0999_01_s_2016_66				
Comment Code					
GA : Garbage					
Inspector Comment					
Garbage on waterward slope.

Looking northwest at garbage on waterward slope and toe.

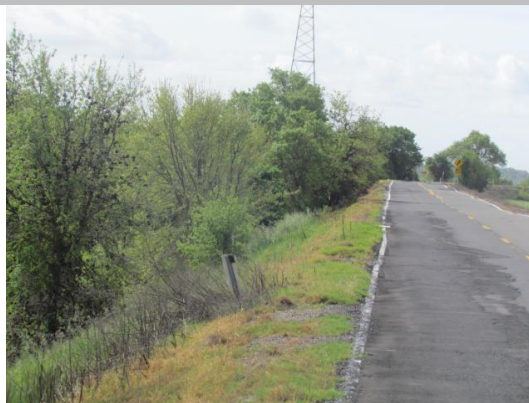
Photo 1 of 5 : SP_2016_RD0999_232_30_20160308_00029.jpg

LM Start	1.79	Rating **	M	Issue No.	30
LM End	2.04	Issue Type +	Ma	Location *	LS
Category	Earthen Levee			GPS Latitude/Longitude	
				Start	End
Item	Trim / Thin Trees			38.479165 °	38.475463 °
				-121.580640 °	-121.580722 °
DWR ID	DWR_RD0999_01_s_2012_30				
Comment Code					
T1 : Trim trees to at least five feet above ground level.					
Inspector Comment

Looking southeast at untrimmed trees on landward slope. (Spring 2015)

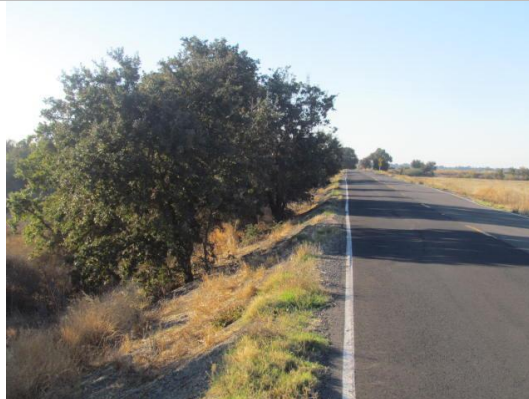
Photo 3 of 5 : SP_2016_RD0999_232_30_20160308_00031.jpg

Looking south at typical view of untrimmed trees on landward slope.

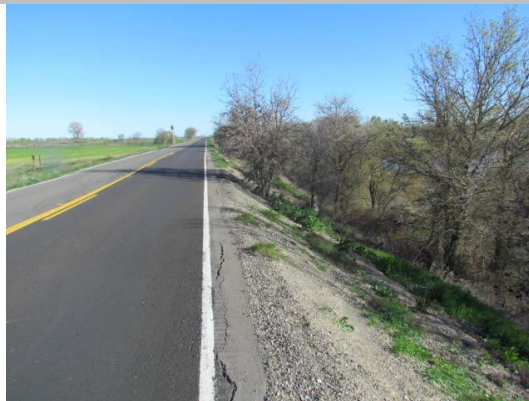
Photo 4 of 5 : SP_2016_RD0999_232_30_20160308_00032.jpg

Looking north at several untrimmed trees on landside slope.

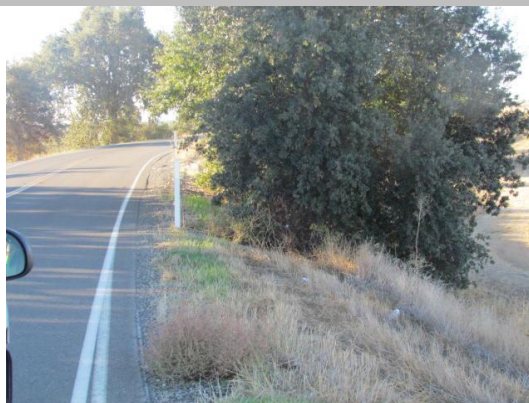
Photo 2 of 3 : SP_2016_RD0999_232_7_20160308_00013.jpg

Looking south at untrimmed trees on waterward slope. (Fall 2014)

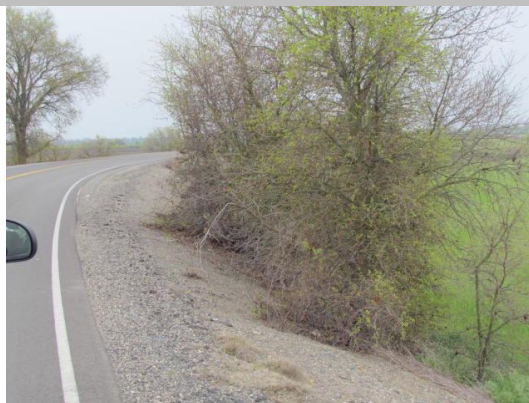
Photo 3 of 3 : SP_2016_RD0999_232_7_20160308_00014.jpg

Looking southwest at untrimmed trees on waterside slope.

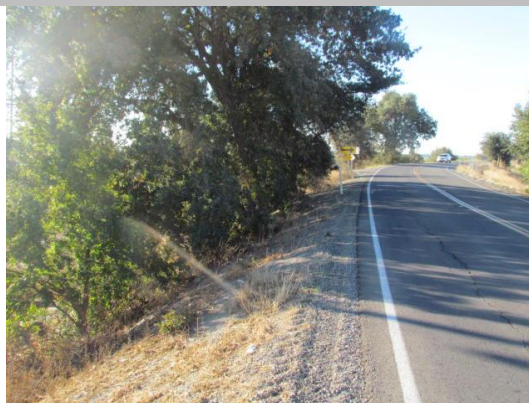
Photo 2 of 3 : SP_2016_RD0999_232_31_20160308_00035.jpg

Looking southeast at untrimmed trees on landward slope. (Fall 2014)

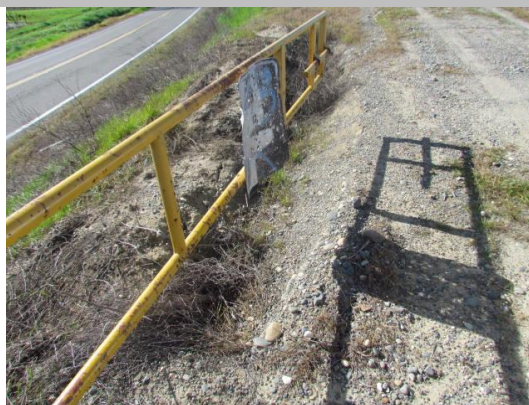
Photo 1 of 4 : SP_2016_RD0999_232_40_20160317_00099.jpg

LM Start	2.51	Rating **	M	Issue No.	40
LM End	2.51	Issue Type +	Ma	Location *	LS
Category	Earthen Levee			GPS Latitude/Longitude	
				Start	End
Item	Encroachments			38.469048 °	38.469048 °
				-121.583075 °	-121.583075 °
DWR ID	DWR_RD0999_01_s_2012_40				
Comment Code					
MA : Material					
Inspector Comment					
Excavation activity on landside shoulder. Hole is approximately 15ft x 12" x 15". Hole appears to be excavated by a backhoe.

Looking south at trench along landward shoulder. (spring 2016)

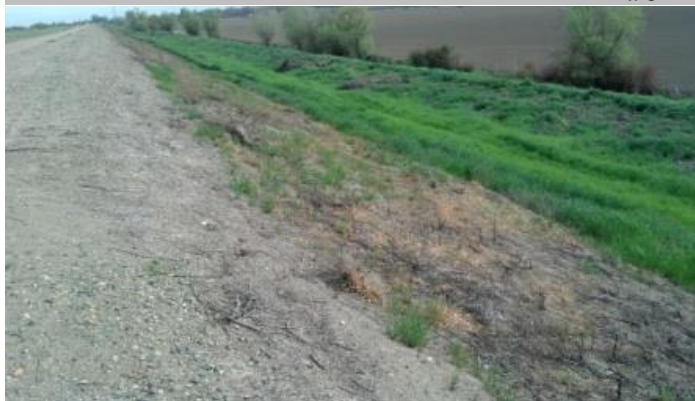
Photo 1 of 2 : SP_2016_RD0999_232_51_20160308_00065.jpg

LM Start	3.22	Rating **	M	Issue No.	51
LM End	3.22	Issue Type +	Ma	Location *	WS
Category	Earthen Levee			GPS Latitude/Longitude	
				Start	End
Item	Slope Stability			38.459399 °	38.459399 °
				-121.587523 °	-121.587523 °
DWR ID	DWR_RD0999_01_s_2013_51				
Comment Code					
S1 : Repair slope instability.					
Inspector Comment					
Depression on landward shoulder and slope 60' x 20'. Earthen material appears to be sliding toward levee toe.

Looking north at depression on landside shoulder and slope.

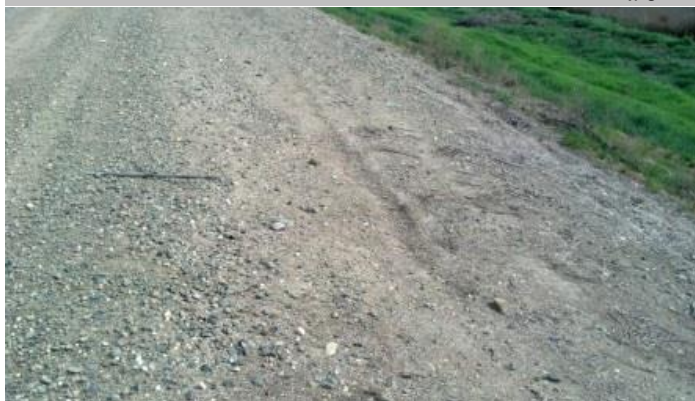
Photo 2 of 2 : SP_2016_RD0999_232_51_20160308_00066.jpg

Looking northeast at depression on landside shoulder.

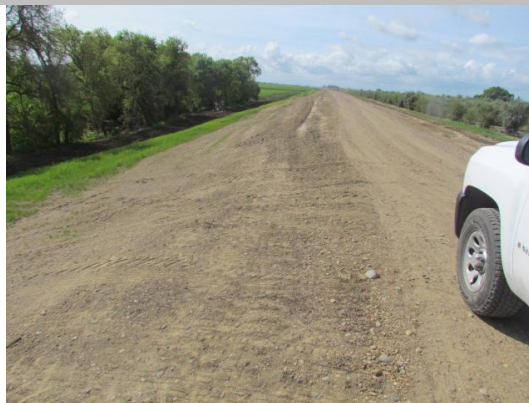
Photo 2 of 4 : SP_2016_RD0999_232_35_20160308_00038.jpg

LM Start	4.31	Rating **	M	Issue No.	35 (cont)	
LM End	4.31	Issue Type +	Ma	Location *	LS	
Category	Earthen Levee			GPS Latitude/Longitude		
				Start		End
Item	Slope Stability			38.444561 °		38.444561 °
				-121.594438 °		-121.594438 °
DWR ID	DWR_RD0999_01_f_2012_35					
Comment Code						
S3 : Repair the levee slope damaged by vehicle traffic and prevent access where possible.						
Inspector Comment						
Depression is caused by vehicle traffic.

Looking south at slope damage cause by vehicle traffic on landward slope. (Spring 2015)

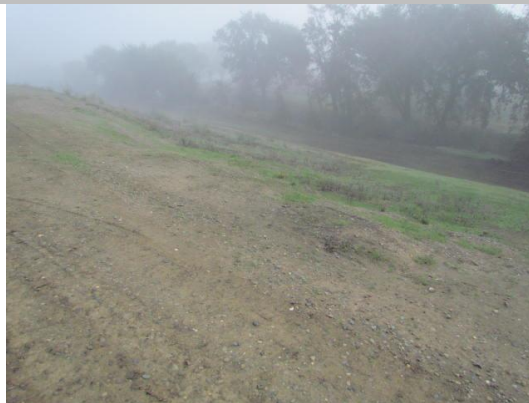
Photo 4 of 4 : SP_2016_RD0999_232_35_20160308_00040.jpg

Looking east at slope damage on landside slope.

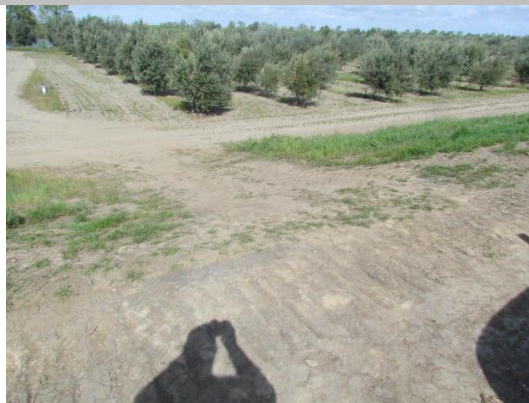
Photo 1 of 3 : SP_2016_RD0999_232_27_20160308_00024.jpg

LM Start	4.31	Rating **	M	Issue No.	27
LM End	4.31	Issue Type +	Ma	Location *	WS
Category	Earthen Levee			GPS Latitude/Longitude	
				Start	End
Item	Slope Stability			38.444560 °	38.444560 °
				-121.594440 °	-121.594440 °
DWR ID	DWR_RD0999_01_f_2012_27				
Comment Code					
S3 : Repair the levee slope damaged by vehicle traffic and prevent access where possible.					
Inspector Comment					
Local farmer causing slope damage by driving equipment and trucks on slope.

Looking west at slope damage cause by vehicle traffice on waterward slope. (Spring 2015)

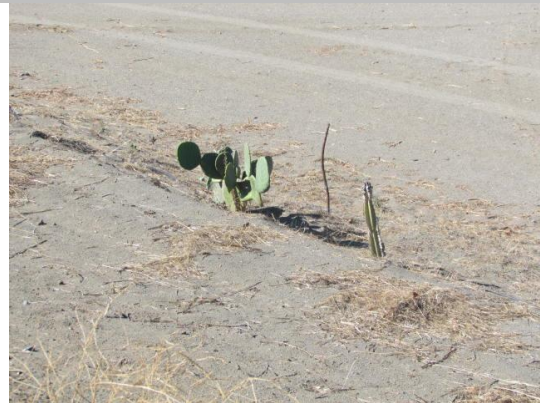
Photo 1 of 1 : SP_2016_RD0999_232_45_20160308_00051.jpg

LM Start	4.36	Rating **	A/W	Issue No.	45
LM End	4.36	Issue Type +	Ma	Location *	WS
Category	Earthen Levee			GPS Latitude/Longitude	
				Start	End
Item	Vegetation			38.443896 °	38.443896 °
				-121.594739 °	-121.594739 °
DWR ID	DWR_RD0999_01_f_2013_45				
Comment Code					
V2 : Remove the wild growth other than native grasses from the levee slopes.					
Inspector Comment					
Landowner has planted cactus on waterward toe.

Looking west at cactus on waterward toe.

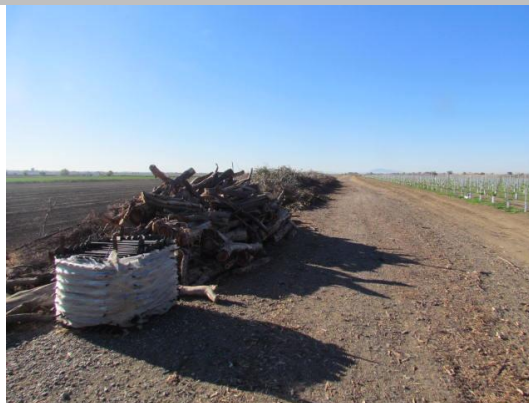
Photo 1 of 2 : SP_2016_RD0999_232_18_20160308_00016.jpg

LM Start	6.53	Rating **	A/W	Issue No.	18
LM End	6.58	Issue Type +	Ma	Location *	LS
Category	Earthen Levee			GPS Latitude/Longitude	
				Start	End
Item	Encroachments			38.414367 °	38.413698 °
				-121.608430 °	-121.608762 °
DWR ID	DWR_RD0999_01_s_2012_18				
Comment Code					
PR : Prunings					
Inspector Comment					
Large pruning piles on landward shoulder. Part of pruning pile blocking levee crown.

Looking south at pruning piles on landward shoulder. (Fall 2014)

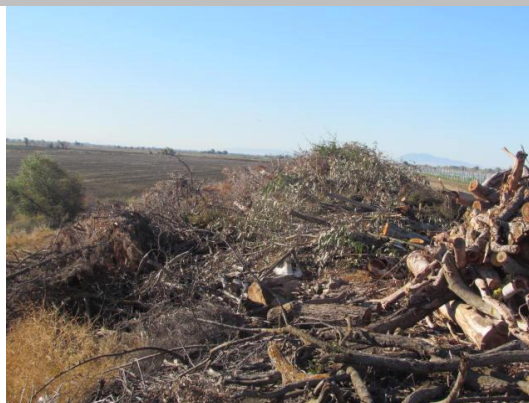
Photo 2 of 2 : SP_2016_RD0999_232_18_20160308_00017.jpg

Looking northwest at large pruning piles on landward shoulder and slope. (Fall 2014)

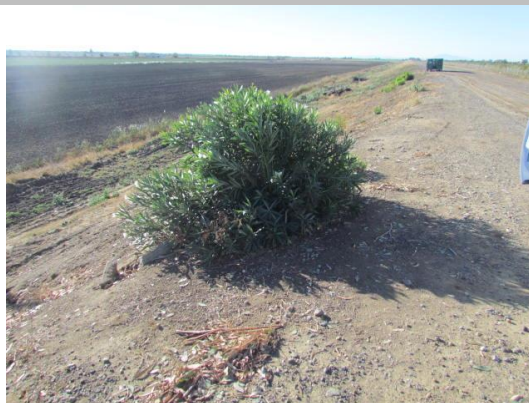
Photo 1 of 1 : SP_2016_RD0999_232_38_20160308_00041.jpg

LM Start	6.53	Rating **	M	Issue No.	38
LM End	6.53	Issue Type +	Ma	Location *	LS
Category	Earthen Levee			GPS Latitude/Longitude	
				Start	End
Item	Vegetation			38.414332 °	38.414332 °
				-121.608413 °	-121.608413 °
DWR ID	DWR_RD0999_01_f_2015_38				
Comment Code					
V2 : Remove the wild growth other than native grasses from the levee slopes.					
Inspector Comment					
Remove young oleander from landward shoulder and slope.

Looking at oleander on landward shoulder.

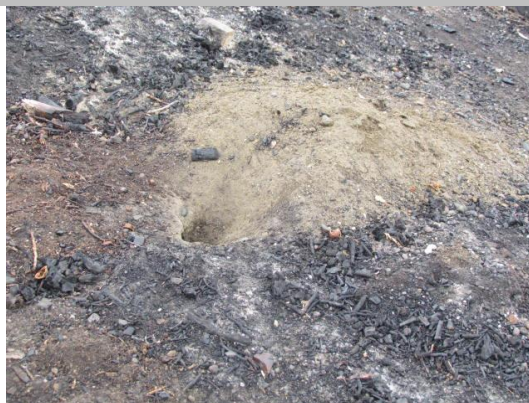
Photo 2 of 2 : SP_2016_RD0999_232_42_20160308_00049.jpg

Looking at typical rodent hole on landside slope.

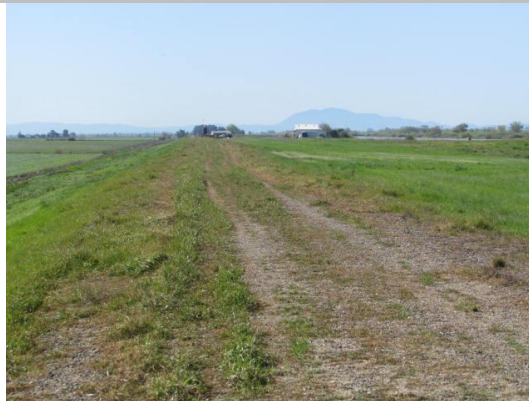
Photo 1 of 2 : SP_2016_RD0999_232_22_20160317_00103.jpg

LM Start	6.77	Rating **	M	Issue No.	22
LM End	9.72	Issue Type +	Ma	Location *	CR
Category	Earthen Levee			GPS Latitude/Longitude	
				Start	End
Item	Crown Surface / Depressions / Rutting			38.411031 °	38.370828 °
				-121.609960 °	-121.628605 °
DWR ID	DWR_RD0999_01_s_2012_22				
Comment Code					
C3 : Add appropriate gravel or road base. Grade and compact.					
Inspector Comment					
Also control growth on levee crown.

Looking south at levee crown. (Spring 2016)

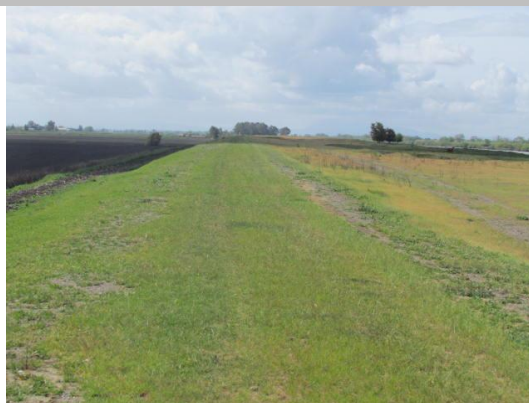
Photo 2 of 2 : SP_2016_RD0999_232_22_20160308_00019.jpg

Looking south at levee crown. (Spring 2015)

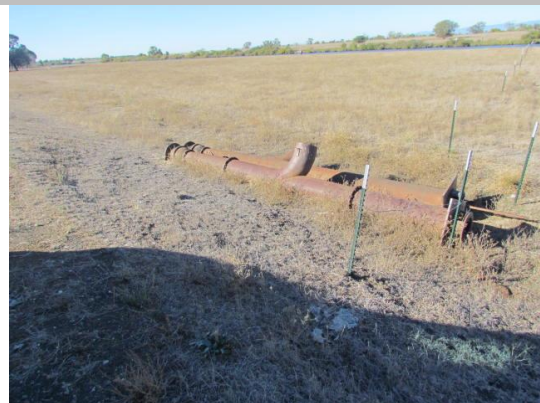
Photo 1 of 1 : SP_2016_RD0999_232_47_20160308_00055.jpg

LM Start	9.51	Rating **	M	Issue No.	47
LM End	9.51	Issue Type +	Ma	Location *	WS
Category	Earthen Levee			GPS Latitude/Longitude	
				Start	End
Item	Encroachments			38.373740 °	38.373740 °
				-121.627257 °	-121.627257 °
DWR ID	DWR_RD0999_01_f_2015_47				
Comment Code					
PI : Pipe					
Inspector Comment					
Abandoned pipes at waterward toe.

Looking southwest at abandoned irrigation pipes at waterward toe.

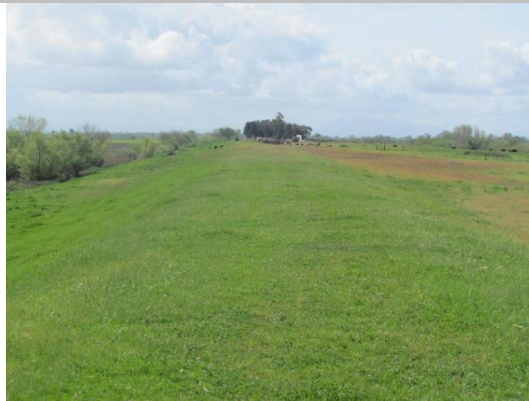
Photo 2 of 3 : SP_2016_RD0999_232_920_20160308_00079.jpg

Looking south at levee crown. (Spring 2015)

LM Start	9.94	Rating **	M	Issue No.	920 (cont)	
LM End	11.60	Issue Type +	Ma	Location *	CR	
Category	Earthen Levee			GPS Latitude/Longitude		
				Start		End
Item	Crown Surface / Depressions / Rutting			38.367831 °		38.345274 °
				-121.629990 °		-121.640482 °
DWR ID	DWR_RD0999_01_s _ 2012_920					
Comment Code						
C1 : Add appropriate material and re-grade the levee to bring the crown above the design elevation.						
Inspector Comment

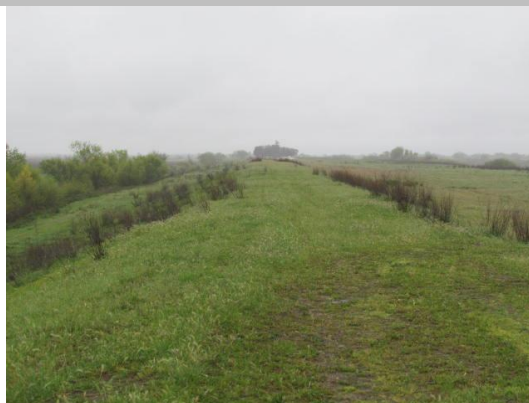
Photo 3 of 3 : SP_2016_RD0999_232_920_20160308_00080.jpg

Looking south at crown roadway. (Spring 2014)

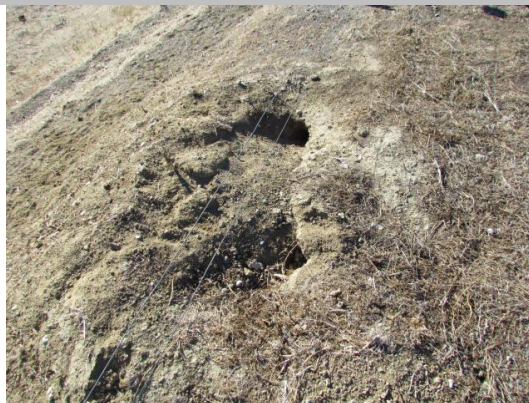
Photo 2 of 5 : SP_2016_RD0999_232_2_20160308_00004.jpg

LM Start	9.95	Rating **	U	Issue No.	2	
LM End	9.95	Issue Type +	Ma	Location *	LS	
Category	Earthen Levee			GPS Latitude/Longitude		
				Start		End
Item	Animal Control			38.367750 °		38.367750 °
				-121.630025 °		-121.630025 °
DWR ID	DWR_RD0999_01_s _ 2012_2					
Comment Code						
A1 : Exterminate rodents and backfill and compact or grout burrows.						
Inspector Comment						
Several large rodent holes on landward shoulder.

Looking southeast at rodent holes on landward shoulder fall 2015.

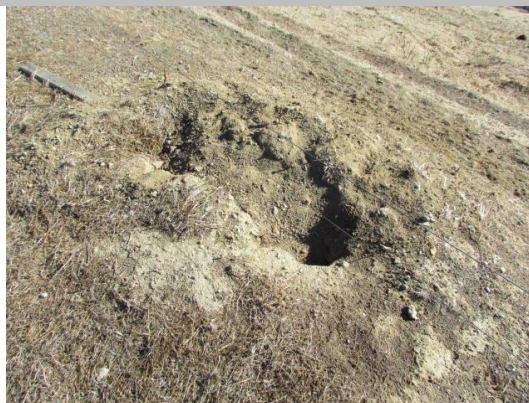
Photo 3 of 5 : SP_2016_RD0999_232_2_20160308_00005.jpg

Looking northeast at rodent holes on landward shoulder fall 2015.

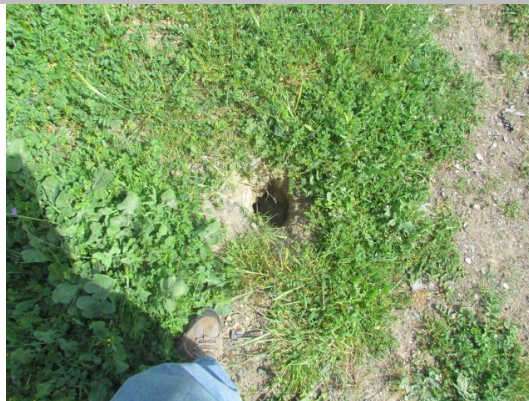
Photo 4 of 5 : SP_2016_RD0999_232_2_20160308_00006.jpg

Looking at typical rodent holes on landward shoulder. (Spring 2015)

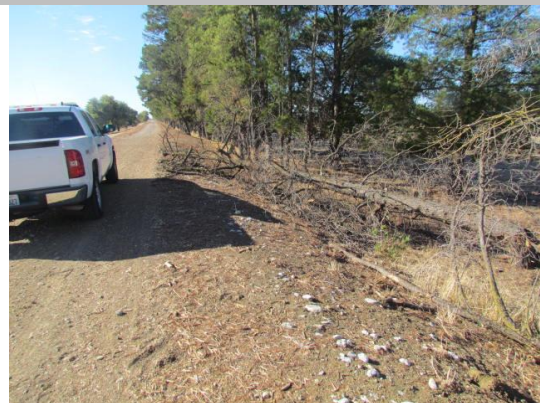
Photo 1 of 1 : SP_2016_RD0999_232_61_20160308_00070.jpg

LM Start	10.75	Rating **	A/W	Issue No.	61
LM End	10.75	Issue Type +	Ma	Location *	WS
Category	Earthen Levee			GPS Latitude/Longitude	
				Start	End
Item	Encroachments			38.356844 °	38.356844 °
				-121.635101 °	-121.635101 °
DWR ID	DWR_RD0999_01_f_2014_61				
Comment Code					
TR : Tree or limb					
Inspector Comment					
Downed tree on waterward slope has been removed, but should be monitored.

Looking southwest at downed tree on waterward slope.

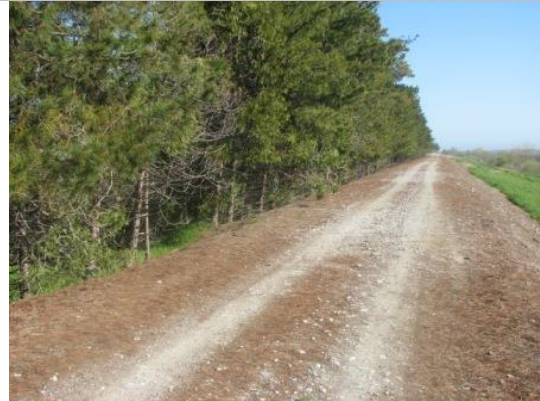
Photo 2 of 2 : SP_2016_RD0999_232_23_20160308_00021.jpg

Pine trees along waterside shoulder & slope. (Site of a old christmas tree farm). (Spring 2011)

LM Start	10.81	Rating **	A/W	Issue No.	23 (cont)
LM End	11.06	Issue Type +	Ma	Location *	WS
Category	Earthen Levee			GPS Latitude/Longitude	
				Start	End
Item	Trim / Thin Trees			38.356077 °	38.352640 °
				-121.635598 °	-121.637078 °
DWR ID	DWR_RD0999_01_s_2012_23				
Comment Code					
T1 : Trim trees to at least five feet above ground level.					
Inspector Comment

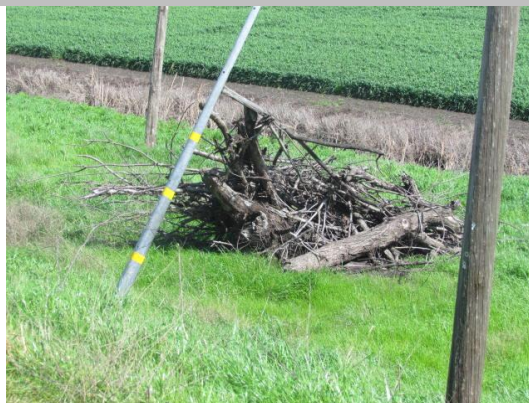
Photo 1 of 2 : SP_2016_RD0999_232_59_20160317_00111.jpg

LM Start	13.46	Rating **	M	Issue No.	59
LM End	13.46	Issue Type +	Ma	Location *	LS
Category	Earthen Levee			GPS Latitude/Longitude	
				Start	End
Item	Encroachments			38.318717 °	38.318717 °
				-121.644955 °	-121.644955 °
DWR ID	DWR_RD0999_01_s_2015_59				
Comment Code					
PR : Prunings					
Inspector Comment					
Pruning pile on landward berm.

Looking east at prunings on landward berm. (Spring 2016)

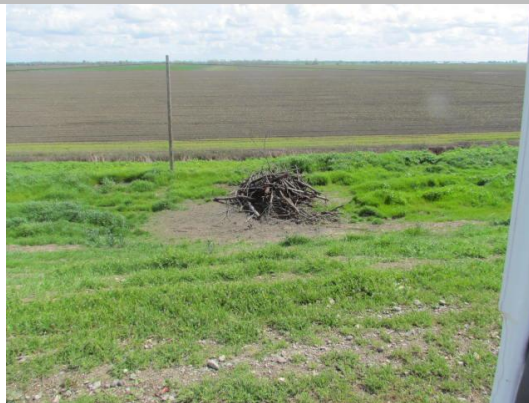
Photo 2 of 2 : SP_2016_RD0999_232_59_20160308_00069.jpg

Looking east at pruning pile on landward berm.

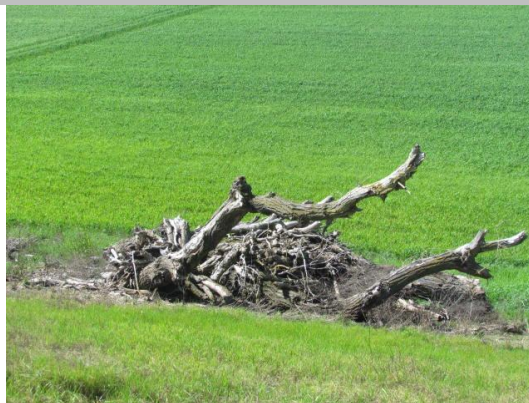
Photo 1 of 1 : SP_2016_RD0999_232_60_20160317_00112.jpg

LM Start	13.49	Rating **	M	Issue No.	60
LM End	13.49	Issue Type +	Ma	Location *	WS
Category	Earthen Levee			GPS Latitude/Longitude	
				Start	End
Item	Encroachments			38.318388 °	38.318388 °
				-121.644958 °	-121.644958 °
DWR ID	DWR_RD0999_01_s_2015_60				
Comment Code					
PR : Prunings					
Inspector Comment					
Pruning pile on waterward toe and berm.

Looking west prunings on waterward toe and berm. (Spring 2016)

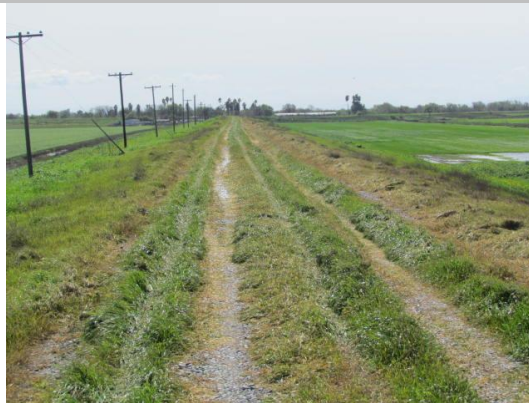
Photo 2 of 2 : SP_2016_RD0999_232_68_20160317_00114.jpg

LM Start	13.75	Rating **	U	Issue No.	68
LM End	15.18	Issue Type +	Ma	Location *	CR
Category	Earthen Levee			GPS Latitude/Longitude	
				Start	End
Item	Crown Surface / Depressions / Rutting			38.314575 °	38.293858 °
				-121.644955 °	-121.644956 °
DWR ID	DWR_RD0999_01_s_2016_68				
Comment Code					
C2 : Repair depressions or ruts in the crown or slope.					
Inspector Comment					
Repair rutting and add appropriate gravel or road base. And control vegetation on levee crown.

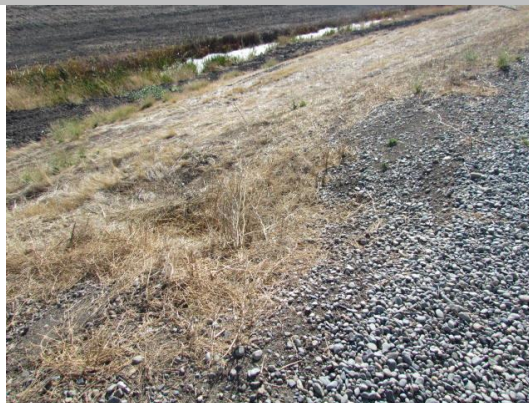
Photo 1 of 4 : SP_2016_RD0999_232_49_20160308_00058.jpg

Looking southeast at caving on landward slope fall 2015.

LM Start	14.04	Rating **	U	Issue No.	49 (cont)	
LM End	14.04	Issue Type +	Ma	Location *	LS	
Category	Earthen Levee			GPS Latitude/Longitude		
				Start		End
Item	Erosion / Bank Caving			38.310347 °		38.310347 °
				-121.644955 °		-121.644955 °
DWR ID	DWR_RD0999_01_f_2012_49					
Comment Code						
E1 : Note and monitor erosion site.						
Inspector Comment						
Caving, 4' x 10', on landside slope.

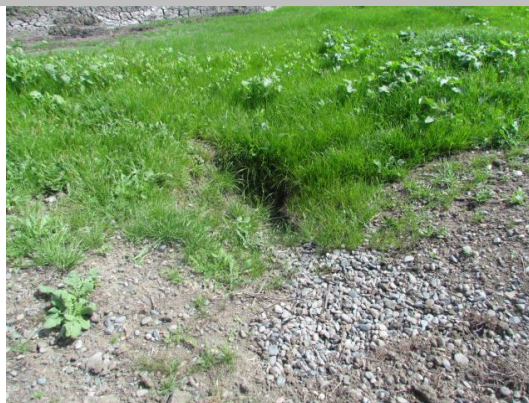
Photo 2 of 4 : SP_2016_RD0999_232_49_20160308_00059.jpg

Looking east at caving on landward shoulder and slope. (Spring 2015)

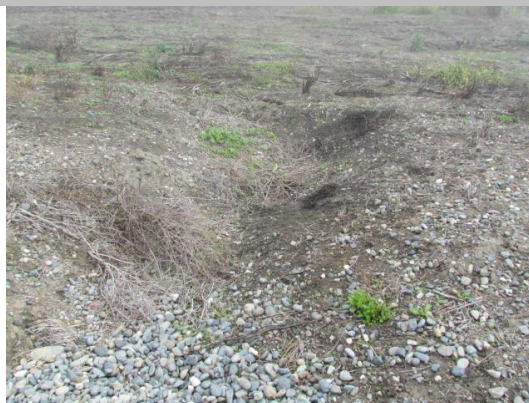
Photo 3 of 4 : SP_2016_RD0999_232_49_20160308_00060.jpg

Looking east caving on landside slope.

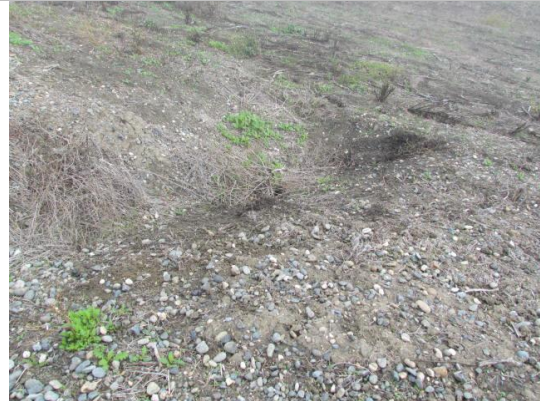
Photo 4 of 4 : SP_2016_RD0999_232_49_20160308_00061.jpg

Looking southeast at caving on landside slope.

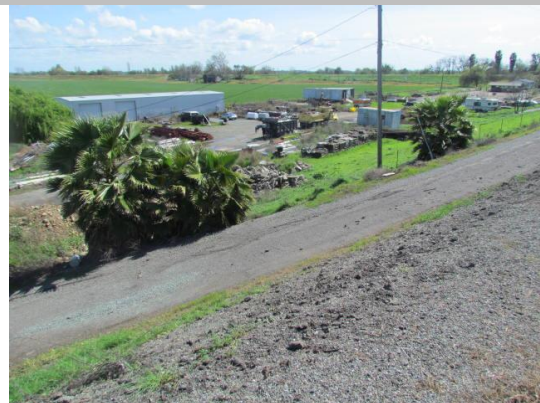
Photo 1 of 1 : SP_2016_RD0999_232_44_20160317_00115.jpg

LM Start	15.26	Rating **	U	Issue No.	44
LM End	15.26	Issue Type +	Ma	Location *	LS
Category	Earthen Levee			GPS Latitude/Longitude	
				Start	End
Item	Vegetation			38.292702 °	38.292702 °
				-121.644967 °	-121.644967 °
DWR ID	DWR_RD0999_01_s_2016_44				
Comment Code					
V7 : Trees / Woody Vegetation					
Inspector Comment					
Unauthorized palm trees on landward slope and toe.

Looking east at palm trees on landward slope next to ramp.

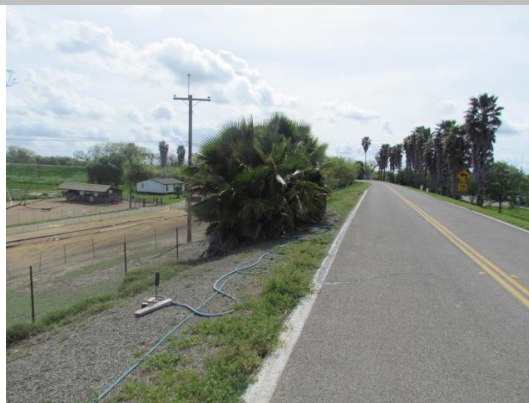
Photo 1 of 3 : SP_2016_RD0999_232_50_20160308_00062.jpg

LM Start	15.33	Rating **	M	Issue No.	50
LM End	15.33	Issue Type +	Ma	Location *	LS
Category	Earthen Levee			GPS Latitude/Longitude	
				Start	End
Item	Encroachments			38.291663 °	38.291663 °
				-121.644962 °	-121.644962 °
DWR ID	DWR_RD0999_01_f_2012_50				
Comment Code					
TR : Tree or limb					
Inspector Comment					
Planted palm trees on landside shoulder.

Looking northeast at a mature palm trees on landward shoulder and slope. (Spring 2015)

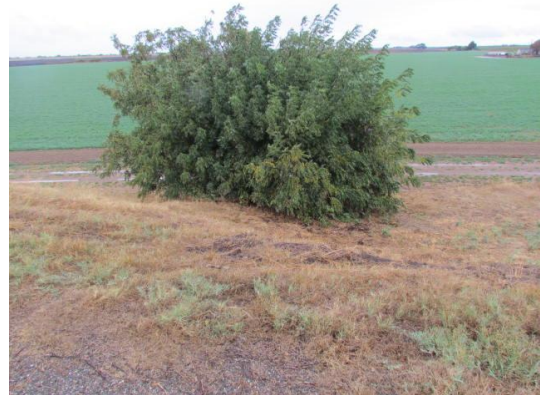
Photo 1 of 1 : SP_2016_RD0999_233_37_20160308_00027.jpg

Looking east at untrimmed tree on landward slope.

LM Start	0.73	Rating **	U	Issue No.	37
LM End	0.73	Issue Type +	Ma	Location *	LS
Category	Earthen Levee			GPS Latitude/Longitude	
				Start	End
Item	Trim / Thin Trees			38.292783 °	38.292783 °
				-121.632317 °	-121.632317 °
DWR ID	DWR_RD0999_02_s_2014_37				
Comment Code					
T1 : Trim trees to at least five feet above ground level.					
Inspector Comment

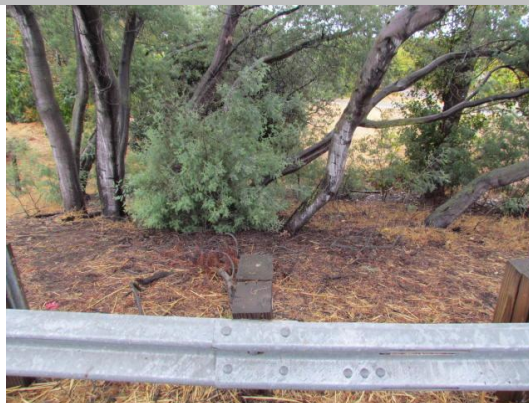
Photo 1 of 2 : SP_2016_RD0999_233_19_20160308_00019.jpg

Looking north at untrimmed and trees to be thinned at landward toe fall 2015.

LM Start	0.83	Rating **	U	Issue No.	19
LM End	0.83	Issue Type +	Ma	Location *	LS
Category	Earthen Levee			GPS Latitude/Longitude	
				Start	End
Item	Trim / Thin Trees			38.292386 °	38.292386 °
				-121.630543 °	-121.630543 °
DWR ID	DWR_RD0999_02_f_2012_19				
Comment Code					
T2 : Thin trees to allow visibility of the ground and room to flood fight.					
Inspector Comment

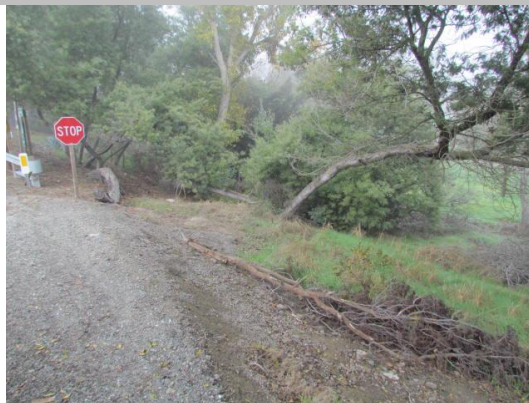
Photo 2 of 2 : SP_2016_RD0999_233_19_20160308_00020.jpg

Looking west at dense trees on landside slope and toe.

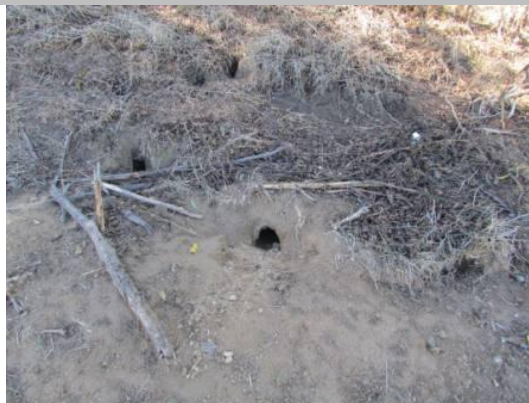
Photo 1 of 1 : SP_2016_RD0999_233_2_20160308_00003.jpg

Looking at several rodent holes on landside slope.

LM Start	0.93	Rating **	M	Issue No.	2
LM End	1.03	Issue Type +	Ma	Location *	LS
Category	Earthen Levee			GPS Latitude/Longitude	
				Start	End
Item	Animal Control			38.291823 °	38.291250 °
				-121.628973 °	-121.627285 °
DWR ID	DWR_RD0999_02_s_2012_2				
Comment Code					
A1 : Exterminate rodents and backfill and compact or grout burrows.					
Inspector Comment

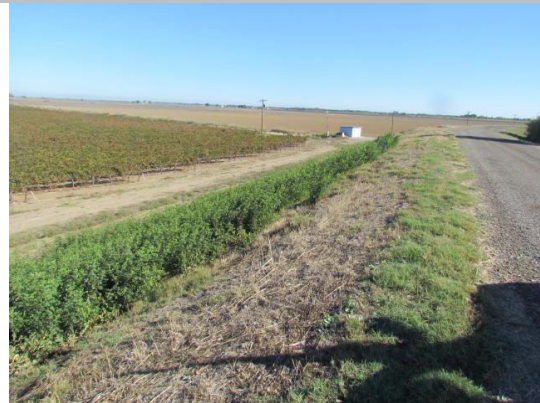
Photo 1 of 1 : SP_2016_RD0999_233_41_20160308_00030.jpg

LM Start	1.19	Rating **	A/W	Issue No.	41
LM End	1.19	Issue Type +	Ma	Location *	LS
Category	Earthen Levee			GPS Latitude/Longitude	
				Start	End
Item	Vegetation			38.291185 °	38.291185 °
				-121.624344 °	-121.624344 °
DWR ID	DWR_RD0999_02_f_2014_41				
Comment Code					
V2 : Remove the wild growth other than native grasses from the levee slopes.					
Inspector Comment					
Dense wild roses on landward slope.

Looking north at moderate vegetation on landward slope and toe.

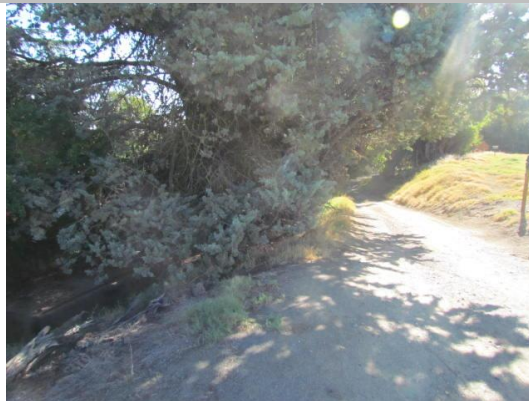
Photo 2 of 2 : SP_2016_RD0999_233_11_20160308_00011.jpg

LM Start	1.70	Rating **	U	Issue No.	11 (cont)	
LM End	1.70	Issue Type +	Ma	Location *	LS	
Category	Earthen Levee			GPS Latitude/Longitude		
				Start		End
Item	Trim / Thin Trees			38.290171 °	38.290171 °	
				-121.615260 °	-121.615260 °	
DWR ID	DWR_RD0999_02_s_2012_11					
Comment Code						
T1 : Trim trees to at least five feet above ground level.						
Inspector Comment

Looking southwest at dense trees on landward slope.

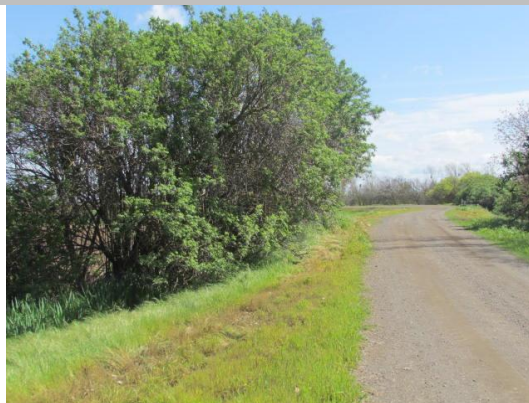
Photo 1 of 3 : SP_2016_RD0999_233_8_20160317_00057.jpg

LM Start	1.73	Rating **	U	Issue No.	8
LM End	1.76	Issue Type +	Ma	Location *	LS
Category	Earthen Levee			GPS Latitude/Longitude	
				Start	End
Item	Vegetation			38.289895 °	38.289595 °
				-121.614688 °	-121.614337 °
DWR ID	DWR_RD0999_02_s_2012_8				
Comment Code					
V2 : Remove the wild growth other than native grasses from the levee slopes.					
Inspector Comment

Looking east at dense vegetation on landward shoulder and slope.
(Spring 2016)

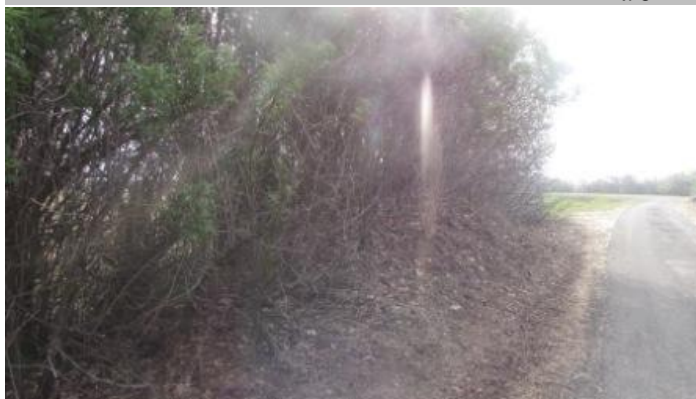
Photo 3 of 3 : SP_2016_RD0999_233_8_20160308_00008.jpg

LM Start	1.73	Rating **	U	Issue No.	8 (cont)	
LM End	1.76	Issue Type +	Ma	Location *	LS	
Category	Earthen Levee			GPS Latitude/Longitude		
				Start		End
Item	Vegetation			38.289895 °		38.289595 °
				-121.614688 °		-121.614337 °
DWR ID	DWR_RD0999_02_s_2012_8					
Comment Code						
V2 : Remove the wild growth other than native grasses from the levee slopes.						
Inspector Comment

Looking east at elderberry bush on landside shoulder and slope. (Fall 2014)

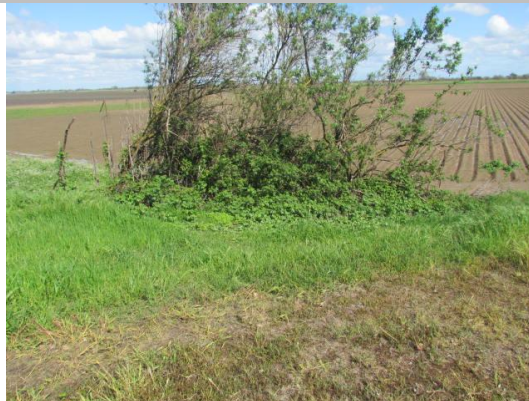
Photo 1 of 3 : SP_2016_RD0999_233_42_20160317_00058.jpg

LM Start	1.78	Rating **	U	Issue No.	42
LM End	1.78	Issue Type +	Ma	Location *	LS
Category	Earthen Levee			GPS Latitude/Longitude	
				Start	End
Item	Vegetation			38.289399 °	38.289399 °
				-121.614130 °	-121.614130 °
DWR ID	DWR_RD0999_02_f_2014_42				
Comment Code					
V4 : Elderberries are blocking visibility and flood fight capability.					
Inspector Comment					
Elderberry and wildroses blocking landward toe.

Looking east at wild roses and other vegetation at landward toe. (Spring 2016)

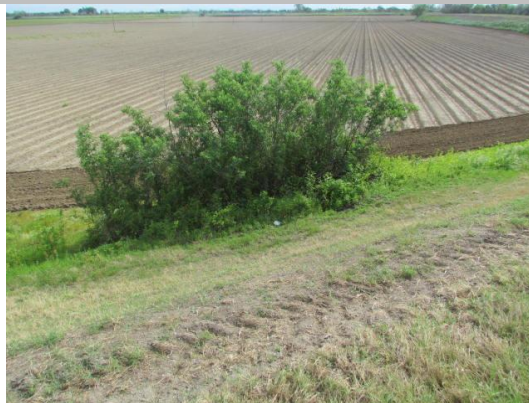
Photo 2 of 3 : SP_2016_RD0999_233_42_20160308_00031.jpg

Looking east at wild rose blocking landward toe. (Spring 2015)

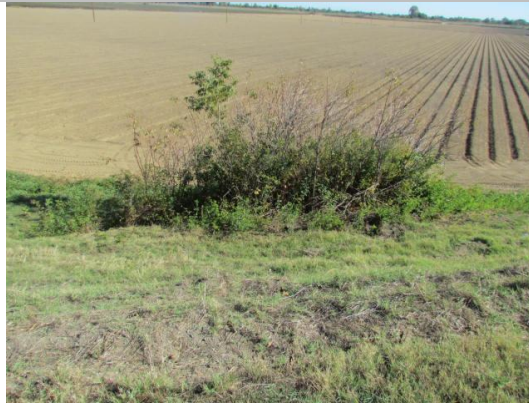
Photo 3 of 3 : SP_2016_RD0999_233_42_20160308_00032.jpg

Looking east at elderberry and wild roses blocking view of landward toe.

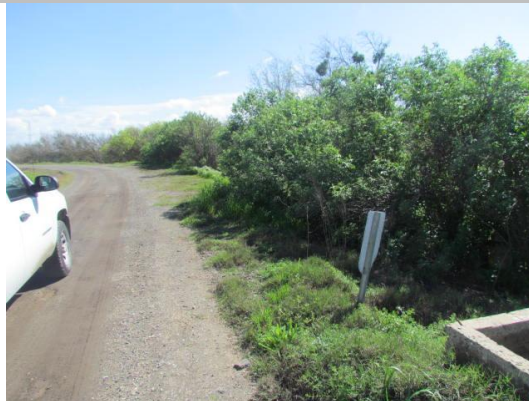
Photo 1 of 3 : SP_2016_RD0999_233_38_20160317_00059.jpg

LM Start	1.78	Rating **	U	Issue No.	38
LM End	1.82	Issue Type +	Ma	Location *	WS
Category	Earthen Levee			GPS Latitude/Longitude	
				Start	End
Item	Vegetation			38.289360 °	38.289006 °
				-121.614086 °	-121.613639 °
DWR ID	DWR_RD0999_02_s_2014_38				
Comment Code					
V4 : Elderberries are blocking visibility and flood fight capability.					
Inspector Comment

Looking east at dense vegetation on waterward shoulder and slope. (Spring 2016)

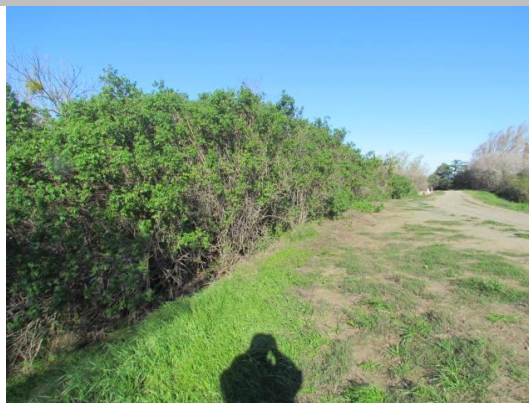
Photo 2 of 3 : SP_2016_RD0999_233_38_20160308_00028.jpg

Looking west at dense vegetation on waterside slope. (Spring 2015)

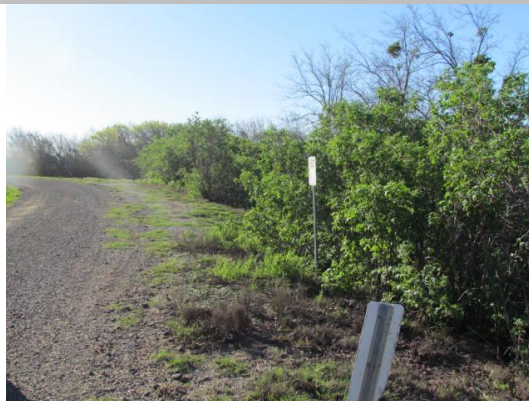
Photo 3 of 3 : SP_2016_RD0999_233_38_20160308_00029.jpg

Looking east at dense vegetation on waterside slope. (Spring 2014)

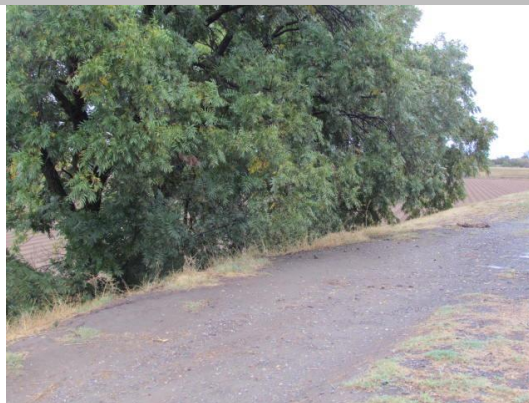
Photo 1 of 1 : SP_2016_RD0999_233_29_20160308_00026.jpg

LM Start	2.06	Rating **	U	Issue No.	29
LM End	2.07	Issue Type +	Ma	Location *	LS
Category	Earthen Levee			GPS Latitude/Longitude	
				Start	End
Item	Trim / Thin Trees			38.288870 °	38.288844 °
				-121.609259 °	-121.609008 °
DWR ID	DWR_RD0999_02_f_2013_29				
Comment Code					
T1 : Trim trees to at least five feet above ground level.					
Inspector Comment

Looking at untrimmed trees on landward slope fall 2015.

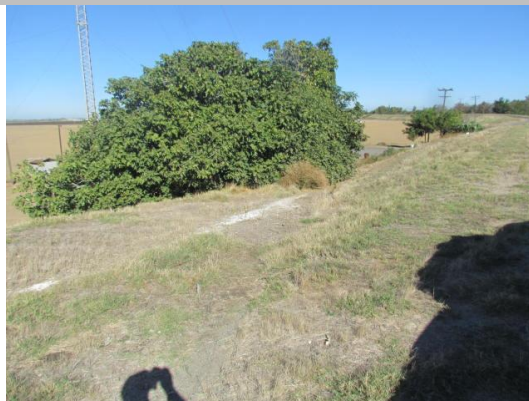
Photo 2 of 5 : SP_2016_RD0999_234_4_20160308_00003.jpg

Looking northwest at dense fig tree on landward toe. 2014

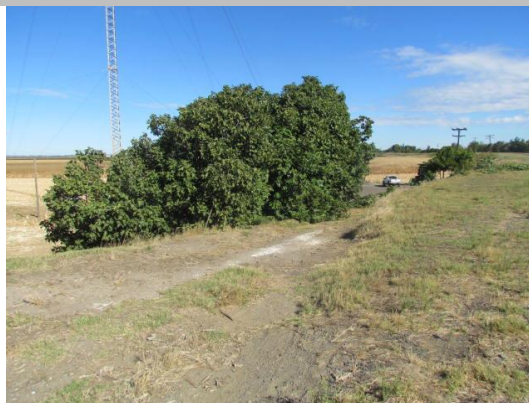
Photo 3 of 5 : SP_2016_RD0999_234_4_20160308_00004.jpg

Looking northwest at dense fig tree on landward slope and toe. 2013

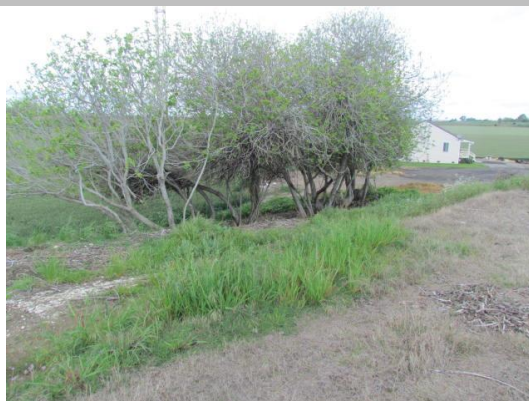
Photo 4 of 5 : SP_2016_RD0999_234_4_20160308_00005.jpg

Looking southwest at trimmed trees on landside toe. (Spring 2012)

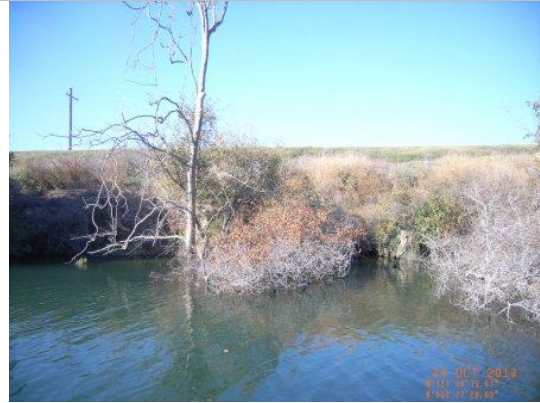
Photo 1 of 1 : SP_2016_RD0999_234_29_20160308_00025.jpg

Comment Code					
Inspector Comment					
1997 - Intermittent over-steepened sections. Large riparian vegetation along the length of the entire reach. Attempts to repair with rock on bank have failed. 1999 - New rock repair at the downstream end. 2002 - Some minor spot repairs. 2009 - Minimal new erosion. 2010 - Appears that fresh rock placed on downstream portion of site. Toe scour and overhanging trees with some overturned. 2012 - Minor new erosion at the toe. 2013 - Site upgraded to CRITICAL. Severe slumping into levee at downstream end of site. Fresh erosion into bank toe. 2015: New slumping, tall vertical sections. [2015 Site ID: STR_24-7_R]

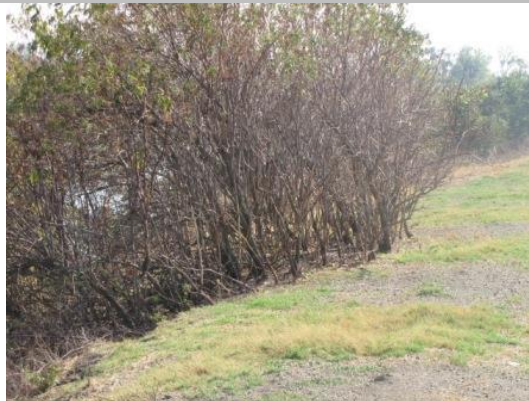
Photo 2 of 2 : SP_2016_RD0999_234_7_20160308_00008.jpg

LM Start	0.45	Rating **	U	Issue No.	7 (cont)	
LM End	0.45	Issue Type +	Ma	Location *	WS	
Category	Earthen Levee			GPS Latitude/Longitude		
				Start		End
Item	Vegetation			38.292748 °		38.292748 °
				-121.604972 °		-121.604972 °
DWR ID	DWR_RD0999_03_s_2012_7					
Comment Code						
V4 : Elderberries are blocking visibility and flood fight capability.						
Inspector Comment

Looking south at thinned Elderberry on waterside slope.

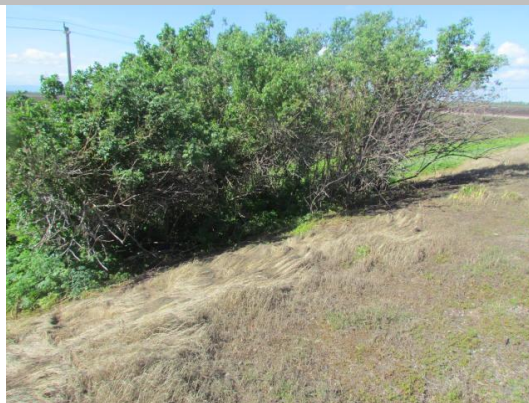
Photo 1 of 2 : SP_2016_RD0999_234_8_20160317_00049.jpg

LM Start	0.66	Rating **	U	Issue No.	8
LM End	0.66	Issue Type +	Ma	Location *	LS
Category	Earthen Levee			GPS Latitude/Longitude	
				Start	End
Item	Vegetation			38.295618 °	38.295618 °
				-121.605923 °	-121.605923 °
DWR ID	DWR_RD0999_03_s_2012_8				
Comment Code					
V4 : Elderberries are blocking visibility and flood fight capability.					
Inspector Comment

Looking east at elderberry at landward slope and toe. (Spring 2016)

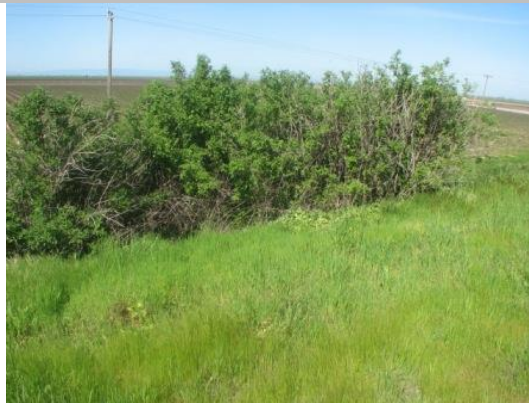
Photo 2 of 2 : SP_2016_RD0999_234_8_20160308_00009.jpg

Elderberries blocking view of landside toe.

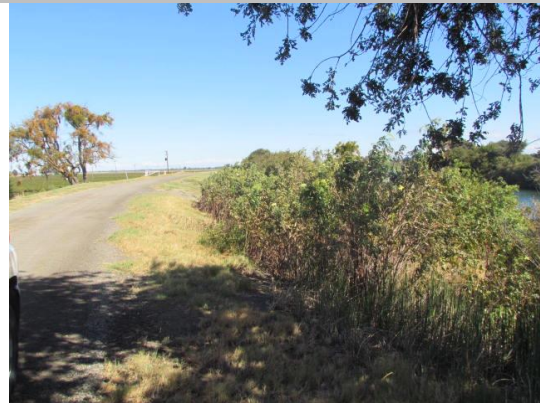
Photo 1 of 1 : SP_2016_RD0999_234_15_20160308_00016.jpg

LM Start	0.69	Rating **	M	Issue No.	15
LM End	0.70	Issue Type +	Ma	Location *	WS
Category	Earthen Levee			GPS Latitude/Longitude	
				Start	End
Item	Vegetation			38.296073 °	38.296203 °
				-121.605872 °	-121.605837 °
DWR ID	DWR_RD0999_03_s_2012_15				
Comment Code					
V4 : Elderberries are blocking visibility and flood fight capability.					
Inspector Comment

Looking northeast at dense elderberry on waterward slope.

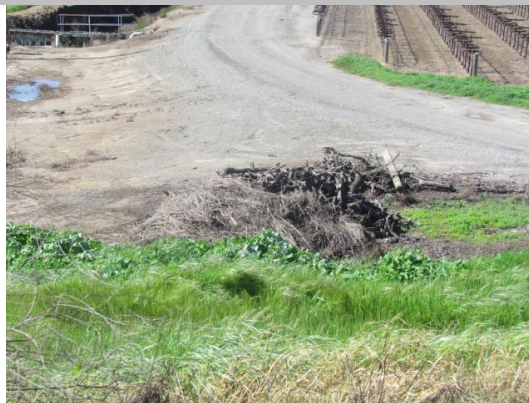
Photo 1 of 2 : SP_2016_RD0999_234_2_20160317_00050.jpg

LM Start	0.75	Rating **	M	Issue No.	2
LM End	0.75	Issue Type +	Ma	Location *	LS
Category	Earthen Levee			GPS Latitude/Longitude	
				Start	End
Item	Encroachments			38.296942 °	38.296942 °
				-121.605528 °	-121.605528 °
DWR ID	DWR_RD0999_03_s_2012_2				
Comment Code					
PR : Prunings					
Inspector Comment

Looking west at prunings at landward toe and berm. (Spring 2016)

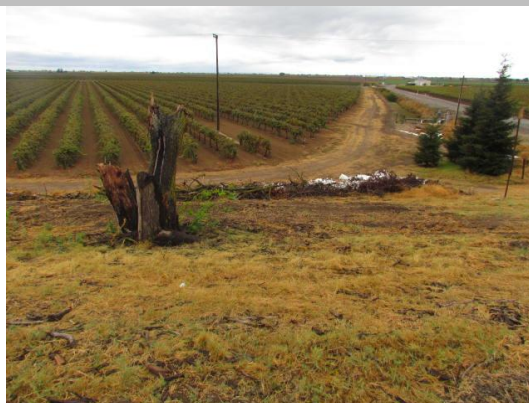
Photo 2 of 2 : SP_2016_RD0999_234_2_20160308_00002.jpg

Looking at prunings at landward toe.

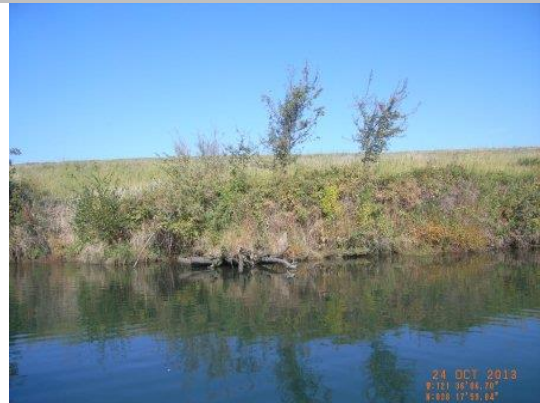
Photo 1 of 1 : SP_2016_RD0999_234_30_20160308_00026.jpg

LM Start	0.97	Rating **	M	Issue No.	30
LM End	1.10	Issue Type +	Ma	Location *	WS
Category	Supplemental			GPS Latitude/Longitude	
				Start	End
Item	2015 USACE Erosion Survey, DRAFT			38.299402 °	38.300542 °
				-121.603056 °	-121.601118 °
DWR ID	DWR_RD0999_03_s_2016_30				
Comment Code					
Inspector Comment					
2008 - Over steepened levee section. 2009 - Significant new erosion. 2010 - Minor new erosion. 2015: No observed changes. [2015 Site ID: STR_25-2_R]

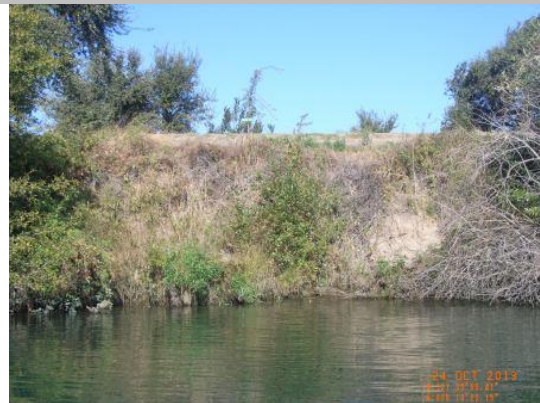
Photo 1 of 1 : SP_2016_RD0999_234_1_20160308_00001.jpg

LM Start	1.43	Rating **	M	Issue No.	1
LM End	1.58	Issue Type +	Ma	Location *	WS
Category	Supplemental			GPS Latitude/Longitude	
				Start	End
Item	2015 USACE Erosion Survey, DRAFT			38.305229 °	38.306667 °
				-121.599933 °	-121.598266 °
DWR ID	DWR_RD0999_03_s_2016_1				
Comment Code					
Inspector Comment					
2011 - Toe scour along length of site and erosion pockets. 2012 - Site extended slightly upstream due to new erosion pocket. 2013 - Tall vertical sections at upstream end of site. 2015: No observed changes. [2015 Site ID: STR_25-7_R]

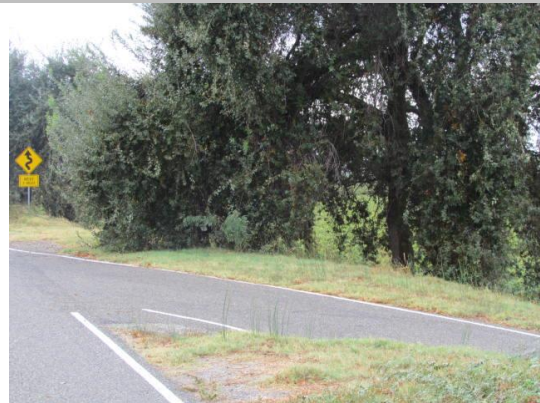
Photo 1 of 1 : SP_2016_RD0999_234_11_20160308_00014.jpg

LM Start	1.50	Rating **	U	Issue No.	11
LM End	1.50	Issue Type +	Ma	Location *	LS
Category	Earthen Levee			GPS Latitude/Longitude	
				Start	End
Item	Trim / Thin Trees			38.306062 °	38.306062 °
				-121.599495 °	-121.599495 °
DWR ID	DWR_RD0999_03_s_2012_11				
Comment Code					
T1 : Trim trees to at least five feet above ground level.					
Inspector Comment

Looking at untrimmed trees on landward slope and toe.

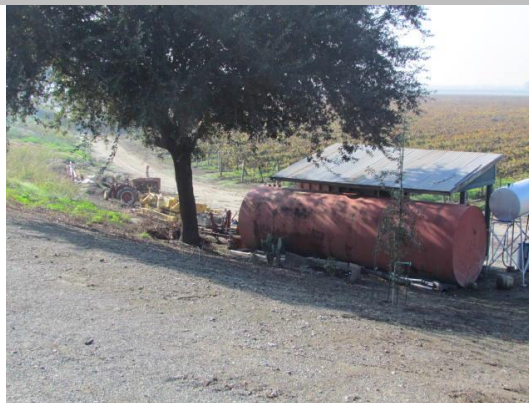
Photo 2 of 3 : SP_2016_RD0999_234_27_20160308_00023.jpg

LM Start	2.54	Rating **	U	Issue No.	27 (cont)	
LM End	2.54	Issue Type +	Ma	Location *	LS	
Category	Earthen Levee			GPS Latitude/Longitude		
				Start		End
Item	Encroachments			38.317840 °	38.317840 °	
				-121.590895 °	-121.590895 °	
DWR ID	DWR_RD0999_03_s_2012_27					
Comment Code						
EQ : Equipment						
Inspector Comment						
Diesel tank stored at landside toe.

Looking southwest at farm equipment stored at landside toe. (Fall Inspection 2012)

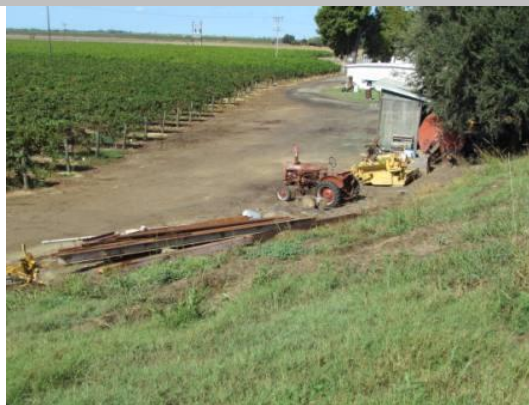
Photo 3 of 3 : SP_2016_RD0999_234_27_20160308_00024.jpg

LM Start	2.54	Rating **	U	Issue No.	27 (cont)
LM End	2.54	Issue Type +	Ma	Location *	LS

Looking northwest at equipment at landside toe.

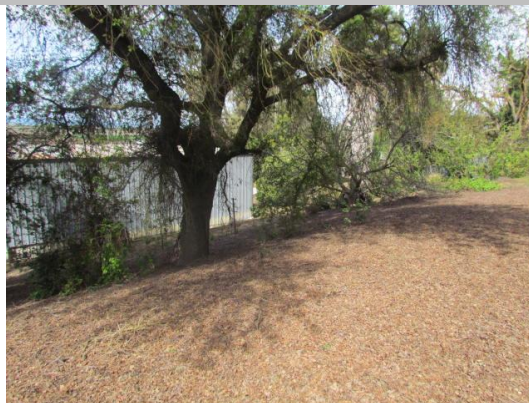
Photo 1 of 1 : SP_2016_RD0999_234_32_20160308_00028.jpg

LM Start	2.69	Rating **	A/W	Issue No.	32
LM End	2.74	Issue Type +	Ma	Location *	LS
Category	Earthen Levee			GPS Latitude/Longitude	
				Start	End
Item	Trim / Thin Trees			38.319943 °	38.320670 °
				-121.590737 °	-121.590802 °
DWR ID	DWR_RD0999_03_s_2012_32				
Comment Code					
T1 : Trim trees to at least five feet above ground level.					
Inspector Comment

Looking northwest at untrimmed trees on landward slope. (Spring 2015)
