**Flood Control Project Maintenance
Levee Inspections**

Maintenance Issue Types Only, Levee Inspection Report By Mile - Spring 2016

Reclamation District No. 0999 Netherlands

Waterway	Bank	Unit Miles	Inspection Start/End	Inspector
Unit No. 01 Yolo Bypass	Left	15.41	03/14/2016 03/16/2016	Richard Willoughby

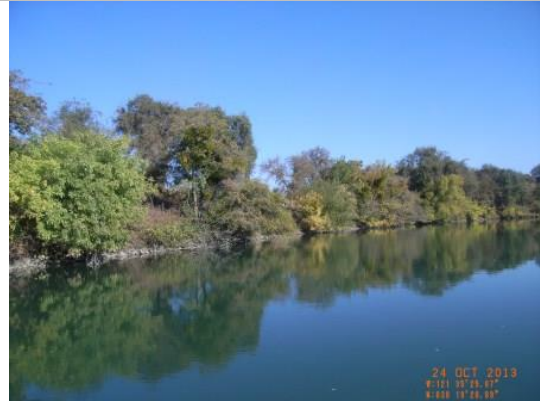
Photo 1 of 1 : SP_2016_RD0999_234_21_20160308_00020.jpg

LM Start	2.87	Rating **	M	Issue No.	21
LM End	2.92	Issue Type +	Ma	Location *	WS
Category	Supplemental			GPS Latitude/Longitude	
				Start	End
Item	2015 USACE Erosion Survey, DRAFT			38.322457 °	38.323042 °
				-121.590693 °	-121.590209 °
DWR ID	DWR_RD0999_03_s_2016_21				
Comment Code					
Inspector Comment					
2012 - Slumping of upper levee slope. 2015: No observed changes. [2015 Site ID: STR_27-1_R]

USACE 2013 Photo #1

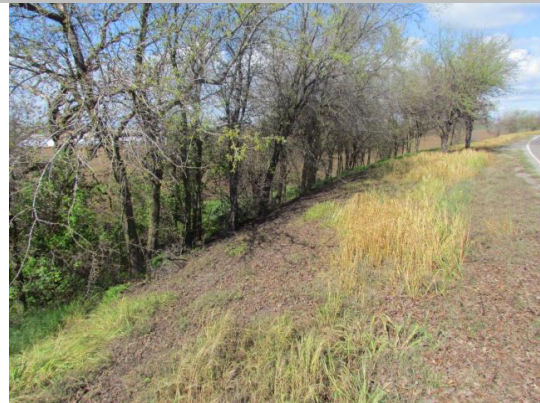
Photo 1 of 4 : SP_2016_RD0999_234_10_20160317_00052.jpg

LM Start	2.88	Rating **	U	Issue No.	10
LM End	2.88	Issue Type +	Ma	Location *	LS
Category	Earthen Levee			GPS Latitude/Longitude	
				Start	End
Item	Trim / Thin Trees			38.322757 °	38.322757 °
				-121.590817 °	-121.590817 °
DWR ID	DWR_RD0999_03_f_2012_10				
Comment Code					
T3 : Trim and thin trees to allow visibility of the ground and room to flood fight.					
Inspector Comment					
Wild growth at landside slope and toe.

Looking northwest at dense vegetation on landward slope and toe.
(Spring 2016)

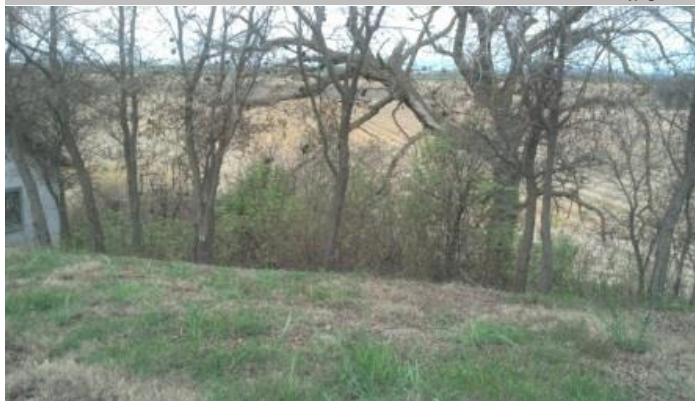
Photo 3 of 4 : SP_2016_RD0999_234_10_20160308_00012.jpg

Looking west at dense trees on landside toe.

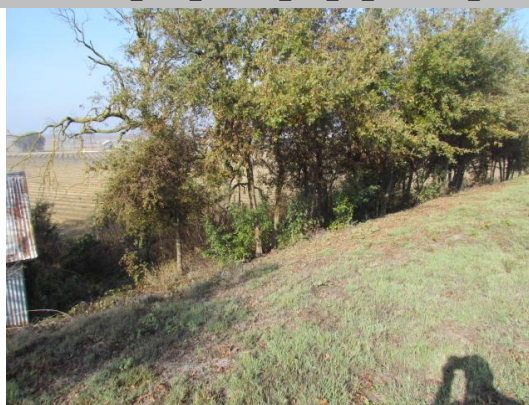
Photo 4 of 4 : SP_2016_RD0999_234_10_20160308_00013.jpg

Looking northwest at dense vegetation at landside slope and toe.

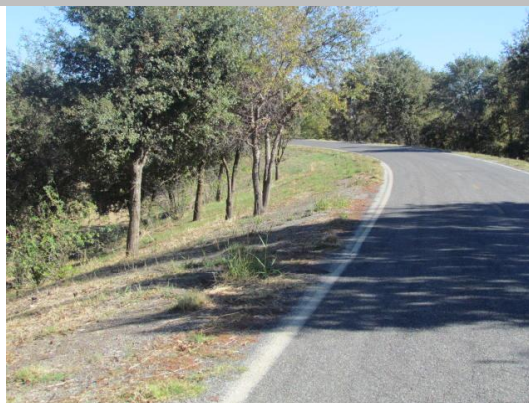
Photo 2 of 2 : SP_2016_RD0999_234_31_20160308_00027.jpg

Looking north at trimmed trees on landward slope.

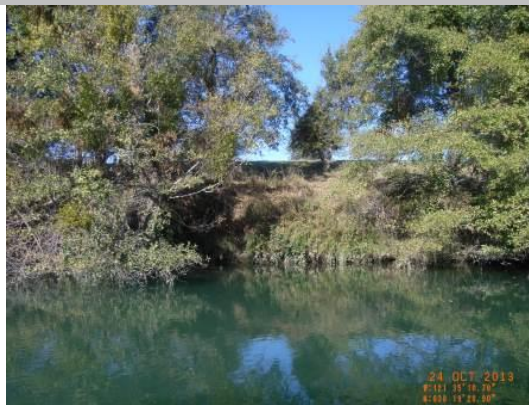
Photo 1 of 1 : SP_2016_RD0999_234_5_20160308_00007.jpg

LM Start	3.05	Rating **	M	Issue No.	5
LM End	3.23	Issue Type +	Ma	Location *	WS
Category	Supplemental			GPS Latitude/Longitude	
				Start	End
Item	2015 USACE Erosion Survey, DRAFT			38.323667 °	38.325592 °
				-121.588226 °	-121.585925 °
DWR ID	DWR_RD0999_03_s_2016_5				
Comment Code					
Inspector Comment					
2011 - Multiple erosion pockets. Some likely from tree popouts. 2013 - Tall vertical sections. 2015: New tree popout and significant new erosion. [2015 Site ID: STR_27-3_R]

USACE 2013 Photo #1

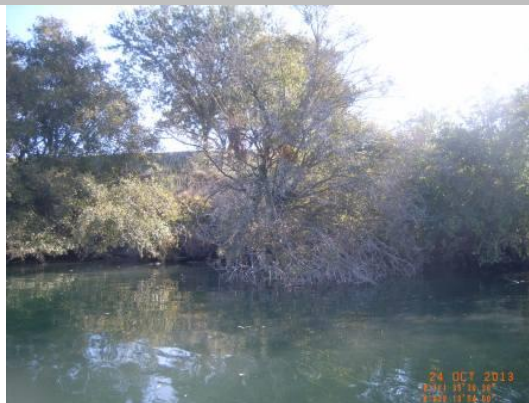
Photo 1 of 1 : SP_2016_RD0999_234_18_20160308_00019.jpg

LM Start	4.56	Rating **	M	Issue No.	18
LM End	4.68	Issue Type +	Ma	Location *	WS
Category	Supplemental			GPS Latitude/Longitude	
				Start	End
Item	2015 USACE Erosion Survey, DRAFT			38.313836 °	38.315407 °
				-121.592259 °	-121.591433 °
DWR ID	DWR_RD0999_03_s_2016_18				
Comment Code					
Inspector Comment					
2002 - Original rock over geotextile is sliding off and the end is coming unraveled. 2003 - Some minor new erosion on the downstream end. 2004 - Site has gotten worse. Underlined geofabric is exposed. 2005 - Still looks bad with exposed geotextile fabric. 2006 - Still have some new unraveling and exposed fabric. Site lengthened upstream. 2009 - Minimal new erosion. 2010 - geotextile fabric placed since last year, possible flood fight. 2012 - Exposed geotech style fabric, assume rock on top slid off. 2015: Erosion pockets covered with plastic. [2015 Site ID: STR_26-5_L]

USACE 2013 Photo #1

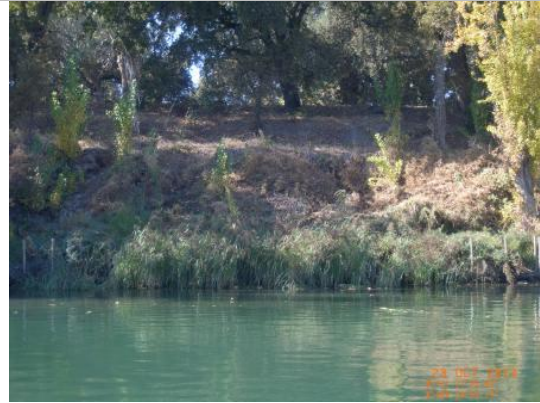
Photo 1 of 1 : SP_2016_RD0999_235_8_20160308_00007.jpg

LM Start	0.02	Rating **	M	Issue No.	8
LM End	0.28	Issue Type +	Ma	Location *	WS
Category	Supplemental			GPS Latitude/Longitude	
				Start	End
Item	2015 USACE Erosion Survey, DRAFT			38.414387 °	38.417692 °
				-121.522871 °	-121.525083 °
DWR ID	DWR_RD0999_04_s_2016_8				
Comment Code					
Inspector Comment					
1997 - Structural problem rather than erosional, failed cobble at downstream end. 2005 - New brush boxes at waterline for several hundred feet downstream, No toe or bank protection present. 2006 - Some minor new erosion. Brush boxes not working well; most of the brush has floated out. 2007 - Brush boxes have recently been repaired. 2015: No observed changes. [2015 Site ID: SAC_41-9_R]

USACE 2013 Photo #1

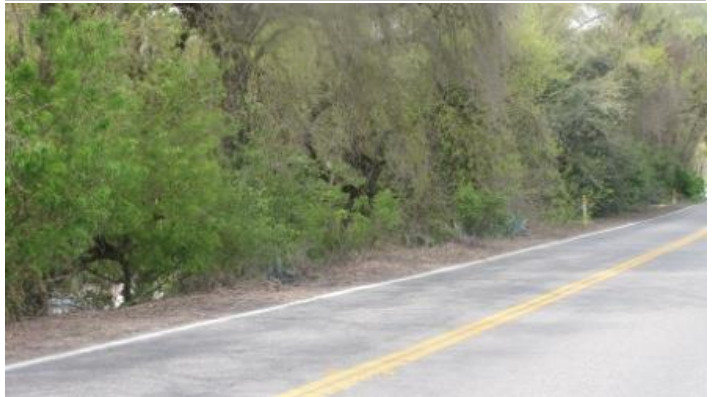
Photo 2 of 2 : SP_2016_RD0999_235_10_20160308_00009.jpg

LM Start	0.38	Rating **	M	Issue No.	10 (cont)	
LM End	0.50	Issue Type +	Ma	Location *	LS	
Category	Earthen Levee			GPS Latitude/Longitude		
				Start	End	
Item	Trim / Thin Trees			38.418838 °	38.420447 °	
				-121.526225 °	-121.527380 °	
DWR ID	DWR_RD0999_04_s_2012_10					
Comment Code						
T1 : Trim trees to at least five feet above ground level.						
Inspector Comment

Looking west at dense trees on waterside slope.

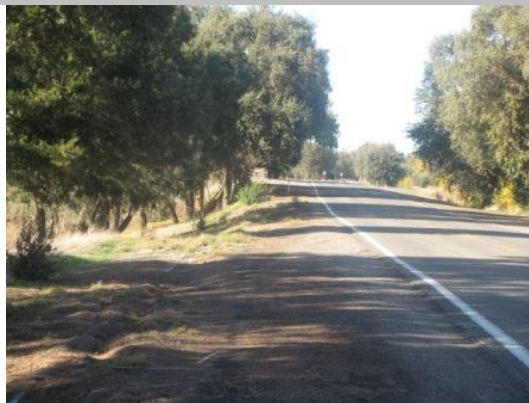
Photo 1 of 2 : SP_2016_RD0999_235_6_20160308_00005.jpg

LM Start	0.71	Rating **	A/W	Issue No.	6
LM End	0.87	Issue Type +	Ma	Location *	LS
Category	Earthen Levee			GPS Latitude/Longitude	
				Start	End
Item	Trim / Thin Trees			38.423035 °	38.425140 °
				-121.529255 °	-121.530742 °
DWR ID	DWR_RD0999_04_s_2012_6				
Comment Code					
T1 : Trim trees to at least five feet above ground level.					
Inspector Comment

Looking north at trimmed trees and removed fence on landside slope.

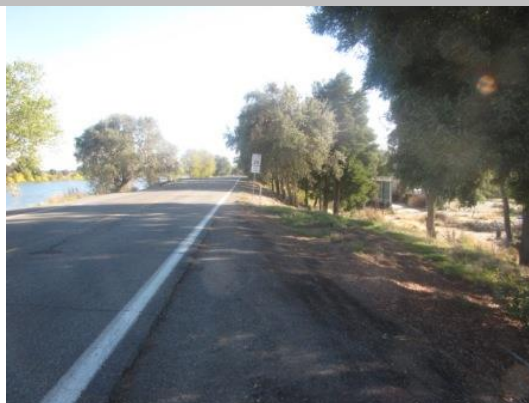
Photo 2 of 2 : SP_2016_RD0999_235_6_20160308_00006.jpg

Looking south at trimmed trees on landside slope and removed fence.

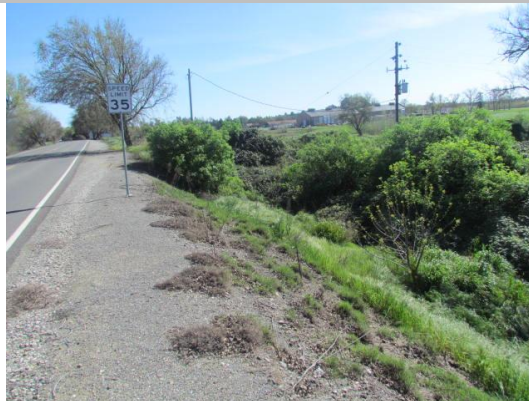
Photo 1 of 4 : SP_2016_RD0999_235_16_20160317_00070.jpg

Looking southwest at dense vegetation on landward slope and toe.
(Spring 2016)

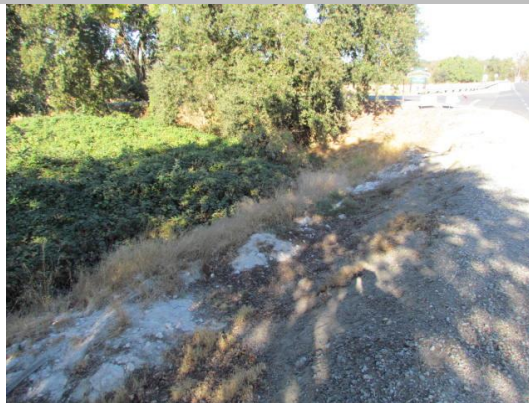
Photo 2 of 4 : SP_2016_RD0999_235_16_20160308_00015.jpg

Looking northwest at dense vines at landward toe. Fall 2015

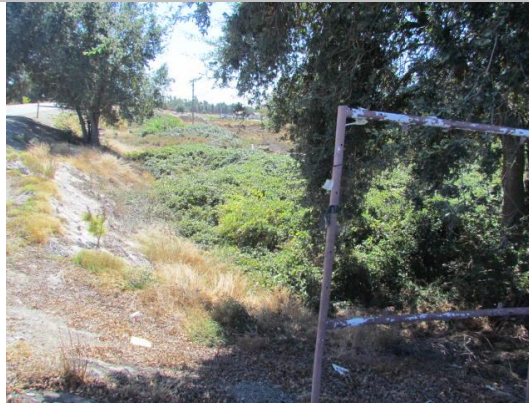
Photo 3 of 4 : SP_2016_RD0999_235_16_20160308_00016.jpg

Looking southwest at dense berry vines at landward toe. 2013

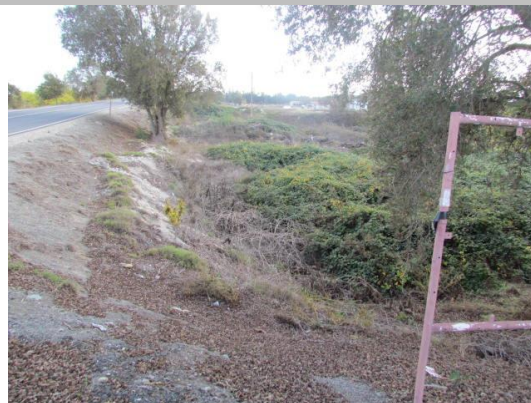
Photo 4 of 4 : SP_2016_RD0999_235_16_20160308_00017.jpg

LM Start	1.01	Rating **	U	Issue No.	16 (cont)	
LM End	1.04	Issue Type +	Ma	Location *	LS	
Category	Earthen Levee			GPS Latitude/Longitude		
				Start		End
Item	Vegetation			38.426873 °		38.427295 °
				-121.531778 °		-121.532164 °
DWR ID	DWR_RD0999_04_f_2012_16					
Comment Code						
V2 : Remove the wild growth other than native grasses from the levee slopes.						
Inspector Comment						
Blackberries blocking view of landward toe.

Looking south at dense berryvines on landside toe. 2012

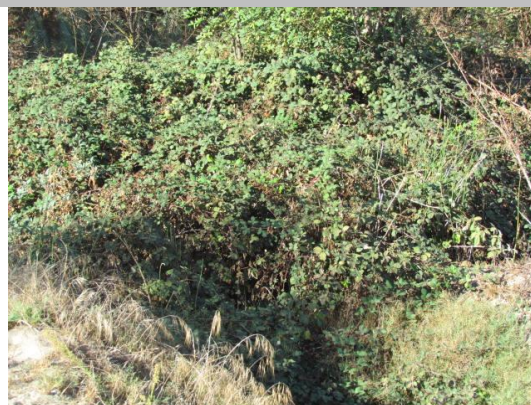
Photo 1 of 3 : SP_2016_RD0999_235_5_20160308_00002.jpg

LM Start	1.15	Rating **	U	Issue No.	5
LM End	1.15	Issue Type +	Ma	Location *	LS
Category	Earthen Levee			GPS Latitude/Longitude	
				Start	End
Item	Vegetation			38.428823 °	38.428823 °
				-121.532885 °	-121.532885 °
DWR ID	DWR_RD0999_04_s_2012_5				
Comment Code					
V2 : Remove the wild growth other than native grasses from the levee slopes.					
Inspector Comment					
Berry vines and wild roses on landside toe.

Looking at dense vines at landward toe. Fall 2015.

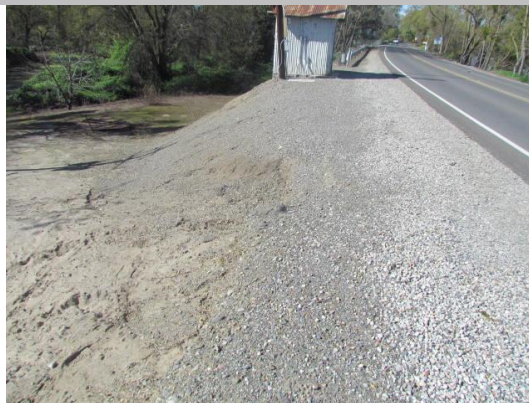
Photo 1 of 6 : SP_2016_RD0999_235_40_20160317_00071.jpg

LM Start	1.16	Rating **	U	Issue No.	40
LM End	1.16	Issue Type +	Ma	Location *	LS
Category	Earthen Levee			GPS Latitude/Longitude	
				Start	End
Item	Erosion / Bank Caving			38.428877 °	38.428877 °
				-121.532922 °	-121.532922 °
DWR ID	DWR_RD0999_04_f_2015_40				
Comment Code					
E2 : Schedule repair of erosion site prior to the next inspection.					
Inspector Comment					
Large hole and erosion on landward shoulder, slope and toe.

Looking east at erosion on landward shoulder and slope. (Spring 2016)

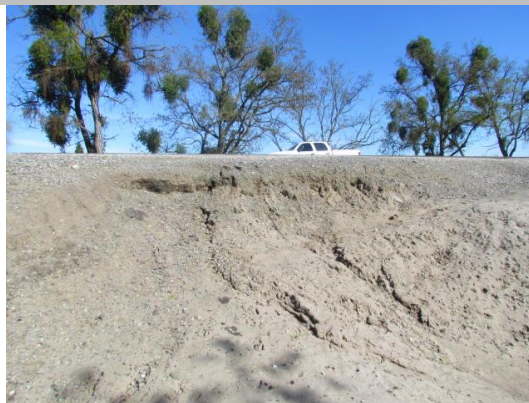
Photo 3 of 6 : SP_2016_RD0999_235_40_20160317_00073.jpg

LM Start	1.16	Rating **	U	Issue No.	40 (cont)	
LM End	1.16	Issue Type +	Ma	Location *	LS	
Category	Earthen Levee			GPS Latitude/Longitude		
				Start		End
Item	Erosion / Bank Caving			38.428877 °		38.428877 °
				-121.532922 °		-121.532922 °
DWR ID	DWR_RD0999_04_f_2015_40					
Comment Code						
E2 : Schedule repair of erosion site prior to the next inspection.						
Inspector Comment						
Large hole and erosion on landward shoulder, slope and toe.

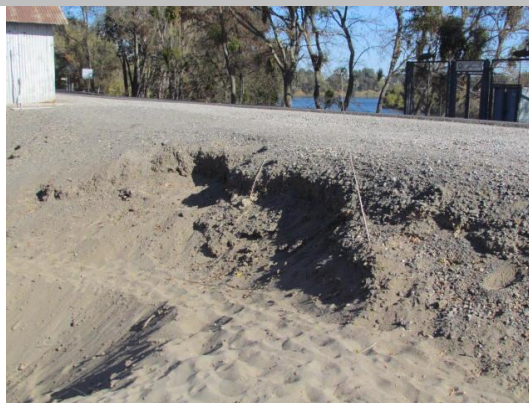
Photo 4 of 6 : SP_2016_RD0999_235_40_20160308_00029.jpg

Looking east at erosion on landward shoulder.

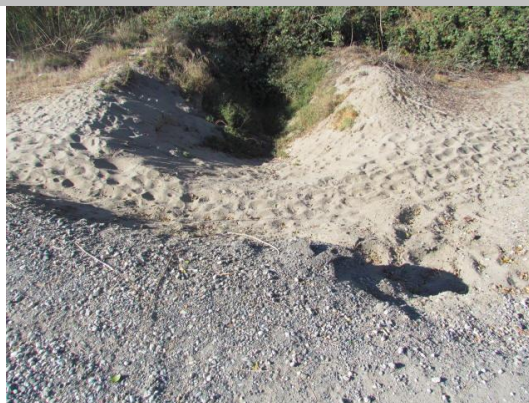
Photo 5 of 6 : SP_2016_RD0999_235_40_20160308_00028.jpg

Looking west at caving at landward slope and toe.

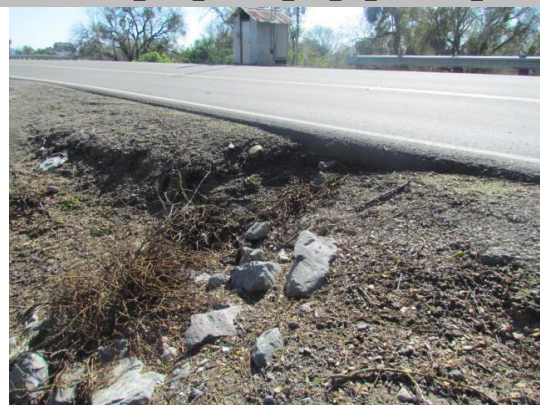
Photo 2 of 2 : SP_2016_RD0999_235_46_20160317_00075.jpg

LM Start	1.18	Rating **	U	Issue No.	46
LM End	1.18	Issue Type +	Ma	Location *	WS
Category	Earthen Levee			GPS Latitude/Longitude	
				Start	End
Item	Erosion / Bank Caving			38.429201 °	38.429201 °
				-121.533012 °	-121.533012 °
DWR ID	DWR_RD0999_04_s_2016_46				
Comment Code					
E2 : Schedule repair of erosion site prior to the next inspection.					
Inspector Comment					
Erosion located just below ashalt on waterward shoulder.

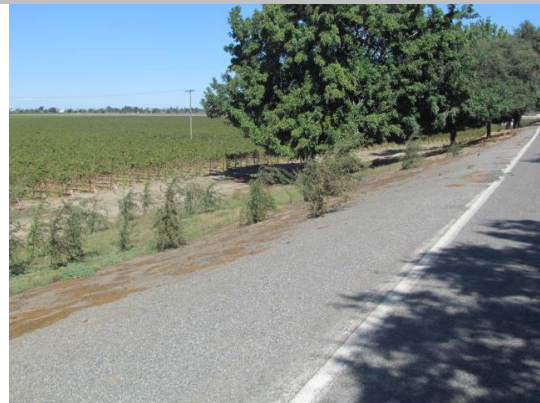
Photo 1 of 1 : SP_2016_RD0999_236_72_20160308_00066.jpg

LM Start	0.10	Rating **	A/W	Issue No.	72
LM End	0.10	Issue Type +	Ma	Location *	LS
Category	Earthen Levee			GPS Latitude/Longitude	
				Start	End
Item	Trim / Thin Trees			38.334093 °	38.334093 °
				-121.584339 °	-121.584339 °
DWR ID	DWR_RD0999_05_f_2013_72				
Comment Code					
T3 : Trim and thin trees to allow visibility of the ground and room to flood fight.					
Inspector Comment					
Remove small oak trees from landward slope before trees are established.

Looking west at small oak trees on landward slope.

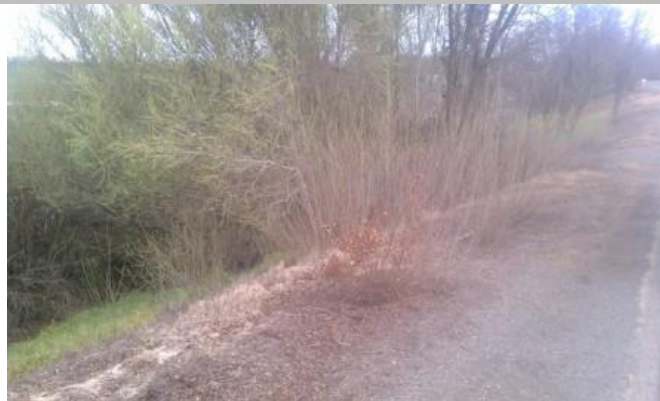
Photo 1 of 4 : SP_2016_RD0999_236_25_20160308_00025.jpg

Looking northwest at dense vegetation on landside slope and toe.

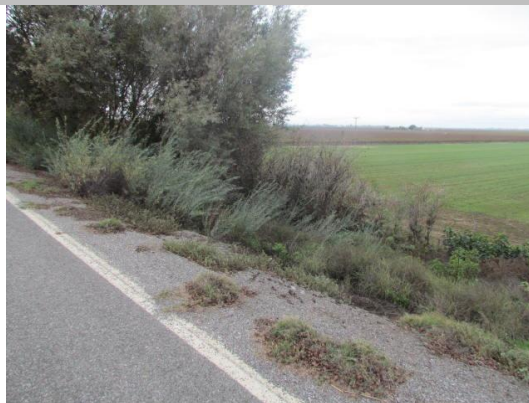
Photo 2 of 4 : SP_2016_RD0999_236_25_20160308_00026.jpg

Looking southwest at vegetation on landside slope and toe. (Fall 2012)

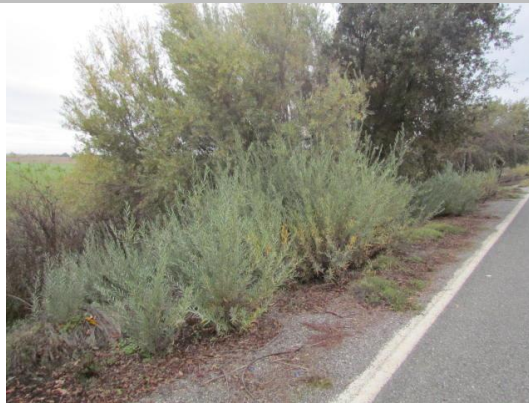
Photo 3 of 4 : SP_2016_RD0999_236_25_20160308_00027.jpg

Looking northwest at vegetation on landside shoulder. (Fall 2012)

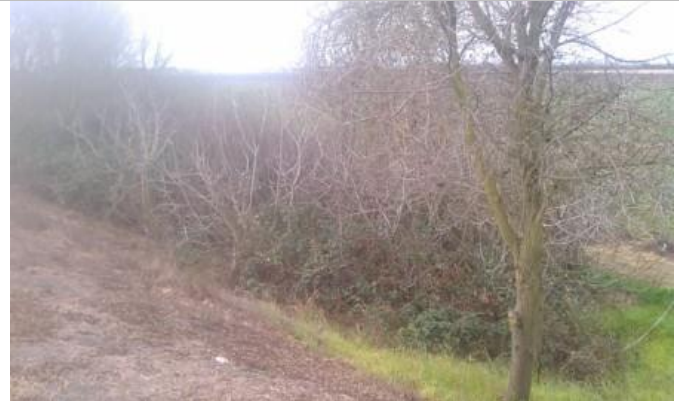
Photo 4 of 4 : SP_2016_RD0999_236_25_20160308_00028.jpg

LM Start	0.40	Rating **	U	Issue No.	25 (cont)	
LM End	0.44	Issue Type +	Ma	Location *	LS	
Category	Earthen Levee			GPS Latitude/Longitude		
				Start		End
Item	Vegetation			38.338075 °		38.338688 °
				-121.582322 °		-121.582193 °
DWR ID	DWR_RD0999_05_s_2012_25					
Comment Code						
V2 : Remove the wild growth other than native grasses from the levee slopes.						
Inspector Comment						
Elderberries within vegetation area.

Looking southwest at dense berry vines on landside toe.

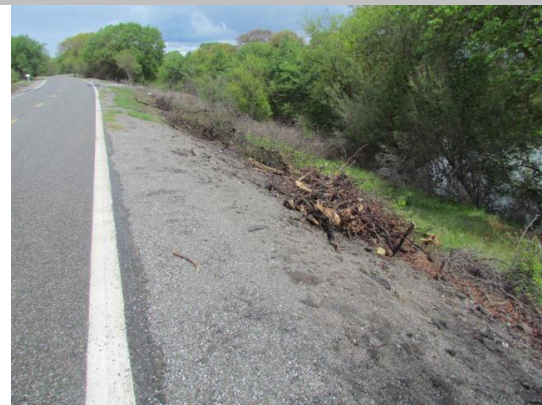
Photo 1 of 1 : SP_2016_RD0999_236_26_20160308_00029.jpg

LM Start	0.44	Rating **	A/W	Issue No.	26
LM End	0.45	Issue Type +	Ma	Location *	WS
Category	Earthen Levee			GPS Latitude/Longitude	
				Start	End
Item	Encroachments			38.338647 °	38.338868 °
				-121.582217 °	-121.582163 °
DWR ID	DWR_RD0999_05_s_2012_26				
Comment Code					
PR : Prunings					
Inspector Comment

Looking northeast at prunings on waterside slope.

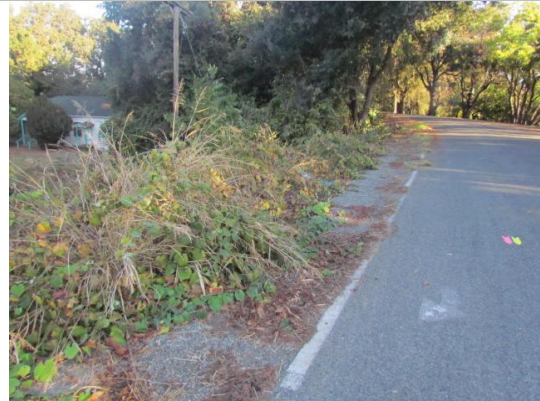
Photo 1 of 1 : SP_2016_RD0999_236_189_20160308_00128.jpg

LM Start	0.68	Rating **	A/W	Issue No.	189
LM End	0.68	Issue Type +	Ma	Location *	LS
Category	Earthen Levee			GPS Latitude/Longitude	
				Start	End
Item	Vegetation			38.342032 °	38.342032 °
				-121.581372 °	-121.581372 °
DWR ID	DWR_RD0999_05_f_2014_189				
Comment Code					
V2 : Remove the wild growth other than native grasses from the levee slopes.					
Inspector Comment					
Dense wild grapevines on landward slope.

Looking northwest at dense vegetation on landward slope.

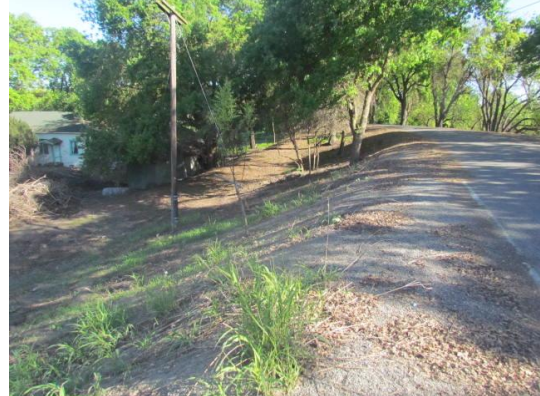
Photo 1 of 6 : SP_2016_RD0999_236_9_20160308_00005.jpg

LM Start	0.69	Rating **	A/W	Issue No.	9
LM End	0.71	Issue Type +	Ma	Location *	LS
Category	Earthen Levee			GPS Latitude/Longitude	
				Start	End
Item	Trim / Thin Trees			38.342180 °	38.342537 °
				-121.581230 °	-121.581263 °
DWR ID	DWR_RD0999_05_s_2012_9				
Comment Code					
T3 : Trim and thin trees to allow visibility of the ground and room to flood fight.					
Inspector Comment					
District or landowner trimmed trees to comply with standards.

Looking northwest at landward slope. (Spring 2015)

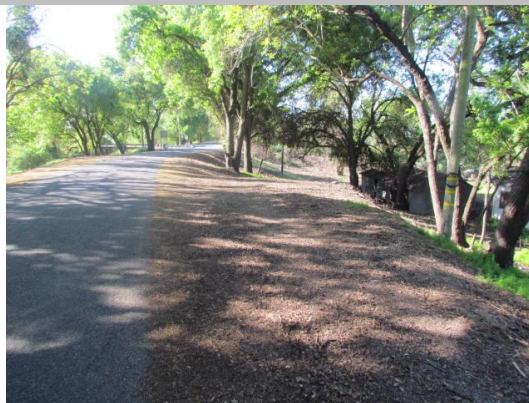
Photo 2 of 6 : SP_2016_RD0999_236_9_20160308_00006.jpg

Looking south at landward slope. (Spring 2015)

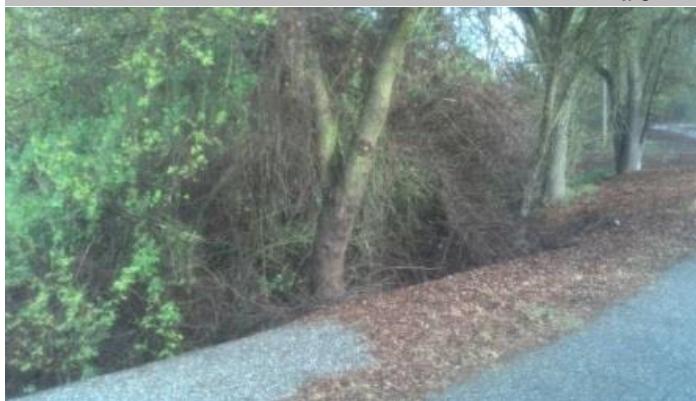
Photo 3 of 6 : SP_2016_RD0999_236_9_20160308_00007.jpg

Looking northwest at dense trees at landside slope and toe. (Spring 2013)

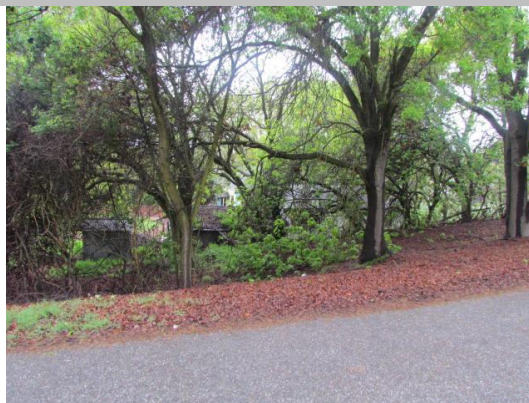
Photo 4 of 6 : SP_2016_RD0999_236_9_20160308_00008.jpg

Looking west at trimmed trees on landside slope. (Spring 2012)

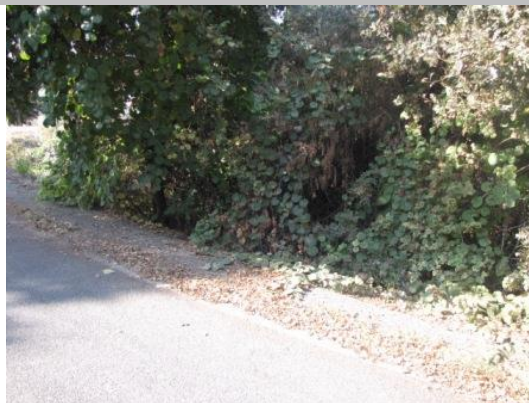
Photo 5 of 6 : SP_2016_RD0999_236_9_20160308_00009.jpg

Looking west at dense trees on landside slope and toe. (Spring 2011)

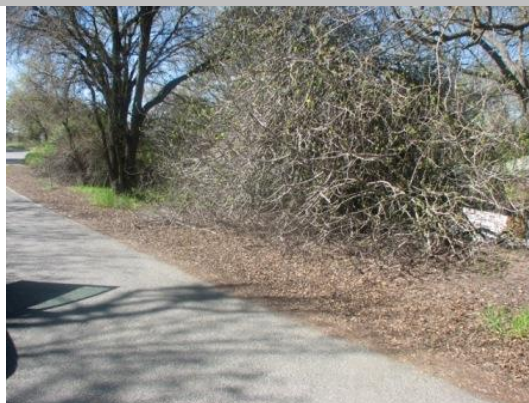
Photo 6 of 6 : SP_2016_RD0999_236_9_20160308_00010.jpg

Front view of dense trees at landside shoulder. (Spring 2011)

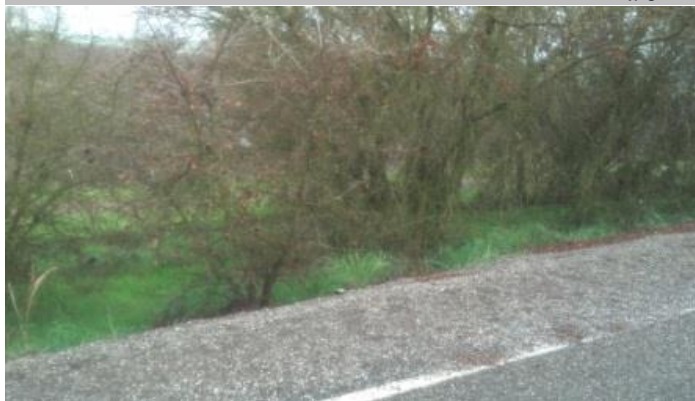
Photo 1 of 1 : SP_2016_RD0999_236_14_20160308_00013.jpg

LM Start	1.07	Rating **	M	Issue No.	14
LM End	1.11	Issue Type +	Ma	Location *	LS
Category	Earthen Levee			GPS Latitude/Longitude	
				Start	End
Item	Trim / Thin Trees			38.347427 °	38.347863 °
				-121.579395 °	-121.579113 °
DWR ID	DWR_RD0999_05_s_2012_14				
Comment Code					
T1 : Trim trees to at least five feet above ground level.					
Inspector Comment

Looking west at dense trees on landside slope and toe.

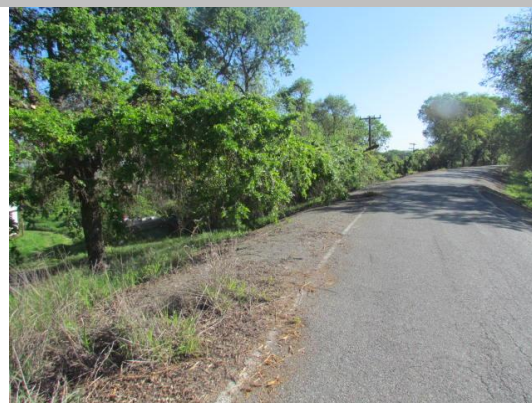
Photo 1 of 1 : SP_2016_RD0999_236_15_20160308_00014.jpg

LM Start	1.15	Rating **	U	Issue No.	15
LM End	1.19	Issue Type +	Ma	Location *	LS
Category	Earthen Levee			GPS Latitude/Longitude	
				Start	End
Item	Trim / Thin Trees			38.348237 °	38.348328 °
				-121.578440 °	-121.577735 °
DWR ID	DWR_RD0999_05_s_2012_15				
Comment Code					
T1 : Trim trees to at least five feet above ground level.					
Inspector Comment

Looking north at untrimmed trees on landward slope and toe.

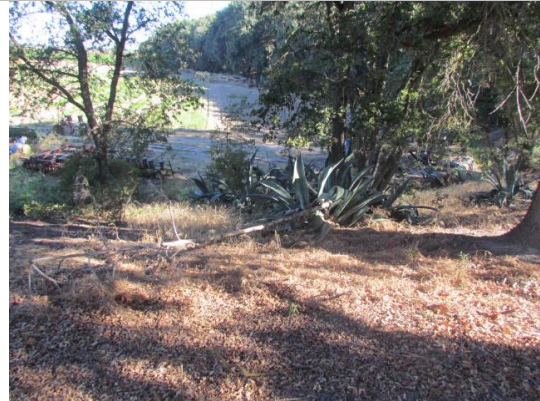
Photo 2 of 2 : SP_2016_RD0999_236_129_20160308_00093.jpg

LM Start	1.39	Rating **	M	Issue No.	129 (cont)	
LM End	1.39	Issue Type +	Ma	Location *	LS	
Category	Earthen Levee			GPS Latitude/Longitude		
				Start		End
Item	Vegetation			38.348100 °		38.348100 °
				-121.574075 °		-121.574075 °
DWR ID	DWR_RD0999_05_s _ 2012_129					
Comment Code						
V2 : Remove the wild growth other than native grasses from the levee slopes.						
Inspector Comment						
Berry vines and century plants on landside toe and slope.

Looking west at century plants on landward slope.

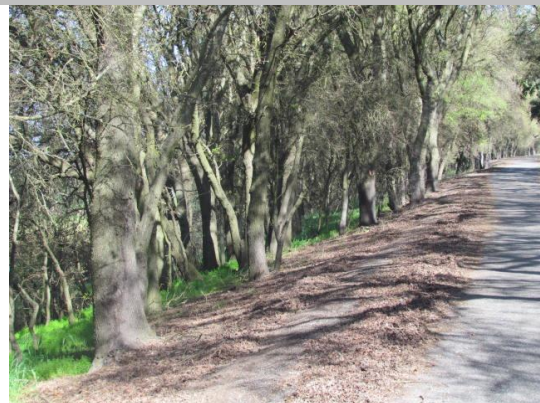
Photo 1 of 1 : SP_2016_RD0999_236_18_20160317_00214.jpg

LM Start	1.46	Rating **	U	Issue No.	18
LM End	1.83	Issue Type +	Ma	Location *	LS
Category	Earthen Levee			GPS Latitude/Longitude	
				Start	End
Item	Trim / Thin Trees			38.348670 °	38.353852 °
				-121.573320 °	-121.573570 °
DWR ID	DWR_RD0999_05_s _ 2012_18				
Comment Code					
T3 : Trim and thin trees to allow visibility of the ground and room to flood fight.					
Inspector Comment

Looking east at dense trees on landward slope.

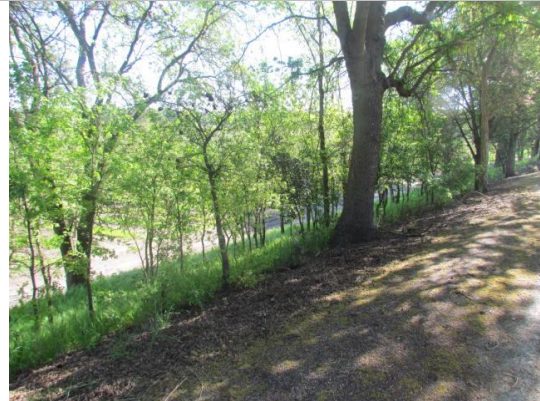
Photo 1 of 1 : SP_2016_RD0999_236_24_20160308_00024.jpg

LM Start	2.14	Rating **	M	Issue No.	24
LM End	2.16	Issue Type +	Ma	Location *	LS
Category	Earthen Levee			GPS Latitude/Longitude	
				Start	End
Item	Trim / Thin Trees			38.355402 °	38.355282 °
				-121.568893 °	-121.568547 °
DWR ID	DWR_RD0999_05_s _ 2012_24				
Comment Code					
T3 : Trim and thin trees to allow visibility of the ground and room to flood fight.					
Inspector Comment

Looking west at dense trees on landward slope. (Spring 2015)

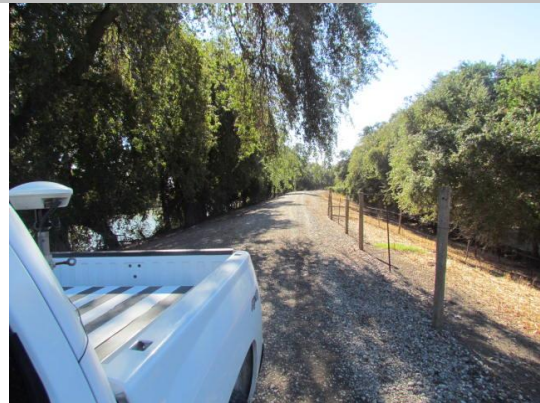
Photo 1 of 1 : SP_2016_RD0999_236_173_20160308_00119.jpg

LM Start	3.56	Rating **	M	Issue No.	173
LM End	3.56	Issue Type +	Ma	Location *	WS
Category	Earthen Levee			GPS Latitude/Longitude	
				Start	End
Item	Trim / Thin Trees			38.365882 °	38.365882 °
				-121.556762 °	-121.556762 °
DWR ID	DWR_RD0999_05_f _ 2015_173				
Comment Code					
T4 : Trim trees over roadway to at least 12 feet above ground level.					
Inspector Comment

Looking at the tree overhanging the levee crown.

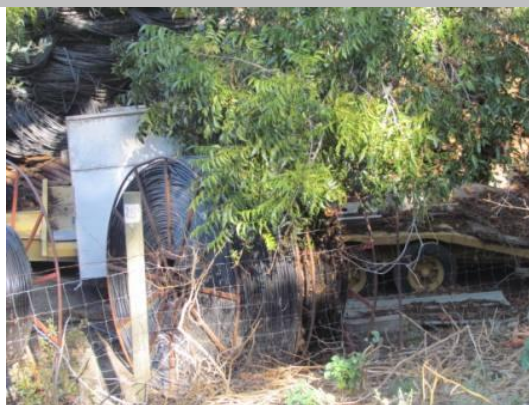
Photo 1 of 2 : SP_2016_RD0999_236_16_20160308_00015.jpg

LM Start	3.64	Rating **	M	Issue No.	16
LM End	3.64	Issue Type +	Ma	Location *	LS
Category	Earthen Levee			GPS Latitude/Longitude	
				Start	End
Item	Encroachments			38.366958 °	38.366958 °
				-121.556822 °	-121.556822 °
DWR ID	DWR_RD0999_05_s_2012_16				
Comment Code					
EQ : Equipment					
Inspector Comment					
Equipment stored at landward toe.

Looking northwest at equipment on landside toe.

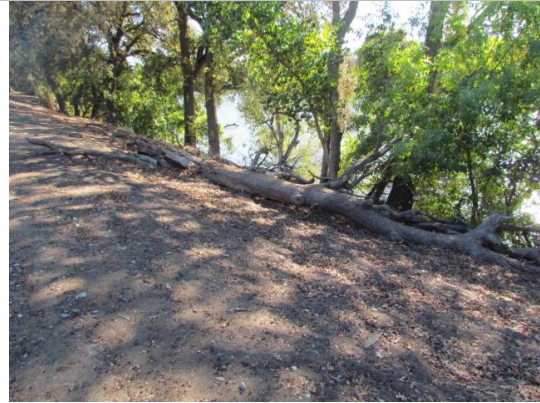
Photo 1 of 1 : SP_2016_RD0999_236_174_20160308_00120.jpg

LM Start	3.80	Rating **	M	Issue No.	174
LM End	3.80	Issue Type +	Ma	Location *	WS
Category	Earthen Levee			GPS Latitude/Longitude	
				Start	End
Item	Encroachments			38.368207 °	38.368207 °
				-121.554360 °	-121.554360 °
DWR ID	DWR_RD0999_05_f_2015_174				
Comment Code					
TR : Tree or limb					
Inspector Comment					
Downed tree branch and limbs on waterward slope.

Looking at downed tree branch on waterward slope.

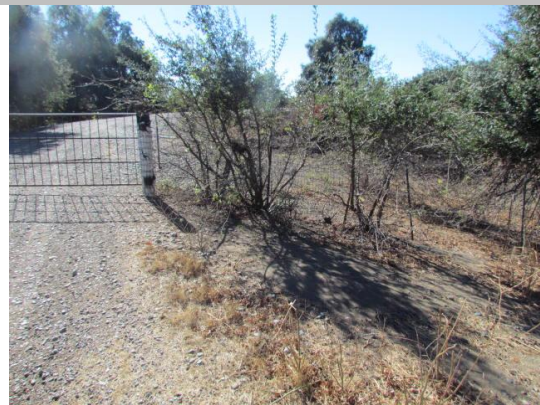
Photo 1 of 1 : SP_2016_RD0999_236_175_20160308_00121.jpg

LM Start	3.94	Rating **	M	Issue No.	175
LM End	3.94	Issue Type +	Ma	Location *	LS
Category	Earthen Levee			GPS Latitude/Longitude	
				Start	End
Item	Trim / Thin Trees			38.368928 °	38.368928 °
				-121.552473 °	-121.552473 °
DWR ID	DWR_RD0999_05_f_2015_175				
Comment Code					
T2 : Thin trees to allow visibility of the ground and room to flood fight.					
Inspector Comment					
Thin or remove young tree from landward shoulder and slope.

Looking at young trees on waterward shoulder and slope.

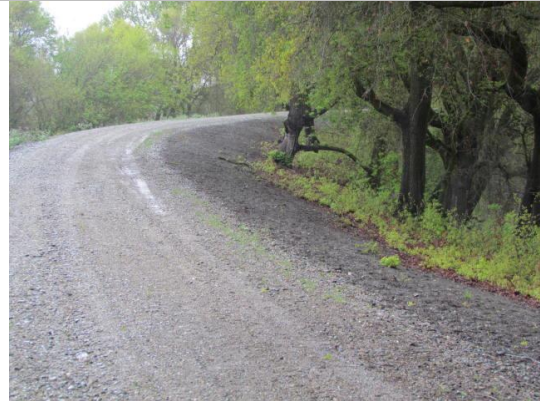
Photo 2 of 2 : SP_2016_RD0999_236_41_20160308_00041.jpg

LM Start	3.98	Rating **	M	Issue No.	41 (cont)	
LM End	4.05	Issue Type +	Ma	Location *	WS	
Category	Earthen Levee			GPS Latitude/Longitude		
				Start		End
Item	Trim / Thin Trees			38.369440 °		38.370398 °
				-121.552747 °		-121.553373 °
DWR ID	DWR_RD0999_05_s_2012_41					
Comment Code						
T3 : Trim and thin trees to allow visibility of the ground and room to flood fight.						
Inspector Comment						
Control oak saplings on waterward slope.

Looking northeast at trimmed trees on waterside slope.

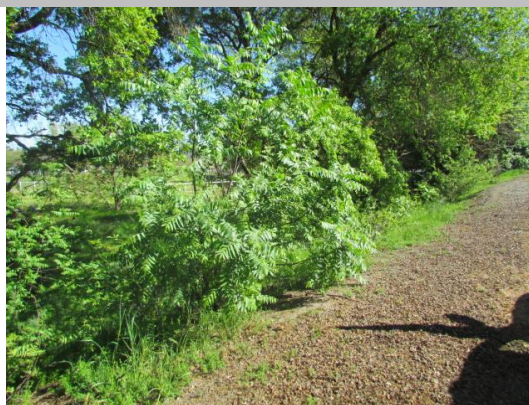
Photo 1 of 1 : SP_2016_RD0999_236_57_20160308_00056.jpg

LM Start	4.42	Rating **	M	Issue No.	57
LM End	4.46	Issue Type +	Ma	Location *	LS
Category	Earthen Levee			GPS Latitude/Longitude	
				Start	End
Item	Trim / Thin Trees			38.374866 °	38.375061 °
				-121.550491 °	-121.549800 °
DWR ID	DWR_RD0999_05_s_2012_57				
Comment Code					
T3 : Trim and thin trees to allow visibility of the ground and room to flood fight.					
Inspector Comment

Looking northwest at dense trees on landward slope. (Spring 2015)

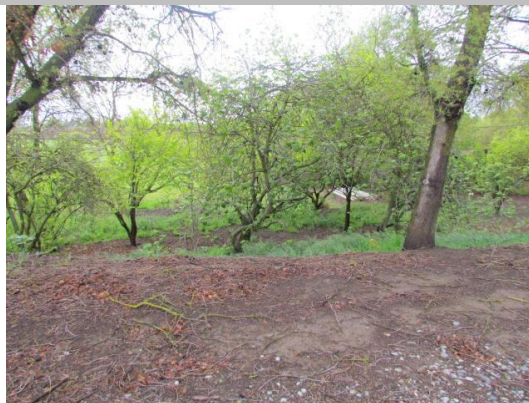
Photo 2 of 3 : SP_2016_RD0999_236_38_20160308_00036.jpg

LM Start	4.51	Rating **	A/W	Issue No.	38 (cont)	
LM End	4.64	Issue Type +	Ma	Location *	LS	
Category	Earthen Levee			GPS Latitude/Longitude		
				Start		End
Item	Trim / Thin Trees			38.375055 °	38.375313 °	
				-121.548792 °	-121.546438 °	
DWR ID	DWR_RD0999_05_s_2012_38					
Comment Code						
T2 : Thin trees to allow visibility of the ground and room to flood fight.						
Inspector Comment

Looking west at trimmed trees on landside slope. (Spring 2012)

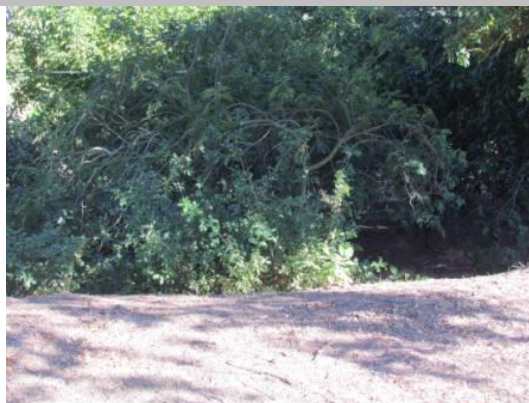
Photo 3 of 3 : SP_2016_RD0999_236_38_20160308_00037.jpg

LM Start	4.51	Rating **	A/W	Issue No.	38 (cont)
LM End	4.64	Issue Type +	Ma	Location *	LS

Looking west at dense trees on landside slope. (Spring 2011)

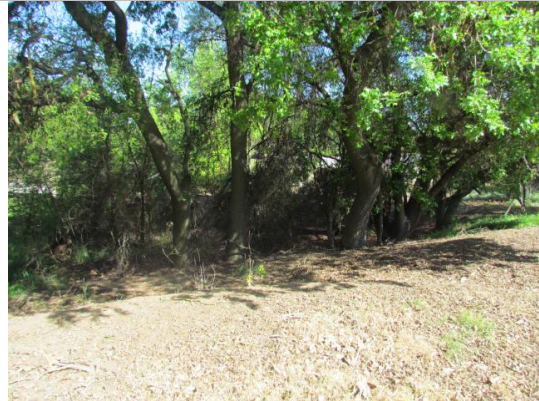
Photo 1 of 1 : SP_2016_RD0999_236_52_20160308_00053.jpg

LM Start	4.67	Rating **	M	Issue No.	52
LM End	4.67	Issue Type +	Ma	Location *	LS
Category	Earthen Levee			GPS Latitude/Longitude	
				Start	End
Item	Trim / Thin Trees			38.375478 °	38.375478 °
				-121.545852 °	-121.545852 °
DWR ID	DWR_RD0999_05_s_2012_52				
Comment Code					
T1 : Trim trees to at least five feet above ground level.					
Inspector Comment

Looking west at untrimmed trees on landward toe. (Spring 2015)

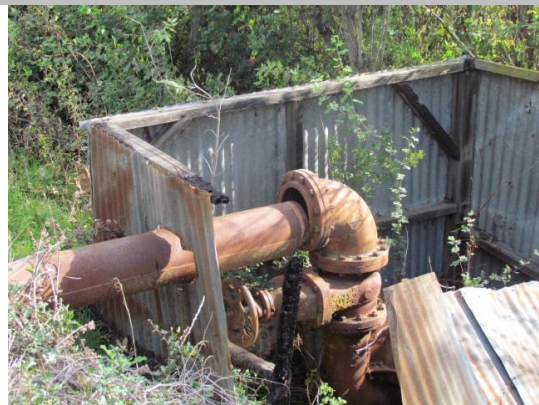
Photo 1 of 1 : SP_2016_RD0999_236_46_20160308_00048.jpg

LM Start	4.68	Rating **	M	Issue No.	46
LM End	4.68	Issue Type +	Ma	Location *	WS
Category	Earthen Levee			GPS Latitude/Longitude	
				Start	End
Item	Encroachments			38.375548 °	38.375548 °
				-121.545693 °	-121.545693 °
DWR ID	DWR_RD0999_05_f_2012_46				
Comment Code					
PI : Pipe					
Inspector Comment					
Pipe is disconnected from pump and should be reconnected or removed.

Looking east at pipe disconnected from pump.

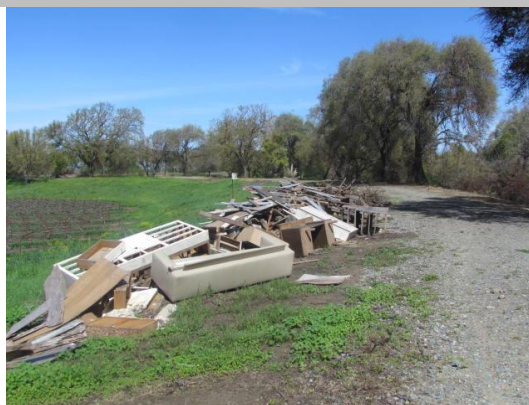
Photo 1 of 3 : SP_2016_RD0999_236_65_20160317_00217.jpg

LM Start	5.07	Rating **	U	Issue No.	65
LM End	5.07	Issue Type +	Ma	Location *	LS
Category	Earthen Levee			GPS Latitude/Longitude	
				Start	End
Item	Encroachments			38.379711 °	38.379711 °
				-121.541070 °	-121.541070 °
DWR ID	DWR_RD0999_05_s _ 2012_65				
Comment Code					
PR : Prunings					
Inspector Comment					
Prunings and garbage pile on landside shoulder and slope.

Looking east at garbage and prunings on landward shoulder. (Spring 2016)

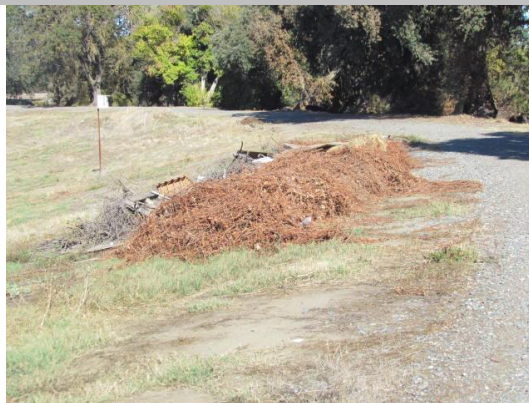
Photo 3 of 3 : SP_2016_RD0999_236_65_20160308_00058.jpg

LM Start	5.07	Rating **	U	Issue No.	65 (cont)	
LM End	5.07	Issue Type +	Ma	Location *	LS	
Category	Earthen Levee			GPS Latitude/Longitude		
				Start		End
Item	Encroachments			38.379711 °		38.379711 °
				-121.541070 °		-121.541070 °
DWR ID	DWR_RD0999_05_s_2012_65					
Comment Code						
PR : Prunings						
Inspector Comment						
Prunings and garbage pile on landside shoulder and slope.

Looking northwest at prunings on landward slope fall 2015

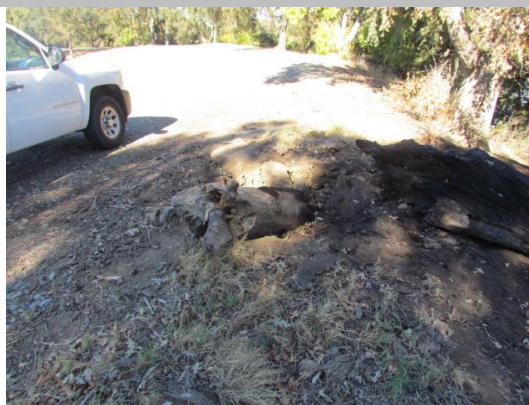
Photo 1 of 2 : SP_2016_RD0999_236_176_20160308_00122.jpg

LM Start	5.12	Rating **	U	Issue No.	176
LM End	5.12	Issue Type +	Ma	Location *	WS
Category	Earthen Levee			GPS Latitude/Longitude	
				Start	End
Item	Slope Stability			38.380420 °	38.380420 °
				-121.541102 °	-121.541102 °
DWR ID	DWR_RD0999_05_f_2015_176				
Comment Code					
S1 : Repair slope instability.					
Inspector Comment					
Large hole on waterward shoulder caused by fallen tree.

Looking at hole on waterward shoulder caused by fallen tree.

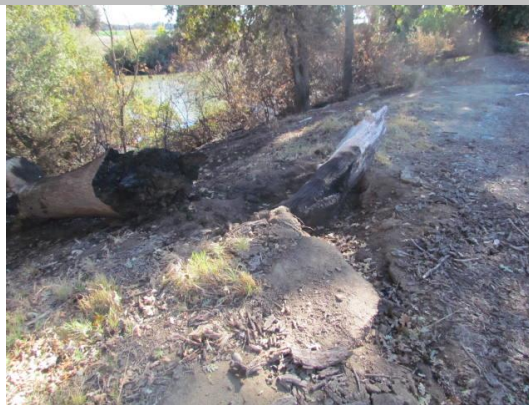
Photo 2 of 2 : SP_2016_RD0999_236_176_20160308_00123.jpg

LM Start	5.12	Rating **	U	Issue No.	176 (cont)
LM End	5.12	Issue Type +	Ma	Location *	WS

Looking at fallen tree and hole on waterward slope and shoulder.

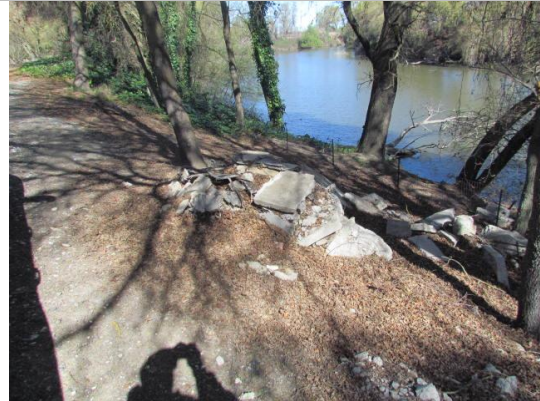
Photo 1 of 1 : SP_2016_RD0999_236_138_20160308_00098.jpg

LM Start	5.41	Rating **	M	Issue No.	138
LM End	5.41	Issue Type +	Ma	Location *	WS
Category	Earthen Levee			GPS Latitude/Longitude	
				Start	End
Item	Encroachments			38.381740 °	38.381740 °
				-121.545864 °	-121.545864 °
DWR ID	DWR_RD0999_05_s_2014_138				
Comment Code					
MA : Material					
Inspector Comment					
Concrete rubble dumped on waterward slope.

Looking northeast at concrete rubble on waterward slope.

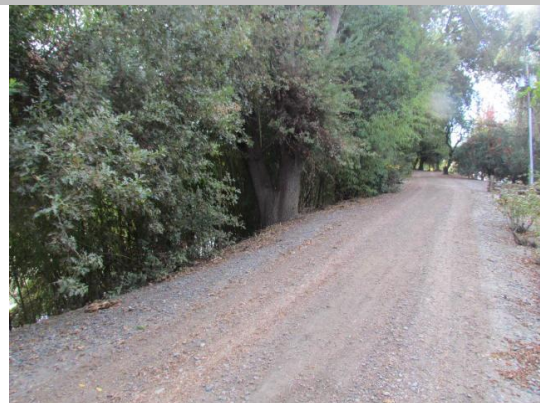
Photo 1 of 1 : SP_2016_RD0999_236_67_20160308_00062.jpg

LM Start	5.47	Rating **	U	Issue No.	67
LM End	5.52	Issue Type +	Ma	Location *	WS
Category	Earthen Levee			GPS Latitude/Longitude	
				Start	End
Item	Trim / Thin Trees			38.382454 °	38.383141 °
				-121.546579 °	-121.546870 °
DWR ID	DWR_RD0999_05_s_2012_67				
Comment Code					
T1 : Trim trees to at least five feet above ground level.					
Inspector Comment

Looking north at dense vegetation on landward shoulder and slope.

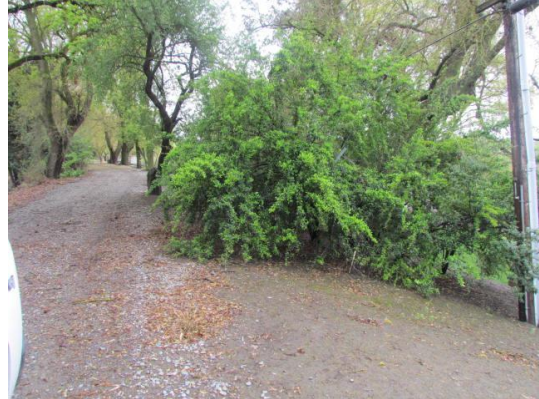
Photo 1 of 1 : SP_2016_RD0999_236_70_20160308_00064.jpg

LM Start	5.49	Rating **	A/W	Issue No.	70
LM End	5.49	Issue Type +	Ma	Location *	LS
Category	Earthen Levee			GPS Latitude/Longitude	
				Start	End
Item	Trim / Thin Trees			38.382698 °	38.382698 °
				-121.546711 °	-121.546711 °
DWR ID	DWR_RD0999_05_s_2012_70				
Comment Code					
T3 : Trim and thin trees to allow visibility of the ground and room to flood fight.					
Inspector Comment

Looking southwest at untrimmed tree on waterside shoulder and slope.

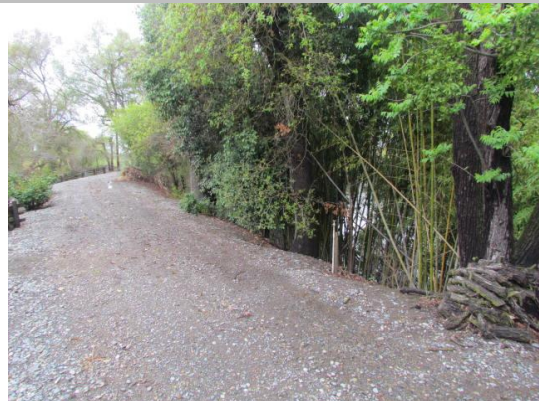
Photo 1 of 1 : SP_2016_RD0999_236_71_20160308_00065.jpg

LM Start	5.50	Rating **	U	Issue No.	71
LM End	5.55	Issue Type +	Ma	Location *	WS
Category	Earthen Levee			GPS Latitude/Longitude	
				Start	End
Item	Vegetation			38.382790 °	38.383548 °
				-121.546754 °	-121.546728 °
DWR ID	DWR_RD0999_05_s_2012_71				
Comment Code					
V2 : Remove the wild growth other than native grasses from the levee slopes.					
Inspector Comment

Looking northeast at dense vegetation on waterside slope.

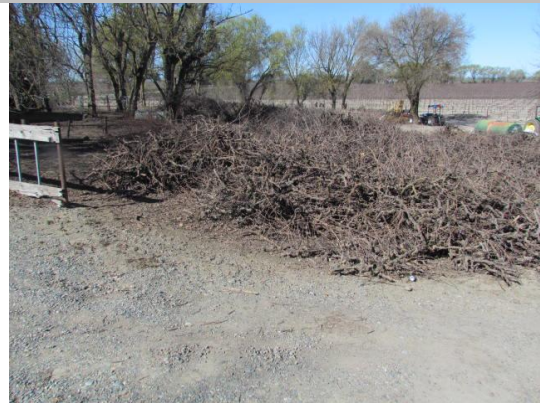
Photo 1 of 1 : SP_2016_RD0999_236_192_20160308_00130.jpg

LM Start	5.58	Rating **	A/W	Issue No.	192
LM End	5.58	Issue Type +	Ma	Location *	LS
Category	Earthen Levee			GPS Latitude/Longitude	
				Start	End
Item	Encroachments			38.383978 °	38.383978 °
				-121.546435 °	-121.546435 °
DWR ID	DWR_RD0999_05_s_2014_192				
Comment Code					
PR : Prunings					
Inspector Comment					
Landowner pile prunings on landside slope.

Looking west at prunings on landward slope and toe.

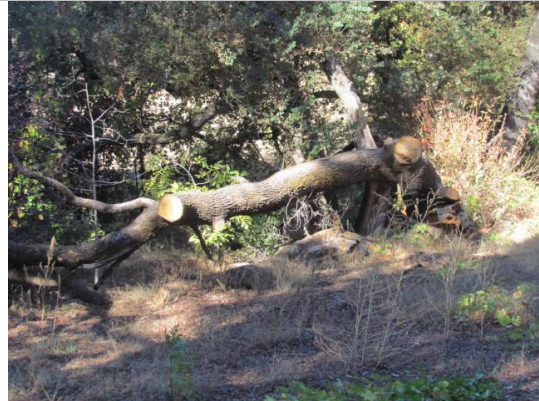
Photo 1 of 2 : SP_2016_RD0999_236_39_20160308_00038.jpg

LM Start	5.93	Rating **	U	Issue No.	39 (cont)
LM End	5.93	Issue Type +	Ma	Location *	LS

Looking west at fallen tree and dense vegetation blocking landward toe. Fall 2015.

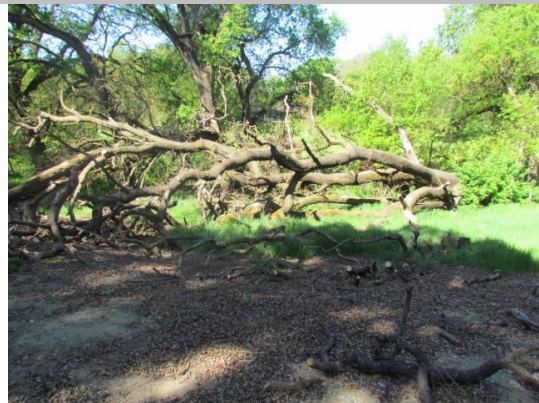
Photo 2 of 2 : SP_2016_RD0999_236_39_20160308_00039.jpg

Looking west at fallen tree on landward slope and toe. (Spring 2015)

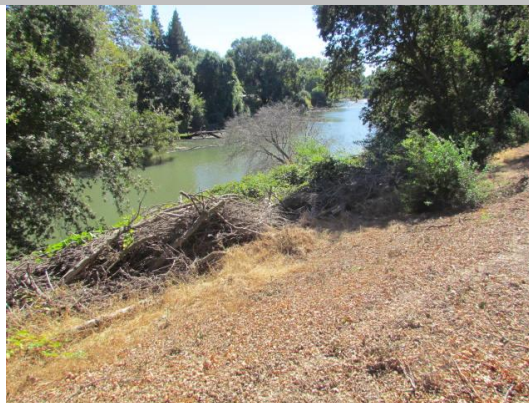
Photo 1 of 1 : SP_2016_RD0999_236_74_20160308_00067.jpg

LM Start	6.20	Rating **	A/W	Issue No.	74
LM End	6.25	Issue Type +	Ma	Location *	WS
Category	Earthen Levee			GPS Latitude/Longitude	
				Start	End
Item	Encroachments			38.389116 °	38.389766 °
				-121.542986 °	-121.542673 °
DWR ID	DWR_RD0999_05_s _ 2012_74				
Comment Code					
PR : Prunings					
Inspector Comment					
Prunings are outside the twenty foot zone should be burned or removed from waterward slope.

Looking southeast at prunings on waterward slope.

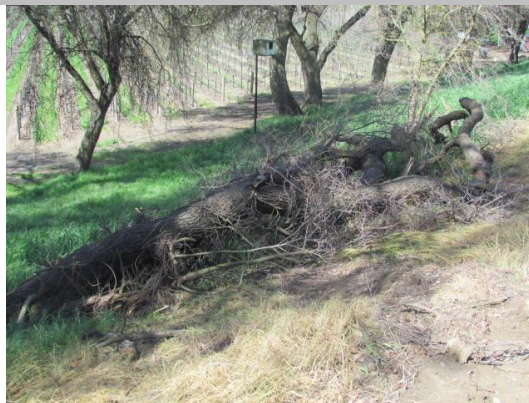
Photo 1 of 1 : SP_2016_RD0999_236_219_20160317_00222.jpg

LM Start	6.60	Rating **	M	Issue No.	219
LM End	6.60	Issue Type +	Ma	Location *	LS
Category	Earthen Levee			GPS Latitude/Longitude	
				Start	End
Item	Encroachments			38.393356 °	38.393356 °
				-121.539213 °	-121.539213 °
DWR ID	DWR_RD0999_05_s_2016_219				
Comment Code					
TR : Tree or limb					
Inspector Comment					
Tree branch and limbs on landward slope.

Looking northeast at tree branch and limbs on landward slope.

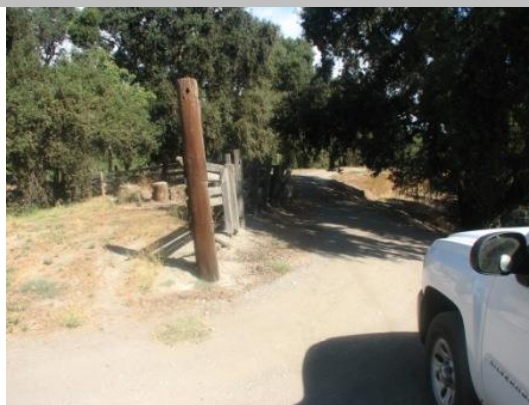
Photo 1 of 4 : SP_2016_RD0999_236_96_20160308_00079.jpg

LM Start	6.73	Rating **	M	Issue No.	96
LM End	6.73	Issue Type +	Ma	Location *	LS
Category	Earthen Levee			GPS Latitude/Longitude	
				Start	End
Item	Encroachments			38.395234 °	38.395234 °
				-121.539323 °	-121.539323 °
DWR ID	DWR_RD0999_05_s_2012_96				
Comment Code					
MA : Material					
Inspector Comment					
Firewood and other material on landside shoulder.

Fence, firewood and material at landside shoulder.

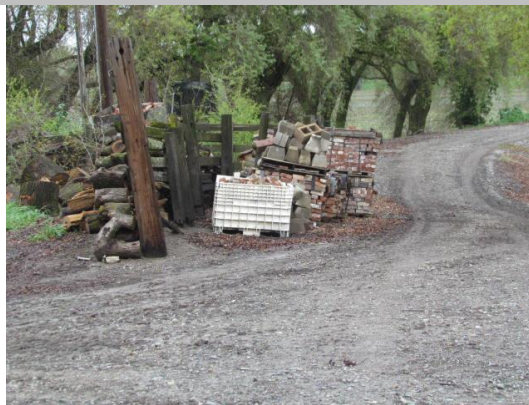
Photo 2 of 4 : SP_2016_RD0999_236_96_20160308_00080.jpg

Looking northeast at firewood and other material on landside shoulder.
(Spring 2012)

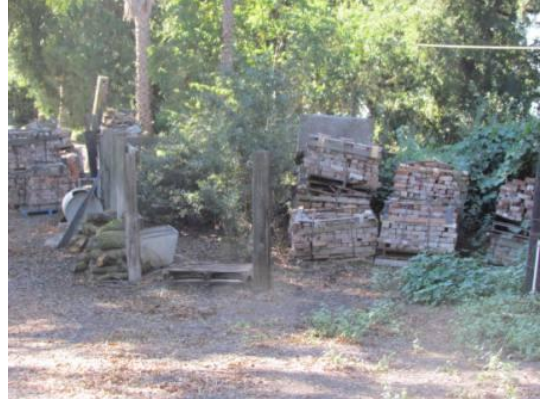
Photo 3 of 4 : SP_2016_RD0999_236_96_20160308_00081.jpg

Looking south at firewood and other material on landside shoulder and crown.

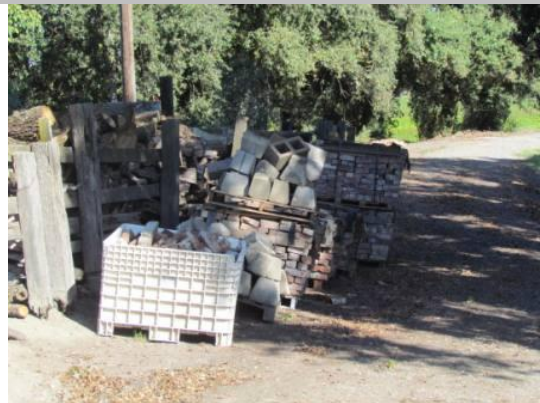
Photo 4 of 4 : SP_2016_RD0999_236_96_20160308_00082.jpg

Looking north at firewood and other material on landside shoulder and crown.

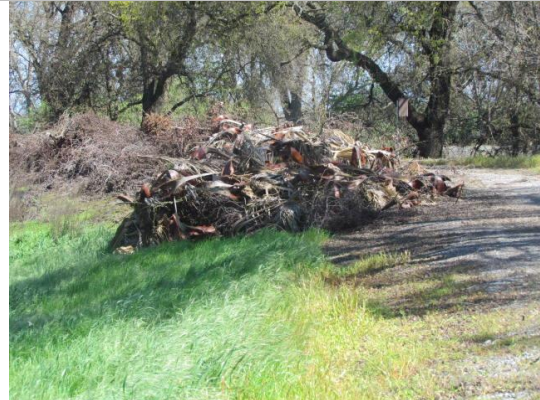
Photo 1 of 1 : SP_2016_RD0999_236_142_20160317_00223.jpg

LM Start	6.95	Rating **	U	Issue No.	142
LM End	6.95	Issue Type +	Ma	Location *	LS
Category	Earthen Levee			GPS Latitude/Longitude	
				Start	End
Item	Encroachments			38.396958 °	38.396958 °
				-121.536148 °	-121.536148 °
DWR ID	DWR_RD0999_05_s_2013_142				
Comment Code					
PR : Prunings					
Inspector Comment					
Large pruning pile on landward shoulder and slope.

Looking northeast at prunings on landward shoulder.

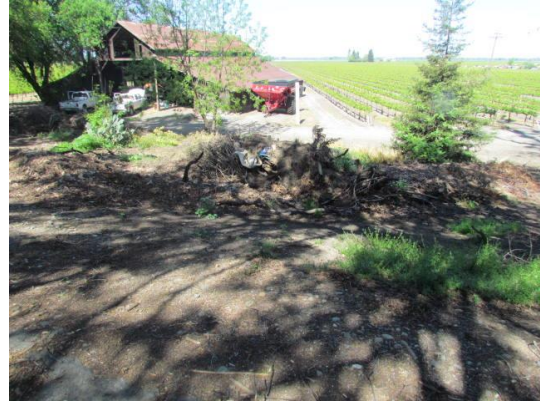
Photo 1 of 1 : SP_2016_RD0999_236_185_20160308_00125.jpg

LM Start	8.03	Rating **	M	Issue No.	185
LM End	8.03	Issue Type +	Ma	Location *	LS
Category	Earthen Levee			GPS Latitude/Longitude	
				Start	End
Item	Encroachments			38.409324 °	38.409324 °
				-121.541223 °	-121.541223 °
DWR ID	DWR_RD0999_05_s_2015_185				
Comment Code					
PR : Prunings					
Inspector Comment					
Garbage within prunings piles.

Looking west at pruning piles on landward slope. (Spring 2015)
