**Flood Control Project Maintenance
Levee Inspections**

Maintenance Issue Types Only, Levee Inspection Report By Mile - Spring 2016

Reclamation District No. 0999 Netherlands

Waterway	Bank	Unit Miles	Inspection Start/End	Inspector
Unit No. 01 Yolo Bypass	Left	15.41	03/14/2016 03/16/2016	Richard Willoughby

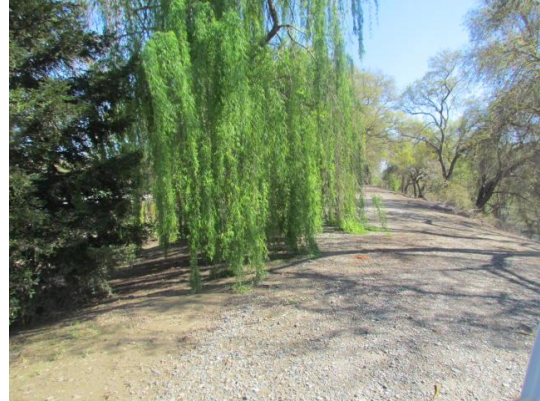
Photo 1 of 1 : SP_2016_RD0999_236_194_20160317_00225.jpg

LM Start	8.29	Rating **	U	Issue No.	194
LM End	8.29	Issue Type +	Ma	Location *	LS
Category	Earthen Levee			GPS Latitude/Longitude	
				Start	End
Item	Trim / Thin Trees			38.409319 °	38.409319 °
				-121.536678 °	-121.536678 °
DWR ID	DWR_RD0999_05_s _ 2014_194				
Comment Code					
T1 : Trim trees to at least five feet above ground level.					
Inspector Comment

Looking southeast at untrimmed trees on landward slope.
