**Flood Control Project Maintenance  
Levee Inspections**

## Maintenance Issue Types Only, Levee Inspection Report By Mile - Spring 2017

### Reclamation District No. 0999 Netherlands

Waterway	Bank	Unit Miles	Inspection Start/End	Inspector
Unit No. 01 Yolo Bypass	Left	15.41	03/22/2017 05/16/2017	Dave Torres

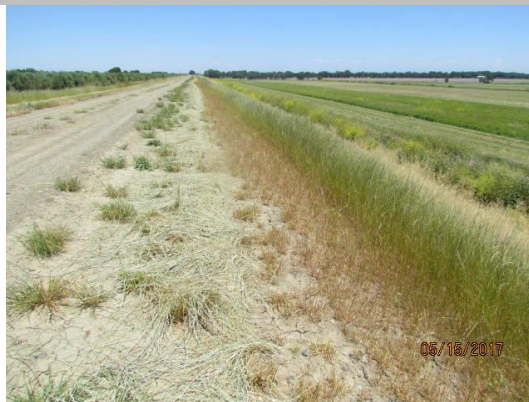
Photo 1 of 2 : SP\_2017\_RD0999\_232\_32\_20170516\_00102.jpg

LM Start	0.00	Rating **	M	Issue No.	32
LM End	13.86	Issue Type +	Ma	Location *	LS
Category	Earthen Levee			GPS Latitude/Longitude	
				Start	End
Item	Vegetation			38.505070 °	38.312917 °
				-121.582033 °	-121.644955 °
DWR ID	DWR_RD0999_01_s_2017_32				
Comment Code					
V1 : Control annual grass and weeds on the levee slopes and easements.					
Inspector Comment

Landside vegetation looking north(Spring 2017)

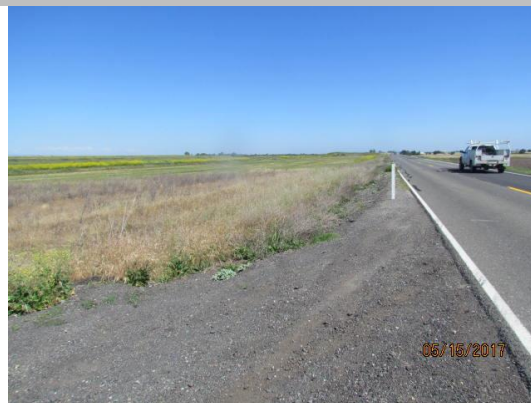
Photo 1 of 1 : SP\_2017\_RD0999\_232\_34\_20170516\_00104.jpg

LM Start	0.00	Rating **	M	Issue No.	34
LM End	13.86	Issue Type +	Ma	Location *	WS
Category	Earthen Levee			GPS Latitude/Longitude	
				Start	End
Item	Vegetation			38.505070 °	38.312917 °
				-121.582033 °	-121.644955 °
DWR ID	DWR_RD0999_01_s_2017_34				
Comment Code					
V1 : Control annual grass and weeds on the levee slopes and easements.					
Inspector Comment

Waterside vegetation looking west(Spring 2017)

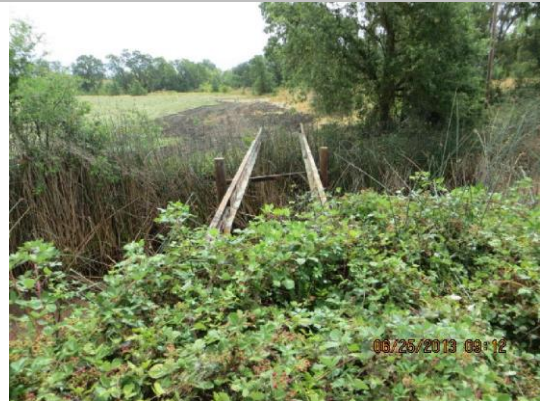
Photo 2 of 3 : UCIP\_SP\_2017\_50092\_25190.jpg

FS\_ID:50092  
DS\_ID:22743  
EP\_NO: N/A  
Repair Type: Urgent  
Crossing Status: Found  
UCIP Comments: 07/07/2016 Condition largely unchanged from previous inspection. Pipe open on the WS, waterward of the siphon breaker. Dense vegetation and steep slope limited inspection of WS outlet into Ship Channel. (T. Hatch/UCIP)  
06/25/2013 Pipe abandoned and open on WS slope. Pipe should be abandoned properly. (W. Wylie/UCIP)  
FIELD\_STRUCT\_DESC: \*ABANDONED\* 30-inch steel pipe through the levee, 6.5 feet below the crown. Pump on a platform in the canal off of the landside (LS) toe, not found. Flap gate on the waterside (WS), not found. Siphon breaker and an air vent on the WS shoulder. 1-inch galvanized iron filler pipe visible on the WS shoulder along same alignment. [Additional Reference(s): DWR Levee Log, 1992. USACE Sacramento O&M Manual 113 (Revised), October 1966 (LM 1.73)].  
FS Date: 7/7/2016

Pump platform visible off LS toe, but no appurtenances remain.

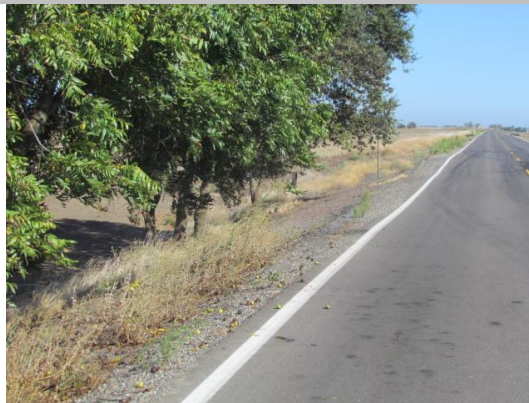
Photo 1 of 2 : SP\_2017\_RD0999\_232\_4\_20170314\_00011.jpg

LM Start	1.73	Rating **	M	Issue No.	4
LM End	1.75	Issue Type +	Ma	Location *	WS
Category	Earthen Levee			GPS Latitude/Longitude	
				Start	End
Item	Trim / Thin Trees			38.480082 °	38.479788 °
				-121.580930 °	-121.580918 °
DWR ID	DWR_RD0999_01_s_2012_4				
Comment Code					
T1 : Trim trees to at least five feet above ground level.					
Inspector Comment

Looking northwest at trimmed trees on waterward slope.

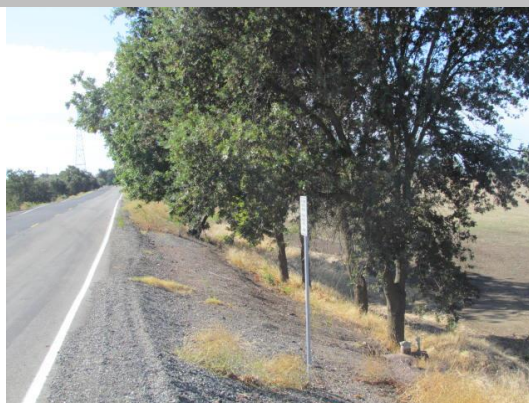
Photo 2 of 2 : SP\_2017\_RD0999\_232\_4\_20170314\_00012.jpg

Looking southwest at trimmed trees on waterward slope.

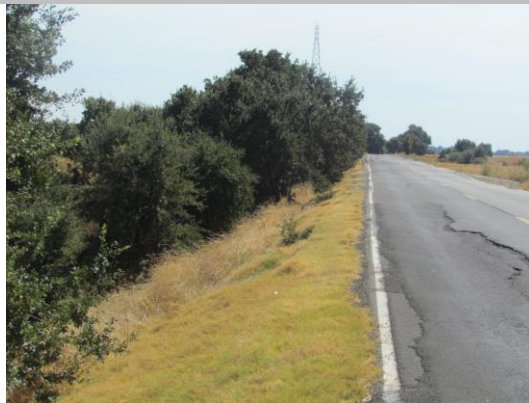
Photo 1 of 2 : SP\_2017\_RD0999\_232\_30\_20170314\_00028.jpg

LM Start	1.79	Rating **	U	Issue No.	30
LM End	2.04	Issue Type +	Ma	Location *	LS
Category	Earthen Levee			GPS Latitude/Longitude	
				Start	End
Item	Trim / Thin Trees			38.479165 °	38.475463 °
				-121.580640 °	-121.580722 °
DWR ID	DWR_RD0999_01_s_2012_30				
Comment Code					
T1 : Trim trees to at least five feet above ground level.					
Inspector Comment

Looking southeast at dense trees on landward slope. (Fall 2016)

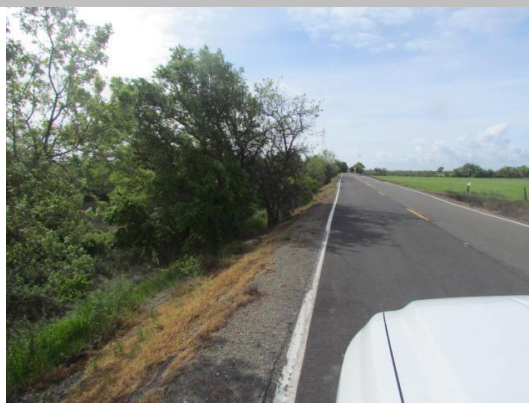
Photo 2 of 2 : SP\_2017\_RD0999\_232\_30\_20170314\_00029.jpg

Looking southeast at dense trees on landward slope. (Spring 2016)

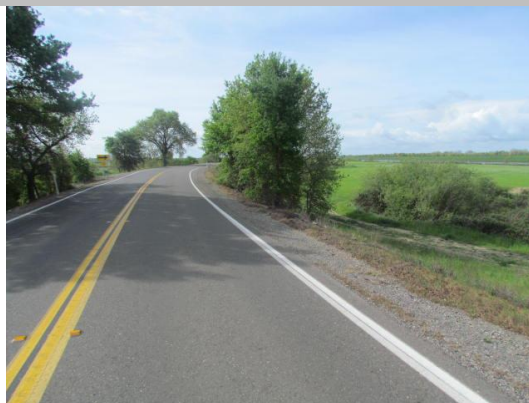
Photo 2 of 2 : SP\_2017\_RD0999\_232\_7\_20170314\_00016.jpg

LM Start	2.13	Rating **	U	Issue No.	7 (cont)	
LM End	2.13	Issue Type +	Ma	Location *	WS	
Category	Earthen Levee			GPS Latitude/Longitude		
				Start		End
Item	Trim / Thin Trees			38.474258 °	38.474258 °	
				-121.580528 °	-121.580528 °	
DWR ID	DWR_RD0999_01_s_2012_7					
Comment Code						
T1 : Trim trees to at least five feet above ground level.						
Inspector Comment

Looking south at untrimmed trees on waterward slope. (Spring 2016)

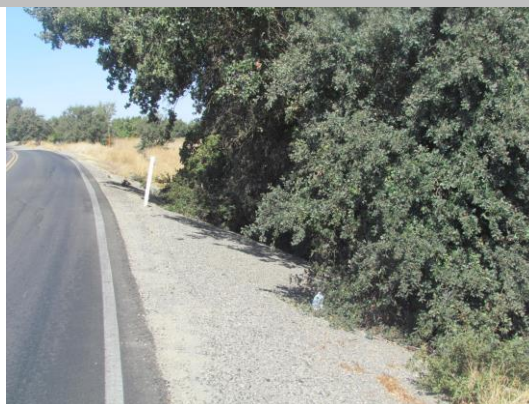
Photo 1 of 2 : SP\_2017\_RD0999\_232\_31\_20170314\_00030.jpg

LM Start	2.13	Rating **	U	Issue No.	31
LM End	2.13	Issue Type +	Ma	Location *	LS
Category	Earthen Levee			GPS Latitude/Longitude	
				Start	End
Item	Trim / Thin Trees			38.474200 °	38.474200 °
				-121.580480 °	-121.580480 °
DWR ID	DWR_RD0999_01_s_2012_31				
Comment Code					
T1 : Trim trees to at least five feet above ground level.					
Inspector Comment

Looking north at untrimmed trees on landward slope. ( Fall 2016)

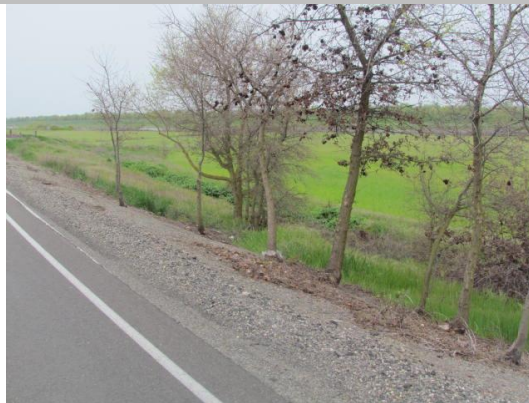
Photo 1 of 1 : SP\_2017\_RD0999\_232\_8\_20170314\_00017.jpg

LM Start	2.18	Rating **	M	Issue No.	8
LM End	2.19	Issue Type +	Ma	Location *	WS
Category	Earthen Levee			GPS Latitude/Longitude	
				Start	End
Item	Trim / Thin Trees			38.473542 °	38.473417 °
				-121.580793 °	-121.580885 °
DWR ID	DWR_RD0999_01_s_2012_8				
Comment Code					
T2 : Thin trees to allow visibility of the ground and room to flood fight.					
Inspector Comment

Looking southwest at trimmed trees on waterside slope. (Spring 2012)

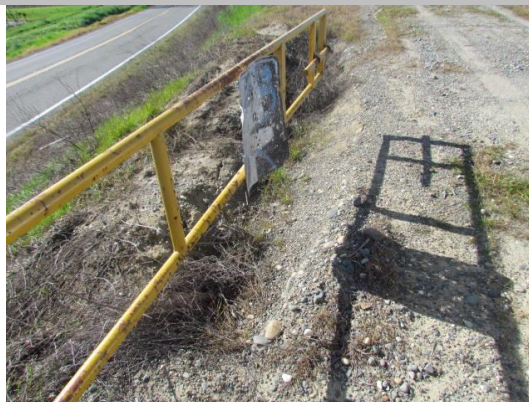
Photo 1 of 4 : SP\_2017\_RD0999\_232\_40\_20170314\_00037.jpg

LM Start	2.51	Rating **	M	Issue No.	40
LM End	2.51	Issue Type +	Ma	Location *	LS
Category	Earthen Levee			GPS Latitude/Longitude	
				Start	End
Item	Encroachments			38.469048 °	38.469048 °
				-121.583075 °	-121.583075 °
DWR ID	DWR_RD0999_01_s_2012_40				
Comment Code					
MA : Material					
Inspector Comment					
Excavation activity on landside shoulder. Hole is approximately 15ft x 12" x 15". Hole appears to be excavated by a backhoe.

Looking south at trench along landward shoulder. (spring 2016)

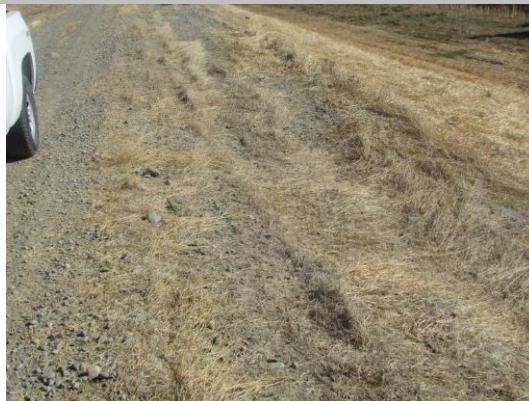
Photo 1 of 2 : SP\_2017\_RD0999\_232\_51\_20170314\_00058.jpg

LM Start	3.22	Rating **	M	Issue No.	51
LM End	3.22	Issue Type +	Ma	Location *	LS
Category	Earthen Levee			GPS Latitude/Longitude	
				Start	End
Item	Slope Stability			38.459399 °	38.459399 °
				-121.587523 °	-121.587523 °
DWR ID	DWR_RD0999_01_s_2013_51				
Comment Code					
S1 : Repair slope instability.					
Inspector Comment					
Depression on landward shoulder and slope 40' x 20'. Earthen material appears to be sliding toward levee toe.

Looking northeast at depression on landward slope. (Fall 2016)

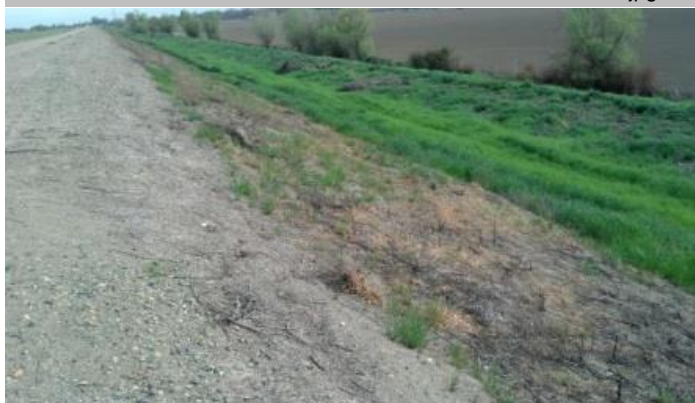
Photo 2 of 2 : SP\_2017\_RD0999\_232\_51\_20170314\_00059.jpg

Looking north at depression on landside shoulder and slope. (Spring 2016)

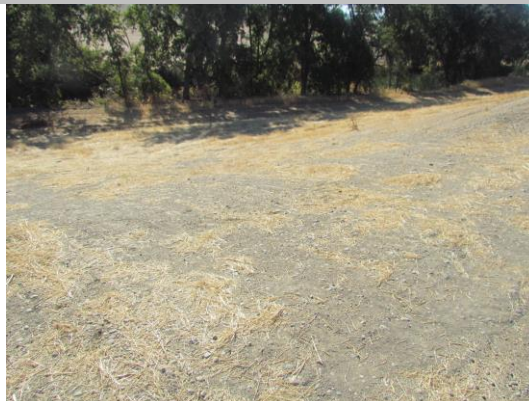
Photo 1 of 2 : SP\_2017\_RD0999\_232\_35\_20170314\_00032.jpg

LM Start	4.31	Rating **	M	Issue No.	35
LM End	4.31	Issue Type +	Ma	Location *	LS
Category	Earthen Levee			GPS Latitude/Longitude	
				Start	End
Item	Slope Stability			38.444561 °	38.444561 °
				-121.594438 °	-121.594438 °
DWR ID	DWR_RD0999_01_f_2012_35				
Comment Code					
S3 : Repair the levee slope damaged by vehicle traffic and prevent access where possible.					
Inspector Comment					
Depression is caused by vehicle traffic.

Looking southeast at slope damage cause by vehicle traffic on landward slope. (Fall 2016)

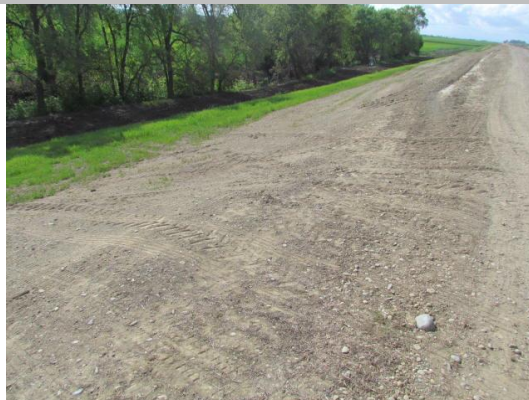
Photo 2 of 2 : SP\_2017\_RD0999\_232\_35\_20170314\_00033.jpg

Looking southeast at slope damage cause by vehicle traffic on landward slope. (Spring 2015)

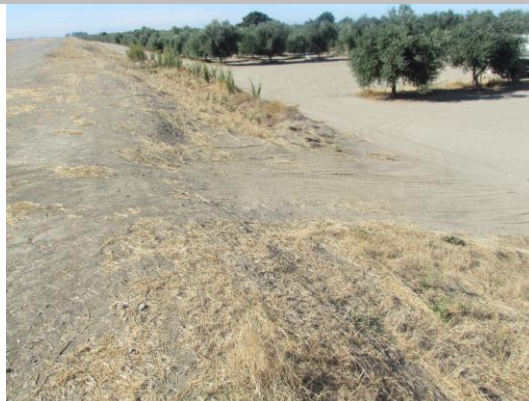
Photo 1 of 2 : SP\_2017\_RD0999\_232\_27\_20170314\_00024.jpg

LM Start	4.31	Rating **	M	Issue No.	27
LM End	4.31	Issue Type +	Ma	Location *	WS
Category	Earthen Levee			GPS Latitude/Longitude	
				Start	End
Item	Slope Stability			38.444560 °	38.444560 °
				-121.594440 °	-121.594440 °
DWR ID	DWR_RD0999_01_f_2012_27				
Comment Code					
S3 : Repair the levee slope damaged by vehicle traffic and prevent access where possible.					
Inspector Comment					
Local farmer causing slope damage by driving equipment and trucks on slope.

Looking at slope damage cause by vehicle traffic on waterward slope.  
(Fall 2016)

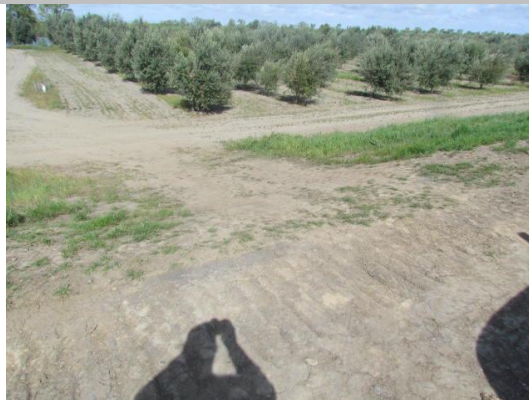
Photo 2 of 2 : SP\_2017\_RD0999\_232\_27\_20170314\_00025.jpg

Looking at slope damage cause by vehicle traffic on waterward slope.  
(Spring 2015)

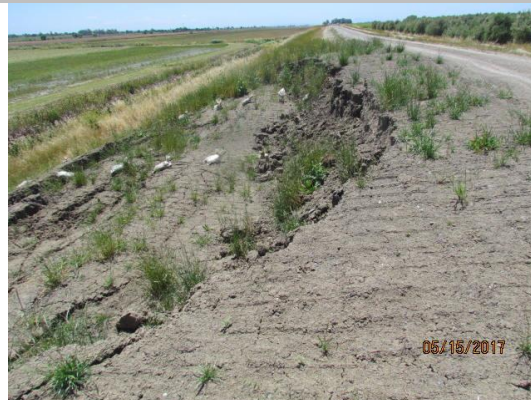
Photo 1 of 1 : SP\_2017\_RD0999\_232\_59\_20170516\_00106.jpg

LM Start	5.19	Rating **	U	Issue No.	59
LM End	5.20	Issue Type +	Ma	Location *	LS
Category	Earthen Levee			GPS Latitude/Longitude	
				Start	End
Item	Erosion / Bank Caving			38.432548 °	38.432434 °
				-121.600031 °	-121.600085 °
DWR ID	DWR_RD0999_01_s_2017_59				
Comment Code					
E2 : Schedule repair of erosion site prior to the next inspection.					
Inspector Comment					
Appears to be a rotational slip on landside.

View of rotation slip looking south (Spring 2017)

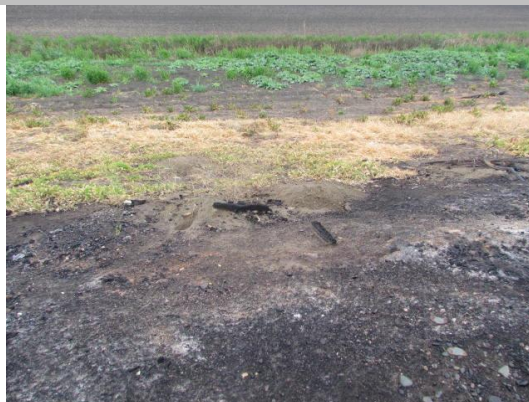
Photo 1 of 2 : SP\_2017\_RD0999\_232\_42\_20170314\_00043.jpg

LM Start	6.56	Rating **	M	Issue No.	42
LM End	6.56	Issue Type +	Ma	Location *	LS
Category	Earthen Levee			GPS Latitude/Longitude	
				Start	End
Item	Animal Control			38.413858 °	38.413858 °
				-121.608638 °	-121.608638 °
DWR ID	DWR_RD0999_01_s_2012_42				
Comment Code					
A1 : Exterminate rodents and backfill and compact or grout burrows.					
Inspector Comment					
More than five holes within 25' of levee.

Looking east at rodent holes on landside slope.

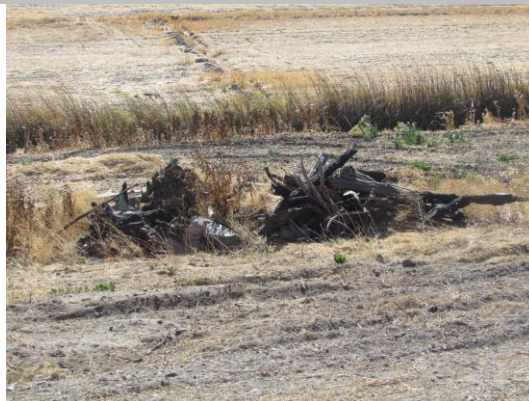
Photo 1 of 2 : SP\_2017\_RD0999\_232\_41\_20170314\_00041.jpg

LM Start	6.56	Rating **	M	Issue No.	41
LM End	6.59	Issue Type +	Ma	Location *	LS
Category	Earthen Levee			GPS Latitude/Longitude	
				Start	End
Item	Encroachments			38.413856 °	38.413475 °
				-121.608635 °	-121.608817 °
DWR ID	DWR_RD0999_01_s_2016_41				
Comment Code					
PR : Prunings					
Inspector Comment					
Pruning piles on landward toe.

Looking east at prunings at landward toe and berm. (Fall 2016)

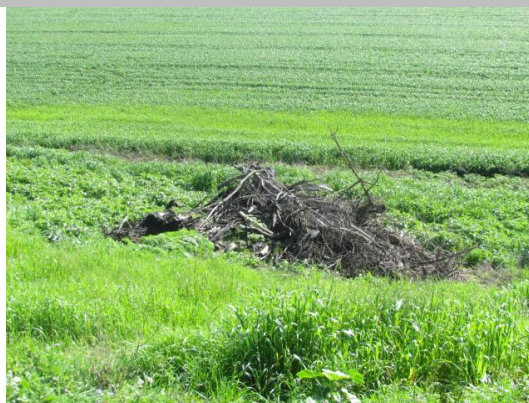
Photo 2 of 2 : SP\_2017\_RD0999\_232\_41\_20170314\_00042.jpg

Looking east at prunings on landward toe and berm. (Spring 2016)

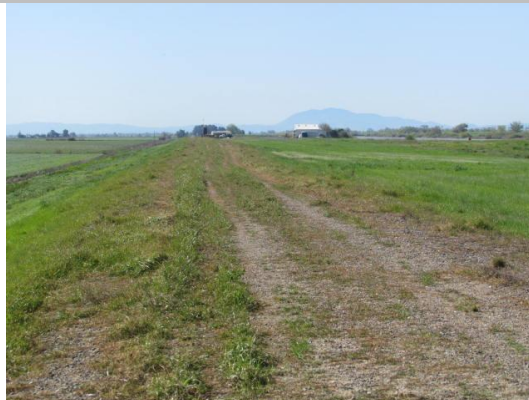
Photo 1 of 2 : SP\_2017\_RD0999\_232\_22\_20170314\_00019.jpg

LM Start	6.77	Rating **	M	Issue No.	22
LM End	9.67	Issue Type +	Ma	Location *	CR
Category	Earthen Levee			GPS Latitude/Longitude	
				Start	End
Item	Crown Surface / Depressions / Rutting			38.411031 °	38.371621 °
				-121.609960 °	-121.628232 °
DWR ID	DWR_RD0999_01_s_2012_22				
Comment Code					
C3 : Add appropriate gravel or road base. Grade and compact.					
Inspector Comment					
Also control growth on levee crown.

Looking south at levee crown. (Spring 2016)

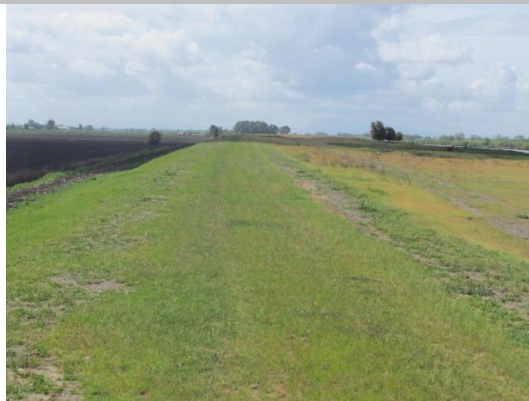
Photo 2 of 2 : SP\_2017\_RD0999\_232\_22\_20170314\_00020.jpg

LM Start	6.77	Rating **	M	Issue No.	22 (cont)
LM End	9.67	Issue Type +	Ma	Location *	CR
Category	Earthen Levee			GPS Latitude/Longitude	
				Start	End
Item	Crown Surface / Depressions / Rutting			38.411031 °	38.371621 °
				-121.609960 °	-121.628232 °
DWR ID	DWR_RD0999_01_s_2012_22				
Comment Code					
C3 : Add appropriate gravel or road base. Grade and compact.					
Inspector Comment					
Also control growth on levee crown.

Looking south at levee crown. (Spring 2015)

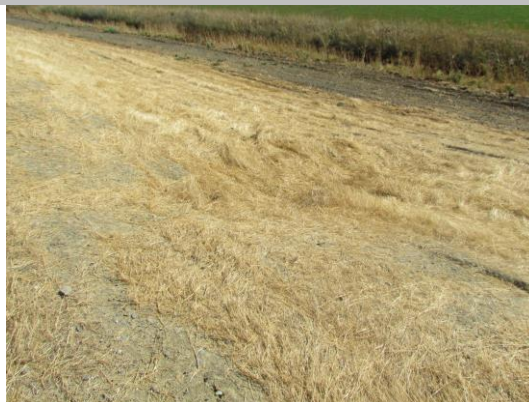
Photo 1 of 2 : SP\_2017\_RD0999\_232\_58\_20170314\_00062.jpg

LM Start	7.61	Rating **	U	Issue No.	58
LM End	7.61	Issue Type +	Ma	Location *	LS
Category	Earthen Levee			GPS Latitude/Longitude	
				Start	End
Item	Erosion / Bank Caving			38.399600 °	38.399600 °
				-121.615224 °	-121.615224 °
DWR ID	DWR_RD0999_01_f_2016_58				
Comment Code					
Inspector Comment					
Depression 10' by 20' on landward slope.

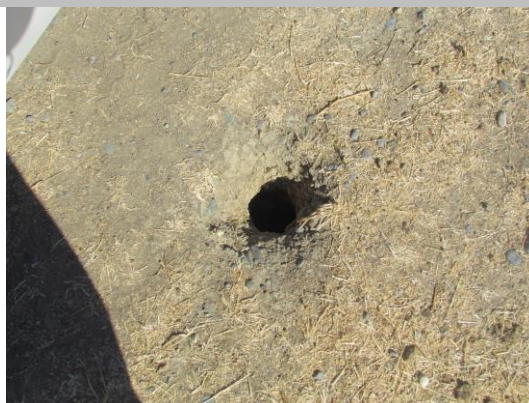
Photo 2 of 3 : SP\_2017\_RD0999\_232\_69\_20170314\_00075.jpg

LM Start	9.34	Rating **	M	Issue No.	69
LM End	9.34	Issue Type +	Ma	Location *	CR
Category	Earthen Levee			GPS Latitude/Longitude	
				Start	End
Item	Animal Control			38.376094 °	38.376094 °
				-121.626178 °	-121.626178 °
DWR ID	DWR_RD0999_01_s_2016_69				
Comment Code					
A1 : Exterminate rodents and backfill and compact or grout burrows.					
Inspector Comment					
Rodent holes noted on levee crown, shoulder and landward slope

Looking at typical rodent hole on landward shoulder. (Fall 2016)

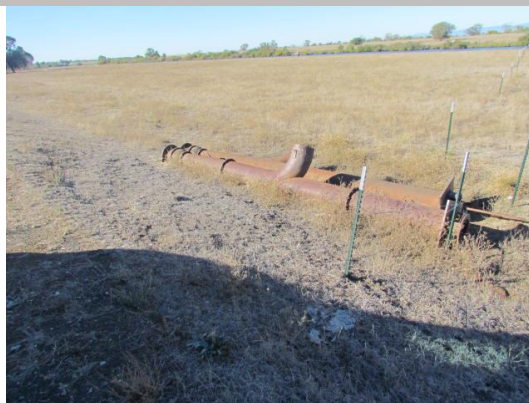
Photo 1 of 1 : SP\_2017\_RD0999\_232\_47\_20170314\_00048.jpg

LM Start	9.51	Rating **	M	Issue No.	47
LM End	9.51	Issue Type +	Ma	Location *	WS
Category	Earthen Levee			GPS Latitude/Longitude	
				Start	End
Item	Encroachments			38.373740 °	38.373740 °
				-121.627257 °	-121.627257 °
DWR ID	DWR_RD0999_01_f_2015_47				
Comment Code					
PI : Pipe					
Inspector Comment					
Abandoned pipes at waterward toe.

Looking southwest at abandoned irrigation pipes at waterward toe.

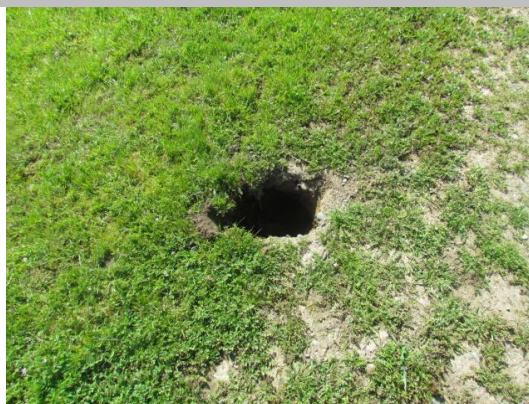
Photo 1 of 5 : SP\_2017\_RD0999\_232\_2\_20170314\_00006.jpg

LM Start	9.95	Rating **	U	Issue No.	2
LM End	9.95	Issue Type +	Ma	Location *	LS
Category	Earthen Levee			GPS Latitude/Longitude	
				Start	End
Item	Animal Control			38.367750 °	38.367750 °
				-121.630025 °	-121.630025 °
DWR ID	DWR_RD0999_01_s_2012_2				
Comment Code					
A1 : Exterminate rodents and backfill and compact or grout burrows.					
Inspector Comment					
Several large rodent holes on landward shoulder.

Looking southeast at large rodent hole on landward shoulder. (Spring 2016)

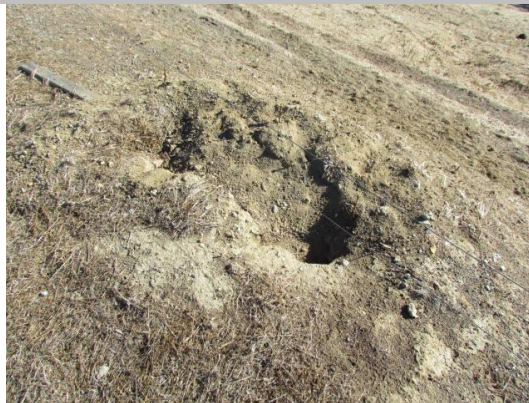
Photo 3 of 5 : SP\_2017\_RD0999\_232\_2\_20170314\_00008.jpg

Looking northeast at rodent holes on landward shoulder fall 2015.

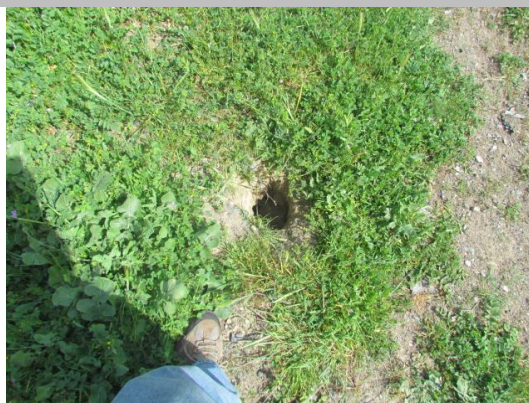
Photo 4 of 5 : SP\_2017\_RD0999\_232\_2\_20170314\_00009.jpg

Looking at typical rodent holes on landward shoulder. (Spring 2015)

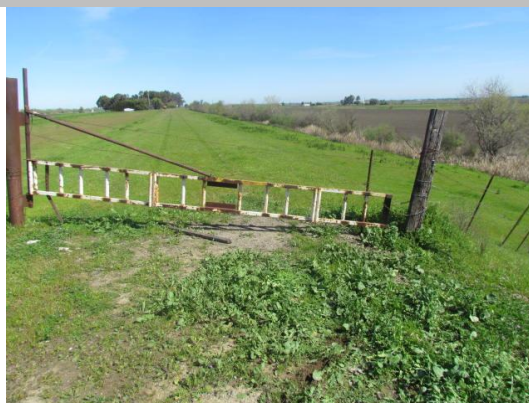
Photo 2 of 4 : SP\_2017\_RD0999\_232\_70\_20170314\_00078.jpg

LM Start	10.21	Rating **	M	Issue No.	70
LM End	10.21	Issue Type +	Ma	Location *	CR
Category	Earthen Levee			GPS Latitude/Longitude	
				Start	End
Item	Repair Gates			38.364229 °	38.364229 °
				-121.631673 °	-121.631673 °
DWR ID	DWR_RD0999_01_s_2016_70				
Comment Code					
Inspector Comment					
Gate drags difficult to open and close. Gate pole leaning.

Looking south at fence pole.

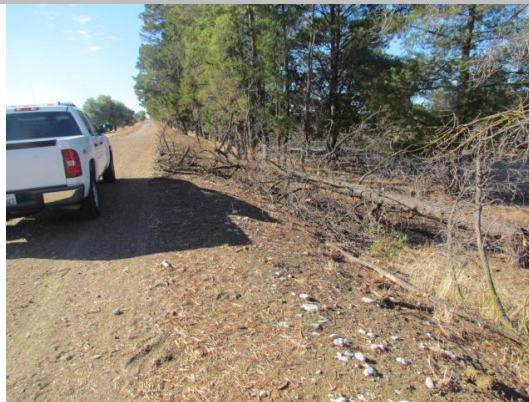
Photo 1 of 2 : SP\_2017\_RD0999\_232\_61\_20170314\_00064.jpg

LM Start	10.75	Rating **	M	Issue No.	61
LM End	10.75	Issue Type +	Ma	Location *	WS
Category	Earthen Levee			GPS Latitude/Longitude	
				Start	End
Item	Encroachments			38.356844 °	38.356844 °
				-121.635101 °	-121.635101 °
DWR ID	DWR_RD0999_01_f_2014_61				
Comment Code					
TR : Tree or limb					
Inspector Comment					
Downed tree on waterward slope

Looking southwest at downed tree on waterward slope.

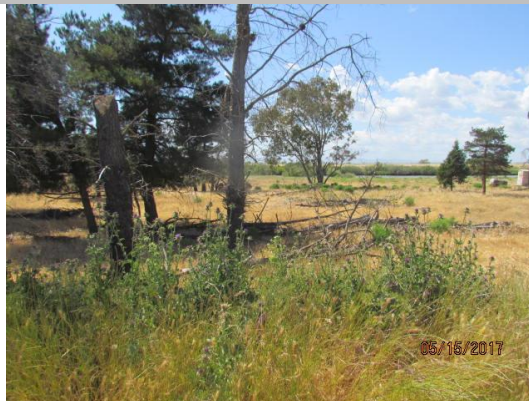
Photo 2 of 2 : SP\_2017\_RD0999\_232\_61\_20170516\_00112.jpg

Looking northwest at downed tree on waterside slope (Spring 2017)

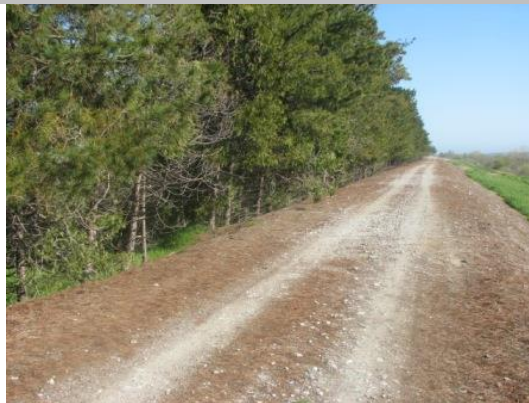
Photo 2 of 2 : SP\_2017\_RD0999\_232\_23\_20170314\_00022.jpg

LM Start	10.81	Rating **	M	Issue No.	23 (cont)	
LM End	11.06	Issue Type +	Ma	Location *	WS	
Category	Earthen Levee			GPS Latitude/Longitude		
				Start		End
Item	Trim / Thin Trees			38.356077 °		38.352640 °
				-121.635598 °		-121.637078 °
DWR ID	DWR_RD0999_01_s_2012_23					
Comment Code						
T1 : Trim trees to at least five feet above ground level.						
Inspector Comment

Pine trees along waterside shoulder & slope. (Site of a old christmas tree farm). (Spring 2011)

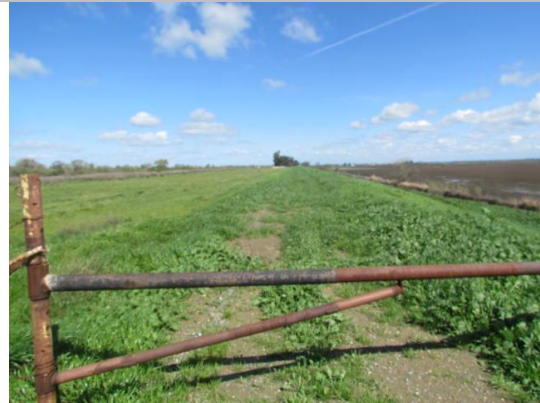
Photo 1 of 1 : SP\_2017\_RD0999\_232\_43\_20170314\_00045.jpg

LM Start	11.30	Rating **	M	Issue No.	43
LM End	11.66	Issue Type +	Ma	Location *	CR
Category	Earthen Levee			GPS Latitude/Longitude	
				Start	End
Item	Crown Surface / Depressions / Rutting			38.349380 °	38.344455 °
				-121.638540 °	-121.640845 °
DWR ID	DWR_RD0999_01_s_2012_43				
Comment Code					
C3 : Add appropriate gravel or road base. Grade and compact.					
Inspector Comment

Looking north at growth on levee crown.

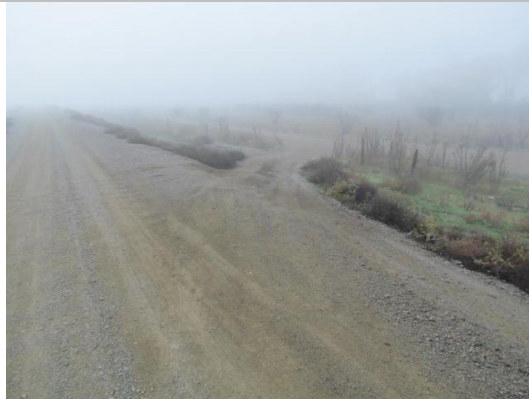
Photo 2 of 2 : SP\_2017\_RD0999\_232\_48\_20170314\_00050.jpg

LM Start	11.84	Rating **	M	Issue No.	48 (cont)	
LM End	11.84	Issue Type +	Ma	Location *	WS	
Category	Earthen Levee			GPS Latitude/Longitude		
				Start		End
Item	Slope Stability			38.342068 °		38.342068 °
				-121.641944 °		-121.641944 °
DWR ID	DWR_RD0999_01_f_2012_48					
Comment Code						
S3 : Repair the levee slope damaged by vehicle traffic and prevent access where possible.						
Inspector Comment						
Slope damage caused by vehicle traffic.

Looking southwest at slope damage caused by vehicle traffic on waterside slope.

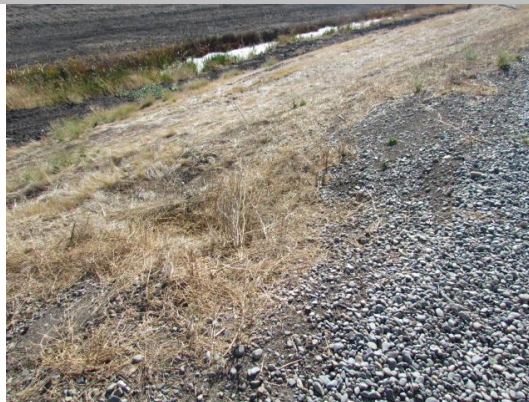
Photo 1 of 4 : SP\_2017\_RD0999\_232\_49\_20170314\_00051.jpg

LM Start	14.04	Rating **	M	Issue No.	49
LM End	14.04	Issue Type +	Ma	Location *	LS
Category	Earthen Levee			GPS Latitude/Longitude	
				Start	End
Item	Erosion / Bank Caving			38.310347 °	38.310347 °
				-121.644955 °	-121.644955 °
DWR ID	DWR_RD0999_01_f_2012_49				
Comment Code					
E1 : Note and monitor erosion site.					
Inspector Comment					
Caving, 4' x 10', on landside slope.

Looking southeast at caving on landward slope fall 2015.

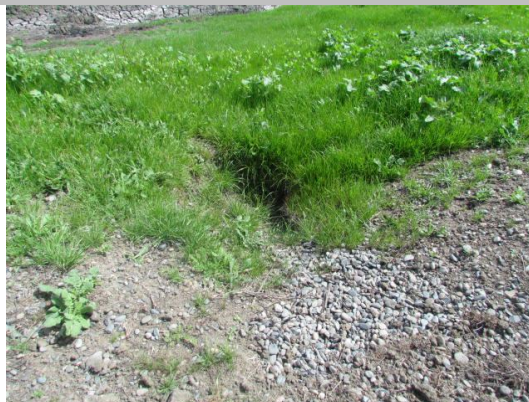
Photo 2 of 4 : SP\_2017\_RD0999\_232\_49\_20170314\_00052.jpg

Looking east at caving on landward shoulder and slope. (Spring 2015)

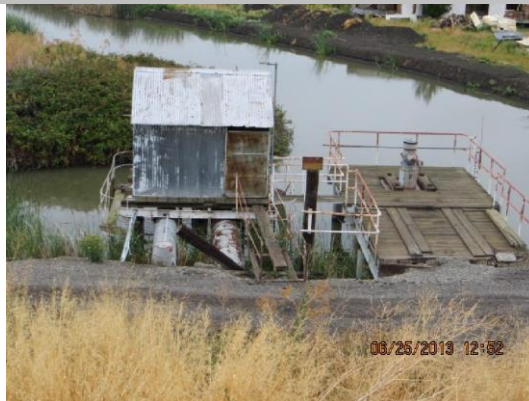
Photo 1 of 3 : UCIP\_SP\_2017\_15365\_25227.jpg

LM Start	15.24	Rating **	A/W	Issue No.	926
LM End	15.24	Issue Type +	Ma	Location *	LS
Category	Supplemental			GPS Latitude/Longitude	
				Start	End
Item	DWR UCIP LMA Responsibility			38.292973 °	38.292973 °
				-121.644977 °	-121.644977 °
DWR ID					
Comment Code					
Inspector Comment					
FS_ID:15365 DS_ID:22756 EP_NO: N/A Repair Type: No Action Needed Crossing Status: Found UCIP Comments: FIELD_STRUCT_DESC: 30-inch pipe through the levee 7.0 feet below the crown. Flap gate on waterward end. Pump in pump house on landward toe. Siphon breaker in CMP riser on WS shoulder. Originally included in the 1966 O&M manual. FS Date: 6/25/2013

Pumphouse on LS toe.

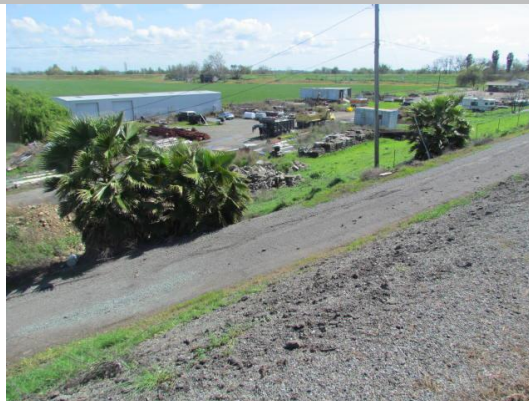
Photo 1 of 2 : SP\_2017\_RD0999\_232\_44\_20170314\_00046.jpg

LM Start	15.26	Rating **	U	Issue No.	44
LM End	15.26	Issue Type +	Ma	Location *	LS
Category	Earthen Levee			GPS Latitude/Longitude	
				Start	End
Item	Vegetation			38.292702 °	38.292702 °
				-121.644967 °	-121.644967 °
DWR ID	DWR_RD0999_01_s_2016_44				
Comment Code					
V7 : Trees / Woody Vegetation					
Inspector Comment					
Unauthorized palm trees on landward slope and toe.

Looking east at palm trees on landward slope next to ramp.

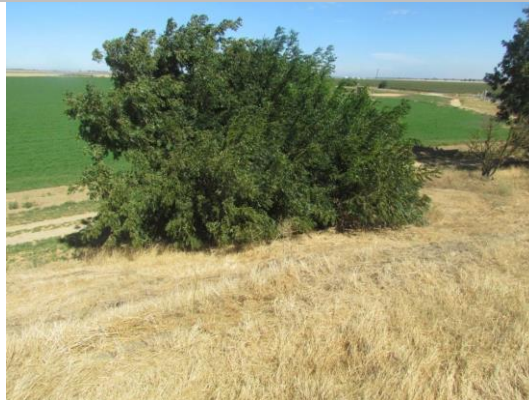
Photo 1 of 2 : SP\_2017\_RD0999\_233\_37\_20170314\_00029.jpg

LM Start	0.73	Rating **	U	Issue No.	37
LM End	0.73	Issue Type +	Ma	Location *	LS
Category	Earthen Levee			GPS Latitude/Longitude	
				Start	End
Item	Trim / Thin Trees			38.292783 °	38.292783 °
				-121.632317 °	-121.632317 °
DWR ID	DWR_RD0999_02_s_2014_37				
Comment Code					
T1 : Trim trees to at least five feet above ground level.					
Inspector Comment

Looking at untrimmed tree on landward slope and toe. (Fall 2016)

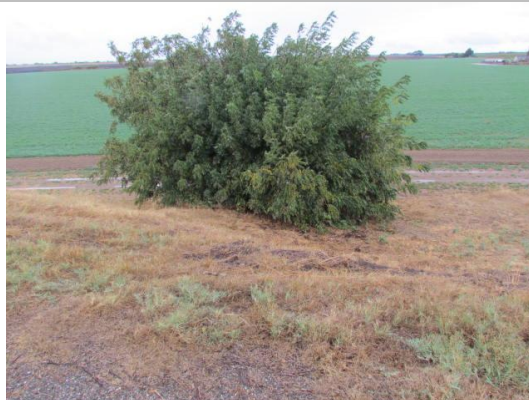
Photo 2 of 2 : SP\_2017\_RD0999\_233\_37\_20170314\_00030.jpg

Looking at untrimmed tree on landward slope. (Spring 2016)

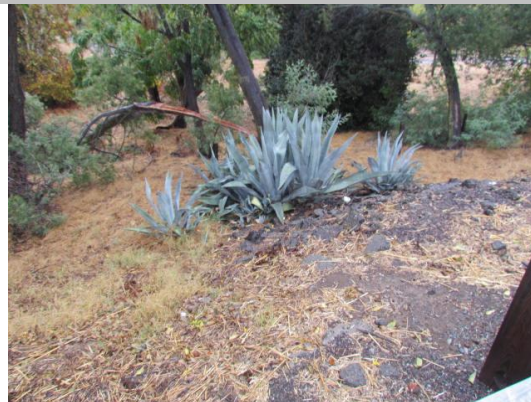
Photo 1 of 2 : SP\_2017\_RD0999\_233\_14\_20170314\_00015.jpg

LM Start	0.82	Rating **	U	Issue No.	14
LM End	0.82	Issue Type +	Ma	Location *	LS
Category	Earthen Levee			GPS Latitude/Longitude	
				Start	End
Item	Vegetation			38.292439 °	38.292439 °
				-121.630781 °	-121.630781 °
DWR ID	DWR_RD0999_02_f_2012_14				
Comment Code					
V2 : Remove the wild growth other than native grasses from the levee slopes.					
Inspector Comment					
Century plant on landside slope.

Looking north at century plant at landward toe fall 2015.

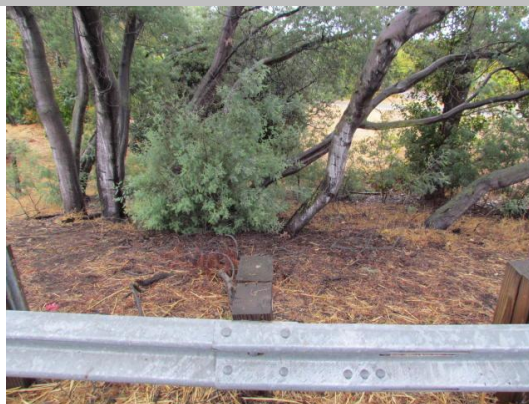
Photo 1 of 2 : SP\_2017\_RD0999\_233\_19\_20170314\_00021.jpg

LM Start	0.83	Rating **	U	Issue No.	19
LM End	0.83	Issue Type +	Ma	Location *	LS
Category	Earthen Levee			GPS Latitude/Longitude	
				Start	End
Item	Trim / Thin Trees			38.292386 °	38.292386 °
				-121.630543 °	-121.630543 °
DWR ID	DWR_RD0999_02_f_2012_19				
Comment Code					
T2 : Thin trees to allow visibility of the ground and room to flood fight.					
Inspector Comment

Looking north at untrimmed trees to be thinned at landward toe fall 2015.

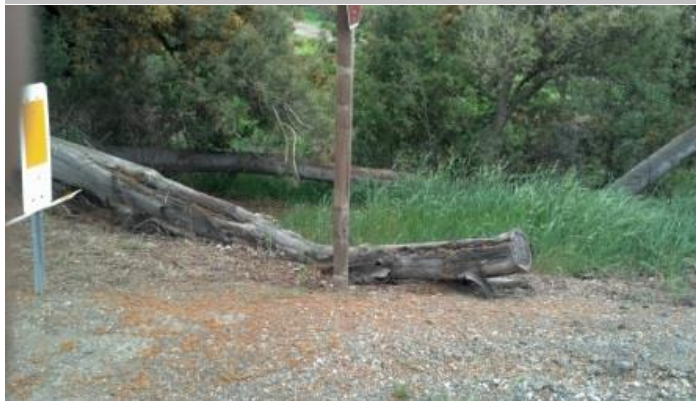
Photo 1 of 1 : SP\_2017\_RD0999\_233\_13\_20170314\_00014.jpg

LM Start	0.84	Rating **	M	Issue No.	13
LM End	0.84	Issue Type +	Ma	Location *	LS
Category	Earthen Levee			GPS Latitude/Longitude	
				Start	End
Item	Encroachments			38.292352 °	38.292352 °
				-121.630452 °	-121.630452 °
DWR ID	DWR_RD0999_02_s_2012_13				
Comment Code					
TR : Tree or limb					
Inspector Comment

Looking northwest at tree limb on landside slope.

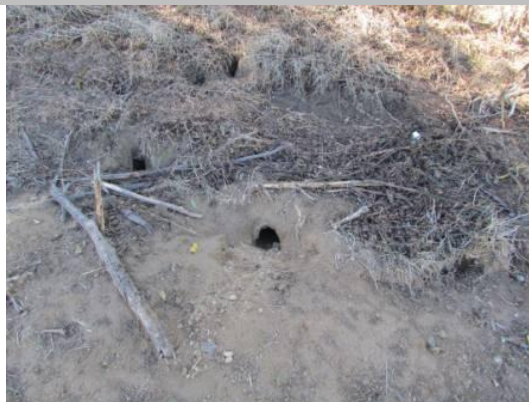
Photo 1 of 1 : SP\_2017\_RD0999\_233\_2\_20170314\_00004.jpg

LM Start	0.93	Rating **	M	Issue No.	2
LM End	1.03	Issue Type +	Ma	Location *	LS
Category	Earthen Levee			GPS Latitude/Longitude	
				Start	End
Item	Animal Control			38.291823 °	38.291250 °
				-121.628973 °	-121.627285 °
DWR ID	DWR_RD0999_02_s_2012_2				
Comment Code					
A1 : Exterminate rodents and backfill and compact or grout burrows.					
Inspector Comment

Looking at several rodent holes on landside slope.

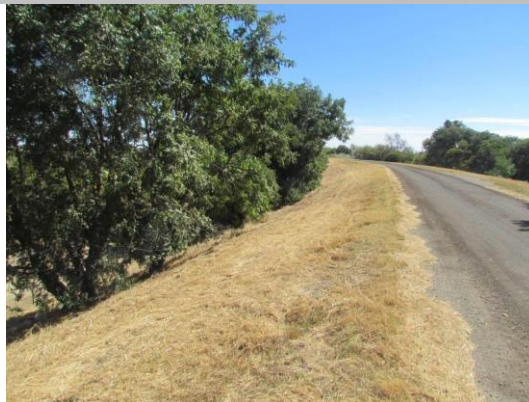
Photo 1 of 1 : SP\_2017\_RD0999\_233\_39\_20170314\_00034.jpg

LM Start	0.96	Rating **	U	Issue No.	39
LM End	1.01	Issue Type +	Ma	Location *	LS
Category	Earthen Levee			GPS Latitude/Longitude	
				Start	End
Item	Trim / Thin Trees			38.291603 °	38.291292 °
				-121.628485 °	-121.627577 °
DWR ID	DWR_RD0999_02_f_2014_39				
Comment Code					
T1 : Trim trees to at least five feet above ground level.					
Inspector Comment					
Untrimmed trees along landward toe.

Looking south at untrimmed trees on landward slope.

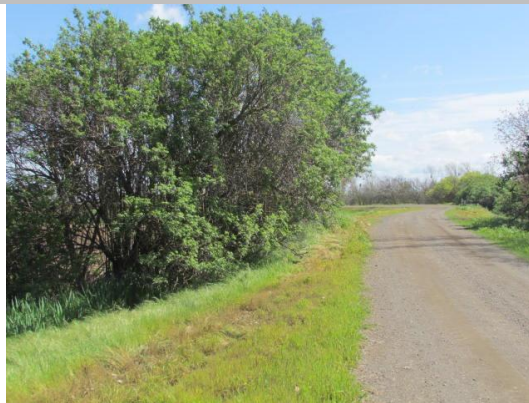
Photo 1 of 3 : SP\_2017\_RD0999\_233\_8\_20170314\_00008.jpg

LM Start	1.73	Rating **	A/W	Issue No.	8
LM End	1.76	Issue Type +	Ma	Location *	LS
Category	Earthen Levee			GPS Latitude/Longitude	
				Start	End
Item	Vegetation			38.289895 °	38.289595 °
				-121.614688 °	-121.614337 °
DWR ID	DWR_RD0999_02_s_2012_8				
Comment Code					
V2 : Remove the wild growth other than native grasses from the levee slopes.					
Inspector Comment

Looking east at dense vegetation on landward shoulder and slope.  
(Spring 2016)

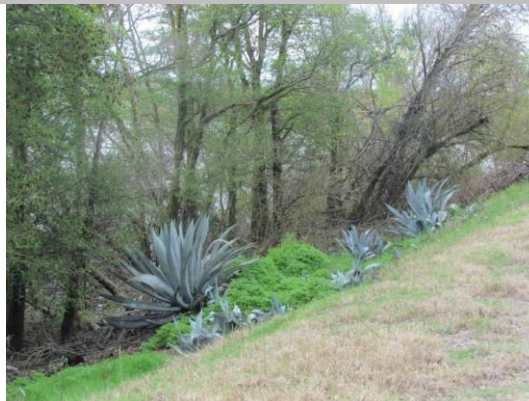
Photo 1 of 1 : SP\_2017\_RD0999\_234\_17\_20170324\_00042.jpg

LM Start	0.06	Rating **	M	Issue No.	17
LM End	0.06	Issue Type +	Ma	Location *	WS
Category	Earthen Levee			GPS Latitude/Longitude	
				Start	End
Item	Vegetation			38.287290 °	38.287290 °
				-121.605472 °	-121.605472 °
DWR ID	DWR_RD0999_03_s_2017_17				
Comment Code					
V2 : Remove the wild growth other than native grasses from the levee slopes.					
Inspector Comment					
Century plants on waterward slope.

Looking east at century plants on waterward slope.

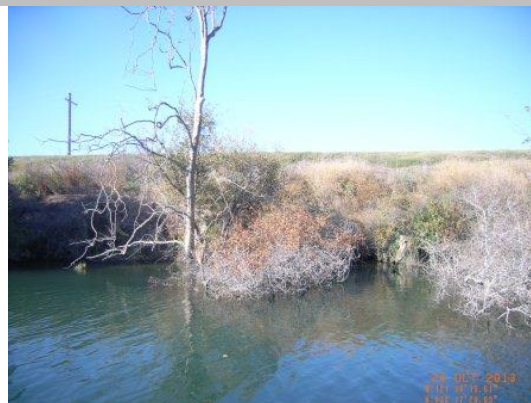
Photo 1 of 1 : SP\_2017\_RD0999\_234\_29\_20170314\_00024.jpg

Comment Code					
Inspector Comment					
1997 - Intermittent over-steepened sections. Large riparian vegetation along the length of the entire reach. Attempts to repair with rock on bank have failed. 1999 - New rock repair at the downstream end. 2002 - Some minor spot repairs. 2009 - Minimal new erosion. 2010 - Appears that fresh rock placed on downstream portion of site. Toe scour and overhanging trees with some overturned. 2012 - Minor new erosion at the toe. 2013 - Site upgraded to CRITICAL. Severe slumping into levee at downstream end of site. Fresh erosion into bank toe. 2015: New slumping, tall vertical sections. [2015 Site ID: STR_24-7_R]

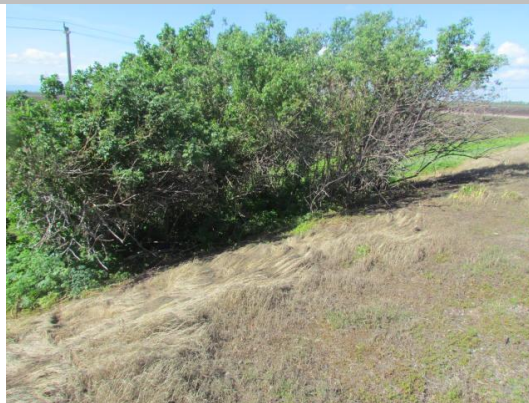
Photo 2 of 3 : SP\_2017\_RD0999\_234\_8\_20170314\_00006.jpg

LM Start	0.66	Rating **	U	Issue No.	8 (cont)	
LM End	0.66	Issue Type +	Ma	Location *	LS	
Category	Earthen Levee			GPS Latitude/Longitude		
				Start	End	
Item	Vegetation			38.295618 °	38.295618 °	
				-121.605923 °	-121.605923 °	
DWR ID	DWR_RD0999_03_s_2012_8					
Comment Code						
V4 : Elderberries are blocking visibility and flood fight capability.						
Inspector Comment						
Dense veg on landward slope.

Looking east at elderberry at landward slope and toe. (Spring 2016)

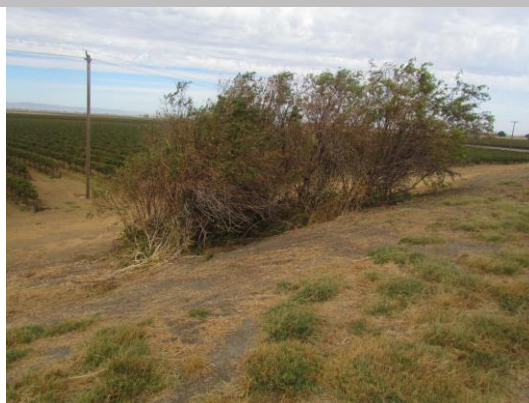
Photo 3 of 3 : SP\_2017\_RD0999\_234\_8\_20170314\_00005.jpg

Looking east at brush on landward slope and toe. (Fall 2016)

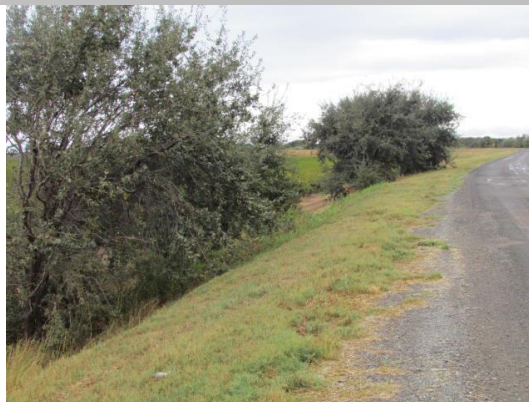
Photo 1 of 1 : SP\_2017\_RD0999\_234\_43\_20170314\_00028.jpg

LM Start	0.93	Rating **	U	Issue No.	43
LM End	0.95	Issue Type +	Ma	Location *	LS
Category	Earthen Levee			GPS Latitude/Longitude	
				Start	End
Item	Trim / Thin Trees			38.299130 °	38.299362 °
				-121.603768 °	-121.603462 °
DWR ID	DWR_RD0999_03_f_2014_43				
Comment Code					
T1 : Trim trees to at least five feet above ground level.					
Inspector Comment

Looking at untrimmed trees on landward slope and toe.

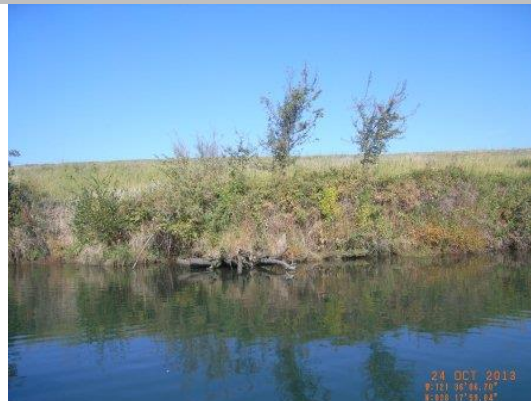
Photo 1 of 1 : SP\_2017\_RD0999\_234\_30\_20170314\_00025.jpg

LM Start	0.97	Rating **	M	Issue No.	30
LM End	1.10	Issue Type +	Ma	Location *	WS
Category	Supplemental			GPS Latitude/Longitude	
				Start	End
Item	2015 USACE Erosion Survey, DRAFT			38.299402 °	38.300542 °
				-121.603056 °	-121.601118 °
DWR ID	DWR_RD0999_03_s_2016_30				
Comment Code					
Inspector Comment					
2008 - Over steepened levee section. 2009 - Significant new erosion. 2010 - Minor new erosion. 2015: No observed changes. [2015 Site ID: STR_25-2_R]

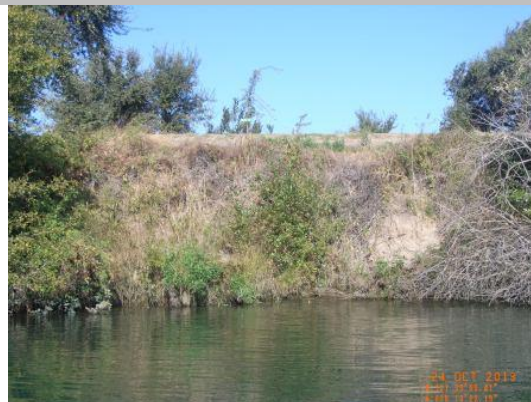
Photo 1 of 1 : SP\_2017\_RD0999\_234\_1\_20170314\_00001.jpg

LM Start	1.43	Rating **	M	Issue No.	1
LM End	1.58	Issue Type +	Ma	Location *	WS
Category	Supplemental			GPS Latitude/Longitude	
				Start	End
Item	2015 USACE Erosion Survey, DRAFT			38.305229 °	38.306667 °
				-121.599933 °	-121.598266 °
DWR ID	DWR_RD0999_03_s_2016_1				
Comment Code					
Inspector Comment					
2011 - Toe scour along length of site and erosion pockets. 2012 - Site extended slightly upstream due to new erosion pocket. 2013 - Tall vertical sections at upstream end of site. 2015: No observed changes. [2015 Site ID: STR_25-7_R]

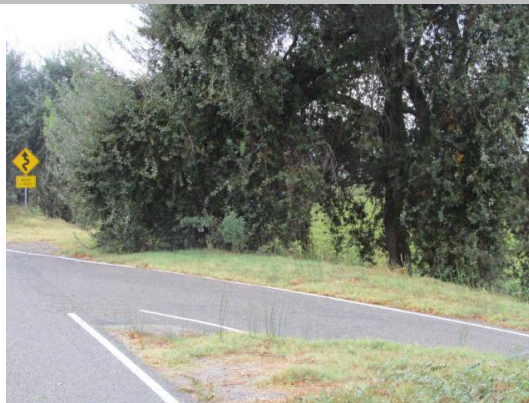
Photo 2 of 2 : SP\_2017\_RD0999\_234\_11\_20170314\_00012.jpg

LM Start	1.50	Rating **	M	Issue No.	11 (cont)	
LM End	1.50	Issue Type +	Ma	Location *	LS	
Category	Earthen Levee			GPS Latitude/Longitude		
				Start		End
Item	Trim / Thin Trees			38.306062 °		38.306062 °
				-121.599495 °		-121.599495 °
DWR ID	DWR_RD0999_03_s_2012_11					
Comment Code						
T1 : Trim trees to at least five feet above ground level.						
Inspector Comment

Looking at untrimmed trees on landward slope and toe. (Spring 2016)

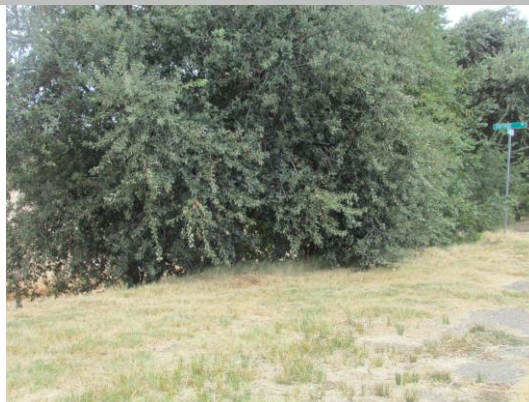
Photo 1 of 1 : SP\_2017\_RD0999\_234\_12\_20170314\_00013.jpg

LM Start	1.53	Rating **	U	Issue No.	12
LM End	1.53	Issue Type +	Ma	Location *	LS
Category	Earthen Levee			GPS Latitude/Longitude	
				Start	End
Item	Trim / Thin Trees			38.306332 °	38.306332 °
				-121.599109 °	-121.599109 °
DWR ID	DWR_RD0999_03_s_2012_12				
Comment Code					
T1 : Trim trees to at least five feet above ground level.					
Inspector Comment

Looking east at untrimmed trees on landward slope.

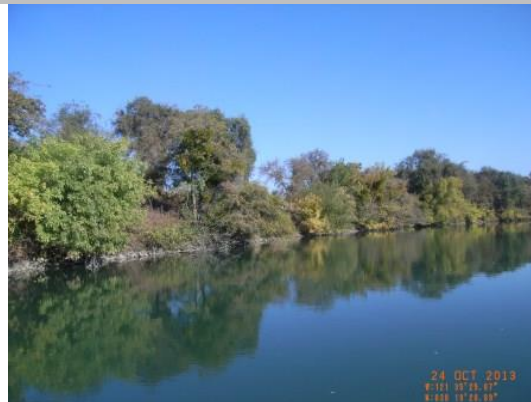
Photo 1 of 1 : SP\_2017\_RD0999\_234\_21\_20170314\_00018.jpg

LM Start	2.87	Rating **	M	Issue No.	21
LM End	2.92	Issue Type +	Ma	Location *	WS
Category	Supplemental			GPS Latitude/Longitude	
				Start	End
Item	2015 USACE Erosion Survey, DRAFT			38.322457 °	38.323042 °
				-121.590693 °	-121.590209 °
DWR ID	DWR_RD0999_03_s_2016_21				
Comment Code					
Inspector Comment					
2012 - Slumping of upper levee slope. 2015: No observed changes. [2015 Site ID: STR_27-1_R]

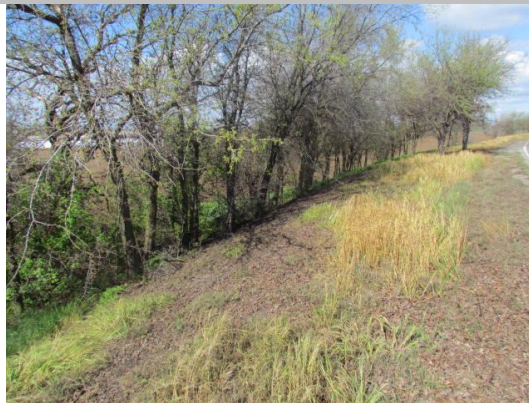
Photo 1 of 4 : SP\_2017\_RD0999\_234\_10\_20170314\_00007.jpg

LM Start	2.88	Rating **	U	Issue No.	10
LM End	2.88	Issue Type +	Ma	Location *	LS
Category	Earthen Levee			GPS Latitude/Longitude	
				Start	End
Item	Trim / Thin Trees			38.322757 °	38.322757 °
				-121.590817 °	-121.590817 °
DWR ID	DWR_RD0999_03_f_2012_10				
Comment Code					
T3 : Trim and thin trees to allow visibility of the ground and room to flood fight.					
Inspector Comment					
Wild growth at landside slope and toe.

Looking northwest at dense vegetation on landward slope and toe.  
(Spring 2016)

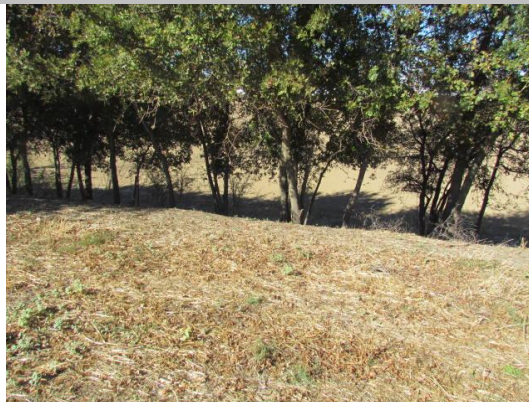
Photo 2 of 4 : SP\_2017\_RD0999\_234\_10\_20170314\_00008.jpg

Looking west at trimmed trees at landward toe. (Fall 2014)

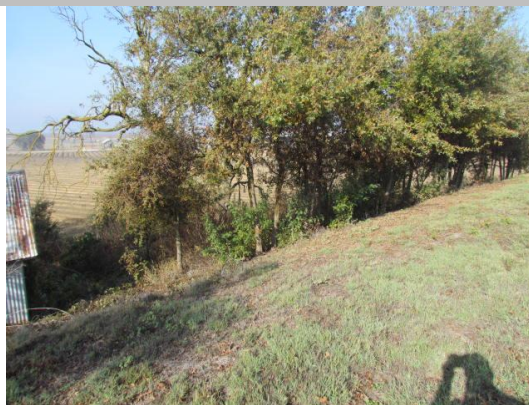
Photo 4 of 4 : SP\_2017\_RD0999\_234\_10\_20170314\_00010.jpg

LM Start	2.88	Rating **	U	Issue No.	10 (cont)	
LM End	2.88	Issue Type +	Ma	Location *	LS	
Category	Earthen Levee			GPS Latitude/Longitude		
				Start		End
Item	Trim / Thin Trees			38.322757 °		38.322757 °
				-121.590817 °		-121.590817 °
DWR ID	DWR_RD0999_03_f_2012_10					
Comment Code						
T3 : Trim and thin trees to allow visibility of the ground and room to flood fight.						
Inspector Comment						
Wild growth at landside slope and toe.

Looking northwest at dense vegetation at landside slope and toe.

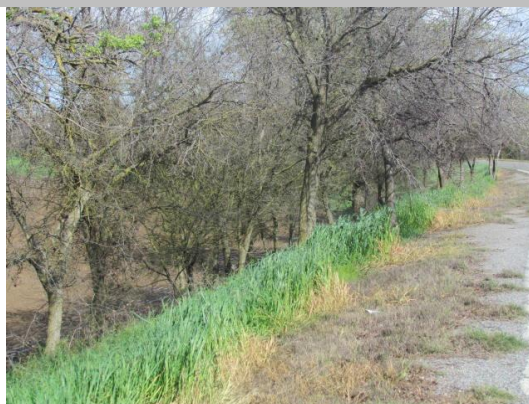
Photo 1 of 2 : SP\_2017\_RD0999\_234\_31\_20170314\_00026.jpg

LM Start	3.01	Rating **	U	Issue No.	31
LM End	3.25	Issue Type +	Ma	Location *	LS
Category	Earthen Levee			GPS Latitude/Longitude	
				Start	End
Item	Trim / Thin Trees			38.323770 °	38.326061 °
				-121.589035 °	-121.586028 °
DWR ID	DWR_RD0999_03_s_2012_31				
Comment Code					
T3 : Trim and thin trees to allow visibility of the ground and room to flood fight.					
Inspector Comment

Looking northwest at untrimmed trees on landward slope. (Spring 2016)

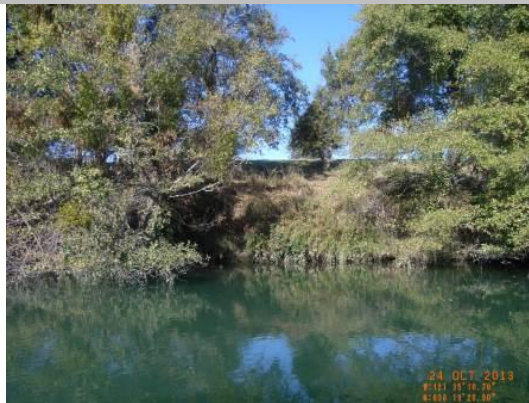
Photo 1 of 1 : SP\_2017\_RD0999\_234\_5\_20170314\_00004.jpg

LM Start	3.05	Rating **	M	Issue No.	5
LM End	3.23	Issue Type +	Ma	Location *	WS
Category	Supplemental			GPS Latitude/Longitude	
				Start	End
Item	2015 USACE Erosion Survey, DRAFT			38.323667 °	38.325592 °
				-121.588226 °	-121.585925 °
DWR ID	DWR_RD0999_03_s_2016_5				
Comment Code					
Inspector Comment					
2011 - Multiple erosion pockets. Some likely from tree popouts. 2013 - Tall vertical sections. 2015: New tree popout and significant new erosion. [2015 Site ID: STR_27-3_R]

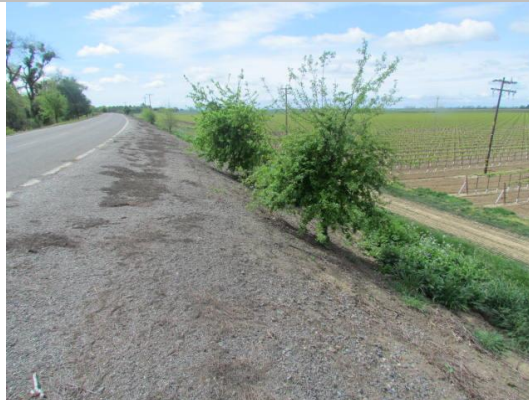
Photo 1 of 1 : SP\_2017\_RD0999\_234\_44\_20170314\_00029.jpg

LM Start	3.60	Rating **	M	Issue No.	44
LM End	3.64	Issue Type +	Ma	Location *	LS
Category	Earthen Levee			GPS Latitude/Longitude	
				Start	End
Item	Trim / Thin Trees			38.330946 °	38.331415 °
				-121.585932 °	-121.585534 °
DWR ID	DWR_RD0999_03_s_2015_44				
Comment Code					
T2 : Thin trees to allow visibility of the ground and room to flood fight.					
Inspector Comment					
Remove trees less than four inches in diameter at chest height. Don't allow young trees to get establish on levee slope.

Looking southwest at typical view of young oak trees on landward slope.  
(Spring 2015)

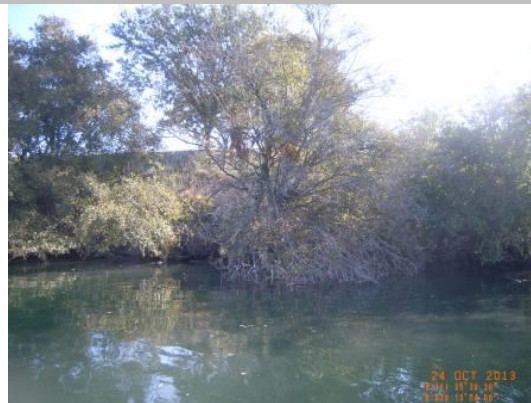
Photo 1 of 1 : SP\_2017\_RD0999\_234\_18\_20170314\_00017.jpg

LM Start	4.56	Rating **	M	Issue No.	18
LM End	4.68	Issue Type +	Ma	Location *	WS
Category	Supplemental			GPS Latitude/Longitude	
				Start	End
Item	2015 USACE Erosion Survey, DRAFT			38.313836 °	38.315407 °
				-121.592259 °	-121.591433 °
DWR ID	DWR_RD0999_03_s_2016_18				
Comment Code					
Inspector Comment					
2002 - Original rock over geotextile is sliding off and the end is coming unraveled. 2003 - Some minor new erosion on the downstream end. 2004 - Site has gotten worse. Underlined geofabric is exposed. 2005 - Still looks bad with exposed geotextile fabric. 2006 - Still have some new unraveling and exposed fabric. Site lengthened upstream. 2009 - Minimal new erosion. 2010 - geotextile fabric placed since last year, possible flood fight. 2012 - Exposed geotech style fabric, assume rock on top slid off. 2015: Erosion pockets covered with plastic. [2015 Site ID: STR_26-5_L]
