**Flood Control Project Maintenance  
Levee Inspections**

## Maintenance Issue Types Only, Levee Inspection Report By Mile - Spring 2017

### Reclamation District No. 0999 Netherlands

Waterway	Bank	Unit Miles	Inspection Start/End	Inspector
Unit No. 01 Yolo Bypass	Left	15.41	03/22/2017 05/16/2017	Dave Torres

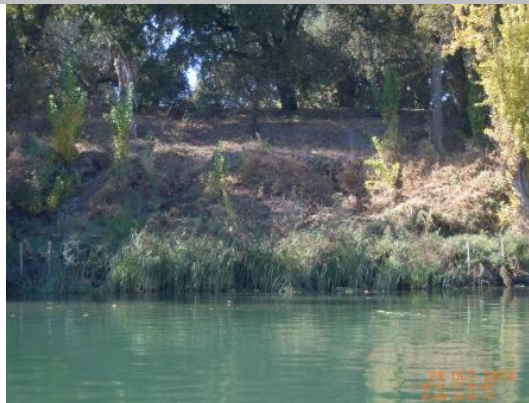
Photo 1 of 1 : SP\_2017\_RD0999\_235\_8\_20170314\_00005.jpg

LM Start	0.02	Rating **	M	Issue No.	8
LM End	0.28	Issue Type +	Ma	Location *	WS
Category	Supplemental			GPS Latitude/Longitude	
				Start	End
Item	2015 USACE Erosion Survey, DRAFT			38.414387 °	38.417692 °
				-121.522871 °	-121.525083 °
DWR ID	DWR_RD0999_04_s_2016_8				
Comment Code					
Inspector Comment					
1997 - Structural problem rather than erosional, failed cobble at downstream end. 2005 - New brush boxes at waterline for several hundred feet downstream, No toe or bank protection present. 2006 - Some minor new erosion. Brush boxes not working well; most of the brush has floated out. 2007 - Brush boxes have recently been repaired. 2015: No observed changes. [2015 Site ID: SAC 41-9 R]

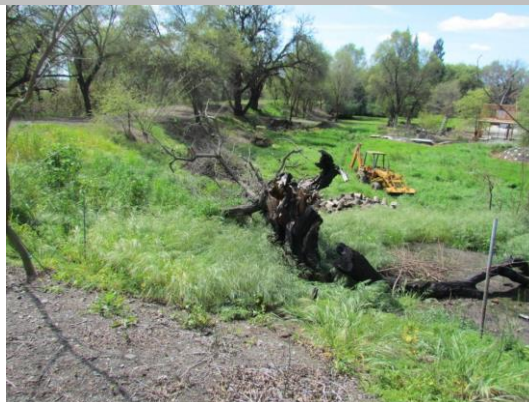
Photo 1 of 1 : SP\_2017\_RD0999\_235\_45\_20170324\_00073.jpg

LM Start	0.03	Rating **	M	Issue No.	45
LM End	0.03	Issue Type +	Ma	Location *	LS
Category	Earthen Levee			GPS Latitude/Longitude	
				Start	End
Item	Encroachments			38.414335 °	38.414335 °
				-121.523348 °	-121.523348 °
DWR ID	DWR_RD0999_04_s_2017_45				
Comment Code					
TR : Tree or limb					
Inspector Comment					
Large downed tree on landward slope.

Looking west at fallen tree on landward slope.

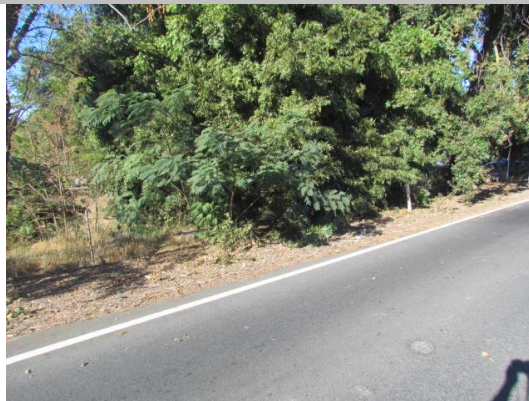
Photo 1 of 1 : SP\_2017\_RD0999\_235\_35\_20170314\_00021.jpg

LM Start	0.03	Rating **	M	Issue No.	35
LM End	0.03	Issue Type +	Ma	Location *	LS
Category	Earthen Levee			GPS Latitude/Longitude	
				Start	End
Item	Trim / Thin Trees			38.414450 °	38.414450 °
				-121.523308 °	-121.523308 °
DWR ID	DWR_RD0999_04_f_2014_35				
Comment Code					
T1 : Trim trees to at least five feet above ground level.					
Inspector Comment					
Untrimmed trees on landward slope and toe.

Looking at untrimmed trees on landward slope.

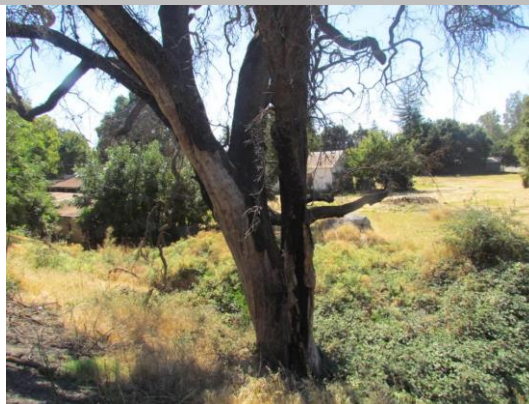
Photo 1 of 2 : SP\_2017\_RD0999\_235\_21\_20170314\_00018.jpg

LM Start	0.58	Rating **	A/W	Issue No.	21
LM End	0.58	Issue Type +	Ma	Location *	LS
Category	Earthen Levee			GPS Latitude/Longitude	
				Start	End
Item	Vegetation			38.421394 °	38.421394 °
				-121.527963 °	-121.527963 °
DWR ID	DWR_RD0999_04_f_2013_21				
Comment Code					
V7 : Trees / Woody Vegetation					
Inspector Comment					
Dead tree on landward slope and toe.

Looking southwest at dead tree at landward toe.

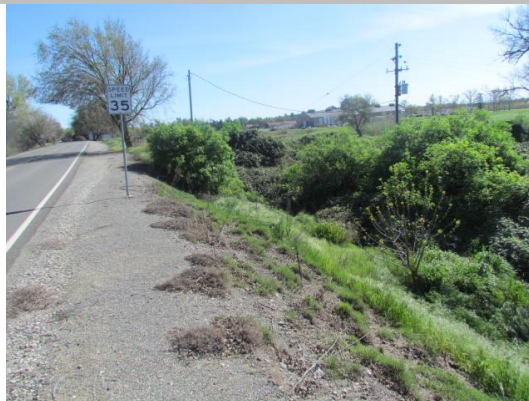
Photo 1 of 4 : SP\_2017\_RD0999\_235\_16\_20170314\_00013.jpg

LM Start	1.01	Rating **	U	Issue No.	16
LM End	1.04	Issue Type +	Ma	Location *	LS
Category	Earthen Levee			GPS Latitude/Longitude	
				Start	End
Item	Vegetation			38.426873 °	38.427295 °
				-121.531778 °	-121.532164 °
DWR ID	DWR_RD0999_04_f_2012_16				
Comment Code					
V2 : Remove the wild growth other than native grasses from the levee slopes.					
Inspector Comment					
Blackberries blocking view of landward toe.

Looking southwest at dense vegetation on landward slope and toe.  
(Spring 2016)

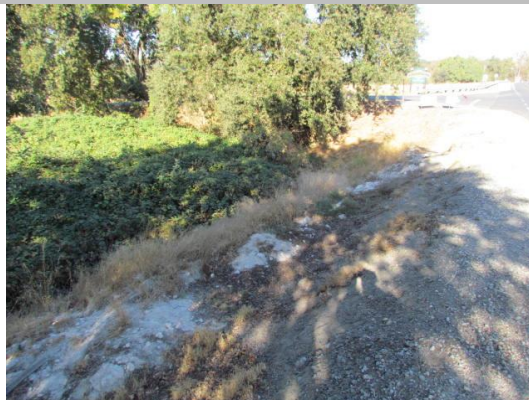
Photo 2 of 4 : SP\_2017\_RD0999\_235\_16\_20170314\_00014.jpg

Looking northwest at dense vines at landward toe. Fall 2015

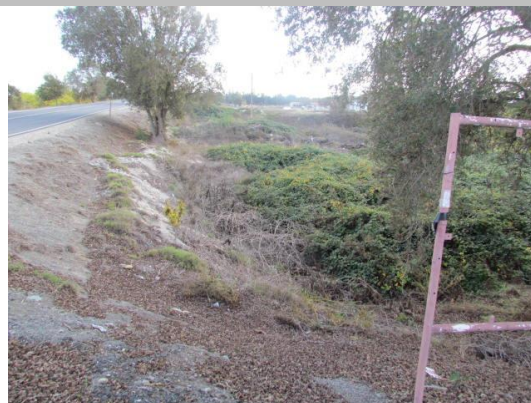
Photo 4 of 4 : SP\_2017\_RD0999\_235\_16\_20170314\_00016.jpg

LM Start	1.01	Rating **	U	Issue No.	16 (cont)	
LM End	1.04	Issue Type +	Ma	Location *	LS	
Category	Earthen Levee			GPS Latitude/Longitude		
				Start		End
Item	Vegetation			38.426873 °		38.427295 °
				-121.531778 °		-121.532164 °
DWR ID	DWR_RD0999_04_f_2012_16					
Comment Code						
V2 : Remove the wild growth other than native grasses from the levee slopes.						
Inspector Comment						
Blackberries blocking view of landward toe.

Looking south at dense berryvines on landside toe. 2012

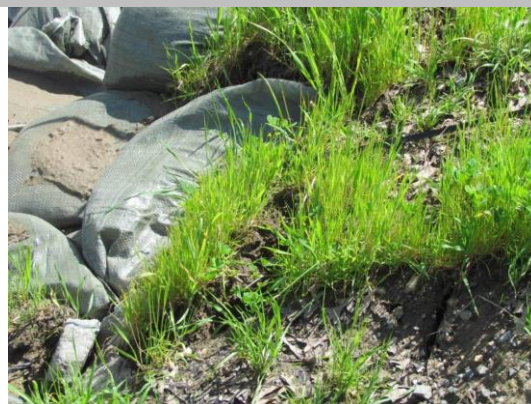
Photo 1 of 2 : SP\_2017\_RD0999\_235\_47\_20170324\_00076.jpg

LM Start	1.10	Rating **	U	Issue No.	47
LM End	1.10	Issue Type +	Ma	Location *	WS
Category	Earthen Levee			GPS Latitude/Longitude	
				Start	End
Item	Erosion / Bank Caving			38.428152 °	38.428152 °
				-121.532502 °	-121.532502 °
DWR ID	DWR_RD0999_04_s_2017_47				
Comment Code					
E1 : Note and monitor erosion site.					
Inspector Comment					
Small erosion just above rip rap on waterward toe.

Looking downstream at erosion just above rock.

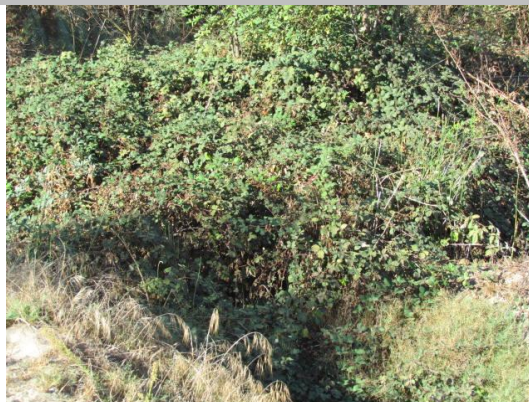
Photo 1 of 3 : SP\_2017\_RD0999\_235\_5\_20170314\_00002.jpg

LM Start	1.15	Rating **	U	Issue No.	5
LM End	1.15	Issue Type +	Ma	Location *	LS
Category	Earthen Levee			GPS Latitude/Longitude	
				Start	End
Item	Vegetation			38.428823 °	38.428823 °
				-121.532885 °	-121.532885 °
DWR ID	DWR_RD0999_04_s_2012_5				
Comment Code					
V2 : Remove the wild growth other than native grasses from the levee slopes.					
Inspector Comment					
Berry vines and wild roses on landside toe.

Looking at dense vines at landward toe. Fall 2015.

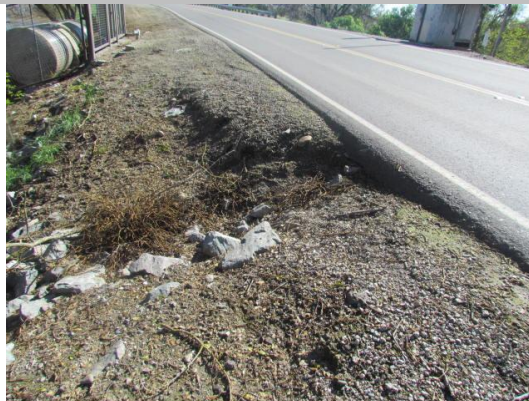
Photo 2 of 2 : SP\_2017\_RD0999\_235\_46\_20170314\_00032.jpg

LM Start	1.18	Rating **	U	Issue No.	46 (cont)	
LM End	1.18	Issue Type +	Ma	Location *	WS	
Category	Earthen Levee			GPS Latitude/Longitude		
				Start		End
Item	Erosion / Bank Caving			38.429201 °	38.429201 °	
				-121.533012 °	-121.533012 °	
DWR ID	DWR_RD0999_04_s_2016_46					
Comment Code						
E2 : Schedule repair of erosion site prior to the next inspection.						
Inspector Comment						
Erosion located just below asphalt on waterward shoulder.

Looking south at foot erosion on waterward shoulder and slope.

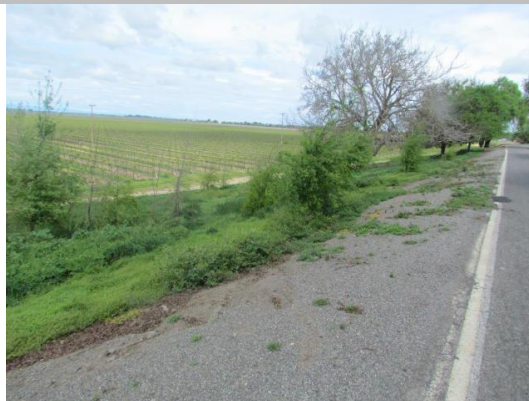
Photo 1 of 1 : SP\_2017\_RD0999\_236\_178\_20170314\_00123.jpg

LM Start	0.02	Rating **	M	Issue No.	178
LM End	0.05	Issue Type +	Ma	Location *	LS
Category	Earthen Levee			GPS Latitude/Longitude	
				Start	End
Item	Trim / Thin Trees			38.332946 °	38.333308 °
				-121.584502 °	-121.584494 °
DWR ID	DWR_RD0999_05_s _ 2015_178				
Comment Code					
T3 : Trim and thin trees to allow visibility of the ground and room to flood fight.					
Inspector Comment					
Remove trees under an inch in diameter on landward slope. Don't allow young trees to get established.

Looking at typical view of young oak trees on landward slope. (Spring 2015)

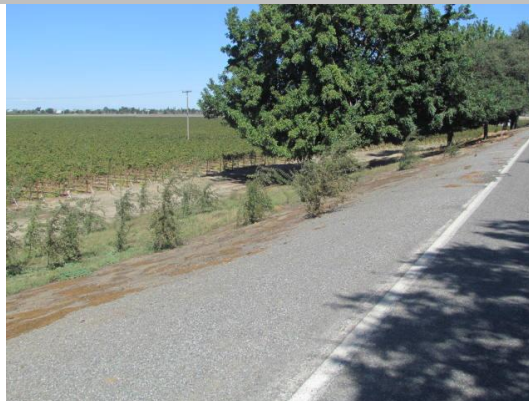
Photo 1 of 1 : SP\_2017\_RD0999\_236\_72\_20170314\_00060.jpg

LM Start	0.10	Rating **	A/W	Issue No.	72
LM End	0.10	Issue Type +	Ma	Location *	LS
Category	Earthen Levee			GPS Latitude/Longitude	
				Start	End
Item	Trim / Thin Trees			38.334093 °	38.334093 °
				-121.584339 °	-121.584339 °
DWR ID	DWR_RD0999_05_f_2013_72				
Comment Code					
T3 : Trim and thin trees to allow visibility of the ground and room to flood fight.					
Inspector Comment					
Remove small oak trees from landward slope before trees are established.

Looking west at small oak trees on landward slope.

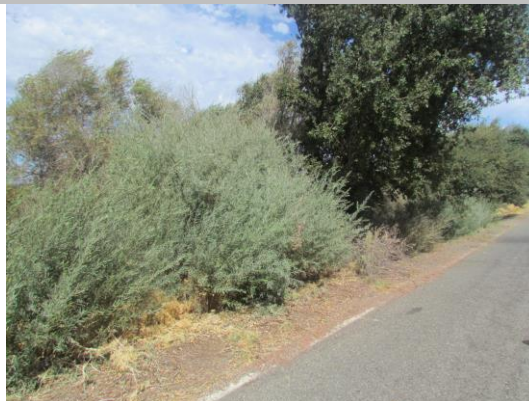
Photo 1 of 1 : SP\_2017\_RD0999\_236\_25\_20170314\_00024.jpg

LM Start	0.40	Rating **	U	Issue No.	25
LM End	0.44	Issue Type +	Ma	Location *	LS
Category	Earthen Levee			GPS Latitude/Longitude	
				Start	End
Item	Vegetation			38.338075 °	38.338688 °
				-121.582322 °	-121.582193 °
DWR ID	DWR_RD0999_05_s_2012_25				
Comment Code					
V2 : Remove the wild growth other than native grasses from the levee slopes.					
Inspector Comment					
Willows within vegetation area.

Looking southwest at dense vegetation (willows) on landward slope.

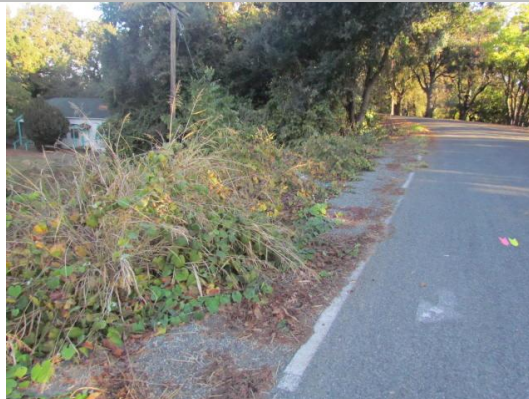
Photo 2 of 2 : SP\_2017\_RD0999\_236\_189\_20170314\_00130.jpg

LM Start	0.68	Rating **	U	Issue No.	189 (cont)	
LM End	0.68	Issue Type +	Ma	Location *	LS	
Category	Earthen Levee			GPS Latitude/Longitude		
				Start	End	
Item	Vegetation			38.342032 °	38.342032 °	
				-121.581372 °	-121.581372 °	
DWR ID	DWR_RD0999_05_f_2014_189					
Comment Code						
V2 : Remove the wild growth other than native grasses from the levee slopes.						
Inspector Comment						
Dense wild grapevines on landward slope.

Looking northwest at dense vegetation on landward slope. (Spring 2016)

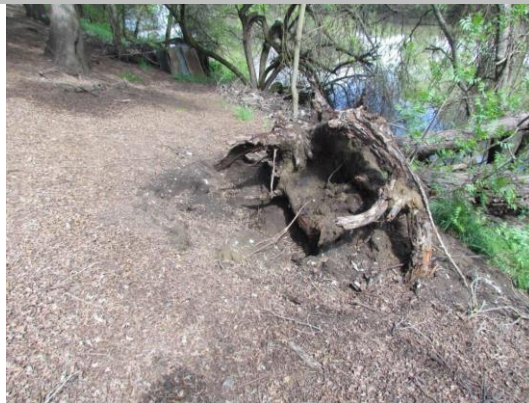
Photo 2 of 3 : SP\_2017\_RD0999\_236\_166\_20170324\_00235.jpg

LM Start	0.71	Rating **	U	Issue No.	166 (cont)	
LM End	0.71	Issue Type +	Ma	Location *	WS	
Category	Earthen Levee			GPS Latitude/Longitude		
				Start		End
Item	Encroachments			38.342483 °	38.342483 °	
				-121.581235 °	-121.581235 °	
DWR ID	DWR_RD0999_05_s_2017_166					
Comment Code						
TR : Tree or limb						
Inspector Comment						
Dead tree fallen on waterward slope. Left hole on waterward slope 10 to 12 inches.

Looking east at fallen tree on waterward slope.

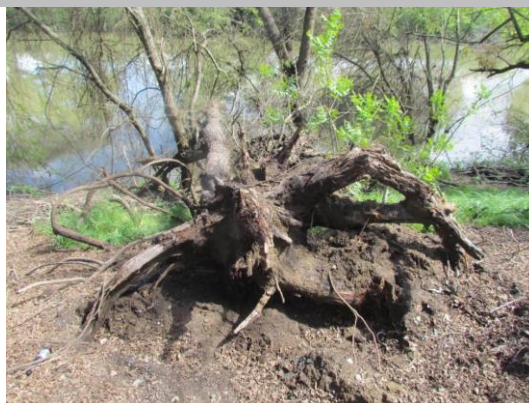
Photo 3 of 3 : SP\_2017\_RD0999\_236\_166\_20170324\_00237.jpg

Looking downstream at fallen tree on waterward slope.

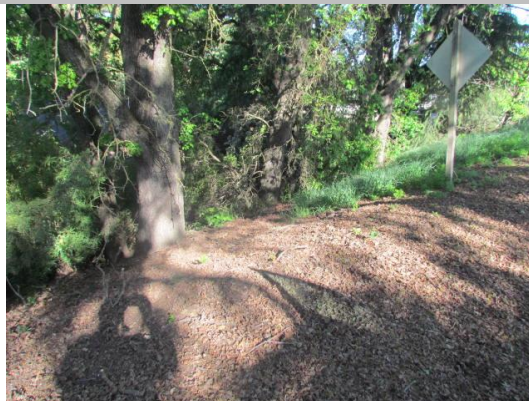
Photo 1 of 2 : SP\_2017\_RD0999\_236\_128\_20170314\_00085.jpg

LM Start	0.78	Rating **	M	Issue No.	128
LM End	0.78	Issue Type +	Ma	Location *	LS
Category	Earthen Levee			GPS Latitude/Longitude	
				Start	End
Item	Trim / Thin Trees			38.343495 °	38.343495 °
				-121.581282 °	-121.581282 °
DWR ID	DWR_RD0999_05_s_2012_128				
Comment Code					
T3 : Trim and thin trees to allow visibility of the ground and room to flood fight.					
Inspector Comment

Looking northwest at untrimmed trees on landward slope. (Spring 2015)

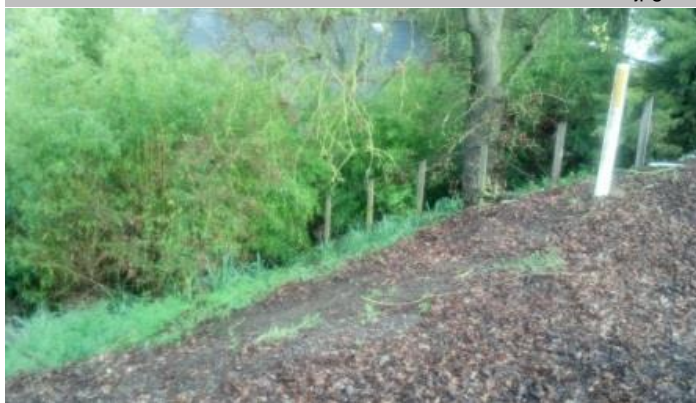
Photo 2 of 2 : SP\_2017\_RD0999\_236\_128\_20170314\_00086.jpg

Looking at dense trees on landside slope and toe.

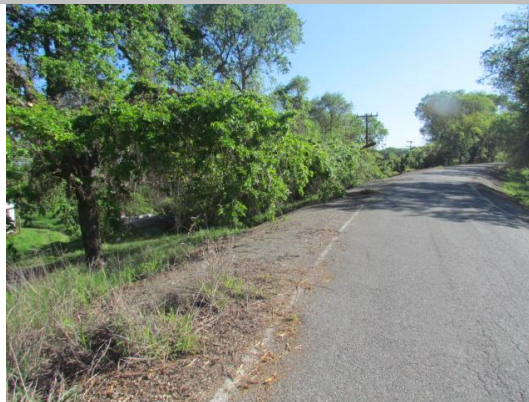
Photo 1 of 1 : SP\_2017\_RD0999\_236\_15\_20170314\_00016.jpg

LM Start	1.15	Rating **	U	Issue No.	15
LM End	1.19	Issue Type +	Ma	Location *	LS
Category	Earthen Levee			GPS Latitude/Longitude	
				Start	End
Item	Trim / Thin Trees			38.348237 °	38.348328 °
				-121.578440 °	-121.577735 °
DWR ID	DWR_RD0999_05_s_2012_15				
Comment Code					
T1 : Trim trees to at least five feet above ground level.					
Inspector Comment

Looking north at untrimmed trees on landward slope and toe.

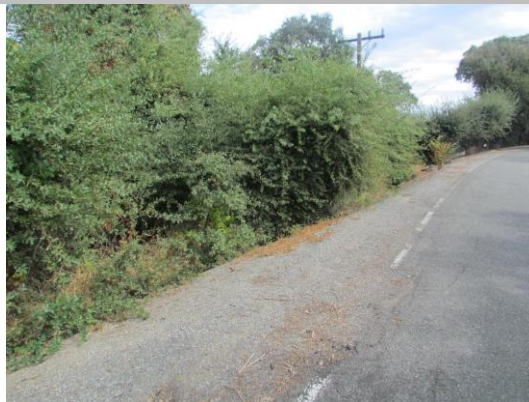
Photo 1 of 1 : SP\_2017\_RD0999\_236\_147\_20170314\_00097.jpg

LM Start	1.19	Rating **	U	Issue No.	147
LM End	1.19	Issue Type +	Ma	Location *	LS
Category	Earthen Levee			GPS Latitude/Longitude	
				Start	End
Item	Vegetation			38.348329 °	38.348329 °
				-121.577740 °	-121.577740 °
DWR ID	DWR_RD0999_05_f_2013_147				
Comment Code					
V2 : Remove the wild growth other than native grasses from the levee slopes.					
Inspector Comment					
Dense vegetation at landward toe.

Looking northwest at untrimmed trees on landward slope.

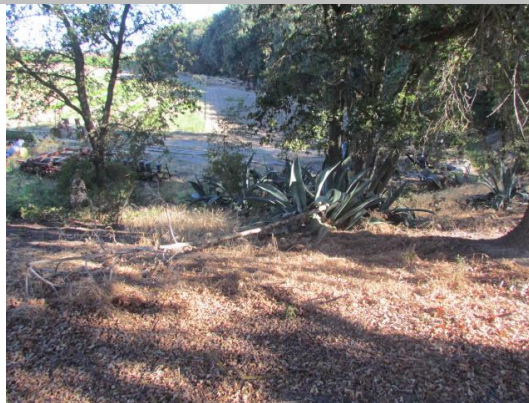
Photo 2 of 2 : SP\_2017\_RD0999\_236\_129\_20170314\_00088.jpg

LM Start	1.39	Rating **	M	Issue No.	129 (cont)	
LM End	1.39	Issue Type +	Ma	Location *	LS	
Category	Earthen Levee			GPS Latitude/Longitude		
				Start		End
Item	Vegetation			38.348100 °		38.348100 °
				-121.574075 °		-121.574075 °
DWR ID	DWR_RD0999_05_s_2012_129					
Comment Code						
V2 : Remove the wild growth other than native grasses from the levee slopes.						
Inspector Comment						
Berry vines and century plants on landside toe and slope.

Looking west at century plants on landward slope.

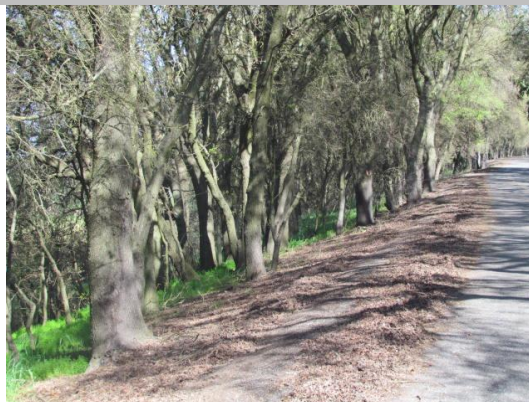
Photo 1 of 1 : SP\_2017\_RD0999\_236\_18\_20170314\_00020.jpg

LM Start	1.46	Rating **	U	Issue No.	18
LM End	1.83	Issue Type +	Ma	Location *	LS
Category	Earthen Levee			GPS Latitude/Longitude	
				Start	End
Item	Trim / Thin Trees			38.348670 °	38.353852 °
				-121.573320 °	-121.573570 °
DWR ID	DWR_RD0999_05_s_2012_18				
Comment Code					
T3 : Trim and thin trees to allow visibility of the ground and room to flood fight.					
Inspector Comment

Looking east at dense trees on landward slope.

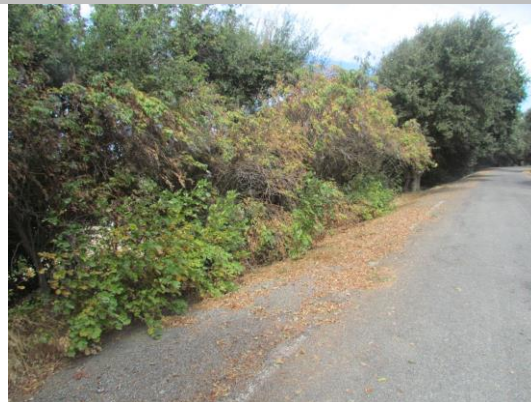
Photo 1 of 1 : SP\_2017\_RD0999\_236\_199\_20170314\_00138.jpg

LM Start	1.69	Rating **	U	Issue No.	199
LM End	1.69	Issue Type +	Ma	Location *	LS
Category	Earthen Levee			GPS Latitude/Longitude	
				Start	End
Item	Vegetation			38.351957 °	38.351957 °
				-121.574096 °	-121.574096 °
DWR ID	DWR_RD0999_05_f_2014_199				
Comment Code					
V2 : Remove the wild growth other than native grasses from the levee slopes.					
Inspector Comment					
Dense vegetation on landward slope.

Looking northwest at dense vegetation on landward slope.

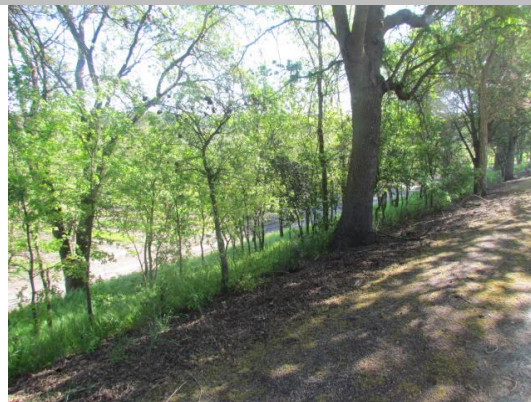
Photo 1 of 1 : SP\_2017\_RD0999\_236\_24\_20170314\_00023.jpg

LM Start	2.14	Rating **	M	Issue No.	24
LM End	2.16	Issue Type +	Ma	Location *	LS
Category	Earthen Levee			GPS Latitude/Longitude	
				Start	End
Item	Trim / Thin Trees			38.355402 °	38.355282 °
				-121.568893 °	-121.568547 °
DWR ID	DWR_RD0999_05_s _ 2012_24				
Comment Code					
T3 : Trim and thin trees to allow visibility of the ground and room to flood fight.					
Inspector Comment

Looking west at dense trees on landward slope. (Spring 2015)

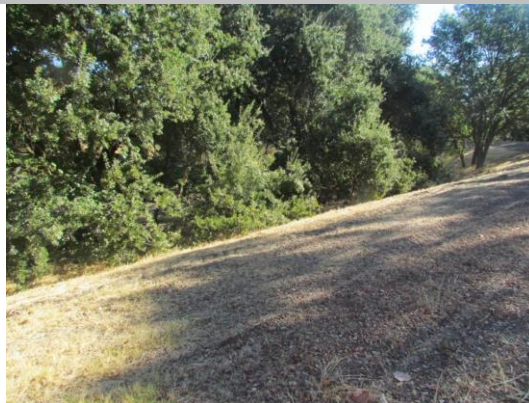
Photo 1 of 2 : SP\_2017\_RD0999\_236\_213\_20170314\_00150.jpg

LM Start	3.39	Rating **	U	Issue No.	213
LM End	3.39	Issue Type +	Ma	Location *	LS
Category	Earthen Levee			GPS Latitude/Longitude	
				Start	End
Item	Trim / Thin Trees			38.363906 °	38.363906 °
				-121.557220 °	-121.557220 °
DWR ID	DWR_RD0999_05_s_2016_213				
Comment Code					
T1 : Trim trees to at least five feet above ground level.					
Inspector Comment

Looking northwest at untrimmed trees on landward toe. (Fall 2016)

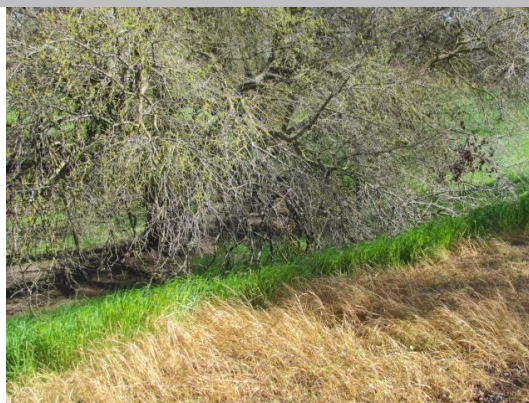
Photo 2 of 2 : SP\_2017\_RD0999\_236\_213\_20170314\_00151.jpg

Looking northwest at untrimmed trees at landward toe. (Spring 2016)

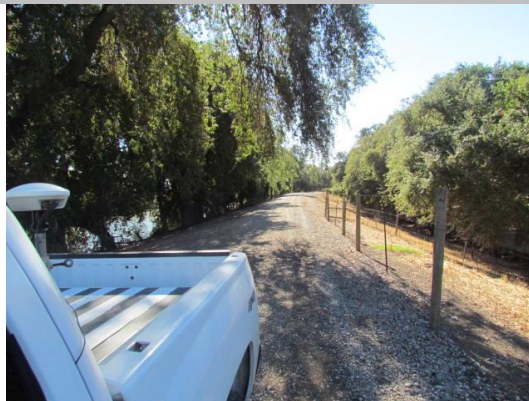
Photo 1 of 1 : SP\_2017\_RD0999\_236\_173\_20170314\_00116.jpg

LM Start	3.56	Rating **	M	Issue No.	173
LM End	3.56	Issue Type +	Ma	Location *	WS
Category	Earthen Levee			GPS Latitude/Longitude	
				Start	End
Item	Trim / Thin Trees			38.365882 °	38.365882 °
				-121.556762 °	-121.556762 °
DWR ID	DWR_RD0999_05_f_2015_173				
Comment Code					
T4 : Trim trees over roadway to at least 12 feet above ground level.					
Inspector Comment

Looking at the tree overhanging the levee crown.

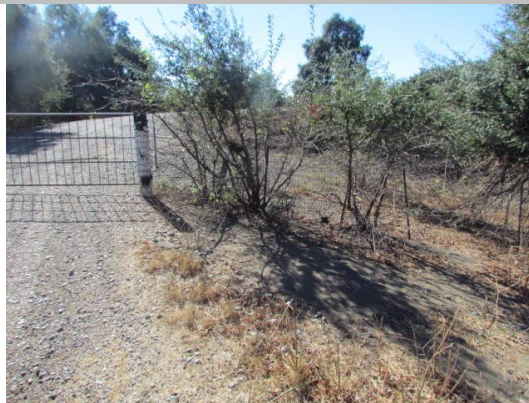
Photo 2 of 2 : SP\_2017\_RD0999\_236\_175\_20170314\_00119.jpg

LM Start	3.94	Rating **	U	Issue No.	175 (cont)	
LM End	3.94	Issue Type +	Ma	Location *	LS	
Category	Earthen Levee			GPS Latitude/Longitude		
				Start		End
Item	Trim / Thin Trees			38.368928 °		38.368928 °
				-121.552473 °		-121.552473 °
DWR ID	DWR_RD0999_05_f_2015_175					
Comment Code						
T2 : Thin trees to allow visibility of the ground and room to flood fight.						
Inspector Comment						
Thin or remove young tree from landward shoulder and slope.

Looking at young trees on waterward shoulder and slope. (Spring 2016)

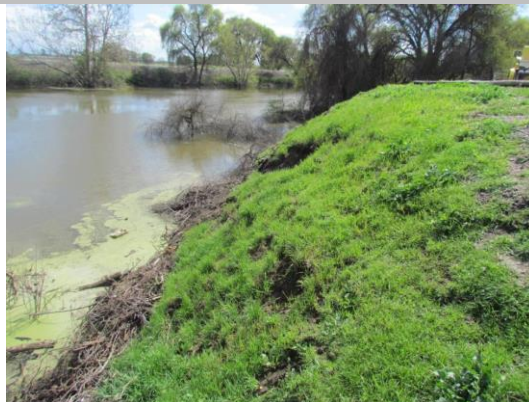
Photo 1 of 2 : SP\_2017\_RD0999\_236\_12\_20170324\_00242.jpg

LM Start	4.25	Rating **	U	Issue No.	12
LM End	4.25	Issue Type +	Ma	Location *	WS
Category	Earthen Levee			GPS Latitude/Longitude	
				Start	End
Item	Slope Stability			38.372872 °	38.372872 °
				-121.552185 °	-121.552185 °
DWR ID	DWR_RD0999_05_s_2017_12				
Comment Code					
S1 : Repair slope instability.					
Inspector Comment					
Large slough on waterward slope.

Looking downstream at finger erosion on downstream side of slough.

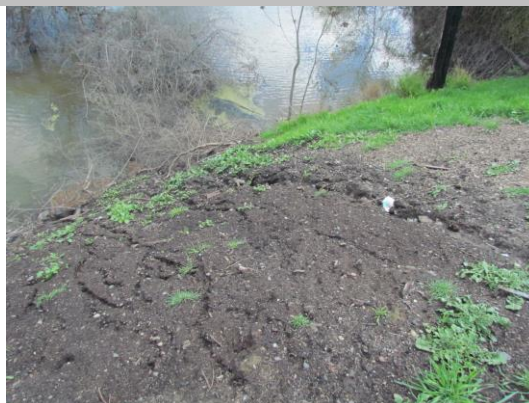
Photo 2 of 2 : SP\_2017\_RD0999\_236\_12\_20170324\_00243.jpg

LM Start	4.25	Rating **	U	Issue No.	12 (cont)	
LM End	4.25	Issue Type +	Ma	Location *	WS	
Category	Earthen Levee			GPS Latitude/Longitude		
				Start		End
Item	Slope Stability			38.372872 °		38.372872 °
				-121.552185 °		-121.552185 °
DWR ID	DWR_RD0999_05_s_2017_12					
Comment Code						
S1 : Repair slope instability.						
Inspector Comment						
Large slough on waterward slope.

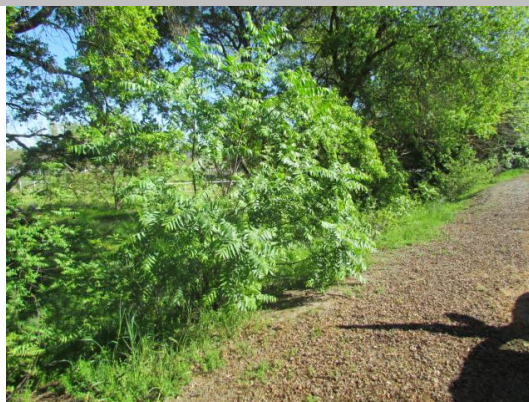
Photo 1 of 1 : SP\_2017\_RD0999\_236\_57\_20170314\_00050.jpg

LM Start	4.42	Rating **	A/W	Issue No.	57
LM End	4.46	Issue Type +	Ma	Location *	LS
Category	Earthen Levee			GPS Latitude/Longitude	
				Start	End
Item	Trim / Thin Trees			38.374866 °	38.375061 °
				-121.550491 °	-121.549800 °
DWR ID	DWR_RD0999_05_s_2012_57				
Comment Code					
T3 : Trim and thin trees to allow visibility of the ground and room to flood fight.					
Inspector Comment

Looking northwest at dense trees on landward slope. (Spring 2015)

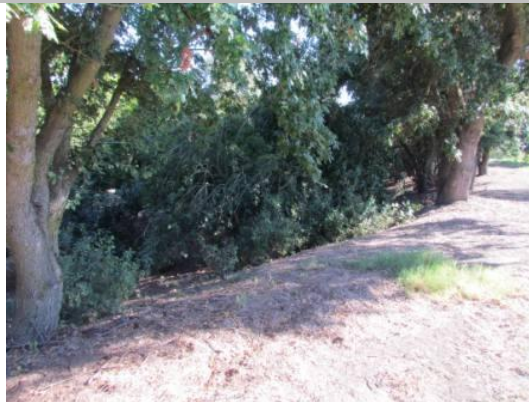
Photo 1 of 3 : SP\_2017\_RD0999\_236\_38\_20170314\_00029.jpg

LM Start	4.51	Rating **	A/W	Issue No.	38
LM End	4.64	Issue Type +	Ma	Location *	LS
Category	Earthen Levee			GPS Latitude/Longitude	
				Start	End
Item	Trim / Thin Trees			38.375055 °	38.375313 °
				-121.548792 °	-121.546438 °
DWR ID	DWR_RD0999_05_s_2012_38				
Comment Code					
T2 : Thin trees to allow visibility of the ground and room to flood fight.					
Inspector Comment

Looking northwest at dense trees on landside slope. (Spring 2011)

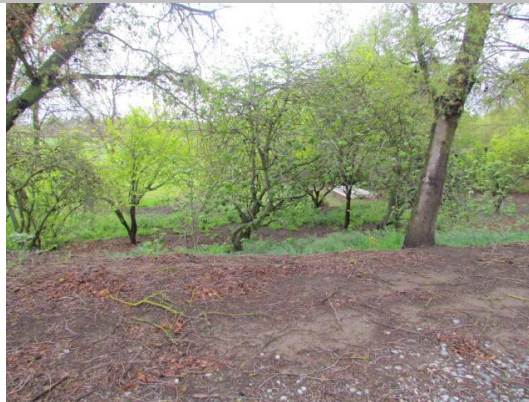
Photo 2 of 3 : SP\_2017\_RD0999\_236\_38\_20170314\_00030.jpg

Looking west at trimmed trees on landside slope. (Spring 2012)

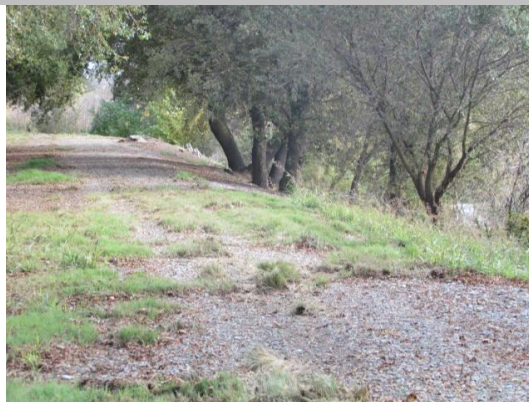
Photo 1 of 1 : SP\_2017\_RD0999\_236\_32\_20170314\_00028.jpg

LM Start	4.51	Rating **	M	Issue No.	32
LM End	4.85	Issue Type +	Ma	Location *	CR
Category	Earthen Levee			GPS Latitude/Longitude	
				Start	End
Item	Crown Surface / Depressions / Rutting			38.375084 °	38.377176 °
				-121.548750 °	-121.543571 °
DWR ID	DWR_RD0999_05_f_2012_32				
Comment Code					
C1 : Add appropriate material and re-grade the levee to bring the crown above the design elevation.					
Inspector Comment

Looking north at vegetation on levee crown.

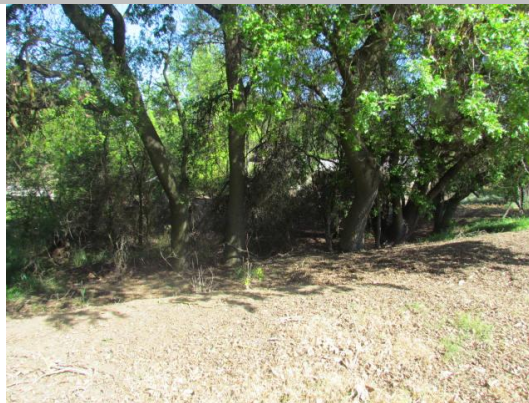
Photo 1 of 1 : SP\_2017\_RD0999\_236\_52\_20170314\_00046.jpg

LM Start	4.67	Rating **	A/W	Issue No.	52
LM End	4.67	Issue Type +	Ma	Location *	LS
Category	Earthen Levee			GPS Latitude/Longitude	
				Start	End
Item	Trim / Thin Trees			38.375478 °	38.375478 °
				-121.545852 °	-121.545852 °
DWR ID	DWR_RD0999_05_s_2012_52				
Comment Code					
T1 : Trim trees to at least five feet above ground level.					
Inspector Comment

Looking west at untrimmed trees on landward toe. (Spring 2015)

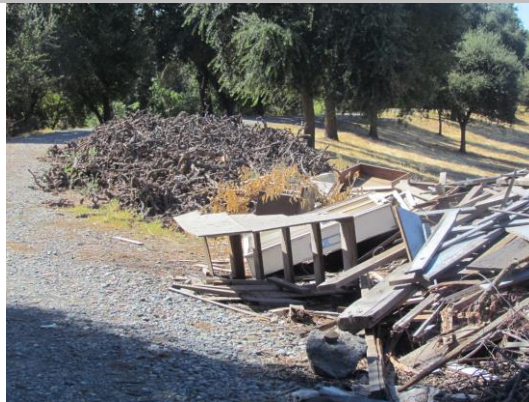
Photo 1 of 2 : SP\_2017\_RD0999\_236\_65\_20170314\_00052.jpg

LM Start	5.07	Rating **	A/W	Issue No.	65
LM End	5.07	Issue Type +	Ma	Location *	LS
Category	Earthen Levee			GPS Latitude/Longitude	
				Start	End
Item	Encroachments			38.379711 °	38.379711 °
				-121.541070 °	-121.541070 °
DWR ID	DWR_RD0999_05_s _ 2012_65				
Comment Code					
PR : Prunings					
Inspector Comment					
Prunings and garbage pile on landside shoulder and slope.

Looking south at prunings and garbage on landward shoulder and slope.  
(Fall 2016)

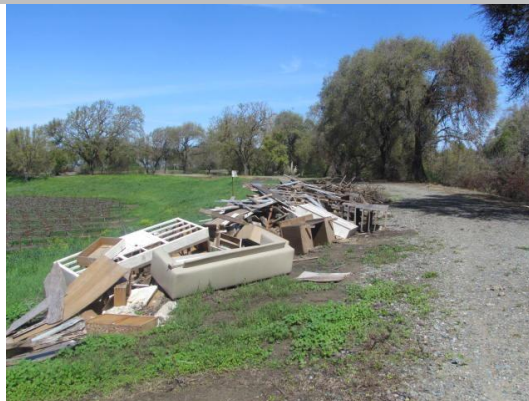
Photo 2 of 2 : SP\_2017\_RD0999\_236\_65\_20170314\_00053.jpg

LM Start	5.07	Rating **	A/W	Issue No.	65 (cont)	
LM End	5.07	Issue Type +	Ma	Location *	LS	
Category	Earthen Levee			GPS Latitude/Longitude		
				Start	End	
Item	Encroachments			38.379711 °	38.379711 °	
				-121.541070 °	-121.541070 °	
DWR ID	DWR_RD0999_05_s_2012_65					
Comment Code						
PR : Prunings						
Inspector Comment						
Prunings and garbage pile on landside shoulder and slope.

Looking east at garbage and prunings on landward shoulder. (Spring 2016)

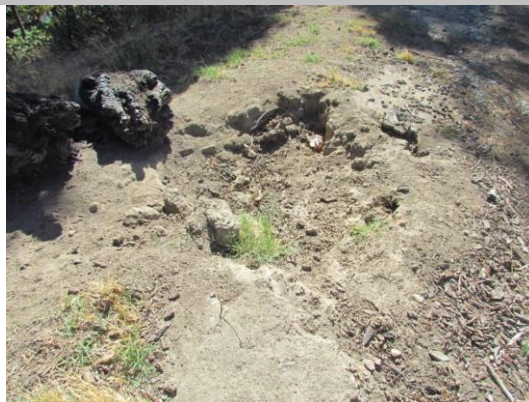
Photo 1 of 3 : SP\_2017\_RD0999\_236\_176\_20170314\_00120.jpg

LM Start	5.12	Rating **	U	Issue No.	176
LM End	5.12	Issue Type +	Ma	Location *	WS
Category	Earthen Levee			GPS Latitude/Longitude	
				Start	End
Item	Slope Stability			38.380420 °	38.380420 °
				-121.541102 °	-121.541102 °
DWR ID	DWR_RD0999_05_f_2015_176				
Comment Code					
S1 : Repair slope instability.					
Inspector Comment					
Large hole on waterward shoulder caused by fallen tree.

Looking at hole from falling tree on waterward shoulder. (Fall 2016)

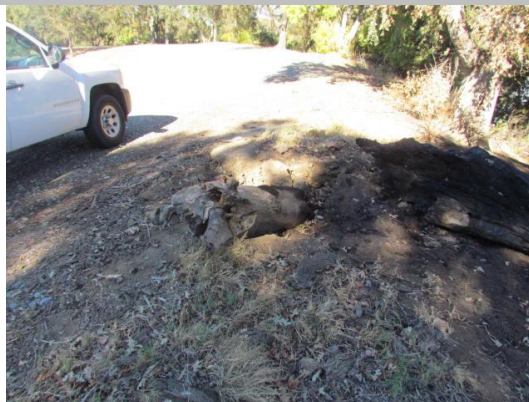
Photo 2 of 3 : SP\_2017\_RD0999\_236\_176\_20170314\_00121.jpg

Looking at hole on waterward shoulder caused by fallen tree.

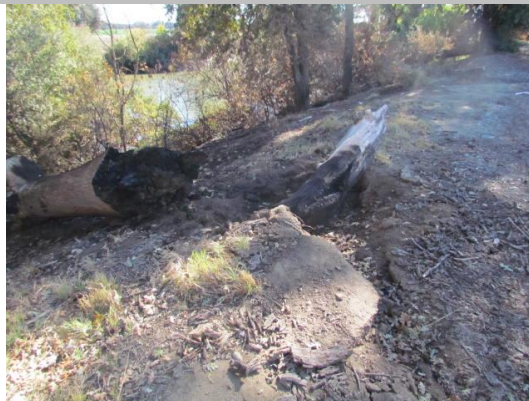
Photo 3 of 3 : SP\_2017\_RD0999\_236\_176\_20170314\_00122.jpg

LM Start	5.12	Rating **	U	Issue No.	176 (cont)	
LM End	5.12	Issue Type +	Ma	Location *	WS	
Category	Earthen Levee			GPS Latitude/Longitude		
				Start		End
Item	Slope Stability			38.380420 °		38.380420 °
				-121.541102 °		-121.541102 °
DWR ID	DWR_RD0999_05_f_2015_176					
Comment Code						
S1 : Repair slope instability.						
Inspector Comment						
Large hole on waterward shoulder caused by fallen tree.

Looking at fallen tree and hole on waterward slope and shoulder.

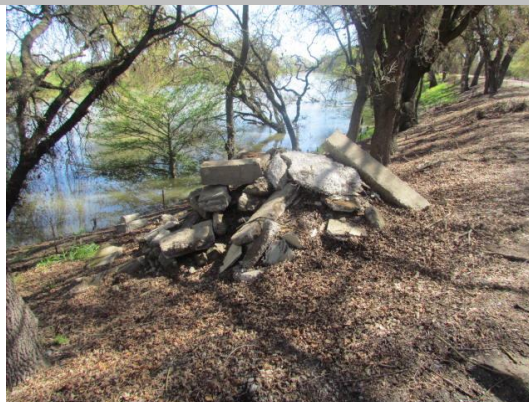
Photo 1 of 1 : SP\_2017\_RD0999\_236\_215\_20170314\_00153.jpg

LM Start	5.41	Rating **	M	Issue No.	215
LM End	5.41	Issue Type +	Ma	Location *	WS
Category	Earthen Levee			GPS Latitude/Longitude	
				Start	End
Item	Encroachments			38.381763 °	38.381763 °
				-121.545904 °	-121.545904 °
DWR ID	DWR_RD0999_05_s_2016_215				
Comment Code					
MA : Material					
Inspector Comment					
Concrete piled on waterward shoulder and slope

Looking southeast at concrete rubble piled on waterward shoulder.

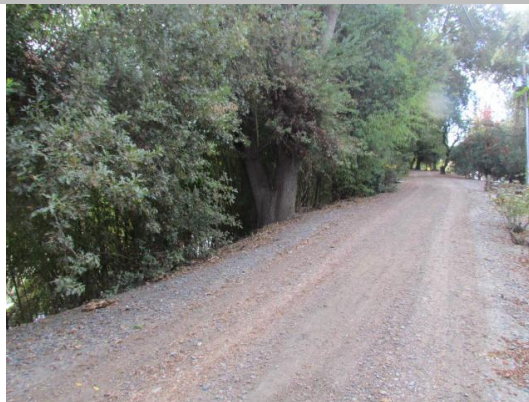
Photo 1 of 1 : SP\_2017\_RD0999\_236\_67\_20170314\_00056.jpg

LM Start	5.47	Rating **	U	Issue No.	67
LM End	5.52	Issue Type +	Ma	Location *	WS
Category	Earthen Levee			GPS Latitude/Longitude	
				Start	End
Item	Trim / Thin Trees			38.382454 °	38.383141 °
				-121.546579 °	-121.546870 °
DWR ID	DWR_RD0999_05_s_2012_67				
Comment Code					
T1 : Trim trees to at least five feet above ground level.					
Inspector Comment

Looking north at dense vegetation on landward shoulder and slope.

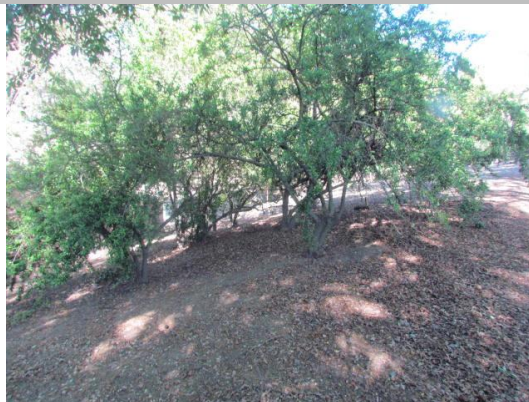
Photo 1 of 1 : SP\_2017\_RD0999\_236\_68\_20170314\_00057.jpg

LM Start	5.48	Rating **	M	Issue No.	68
LM End	5.48	Issue Type +	Ma	Location *	LS
Category	Earthen Levee			GPS Latitude/Longitude	
				Start	End
Item	Trim / Thin Trees			38.382553 °	38.382553 °
				-121.546651 °	-121.546651 °
DWR ID	DWR_RD0999_05_s_2012_68				
Comment Code					
T1 : Trim trees to at least five feet above ground level.					
Inspector Comment

Looking northeast at untrimmed trees on landward slope. (Spring 2015)

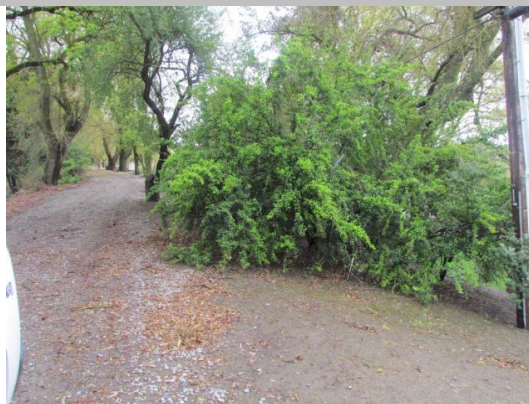
Photo 1 of 1 : SP\_2017\_RD0999\_236\_70\_20170314\_00058.jpg

LM Start	5.49	Rating **	M	Issue No.	70
LM End	5.49	Issue Type +	Ma	Location *	LS
Category	Earthen Levee			GPS Latitude/Longitude	
				Start	End
Item	Trim / Thin Trees			38.382698 °	38.382698 °
				-121.546711 °	-121.546711 °
DWR ID	DWR_RD0999_05_s_2012_70				
Comment Code					
T3 : Trim and thin trees to allow visibility of the ground and room to flood fight.					
Inspector Comment

Looking southwest at untrimmed tree on waterside shoulder and slope.

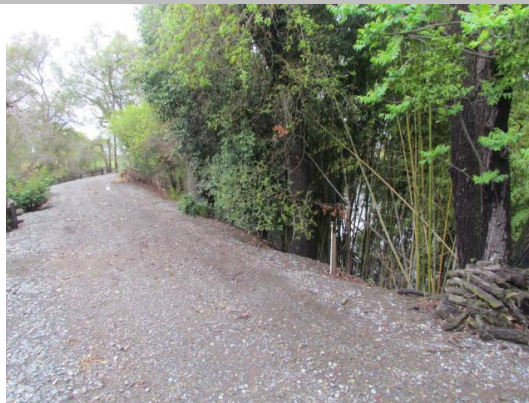
Photo 1 of 1 : SP\_2017\_RD0999\_236\_71\_20170314\_00059.jpg

LM Start	5.50	Rating **	U	Issue No.	71
LM End	5.55	Issue Type +	Ma	Location *	WS
Category	Earthen Levee			GPS Latitude/Longitude	
				Start	End
Item	Vegetation			38.382790 °	38.383548 °
				-121.546754 °	-121.546728 °
DWR ID	DWR_RD0999_05_s_2012_71				
Comment Code					
V2 : Remove the wild growth other than native grasses from the levee slopes.					
Inspector Comment

Looking northeast at dense vegetation on waterside slope.

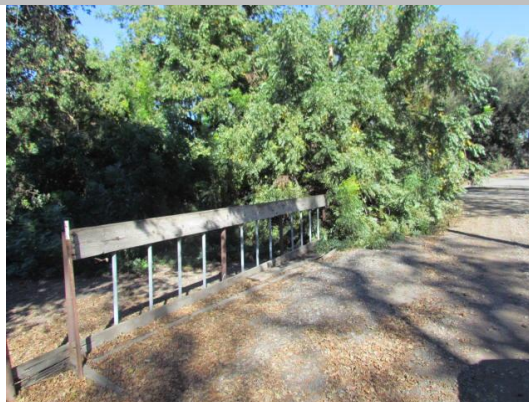
Photo 1 of 1 : SP\_2017\_RD0999\_236\_203\_20170314\_00143.jpg

LM Start	5.56	Rating **	A/W	Issue No.	203
LM End	5.61	Issue Type +	Ma	Location *	LS
Category	Earthen Levee			GPS Latitude/Longitude	
				Start	End
Item	Trim / Thin Trees			38.383740 °	38.384218 °
				-121.546628 °	-121.546095 °
DWR ID	DWR_RD0999_05_f_2014_203				
Comment Code					
T1 : Trim trees to at least five feet above ground level.					
Inspector Comment

Looking at untrimmed trees on landward slope and toe.

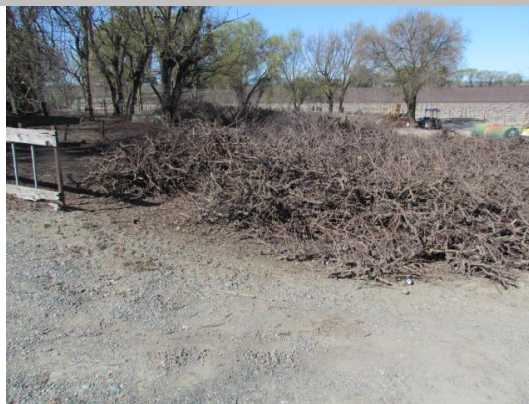
Photo 1 of 1 : SP\_2017\_RD0999\_236\_192\_20170314\_00132.jpg

LM Start	5.58	Rating **	A/W	Issue No.	192
LM End	5.58	Issue Type +	Ma	Location *	LS
Category	Earthen Levee			GPS Latitude/Longitude	
				Start	End
Item	Encroachments			38.383978 °	38.383978 °
				-121.546435 °	-121.546435 °
DWR ID	DWR_RD0999_05_s_2014_192				
Comment Code					
PR : Prunings					
Inspector Comment					
Landowner pile prunings on landside slope.

Looking west at prunings on landward slope and toe.

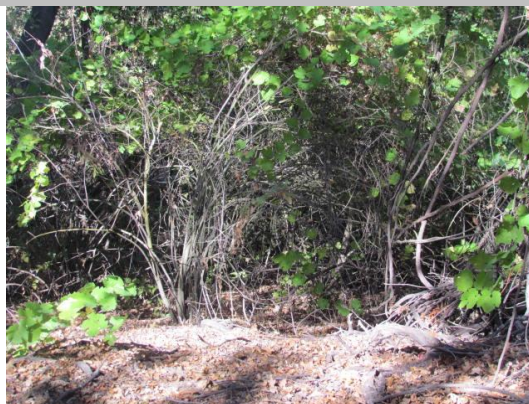
Photo 1 of 2 : SP\_2017\_RD0999\_236\_48\_20170314\_00042.jpg

LM Start	5.80	Rating **	A/W	Issue No.	48
LM End	5.84	Issue Type +	Ma	Location *	LS
Category	Earthen Levee			GPS Latitude/Longitude	
				Start	End
Item	Vegetation			38.384718 °	38.384930 °
				-121.542590 °	-121.541883 °
DWR ID	DWR_RD0999_05_s_2012_48				
Comment Code					
V2 : Remove the wild growth other than native grasses from the levee slopes.					
Inspector Comment					
Dense vegetation at landward slope and toe.

Looking west at dense vegetation on landward slope and toe. Fall 2015

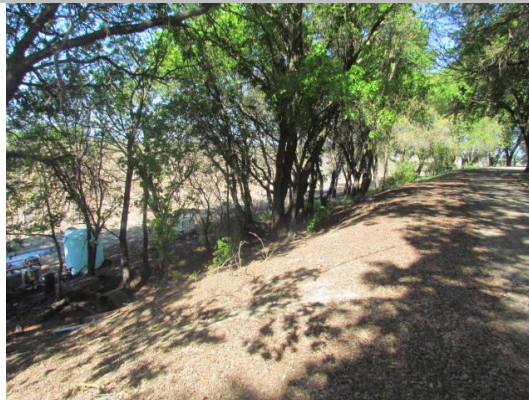
Photo 1 of 1 : SP\_2017\_RD0999\_236\_60\_20170314\_00051.jpg

LM Start	6.13	Rating **	M	Issue No.	60
LM End	6.13	Issue Type +	Ma	Location *	LS
Category	Earthen Levee			GPS Latitude/Longitude	
				Start	End
Item	Trim / Thin Trees			38.388225 °	38.388225 °
				-121.542697 °	-121.542697 °
DWR ID	DWR_RD0999_05_s _ 2012_60				
Comment Code					
T3 : Trim and thin trees to allow visibility of the ground and room to flood fight.					
Inspector Comment

Looking north at dense trees on landward slope. (Spring 2015)

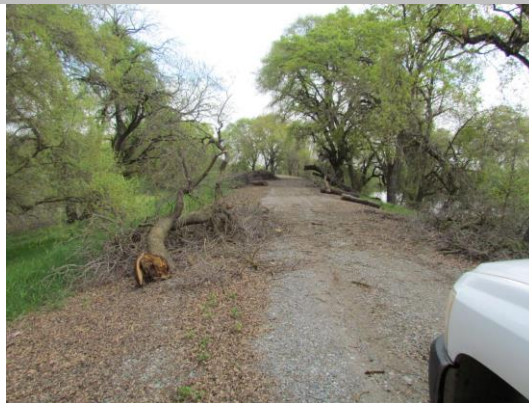
Photo 1 of 2 : SP\_2017\_RD0999\_236\_92\_20170324\_00248.jpg

LM Start	6.43	Rating **	U	Issue No.	92
LM End	6.48	Issue Type +	Ma	Location *	LS
Category	Earthen Levee			GPS Latitude/Longitude	
				Start	End
Item	Encroachments			38.391355 °	38.391776 °
				-121.540113 °	-121.539295 °
DWR ID	DWR_RD0999_05_s_2012_92				
Comment Code					
PR : Prunings					
Inspector Comment					
Large pruning piles and fallen tree on waterward and landward shoulder and slope.

Looking east at fallen tree and pruning on landward and waterward shoulder and slope.

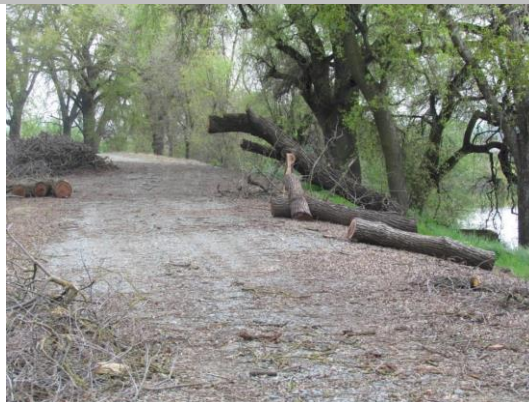
Photo 2 of 2 : SP\_2017\_RD0999\_236\_92\_20170324\_00249.jpg

LM Start	<b>6.43</b>	Rating **	U	Issue No.	<b>92 (cont)</b>
LM End	<b>6.48</b>	Issue Type +	Ma	Location *	LS

Looking east at tree branches and limbs on waterward and landward shoulder and slope.

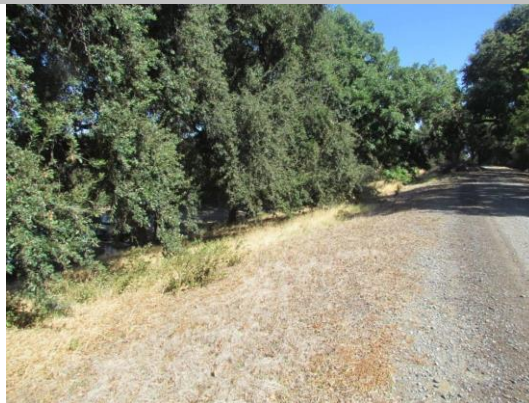
Photo 1 of 1 : SP\_2017\_RD0999\_236\_181\_20170314\_00124.jpg

LM Start	6.44	Rating **	U	Issue No.	181
LM End	6.44	Issue Type +	Ma	Location *	LS
Category	Earthen Levee			GPS Latitude/Longitude	
				Start	End
Item	Trim / Thin Trees			38.391502 °	38.391502 °
				-121.539897 °	-121.539897 °
DWR ID	DWR_RD0999_05_f_2015_181				
Comment Code					
T1 : Trim trees to at least five feet above ground level.					
Inspector Comment					
Untrimmed trees on landward slope and toe.

Looking northwest at untrimmed trees on landward slope and toe.

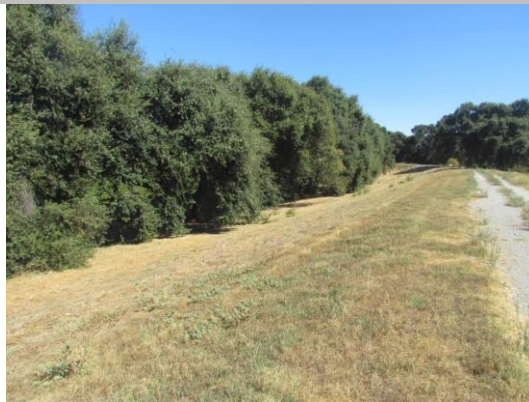
Photo 1 of 1 : SP\_2017\_RD0999\_236\_204\_20170314\_00144.jpg

LM Start	6.85	Rating **	U	Issue No.	204
LM End	7.49	Issue Type +	Ma	Location *	LS
Category	Earthen Levee			GPS Latitude/Longitude	
				Start	End
Item	Trim / Thin Trees			38.396379 °	38.403600 °
				-121.537814 °	-121.540311 °
DWR ID	DWR_RD0999_05_f _ 2014_204				
Comment Code					
T1 : Trim trees to at least five feet above ground level.					
Inspector Comment					
Trees at landward toe blocking visibility.

Looking northwest at dense trees at landward toe.

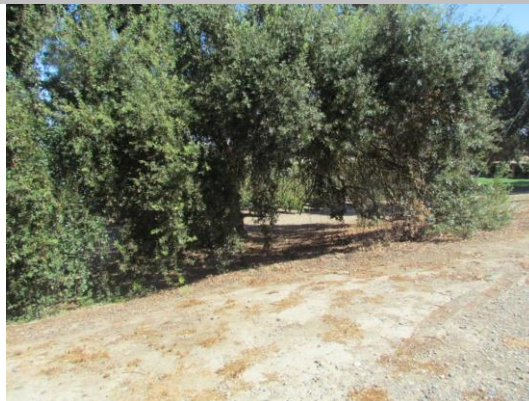
Photo 1 of 1 : SP\_2017\_RD0999\_236\_206\_20170314\_00145.jpg

LM Start	8.22	Rating **	U	Issue No.	206
LM End	8.22	Issue Type +	Ma	Location *	LS
Category	Earthen Levee			GPS Latitude/Longitude	
				Start	End
Item	Trim / Thin Trees			38.409679 °	38.409679 °
				-121.537920 °	-121.537920 °
DWR ID	DWR_RD0999_05_f_2014_206				
Comment Code					
T1 : Trim trees to at least five feet above ground level.					
Inspector Comment

Looking west at untrimmed trees on landward toe.

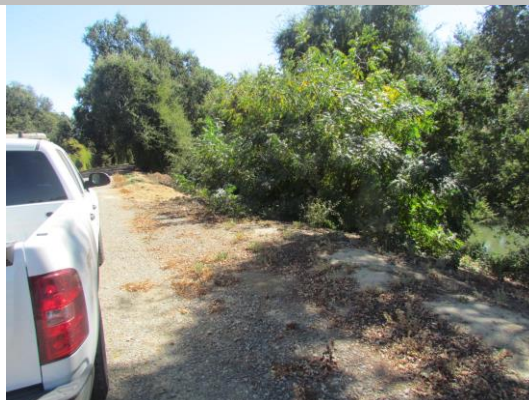
Photo 1 of 1 : SP\_2017\_RD0999\_236\_118\_20170314\_00082.jpg

LM Start	8.22	Rating **	U	Issue No.	118
LM End	8.22	Issue Type +	Ma	Location *	WS
Category	Earthen Levee			GPS Latitude/Longitude	
				Start	End
Item	Trim / Thin Trees			38.409665 °	38.409665 °
				-121.537898 °	-121.537898 °
DWR ID	DWR_RD0999_05_s_2012_118				
Comment Code					
T1 : Trim trees to at least five feet above ground level.					
Inspector Comment

Looking northeast at untrimmed trees on watward slope.

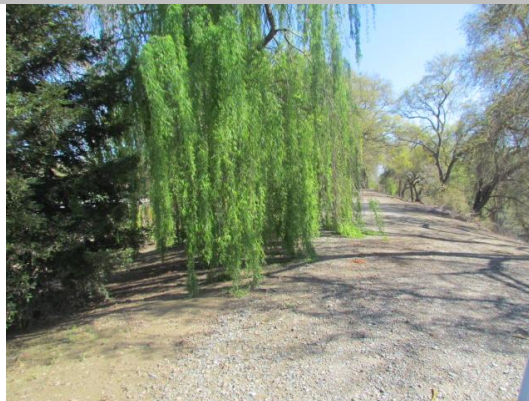
Photo 1 of 1 : SP\_2017\_RD0999\_236\_194\_20170314\_00134.jpg

LM Start	8.29	Rating **	U	Issue No.	194
LM End	8.29	Issue Type +	Ma	Location *	LS
Category	Earthen Levee			GPS Latitude/Longitude	
				Start	End
Item	Trim / Thin Trees			38.409319 °	38.409319 °
				-121.536678 °	-121.536678 °
DWR ID	DWR_RD0999_05_s _ 2014_194				
Comment Code					
T1 : Trim trees to at least five feet above ground level.					
Inspector Comment					
Trees blocking view of landward slope.

Looking southeast at untrimmed trees on landward slope.
