**Flood Control Project Maintenance  
Levee Inspections**

## Maintenance Issue Types Only, Levee Inspection Report By Mile - Spring 2018

### Reclamation District No. 0999 Netherlands

Waterway	Bank	Unit Miles	Inspection Start/End	Inspector
Unit No. 01 Yolo Bypass	Left	15.41	05/08/2018 05/08/2018	Dave Torres

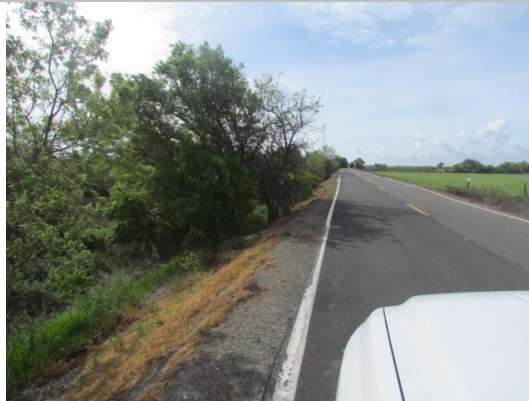
Photo 2 of 2 : SP\_2018\_RD0999\_232\_30\_20180301\_00025.jpg

LM Start	1.79	Rating **	M	Issue No.	30 (cont)	
LM End	2.04	Issue Type +	Ma	Location *	LS	
Category	Earthen Levee			GPS Latitude/Longitude		
				Start		End
Item	Trim / Thin Trees			38.479165 °		38.475463 °
				-121.580640 °		-121.580722 °
DWR ID	DWR_RD0999_01_s_2012_30					
Comment Code						
T1 : Trim trees to at least five feet above ground level.						
Inspector Comment

Looking southeast at dense trees on landward slope. (Spring 2016)

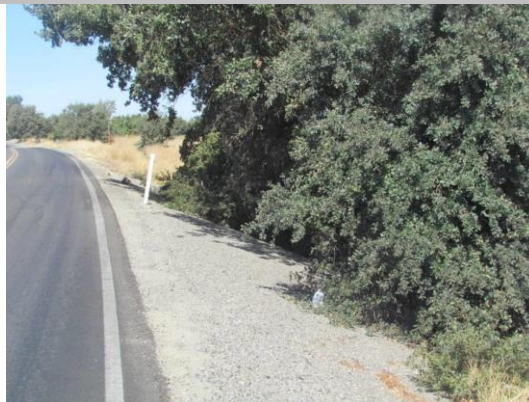
Photo 1 of 2 : SP\_2018\_RD0999\_232\_31\_20180301\_00026.jpg

LM Start	2.13	Rating **	U	Issue No.	31
LM End	2.13	Issue Type +	Ma	Location *	LS
Category	Earthen Levee			GPS Latitude/Longitude	
				Start	End
Item	Trim / Thin Trees			38.474200 °	38.474200 °
				-121.580480 °	-121.580480 °
DWR ID	DWR_RD0999_01_s_2012_31				
Comment Code					
T1 : Trim trees to at least five feet above ground level.					
Inspector Comment

Looking north at untrimmed trees on landward slope. ( Fall 2016)

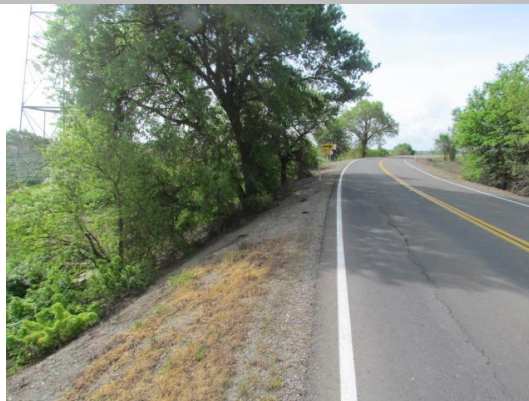
Photo 2 of 2 : SP\_2018\_RD0999\_232\_31\_20180301\_00027.jpg

LM Start	2.13	Rating **	U	Issue No.	31 (cont)	
LM End	2.13	Issue Type +	Ma	Location *	LS	
Category	Earthen Levee			GPS Latitude/Longitude		
				Start		End
Item	Trim / Thin Trees			38.474200 °		38.474200 °
				-121.580480 °		-121.580480 °
DWR ID	DWR_RD0999_01_s_2012_31					
Comment Code						
T1 : Trim trees to at least five feet above ground level.						
Inspector Comment

Looking southeast at untrimmed trees on landward slope. (Spring 2016)

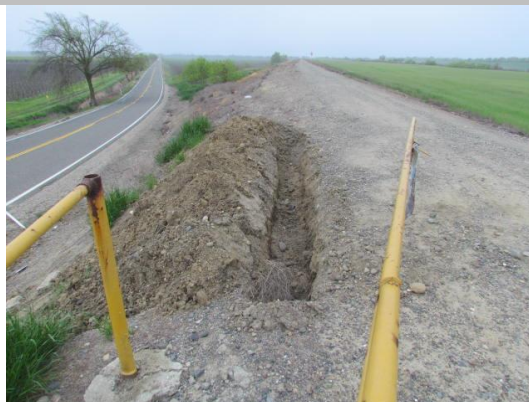
Photo 2 of 4 : SP\_2018\_RD0999\_232\_40\_20180301\_00034.jpg

LM Start	<b>2.51</b>	Rating **	M	Issue No.	<b>40 (cont)</b>
LM End	<b>2.51</b>	Issue Type +	Ma	Location *	LS

Looking south at excavation on landside shoulder.

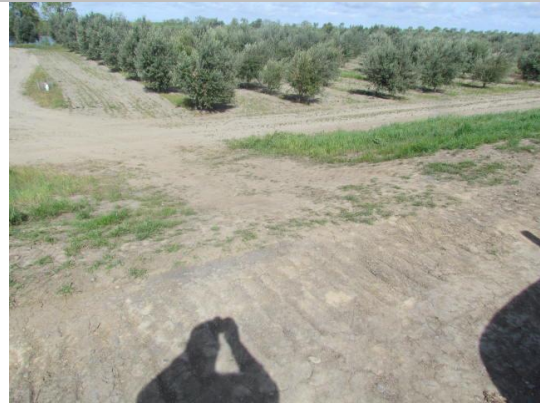
Photo 2 of 2 : SP\_2018\_RD0999\_232\_27\_20180301\_00021.jpg

LM Start	4.31	Rating **	M	Issue No.	27
LM End	4.31	Issue Type +	Ma	Location *	WS
Category	Earthen Levee			GPS Latitude/Longitude	
				Start	End
Item	Slope Stability			38.444560 °	38.444560 °
				-121.594440 °	-121.594440 °
DWR ID	DWR_RD0999_01_f_2012_27				
Comment Code					
S3 : Repair the levee slope damaged by vehicle traffic and prevent access where possible.					
Inspector Comment					
Local farmer causing slope damage by driving equipment and trucks on slope.

Looking at slope damage cause by vehicle traffic on waterward slope.  
(Fall 2016)

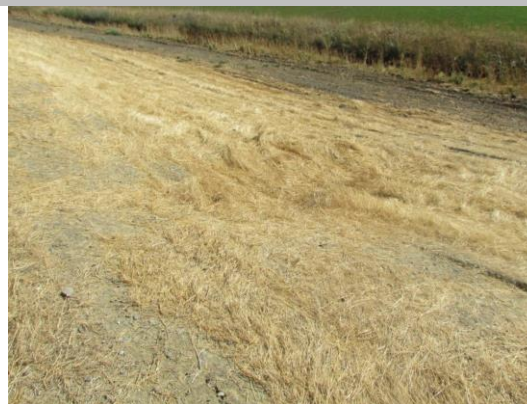
Photo 1 of 2 : SP\_2018\_RD0999\_232\_58\_20180301\_00057.jpg

LM Start	7.61	Rating **	M	Issue No.	58
LM End	7.61	Issue Type +	Ma	Location *	LS
Category	Earthen Levee			GPS Latitude/Longitude	
				Start	End
Item	Erosion / Bank Caving			38.399600 °	38.399600 °
				-121.615224 °	-121.615224 °
DWR ID	DWR_RD0999_01_f_2016_58				
Comment Code					
Inspector Comment					
Depression 10' by 20' on landward slope.

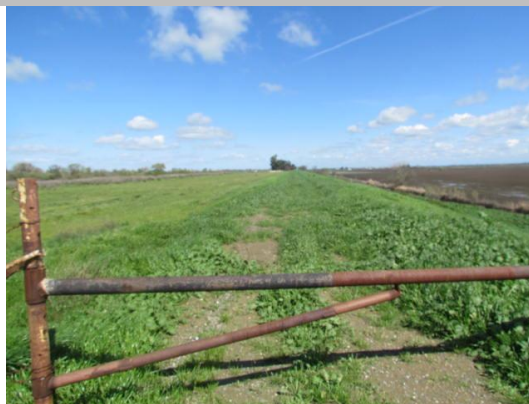
Photo 1 of 1 : SP\_2018\_RD0999\_232\_43\_20180301\_00040.jpg

LM Start	11.30	Rating **	M	Issue No.	43
LM End	11.59	Issue Type +	Ma	Location *	CR
Category	Earthen Levee			GPS Latitude/Longitude	
				Start	End
Item	Crown Surface / Depressions / Rutting			38.349380 °	38.345353 °
				-121.638540 °	-121.640432 °
DWR ID	DWR_RD0999_01_s_2012_43				
Comment Code					
C3 : Add appropriate gravel or road base. Grade and compact.					
Inspector Comment

Looking north at growth on levee crown.

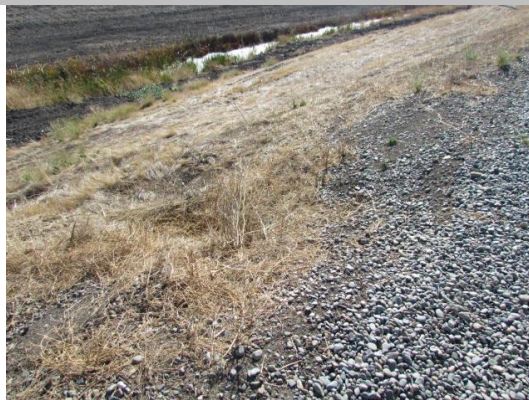
Photo 1 of 4 : SP\_2018\_RD0999\_232\_49\_20180301\_00044.jpg

LM Start	14.04	Rating **	M	Issue No.	49
LM End	14.04	Issue Type +	Ma	Location *	LS
Category	Earthen Levee			GPS Latitude/Longitude	
				Start	End
Item	Erosion / Bank Caving			38.310347 °	38.310347 °
				-121.644955 °	-121.644955 °
DWR ID	DWR_RD0999_01_f_2012_49				
Comment Code					
E1 : Note and monitor erosion site.					
Inspector Comment					
Caving, 4' x 10', on landside slope.

Looking southeast at caving on landward slope fall 2015.

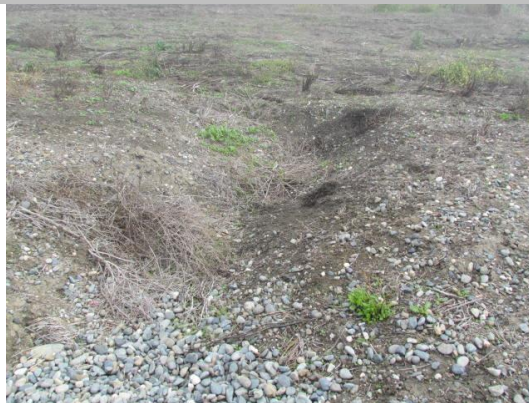
Photo 3 of 4 : SP\_2018\_RD0999\_232\_49\_20180301\_00046.jpg

LM Start	14.04	Rating **	M	Issue No.	49 (cont)	
LM End	14.04	Issue Type +	Ma	Location *	LS	
Category	Earthen Levee			GPS Latitude/Longitude		
				Start		End
Item	Erosion / Bank Caving			38.310347 °		38.310347 °
				-121.644955 °		-121.644955 °
DWR ID	DWR_RD0999_01_f_2012_49					
Comment Code						
E1 : Note and monitor erosion site.						
Inspector Comment						
Caving, 4' x 10', on landside slope.

Looking east caving on landside slope.

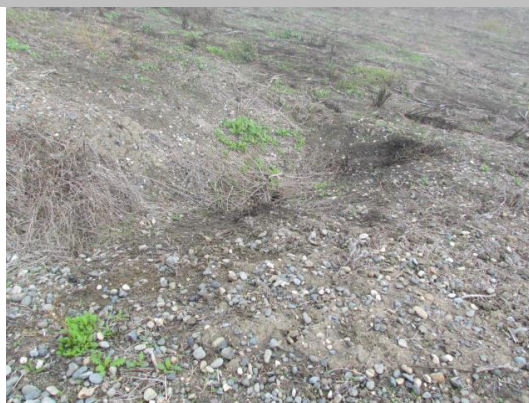
Photo 4 of 4 : SP\_2018\_RD0999\_232\_49\_20180301\_00047.jpg

LM Start	<b>14.04</b>	Rating **	M	Issue No.	<b>49 (cont)</b>
LM End	<b>14.04</b>	Issue Type +	Ma	Location *	LS

Looking southeast at caving on landside slope.

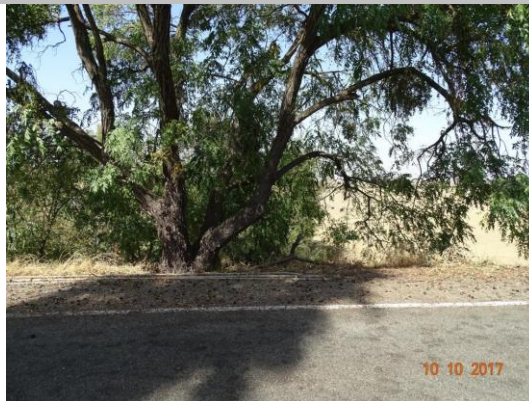
Photo 1 of 1 : SP\_2018\_RD0999\_233\_21\_20180301\_00018.jpg

LM Start	0.06	Rating **	M	Issue No.	21
LM End	0.06	Issue Type +	Ma	Location *	LS
Category	Earthen Levee			GPS Latitude/Longitude	
				Start	End
Item	Trim / Thin Trees			38.290434 °	38.290434 °
				-121.643873 °	-121.643873 °
DWR ID	DWR_RD0999_02_f_2017_21				
Comment Code					
T1 : Trim trees to at least five feet above ground level.					
Inspector Comment

View of landside slope looking north.

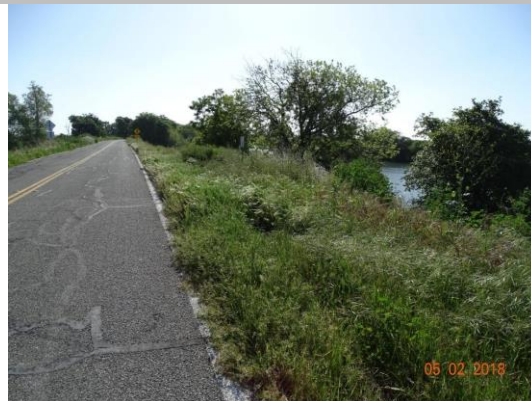
Photo 1 of 1 : SP\_2018\_RD0999\_233\_34\_20180507\_00054.jpg

LM Start	0.08	Rating **	U	Issue No.	34
LM End	0.15	Issue Type +	Ma	Location *	WS
Category	Earthen Levee			GPS Latitude/Longitude	
				Start	End
Item	Vegetation			38.290543 °	38.290753 °
				-121.643501 °	-121.642288 °
DWR ID	DWR_RD0999_02_s_2018_34				
Comment Code					
V1 : Control annual grass and weeds on the levee slopes and easements.					
Inspector Comment

Vegetation waterside looking east.

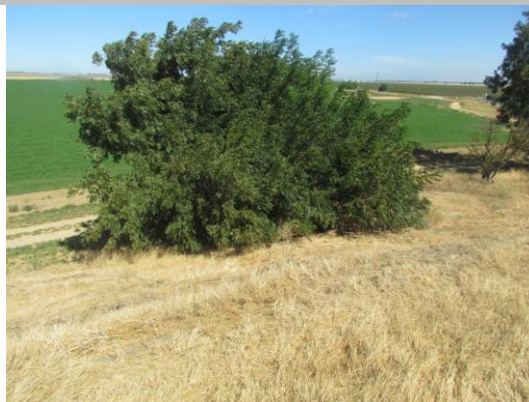
Photo 2 of 3 : SP\_2018\_RD0999\_233\_37\_20180301\_00026.jpg

LM Start	<b>0.73</b>	Rating **	M	Issue No.	<b>37 (cont)</b>
LM End	<b>0.73</b>	Issue Type +	Ma	Location *	LS

Looking at untrimmed tree on landward slope and toe. (Fall 2016)

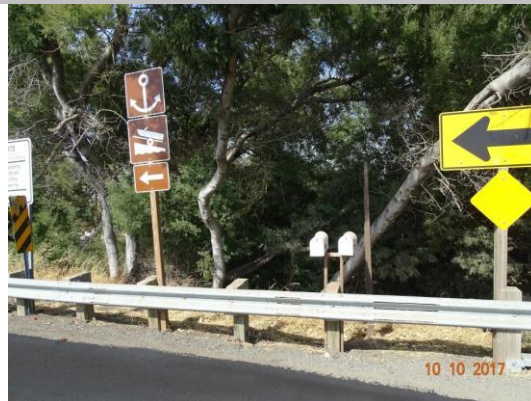
Photo 1 of 2 : SP\_2018\_RD0999\_233\_19\_20180301\_00016.jpg

LM Start	0.83	Rating **	M	Issue No.	19
LM End	0.83	Issue Type +	Ma	Location *	LS
Category	Earthen Levee			GPS Latitude/Longitude	
				Start	End
Item	Trim / Thin Trees			38.292386 °	38.292386 °
				-121.630543 °	-121.630543 °
DWR ID	DWR_RD0999_02_f_2012_19				
Comment Code					
T2 : Thin trees to allow visibility of the ground and room to flood fight.					
Inspector Comment

View of landside slope looking north.

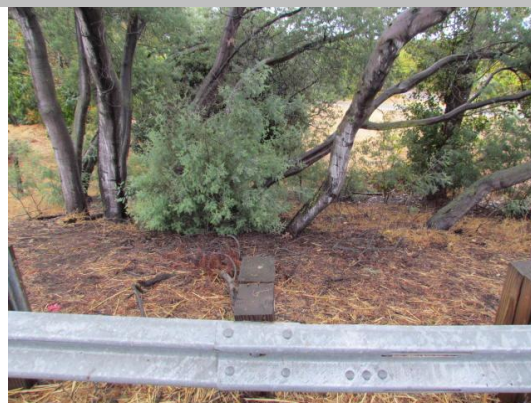
Photo 2 of 2 : SP\_2018\_RD0999\_233\_19\_20180301\_00017.jpg

LM Start	<b>0.83</b>	Rating **	M	Issue No.	<b>19 (cont)</b>
LM End	<b>0.83</b>	Issue Type +	Ma	Location *	LS

Looking north at untrimmed trees to be thinned at landward toe fall 2015.

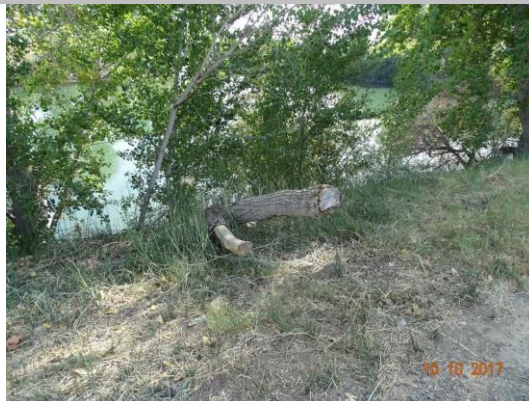
Photo 1 of 1 : SP\_2018\_RD0999\_234\_16\_20180301\_00017.jpg

LM Start	0.01	Rating **	M	Issue No.	16
LM End	0.01	Issue Type +	Ma	Location *	WS
Category	Earthen Levee			GPS Latitude/Longitude	
				Start	End
Item	Encroachments			38.286678 °	38.286678 °
				-121.605971 °	-121.605971 °
DWR ID	DWR_RD0999_03_f_2017_16				
Comment Code					
TR : Tree or limb					
Inspector Comment

View of waterside slope looking east.

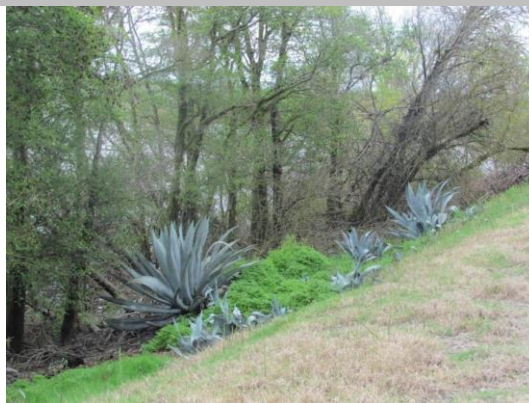
Photo 1 of 1 : SP\_2018\_RD0999\_234\_17\_20180301\_00018.jpg

LM Start	0.06	Rating **	M	Issue No.	17
LM End	0.06	Issue Type +	Ma	Location *	WS
Category	Earthen Levee			GPS Latitude/Longitude	
				Start	End
Item	Vegetation			38.287290 °	38.287290 °
				-121.605472 °	-121.605472 °
DWR ID	DWR_RD0999_03_s_2017_17				
Comment Code					
V2 : Remove the wild growth other than native grasses from the levee slopes.					
Inspector Comment					
Century plants on waterward slope.

Looking east at century plants on waterward slope.

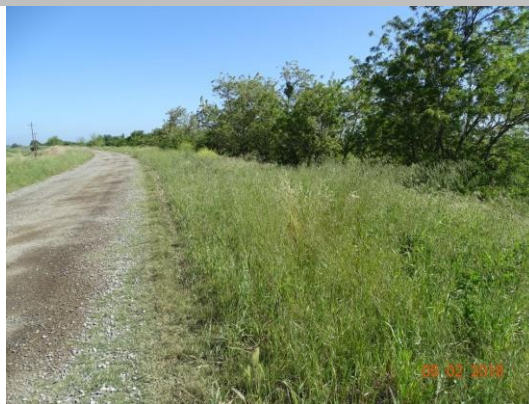
Photo 1 of 1 : SP\_2018\_RD0999\_234\_36\_20180507\_00051.jpg

LM Start	0.22	Rating **	U	Issue No.	36
LM End	0.29	Issue Type +	Ma	Location *	WS
Category	Earthen Levee			GPS Latitude/Longitude	
				Start	End
Item	Vegetation			38.289427 °	38.290416 °
				-121.604544 °	-121.604545 °
DWR ID	DWR_RD0999_03_s_2018_36				
Comment Code					
V1 : Control annual grass and weeds on the levee slopes and easements.					
Inspector Comment

Vegetation waterside looking north.

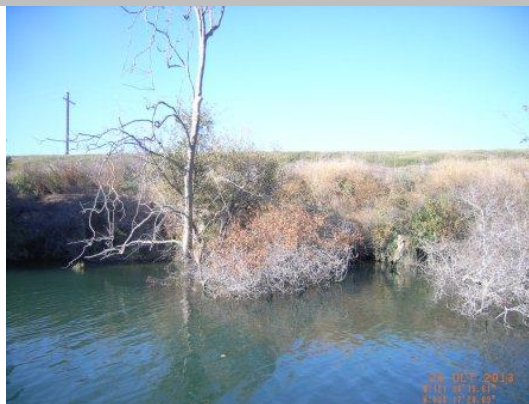
Photo 1 of 1 : SP\_2018\_RD0999\_234\_29\_20180301\_00029.jpg

LM Start	0.24	Rating **	U	Issue No.	29
LM End	0.65	Issue Type +	Ma	Location *	WS
Category	Supplemental			GPS Latitude/Longitude	
				Start	End
Item	2015 USACE Erosion Survey, DRAFT			38.289634 °	38.295505 °
				-121.604343 °	-121.605648 °
DWR ID	DWR_RD0999_03_s_2016_29

Comment Code					
Inspector Comment					
1997 - Intermittent over-steepened sections. Large riparian vegetation along the length of the entire reach. Attempts to repair with rock on bank have failed. 1999 - New rock repair at the downstream end. 2002 - Some minor spot repairs. 2009 - Minimal new erosion. 2010 - Appears that fresh rock placed on downstream portion of site. Toe scour and overhanging trees with some overturned. 2012 - Minor new erosion at the toe. 2013 - Site upgraded to CRITICAL. Severe slumping into levee at downstream end of site. Fresh erosion into bank toe. 2015: New slumping, tall vertical sections. [2015 Site ID: STR_24-7 R]

USACE 2013 Photo #1

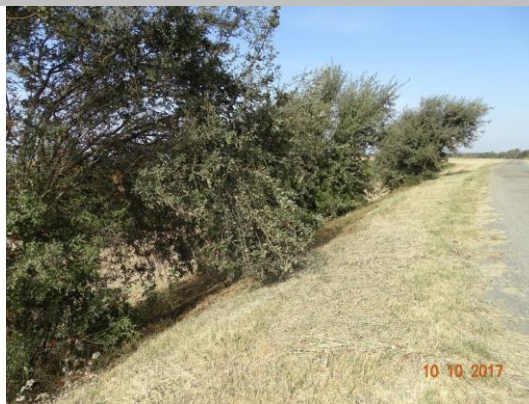
Photo 1 of 2 : SP\_2018\_RD0999\_234\_43\_20180301\_00035.jpg

LM Start	0.93	Rating **	M	Issue No.	43
LM End	0.95	Issue Type +	Ma	Location *	LS
Category	Earthen Levee			GPS Latitude/Longitude	
				Start	End
Item	Trim / Thin Trees			38.299130 °	38.299362 °
				-121.603768 °	-121.603462 °
DWR ID	DWR_RD0999_03_f_2014_43				
Comment Code					
T1 : Trim trees to at least five feet above ground level.					
Inspector Comment

View of landside slope looking northeast.

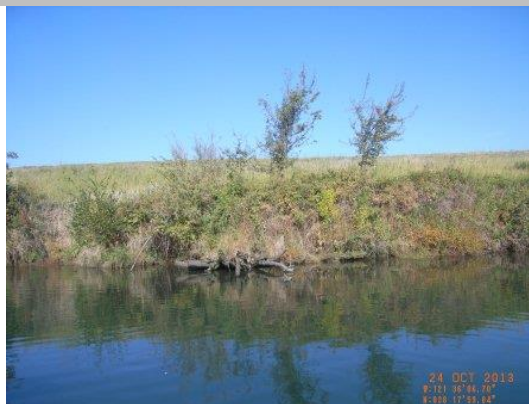
Photo 1 of 1 : SP\_2018\_RD0999\_234\_30\_20180301\_00030.jpg

LM Start	0.97	Rating **	M	Issue No.	30
LM End	1.10	Issue Type +	Ma	Location *	WS
Category	Supplemental			GPS Latitude/Longitude	
				Start	End
Item	2015 USACE Erosion Survey, DRAFT			38.299402 °	38.300542 °
				-121.603056 °	-121.601118 °
DWR ID	DWR_RD0999_03_s_2016_30				
Comment Code					
Inspector Comment					
2008 - Over steepened levee section. 2009 - Significant new erosion. 2010 - Minor new erosion. 2015: No observed changes. [2015 Site ID: STR_25-2_R]

USACE 2013 Photo #1

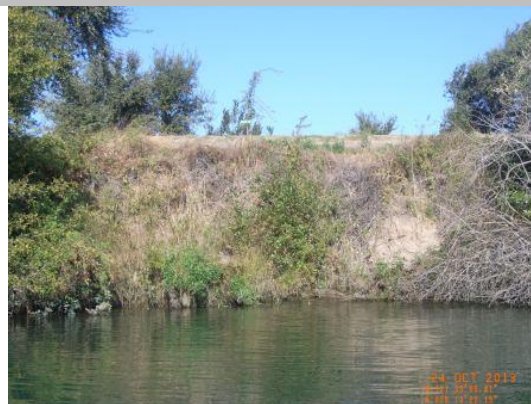
Photo 1 of 1 : SP\_2018\_RD0999\_234\_1\_20180301\_00001.jpg

LM Start	1.43	Rating **	M	Issue No.	1
LM End	1.58	Issue Type +	Ma	Location *	WS
Category	Supplemental			GPS Latitude/Longitude	
				Start	End
Item	2015 USACE Erosion Survey, DRAFT			38.305229 °	38.306667 °
				-121.599933 °	-121.598266 °
DWR ID	DWR_RD0999_03_s_2016_1				
Comment Code					
Inspector Comment					
2011 - Toe scour along length of site and erosion pockets. 2012 - Site extended slightly upstream due to new erosion pocket. 2013 - Tall vertical sections at upstream end of site. 2015: No observed changes. [2015 Site ID: STR_25-7_R]

USACE 2013 Photo #1

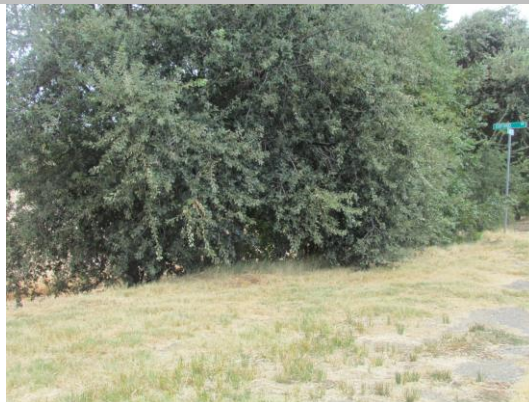
Photo 1 of 1 : SP\_2018\_RD0999\_234\_12\_20180301\_00012.jpg

LM Start	1.53	Rating **	U	Issue No.	12
LM End	1.53	Issue Type +	Ma	Location *	LS
Category	Earthen Levee			GPS Latitude/Longitude	
				Start	End
Item	Trim / Thin Trees			38.306332 °	38.306332 °
				-121.599109 °	-121.599109 °
DWR ID	DWR_RD0999_03_s_2012_12				
Comment Code					
T1 : Trim trees to at least five feet above ground level.					
Inspector Comment

Looking east at untrimmed trees on landward slope.

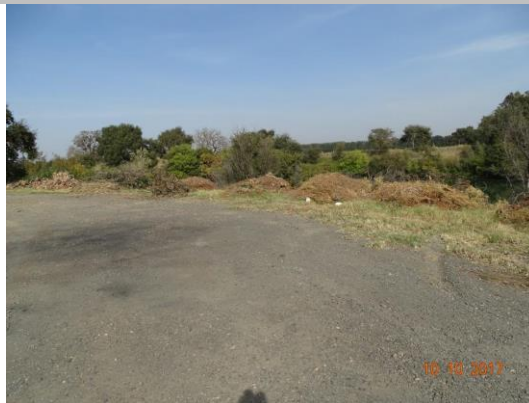
Photo 1 of 2 : SP\_2018\_RD0999\_234\_25\_20180301\_00024.jpg

LM Start	1.61	Rating **	M	Issue No.	25
LM End	1.61	Issue Type +	Ma	Location *	WS
Category	Earthen Levee			GPS Latitude/Longitude	
				Start	End
Item	Encroachments			38.307295 °	38.307295 °
				-121.598202 °	-121.598202 °
DWR ID	DWR_RD0999_03_s_2017_25				
Comment Code					
PR : Prunings					
Inspector Comment

View of waterside slope looking east.

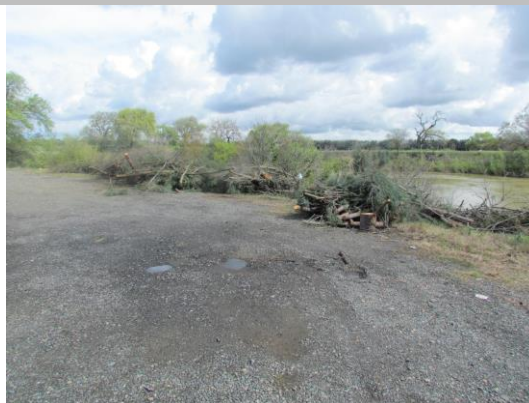
Photo 2 of 2 : SP\_2018\_RD0999\_234\_25\_20180301\_00025.jpg

LM Start	<b>1.61</b>	Rating **	M	Issue No.	<b>25 (cont)</b>
LM End	<b>1.61</b>	Issue Type +	Ma	Location *	WS

Looking east at several large pruning piles on waterward slope.

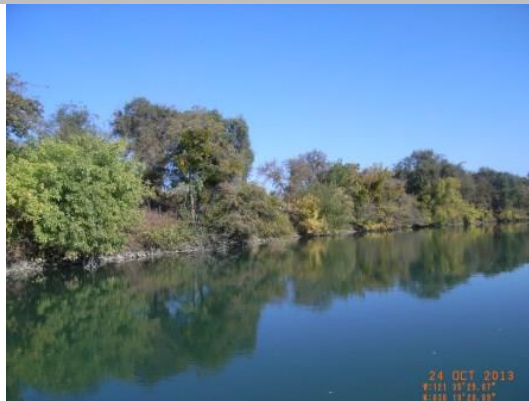
Photo 1 of 1 : SP\_2018\_RD0999\_234\_21\_20180301\_00020.jpg

LM Start	2.87	Rating **	M	Issue No.	21
LM End	2.92	Issue Type +	Ma	Location *	WS
Category	Supplemental			GPS Latitude/Longitude	
				Start	End
Item	2015 USACE Erosion Survey, DRAFT			38.322457 °	38.323042 °
				-121.590693 °	-121.590209 °
DWR ID	DWR_RD0999_03_s_2016_21				
Comment Code					
Inspector Comment					
2012 - Slumping of upper levee slope. 2015: No observed changes. [2015 Site ID: STR_27-1_R]

USACE 2013 Photo #1

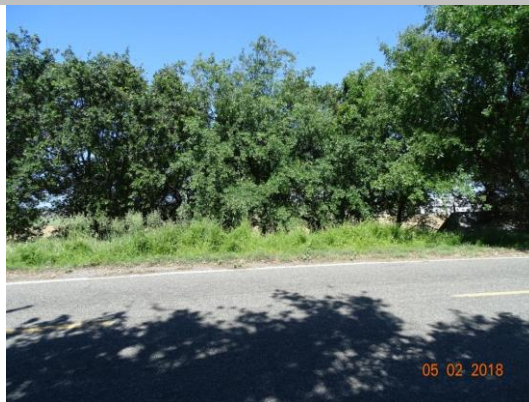
Photo 1 of 2 : SP\_2018\_RD0999\_234\_10\_20180507\_00053.jpg

LM Start	2.88	Rating **	U	Issue No.	10
LM End	2.88	Issue Type +	Ma	Location *	LS
Category	Earthen Levee			GPS Latitude/Longitude	
				Start	End
Item	Trim / Thin Trees			38.322757 °	38.322757 °
				-121.590817 °	-121.590817 °
DWR ID	DWR_RD0999_03_f_2012_10				
Comment Code					
T3 : Trim and thin trees to allow visibility of the ground and room to flood fight.					
Inspector Comment					
Wild growth at landside slope and toe.

Trim thin trees landside looking west.

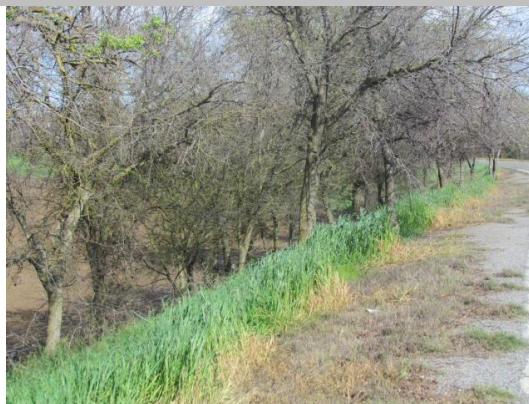
Photo 1 of 2 : SP\_2018\_RD0999\_234\_31\_20180301\_00031.jpg

LM Start	3.02	Rating **	U	Issue No.	31
LM End	3.08	Issue Type +	Ma	Location *	LS
Category	Earthen Levee			GPS Latitude/Longitude	
				Start	End
Item	Trim / Thin Trees			38.323832 °	38.324031 °
				-121.588736 °	-121.587763 °
DWR ID	DWR_RD0999_03_s_2012_31				
Comment Code					
T3 : Trim and thin trees to allow visibility of the ground and room to flood fight.					
Inspector Comment

Looking northwest at untrimmed trees on landward slope. (Spring 2016)

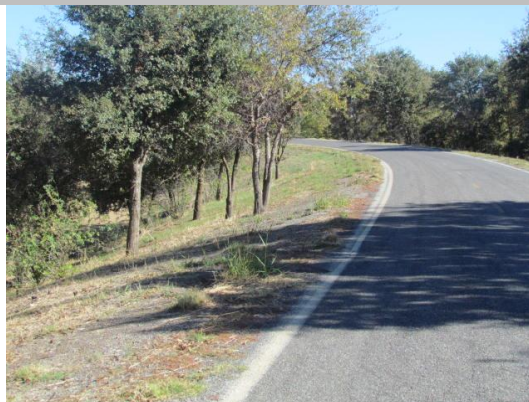
Photo 2 of 2 : SP\_2018\_RD0999\_234\_31\_20180301\_00032.jpg

LM Start	<b>3.02</b>	Rating **	U	Issue No.	<b>31 (cont)</b>
LM End	<b>3.08</b>	Issue Type +	Ma	Location *	LS

Looking north at trimmed trees on landward slope.

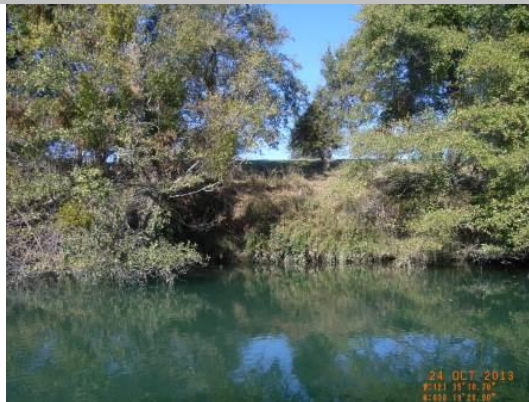
Photo 1 of 1 : SP\_2018\_RD0999\_234\_5\_20180301\_00002.jpg

LM Start	3.05	Rating **	A/W	Issue No.	5
LM End	3.23	Issue Type +	Ma	Location *	WS
Category	Supplemental			GPS Latitude/Longitude	
				Start	End
Item	2015 USACE Erosion Survey, DRAFT			38.323667 °	38.325592 °
				-121.588226 °	-121.585925 °
DWR ID	DWR_RD0999_03_s_2016_5				
Comment Code					
Inspector Comment					
2011 - Multiple erosion pockets. Some likely from tree popouts. 2013 - Tall vertical sections. 2015: New tree popout and significant new erosion. [2015 Site ID: STR_27-3_R]

USACE 2013 Photo #1

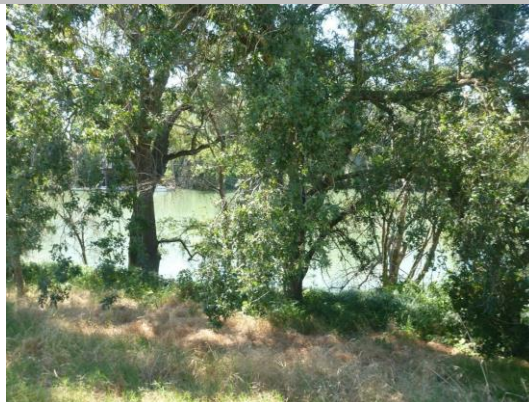
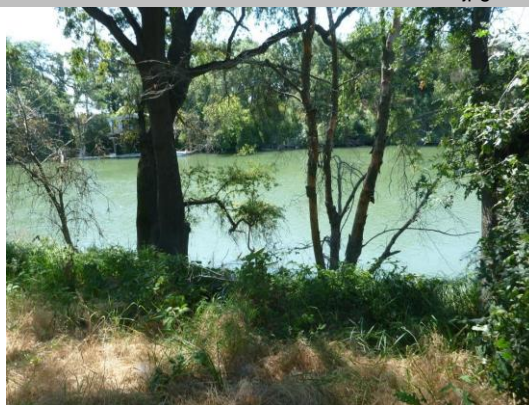
Photo 1 of 3 : LEVAL\_SP\_2018\_355\_2523.jpg

LM Start	3.09	Rating **	A/W	Issue No.	9	
LM End	3.12	Issue Type +	Ma	Location *		
Category	Supplemental			GPS Latitude/Longitude		
				Start	End	
Item	2017 Storm Damage			38.323986 °	38.324275 °	
				-121.587403 °	-121.586967 °	
DWR ID	DWR_RD0999_03_f_2017_9					
Comment Code						
Inspector Comment						
Levee Evaluation Comments						
Description:The damage consists of erosion of the lower waterside levee slope and bank approximately 147 feet in length along the west (right) bank of Sutter Slough. See attached pages for photos. Site location T06N R03E Section 36 and 25.						
Site ID No:355						
Site Designation:LMA-182						
Repair Type: Erosion						
Rating:Area of Concern						
Field Date:7/27/2017						
Notes:

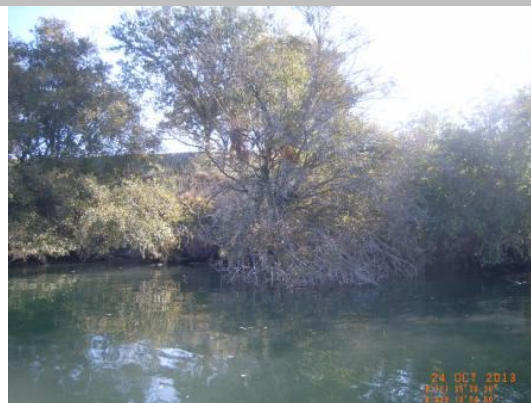
Photo 1 of 1 : SP\_2018\_RD0999\_234\_18\_20180301\_00019.jpg

LM Start	4.56	Rating **	M	Issue No.	18
LM End	4.68	Issue Type +	Ma	Location *	WS
Category	Supplemental			GPS Latitude/Longitude	
				Start	End
Item	2015 USACE Erosion Survey, DRAFT			38.313836 °	38.315407 °
				-121.592259 °	-121.591433 °
DWR ID	DWR_RD0999_03_s_2016_18				
Comment Code					
Inspector Comment					
2002 - Original rock over geotextile is sliding off and the end is coming unraveled. 2003 - Some minor new erosion on the downstream end. 2004 - Site has gotten worse. Underlined geofabric is exposed. 2005 - Still looks bad with exposed geotextile fabric. 2006 - Still have some new unraveling and exposed fabric. Site lengthened upstream. 2009 - Minimal new erosion. 2010 - geotextile fabric placed since last year, possible flood fight. 2012 - Exposed geotech style fabric, assume rock on top slid off. 2015: Erosion pockets covered with plastic. [2015 Site ID: STR_26-5_L]

USACE 2013 Photo #1

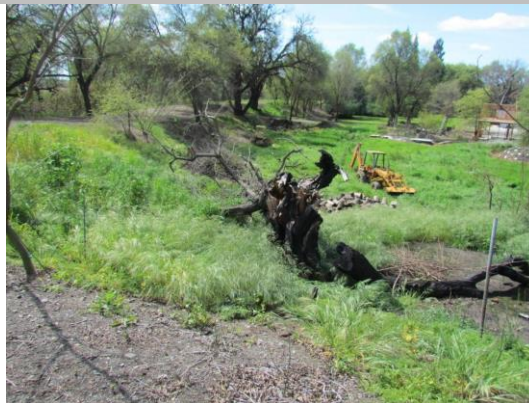
Photo 2 of 2 : SP\_2018\_RD0999\_235\_45\_20180301\_00035.jpg

LM Start	0.03	Rating **	M	Issue No.	45 (cont)	
LM End	0.03	Issue Type +	Ma	Location *	LS	
Category	Earthen Levee			GPS Latitude/Longitude		
				Start		End
Item	Encroachments			38.414335 °		38.414335 °
				-121.523348 °		-121.523348 °
DWR ID	DWR_RD0999_04_s_2017_45					
Comment Code						
TR : Tree or limb						
Inspector Comment						
Large downed tree on landside slope.

Looking west at fallen tree on landward slope.

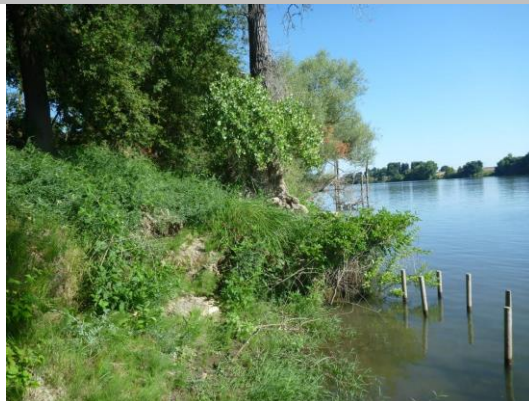
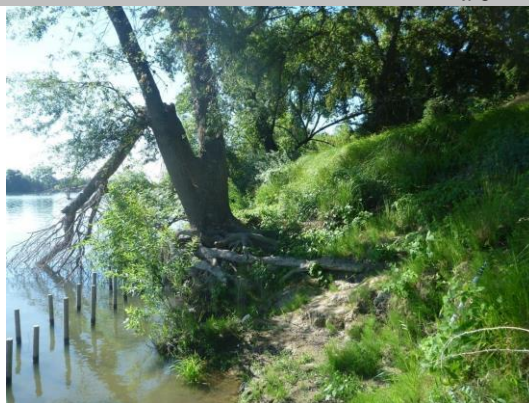
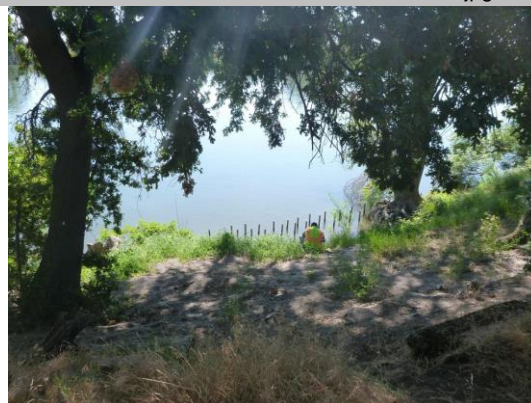
Photo 1 of 3 : LEVAL\_SP\_2018\_357\_2461.jpg

LM Start	0.10	Rating **	A/W	Issue No.	42
LM End	0.29	Issue Type +	Ma	Location *	
Category	Supplemental			GPS Latitude/Longitude	
				Start	End
Item	2017 Storm Damage			38.415319 °	38.417744 °
				-121.523717 °	-121.525344 °
DWR ID	DWR_RD0999_04_f_2017_42				
Comment Code					
Inspector Comment					
Levee Evaluation Comments					
Description:The damage consists of erosion of the lower and mid waterside levee slope approximately 997 feet in length along the west (right) bank of the Sacramento River. See attached pages for photos.					
Site location T06N R04E Section 3 and 4.					
Site ID No:357					
Site Designation:LMA-184					
Repair Type: Erosion					
Rating:Serious					
Field Date:7/27/2017					
Notes: on bank slope, big trees with exposed tree roots observed

LM Start	0.10	Rating **	A/W	Issue No.	42 (cont)
LM End	0.29	Issue Type +	Ma	Location *	
Category	Supplemental			GPS Latitude/Longitude	
				Start	End
Item	2017 Storm Damage			38.415319 °	38.417744 °
				-121.523717 °	-121.525344 °
DWR ID	DWR_RD0999_04_f_2017_42				
Comment Code					
Inspector Comment					
Levee Evaluation Comments					
Description:The damage consists of erosion of the lower and mid waterside levee slope approximately 997 feet in length along the west (right) bank of the Sacramento River. See attached pages for photos. Site location T06N R04E Section 3 and 4.					
Site ID No:357					
Site Designation:LMA-184					
Repair Type: Erosion					
Rating:Serious					
Field Date:7/27/2017					
Notes: on bank slope, big trees with exposed tree roots observed

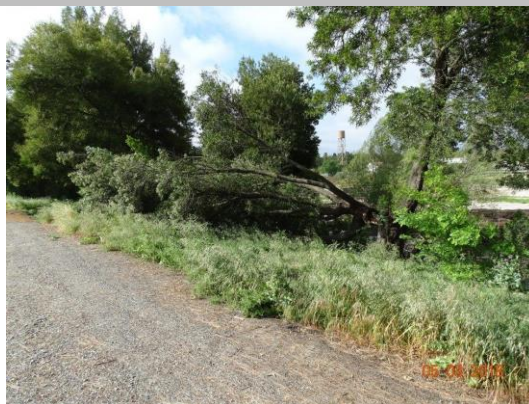
Photo 1 of 1 : SP\_2018\_RD0999\_235\_33\_20180503\_00085.jpg

LM Start	0.79	Rating **	U	Issue No.	33
LM End	0.79	Issue Type +	Ma	Location *	LS
Category	Earthen Levee			GPS Latitude/Longitude	
				Start	End
Item	Encroachments			38.424068 °	38.424068 °
				-121.530017 °	-121.530017 °
DWR ID	DWR_RD0999_04_s_2018_33				
Comment Code					
TR : Tree or limb					
Inspector Comment					
Remove downed tree on landside slope.

Downed tree landside looking southwest.

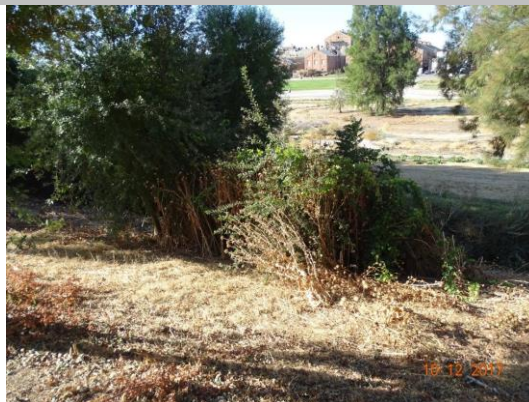
Photo 1 of 1 : SP\_2018\_RD0999\_235\_50\_20180301\_00041.jpg

Looking west at the landside slope.

LM Start	0.85	Rating **	M	Issue No.	50
LM End	0.85	Issue Type +	Ma	Location *	LS
Category	Earthen Levee			GPS Latitude/Longitude	
				Start	End
Item	Vegetation			38.424805 °	38.424805 °
				-121.530541 °	-121.530541 °
DWR ID	DWR_RD0999_04_f_2017_50				
Comment Code					
V2 : Remove the wild growth other than native grasses from the levee slopes.					
Inspector Comment

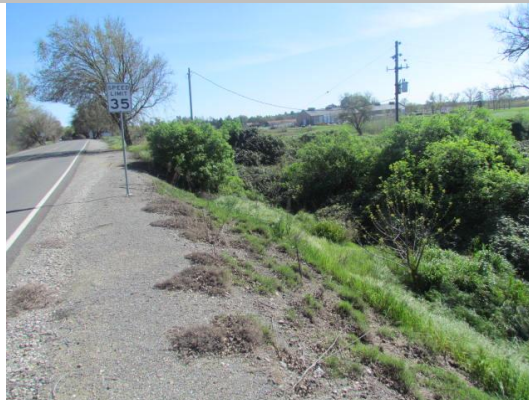
Photo 1 of 4 : SP\_2018\_RD0999\_235\_16\_20180301\_00014.jpg

LM Start	1.01	Rating **	U	Issue No.	16	
LM End	1.04	Issue Type +	Ma	Location *	LS	
Category	Earthen Levee			GPS Latitude/Longitude		
				Start		End
Item	Vegetation			38.426873 °		38.427295 °
				-121.531778 °		-121.532164 °
DWR ID	DWR_RD0999_04_f_2012_16					
Comment Code						
V2 : Remove the wild growth other than native grasses from the levee slopes.						
Inspector Comment						
Blackberries blocking view of landside toe.

Looking southwest at dense vegetation on landward slope and toe.  
(Spring 2016)

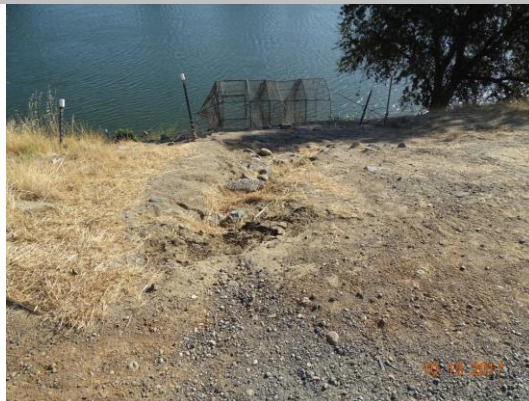
Photo 2 of 3 : SP\_2018\_RD0999\_235\_47\_20180301\_00039.jpg

LM Start	1.10	Rating **	M	Issue No.	47 (cont)	
LM End	1.10	Issue Type +	Ma	Location *	WS	
Category	Earthen Levee			GPS Latitude/Longitude		
				Start		End
Item	Erosion / Bank Caving			38.428152 °		38.428152 °
				-121.532502 °		-121.532502 °
DWR ID	DWR_RD0999_04_s_2017_47					
Comment Code						
E1 : Note and monitor erosion site.						
Inspector Comment						
Small erosion just above rip rap on waterside toe and runoff erosion on waterside slope.

Looking east at the waterside slope.

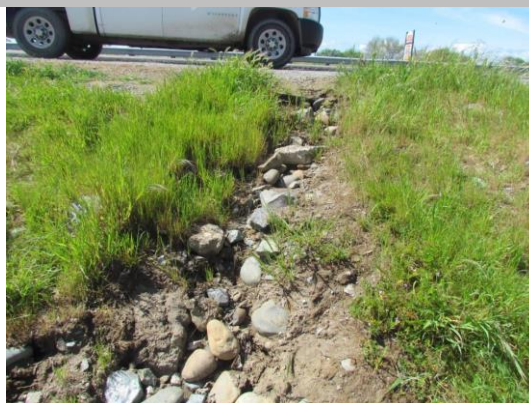
Photo 3 of 3 : SP\_2018\_RD0999\_235\_47\_20180301\_00040.jpg

Looking west at runoff erosion on waterward slope.

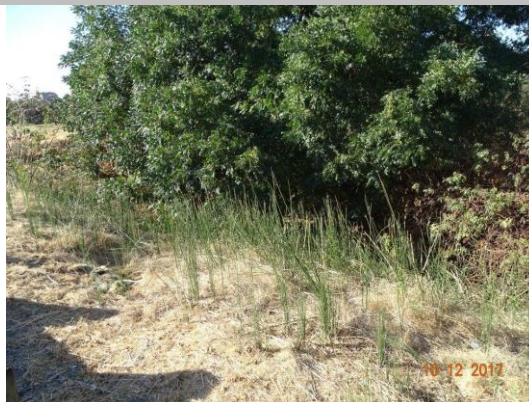
Photo 1 of 3 : SP\_2018\_RD0999\_235\_5\_20180301\_00003.jpg

LM Start	1.15	Rating **	U	Issue No.	5
LM End	1.15	Issue Type +	Ma	Location *	LS
Category	Earthen Levee			GPS Latitude/Longitude	
				Start	End
Item	Vegetation			38.428823 °	38.428823 °
				-121.532885 °	-121.532885 °
DWR ID	DWR_RD0999_04_s_2012_5				
Comment Code					
V2 : Remove the wild growth other than native grasses from the levee slopes.					
Inspector Comment					
Berry vines and wild roses on landside toe.

Looking south at the dense vegetation on the landside slope.

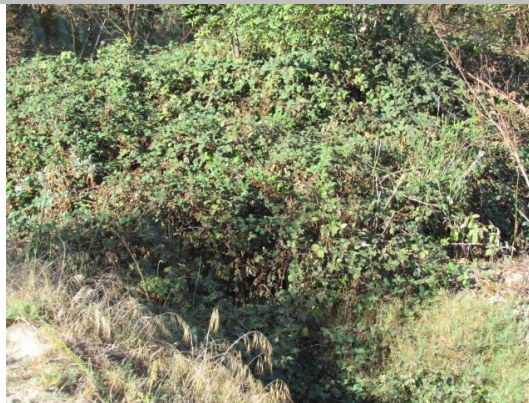
Photo 2 of 3 : SP\_2018\_RD0999\_235\_5\_20180301\_00004.jpg

LM Start	1.15	Rating **	U	Issue No.	5 (cont)	
LM End	1.15	Issue Type +	Ma	Location *	LS	
Category	Earthen Levee			GPS Latitude/Longitude		
				Start		End
Item	Vegetation			38.428823 °		38.428823 °
				-121.532885 °		-121.532885 °
DWR ID	DWR_RD0999_04_s_2012_5					
Comment Code						
V2 : Remove the wild growth other than native grasses from the levee slopes.						
Inspector Comment						
Berry vines and wild roses on landside toe.

Looking at dense vines at landward toe. Fall 2015.

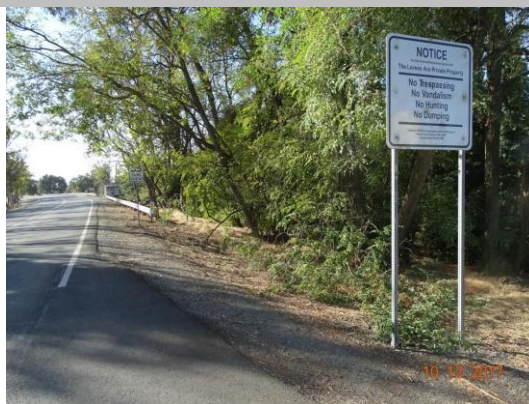
Photo 1 of 2 : SP\_2018\_RD0999\_235\_22\_20180301\_00020.jpg

Looking south at dense trees on landside slope.

LM Start	1.20	Rating **	M	Issue No.	22
LM End	1.22	Issue Type +	Ma	Location *	LS
Category	Earthen Levee			GPS Latitude/Longitude	
				Start	End
Item	Trim / Thin Trees			38.429467 °	38.429750 °
				-121.533110 °	-121.533188 °
DWR ID	DWR_RD0999_04_f_2013_22				
Comment Code					
T3 : Trim and thin trees to allow visibility of the ground and room to flood fight.					
Inspector Comment

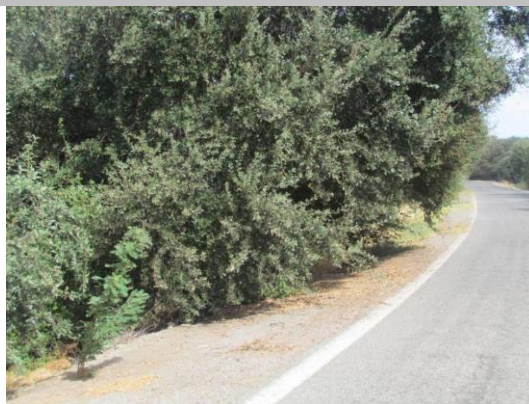
Photo 1 of 2 : SP\_2018\_RD0999\_236\_8\_20180301\_00005.jpg

Looking northwest at dense vegetation on landward slope. (Fall 2016)

LM Start	0.37	Rating **	M	Issue No.	8
LM End	0.42	Issue Type +	Ma	Location *	LS
Category	Earthen Levee			GPS Latitude/Longitude	
				Start	End
Item	Trim / Thin Trees			38.337654 °	38.338412 °
				-121.582427 °	-121.582267 °
DWR ID	DWR_RD0999_05_s_2012_8				
Comment Code					
T3 : Trim and thin trees to allow visibility of the ground and room to flood fight.					
Inspector Comment

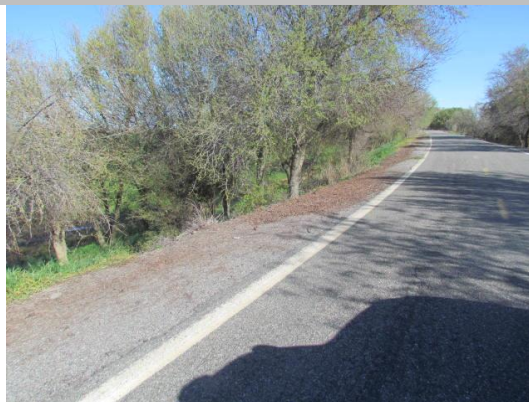
Photo 2 of 2 : SP\_2018\_RD0999\_236\_8\_20180301\_00006.jpg

Looking northwest at dense vegetation on landward slope. (Spring 2016)

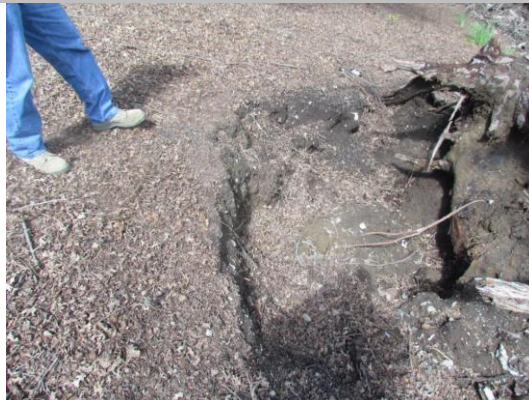
Photo 1 of 3 : SP\_2018\_RD0999\_236\_166\_20180301\_00083.jpg

LM Start	0.71	Rating **	U	Issue No.	166
LM End	0.71	Issue Type +	Ma	Location *	WS
Category	Earthen Levee			GPS Latitude/Longitude	
				Start	End
Item	Encroachments			38.342483 °	38.342483 °
				-121.581235 °	-121.581235 °
DWR ID	DWR_RD0999_05_s_2017_166				
Comment Code					
TR : Tree or limb					
Inspector Comment					
Dead tree fallen on waterward slope. Root ball Left hole on waterward slope 10 to 12 inches deep and approximately 5-ft in diameter.

Looking at hole left by fallen tree on waterward slope.

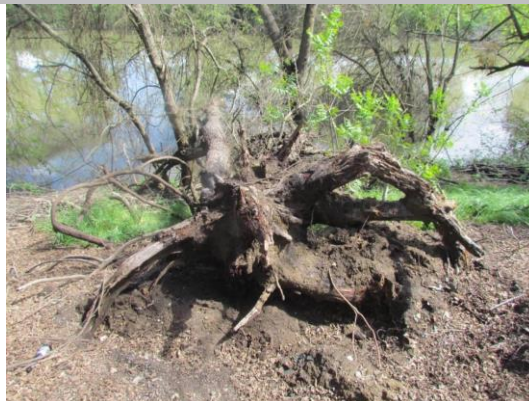
Photo 3 of 3 : SP\_2018\_RD0999\_236\_166\_20180301\_00085.jpg

LM Start	0.71	Rating **	U	Issue No.	166 (cont)	
LM End	0.71	Issue Type +	Ma	Location *	WS	
Category	Earthen Levee			GPS Latitude/Longitude		
				Start		End
Item	Encroachments			38.342483 °	38.342483 °	
				-121.581235 °	-121.581235 °	
DWR ID	DWR_RD0999_05_s_2017_166					
Comment Code						
TR : Tree or limb						
Inspector Comment						
Dead tree fallen on waterward slope. Root ball Left hole on waterward slope 10 to 12 inches deep and approximately 5-ft in diameter.

Looking downstream at fallen tree on waterward slope.

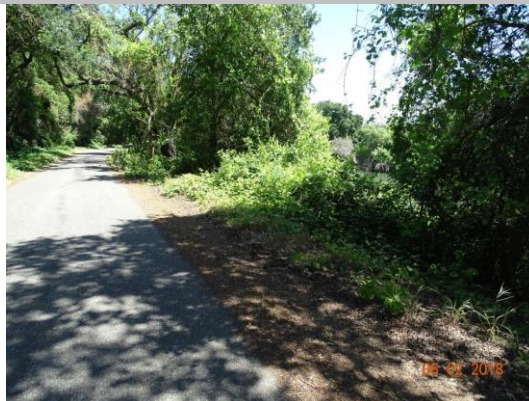
Photo 1 of 1 : SP\_2018\_RD0999\_236\_10\_20180507\_00200.jpg

Vegetation waterside looking north.

LM Start	0.84	Rating **	U	Issue No.	10
LM End	0.84	Issue Type +	Ma	Location *	WS
Category	Earthen Levee			GPS Latitude/Longitude	
				Start	End
Item	Vegetation			38.344294 °	38.344294 °
				-121.581054 °	-121.581054 °
DWR ID	DWR_RD0999_05_s_2018_10				
Comment Code					
V2 : Remove the wild growth other than native grasses from the levee slopes.					
Inspector Comment

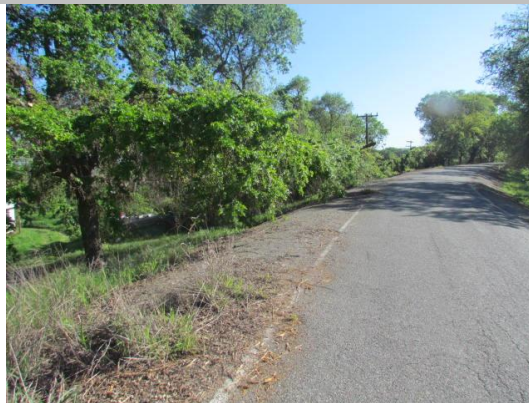
Photo 1 of 1 : SP\_2018\_RD0999\_236\_15\_20180301\_00012.jpg

Looking north at untrimmed trees on landward slope and toe.

LM Start	1.15	Rating **	U	Issue No.	15
LM End	1.19	Issue Type +	Ma	Location *	LS
Category	Earthen Levee			GPS Latitude/Longitude	
				Start	End
Item	Trim / Thin Trees			38.348237 °	38.348328 °
				-121.578440 °	-121.577735 °
DWR ID	DWR_RD0999_05_s_2012_15				
Comment Code					
T1 : Trim trees to at least five feet above ground level.					
Inspector Comment

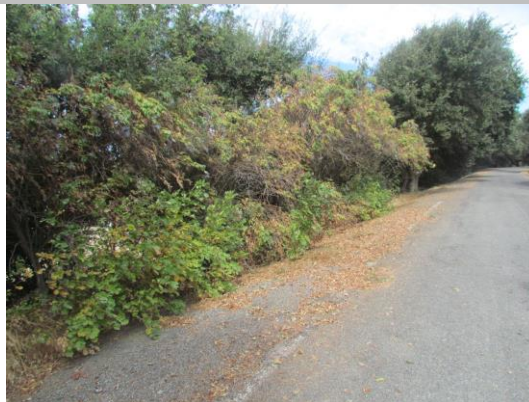
Photo 1 of 1 : SP\_2018\_RD0999\_236\_199\_20180301\_00109.jpg

LM Start	1.69	Rating **	U	Issue No.	199
LM End	1.69	Issue Type +	Ma	Location *	LS
Category	Earthen Levee			GPS Latitude/Longitude	
				Start	End
Item	Vegetation			38.351957 °	38.351957 °
				-121.574096 °	-121.574096 °
DWR ID	DWR_RD0999_05_f_2014_199				
Comment Code					
V2 : Remove the wild growth other than native grasses from the levee slopes.					
Inspector Comment					
Dense vegetation on landward slope.

Looking northwest at dense vegetation on landward slope.

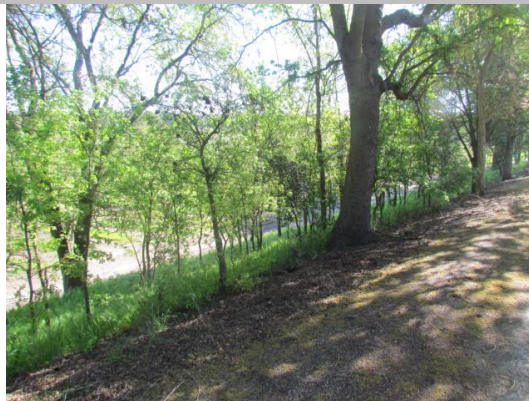
Photo 1 of 1 : SP\_2018\_RD0999\_236\_24\_20180301\_00021.jpg

Looking west at dense trees on landward slope. (Spring 2015)

LM Start	2.14	Rating **	M	Issue No.	24
LM End	2.16	Issue Type +	Ma	Location *	LS
Category	Earthen Levee			GPS Latitude/Longitude	
				Start	End
Item	Trim / Thin Trees			38.355402 °	38.355282 °
				-121.568893 °	-121.568547 °
DWR ID	DWR_RD0999_05_s _ 2012_24				
Comment Code					
T3 : Trim and thin trees to allow visibility of the ground and room to flood fight.					
Inspector Comment

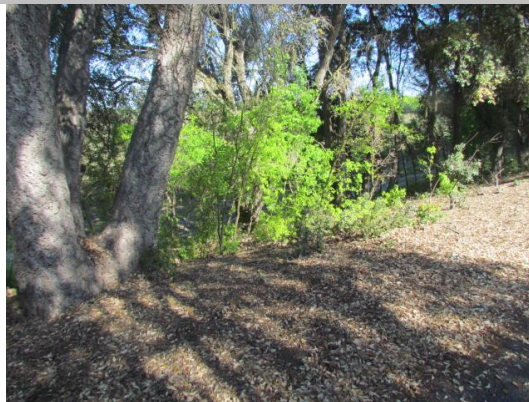
Photo 1 of 1 : SP\_2018\_RD0999\_236\_82\_20180301\_00041.jpg

Looking northwest at dense trees on landward slope. (Spring 2015)

LM Start	2.51	Rating **	M	Issue No.	82
LM End	2.65	Issue Type +	Ma	Location *	LS
Category	Earthen Levee			GPS Latitude/Longitude	
				Start	End
Item	Trim / Thin Trees			38.356270 °	38.358132 °
				-121.563218 °	-121.562347 °
DWR ID	DWR_RD0999_05_s _ 2012_82				
Comment Code					
T3 : Trim and thin trees to allow visibility of the ground and room to flood fight.					
Inspector Comment

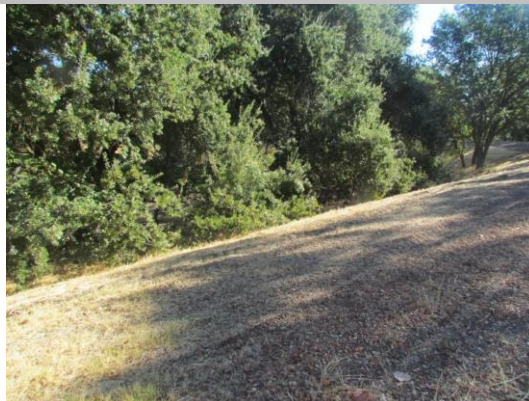
Photo 1 of 2 : SP\_2018\_RD0999\_236\_213\_20180301\_00116.jpg

Looking northwest at untrimmed trees on landward toe. (Fall 2016)

LM Start	3.39	Rating **	U	Issue No.	213
LM End	3.39	Issue Type +	Ma	Location *	LS
Category	Earthen Levee			GPS Latitude/Longitude	
				Start	End
Item	Trim / Thin Trees			38.363906 °	38.363906 °
				-121.557220 °	-121.557220 °
DWR ID	DWR_RD0999_05_s_2016_213				
Comment Code					
T1 : Trim trees to at least five feet above ground level.					
Inspector Comment

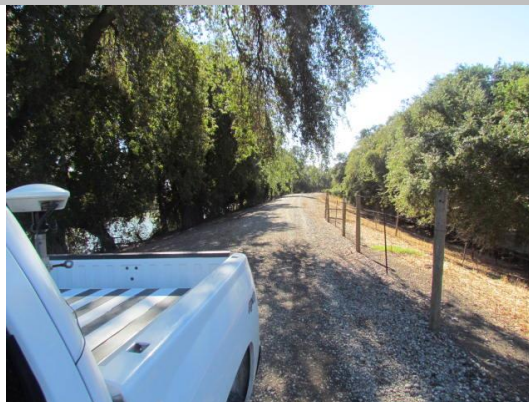
Photo 1 of 1 : SP\_2018\_RD0999\_236\_173\_20180301\_00095.jpg

Looking at the tree overhanging the levee crown.

LM Start	3.56	Rating **	M	Issue No.	173
LM End	3.56	Issue Type +	Ma	Location *	WS
Category	Earthen Levee			GPS Latitude/Longitude	
				Start	End
Item	Trim / Thin Trees			38.365882 °	38.365882 °
				-121.556762 °	-121.556762 °
DWR ID	DWR_RD0999_05_f_2015_173				
Comment Code					
T4 : Trim trees over roadway to at least 12 feet above ground level.					
Inspector Comment

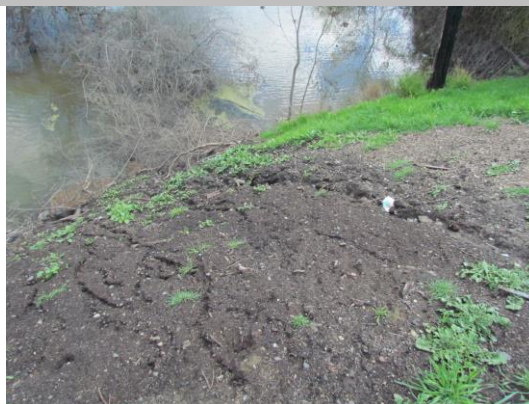
Photo 2 of 2 : SP\_2018\_RD0999\_236\_12\_20180301\_00010.jpg

LM Start	4.25	Rating **	U	Issue No.	12
LM End	4.25	Issue Type +	Ma	Location *	WS
Category	Earthen Levee			GPS Latitude/Longitude	
				Start	End
Item	Slope Stability			38.372872 °	38.372872 °
				-121.552185 °	-121.552185 °
DWR ID	DWR_RD0999_05_s_2017_12				
Comment Code					
S1 : Repair slope instability.					
Inspector Comment					
Large slough on waterside slope.

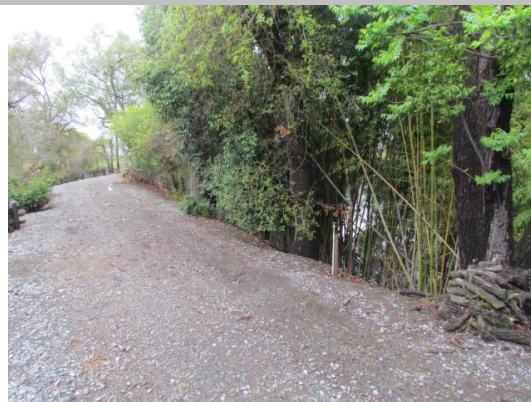
Photo 1 of 1 : SP\_2018\_RD0999\_236\_71\_20180301\_00039.jpg

Looking northeast at dense vegetation on waterside slope.

LM Start	5.50	Rating **	U	Issue No.	71
LM End	5.55	Issue Type +	Ma	Location *	WS
Category	Earthen Levee			GPS Latitude/Longitude	
				Start	End
Item	Vegetation			38.382790 °	38.383548 °
				-121.546754 °	-121.546728 °
DWR ID	DWR_RD0999_05_s_2012_71				
Comment Code					
V2 : Remove the wild growth other than native grasses from the levee slopes.					
Inspector Comment

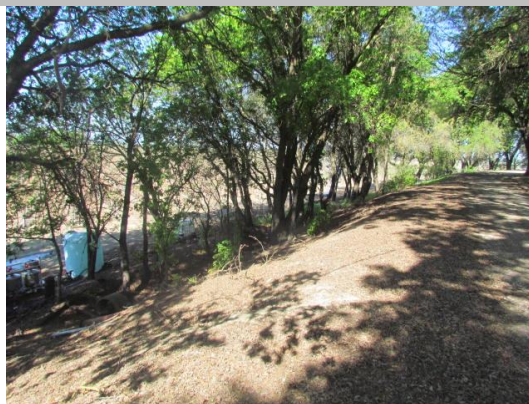
Photo 1 of 1 : SP\_2018\_RD0999\_236\_60\_20180301\_00034.jpg

LM Start	6.13	Rating **	M	Issue No.	60
LM End	6.13	Issue Type +	Ma	Location *	LS
Category	Earthen Levee			GPS Latitude/Longitude	
				Start	End
Item	Trim / Thin Trees			38.388225 °	38.388225 °
				-121.542697 °	-121.542697 °
DWR ID	DWR_RD0999_05_s_2012_60				
Comment Code					
T3 : Trim and thin trees to allow visibility of the ground and room to flood fight.					
Inspector Comment

Looking north at dense trees on landward slope. (Spring 2015)

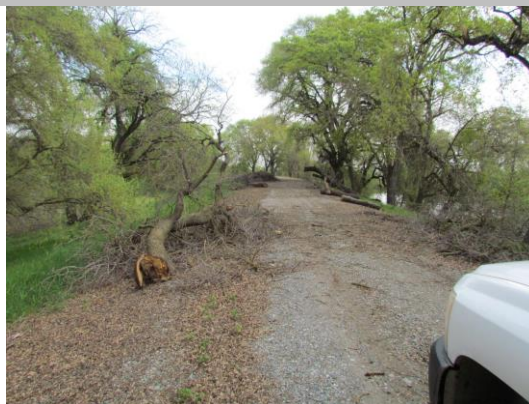
Photo 1 of 2 : SP\_2018\_RD0999\_236\_92\_20180301\_00045.jpg

LM Start	6.43	Rating **	M	Issue No.	92
LM End	6.48	Issue Type +	Ma	Location *	LS
Category	Earthen Levee			GPS Latitude/Longitude	
				Start	End
Item	Encroachments			38.391355 °	38.391776 °
				-121.540113 °	-121.539295 °
DWR ID	DWR_RD0999_05_s_2012_92				
Comment Code					
PR : Prunings					
Inspector Comment					
Large pruning piles and fallen tree on waterside and landside shoulder and slope.

Looking east at fallen tree and pruning on landward and waterward shoulder and slope.

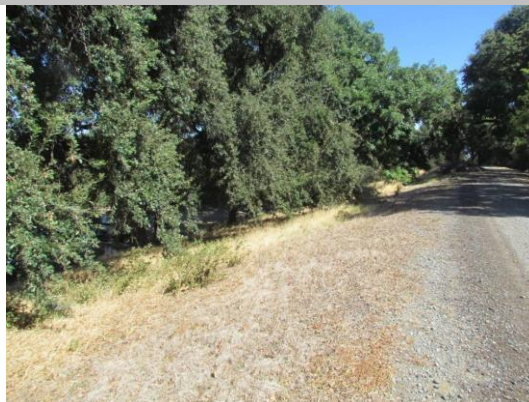
Photo 1 of 1 : SP\_2018\_RD0999\_236\_181\_20180301\_00100.jpg

LM Start	6.44	Rating **	M	Issue No.	181
LM End	6.44	Issue Type +	Ma	Location *	LS
Category	Earthen Levee			GPS Latitude/Longitude	
				Start	End
Item	Trim / Thin Trees			38.391502 °	38.391502 °
				-121.539897 °	-121.539897 °
DWR ID	DWR_RD0999_05_f_2015_181				
Comment Code					
T1 : Trim trees to at least five feet above ground level.					
Inspector Comment					
Untrimmed trees on landside slope and toe.

Looking northwest at untrimmed trees on landward slope and toe.

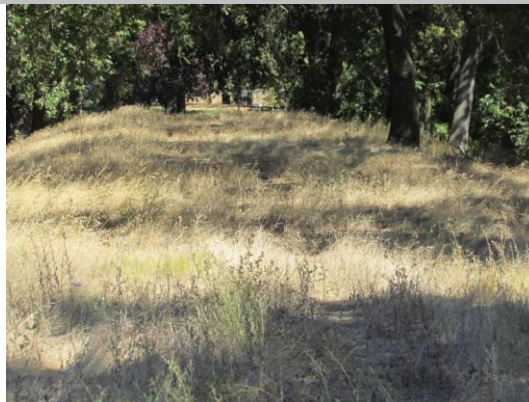
Photo 1 of 1 : SP\_2018\_RD0999\_236\_223\_20180301\_00125.jpg

LM Start	8.64	Rating **	M	Issue No.	223
LM End	8.72	Issue Type +	Ma	Location *	CR
Category	Earthen Levee			GPS Latitude/Longitude	
				Start	End
Item	Vegetation			38.410696 °	38.411560 °
				-121.531584 °	-121.530479 °
DWR ID	DWR_RD0999_05_f_2016_223				
Comment Code					
V9 : Keep the crown roadway free of vegetation.					
Inspector Comment					
Control growth on levee crown

Looking east at overgrowth on levee crown.

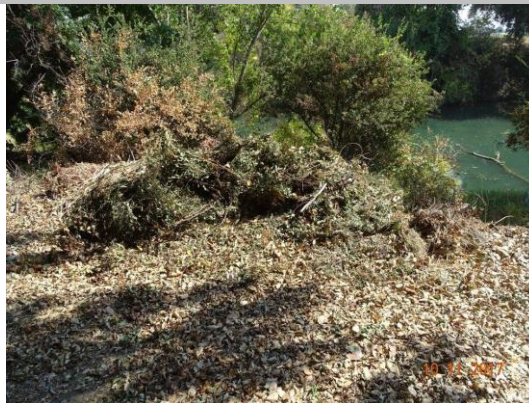
Photo 1 of 1 : SP\_2018\_RD0999\_236\_108\_20180301\_00057.jpg

LM Start	9.01	Rating **	M	Issue No.	108
LM End	9.01	Issue Type +	Ma	Location *	WS
Category	Earthen Levee			GPS Latitude/Longitude	
				Start	End
Item	Encroachments			38.415412 °	38.415412 °
				-121.529500 °	-121.529500 °
DWR ID	DWR_RD0999_05_f_2017_108				
Comment Code					
PR : Prunings					
Inspector Comment

Looking southeast at the waterside slope.
