**Flood Control Project Maintenance
Levee Inspections**

Maintenance Issue Types Only, Levee Inspection Report By Mile - Spring 2019

Reclamation District No. 0999 Netherlands

Waterway	Bank	Unit Miles	Inspection Start/End	Inspector
Unit No. 01 Yolo Bypass	Left	15.41	03/21/2019 03/21/2019	Luz Dial

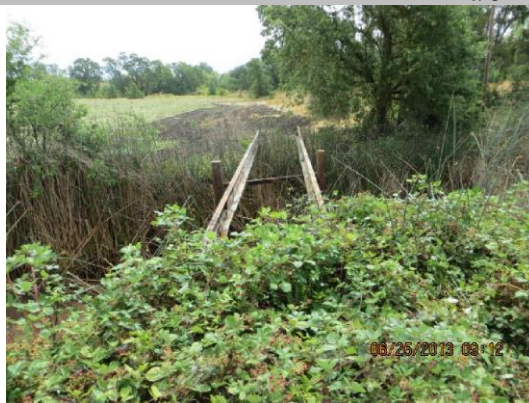
Photo 2 of 3 : UCIP_SP_2019_53368_25190.jpg

Pump platform visible off LS toe, but no appurtenances remain.

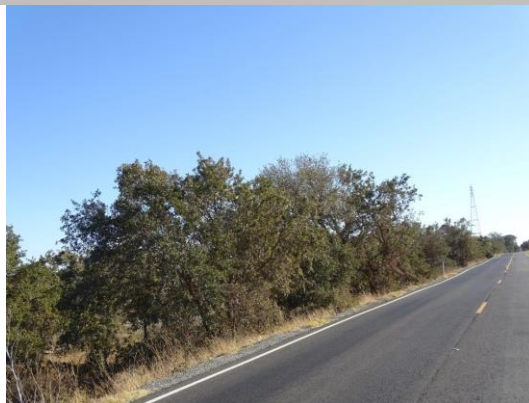
Photo 1 of 2 : SP_2019_RD0999_232_30_20190307_00015.jpg

LM Start	1.79	Rating **	M	Issue No.	30
LM End	2.04	Issue Type +	Ma	Location *	LS
Category	Earthen Levee			GPS Latitude/Longitude	
				Start	End
Item	Trim / Thin Trees			38.479165 °	38.475463 °
				-121.580640 °	-121.580722 °
DWR ID	DWR_RD0999_01_s_2012_30				
Comment Code					
T1 : Trim trees to at least five feet above ground level.					
Inspector Comment					
LMA claimed that RD765 is responsible for maintenance for landside section approximately between LM 1.79-2.25, but DWR forwarded the LMA their boundary map located in the USACE Unit 113 O&M Manual.

View of untrimmed trees on landside slope. LMA claims that RD 765 is responsible for maintenance. Fall 2018

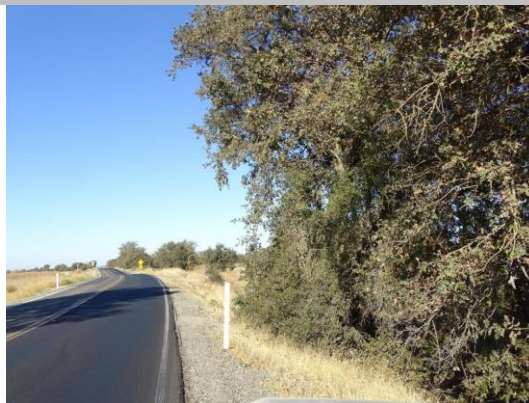
Photo 1 of 3 : SP_2019_RD0999_232_31_20190307_00017.jpg

LM Start	2.13	Rating **	M	Issue No.	31
LM End	2.13	Issue Type +	Ma	Location *	LS
Category	Earthen Levee			GPS Latitude/Longitude	
				Start	End
Item	Trim / Thin Trees			38.474200 °	38.474200 °
				-121.580480 °	-121.580480 °
DWR ID	DWR_RD0999_01_f_2018_31				
Comment Code					
T3 : Trim and thin trees to allow visibility of the ground and room to flood fight.					
Inspector Comment					
LMA claims that RD765 is responsible for maintenance and is searching for documentation.

View of untrimmed trees on landside slope. LMA claims that RD 765 is responsible for maintenance. Fall 2018

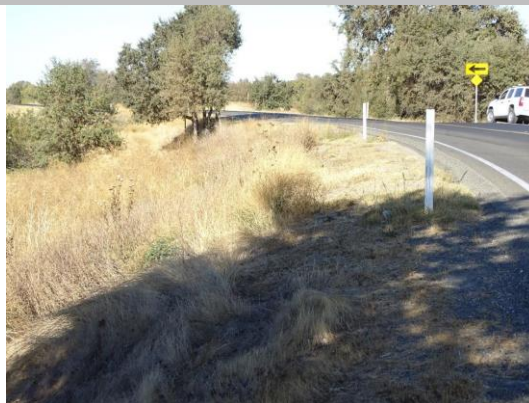
Photo 1 of 2 : SP_2019_RD0999_232_32_20190307_00020.jpg

LM Start	2.17	Rating **	M	Issue No.	32
LM End	2.17	Issue Type +	Ma	Location *	WS
Category	Earthen Levee			GPS Latitude/Longitude	
				Start	End
Item	Vegetation			38.473650 °	38.473650 °
				-121.580756 °	-121.580756 °
DWR ID	DWR_RD0999_01_f_2017_32				
Comment Code					
V2 : Remove the wild growth other than native grasses from the levee slopes.					
Inspector Comment					
Trim wild growth on levee slope, and monitor Arundo in area.

View of tall weeds on levee slope. Fall 2018

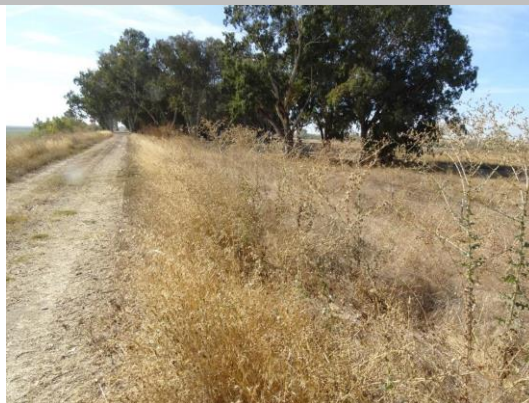
Photo 1 of 1 : SP_2019_RD0999_232_29_20190307_00014.jpg

LM Start	9.64	Rating **	M	Issue No.	29
LM End	9.69	Issue Type +	Ma	Location *	WS
Category	Earthen Levee			GPS Latitude/Longitude	
				Start	End
Item	Vegetation			38.372002 °	38.371283 °
				-121.627998 °	-121.628382 °
DWR ID	DWR_RD0999_01_f_2018_29				
Comment Code					
V1 : Control annual grass and weeds on the levee slopes and easements.					
Inspector Comment					
Trim vegetation on slope.

View of slope vegetation that needs to be trimmed. Fall 2018

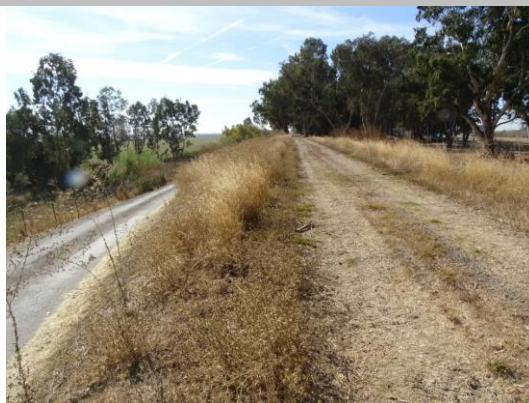
Photo 1 of 1 : SP_2019_RD0999_232_25_20190307_00010.jpg

LM Start	9.68	Rating **	M	Issue No.	25
LM End	9.72	Issue Type +	Ma	Location *	LS
Category	Earthen Levee			GPS Latitude/Longitude	
				Start	End
Item	Vegetation			38.371462 °	38.370848 °
				-121.628370 °	-121.628610 °
DWR ID	DWR_RD0999_01_f_2018_25				
Comment Code					
V1 : Control annual grass and weeds on the levee slopes and easements.					
Inspector Comment					
Trim vegetation on slopes.

View of landside vegetation that needs to be trimmed. Fall 2018

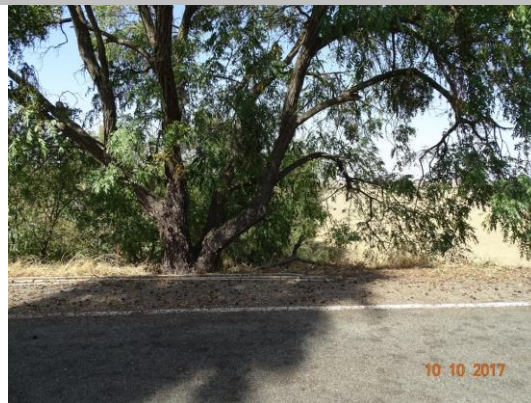
Photo 1 of 1 : SP_2019_RD0999_233_21_20190307_00019.jpg

LM Start	0.06	Rating **	M	Issue No.	21
LM End	0.06	Issue Type +	Ma	Location *	LS
Category	Earthen Levee			GPS Latitude/Longitude	
				Start	End
Item	Trim / Thin Trees			38.290434 °	38.290434 °
				-121.643873 °	-121.643873 °
DWR ID	DWR_RD0999_02_f_2017_21				
Comment Code					
T1 : Trim trees to at least five feet above ground level.					
Inspector Comment

View of landside slope looking north. Fall 2017

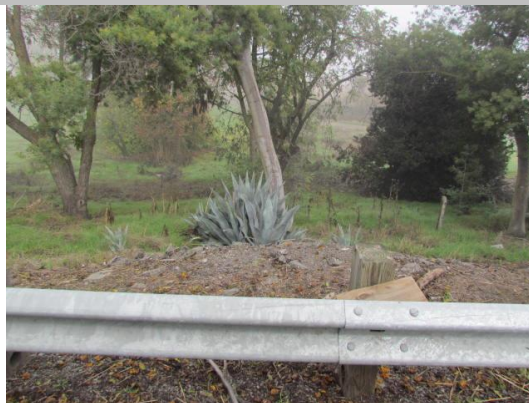
Photo 2 of 2 : SP_2019_RD0999_233_14_20190307_00013.jpg

LM Start	0.82	Rating **	M	Issue No.	14 (cont)	
LM End	0.82	Issue Type +	Ma	Location *	LS	
Category	Earthen Levee			GPS Latitude/Longitude		
				Start		End
Item	Vegetation			38.292439 °		38.292439 °
				-121.630781 °		-121.630781 °
DWR ID	DWR_RD0999_02_f_2012_14					
Comment Code						
V2 : Remove the wild growth other than native grasses from the levee slopes.						
Inspector Comment						
LMA has not removed Century plant on landside slope.

Looking north at century plant at landside toe.

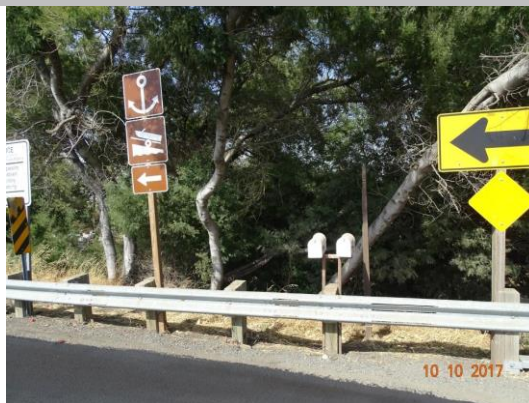
Photo 1 of 2 : SP_2019_RD0999_233_19_20190307_00017.jpg

LM Start	0.83	Rating **	M	Issue No.	19
LM End	0.83	Issue Type +	Ma	Location *	LS
Category	Earthen Levee			GPS Latitude/Longitude	
				Start	End
Item	Trim / Thin Trees			38.292386 °	38.292386 °
				-121.630543 °	-121.630543 °
DWR ID	DWR_RD0999_02_f_2012_19				
Comment Code					
T2 : Thin trees to allow visibility of the ground and room to flood fight.					
Inspector Comment

View of landside slope looking north. Fall 2017

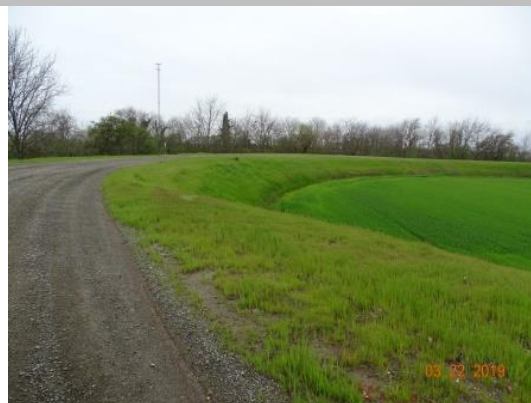
Photo 1 of 1 : SP_2019_RD0999_233_38_20190327_00048.jpg

LM Start	2.17	Rating **	A	Issue No.	38
LM End	2.30	Issue Type +	Ma	Location *	LS
Category	Earthen Levee			GPS Latitude/Longitude	
				Start	End
Item	Vegetation			38.287928 °	38.286575 °
				-121.607800 °	-121.606290 °
DWR ID	DWR_RD0999_02_s_2019_38				
Comment Code					
V1 : Control annual grass and weeds on the levee slopes and easements.					
Inspector Comment					
Vegetation in this section is well-maintained.

View of well-maintained landside vegetation. Spring 2019

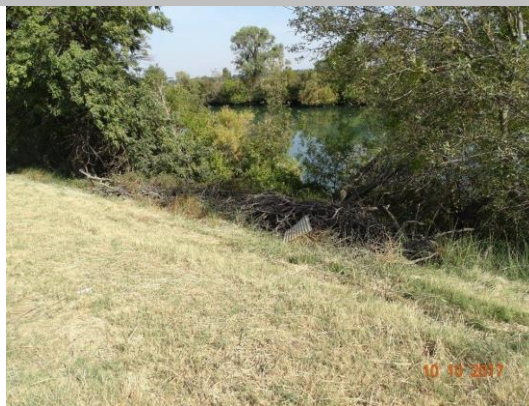
Photo 1 of 1 : SP_2019_RD0999_234_32_20190307_00020.jpg

LM Start	0.04	Rating **	M	Issue No.	32
LM End	0.04	Issue Type +	Ma	Location *	WS
Category	Earthen Levee			GPS Latitude/Longitude	
				Start	End
Item	Encroachments			38.287040 °	38.287040 °
				-121.605667 °	-121.605667 °
DWR ID	DWR_RD0999_03_f_2017_32				
Comment Code					
PR : Prunings					
Inspector Comment					
Remove large pruning pile on waterside slope.

View of waterside slope looking east. Fall 2017

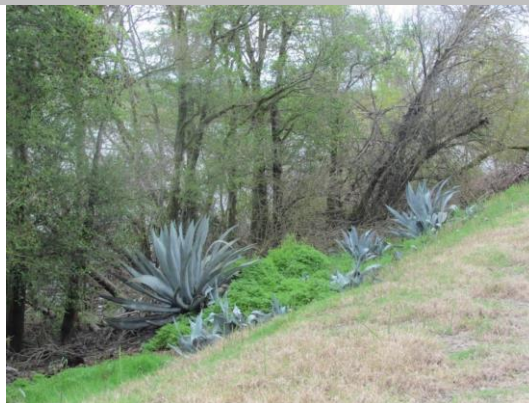
Photo 1 of 1 : SP_2019_RD0999_234_17_20190307_00012.jpg

LM Start	0.06	Rating **	M	Issue No.	17
LM End	0.06	Issue Type +	Ma	Location *	WS
Category	Earthen Levee			GPS Latitude/Longitude	
				Start	End
Item	Vegetation			38.287290 °	38.287290 °
				-121.605472 °	-121.605472 °
DWR ID	DWR_RD0999_03_s_2017_17				
Comment Code					
V2 : Remove the wild growth other than native grasses from the levee slopes.					
Inspector Comment					
Remove Century plants that are not allowed on waterward slope.

Looking east at century plants on waterward slope.

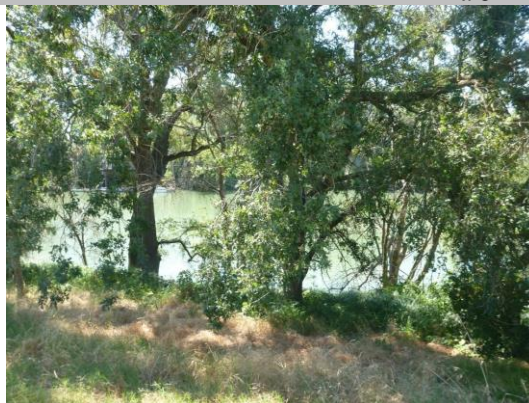
Photo 3 of 5 : LEVAL_SP_2019_355_2523.jpg

LM Start	3.09	Rating **	A/W	Issue No.	9 (cont)	
LM End	3.12	Issue Type +	Ma	Location *	WS	
Category	Supplemental			GPS Latitude/Longitude		
				Start	End	
Item	2017 Storm Damage			38.323986 °	38.324275 °	
				-121.587403 °	-121.586967 °	
DWR ID	DWR_RD0999_03_f _ 2017_9					
Comment Code						
Inspector Comment						
Levee Evaluation Comments						
Description:The damage consists of erosion of the lower waterside levee slope and bank approximately 147 feet in length along the west (right) bank of Sutter Slough. See attached pages for photos. Site location T06N R03E Section 36 and 25.						
Site ID No:355						
Site Designation:LMA-182						
Repair Type: Erosion						
Rating:Area of Concern						
Field Date:7/27/2017						
Notes: Fall 2018 DWR Inspector: Observed erosion into the bank and fallen tree. End LM not given on report.

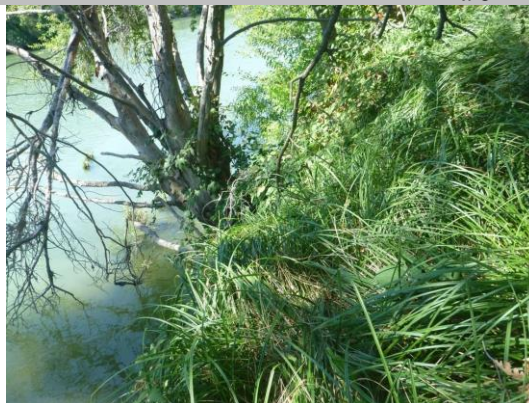
Photo 5 of 5 : LEVAL_SP_2019_355_2529.jpg

LM Start	3.09	Rating **	A/W	Issue No.	9 (cont)	
LM End	3.12	Issue Type +	Ma	Location *	WS	
Category	Supplemental			GPS Latitude/Longitude		
				Start	End	
Item	2017 Storm Damage			38.323986 °	38.324275 °	
				-121.587403 °	-121.586967 °	
DWR ID	DWR_RD0999_03_f_2017_9					
Comment Code						
Inspector Comment						
Levee Evaluation Comments						
Description:The damage consists of erosion of the lower waterside levee slope and bank approximately 147 feet in length along the west (right) bank of Sutter Slough. See attached pages for photos. Site location T06N R03E Section 36 and 25.						
Site ID No:355						
Site Designation:LMA-182						
Repair Type: Erosion						
Rating:Area of Concern						
Field Date:7/27/2017						
Notes: Fall 2018 DWR Inspector: Observed erosion into the bank and fallen tree. End LM not given on report.

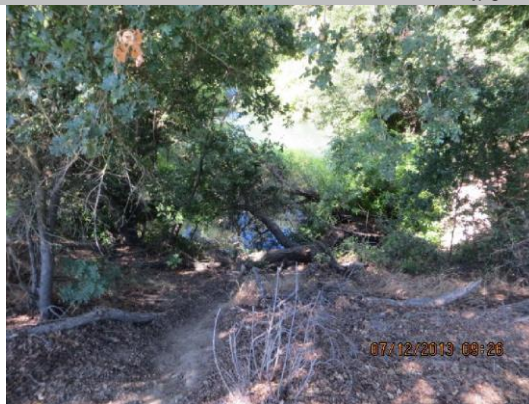
Photo 2 of 2 : UCIP_SP_2019_15708_26136.jpg

Toe of LS at approximate location of outlet/inlet.

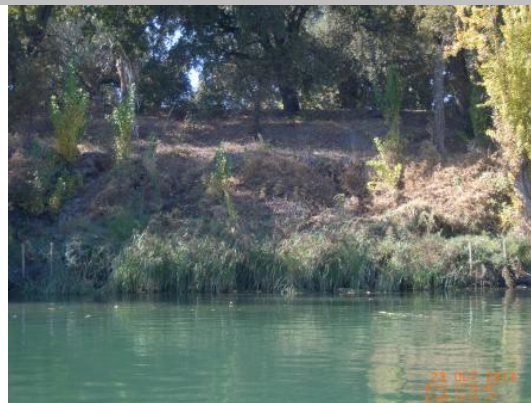
Photo 1 of 1 : SP_2019_RD0999_235_23_20190408_00070.jpg

Comment Code					
Inspector Comment					
2017 Site ID: SAC 41.9 R					
Status: Critical					
2017 Field Notes: Fresh erosion on entire bank. Upgraded to critical.					
Site History: 1997 - Structural problem rather than erosional, failed cobble at downstream end. 2005 - New brush boxes at waterline for several hundred feet downstream, No toe or bank protection present.					
2006 - Some minor new erosion. Brush boxes not working well; most of the brush has floated out. 2007 - Brush boxes have recently been repaired. 2016 - Minor new slumping. Spring 2019 DWR Inspection: Erosion was not visible during this inspection.

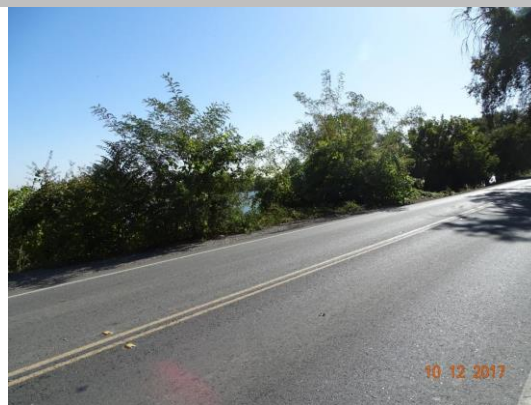
Photo 1 of 1 : SP_2019_RD0999_235_53_20190307_00026.jpg

LM Start	0.04	Rating **	U	Issue No.	53
LM End	0.06	Issue Type +	Ma	Location *	WS
Category	Earthen Levee			GPS Latitude/Longitude	
				Start	End
Item	Vegetation			38.414533 °	38.414750 °
				-121.523394 °	-121.523543 °
DWR ID	DWR_RD0999_04_f_2017_53				
Comment Code					
V2 : Remove the wild growth other than native grasses from the levee slopes.					
Inspector Comment					
Remove wild growth vegetation on waterside slope.

Looking southeast at the waterside slope.

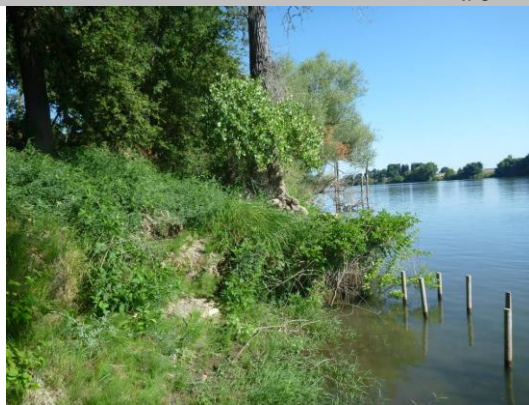
Photo 2 of 4 : LEVAL_SP_2019_357_2461.jpg

LM Start	0.10	Rating **	A/W	Issue No.	42 (cont)
LM End	0.29	Issue Type +	Ma	Location *	WS
Category	Supplemental			GPS Latitude/Longitude	
				Start	End
Item	2017 Storm Damage			38.415319 °	38.417744 °
				-121.523717 °	-121.525344 °
DWR ID	DWR_RD0999_04_f _ 2017_42				
Comment Code					
Inspector Comment					
Levee Evaluation Comments					
Description:The damage consists of erosion of the lower and mid waterside levee slope approximately 997 feet in length along the west (right) bank of the Sacramento River. See attached pages for photos.					
Site location T06N R04E Section 3 and 4.					
Site ID No:357					
Site Designation:LMA-184					
Repair Type: Erosion					
Rating:Serious					
Field Date:7/27/2017					
Notes: on bank slope, big trees with exposed tree roots observed 2018 DWR Inspector: Fallen tree on water's edge.					
Erosion not visible from slope.

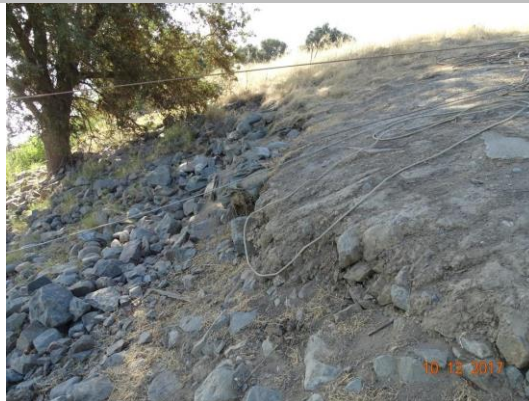
Photo 1 of 3 : SP_2019_RD0999_235_47_20190307_00023.jpg

LM Start	1.10	Rating **	M	Issue No.	47
LM End	1.10	Issue Type +	Ma	Location *	WS
Category	Earthen Levee			GPS Latitude/Longitude	
				Start	End
Item	Erosion / Bank Caving			38.428152 °	38.428152 °
				-121.532502 °	-121.532502 °
DWR ID	DWR_RD0999_04_s_2017_47				
Comment Code					
E1 : Note and monitor erosion site.					
Inspector Comment					
Small erosion just above riprap and runoff erosion on waterside slope.

Looking southeast at the waterside slope.

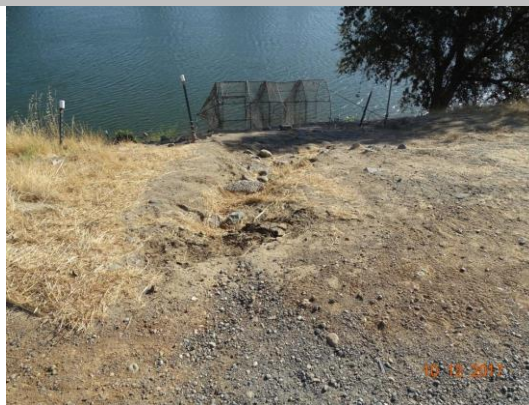
Photo 2 of 3 : SP_2019_RD0999_235_47_20190307_00024.jpg

Looking east at the waterside slope.

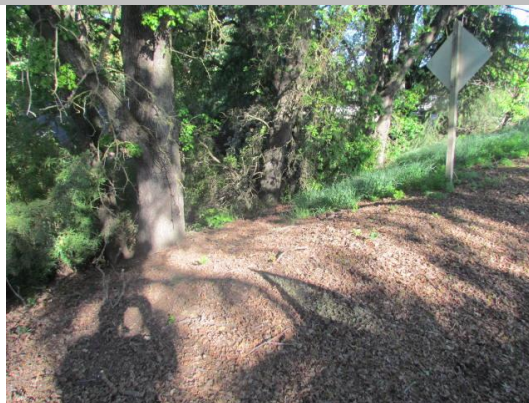
Photo 1 of 2 : SP_2019_RD0999_236_128_20190307_00053.jpg

LM Start	0.78	Rating **	M	Issue No.	128
LM End	0.79	Issue Type +	Ma	Location *	LS
Category	Earthen Levee			GPS Latitude/Longitude	
				Start	End
Item	Trim / Thin Trees			38.343495 °	38.343617 °
				-121.581282 °	-121.581249 °
DWR ID	DWR_RD0999_05_s_2012_128				
Comment Code					
T3 : Trim and thin trees to allow visibility of the ground and room to flood fight.					
Inspector Comment

Looking northwest at untrimmed trees on landward slope. (Spring 2015)

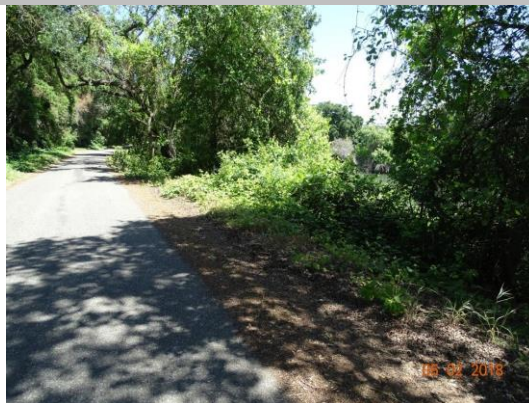
Photo 1 of 1 : SP_2019_RD0999_236_10_20190307_00005.jpg

LM Start	0.84	Rating **	M	Issue No.	10
LM End	0.84	Issue Type +	Ma	Location *	WS
Category	Earthen Levee			GPS Latitude/Longitude	
				Start	End
Item	Vegetation			38.344294 °	38.344294 °
				-121.581054 °	-121.581054 °
DWR ID	DWR_RD0999_05_s_2018_10				
Comment Code					
V2 : Remove the wild growth other than native grasses from the levee slopes.					
Inspector Comment					
LMA sprayed vegetation but needs to clear dead vegetation.

Vegetation waterside looking north. Spring 2018

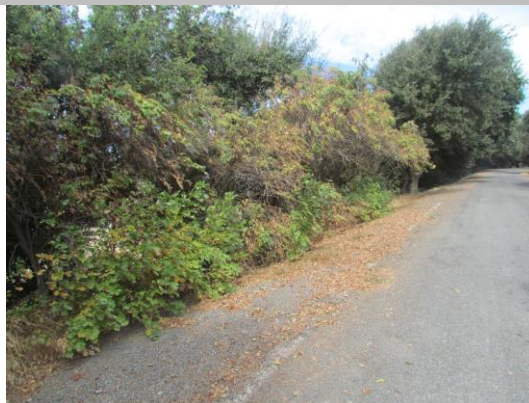
Photo 1 of 1 : SP_2019_RD0999_236_199_20190307_00092.jpg

LM Start	1.69	Rating **	U	Issue No.	199
LM End	1.69	Issue Type +	Ma	Location *	LS
Category	Earthen Levee			GPS Latitude/Longitude	
				Start	End
Item	Vegetation			38.351957 °	38.351957 °
				-121.574096 °	-121.574096 °
DWR ID	DWR_RD0999_05_f_2014_199				
Comment Code					
V2 : Remove the wild growth other than native grasses from the levee slopes.					
Inspector Comment					
Remove wild vegetation on landward easement. Poison oak is in area, according to LMA.

Looking northwest at dense vegetation on landward slope.

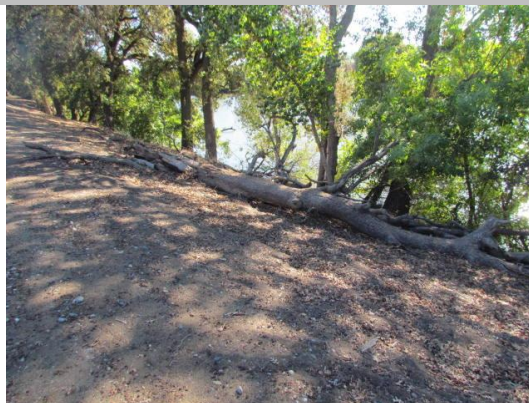
Photo 1 of 1 : SP_2019_RD0999_236_174_20190307_00082.jpg

LM Start	3.80	Rating **	M	Issue No.	174
LM End	3.80	Issue Type +	Ma	Location *	WS
Category	Earthen Levee			GPS Latitude/Longitude	
				Start	End
Item	Encroachments			38.368207 °	38.368207 °
				-121.554360 °	-121.554360 °
DWR ID	DWR_RD0999_05_s_2019_174				
Comment Code					
TR : Tree or limb					
Inspector Comment					
Remove tree branch and limbs on waterside slope.

Looking at tree branch on waterward slope.

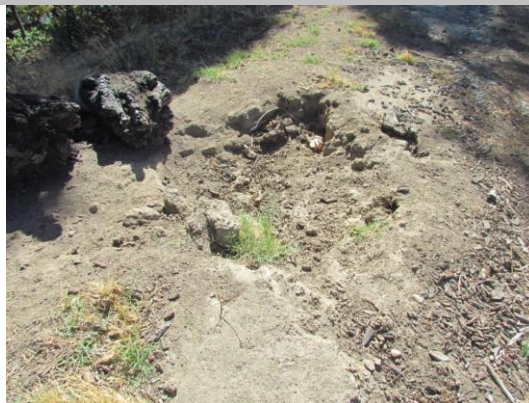
Photo 1 of 3 : SP_2019_RD0999_236_176_20190307_00083.jpg

Looking at hole from fallen tree on waterward shoulder. (Fall 2016)

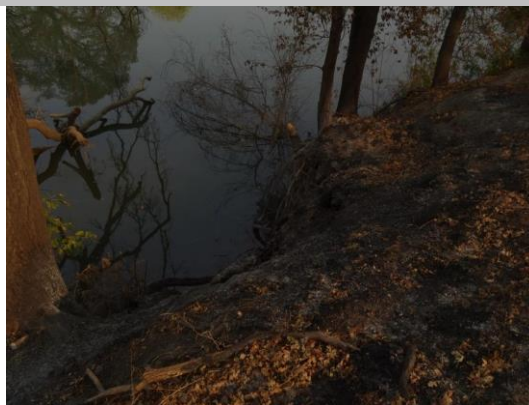
Photo 2 of 2 : SP_2019_RD0999_236_97_20190307_00045.jpg

View of fallen tree and levee scarp. Fall 2018

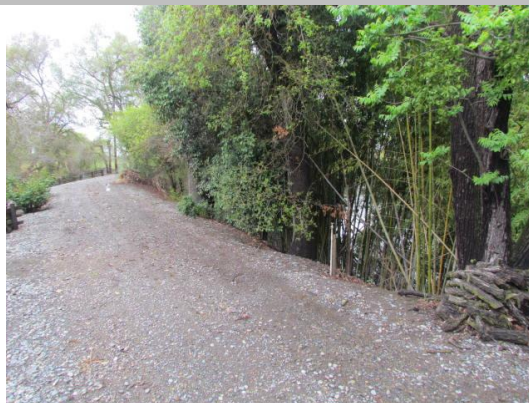
Photo 1 of 1 : SP_2019_RD0999_236_71_20190307_00030.jpg

LM Start	5.50	Rating **	U	Issue No.	71
LM End	5.55	Issue Type +	Ma	Location *	WS
Category	Earthen Levee			GPS Latitude/Longitude	
				Start	End
Item	Vegetation			38.382790 °	38.383548 °
				-121.546754 °	-121.546728 °
DWR ID	DWR_RD0999_05_s_2012_71				
Comment Code					
V2 : Remove the wild growth other than native grasses from the levee slopes.					
Inspector Comment

Looking northeast at dense vegetation on waterside slope.
