**Flood Control Project Maintenance
Levee Inspections**

Maintenance Issue Types Only, Levee Inspection Report By Mile - Spring 2022

Reclamation District No. 0999 Netherlands

| Waterway | Bank | Unit Miles | Inspection Start/End | Inspector |
|---|---|---|---|---|
| Unit No. 01 Yolo Bypass | Left | 15.41 | 05/18/2022 05/20/2022 | Marvin Marshall |

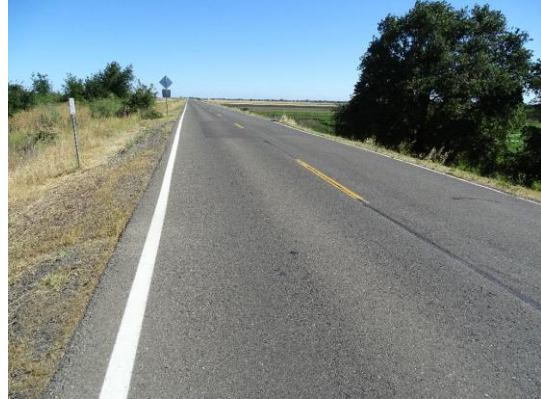
Photo 1 of 3 : UCIP_SP_2022_69815_88522.jpg

Top of Levee: view of crown.

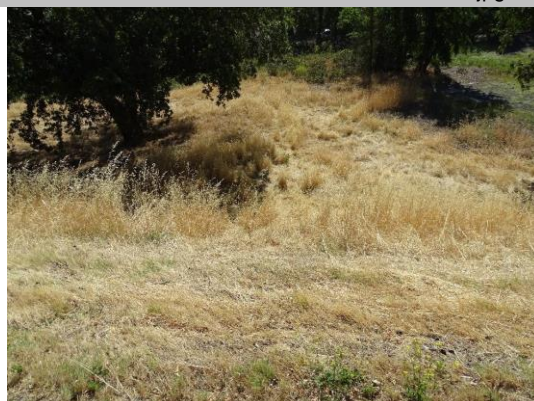
Photo 3 of 3 : UCIP_SP_2022_69815_88524.jpg

Land-Side: view of LS slope and pump platform off in distance.

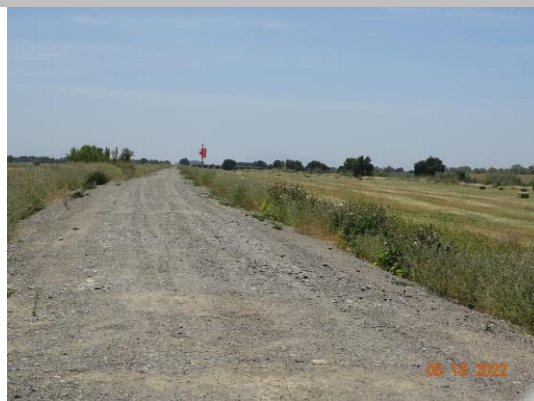
Photo 1 of 1 : SP_2022_RD0999_232_23_20220524_00085.jpg

Annual vegetation growth on the waterside slope. Spring 2022

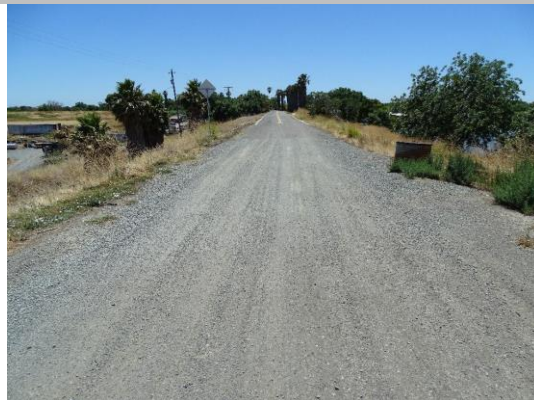
Photo 1 of 3 : UCIP_SP_2022_69886_88563.jpg

Top of Levee: view of crown with riser to this pipe on WS shoulder.

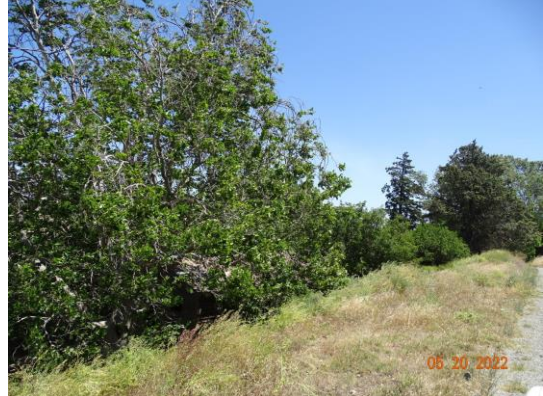
Photo 1 of 1 : SP_2022_RD0999_233_20_20220524_00035.jpg

Tree growth on the landside slope and toe. Spring 2022

| Trim trees to 5' above grade on the landside slope and within 10' of the toe. | | | | | |

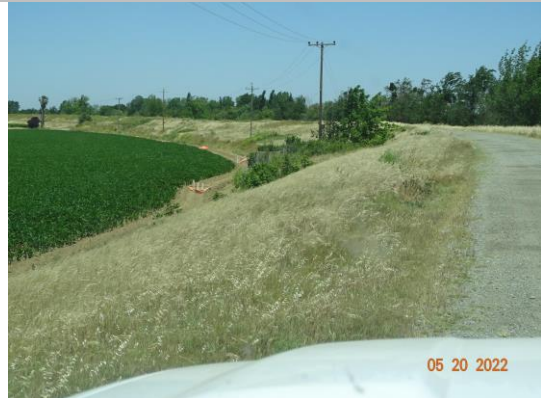
Photo 1 of 1 : SP_2022_RD0999_234_15_20220524_00036.jpg

Annual vegetation on the landside slope and toe. Spring 2022

| Maintain annual vegetation growth on the landside slope and within 10' of the toe. | | | | | |

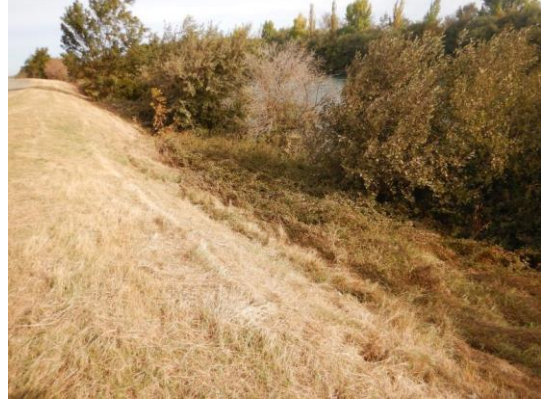
Photo 1 of 2 : SP_2022_RD0999_234_5_20220307_00001.jpg

USACE 2018 Erosion Photo #1

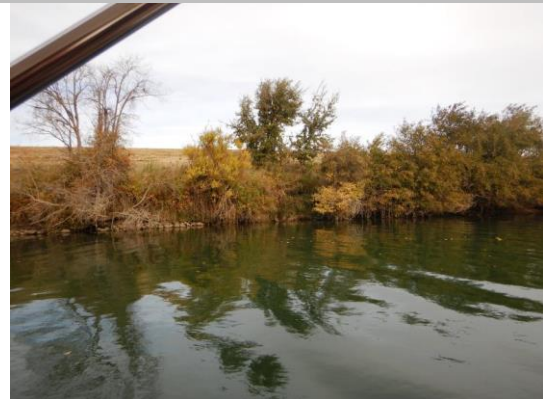
Photo 1 of 2 : SP_2022_RD0999_234_6_20220307_00003.jpg

| Site History: 2008 - Over steepened levee section. 2009 - Significant new erosion. 2010 - Minor new erosion. 2017 - Minor new erosion at toe. | | | | | |

USACE 2018 Erosion Photo #1

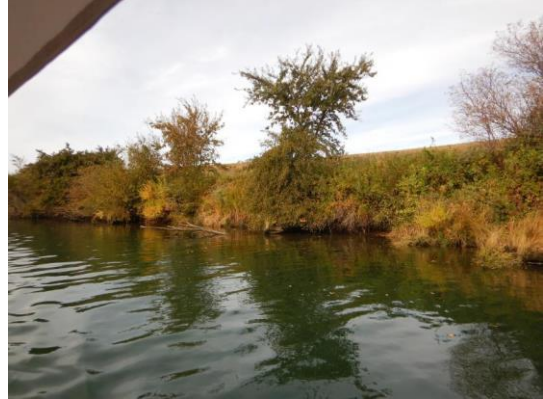
Photo 2 of 2 : SP_2022_RD0999_234_6_20220307_00004.jpg

USACE 2018 Erosion Photo #2

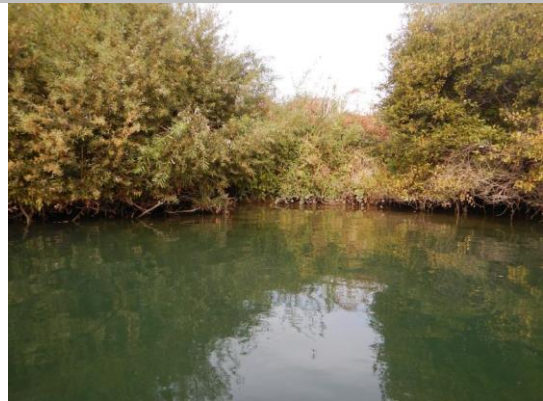
Photo 1 of 2 : SP_2022_RD0999_234_10_20220307_00006.jpg

2018 Site ID: STR 25.7 R
 Status: Eroding
 2018 Field Notes: Site extended upstream.
 Site History: 2011 - Toe scour along length of site and erosion pockets.
 2012 - Site extended slightly upstream due to new erosion pocket.
 2013 - Tall vertical sections at upstream end of site. 2017 - Large erosion scarp near downstream end.

USACE 2018 Erosion Photo #1

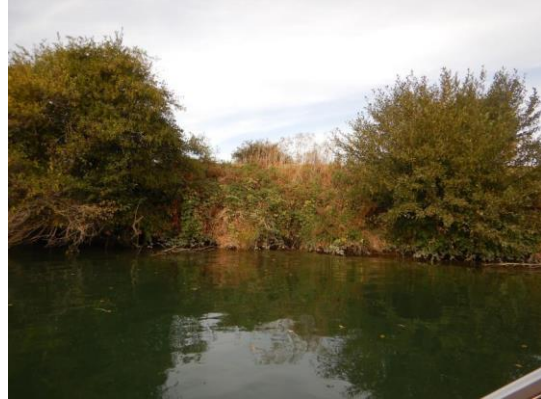
Photo 2 of 2 : SP_2022_RD0999_234_10_20220307_00007.jpg

USACE 2018 Erosion Photo #2

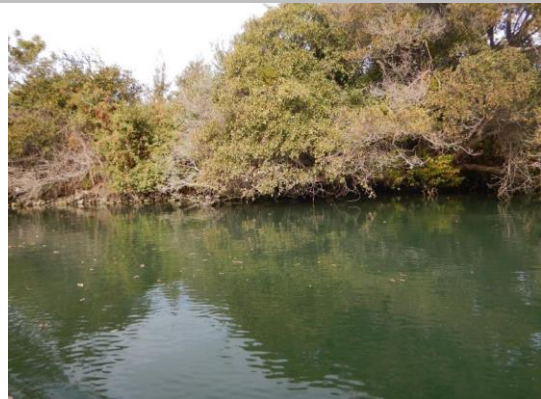
Photo 1 of 2 : SP_2022_RD0999_234_12_20220307_00009.jpg

USACE 2018 Erosion Photo #1

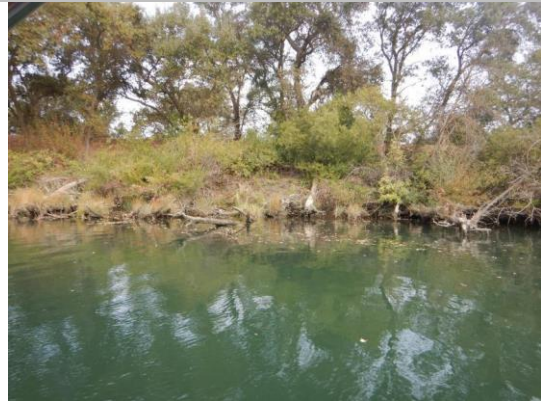
Photo 1 of 1 : SP_2022_RD0999_234_14_20220307_00012.jpg

| Site History: 2011 - Multiple erosion pockets. Some likely from tree popouts. 2013 - Tall vertical sections. 2015 - New tree pop-out and significant new erosion. 2016 - New erosion at toe. 2017 - Site extended downstream, section of lower bank has slumped off. Fresh toe erosion and fresh tree popout. | | | | | |

USACE 2018 Erosion Photo #1

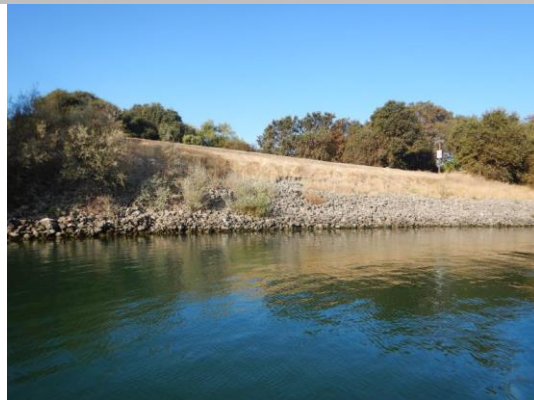
Photo 2 of 2 : SP_2022_RD0999_235_23_20220307_00005.jpg

USACE 2018 Erosion Photo #2

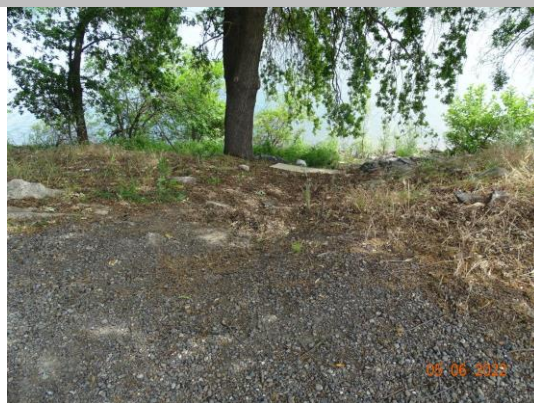
Photo 1 of 1 : SP_2022_RD0999_235_39_20220506_00084.jpg

Footpath on the waterside slope. Spring 2022

Monitor footpath for erosion.

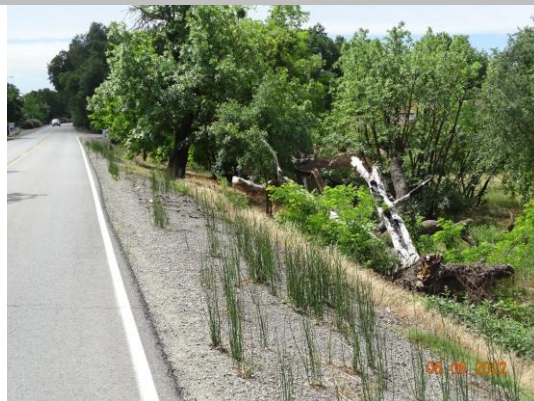
Photo 1 of 1 : SP_2022_RD0999_235_35_20220506_00085.jpg

Fallen tree on the landside slope. Spring 2022

Remove fallen tree from landside slope.

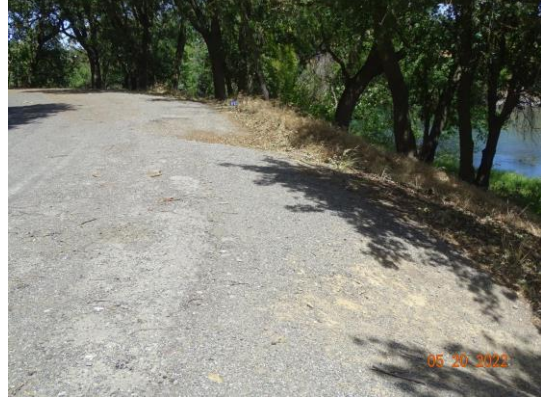
Photo 1 of 1 : SP_2022_RD0999_236_61_20220524_00214.jpg

Footpaths on the waterside slope. Spring 2022

| Monitor three footpaths for further erosion of the waterside slope. | | | | | |

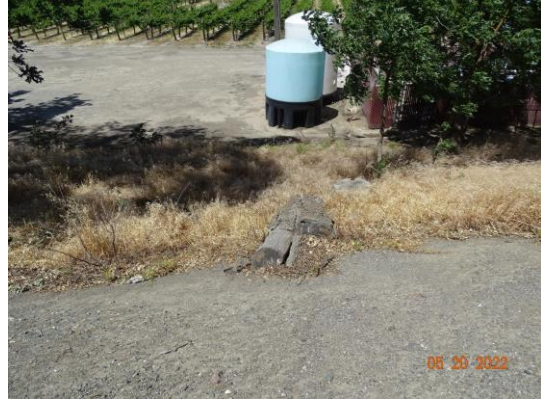
Photo 1 of 1 : SP_2022_RD0999_236_90_20220524_00219.jpg

| A tree stump and two tree logs are located on the LS levee slope. | | | | | |

Tree stump and logs on the landside slope. Spring 2022

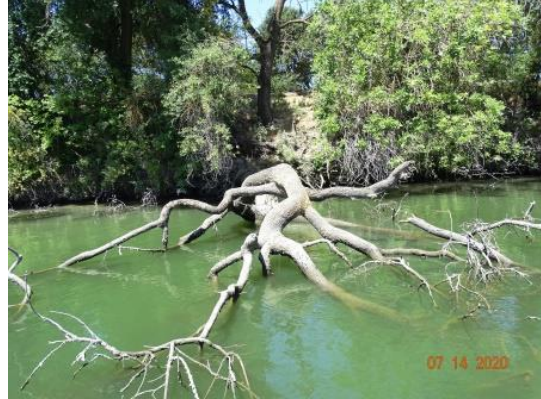
Photo 1 of 2 : SP_2022_RD0999_236_82_20220307_00021.jpg

View of large, fallen tree with exposed rootball. Summer 2020

| Monitor erosion at the water's edge due to a fallen tree with exposed rootball. | | | | | |

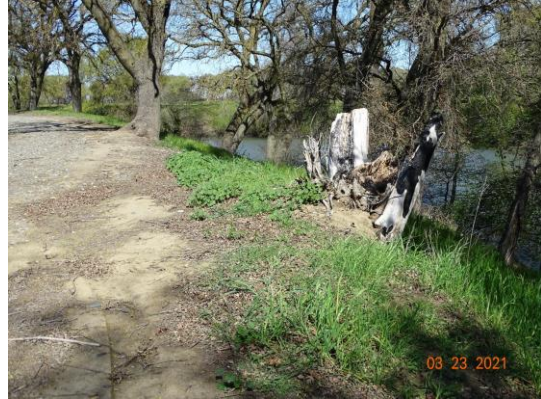
Photo 1 of 1 : SP_2022_RD0999_236_117_20220307_00036.jpg

| A tree stump is located on the WS levee slope. Spring 2021. | | | | | |

View of the tree stump on the WS levee slope. Spring 2021.

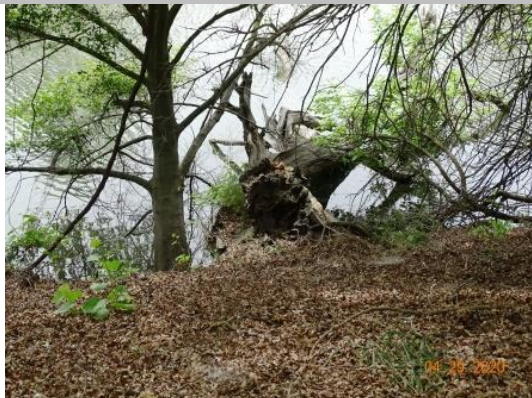
Photo 1 of 1 : SP_2022_RD0999_236_227_20220307_00081.jpg

View of a fallen tree on the waterside slope. Spring 2020

| Remove a fallen tree from the slope. | | | | | |

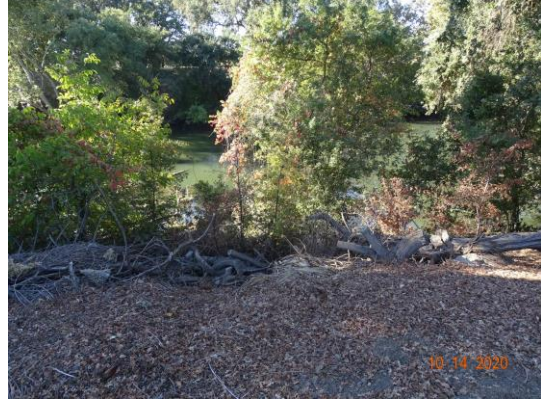
Photo 1 of 1 : SP_2022_RD0999_236_177_20220307_00062.jpg

View of tree logs and limbs on the waterside slope. Fall 2020

| Remove tree log debris from the waterside slope. | | | | | |
