**Flood Control Project Maintenance  
Levee Inspections**

**Maintenance Issue Types Only, Levee Inspection Report By Mile - Spring 2023**

**Reclamation District No. 0999 Netherlands**

Waterway	Bank	Unit Miles	Inspection Start/End	Inspector
Unit No. 01 Yolo Bypass	Left	15.41	04/25/2023 04/25/2023	Marvin Marshall

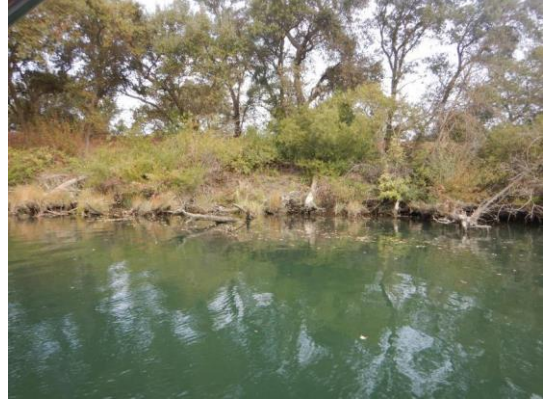
Photo 1 of 1 : SP\_2023\_RD0999\_234\_14\_20230306\_00011.jpg

LM Start	2.97	Rating **	A/W	Issue No.	14
LM End	3.22	Issue Type +	Ma	Location *	WS
Category	Supplemental			GPS Latitude/Longitude	
				Start	End
Item	2018 USACE Erosion Survey			38.323419°	38.325592°
				-121.589645°	-121.585925°
DWR ID	DWR_RD0999_03_s_2022_14				
Comment Code					
Inspector Comment					
2018 Site ID: STR 27.3 R					
Status: Eroding					
2022 Field Notes: No observed change.					
Site History: 2011 - Multiple erosion pockets. Some likely from tree popouts. 2013 - Tall vertical sections. 2015 - New tree pop-out and significant new erosion. 2016 - New erosion at toe. 2017 - Site extended downstream, section of lower bank has slumped off. Fresh toe erosion and fresh tree popout. 2018 - No observed change.

USACE 2018 Erosion Photo #1

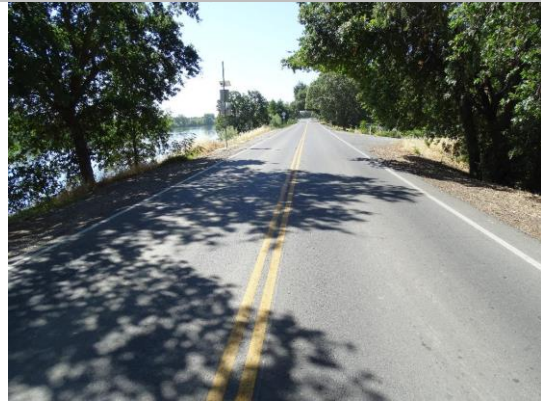
Photo 1 of 3 : UCIP\_SP\_2023\_73928\_88712.jpg

Comment Code						
Inspector Comment						
DS_ID:22788 FS_ID:73928 EP_NO: N/A Repair Type: No Action Needed EVAL Issue: Crossing Status: Found UCIP Comments: 07/01/2020 Record remains No Action Needed. No issues observed during inspection. System Feature. (D.Sanoski - DWR UCIP) 10/27/2017 This structure is inspected annually under the Structure and Channel Summer Inspection (part of the Levee Inspection Program) conducted by the DWR Flood Project Integrity and Inspection Branch (FPIIB). (DWR UCIP - O. Magana) FIELD_STRUCT_DESC: [Elk Slough Inlet Structure] 60-inch by 60-inch reinforced concrete drainage culvert through the levee, 30 feet below the crown. Slide gate in a 6-foot by 8-foot concrete vault on the waterside (WS) shoulder. [Additional Reference(s): DWR Levee Log, 1992 (HLM 0.00). USACE Sacramento O&M Manual, Unit 113, October 1966, Revised 29 December 2016, (0.00), listed as 5-foot by 5-foot culvert.] FS Date: 7/1/2020 10:09:00 AM

Top of Levee: view of crown.

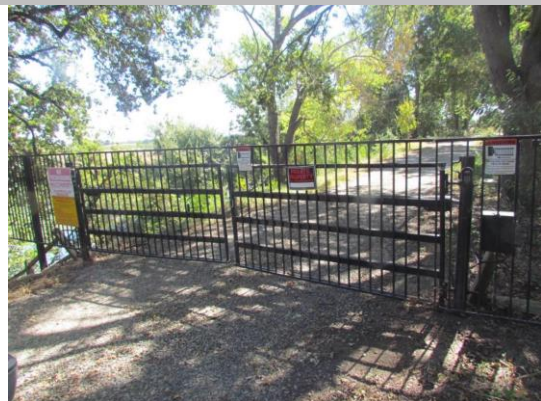
Photo 1 of 1 : SP\_2023\_RD0999\_236\_224\_20230306\_00090.jpg

LM Start	8.82	Rating **	U	Issue No.	224
LM End	8.82	Issue Type +	Ma	Location *	CR
Category	Earthen Levee			GPS Latitude/Longitude	
				Start	End
Item	Access Gates			38.412718°	38.412718°
				-121.529724°	-121.529724°
DWR ID	DWR_RD0999_05_f_2016_224				
Comment Code					
AG : Access Gates					
Inspector Comment					
A landowner installed a gate across the levee crown without a permit.

Looking west at code pad on right side of gate.
