**Flood Control Project Maintenance
Levee Inspections**

Maintenance Issue Types Only, Levee Inspection Report By Mile - Spring 2024

Reclamation District No. 0999 Netherlands

Waterway	Bank	Unit Miles	Inspection Start/End	Inspector
Unit No. 01 Yolo Bypass	Left	15.41	04/18/2024 04/18/2024	Marvin Marshall

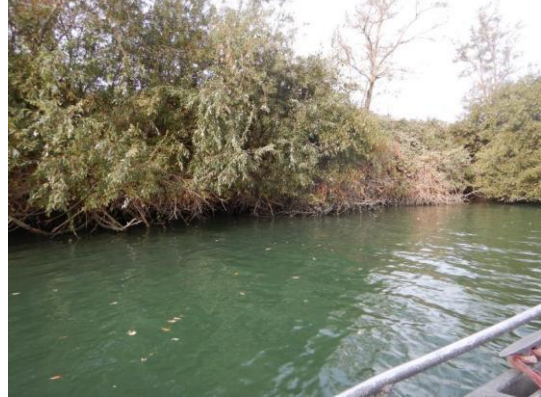
Photo 2 of 2 : SP_2024_RD0999_234_5_20240212_00002.jpg

LM Start	0.24	Rating **	U	Issue No.	5 (cont)
LM End	0.65	Issue Type +	Ma	Location *	WS
Category	Supplemental			GPS Latitude/Longitude	
				Start	End
Item	2018 USACE Erosion Survey			38.289634°	38.295505°
				-121.604343°	-121.605648°
DWR ID	DWR_RD0999_03_s_2022_5

USACE 2018 Erosion Photo #2
