**Flood Control Project Maintenance
Levee Inspections**

Fall 2012 Levee Maintenance Deficiency Summary Report

Sacramento River Basin

Reclamation District No. 1000 Natomas

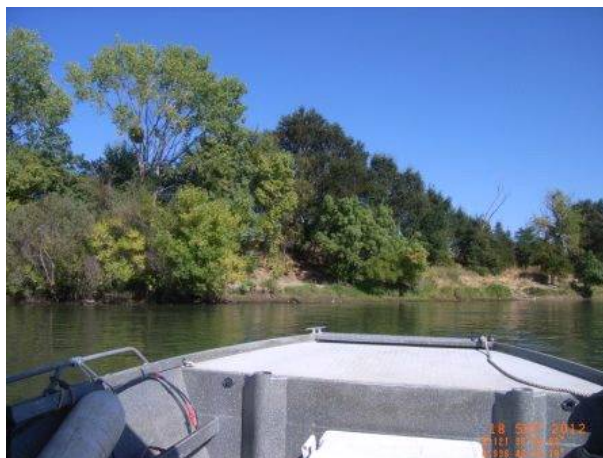
USACE 2012 Photo #1

Levee Mile Report Line	8
Start Levee Mile	0.51
End Levee Mile	0.61
Location	Water Side
Category	Supplemental
Item	USACE Erosion Survey
