**Flood Control Project Maintenance
Levee Inspections**

Fall 2015 Levee Maintenance Deficiency Summary Report

**Flood Control Project Maintenance
Levee Inspections**
LMA District Cover Sheet
Fall 2015 Levee Inspection Results

Reclamation District No. 1000 Natomas

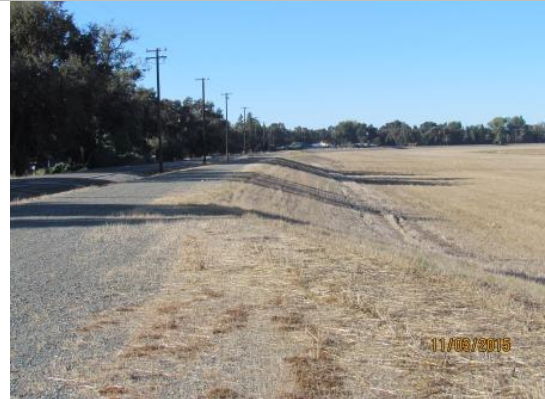
Photo 1 of 1 : FA_2015_RD1000_31_12_20151112_00036.jpg

LM Start	11.81	Rating **	A	Issue No.	12
LM End	11.81	Issue Type +	Ma	Location *	LS
Category	Earthen Levee			GPS Latitude/Longitude	
				Start	End
Item	Vegetation			38.648797 °	38.648797 °
				-121.579782 °	-121.579782 °
DWR ID	DWR_RD1000_01_f _ 2015_12				
Action/Comments					
Control annual grass and weeds on the levee slopes and easements.

View of the acceptable vegetation control on the landside levee slope.

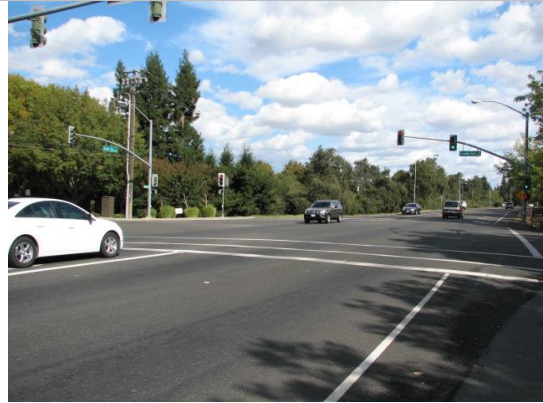
Photo 1 of 3 : FA_2015_RD1000_32_1_20151103_00001.jpg

LM Start	0.56	Rating **	M	Issue No.	1
LM End	2.32	Issue Type +	En	Location *	LS
Category	Earthen Levee			GPS Latitude/Longitude	
				Start	End
Item	Encroachments			38.607549 °	38.605980 °
				-121.501797 °	-121.470627 °
DWR ID	DWR_RD1000_02_s_2012_1				
Action/Comments					
Urban

Levee mile 0.56. This photo is looking upstream from the waterside levee shoulder to the landside shoulder.

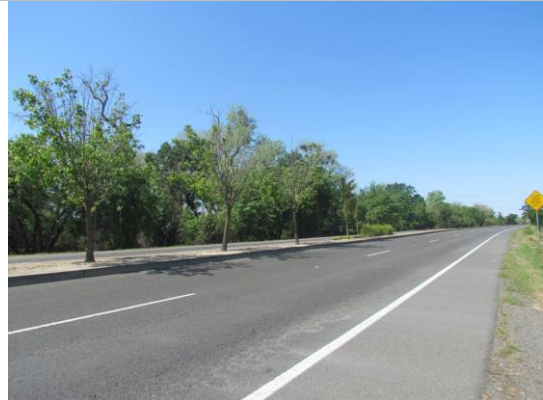
Photo 2 of 3 : FA_2015_RD1000_32_1_20151103_00002.jpg

LM Start	0.56	Rating **	M	Issue No.	1 (cont)
LM End	2.32	Issue Type +	En	Location *	LS

Taken on the landside facing the waterside looking downstream.

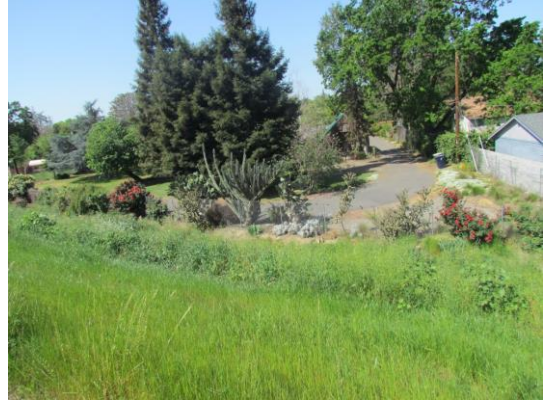
Photo 1 of 2 : FA_2015_RD1000_33_7_20151103_00005.jpg

LM Start	0.09	Rating **	M	Issue No.	7
LM End	0.14	Issue Type +	En	Location *	LS
Category	Earthen Levee			GPS Latitude/Longitude	
				Start	End
Item	Vegetation			38.606882 °	38.607523 °
				-121.469480 °	-121.469033 °
DWR ID	DWR_RD1000_03_s _ 2012_7				
Action/Comments					
Landscaping

Taken facing the landside looking downstream.

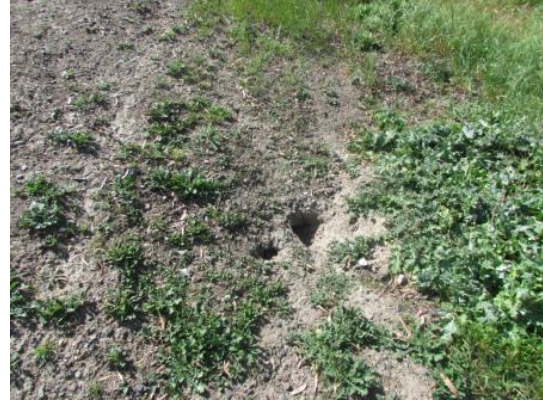
Photo 1 of 1 : FA_2015_RD1000_33_12_20151103_00010.jpg

LM Start	3.29	Rating **	A/W	Issue No.	12
LM End	3.29	Issue Type +	Ma	Location *	LS
Category	Earthen Levee			GPS Latitude/Longitude	
				Start	End
Item	Animal Control			38.652670 °	38.652670 °
				-121.475588 °	-121.475588 °
DWR ID	DWR_RD1000_03_s_2015_12				
Action/Comments					
No rodents visible, but rodent burrows visible; need to backfill and compact or grout burrows.

This photo was taken looking at the landside facing downstream.

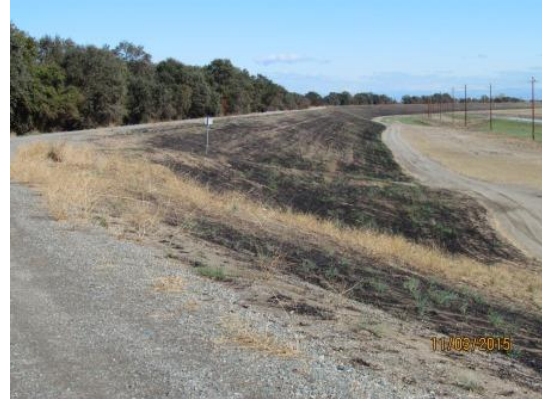
Photo 1 of 1 : FA_2015_RD1000_34_1_20151112_00001.jpg

LM Start	0.19	Rating **	A	Issue No.	1
LM End	4.25	Issue Type +	Ma	Location *	LS
Category	Earthen Levee			GPS Latitude/Longitude	
				Start	End
Item	Vegetation			38.818972 °	38.781306 °
				-121.546581 °	-121.603435 °
DWR ID	DWR_RD1000_04_f _ 2015_1				
Action/Comments					
Control annual grass and weeds on the levee slopes and easements.

View of the acceptable vegetation control on the landside levee slope.
