**Flood Control Project Maintenance
Levee Inspections**

Fall 2017 Levee Maintenance Deficiency Summary Report

Sacramento River Basin

Reclamation District No. 1000 Natomas

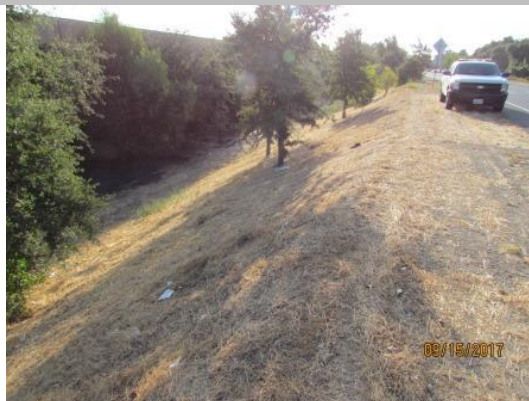
Photo 1 of 1 : FA_2017_RD1000_32_10_20170918_00014.jpg

LM Start	1.74	Rating **	A	Issue No.	10
LM End	2.32	Issue Type +	Ma	Location *	LS
Category	Earthen Levee			GPS Latitude/Longitude	
				Start	End
Item	Vegetation			38.606963 °	38.605969 °
				-121.480301 °	-121.470669 °
DWR ID	DWR_RD1000_02_f_2017_10				
Comment Code					
V1 : Control annual grass and weeds on the levee slopes and easements.					
Inspector Comment					
Well maintained vegetation, Fall 2017.

View of landside looking upstream at well maintained vegetation, Fall 2017.

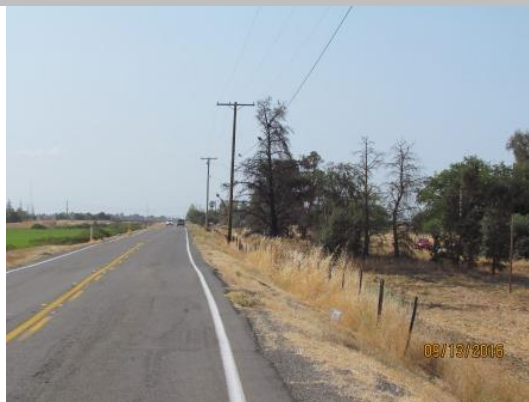
Photo 1 of 1 : FA_2017_RD1000_33_8_20170911_00007.jpg

LM Start	6.27	Rating **	M	Issue No.	8
LM End	6.36	Issue Type +	En	Location *	LS
Category	Earthen Levee			GPS Latitude/Longitude	
				Start	End
Item	Encroachments			38.692847 °	38.694141 °
				-121.485595 °	-121.485596 °
DWR ID	DWR_RD1000_03_f_2015_8				
Comment Code					
FE : Fence					
Inspector Comment					
Fence on landside levee slope.

View of fence on landside levee slope, looking downstream.

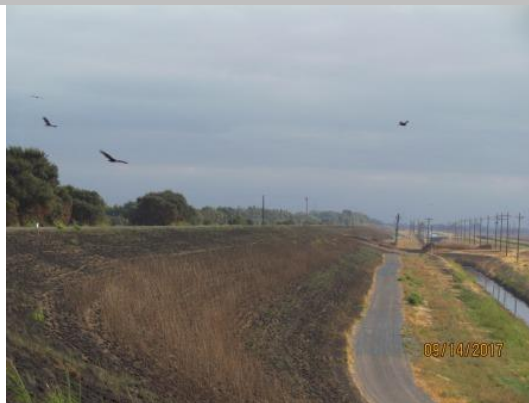
Photo 1 of 1 : FA_2017_RD1000_34_13_20170918_00002.jpg

LM Start	0.02	Rating **	A	Issue No.	13
LM End	4.21	Issue Type +	Ma	Location *	LS
Category	Earthen Levee			GPS Latitude/Longitude	
				Start	End
Item	Vegetation			38.820465 °	38.781834 °
				-121.544003 °	-121.603284 °
DWR ID	DWR_RD1000_04_f_2017_13				
Comment Code					
V1 : Control annual grass and weeds on the levee slopes and easements.					
Inspector Comment					
Well maintained vegetation, Fall 2017.

View looking upstream on the landside at the well maintained vegetation, Fall 2017.
