Flood Control Project Maintenance Levee Inspections

Fall 2021 Levee Maintenance Deficiency Summary Report

Sacramento River Basin

Reclamation District No. 1000 Natomas

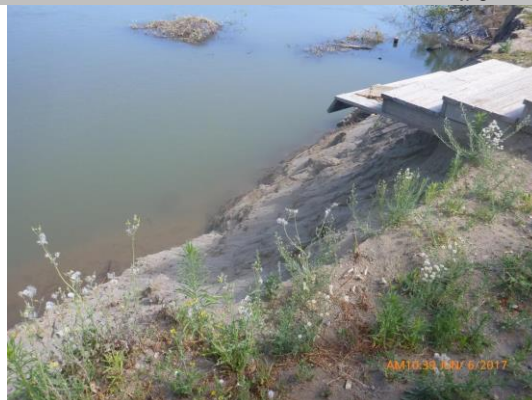
Photo 1 of 3 : LEVAL_FA_2021_45_1257.jpg

LM Start	5.21	Rating **	A/W	Issue No.	4
LM End	5.21	Issue Type +	Ma	Location *	WS
Category	Earthen Levee			GPS Latitude/Longitude	
				Start	End
Item	Erosion / Bank Caving			38.710830 °	38.710830 °
				-121.611100 °	-121.611100 °
DWR ID	LMA-12				
Comment Code					
E1 : Note and monitor erosion site.					
Inspector Comment					
Erosion site is at a private residence.					
Site ID No:45					
Site Designation:LMA-12

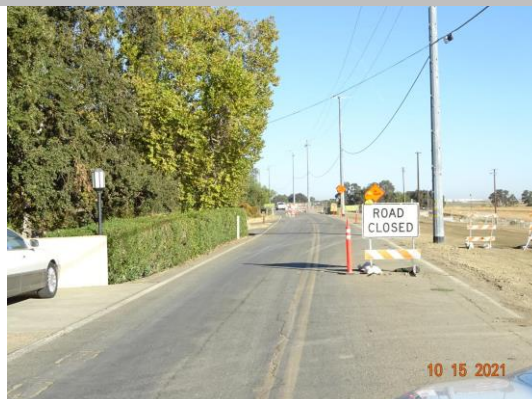
Photo 1 of 1 : FA_2021_RD1000_31_11_20211019_00082.jpg

LM Start	12.53	Rating **	A/W	Issue No.	11
LM End	14.53	Issue Type +	Ma	Location *	CR
Category	Earthen Levee			GPS Latitude/Longitude	
				Start	End
Item	Crown Surface / Depressions / Rutting			38.647855 °	38.620405 °
				-121.567796 °	-121.560157 °
DWR ID	DWR_RD1000_01_f_2020_11				
Comment Code					
C1 : Add appropriate material and re-grade the levee to bring the crown above the design elevation.					
Inspector Comment					
Current section of Unit 1 under construction (Reach B), Fall 2021.

View of construction in Reach B looking upstream, Fall 2021.

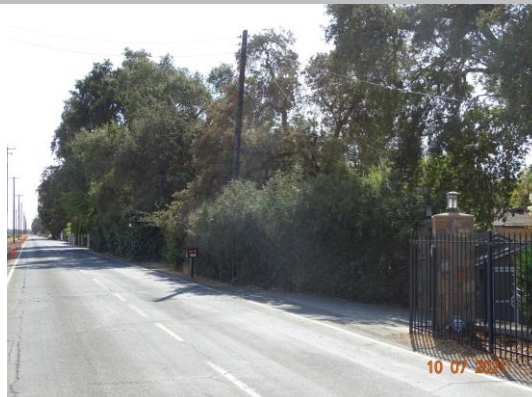
Photo 1 of 1 : FA_2021_RD1000_31_48_20211019_00069.jpg

LM Start	13.33	Rating **	M	Issue No.	48
LM End	13.37	Issue Type +	En	Location *	WS
Category	Earthen Levee			GPS Latitude/Longitude	
				Start	End
Item	Vegetation			38.637602 °	38.637060 °
				-121.561930 °	-121.561833 °
DWR ID	DWR_RD1000_01_s_2012_48				
Comment Code					
V6 : Landscaping					
Inspector Comment					
The landscape vegetation prevents the ability to see waterside slope and will make it difficult to access for flood fight, Fall 2021.

View taken from the crown facing downstream looking at the waterward levee slope at the landscaping, Fall 2021.

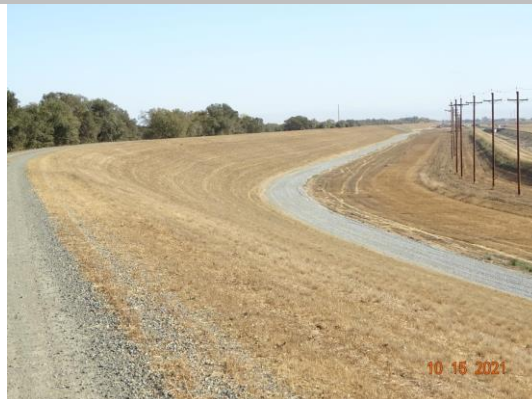
Photo 1 of 1 : FA_2021_RD1000_34_13_20211019_00001.jpg

LM Start	0.01	Rating **	A	Issue No.	13
LM End	3.84	Issue Type +	Ma	Location *	LS
Category	Earthen Levee			GPS Latitude/Longitude	
				Start	End
Item	Vegetation			38.820549 °	38.786427 °
				-121.543915 °	-121.599647 °
DWR ID	DWR_RD1000_04_f_2021_13				
Comment Code					
V1 : Control annual grass and weeds on the levee slopes and easements.					
Inspector Comment					
Annual vegetation is well maintained, Fall 2021.

View of well maintained vegetation on the landside slope, Fall 2021.

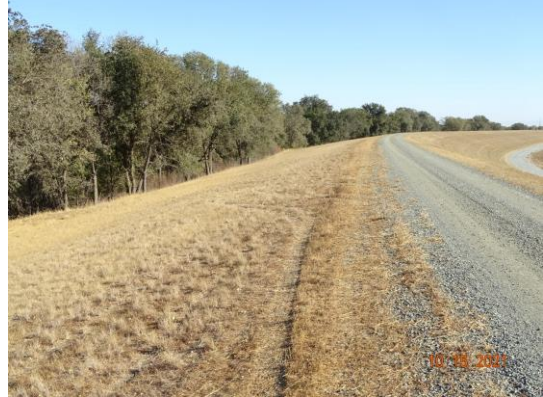
Photo 1 of 1 : FA_2021_RD1000_34_14_20211019_00002.jpg

LM Start	0.01	Rating **	A	Issue No.	14
LM End	3.84	Issue Type +	Ma	Location *	WS
Category	Earthen Levee			GPS Latitude/Longitude	
				Start	End
Item	Vegetation			38.820549 °	38.786426 °
				-121.543915 °	-121.599653 °
DWR ID	DWR_RD1000_04_f _ 2021_14				
Comment Code					
V1 : Control annual grass and weeds on the levee slopes and easements.					
Inspector Comment					
Annual vegetation is well maintained, Fall 2021.

View of well maintained vegetation on the waterside slope, Fall 2021.
