## Flood Control Project Maintenance Levee Inspections

### Fall 2023 Levee Maintenance Deficiency Summary Report

#### Sacramento River Basin

**Reclamation District No. 1000 Natomas**

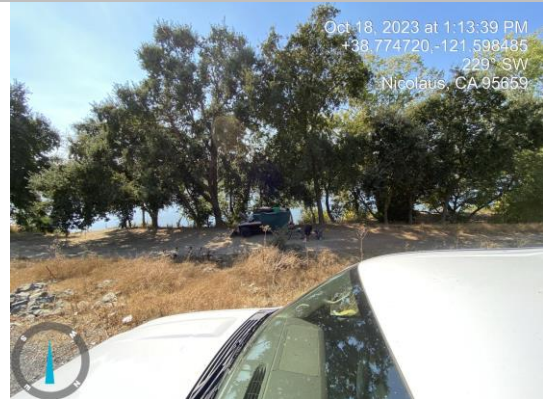
Photo 1 of 1 : FA\_2023\_RD1000\_31\_209\_20231023\_00280.jpg

LM Start	0.48	Rating **	M	Issue No.	209
LM End	0.48	Issue Type +	En	Location *	WS
Category	Earthen Levee			GPS Latitude/Longitude	
				Start	End
Item	Encroachments			38.774808°	38.774808°
				-121.598498°	-121.598498°
DWR ID	DWR_RD1000_01_f _ 2023_209				
Comment Code					
CA : Campers					
Inspector Comment					
There is a camper with a van along the waterside toe road.

View of camper on waterside toe (Fall 2023).

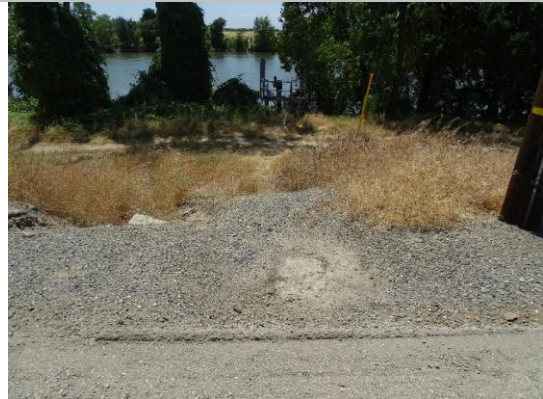
Photo 2 of 3 : UCIP\_FA\_2023\_81189\_116412.jpg

Comment Code					
Inspector Comment					
DS_ID:25177 FS_ID:81189 EP_NO: 4722 Repair Type: Non-Urgent EVAL Issue: Crossing Status: Found UCIP Comments: 06/08/2023 Record updated to Non-Urgent. A minor (less than 1/2-foot) surface erosion located waterward of Garden Highway. Lid was not closed on landside riser creating a safety hazard. Coordinates have been updated from 38.773867, -121.597746 to 38.773700, -121.597690. (M. Thao - DWR UCIP) FIELD_STRUCT_DESC: 10-inch pipe through the levee, 4.0 feet below the crown. Slant pump connected to intake pipe on waterside (WS). 24-inch corrugated metal risers at each of WS and landside (LS) shoulders. (10-inch pipe removed and replaced under Permit No. 4722, 1966 - E.L. Kearns). [Additional Reference(s): DWR Levee Log, 2002 (HLM 0.56). USACE Sacramento O&M Manual, Unit No. 124, June1953, Revised 25 February 2022, River Mile 78.27, listed as 10-inch pipe]. FS Date: 6/8/2023

WS view: Minor (less than 1/2 foot) surface erosion along alignment of pipe; looking waterward.

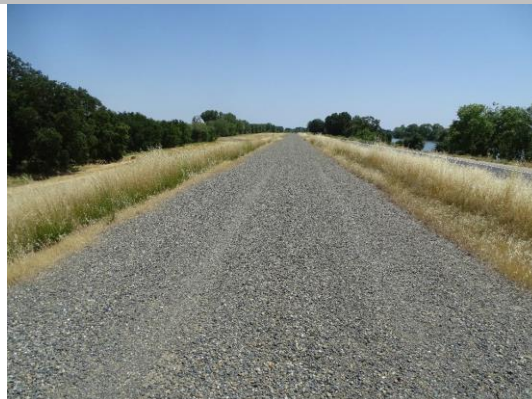
Photo 1 of 3 : UCIP\_FA\_2023\_81228\_117080.jpg

LM Start	0.64	Rating **	M	Issue No.	228
LM End	0.64	Issue Type +	En	Location *	
Category	Supplemental			GPS Latitude/Longitude	
				Start	End
Item	DWR UCIP Field Study			38.772719°	38.772719°
				-121.597002°	-121.597002°
DWR ID	25366				
Comment Code					
Inspector Comment					
DS_ID:25366					
FS_ID:81228					
EP_NO: 7955					
Repair Type: Non-Urgent					
EVAL Issue:					
Crossing Status: Not Found					
UCIP Comments: 06/08/2023 Record updated to Non-Urgent. Crossing not found. (M. Thao - DWR UCIP)					
FIELD_STRUCT_DESC: 2-inch galvanized steel conduit, 1.5 feet below crown. (2-inch pipe authorized under Permit No. 7955, 1972 - Mr. Burton H. Lauppe).					
FS Date: 6/8/2023

Levee crown looking downstream.

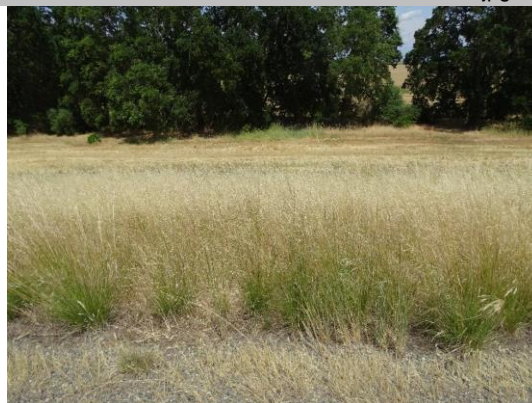
Photo 2 of 3 : UCIP\_FA\_2023\_81228\_117082.jpg

LS view: General overview looking from crown.

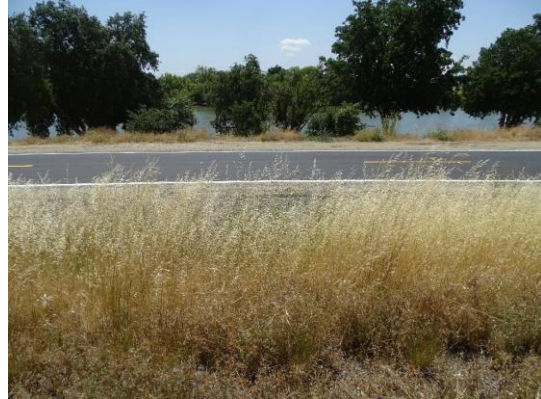
Photo 3 of 3 : UCIP\_FA\_2023\_81228\_117081.jpg

WS view: General overview looking from crown.

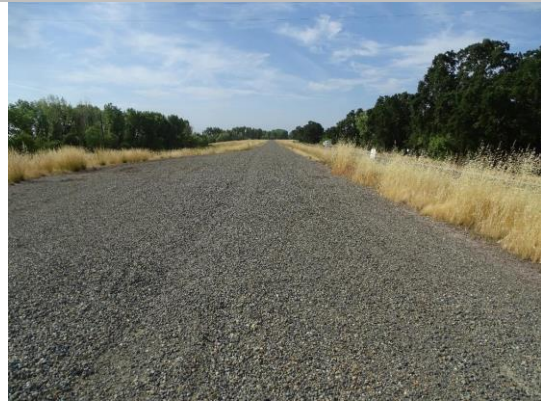
Photo 1 of 3 : UCIP\_FA\_2023\_80942\_116446.jpg

DS\_ID:25193  
 FS\_ID:80942  
 EP\_NO: N/A  
 Repair Type: Non-Urgent  
 EVAL Issue:  
 Crossing Status: Found  
 UCIP Comments: 06/15/2023 Record updated to Non-Urgent. No issues observed during inspection. Coordinates updated from 38.767069, -121.593462 to 38.767016, -121.593246. (M. Thao - DWR UCIP)  
 FIELD\_STRUCT\_DESC: 12-inch steel irrigation pipe through the levee, 8.5 feet below the crown. Pump on pile structure and electrical power pole on waterside (WS) end. Overhead power line crosses levee. Manhole cover located at both WS and landside (LS) shoulders.  
 [Additional Reference(s): DWR Levee Log, 2002 (HLM 1.09). USACE Sacramento O&M Manual, Unit No. 124, June 1953, Revised 25 February 2022, River Mile 77.74, listed as 12-inch pipe].  
 FS Date: 6/15/2023

Levee crown looking downstream.

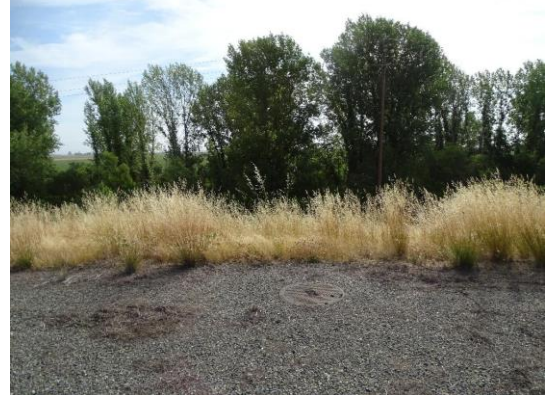
Photo 2 of 3 : UCIP\_FA\_2023\_80942\_116447.jpg

LS view: 24-inch storm drain cover on shoulder.

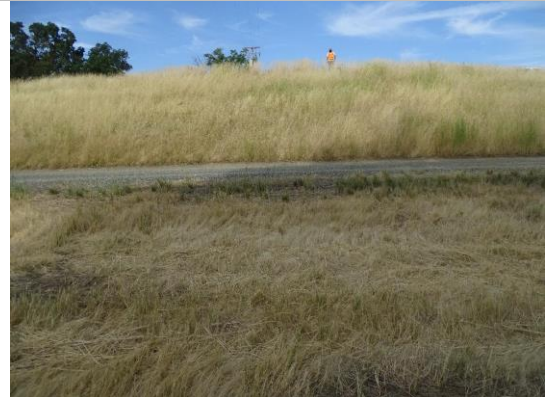
Photo 3 of 3 : UCIP\_FA\_2023\_80942\_116451.jpg

LS view: General overview looking towards levee.

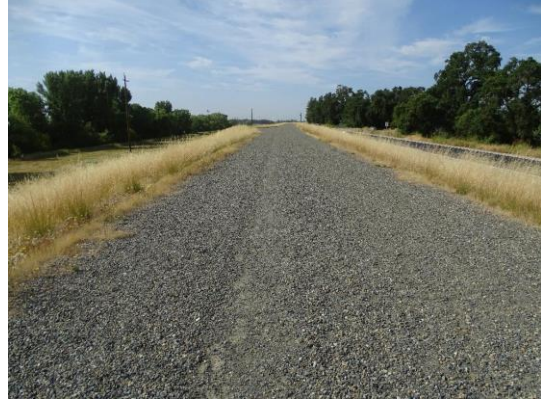
Photo 1 of 3 : UCIP\_FA\_2023\_80943\_116455.jpg

LM Start	1.49	Rating **	M	Issue No.	230	
LM End	1.49	Issue Type +	En	Location *		
Category	Supplemental			GPS Latitude/Longitude		
				Start	End	
Item	DWR UCIP Field Study			38.761321 °	38.761321 °	
				-121.591431 °	-121.591431 °	
DWR ID	25276					
Comment Code						
Inspector Comment						
DS_ID:25276 FS_ID:80943 EP_NO: N/A Repair Type: Non-Urgent EVAL Issue: Crossing Status: Not Found UCIP Comments: 06/15/2023 Record updated to Non-Urgent. Crossing not found. (M. Thao - DWR UCIP) FIELD_STRUCT_DESC: 24-inch pipe through levee, 13.9 feet below the crown. [Additional Reference(s): USACE Sacramento O&M Manual, Unit No. 125, June 1953, Revised 25 February 2022, River Mile 77.32, listed as 24-inch pipe]. FS Date: 6/15/2023

Levee crown looking downstream.

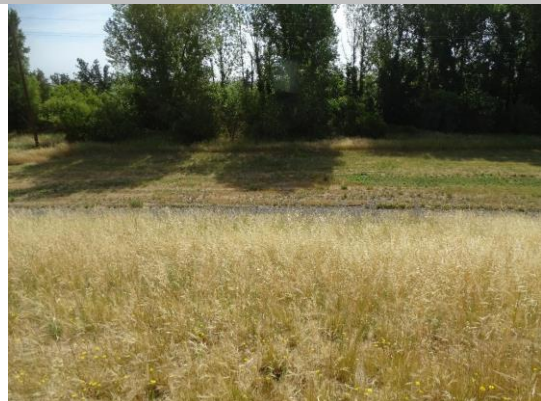
Photo 2 of 3 : UCIP\_FA\_2023\_80943\_116456.jpg

LS view: General overview looking from crown.

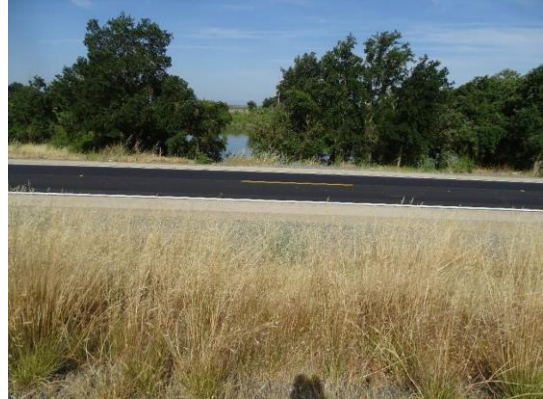
Photo 3 of 3 : UCIP\_FA\_2023\_80943\_116457.jpg

WS view: General overview looking from crown.

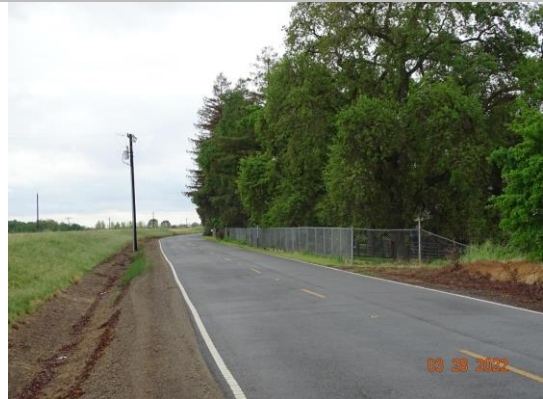
Photo 1 of 1 : FA\_2023\_RD1000\_31\_136\_20231016\_00053.jpg

LM Start	1.63	Rating **	M	Issue No.	136
LM End	1.69	Issue Type +	En	Location *	WS
Category	Earthen Levee			GPS Latitude/Longitude	
				Start	End
Item	Encroachments			38.759320°	38.758415°
				-121.591343°	-121.591348°
DWR ID	DWR_RD1000_01_s_2012_136				
Comment Code					
FE : Fence					
Inspector Comment					
A fence on the waterside slope prevents access.

View of the fence encroachment, Spring 2022.

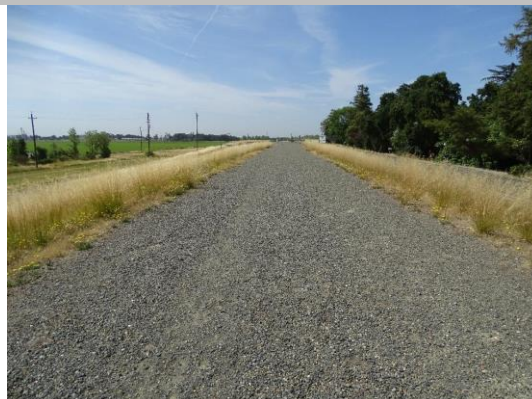
Photo 1 of 3 : UCIP\_FA\_2023\_80560\_116474.jpg

LM Start	1.73	Rating **	M	Issue No.	231
LM End	1.73	Issue Type +	En	Location *	
Category	Supplemental			GPS Latitude/Longitude	
				Start	End
Item	DWR UCIP Field Study			38.757889°	38.757889°
				-121.591345°	-121.591345°
DWR ID	25361				
Comment Code					
Inspector Comment					
DS_ID:25361 FS_ID:80560 EP_NO: N/A Repair Type: Non-Urgent EVAL Issue: Crossing Status: Not Found UCIP Comments: 06/15/2023 Record updated to Non-Urgent. Crossing not found. (M. Thao - DWR UCIP) FIELD_STRUCT_DESC: 12 inch diameter metal pipe through levee open on both ends with smaller sleeved aluminium irrigation pipe. (Permit No. 7226-1972, J.F & C.E. Bennett) FS Date: 6/15/2023

Levee crown looking downstream.

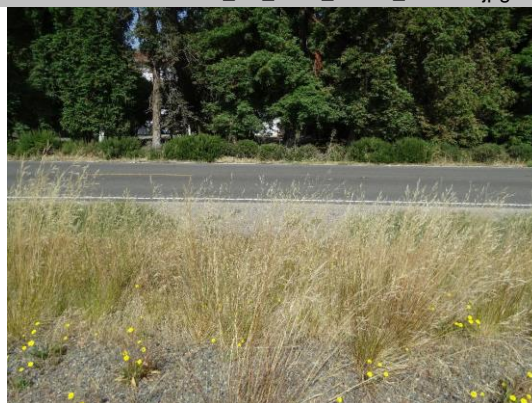
Photo 2 of 3 : UCIP\_FA\_2023\_80560\_116475.jpg

WS view: General overview looking from crown.

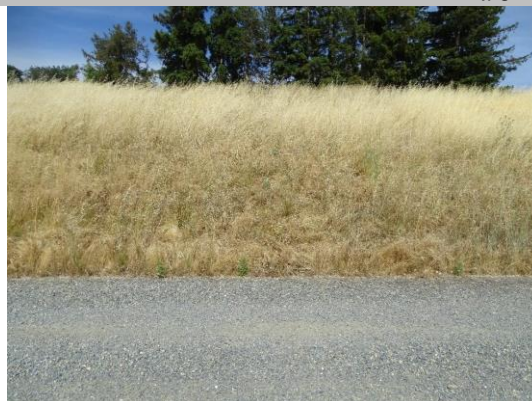
Photo 3 of 3 : UCIP\_FA\_2023\_80560\_116476.jpg

LS view: General overview looking towards levee.

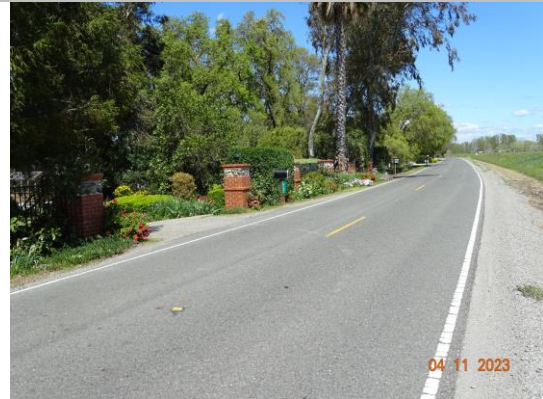
Photo 1 of 1 : FA\_2023\_RD1000\_31\_132\_20231016\_00051.jpg

LM Start	1.94	Rating **	M	Issue No.	132
LM End	1.96	Issue Type +	En	Location *	WS
Category	Earthen Levee			GPS Latitude/Longitude	
				Start	End
Item	Vegetation			38.754848 °	38.754562 °
				-121.591742 °	-121.591795 °
DWR ID	DWR_RD1000_01_s_2012_132				
Comment Code					
V6 : Landscaping					
Inspector Comment					
The landscape vegetation limits the ability to see the waterside slope and will make it difficult to access for flood fight.

View taken from the crown facing upstream looking at the waterward levee slope at the landscaping (Spring 2023).

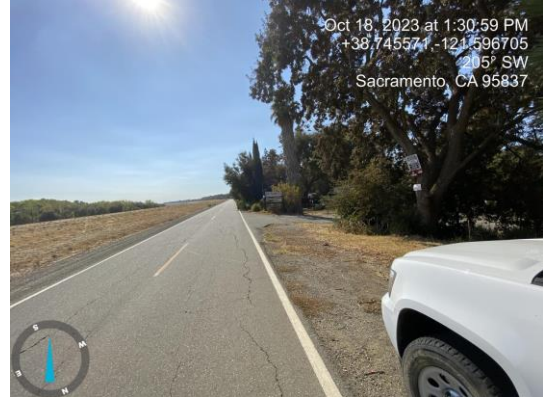
Photo 1 of 1 : FA\_2023\_RD1000\_31\_211\_20231023\_00284.jpg

LM Start	2.64	Rating **	M	Issue No.	211
LM End	2.67	Issue Type +	En	Location *	WS
Category	Earthen Levee			GPS Latitude/Longitude	
				Start	End
Item	Vegetation			38.745529°	38.745128°
				-121.596697°	-121.596935°
DWR ID	DWR_RD1000_01_f_2023_211				
Comment Code					
V6 : Landscaping					
Inspector Comment					
The landscape vegetation limits the ability to see the waterside slope and will make it difficult to access for flood fight.

View of vegetation (bushes) along the waterward slope and looking downstream (Fall 2023).

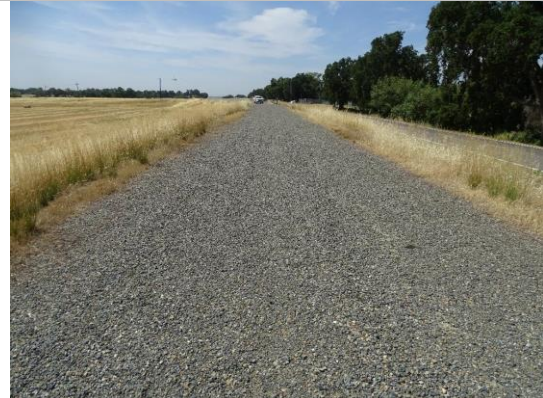
Photo 1 of 3 : UCIP\_FA\_2023\_80955\_116488.jpg

LM Start	3.60	Rating **	M	Issue No.	232	
LM End	3.60	Issue Type +	En	Location *		
Category	Supplemental			GPS Latitude/Longitude		
				Start		End
Item	DWR UCIP Field Study			38.732434°		38.732434°
				-121.602631°		-121.602631°
DWR ID	25269					
Comment Code						
Inspector Comment						
DS_ID:25269 FS_ID:80955 EP_NO: N/A Repair Type: Non-Urgent EVAL Issue: Crossing Status: Not Found UCIP Comments: 06/15/2023 Record updated to Non-Urgent. Crossing not found. (M. Thao - DWR UCIP) FIELD_STRUCT_DESC: 40-inch steel pipe through levee, 16 feet below the Garden Highway. Slide gate on waterside (WS) end. [Additional Reference(s): USACE Sacramento O&M Manual, Unit No. 124, June 1953, Revised 25 February 2022, River Mile 75.18, listed as 40-inch pipe. USACE As-Built Drawing No. 50-13-2810, River Mile 75.18, November 1922]. FS Date: 6/15/2023

Levee crown looking downstream.

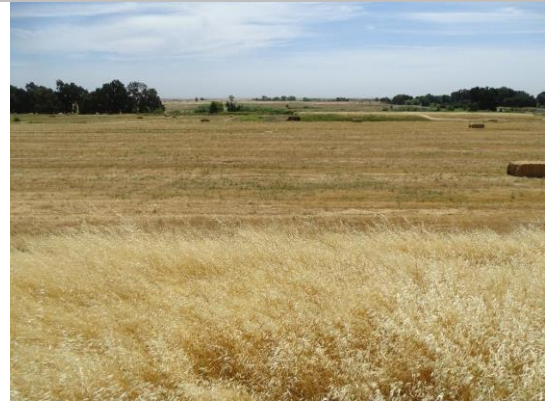
Photo 2 of 3 : UCIP\_FA\_2023\_80955\_116489.jpg

LS view: General overview looking from crown.

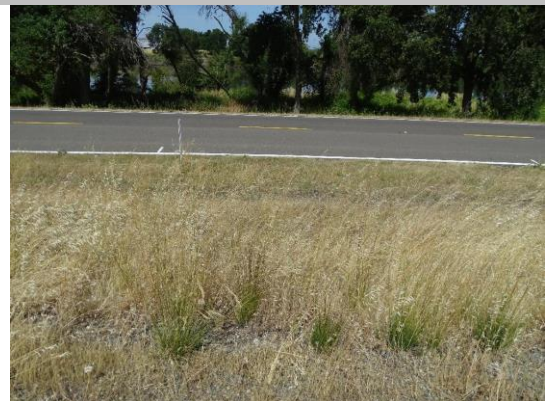
Photo 3 of 3 : UCIP\_FA\_2023\_80955\_116490.jpg

WS view: General overview looking from crown.

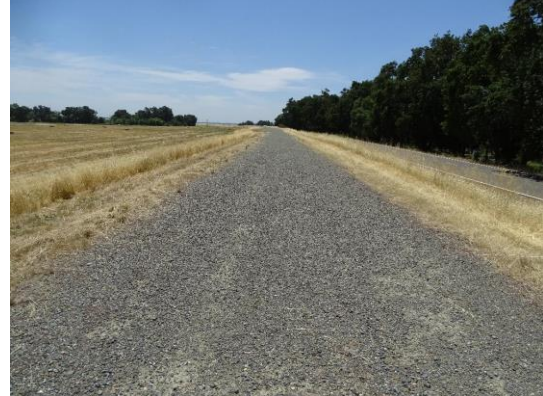
Photo 1 of 3 : UCIP\_FA\_2023\_80953\_116492.jpg

LM Start	3.99	Rating **	M	Issue No.	235
LM End	3.99	Issue Type +	En	Location *	
Category	Supplemental			GPS Latitude/Longitude	
				Start	End
Item	DWR UCIP Field Study			38.726889°	38.726889°
				-121.603412°	-121.603412°
DWR ID	25166				
Comment Code					
Inspector Comment					
DS_ID:25166 FS_ID:80953 EP_NO: N/A Repair Type: Non-Urgent EVAL Issue: Crossing Status: Not Found UCIP Comments: 06/15/2023 Record updated to Non-Urgent. Crossing not found. Unauthorized encroachment recorded in Levee Log. Permit No. 5148 authorizes an overhead power line crossing at the west levee of Yolo Bypass, not underground power cable. (M. Thao - DWR UCIP) FIELD_STRUCT_DESC: Underground power cable along the waterward berm, 5.0 feet from the levee toe. [Additional Reference(s): DWR Levee Log, 2002 (HLM 4.04)]. FS Date: 6/15/2023

Levee crown looking downstream.

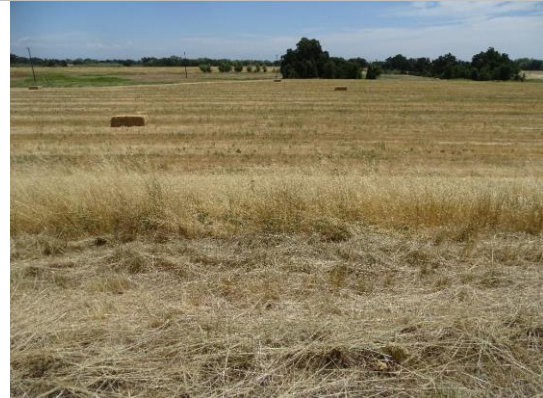
Photo 2 of 3 : UCIP\_FA\_2023\_80953\_116493.jpg

LS view: General overview looking from crown.

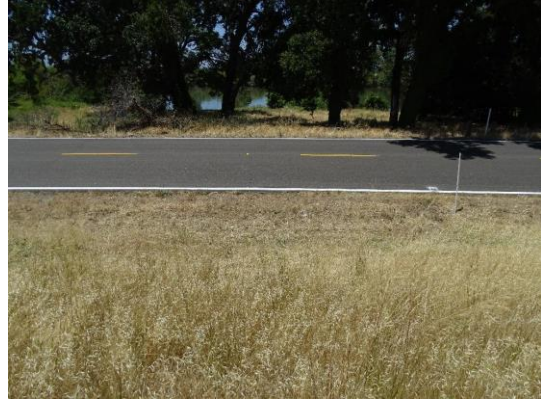
Photo 3 of 3 : UCIP\_FA\_2023\_80953\_116494.jpg

WS view: General overview looking from crown.

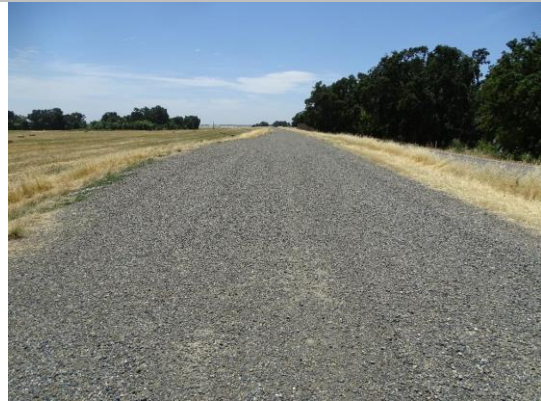
Photo 1 of 3 : UCIP\_FA\_2023\_80954\_116495.jpg

DS\_ID:25181  
 FS\_ID:80954  
 EP\_NO: 10944  
 Repair Type: Non-Urgent  
 EVAL Issue:  
 Crossing Status: Indicator Found  
 UCIP Comments: 06/15/2023 Record updated from No Action Needed to Non-Urgent. No inspection records were available to determine status of line through the levee. (M. Thao - DWR UCIP)  
 FIELD\_STRUCT\_DESC: 4-inch gas line, 3.0 feet below the crown. Shut off valve located approximately 40 feet off the landside (LS) toe. Pipe profile through levee was modified under the Natomas Levee Improvement Program. (4-inch pipe authorized under Permit No. 10944, 1976 - Shell Oil). [Additional Reference(s): DWR Levee Log, 2002 (HLM 4.13). SAFCA As-Built Drawing No. 6-04-2269, Sacramento River East Levee Phase 1B, Volume 3B, 19 August 2013, Sheet 55, Station 215+78.55].  
 FS Date: 6/15/2023

Levee crown looking downstream.

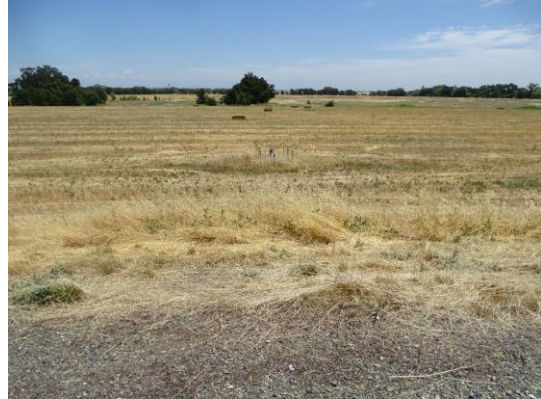
Photo 2 of 3 : UCIP\_FA\_2023\_80954\_116496.jpg

LS view: General overview from crown with shut-off valve approximately 40 feet off toe.

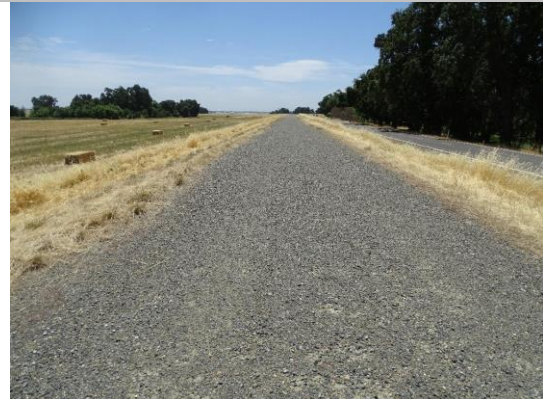
Photo 1 of 3 : UCIP\_FA\_2023\_80570\_116500.jpg

LM Start	4.13	Rating **	M	Issue No.	237	
LM End	4.13	Issue Type +	En	Location *		
Category	Supplemental			GPS Latitude/Longitude		
				Start	End	
Item	DWR UCIP Field Study			38.724892 °	38.724892 °	
				-121.603608 °	-121.603608 °	
DWR ID	25182					
Comment Code						
Inspector Comment						
DS_ID:25182 FS_ID:80570 EP_NO: N/A Repair Type: Non-Urgent EVAL Issue: Crossing Status: Not Found UCIP Comments: 06/15/2023 Record updated to Non-Urgent. Crossing not found. Unauthorized encroachment recorded in Levee Log. (M. Thao - DWR UCIP) FIELD_STRUCT_DESC: Abandoned 7-inch pipe through the levee, 5.8 feet below the crown. [Additional Reference(s): DWR Levee Log, 2002 (HLM 4.18), grouted by Reclamation District 1000]. FS Date: 6/15/2023

Levee crown looking downstream.

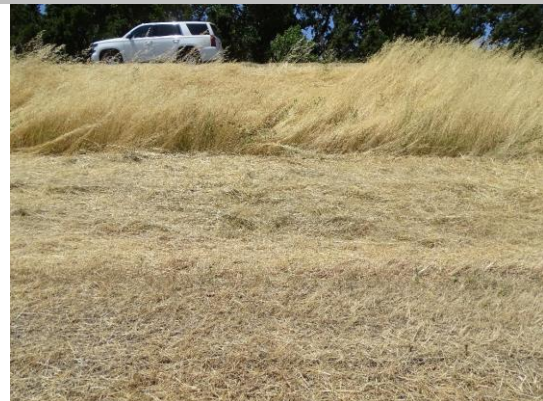
Photo 2 of 3 : UCIP\_FA\_2023\_80570\_116501.jpg

LS view: General overview looking towards levee.

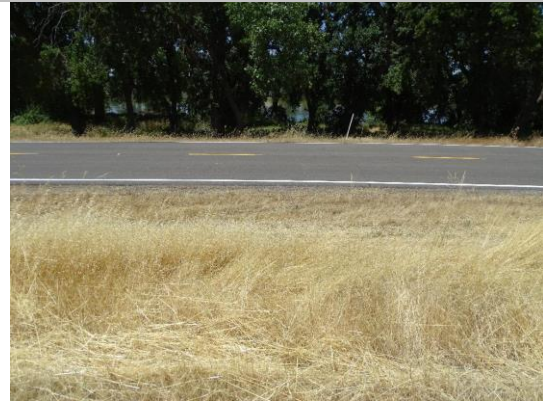
Photo 3 of 3 : UCIP\_FA\_2023\_80570\_116502.jpg

WS view: General overview looking from crown.

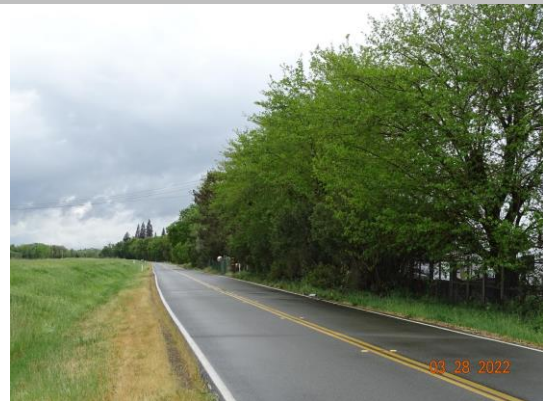
Photo 1 of 1 : FA\_2023\_RD1000\_31\_120\_20231016\_00047.jpg

LM Start	5.17	Rating **	M	Issue No.	120
LM End	5.21	Issue Type +	En	Location *	WS
Category	Earthen Levee			GPS Latitude/Longitude	
				Start	End
Item	Vegetation			38.711248°	38.710806°
				-121.610500°	-121.611110°
DWR ID	DWR_RD1000_01_s_2012_120				
Comment Code					
V6 : Landscaping					
Inspector Comment					
The landscape vegetation limits the ability to see the waterside slope and will make it difficult to access for flood fight.

Typical landscape vegetation along the waterside in front of residences.

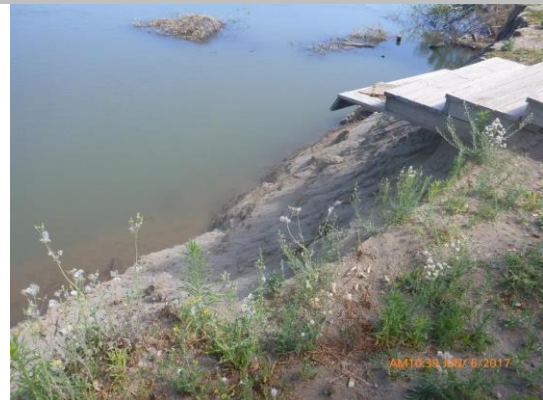
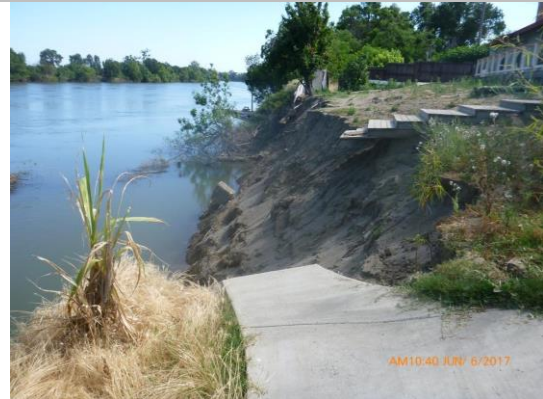
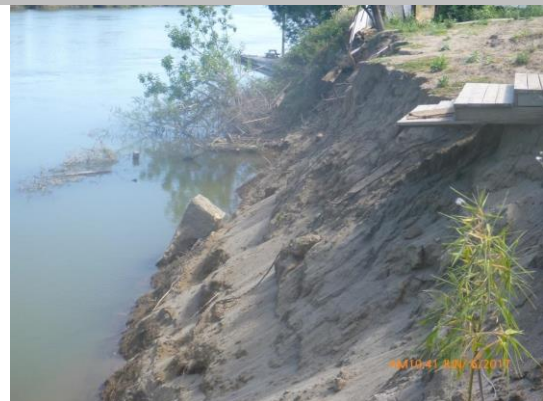
LM Start	5.21	Rating **	A/W	Issue No.	4
LM End	5.21	Issue Type +	Ma	Location *	WS
Category	Earthen Levee			GPS Latitude/Longitude	
				Start	End
Item	Erosion / Bank Caving			38.710830°	38.710830°
				-121.611100°	-121.611100°
DWR ID	LMA-12				
Comment Code					
E1 : Note and monitor erosion site.					
Inspector Comment					
Erosion site is at a private residence.					
Site ID No:45					
Site Designation:LMA-12

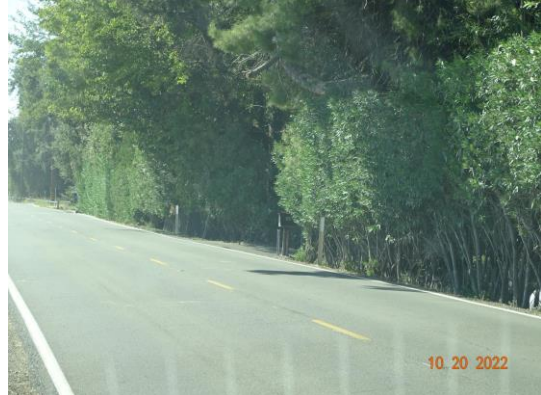
Photo 1 of 1 : FA\_2023\_RD1000\_31\_118\_20231016\_00046.jpg

LM Start	5.62	Rating **	M	Issue No.	118
LM End	5.65	Issue Type +	En	Location *	WS
Category	Earthen Levee			GPS Latitude/Longitude	
				Start	End
Item	Vegetation			38.706456°	38.706082°
				-121.616223°	-121.616385°
DWR ID	DWR_RD1000_01_s_2012_118				
Comment Code					
V6 : Landscaping					
Inspector Comment					
The landscape vegetation limits the ability to see the waterside slope and will make it difficult to access for flood fight.

This photo was taken from the crown facing downstream looking at the landscaping, Fall 2022.

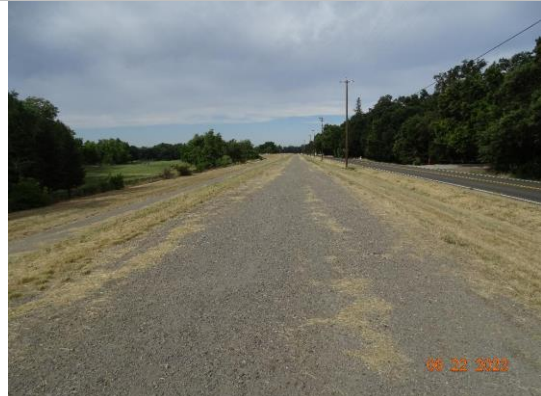
Photo 1 of 3 : UCIP\_FA\_2023\_80573\_116510.jpg

Comment Code						
Inspector Comment						
DS_ID:25184						
FS_ID:80573						
EP_NO: N/A						
Repair Type: Non-Urgent						
EVAL Issue:						
Crossing Status: Not Found						
UCIP Comments: 06/22/2023 Record updated to Non-Urgent. Crossing not found. (M. Thao - DWR UCIP)						
FIELD_STRUCT_DESC: Two 2-inch electric steel conduits through the levee, 3.0 feet below the crown. Pole at the toe of the landside (LS) slope. Transformer pad on the waterside (WS) end. (15 kV power cable authorized under Permit No. 6691, 1969 - Sacramento Municipal Utility District). [Additional Reference(s): DWR Levee Log, 2002 (HLM 5.99), listed as two 3.5-inch electrical conduits].						
FS Date: 6/22/2023

Levee crown looking downstream.

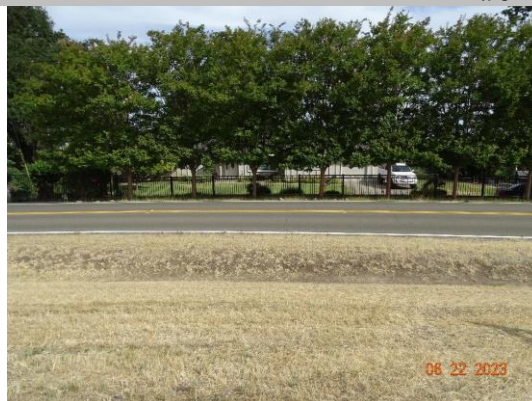
Photo 2 of 3 : UCIP\_FA\_2023\_80573\_116511.jpg

WS view: General overview looking from crown.

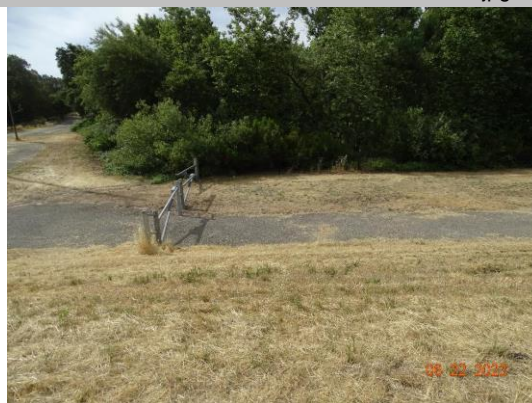
Photo 3 of 3 : UCIP\_FA\_2023\_80573\_116512.jpg

LS view: General overview looking from crown.

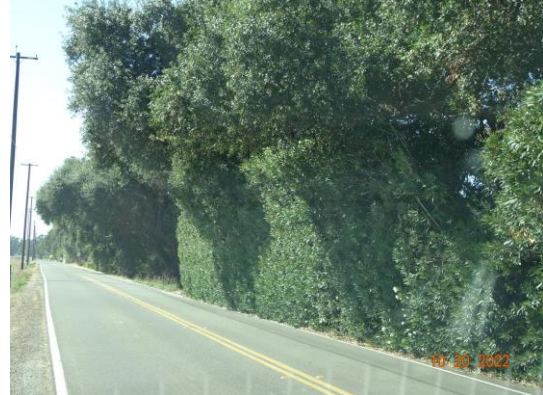
Photo 1 of 1 : FA\_2023\_RD1000\_31\_116\_20231016\_00045.jpg

LM Start	5.97	Rating **	M	Issue No.	116
LM End	6.00	Issue Type +	En	Location *	WS
Category	Earthen Levee			GPS Latitude/Longitude	
				Start	End
Item	Vegetation			38.702742°	38.702467°
				-121.620557°	-121.620947°
DWR ID	DWR_RD1000_01_s_2012_116				
Comment Code					
V6 : Landscaping					
Inspector Comment					
The landscape vegetation limits the ability to see the waterside slope and will make it difficult to access for flood fight.

View looking at waterside landscape vegetation that is blocking access and visibility to the levee, Fall 2022.

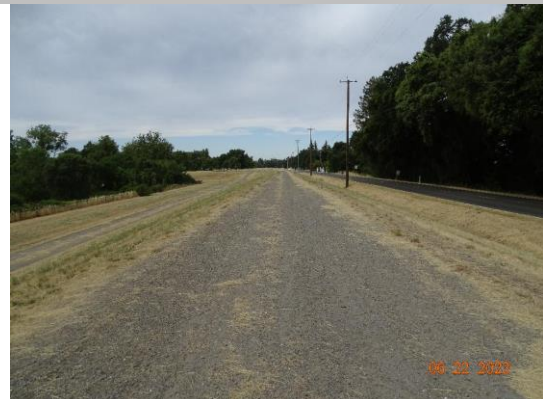
Photo 1 of 3 : UCIP\_FA\_2023\_80574\_116513.jpg

LM Start	6.01	Rating **	M	Issue No.	239
LM End	6.01	Issue Type +	En	Location *	
Category	Supplemental			GPS Latitude/Longitude	
				Start	End
Item	DWR UCIP Field Study			38.702458°	38.702458°
				-121.621181°	-121.621181°
DWR ID	25185				
Comment Code					
Inspector Comment					
DS_ID:25185 FS_ID:80574 EP_NO: 12820 Repair Type: Non-Urgent EVAL Issue: Crossing Status: Not Found UCIP Comments: 06/22/2023 Record updated to Non-Urgent. Crossing not found. (M. Thao - DWR UCIP) FIELD_STRUCT_DESC: Two 3-inch PVC conduits (electrical and communication) through levee, 3 feet below crown. (Two 3-inch conduits authorized under Permit No. 12820 , 1979 - Sacramento Municipal Utility District). [Additional Reference(s): DWR Levee Log, 2002 (HLM 6.09)]. FS Date: 6/22/2023

Levee crown looking downstream.

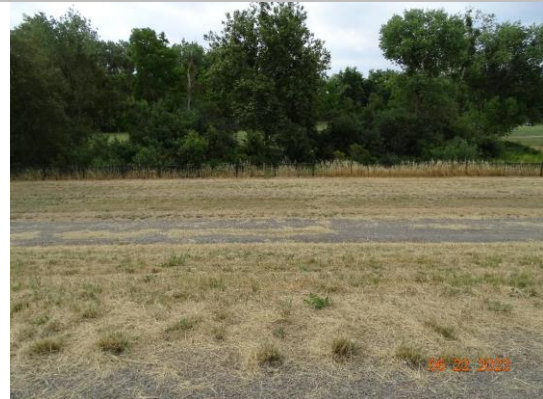
Photo 2 of 3 : UCIP\_FA\_2023\_80574\_116514.jpg

LS view: General overview looking from crown.

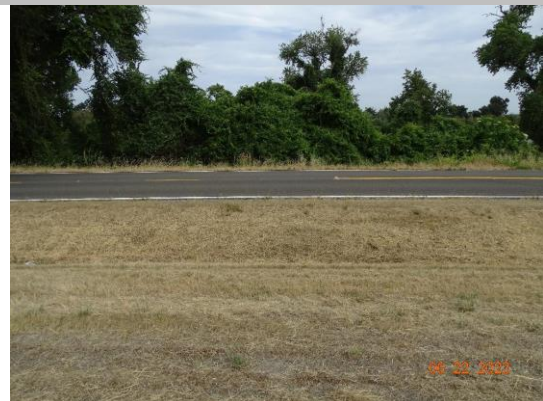
Photo 3 of 3 : UCIP\_FA\_2023\_80574\_116515.jpg

WS view: General overview looking from crown.

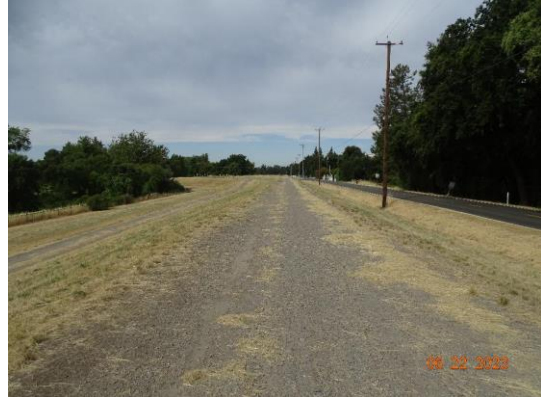
Photo 1 of 3 : UCIP\_FA\_2023\_80576\_116521.jpg

LM Start	6.03	Rating **	M	Issue No.	240
LM End	6.03	Issue Type +	En	Location *	
Category	Supplemental			GPS Latitude/Longitude	
				Start	End
Item	DWR UCIP Field Study			38.702283°	38.702283°
				-121.621470°	-121.621470°
DWR ID	25186				
Comment Code					
Inspector Comment					
DS_ID:25186 FS_ID:80576 EP_NO: 12490 Repair Type: Non-Urgent EVAL Issue: Crossing Status: Not Found UCIP Comments: 06/22/2023 Record updated to Non-Urgent. Crossing not found. (M. Thao - DWR UCIP) FIELD_STRUCT_DESC: 1 of 2: 3-inch electrical PVC conduit through levee, 3 feet below crown. (3-inch conduit authorized under Permit No. 12490, 1978 - SMUD). [Additional Reference(s): DWR Levee Log, 2002 (HLM 6.14)]. FS Date: 6/22/2023

Levee crown looking downstream.

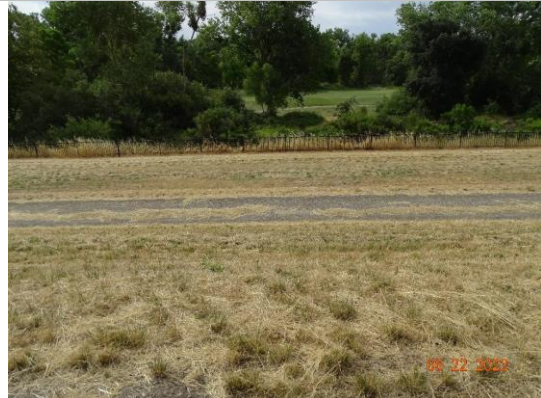
Photo 2 of 3 : UCIP\_FA\_2023\_80576\_116523.jpg

LS view: General overview looking from crown.

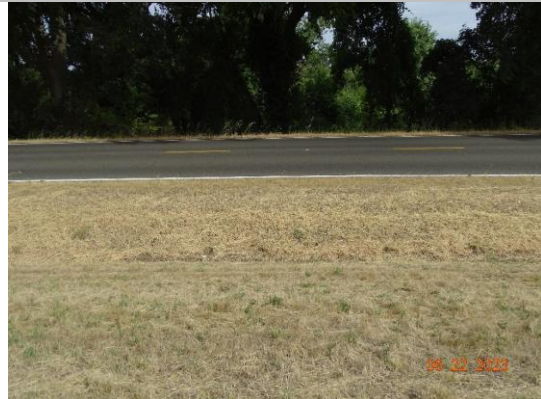
Photo 3 of 3 : UCIP\_FA\_2023\_80576\_116522.jpg

WS view: General overview looking from crown.

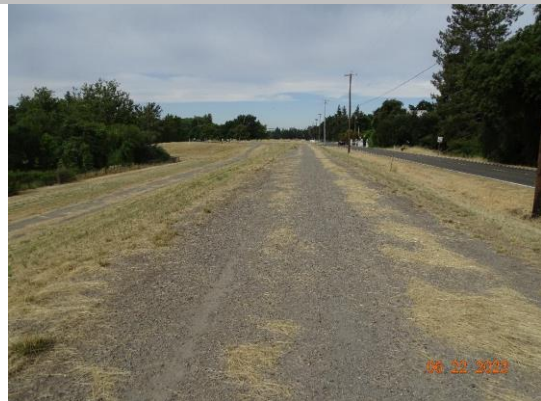
Photo 1 of 3 : UCIP\_FA\_2023\_80959\_116528.jpg

DS\_ID:25314  
 FS\_ID:80959  
 EP\_NO: 12513  
 Repair Type: Non-Urgent  
 EVAL Issue:  
 Crossing Status: Not Found  
 UCIP Comments: 06/22/2023 Record updated to Non-Urgent. Crossing not found. Coordinates updated from 38.702195, -121.621614 to 38.702270, -121.621494. (M. Thao - DWR UCIP)  
 FIELD\_STRUCT\_DESC: 2 of 2: 3-inch PVC communication conduit through levee, 3 feet below crown. (3-inch conduit authorized under Permit No. 12490, 1978 - SMUD; service wire placed in the 3-inch conduit authorized under Permit No. 12513, 1980 - Pacific Telephone and Telegraph Company). [Additional Reference(s): DWR Levee Log, 2002 (HLM 6.14)].  
 FS Date: 6/22/2023

Levee crown looking downstream.

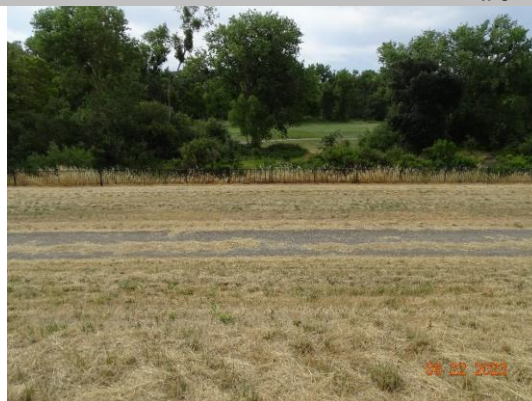
Photo 2 of 3 : UCIP\_FA\_2023\_80959\_116529.jpg

LS view: General overview looking from crown.

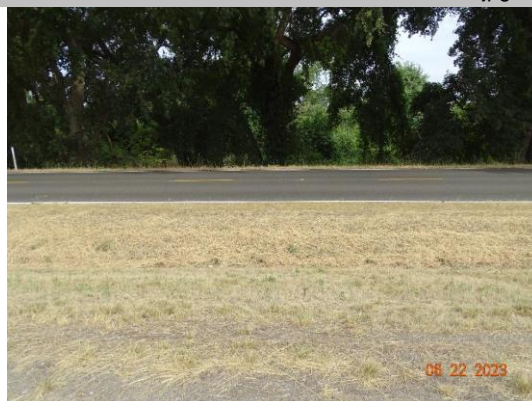
Photo 3 of 3 : UCIP\_FA\_2023\_80959\_116530.jpg

WS view: General overview looking from crown.

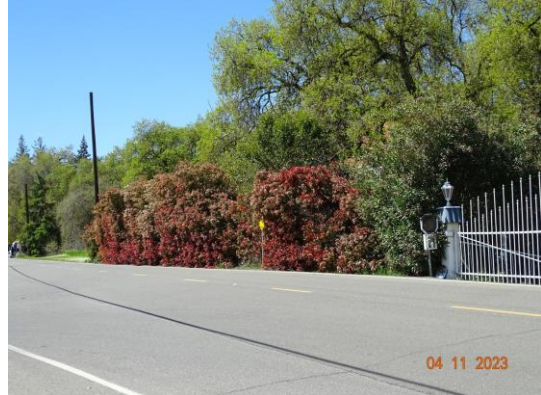
Photo 1 of 1 : FA\_2023\_RD1000\_31\_113\_20231016\_00044.jpg

LM Start	6.12	Rating **	M	Issue No.	113
LM End	6.17	Issue Type +	En	Location *	WS
Category	Earthen Levee			GPS Latitude/Longitude	
				Start	End
Item	Vegetation			38.701422°	38.700987°
				-121.622755°	-121.623564°
DWR ID	DWR_RD1000_01_s_2012_113				
Comment Code					
V6 : Landscaping					
Inspector Comment					
The landscape vegetation limits the ability to see the waterside slope and will make it difficult to access for flood fight.

View taken from the crown facing downstream looking at the waterward levee slope at the landscaping (Spring 2023).

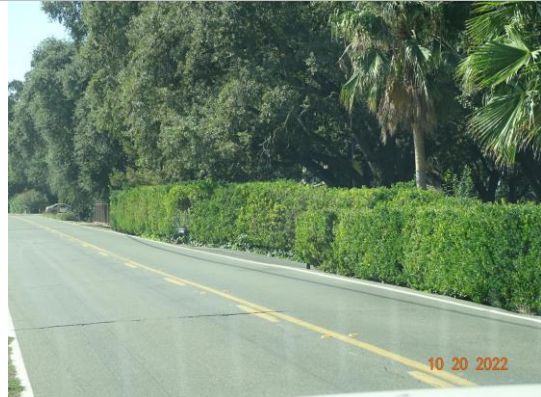
Photo 1 of 1 : FA\_2023\_RD1000\_31\_68\_20231016\_00031.jpg

LM Start	6.36	Rating **	M	Issue No.	68
LM End	6.40	Issue Type +	En	Location *	WS
Category	Earthen Levee			GPS Latitude/Longitude	
				Start	End
Item	Vegetation			38.699313°	38.698978°
				-121.626281°	-121.626777°
DWR ID	DWR_RD1000_01_s_2015_68				
Comment Code					
V6 : Landscaping					
Inspector Comment					
The landscape vegetation limits the ability to see the waterside slope and will make it difficult to access for flood fight.

View at landscape vegetation that is blocking visibility and access, Fall 2022.

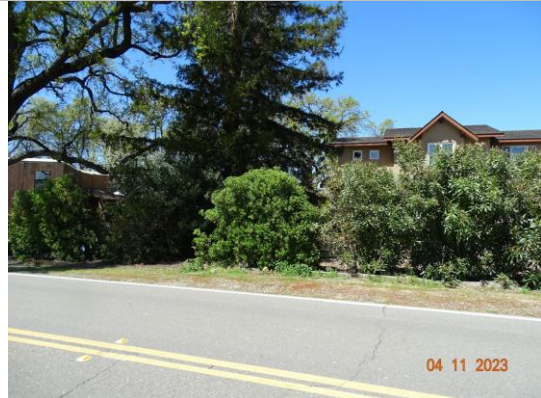
Photo 1 of 1 : FA\_2023\_RD1000\_31\_125\_20231016\_00050.jpg

LM Start	6.49	Rating **	M	Issue No.	125
LM End	6.49	Issue Type +	En	Location *	WS
Category	Earthen Levee			GPS Latitude/Longitude	
				Start	End
Item	Vegetation			38.758607°	38.758607°
				-121.601933°	-121.601933°
DWR ID	DWR_RD1000_01_s_2012_125				
Comment Code					
V6 : Landscaping					
Inspector Comment					
The landscape vegetation limits the ability to see the waterside slope and will make it difficult to access for flood fight.

View taken from the crown facing downstream looking at the waterward levee slope at the landscaping (Spring 2023).

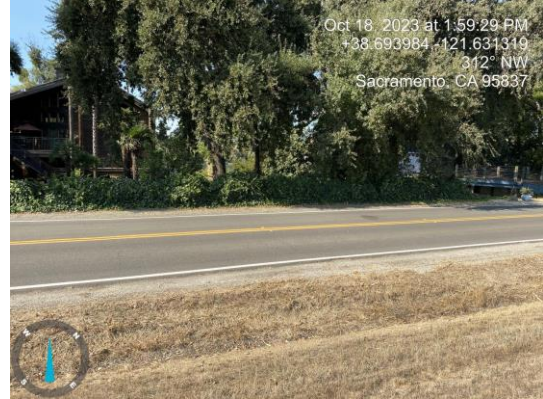
Photo 1 of 1 : FA\_2023\_RD1000\_31\_215\_20231025\_00287.jpg

LM Start	6.80	Rating **	M	Issue No.	215
LM End	6.83	Issue Type +	En	Location *	WS
Category	Earthen Levee			GPS Latitude/Longitude	
				Start	End
Item	Vegetation			38.694273°	38.693865°
				-121.631076°	-121.631349°
DWR ID	DWR_RD1000_01_f_2023_215				
Comment Code					
V6 : Landscaping					
Inspector Comment					
The landscape vegetation limits the ability to see the waterside slope and will make it difficult to access for flood fight.

View of landscaping on the waterside slope (Fall 2023).

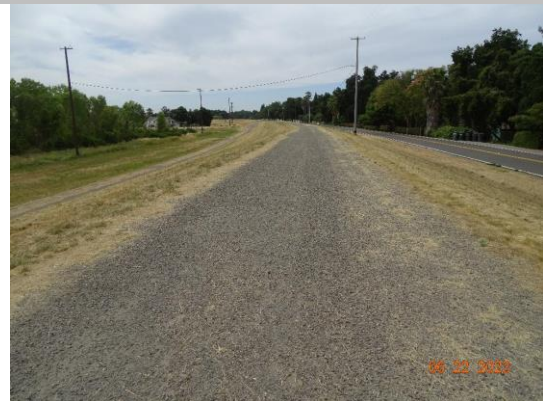
Photo 1 of 3 : UCIP\_FA\_2023\_80608\_116547.jpg

LM Start	7.09	Rating **	M	Issue No.	243	
LM End	7.09	Issue Type +	En	Location *		
Category	Supplemental			GPS Latitude/Longitude		
				Start		End
Item	DWR UCIP Field Study			38.690430 °		38.690430 °
				-121.632735 °		-121.632735 °
DWR ID	25191					
Comment Code						
Inspector Comment						
DS_ID:25191 FS_ID:80608 EP_NO: 12604 Repair Type: Non-Urgent EVAL Issue: Crossing Status: Not Found UCIP Comments: 06/22/2023 Record updated to Non-Urgent. Crossing not found. (M. Thao - DWR UCIP) FIELD_STRUCT_DESC: Two 3-inch PVC conduits through the levee, 2 feet below the crown. (Two 3-inch conduits authorized under Permit No. 12565, 1978 - Sacramento Municipal Utility District; service wire placed in one of the 3-inch conduit under Permit No. 12604, 1979 - Pacific Telephone and Telegraph Company). [Additional Reference(s): DWR Levee Log, 2002 (HLM 7.18)]. FS Date: 6/22/2023

Levee crown looking downstream.

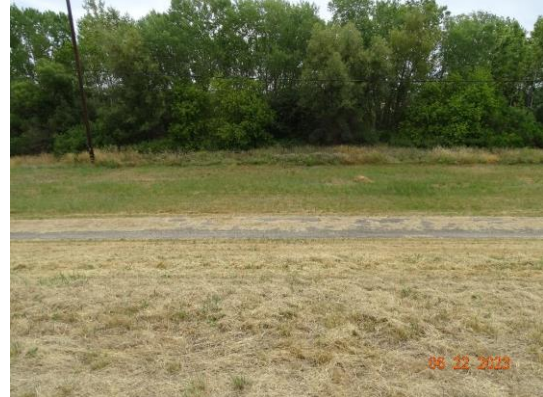
Photo 2 of 3 : UCIP\_FA\_2023\_80608\_116548.jpg

LS view: General overview looking from crown.

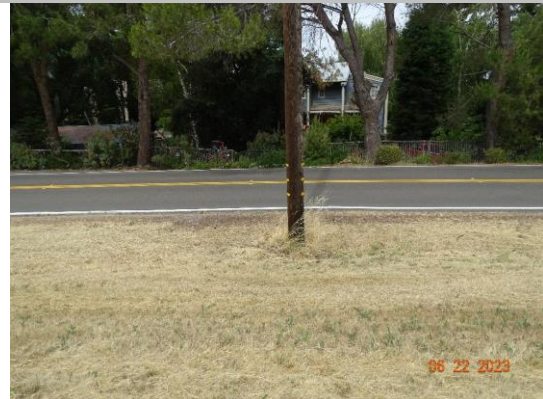
Photo 3 of 3 : UCIP\_FA\_2023\_80608\_116546.jpg

WS view: General overview looking from crown; no conduit attached to wooden power pole on toe.

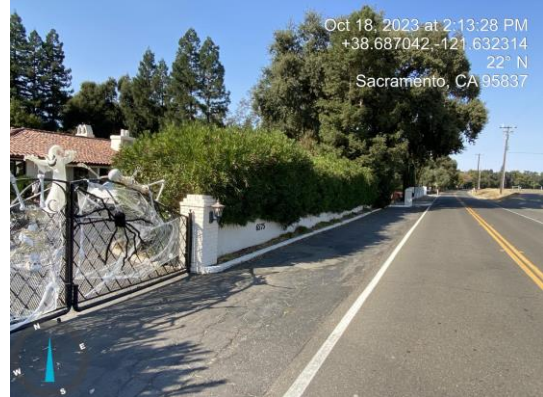
Photo 1 of 1 : FA\_2023\_RD1000\_31\_96\_20231025\_00289.jpg

LM Start	7.30	Rating **	M	Issue No.	96
LM End	7.34	Issue Type +	En	Location *	WS
Category	Earthen Levee			GPS Latitude/Longitude	
				Start	End
Item	Vegetation			38.687347°	38.686780°
				-121.632433°	-121.632138°
DWR ID	DWR_RD1000_01_f_2023_96				
Comment Code					
V6 : Landscaping					
Inspector Comment					
The landscape vegetation limits the ability to see the waterside slope and will make it difficult to access for flood fight.

View of landscaping on the waterside slope (Fall 2023).

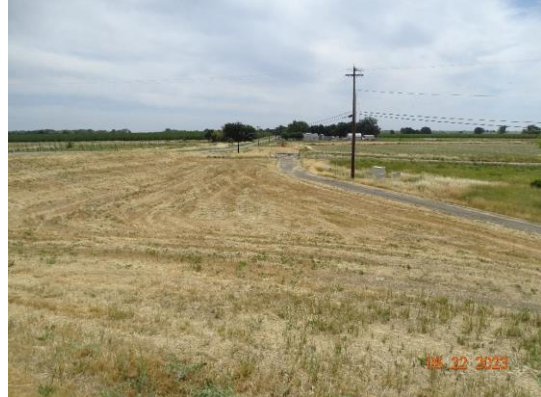
Photo 1 of 2 : UCIP\_FA\_2023\_80612\_116556.jpg

LM Start	7.41	Rating **	M	Issue No.	246	
LM End	7.41	Issue Type +	En	Location *		
Category	Supplemental			GPS Latitude/Longitude		
				Start	End	
Item	DWR UCIP Field Study			38.685760 °	38.685760 °	
				-121.631957 °	-121.631957 °	
DWR ID	25178					
Comment Code						
Inspector Comment						
DS_ID:25178 FS_ID:80612 EP_NO: 12287 Repair Type: Non-Urgent EVAL Issue: Crossing Status: Not Found UCIP Comments: 06/22/2023 Record updated to Non-Urgent. Crossing not found. (M.Thao - DWR UCIP)  FIELD_STRUCT_DESC: Four 3-inch PVC conduits through levee, 1.5 feet below crown. (Two 3-inch conduits authorized under Permit No. 12287, 1978 - Sacramento Municipal Utility District; two other 3-inch conduits authorized under Permit No. 12779, 1979 - Sacramento Municipal Utility District). [Additional Reference(s): DWR Levee Log, 2002 (HLM 7.51)]. FS Date: 6/22/2023

LS view: General overview looking from crown.

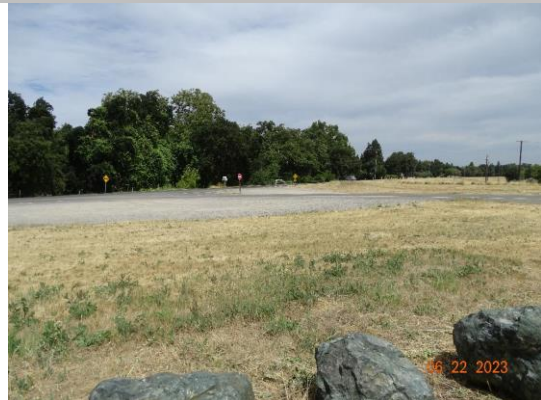
Photo 2 of 2 : UCIP\_FA\_2023\_80612\_116555.jpg

WS view: General overview looking from crown.

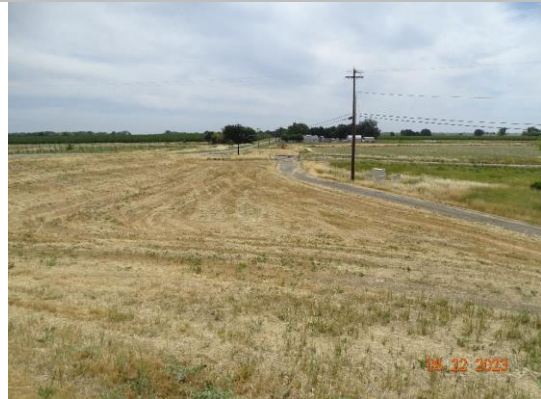
Photo 1 of 2 : UCIP\_FA\_2023\_81198\_116558.jpg

Comment Code					
Inspector Comment					
DS_ID:25140 FS_ID:81198 EP_NO: 10944 Repair Type: Non-Urgent EVAL Issue: Crossing Status: Not Found UCIP Comments: 06/22/2023 Record updated to Non-Urgent. Crossing not found. Coordinates updated from 38.684921, -121.631753 to 38.685436, -121.631878 based on the SAFCA As-Built Drawing. (M. Thao - DWR UCIP) FIELD_STRUCT_DESC: 8-inch gas line through the levee, 3 feet below the Garden Highway. Pipe profile through the levee was modified under the Natomas Levee Improvement Program. (8-inch pipe authorized under Permit No. 10944, 1976 - Shell Oil Company). [Additional Reference(s): DWR Levee Log, 2002 (HLM 7.57). SAFCA As-Built Drawing No. 6-04-2269, Sacramento River East Levee Phase 2B, Volume 2B, 28 February 2013, Sheet 169, Station 393+40]. FS Date: 6/22/2023

LS view: General overview looking from crown.

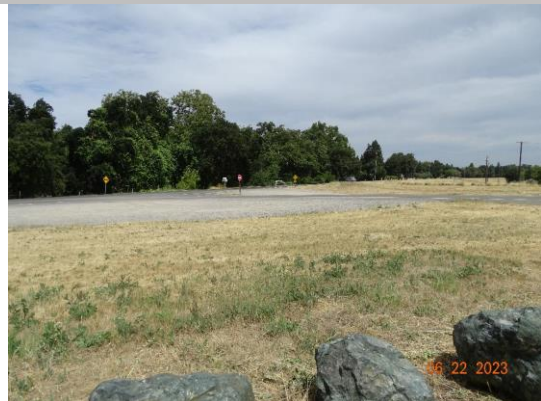
Photo 2 of 2 : UCIP\_FA\_2023\_81198\_116557.jpg

WS view: General overview looking from crown.

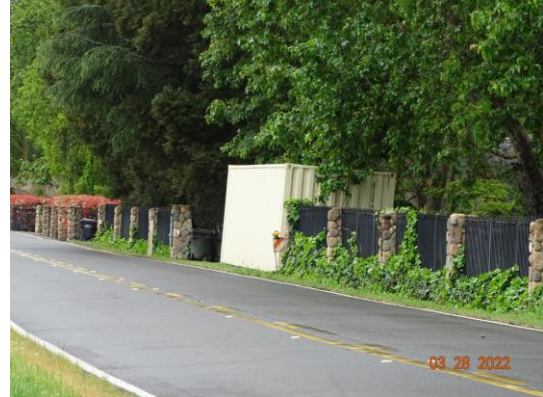
Photo 1 of 1 : FA\_2023\_RD1000\_31\_9\_20231016\_00009.jpg

LM Start	7.55	Rating **	M	Issue No.	9
LM End	7.55	Issue Type +	En	Location *	WS
Category	Earthen Levee			GPS Latitude/Longitude	
				Start	End
Item	Encroachments			38.683799°	38.683799°
				-121.631432°	-121.631432°
DWR ID	DWR_RD1000_01_s_2022_9				
Comment Code					
EQ : Equipment					
Inspector Comment					
Shipping container on waterside slope is blocking access and visibility and should be removed.

View of shipping container on waterside.

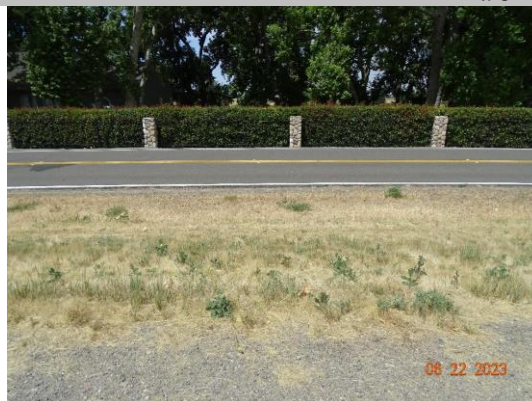
Photo 1 of 3 : UCIP\_FA\_2023\_80614\_116559.jpg

LM Start	7.59	Rating **	M	Issue No.	248
LM End	7.59	Issue Type +	En	Location *	
Category	Supplemental			GPS Latitude/Longitude	
				Start	End
Item	DWR UCIP Field Study			38.683251°	38.683251°
				-121.631344°	-121.631344°
DWR ID	25319				
Comment Code					
Inspector Comment					
DS_ID:25319 FS_ID:80614 EP_NO: 12564 Repair Type: Non-Urgent EVAL Issue: Crossing Status: Not Found UCIP Comments: 06/22/2023 Record updated to Non-Urgent. Crossing not found. (M. Thao - DWR UCIP) FIELD_STRUCT_DESC: Two 3-inch PVC conduits through the levee, 1.5 feet below the crown. (Two 3-inch conduits authorized under Permit No. 12564, 1978 - Sacramento Municipal Utility District). FS Date: 6/22/2023

WS view: General overview looking from crown.

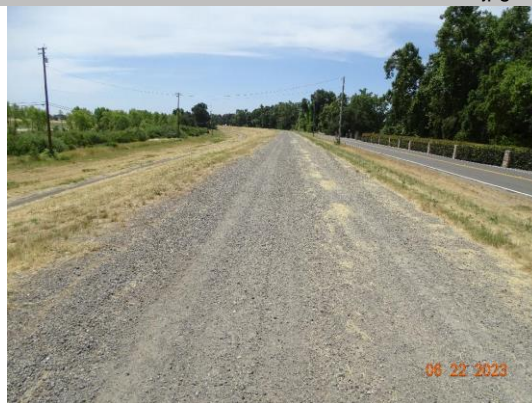
Photo 2 of 3 : UCIP\_FA\_2023\_80614\_116560.jpg

Levee crown looking downstream.

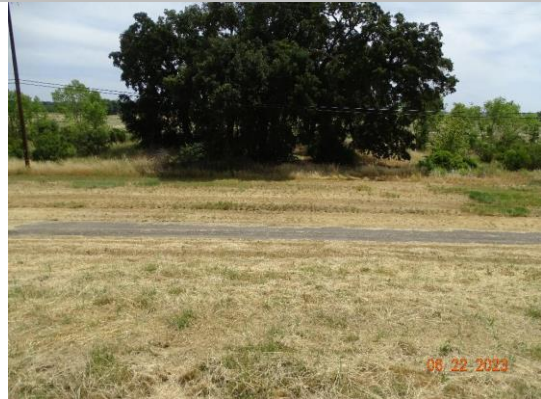
Photo 3 of 3 : UCIP\_FA\_2023\_80614\_116561.jpg

LS view: General overview looking from crown.

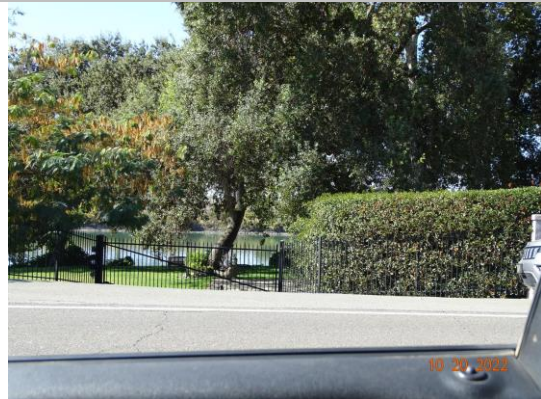
Photo 1 of 1 : FA\_2023\_RD1000\_31\_94\_20231016\_00040.jpg

LM Start	7.62	Rating **	M	Issue No.	94
LM End	7.65	Issue Type +	En	Location *	WS
Category	Earthen Levee			GPS Latitude/Longitude	
				Start	End
Item	Vegetation			38.682742°	38.682310°
				-121.631168°	-121.631085°
DWR ID	DWR_RD1000_01_s_2012_94				
Comment Code					
V6 : Landscaping					
Inspector Comment					
The landscape vegetation limits the ability to see the waterside slope and will make it difficult to access for flood fight.

View looking at waterside landscape vegetation that is blocking access and visibility to the levee, Fall 2022.

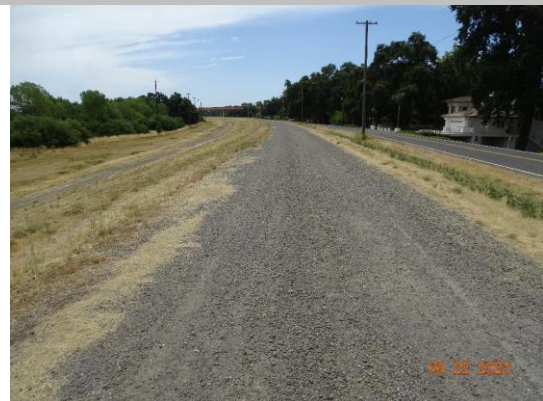
Photo 1 of 3 : UCIP\_FA\_2023\_81258\_117116.jpg

LM Start	7.99	Rating **	M	Issue No.	249	
LM End	7.99	Issue Type +	En	Location *		
Category	Supplemental			GPS Latitude/Longitude		
				Start	End	
Item	DWR UCIP Field Study			38.677876°	38.677876°	
				-121.628686°	-121.628686°	
DWR ID	25142					
Comment Code						
Inspector Comment						
DS_ID:25142 FS_ID:81258 EP_NO: 1933 Repair Type: Non-Urgent EVAL Issue: Crossing Status: Not Found UCIP Comments: 06/22/2023 Record updated to Non-Urgent. Crossing not found. (M. Thao - DWR UCIP)						
FIELD_STRUCT_DESC: Underground telephone cable through the levee, 3 feet below the Garden Highway. (Underground telephone cable authorized under Permit No. 1933, 1954 - Pacific Telephone and Telegraph Company). [Additional Reference(s): DWR Levee Log, 2002 (HLM 8.10)]. FS Date: 6/22/2023

Levee crown looking downstream.

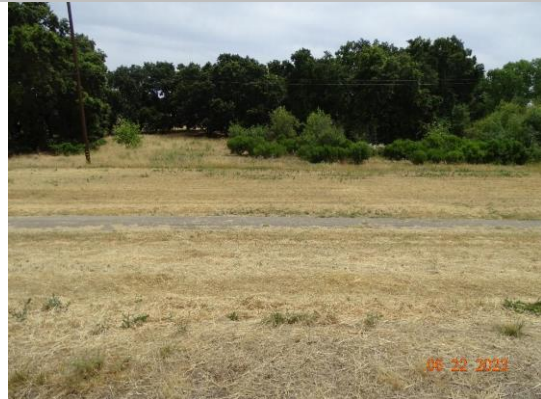
Photo 2 of 3 : UCIP\_FA\_2023\_81258\_117115.jpg

LS view: General overview looking from crown.

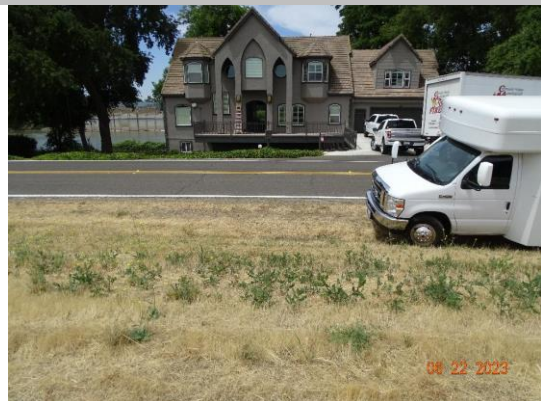
Photo 3 of 3 : UCIP\_FA\_2023\_81258\_117117.jpg

WS view: General overview looking from crown.

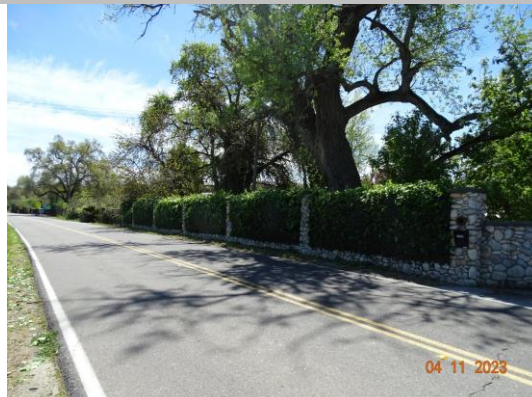
Photo 1 of 1 : FA\_2023\_RD1000\_31\_89\_20231016\_00038.jpg

LM Start	8.14	Rating **	M	Issue No.	89
LM End	8.19	Issue Type +	En	Location *	WS
Category	Earthen Levee			GPS Latitude/Longitude	
				Start	End
Item	Vegetation			38.676040°	38.675461°
				-121.627063°	-121.626617°
DWR ID	DWR_RD1000_01_s_2012_89				
Comment Code					
V6 : Landscaping					
Inspector Comment					
The landscape vegetation limits the ability to see the waterside slope and will make it difficult to access for flood fight.

View of landscape vegetation that is blocking visibility and access (Spring 2023).
