## Flood Control Project Maintenance Levee Inspections

### Fall 2023 Levee Maintenance Deficiency Summary Report

#### Sacramento River Basin

**Reclamation District No. 1000 Natomas**

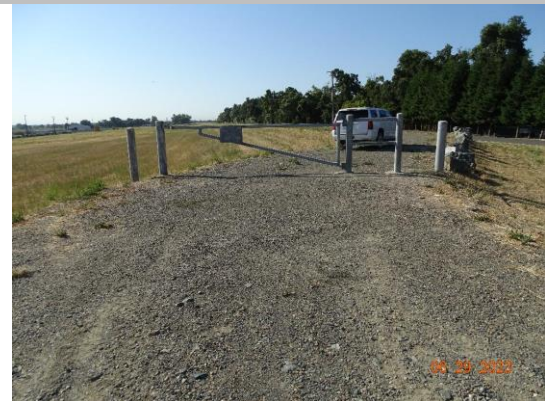
Photo 1 of 3 : UCIP\_FA\_2023\_80632\_116594.jpg

LM Start	8.67	Rating **	M	Issue No.	250
LM End	8.67	Issue Type +	En	Location *	
Category	Supplemental			GPS Latitude/Longitude	
				Start	End
Item	DWR UCIP Field Study			38.670394°	38.670394°
				-121.620449°	-121.620449°
DWR ID	25144				
Comment Code					
Inspector Comment					
DS_ID:25144 FS_ID:80632 EP_NO: 12154 Repair Type: Non-Urgent EVAL Issue: Crossing Status: Not Found UCIP Comments: 06/29/2023 Record updated to Non-Urgent. Crossing not found. (M. Thao - DWR UCIP) FIELD_STRUCT_DESC: Two 3-inch PVC conduits (one electric and the other communication) through the levee, 1.5 feet below the crown. (Two 3-inch conduits authorized under Permit No. 12154, 1977 - Sacramento Municipal Utility District). [Additional Reference(s): DWR Levee Log, 2002 (HLM 8.80)]. FS Date: 6/29/2023

Levee crown looking downstream.

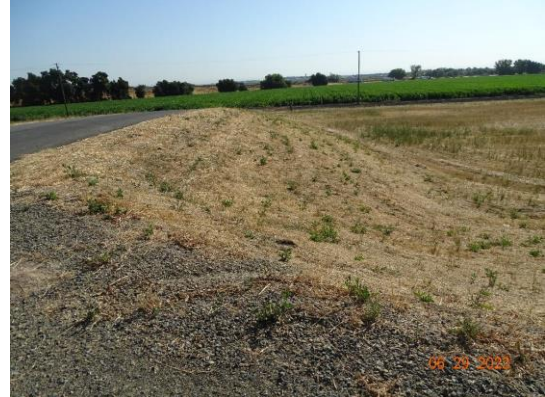
Photo 2 of 3 : UCIP\_FA\_2023\_80632\_116595.jpg

LS view: General overview looking from crown.

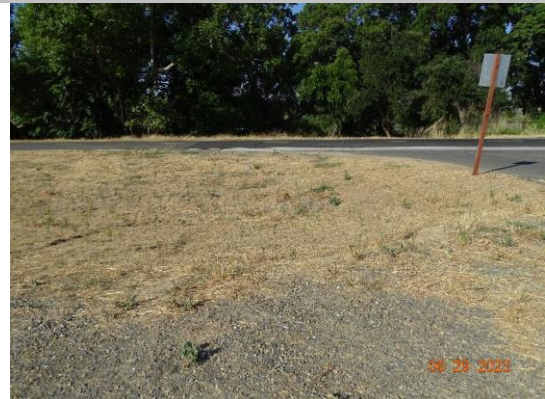
Photo 3 of 3 : UCIP\_FA\_2023\_80632\_116593.jpg

WS view: General overview looking from crown.

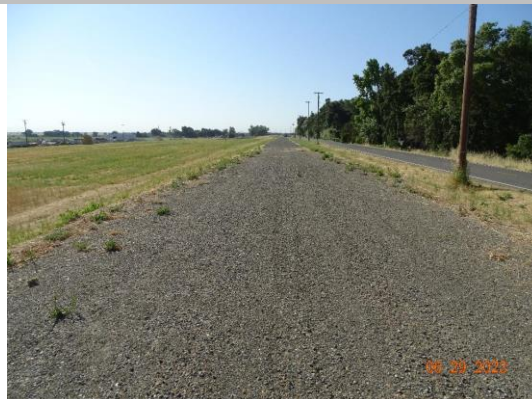
Photo 1 of 3 : UCIP\_FA\_2023\_80634\_116599.jpg

LM Start	8.78	Rating **	M	Issue No.	251
LM End	8.78	Issue Type +	En	Location *	
Category	Supplemental			GPS Latitude/Longitude	
				Start	End
Item	DWR UCIP Field Study			38.669331°	38.669331°
				-121.618998°	-121.618998°
DWR ID	25338				
Comment Code					
Inspector Comment					
DS_ID:25338 FS_ID:80634 EP_NO: 10548 Repair Type: Non-Urgent EVAL Issue: Crossing Status: Not Found UCIP Comments: 06/29/2023 Record updated to Non-Urgent. Crossing not found. (M. Thao - DWR UCIP) FIELD_STRUCT_DESC: 3-inch communication conduit through the levee, 3.5 feet below the crown. (3-inch conduit authorized under Permit No. 10548, 1978 - Pacific Telephone and Telegraph Company). FS Date: 6/29/2023

Levee crown looking downstream.

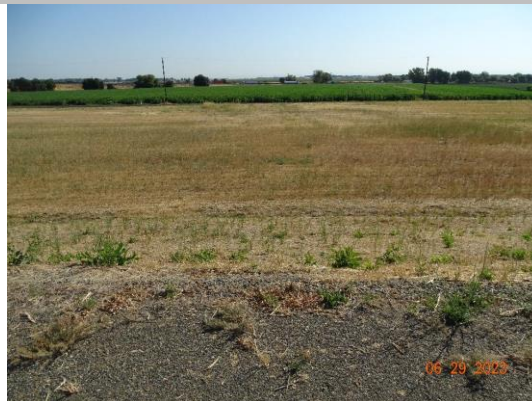
Photo 2 of 3 : UCIP\_FA\_2023\_80634\_116600.jpg

LS view: General overview looking from crown.

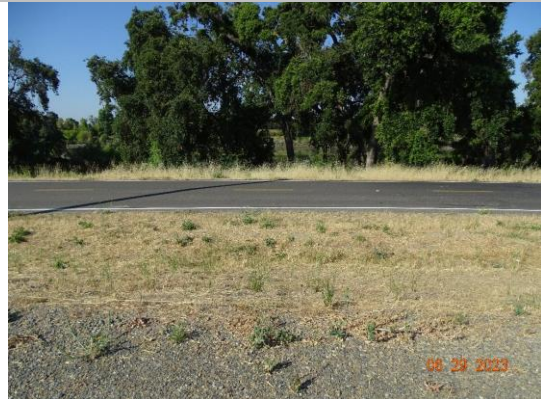
Photo 3 of 3 : UCIP\_FA\_2023\_80634\_116601.jpg

WS view: General overview looking from crown.

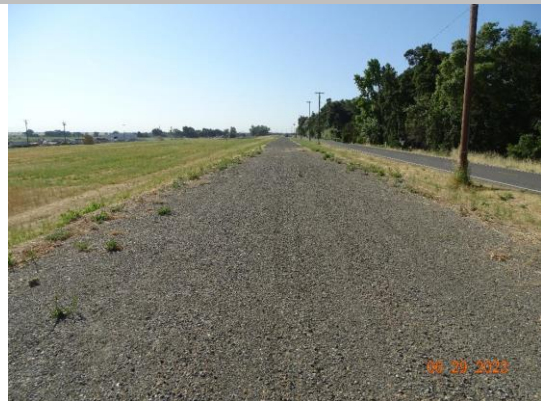
Photo 1 of 3 : UCIP\_FA\_2023\_80636\_116605.jpg

DS\_ID:25146  
 FS\_ID:80636  
 EP\_NO: 10757  
 Repair Type: Non-Urgent  
 EVAL Issue:  
 Crossing Status: Not Found  
 UCIP Comments: 06/29/2023 Record updated to Non-Urgent. Crossing not found. (M. Thao - DWR UCIP)  
 FIELD\_STRUCT\_DESC: Two 3-inch PVC conduits (one for two 12kV conductors and the other for a communication line) through the levee, 2 feet below the crown. (Two 3-inch conduits authorized under Permit No. 10757, 1975 - Sacramento Municipal Utility District; place a communication line in one of the 3-inch conduit authorized under Permit No. 12234, 1977 - Pacific Telephone and Telegraph Company).  
 [Additional Reference(s): DWR Levee Log, 2002 (HLM 8.91)].  
 FS Date: 6/29/2023

Levee crown looking downstream.

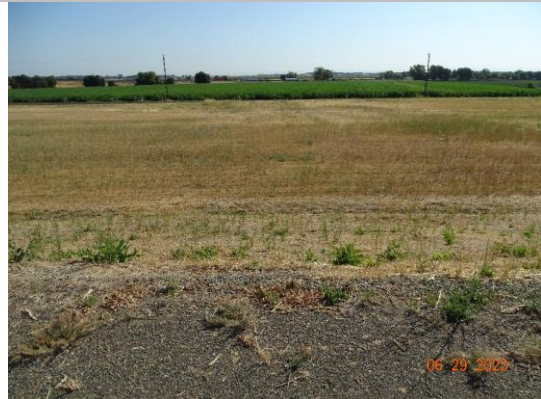
Photo 2 of 3 : UCIP\_FA\_2023\_80636\_116606.jpg

LS view: General overview looking from crown.

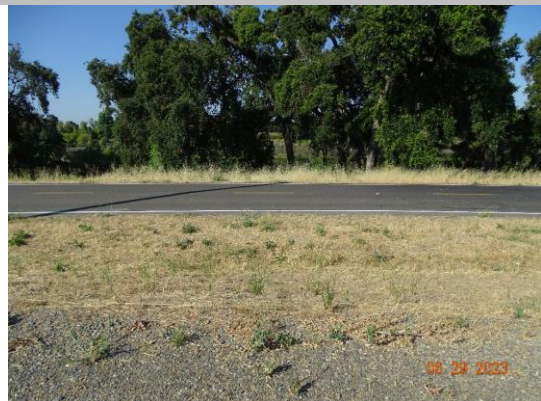
Photo 3 of 3 : UCIP\_FA\_2023\_80636\_116607.jpg

WS view: General overview looking from crown.

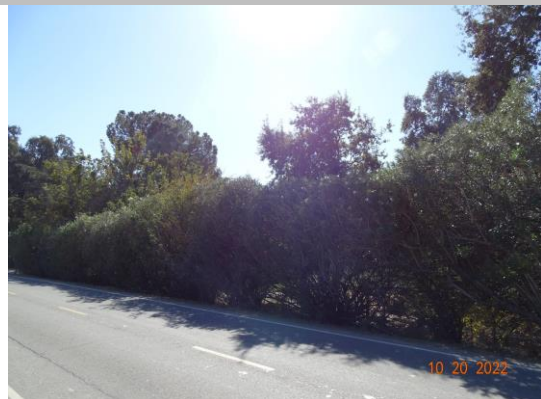
Photo 1 of 1 : FA\_2023\_RD1000\_31\_82\_20231016\_00037.jpg

LM Start	8.86	Rating **	M	Issue No.	82
LM End	8.89	Issue Type +	En	Location *	WS
Category	Earthen Levee			GPS Latitude/Longitude	
				Start	End
Item	Vegetation			38.668673°	38.668405°
				-121.617772°	-121.617278°
DWR ID	DWR_RD1000_01_s_2012_82				
Comment Code					
V6 : Landscaping					
Inspector Comment					
The landscape vegetation limits the ability to see the waterside slope and will make it difficult to access for flood fight.

This photo was taken from the crown facing downstream waterside levee slope at the landscaping, Fall 2022.

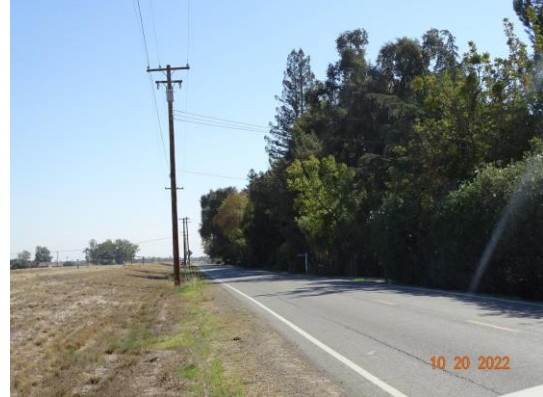
Photo 1 of 1 : FA\_2023\_RD1000\_31\_81\_20231016\_00036.jpg

LM Start	8.90	Rating **	M	Issue No.	81
LM End	8.96	Issue Type +	En	Location *	WS
Category	Earthen Levee			GPS Latitude/Longitude	
				Start	End
Item	Vegetation			38.668312°	38.667783°
				-121.617138°	-121.616382°
DWR ID	DWR_RD1000_01_s_2012_81				
Comment Code					
V6 : Landscaping					
Inspector Comment					
The landscape vegetation limits the ability to see the waterside slope and will make it difficult to access for flood fight.

View of landscape vegetation that blocks visibility and access, Fall 2022.

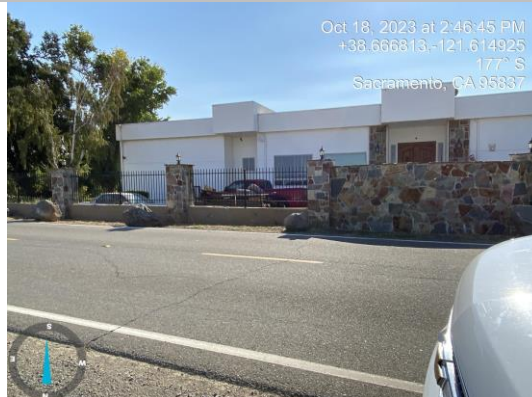
Photo 1 of 1 : FA\_2023\_RD1000\_31\_2\_20231025\_00292.jpg

LM Start	9.06	Rating **	M	Issue No.	2
LM End	9.08	Issue Type +	En	Location *	WS
Category	Earthen Levee			GPS Latitude/Longitude	
				Start	End
Item	Encroachments			38.666821°	38.666604°
				-121.615019°	-121.614672°
DWR ID	DWR_RD1000_01_s_2012_2				
Comment Code					
FE : Fence					
Inspector Comment					
There is an unacceptable fence at this location. According to the NOV, all panels of the fence are to be removed. The owner has removed some of the panels between the posts.

This photo was taken during Fall 2023 from the crown facing downstream on the waterward levee slope at a fence enforcement issue.

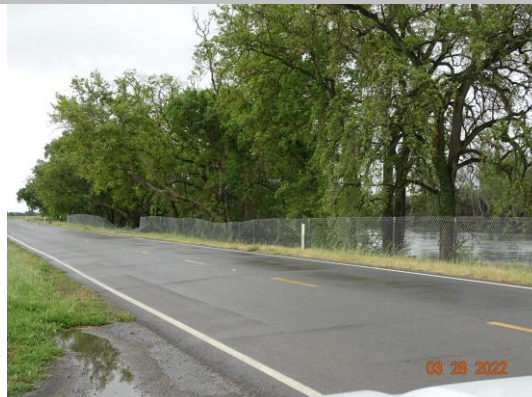
Photo 1 of 1 : FA\_2023\_RD1000\_31\_10\_20231016\_00010.jpg

LM Start	9.09	Rating **	M	Issue No.	10
LM End	9.18	Issue Type +	En	Location *	WS
Category	Earthen Levee			GPS Latitude/Longitude	
				Start	End
Item	Encroachments			38.666650°	38.665750°
				-121.614461°	-121.613078°
DWR ID	DWR_RD1000_01_f_2017_10				
Comment Code					
FE : Fence					
Inspector Comment					
Non-permitted fence needs to be removed.

View on waterside of a non-permitted fence.

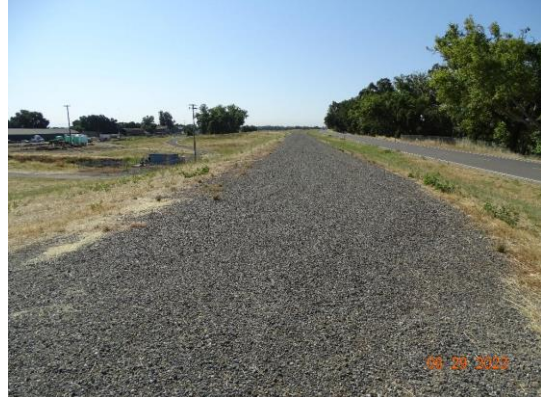
Photo 1 of 3 : UCIP\_FA\_2023\_80639\_116613.jpg

LM Start	9.13	Rating **	M	Issue No.	253
LM End	9.13	Issue Type +	En	Location *	
Category	Supplemental			GPS Latitude/Longitude	
				Start	End
Item	DWR UCIP Field Study			38.666148 °	38.666148 °
				-121.613914 °	-121.613914 °
DWR ID	25307				
Comment Code					
Inspector Comment					
DS_ID:25307 FS_ID:80639 EP_NO: N/A Repair Type: Non-Urgent EVAL Issue: Crossing Status: Not Found UCIP Comments: 06/29/2023 Record updated to Non-Urgent. Crossing not found. (M.Thao - DWR UCIP)  FIELD_STRUCT_DESC: Buried telephone cable on the landside (LS) levee slope. Telephone cable is connected to a power pole on the LS slope. (Telephone cable and replacement pole authorized under Permit No. 5219, 1966 - Pacific Telephone and Telegraph Company). FS Date: 6/29/2023

Levee crown looking downstream.

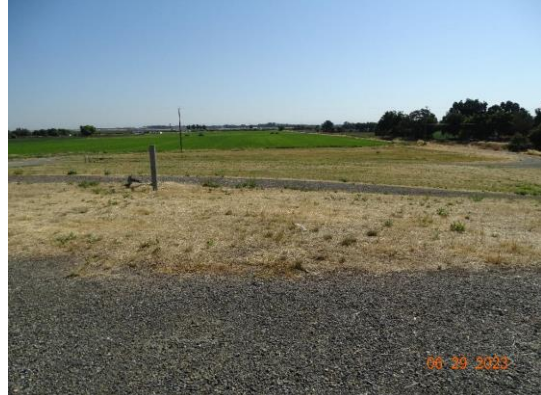
Photo 2 of 3 : UCIP\_FA\_2023\_80639\_116614.jpg

LS view: General overview looking from crown.

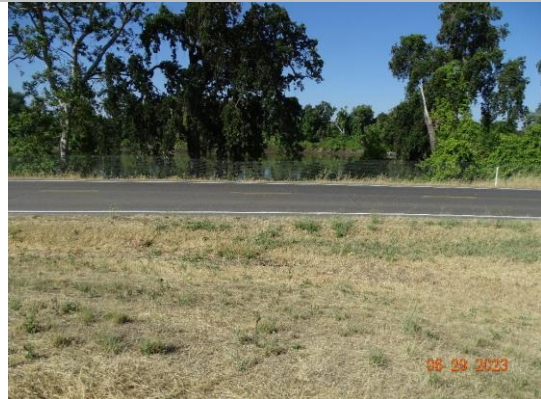
Photo 3 of 3 : UCIP\_FA\_2023\_80639\_116612.jpg

WS view: General overview looking from crown.

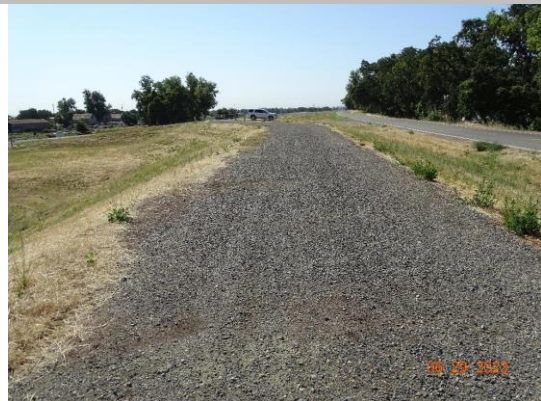
Photo 1 of 3 : UCIP\_FA\_2023\_81550\_118104.jpg

DS\_ID:25308  
 FS\_ID:81550  
 EP\_NO: 5430  
 Repair Type: Non-Urgent  
 EVAL Issue:  
 Crossing Status: Not Found  
 UCIP Comments: 06/29/2023 Record updated to Non-Urgent. Power pole on LS slope of Garden Highway (old levee) not found. (M. Thao - DWR UCIP)  
 FIELD\_STRUCT\_DESC: Buried cable along the east and north banks of West Drainage Canal, connecting to existing power pole on the levee. Power pole on landside (LS) slope of Garden Highway. (Buried cable authorized under Permit No 5430, 1966 - Pacific Telephone and Telegraph Company).  
 FS Date: 6/29/2023

Levee crown looking downstream.

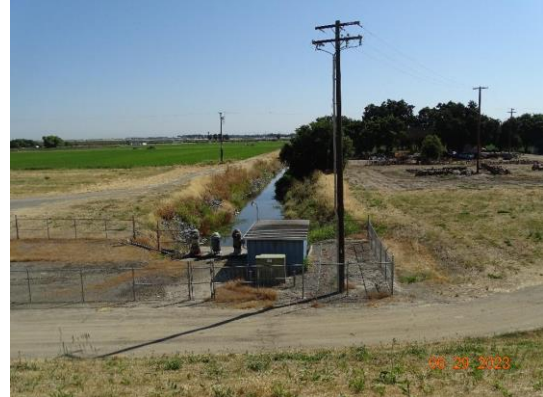
Photo 2 of 3 : UCIP\_FA\_2023\_81550\_118105.jpg

LS view: General overview looking from crown; no power pole found on levee.

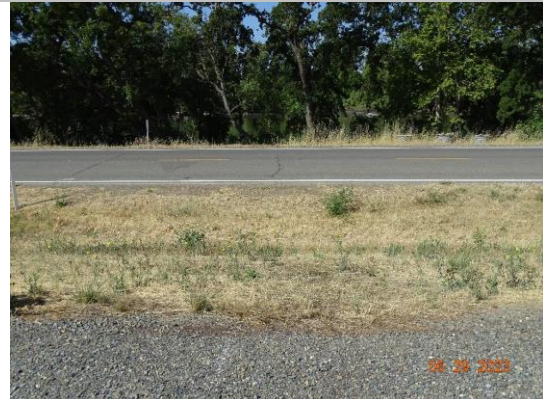
Photo 3 of 3 : UCIP\_FA\_2023\_81550\_118106.jpg

WS view: General overview looking from crown.

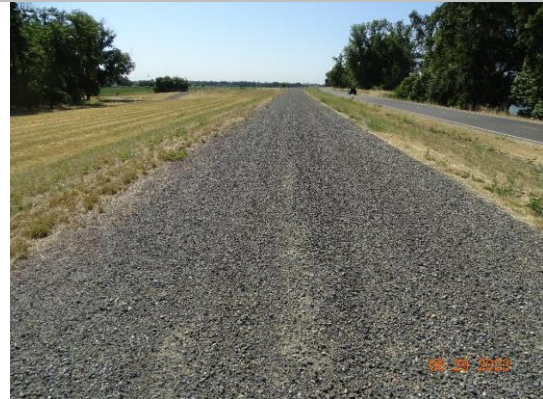
Photo 1 of 3 : UCIP\_FA\_2023\_80640\_116615.jpg

Comment Code						
Inspector Comment						
DS_ID:25273 FS_ID:80640 EP_NO: N/A Repair Type: Non-Urgent EVAL Issue: Crossing Status: Not Found UCIP Comments: 06/29/2023 Pipe has been removed from the levee; therefore, does not need to be evaluated. Record will remain in UCIP database as a historical record. (M. Thao - DWR UCIP) FIELD_STRUCT_DESC: *REMOVED* 12-inch irrigation pipe through levee, 9.8 feet below the crown. Waterside (WS) pump on incline. (12-inch pipe authorized under Permit No. 5457, 1966 - County of Sacramento; 12-inch pipe removed under Permit No. 5457-A, 1966 - County of Sacramento). [Additional Reference(s): USACE Sacramento O&M Manual, Unit No. 124, June 1953, Revised 25 February 2022, (River Mile 69.70), listed as 12-inch pipe. USACE As-Built Drawing No. 50-13-2810, November 1922, listed as River Mile 67.90 but should be River Mile 69.70 instead]. FS Date: 6/29/2023

Levee crown looking downstream.

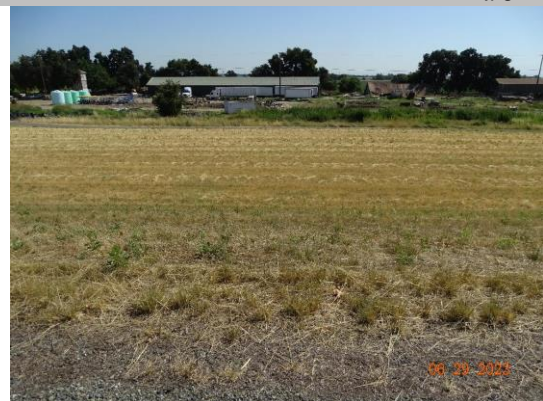
Photo 2 of 3 : UCIP\_FA\_2023\_80640\_116616.jpg

LS view: General overview looking from crown.

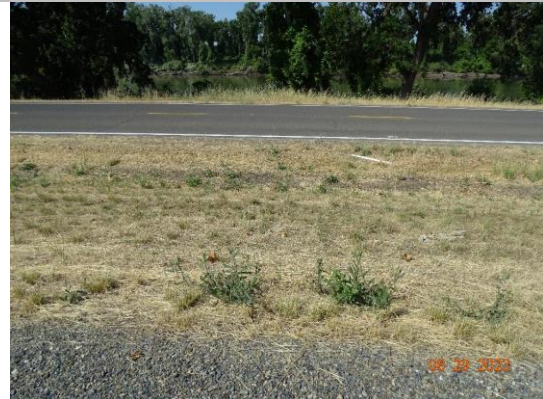
Photo 3 of 3 : UCIP\_FA\_2023\_80640\_116617.jpg

WS view: General overview looking from crown.

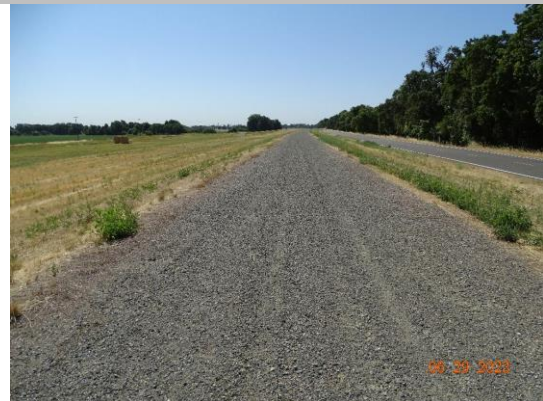
Photo 1 of 3 : UCIP\_FA\_2023\_80982\_116625.jpg

DS\_ID:25274  
 FS\_ID:80982  
 EP\_NO: N/A  
 Repair Type: Non-Urgent  
 EVAL Issue:  
 Crossing Status: Not Found  
 UCIP Comments: 06/29/2023 Record updated to Non-Urgent. Crossing not found. (M. Thao - DWR UCIP)  
 FIELD\_STRUCT\_DESC: 14-inch steel pipe through levee, 4 feet below the Garden Highway. [Additional Reference(s): USACE Sacramento O&M Manual, Unit No. 124, June 1953, Revised 25 February 2022, (River Mile 69.15), listed as 14-inch pipe. USACE As-Built Drawing No. 50-13-2810, November 1922, listed as River Mile 69.15].  
 FS Date: 6/29/2023

Levee crown looking downstream.

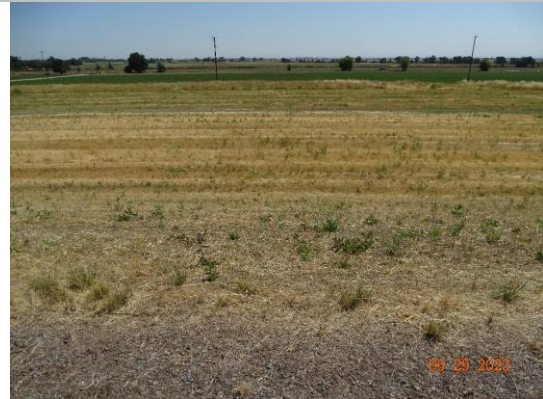
Photo 2 of 3 : UCIP\_FA\_2023\_80982\_116626.jpg

LS view: General overview looking from crown.

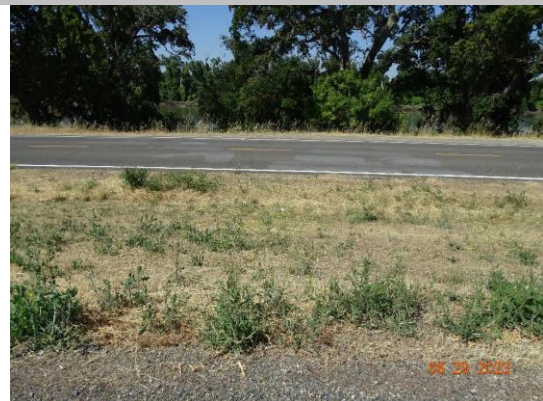
Photo 3 of 3 : UCIP\_FA\_2023\_80982\_116627.jpg

WS view: General overview looking from crown.

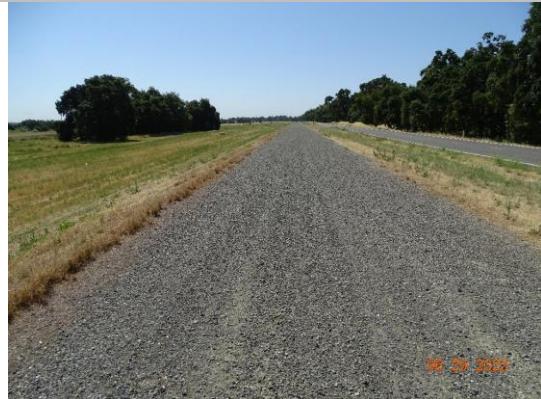
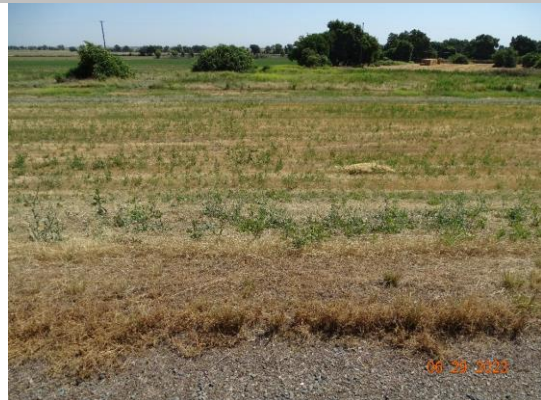
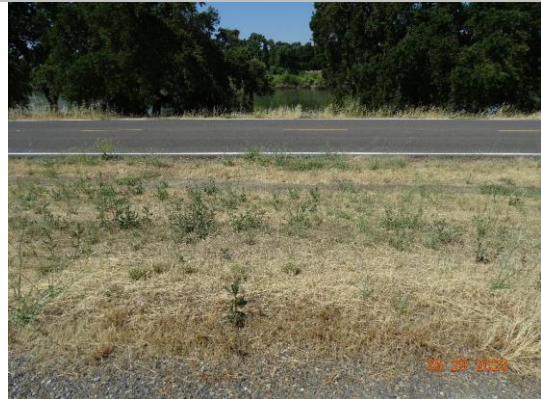
Photo 1 of 3 : UCIP\_FA\_2023\_80650\_116630.jpg

Comment Code						
Inspector Comment						
DS_ID:25165 FS_ID:80650 EP_NO: N/A Repair Type: Non-Urgent EVAL Issue: Crossing Status: Not Found UCIP Comments: 04/01/2002 16-inch pipe open on waterward end. 06/29/2023 Record updated to Non-Urgent. Crossing not found. Unauthorized encroachment recorded in Levee Log. (M. Thao - DWR UCIP) FIELD_STRUCT_DESC: 10-inch pipe within 16-inch pipe through the levee, annular space grouted. Pump in pump house on the waterside (WS) berm. Gate valve on WS end. Concrete distribution box at the toe of the landside (LS) slope. [Additional Reference(s): DWR Levee Log, 2002 (HLM 10.25), listed as abandoned]. FS Date: 6/29/2023

Levee crown looking downstream.

LS view: General overview looking from crown.

WS view: General overview looking from crown.

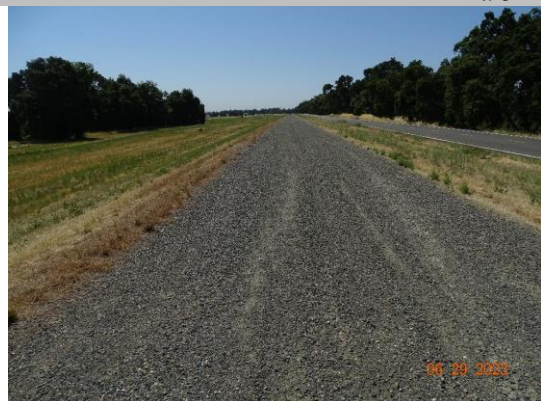
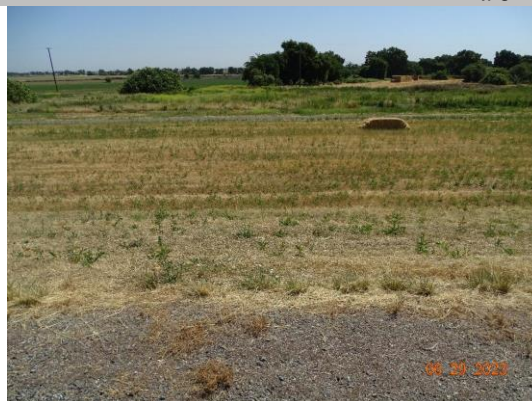
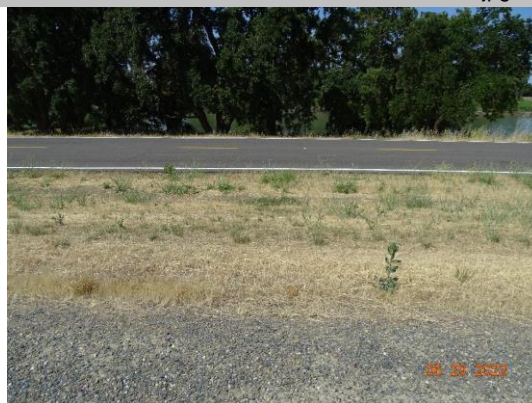
Photo 1 of 3 : UCIP\_FA\_2023\_80651\_116633.jpg

DS\_ID:25151  
 FS\_ID:80651  
 EP\_NO: N/A  
 Repair Type: Non-Urgent  
 EVAL Issue:  
 Crossing Status: Not Found  
 UCIP Comments: 06/29/2023 Record updated to Non-Urgent. Crossing not found. Unauthorized encroachment recorded in Levee Log. (M. Thao - DWR UCIP)  
 FIELD\_STRUCT\_DESC: 10-inch pipe through the levee, at an unknown depth. Pump on platform on the waterside (WS) berm. [Additional Reference(s): DWR Levee Log, 2002 (HLM 10.26)].  
 FS Date: 6/29/2023

Levee crown looking downstream.

LS view: General overview looking from crown.

WS view: General overview looking from crown.

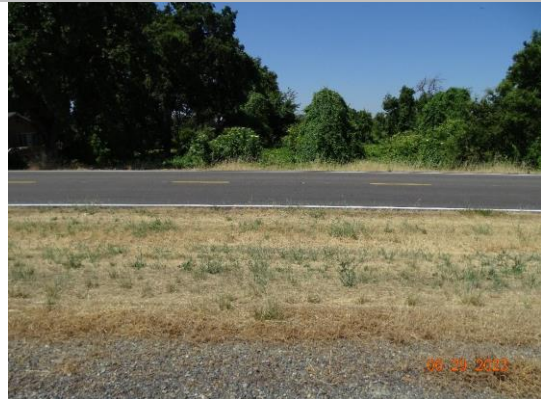
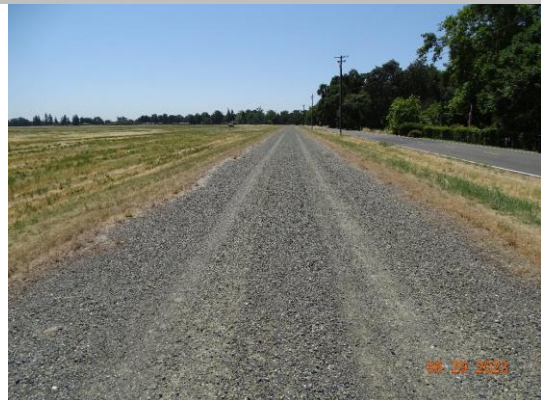
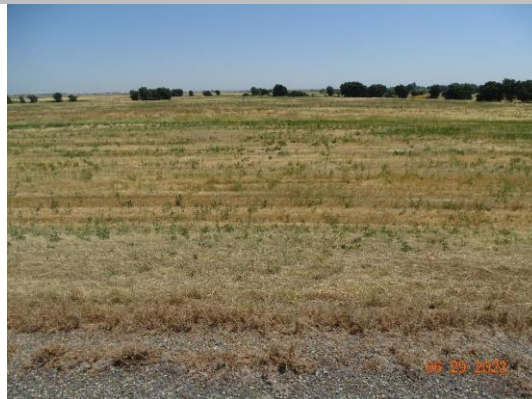
Photo 1 of 3 : UCIP\_FA\_2023\_80652\_116637.jpg

Comment Code						
Inspector Comment						
DS_ID:25342						
FS_ID:80652						
EP_NO: N/A						
Repair Type: Non-Urgent						
EVAL Issue:						
Crossing Status: Not Found						
UCIP Comments: 06/29/2023 Record updated to Non-Urgent. Crossing not found. (M. Thao - DWR UCIP)						
FIELD_STRUCT_DESC: Two 3-inch conduits (electrical and communication cables) through the levee, 2.3 feet below the crown. A 45-foot utility pole on landside toe of the levee, not found in 2023. (Two 3-inch conduits authorized under Permit No. 12123, 1977 - Sacramento Municipal Utility District). [Additional Reference(s): DWR Levee Log, 2002 (HLM 10.89)].						
FS Date: 6/29/2023

WS view: General overview looking from crown.

Levee crown looking downstream.

LS view: General overview looking from crown.

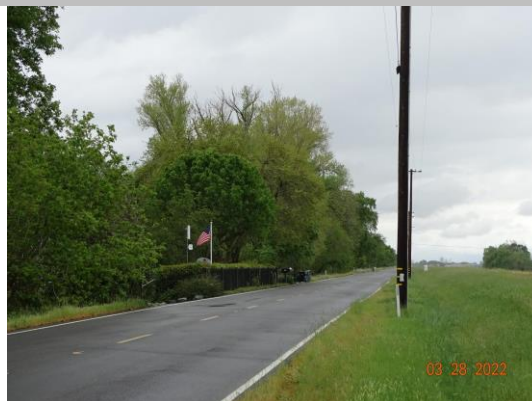
Photo 1 of 1 : FA\_2023\_RD1000\_31\_74\_20231016\_00034.jpg

LM Start	10.72	Rating **	M	Issue No.	74
LM End	10.76	Issue Type +	En	Location *	WS
Category	Earthen Levee			GPS Latitude/Longitude	
				Start	End
Item	Vegetation			38.648127°	38.647663°
				-121.595872°	-121.595483°
DWR ID	DWR_RD1000_01_s_2012_74				
Comment Code					
V6 : Landscaping					
Inspector Comment					
The landscape vegetation limits the ability to see the waterside slope and will make it difficult to access for flood fight.

This photo was taken from the crown facing downstream looking down the waterward levee slope at unacceptable landscaping.

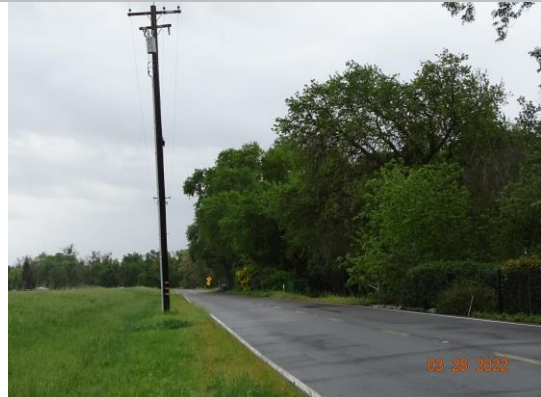
Photo 1 of 1 : FA\_2023\_RD1000\_31\_73\_20231016\_00033.jpg

LM Start	10.78	Rating **	M	Issue No.	73
LM End	10.83	Issue Type +	En	Location *	WS
Category	Earthen Levee			GPS Latitude/Longitude	
				Start	End
Item	Vegetation			38.647373°	38.646825°
				-121.595248°	-121.594800°
DWR ID	DWR_RD1000_01_s_2012_73				
Comment Code					
V6 : Landscaping					
Inspector Comment					
The landscape vegetation limits the ability to see the waterside slope and will make it difficult to access for flood fight.

This photo was taken from the crown facing downstream looking down the waterward levee slope at the landscaping.

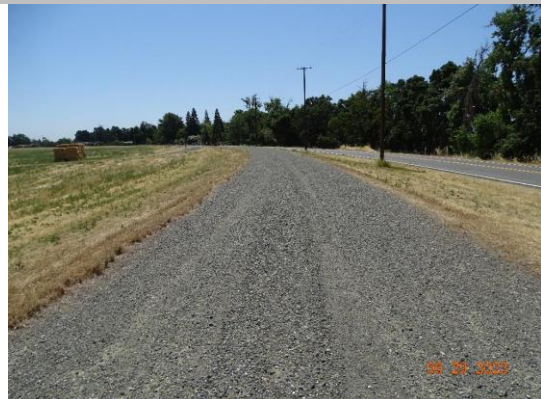
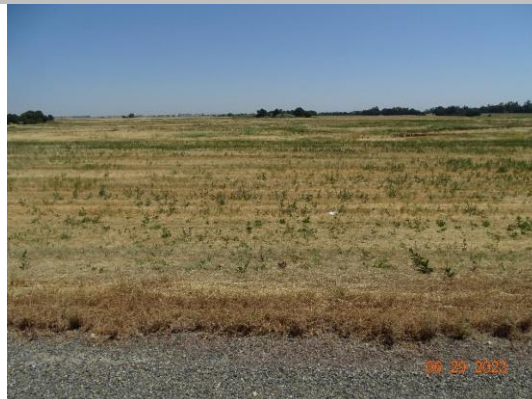
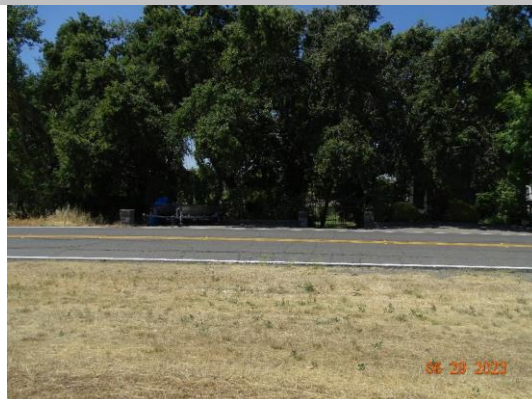
Photo 1 of 3 : UCIP\_FA\_2023\_80655\_116647.jpg

Comment Code						
Inspector Comment						
DS_ID:25326 FS_ID:80655 EP_NO: N/A Repair Type: Non-Urgent EVAL Issue: Crossing Status: Not Found UCIP Comments: 06/29/2023 Record updated to Non-Urgent. Crossing not found. (M. Thao - DWR UCIP)  FIELD_STRUCT_DESC: Two 3-inch PVC conduits through the levee, 3 feet below the Garden Highway. Two 12 kV conductors in one 3-inch conduit and a telephone service wire in the other conduit. (Two 3-inch conduits authorized under Permit No. 12441, 1978 - Sacramento Municipal Utility District; telephone service wire placed in one of the conduits under Permit No. 12477, 1978 - Pacific Telephone and Telegraph Company). FS Date: 6/29/2023

Levee crown looking downstream.

LS view: General overview looking from crown.

WS view: General overview looking from crown.

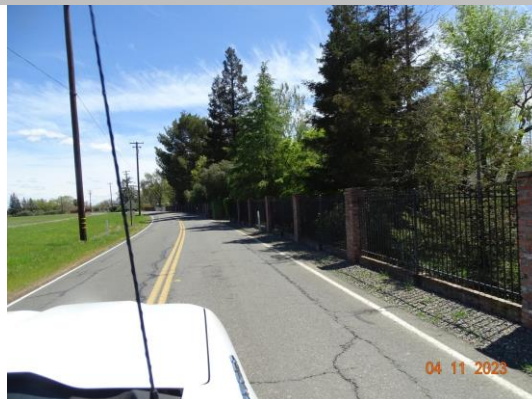
Photo 1 of 1 : FA\_2023\_RD1000\_31\_72\_20231016\_00032.jpg

LM Start	11.06	Rating **	M	Issue No.	72
LM End	11.13	Issue Type +	En	Location *	WS
Category	Earthen Levee			GPS Latitude/Longitude	
				Start	End
Item	Vegetation			38.644548°	38.644302°
				-121.591768°	-121.590572°
DWR ID	DWR_RD1000_01_s_2012_72				
Comment Code					
V6 : Landscaping					
Inspector Comment					
The landscape vegetation limits the ability to see the waterside slope and will make it difficult to access for flood fight.

View taken from the crown facing downstream looking at the waterward levee slope at the landscaping (Spring 2023).

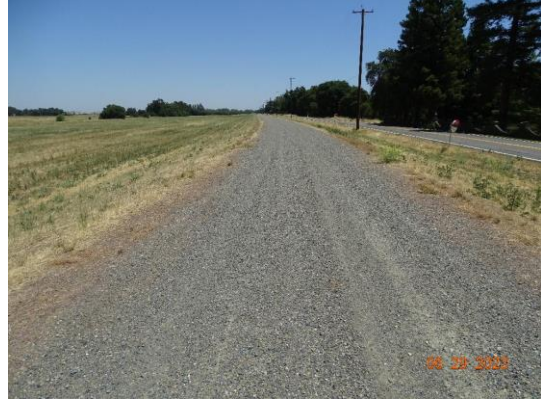
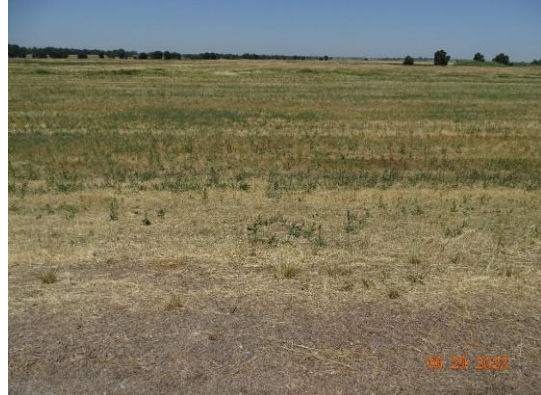
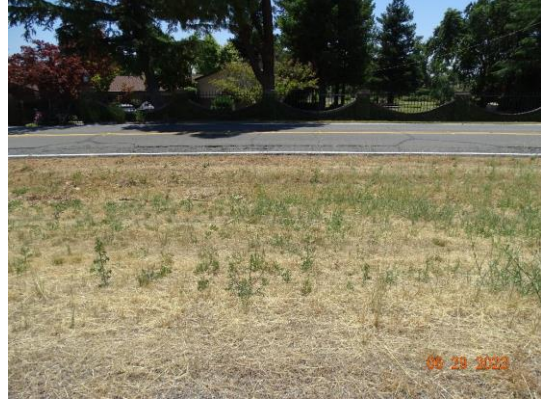
Photo 1 of 3 : UCIP\_FA\_2023\_80658\_116656.jpg

LM Start	11.35	Rating **	M	Issue No.	261
LM End	11.35	Issue Type +	En	Location *	
Category	Supplemental			GPS Latitude/Longitude	
				Start	End
Item	DWR UCIP Field Study			38.644763 °	38.644763 °
				-121.586616 °	-121.586616 °
DWR ID	25156				
Comment Code					
Inspector Comment					
DS_ID:25156 FS_ID:80658 EP_NO: N/A Repair Type: Non-Urgent EVAL Issue: Crossing Status: Not Found UCIP Comments: 06/29/2023 Record updated to Non-Urgent. Crossing not found. (M. Thao - DWR UCIP)  FIELD_STRUCT_DESC: 4-inch PVC conduit through the levee, 3 feet below crown. (4-inch conduit authorized under Permit No. 14943, 1988 - Pacific Bell). [Additional Reference(s): DWR Levee Log, 2002 (HLM 11.54)]. FS Date: 6/29/2023

Levee crown looking downstream.

LS view: General overview looking from crown.

WS view: General overview looking from crown.

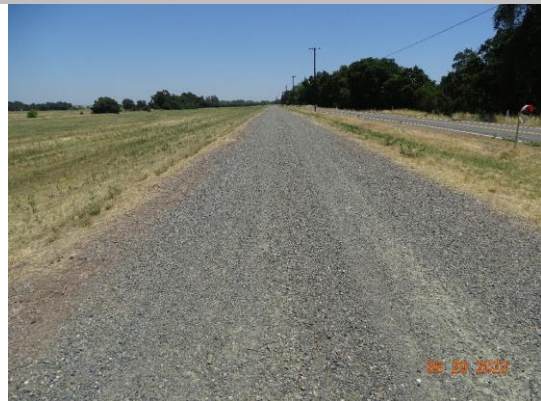
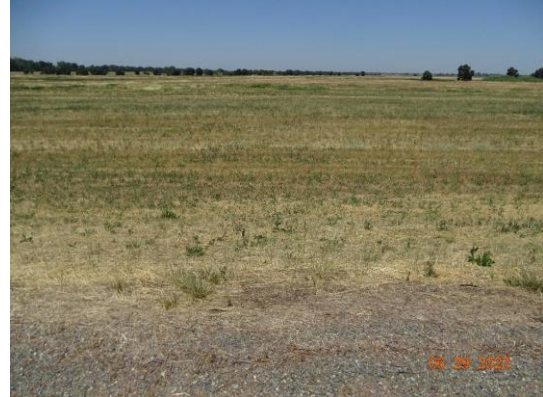
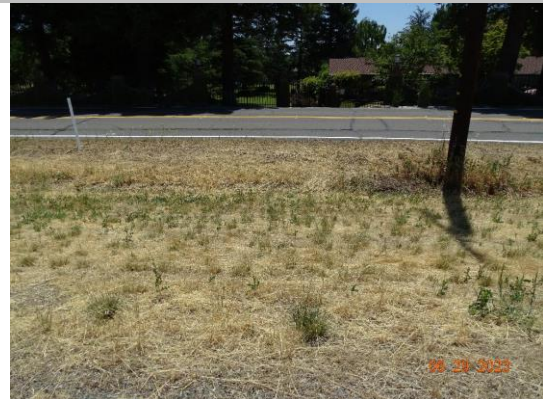
Photo 1 of 3 : UCIP\_FA\_2023\_80659\_116659.jpg

DS\_ID:25304  
 FS\_ID:80659  
 EP\_NO: N/A  
 Repair Type: Non-Urgent  
 EVAL Issue:  
 Crossing Status: Not Found  
 UCIP Comments: 06/29/2023 Record updated to Non-Urgent. Crossing not found. (M. Thao - DWR UCIP)  
 FIELD\_STRUCT\_DESC: Installation of a concrete pipeline with necessary fittings and valves along the waterward toe of the left bank levee at Monument Bend, (permit 3442)  
 FS Date: 6/29/2023

Levee crown looking downstream.

LS view: General overview looking from crown.

WS view: General overview looking from crown.

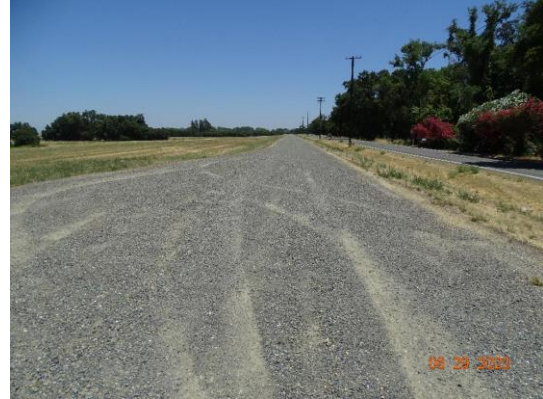
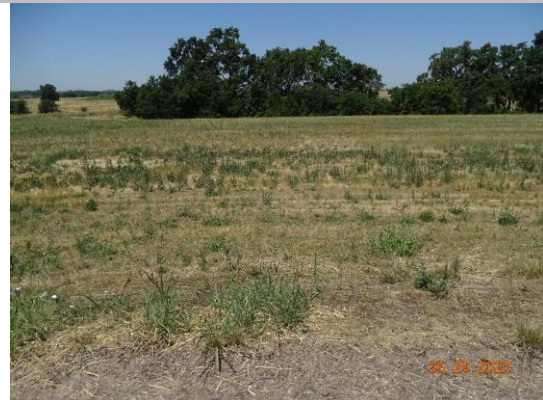
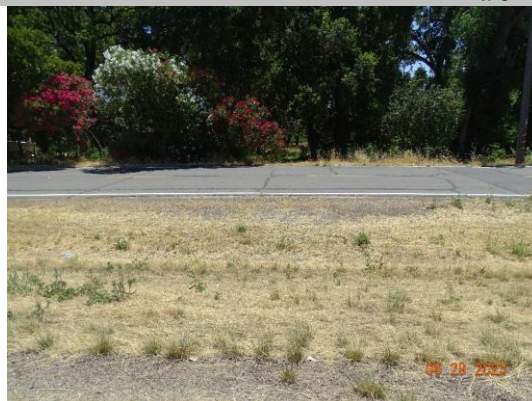
Photo 1 of 3 : UCIP\_FA\_2023\_80988\_116662.jpg

Comment Code					
Inspector Comment					
DS_ID:25209 FS_ID:80988 EP_NO: N/A Repair Type: Non-Urgent EVAL Issue: Crossing Status: Not Found UCIP Comments: 06/29/2023 Record updated to Non-Urgent. Crossing not found. (M. Thao - DWR UCIP) FIELD_STRUCT_DESC: 10-inch pipe through the levee, 6.9 feet below the crown. Pump gate valve in pump house on the waterside (WS) berm. 24-inch concrete standpipe at the landside (LS) toe. [Additional Resource(s): DWR Levee Log, 2002 (HLM 11.85). USACE Sacramento O&M Manual, Unit No. 124, June 1953, Revised 25 February 2022, (River Mile 66.94), listed as 10-inch pipe. USACE As-Built Drawing No. 50-13-2810, November 1922, River Mile 66.94]. FS Date: 6/29/2023

Levee crown looking downstream.

LS view: General overview looking from crown.

WS view: General overview looking from crown.

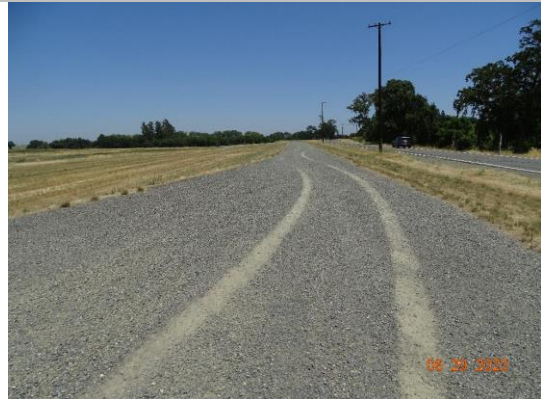
Photo 1 of 3 : UCIP\_FA\_2023\_81016\_116665.jpg

Comment Code						
Inspector Comment						
DS_ID:25336 FS_ID:81016 EP_NO: 9816 Repair Type: Non-Urgent EVAL Issue: Crossing Status: Not Found UCIP Comments: 06/29/2023 Record updated to Non-Urgent. Crossing not found. (M. Thao - DWR UCIP) FIELD_STRUCT_DESC: Two 3-inch PVC conduits through the levee, 3 feet below the Garden Highway. Two conductors in one 3-inch conduit and a telephone cable in the other conduit. (Two 3-inch conduits authorized under Permit No. 9816, 1974 - Sacramento Municipal Utility District; telephone cable placed in one of the conduits under Permit No. 9837, 1974 - Pacific Telephone and Telegraph Company). FS Date: 6/29/2023

Levee crown looking downstream.

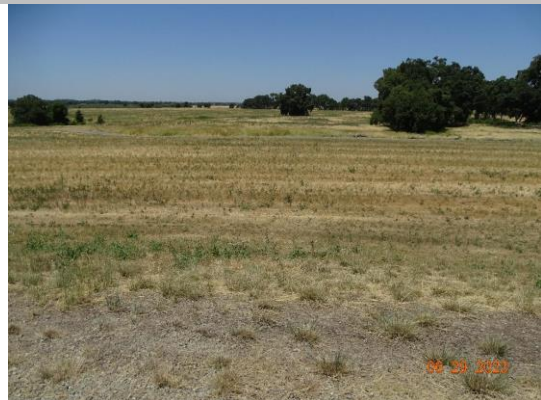
Photo 2 of 3 : UCIP\_FA\_2023\_81016\_116666.jpg

LS view: General overview looking from crown.

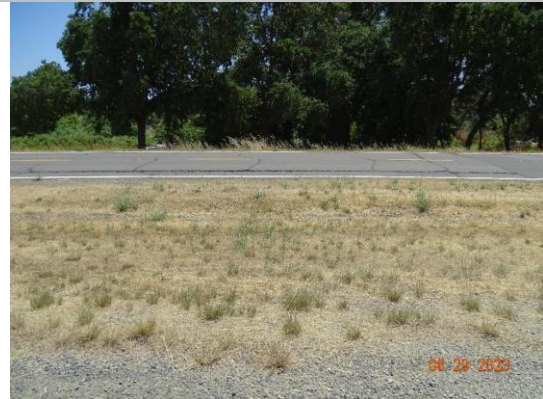
Photo 3 of 3 : UCIP\_FA\_2023\_81016\_116667.jpg

WS view: General overview looking from crown.

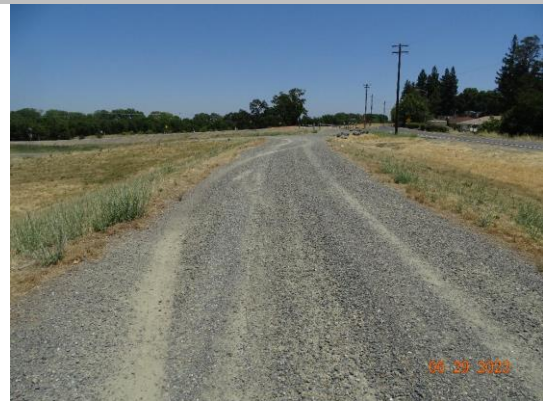
Photo 1 of 3 : UCIP\_FA\_2023\_81263\_117034.jpg

DS\_ID:25277  
 FS\_ID:81263  
 EP\_NO: N/A  
 Repair Type: Non-Urgent  
 EVAL Issue:  
 Crossing Status: Not Found  
 UCIP Comments: 06/29/2023 Record updated to Non-Urgent. Crossing not found. (M. Thao - DWR UCIP)  
 FIELD\_STRUCT\_DESC: 14-inch steel pipe through the levee, 5.1 feet below the crown. Pump and gate valve on the waterside (WS) end.  
 [Additional Reference(s): USACE Sacramento O&M Manual, Unit No. 124, June 1953, Revised 25 February 2022, (River Mile 66.67), listed as 14-inch pipe. USACE As-Built Drawing No. 50-13-2810, November 1922, River Mile 66.67].  
 FS Date: 6/29/2023

Levee crown looking downstream.

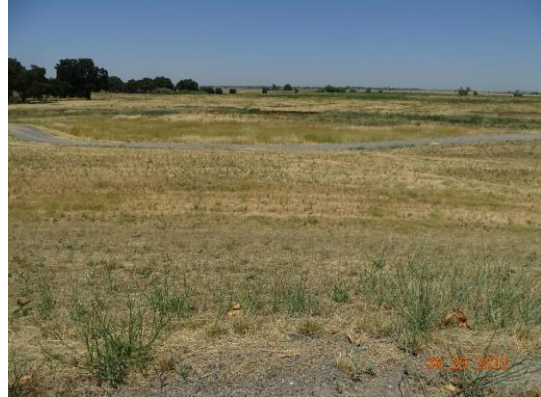
Photo 2 of 3 : UCIP\_FA\_2023\_81263\_117035.jpg

LS view: General overview looking from crown.

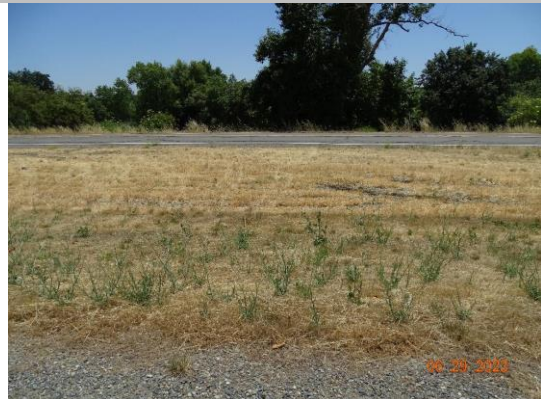
Photo 3 of 3 : UCIP\_FA\_2023\_81263\_117033.jpg

WS view: General overview looking from crown.

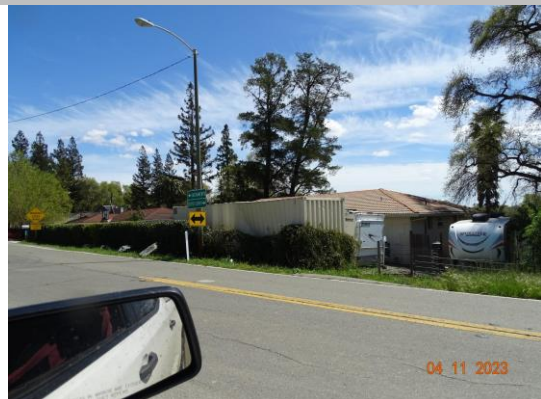
Photo 1 of 1 : FA\_2023\_RD1000\_31\_12\_20231016\_00012.jpg

LM Start	12.00	Rating **	M	Issue No.	12
LM End	12.00	Issue Type +	En	Location *	WS
Category	Earthen Levee			GPS Latitude/Longitude	
				Start	End
Item	Encroachments			38.650103°	38.650103°
				-121.576796°	-121.576796°
DWR ID	DWR_RD1000_01_s_2023_12				
Comment Code					
BU : Building					
Inspector Comment					
Shipping container blocking visibility and access on waterside slope.

View facing downstream looking at the shipping container on the waterside slope (Spring 2023).

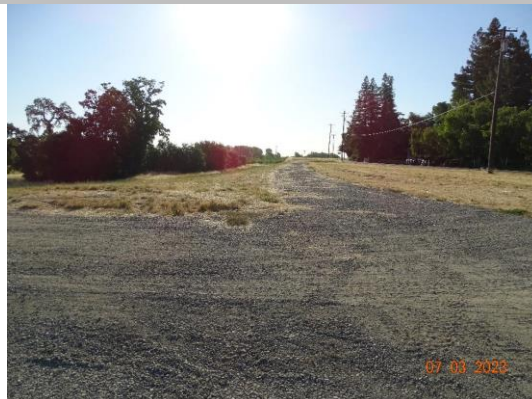
Photo 1 of 3 : UCIP\_FA\_2023\_80663\_116674.jpg

LM Start	12.02	Rating **	M	Issue No.	267
LM End	12.02	Issue Type +	En	Location *	
Category	Supplemental			GPS Latitude/Longitude	
				Start	End
Item	DWR UCIP Field Study			38.650155°	38.650155°
				-121.576262°	-121.576262°
DWR ID	25368				
Comment Code					
Inspector Comment					
DS_ID:25368 FS_ID:80663 EP_NO: N/A Repair Type: Non-Urgent EVAL Issue: Crossing Status: Not Found UCIP Comments: 07/03/2023 Record updated to Non-Urgent. Crossing not found. (M. Thao - DWR UCIP) FIELD_STRUCT_DESC: Two 3-inch PVC conduits (electrical and communication) through the levee, 3 feet below the Garden Highway. (Two 3-inch conduits authorized under Permit No. 8792, 1973 - Sacramento Municipal Utility District). FS Date: 7/3/2023

Levee crown looking downstream.

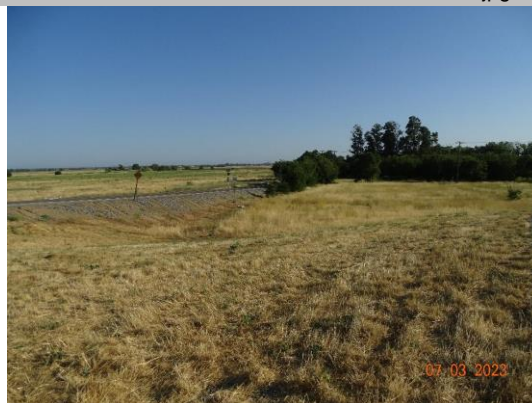
Photo 2 of 3 : UCIP\_FA\_2023\_80663\_116675.jpg

LS view: General overview looking from crown.

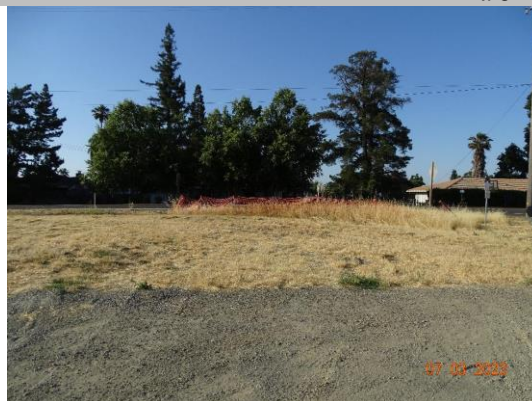
Photo 3 of 3 : UCIP\_FA\_2023\_80663\_116673.jpg

WS view: General overview looking from crown.

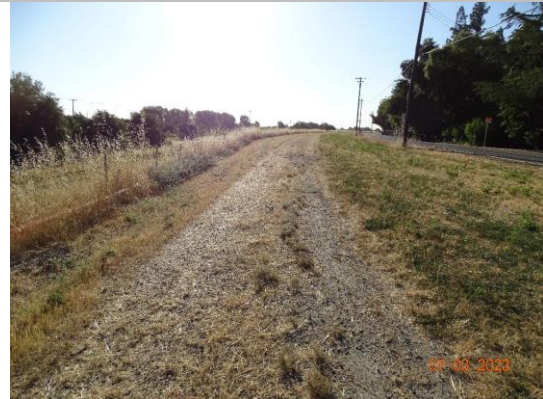
Photo 1 of 3 : UCIP\_FA\_2023\_80665\_116679.jpg

LM Start	12.09	Rating **	M	Issue No.	268
LM End	12.09	Issue Type +	En	Location *	
Category	Supplemental			GPS Latitude/Longitude	
				Start	End
Item	DWR UCIP Field Study			38.650364 °	38.650364 °
				-121.575014 °	-121.575014 °
DWR ID	25180				
Comment Code					
Inspector Comment					
DS_ID:25180 FS_ID:80665 EP_NO: N/A Repair Type: Non-Urgent EVAL Issue: Crossing Status: Not Found UCIP Comments: 07/03/2023 Record updated to Non-Urgent. Crossing not found. (M. Thao - DWR UCIP) FIELD_STRUCT_DESC: 12-inch pipe through the levee, 6.0 feet below the crown. Gate valve on the waterward side. (12-inch pipe is a replacement authorized under Permit No. 3103, 1959 - E.D. Willey; Permit No. 6006- , ). [Additional Reference(s): DWR Levee Log, 2002 (HLM 12.30)]. FS Date: 7/3/2023

Levee crown looking downstream.

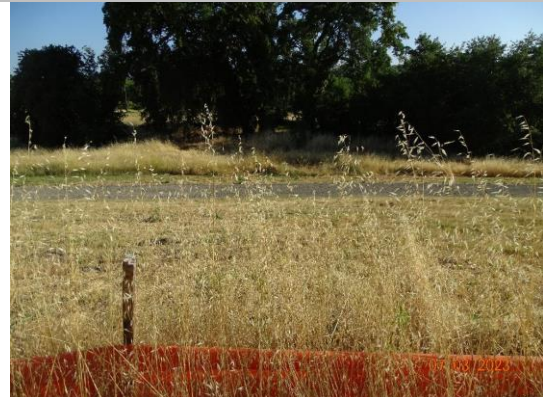
Photo 2 of 3 : UCIP\_FA\_2023\_80665\_116681.jpg

LS view: General overview looking from crown.

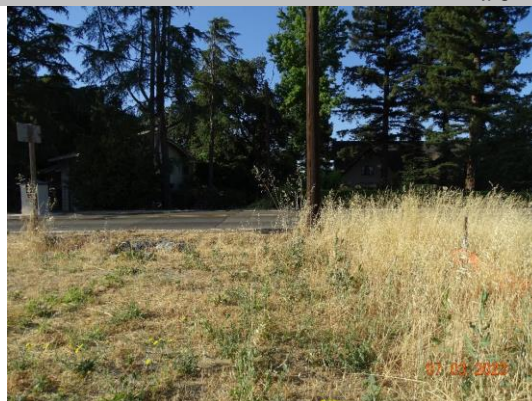
Photo 3 of 3 : UCIP\_FA\_2023\_80665\_116680.jpg

WS view: General overview looking from crown.

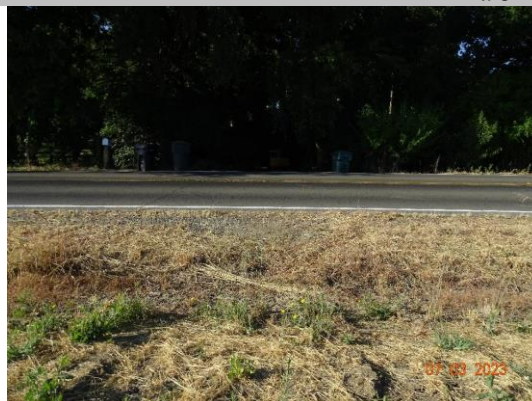
Photo 1 of 3 : UCIP\_FA\_2023\_80667\_116682.jpg

LM Start	12.13	Rating **	M	Issue No.	269	
LM End	12.13	Issue Type +	En	Location *		
Category	Supplemental			GPS Latitude/Longitude		
				Start	End	
Item	DWR UCIP Field Study			38.650372°	38.650372°	
				-121.574291°	-121.574291°	
DWR ID	25301					
Comment Code						
Inspector Comment						
DS_ID:25301						
FS_ID:80667						
EP_NO: N/A						
Repair Type: Non-Urgent						
EVAL Issue:						
Crossing Status: Not Found						
UCIP Comments: 07/03/2023 Record updated to Non-Urgent. Crossing not found. (M. Thao - DWR UCIP)						
FIELD_STRUCT_DESC: 1.5-inch galvanized iron pipe through the levee, 1.5 feet below the crown. (1.5-inch pipe authorized under Permit No. 2749, 1958 - Frederick A. Novak).						
FS Date: 7/3/2023

WS view: General overview looking from crown.

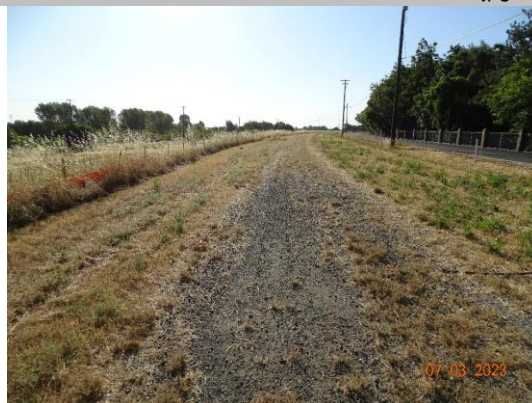
Photo 2 of 3 : UCIP\_FA\_2023\_80667\_116683.jpg

Levee crown looking downstream.

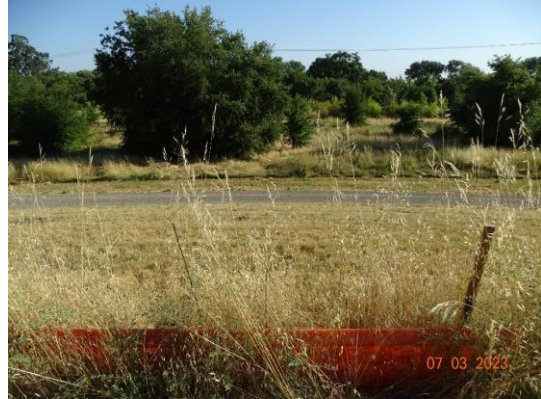
Photo 3 of 3 : UCIP\_FA\_2023\_80667\_116684.jpg

LS view: General overview looking from crown.

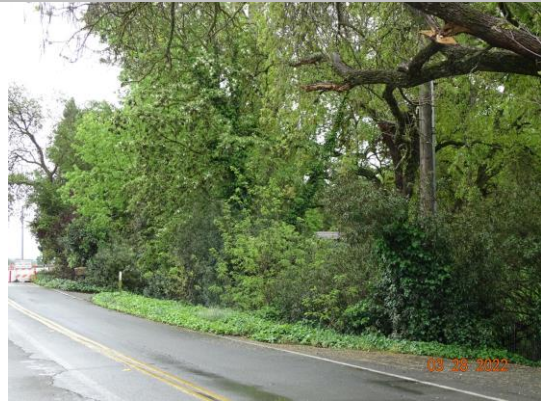
Photo 1 of 1 : FA\_2023\_RD1000\_31\_66\_20231016\_00030.jpg

LM Start	12.24	Rating **	M	Issue No.	66
LM End	12.33	Issue Type +	En	Location *	WS
Category	Earthen Levee			GPS Latitude/Longitude	
				Start	End
Item	Vegetation			38.650245°	38.653208°
				-121.572188°	-121.573895°
DWR ID	DWR_RD1000_01_s_2012_66				
Comment Code					
V6 : Landscaping					
Inspector Comment					
The landscape vegetation limits the ability to see the waterside slope and will make it difficult to access for flood fight.

View of the landscaping on the waterside levee slope.

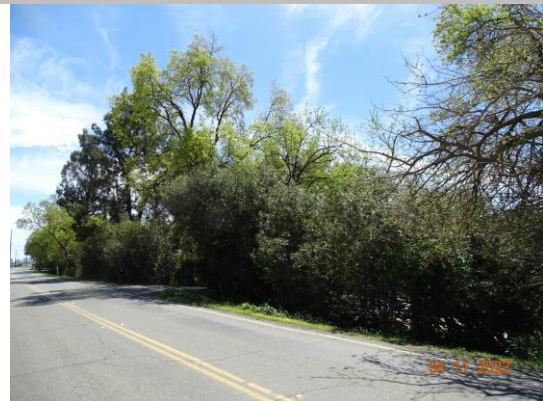
Photo 1 of 1 : FA\_2023\_RD1000\_31\_5\_20231016\_00006.jpg

LM Start	12.52	Rating **	U	Issue No.	5
LM End	12.61	Issue Type +	En	Location *	WS
Category	Earthen Levee			GPS Latitude/Longitude	
				Start	End
Item	Vegetation			38.648056°	38.647220°
				-121.567900°	-121.566708°
DWR ID	DWR_RD1000_01_s_2020_5				
Comment Code					
V6 : Landscaping					
Inspector Comment					
The landscape vegetation prevents the ability to see waterside slope and will make it difficult to access for flood fight.

View taken from the crown facing downstream looking at the waterward levee slope at landscaping (Spring 2023).

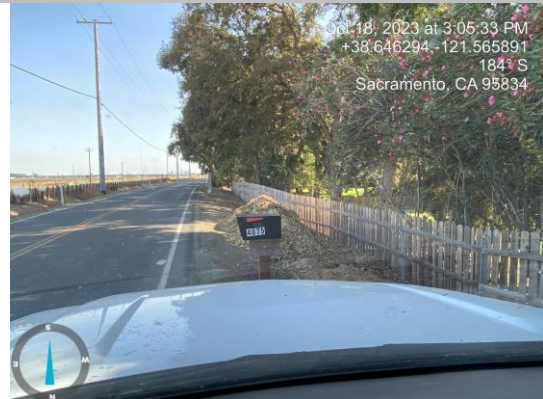
Photo 1 of 1 : FA\_2023\_RD1000\_31\_224\_20231025\_00293.jpg

LM Start	12.69	Rating **	M	Issue No.	224
LM End	12.69	Issue Type +	En	Location *	WS
Category	Earthen Levee			GPS Latitude/Longitude	
				Start	End
Item	Encroachments			38.646256°	38.646256°
				-121.565718°	-121.565718°
DWR ID	DWR_RD1000_01_f_2023_224				
Comment Code					
DE : Debris					
Inspector Comment

View of wood chippings on the waterside slope (Fall 2023).

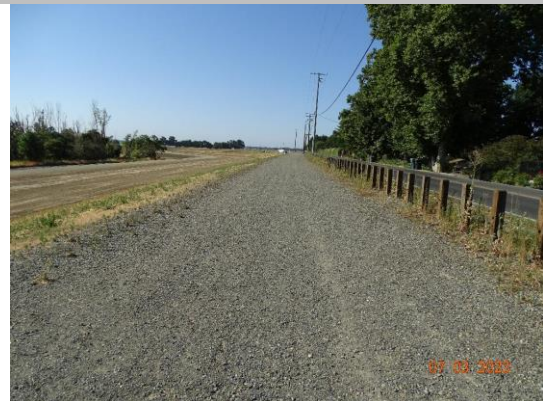
Photo 1 of 3 : UCIP\_FA\_2023\_81017\_117051.jpg

LM Start	13.08	Rating **	M	Issue No.	270
LM End	13.08	Issue Type +	En	Location *	
Category	Supplemental			GPS Latitude/Longitude	
				Start	End
Item	DWR UCIP Field Study			38.641262°	38.641262°
				-121.562681°	-121.562681°
DWR ID	25161				
Comment Code					
Inspector Comment					
DS_ID:25161					
FS_ID:81017					
EP_NO: N/A					
Repair Type: Non-Urgent					
EVAL Issue:					
Crossing Status: Not Found					
UCIP Comments: 07/03/2023 Record updated to Non-Urgent. Crossing not found. (M. Thao - DWR UCIP)					
FIELD_STRUCT_DESC: 4-inch PVC communication conduit through levee, 3 feet below the Garden Highway. Utility pole on the landward slope. (4-inch conduit authorized under Permit No. 12519, 1978 - Pacific Telephone and Telegraph Company). [Additional Reference(s): DWR Levee Log, 2002 (HLM 13.30)].					
FS Date: 7/3/2023

Levee crown looking downstream.

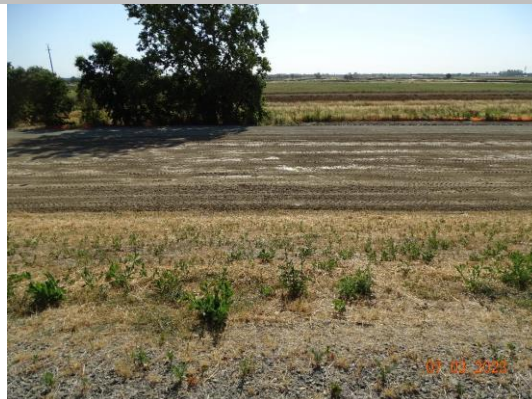
Photo 2 of 3 : UCIP\_FA\_2023\_81017\_117052.jpg

LS view: General overview looking from crown.

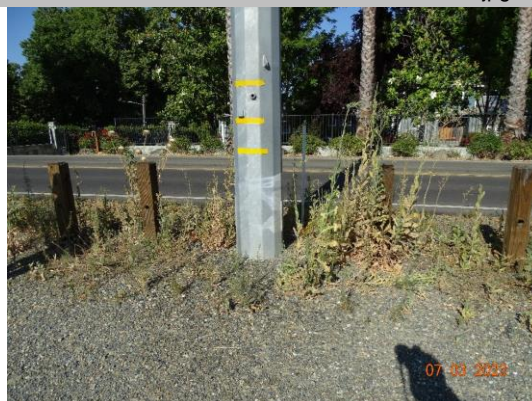
Photo 3 of 3 : UCIP\_FA\_2023\_81017\_117050.jpg

WS view: General overview looking from crown; metal utility pole on WS shoulder with no conduits attached.

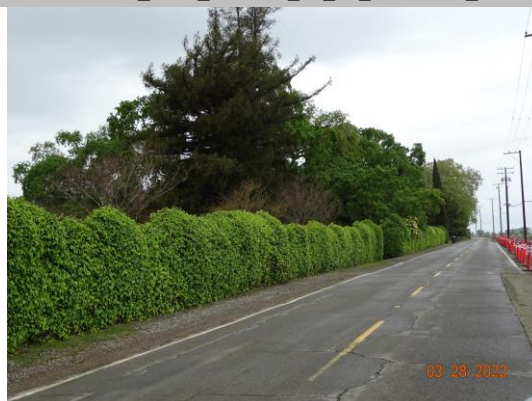
Photo 1 of 1 : FA\_2023\_RD1000\_31\_51\_20231016\_00027.jpg

LM Start	13.15	Rating **	U	Issue No.	51
LM End	13.20	Issue Type +	En	Location *	WS
Category	Earthen Levee			GPS Latitude/Longitude	
				Start	End
Item	Vegetation			38.640205°	38.639540°
				-121.562370°	-121.562238°
DWR ID	DWR_RD1000_01_s_2012_51				
Comment Code					
V6 : Landscaping					
Inspector Comment					
The landscape vegetation prevents the ability to see waterside slope and will make it difficult to access for flood fight.

View of the landscaping on the waterside levee slope.
